**Asbestos & Lead-Based Paint
Assessment
I-77 South Bound over US 21
Structure No. 401007732200
Blythewood, South Carolina
S&ME Project No. 23610178A**

Reference: **Asbestos & Lead-Based Paint Assessment**
I-77 South Bound over US 21
Structure No. 40100773220
Blythewood, South Carolina
S&ME Project No. 23610178A

The bridge consists of a four-lane asphalt paved roadway with concrete deck and concrete guard rails resting on metal beams on concrete bents supported by concrete piers. The bridge is approximately 245 feet long and 45 feet wide. It is our understanding that the bridge is scheduled for future renovation/demolition actions.

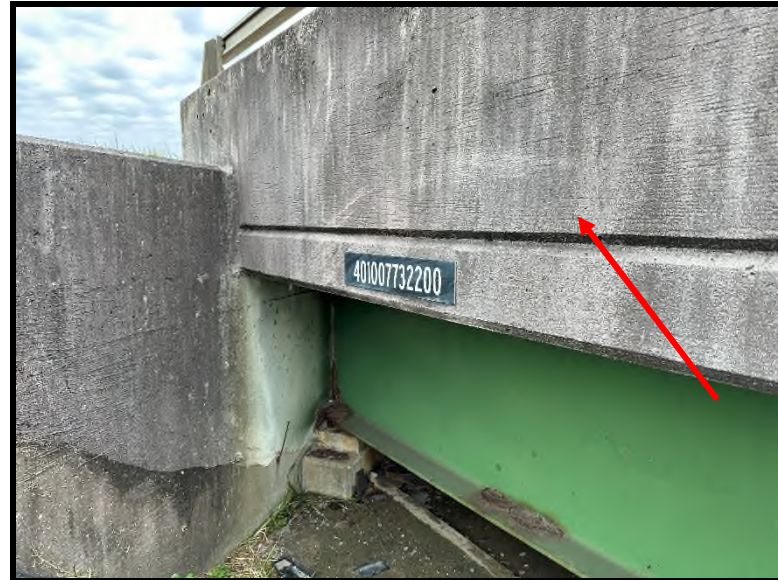
2 Structure number. **The concrete surfacing texture tested positive for asbestos (2% Chrysotile).**

S&ME recommends proper removal and disposal of the ACM by a licensed asbestos abatement contractor prior to activities that may disturb an ACM. State and Federal regulations should be carefully considered in order to verify compliance before any actions are initiated that may disturb an ACM. If additional suspect ACMs not included in this report are discovered and will be disturbed by renovation or demolition activities, bulk samples must be collected by a licensed asbestos inspector and analyzed for asbestos content, prior to disturbance of the suspect material(s).

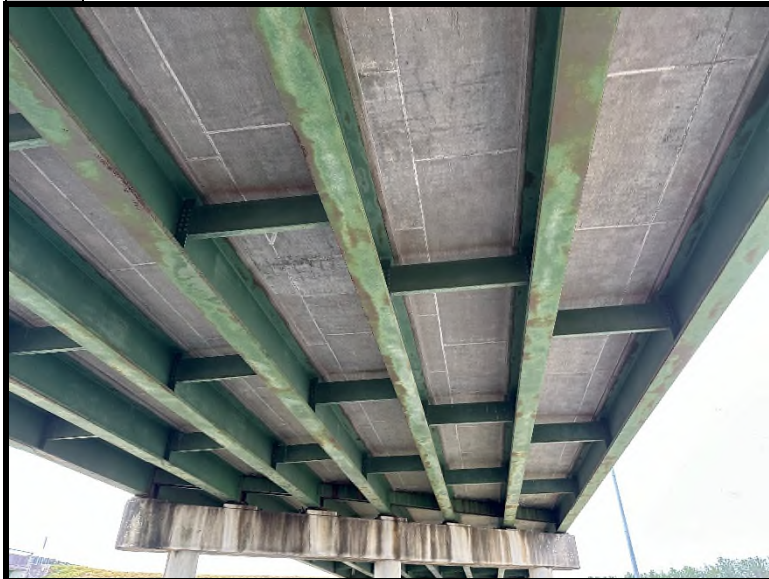
3 View beneath the bridge. **The green structural steel tested positive for lead-based paint (5.9-6.4 mg/cm²).**

Destructive actions to paint containing detectable levels of lead (*e.g.* paint preparation, component removal, demolition, sanding, grinding, burning, etc.) may require the contractor to comply with the standards of the OSHA regulations 29 CFR 1926.62 (Lead in Construction), including but not limited to training, initial exposure
