# I-95 BRIDGE REPLACEMENT OVER LAKE MARION

## PIPE INSPECTION REPORT

This report contains the results of the video pipe inspection and assessment of the existing storm water drainage pipes within the project area in Orangeburg and Clarendon Counties.

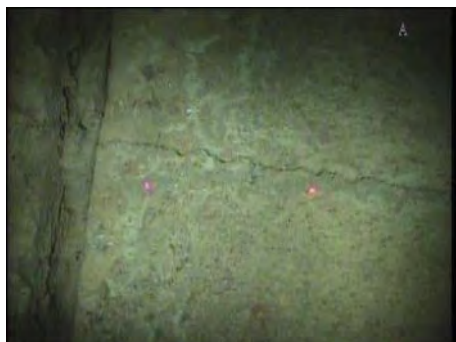
| Distance | Dir. | Length | From/To | Code | Modifier/Severity | Rating | Comments |
|---|---|---|---|---|---|---|---|
| 5.2 ft. | D | | 3 / | Crack | | | |

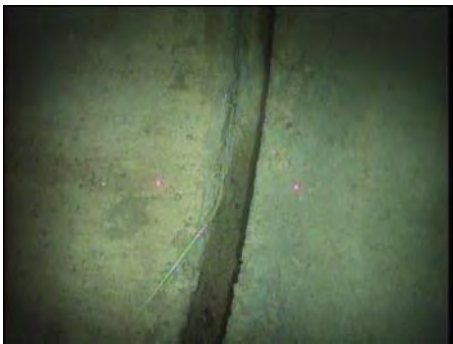
86.9 ft. D / Joint Offset

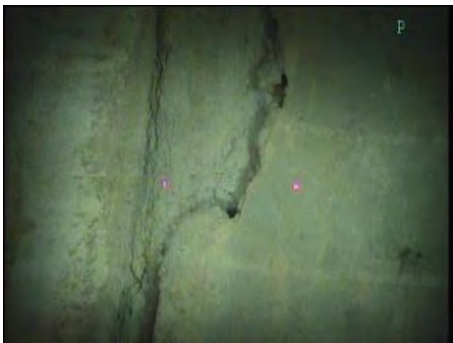
86.9 ft. D 10 / 11 Broken

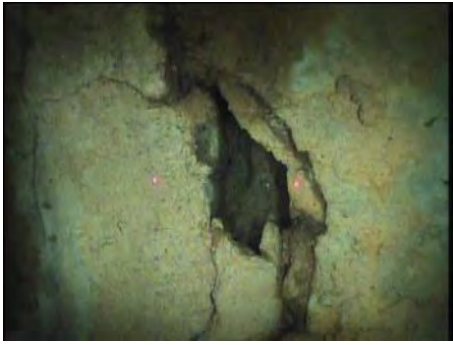
99.0 ft. D 12 / Hole

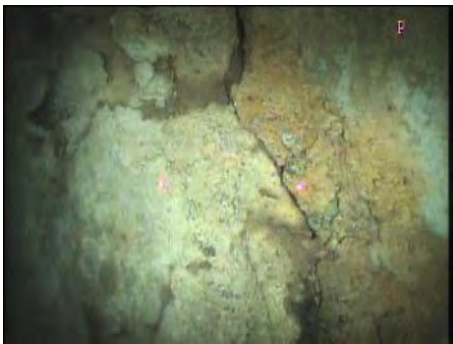
99.0 ft. D / Repair

Failed

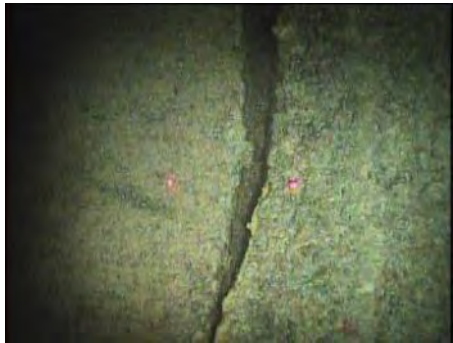
| Distance | Dir. | Length | From/To | Code | Modifier/Severity | Rating | Comments |
|---|---|---|---|---|---|---|---|
| 22.0 ft. | D | | / | Joint Offset | | | |

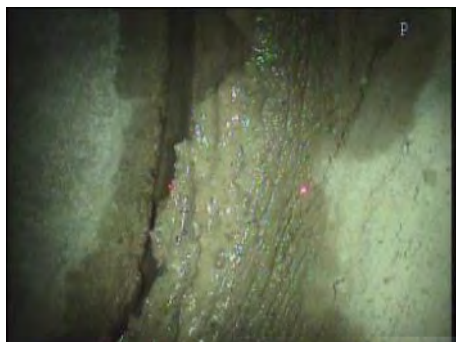
| Distance | Dir. | Length | From/To | Code | Modifier/Severity | Rating | Comments |
|---|---|---|---|---|---|---|---|
| 14.8 ft. | D | | / | Joint - Infiltration | | | |

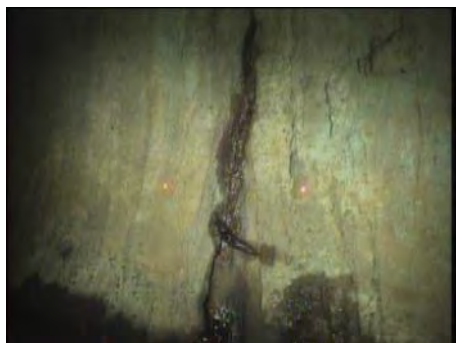
| 19.0 ft. | D | | / | Joint - Infiltration | | | |

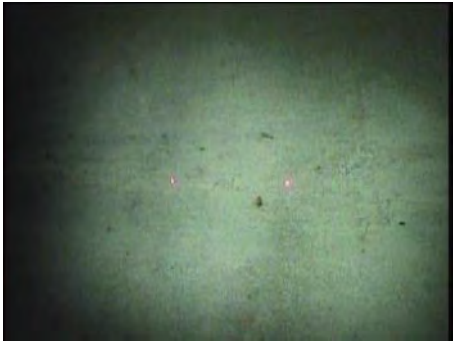
31.6 ft. D 12 / Crack

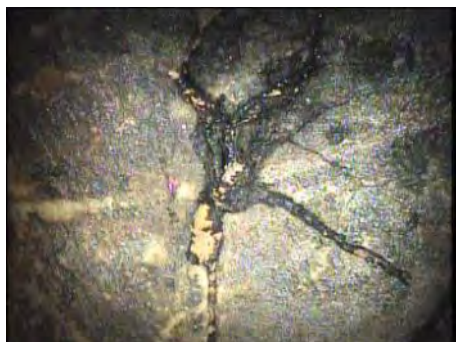
| Distance | Dir. | Length | From/To | Code | Modifier/Severity | Rating | Comments |
|---|---|---|---|---|---|---|---|
| 2.1 ft. | D | | / | Root-in-Joint | | | |

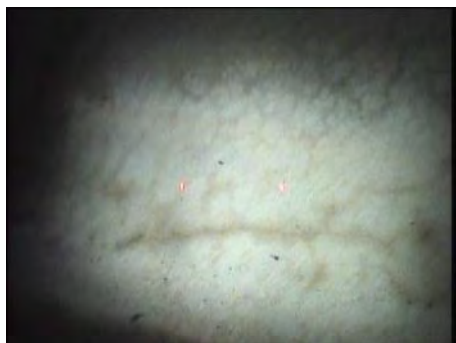
| 27.0 ft. | D | | 4 / | Crack |

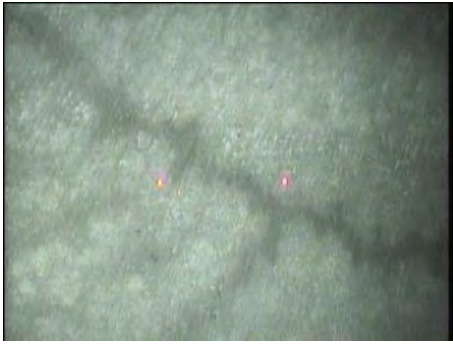
38.2 ft. D 12 / Crack

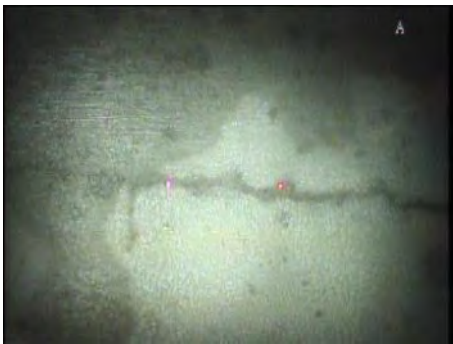
48.3 ft. D 9 / Crack

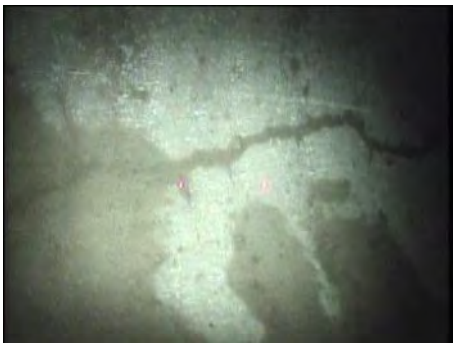
51.5 ft. D 9 / Crack

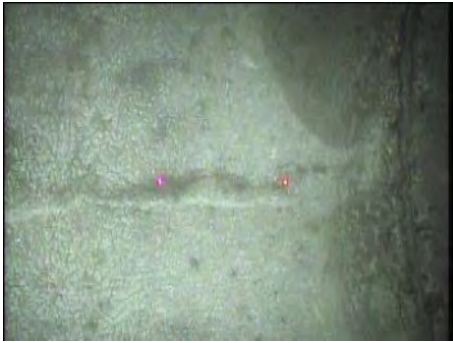
69.1 ft. D 12 / Crack

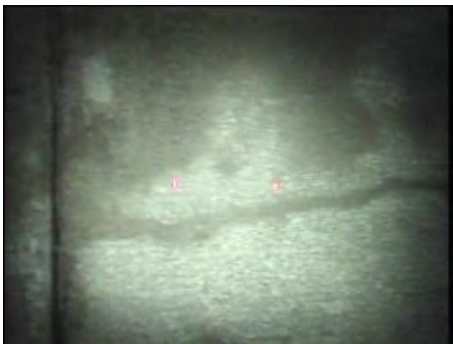
99.1 ft. D 9 / Crack

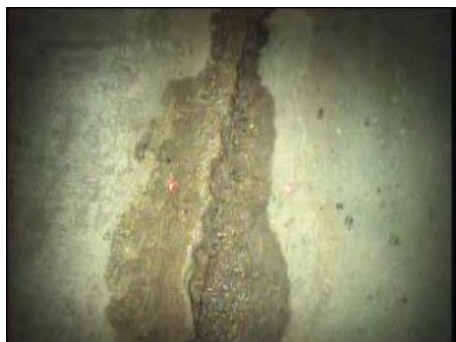
| Distance | Dir. | Length | From/To | Code | Modifier/Severity | Rating | Comments |
|---|---|---|---|---|---|---|---|
| 6.7 ft. | D | | / | Joint Offset | | | |

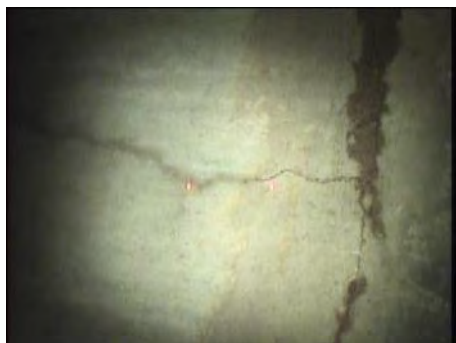
| 6.7 ft. | D | 12 / | Crack | | | | |

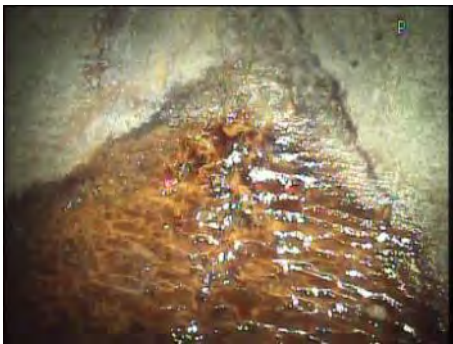
43.5 ft. D / Joint - Infiltration

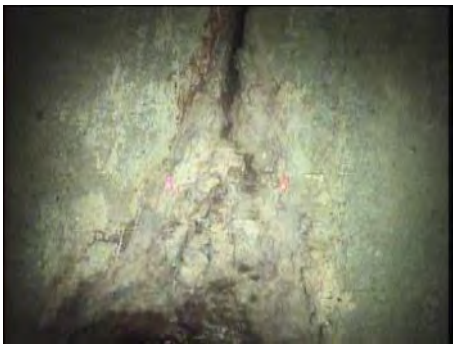
55.8 ft. D / Joint - Infiltration

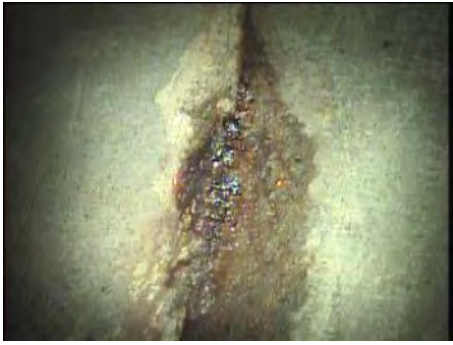
67.9 ft. D / Joint - Infiltration

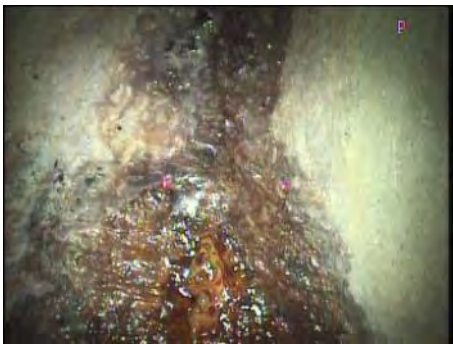
72.4 ft. D / Joint - Infiltration

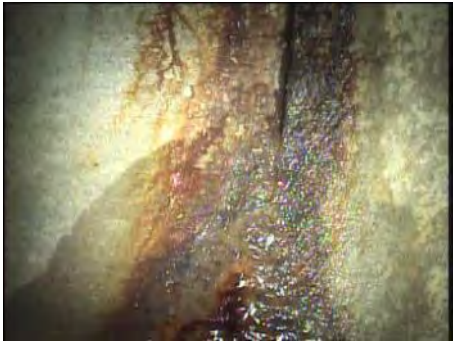
80.3 ft. D / Joint - Infiltration

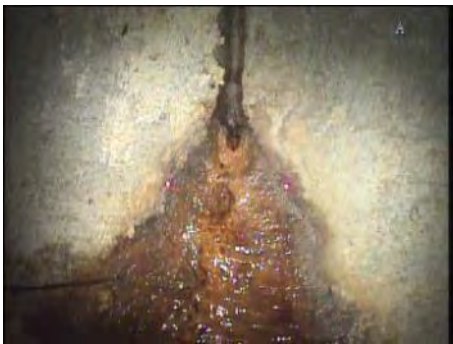
84.4 ft. D / Joint - Infiltration

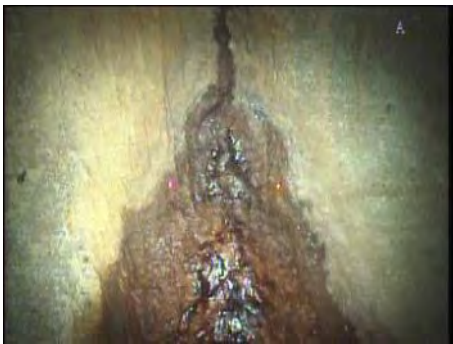
100.8 ft. D / Joint - Infiltration

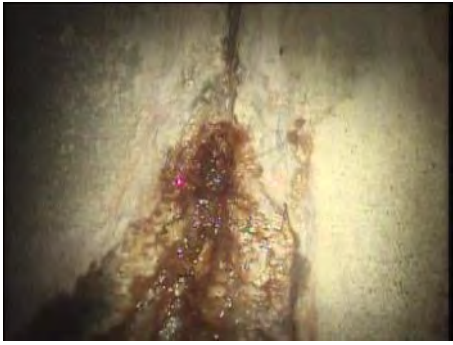
112.9 ft. D / Joint - Infiltration

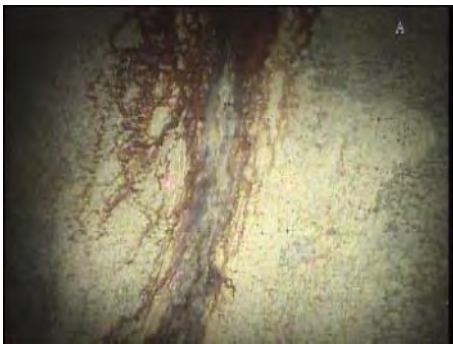
117.1 ft. D 169.4 ft. 3 / 9 Joint - Infiltration

Every 4 ft

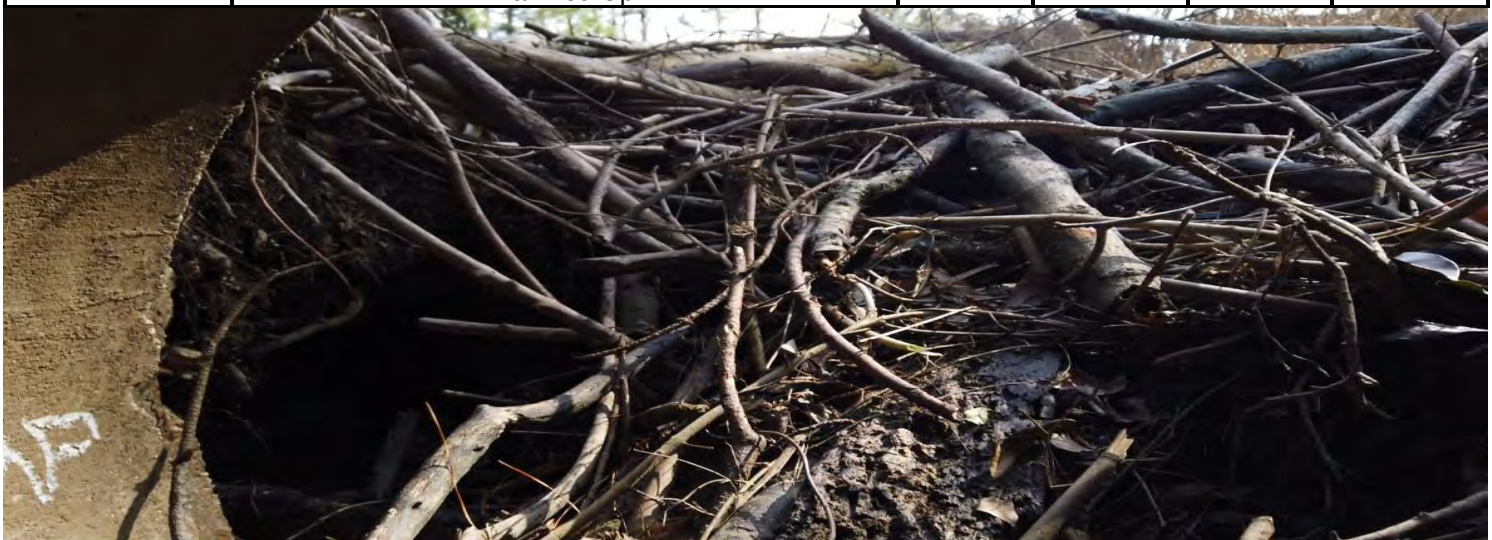
| Footage | Defect Description | Top | Right | Left | Bottom |
|---|---|---|---|---|---|
| | Start of EP-10 – Damned Up | | | | |

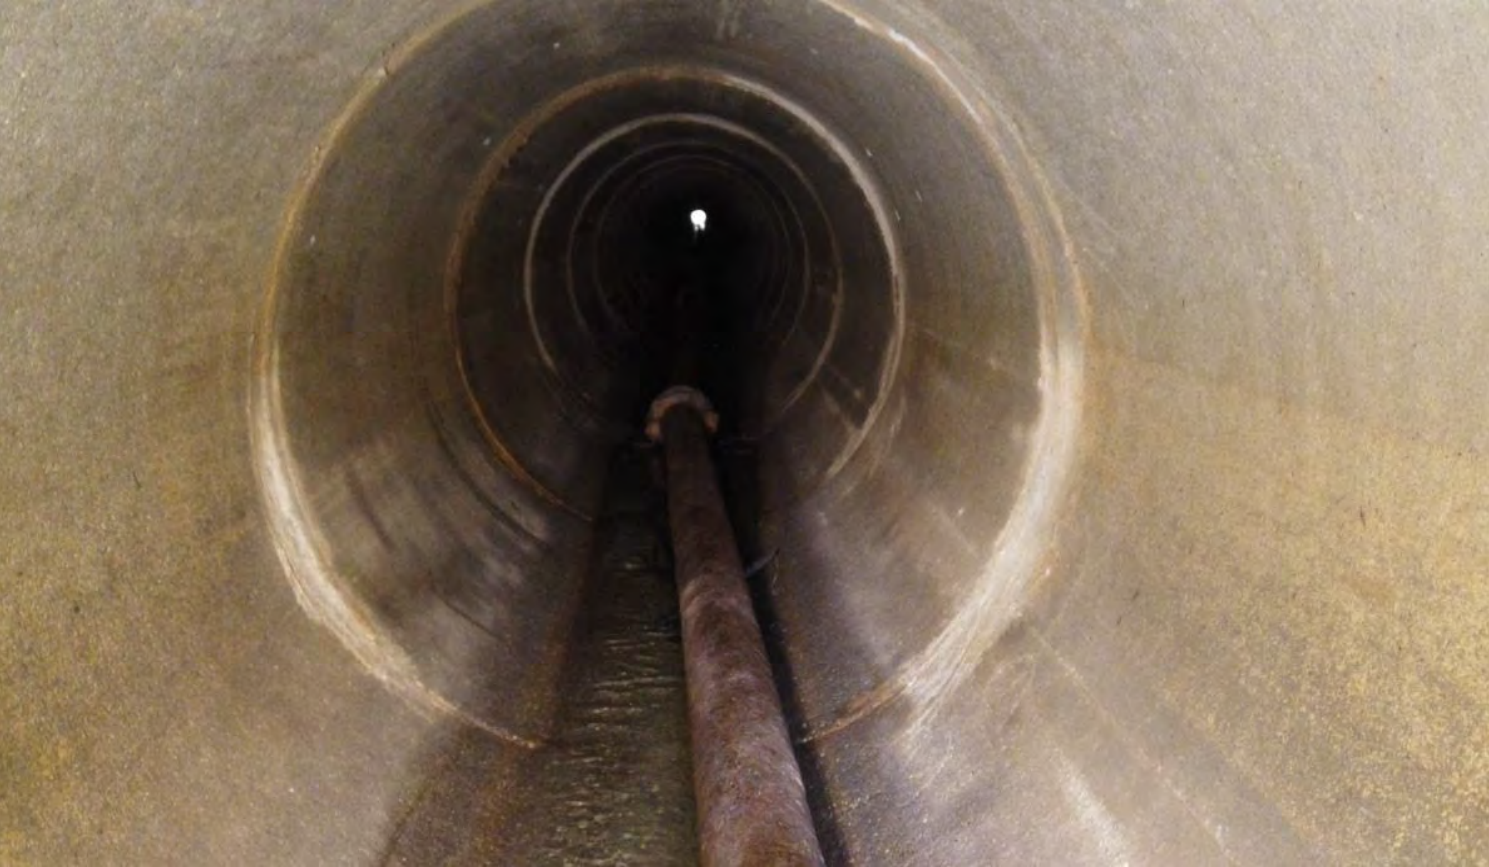
| Footage | Defect Description | Top | Right | Left | Bottom |
|---|---|---|---|---|---|
| | Start of EP-10 – Sewer Line Running down whole middle of pipe. | | | | |

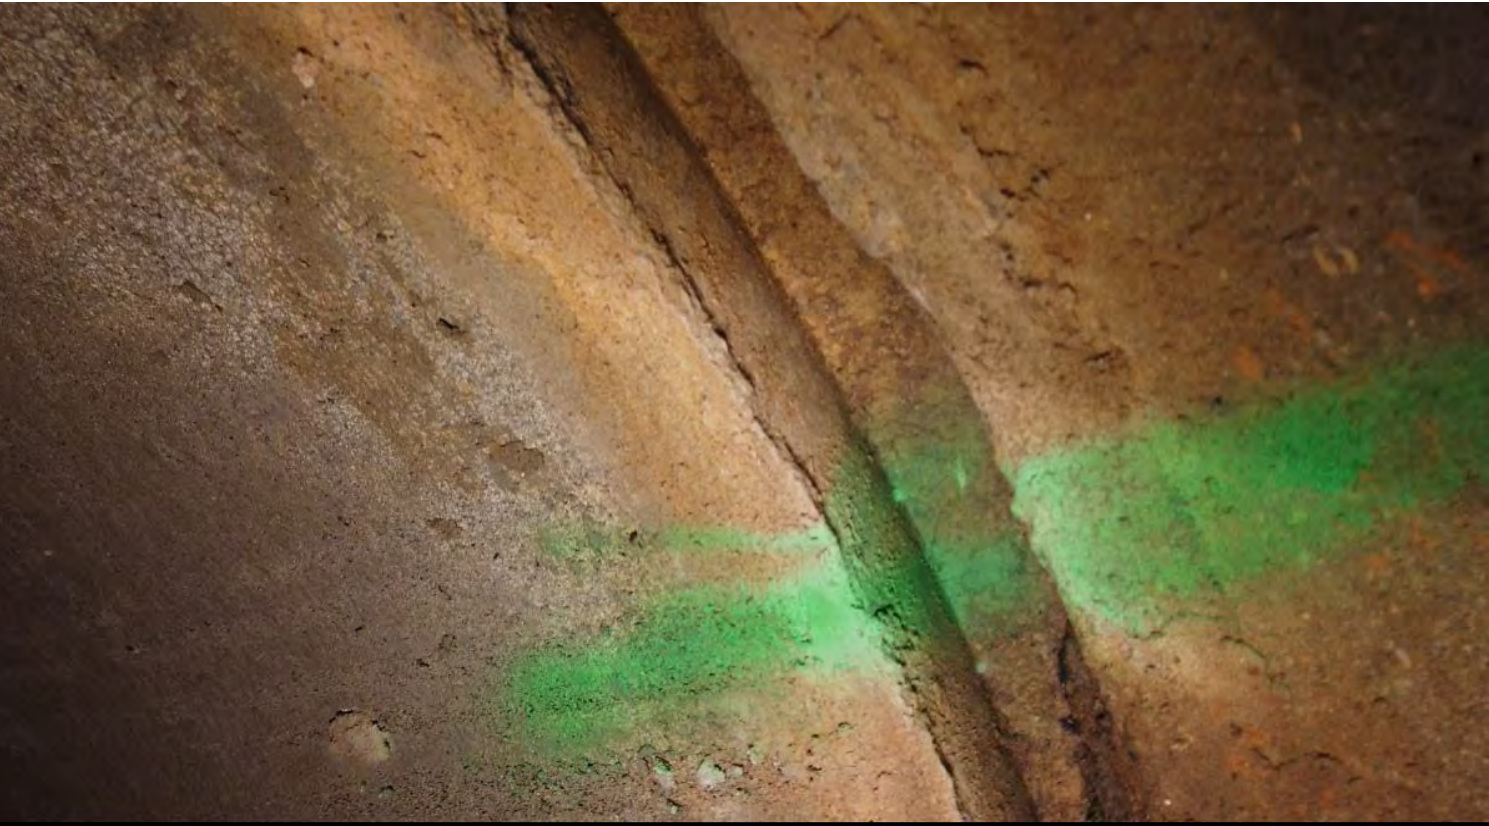
| Footage | Defect Description | Top | Right | Left | Bottom |
|---|---|---|---|---|---|
| 4 ft | Wide Joint | | Y | | |

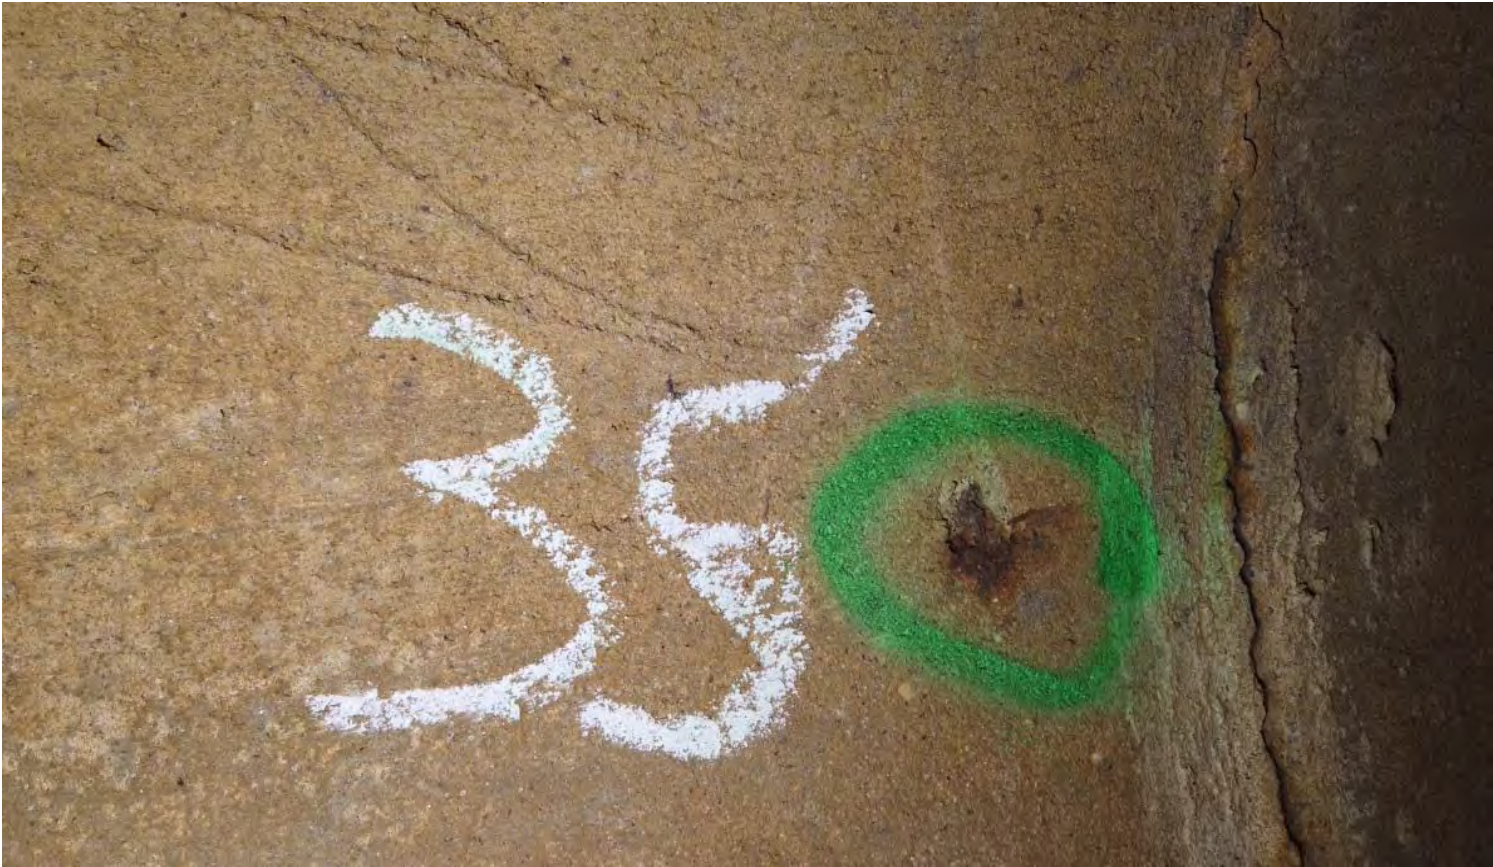
| Footage | Defect Description | Top | Right | Left | Bottom |
|---|---|---|---|---|---|
| 35 ft | Rebar Showing | | Y | | |

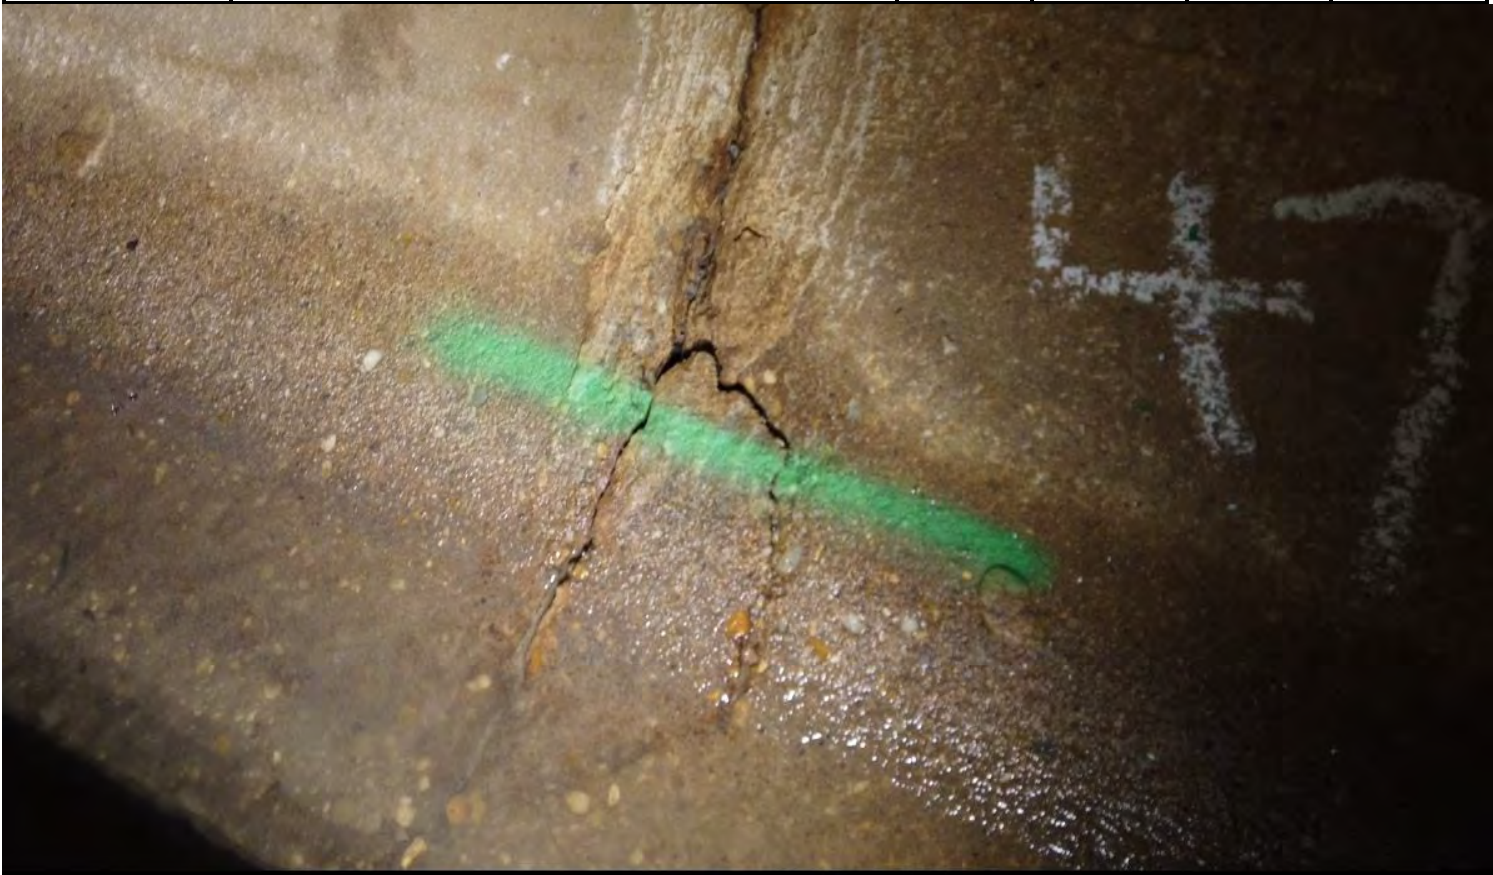
| Footage | Defect Description | Top | Right | Left | Bottom |
|---|---|---|---|---|---|
| 47 ft | Broken/Chip | | Y | | |

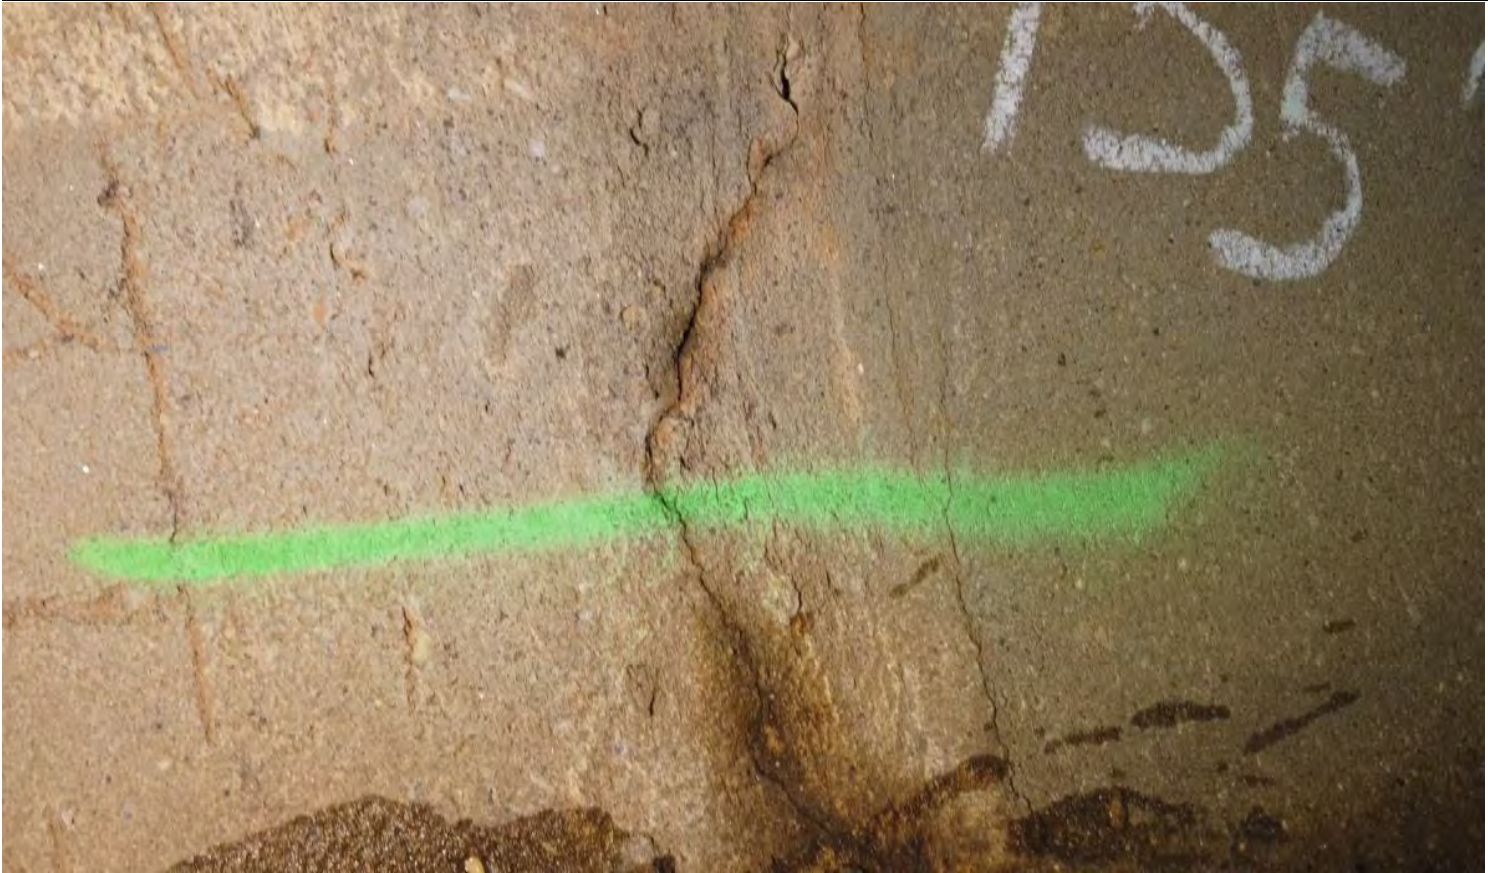
| Footage | Defect Description | Top | Right | Left | Bottom |
|---|---|---|---|---|---|
| 155 ft | Crack | | | Y | |

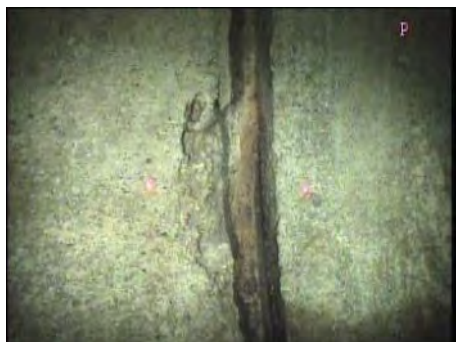
| Distance | Dir. | Length | From/To | Code | Modifier/Severity | Rating | Comments |
|---|---|---|---|---|---|---|---|
| 6.8 ft. | U | | 9 / | Broken | | | |

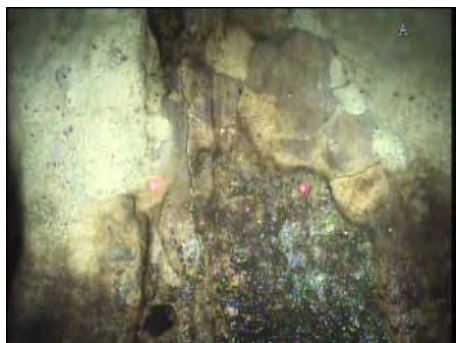
| 40.3 ft. | U | | 7 / 8 | Broken | | | |

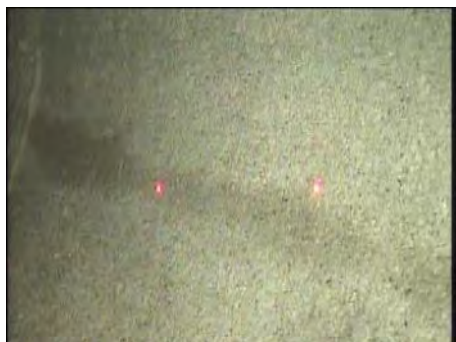
| Distance | Dir. | Length | From/To | Code | Modifier/Severity | Rating | Comments |
|---|---|---|---|---|---|---|---|
| 14.1 ft. | U | | 4 / | Crack | | | |

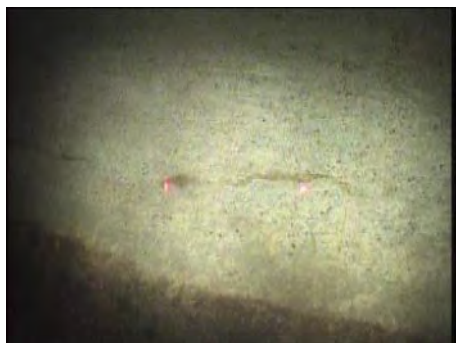
| 59.0 ft. | U | | 5 / | Crack | | | |

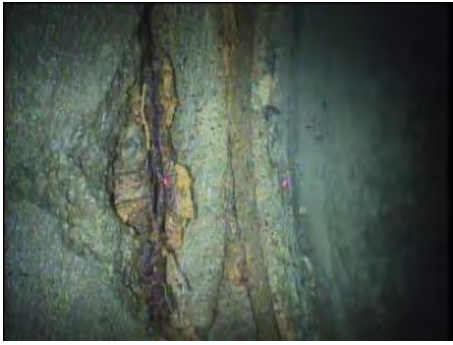
35.3 ft. U 10 / Broken

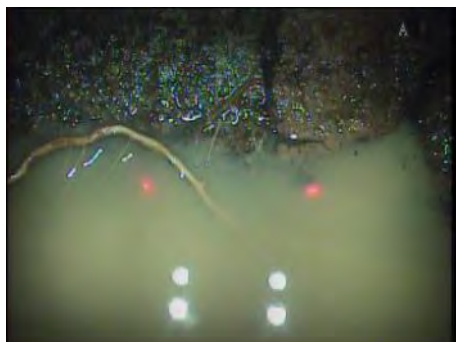
| Distance | Dir. | Length | From/To | Code | Modifier/Severity | Rating | Comments |
|---|---|---|---|---|---|---|---|
| 15.7 ft. | D | | / | Root-in-Joint | | r | |

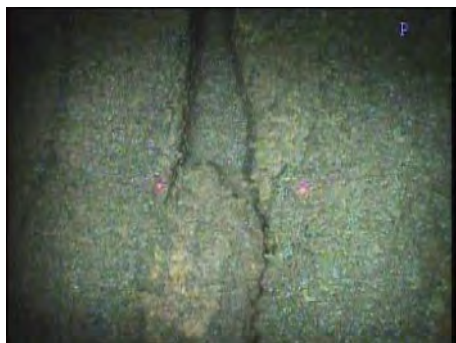
| 74.0 ft. | D | | 3 / 4 | Broken | | | |

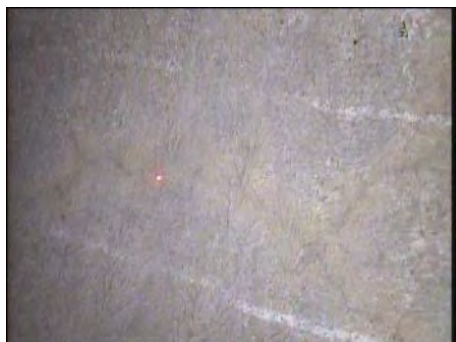
| Distance | Dir. | Length | From/To | Code | Modifier/Severity | Rating | Comments |
|---|---|---|---|---|---|---|---|
| 14.4 ft. | D | 251.6 ft. | 12 / | Crack | | | |

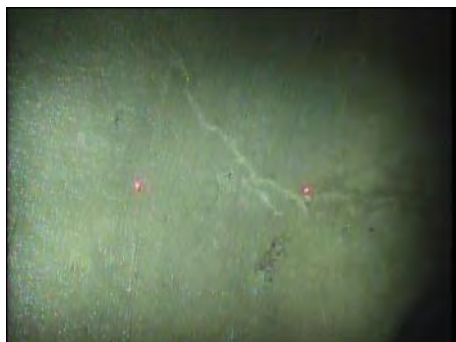
| Distance | Dir. | Length | From/To | Code | Modifier/Severity | Rating | Comments |
|---|---|---|---|---|---|---|---|
| 2.1 ft. | D | | 3 / | Crack | | | |

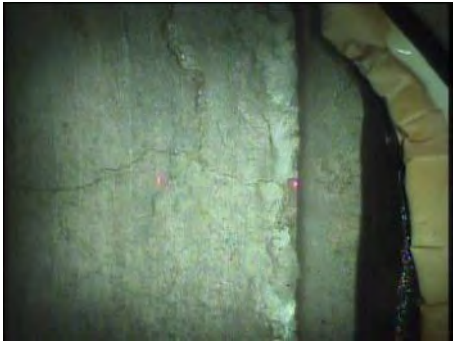
6.4 ft. D 43.7 ft. 12 / Crack

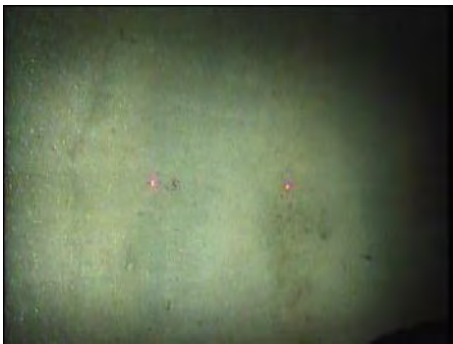
40.5 ft. D 9 / Crack Multiple - Narrow

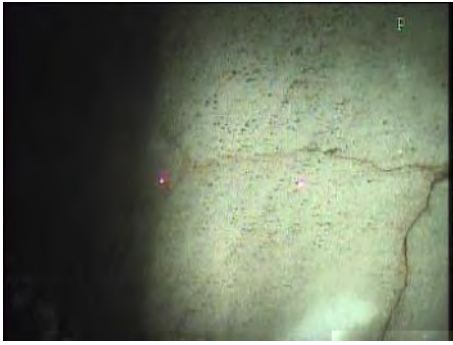
109.0 ft. D 9 / Crack

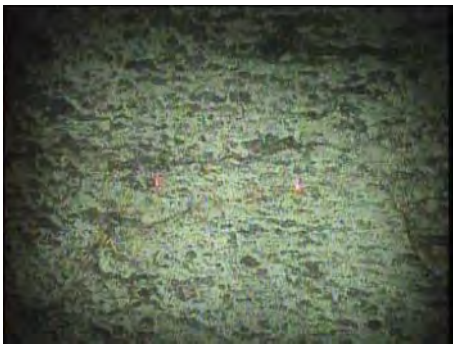
109.0 ft. D 3 / Crack

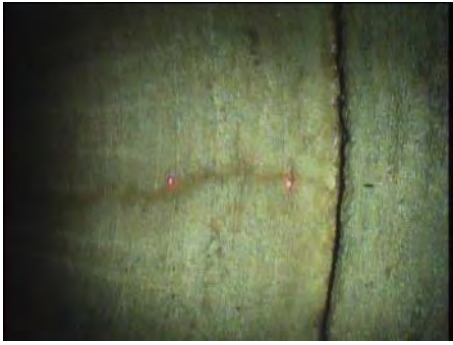
15.2 ft. D 67.6 ft. 12 / Crack

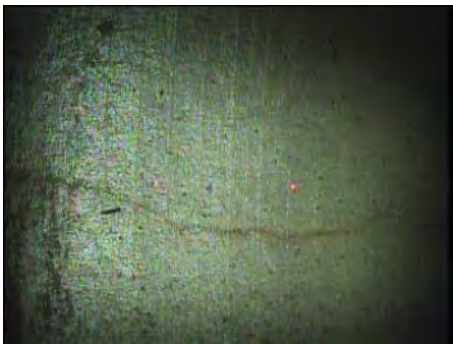
23.4 ft. D 9 / Crack

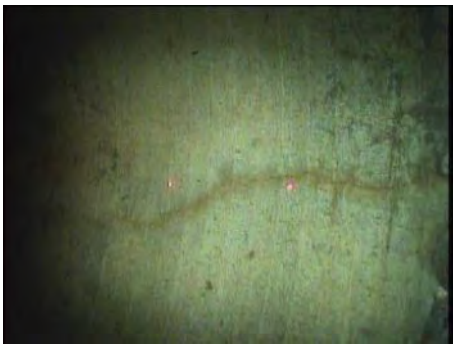
88.1 ft. D 8.2 ft. 12 / Crack

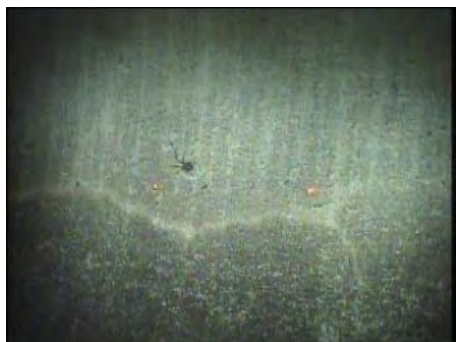
| Distance | Dir. | Length | From/To | Code | Modifier/Severity | Rating | Comments |
|---|---|---|---|---|---|---|---|
| 11.8 ft. | D | | 6 / | Crack | | | |

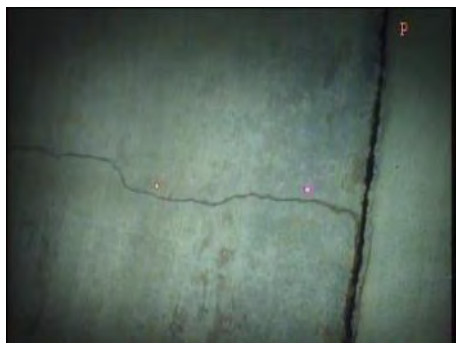
| 17.6 ft. | D | | 5 / | Crack | | | |

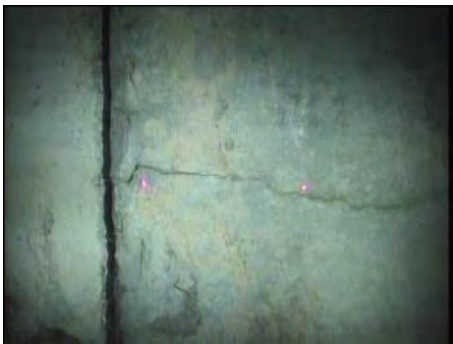
25.9 ft. D 25.5 ft. 9 / Crack

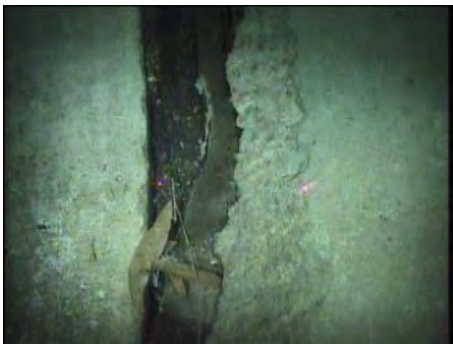
99.6 ft. D / Broken

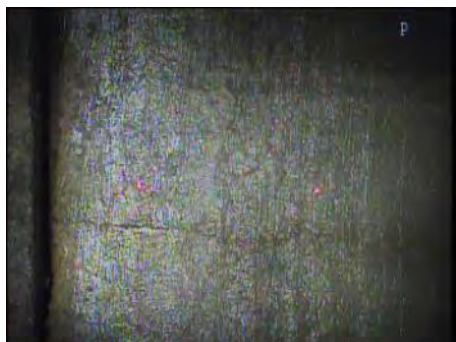
| Distance | Dir. | Length | From/To | Code | Modifier/Severity | Rating | Comments |
|---|---|---|---|---|---|---|---|
| 11.0 ft. | D | | 10 / | Crack | | | |

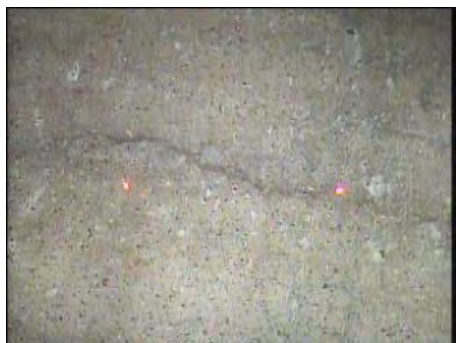
| 18.3 ft. | D | | 4 / | Crack | | | |

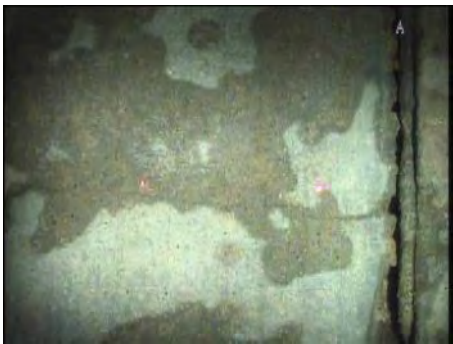
27.1 ft. D 45.6 ft. 12 / Crack

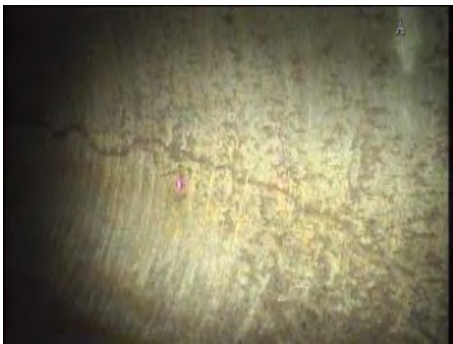
88.1 ft. D 3 / Crack

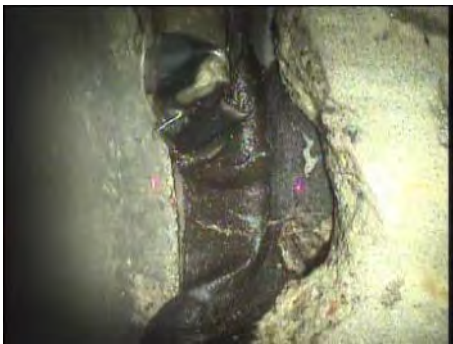
140.5 ft. D / Joint - Gasket

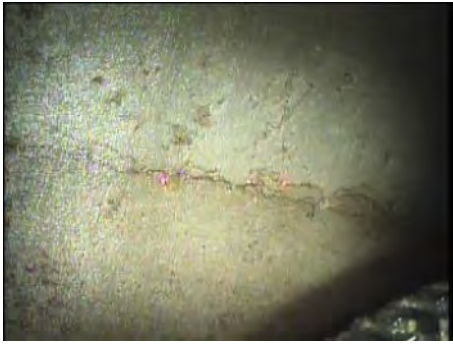
142.0 ft. D 5 / Crack

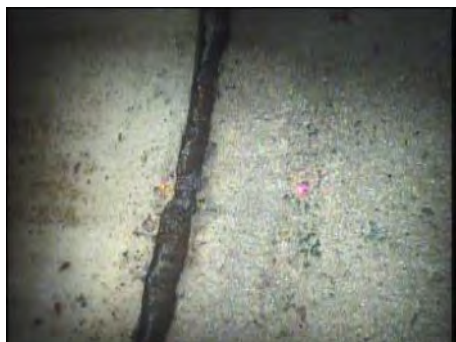
| Distance | Dir. | Length | From/To | Code | Modifier/Severity | Rating | Comments |
|---|---|---|---|---|---|---|---|
| 3.4 ft. | U | | / | Joint - Gasket | | | |

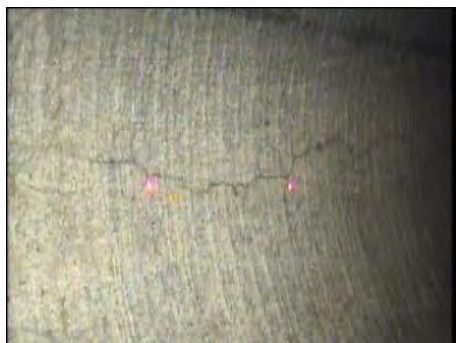
| 19.8 ft. | U | | 9 / | Crack | | | |

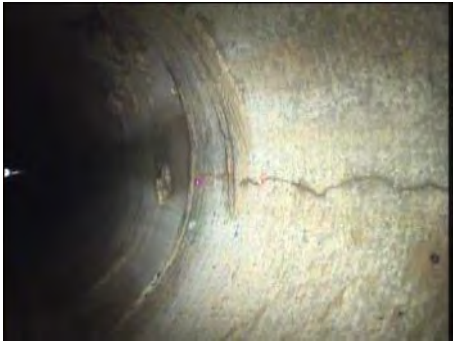
26.0 ft. U 85.1 ft. 6 / Crack

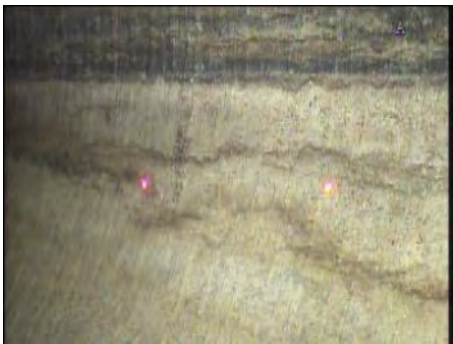
45.8 ft. U 3 / Crack

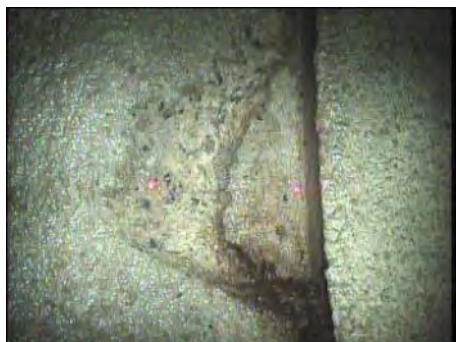
| Distance | Dir. | Length | From/To | Code | Modifier/Severity | Rating | Comments |
|---|---|---|---|---|---|---|---|
| 36.8 ft. | D | | 9 / | Broken | | | |

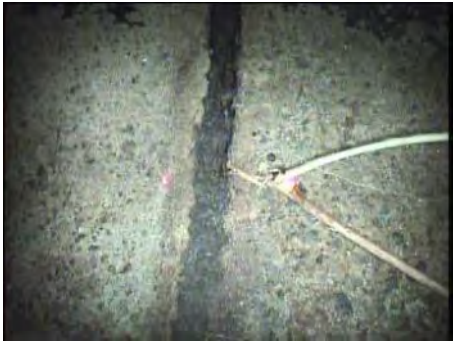
77.2 ft. U 3 / Root-in-Joint

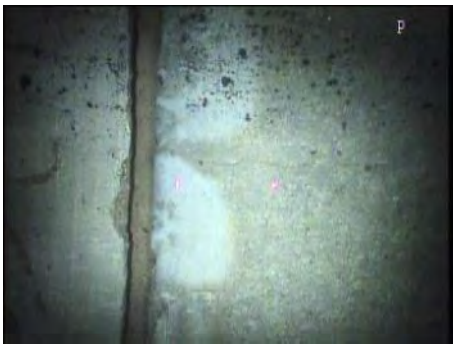
77.2 ft. U 8 / Crack
