Reference: **Asbestos and Lead-Based Paint Assessment Report
I-526 at Long Point Road – Bridge 08326**
Mount Pleasant, South Carolina
S&ME Project No. 200424A

**Asbestos and Lead-Based Paint Assessment Report
I-526 at S-97 Long Point Road – Bridge 08326
Mount Pleasant, South Carolina
S&ME Project No. 200424A**

Inspection Dates: April 7, 2023 & May 7, 2023

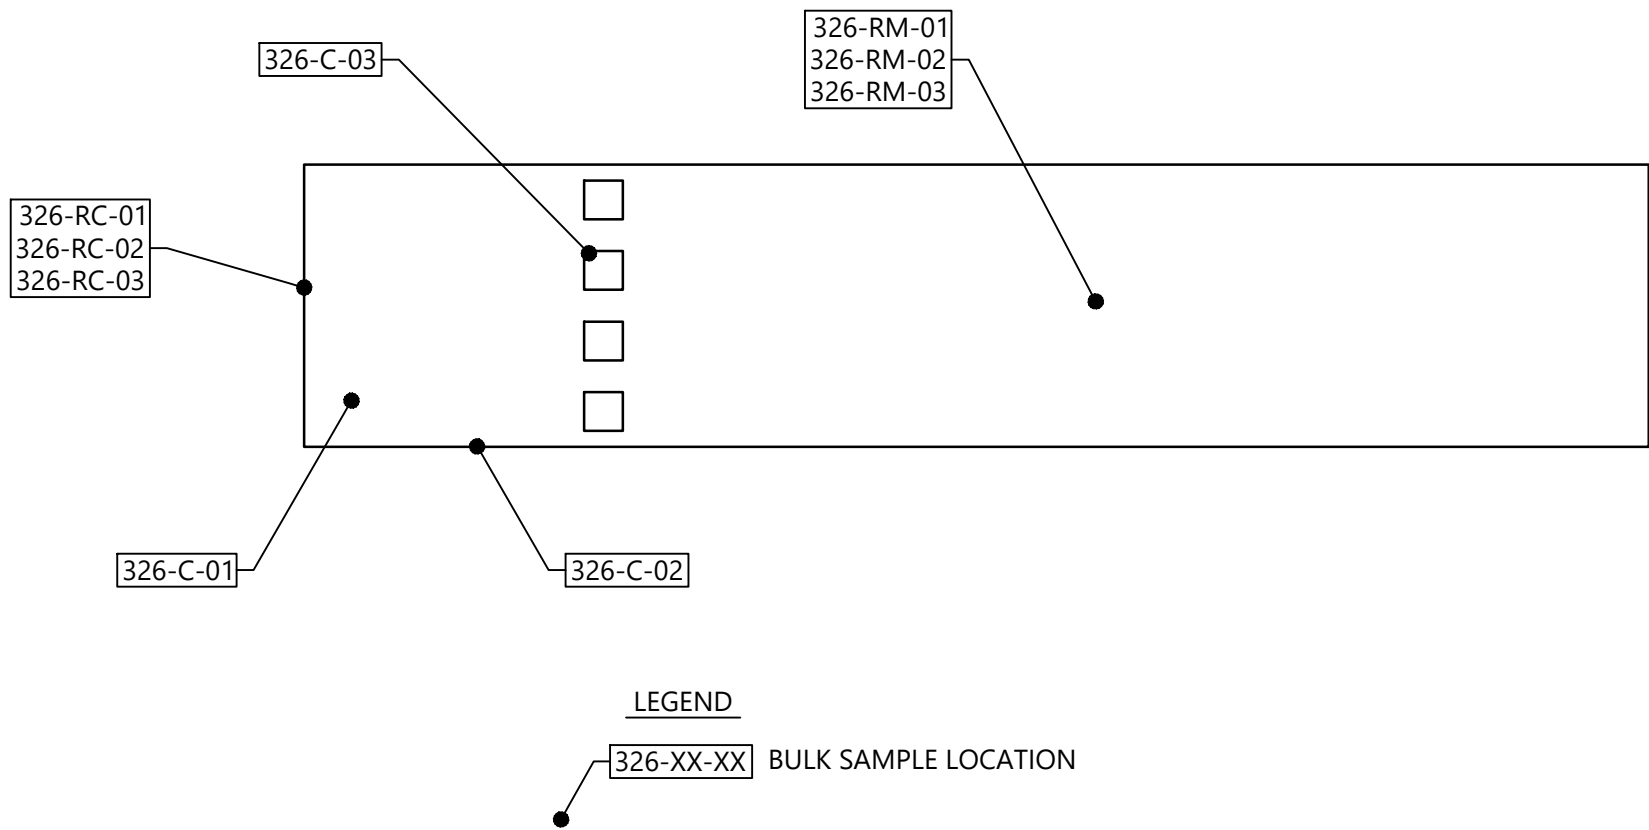
2

NOTE: NO ASBESTOS WAS DETECTED IN THE BULK SAMPLES COLLECTED AND ANALYZED.

NO LEAD CONCENTRATION MEETING IN THE SCDHEC DISPOSAL LIMIT OF 0.7 mg/cm² WAS IDENTIFIED IN THE SUBJECT AREA.
