Reference: **Asbestos and Lead-Based Paint Assessment Report
I-526 at Long Point Road – Bridge 08329**
Mount Pleasant, South Carolina
S&ME Project No. 200424A

**Asbestos and Lead-Based Paint Assessment Report
I-526 at S-97 Long Point Road – Bridge 08329
Mount Pleasant, South Carolina
S&ME Project No. 200424A**

Inspection Dates: April 7, 2023 & May 7, 2023

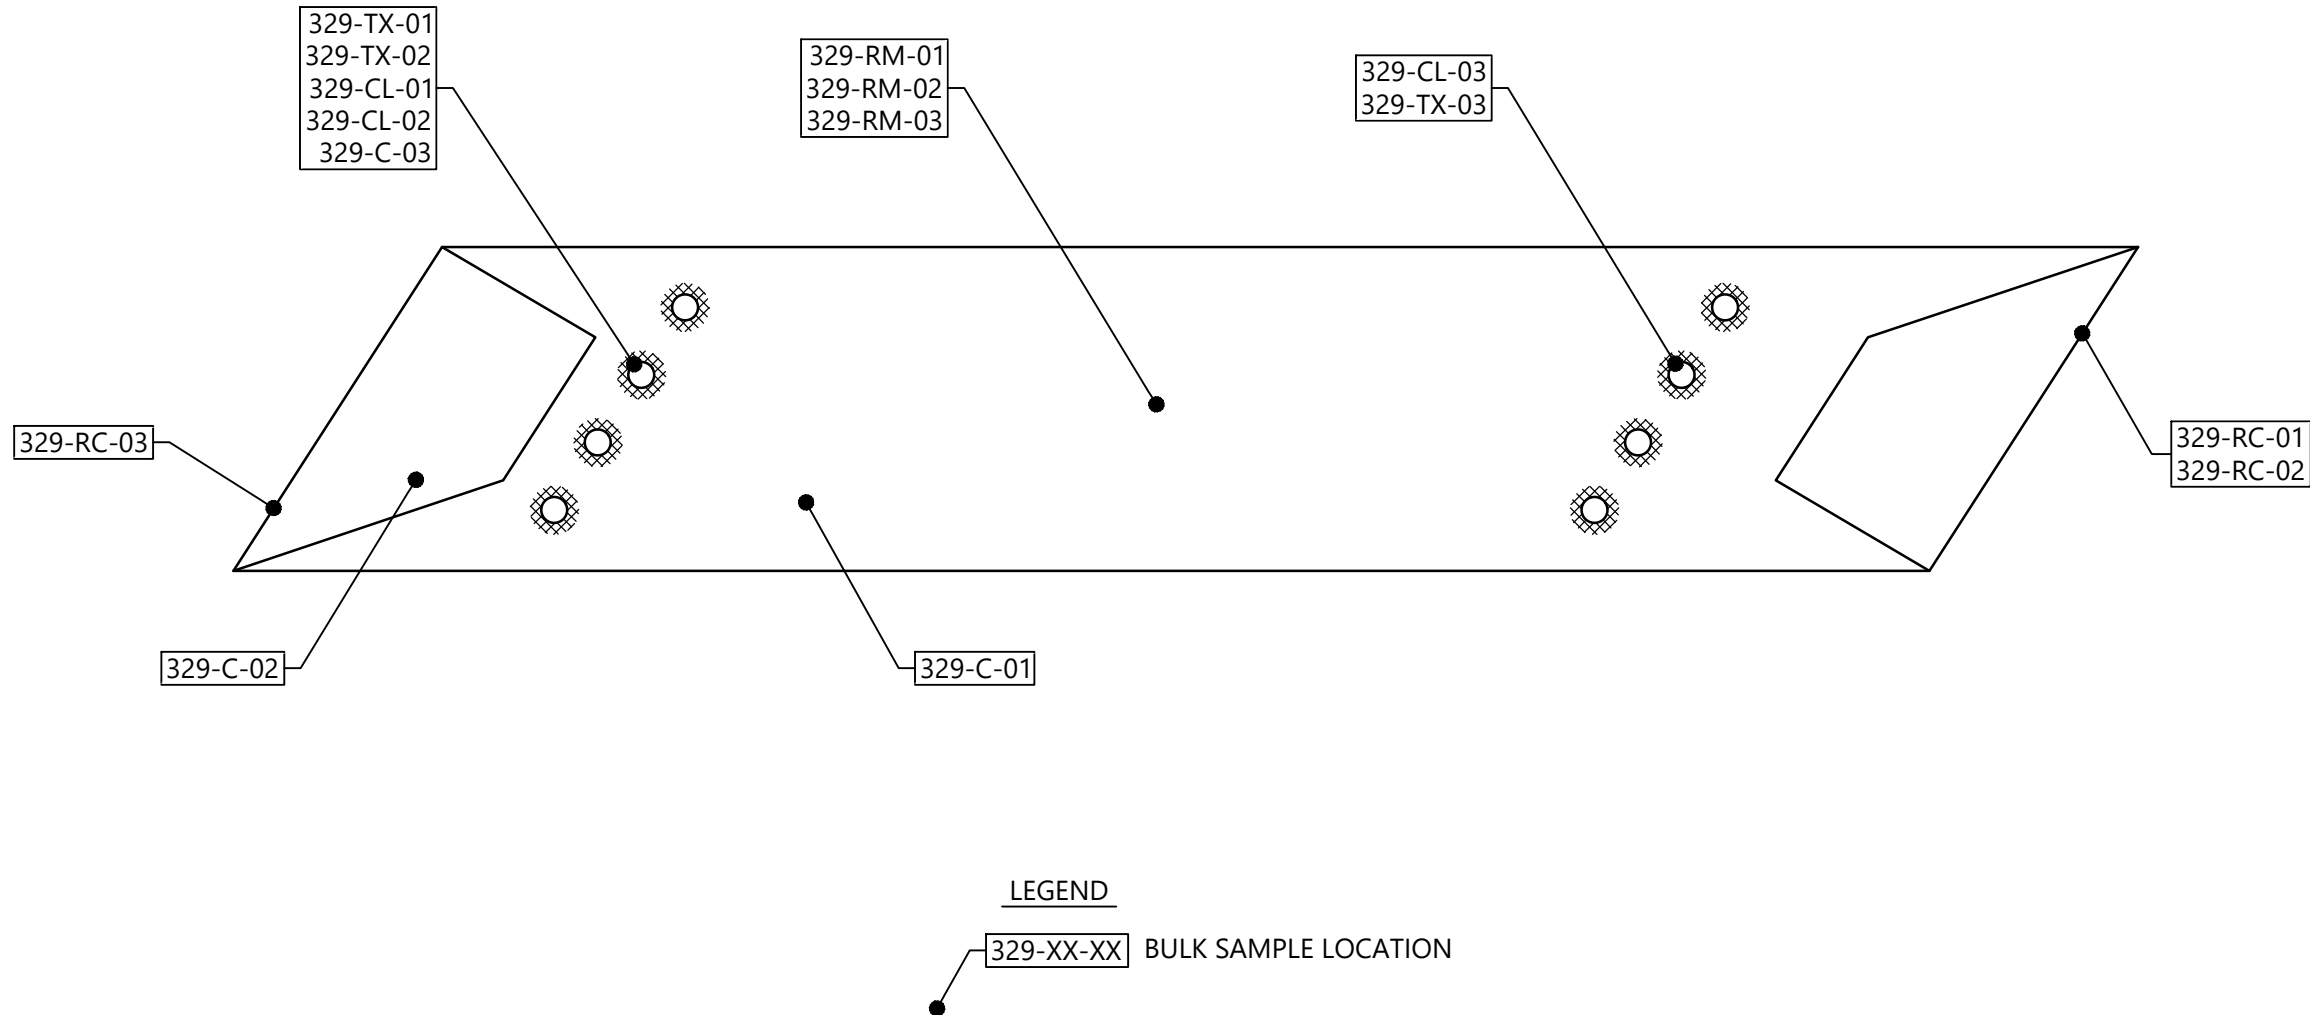
2

CAULK/SEALANT (BLACK) ASSOCIATED WITH BRIDGE COLUMNS AT SIDEWALK/FOOTER APPROXIMATELY 72 LINEAR FEET

NOTE: NO LEAD CONCENTRATION MEETING IN THE SCDHEC DISPOSAL LIMIT OF 0.7 mg/cm² WAS IDENTIFIED IN THE SUBJECT AREA
