Reference: **Asbestos and Lead-Based Paint Assessment Report
I-526 at Long Point Road – Bridge 08330**
Mount Pleasant, South Carolina
S&ME Project No. 200424A

**Asbestos and Lead-Based Paint Assessment Report
I-526 at S-97 Long Point Road – Bridge 08330
Mount Pleasant, South Carolina
S&ME Project No. 200424A**

Inspection Dates: April 7, 2023

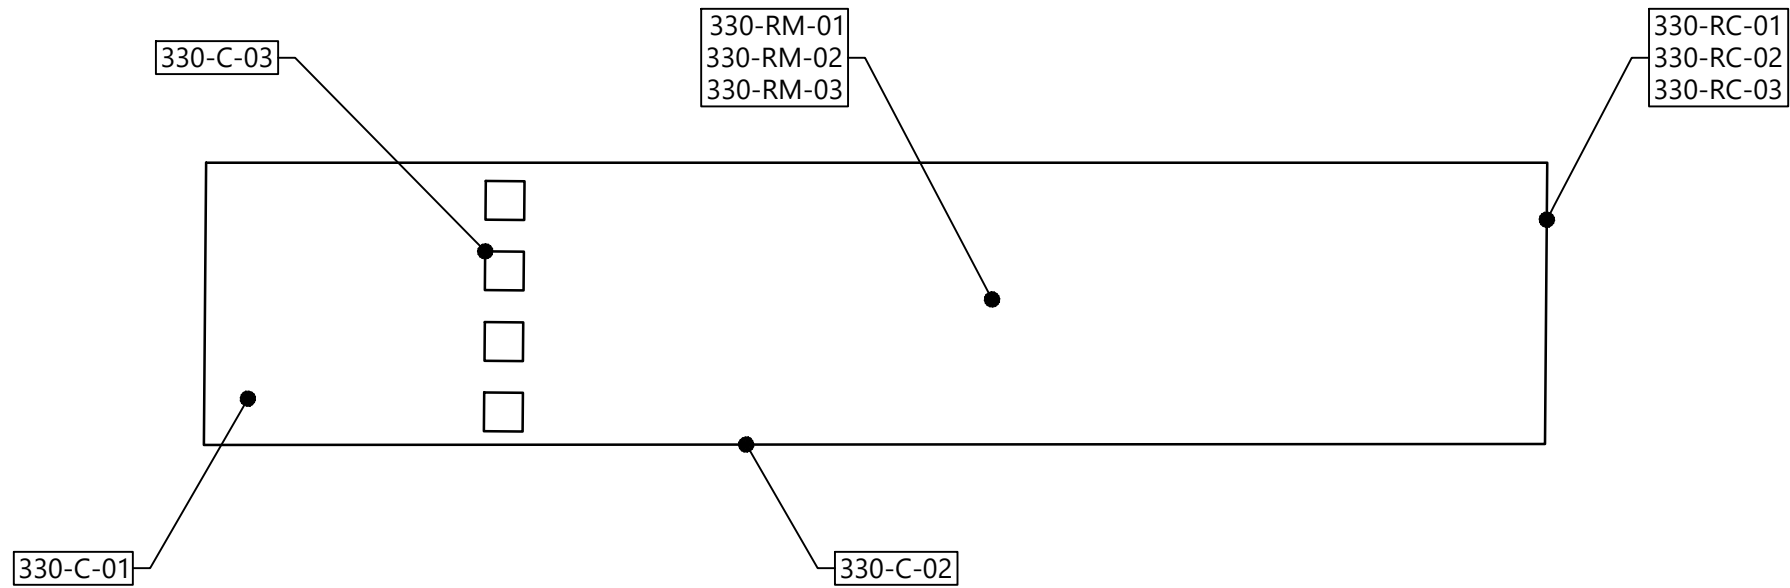
NOTE: NO ASBESTOS WAS DETECTED IN THE BULK SAMPLES COLLECTED AND ANALYZED.

NO LEAD CONCENTRATION MEETING IN THE SCDHEC DISPOSAL LIMIT OF 0.7 mg/cm² WAS IDENTIFIED IN THE SUBJECT AREA.
