Reference: **Asbestos and Lead-Based Paint Assessment Report
I-526 at Long Point Road – On-Ramp Bridge 07428**
Mount Pleasant, South Carolina
S&ME Project No. 200424A

**Asbestos and Lead-Based Paint Assessment Report
I-526 at S-97 Long Point Road – On-Ramp Bridge 07428
Mount Pleasant, South Carolina
S&ME Project No. 200424A**

Inspection Dates: April 7, 2023 & May 7, 2023

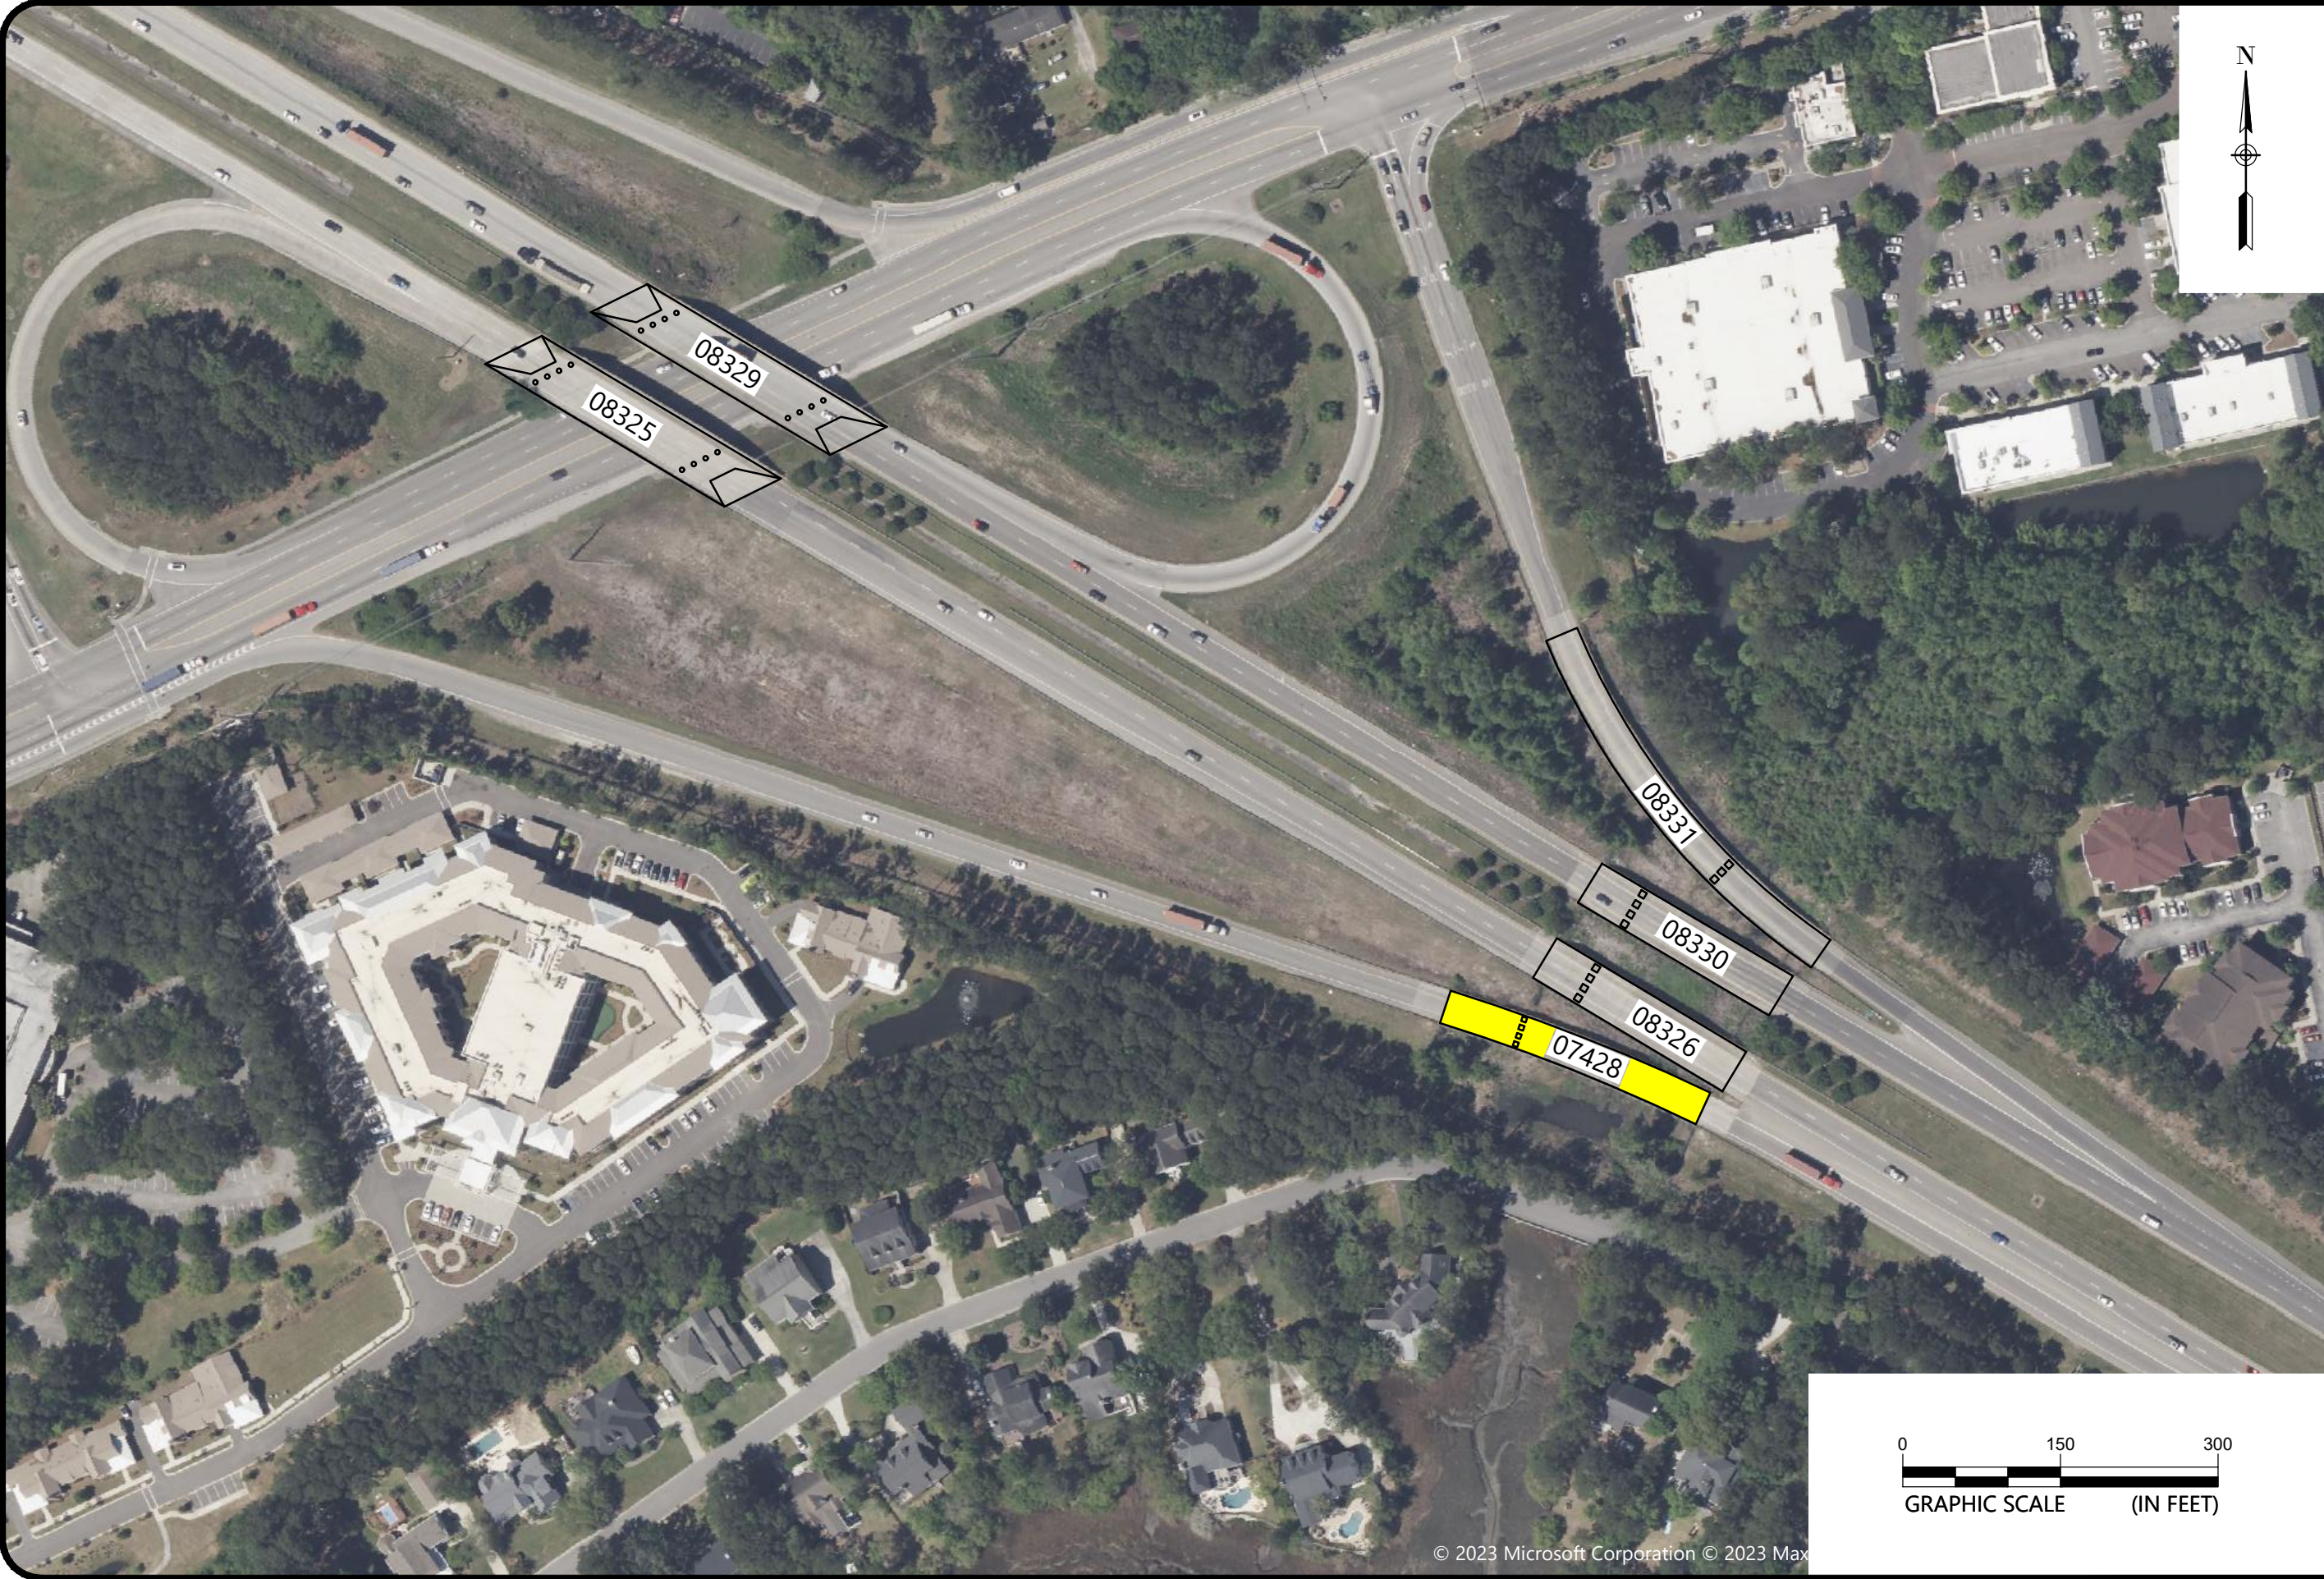
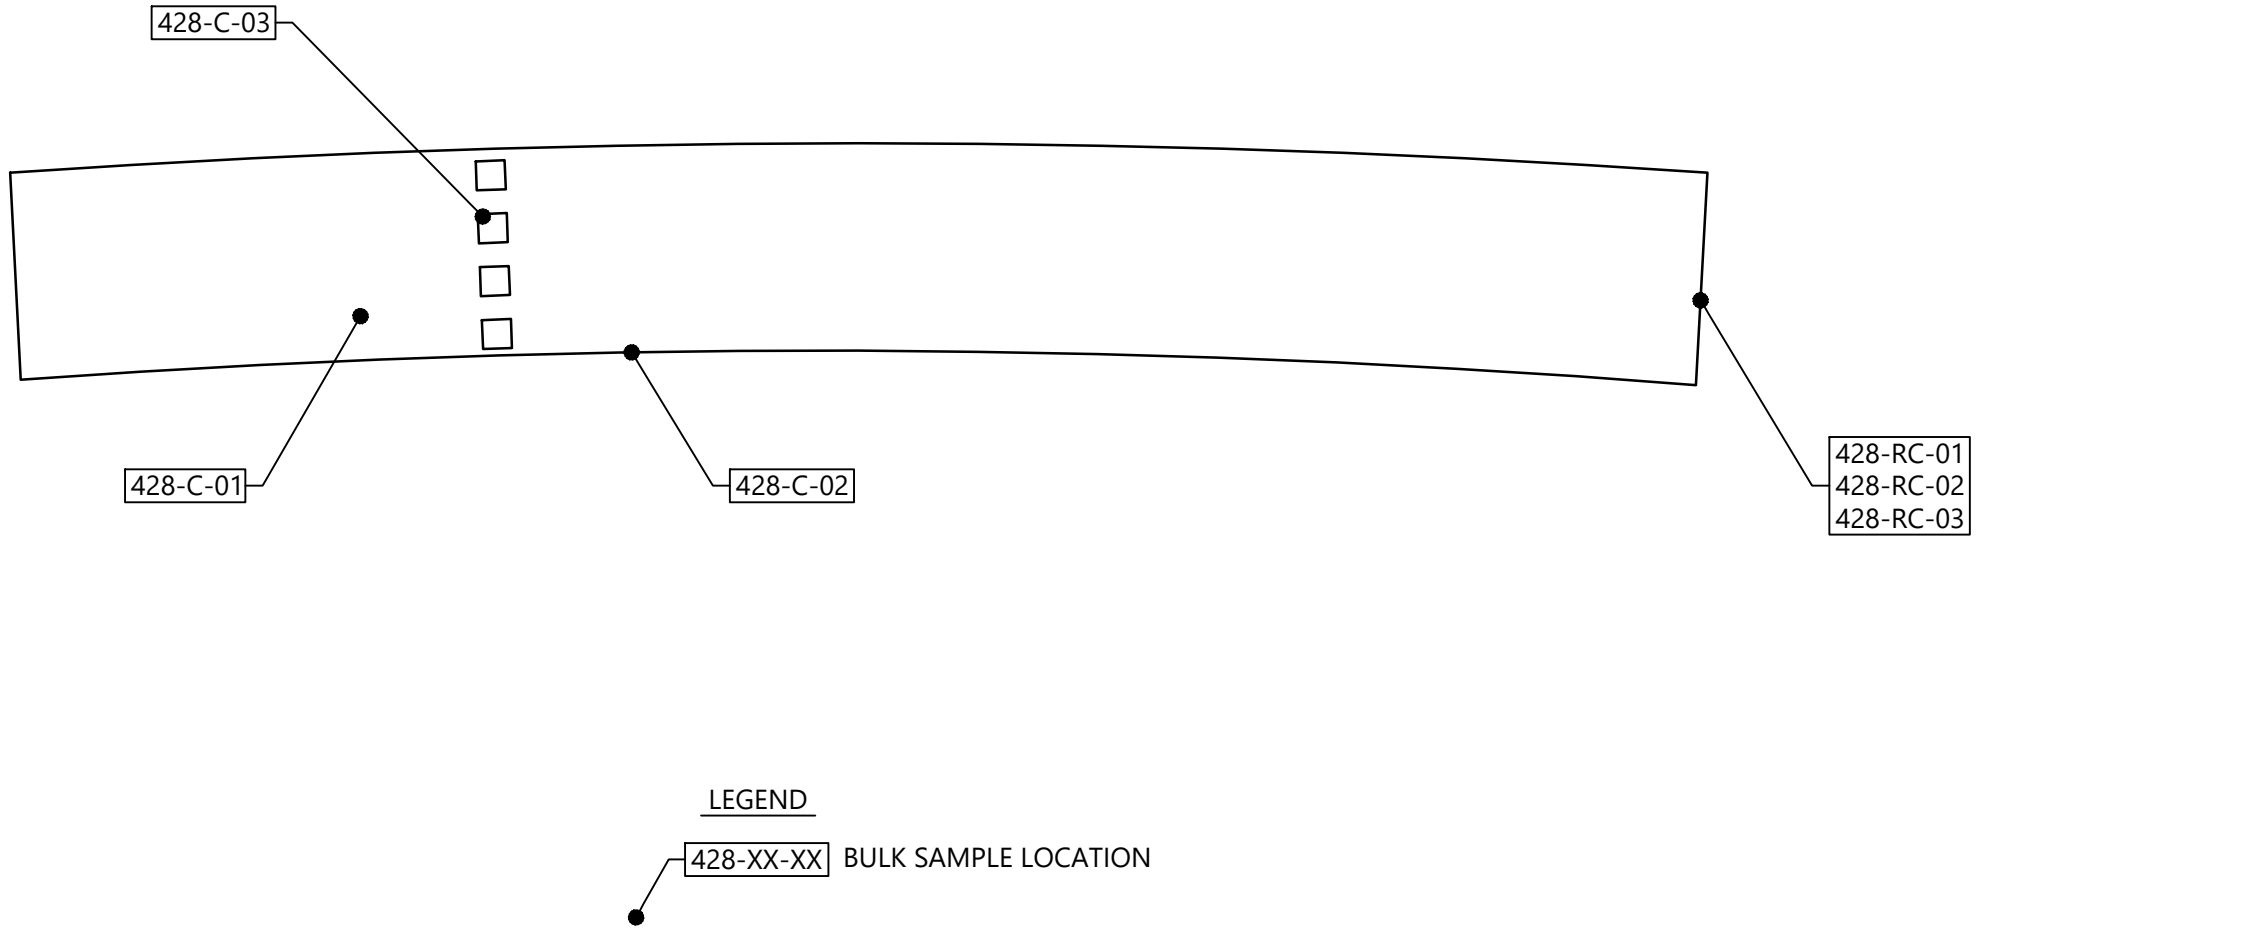
Appendix II – Diagram of Bulk Sample Locations

NOTE: NO ASBESTOS WAS DETECTED IN THE BULK SAMPLES COLLECTED AND ANALYZED.

NO LEAD CONCENTRATION MEETING IN THE SCDHEC DISPOSAL LIMIT OF 0.7 mg/cm² WAS IDENTIFIED IN THE SUBJECT AREA.
