I-526 Long Point Project Pavement Investigation Information

- **Original Typical Section**
- **Core Log**
- **FWD Data**

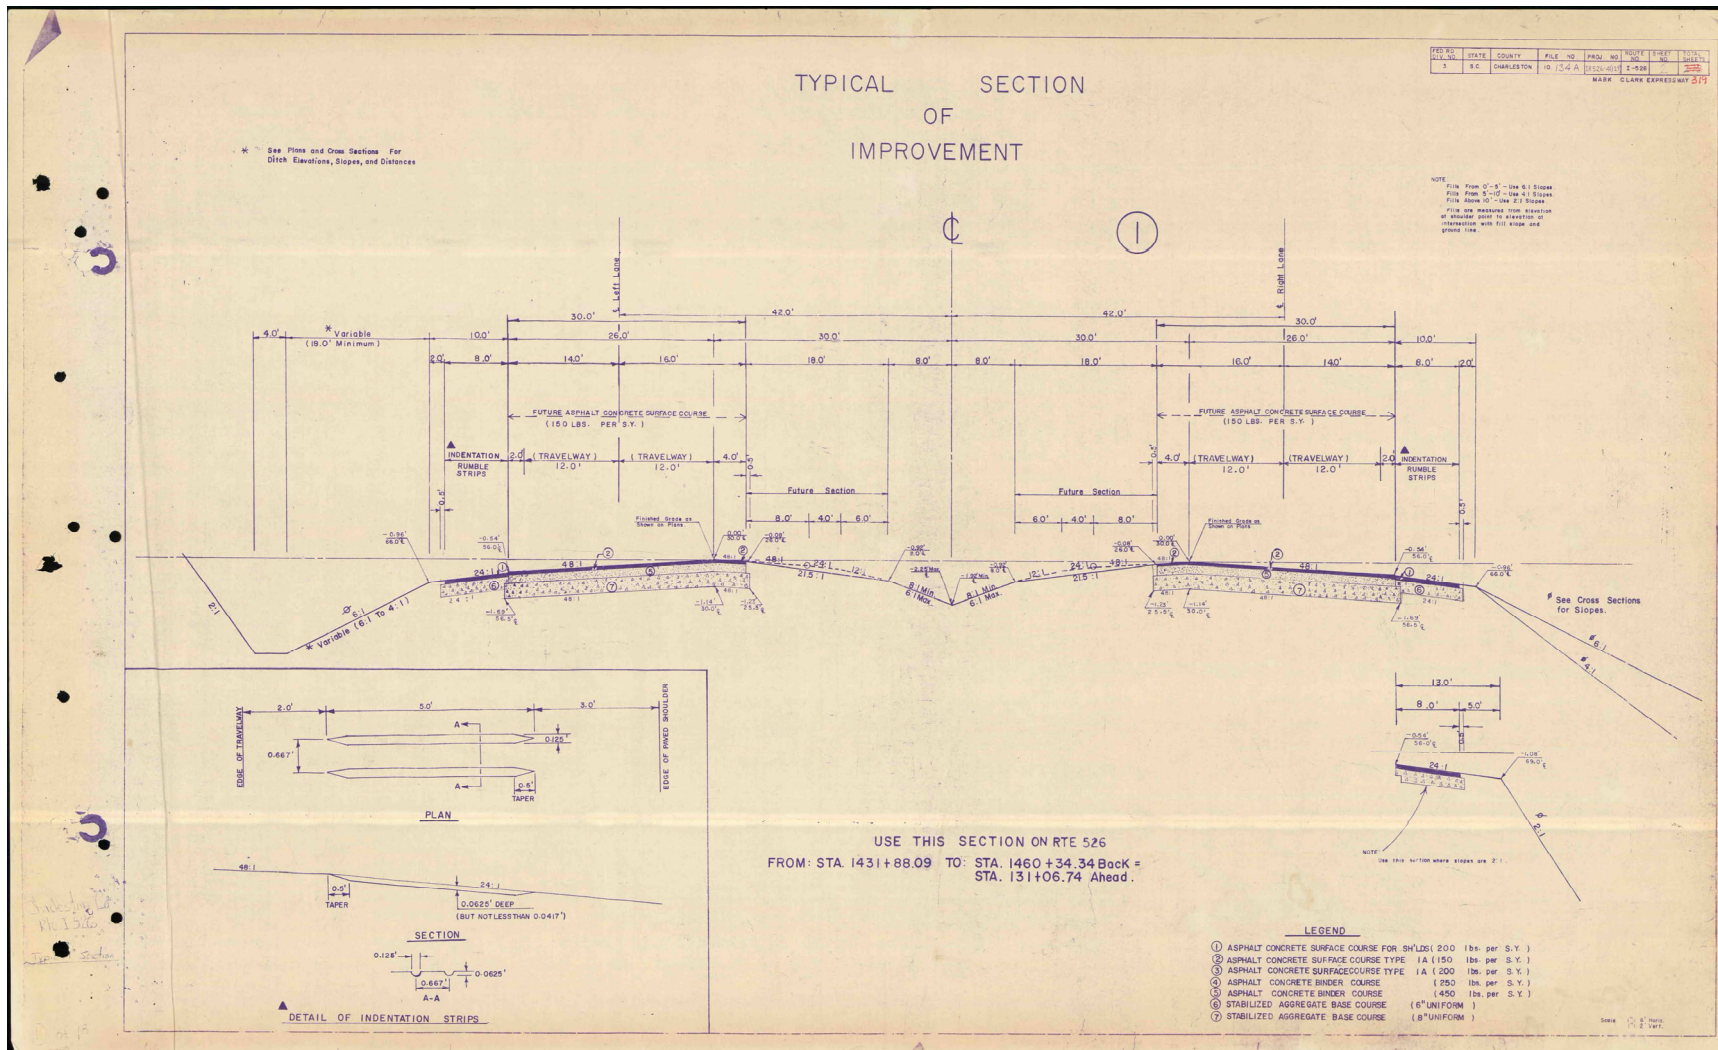
Original Typical Section

*Note : Based on the field observations and the original typical sections, it appears that there is a break/discontinuity in the shoulder pavement. As a result, any cores and FWD testing obtained near the white line on the shoulder were treated as mainline pavement for the subsequent analysis.

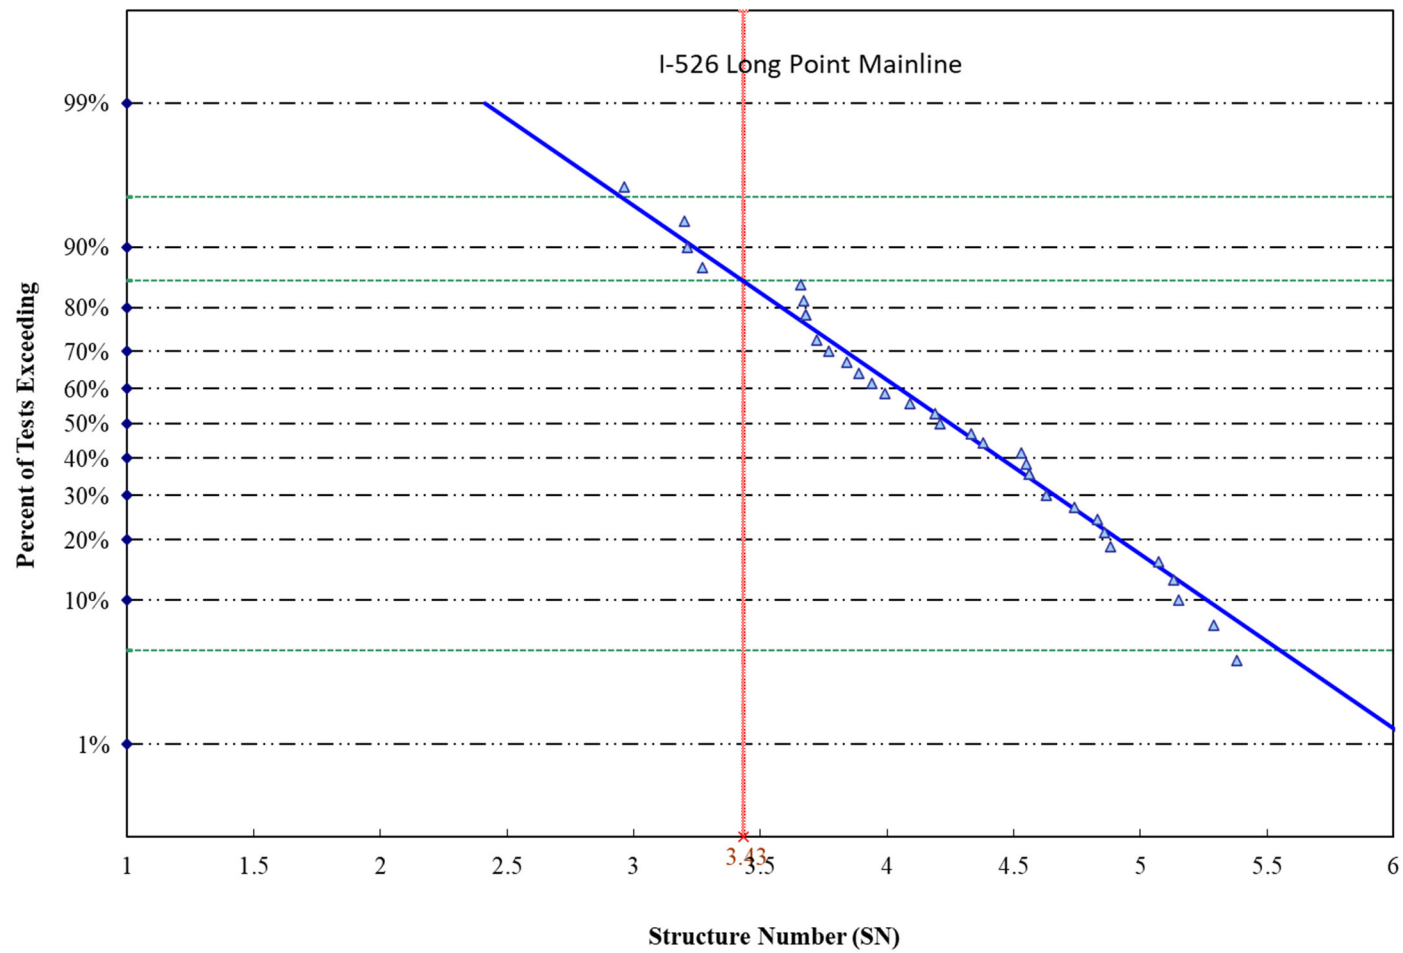
I-526 Mainline - 85th Percentile SN is 3.43

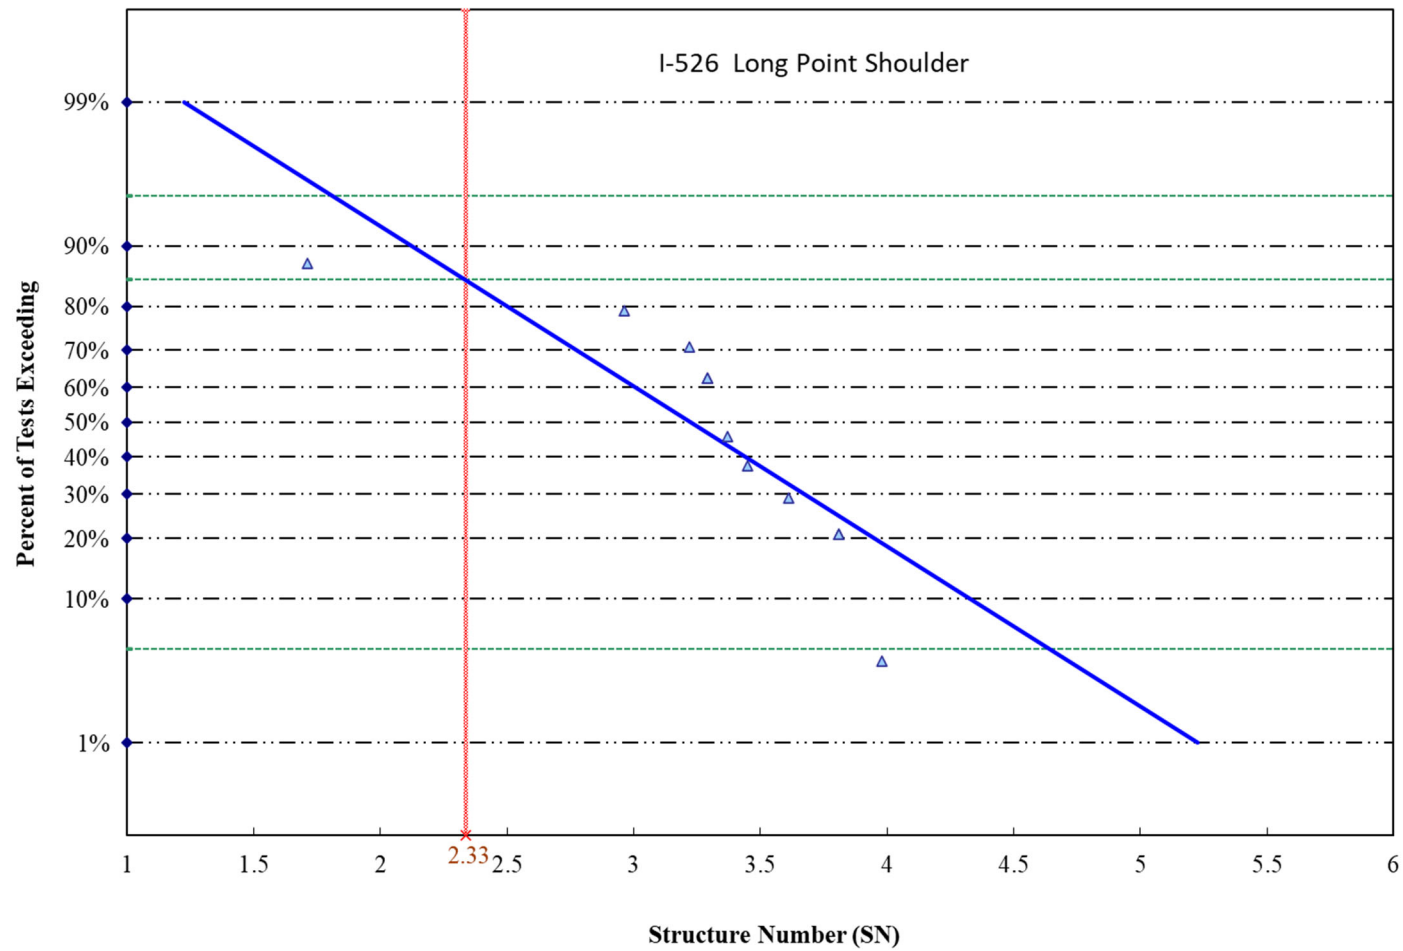
I-526 Shoulders - 85th Percentile SN is 2.33
