**Preliminary Geotechnical Subsurface Data Report
Emergency Bridge Package 4
S-28-36 Pine Grove Road over Twenty-Five Mile Creek
Kershaw County, South Carolina
F&R Project No. 65T-0215**

Reference: Preliminary Geotechnical Subsurface Data Report
Emergency Bridge Package 4
S-28-36 Pine Grove Road over Twentyfive Mile Creek
Kershaw County, South Carolina
F&R Project No. 65T-0215

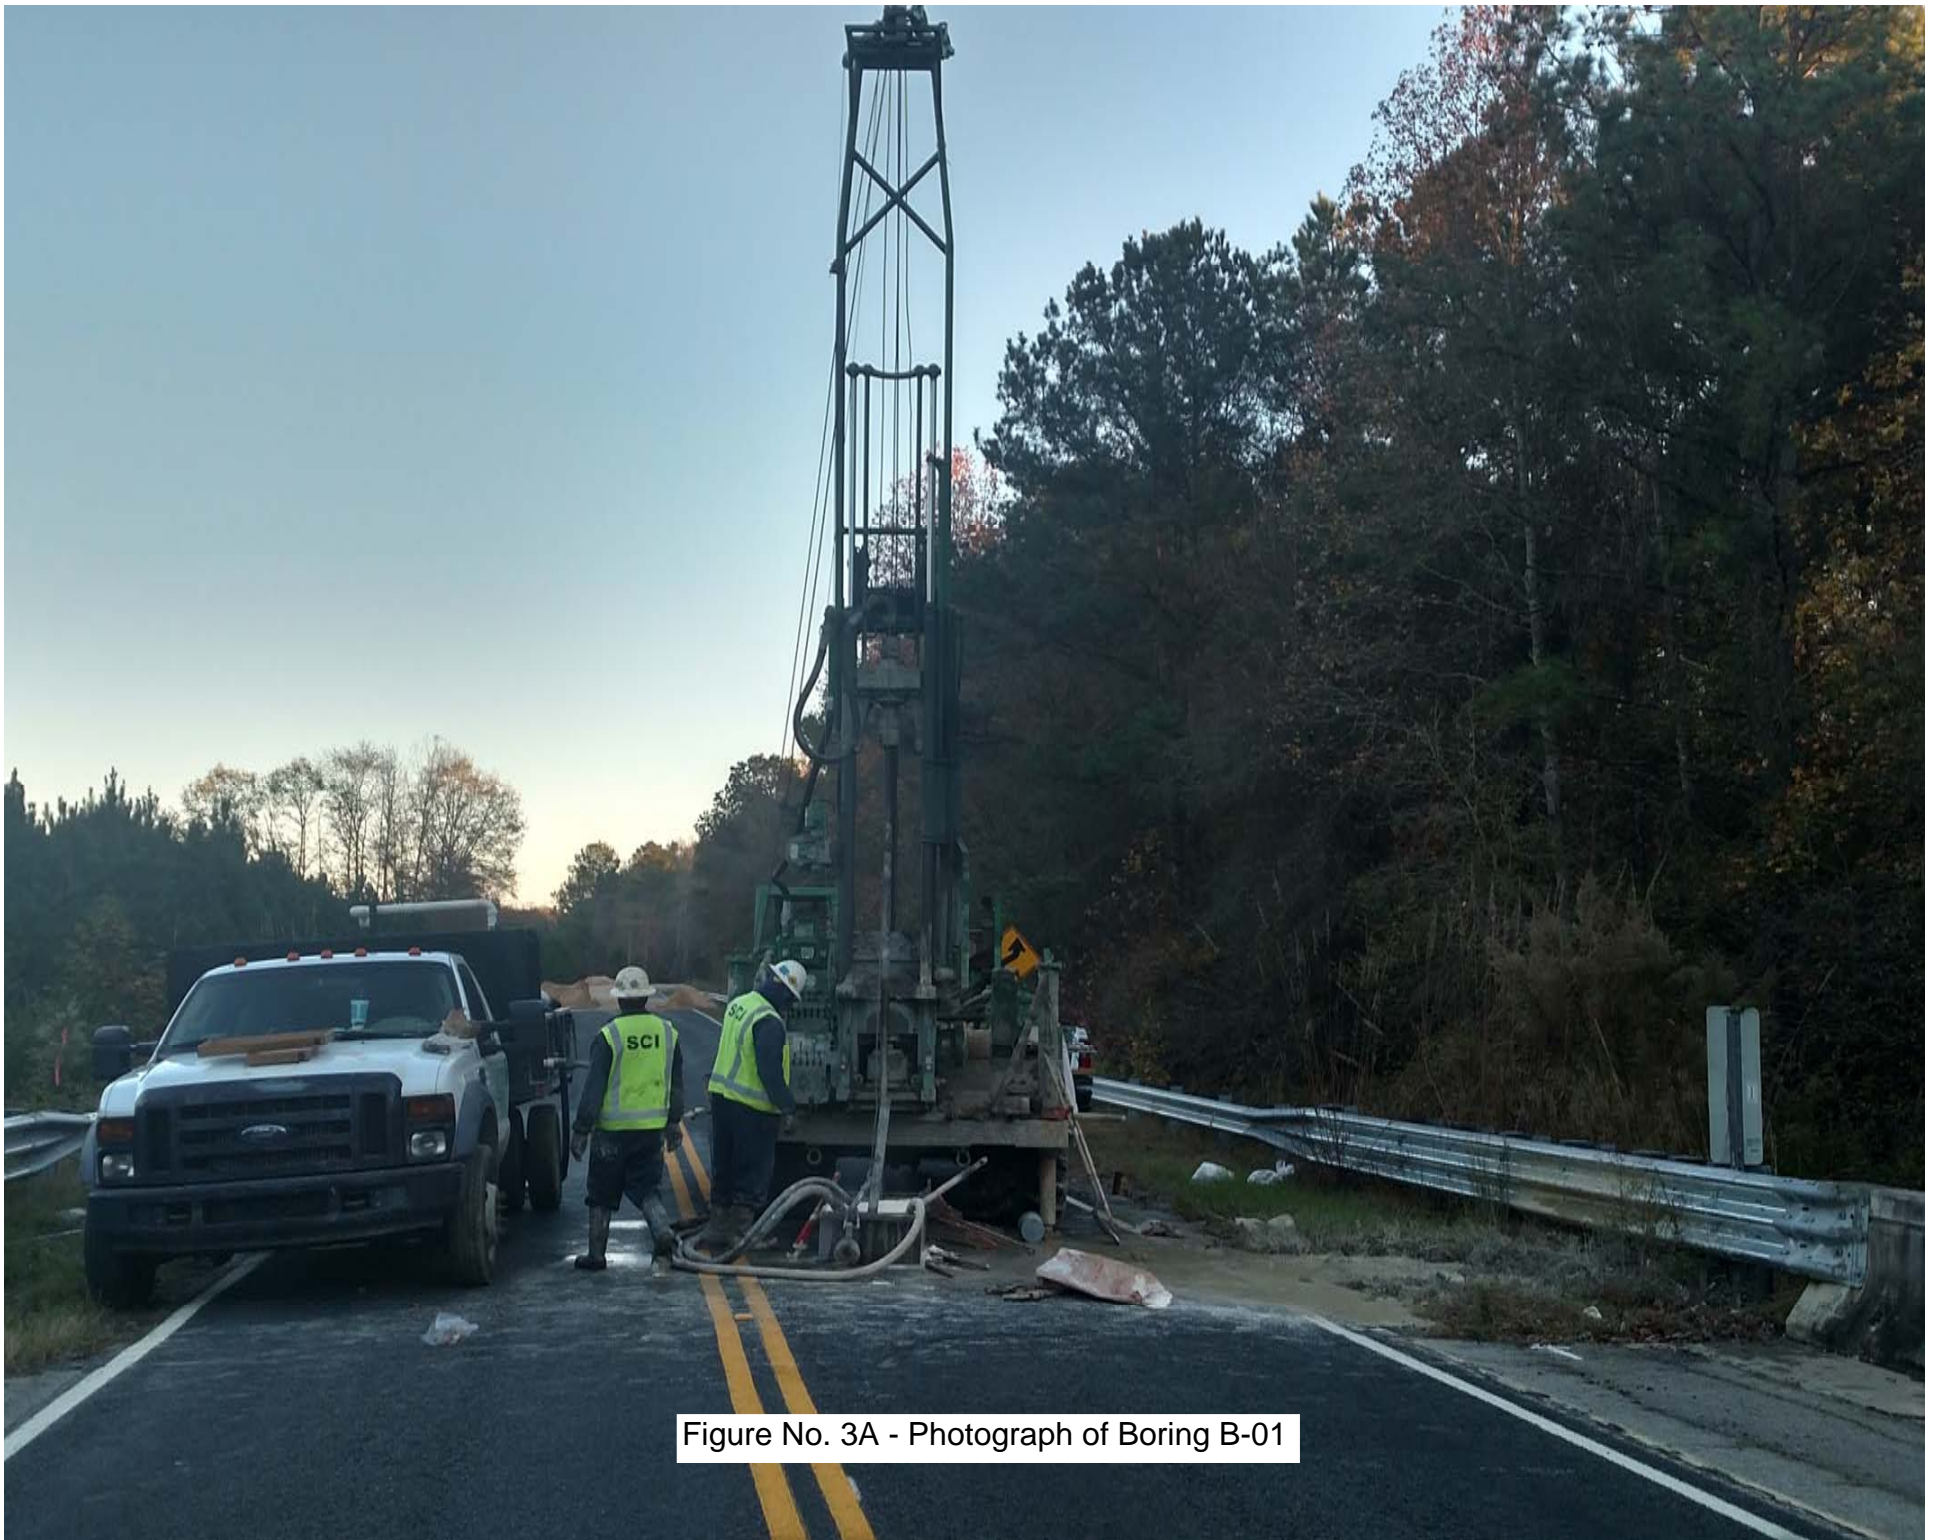
Figure No. 3A - Photograph of Boring B-01

The subsurface investigation program consisted of two soil test borings (STB) with rock coring. The borings, designated as B-01 and B-02 were advanced to a termination depth of approximately 39.5 and 68 ft below the existing ground surface on the approaches adjacent to the location of the bridge. Upon auger refusal, the borings were then advanced into rock using NQ rock coring techniques. Approximate boring locations are identified on Figure No. 2 - Boring Location Plan included in Appendix I. Photographs of Borings B-01 and B-02 being drilled are also included as Figure Nos. 3A and 3B in Appendix I.

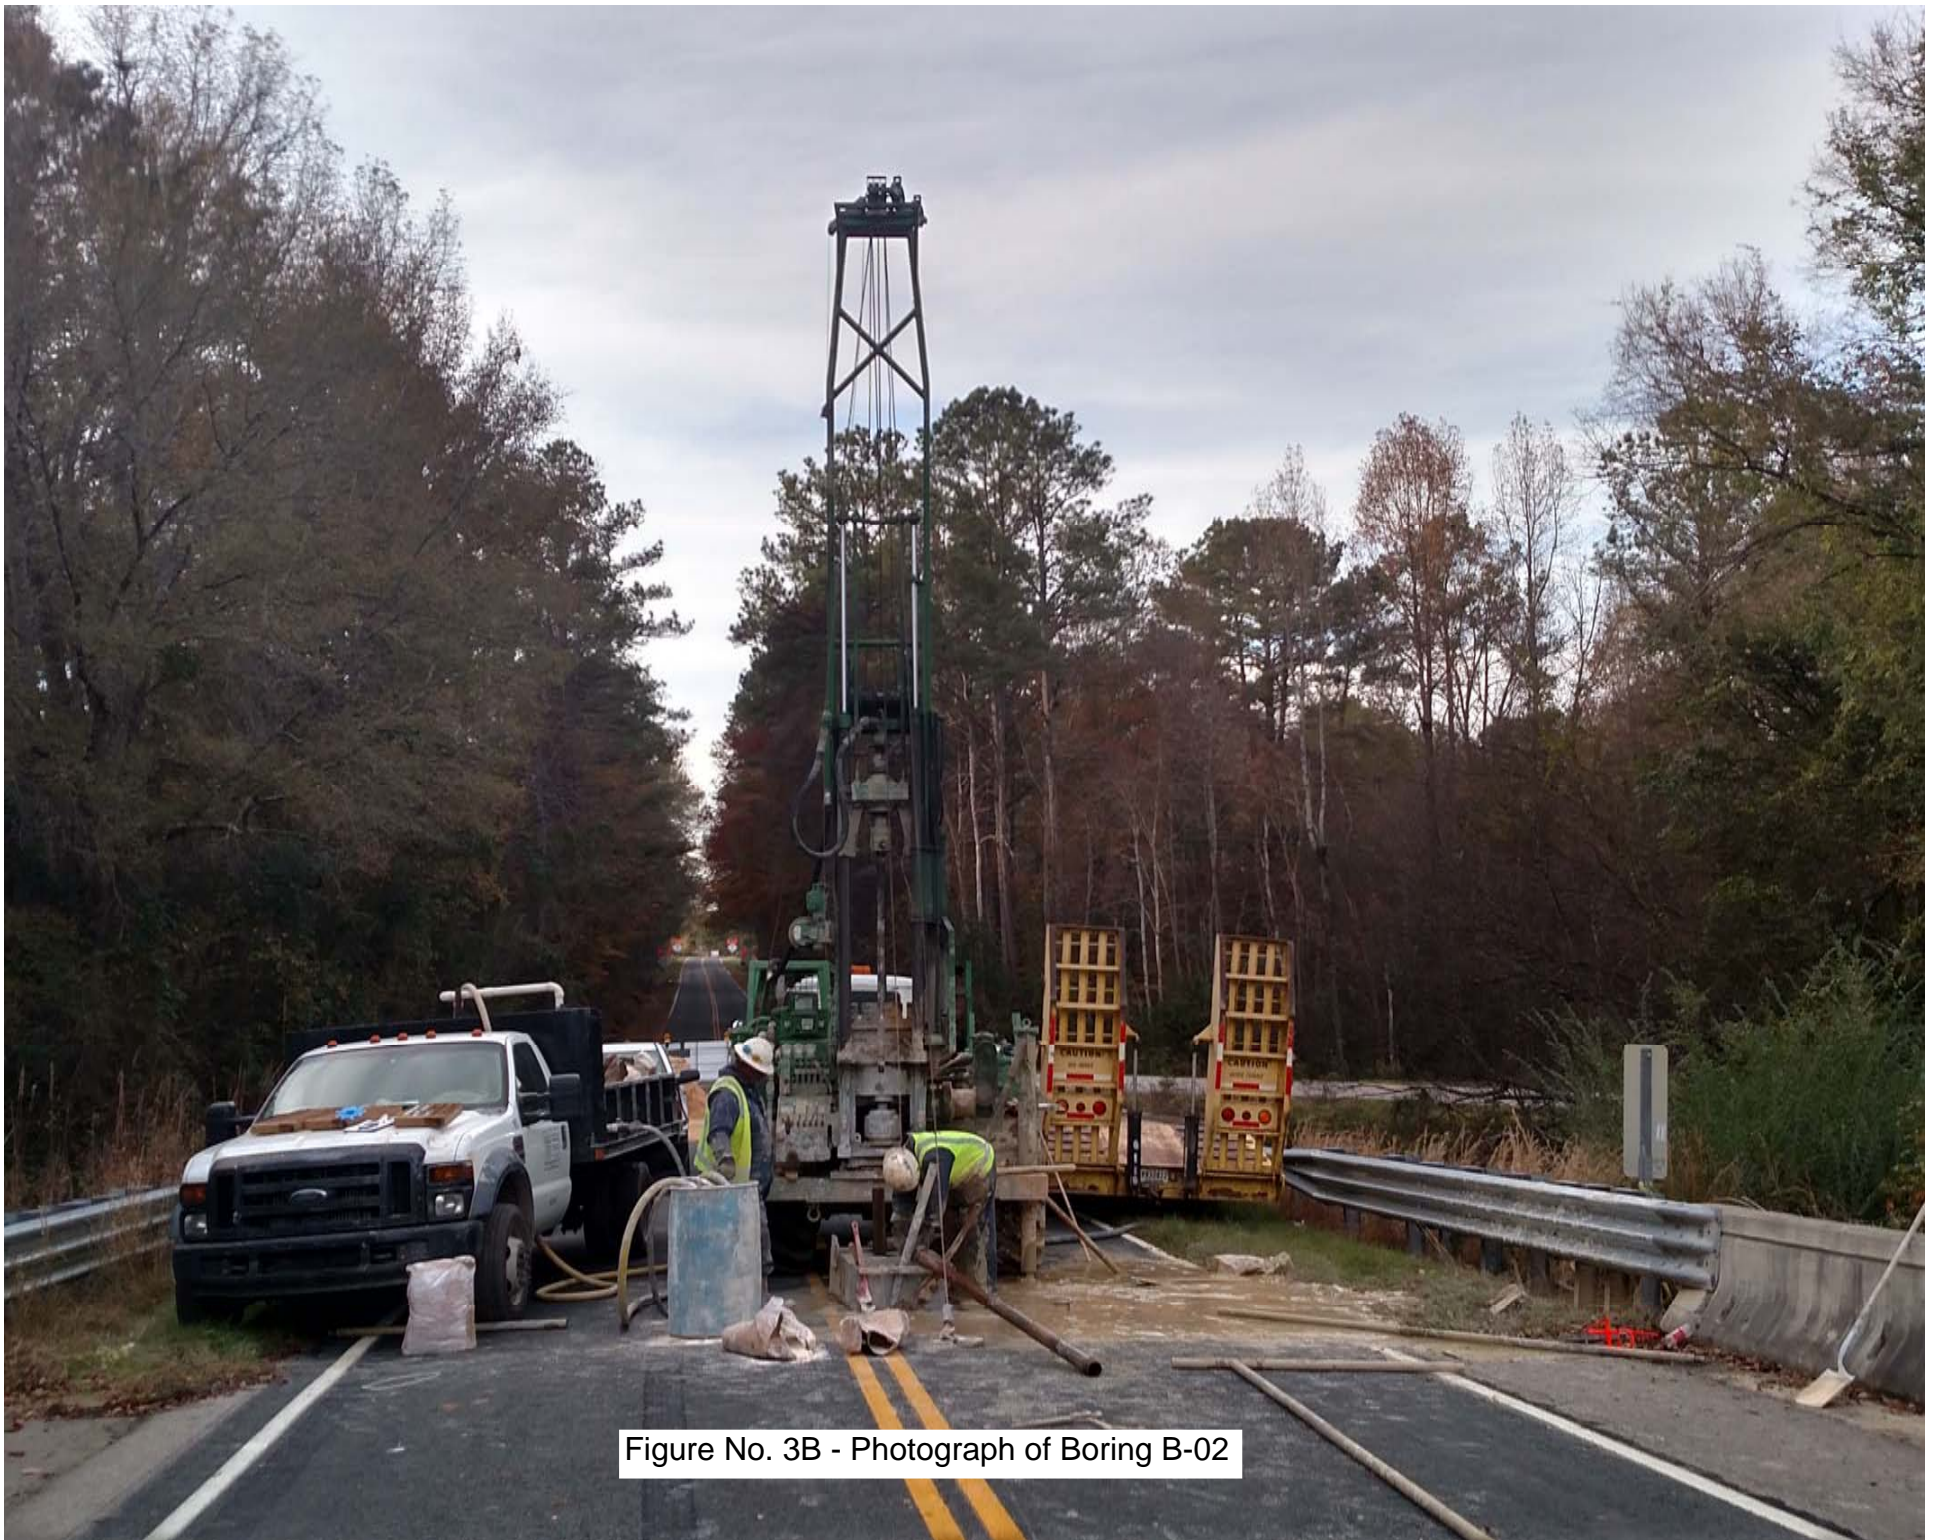
Figure No. 3B - Photograph of Boring B-02

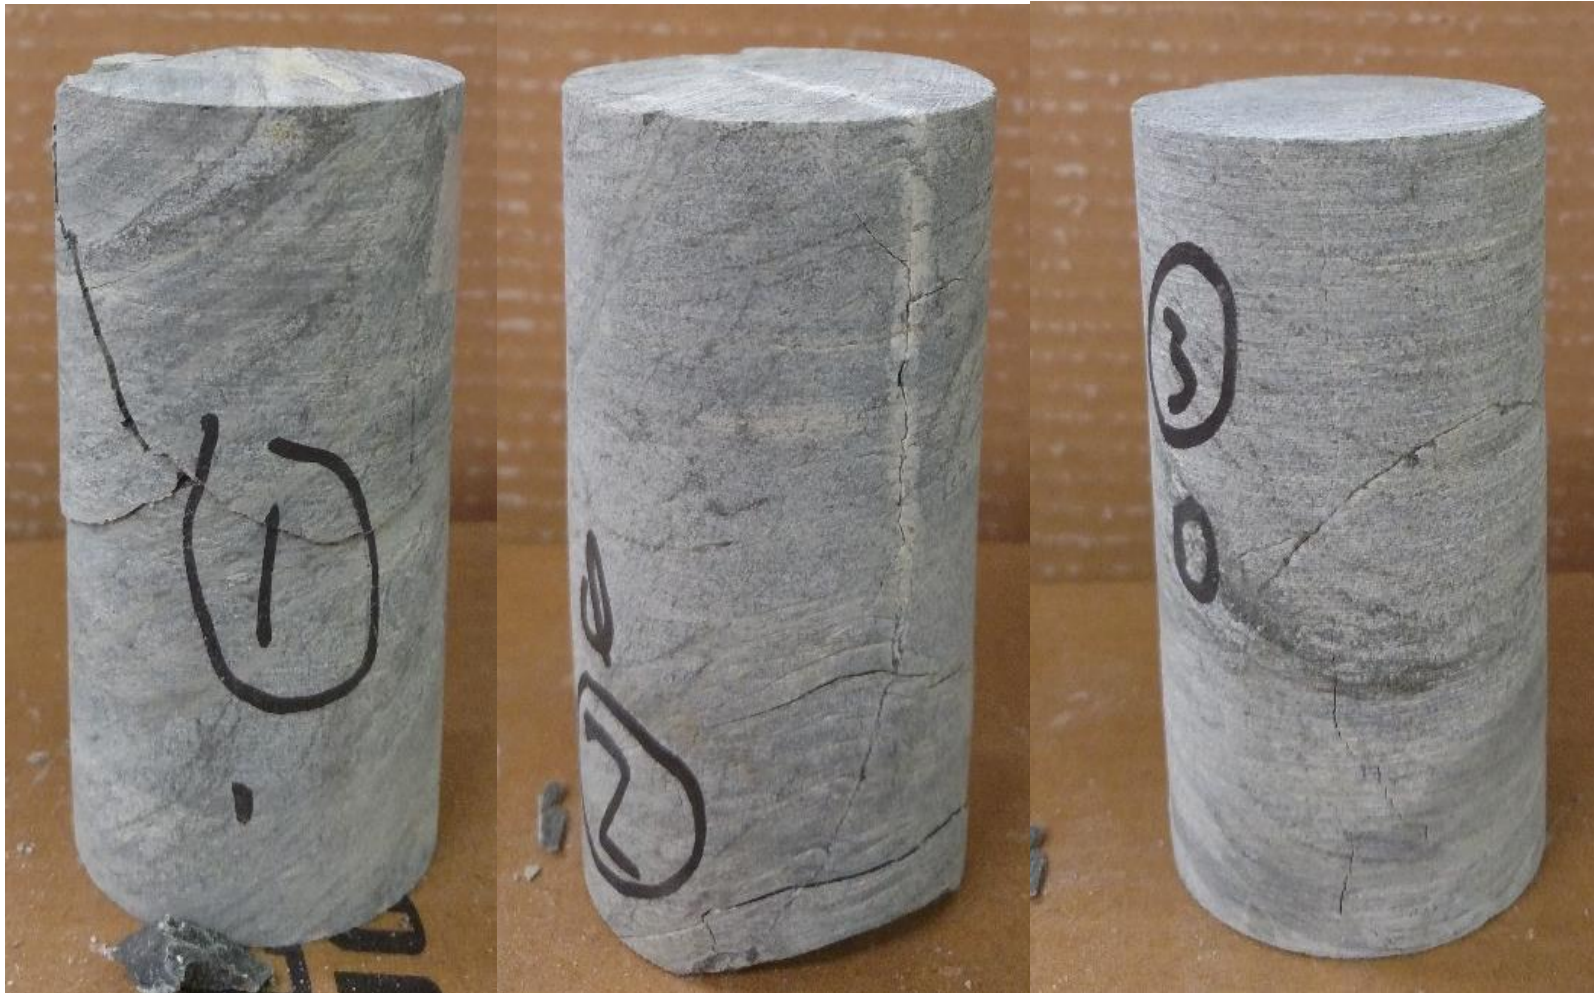
Fig. 4A - Compressive Strength Test Sample Photos - B-01

Core No. 1
UC Strength = 1,120 psi

Core No. 2
UC Strength = 4,283 psi

Core No. 3
UC Strength = 3,850 psi

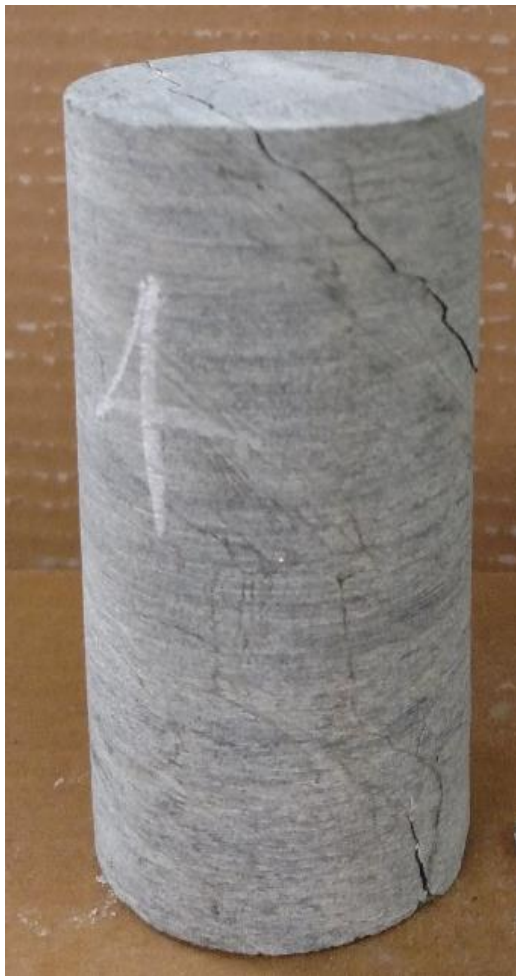
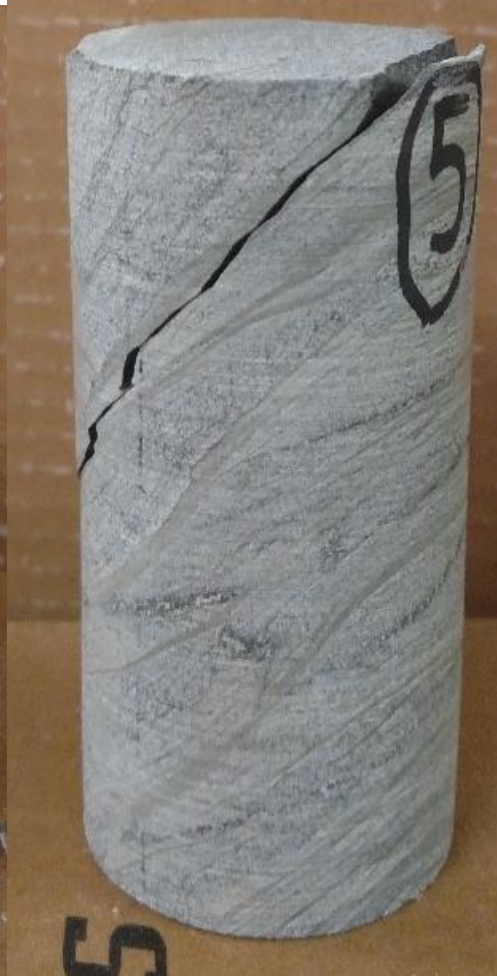
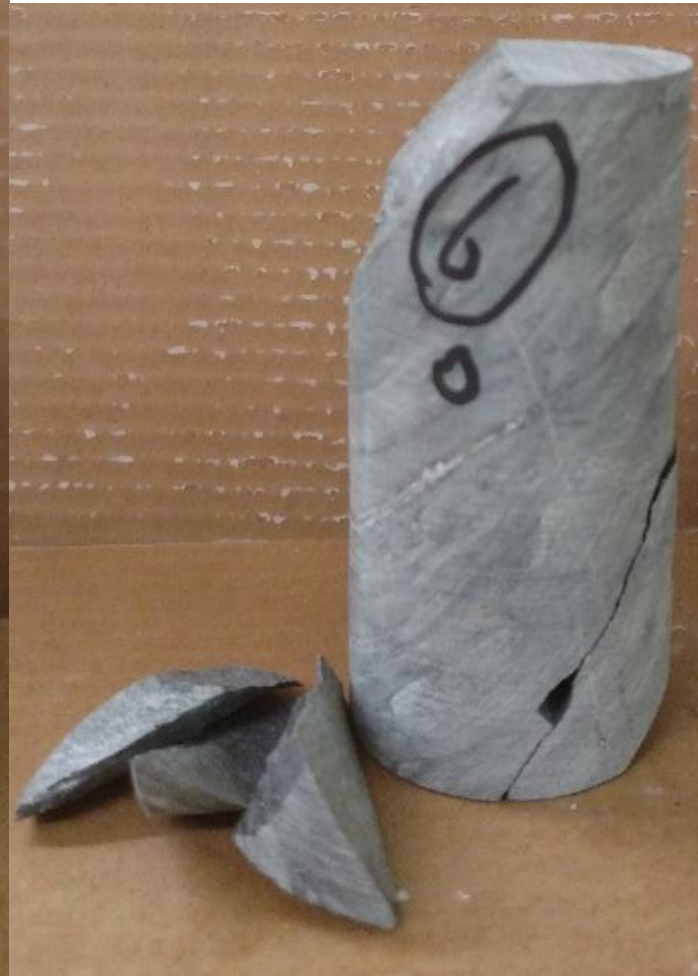
Fig. 4B - Compressive Strength Test Sample Photos - B-01

Core No. 4
UC Strength = 2,842 psi

Core No. 5
UC Strength = 3,202 psi

Core No. 6
UC Strength = 3,641 psi

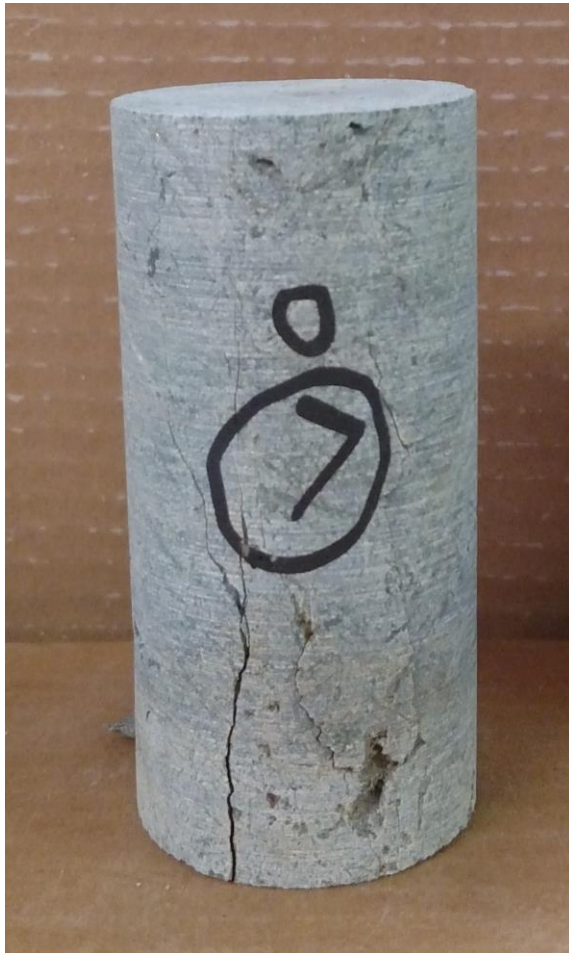
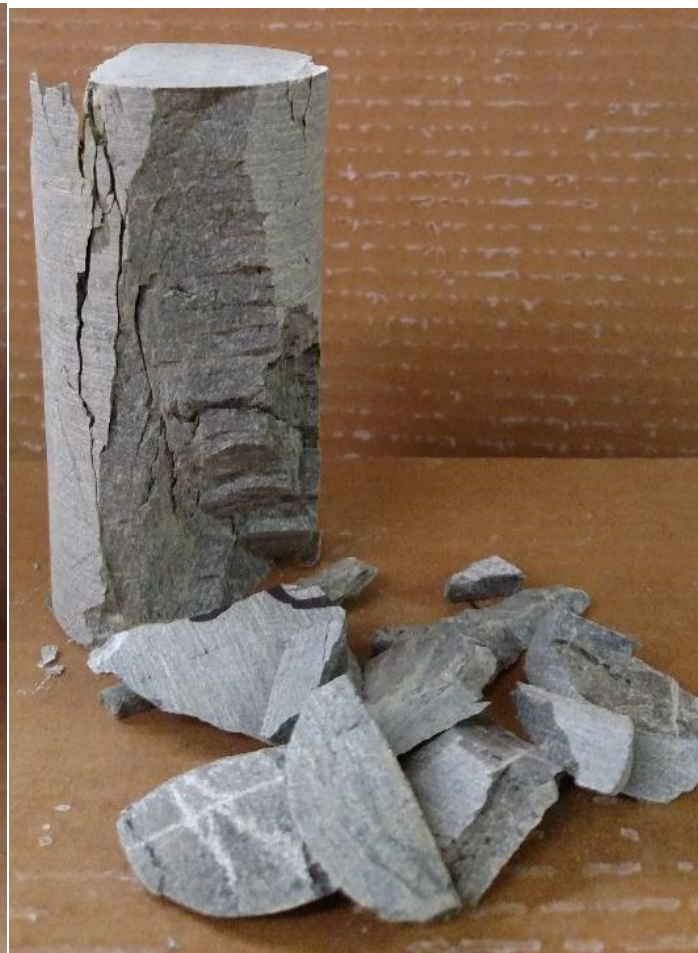
Fig. 4C - Compressive Strength Test Sample Photos - B-02

Core No. 7
UC Strength = 8,742 psi

Core No. 8
UC Strength = 14,157 psi

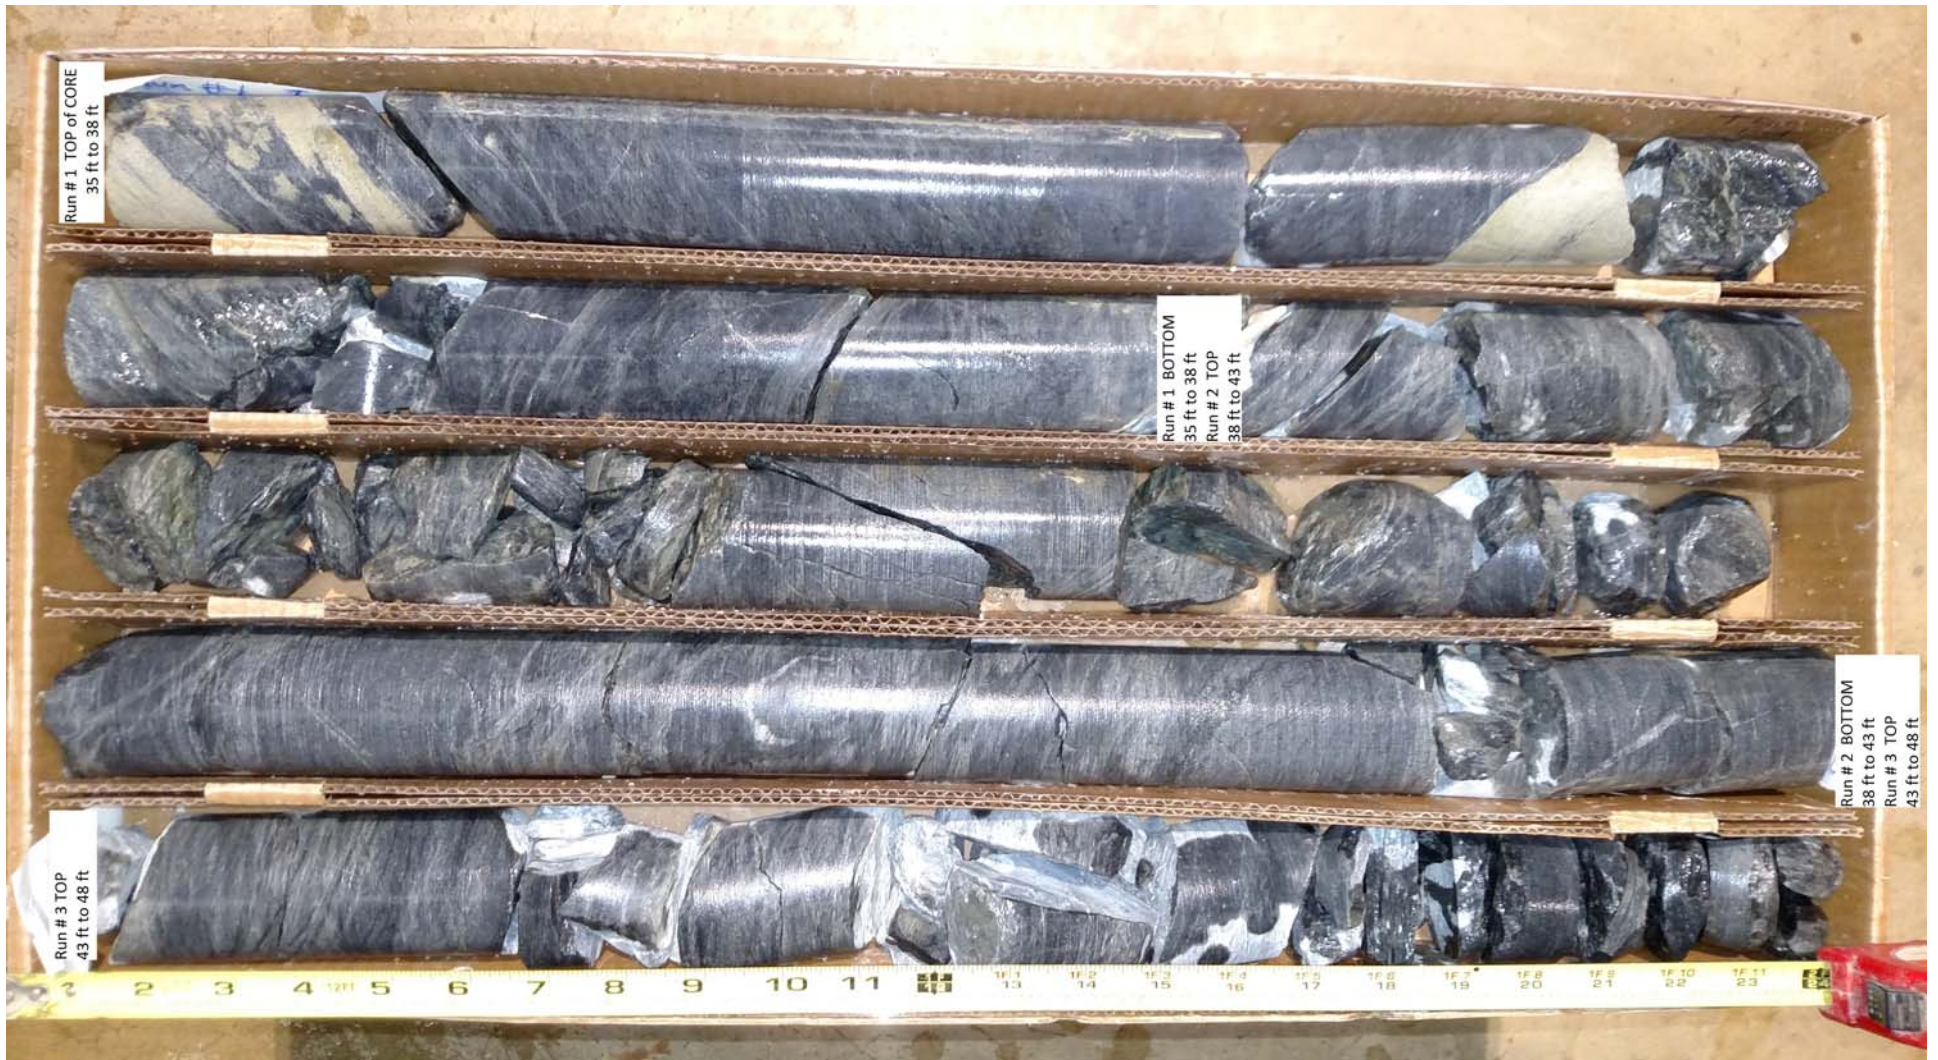
Figure No. 5A Rock Core Photographic Log
 S-28-36 Pine Grove Road, Kershaw County, South Carolina

Boring B-01

| Rock Sample Depth | Run No. | Run Length | Recovery | RQD |
|---|---|---|---|---|
| 38 ft - 43 ft | #2 | 5 ft | 47.5 inches | 30 % |
| 43 ft - 48 ft | #3 | 5 ft | 21 inches | 8 % |

Upon auger refusal, the borings were then advanced into rock to depths of 39.5 to 68 feet using NQ rock-coring techniques generally following procedures outlined in ASTM D 2113 using a 2-inch nominal inside diameter diamond-impregnated drill attached to the end of a double-tube core barrel. Rock core specimens were measured for recovery immediately upon retrieval, placed in core boxes for protection, labeled and transported to the laboratory for further evaluation by our professional staff. In the laboratory, the rock core specimens were measured for Percent Recovery and Rock Quality Designation (RQD) by a member of our professional

staff. Percent Recovery is the ratio of the recovered core length to the length of rock drilled, expressed by a percentage. RQD is the ratio of the cumulative length of all pieces of rock greater than or equal to four (4) inches to the total amount drilled, expressed as a percent of the total amount drilled. The RQD value is related to the soundness and quality of the rock mass and has been correlated with engineering properties of rock.

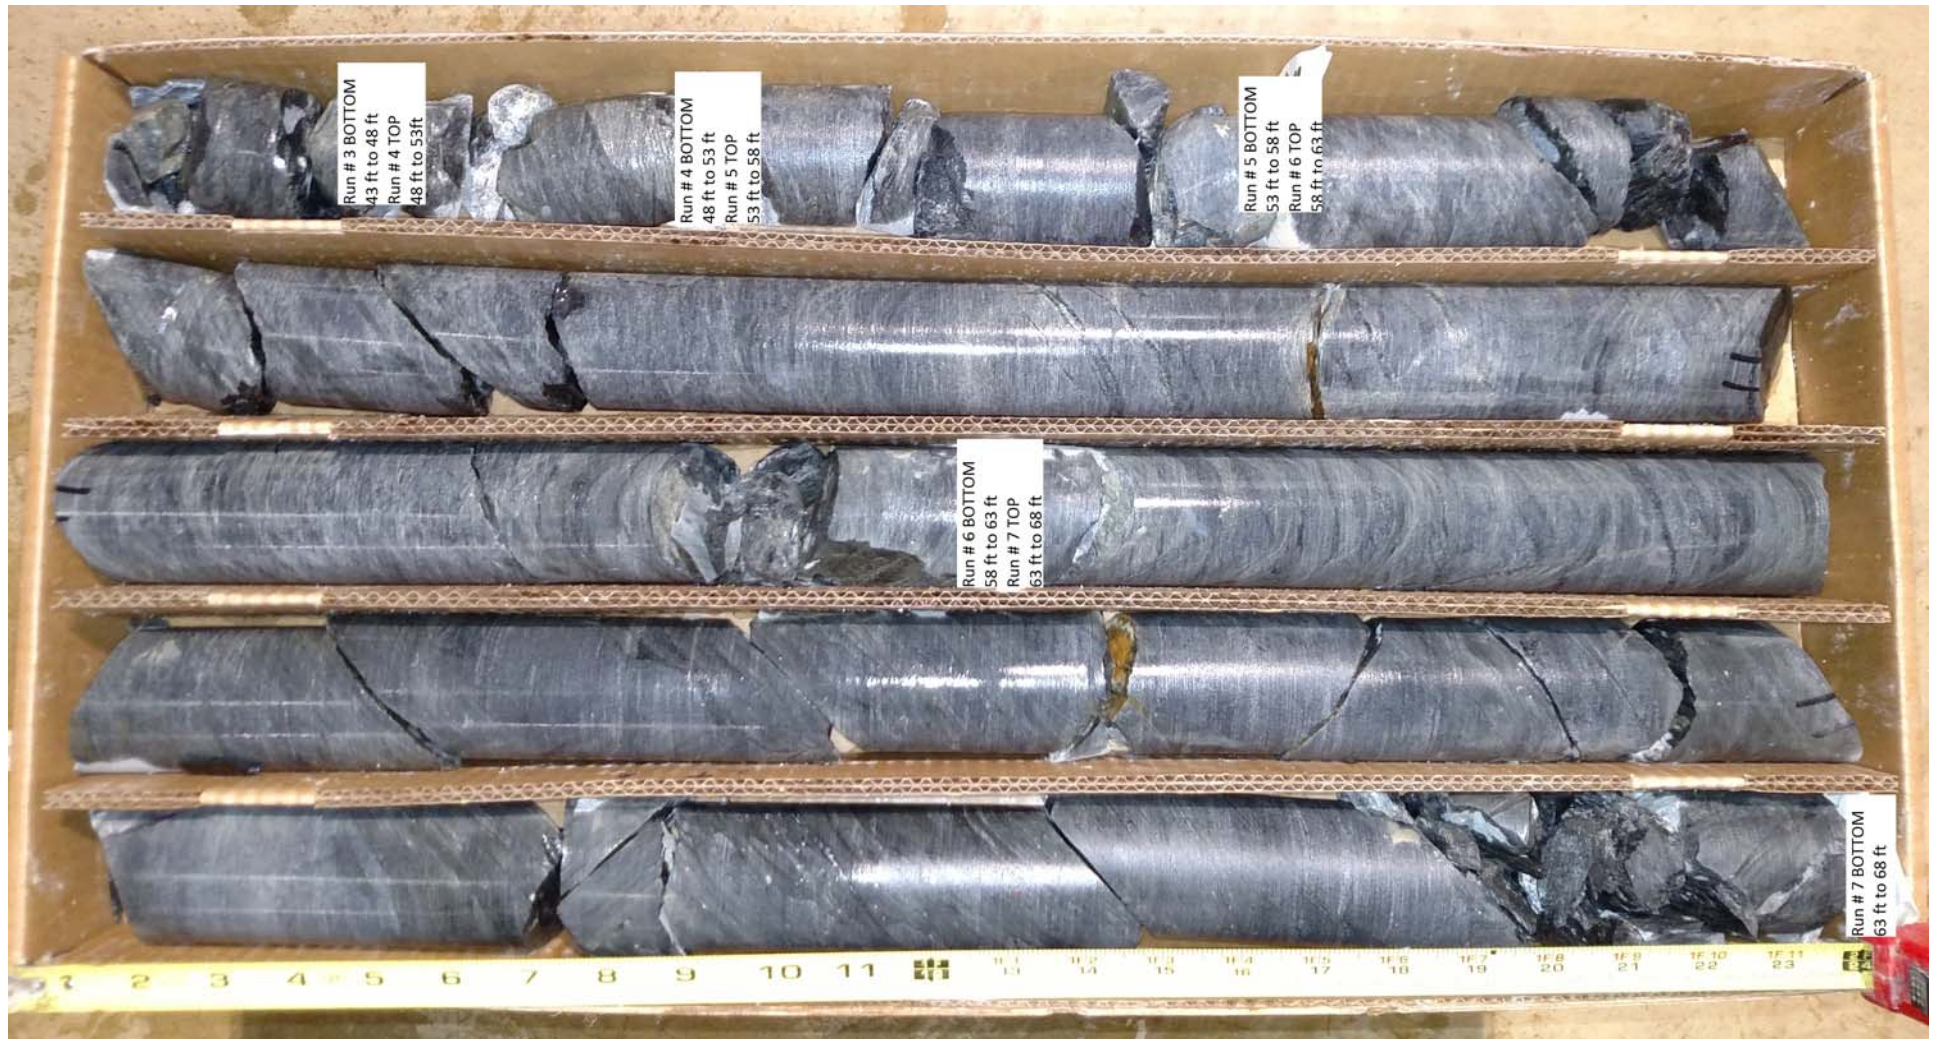
Figure No. 5B Rock Core Photographic Log
 S-28-36 Pine Grove Road, Kershaw County, South Carolina

Boring B-01

| Rock Sample Depth | Run No. | Run Length | Recovery | RQD |
|---|---|---|---|---|
| 58 ft - 63 ft | #6 | 5 ft | 41 inches | 41 % |
| 63 ft - 68 ft | #7 | 5 ft | 56.5 inches | 70 % |
