**PHASE I CULTURAL RESOURCE SURVEY FOR PROPOSED  
WIDENING OF INTERSTATE 85 FROM MILE MARKER 80 TO 96,  
CHEROKEE AND SPARTANBURG COUNTIES, SOUTH CAROLINA.**

**FINAL REPORT**

**JULY 2015**

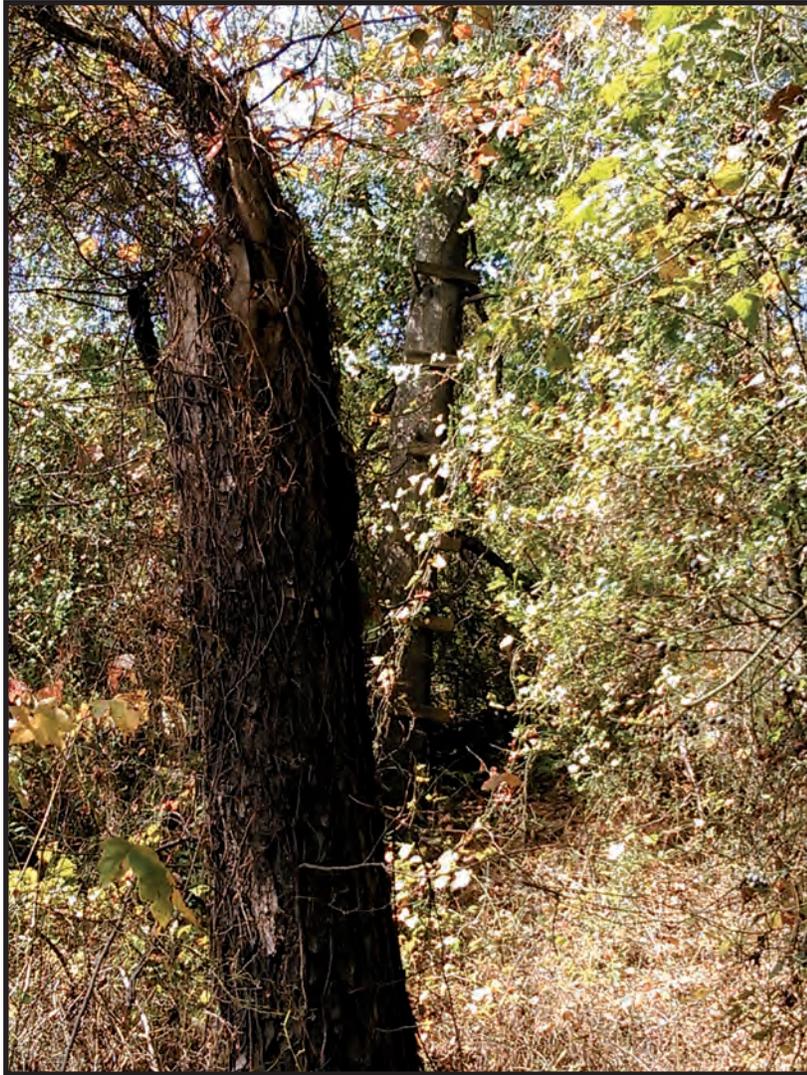
**Figure 4.2.** Photograph of Site 38CK197, facing west.

Site 38CK197 was identified within the western portion of the survey area on a broad landform dissected by unnamed drainages of Little Thicketty Creek. More specifically, the site is located in a wooded parcel on the Frontage Road, on the west side of I-85 at approximately MM 84 (Figure 4.1b). The site is primarily located within the ROW of Frontage Road, which is characterized by a gently sloping landform, truncated by the road corridor itself. The wooded portion of the site is separated from the ROW by a fence and is characterized by mixed pine forest (Figure 4.2).

conducted to the southeast of the site due to the existing paved corridor of Frontage Road and I-85. Artifact density ranged between 1 and 4 per positive shovel test and all material was recovered from between 30 and 90 centimeters below surface. A representative soil profile from 38CK197 revealed two strata: Stratum I (0-35 centimeters below surface) was a grayish brown humic sand and Stratum II (35-80 centimeters below surface) was a yellowish brown sand.

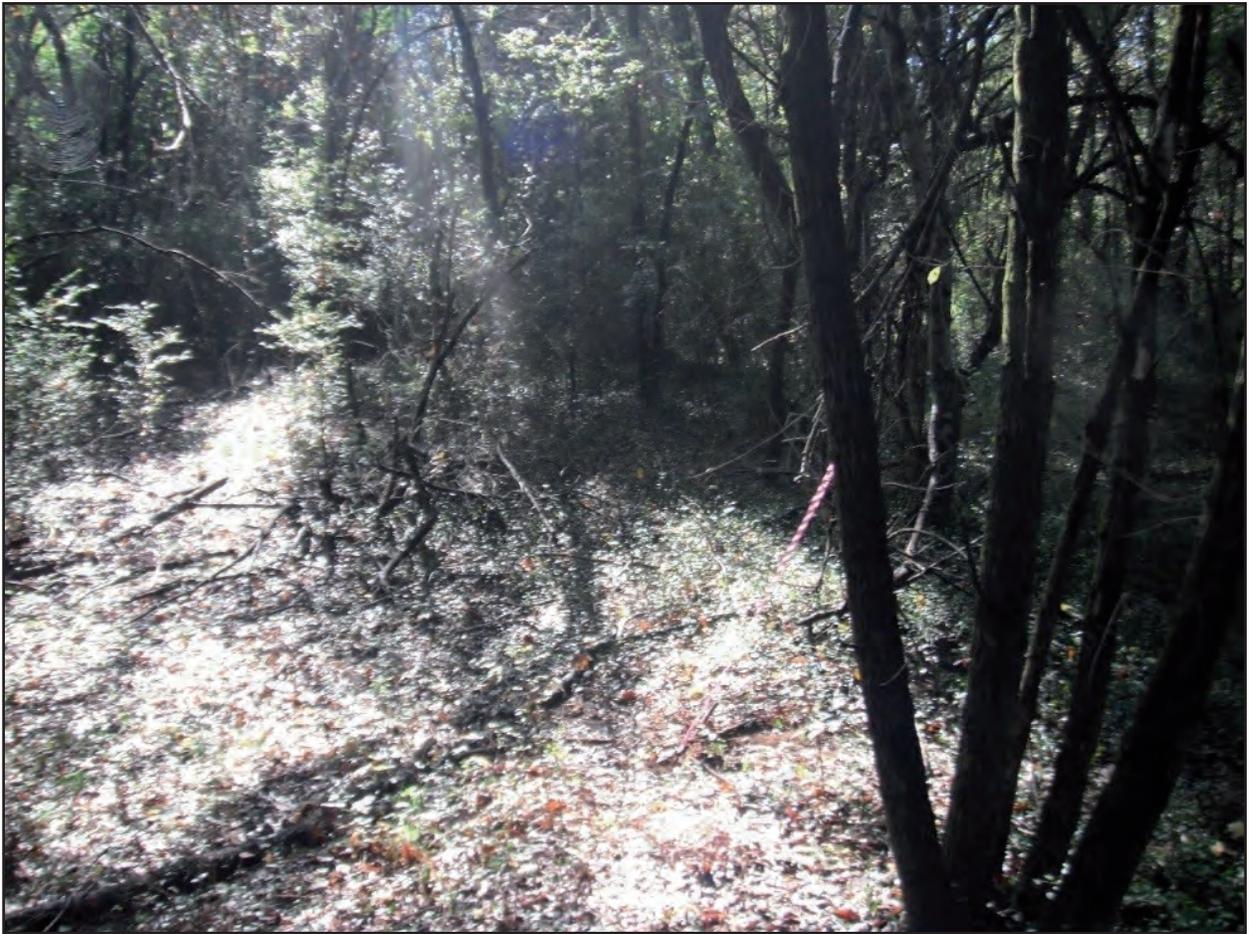
**Figure 4.5.** Photograph of Site 38SP410, facing northeast.

Archaeological investigation at Site 38SP410 indicates that this resource represents a low density artifact scatter associated with a short-term encampment dating to the general prehistoric period, as well as a historic artifact scatter associated with a small agricultural complex dating to the early

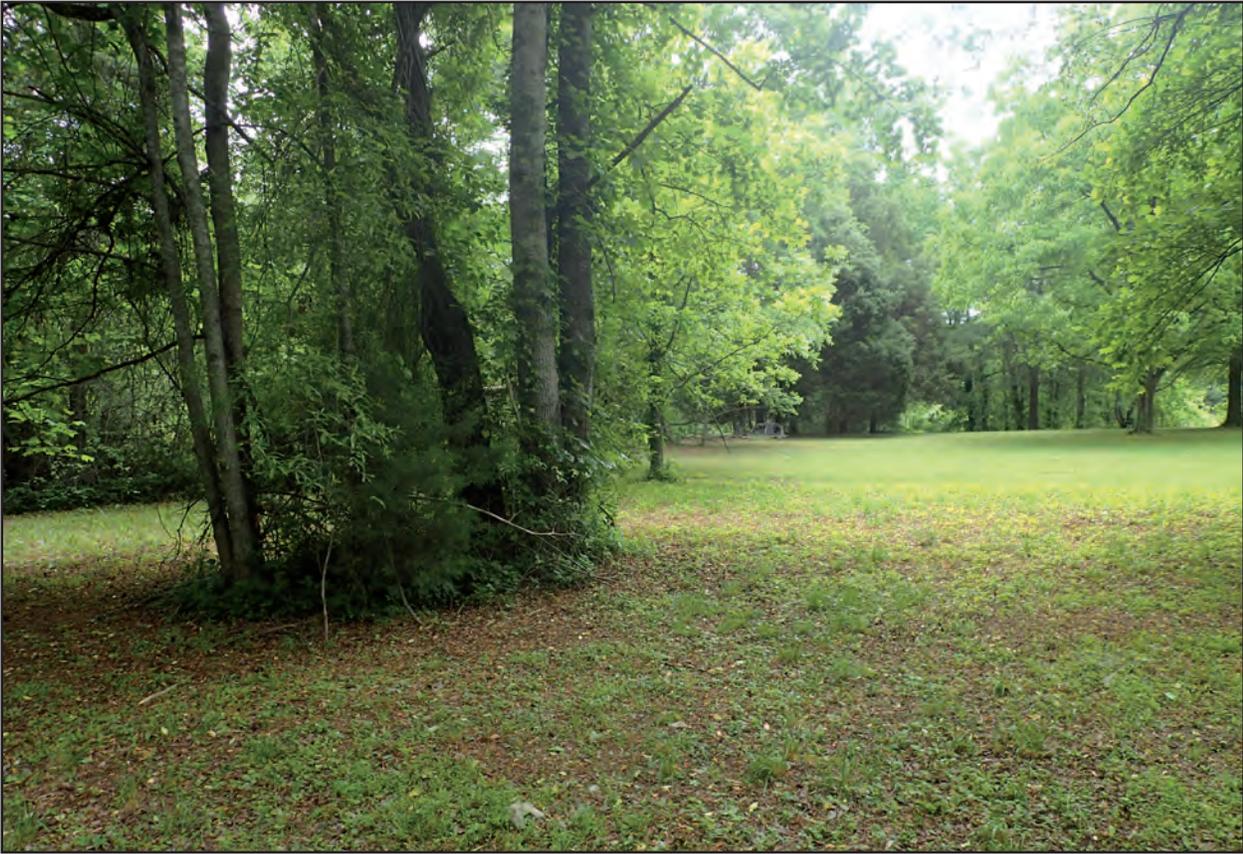
**Figure 4.8.** Photograph of Site 38CK198, facing southeast.

Site 38CK198 was identified within the southeastern quadrant of Area B, on a broad landform dissected by an unnamed drainage of Thicketty Creek (see Figure 4.7). The site represents a moderate-to-dense prehistoric artifact scatter that was likely occupied during the Archaic and Woodland Periods, based on the presence of diagnostic projectile points and pottery. Its setting is characterized by a manicured, rural lawn in the southern half of Site 38CK198 and intact forest in its northern half (Figure 4.8).

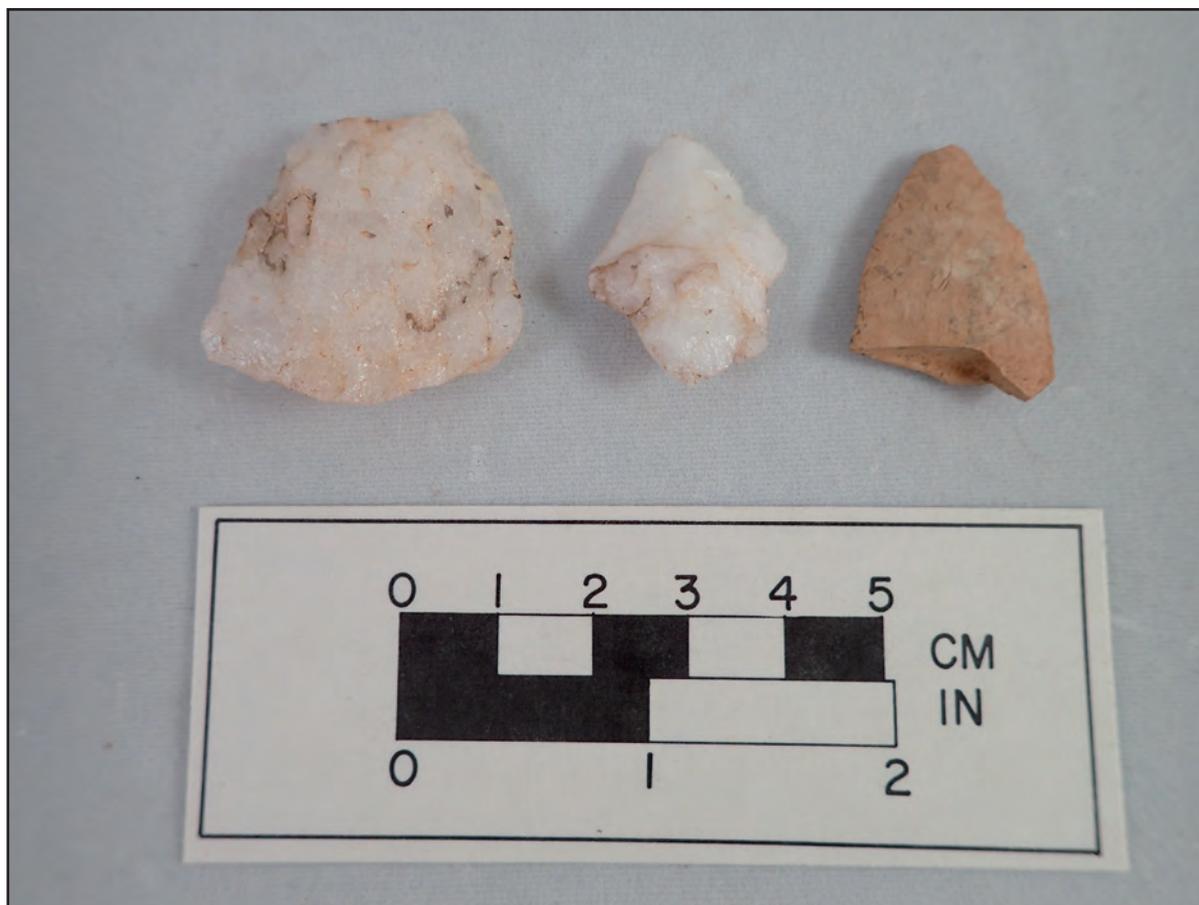
**Figure 4.10.** Left to right - 38CK198 - 15-3 biface fragment, -15-4 Morrow Mountain Type II, -50-4 PP/K tip.

There were 55 artifacts recovered from shovel tests at Site 38CK198, including lithic debitage (n=53) and bifaces (n=2) (Table 4.3). The majority of this material was non-diagnostic; however, one quartz biface was representative of a Morrow Mountain style projectile point/knife (PP/K) (Figure 4.10). Artifacts of this type are typically considered diagnostic of the Middle Archaic Period within a timeframe of between 5400 and 3500 B.C. (Benson et al. 2006). An additional quartz biface fragment was recovered within the same shovel test as the Morrow Mountain. This biface fragment appears to be the medial portion of a larger PP/K; however, it is impossible to type without the base or tip. The remainder of the assemblage from shovel tests at 38CK198 consisted of lithic debitage including quartz (n=48), rhyolite (n=4), and Coastal Plain chert (n=1). Quartz

The assemblage from the test units at Site 38CK198 was dominated by lithic material (n=311); however, one fragment of grit tempered pottery was also identified within TU 7, in the southern portion of the site (Table 4.4). The pottery was of diminutive (under 2 centimeters) size and was left unclassified due to the inability to identify its surface treatment. The pottery does appear to be grit tempered, which would typically associate it with a Woodland Period or later occupation. The remainder of the assemblage included lithic material of quartz (n=297), rhyolite (n=8), unclassified metavolcanic (n=4), Coastal Plain chert (n=1), and quartzite (n=1) material. As with the shovel tests, the majority of the material was quartz, including one biface fragment and three Stage 3 bifaces (Figure 4.10). The remainder of the quartz material was debitage and consisted of flake

fragments (n=261), bipolar flakes (n=3), retouched flakes (n=3), reduction flakes (n=3), and shatter (n=23). Rhyolite was the next most commonly encountered lithic material recovered during the excavation of test units at Site 38CK198. Items of this type include the tip of a PP/K (see Figure 4.10) and flake fragments (n=7). Other unclassified metavolcanic material was recovered from the units and included four flake fragments.

Site 38CK198 represents a relatively high density prehistoric artifact scatter; however, very few of the artifacts are temporally diagnostic. One quartz Morrow Mountain PP/K was the only truly diagnostic artifact recovered from the site and seems to indicate a Middle Archaic occupation. One diminutive fragment of grit tempered pottery was also recovered and, while it is not diagnostic of a specific period, it is indicative of a later occupation of the site as grit tempered pottery was

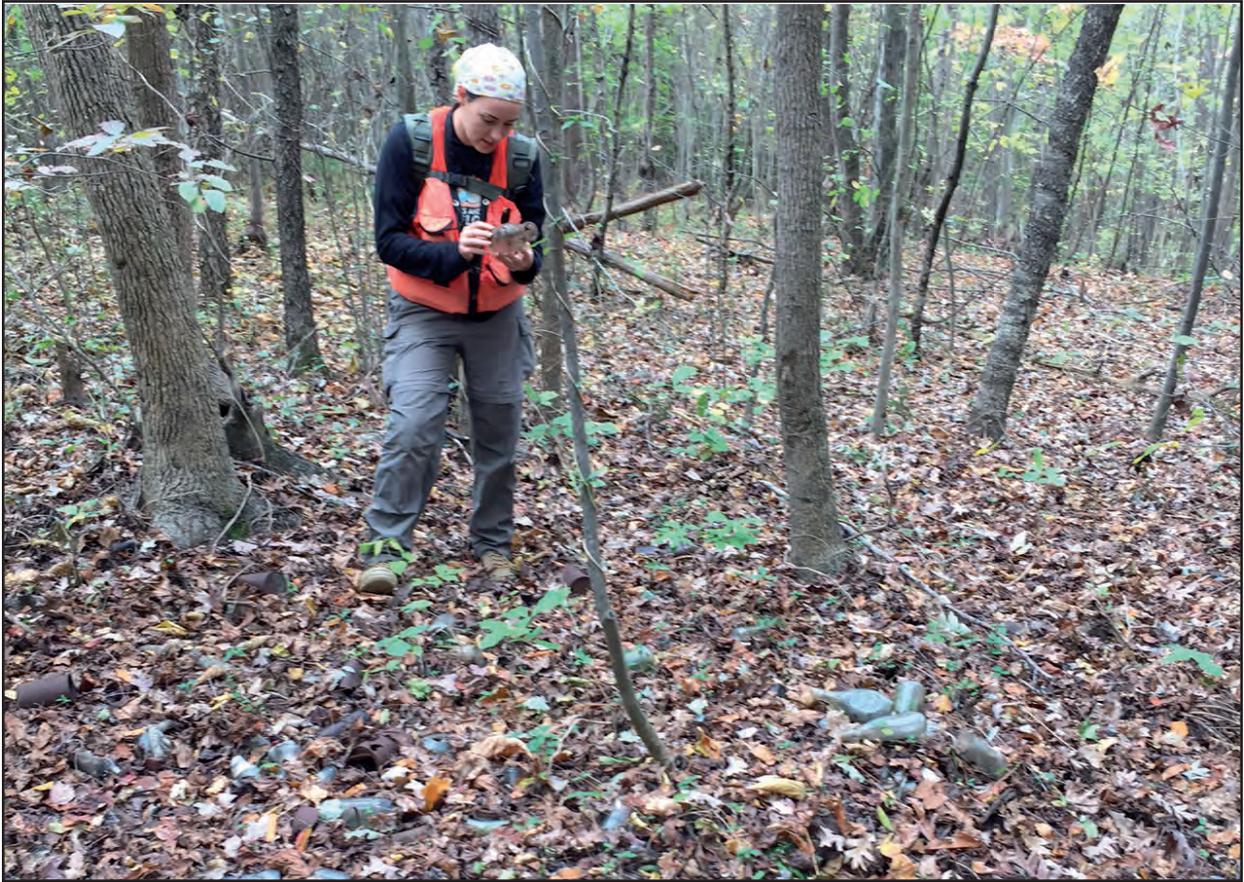
**Figure 4.13.** Photograph of 38CK81, facing northwest.

The boundaries of 38CK81 were significantly extended to measure 220-x-140 meters due to the historic artifact scatter identified on the surface and within shovel tests during the present study. Sixty shovel tests were dug at 15- and 30-meter intervals in order to firmly establish the boundaries of this resource, including one test that was positive. Testing was conducted at 15-meter intervals throughout the testable portion of the previously recorded boundaries of the site, around the positive shovel test, and in areas of heavy surface scatter. The new boundaries for 38CK81 were established by combining the limits of the historic artifact scatter and the original 1992 site boundary (see Figure 10). The boundaries of this surface scatter seem to conform to a cluster of two historic structures and associated outbuildings at 1131 and 1143 Wilcox Avenue. A representative soil profile revealed two strata: Stratum I (0-40 centimeters below surface) was a brown loamy sand and Stratum II (40-50 centimeters below surface) was a gray loam. Shovel tests were terminated at approximately 50 centimeters below surface when red clay hard pan was encountered.

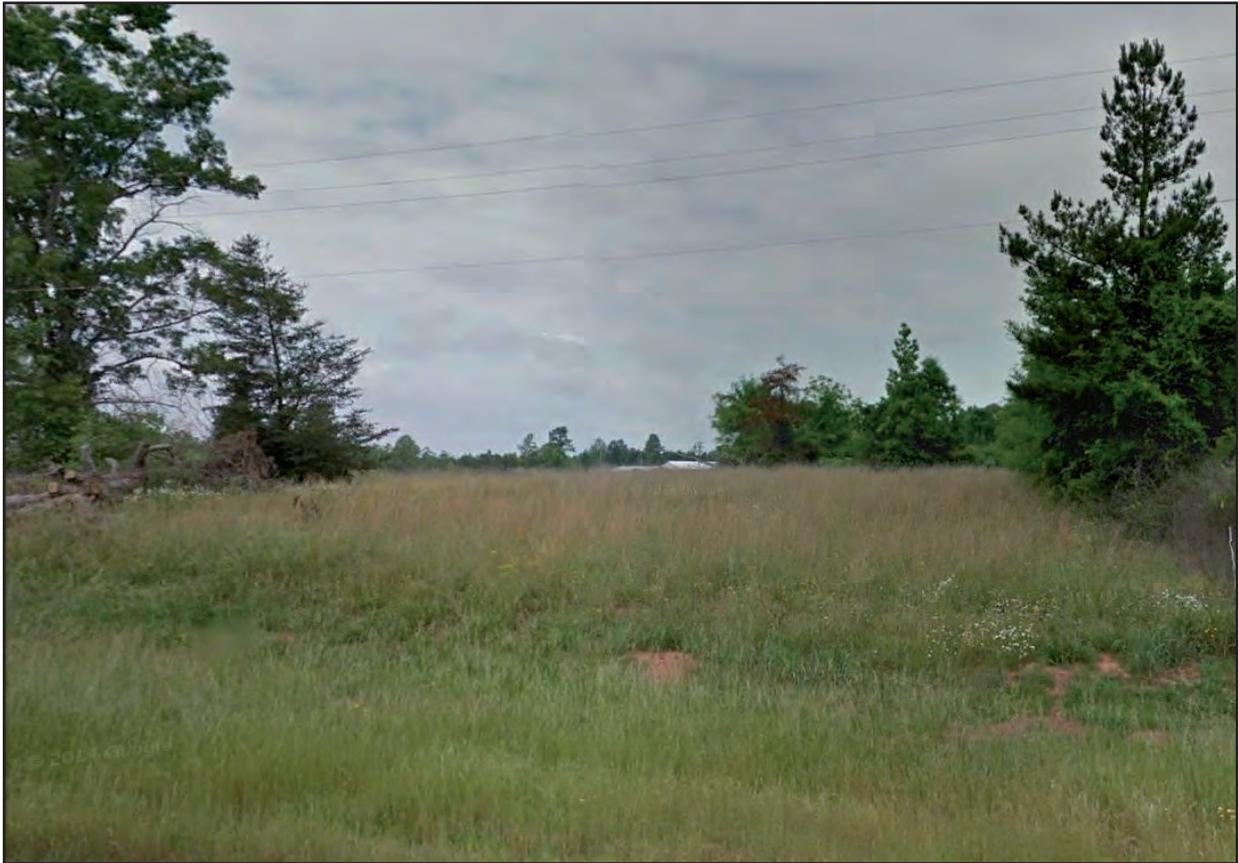
**Figure 4.17.** Photograph of 38CK82, facing southwest.

Presently, the site is located within a grass field (Figure 4.17), cleared of vegetation and the overgrown remains of the residential lot northeast of a former gas station at the corner of Lemuel Road and S-11-668 (see Figure 4.1g). The limits of the residence are clearly marked by the remains of a chain link fence. A concrete pad and the former privy were also identified within the fenced portion of the site (Figure 4.18). Sixty-four shovel tests were excavated at 15-meter intervals along transects spaced 15 meters apart in order to investigate this previously recorded site. Five shovel tests were positive for cultural material within the northwestern, central, and southern portions of the site; and a light surface scatter was identified within the fenced lot. Artifacts were identified between 0 and 30 centimeters below surface and artifact density ranged between 1 and 2 artifacts per positive shovel test. A representative soil profile from a centrally located shovel test revealed two Strata: Stratum I (0-30 centimeters below surface) was a grayish brown sandy loam and Stratum II (30-40 centimeters below surface) was a brown loamy sand. Clay hardpan was reached at 40 centimeters below surface and shovel tests were terminated.

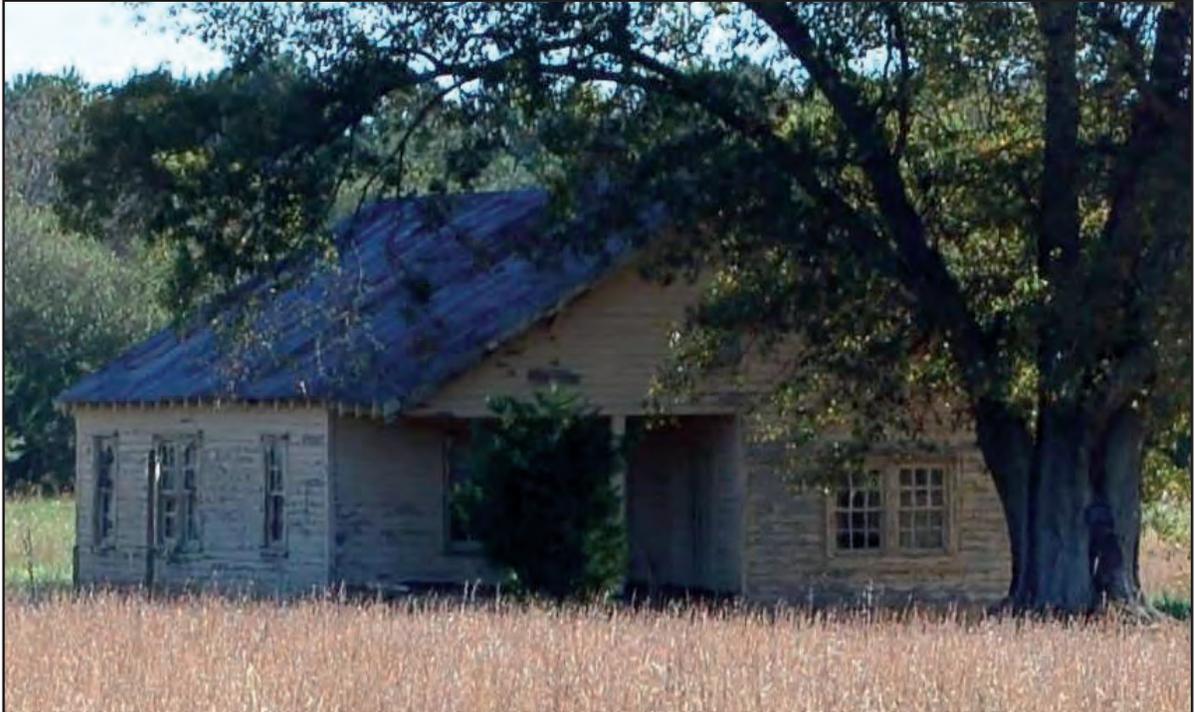
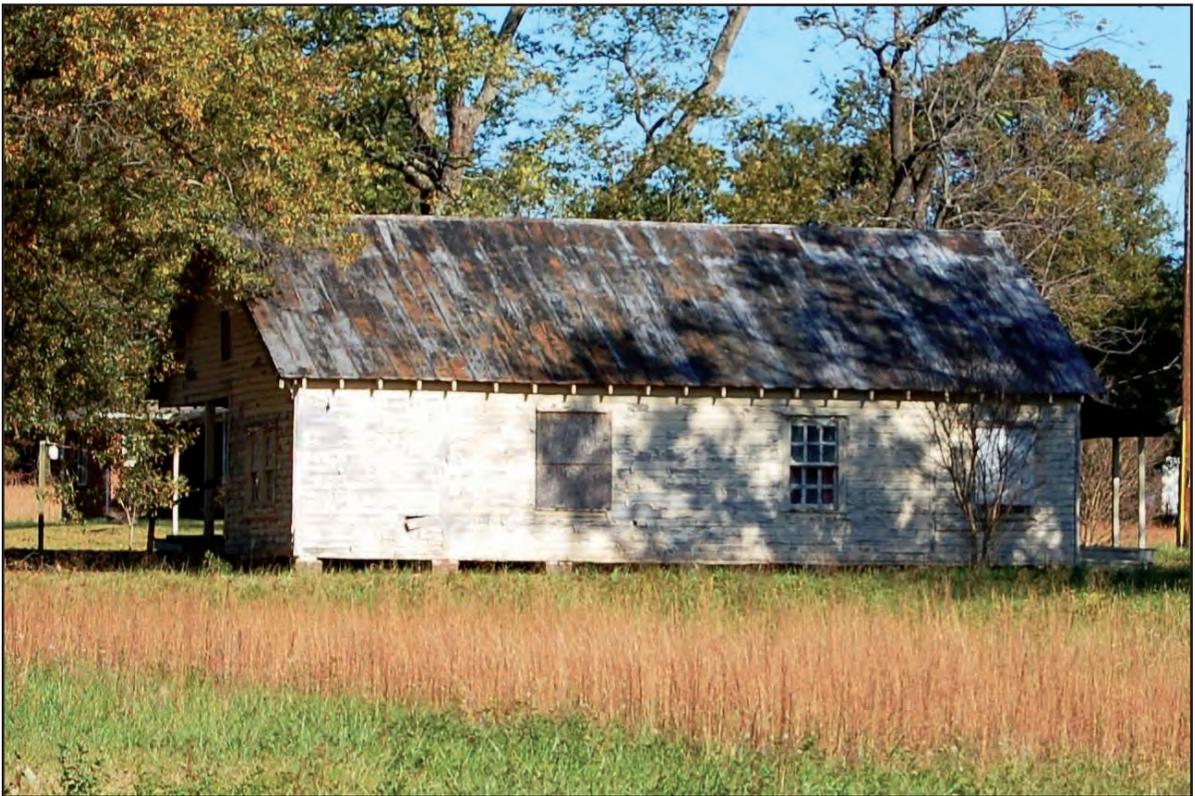
**Figure 5.3.** Resource 113-1056 (145 Vintage Drive) - Oblique view of façade and north side elevation facing southeast.

**Figure 5.4.** Resource 113-1056 (145 Vintage Drive) - View of south side elevations facing northeast.

Resource 113-1056 is located at 145 Vintage Drive on the east side of the roadway approximately 500 feet south of the intersection of Vintage Drive and Dewberry Road northwest of Cowpens in Spartanburg County (refer to Figure 5.2a). The Spartanburg County tax assessor’s record does not have an estimated date of construction for the resource. Based on a review of historic topographic maps and an evaluation of the resource’s form and construction materials, Resource 113-1056 appears to have been constructed ca. 1925. The resource is depicted in its current location on the oldest aerial photography available on the [www.historicaerials.com](http://www.historicaerials.com) website dated 1955. The resource is a one-story, asymmetric, front-gabled bungalow of frame construction. The house features a front-gabled metal roof with exposed rafter ends; weatherboard exterior siding; a brick pier foundation; a partial-width, an integral recessed entry porch on the façade; and single and paired original wood-framed 6/6 light double-hung sash windows (see Figures 5.3 and 5.4). The house is currently vacant and unoccupied and the land historically associated with the resource is no longer used for agricultural purposes and has been greatly reduced by the original construction and subsequent larger redesign of the I-85 at Gossett Road interchange immediately southwest of the resource.

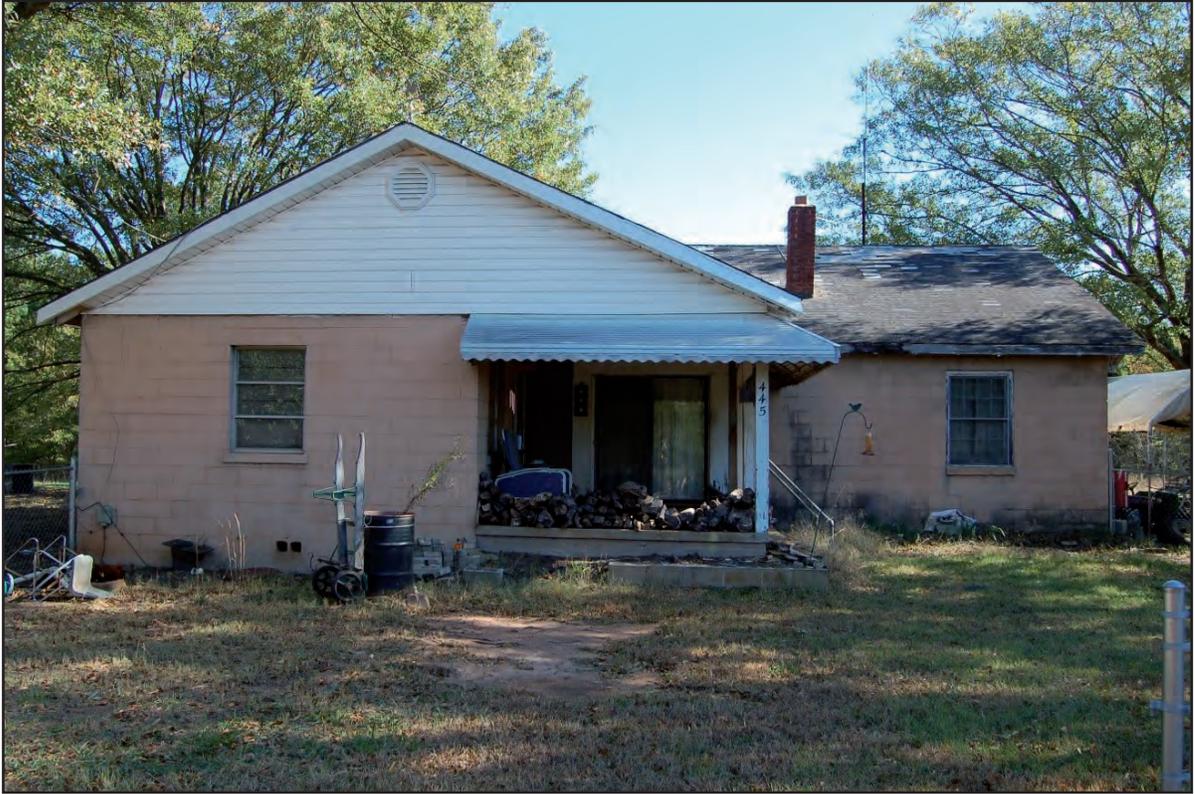
**Figure 5.5.** Resource 113-1057 (445 Rupe Easler Drive) - Oblique view of façade and north side elevation facing southeast.

Resource 113-1057 is located at 445 Rupe Easler Drive on the east side of the roadway approximately 700 feet north of the intersection of Rupe Easler Drive and Vintage Drive northwest of Cowpens in Spartanburg County (refer to Figure 5.2a). The Spartanburg County tax assessor’s record has a 1948 estimated date of construction for the resource. This estimated date of construction was supported by the review of historic topographic maps and an evaluation of the resource’s

form and construction materials. The resource was depicted in its current location on the earliest aerial photograph available on the [www.historicaerials.com](http://www.historicaerials.com) website dated 1955. The resource is a one-story, asymmetric, cross-gabled bungalow of concrete block load-bearing wall construction. The house features a cross-gabled asphalt shingle roof; two square brick interior roof surface chimneys; a partial-width, integral recessed porch with a wrap-around metal awning on the facade; and concrete block, flush board, and vinyl exterior siding (see Figures 5.5 and 5.6). The flush board siding is in the gable ends and the gable on the facade has had vinyl siding applied. There is a sliding glass door on the facade used as the primary entrance and the remaining windows are a mix of metal awning and 8/8 light wood-framed double-hung sash.

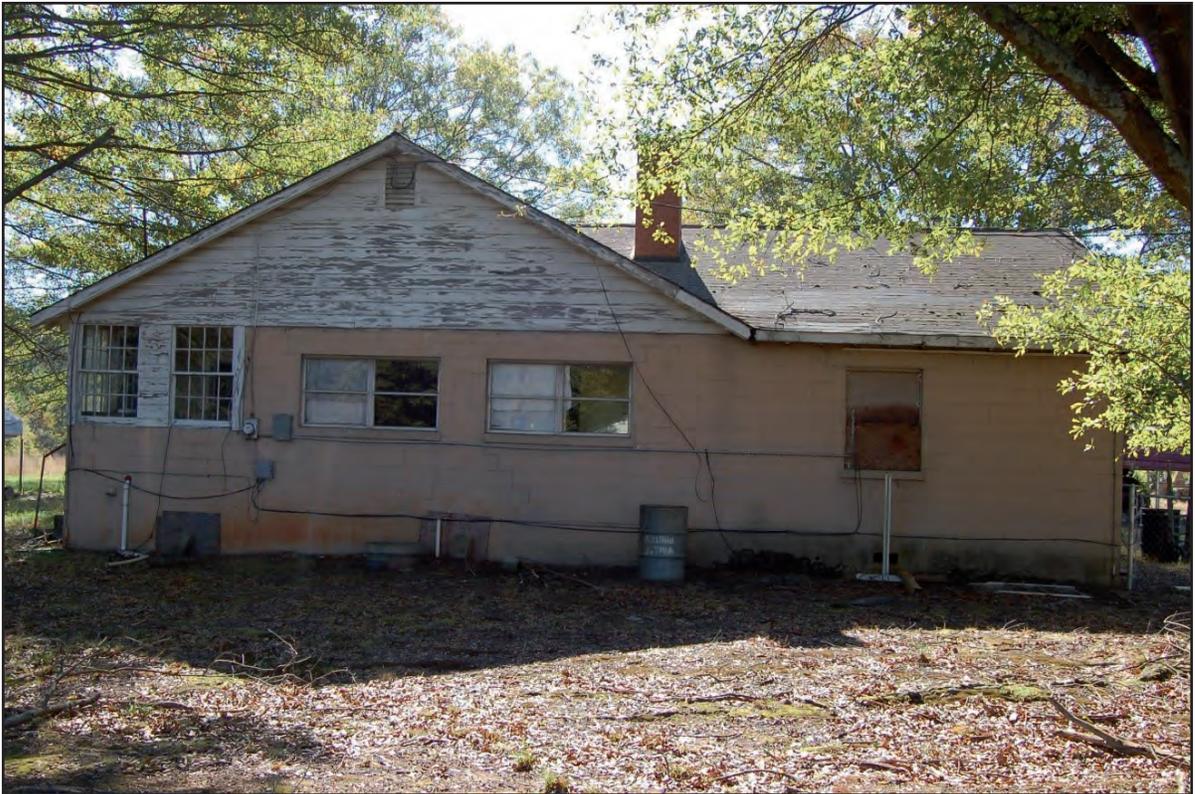
**Figure 5.6.** Resource 113-1057 (445 Rupe Easler Drive) - View of north side elevation facing south.

non-historic replacement; and a narrow, full-width, shed-roofed addition has been constructed on the rear elevation (see Figures 5.7 and 5.8).

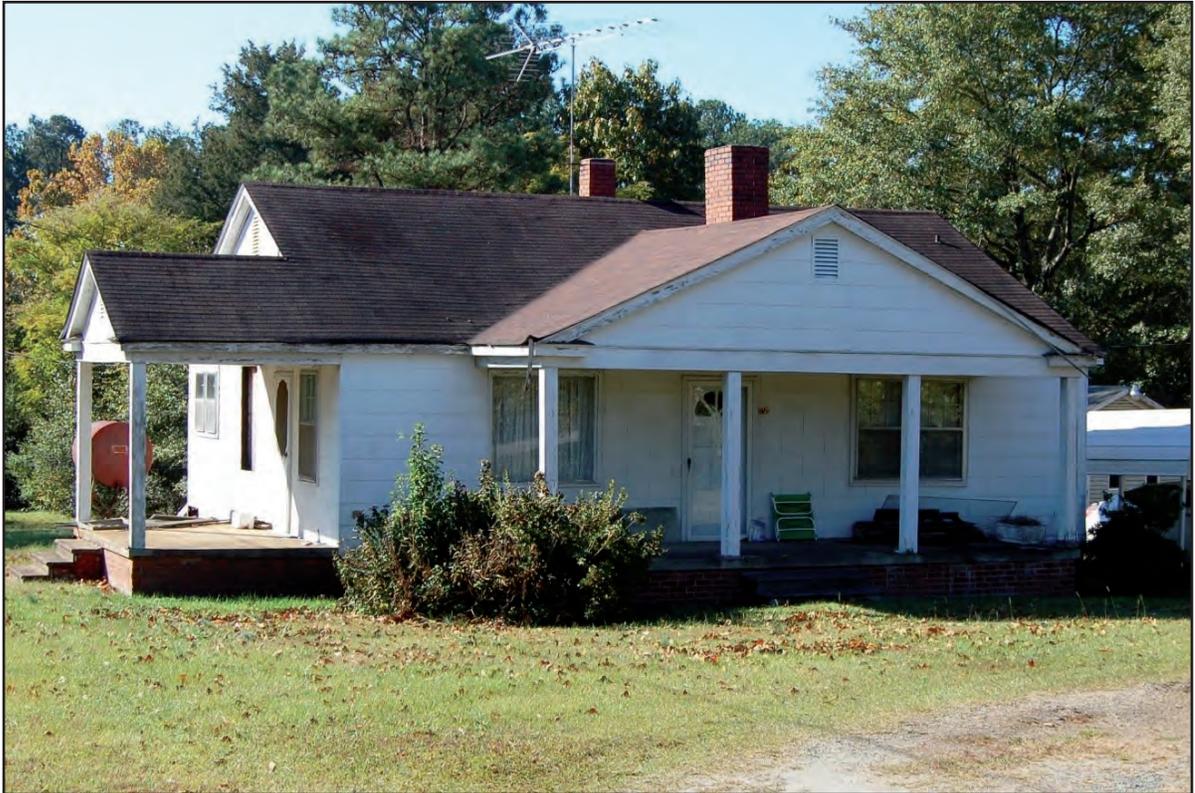
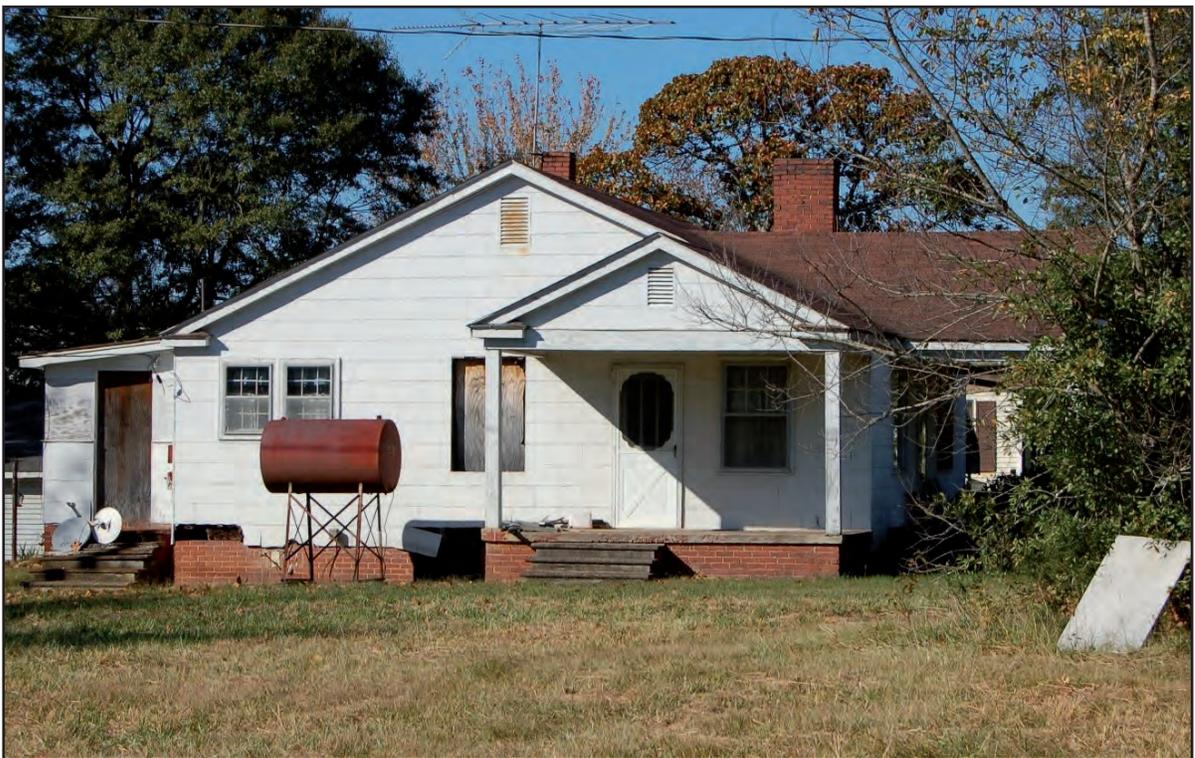
**Figure 5.7.** Resource 113-1058 (1759 Dewberry Road) – View of façade facing southwest.

**Figure 5.8.** Resource 113-1058 (1759 Dewberry Road) – View of east side elevation facing southwest.

Resource 113-1058 is located at 1759 Dewberry Road on the south side of the roadway in the southeast corner of the intersection of Dewberry Road and Courtney Louise Lane northwest of Cowpens in Spartanburg County (refer to Figure 5.2a). The Spartanburg County tax assessor's record has a 1940 date of construction for the resource. This estimated date of construction is supported by the depiction of the resource in its current location on the oldest aerial photography available on the [www.historicaerials.com](http://www.historicaerials.com) website dated 1955. The resource is a one-story, asymmetric, cross-gabled bungalow of frame construction. The house features a cross-gabled asphalt shingle roof; two square brick interior roof surface chimneys; a continuous brick foundation; a partial-width, projecting gable-roofed porch supported by four square posts on the facade; a small projecting gable-roofed entry porch supported by two square posts on the east side elevation; and concrete asbestos tile exterior siding. There is a square picture window on the east side of the facade and the remaining windows are original single and paired wood-framed 6/6-light double-hung sash of various sizes. The front door is a non-historic replacement; a window opening on the east side elevation has been enclosed with plywood; the picture window on the facade is a

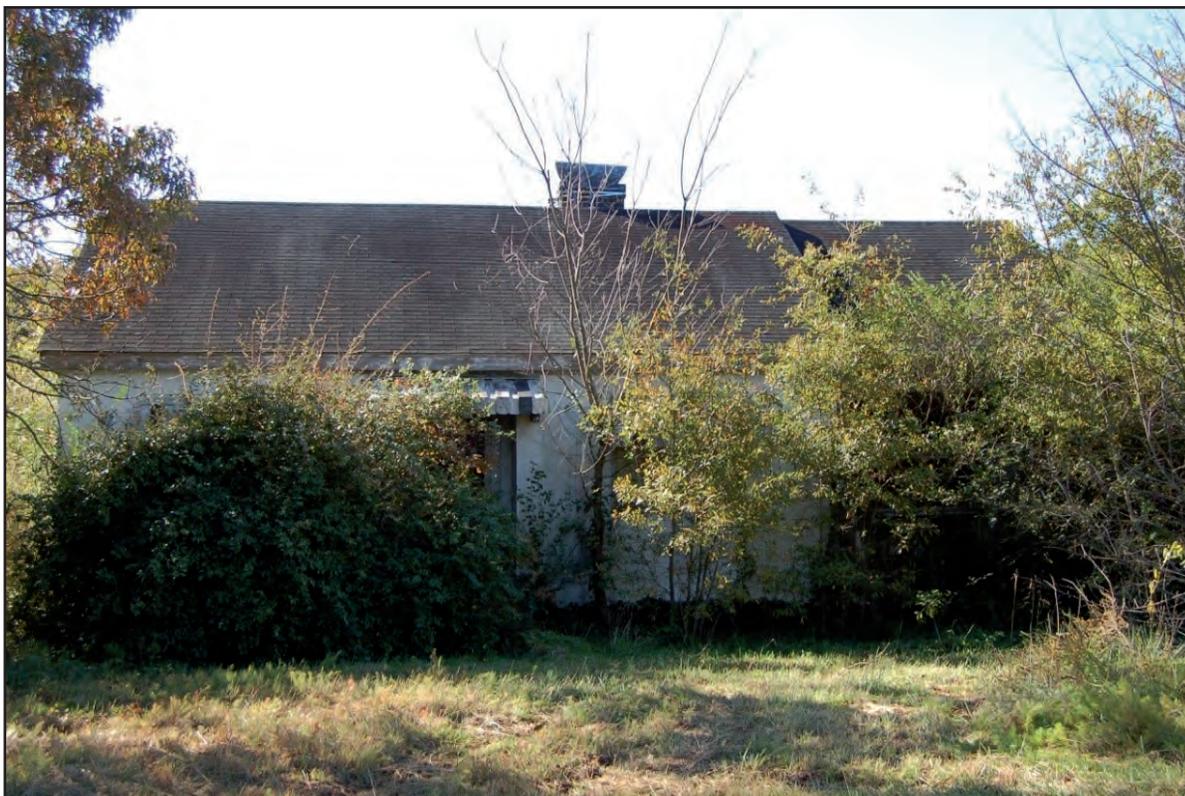
**Figure 5.9.** Resource 113-1059 (1701 Dewberry Road) – Obscured view of façade facing south.

Resource 113-1059 is located at 1701 Dewberry Road on the south side of the roadway directly opposite the intersection of Dewberry Road and Whitlock Drive northwest of Cowpens in Spartanburg County (refer to Figure 5.2a). The Spartanburg County tax assessor's record does not have an estimated date of construction for the resource. The earliest aerial photograph available on the www.historicaerials.com does not depict the resource. Based on a review of historic topographic maps and an evaluation of the resource's form and construction materials, Resource 113-1059 appears to have been constructed ca. 1955. The resource is a one-story, asymmetric, side-gabled cottage of frame construction. The house features a steeply-pitched, side-gabled asphalt shingle roof; a small brick interior roof surface chimney near the ridge; and concrete asbestos tile exterior siding (see Figure 5.9). The building is vacant and has dense vegetation growing on or very near on all sides so that many features could not be observed. The door and windows on the façade have metal awnings above them.

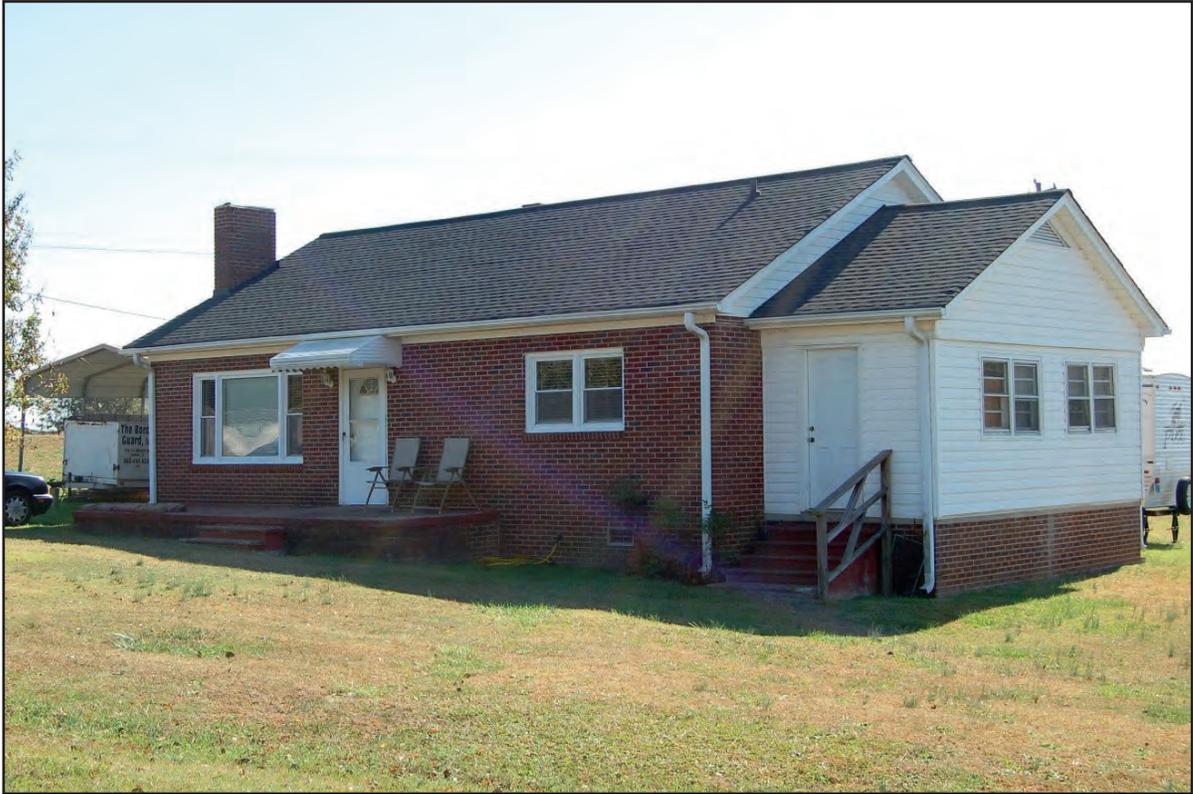
**Figure 5.10.** Resource 113-1060 (120 Conway Black Road) – Oblique view of façade and west side elevation facing southeast.

Resource 113-1060 is located at 120 Conway Black Road on the north side of the roadway approximately 0.21 mile east of the intersection of Conway Black Road and Gossett Road northwest of Cowpens in Spartanburg County (refer to Figure 5.2a). The Spartanburg County tax assessor's record has a 1949 estimated date of construction for the resource. This estimated date of construction was supported by the review of historic topographic maps and an evaluation of the resource's form and construction materials. The resource was depicted in its current location on the earliest aerial photograph available on the [www.historicaerials.com](http://www.historicaerials.com) website dated 1955. The resource is a one-story, asymmetric, side-gabled residence of no defined academic type without stylistic features. The house features a side-gabled asphalt shingle roof; an exterior end wall brick slab chimney on the east side elevation; a small brick interior roof surface chimney on the rear elevation; an open partial-width, patio/porch on the façade; an enclosed former porch on the west side elevation; and brick and vinyl exterior siding. There is a tripartite window comprised of a large square fixed light flanked by 1/1-light double-hung sash windows on the façade and the remaining windows are 1/1 and 2/2 light double-hung sash of various sizes (refer to Figure 5.10). All of the windows appear to be non-historic replacements.

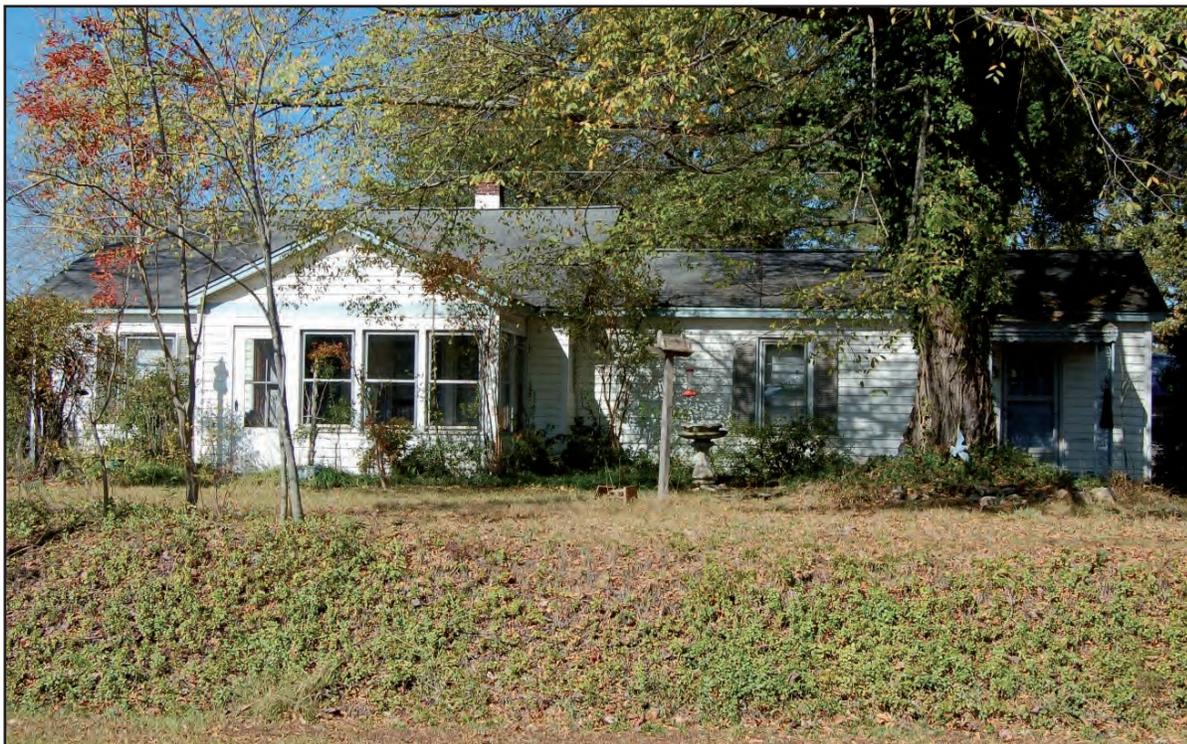
The resource is not known to be associated with a significant activity or event and there is not a known connection between the resource and any individual whose activities or achievements are historically significant. Therefore, there was no basis for evaluating the resource under Criterion A or B. Also, there is no indication that the resource is likely to yield information on important research questions in history or prehistory. The resource does not appear to have the potential to be the principal source of important information. Therefore, there was no basis for evaluating the resource under Criterion D. The resource does not represent a recognized architectural type or style and does not otherwise appear to represent a significant trend in South Carolina's architectural history. Additionally, due to the construction of the addition and the enclosure of the projecting gable-roofed porch on the façade, the resource has lost integrity in the areas of design, materials, and feeling and cannot convey significance in the area of architecture. Therefore, Resource 113-1061 is recommended **Not Eligible** for listing in the NRHP under Criterion C in the area of architecture.

**Figure 5.11.** Resource 113-1061 (830 Dewberry Road) – View of façade facing north.

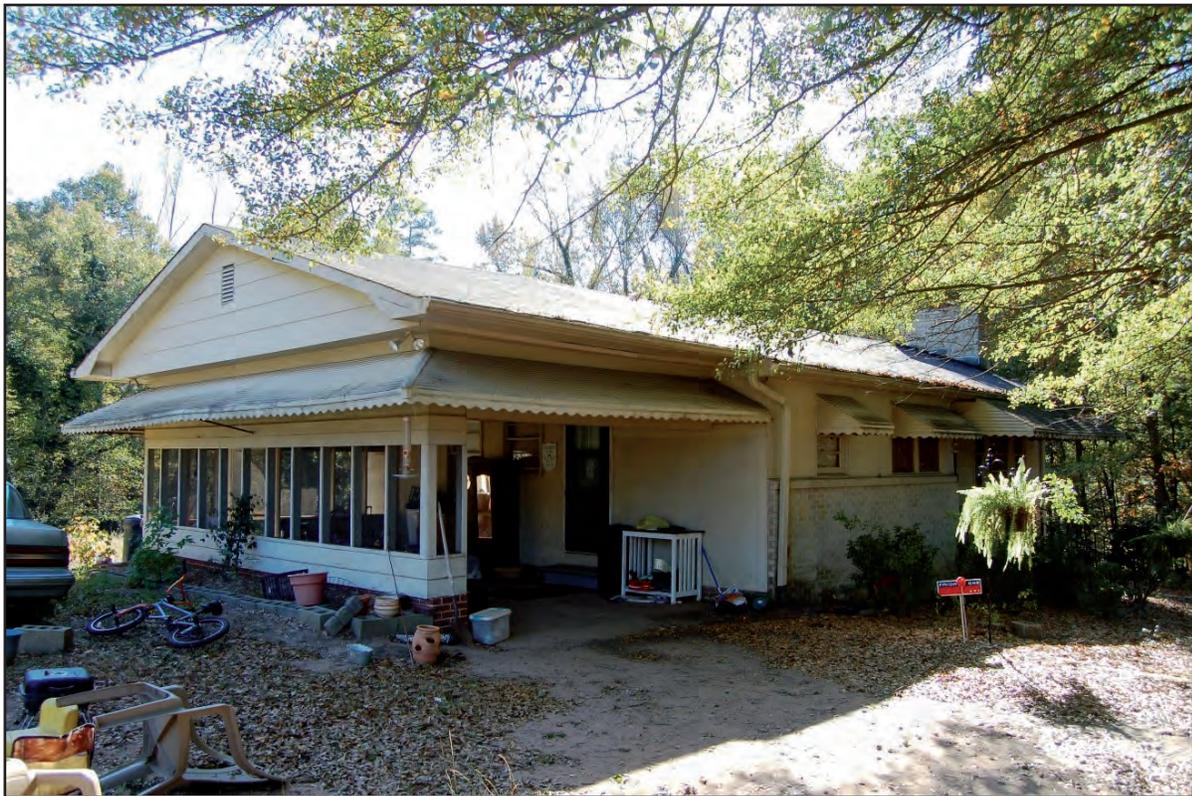
**Figure 5.13.** Resource 113-1062 (305 Bud Arthur Bridge Road) – Oblique view of façade and east side elevation facing southwest

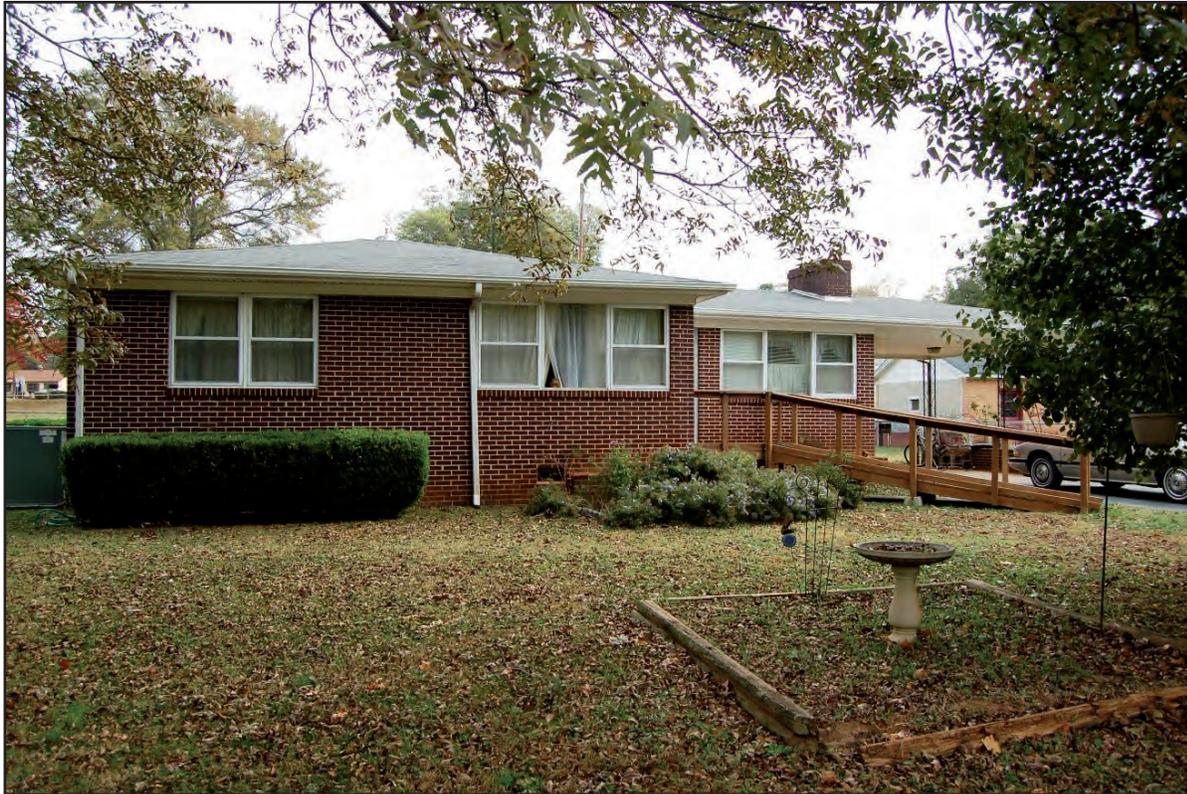
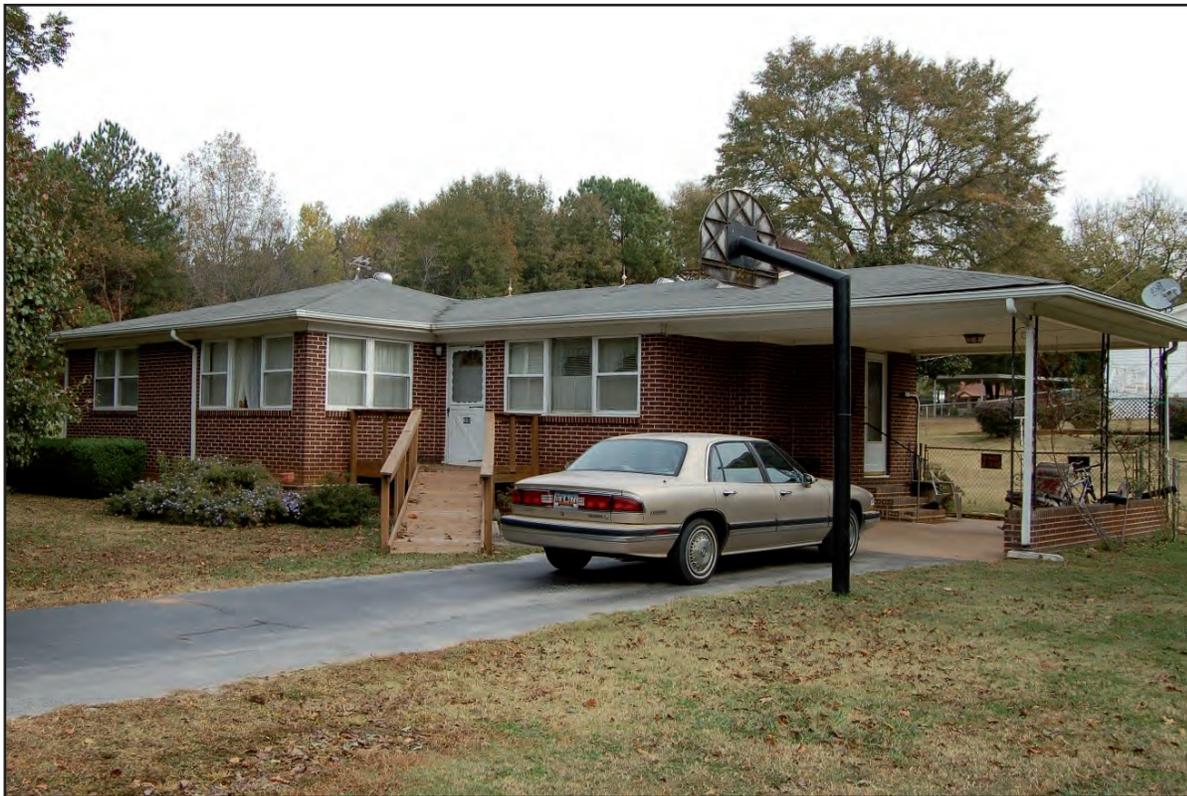
**Figure 5.14.** Resource 113-1063 (480 Battleground Road) – View of façade facing east.

**Figure 5.15.** Resource 113-1063 (480 Battleground Road) – Oblique view of façade and south side elevation facing northeast.

Resource 113-1063 is located at 480 Battleground Road on the east side of the roadway in the southeast quadrant of the intersection of Battleground Road and Bud Arthur Bridge Road north of Cowpens in Spartanburg County (refer to Figure 5.2a). The Spartanburg County tax assessor's record has a 1960 estimated date of construction for the resource. This estimated date of construction was supported by the review of historic topographic maps and aerial photography, and an evaluation of the resource's form and construction materials. The resource is not depicted in its current location on the earliest aerial photograph available on the [www.historicaerials.com](http://www.historicaerials.com) website dated 1955 or on the earliest USGS topographic map available on the <http://viewer.nationalmap.gov/viewer/> website dated 1959. The house features a hipped asphalt shingle roof with wide eaves;
