**PHASE I CULTURAL RESOURCE SURVEY FOR PROPOSED  
WIDENING OF INTERSTATE 85 FROM MILE MARKER 80 TO 96,  
CHEROKEE AND SPARTANBURG COUNTIES, SOUTH CAROLINA.**

**FINAL REPORT**

**JULY 2015**

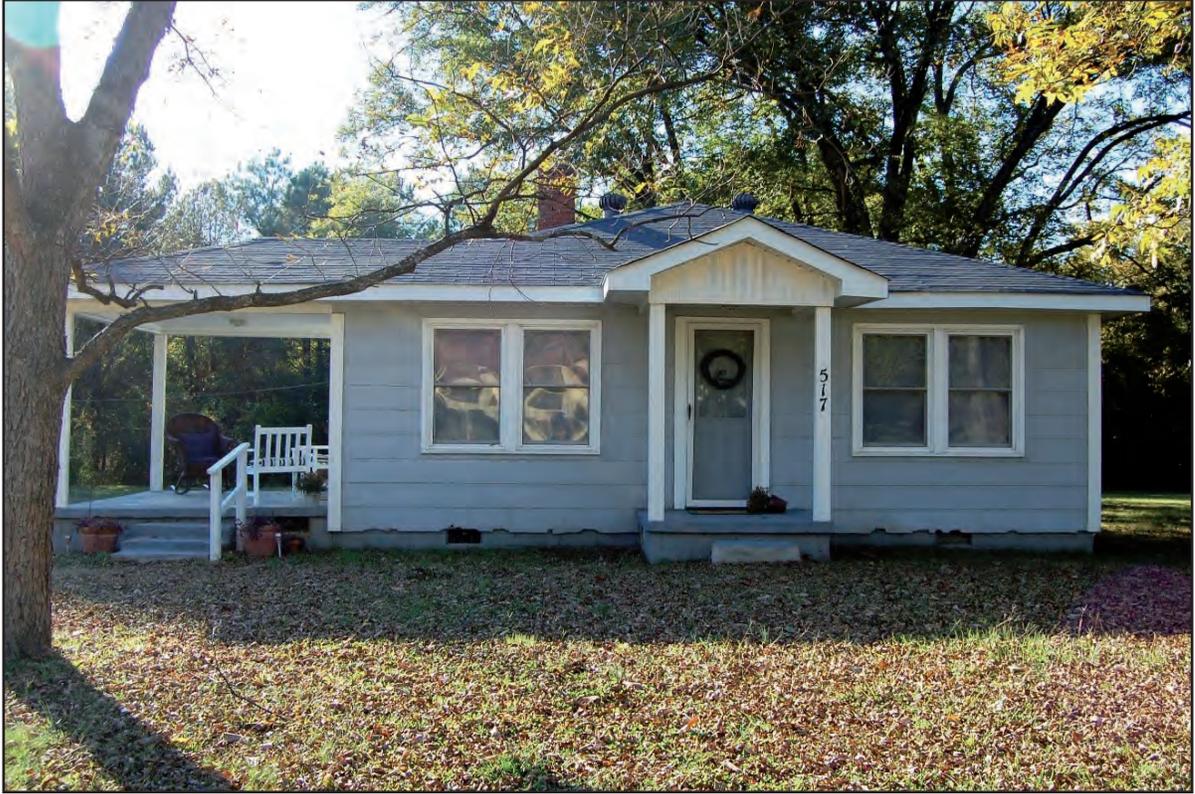
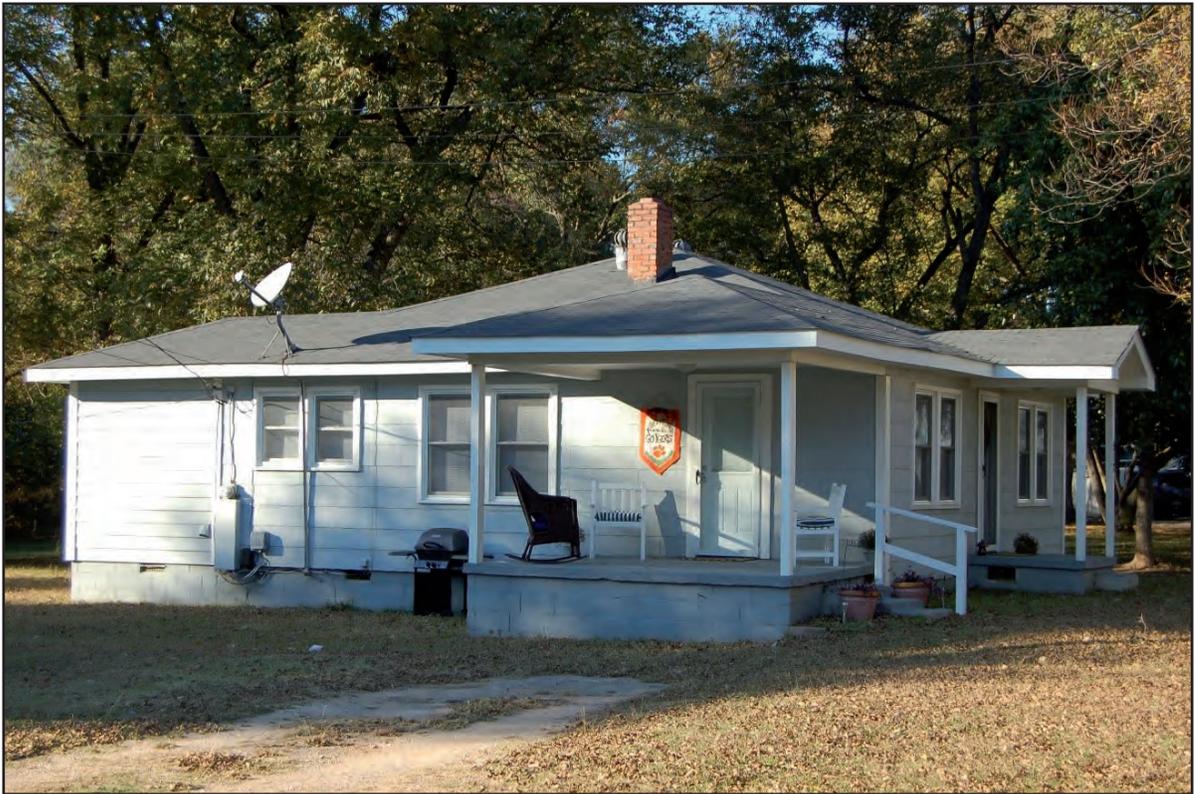
**Figure 5.16.** Resource 113-1064 (517 Edgefield Road) – View of façade facing west.

**Figure 5.17.** Resource 113-1064 (517 Edgefield Road) – Oblique view of façade and south side elevation facing northwest.

Resource 113-1064 is located at 517 Edgefield Road on the west side of the roadway approximately 140 feet north of the intersection of Edgefield Road and Bud Arthur Bridge Road north of Cowpens in Spartanburg County (refer to Figure 5.2a). The Spartanburg County tax assessor's record has a 1940 estimated date of construction for the resource. This estimated date of construction was supported by the review of historic topographic maps and aerial photography, and an evaluation of the resource's form and construction materials. The resource is depicted in its current location on the earliest aerial photograph available on the [www.historicaerials.com](http://www.historicaerials.com) website dated 1955 and on the earliest USGS topographic map available on the <http://viewer.nationalmap.gov/viewer/> website dated 1959. The resource is a one-story, asymmetric, hipped-roof cottage of frame construction. The house features a hipped asphalt shingle roof; a small brick interior roof surface chimney in the rear roof slope; a projecting gable-roofed stoop entry porch supported by two square posts on the façade; a partial-width, projecting, hipped-roofed porch supported by two square posts on the south side elevation; and concrete asbestos tile exterior siding (see Figures 5.16 and 5.17). The windows on the resource are single and paired metal-framed 1/1-light double-hung sash non-historic replacement windows of various sizes.

The resource is not known to be associated with a significant activity or event and there is not a known connection between the resource and any individual whose activities or achievements are historically significant. Therefore, there was no basis for evaluating the resource under Criterion A or B. Also, there is no indication that the resource is likely to yield information on important research questions in history or prehistory. The resource does not appear to have the potential to be the principal source of important information. Therefore, there was no basis for evaluating the resource under Criterion D. The resource does not represent a recognized architectural type or style and does not otherwise appear to represent a significant trend in South Carolina's architectural history. Additionally, due to the apparent replacement of all original windows it has lost integrity in the areas of materials and feeling and cannot convey significance in the area of architecture. Therefore, Resource 113-1064 is recommended **Not Eligible** for listing in the NRHP under Criterion C in the area of architecture.

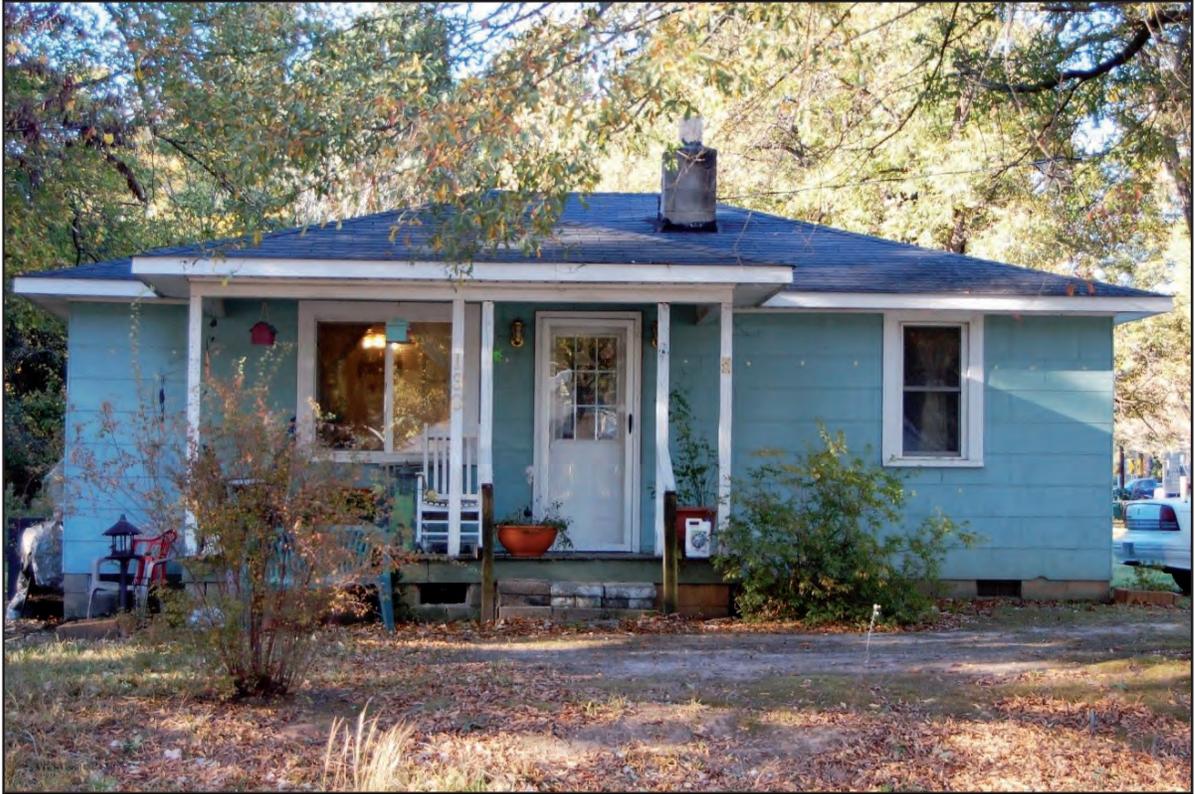
**Figure 5.18.** Resource 113-1065 (130 Bud Arthur Bridge Road) – View of façade facing north.

Resource 113-1065 is located at 130 Bud Arthur Bridge Road on the north side of the roadway approximately 125 feet west of the intersection of Bud Arthur Bridge Road and Edgefield Road north of Cowpens in Spartanburg County (refer to Figure 5.2a). The Spartanburg County tax assessor's record has a 1956 estimated date of construction for the resource. This estimated date of construction was supported by the review of historic topographic maps and aerial photography, and an evaluation of the resource's form and construction materials. The resource is not depicted in its current location on the earliest aerial photograph available on the [www.historicaerials.com](http://www.historicaerials.com) website dated 1955. The resource is a one-story, asymmetric, hipped-roof cottage of frame construction. The house features a hipped asphalt shingle roof; a small stuccoed brick interior roof surface chimney within the front roof slope; a projecting hipped-roofed entry porch supported by three square posts on the façade; and concrete asbestos tile exterior siding (see Figures 5.18 and 5.19). There is a large two-light sliding glass window on the façade and the remaining windows are 1/1 double-hung sash. The windows on the resource are metal-framed non-historic vinyl replacements.

The resource is not known to be associated with a significant activity or event and there is not a known connection between the resource and any individual whose activities or achievements are historically significant. Therefore, there was no basis for evaluating the resource under Criterion A or B. Also, there is no indication that the resource is likely to yield information on important research questions in history or prehistory. The resource does not appear to have the potential to be the principal source of important information. Therefore, there was no basis for evaluating the resource under Criterion D. The resource does not represent a recognized architectural type or style and does not otherwise appear to represent a significant trend in South Carolina's architectural history. Additionally, due to the apparent replacement of all original windows it has

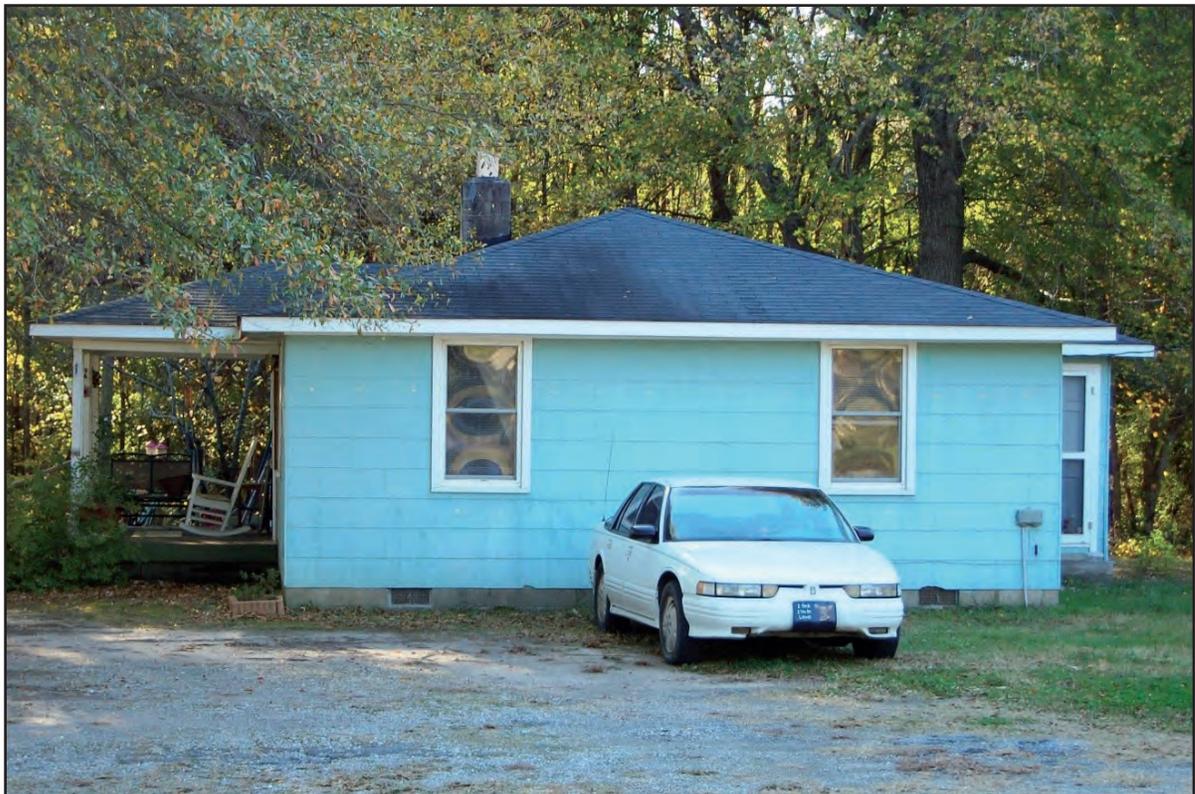
**Figure 5.19.** Resource 113-1065 (130 Bud Arthur Bridge Road) - View of east side elevation facing west.

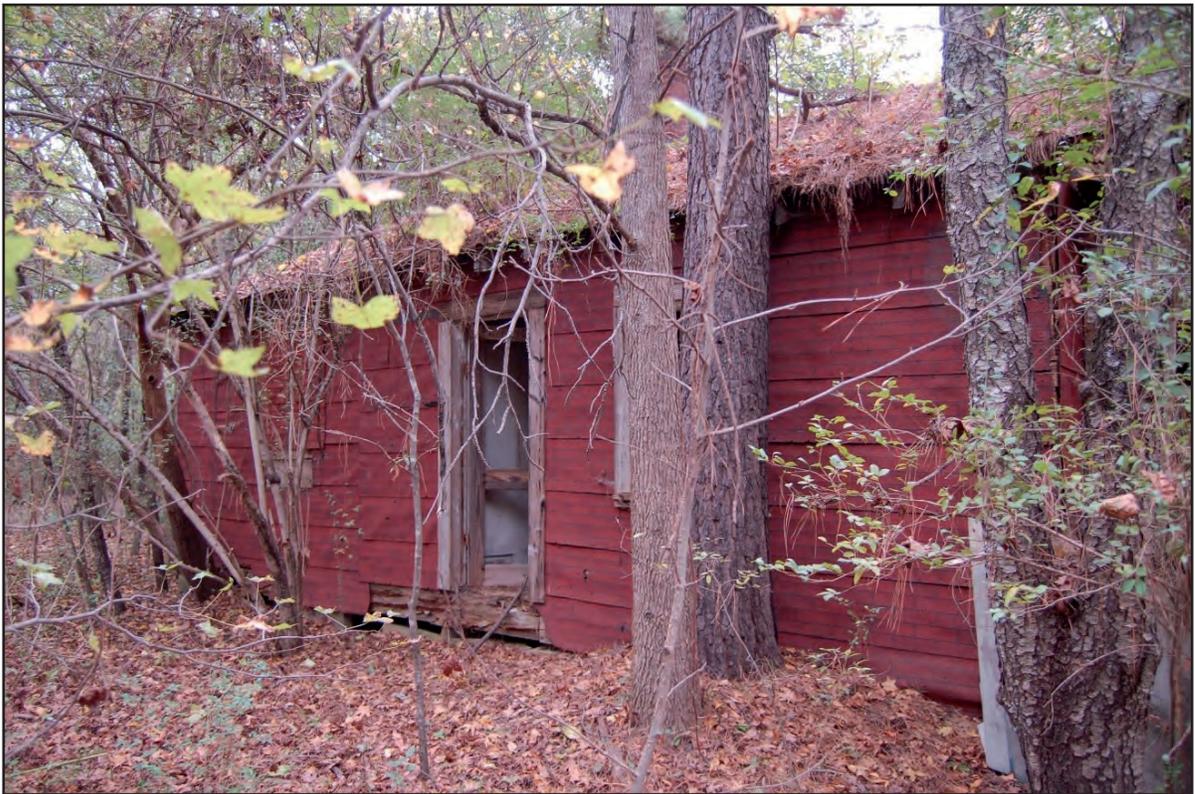
**Figure 5.21.** Resource 113-1066 (Bud Arthur Bridge Road) – Oblique view of rear elevation facing northeast.

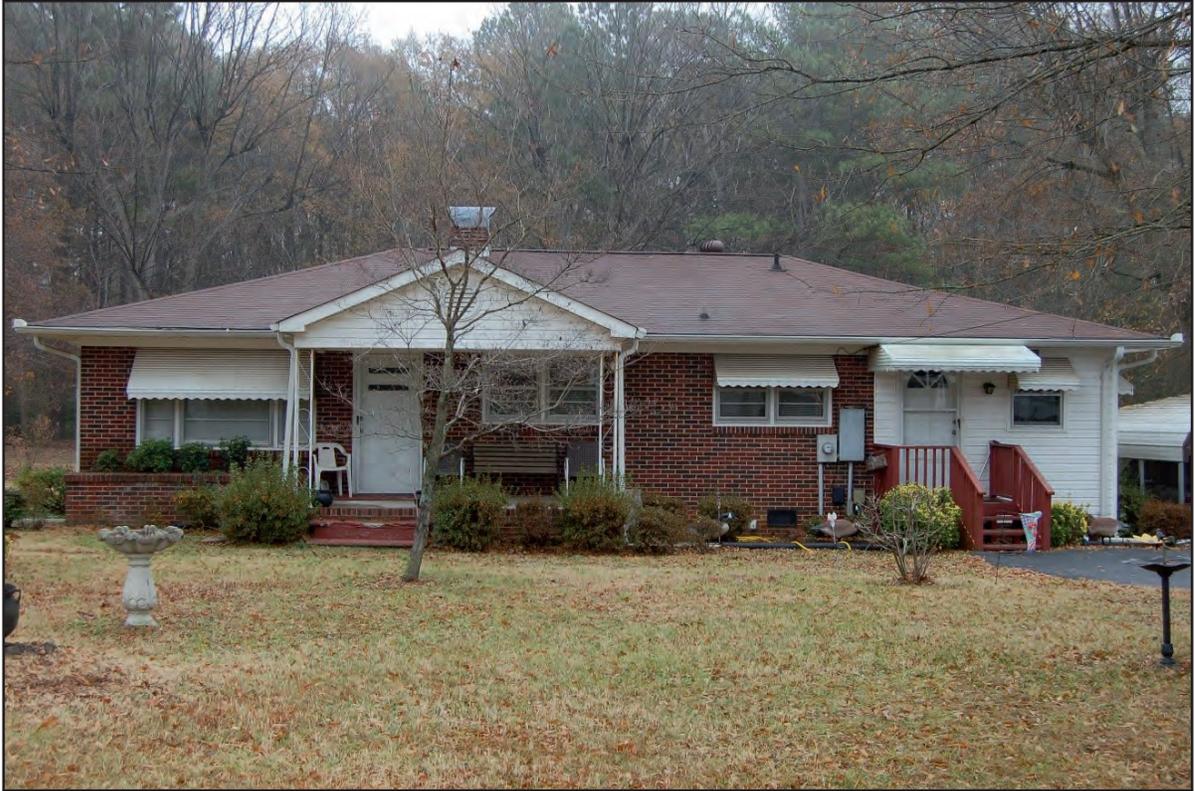
**Figure 5.22.** Resource 113-1067 (480 Edgefield Road) - View of façade facing east.

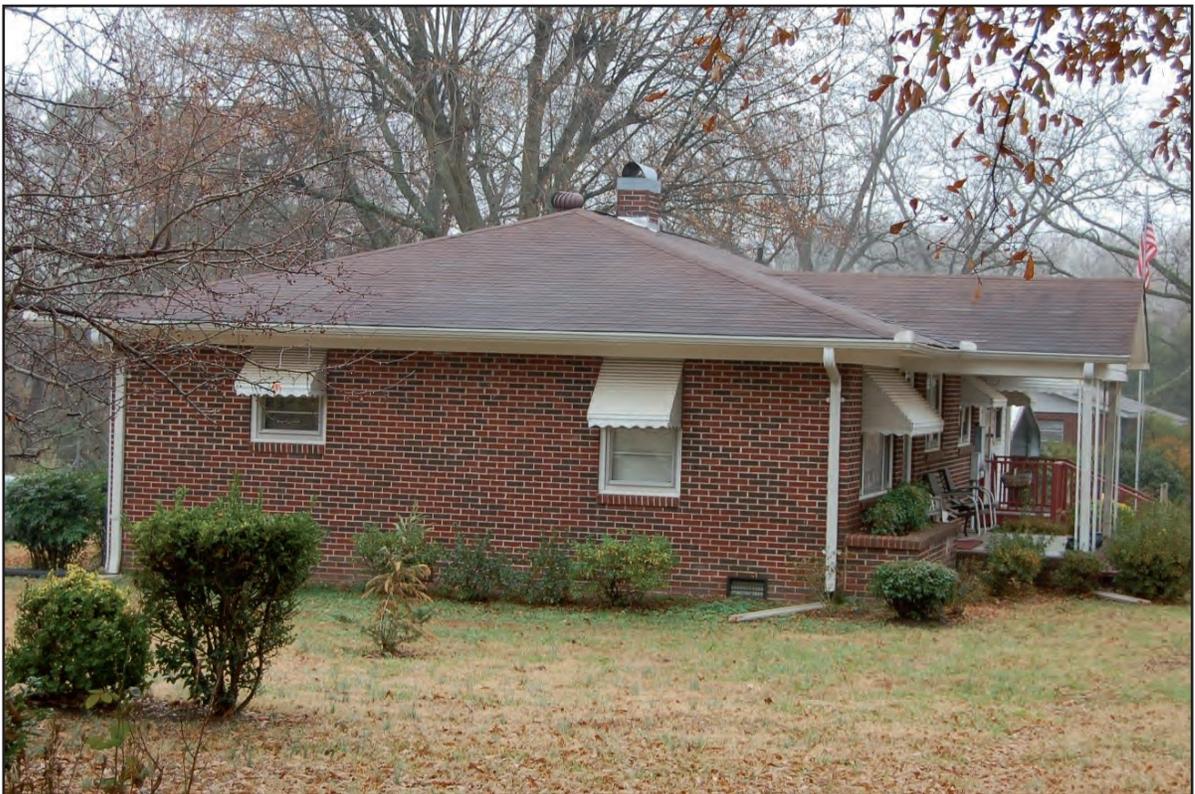
**Figure 5.23.** Resource 113-1067 (480 Edgefield Road) - View of north side elevation facing southeast.

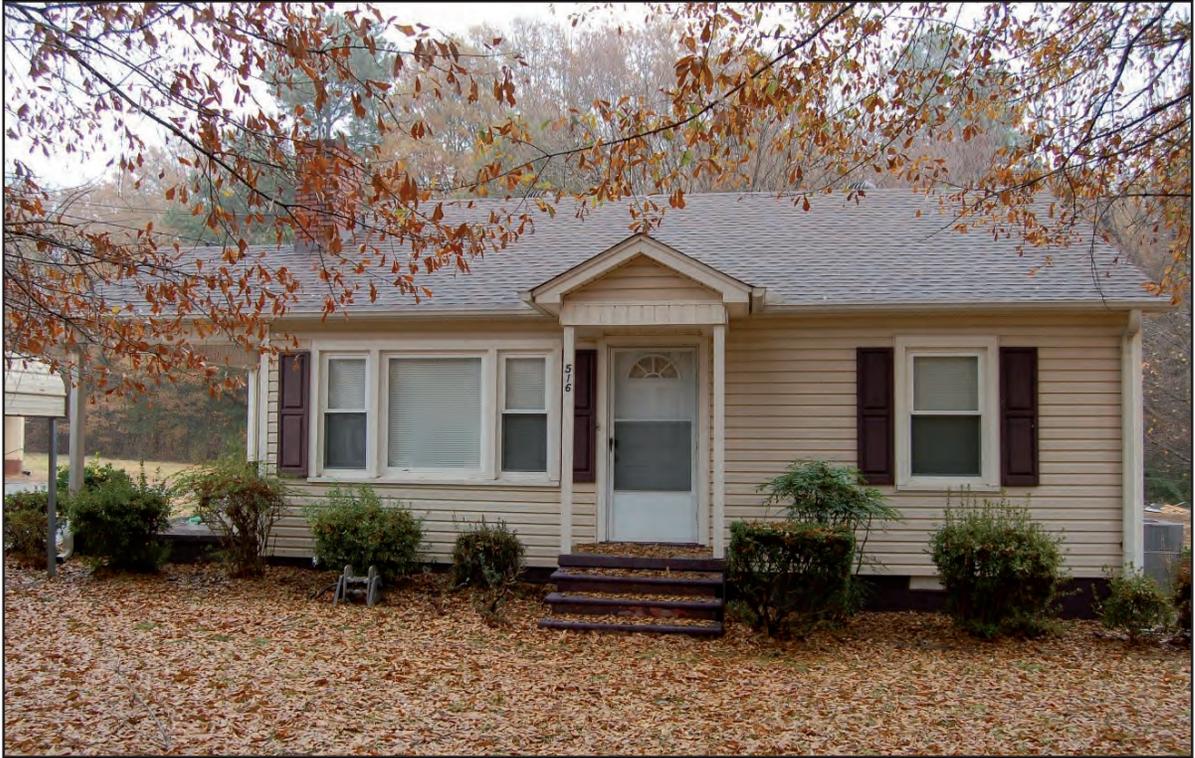
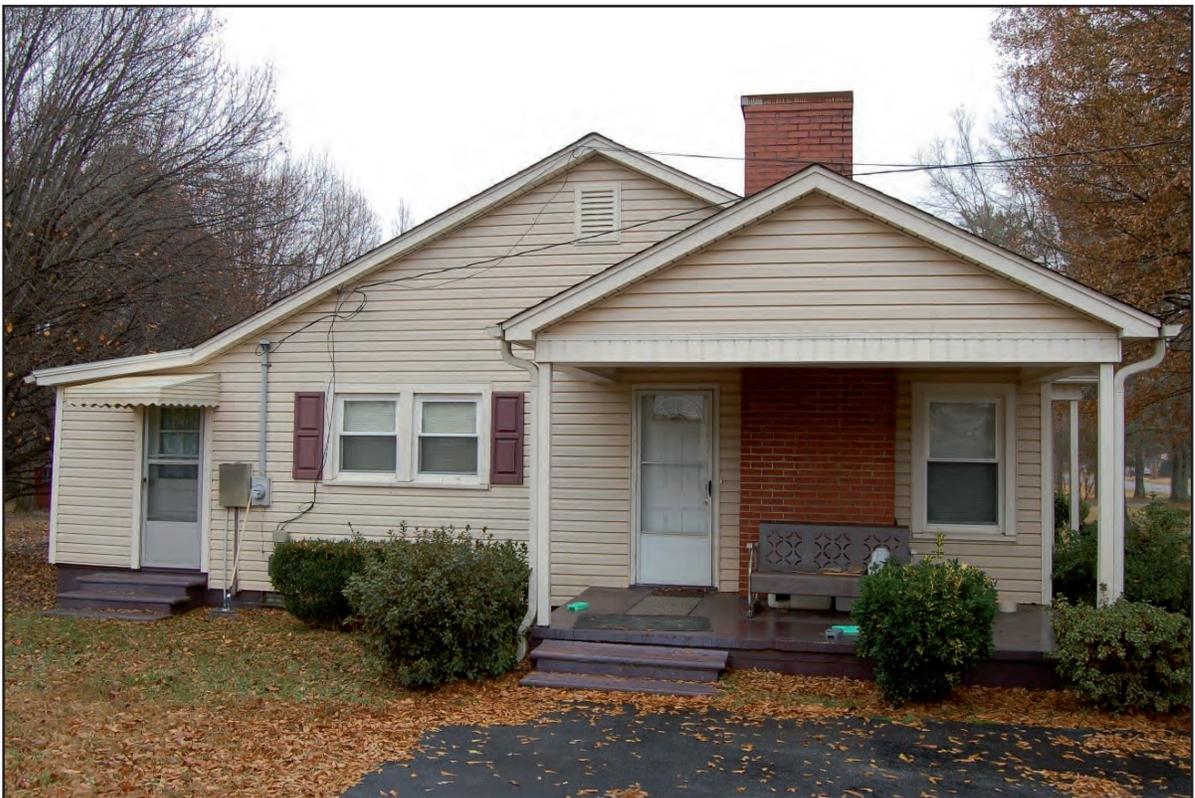
chimney on the north side elevation; a projecting gable-roofed stoop entry porch supported by two square posts on the façade; a partial-width, projecting, gable-roofed porch supported by two square posts on the north side elevation; and vinyl exterior siding (see Figures 5.24 and 5.25). There is a tripartite window comprised of a large rectangular fixed light flanked by 1/1-light double-hung sash windows on the façade and the remaining windows are single and paired 1/1-light double-hung sash of various sizes. All windows are metal-framed vinyl replacement windows.

**Figure 5.24.** Resource 113-1068 (516 Edgefield Road) - View of façade facing east.

**Figure 5.25.** Resource 113-1068 (516 Edgefield Road) - View of north side elevation facing south.

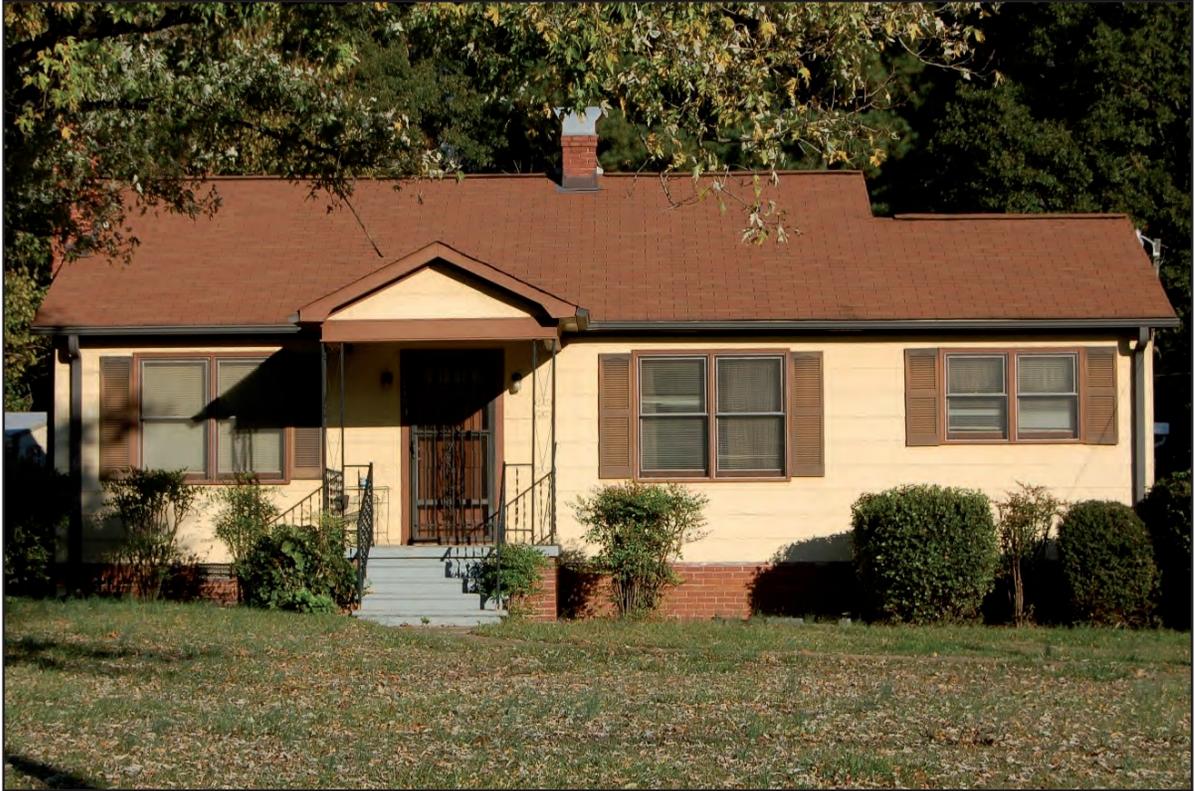
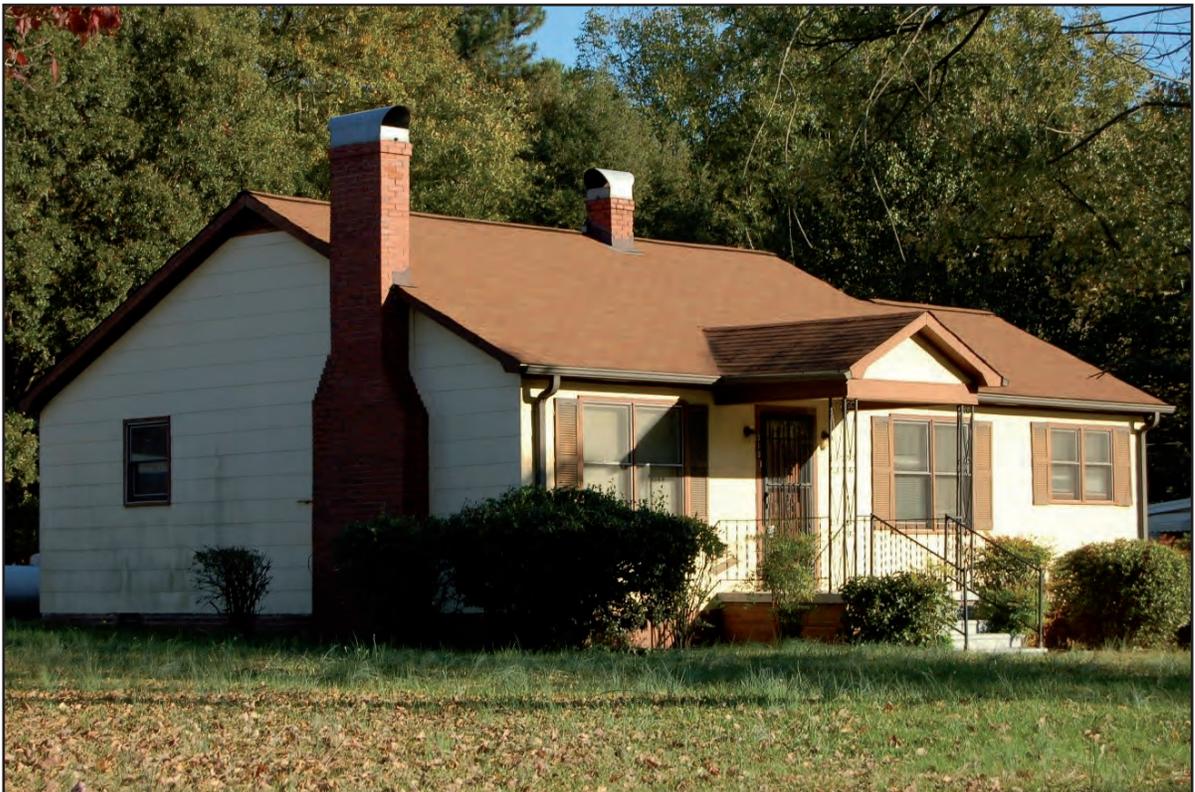
Resource 113-1069 is located at 510 Edgefield Road on the east side of the roadway approximately 135 feet south of the intersection of Edgefield Road and Bud Arthur Bridge Road north of Cowpens in Spartanburg County (refer to Figure 5.2a). The Spartanburg County tax assessor's record has a 1951 estimated date of construction for the resource. This estimated date of construction was supported by the review of historic topographic maps and aerial photography, and an evaluation of the resource's form and construction materials. The resource is depicted in its current location on the earliest aerial photograph available on the [www.historicaerials.com](http://www.historicaerials.com) website dated 1955 and on the earliest USGS topographic map available on the <http://viewer.nationalmap.gov/viewer/> website dated 1959. The resource is a one-story, asymmetric, side-gabled cottage of frame construction. The house features a side-gabled asphalt shingle roof with narrow eaves; a large brick exterior end wall chimney on the north side elevation; a small brick interior ridgeline chimney; a projecting gable-roofed stoop entry porch supported by decorative metal posts on the façade; a shed- and flat-roofed carport addition on the south side elevation; and concrete asbestos tile exterior siding (see Figures 5.26 and 5.27). The windows on the resources are single and paired 1/1-light double-hung sash of various sizes.

**Figure 5.26.** Resource 113-1069 (510 Edgefield Road) – View of façade facing east.

**Figure 5.27.** Resource 113-1069 (510 Edgefield Road) – Oblique view of façade and north side elevation facing southeast.

The resource is not known to be associated with a significant activity or event and there is not a known connection between the resource and any individual whose activities or achievements are historically significant. Therefore, there was no basis for evaluating the resource under Criterion A or B. Also, there is no indication that the resource is likely to yield information on important research questions in history or prehistory. The resource does not appear to have the potential to be the principal source of important information. Therefore, there was no basis for evaluating the resource under Criterion D. The resource does not represent a recognized architectural type or style and does not otherwise appear to represent a significant trend in South Carolina's architectural history. Therefore, Resource 113-1069 is recommended **Not Eligible** for listing in the NRHP under Criterion C in the area of architecture.

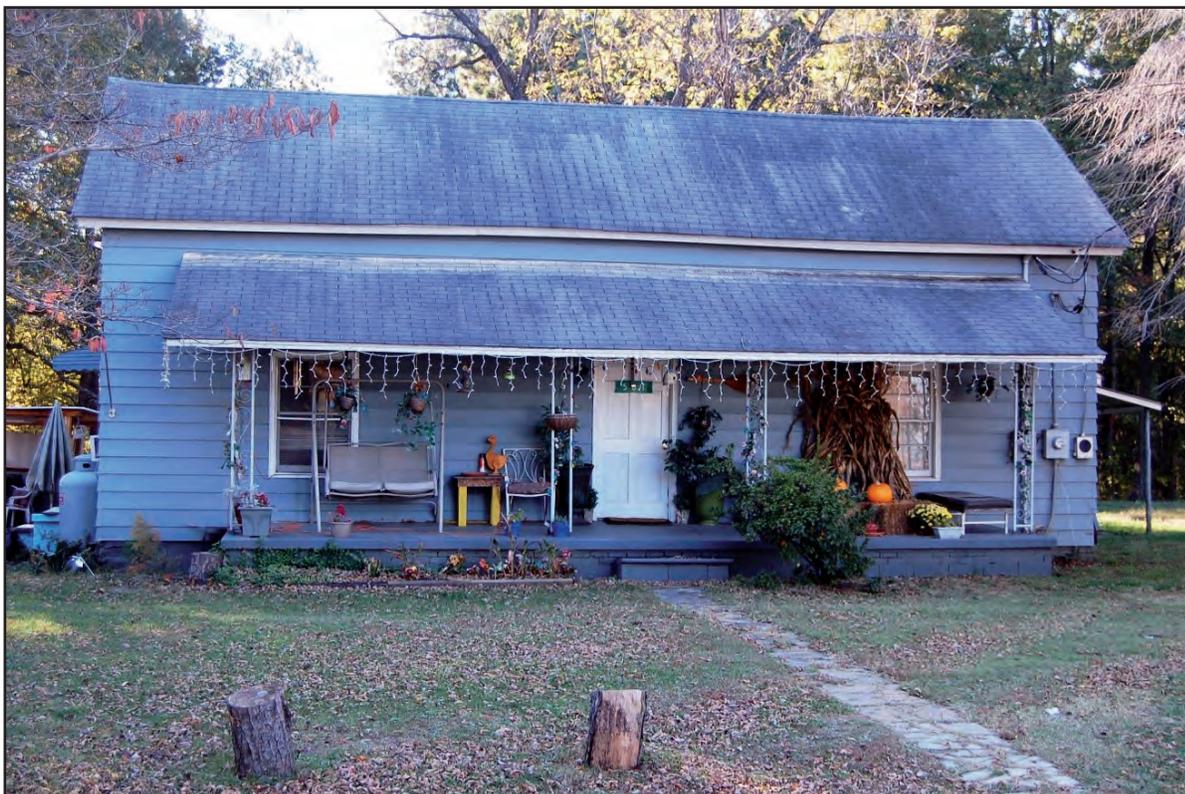
Resource 113-1070 is located at 579 or 581 Edgefield Road on the west side of the roadway directly opposite the intersection of Edgefield Road and Smith Road north of Cowpens in Spartanburg County (refer to Figure 5.2a). The house has a 581 number sign displayed on the façade next to the door but the Spartanburg County tax assessor's record has 579 Edgefield Road as the location address. The tax assessor's record has a 1920 estimated date of construction for the resource. This estimated date of construction was supported by the review of historic topographic maps and aerial photography, and an evaluation of the resource's form and construction materials. The resource is depicted in its current location on the earliest aerial photograph available on the [www.historicerials.com](http://www.historicerials.com) website dated 1955 and on the earliest USGS topographic map available on the <http://viewer.nationalmap.gov/viewer/> website dated 1959. The resource is a one-and-one-half-story, symmetric, side-gabled residence of frame construction. The house features a side-gabled asphalt shingle roof; a near-full-width, shed-roofed entry porch supported by four decorative metal posts on the façade; a shed-roofed and a gable-roofed addition on the rear elevation; a shed-roofed addition on the north side elevation; and aluminum exterior siding. No chimney was observed (see Figures 5.28 and 5.29). The windows on the resource are a mix of wood-framed 6/6-light and 2/2-light double-hung sash and metal-framed 1/1-light double-hung sash.

**Figure 5.28.** Resource 113-1070 (581 Edgefield Road) - View of façade facing west, facing southeast.

The resource is not known to be associated with a significant activity or event and there is not a known connection between the resource and any individual whose activities or achievements are historically significant. Therefore, there was no basis for evaluating the resource under Criterion A or B. Also, there is no indication that the resource is likely to yield information on important research questions in history or prehistory. The resource does not appear to have the potential to be the principal source of important information. Therefore, there was no basis for evaluating the resource under Criterion D. The resource does not represent a recognized architectural type or style and does not otherwise appear to represent a significant trend in South Carolina's architectural history. Additionally, due to the rear and side additions, the application of aluminum exterior

siding, and the replacement of original doors and windows with non-historic replacements, the resource has lost integrity in the areas of design, materials, workmanship, and feeling and cannot convey significance in the area of architecture. Therefore, Resource 113-1070 is recommended **Not Eligible** for listing in the NRHP under Criterion C in the area of architecture.

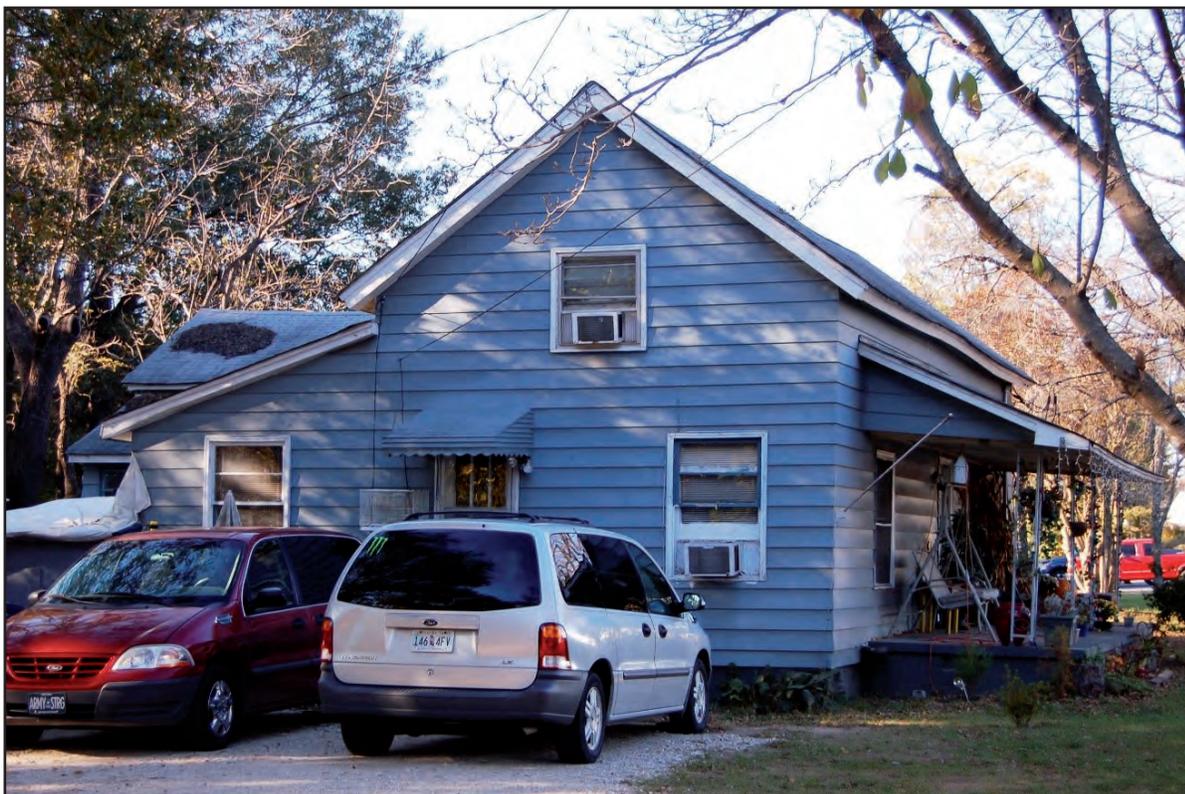
**Figure 5.29.** Resource 113-1070 (581 Edgefield Road) - View of south side elevation facing northwest.

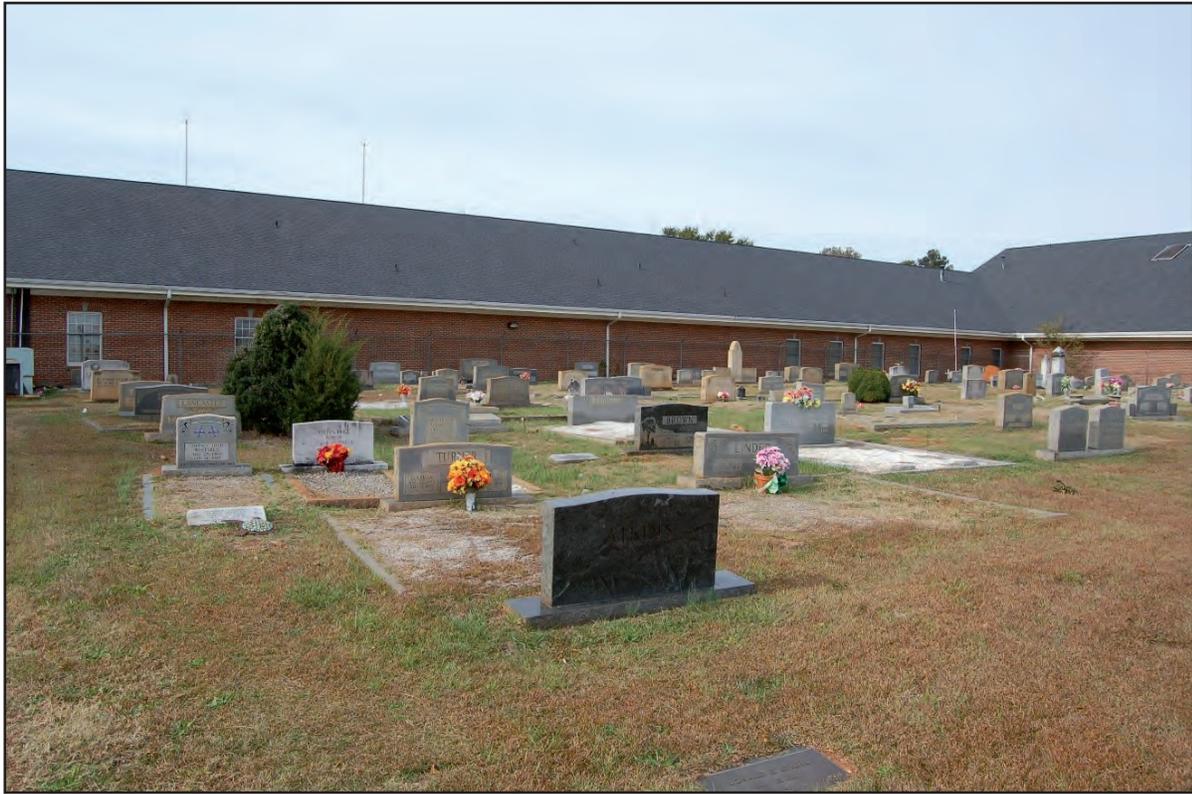
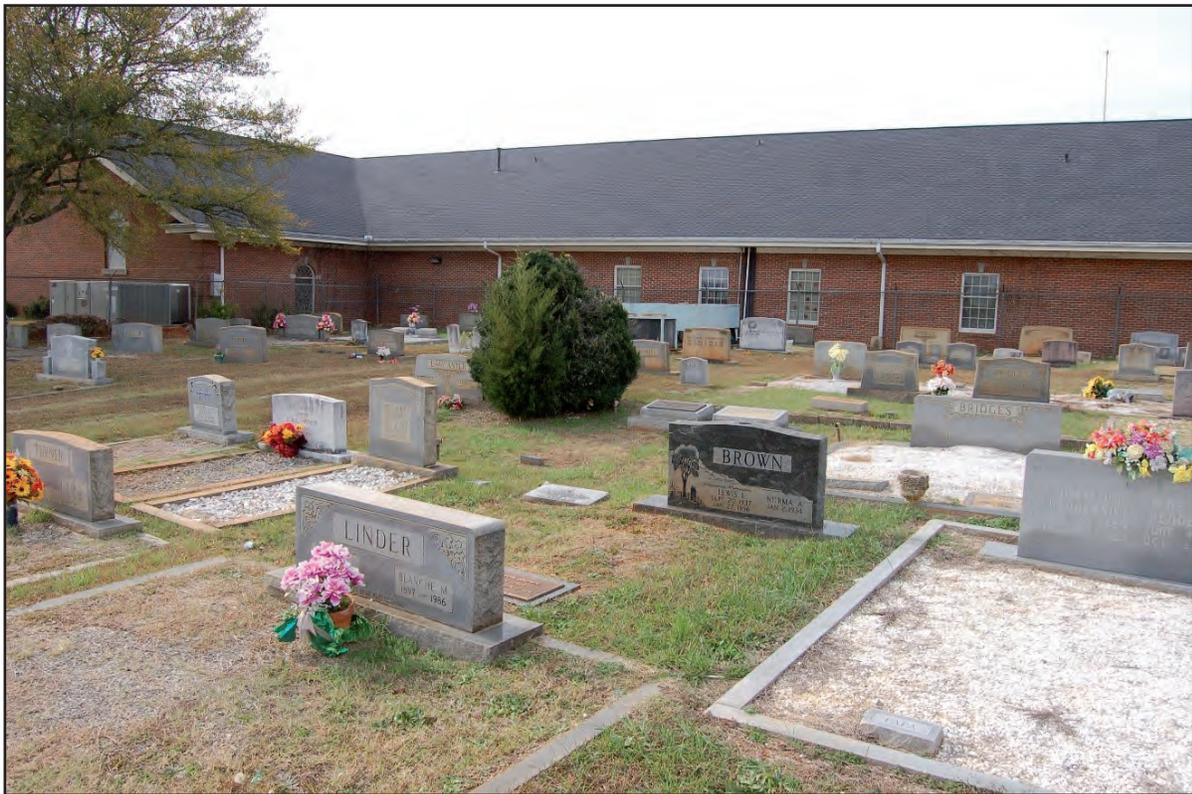
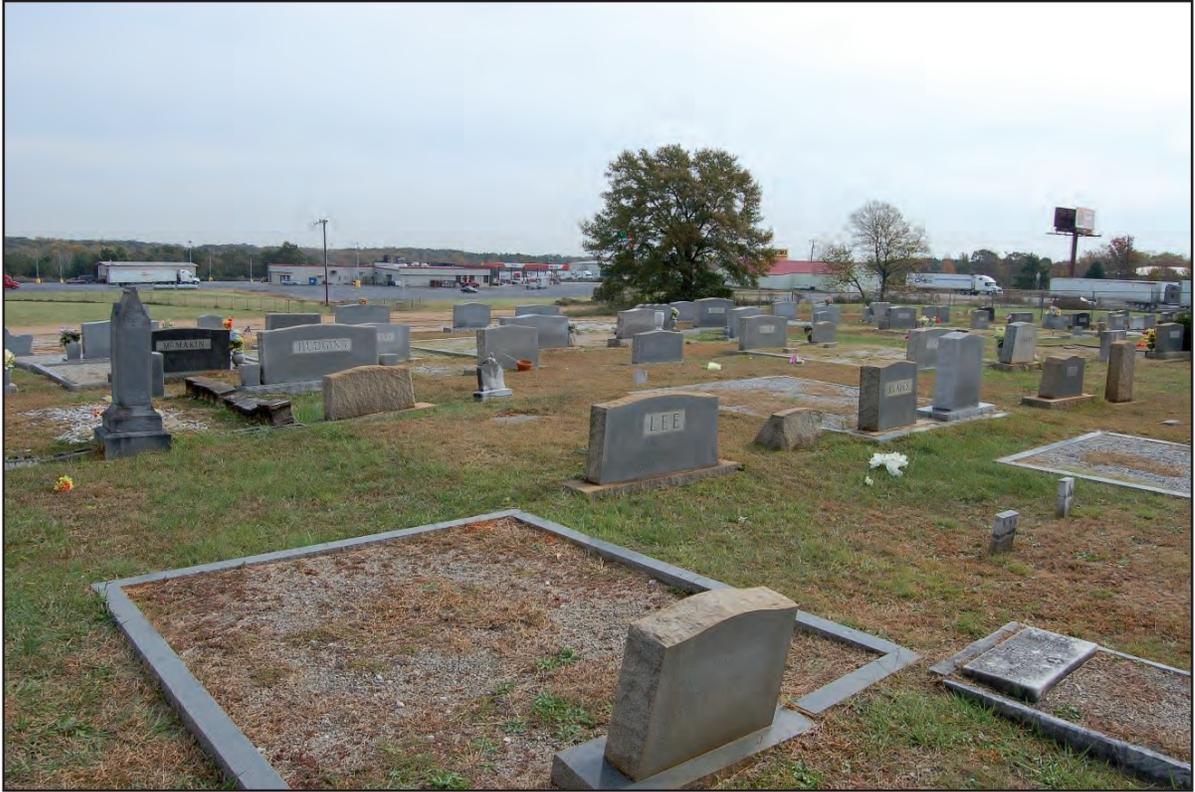
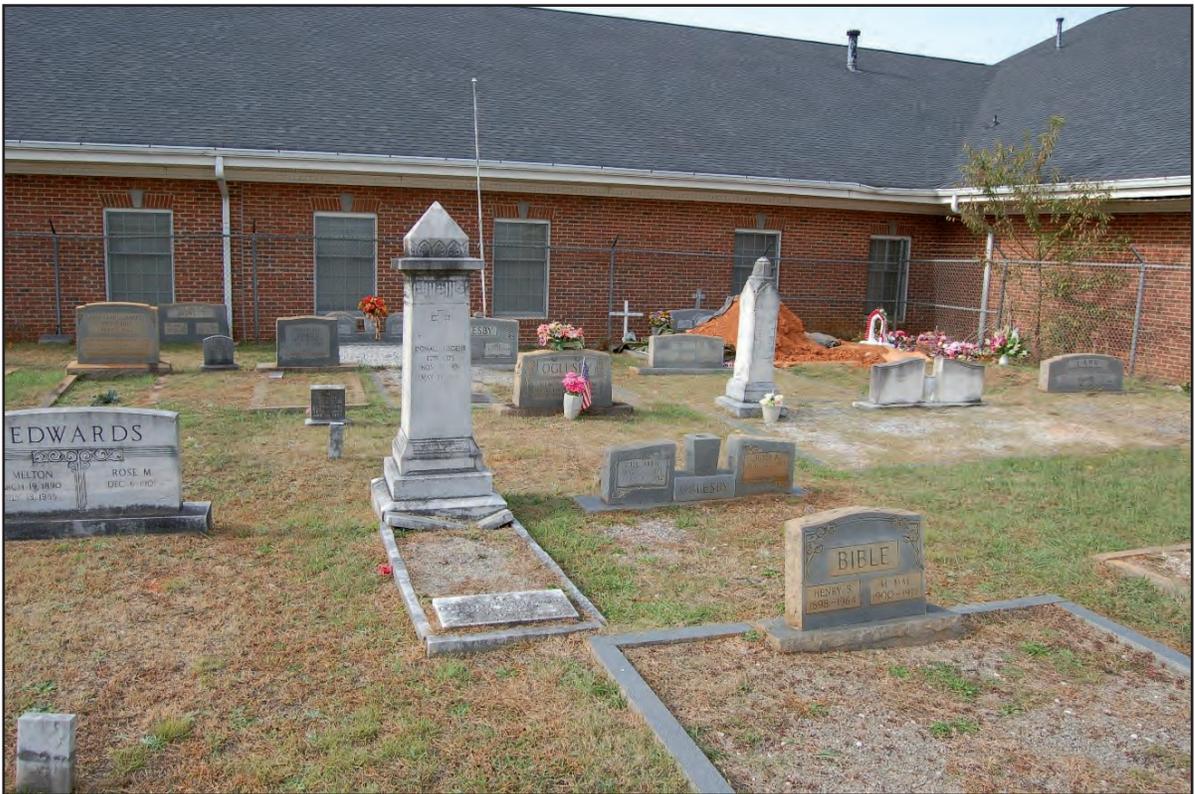
The cemetery is bordered on the west side and short segments of the north and south sides by the Mountain View Christian Academy School building and by a 6-foot tall chain-link fence topped with barbed wire that is located between the cemetery and the school building and aligned parallel to the walls of the school building on those three sides. The east side of the cemetery is unfenced. The monuments uniformly face to the northeast and the monuments are generally aligned in rows that extend from northwest to southeast. However, this is interrupted by the irregular size and placement of the family plots within the cemetery. Landscaping within the cemetery consist of a couple of shrubs, a tree, lawn, and brick and stone plot family borders that are flush with the ground surface. The oldest monuments in the cemetery are a couple of tall pedestal uprights and nearly all of the remaining monuments are headstones, die in socket, and die on base that are close to the same height (refer to Figures 5.30 – 5.33). The only other types of monuments are a few raised tops and garden types.

**Figure 5.30.** Resource 113-1071 (255 Horry Road) – Representative view of the Mountain View Baptist Church Cemetery facing northwest.

**Figure 5.31.** Resource 113-1071 (255 Horry Road) – Representative view of the Mountain View Baptist Church Cemetery facing southwest.

**Figure 5.32.** Resource 113-1071 (255 Horry Road) – Representative view of the Mountain View Baptist Church Cemetery facing southeast.

**Figure 5.33.** Resource 113-1071 (255 Horry Road) – Representative view of the Mountain View Baptist Church Cemetery facing west.

The resource was evaluated under Criterion C and does not appear to possess significance in the areas of architecture or landscape architecture. The majority of the interments in the cemetery are historic; the cemetery lacks any notable landscape design features; the monuments within the

cemetery are primarily common headstone, die in socket, and die on base types; and, the immediate setting of the cemetery has been compromised by the construction of the non-historic school building that wraps around the south, west, and east sides. For these reasons, the resource is recommended **Not Eligible** for listing in the NRHP under Criterion C in the areas of architecture and landscape architecture.

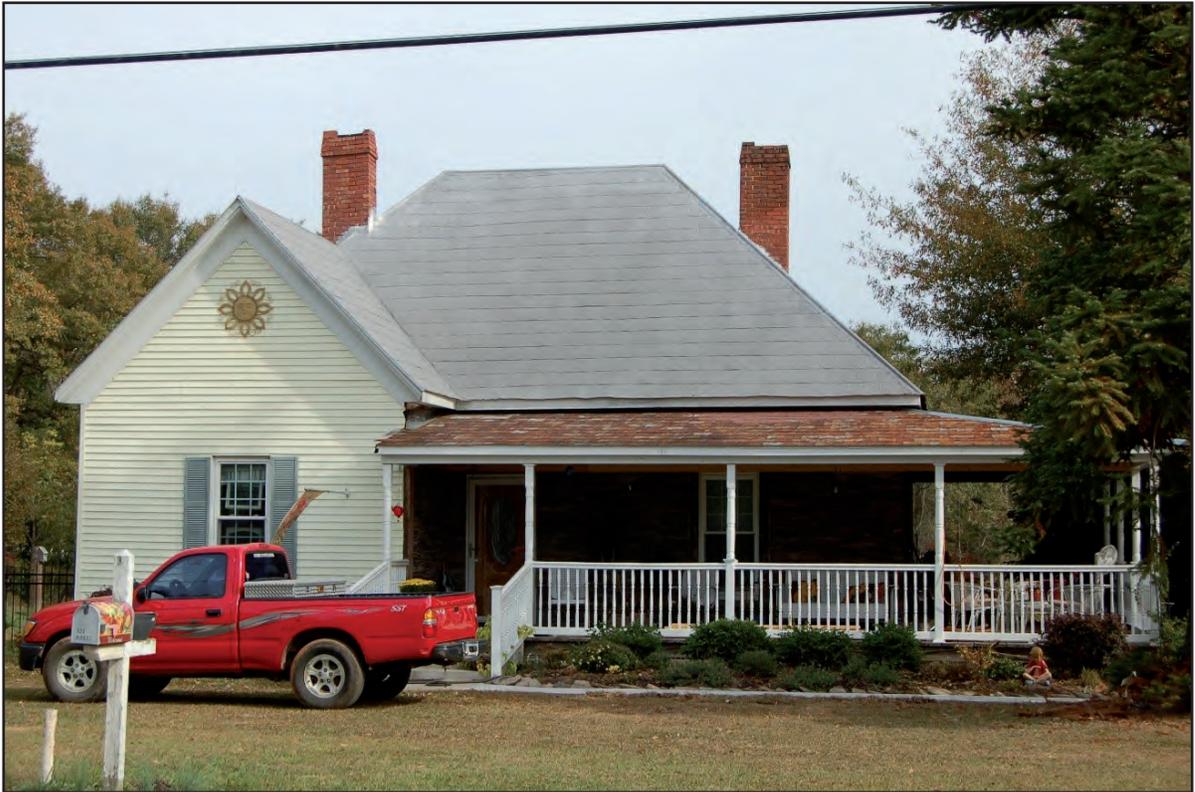
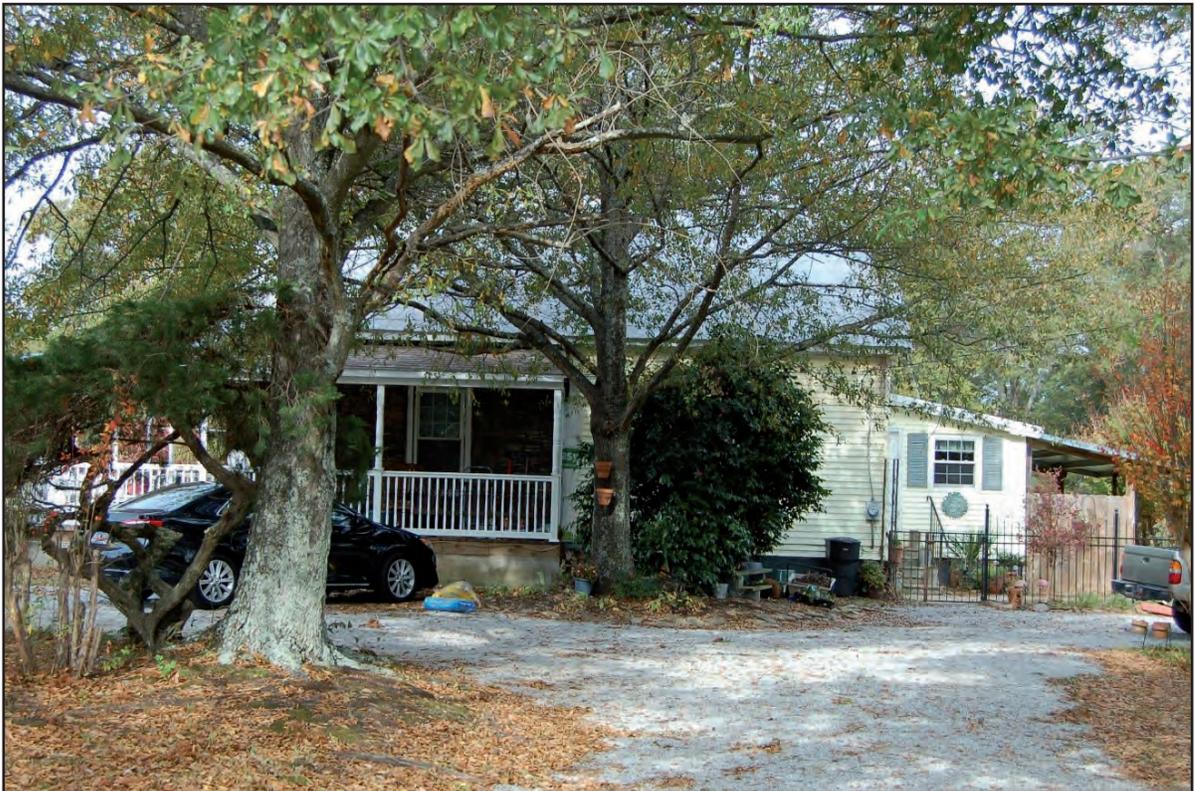
Resource 113-1072 is located at 121 Horry Road on the east side of the roadway in the northeast quadrant of the intersection of Horry Road and Phillips Drive north of Cowpens in Spartanburg County (refer to Figure 5.2a). The Spartanburg County tax assessor's record has a 1908 estimated date of construction for the resource. This estimated date of construction was supported by the review of historic topographic maps and aerial photography, and an evaluation of the resource's form and construction materials. The resource is depicted in its current location on the earliest aerial photograph available on the [www.historicaerials.com](http://www.historicaerials.com) website dated 1955 and on the earliest USGS topographic map available on the <http://viewer.nationalmap.gov/viewer/> website dated 1959. The resource is a one-story, asymmetric, New South Cottage of frame construction. The house features a steeply-pitched hipped pressed metal roof; two tall interior roof slope brick chimneys; a continuous concrete block foundation; a wrap-around shed-roofed porch supported by turned posts on the façade and south side elevation; and vinyl and stone veneer exterior siding (see Figures 5.34 and 5.35). The stone veneer siding is located on the sides of the resource covered by the porch roof. The windows on the resource are non-historic metal-framed vinyl windows with faux muntins. There is a full-width, shed-roofed addition on the rear elevation.

**Figure 5.34.** Resource 113-1072 (121 Horry Road) – View of façade facing east. Note: exterior siding under porch roof is stone panel.

**Figure 5.35.** Resource 113-1072 (121 Horry Road) - View of south side elevation facing north. Note: exterior siding under porch roof is stone panel.

The resource is not known to be associated with a significant activity or event and there is not a known connection between the resource and any individual whose activities or achievements are historically significant. Therefore, there was no basis for evaluating the resource under Criterion A or B. Also, there is no indication that the resource is likely to yield information on important research questions in history or prehistory. The resource does not appear to have the potential to be the principal source of important information. Therefore, there was no basis for evaluating the resource under Criterion D. While the resource represents a recognized architectural building type, due to the loss of original building materials and the installation of non-historic exterior siding, windows, doors, porch supports, and railings, the resource has lost integrity in the areas of materials, workmanship, feeling and cannot convey significance in the area of architecture. Therefore, Resource 113-1072 is recommended **Not Eligible** for listing in the NRHP under Criterion C in the area of architecture.
