**PHASE I CULTURAL RESOURCE SURVEY FOR PROPOSED  
WIDENING OF INTERSTATE 85 FROM MILE MARKER 80 TO 96,  
CHEROKEE AND SPARTANBURG COUNTIES, SOUTH CAROLINA.**

**FINAL REPORT**

**JULY 2015**

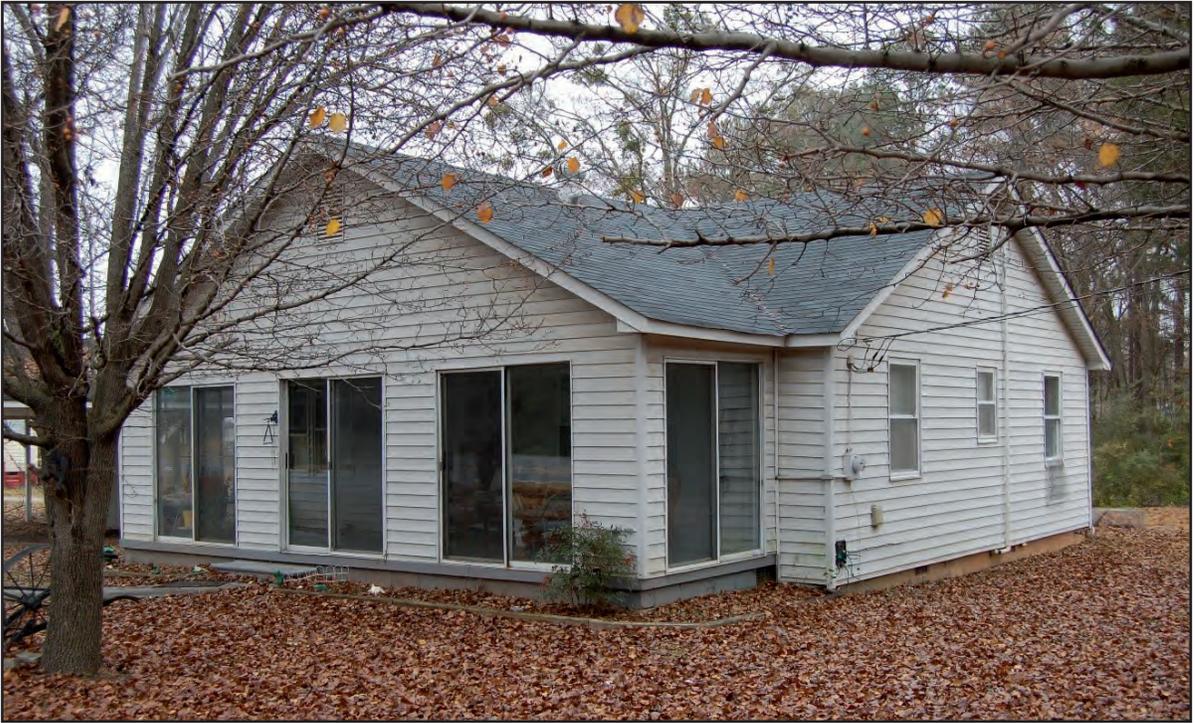
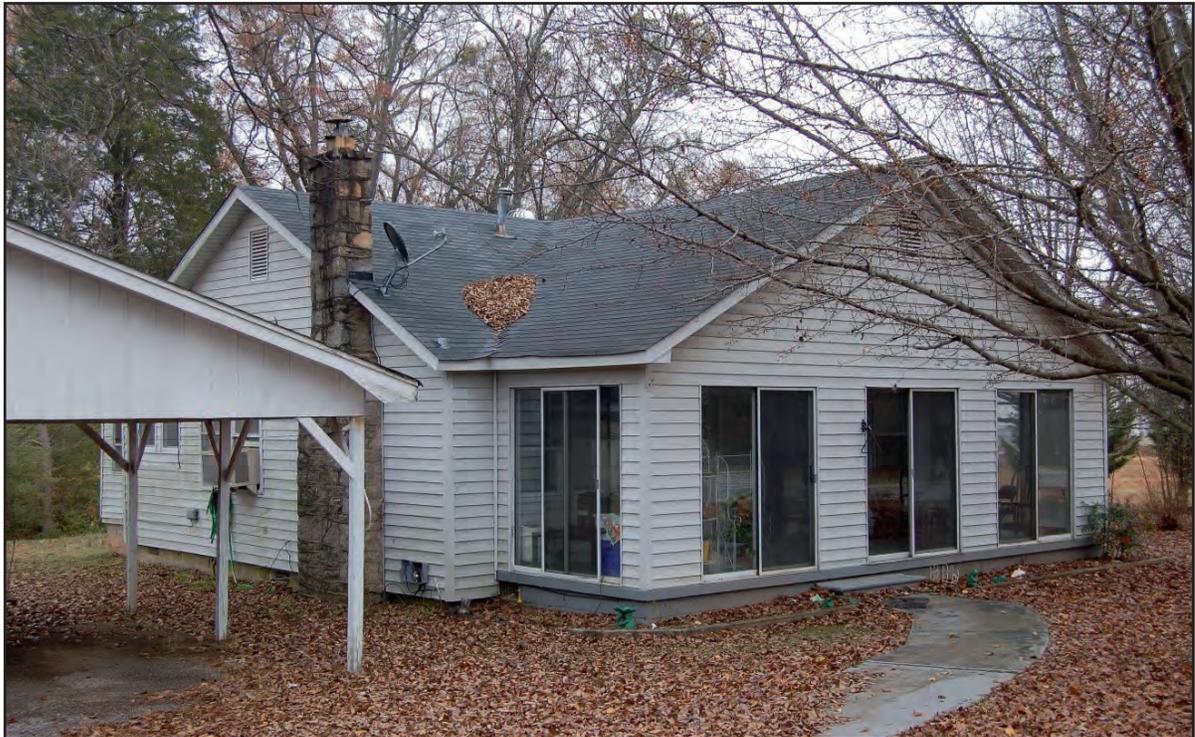
Resource 113-1073 is located at 111 Horry Road on the east side of the roadway approximately 175 feet southeast of the intersection of Horry Road and Battleground Road north of Cowpens in Spartanburg County (refer to Figure 2A). The Spartanburg County tax assessor's record has a 1950 estimated date of construction for the resource. This estimated date of construction was supported by the review of historic topographic maps and aerial photography, and an evaluation of the resource's form and massing. The resource is not depicted in its current location on the earliest aerial photograph available on the [www.historicaerials.com](http://www.historicaerials.com) website dated 1955 or on the earliest USGS topographic map available on the <http://viewer.nationalmap.gov/viewer/> website dated 1959. The resource is a one-story, asymmetric, cross-gabled bungalow of frame construction. The house features a cross-gabled asphalt shingle roof; a small exterior end wall stone chimney on the north side elevation; an enclosed project integral porch on the façade; and vinyl exterior siding (see Figures 5.36 and 5.37). The enclosed porch has five sliding glass doors and the windows on the resource are non-historic metal-framed vinyl 1/1-light double-hung sash windows.

**Figure 5.36.** Resource 113-1073 (111 Horry Road) – Oblique view of façade and south side elevation facing northeast.

**Figure 5.37.** Resource 113-1073 (111 Horry Road) – Oblique view of façade and north side elevation facing southeast.

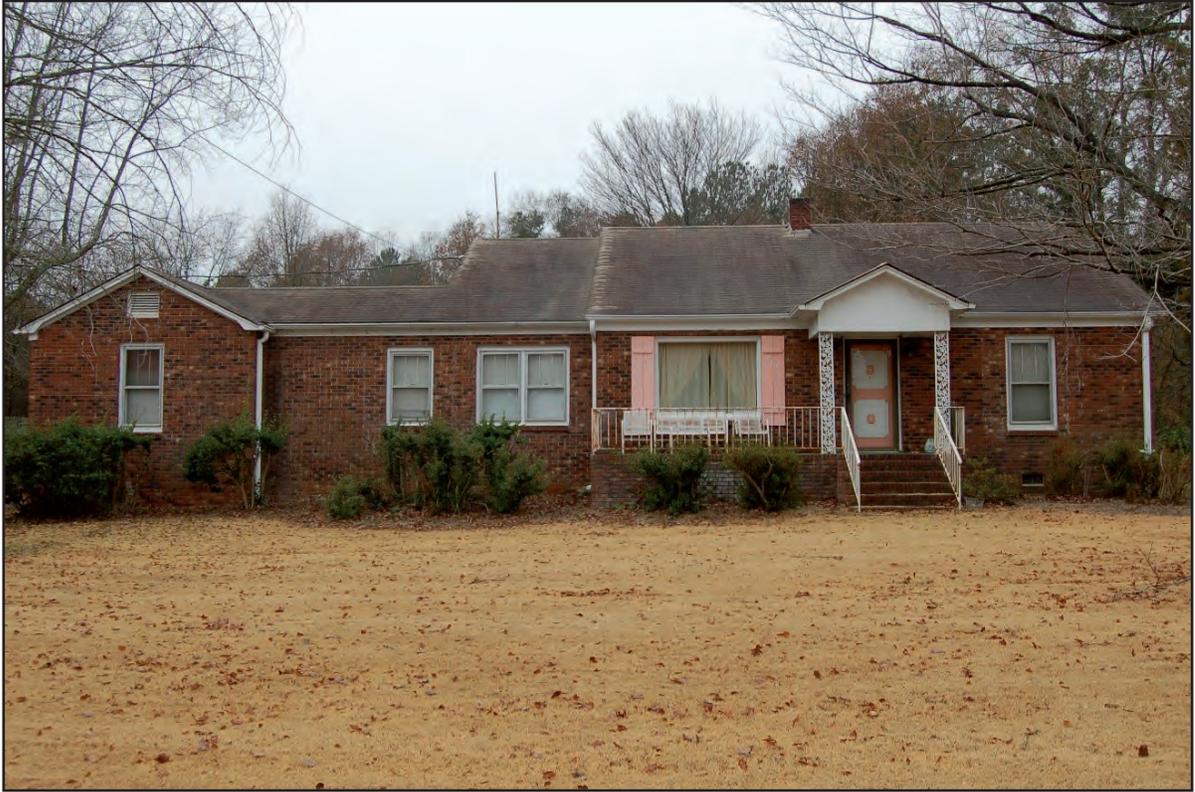
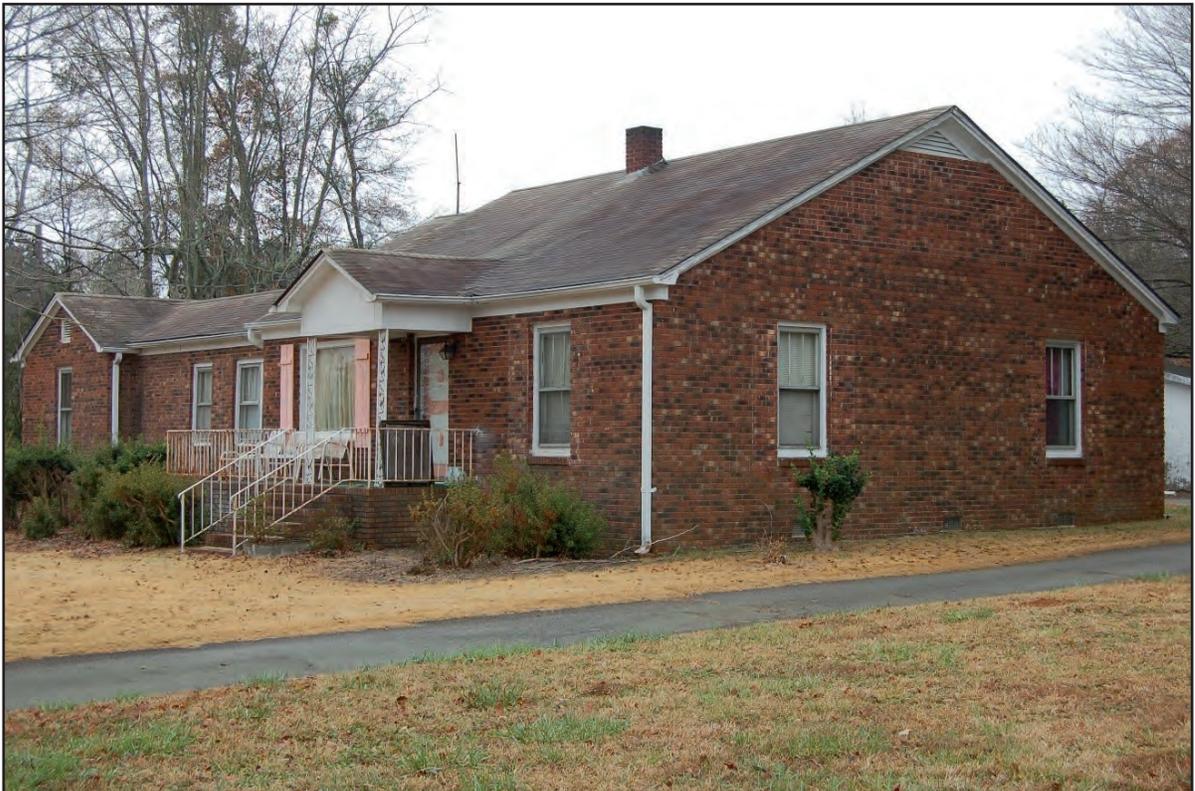
an off-center small brick interior roof surface chimney near the ridgeline on the front slope; a projecting gable-roofed stoop entry porch supported by two decorative metal posts on the façade; and running bond brick exterior siding (see Figures 5.38 and 5.39). The brick veneer exterior siding may be a later addition to the building.

**Figure 5.38.** Resource 113-1074 (749 Battleground Road) – View of façade facing west.

**Figure 5.39.** Resource 113-1074 (749 Battleground Road) – Oblique view of façade and north side elevation facing southwest.

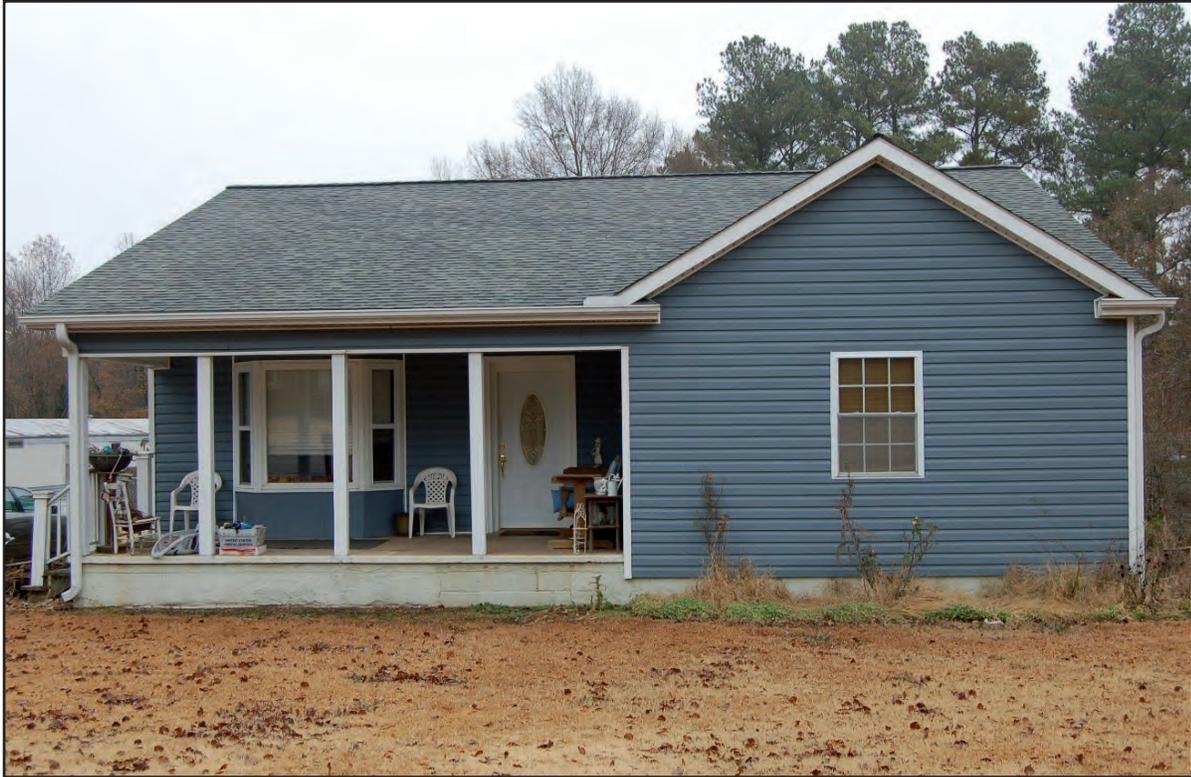
Resource 113-1075 is located at 756 Battleground Road on the east side of the roadway approximately 100 feet south of the intersection of Battleground Road and Horry Road north of Cowpens in Spartanburg County (refer to Figure 2A). The Spartanburg County tax assessor's record has a 1950 estimated date of construction for the resource. This estimated date of construction was supported by the review of historic topographic maps and aerial photography, and an evaluation of the resource's form and construction materials. The resource is not depicted in its current location on the earliest aerial photograph available on the [www.historicaerials.com](http://www.historicaerials.com) website dated 1955 or on the earliest USGS topographic map available on the <http://viewer.nationalmap.gov/viewer/> website dated 1959. The resource is a one-story, asymmetric, cross-gabled cottage of frame construction. The house features a cross-gabled asphalt shingle roof; a partial-width, integral recessed porch supported by four wooden posts on the façade; a continuous concrete block foundation; and vinyl exterior siding (see Figures 5.40 and 5.41). There is a bay window on the façade and the remaining windows are metal-framed vinyl windows with faux muntins. All of the windows on the resource are non-historic replacements.

**Figure 5.40.** Resource 113-1075 (756 Battleground Road) – View of façade facing east.

The resource is not known to be associated with a significant activity or event and there is not a known connection between the resource and any individual whose activities or achievements are historically significant. Therefore, there was no basis for evaluating the resource under Criterion A or B. Also, there is no indication that the resource is likely to yield information on important research questions in history or prehistory. The resource does not appear to have the potential to be the principal source of important information. Therefore, there was no basis for evaluating

the resource under Criterion D. The resource does not represent a recognized architectural type or style and does not otherwise appear to represent a significant trend in South Carolina's architectural history. Additionally, due to the application of vinyl exterior siding, the installation of the bay window on the façade, and the replacement of the original windows with non-historic metal-framed vinyl replacements, the resource does not retain integrity in the areas of materials, workmanship, and feeling and cannot convey significance in the area of architecture. Therefore, Resource 113-1075 is recommended **Not Eligible** for listing in the NRHP under Criterion C in the area of architecture.

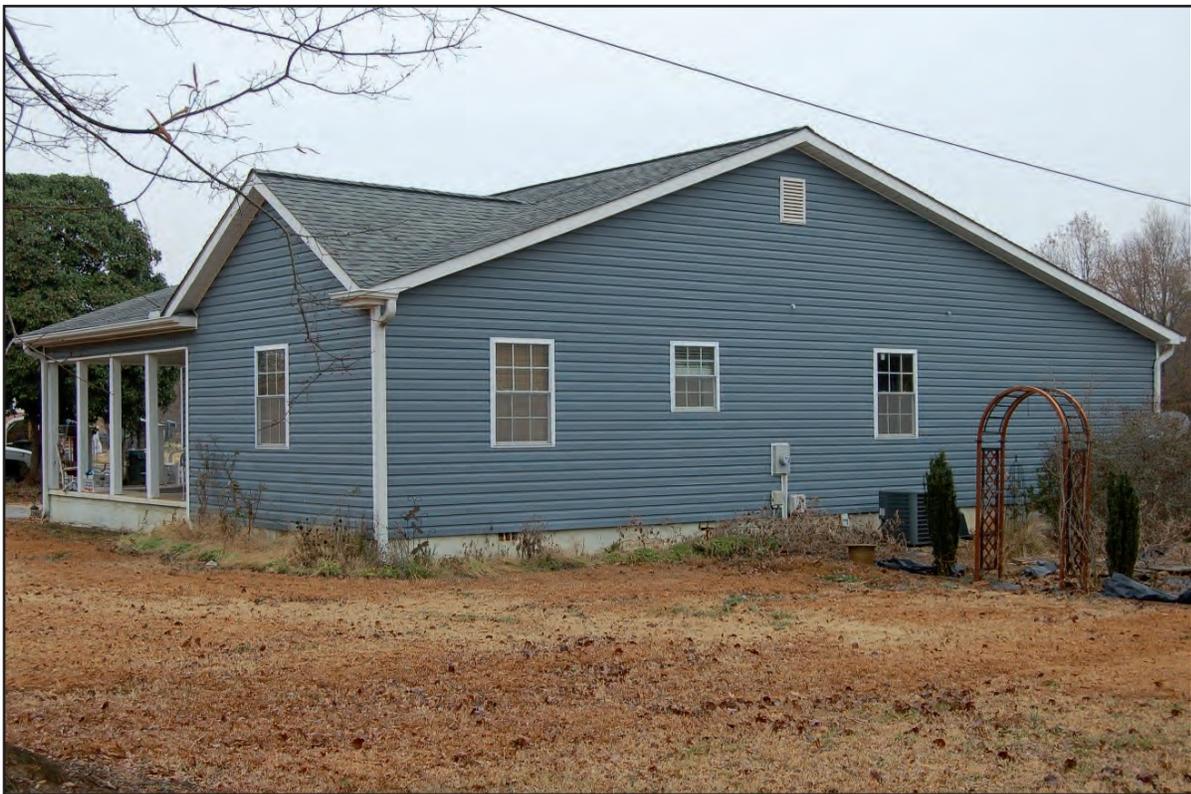
**Figure 5.41.** Resource 113-1075 (756 Battleground Road) – Oblique view of façade and south side elevation facing northeast.

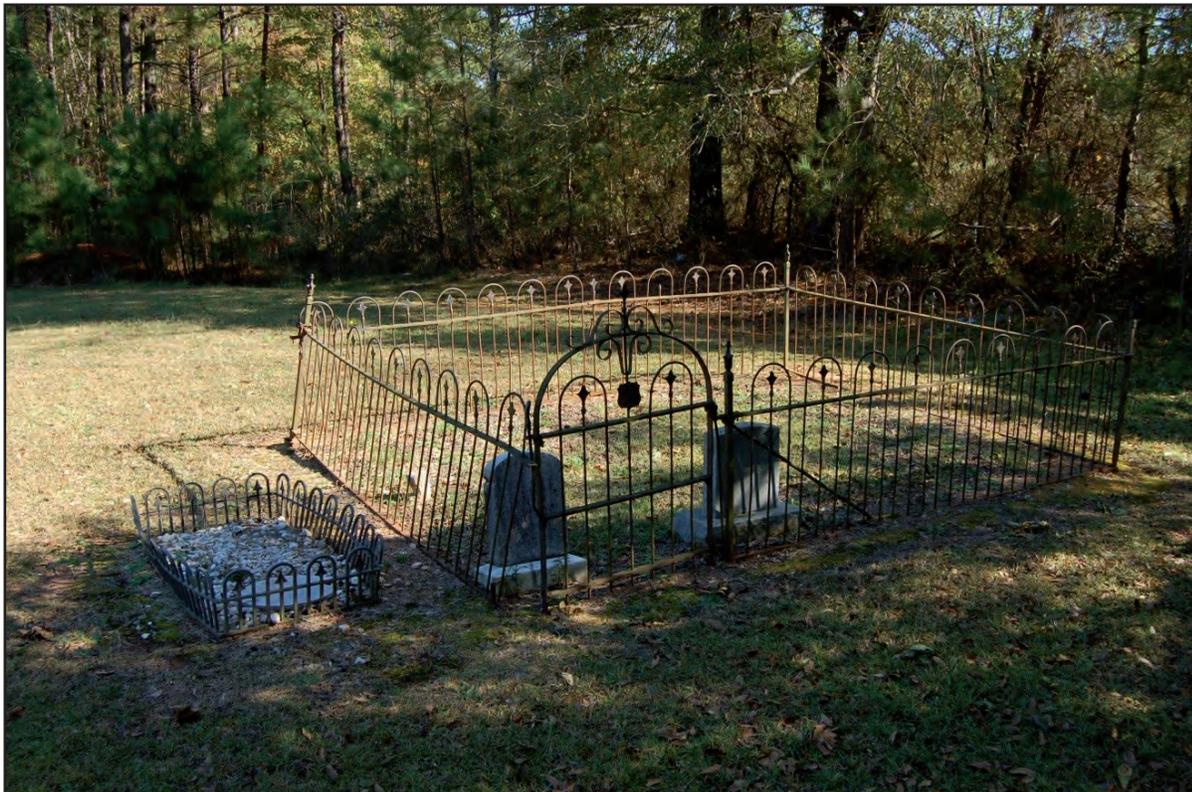
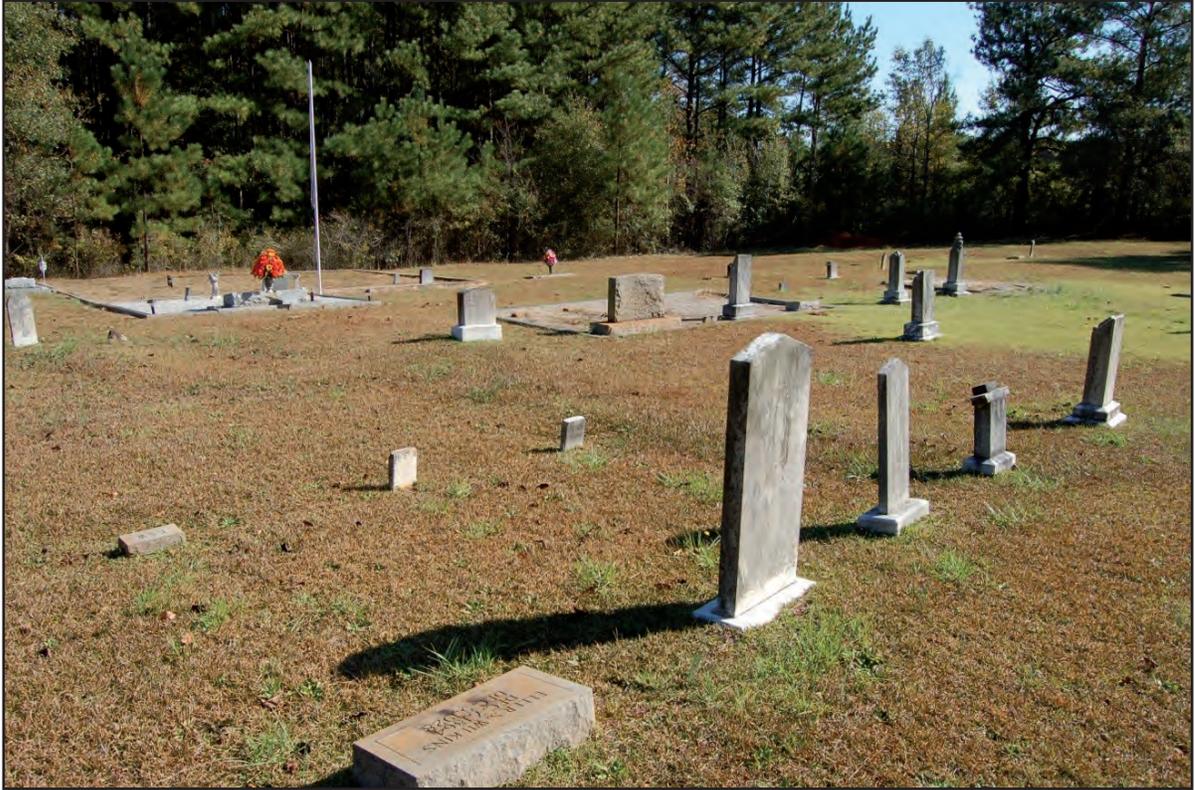
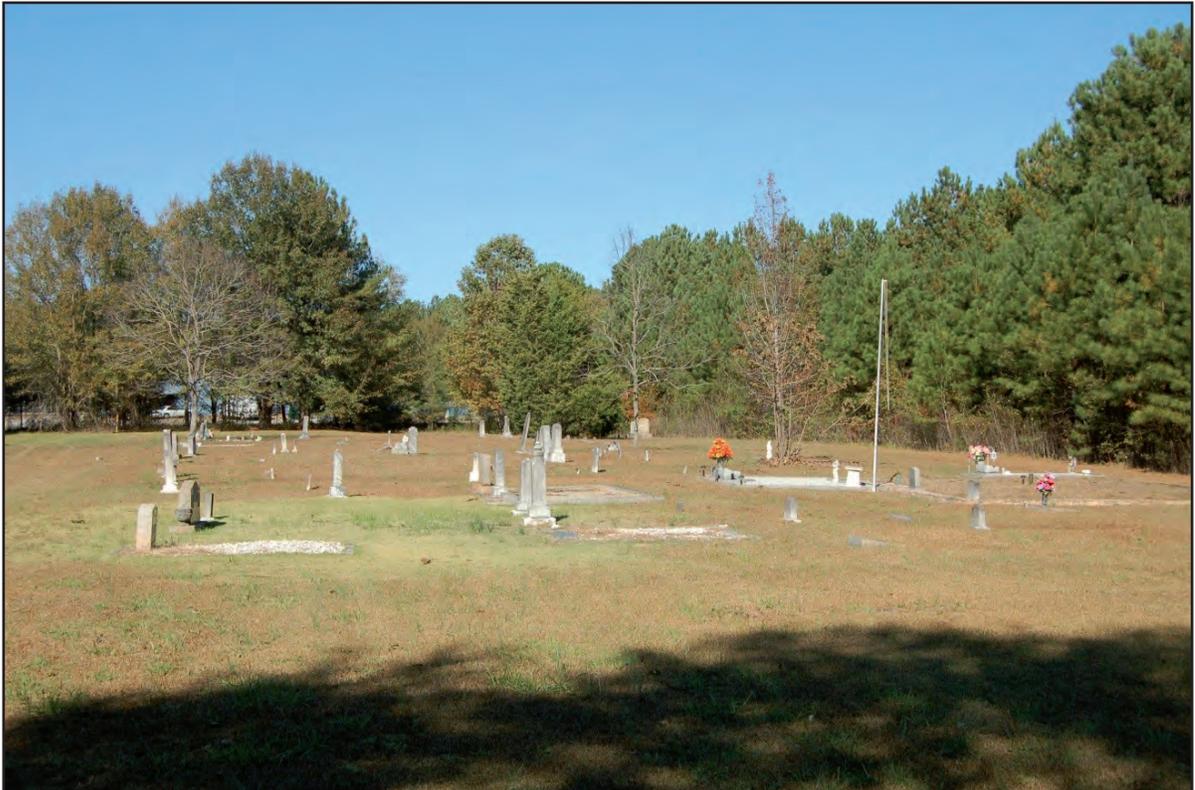
The cemetery is located in a grassed clearing. There are no trees, shrubs, or vegetation of any kind other than grass within the cemetery. The monuments uniformly face to the east and the monuments are generally aligned in rows that extend from north to south. The north-south rows are evenly maintained through most of the family plots. There is a tall flag pole within the cemetery and one grave and one small family plot are marked by metal fencing. A few other family plots are marked by polished stone borders that are flush with the ground surface. Monuments within the cemetery consist of pedestals, headstones, die in socket, and die on base (see Figures 5.42 – 5.45).

**Figure 5.43.** Resource 113-1077 (0 Zimmer Drive) – Representative view of cemetery facing southeast.

**Figure 5.44.** Resource 113-1077 (0 Zimmer Drive) – Representative view of cemetery facing southeast.

**Figure 5.45.** Resource 113-1077 (0 Zimmer Drive) – Representative view of cemetery facing north.

be the principal source of important information. Therefore, there was no basis for evaluating the resource under Criterion D. The cemetery does not contain significant or noteworthy landscape features and the monuments are common and undistinguished examples from the cemetery's period of active use. Therefore, Resource 113-0237 is recommended **Not Eligible** for listing in the NRHP under Criterion C in the areas of architecture and landscape architecture.

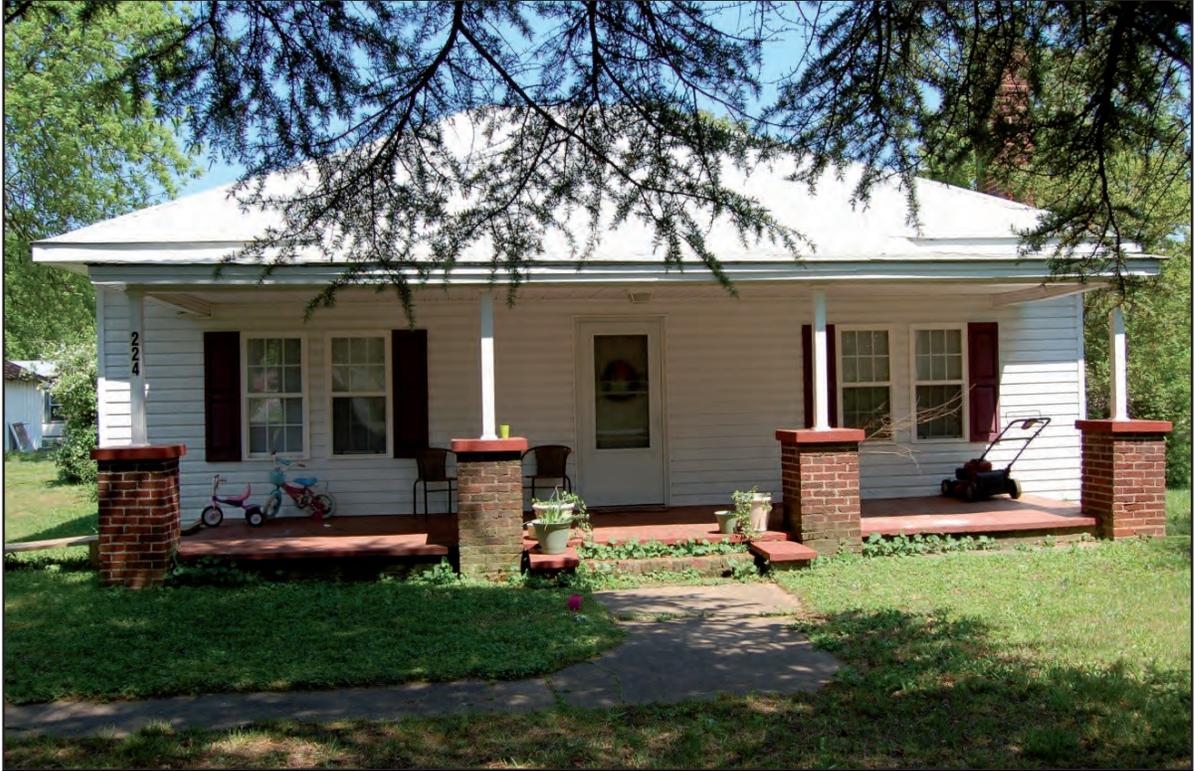
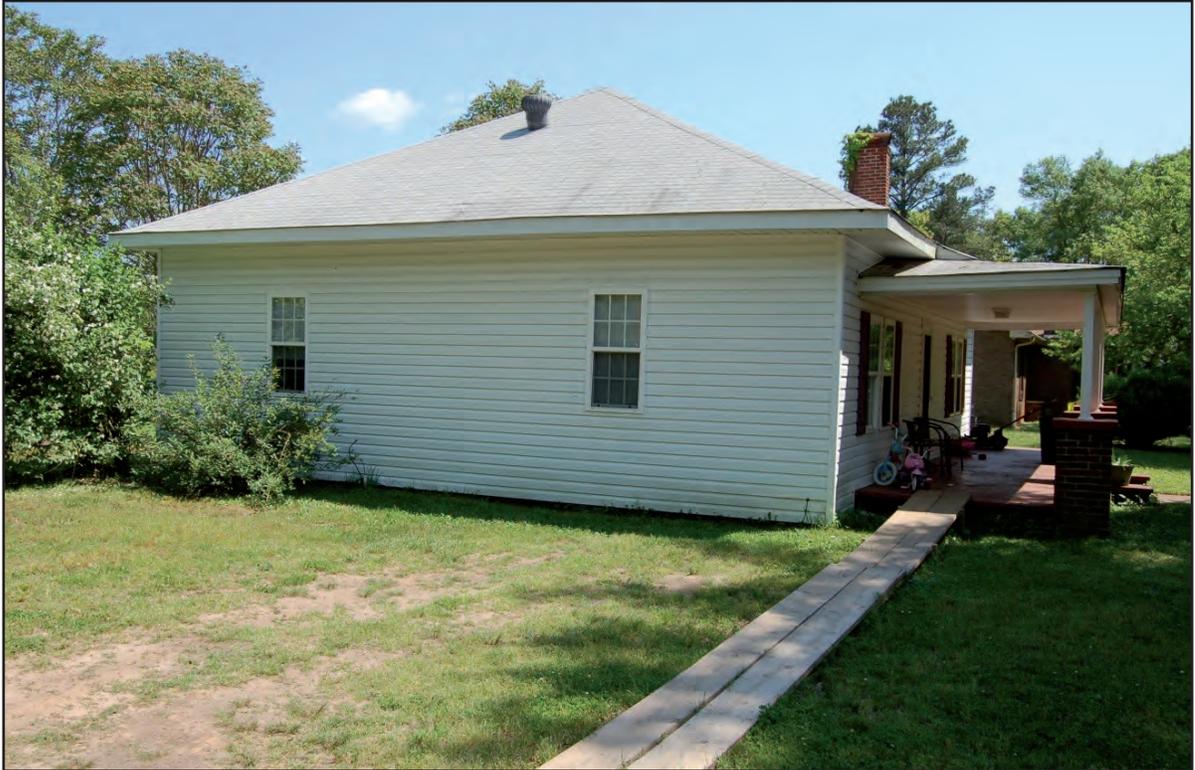
Resource 113-1078 is located at on a large legal parcel with the address of 220 Edgefield Road. The resource is located on the east side of the roadway approximately 850 feet north of the intersection of Edgefield Road and Battleground Road north of Cowpens in Spartanburg County (refer to Figure 5.2a). The Spartanburg County tax assessor's record has a 1940 estimated date of construction for the resource. This estimated date of construction was supported by the review of historic topographic maps and aerial photography, and an evaluation of the resource's plan shape and form. The resource is depicted in its current location on the earliest aerial photograph available on the [www.historicaerials.com](http://www.historicaerials.com) website dated 1955 and on the earliest USGS topographic map available on the <http://viewer.nationalmap.gov/viewer/> website dated 1959. The resource is a one-story, symmetric, hipped-roof cottage of frame construction. The house features a hipped asphalt shingle roof; a full-width, engaged porch supported by four small wooden posts atop large brick piers on the façade; a small brick interior roof surface chimney, a continuous concrete block foundation; and vinyl exterior siding (see Figures 5.46 and 5.47). All of the windows on the resource are non-historic replacements with the original windows having been replaced with metal-framed vinyl windows with faux muntins.

**Figure 5.46.** Resource 113-1078 (220 Edgefield Road) – View of façade facing east.

**Figure 5.47.** Resource 113-1078 (220 Edgefield Road) – View of north side elevation facing southeast.

The resource is not known to be associated with a significant activity or event and there is not a known connection between the resource and any individual whose activities or achievements are historically significant. Therefore, there was no basis for evaluating the resource under Criterion A or B. Also, there is no indication that the resource is likely to yield information on important research questions in history or prehistory. The resource does not appear to have the potential to be the principal source of important information. Therefore, there was no basis for evaluating the resource under Criterion D. The resource does not represent a recognized architectural type or style and does not otherwise appear to represent a significant trend in South Carolina's architectural history. Additionally, due to the application of vinyl exterior siding and the replacement of the original windows with non-historic metal-framed vinyl replacements, the resource does not retain integrity in the areas of materials, workmanship, and feeling and cannot convey significance in the area of architecture. Therefore, Resource 113-1078 is recommended **Not Eligible** for listing in the NRHP under Criterion C in the area of architecture.

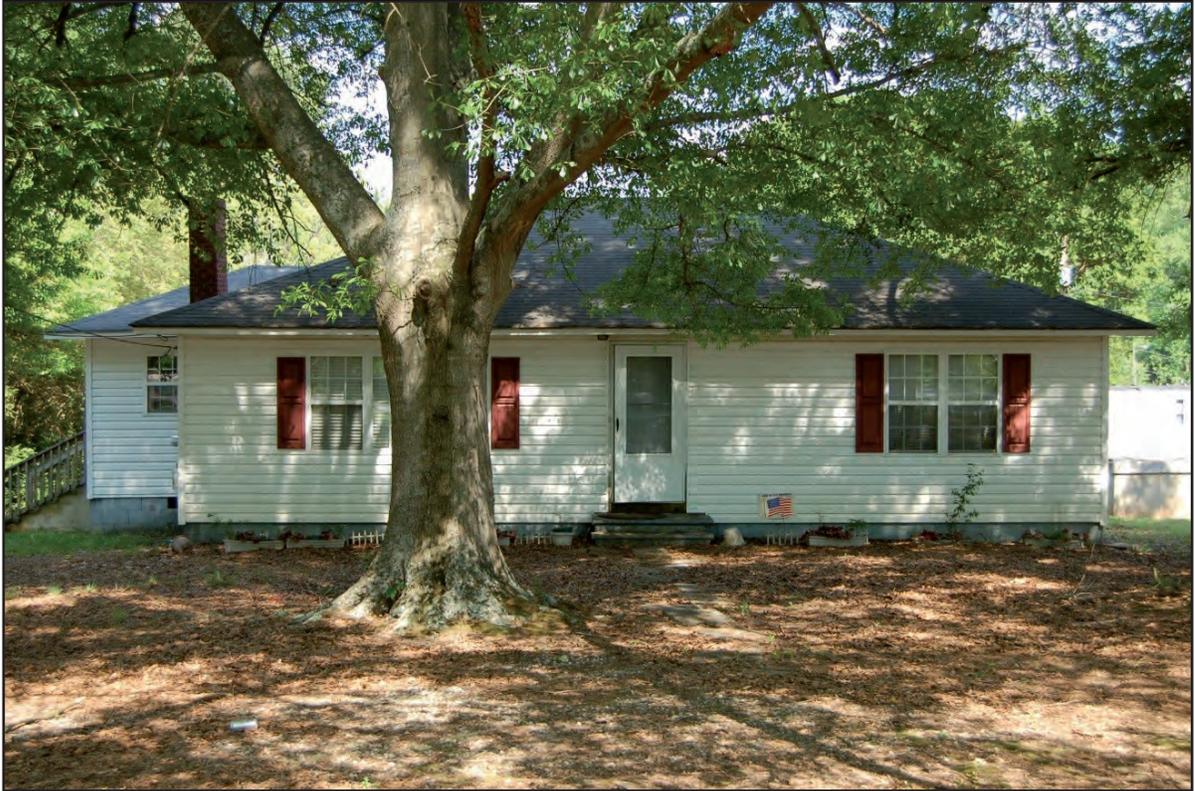
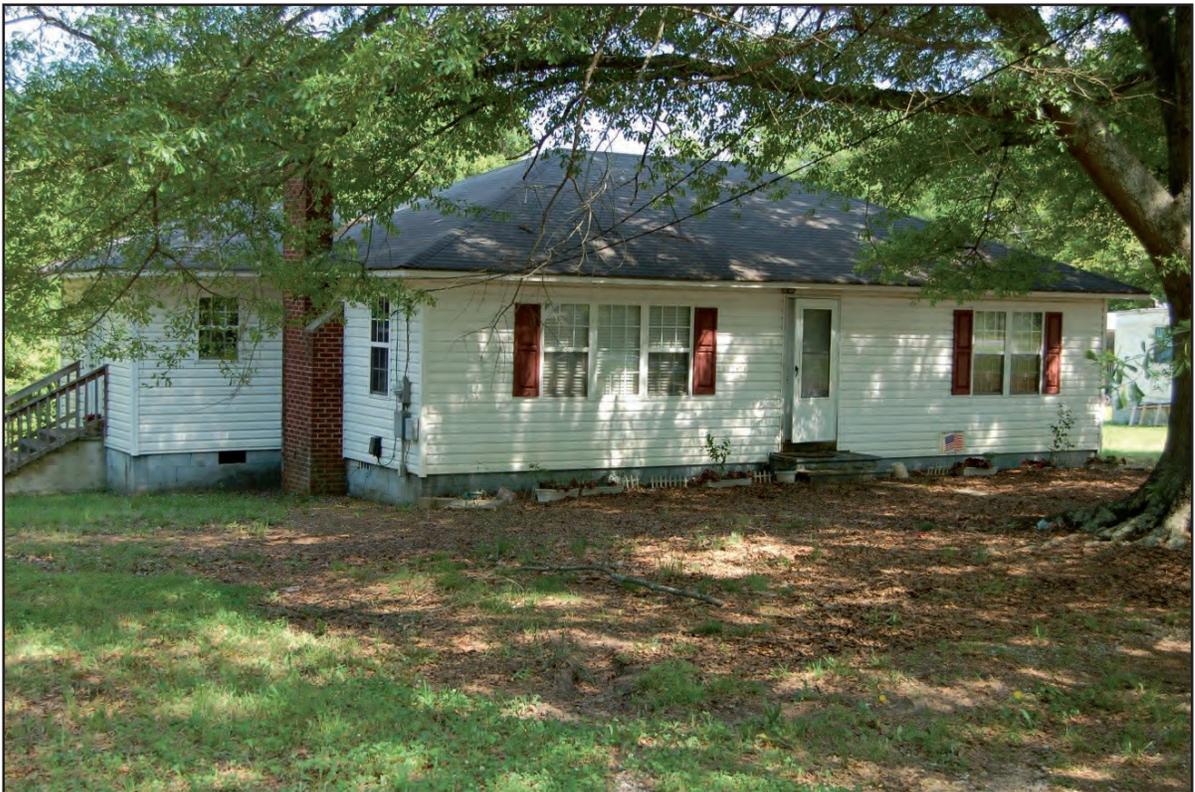
Resource 113-1079 is located on the same large legal parcel as Resource 113-1078 with the address of 220 Edgefield Road. The resource is located on the east side of the roadway approximately 400 feet south of the intersection of Edgefield Road and Bud Arthur Bridge Road north of Cowpens in Spartanburg County (refer to Figure 5.2a). The Spartanburg County tax assessor's record has a 1950 estimated date of construction for the resource. This estimated date of construction was supported by the review of historic topographic maps and aerial photography, and an evaluation of the resource's plan shape and form. The resource is depicted in its current location on the earliest aerial photograph available on the [www.historicaerials.com](http://www.historicaerials.com) website dated 1955 and on the earliest USGS topographic map available on the <http://viewer.nationalmap.gov/viewer/> website dated 1959. The resource is a one-story, asymmetric, hipped-roofed house of frame construction. The house features a hipped asphalt shingle roof; a continuous concrete block foundation; and vinyl exterior siding (see Figures 5.48 and 5.49). All of the windows on the resource are non-historic replacements with the original windows having been replaced with metal-framed vinyl windows with faux muntins.

**Figure 5.48.** Resource 113-1079 (220 Edgefield Road) – View of façade facing east.

**Figure 5.49.** Resource 113-1079 (220 Edgefield Road) – Oblique view of façade and north side elevation facing southeast.

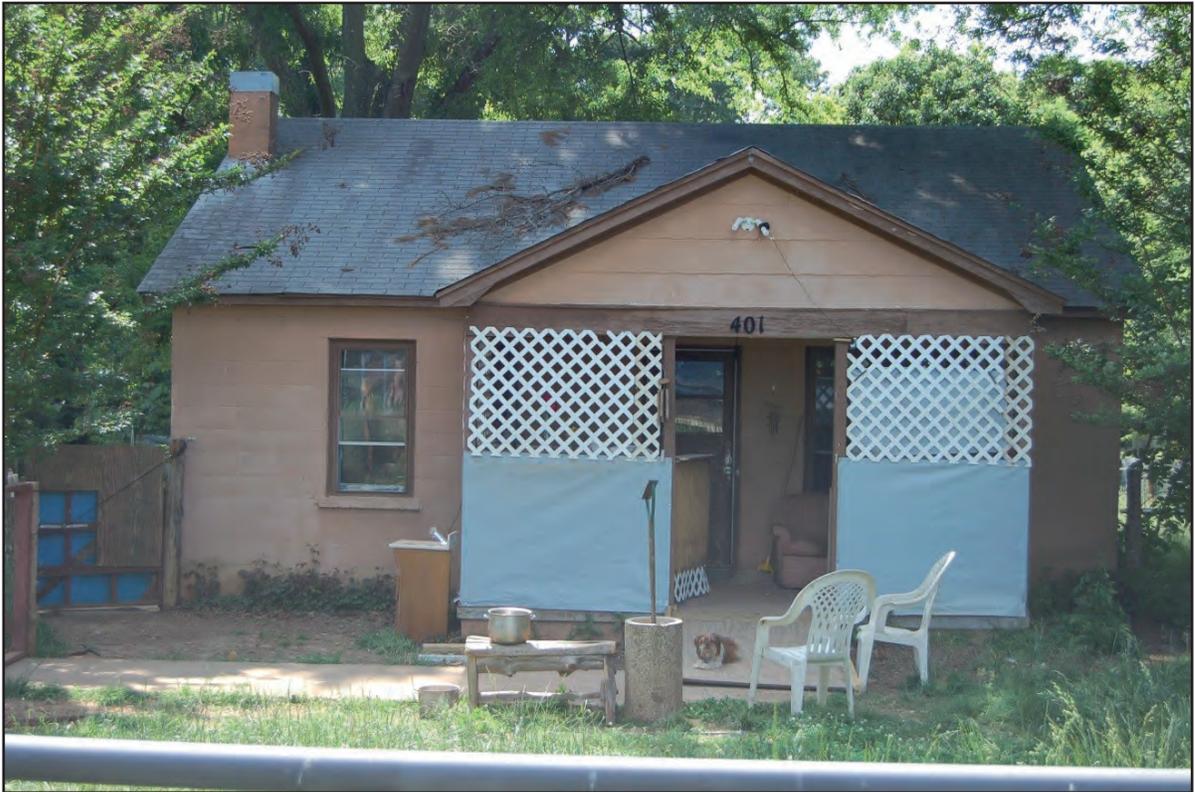
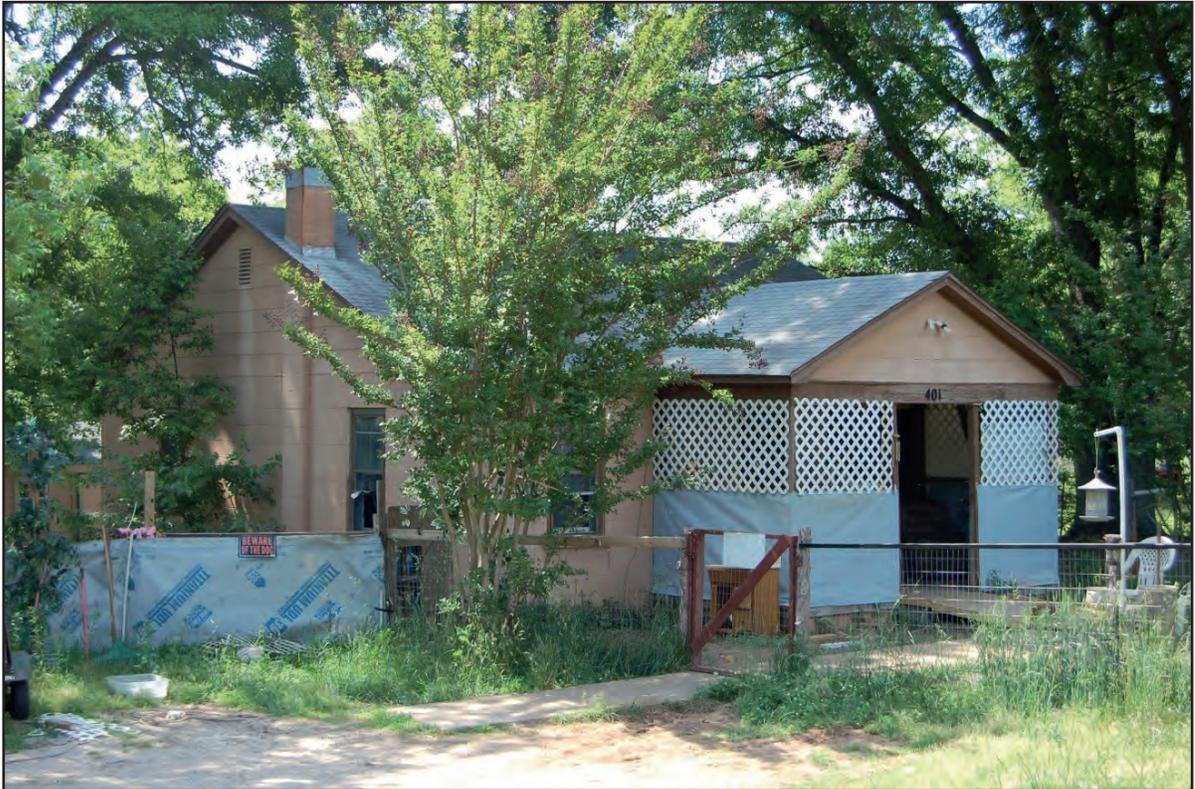
dated 1955 and on the earliest USGS topographic map available on the <http://viewer.nationalmap.gov/viewer/> website dated 1959. The resource is a one-story, asymmetric, cross-gabled cottage of concrete block load-bearing wall construction. The house features a cross-gabled asphalt shingle roof; a partial-width, projecting gable-roofed porch supported by wooden posts on the façade, concrete block walls, concrete asbestos tile exterior siding in the gable ends, a small exterior end wall masonry chimney covered with stucco on the south side elevation, and wood-framed 3/1-light double-hung sash windows (see Figures 5.50 and 5.51).

**Figure 5.50.** Resource 113-1080 (401 Edgefield Road) – View of façade facing west.

**Figure 5.51.** Resource 113-1080 (401 Edgefield Road) – Oblique view of façade and south side elevation facing northwest.

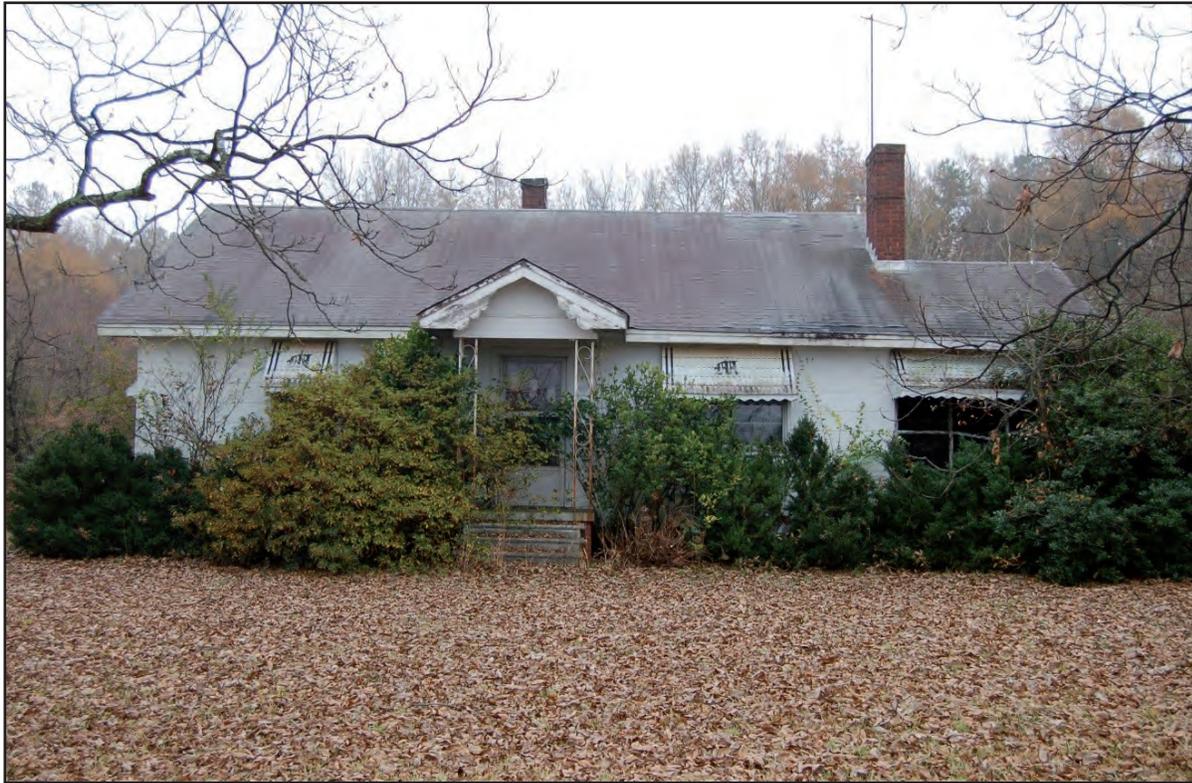
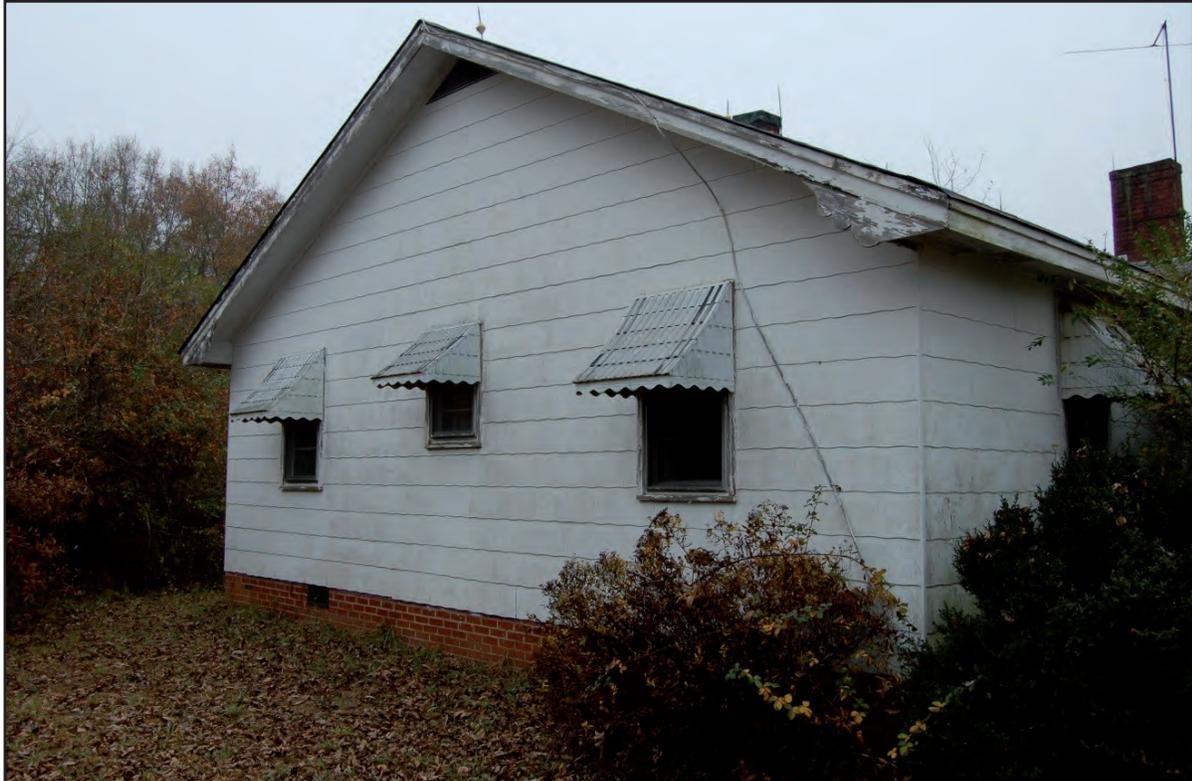
Resource 113-1081 is located at 140 Smith Road on the south side of the roadway approximately 350 feet east of the intersection of Smith Road and Edgefield Road north of Cowpens in Spartanburg County (refer to Figure 5.2a). The Spartanburg County tax assessor's record has a 1954 estimated date of construction for the resource. This estimated date of construction was supported by the review of historic topographic maps and aerial photography, and an evaluation of the resource's form and construction materials. The resource is depicted in its current location on the earliest aerial photograph available on the [www.historicaerials.com](http://www.historicaerials.com) website dated 1955 and on the earliest USGS topographic map available on the <http://viewer.nationalmap.gov/viewer/> website dated 1959. The resource is a one-story, asymmetric, side-gabled residence of frame construction. The house features a side-gabled asphalt shingle roof; two tall brick interior roof surface chimneys; a stoop entry porch with a gable roof supported by two decorative metal posts on the façade; a gable-roofed screened porch on the east side elevation; a continuous concrete block foundation; and concrete asbestos tile exterior siding (see Figures 5.52 and 5.53). Windows are single and paired original wood-framed 2/2-light double hung sash of various sizes and metal canopy awnings are installed above the windows and around the screened porch on the east side elevation.

**Figure 5.52.** Resource 113-1081 (140 Smith Road) – View of façade facing east.

**Figure 5.53.** Resource 113-1081 (140 Smith Road) – Oblique view of façade and south side elevation facing northeast.

historically significant. Therefore, there was no basis for evaluating the resource under Criterion A or B. Also, there is no indication that the resource is likely to yield information on important research questions in history or prehistory. The resource does not appear to have the potential to be the principal source of important information. Therefore, there was no basis for evaluating the resource under Criterion D. The resource does not represent a recognized architectural type or style and does not otherwise appear to represent a significant trend in South Carolina's architectural history. Therefore, Resource 113-1081 is recommended **Not Eligible** for listing in the NRHP under Criterion C in the area of architecture.

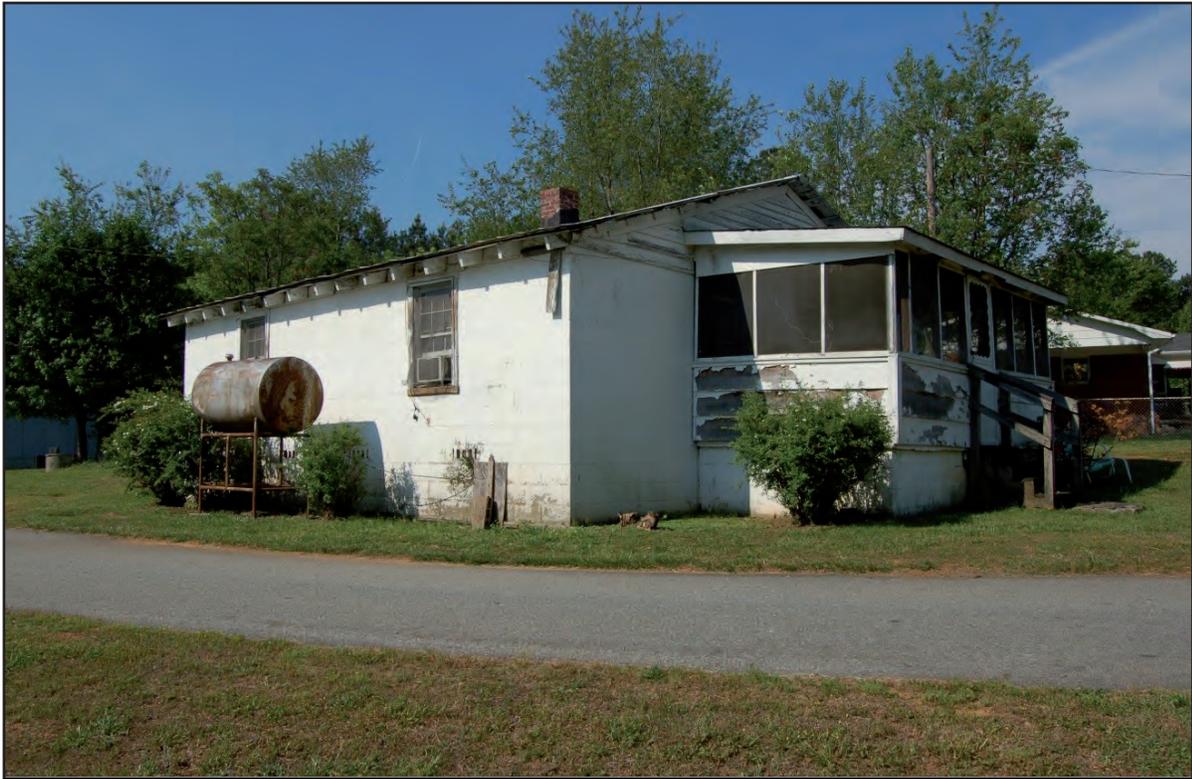
Resource 113-1082 is located at 190 Smith Road on the south side of the roadway in the southwest corner of the intersection of Smith Road and Huff Road north of Cowpens in Spartanburg County (refer to Figure 5.2a). The Spartanburg County tax assessor's record has a 1950 estimated date of construction for the resource. However, this estimated date of construction was not supported by the review of historic topographic maps and aerial photography. The resource is not depicted in its current location on the earliest aerial photograph available on the [www.historicaerials.com](http://www.historicaerials.com) website dated 1955 or on the earliest USGS topographic map available on the <http://viewer.nationalmap.gov/viewer/> website dated 1959. Based on the resource's form and construction materials, the resource appears to have been constructed ca. 1960. The resource is a one-story, asymmetric, front-gabled bungalow of concrete block load-bearing wall construction. The house features a front-gabled asphalt shingle roof; a partial-width, projecting shed-roofed porch on the façade; a smaller partial-width projecting shed-roofed porch on the rear elevation; a gable-roofed addition on the rear elevation; a small brick interior ridge line chimney; concrete block exterior walls; weatherboard exterior siding in the gable ends; and original wood-framed 6/6-light double hung sash windows (see Figures 5.54 and 5.55).

**Figure 5.54.** Resource 113-1082 (190 Smith Road) – Oblique view of façade and east side elevation facing southwest.

The resource is not known to be associated with a significant activity or event and there is not a known connection between the resource and any individual whose activities or achievements are historically significant. Therefore, there was no basis for evaluating the resource under Criterion A or B. Also, there is no indication that the resource is likely to yield information on important research questions in history or prehistory. The resource does not appear to have the potential to be the principal source of important information. Therefore, there was no basis for evaluating the resource under Criterion D. The resource is a late and undistinguished example of a common architectural type and due to the reconstruction of the front and rear porches the resource does not retain integrity in the areas of design, materials, workmanship, and feeling and cannot convey significance in the area of architecture. Therefore, Resource 113-1081 is recommended **Not Eligible** for listing in the NRHP under Criterion C in the area of architecture.
