**PHASE I CULTURAL RESOURCE SURVEY FOR PROPOSED  
WIDENING OF INTERSTATE 85 FROM MILE MARKER 80 TO 96,  
CHEROKEE AND SPARTANBURG COUNTIES, SOUTH CAROLINA.**

**FINAL REPORT**

**JULY 2015**

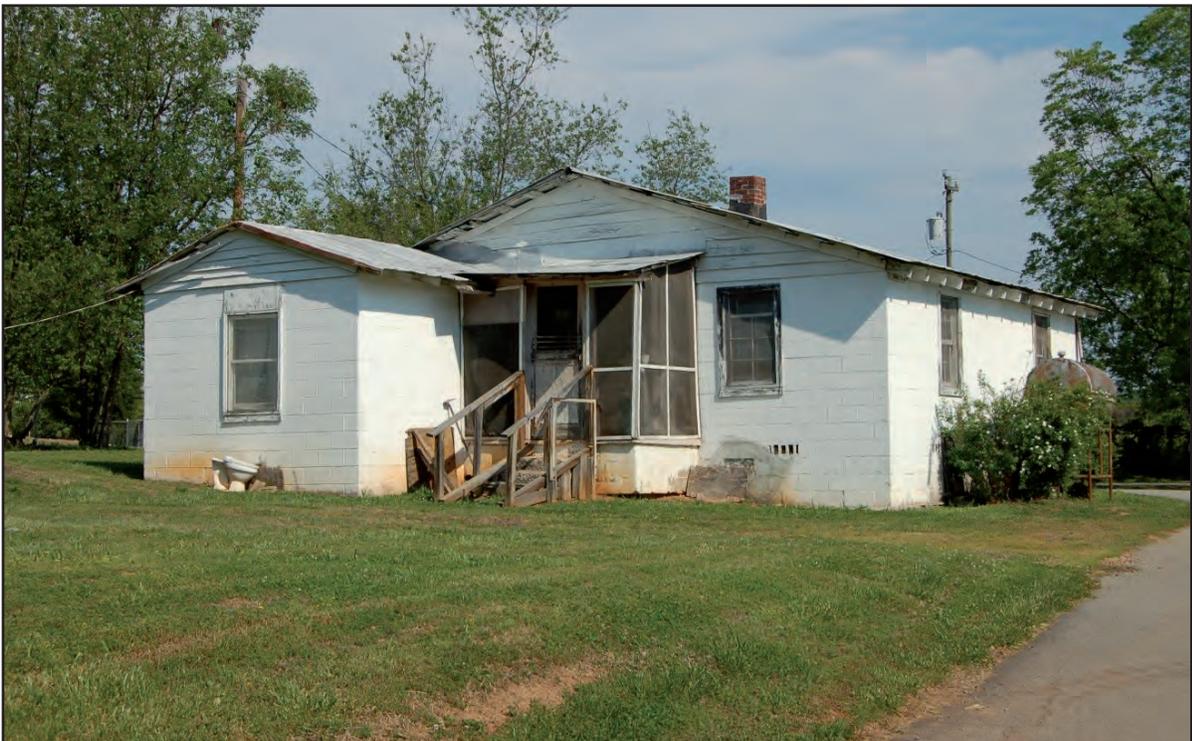
Resource 113-1082 is located at 190 Smith Road on the south side of the roadway in the southwest corner of the intersection of Smith Road and Huff Road north of Cowpens in Spartanburg County (refer to Figure 5.2a). The Spartanburg County tax assessor's record has a 1950 estimated date of construction for the resource. However, this estimated date of construction was not supported by the review of historic topographic maps and aerial photography. The resource is not depicted in its current location on the earliest aerial photograph available on the [www.historicaerials.com](http://www.historicaerials.com) website dated 1955 or on the earliest USGS topographic map available on the <http://viewer.nationalmap.gov/viewer/> website dated 1959. Based on the resource's form and construction materials, the resource appears to have been constructed ca. 1960. The resource is a one-story, asymmetric, front-gabled bungalow of concrete block load-bearing wall construction. The house features a front-gabled asphalt shingle roof; a partial-width, projecting shed-roofed porch on the façade; a smaller partial-width projecting shed-roofed porch on the rear elevation; a gable-roofed addition on the rear elevation; a small brick interior ridge line chimney; concrete block exterior walls; weatherboard exterior siding in the gable ends; and original wood-framed 6/6-light double hung sash windows (see Figures 5.54 and 5.55).

**Figure 5.55.** Resource 113-1082 (190 Smith Road) – Oblique view of rear and east side elevations facing northwest.

The resource is not known to be associated with a significant activity or event and there is not a known connection between the resource and any individual whose activities or achievements are historically significant. Therefore, there was no basis for evaluating the resource under Criterion A or B. Also, there is no indication that the resource is likely to yield information on important research questions in history or prehistory. The resource does not appear to have the potential to be the principal source of important information. Therefore, there was no basis for evaluating the resource under Criterion D. The resource is a late and undistinguished example of a common architectural type and due to the reconstruction of the front and rear porches the resource does not retain integrity in the areas of design, materials, workmanship, and feeling and cannot convey significance in the area of architecture. Therefore, Resource 113-1081 is recommended **Not Eligible** for listing in the NRHP under Criterion C in the area of architecture.

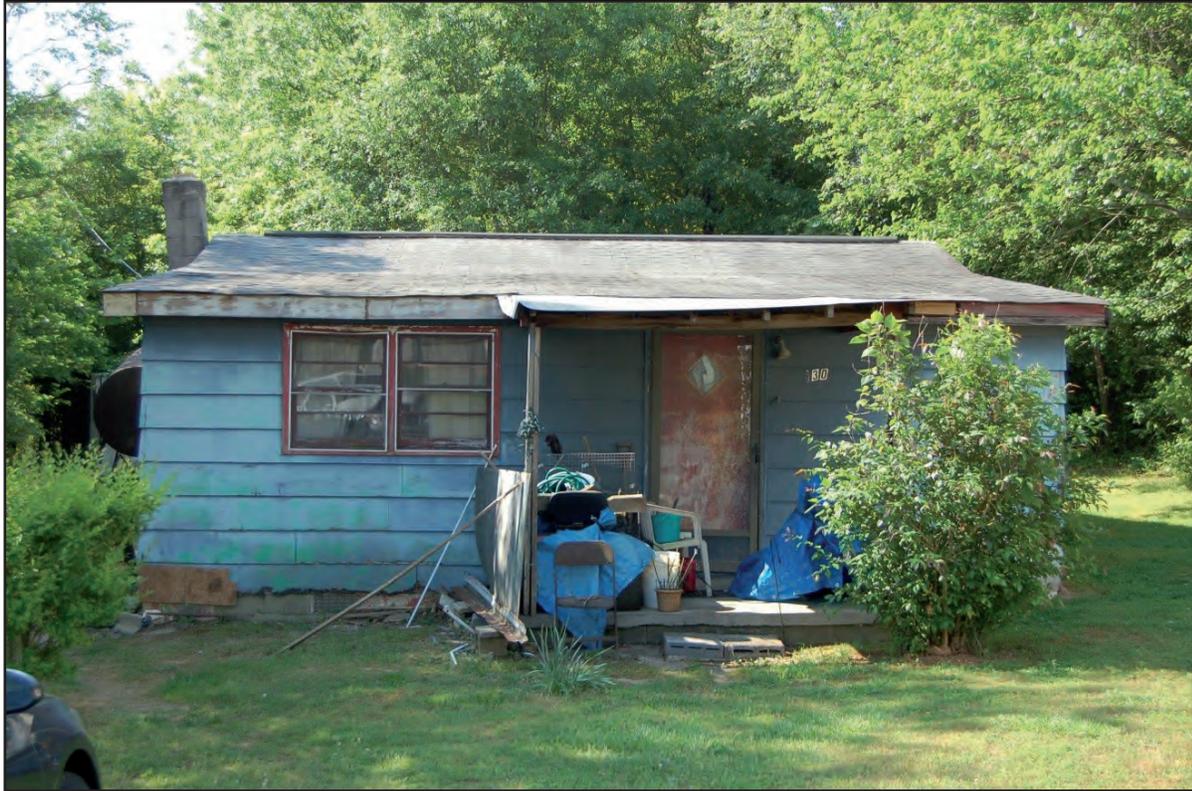
Resource 113-1083 is located at 130 Huff Road on the west side of the roadway approximately 325 feet south of the intersection of Huff Road and Smith Road north of Cowpens in Spartanburg County (refer to Figure 5.2a). The Spartanburg County tax assessor's record has a 1956 estimated date of construction for the resource. While the resource could not be identified on the earliest aerial photograph available on the [www.historicaerials.com](http://www.historicaerials.com) website dated 1955 and was not depicted on the earliest USGS topographic map available on the <http://viewer.nationalmap.gov/viewer/> website dated 1959, the resource's form and massing and construction materials are consistent with the tax assessor's 1956 date of construction. The resource is a one-story, asymmetric, side-gabled cottage of frame construction. The house features a side-gabled asphalt shingle roof; a small exterior end wall chimney on the east side elevation; a partial-width, shed-roofed porch supported by wooden posts; weatherboard exterior siding; a continuous concrete block foundation; and single and paired wood-framed 2/2-light double-hung sash windows (see Figures 5.56 and 5.57).

**Figure 5.56.** Resource 113-1083 (130 Huff Road) – View of façade facing northwest.

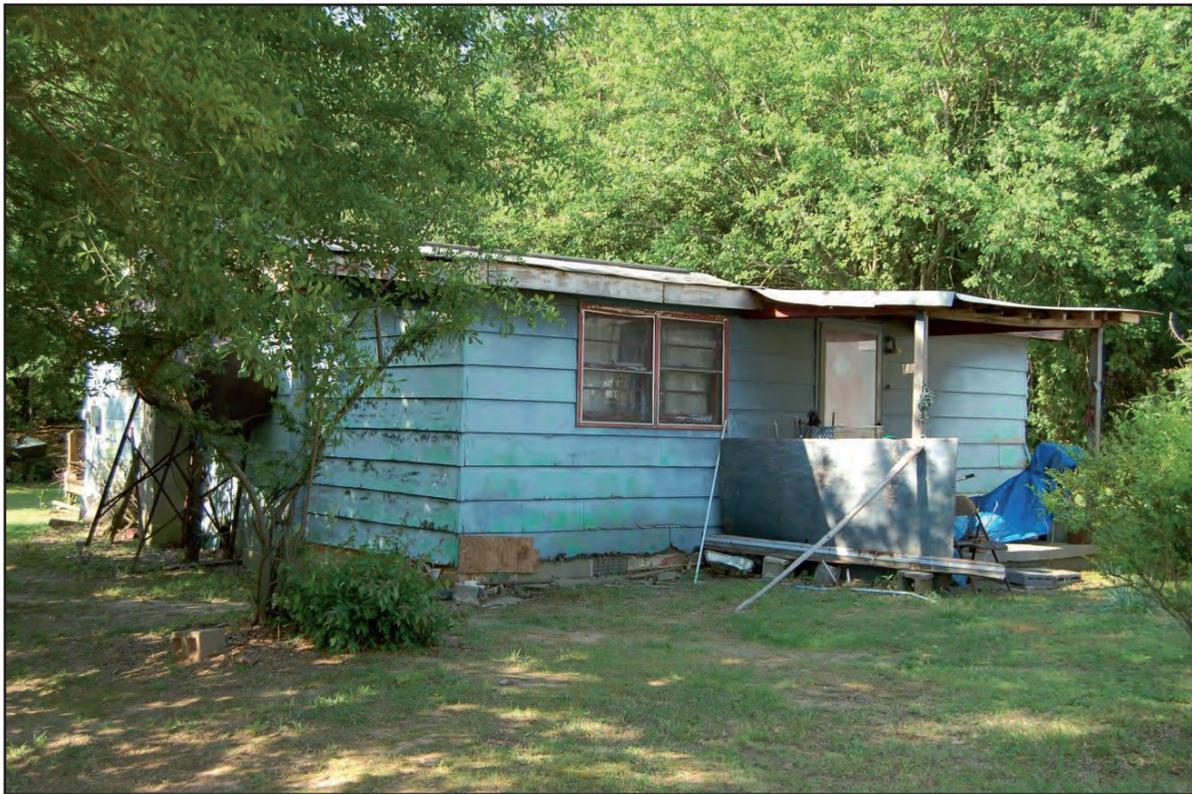
**Figure 5.57.** Resource 113-1083 (130 Huff Road) – Oblique view of façade and east side elevations facing northwest.

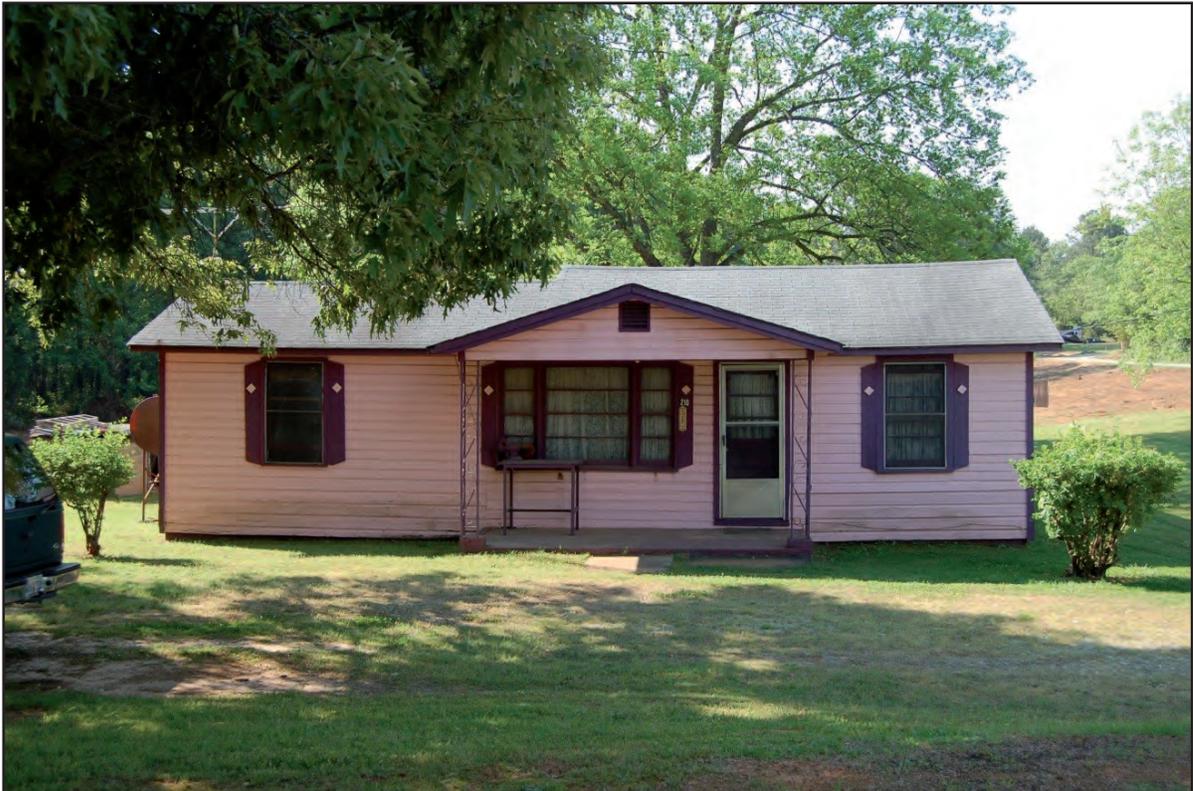
shingle roof; a partial-width, projecting gable-roofed porch supported by two decorative metal posts on the façade; a tripartite window on the façade comprised of large four-light picture window flanked by narrow 2/2-light double-hung sash windows; a continuous concrete block foundation; and novelty board exterior siding (see Figures 5.58 and 5.59).

**Figure 5.58.** Resource 113-1084 (210 Smith Road) – View of façade facing south.

The resource is not known to be associated with a significant activity or event and there is not a known connection between the resource and any individual whose activities or achievements are historically significant. Therefore, there was no basis for evaluating the resource under Criterion A or B. Also, there is no indication that the resource is likely to yield information on important research questions in history or prehistory. The resource does not appear to have the potential to be the principal source of important information. Therefore, there was no basis for evaluating the resource under Criterion D. The resource does not represent a recognized architectural type or style and does not otherwise appear to represent a significant trend in South Carolina’s architectural history. Therefore, Resource 113-1084 is recommended **Not Eligible** for listing in the NRHP under Criterion C in the area of architecture.

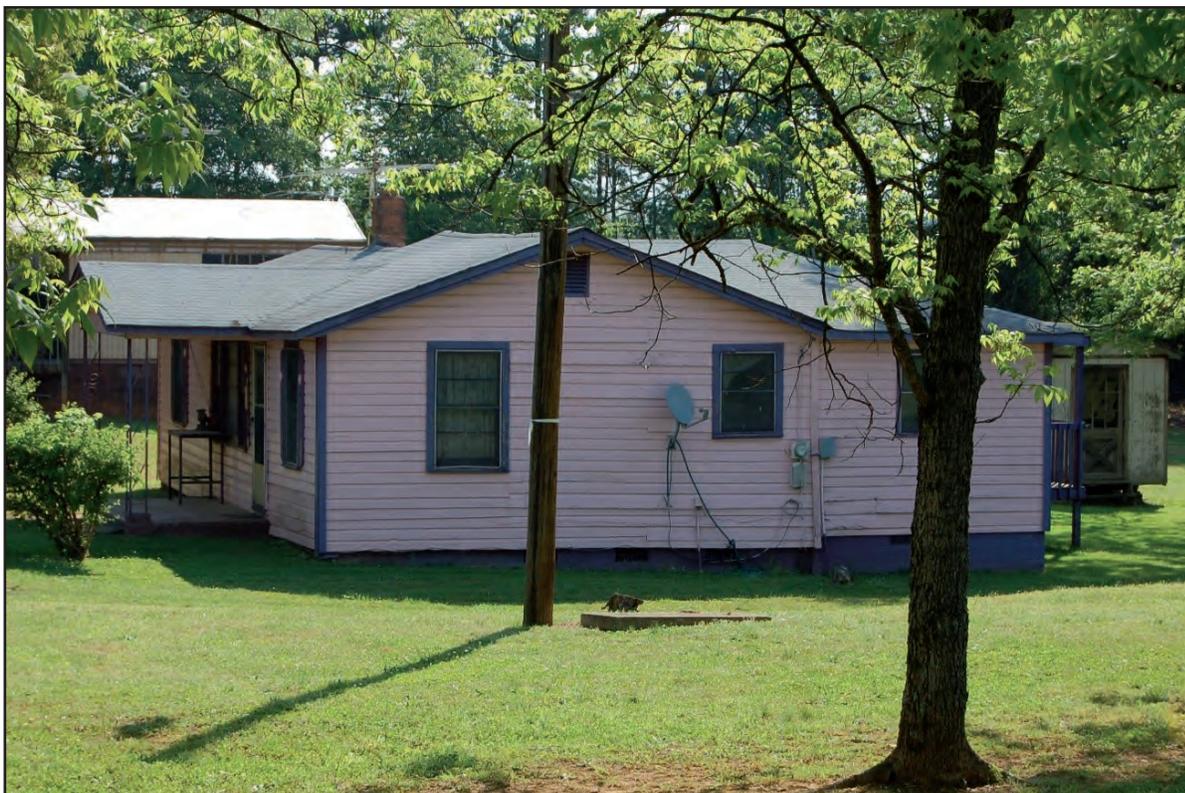
**Figure 5.59.** Resource 113-1084 (210 Smith Road) – View of west side elevation facing southeast.

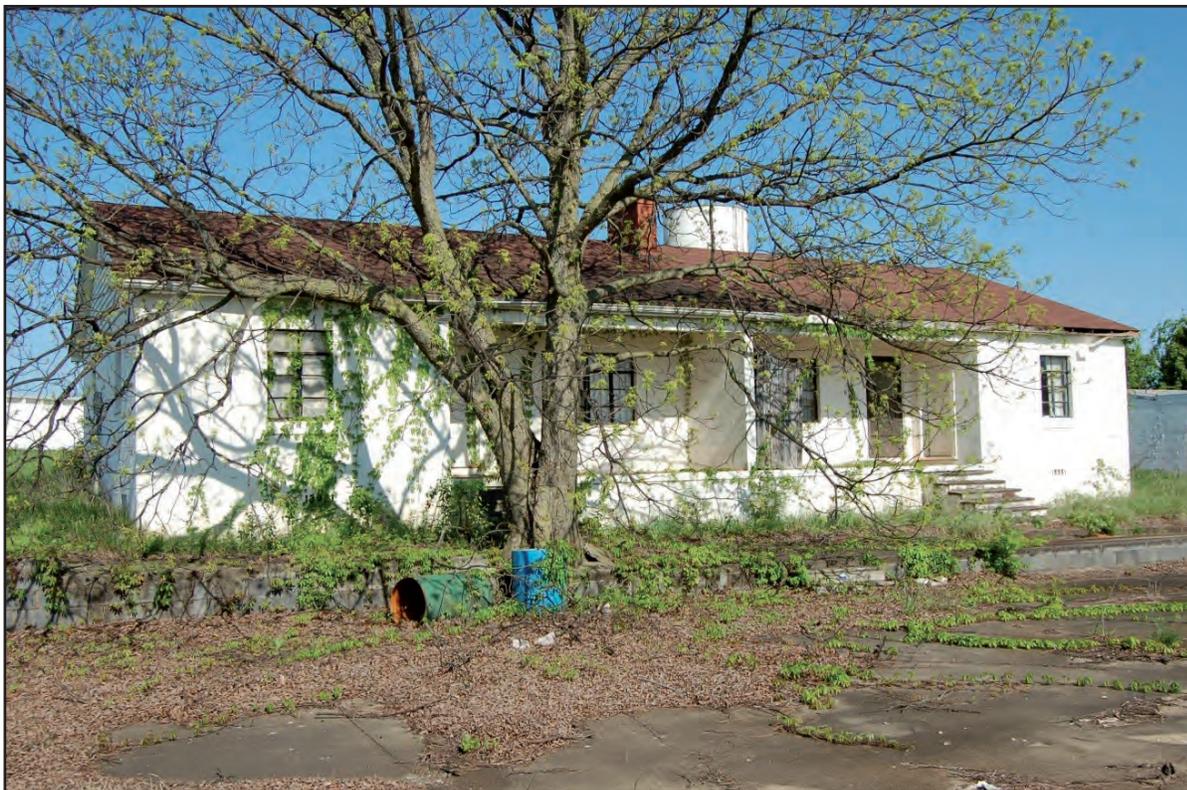
The camp office/administrative building and/or original kitchen/common area (113-0174.00) is a one-story, asymmetric, side-gabled building of concrete block load-bearing wall construction. The building features a side-gabled asphalt shingle roof; a small brick interior ridgeline chimney; a partial-width, integral porch on the façade; and original metal casement windows (see Figures 5.62 and 5.63).

**Figure 5.62.** Resource 113-0174.00 (568 Webber Road) - View of façade of camp complex main building facing northwest.

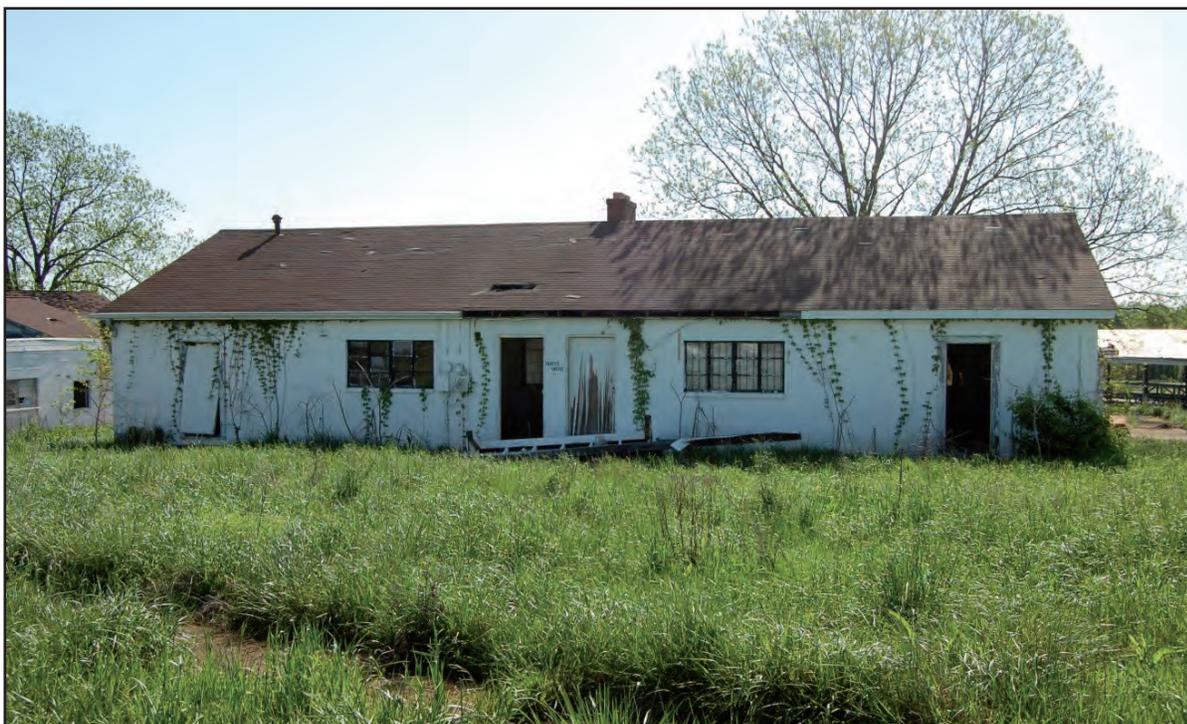
**Figure 5.63.** Resource 113-0174.00 (568 Webber Road) - View of rear elevation of camp complex main building facing southeast.

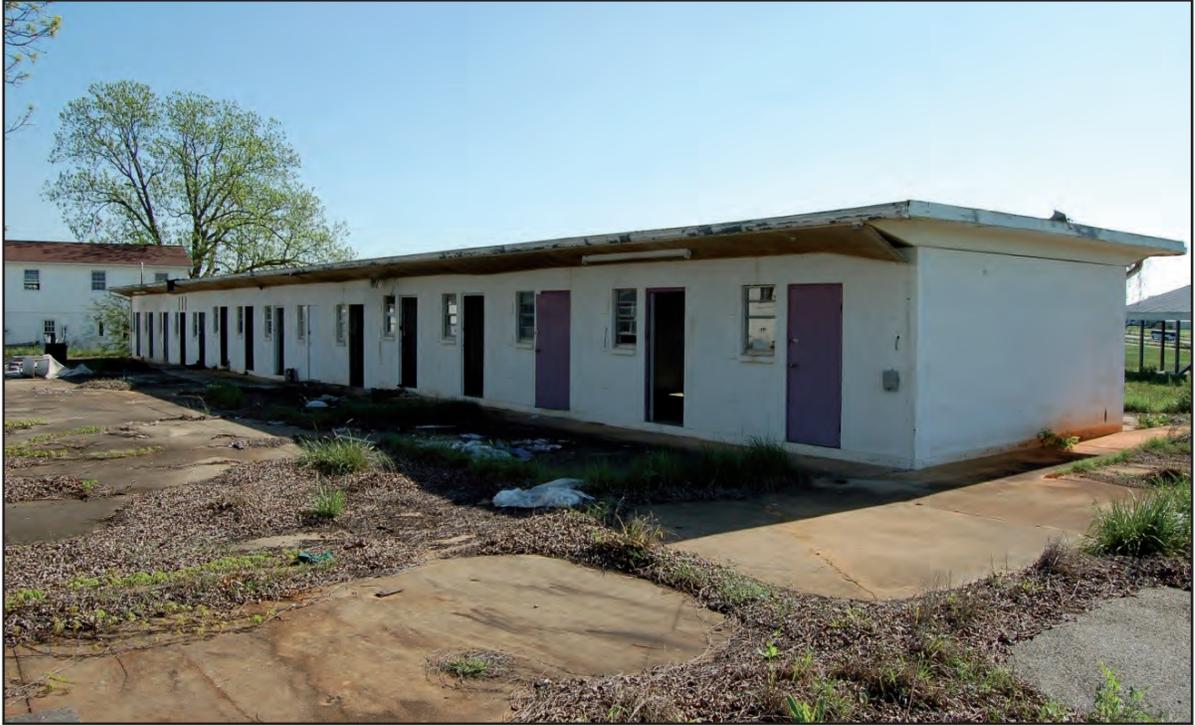
The dormitory building (113-0174.01) is a one-story, asymmetric, flat-roofed building of concrete block load-bearing wall construction. The building features a flat metal roof and 15 rooms on both the east and the west elevations (see Figures 5.64 and 5.65). Each room has a door and a small metal-framed 2/2-light double-hung sash window.

**Figure 5.64.** Resource 113-0174.01 (568 Webber Road) - View of west elevation of dormitory building facing northeast.

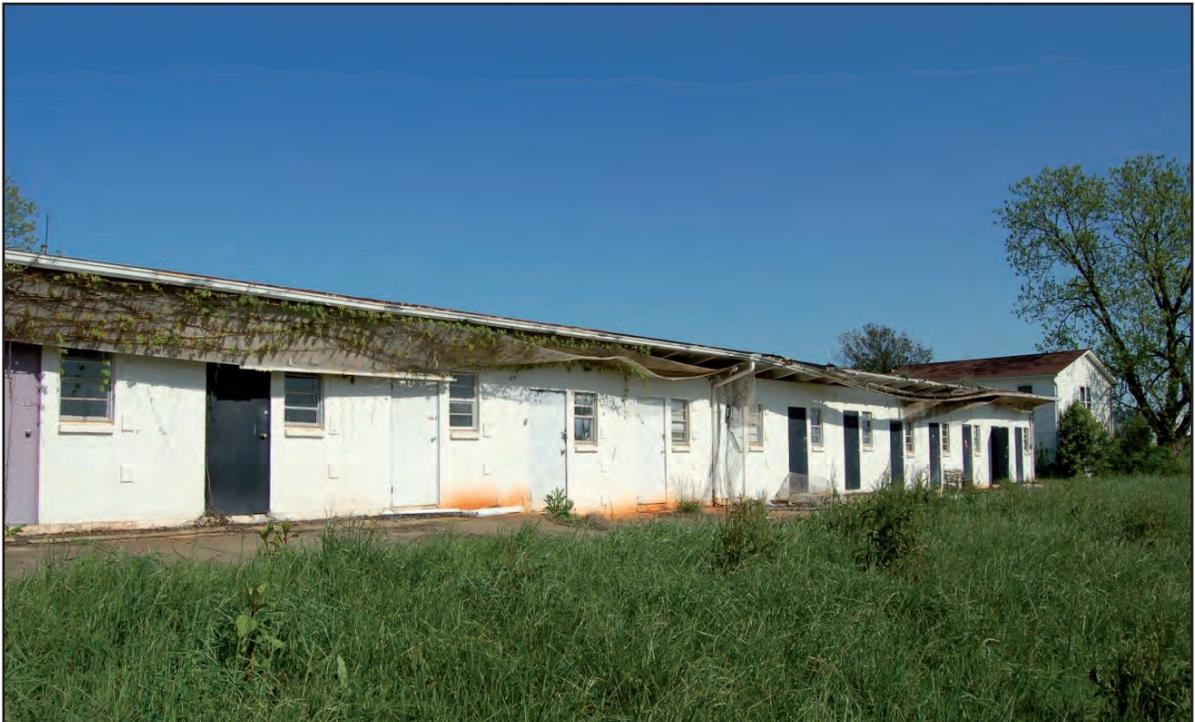
**Figure 5.65.** Resource 113-0174.01 (568 Webber Road) - View of east elevation of dormitory building facing northwest.

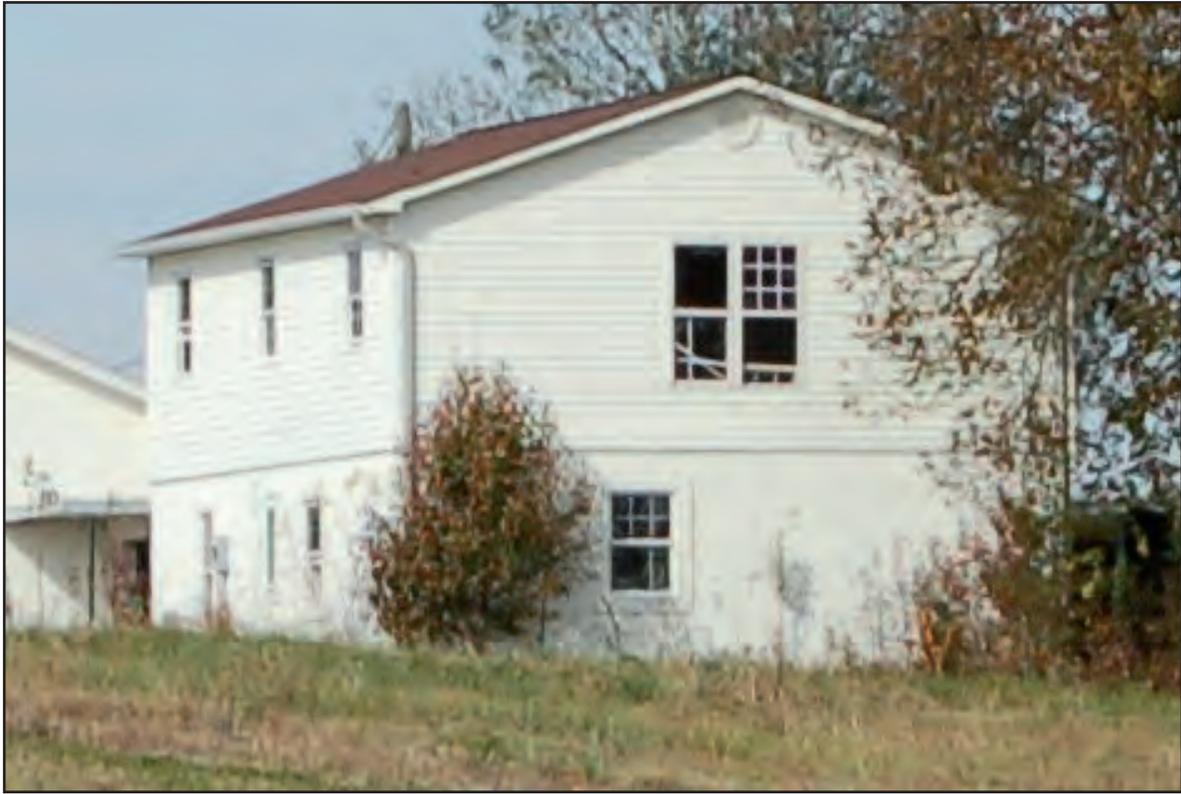
One building of unknown use (113-0174.02) is a two-story, asymmetric, side-gabled building of concrete block load-bearing wall construction on the lower level and frame construction on the upper level. The building features a side-gabled asphalt shingle roof; novelty board exterior siding on the upper level; concrete block exterior siding on the lower level; and single and paired 6/6-light and 9/9-light double-hung sash windows (see Figure 5.66).

**Figure 5.66.** Resource 113-0174.02 (568 Webber Road) - View of building of unknown use facing northwest.

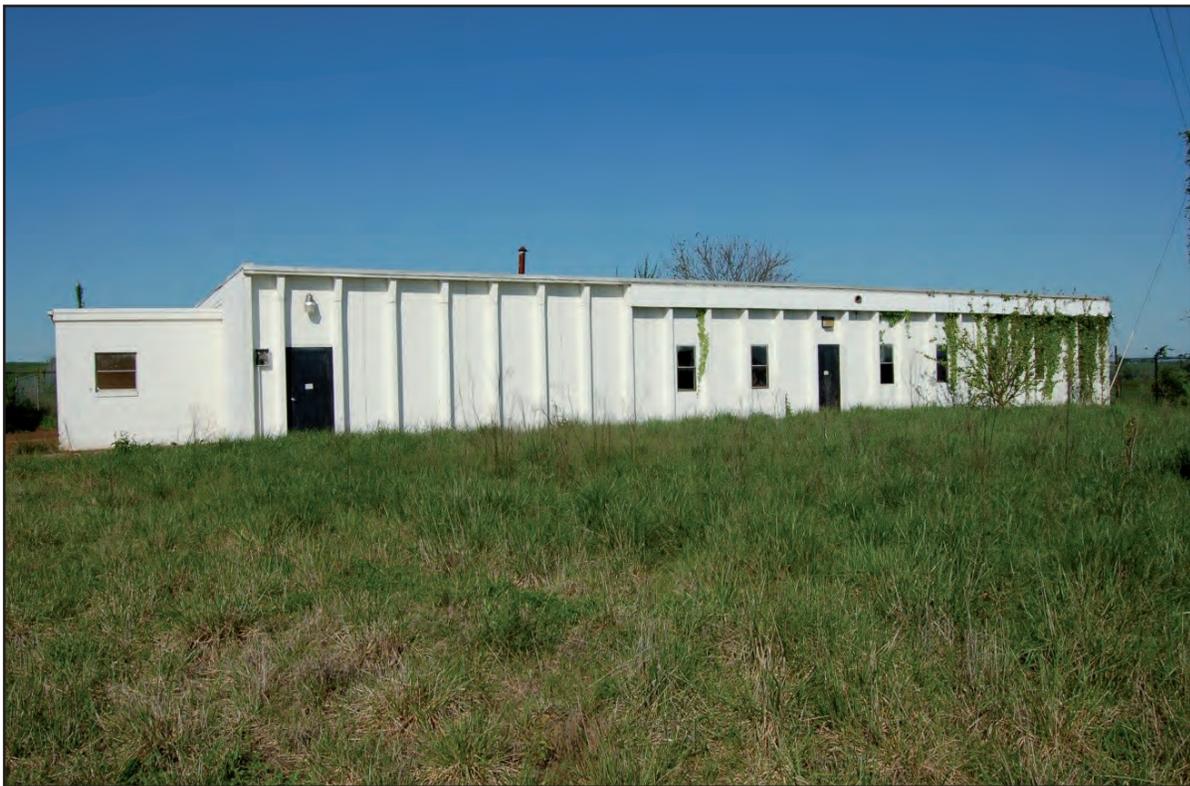
The non-historic buildings on the property consist a kitchen and dining hall building (see Figure 5.67), a common room building (see Figure 5.68), a hipped-roof building of unknown use (see Figure 5.69), two open sheds (see Figures 5.70 and 5.71) and two shelters erected ca. 1995 when site was used as flea market (see Figure 5.73)

**Figure 5.67.** Resource 113-0174 (568 Webber Road) - View of non-historic building added to complex reported to have been kitchen and dining hall.

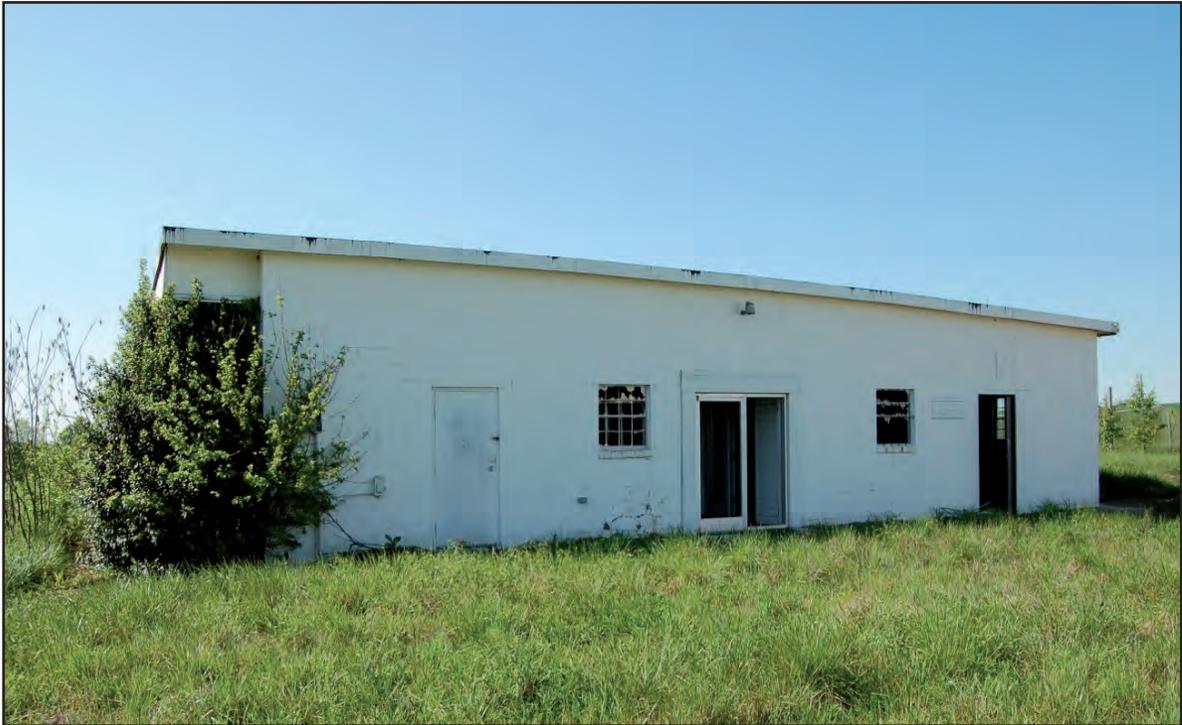
**Figure 5.68.** Resource 113-0174 (568 Webber Road) - View of non-historic building added to complex reported to have been common rooms.

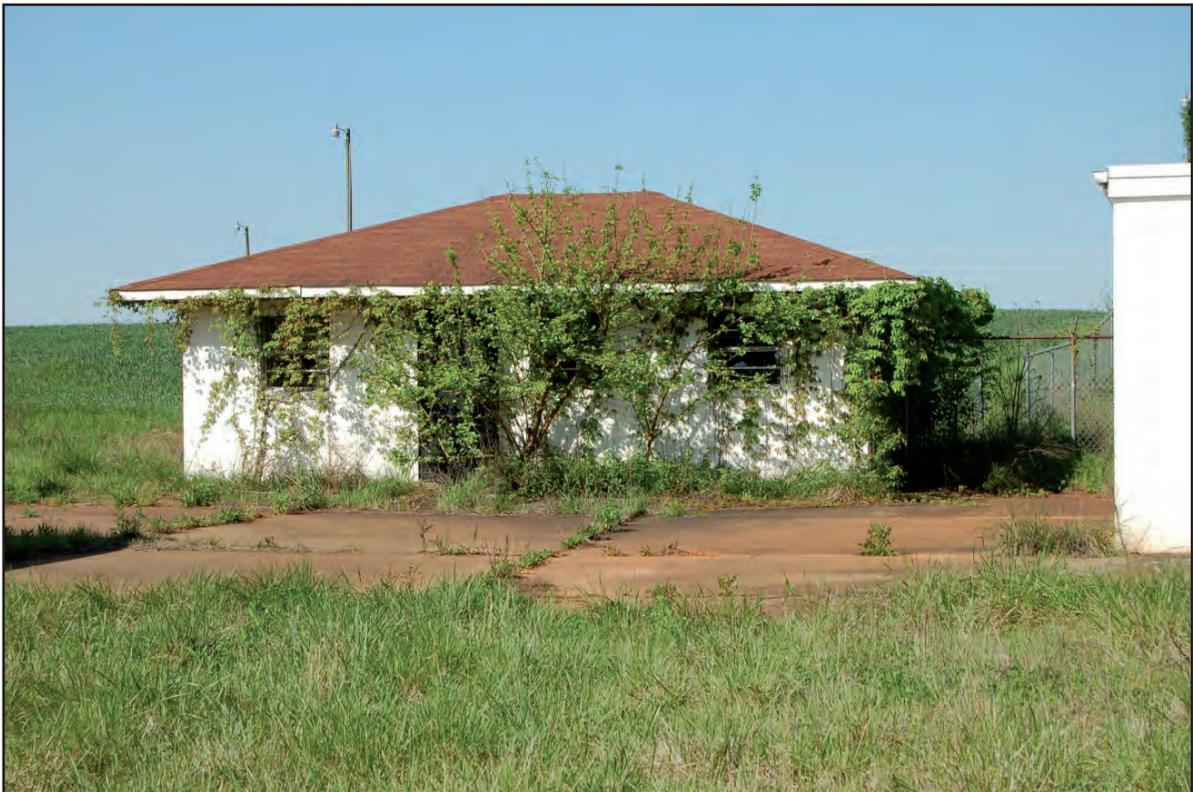
**Figure 5.69.** Resource 113-0174 (568 Webber Road) - View of non-historic building of unknown use facing west.

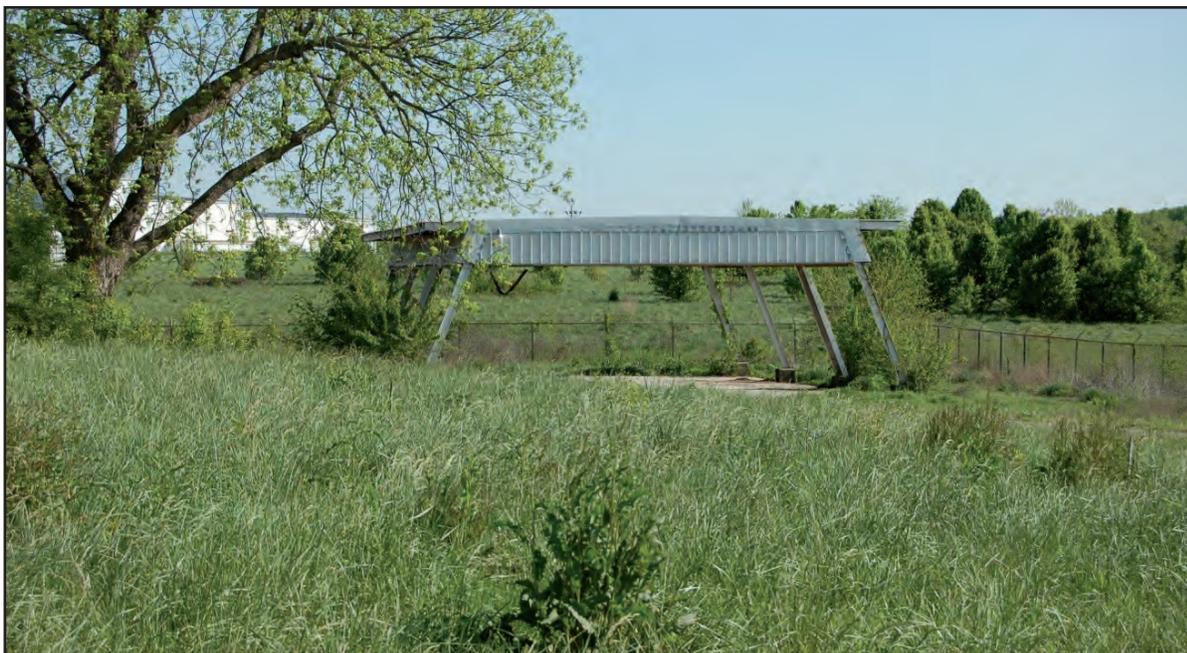
**Figure 5.70.** Resource 113-0174 (568 Webber Road) – Peach shelter constructed after 1955.

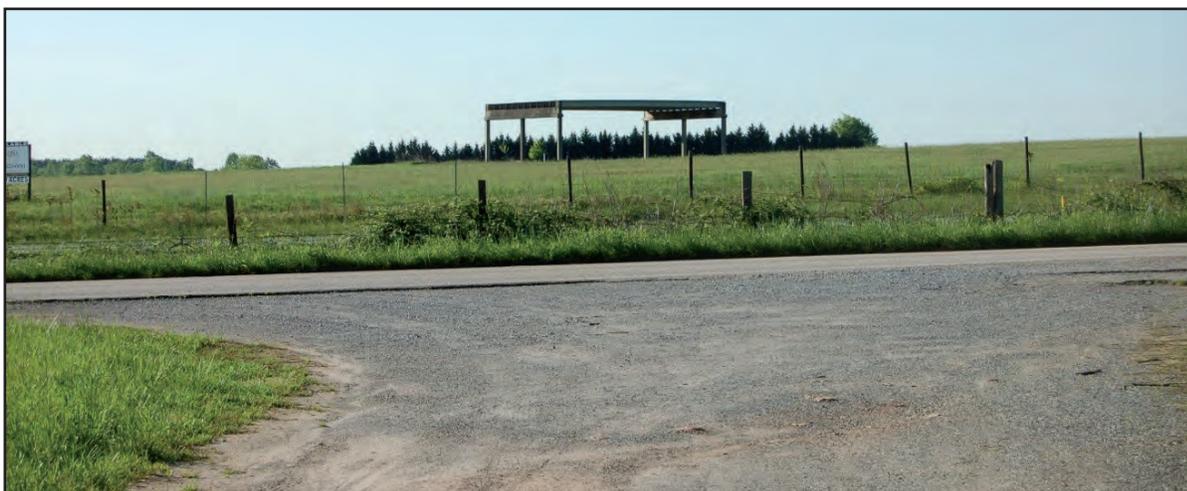
**Figure 5.71.** Resource 113-0174 (568 Webber Road) – View of peach shelter on opposite side of I-85 from farm camp.

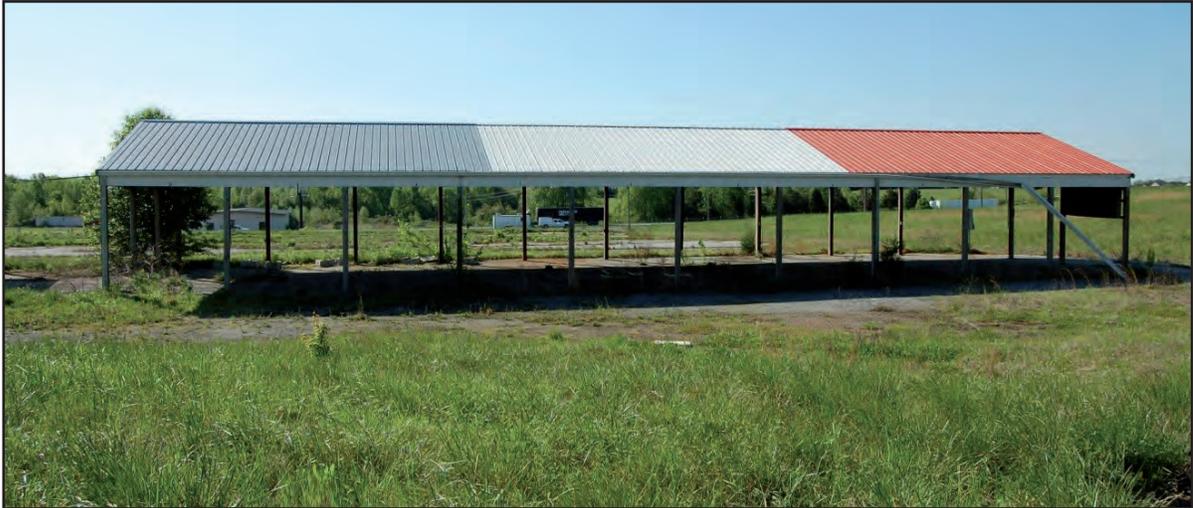
**Figure 5.73.** Resource 113-0174 (568 Webber Road) - View of one of two non-historic shelters constructed ca. 1995 when site was used as flea market.

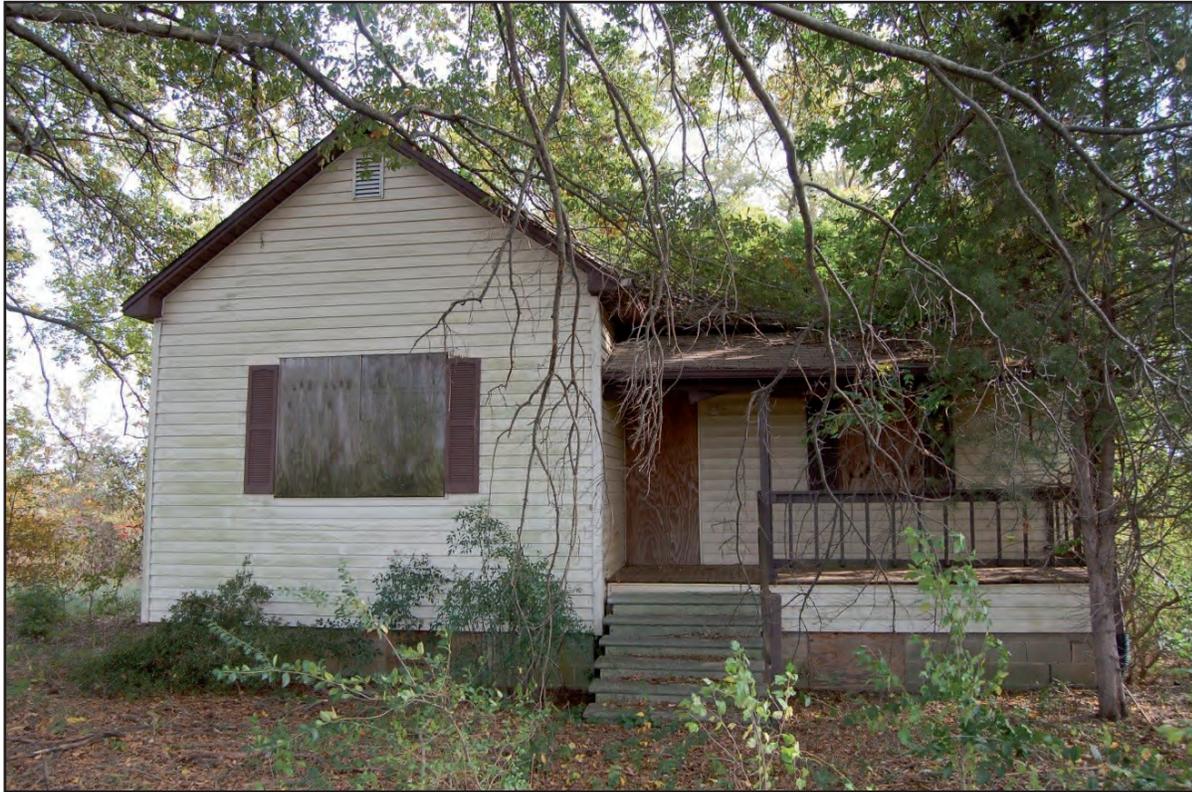
Resource 113-0176 is located at 5986 Cannons Campground Road on the east side of the roadway approximately 0.41 mile north of the intersection of Cannons Campground Road and Sunny Slope Drive west of Gaffney in Cherokee County (refer to Figure 5.2b). The Cherokee County tax assessor's record does not have an estimated date of construction for the resource. Based on a review of historic aerial photography and topographic maps, and an evaluation of the resource's form and construction materials, the resource is estimated to have been constructed ca. 1935. This estimated date of construction is supported by the depiction of the resource in its current location on the earliest aerial photograph available on the [www.historicaerials.com](http://www.historicaerials.com) website dated 1955. The resource is a one-story, asymmetric, cross-gabled residence of no defined type without stylistic features. The house features a cross-gabled asphalt shingle roof; a continuous concrete block foundation; a small brick interior ridgeline chimney; a small exterior end-wall chimney on the west side elevation; a partial-width, shed-roofed porch on the facade; and vinyl exterior siding (see Figures 5.76 and 5.77). All of the window openings are covered with plywood, but it appears from the size of some of the openings that the fenestration of the house was altered. The shed-roofed porch on the façade has been reconstructed and is supported by two square posts and the railing on the porch and stairs is constructed of dimensional lumber.

**Figure 5.76.** Resource 113-0176 (5986 Cannons Campground Road) - View of façade facing south.

The resource is not known to be associated with a significant activity or event and there is not a known connection between the resource and any individual whose activities or achievements are historically significant. Therefore, there was no basis for evaluating the resource under Criterion A or B. Also, there is no indication that the resource is likely to yield information on important research questions in history or prehistory. The resource does not appear to have the potential to be the principal source of important information. Therefore, there was no basis for evaluating the resource under Criterion D. The resource does not represent a recognized architectural type or style and does not otherwise appear to represent a significant trend in South Carolina's architectural history. Additionally, due to the application of vinyl siding, alteration of fenestration, and reconstruction of the porch on the façade, the resource has lost integrity in the areas of materials, workmanship, and feeling and cannot convey significance in the area of architecture. Therefore, Resource 113-0176 is recommended **Not Eligible** for listing in the NRHP under Criterion C in the area of architecture.

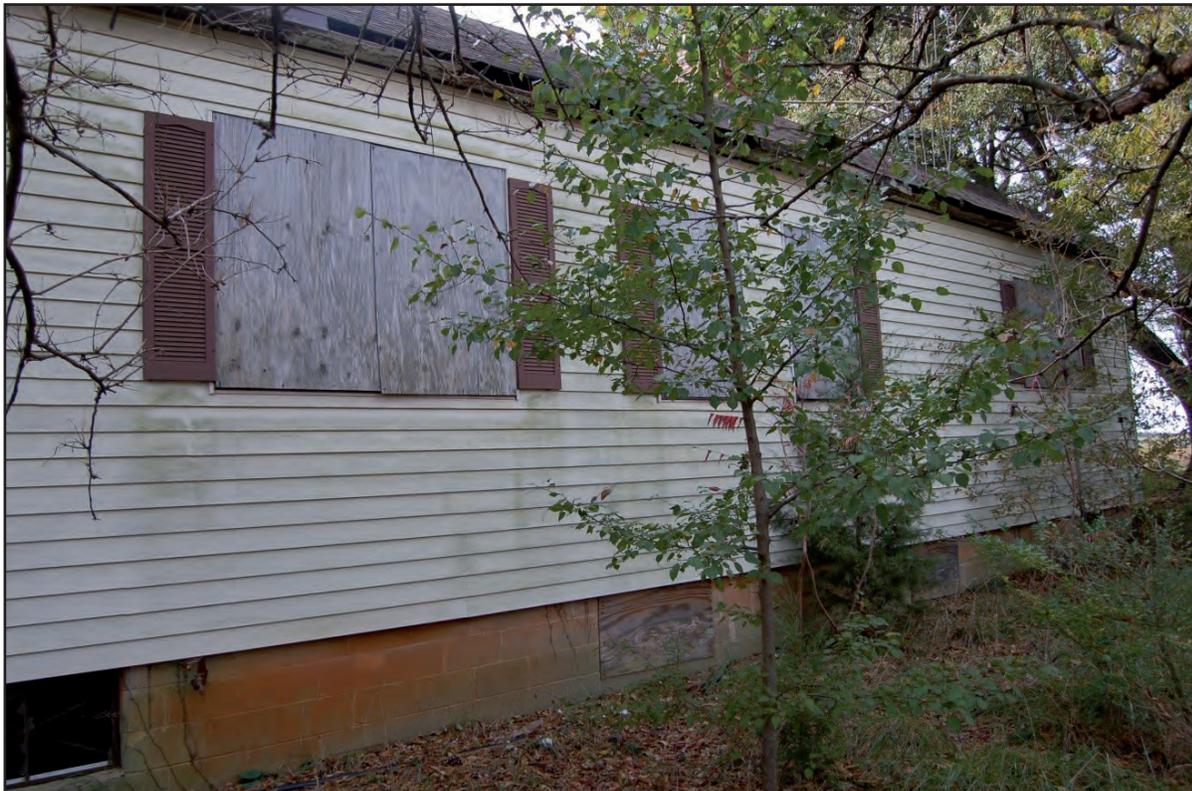
**Figure 5.77.** Resource 113-0176 (5986 Cannons Campground Road) - Oblique view of east side elevation facing northwest.

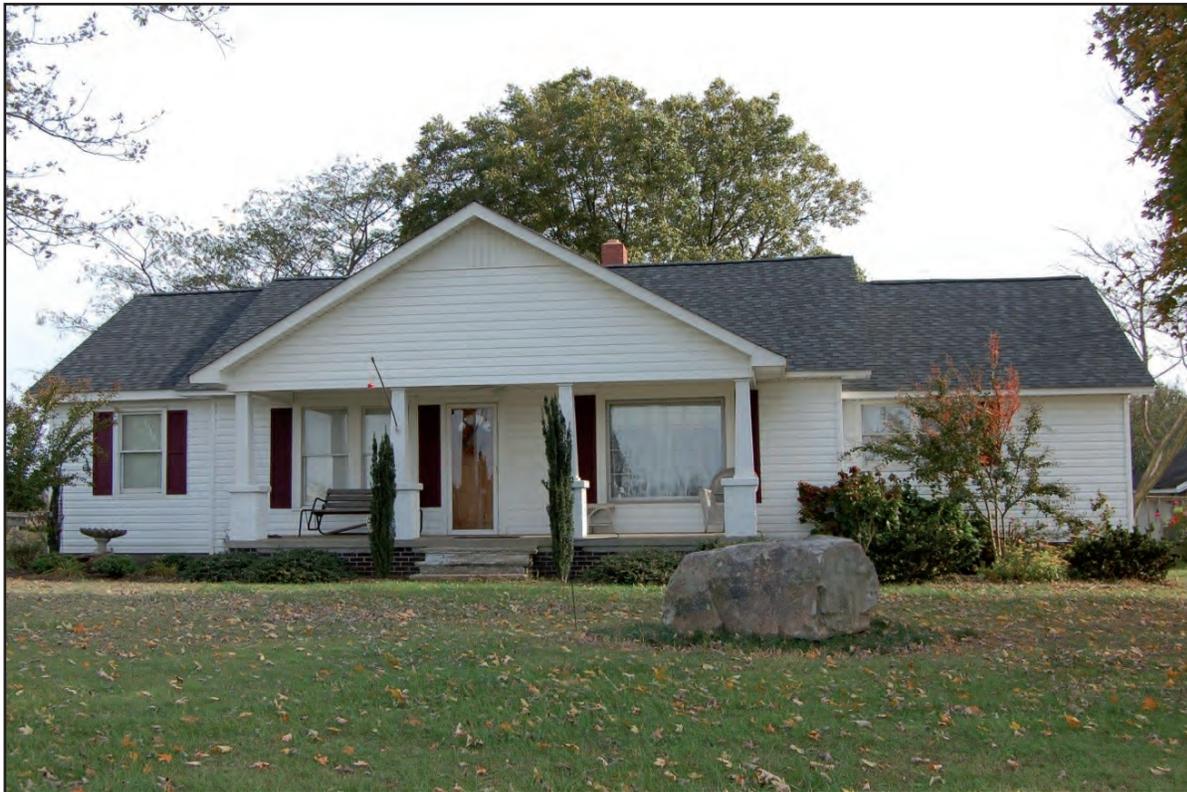
Resource 113-0177 is located at 6216 Cannons Campground Road on the east side of the roadway approximately 0.19 mile south of the intersection of Cannons Campground Road and Thornbird Road west of Gaffney in Cherokee County (refer to Figure 5.2b). The Cherokee County tax assessor's record does not have an estimated date of construction for the resource. Based on a review of historic aerial photography and topographic maps, and an evaluation of the resource's form, Resource 113-0177 appears to have been constructed ca. 1950. This estimated date of construction is supported by the depiction of the resource in its current location on the earliest aerial photograph available on the [www.historicaerials.com](http://www.historicaerials.com) website dated 1955. The resource is a one-story, asymmetric, cross-gabled residence of frame construction. The house features a cross-gabled asphalt shingle roof with wide eaves; continuous concrete block and brick foundation; a small brick interior ridgeline chimney; a partial-width, projecting gable-roofed porch on the façade supported by four battered posts atop brick piers; an integral recessed entry porch on the west side elevation; and vinyl exterior siding (see Figures 5.78 and 5.79). There is a large 24-light window on the façade and the remaining windows are single and paired wood-framed 1/1 light double-hung sash windows. There is a large addition on the west side and rear elevations with large fixed-light windows and sliding-glass doors used as windows.

**Figure 5.78.** Resource 113-0177 (6216 Cannons Campground Road) - View of façade facing southeast.

resource under Criterion D. The resource does not represent a recognized architectural type or style and does not otherwise appear to represent a significant trend in South Carolina's architectural history. Additionally, due to the application of vinyl exterior siding and the construction of a large addition on the west side and rear elevations that has obscured the original form and massing of the house, the resource has lost integrity in the areas of design, materials, workmanship, and feeling and cannot convey significance in the area of architecture. Therefore, Resource 113-0177 is recommended **Not Eligible** for listing in the NRHP under Criterion C in the area of architecture.

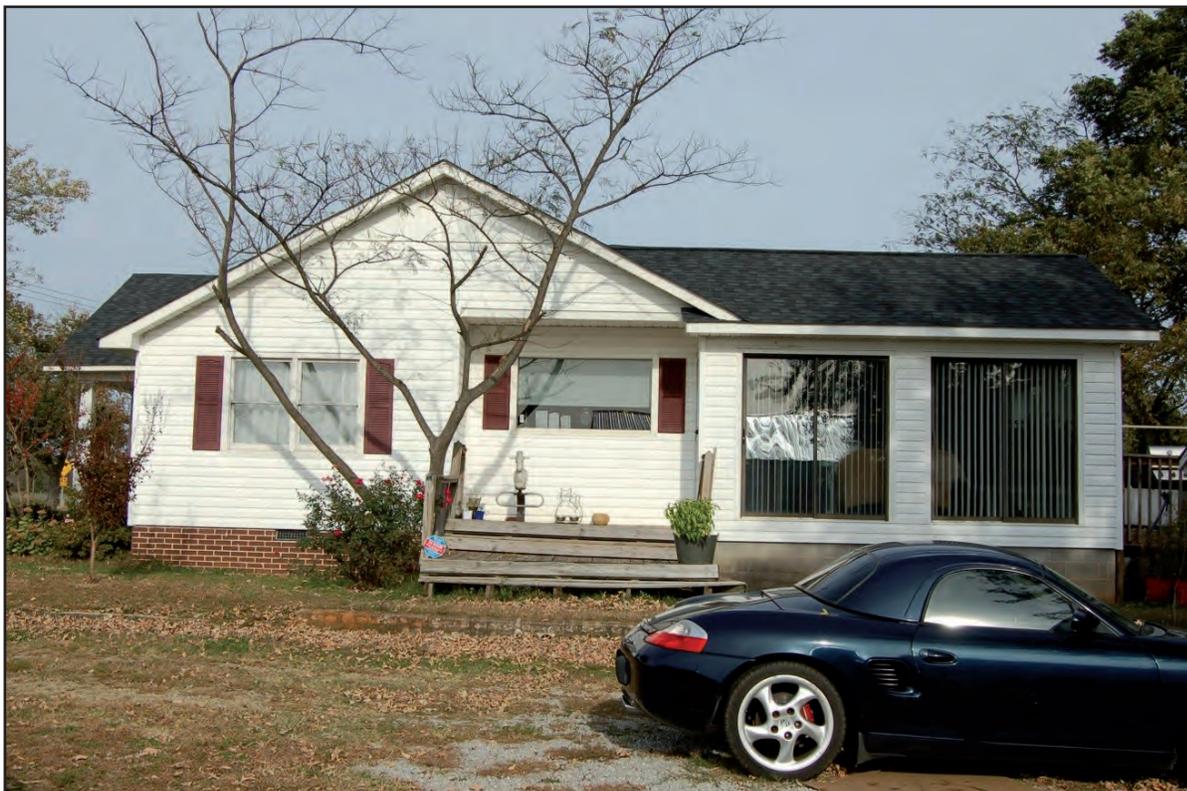
**Figure 5.79.** Resource 113-0177 (6216 Cannons Campground Road) - View of west side elevation facing north-east.
