**PHASE I CULTURAL RESOURCE SURVEY FOR PROPOSED  
WIDENING OF INTERSTATE 85 FROM MILE MARKER 80 TO 96,  
CHEROKEE AND SPARTANBURG COUNTIES, SOUTH CAROLINA.**

**FINAL REPORT**

**JULY 2015**

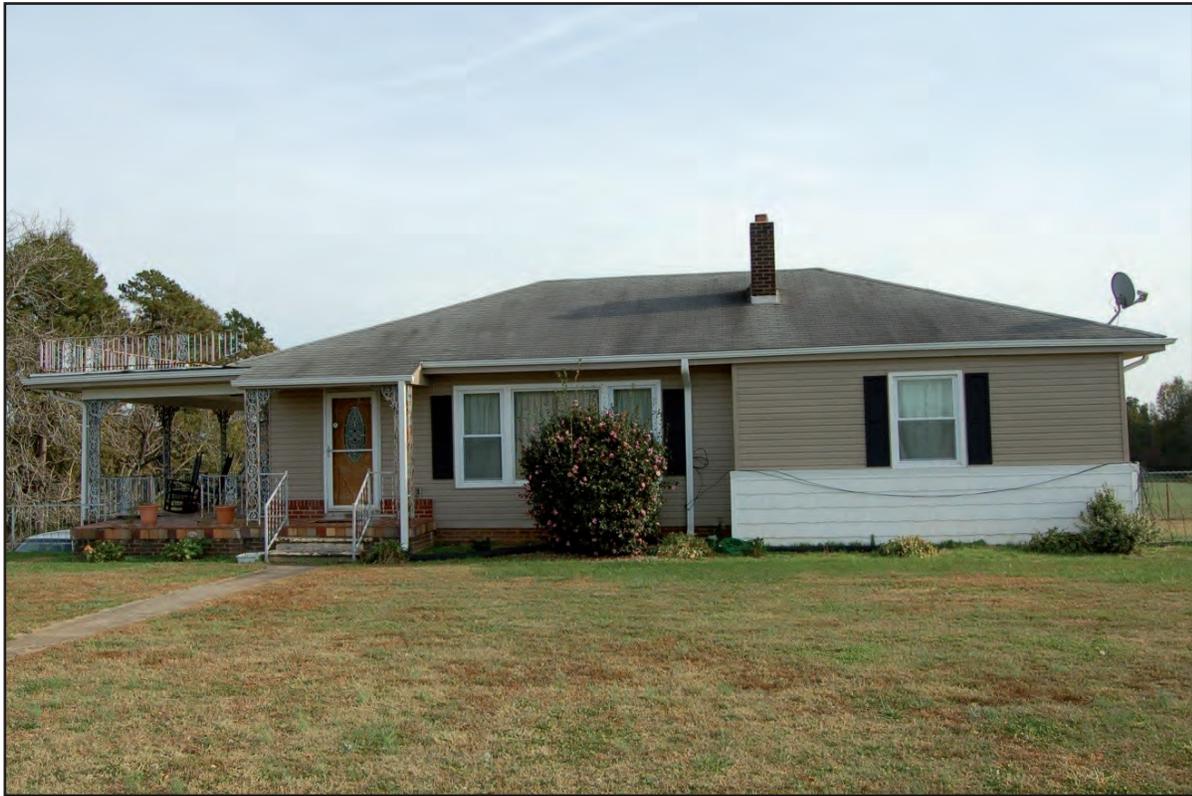
Resource 113-0178 is located at 6230 Cannons Campground Road on the east side of the roadway approximately 0.14 mile south of the intersection of Cannons Campground Road and Thornbird Road west of Gaffney in Cherokee County (refer to Figure 5.2b). The Cherokee County tax assessor's record does not have an estimated date of construction for the resource. Based on a review of historic aerial photography and topographic maps, and an evaluation of the resource's form and construction materials, Resource 113-0178 appears to have been constructed ca. 1958. The resource is not depicted on the earliest aerial photograph available on the [www.historicaerials.com](http://www.historicaerials.com) website dated 1955, but it is depicted on the earliest USGS topographic map available on the <http://viewer.nationalmap.gov/viewer/> website dated 1959. The resource is a one-story, asymmetric, hipped-roofed residence of frame construction. The house features a hipped asphalt shingle roof; a continuous brick foundation; a tall brick interior roof surface chimney on the front roof slope; vinyl exterior siding; and a wrap-around porch on the façade and east side elevations supported by decorative metal posts with a terrazzo tile floor and metal railings (see Figures 5.80 and 5.81). There is also metal railing on three sides of the flat roof above the porch, but no evident way to access this space. There is a tripartite window comprised of a large square fixed light flanked by 1/1-light double-hung sash windows on the façade and the remaining windows are 1/1-light double-hung sash of various sizes. All visible windows are non-historic vinyl replacements and the visible doors are non-historic replacements.

**Figure 5.80.** Resource 113-0178 (6230 Cannons Campground Road) - View of façade facing south.

feeling and cannot convey significance in the area of architecture. Therefore, Resource 113-0178 is recommended **Not Eligible** for listing in the NRHP under Criterion C in the area of architecture.

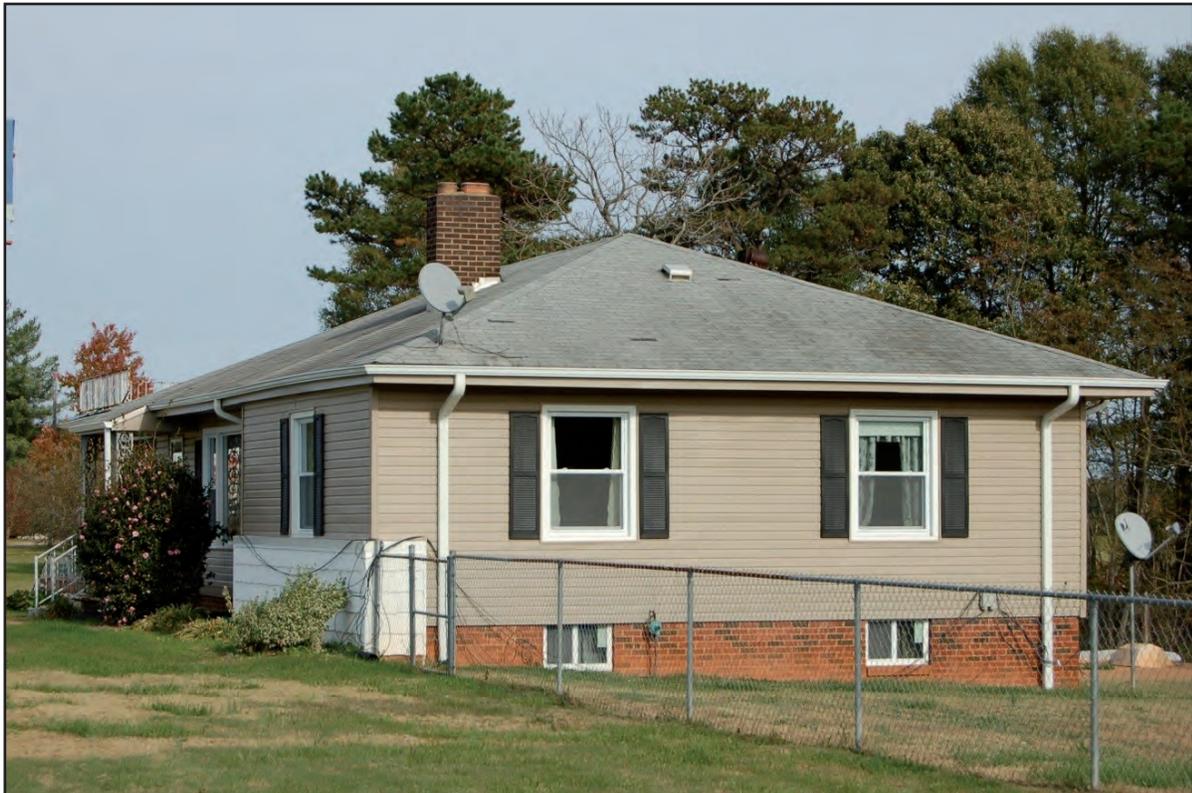
**Figure 5.81.** Resource 113-0178 (6230 Cannons Campground Road) - View of west side elevation facing southeast.

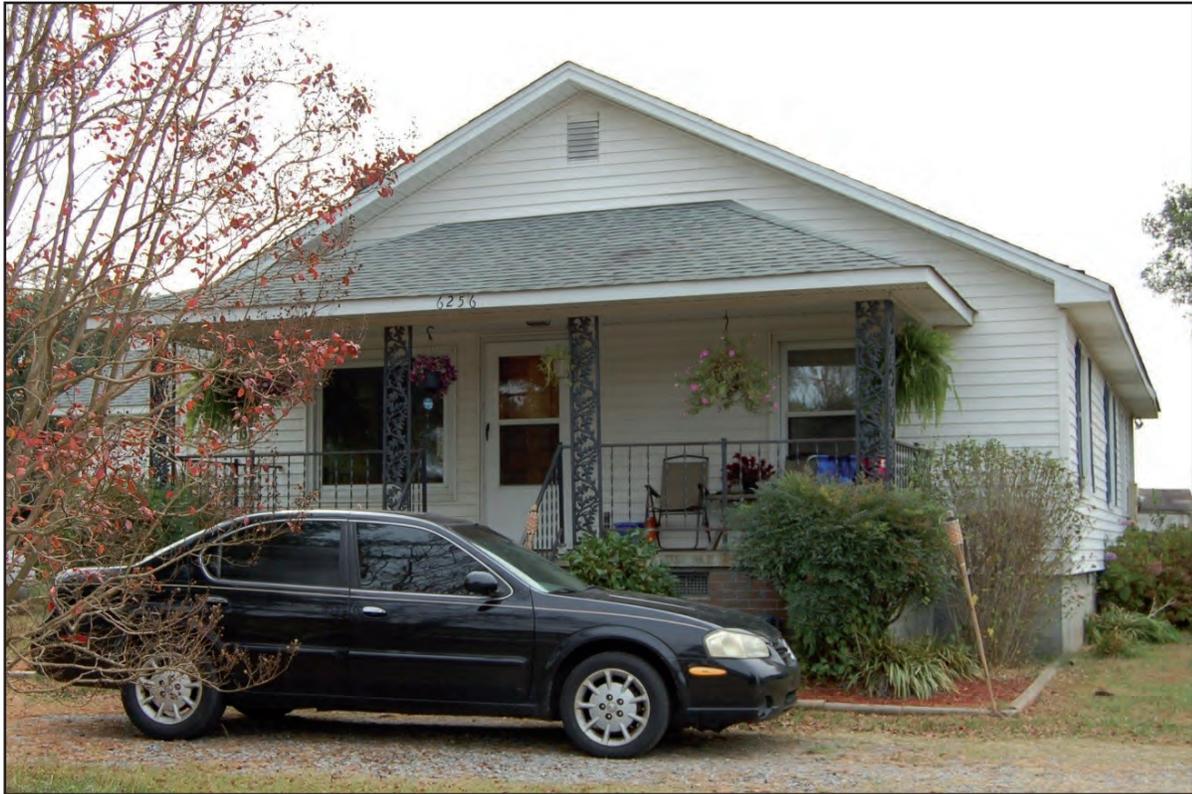
Resource 113-0179 is located at 6256 Cannons Campground Road on the south side of the roadway approximately on the east side of the roadway approximately 250 feet south of the intersection of Cannons Campground Road and Thornbird Road west of Gaffney in Cherokee County (refer to Figure 5.2b). The Cherokee County tax assessor's record has a 1940 estimated date of construction for the resource. This estimated date of construction is supported by the depiction of the resource in its current location on the earliest aerial photograph available on the www.historicaerials.com website dated 1955. The resource is a one-story, symmetric, side-gabled residence of no defined academic type without stylistic features. The house features a side-gabled asphalt shingle roof; running bond brick exterior siding, a former full-width porch that has been enclosed with vinyl siding and non-historic vinyl windows; and a small exterior brick chimney on the west side elevation (see Figures 5.82 and 5.83). There is a large square fixed-light window on the façade and the remaining windows are non-historic 1/1-light vinyl replacement windows of various sizes. A large gable-roofed addition constructed on the rear of the east side elevation has changed the plan shape of the resource from rectangular to L-shaped.

**Figure 5.82.** Resource 113-0179 (6256 Cannons Campground Road) - View of façade facing south.

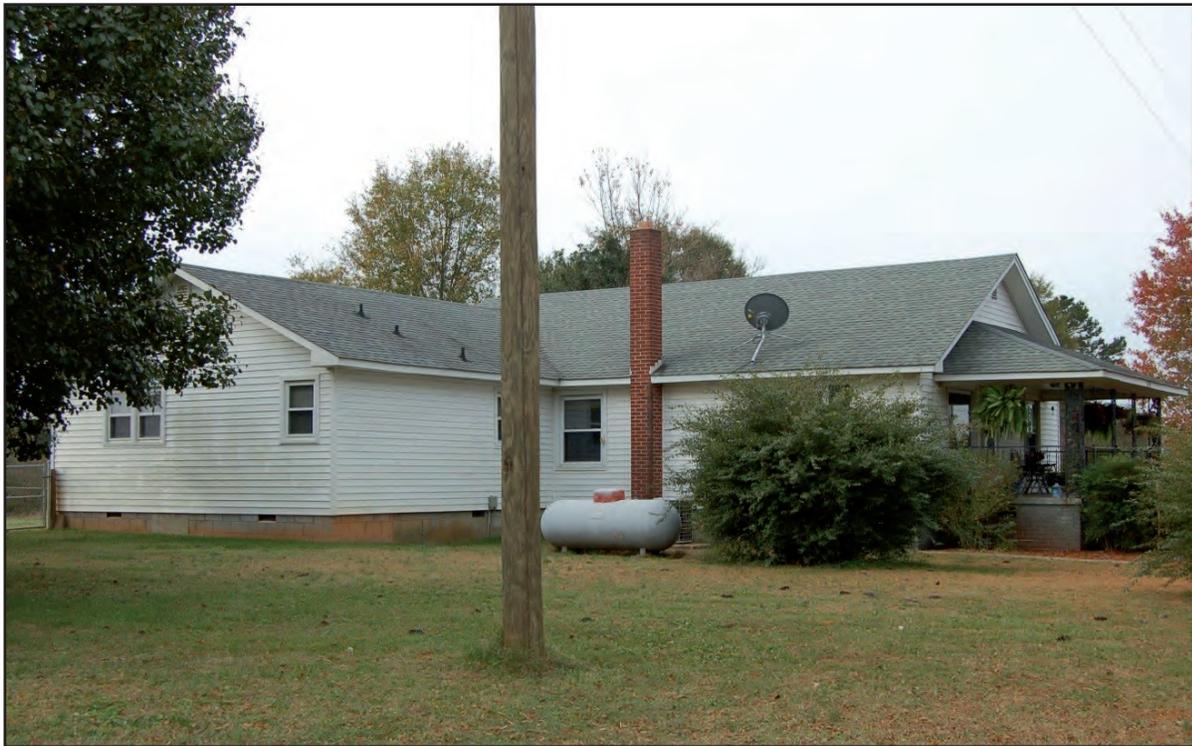
**Figure 5.83.** Resource 113-0179 (6256 Cannons Campground Road) - Oblique view of east side elevation facing southwest.

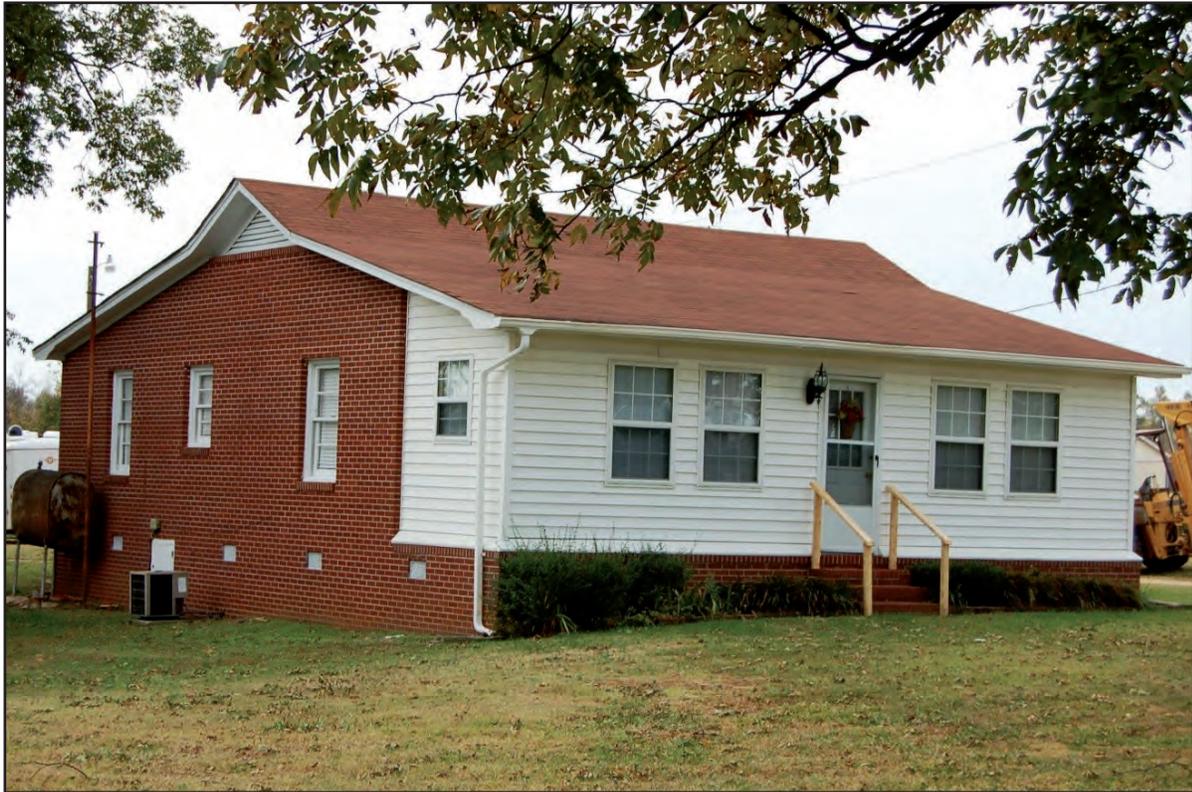
topographic maps and an evaluation of the resource's form and construction materials, Resource 113-0180 appears to have been constructed ca. 1958. The resource is not depicted on the earliest aerial photograph available on the [www.historicaerials.com](http://www.historicaerials.com) website dated 1955, but it is depicted on the earliest USGS topographic map available on the <http://viewer.nationalmap.gov/viewer/> website dated 1959. The resource is a one-story, symmetric, side-gabled residence of no defined academic type without stylistic features. The house features a side-gabled asphalt shingle roof; a large brick exterior chimney on the west side elevation; and a mix of original wood-framed 2/2-light double-hung sash windows and non-historic vinyl windows (see Figures 5.84 and 5.85). The former full-width porch has been enclosed and now has vinyl exterior siding and vinyl windows with faux muntins.

**Figure 5.84.** Resource 113-0180 (6306 Cannons Campground Road) - Oblique view of façade and east side elevation facing southwest.

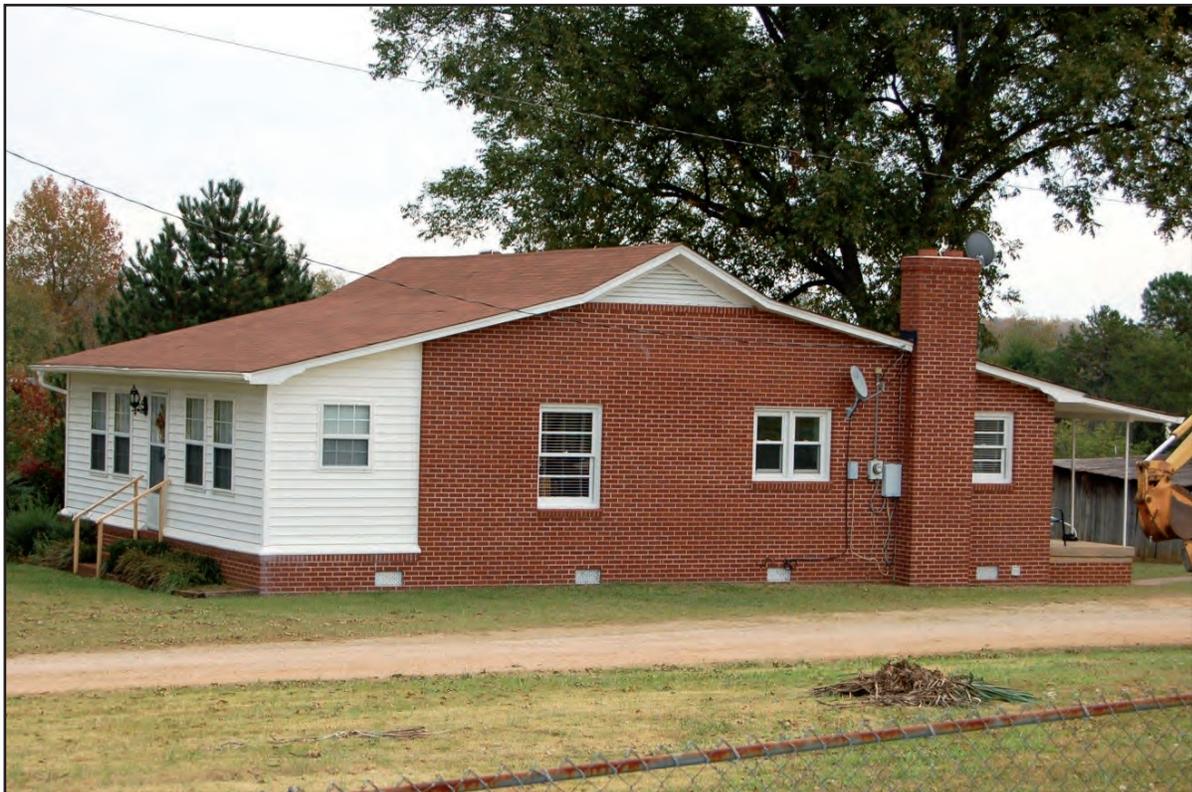
**Figure 5.85.** Resource 113-0180 (6306 Cannons Campground Road) - Oblique view of façade and west side elevation facing southeast.

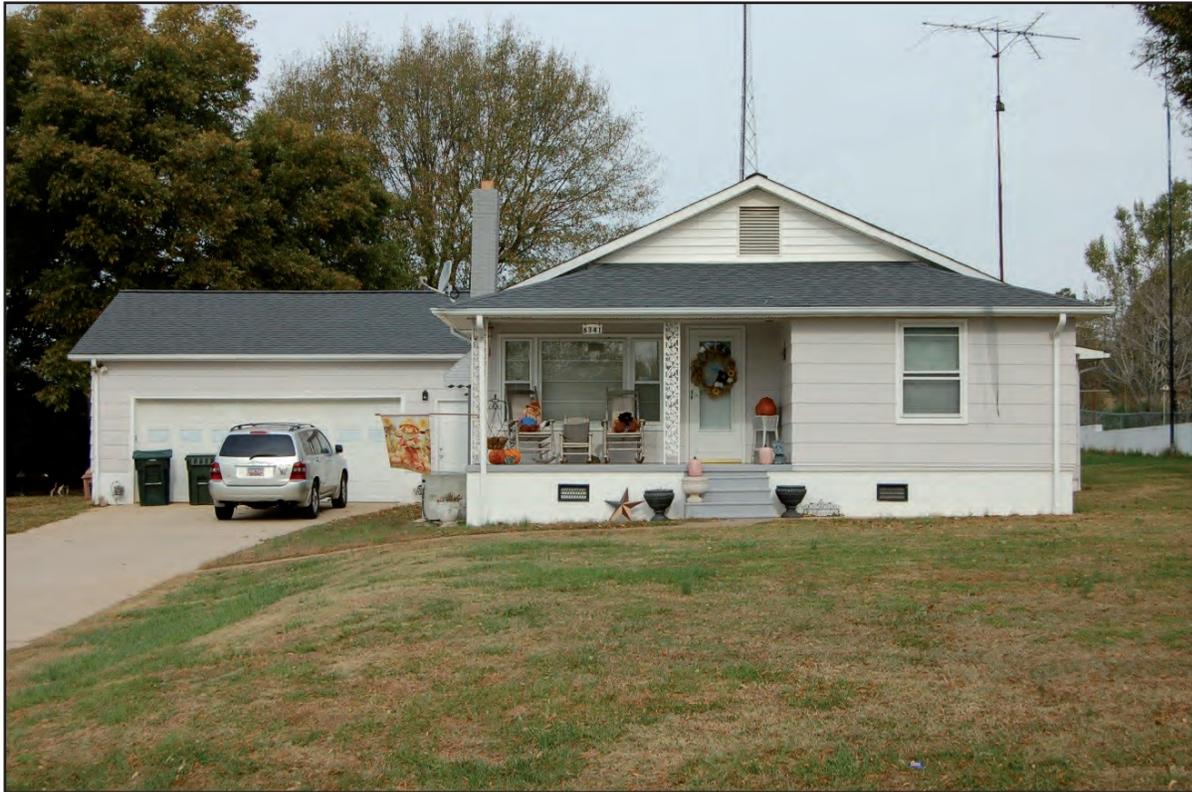
Resource 113-0181 is located at 6341 Cannons Campground Road on the west side of the roadway approximately 0.14 mile north of the intersection of Cannons Campground Road and Thornbird Road west of Gaffney in Cherokee County (refer to Figure 5.2b). The Cherokee County tax assessor's record does not have an estimated date of construction for the resource. Based on a review of historic aerial photography and topographic maps, and an evaluation of the resource's form and construction materials, Resource 113-0181 appears to have been constructed ca. 1940. This estimated date of construction is supported by the depiction of the resource in its current location on the earliest aerial photograph available on the [www.historicaerials.com](http://www.historicaerials.com) website dated 1955. The resource is a one-story, asymmetric, front-gabled bungalow of frame construction. The house features a front-gabled asphalt shingle roof; a brick pier with concrete block infill foundation; a painted brick exterior chimney on the west side elevation; a partial-width, projecting hipped-roofed porch on the façade that has been partially enclosed; and aluminum exterior siding (see

Figures 5.86 and 5.87). There is a large tripartite window comprised of a large square four-light window flanked by 2/2-light double-hung sash windows on the façade and the remaining windows are 1/1-light double-hung sash windows of various sizes. The porch on the façade is supported with two decorative metal posts on the western portion and the eastern porch of the original open porch has been enclosed. A small shed-roofed addition has been constructed on the east side elevation and a large two-car garage addition has been constructed on the west side elevation.

**Figure 5.86.** Resource 113-0181 (6341 Cannons Campground Road) - View of façade facing north.

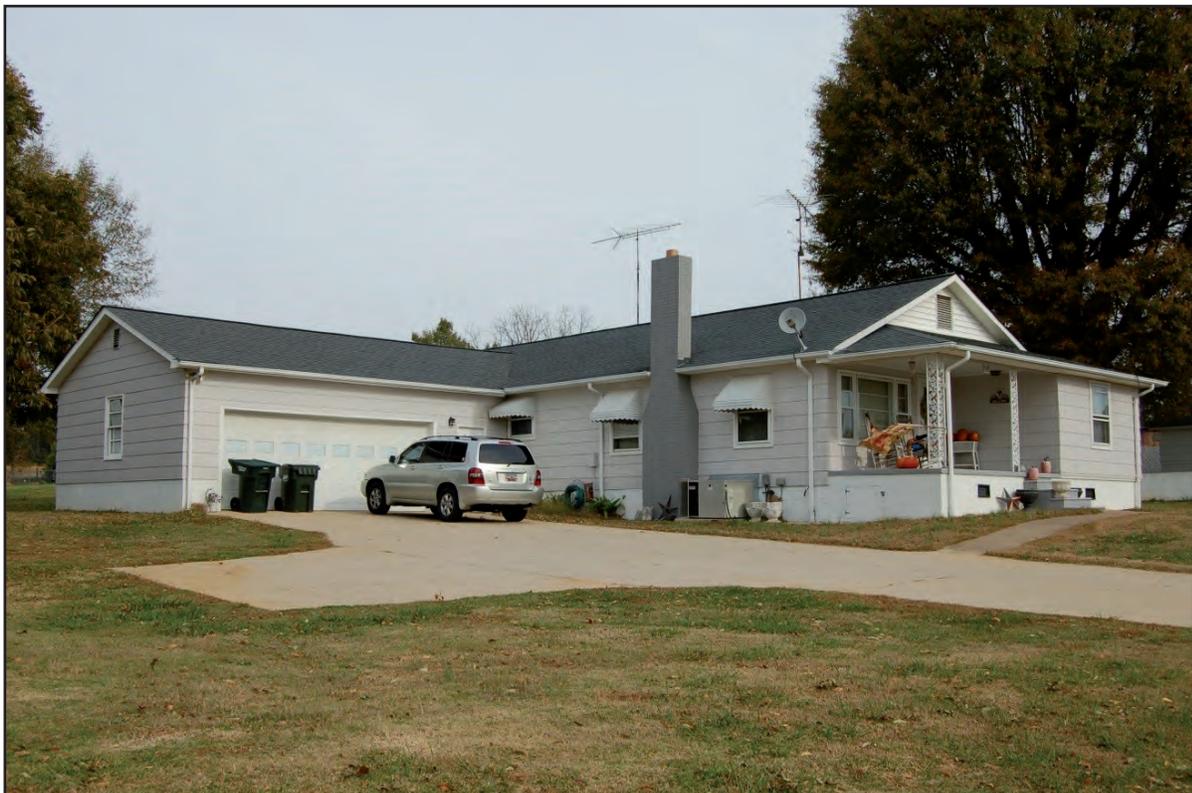
**Figure 5.87.** Resource 113-0181 (6341 Cannons Campground Road) - Oblique view of façade and west side elevation facing northeast.

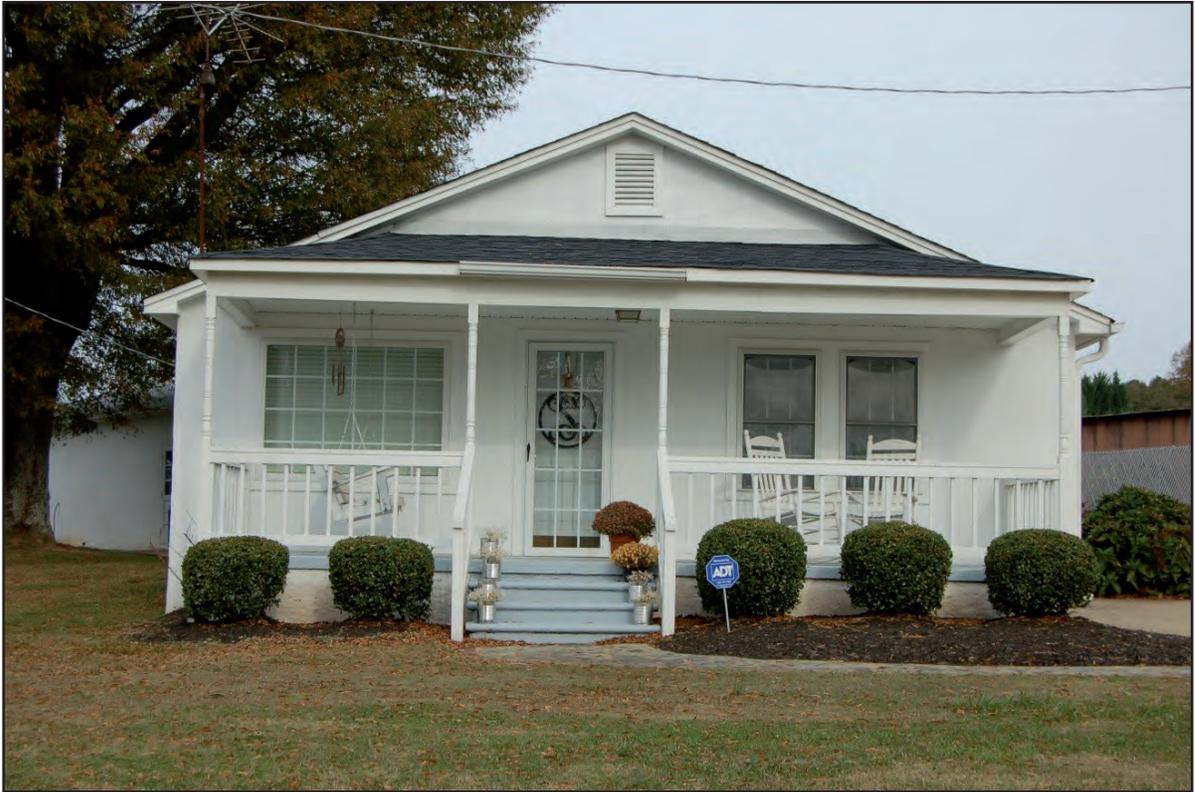
Resource 113-0182 is located at 6345 Cannons Campground Road on the west side of the roadway approximately 0.17 mile north of the intersection of Cannons Campground Road and Thornbird Road west of Gaffney in Cherokee County (refer to Figure 2B). The Cherokee County tax assessor's record does not have an estimated date of construction for the resource. Based on a review of historic aerial photography and topographic maps, and an evaluation of the resource's form, Resource 113-0182 appears to have been constructed ca. 1940. This estimated date of construction is supported by the depiction of the resource in its current location on the earliest aerial photograph available on the [www.historicaerials.com](http://www.historicaerials.com) website dated 1955. The resource is a one-story, asymmetric, front-gabled bungalow. The house features a front-gabled asphalt shingle roof; a near-full-width, projecting hipped-roofed porch on the facade; an enclosed porch on the rear elevation; and stuccoed masonry exterior siding (see Figures 5.88 and 5.89). All windows are non-historic vinyl replacement windows. There is a large fixed-light window with faux muntins on the façade and the remaining windows are single, paired, and triple double-hung sash windows of various sizes. The porch on the façade has been reconstructed and the four turned posts and railings are not historic.

**Figure 5.88.** Resource 113-0182 (6345 Cannons Campground Road) - View of façade facing north.

historically significant. Therefore, there was no basis for evaluating the resource under Criterion A or B. Also, there is no indication that the resource is likely to yield information on important research questions in history or prehistory. The resource does not appear to have the potential to be the principal source of important information. Therefore, there was no basis for evaluating the resource under Criterion D. The resource is an undistinguished example of a common architectural type and due to the reconstruction of the porch and the replacement of all original doors and windows the resource has lost integrity in the areas of materials, workmanship, and feeling and cannot convey significance in the area of architecture. Therefore, Resource 113-0182 is recommended **Not Eligible** for listing in the NRHP under Criterion C in the area of architecture.

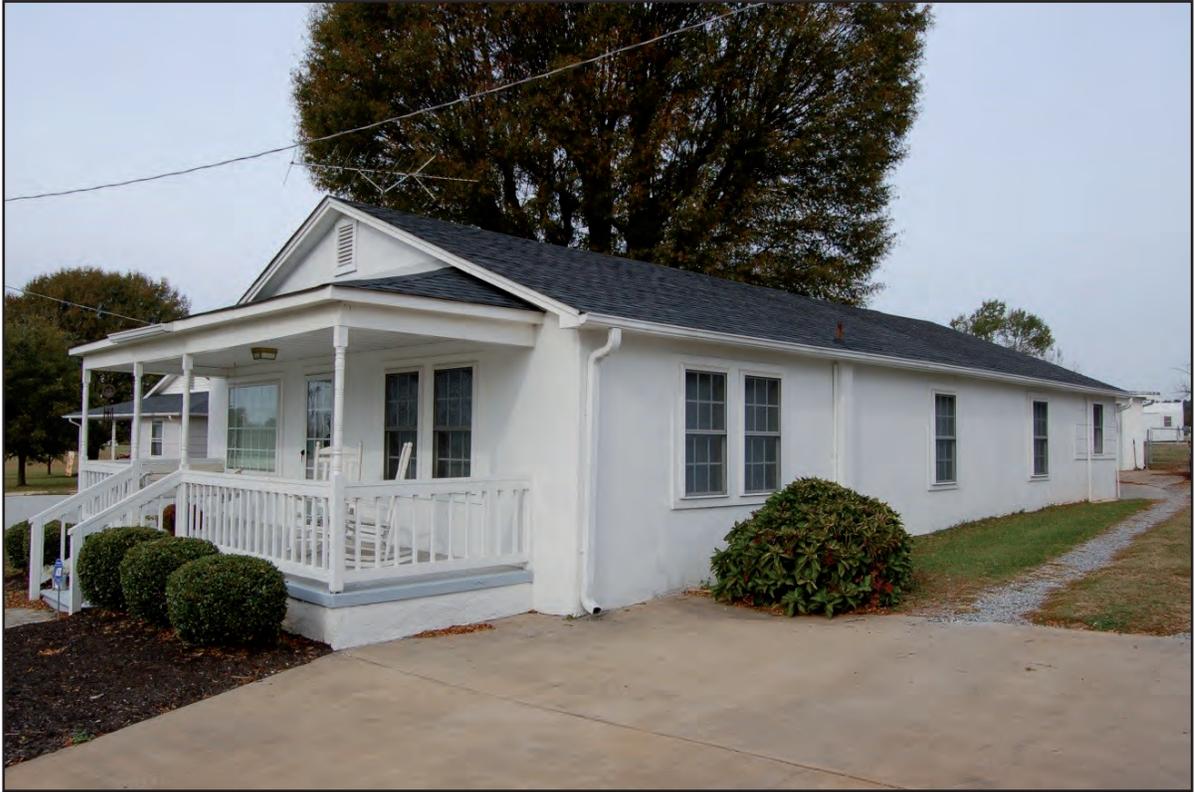
**Figure 5.89.** Resource 113-0182 (6345 Cannons Campground Road) - Oblique view of façade and east side elevation facing northwest.

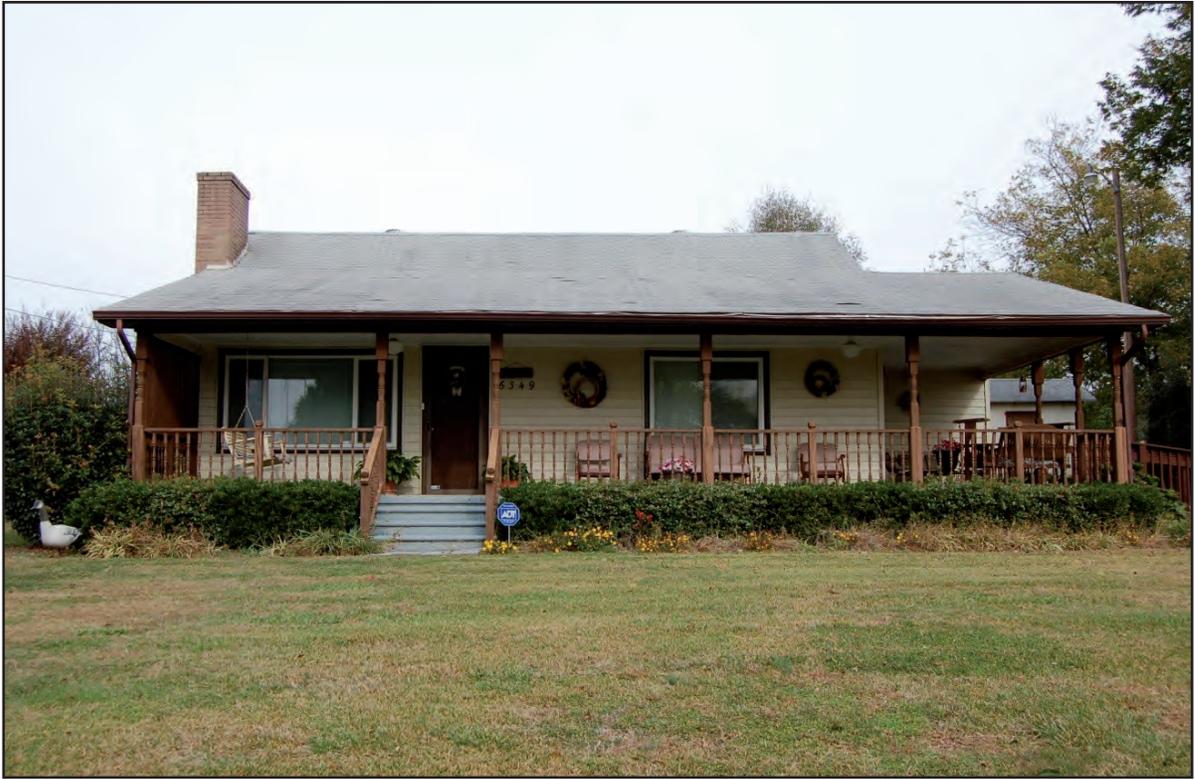
Resource 113-0183 is located at 6349 Cannons Campground Road on the west side of the roadway approximately 0.19 mile north of the intersection of Cannons Campground Road and Thornbird Road west of Gaffney in Cherokee County (refer to Figure 5.2b). The Cherokee County tax assessor's record does not have an estimated date of construction for the resource. Based on a review of historic aerial photography and topographic maps, and an evaluation of the resource's form, Resource 113-0183 appears to have been constructed ca. 1940. This estimated date of construction is supported by the depiction of the resource in its current location on the earliest aerial photograph available on the [www.historicaerials.com](http://www.historicaerials.com) website dated 1955. The resource is a one-story, asymmetric, side-gabled residence of frame construction. The house features a side-gabled asphalt shingle roof; a large brick slab chimney on the west side elevation; an integral wrap-around porch across the façade and the east side elevation; and vinyl exterior siding. All original windows appear to have been replaced (see Figures 5.90 and 5.91). There is a large tripartite window comprised of a large square fixed light flanked by rectangular fixed lights and a large window comprised of two horizontally-sliding lights on the façade. The remaining windows are non-historic metal-framed 1/1-light double-hung sash vinyl windows. The porch appears to have been reconstructed and has eight turned-post roof supports and spindle work balustrades along the porch and stairs.

**Figure 5.90.** Resource 113-0183 (6349 Cannons Campground Road) - View of façade facing north.

integrity in the areas of materials, workmanship, and feeling and cannot convey significance in the area of architecture. Therefore, Resource 113-0183 is recommended Not Eligible for listing in the NRHP under Criterion C in the area of architecture.

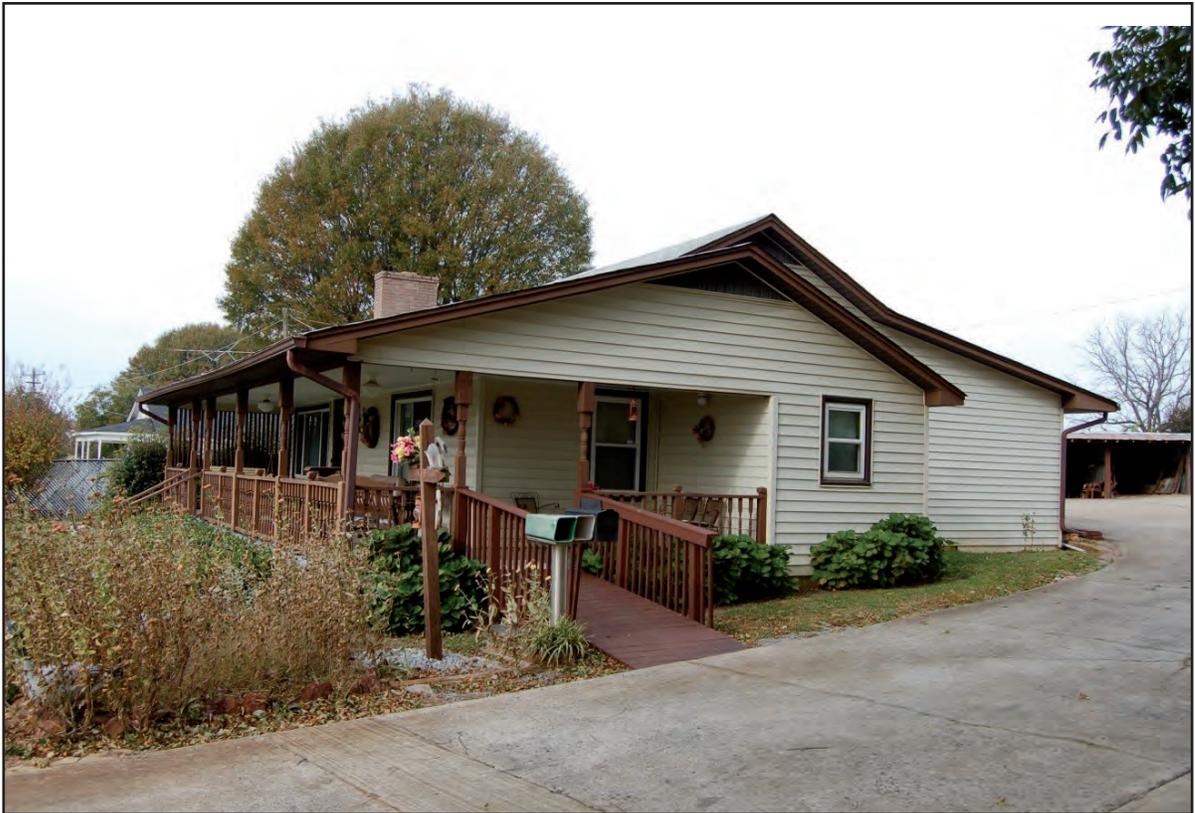
**Figure 5.91.** Resource 113-0183 (6349 Cannons Campground Road) - Oblique view of façade and east side elevation facing northwest.

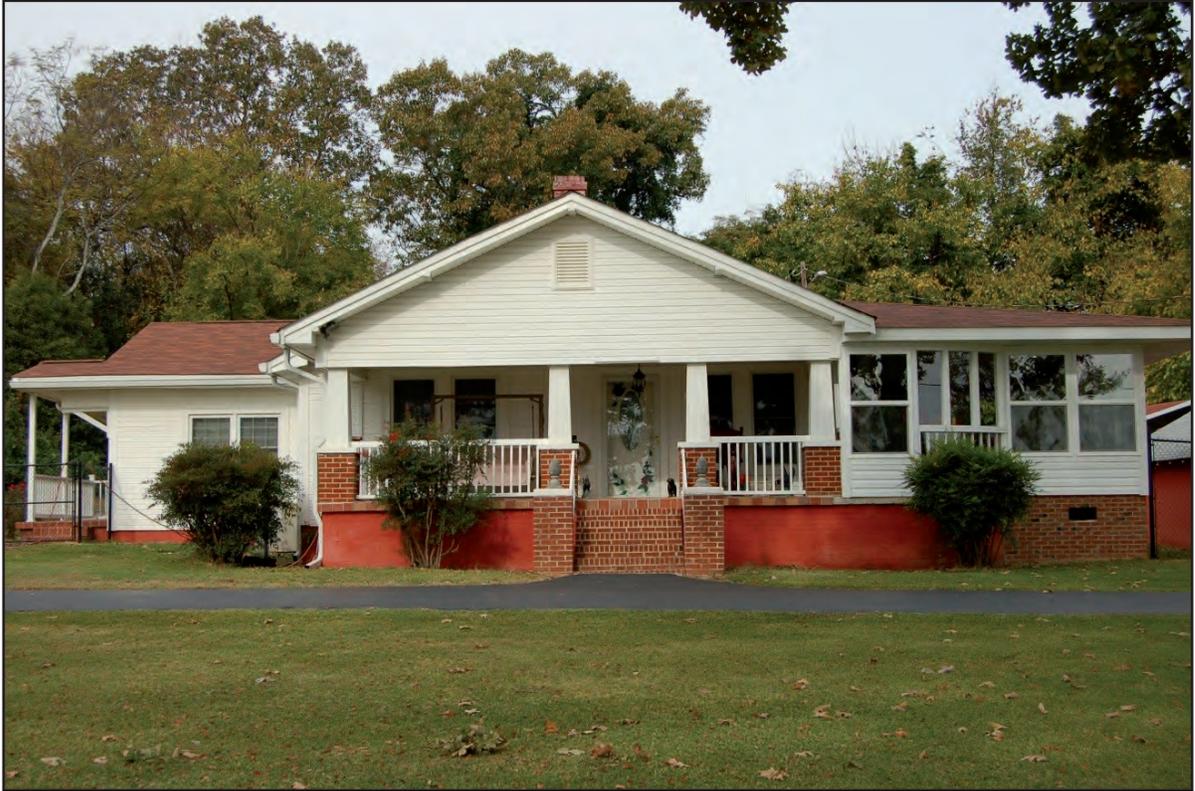
Resource 113-0184 is located at 6437 Cannons Campground Road on the west side of the roadway approximately 0.17 mile south of the intersection of Cannons Campground Road and Lindley Road west of Gaffney in Cherokee County (refer to Figure 5.2b). The Cherokee County tax assessor's record does not have an estimated date of construction for the resource. Based on a review of historic aerial photography and topographic maps, and an evaluation of the resource's form and construction materials, Resource 113-0184 appears to have been constructed ca. 1950. This estimated date of construction is supported by the depiction of the resource in its current location on the earliest aerial photograph available on the [www.historicaerials.com](http://www.historicaerials.com) website dated 1955. The resource is a one-story, asymmetric, cross-gabled bungalow of frame construction. The house features a cross-gabled asphalt shingle; a brick pier with brick infill and continuous brick foundation; a brick interior ridgeline chimney; a projecting near-full-width porch on the façade; and vinyl exterior siding (see Figures 5.92 and 5.93). The porch roof is supported by massive battered posts atop brick piers. All visible windows appear to be non-historic metal-framed vinyl double-hung sash windows. Some of the windows are 1/1-light double-hung sash and some are double-hung sash with faux muntins. A large gable roofed addition has been constructed on the west side elevation and a large hipped-roofed addition has been constructed on the east side elevation. The addition on the east side elevation is a sun room and is more recent as indicated by the unpainted brick foundation.

**Figure 5.92.** Resource 113-0184 (6437 Cannons Campground Road) - View of façade facing north.

The resource is not known to be associated with a significant activity or event and there is not a known connection between the resource and any individual whose activities or achievements are historically significant. Therefore, there was no basis for evaluating the resource under Criterion A or B. Also, there is no indication that the resource is likely to yield information on important research questions in history or prehistory. The resource does not appear to have the potential to be the principal source of important information. Therefore, there was no basis for evaluating the resource under Criterion D. The resource is an undistinguished example of a common architectural type and due to the construction of large additions on both the east and west side elevations and the application of vinyl exterior siding and the replacement of the original windows, the resource has lost integrity in the areas of design, materials, workmanship, and feeling and cannot convey significance in the area of architecture. Therefore, Resource 113-0184 is recommended **Not Eligible** for listing in the NRHP under Criterion C in the area of architecture.

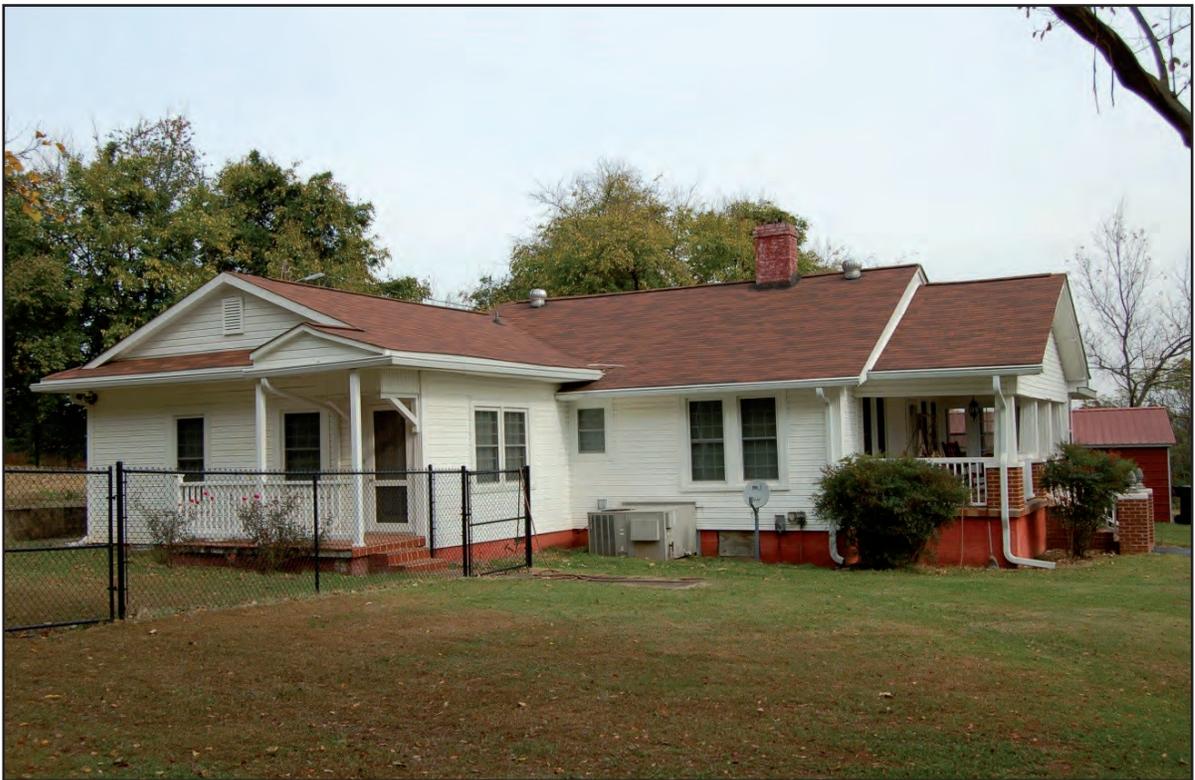
**Figure 5.93.** Resource 113-0184 (6437 Cannons Campground Road) - Oblique view of west side elevation facing northeast.

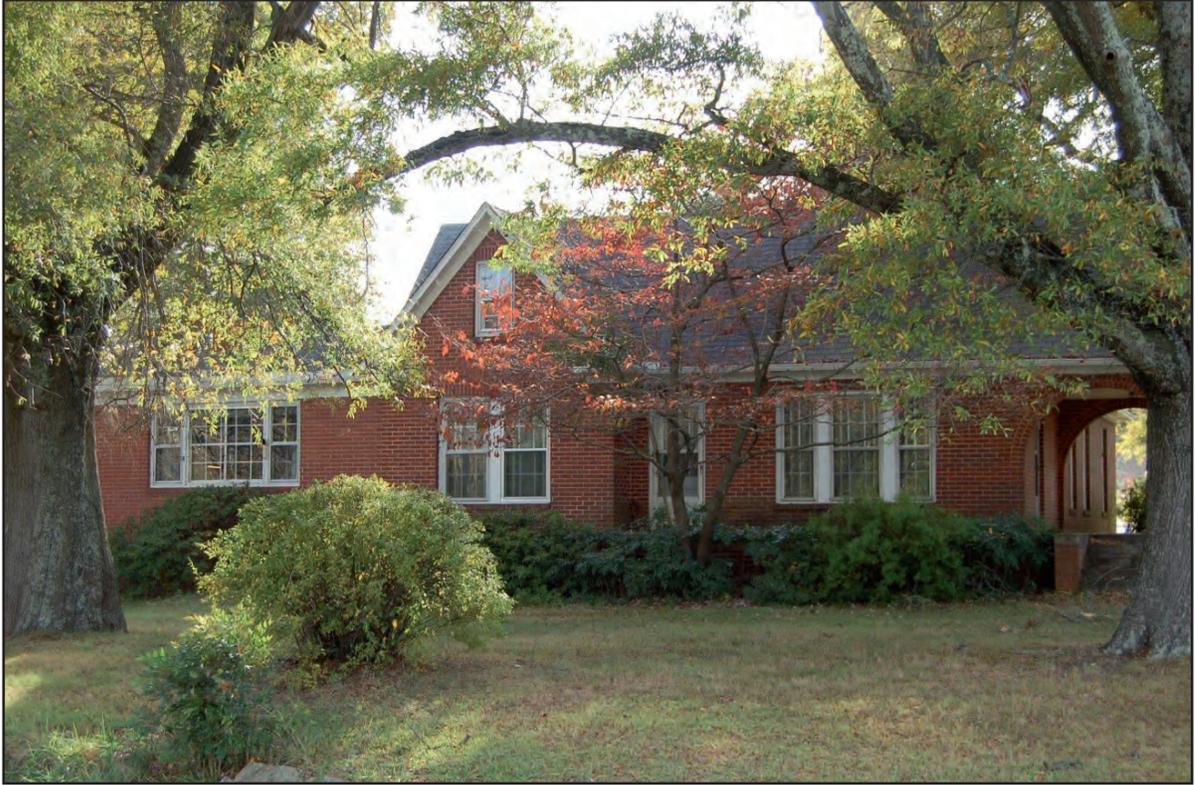
Resource 113-0185 is located at 143 Lindley Road on the south side of the roadway in the southeast quadrant of the intersection of Cannons Campground Road and Lindley Road west of Gaffney in Cherokee County (refer to Figure 5.2b). The Cherokee County tax assessor's record has a 1935 estimated date of construction for the resource. This estimated date of construction is supported by the depiction of the resource in its current location on the earliest aerial photograph available on the [www.historicaerials.com](http://www.historicaerials.com) website dated 1955. The resource is a one-story, asymmetric, cross-gabled residence with English Vernacular Revival stylistic elements. The stylistic elements are represented by the steeply-pitched roof with narrow eaves, the sharp angles of the gables on the façade and north side elevations, and the rounded arches that support the porch roof on the north side elevation. The house features a steeply-pitched, cross-gabled asphalt shingle roof with narrow eaves; two tall brick interior roof surface chimneys within the roof surfaces on the north and south sides; a small exterior brick chimney on the rear elevation; a wrap-around porch that is open on the façade and covered on the north side elevation; and running bond brick exterior siding (see Figures 5.94 and 5.95). The porch on the north side elevation is supported by six brick piers (two of which are engaged with the wall surface) connected by rounded arches. There are two tripartite windows on the façade and the remaining windows are single and paired wood-framed 6/6-light double-hung sash. Based on the change in the height of the roof and the absence of soldier courses under the eaves and simulating a water table as observed elsewhere on the house, the low hipped-roofed mass on the rear elevation appears to be a historic addition.

**Figure 5.94.** Resource 113-0185 (143 Lindley Road) - View of façade facing west.

The resource is not known to be associated with a significant activity or event and there is not a known connection between the resource and any individual whose activities or achievements are historically significant. Therefore, there was no basis for evaluating the resource under Criterion A or B. Also, there is no indication that the resource is likely to yield information on important research questions in history or prehistory. The resource does not appear to have the potential to be the principal source of important information. Therefore, there was no basis for evaluating the resource under Criterion D. While the resource exhibits elements of the English Vernacular Revival style, those elements are weakly expressed and the resource is not considered a significant

example of its style. Therefore, Resource 113-0185 is recommended **Not Eligible** for listing in the NRHP under Criterion C in the area of architecture.

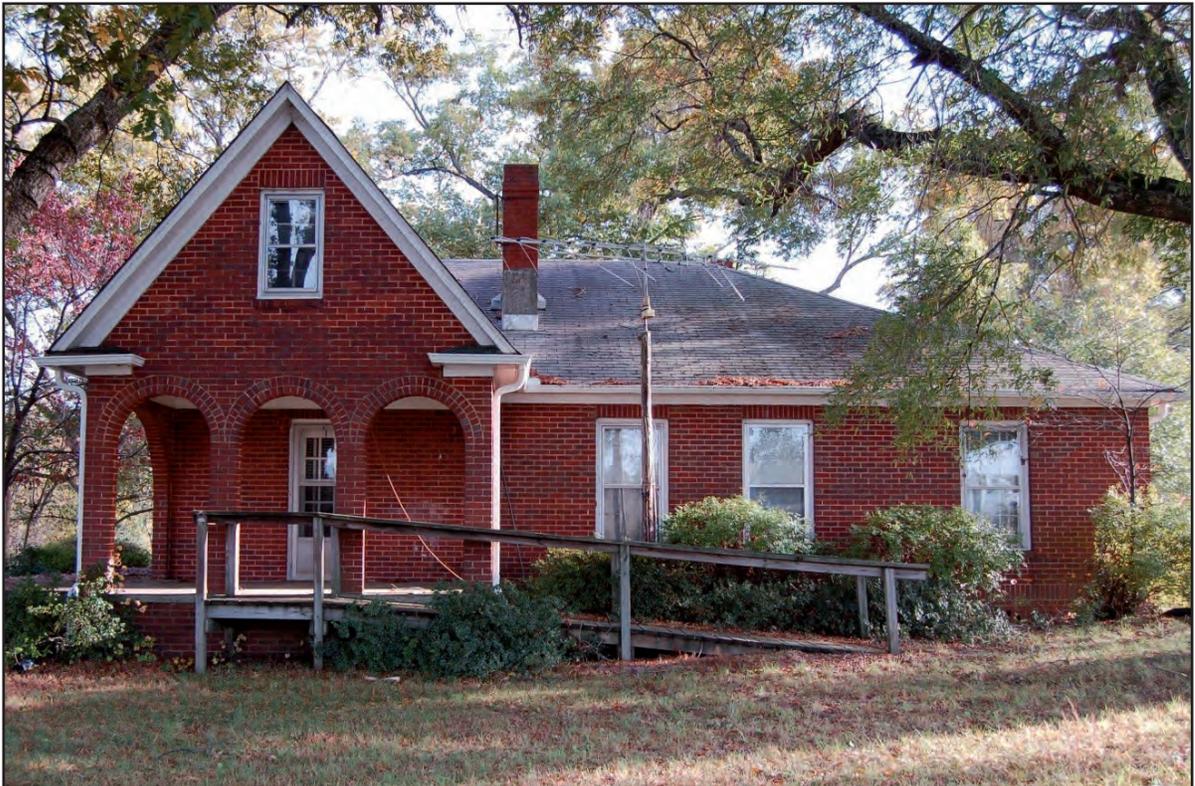
**Figure 5.95.** Resource 113-0185 (143 Lindley Road) - View of north side elevation facing south.

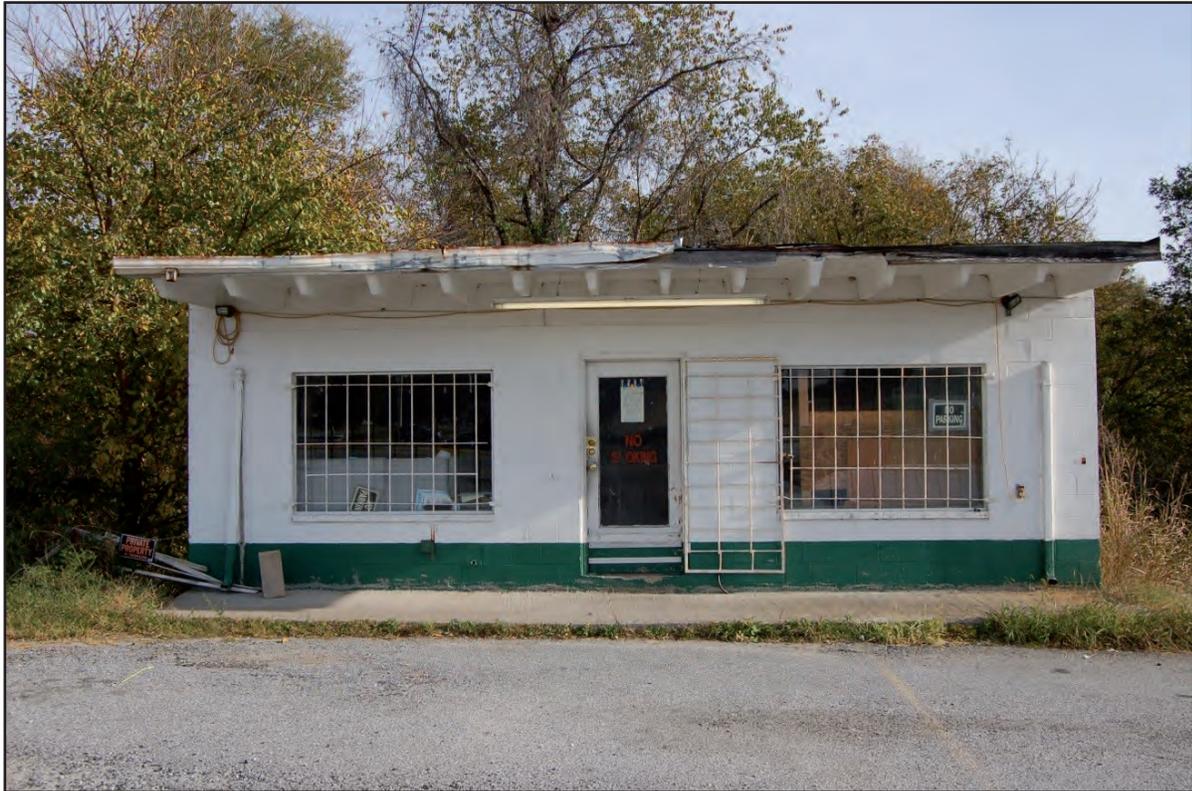
The resource is located on the same legal parcel on the opposite side of Lindley Road from previously-identified site 113-0162. This building is a one-part vernacular commercial building of concrete block load-bearing wall construction that was evaluated and determined not eligible for inclusion in the NRHP in *Rural Commerce in Context: South Carolina's Country Stores, 1850-1950* prepared by New South Associates in 2012 (see Figures 5.96 and 5.97). It is suspected, but could not be confirmed, that 113-0162 was constructed and operated by the occupants of this house. Several attempts to contact and interview the owners of the property were not successful.

**Figure 5.96.** Resource 113-0162 (6578 Cannons Campground Road) - View of façade facing south.

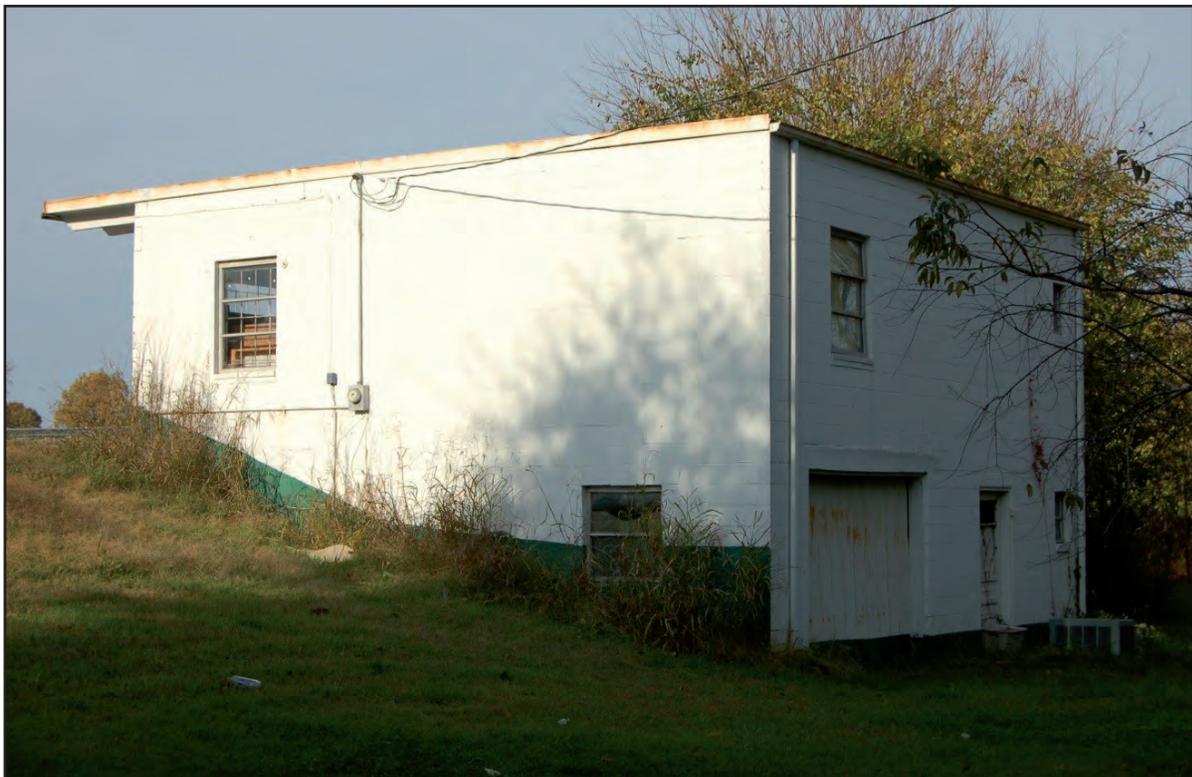
**Figure 5.97.** Resource 113-0162 (6578 Cannons Campground Road) - Oblique view of west side and rear elevations facing northeast.
