**PHASE I CULTURAL RESOURCE SURVEY FOR PROPOSED  
WIDENING OF INTERSTATE 85 FROM MILE MARKER 80 TO 96,  
CHEROKEE AND SPARTANBURG COUNTIES, SOUTH CAROLINA.**

**FINAL REPORT**

**JULY 2015**

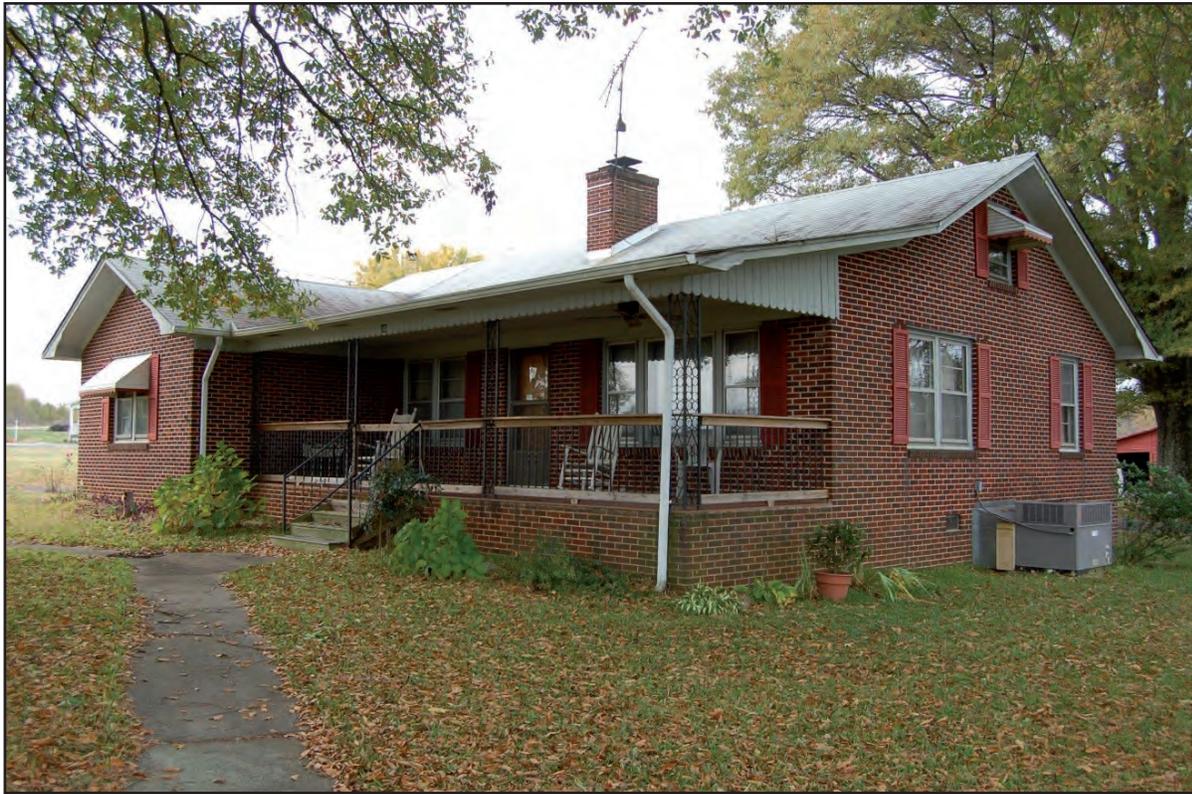
Resource 113-0186 is located at 249 Old Post Road on the north side of the roadway approximately 0.17 mile east of the intersection of Old Post Road and Malone Road west of Gaffney in Cherokee County (refer to Figure 5.2b). The Cherokee County tax assessor's record does not have an estimated date of construction for the resource. Based on a review of historic topographic maps and an evaluation of the resource's form and construction materials, Resource 113-0186 appears to have been constructed ca. 1947. This estimated date of construction is supported by the depiction of the resource in its current location on the earliest aerial photograph available on the [www.historicaerials.com](http://www.historicaerials.com) website dated 1955. The resource is a one-and-one-half-story, asymmetric, cross-gabled residence of no defined type without stylistic features. The house features a cross-gabled asphalt shingle roof with wide eaves; a large brick interior ridgeline chimney; a small brick exterior end wall chimney on the rear elevation; a partial-width, extended, shed-roofed porch with roof supported by four decorative metal posts on the façade; and running bond brick exterior siding (see Figures 5.98 and 5.99). There is a tripartite window comprised of a large square fixed light flanked by 2/2-light double-hung sash windows on the façade and the remaining windows are original single and paired wood-framed 2/2-light double-hung sash of various sizes. A non-historic shed-roofed open carport has been constructed on the rear elevation.

**Figure 5.98.** Resource 113-0186 (249 Old Post Road) - Oblique view of façade and east side elevation facing northwest.

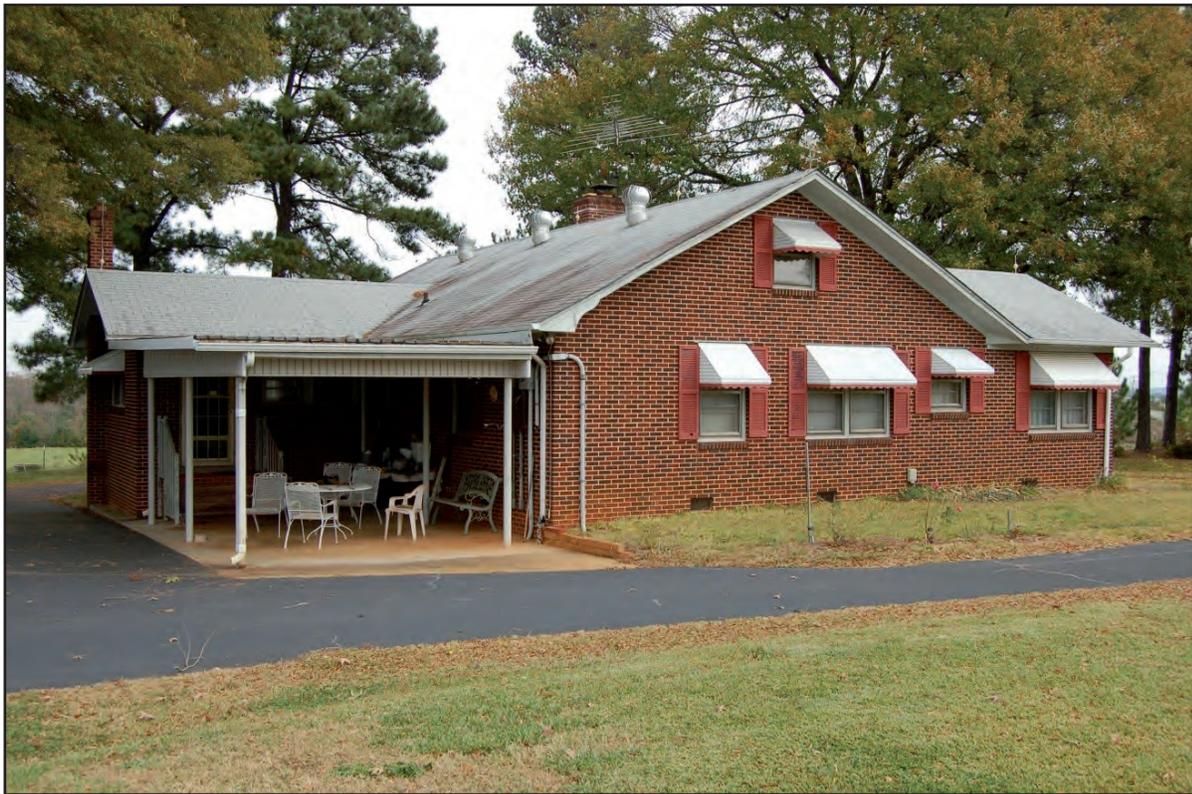
**Figure 5.99.** Resource 113-0186 (249 Old Post Road) - Oblique view of rear and west side elevations facing southeast.

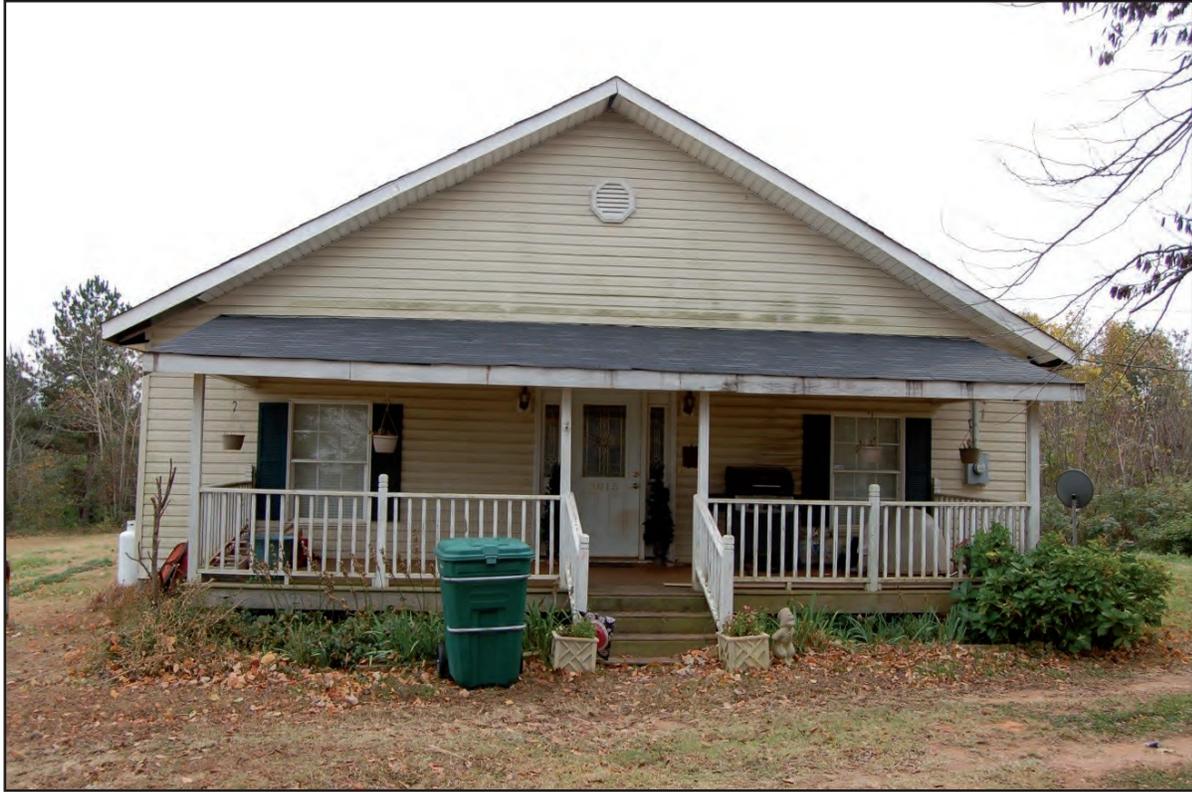
Resource 113-0187 appears to have been constructed ca. 1958. The resource is not depicted on the earliest aerial photograph available on the [www.historicaerials.com](http://www.historicaerials.com) website dated 1955, but it is depicted on the earliest USGS topographic map available on the <http://viewer.nationalmap.gov/viewer/> website dated 1959. The resource is a one-story, asymmetric, front-gabled bungalow of frame construction. The house features a front-gabled asphalt shingle roof; a concrete block pier with continuous brick infill foundation; a near-full-width, projecting, shed-roofed porch on the facade; and vinyl exterior siding (see Figures 5.100 and 5.101). The porch has been reconstructed with the flooring, four support posts, and railing constructed with dimensional pressure-treated lumber. The windows are non-historic metal-framed vinyl units with faux muntins. A small, full-width, shed-roofed addition has been constructed on the rear elevation.

**Figure 5.100.** Resource 113-0187 (3015 Overbrook Drive) - View of façade facing south.

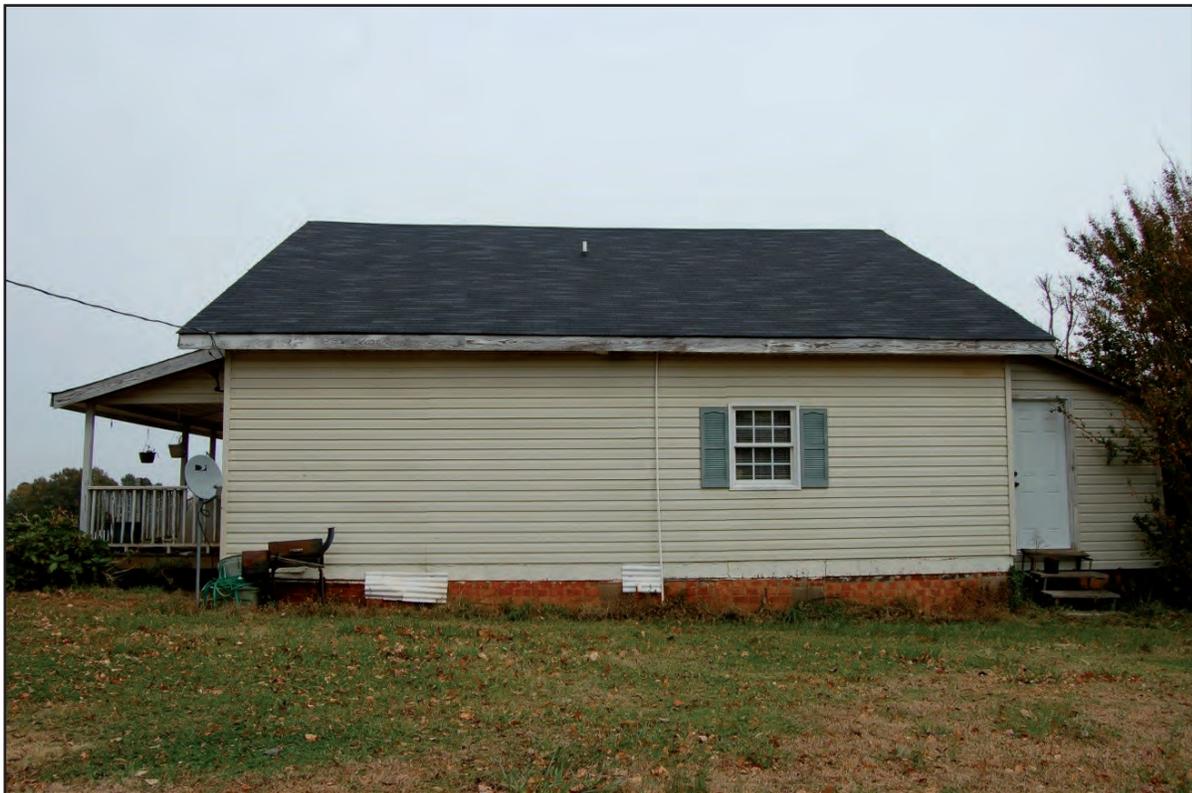
**Figure 5.101.** Resource 113-0187 (3015 Overbrook Drive) - View of west side elevation facing east.

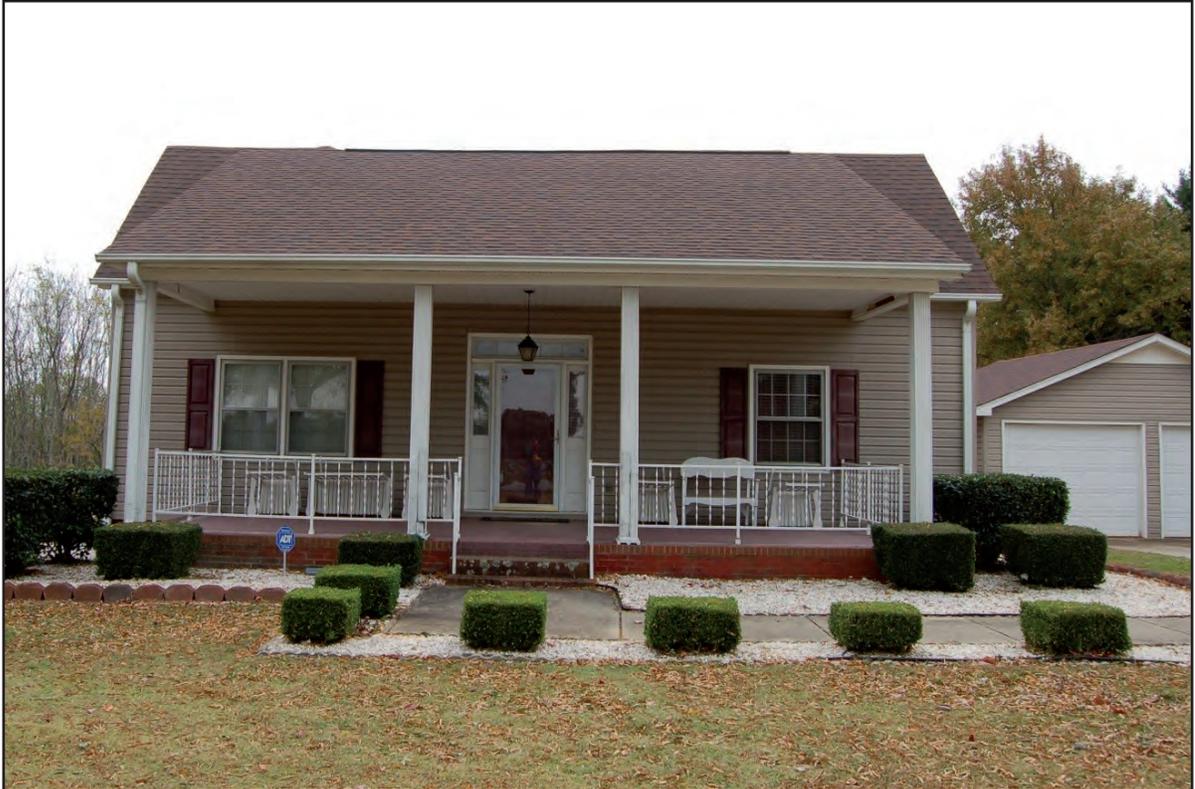
Resource 113-0188 is located at 2911 Overbrook Drive on the south side of the roadway in the southeast corner of the intersection of Overbrook Drive and Byars Farm Road west of Gaffney in Cherokee County (refer to Figure 5.2b). The Cherokee County tax assessor's record does not have an estimated date of construction for the resource. Based on a review of historic topographic maps and an evaluation of the resource's form and construction materials, Resource 113-0188 appears to have been constructed ca. 1920. The resource is a one-story, symmetric, central-hallway plan house of frame construction. The house features a cross-gabled asphalt shingle roof; a continuous brick foundation; a small brick interior roof surface chimney on the rear roof surface; a small brick exterior end wall chimney on the rear elevation; a near-full-width, projecting shed-roofed porch on the facade; and vinyl exterior siding (see Figures 5.102 and 5.103). The porch on the facade is a mid-twentieth century addition with four fluted post roof supports and metal railings. The central entrance has transom light and side lights. Windows are primarily single and paired 6/6-light

**Figure 5.102.** Resource 113-0188 (2911 Overbrook Drive) - View of façade facing south

double-hung sash windows of various sizes with a single 8/8-light double-hung sash window on the façade. A shed- and gable-roofed addition has been constructed on the rear elevation.

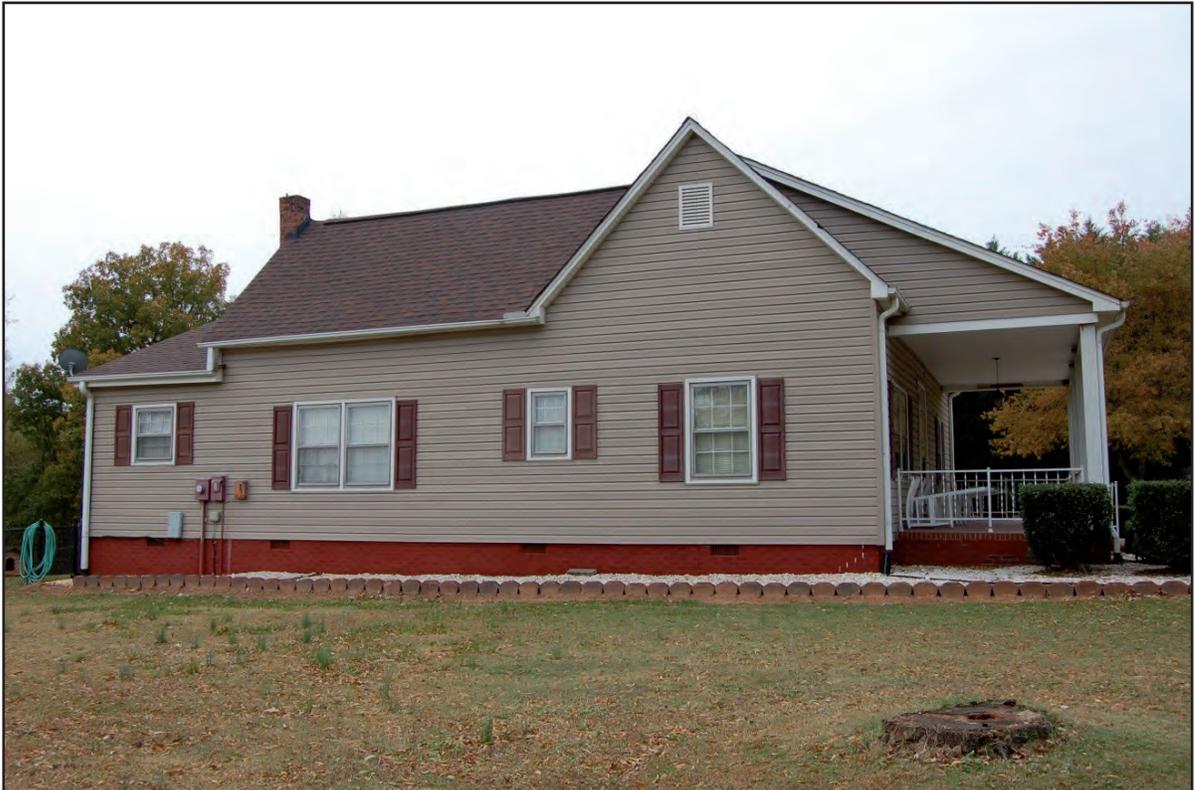
**Figure 5.103.** Resource 113-0188 (2911 Overbrook Drive) - View of east side elevation facing west.

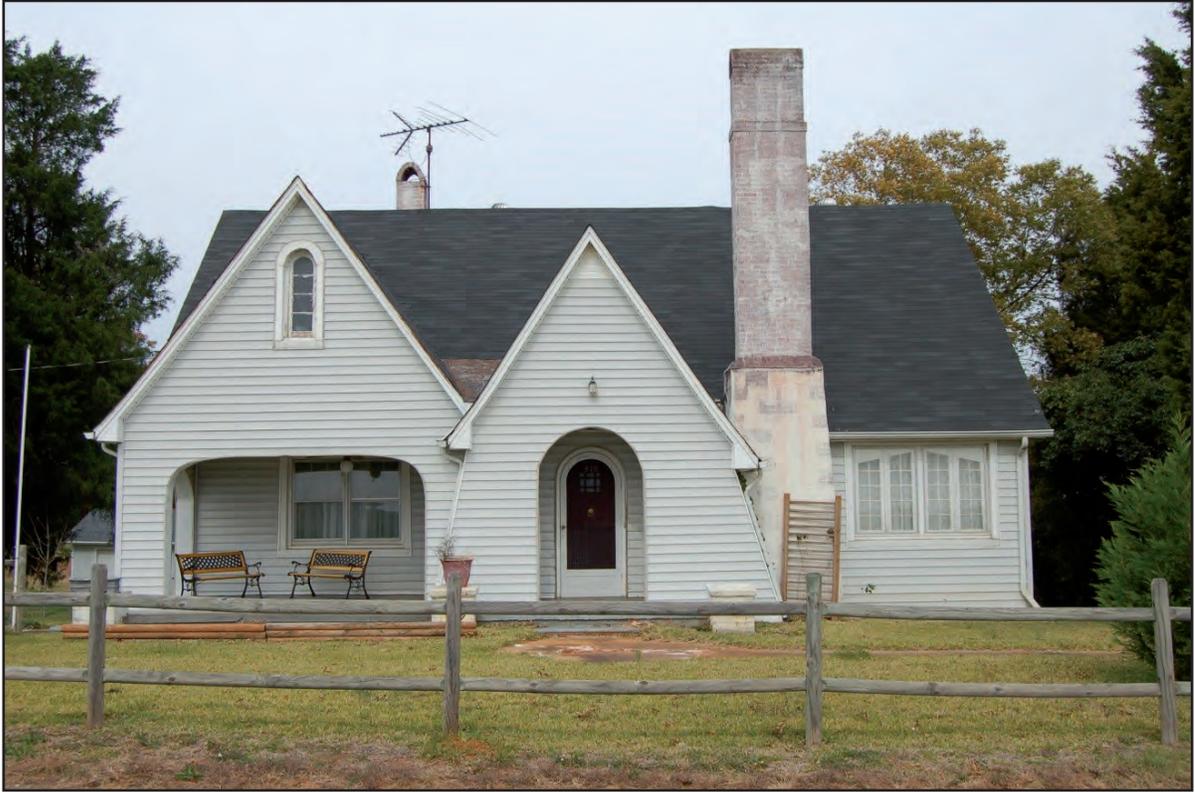
Resource 186-0189 is located at 313 Old Post Road on the north side of the roadway immediately east of the intersection of Old Post Road and Magg Road west of Gaffney in Cherokee County (refer to Figure 5.2b). The Cherokee County tax assessor's record does not have an estimated date of construction for the resource. Based on a review of historic aerial photography and topographic maps, and an evaluation of the resource's form and construction materials, Resource 186-0189 appears to have been constructed ca. 1930. The resource is depicted in its current location on a topographic map dated 1937 available on the [www.historicaerials.com](http://www.historicaerials.com) website. The resource is a one-and-one-half-story, asymmetric, cross-gabled cottage of frame construction with English Vernacular Revival stylistic elements. The stylistic elements are represented by the steeply-pitched roof with narrow eaves, the sharp angles of the gables on the façade and side elevations, the tall and prominent exterior chimney on the façade, and the rounded arches utilized on several features of the house. The house features a steeply-pitched, cross-gabled asphalt shingle roof with narrow eaves; a continuous concrete block foundation; a tall brick exterior chimney on the façade, an interior roof surface chimneys within the rear roof surface; a partial-width porch under two projecting gables on the façade; and vinyl exterior siding (see Figures 5.104 and 5.105). Openings to access the porch are round-arched and other round arches are visible on the front door, door surround, chimney caps, and windows on the façade. A wide variety of window types are present on the building and include 3/1-light double-hung sash of various sizes, bands of multi-light casement windows, and fixed multi-light windows.

**Figure 5.104.** Resource 186-0189 (313 Old Post Road) - View of façade facing north.

The resource is not known to be associated with a significant activity or event and there is not a known connection between the resource and any individual whose activities or achievements are historically significant. Therefore, there was no basis for evaluating the resource under Criterion A or B. Also, there is no indication that the resource is likely to yield information on important research questions in history or prehistory. The resource does not appear to have the potential to be the principal source of important information. Therefore, there was no basis for evaluating the resource under Criterion D. While the resource represents the recognized English Vernacular Revival architectural style, due to the application of vinyl exterior siding the resource has lost integrity in the areas of materials and feeling and cannot convey significance in the area of architecture. Therefore, Resource 186-0189 is recommended **Not Eligible** for listing in the NRHP under Criterion C in the area of architecture.

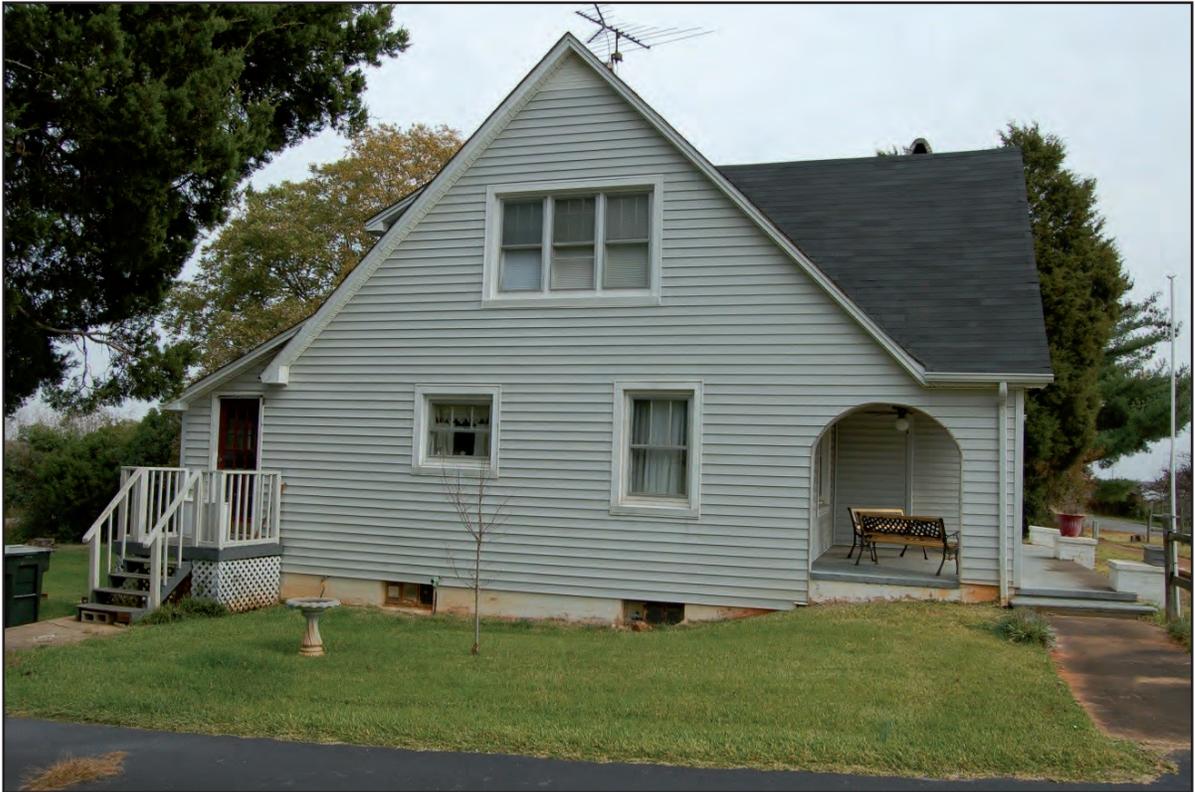
**Figure 5.105.** Resource 186-0189 (313 Old Post Road) - View of west side elevation facing east.

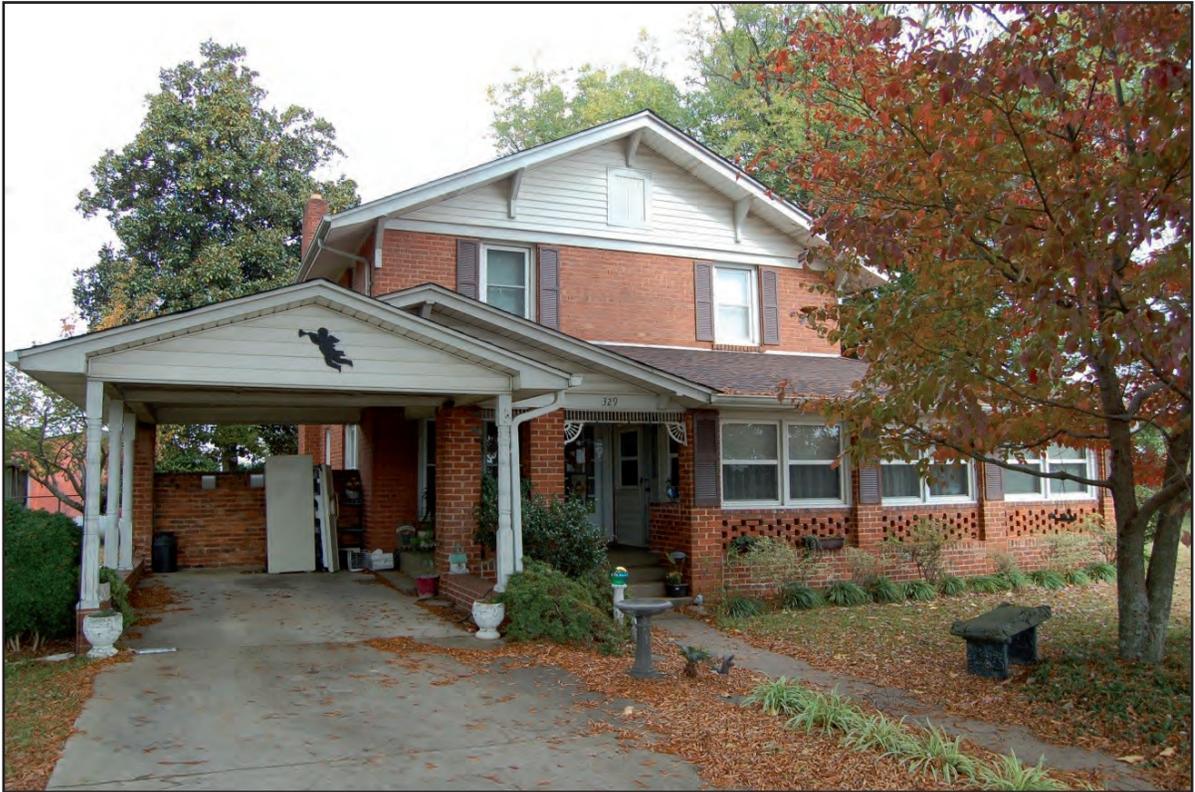
Resource 186-0190 is located at 329 Old Post Road on the north side of the roadway approximately 580 feet east of the intersection of Old Post Road and Magg Road west of Gaffney in Cherokee County (refer to Figure 5.2b). The Cherokee County tax assessor's record does not have an estimated date of construction for the resource. Based on a review of historic aerial photography and topographic maps, and an evaluation of the resource's form and construction materials, Resource 186-0190 appears to have been constructed ca. 1947. This estimated date of construction is supported by the depiction of the resource in its current location on the earliest aerial photograph available on the [www.historicaerials.com](http://www.historicaerials.com) website dated 1955. The resource is a two-story, asymmetric, front-gabled residence of no defined type. The house features a front-gabled asphalt shingle roof with wide eaves and knee-braces covered with vinyl; a large exterior brick chimney on the west side elevation; a former wrap-around porch with hipped-roof supported by brick piers that has been substantially enclosed; vinyl exterior siding in the gabled ends; and running bond brick exterior siding on the remainder (see Figures 5.106 and 5.107). A one-car carport with a front-gabled roof has been constructed on the west side elevation. The porch has been enclosed with brick of a different color than that used on the rest of the house. Paired non-historic metal-framed double-hung sash vinyl windows have been added to the enclosed porch and all of the original windows have are non-historic metal-framed vinyl double-hung sash windows.

**Figure 5.106.** Resource 186-0190 (329 Old Post Road) - View of façade facing northeast.

and does not otherwise appear to represent a significant trend in South Carolina's architectural history. Additionally, due to the enclosure of the former wrap-around porch and the replacement of the original windows with non-historic vinyl replacements, the resource has lost integrity in the areas of design, materials, workmanship, and feeling and cannot convey significance in the area of architecture. Therefore, Resource 186-0190 is recommended **Not Eligible** for listing in the NRHP under Criterion C in the area of architecture.

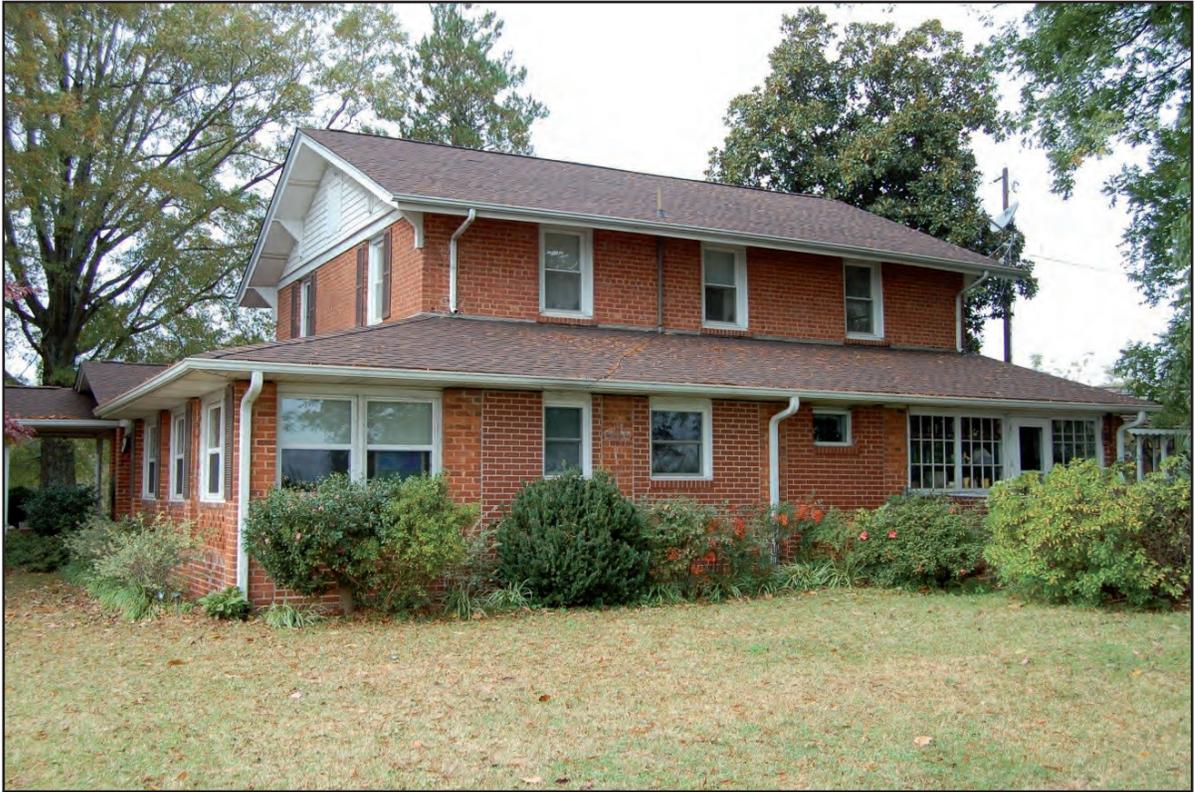
**Figure 5.107.** Resource 186-0190 (329 Old Post Road) - Oblique view of rear and west side elevations facing southeast.

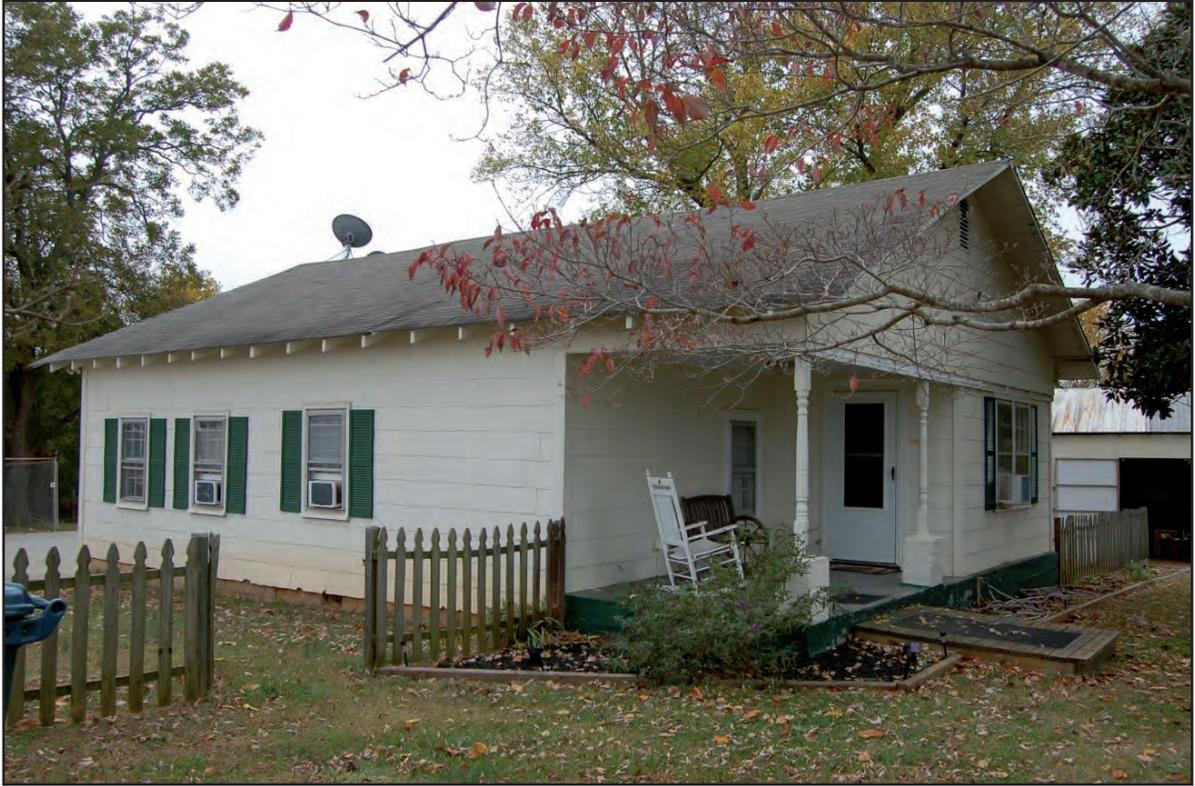
Resource 186-0191 is located at 2761 Overbrook Drive on the south side of the roadway approximately 0.22 mile west of the intersection of Overbrook Drive and Sarratt School Road west of Gaffney in Cherokee County (refer to Figure 5.2b). The Cherokee County tax assessor's record does not have an estimated date of construction for the resource. Based on a review of historic aerial photography and topographic maps, and an evaluation of the resource's form and construction materials, Resource 186-0191 appears to have been constructed ca. 1935. This estimated date of construction is supported by the depiction of the resource in its current location on the earliest aerial photograph available on the [www.historicaerials.com](http://www.historicaerials.com) website dated 1955. The resource is a one-story, asymmetric, front-gabled bungalow of frame construction. According to the current owner of the property who was interviewed at the time of the historic resources field survey, the resource was formerly associated with Resource 186-0190 and was moved to its present location ca. 1957 from the alignment of I-85 during construction of the highway. The house features a front-gabled asphalt shingle roof with exposed rafter ends; a small brick exterior chimney on the west side elevation; a partial-width, integral recessed porch on the façade; and concrete asbestos tile exterior siding (see Figures 5.108 and 5.109). The integral porch is supported by turned posts atop concrete block piers. Windows are primarily single and paired original wood-framed 6/6-light double-hung sash with a single fixed light and a two-light awning window on the west side elevation.

**Figure 5.108.** Resource 186-0191 (2761 Overbrook Drive) - Oblique view of façade and east side elevation facing southwest.

The resource is not known to be associated with a significant activity or event and there is not a known connection between the resource and any individual whose activities or achievements are historically significant. Therefore, there was no basis for evaluating the resource under Criterion A or B. Also, there is no indication that the resource is likely to yield information on important research questions in history or prehistory. The resource does not appear to have the potential to be the principal source of important information. Therefore, there was no basis for evaluating the resource under Criterion D. The resource is an undistinguished example of a common architectural type. Therefore, Resource 186-0191 is recommended **Not Eligible** for listing in the NRHP under Criterion C in the area of architecture.

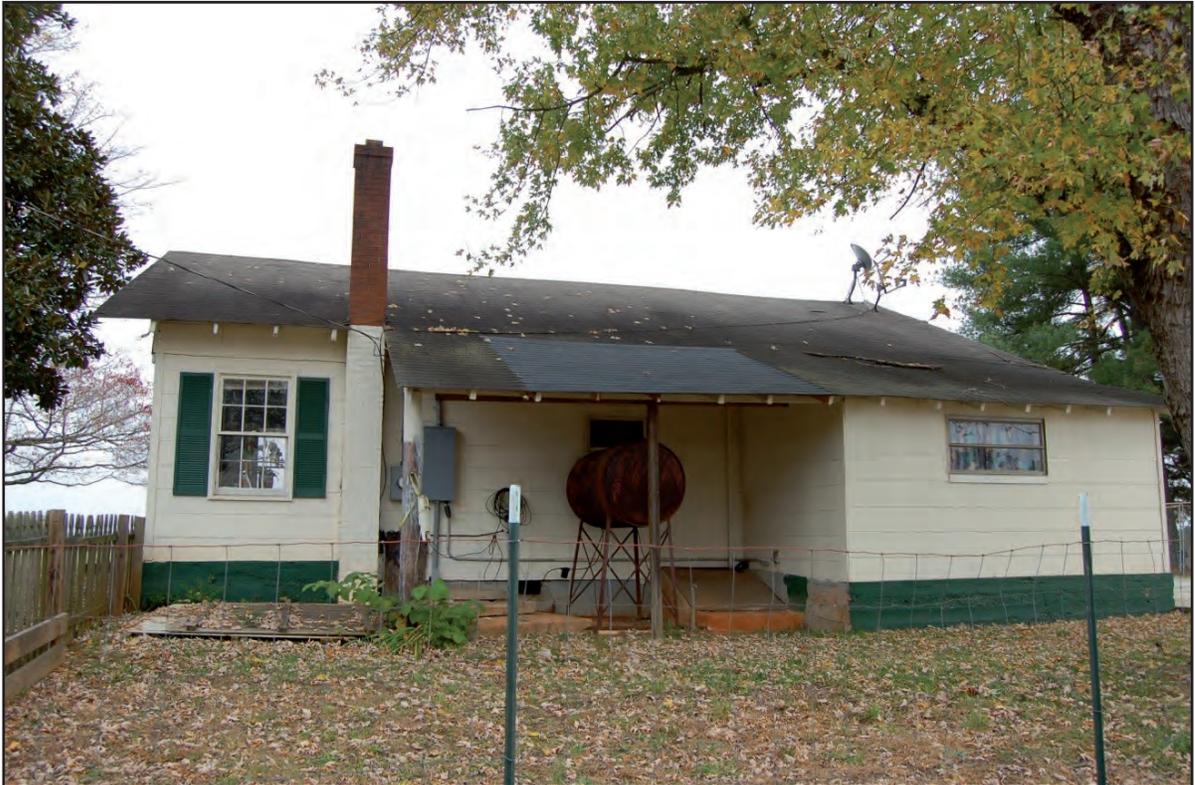
**Figure 5.109.** Resource 186-0191 (2761 Overbrook Drive) - View of west side elevation facing east.

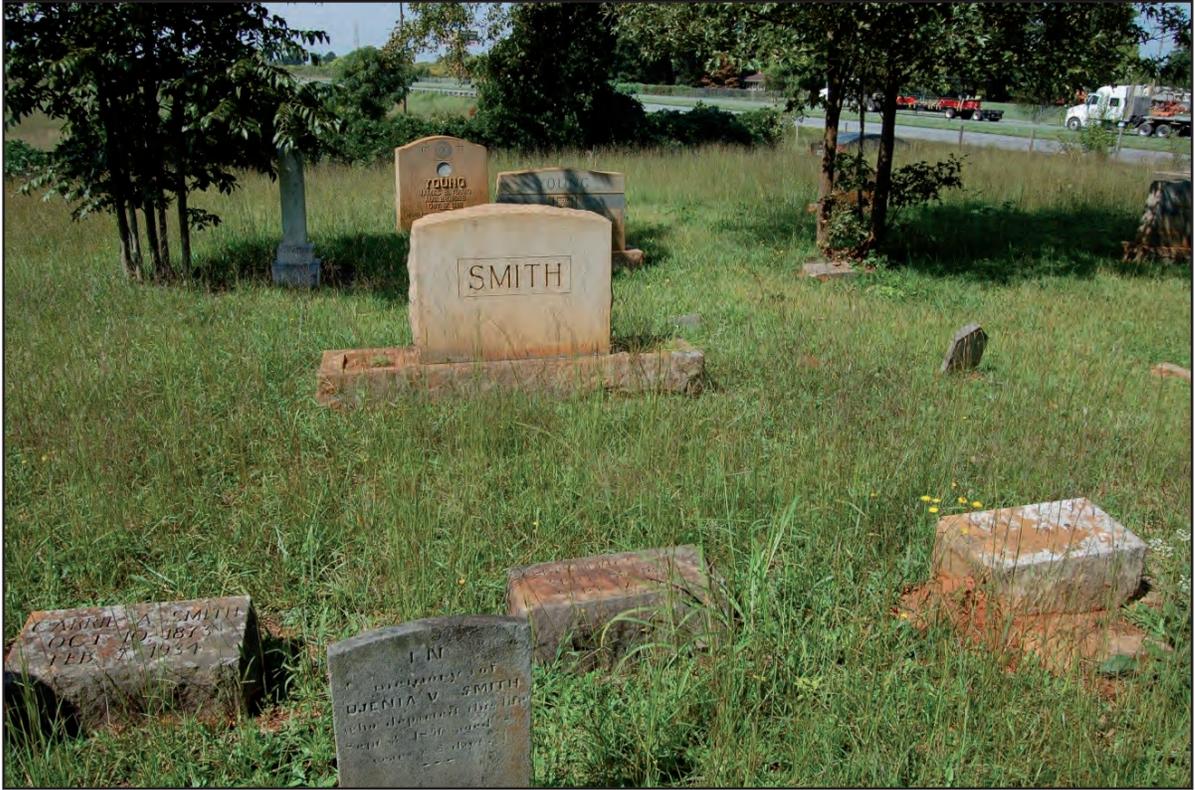
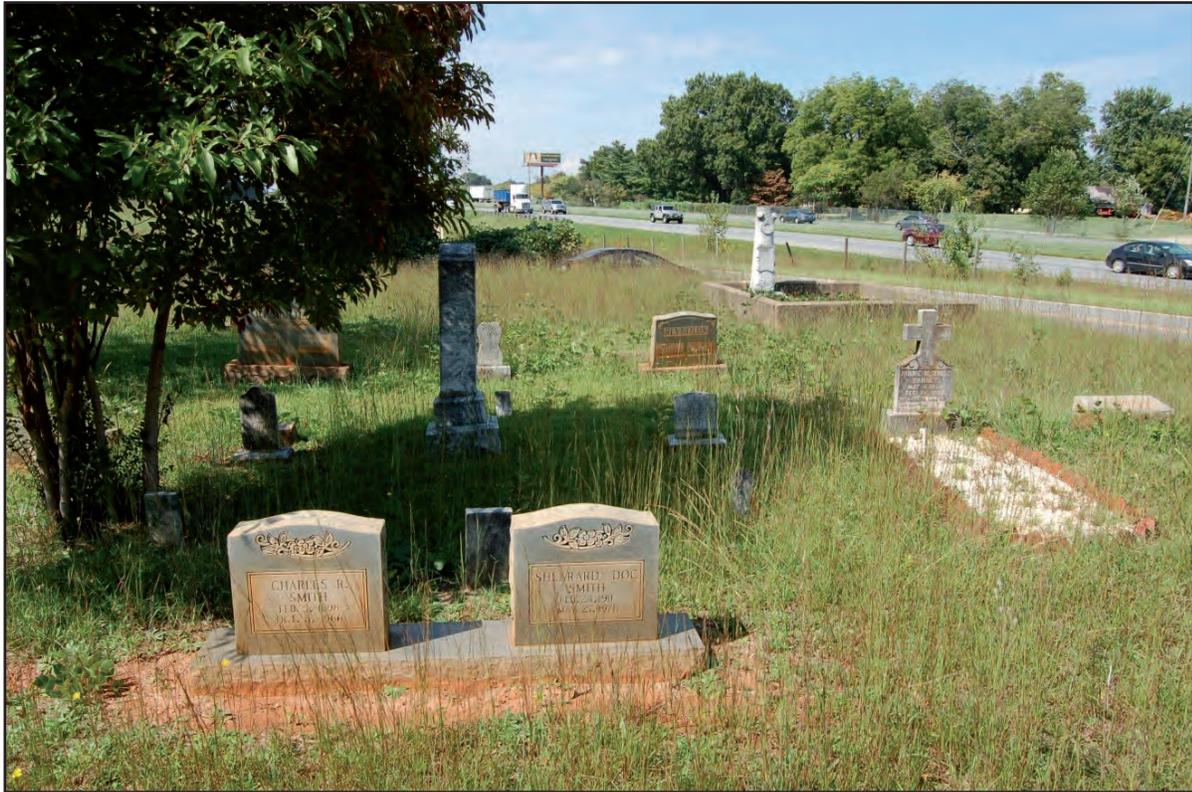
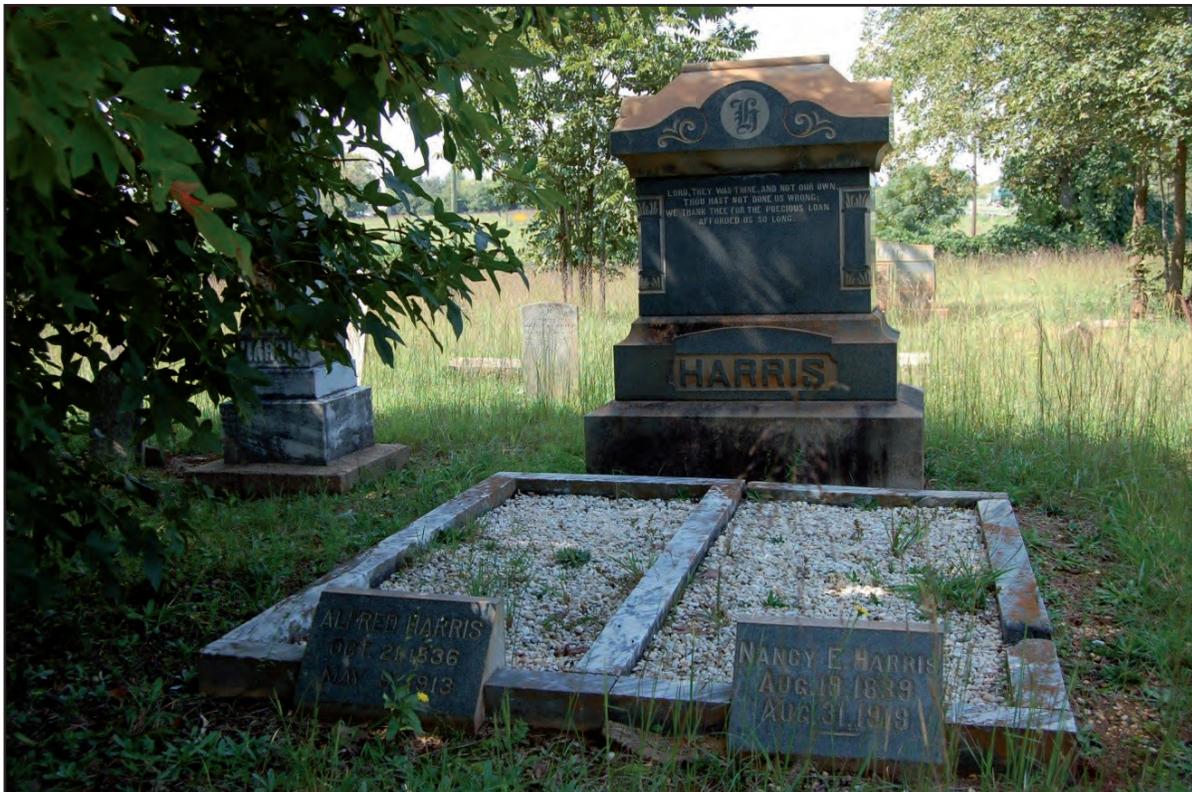
The cemetery is located in a lot that is primarily grassed with a few immature trees and shrubs irregular placed within the cemetery. There are no walkways or fences within the cemetery and the only landscape features other than the monuments appear to be family plot markers. Family plots are marked by polished stone borders, poured concrete borders, and border of brick that all extend a few inches above the ground surface. The monuments face to the east and are not aligned or organized in any discernable fashion. Monument types within the cemetery consist of die, base, and cap; headstones; die in socket; die on base; raised tops; and pedestals (see Figures 5.110 – 5.113).

**Figure 5.110.** Resource 186-0192 (Smith-Harris Cemetery) – Representative view of Smith-Harris Cemetery facing northwest.

**Figure 5.112.** Resource 186-0192 (Smith-Harris Cemetery) – Representative view of Smith-Harris Cemetery facing west.

**Figure 5.113.** Resource 186-0192 (Smith-Harris Cemetery) – Representative view of Smith-Harris Cemetery facing northwest.

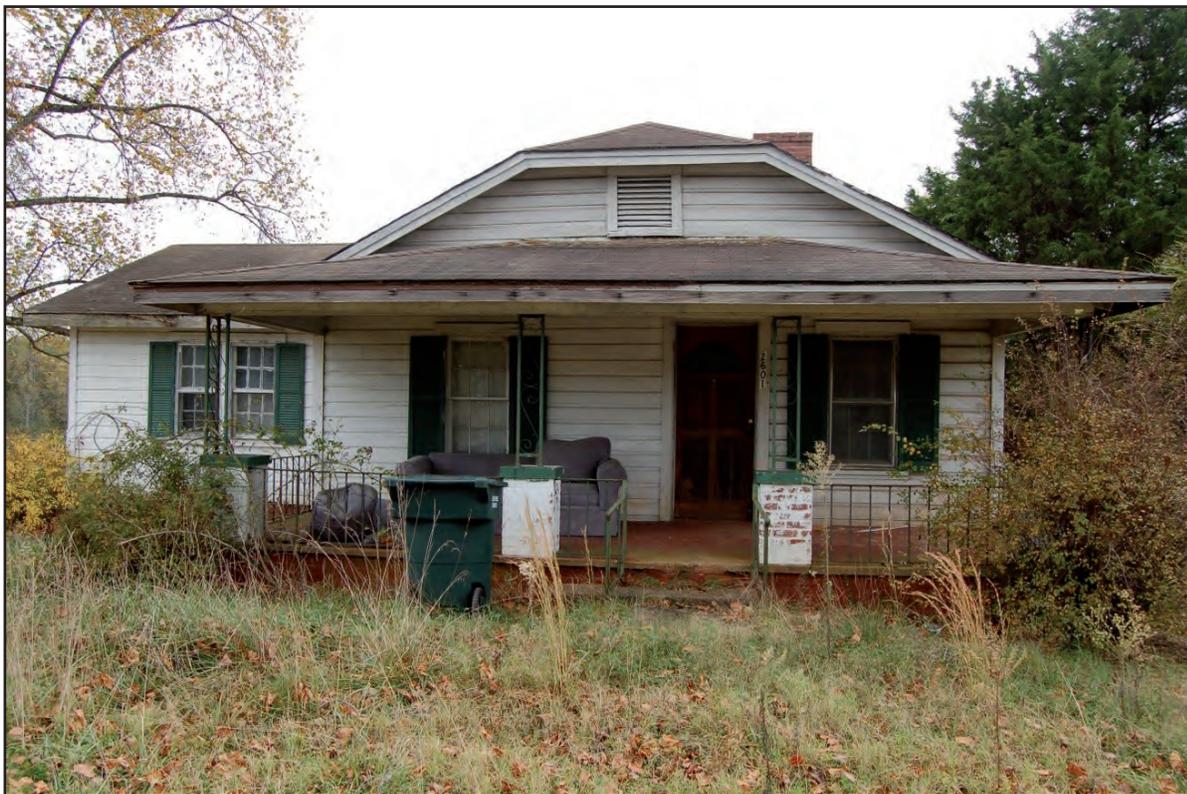
Resource 186-0193 is located at 2601 Overbrook Drive on the south side of the roadway approximately 0.28 mile east of the intersection of Overbrook Drive and Sarratt School Road west of Gaffney in Cherokee County (refer to Figure 2B). The Cherokee County tax assessor's record has a 1932 estimated date of construction for the resource. This estimated date of construction is supported by the depiction of the resource in its current location on the earliest aerial photograph

available on the [www.historicaerials.com](http://www.historicaerials.com) website dated 1955 and by an evaluation of the resource's form and construction materials. The resource is a one-story, asymmetric, cross-gabled bungalow of frame construction. The house features a cross-gabled asphalt shingle roof; a brick pier with continuous brick infill foundation; a small brick interior roof surface chimney on the west roof surface; a full-width, projecting hipped-roofed porch façade; and novelty board exterior siding (see Figures 5.114 and 5.115). The front-facing gable is clipped and the gabled-wing on the east side elevation is a later addition to the house. The porch on the façade is supported by four decorative metal posts atop painted brick piers. Windows on the resource are single and paired original wood-framed 6/6-light double-hung sash windows.

**Figure 5.114.** Resource 186-0193 (2601 Overbrook Drive) - View of façade facing south.

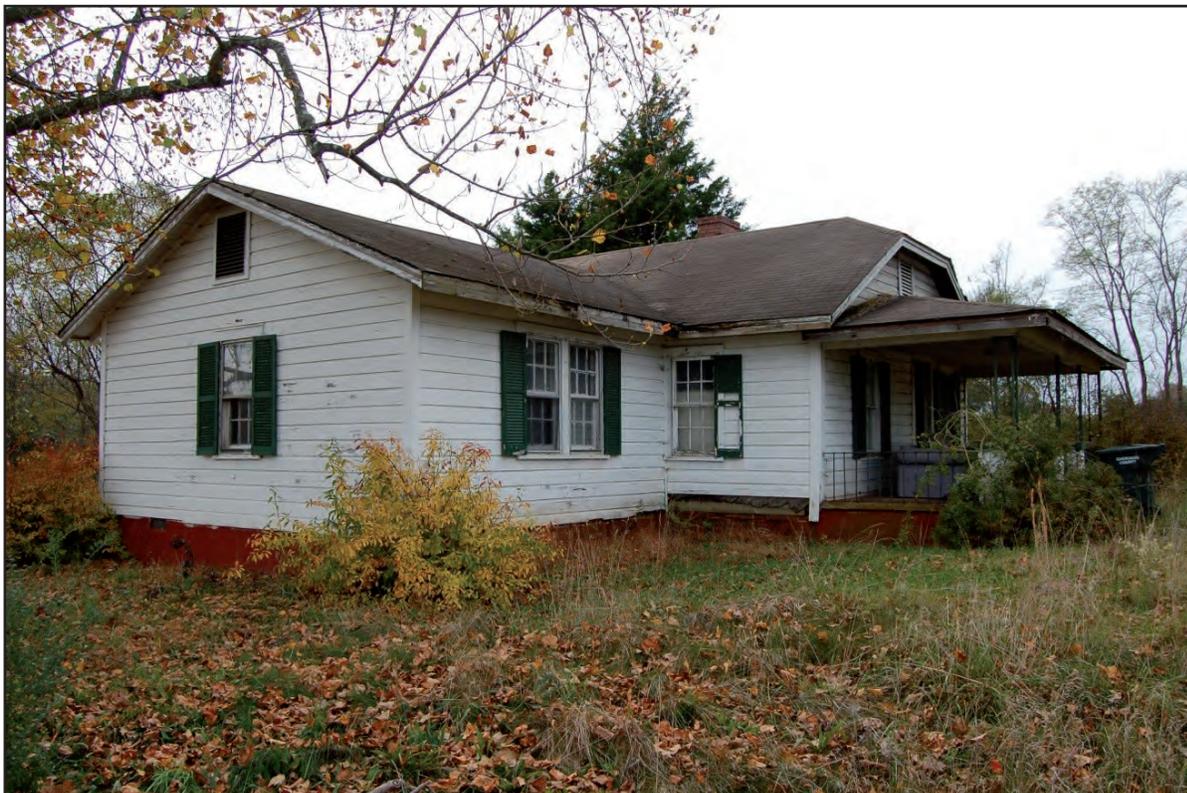
**Figure 5.115.** Resource 186-0193 (2601 Overbrook Drive) - Oblique view of façade and east side elevation facing southwest.

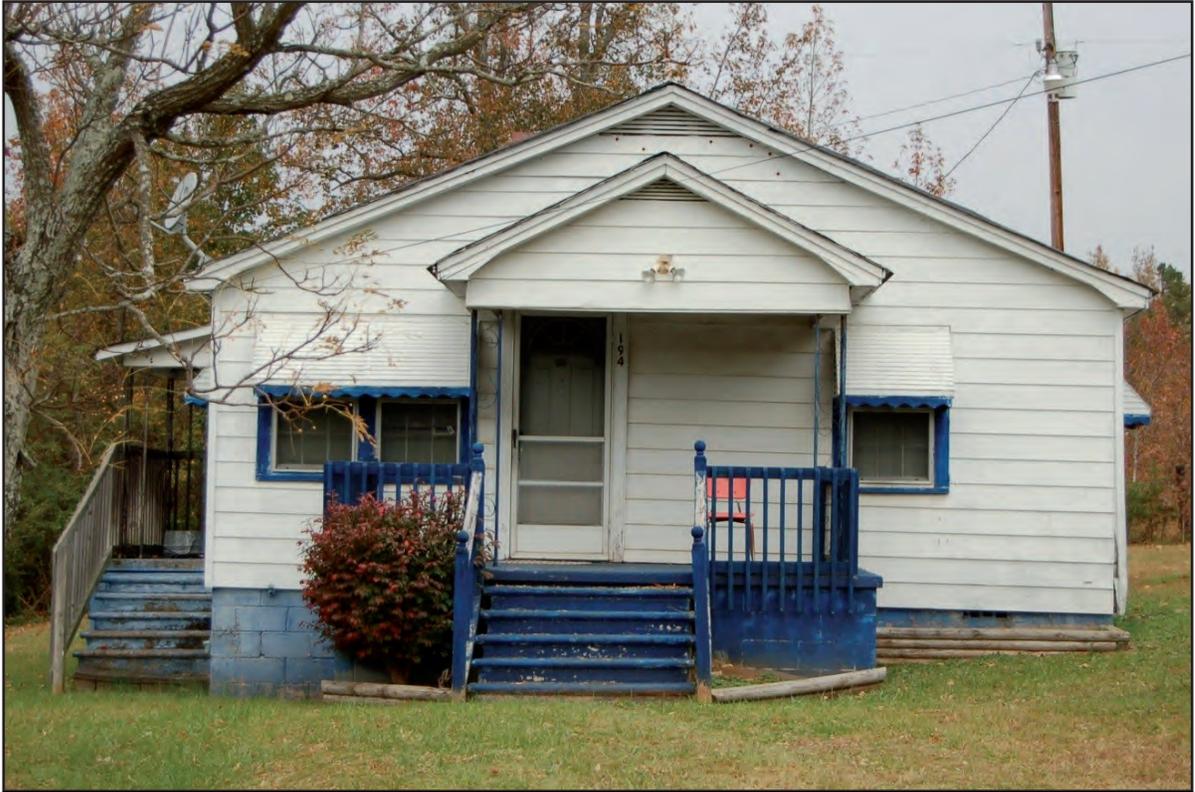
Resource 186-0194 is located at 194 Zelure Road on the north side of the roadway approximately 600 feet west of the intersection of Zelure Road and an unnamed roadway west of Gaffney in Cherokee County (refer to Figure 5.2c). The Cherokee County tax assessor's record does not have an estimated date of construction for the resource. Based on a review of historic topographic maps and an evaluation of the resource's form and construction materials, Resource 186-0194 appears to have been constructed ca. 1940. This estimated date of construction is supported by the depiction of the resource in its current location on the earliest aerial photograph available on the [www.historicaerials.com](http://www.historicaerials.com) website dated 1955. The resource is a one-story, asymmetric, front-gabled bungalow of frame construction. The house features a front-gabled asphalt shingle roof; continuous concrete block foundation; a small brick interior roof surface chimney within the west-side roof surface; a partial-width, projecting gable-roofed entry porch on the façade; a partial-width, shed-roofed entry porch on the west side elevation; and aluminum exterior siding (see Figures 5.116 and 5.117). A gable-roofed addition has been constructed on the west side elevation and the porches and porch supports and railings appear to have been reconstructed. Windows are single and paired original wood-framed 6/6-light double-hung sash windows with metal awnings.

**Figure 5.116.** Resource 186-0194 (194 Zelure Road) - View of façade facing north.

The resource is not known to be associated with a significant activity or event and there is not a known connection between the resource and any individual whose activities or achievements are historically significant. Therefore, there was no basis for evaluating the resource under Criterion A or B. Also, there is no indication that the resource is likely to yield information on important research questions in history or prehistory. The resource does not appear to have the potential to be the principal source of important information. Therefore, there was no basis for evaluating the resource under Criterion D. The resource is an undistinguished example of a common architectural type and due to the construction of the gable-roofed addition on the west side elevation, the reconstruction of the porches, and the application of aluminum exterior siding the resource has lost integrity in the areas of design, materials, workmanship, and feeling and cannot convey significance in the area of architecture. Therefore, Resource 186-0194 is recommended **Not Eligible** for listing in the NRHP under Criterion C in the area of architecture.
