**PHASE I CULTURAL RESOURCE SURVEY FOR PROPOSED  
WIDENING OF INTERSTATE 85 FROM MILE MARKER 80 TO 96,  
CHEROKEE AND SPARTANBURG COUNTIES, SOUTH CAROLINA.**

**FINAL REPORT**

**JULY 2015**

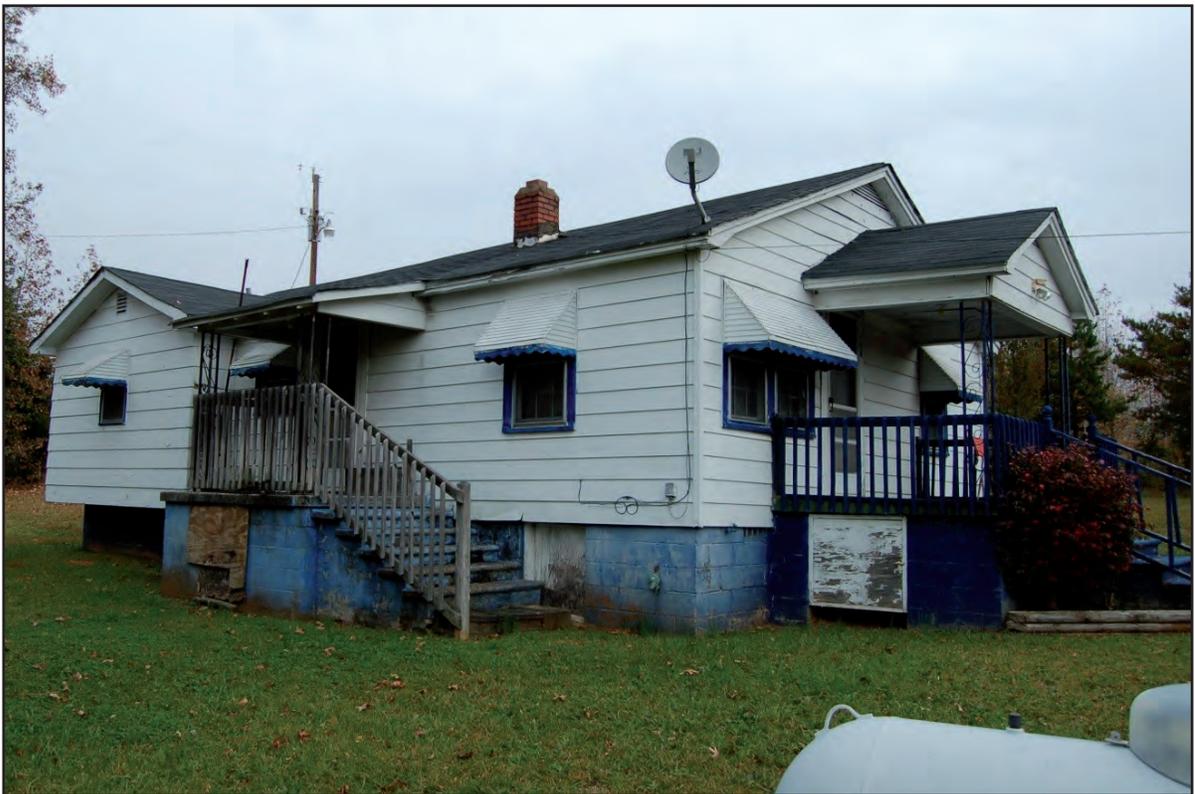
**Figure 5.117.** Resource 186-0194 (194 Zelure Road) - Oblique view of façade and west side elevation facing northeast.

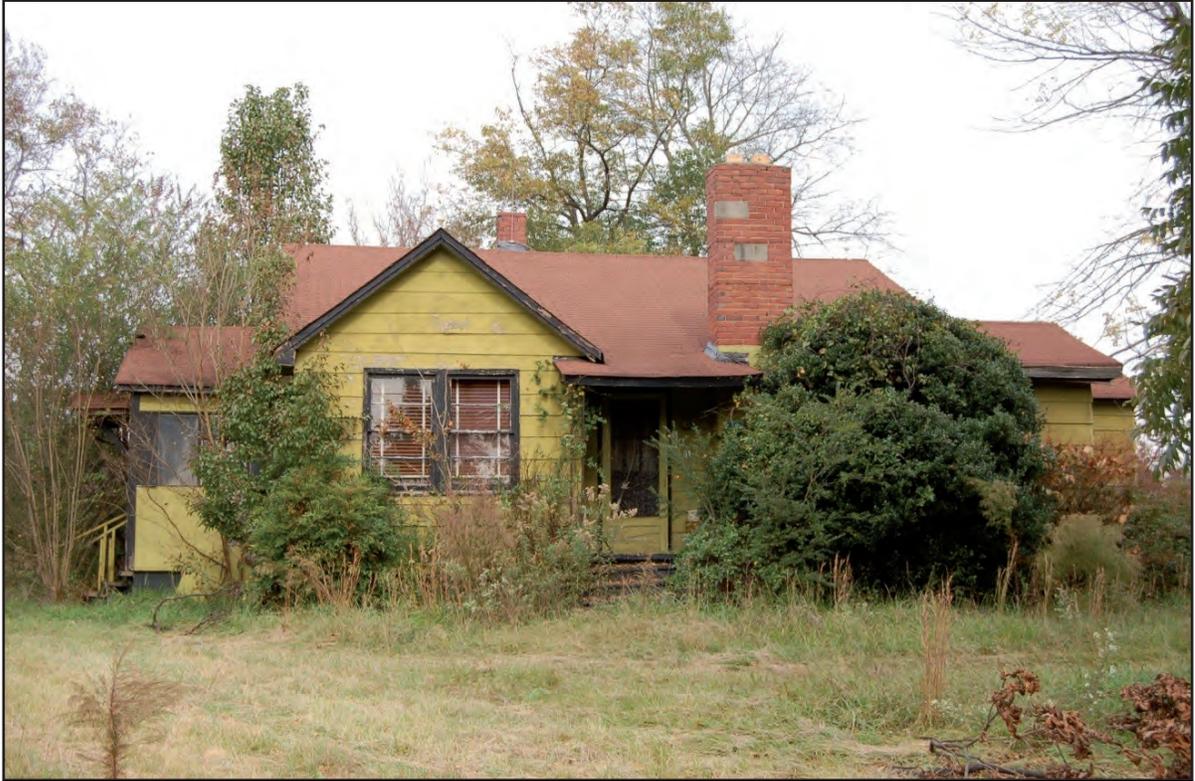
Resource 186-0195 is located at 162 Zelure Road on the north side of the roadway in the northeast corner of the intersection of Zelure Road and an unnamed roadway west of Gaffney in Cherokee County (refer to Figure 5.2c). The Cherokee County tax assessor's record does not have an estimated date of construction for the resource. Based on a review of historic aerial photography and topographic maps, and an evaluation of the resource's form and construction materials, Resource 186-0195 appears to have been constructed ca. 1940. This estimated date of construction is supported by the depiction of the resource in its current location on the earliest aerial photograph available on the [www.historicaerials.com](http://www.historicaerials.com) website dated 1955. The resource is a one-story, asymmetric, cross-gabled residence of frame construction. The house features a cross-gabled asphalt shingle roof; a continuous concrete block foundation; a tall brick interior roof surface chimney on the front roof slope; a small brick interior roof surface chimney on the rear roof surface; a shed-roofed stoop porch on the façade; a gabled-roofed stoop entry porch on the west side elevation; and aluminum exterior siding (see Figures 5.118 and 5.119). A former porch on the west side elevation has been enclosed with plywood. Windows are single and paired original wood-framed 2/2-light double-hung sash windows.

**Figure 5.118.** Resource 186-0195 (162 Zelure Road) - View of façade facing north.

The resource is not known to be associated with a significant activity or event and there is not a known connection between the resource and any individual whose activities or achievements are historically significant. Therefore, there was no basis for evaluating the resource under Criterion A or B. Also, there is no indication that the resource is likely to yield information on important research questions in history or prehistory. The resource does not appear to have the potential to be the principal source of important information. Therefore, there was no basis for evaluating the resource under Criterion D. The resource does not represent a recognized architectural type or style and does not otherwise appear to represent a significant trend in South Carolina's architectural

history. Therefore, Resource 186-0195 is recommended **Not Eligible** for listing in the NRHP under Criterion C in the area of architecture.

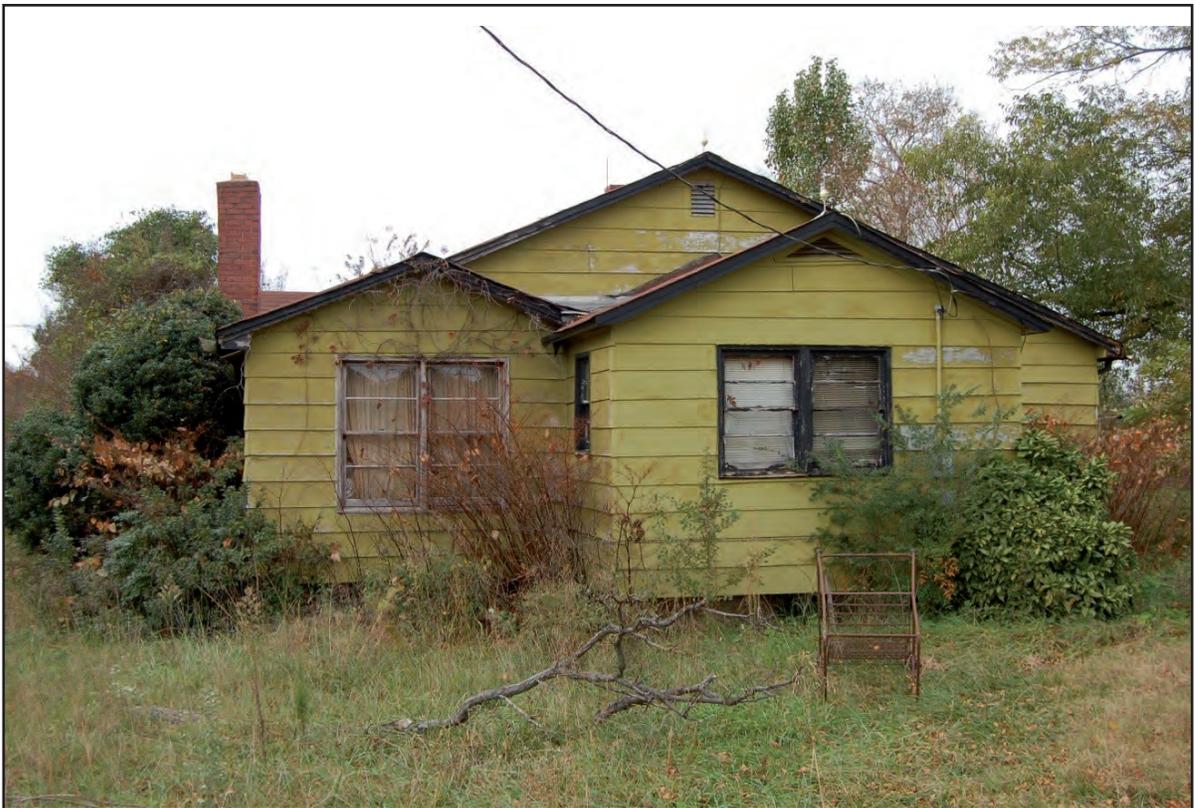
**Figure 5.119.** Resource 186-0195 (162 Zelure Road) - View of east side elevation facing west.

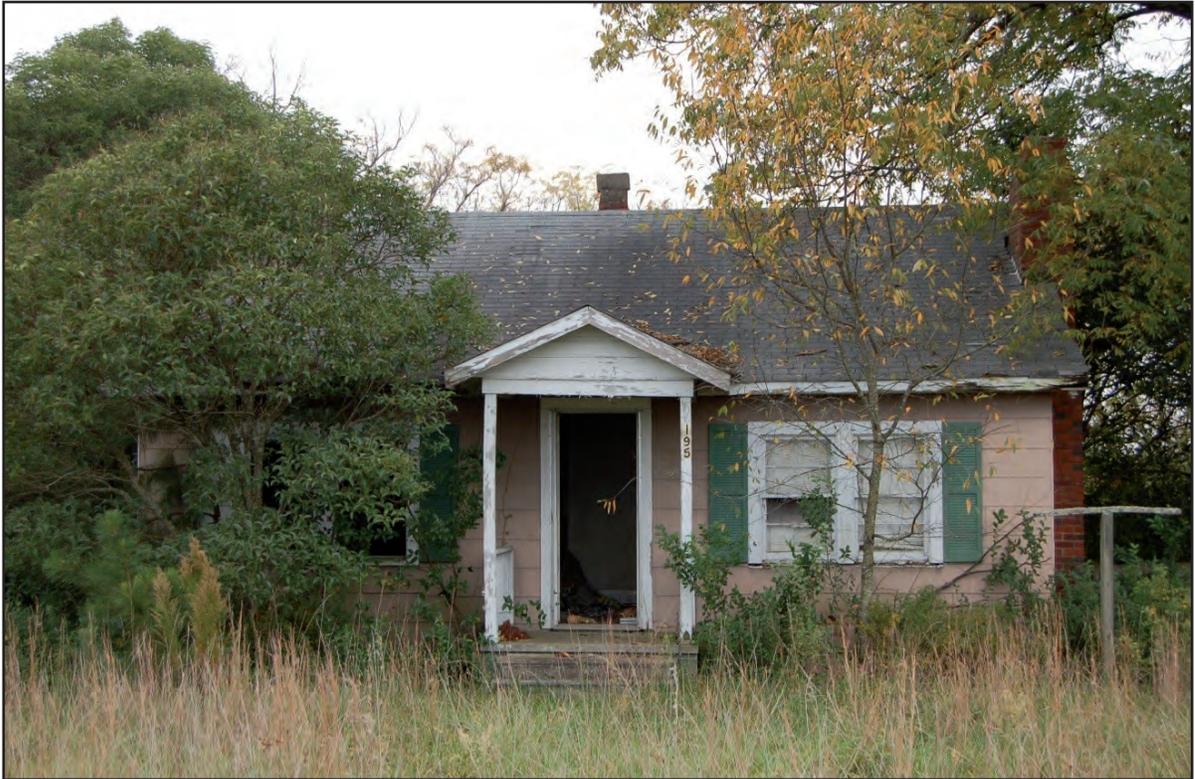
Resource 186-0196 is located at 195 Lemmons Lane on the south side of the roadway approximately 0.16 mile west of the intersection of Lemmons Lane and Forestdale Drive west of Gaffney in Cherokee County (refer to Figure 5.2c). The Cherokee County tax assessor's record does not have an estimated date of construction for the resource. Based on a review of historic aerial photography and topographic maps, and an evaluation of the resource's form and construction materials, Resource 186-0196 appears to have been constructed ca. 1940. This estimated date of construction is supported by the depiction of the resource in its current location on the earliest aerial photograph available on the [www.historicaerials.com](http://www.historicaerials.com) website dated 1955. The resource is a one-story, symmetric, side-gabled cottage of frame construction. The house features a side-gabled asphalt shingle roof; a continuous concrete block foundation; a small brick interior roof surface chimney within the rear roof surface; a large brick exterior end wall chimney on the west side elevation; a gable-roofed stoop entry porch on the façade; and concrete asbestos tile exterior siding (see Figures 5.120 and 5.121). There is shed-roofed addition on the rear and west side elevation. Windows are single and paired wood-framed 6/6-light double-hung sash windows.

**Figure 5.120.** Resource 186-0196 (195 Lemmons Lane) - View of façade facing north.

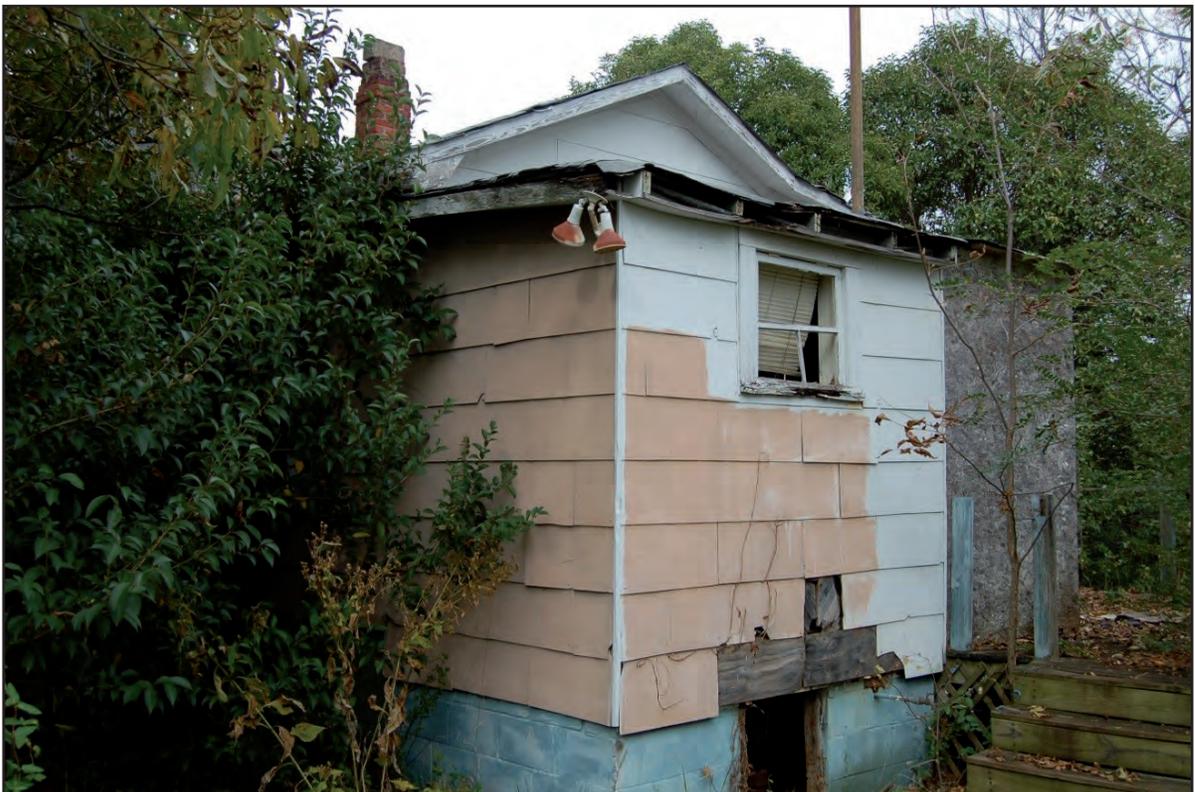
**Figure 5.121.** Resource 186-0196 (195 Lemmons Lane) - Oblique view of rear elevation facing northeast.

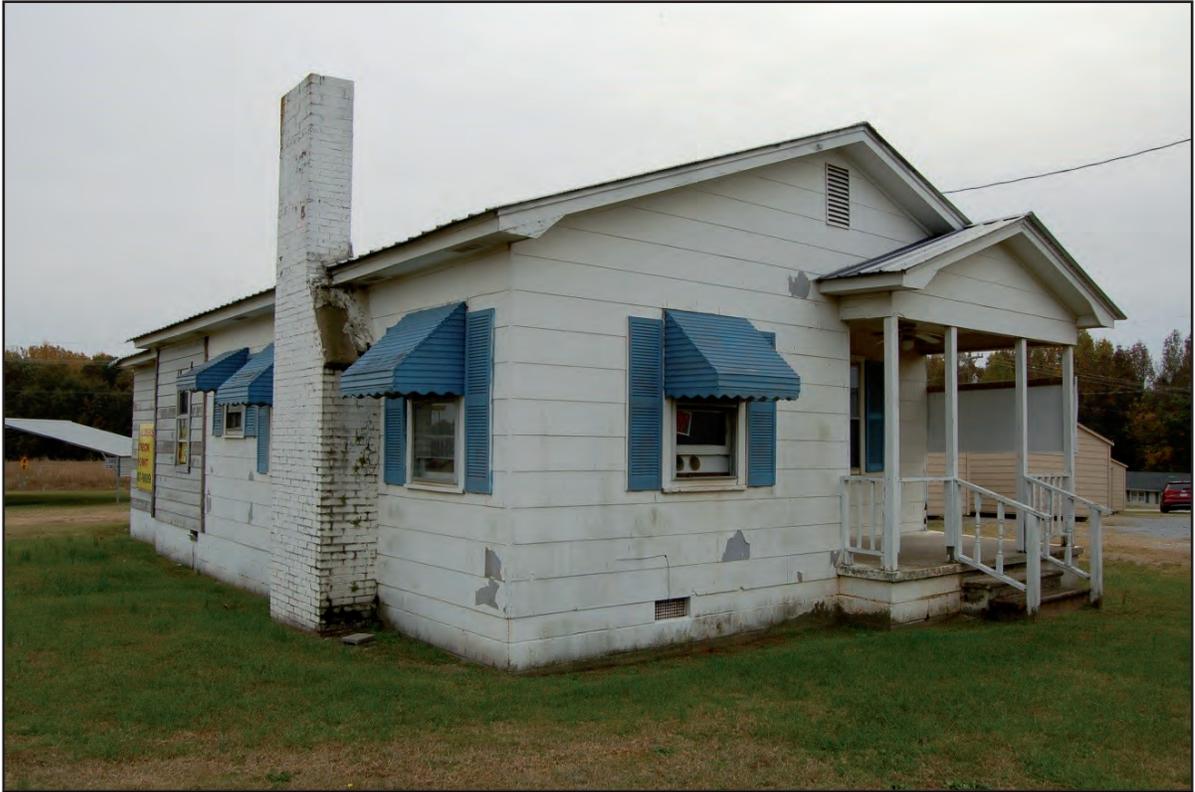
**Figure 5.122.** Resource 186-0197 (102 Lemmons Lane) – Oblique view of façade and east side elevation facing southwest.

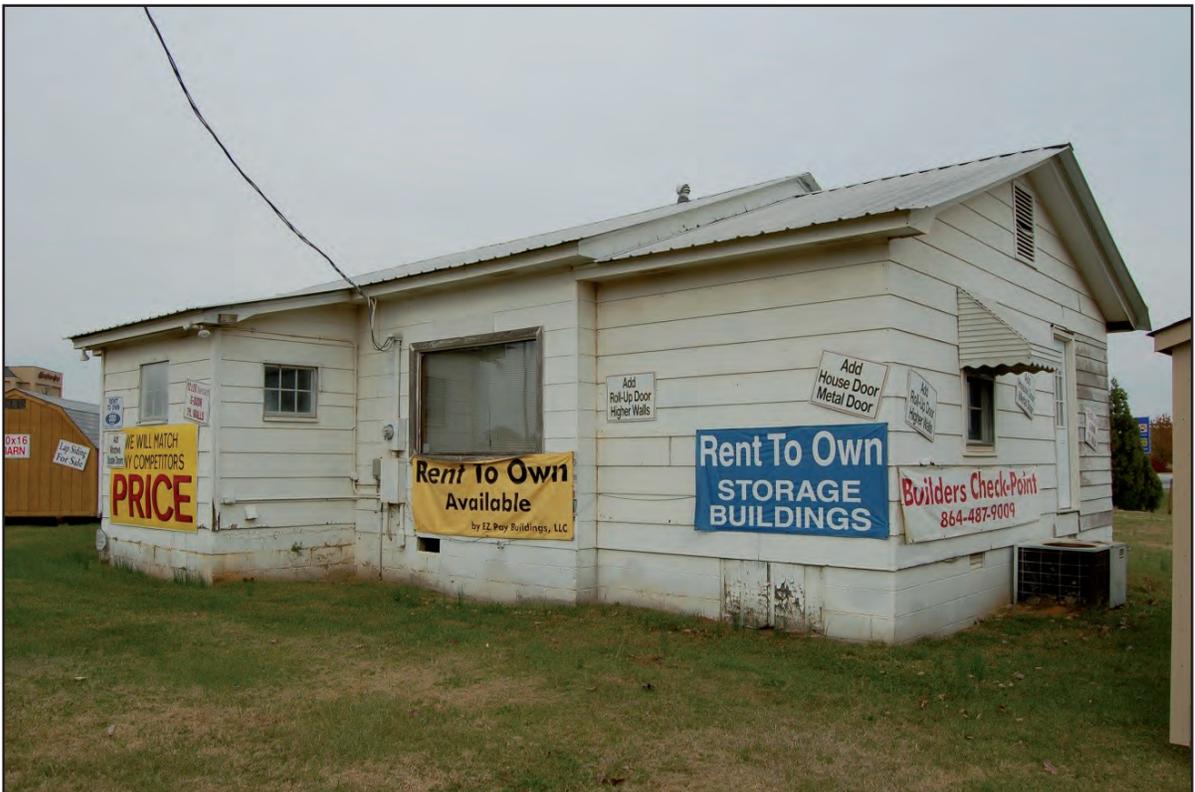
**Figure 5.123.** Resource 186-0197 (102 Lemmons Lane) - Oblique view of rear and west side elevations facing northeast.

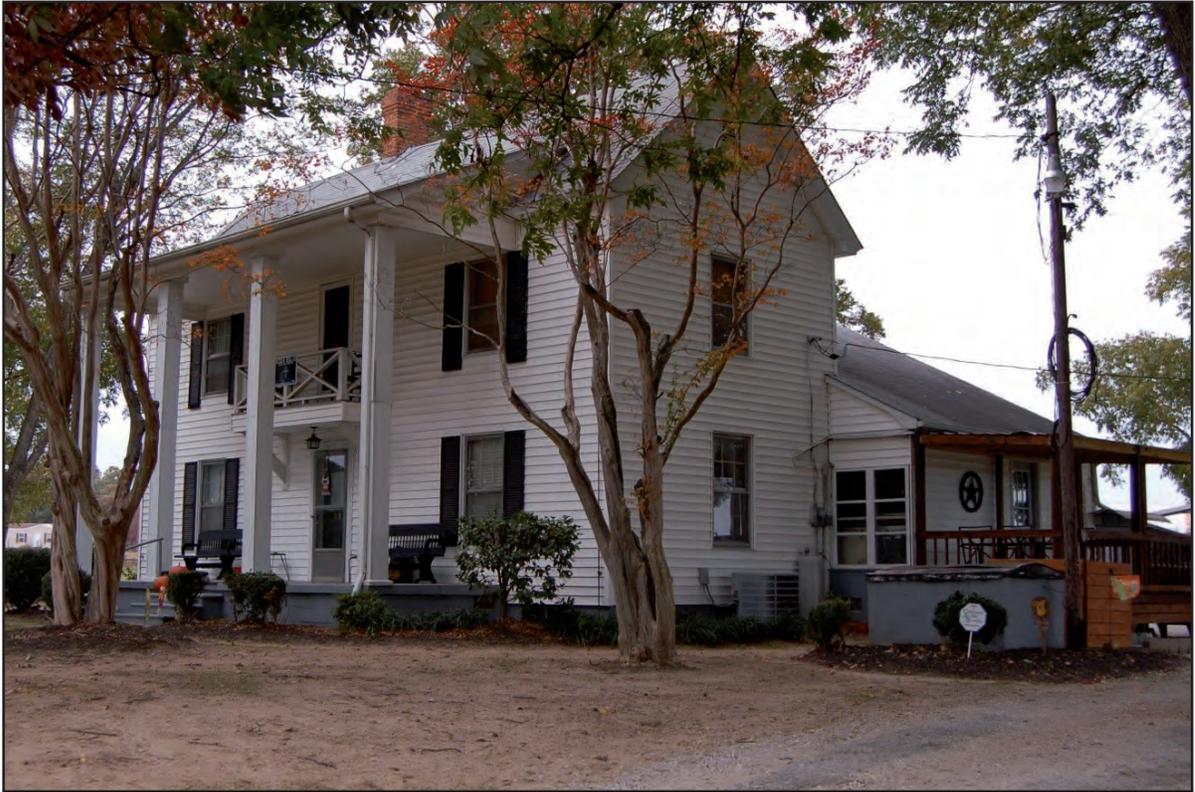
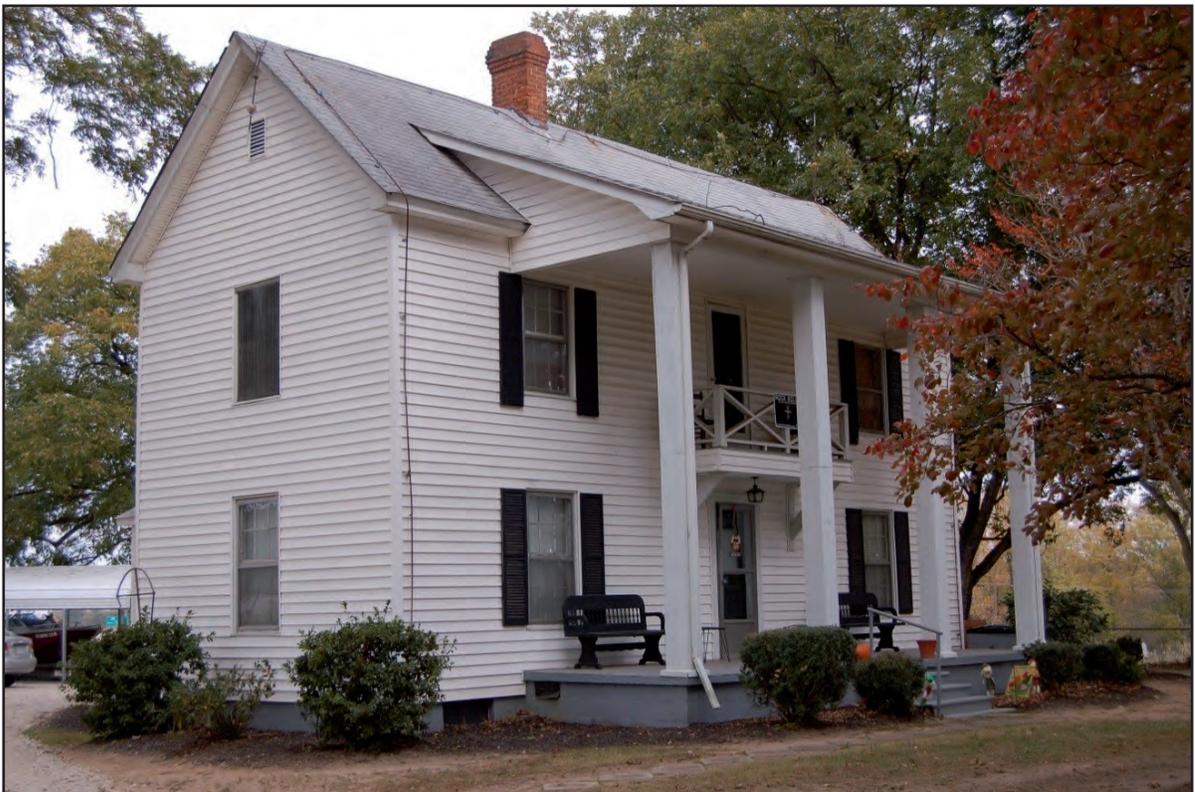
The house (186-0198.00) is a two-story, symmetric, I-House of frame construction. It features a side-gabled asphalt shingle roof; a continuous concrete block foundation; a partial-width, full-height, shed-roofed portico supported by four large square posts; centered doorways on each floor on the façade; a small balcony supported by straight brackets on the upper level; and a tall corbeled brick central ridgeline chimney (see Figures 5.124 and 5.125). Windows are original wood-framed 6/6-light double-hung sash.

**Figure 5.124.** Resource 186-0198.00 (1820 West Rutledge Avenue) – Oblique view of façade and south side elevation of house facing northeast.

**Figure 5.125.** Resource 186-0198.00 (1820 West Rutledge Avenue) - Oblique view of façade and north side elevation facing southeast.

areas of materials and workmanship for both the house and outbuildings, they still retain integrity in the areas of location, setting, design, feeling, and association. Therefore, Resource 186-0198 is recommended **Eligible** for listing in the NRHP under Criteria A and C in the areas of agriculture and architecture.

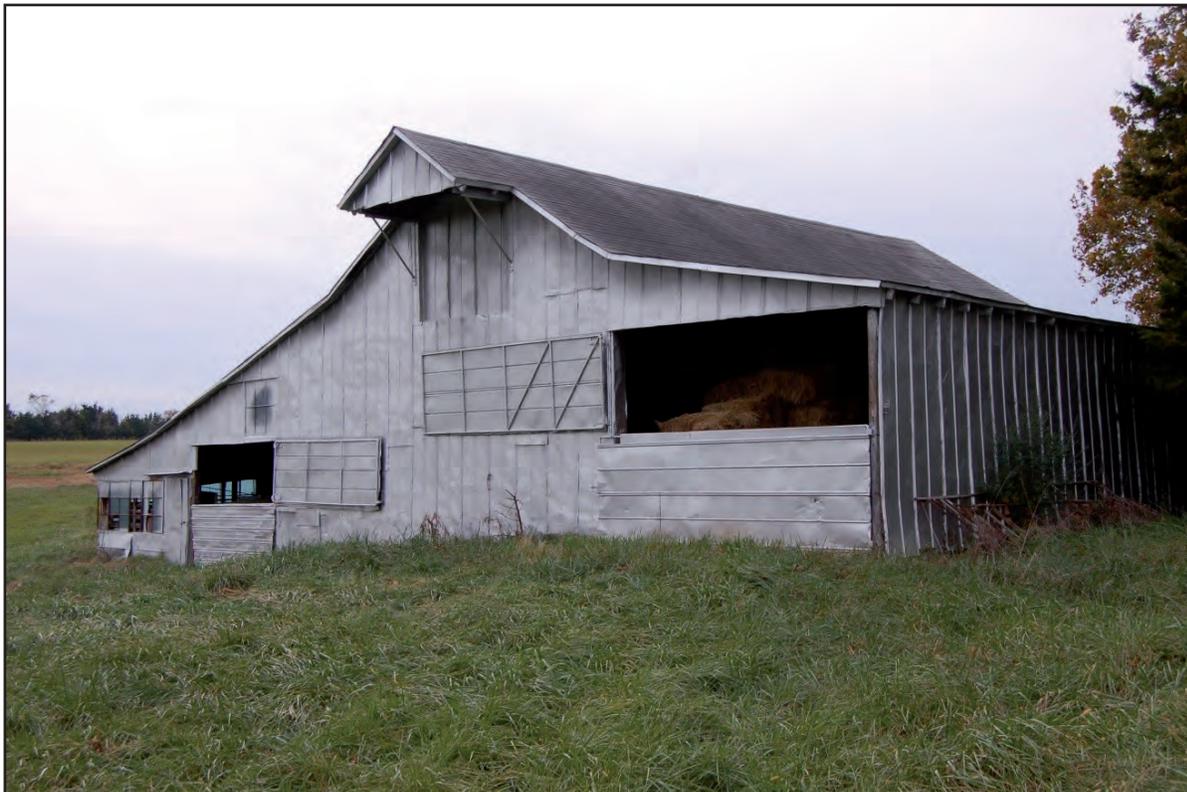
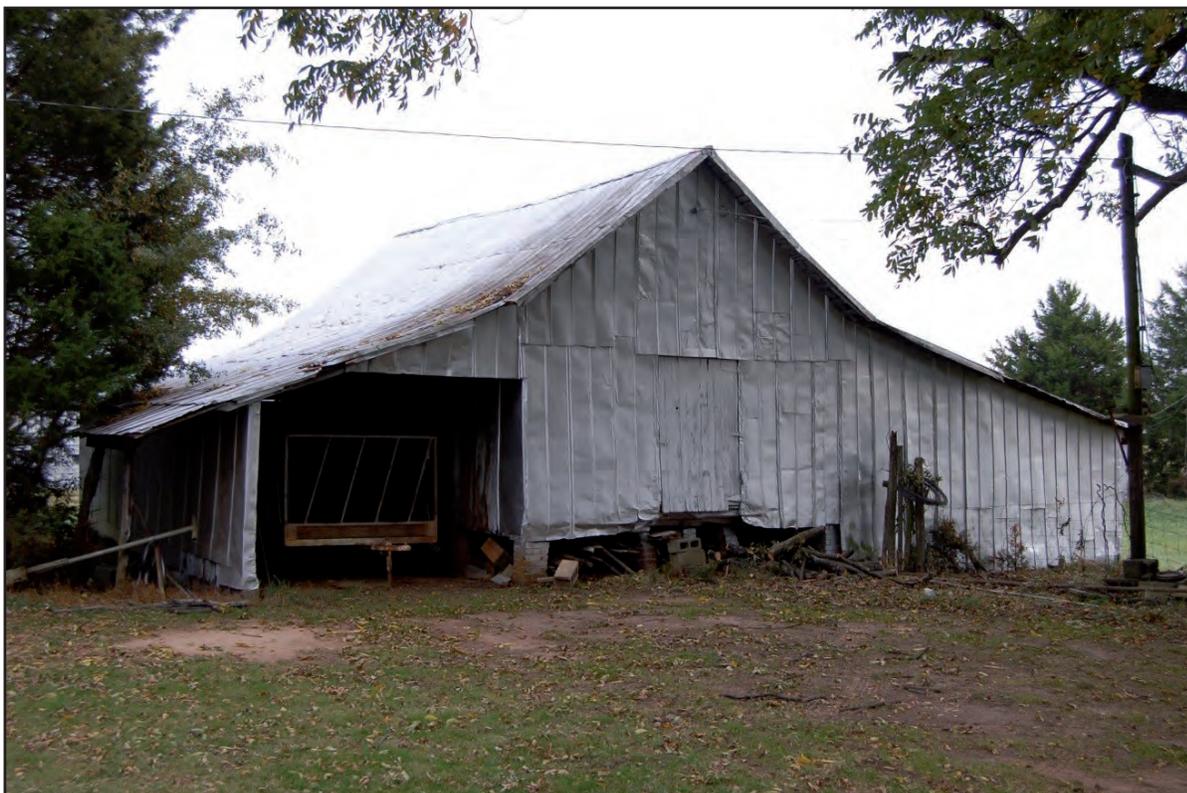
The current owner reported that the large transverse crib barn (186-0198.01) was constructed ca. 1960 and the remaining outbuildings were presumed to have been constructed at near the same time as the house. The transverse crib barn has an asphalt shingle roof and metal sheet exterior siding that has covered former openings in the structure (see Figures 5.126 and 5.127). There is a hay loft and a side-drive bay on the east side elevation.

**Figure 5.126.** Resource 186-0198.01 (1820 West Rutledge Avenue) - View of south elevation of transverse crib barn facing northwest.

**Figure 5.127.** Resource 186-0198.01 (1820 West Rutledge Avenue) - View of north elevation of transverse crib barn facing southwest.

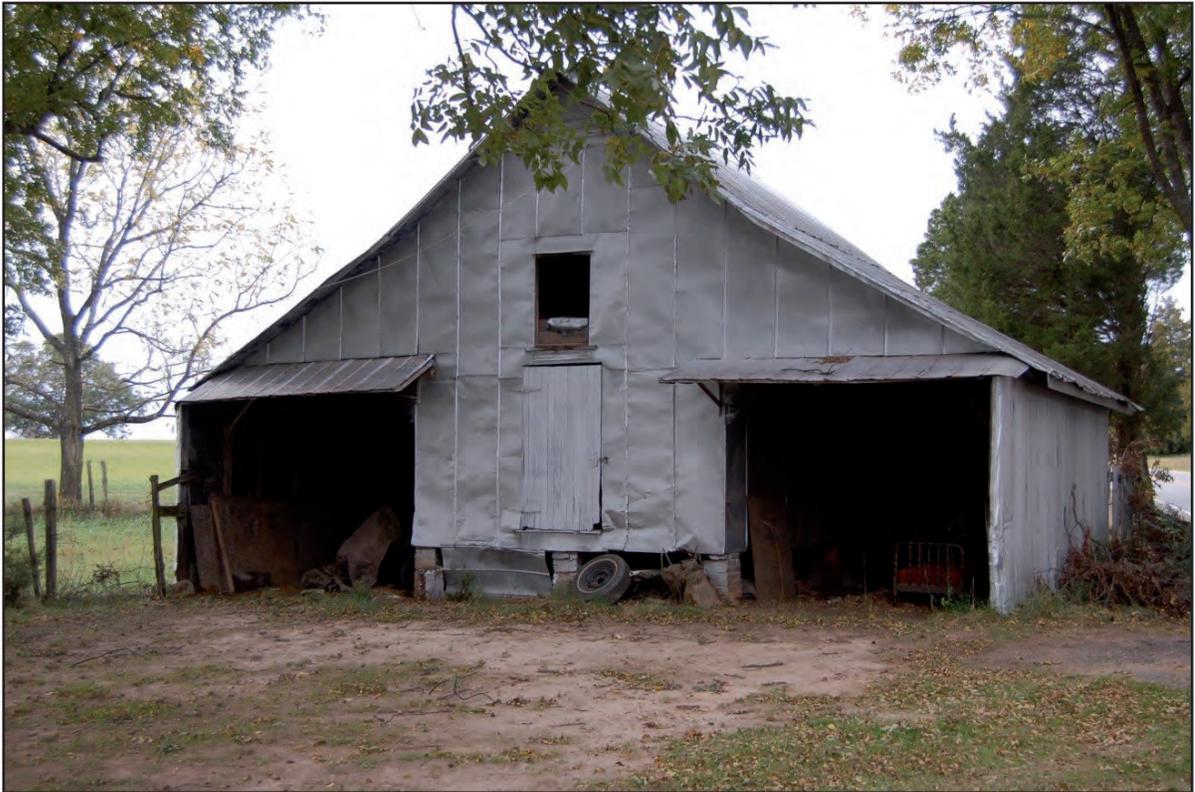
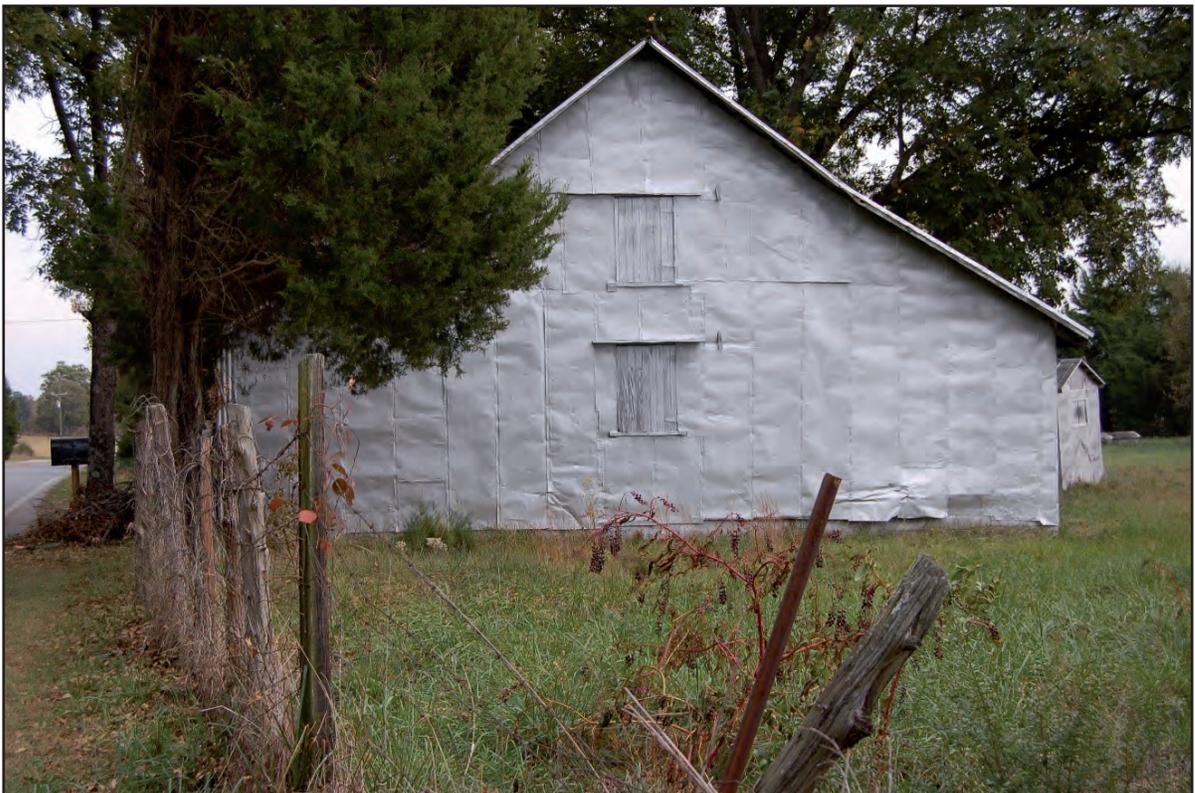
The double-crib barn (186-0198.02) has a steeply-pitched front-gabled metal roof; a hayloft; metal sheet exterior siding; and side-drive bays on the east and west side elevations (see Figures 5.128 and 5.129).

**Figure 5.128.** Resource 186-0198.02 (1820 West Rutledge Avenue) - View of south elevation of second barn facing northwest.

**Figure 5.129.** Resource 186-0198.02 (1820 West Rutledge Avenue) - View of north elevation of second barn facing southwest.

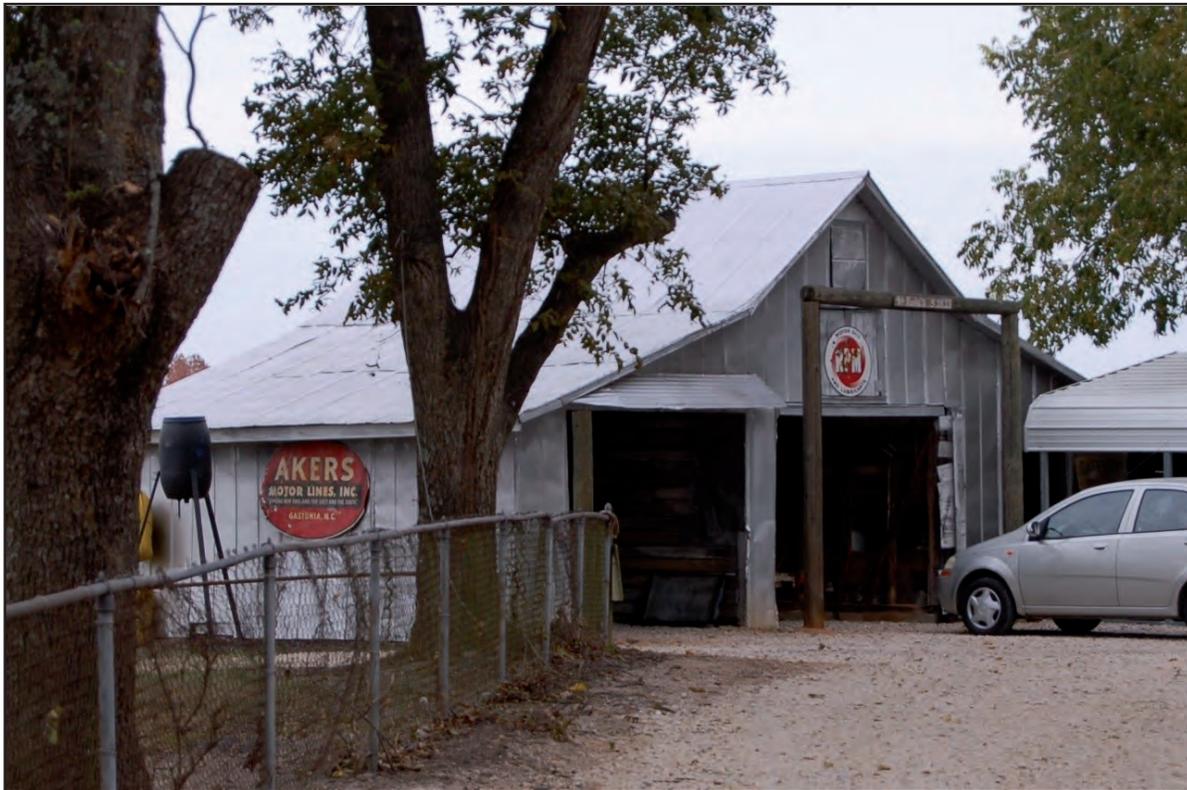
The former barn converted for use as a garage (186-0198.03) has a dual-pitched front-gabled metal roof; metal sheet exterior siding; a small addition on the south side elevation; and two bays for vehicles on the façade (see Figures 5.130 and 5.131).

**Figure 5.130.** Resource 186-0198.03 (1820 West Rutledge Avenue) - Oblique view of façade and north side elevation of third barn facing northeast.

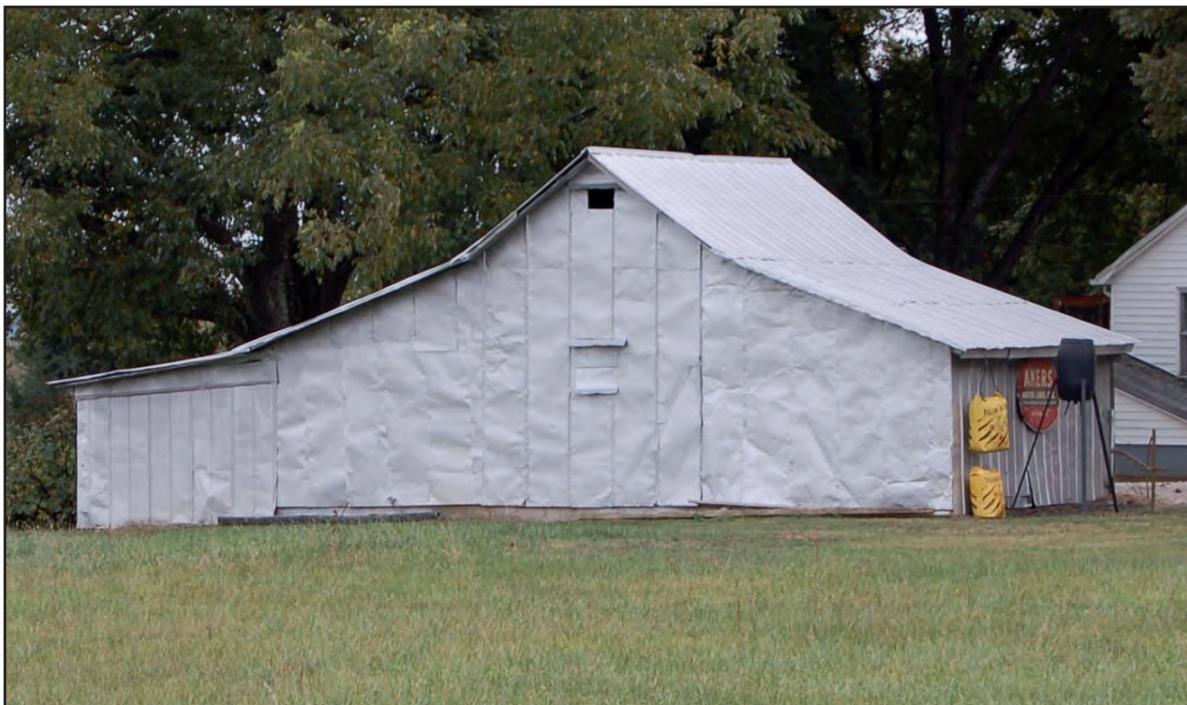
**Figure 5.131.** Resource 186-0198.03 (1820 West Rutledge Avenue) - View of rear elevation of third barn facing southwest.

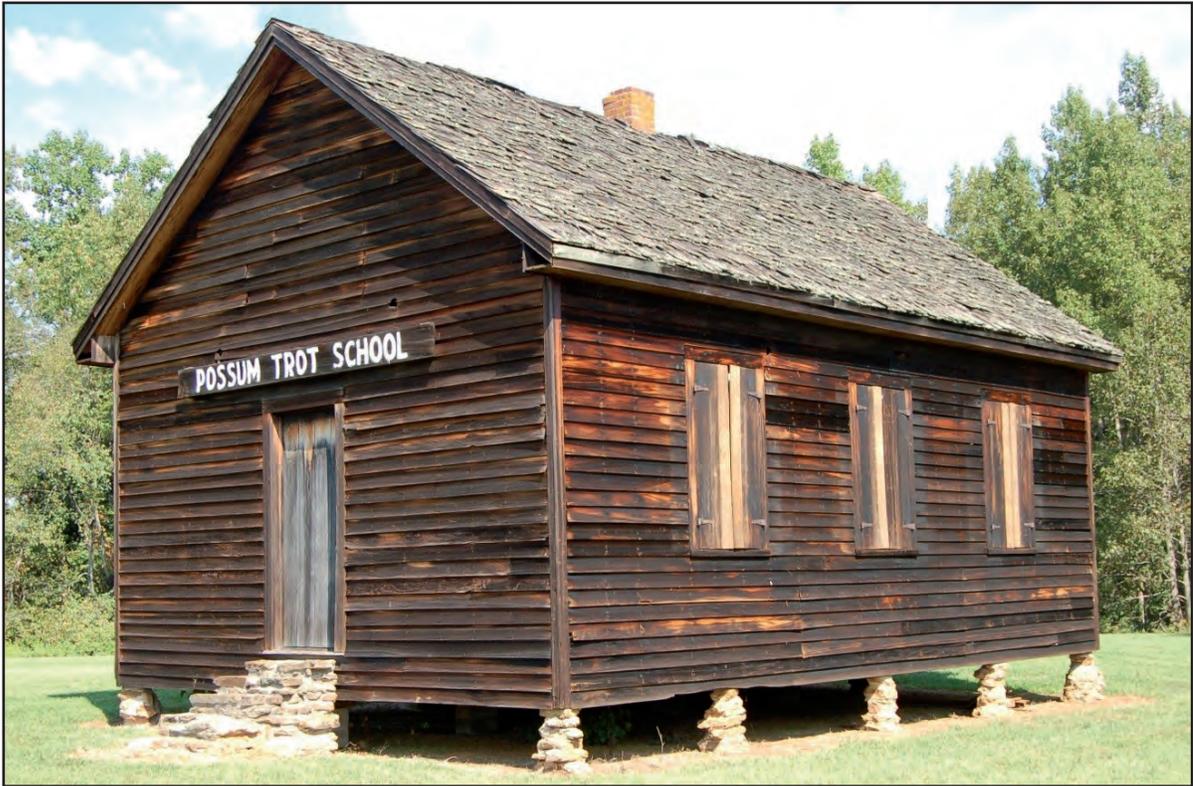
**Figure 5.133.** Resource 186-0199 (742 Peachoid Road) - Oblique view of façade and east side elevation of Possum Trot School facing north.

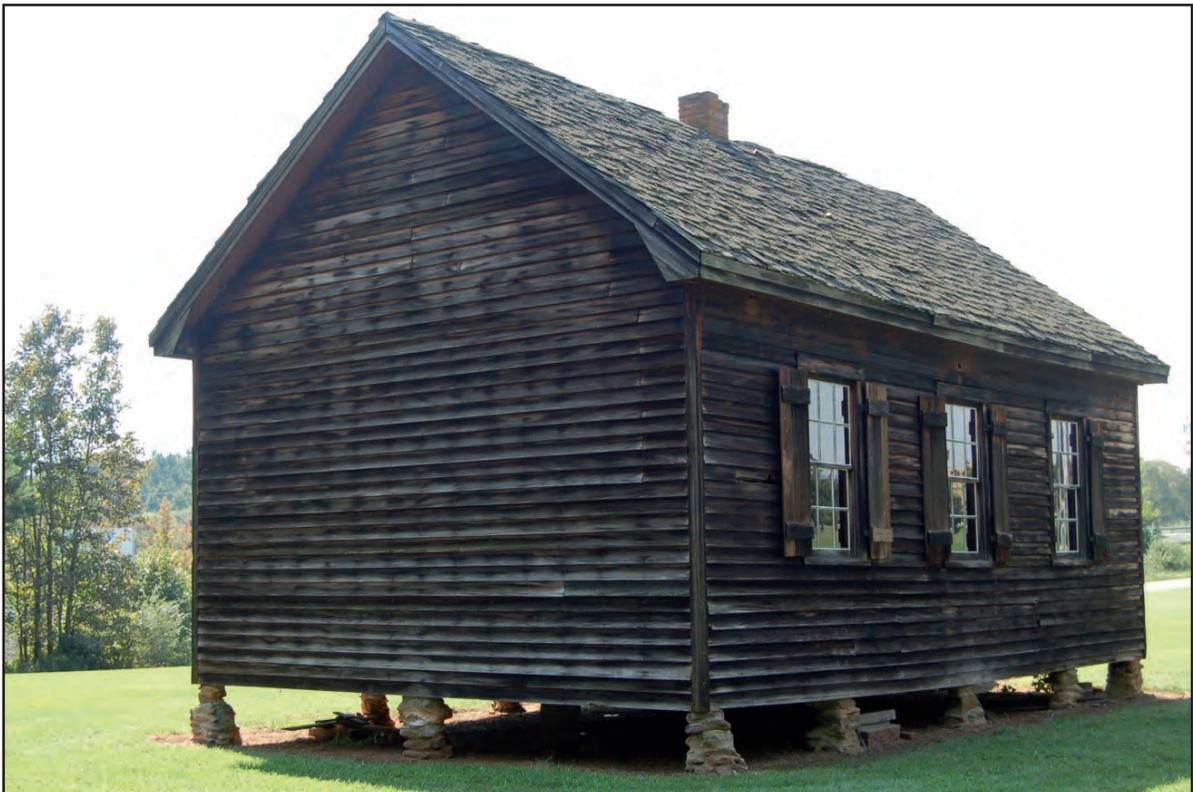
The resource is a reconstructed one-story, symmetric, one-room schoolhouse of frame construction. The building was largely reconstructed with redwood and features a front-gabled wood shingle roof; a stone pier foundation; stone steps; a small, central ridgeline brick chimney; weatherboard exterior siding; wood-framed 6/6-light double-hung sash windows; a wood plank door; and wood plank shutters (see Figures 5.133 and 5.134).

**Figure 5.134.** Resource 186-0199 (742 Peachoid Road) - Oblique view of rear and west side elevations of Possum Trot School facing south.

important research questions in history or prehistory. The resource does not appear to have the potential to be the principal source of important information. Therefore, there was no basis for evaluating the resource under Criterion D. Because the resource was moved from its original rural location and sited between a large commercial facility and interstate, it has lost integrity in the areas of location, setting, and feeling. Because the resource was reconstructed with redwood 1969-70, it has lost integrity in the areas of materials and workmanship. Due to the loss of integrity in the areas of location, setting, materials, workmanship and feeling, Resource 186-0199 cannot convey significance under Criterion A or C and is recommended **Not Eligible** for listing in the NRHP.

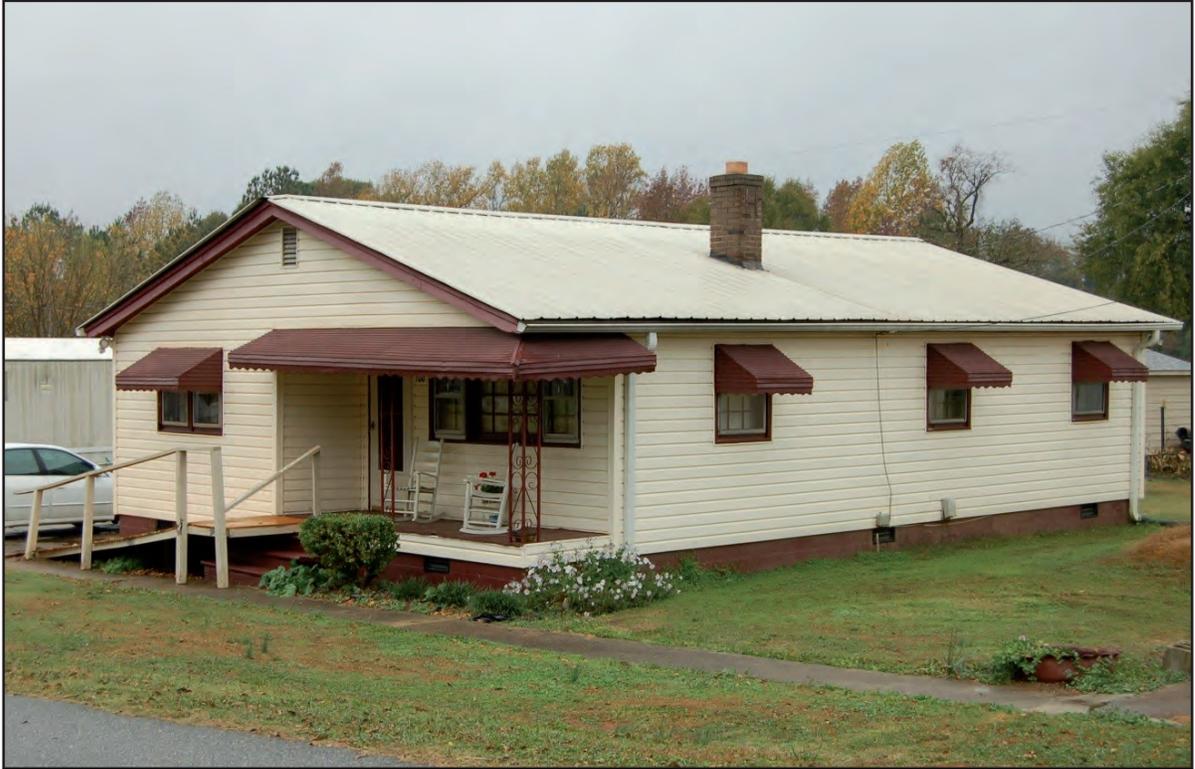
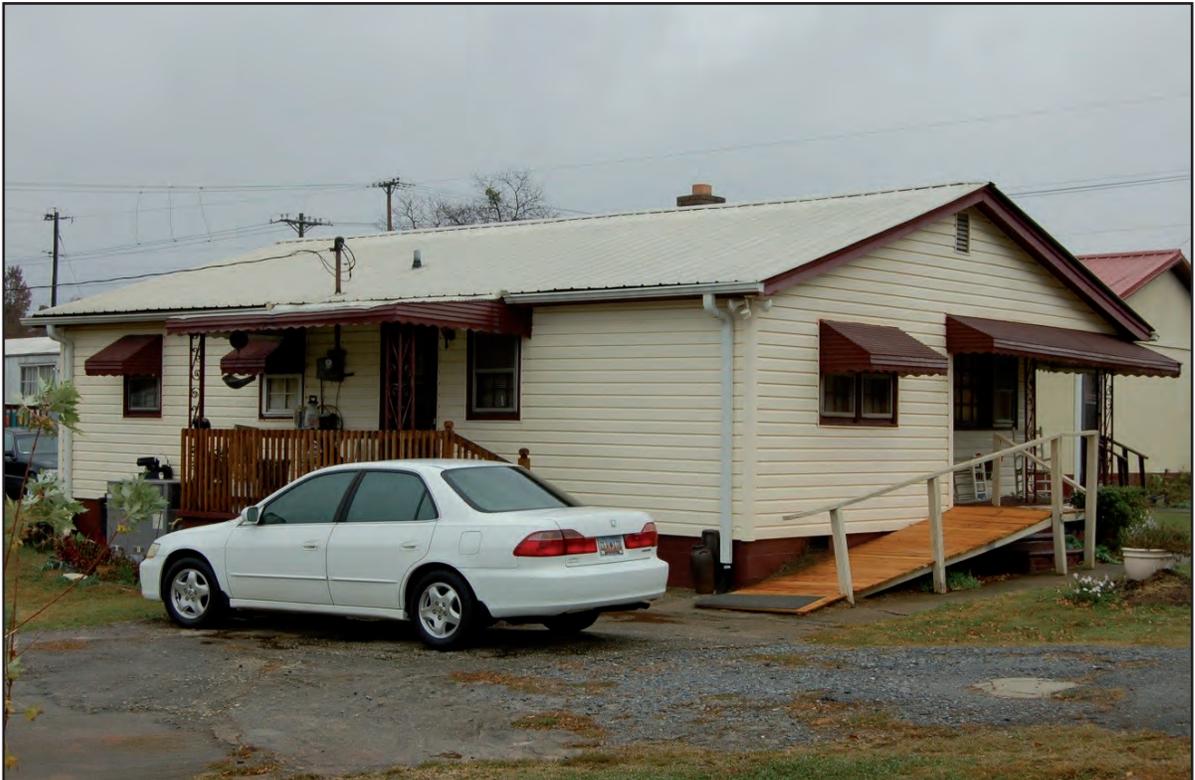
to have been to have been constructed ca. 1958. The resource is not depicted in its current location on the earliest aerial photograph available on the [www.historicaerials.com](http://www.historicaerials.com) website dated 1955. The resource is a one-story, asymmetric, front-gabled bungalow of frame construction. The house features a front-gabled metal roof; a small brick interior roof surface chimney within the roof surface on the east side of the ridgeling a partial-width, integral recessed porch on the façade; a partial-width, projecting awning-roofed porch on the west side elevation; and novelty board exterior siding (see Figures 5.135 and 5.136). The porch roofs are supported with decorative metal posts. There is a tripartite window comprised of a large square 8/8-light double-hung sash window flanked by small 4/4-light double-hung sash windows on the façade and the remaining windows are single and paired wood-framed 6/6-light double-hung sash of various sizes with metal awnings.

**Figure 5.135.** Resource 186-0200 (2401 West Buford Drive) - Oblique view of façade and east side elevation facing northwest.

**Figure 5.136.** Resource 186-0200 (2401 West Buford Drive) - Oblique view of façade and west side elevation facing northeast.

The resource is not known to be associated with a significant activity or event and there is not a known connection between the resource and any individual whose activities or achievements are historically significant. Therefore, there was no basis for evaluating the resource under Criterion A or B. Also, there is no indication that the resource is likely to yield information on important research questions in history or prehistory. The resource does not appear to have the potential to be the principal source of important information. Therefore, there was no basis for evaluating the resource under Criterion D. The resource is a late and undistinguished example of its architectural type and Resource 186-0200 is recommended **Not Eligible** for listing in the NRHP under Criterion C in the area of architecture.
