**PHASE I CULTURAL RESOURCE SURVEY FOR PROPOSED  
WIDENING OF INTERSTATE 85 FROM MILE MARKER 80 TO 96,  
CHEROKEE AND SPARTANBURG COUNTIES, SOUTH CAROLINA.**

**FINAL REPORT**

**JULY 2015**

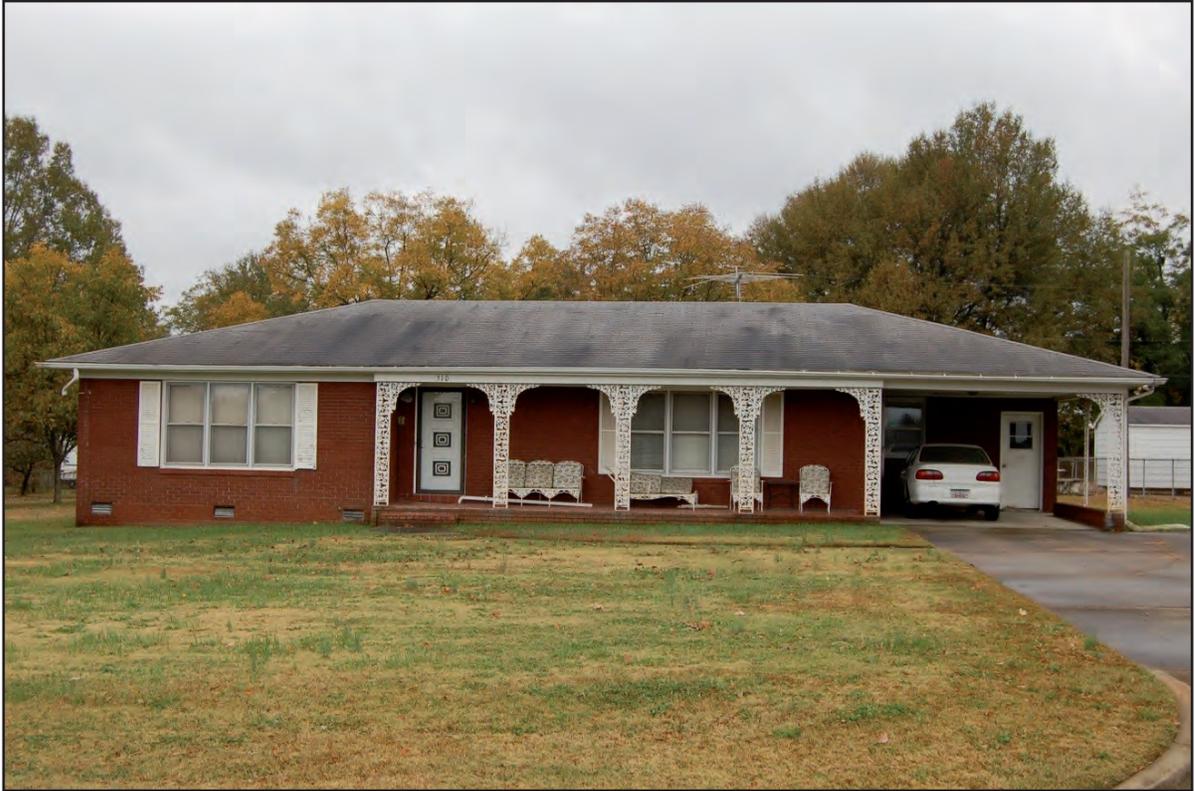
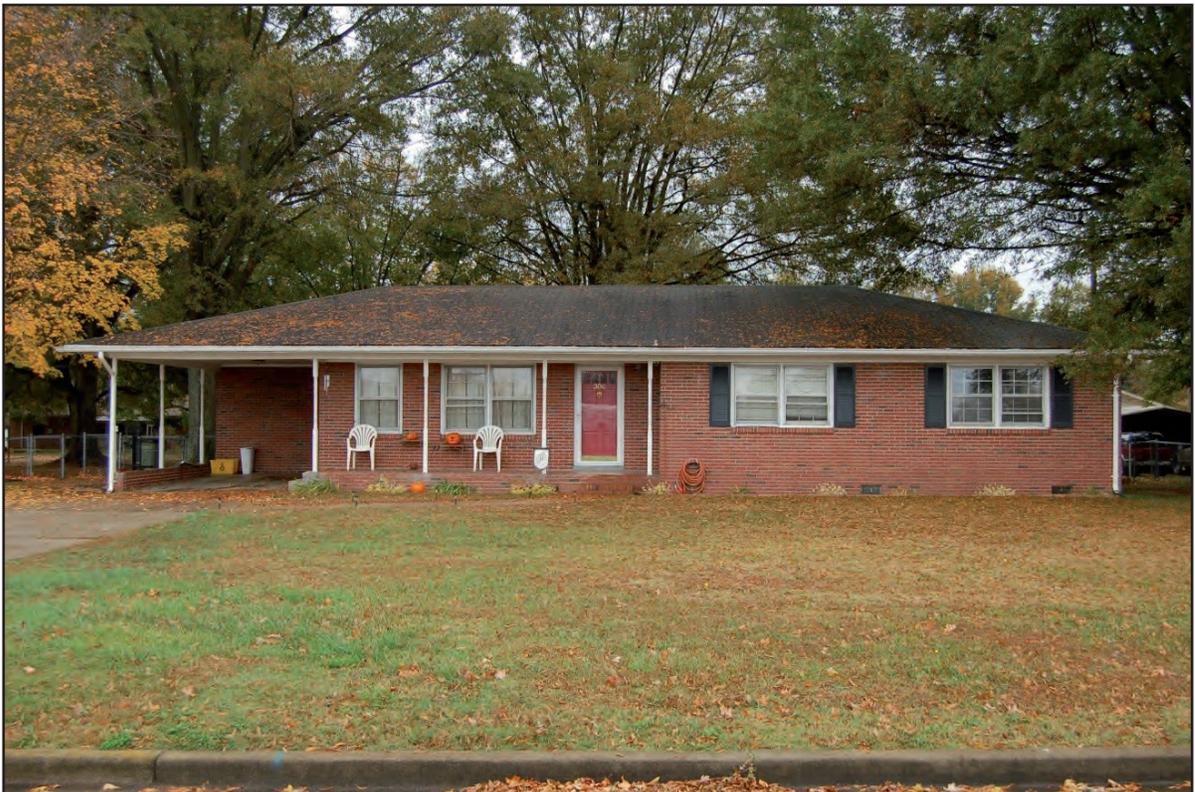
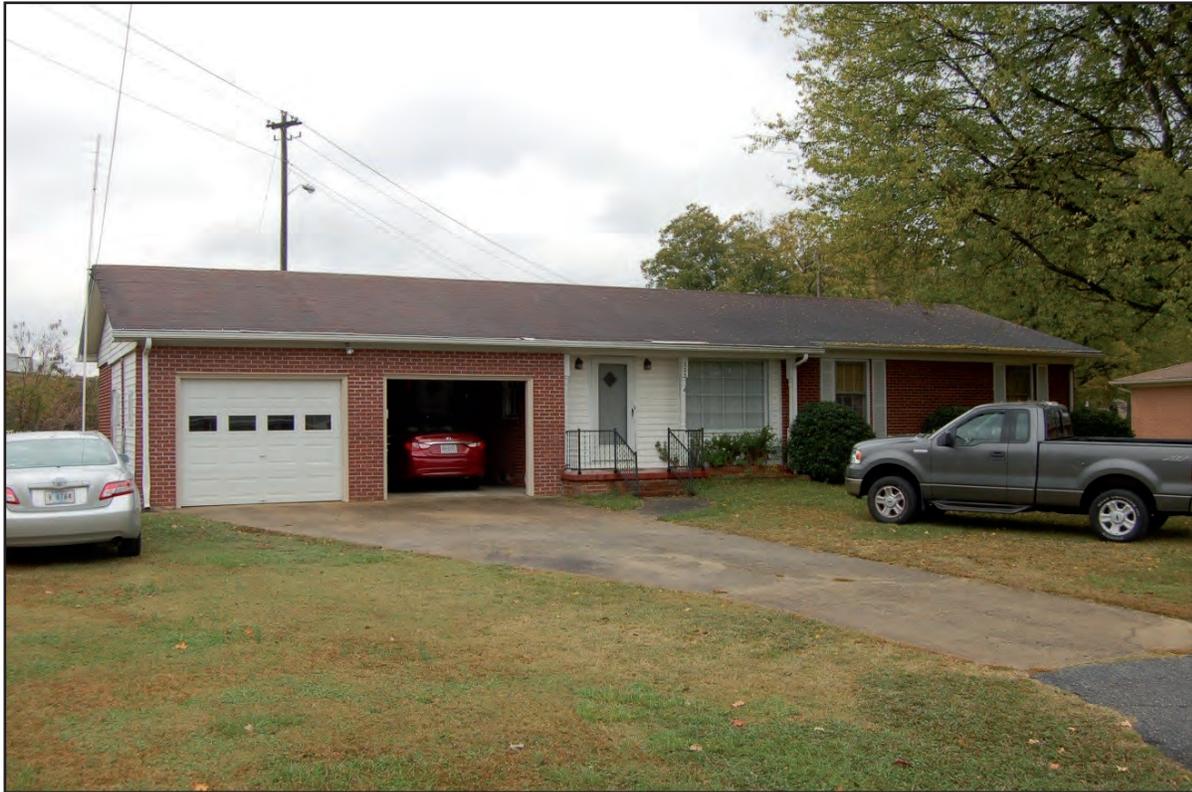
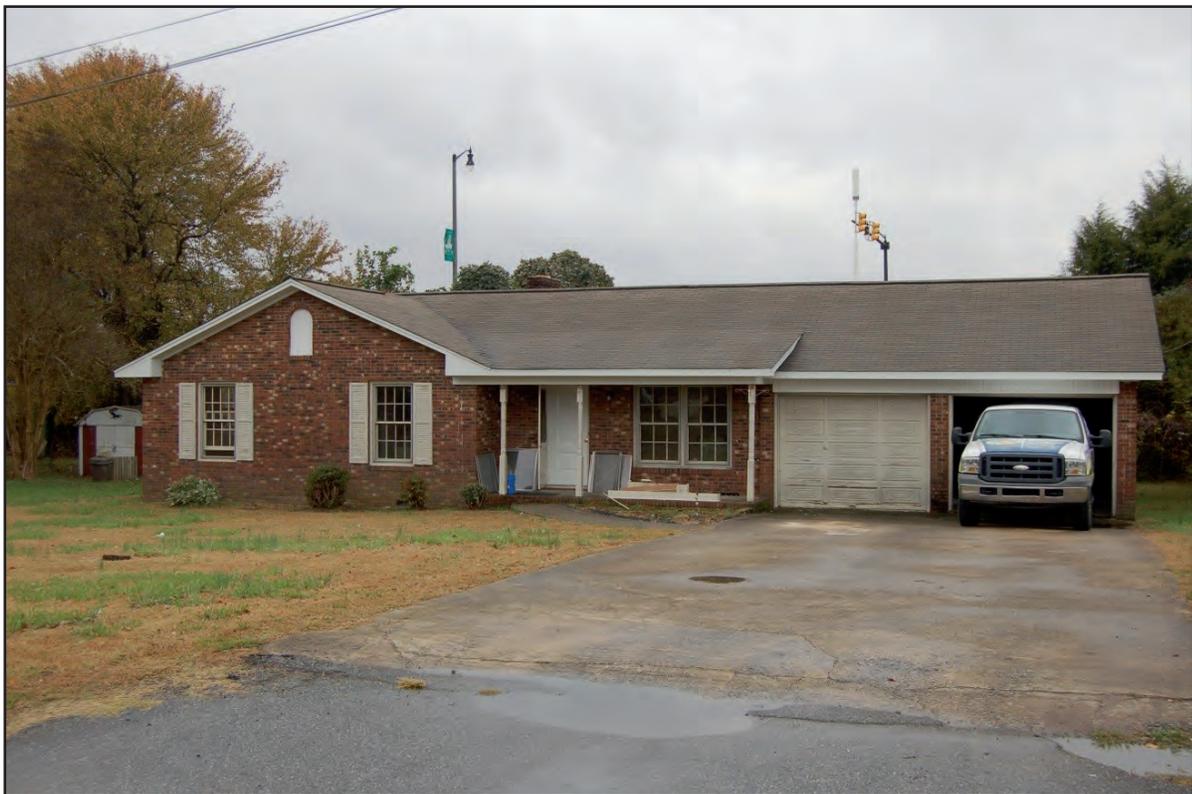
Resource 186-0201, the Cresthaven Subdivision, is located south of I-85 and Cresthaven Drive between SC 11/Floyd Baker Boulevard and SC 150/Providence Road within the city limits of Gaffney in Cherokee County (refer to Figure 5.2c). A review of Cherokee County tax assessor's records for properties within the subdivision revealed that the vast majority of the buildings were constructed from 1964 to 1972. The subdivision encompasses approximately 91 parcels and the houses within the subdivision are exclusively traditional Ranch types. Approximately 61 parcels are located west of Ellis Ferry Avenue (the major north-side roadway that divides the subdivision) and approximately 30 parcels are located east of Ellis Ferry Road. Several lots on the western edge of the subdivision between Panaview Drive and SC 3/W. Floyd Baker Boulevard north of Maple Drive and on the west side of SC 3/W. Floyd Baker Boulevard south of Maple Drive now contain commercial businesses. The alignment of Mimosa Drive in this area has been shortened and altered. The Ranch houses within the subdivision have side-gabled, cross-gabled, hipped, and cross-hipped roofs; integral open carports or garages; and brick exterior siding (see Figures 5.137 to 5.140). A majority of the buildings have either a covered stoop entry porch or a partial-width porch on the façade.

**Figure 5.137.** Resource 186-0201 (Cresthaven Subdivision) - View of façade of representative house on Cresthaven Drive facing south.

**Figure 5.138.** Resource 186-0201 (Cresthaven Subdivision) - View of representative house on Cresthaven Drive facing south.

**Figure 5.139.** Resource 186-0201 (Cresthaven Subdivision) - View of representative house on Panaview Drive facing southeast.

**Figure 5.140.** Resource 186-0201 (Cresthaven Subdivision) - View of representative house on Panaview Drive facing west.

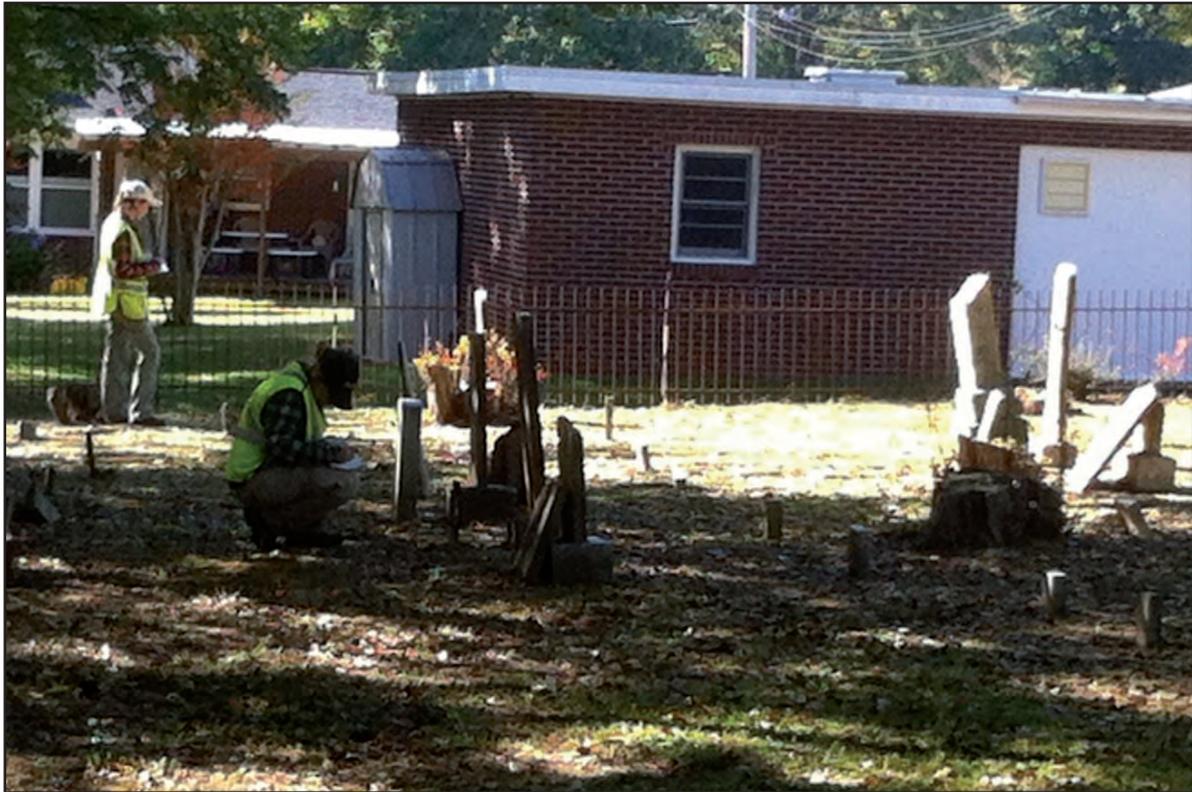
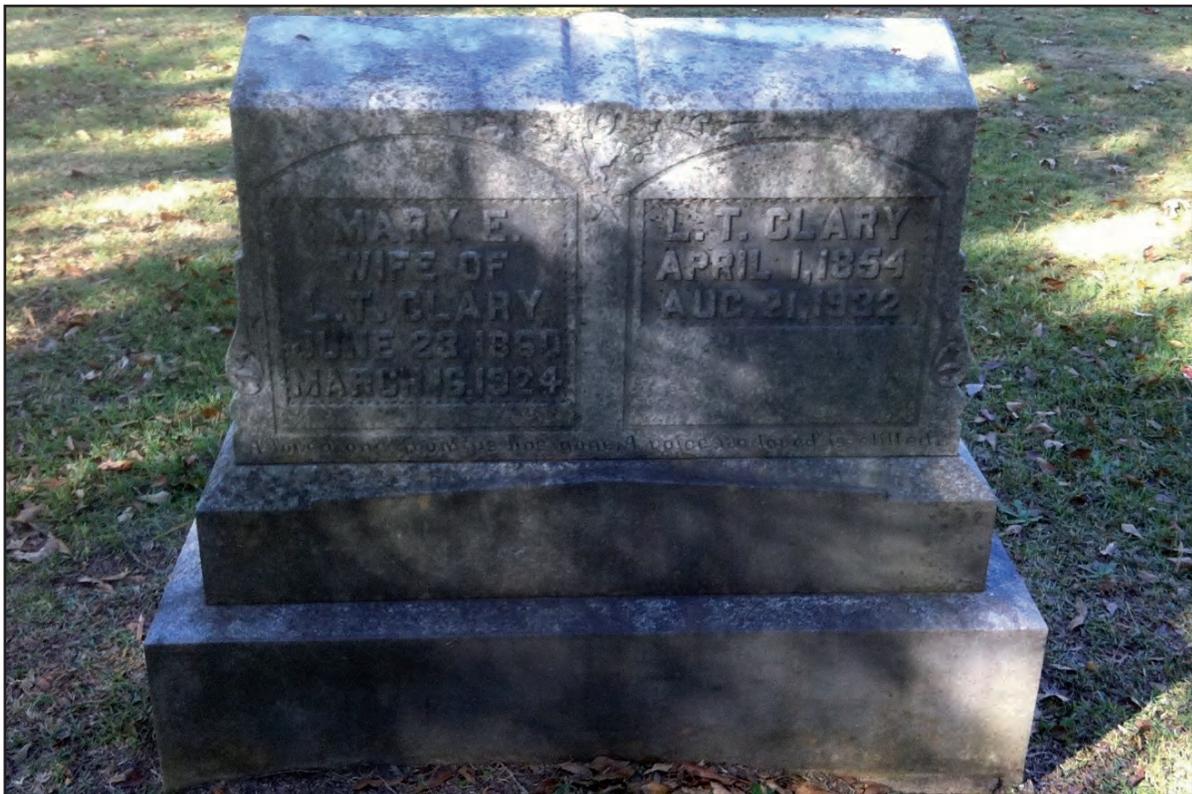
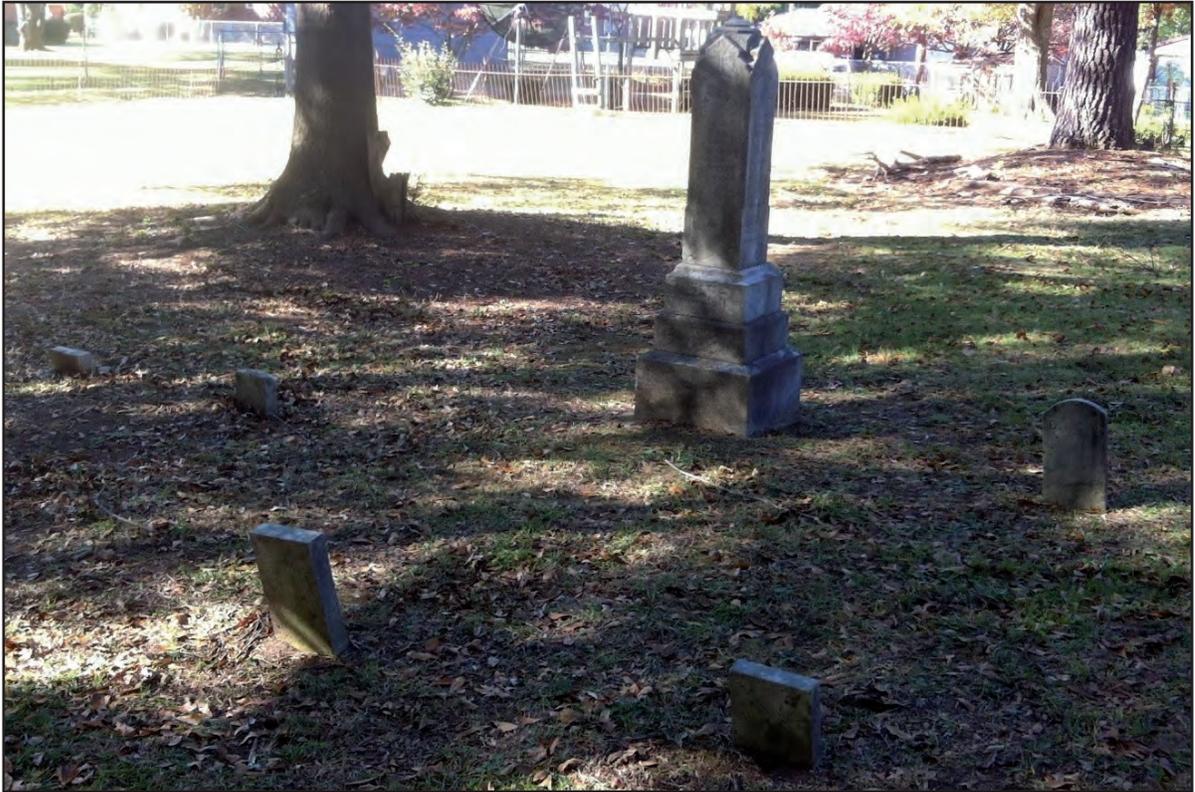
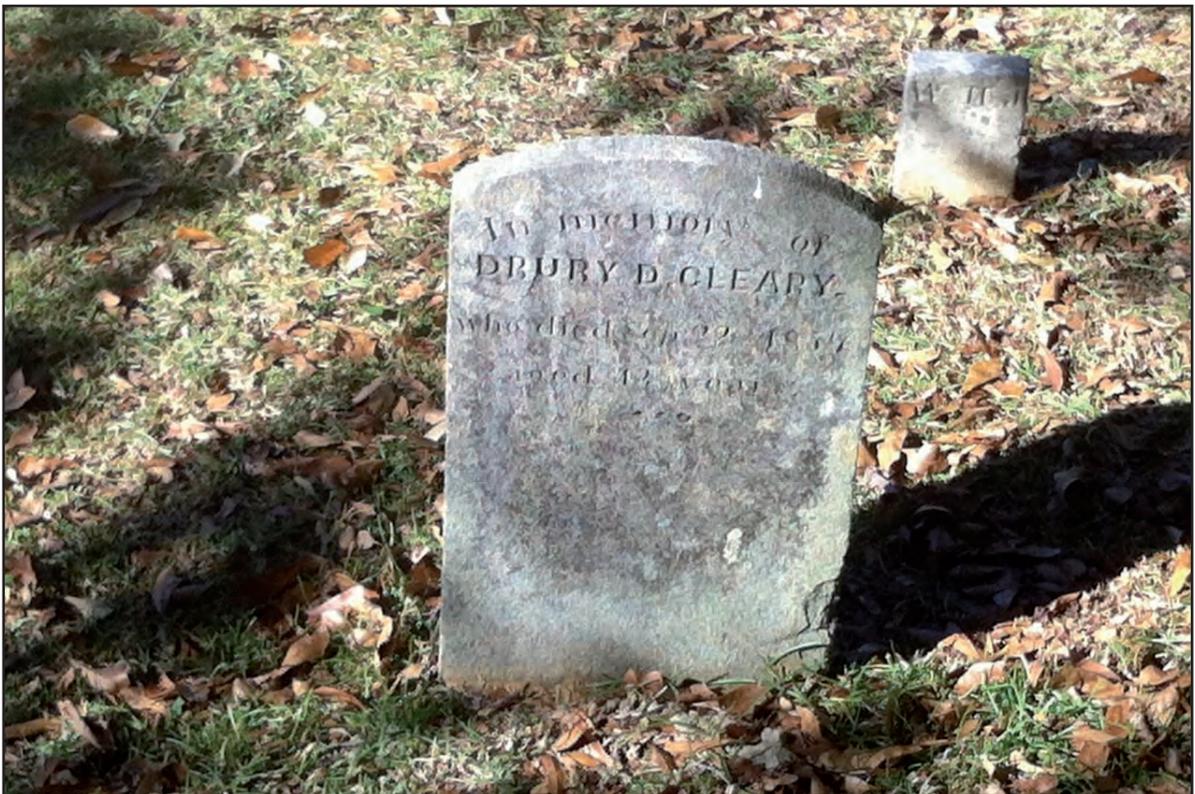
The cemetery is located on a lot within the Cresthaven Subdivision (Resource 186-0201). The parcel has pine and hardwood trees and areas of grass and exposed soil. The monuments face to the east and are generally aligned in rows that extend from north to south. Monuments within the cemetery are primarily headstones, but there is a large pulpit-like die on base, a pedestal, and a few die in socket or die on base types (see Figures 5.141 – 5.144).

**Figure 5.141.** Resource 186-0202 (332 Cresthaven Drive) – Representative view of Clary Cemetery facing south.

**Figure 5.142.** Resource 186-0202 (332 Cresthaven Drive) – Representative view of Clary Cemetery facing west.

**Figure 5.143.** Resource 186-0202 (332 Cresthaven Drive) – Representative view of Clary Cemetery facing southwest.

**Figure 5.144.** Resource 186-0202 (332 Cresthaven Drive) – Representative view of Clary Cemetery facing west.

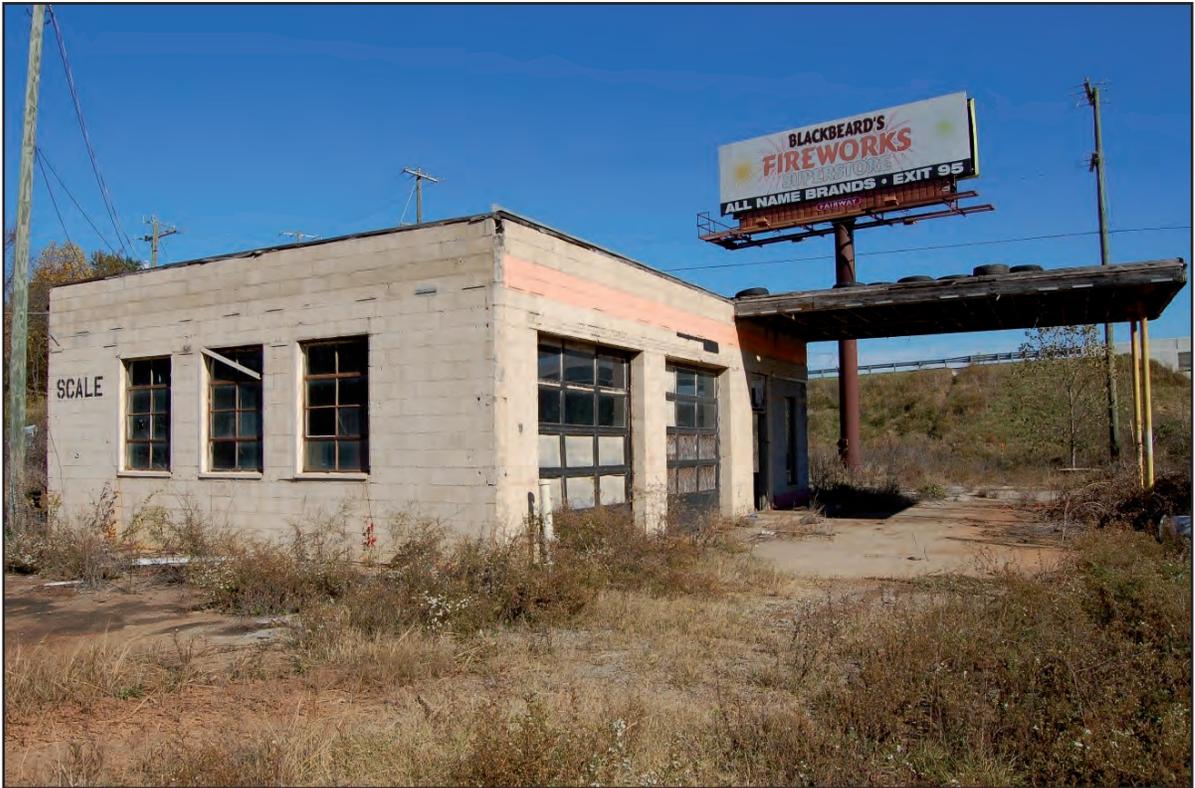
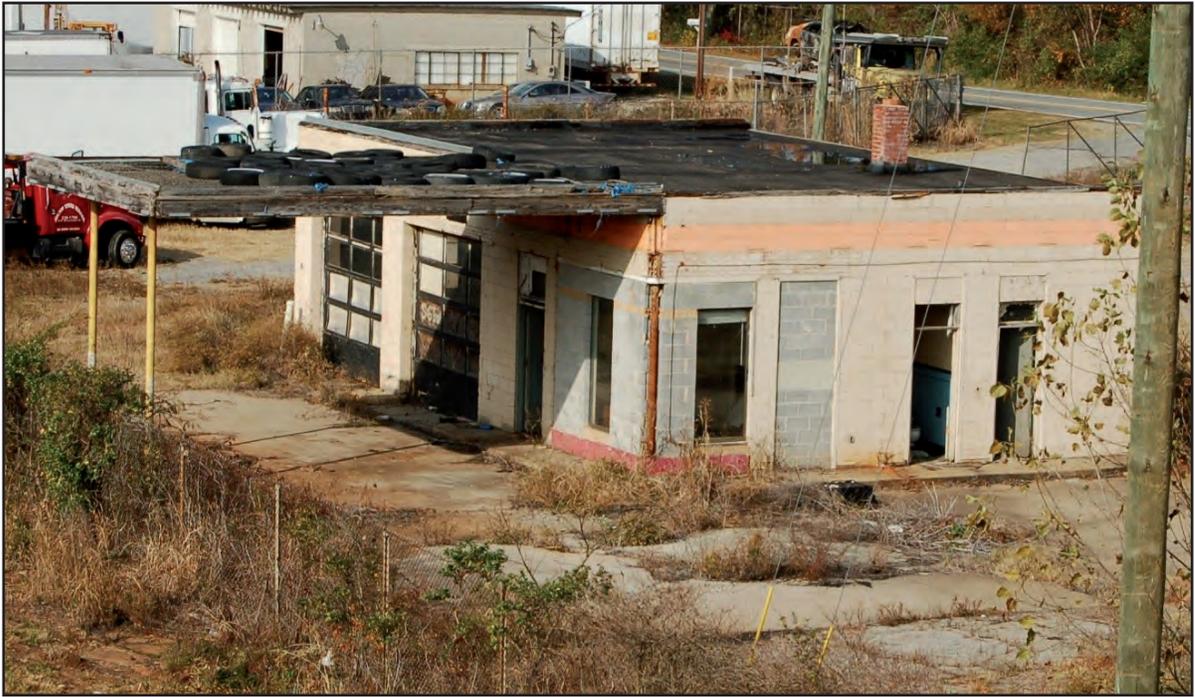
Resource 186-0203 is located at 422 Wilcox Avenue on the south side of the roadway in the southwest quadrant of the intersection of Wilcox Avenue and Providence Road just outside the northern city limits of Gaffney in Cherokee County (refer to Figure 5.2c). The Cherokee County tax assessor's record does not have an estimated date of construction for the resource. Based on a review of historic aerial photography and topographic maps, and an evaluation of the resource's form and construction materials, Resource 186-0203 appears to have been constructed ca. 1958. The resource is not depicted in its current location on the earliest aerial photograph available on the [www.historicaerials.com](http://www.historicaerials.com) website dated 1955. The resource is a one-story, asymmetric, oblong box type service station. The building features concrete block bearing wall construction; a flat roof; a small brick interior roof surface chimney; two service bays with roll-up doors on the west side of the façade; an office with glass door and transom light, on the façade and picture windows on the façade and east side elevation; and two rest rooms on the east side elevation (see Figures

5.145 and 5.146). The former large picture windows are largely enclosed with concrete block as is an apparent former doorway on the east side elevation. The windows on the west side and rear elevations are metal casements and metal-framed sliding glass windows of various sizes. A large flat-roofed canopy that extends from the east end of the façade is supported by two metal poles.

**Figure 5.145.** Resource 186-0203 (422 Wilcox Avenue) – Oblique view of façade and west side elevation facing northeast.

**Figure 5.146.** Resource 186-0203 (422 Wilcox Avenue) - Oblique view of façade and east side elevation facing northwest.

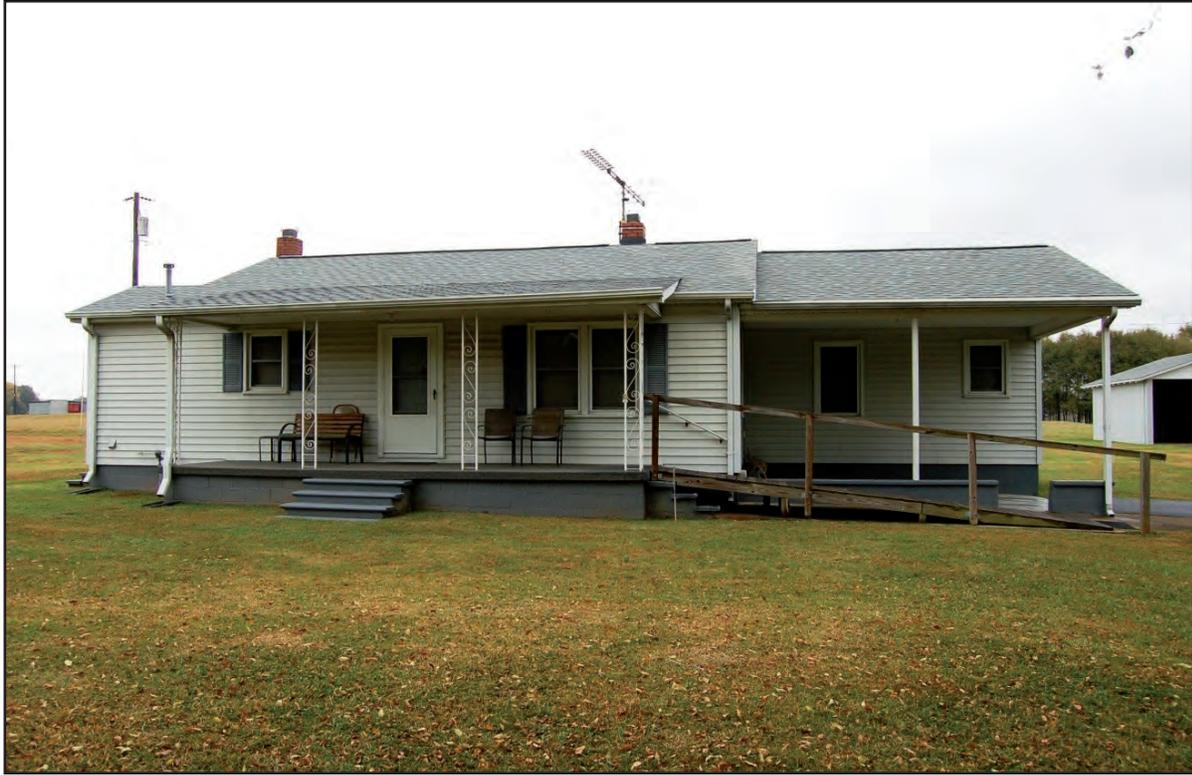
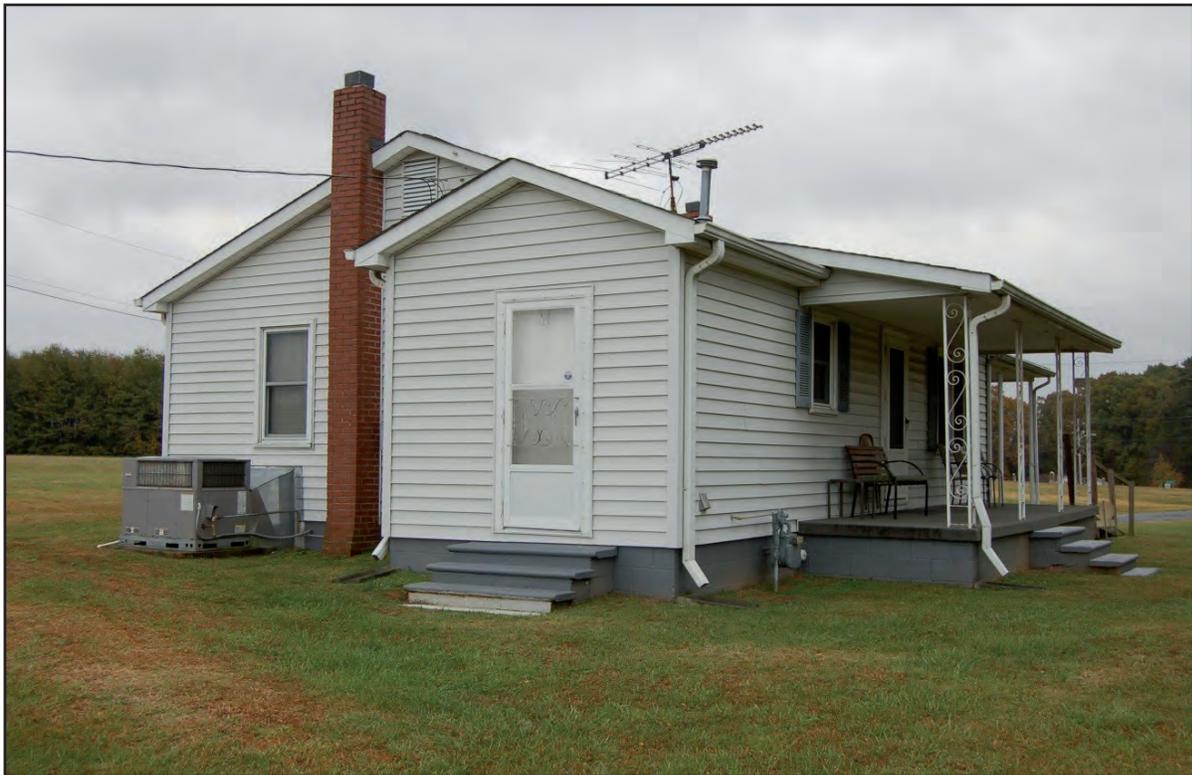
Resource 186-0204 is located at 916 Providence Road on the east side of the roadway approximately 475 feet south of the Providence Road overpass over I-85 within the city limits of Gaffney in Cherokee County (refer to Figures 5.2C and 5.2D). The Cherokee County tax assessor's record does not have an estimated date of construction for the resource. Based on a review of historic aerial photography and topographic maps, and an evaluation of the resource's form and construction materials, Resource 186-0204 appears to have been constructed ca. 1958. The resource is not depicted in its current location on the earliest aerial photograph available on the [www.historicaerials.com](http://www.historicaerials.com) website dated 1955. According to the owner and occupant of an adjacent property (Resource 186-0206) who was interviewed at the time of the historic resources field survey, Resource 186-0204 originally faced north and was moved and reoriented to face due west at the time of the construction of I-85 and the Providence Road overpass. The resource is a one-story, asymmetric, side-gabled residence of frame construction. The house features a side-gabled asphalt shingle roof; a continuous concrete block foundation; a small brick interior roof surface chimney with the rear roof surface; a small exterior end wall chimney on the north side elevation a partial-width, projecting shed-roofed porch on the façade; a partial-width integral carport on the south side elevation; and vinyl exterior siding (see Figures 5.147 and 5.148). The roof of the porch on the façade is supported by four decorative metal post and the roof of the carport is supported by two metal poles. The windows on the building are single and paired 1/1-light double-hung sash.

**Figure 5.147.** Resource 186-0204 (916 Providence Road) - View of façade facing east.

**Figure 5.148.** Resource 186-0204 (916 Providence Road) - Oblique view of façade and north side elevation facing southeast.

The resource is not known to be associated with a significant activity or event and there is not a known connection between the resource and any individual whose activities or achievements are historically significant. Therefore, there was no basis for evaluating the resource under Criterion A or B. Also, there is no indication that the resource is likely to yield information on important research questions in history or prehistory. The resource does not appear to have the potential to be the principal source of important information. Therefore, there was no basis for evaluating the resource under Criterion D. The resource does not represent a recognized architectural type or style and does not otherwise appear to represent a significant trend in South Carolina's architectural history. Additionally, due to the relocation of the resource, the construction I-85 and the Providence Road in the immediate vicinity of the resource, and the reapplication of vinyl exterior siding, the resource has lost integrity in the areas of location, setting, materials, workmanship, and feeling and cannot convey significance in the area of architecture. Therefore, Resource 186-0204 is recommended **Not Eligible** for listing in the NRHP under Criterion C in the area of architecture.

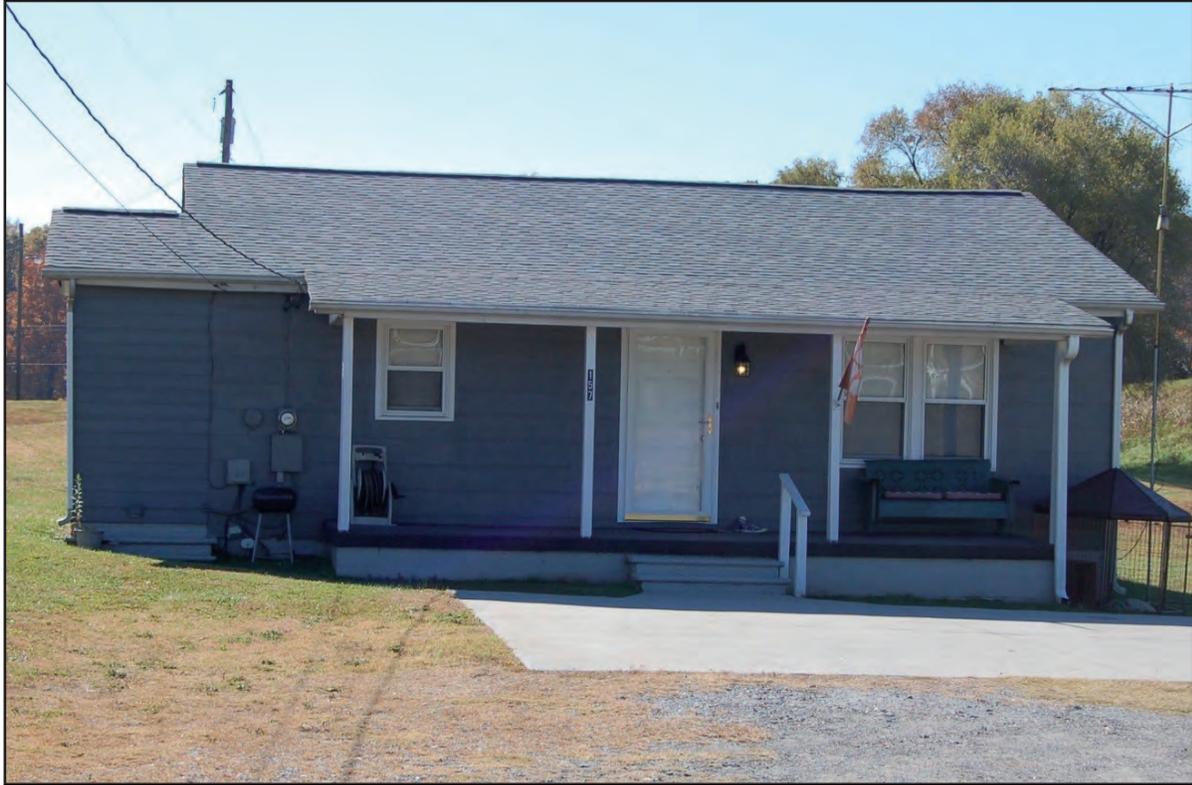
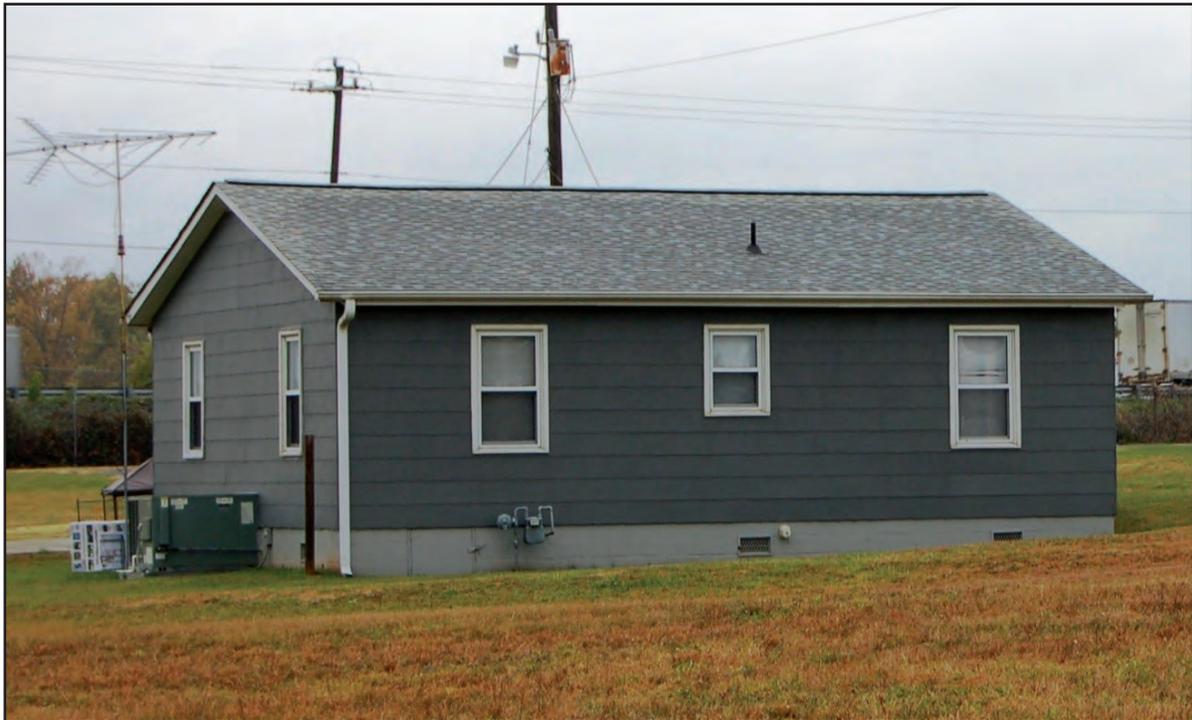
Resource 186-0205 is located at 157 Canty Way on the south side of the roadway approximately 0.21 mile west of the intersection of Canty Way and Hampshire Drive within the city limits of Gaffney in Cherokee County (refer to Figures 5.2C and 5.2D). The Cherokee County tax assessor's record does not have an estimated date of construction for the resource. Based on a review of historic aerial photography and topographic maps, an evaluation of the resource's form and construction materials, and an interview with an adjacent property owner, Resource 186-0205 appears to have been constructed ca. 1958. The resource is not depicted in its current location on the earliest aerial photograph available on the [www.historicaerials.com](http://www.historicaerials.com) website dated 1955 and according to the owner and occupant of an adjacent property (Resource 186-0206) who was interviewed at the time of the historic resources field survey, Resource 186-0205 was constructed to replace a house that was destroyed during the construction of I-85 and the Providence Road overpass. The resource is a one-story, asymmetric, side-gabled residence of frame construction. The house features a side-gabled asphalt shingle roof; a continuous concrete block foundation; a partial-width, extended, gable-roofed porch on the façade; and concrete asbestos tile and weatherboard exterior siding (see Figures 5.149 and 5.150). The porch roof is supported by four small posts. Windows are single and paired non-historic, metal-framed vinyl 1/1-light double-hung sash of various sizes. A small gable-roofed addition appears to have been constructed on the east side elevation based on the change in exterior siding material.

**Figure 5.149.** Resource 186-0205 (157 Canty Way) - View of façade facing north.

**Figure 5.150.** Resource 186-0205 (157 Canty Way) - Oblique view of rear and west side elevations facing northeast.

research questions in history or prehistory. The resource does not appear to have the potential to be the principal source of important information. Therefore, there was no basis for evaluating the resource under Criterion D. The resource does not represent a recognized architectural type or style and does not otherwise appear to represent a significant trend in South Carolina's architectural history. Additionally, due to the replacement of all original windows and doors, the resource has lost integrity in the area of materials and cannot convey significance in the area of architecture. Therefore, Resource 186-0205 is recommended **Not Eligible** for listing in the NRHP under Criterion C in the area of architecture.

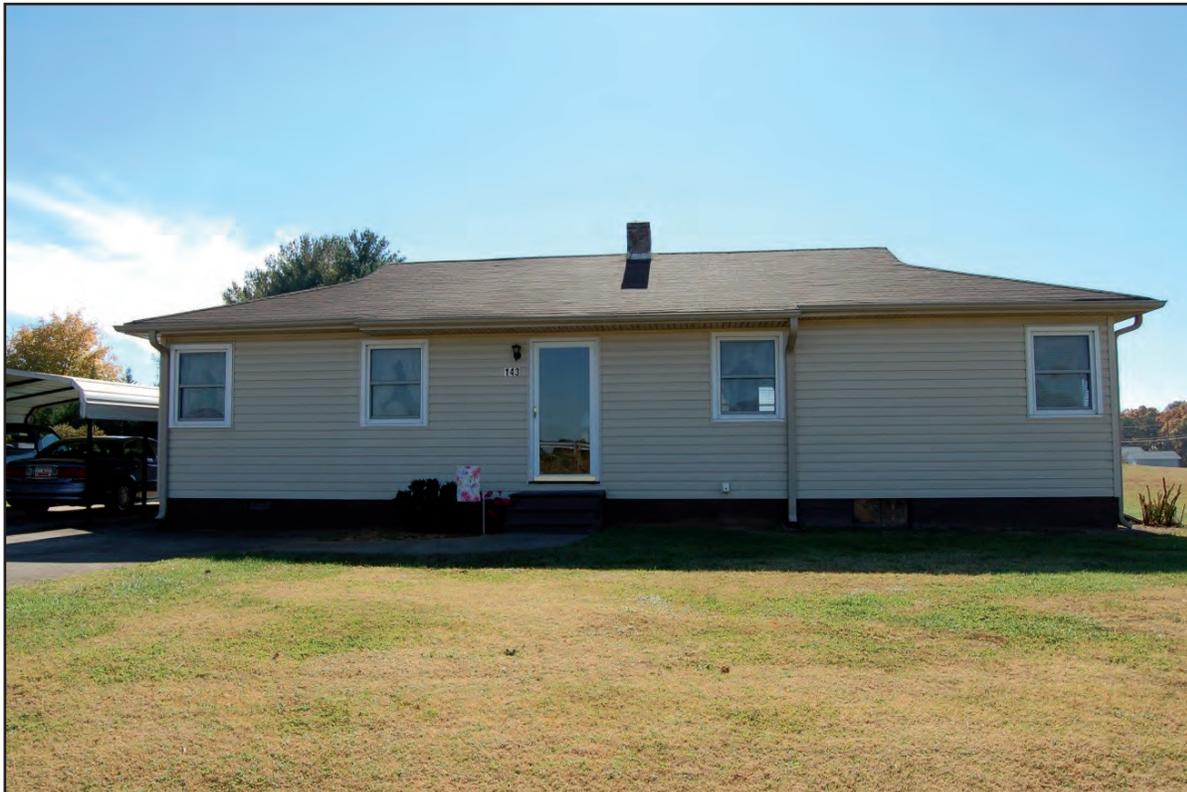
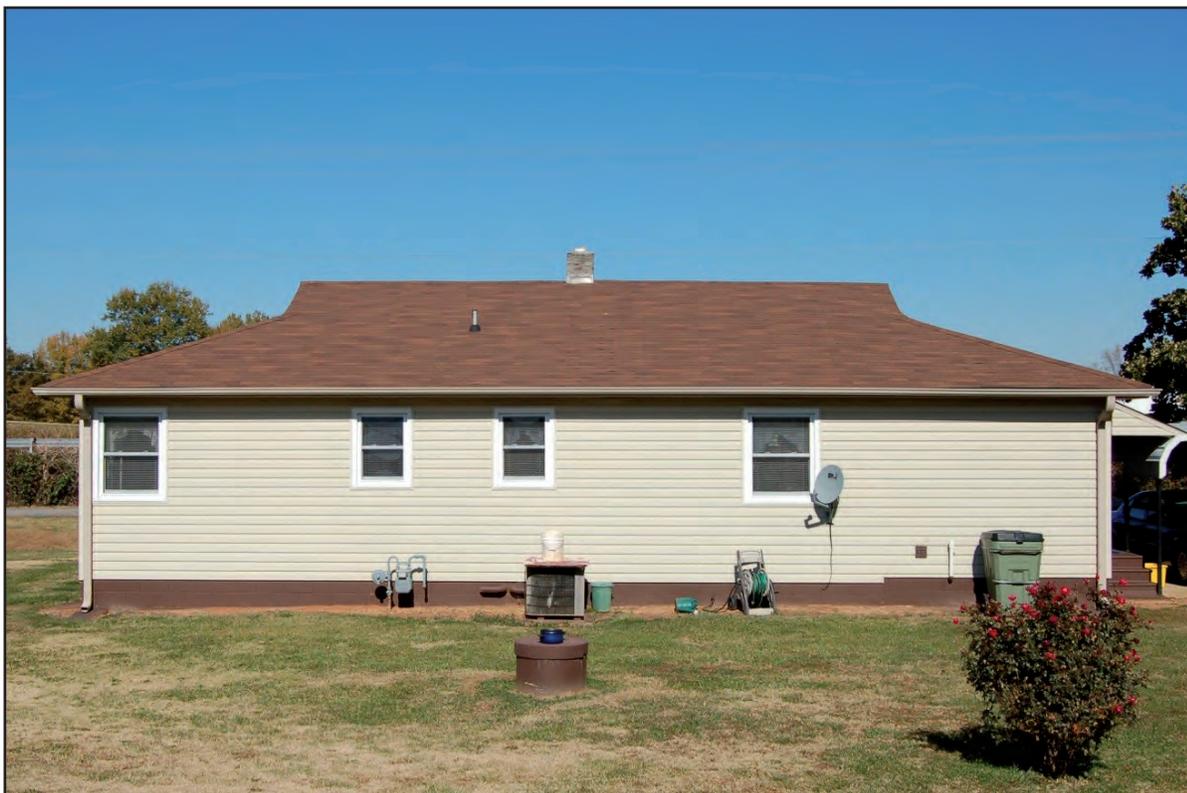
Resource 186-0206 is located at 143 Canty Way on the south side of the roadway approximately 0.17 mile west of the intersection of Canty Way and Hampshire Drive within the city limits of Gaffney in Cherokee County (refer to Figures 5.2C and 5.2D). The Cherokee County tax assessor's record does not have an estimated date of construction for the resource. Based on a review of historic topographic maps and an evaluation of the resource's form and construction materials, Resource 186-0206 appears to have been constructed ca. 1950. This estimated date of construction is supported by the depiction of the resource in its current location on the earliest aerial photograph available on the [www.historicaerials.com](http://www.historicaerials.com) website dated 1955. The resource is a one-story, asymmetric, gable-over-hipped-roofed residence of frame construction. The house features a gable-over-hipped asphalt shingle roof; a continuous concrete block foundation; a small brick interior ridgeline chimney; and vinyl exterior siding. All of the doors and windows are non-historic replacements (see Figures 5.151 and 5.152). The windows are metal-framed vinyl 1/1-light double-hung sash of various sizes.

**Figure 5.151.** Resource 186-0206 (143 Canty Way) - View of façade facing south.

**Figure 5.152.** Resource 186-0206 (143 Canty Way) - View of rear elevation facing north.

The resource is not known to be associated with a significant activity or event and there is not a known connection between the resource and any individual whose activities or achievements are historically significant. Therefore, there was no basis for evaluating the resource under Criterion A or B. Also, there is no indication that the resource is likely to yield information on important research questions in history or prehistory. The resource does not appear to have the potential to be the principal source of important information. Therefore, there was no basis for evaluating the resource under Criterion D. The resource does not represent a recognized architectural type or style and does not otherwise appear to represent a significant trend in South Carolina's architectural history. Additionally, due to the application of vinyl exterior siding and the replacement of all original doors and windows, the resource has lost integrity in the areas of materials, workmanship, and feeling and cannot convey significance in the area of architecture. Therefore, Resource 186-0206 is recommended **Not Eligible** for listing in the NRHP under Criterion C in the area of architecture.
