**PHASE I CULTURAL RESOURCE SURVEY FOR PROPOSED  
WIDENING OF INTERSTATE 85 FROM MILE MARKER 80 TO 96,  
CHEROKEE AND SPARTANBURG COUNTIES, SOUTH CAROLINA.**

**FINAL REPORT**

**JULY 2015**

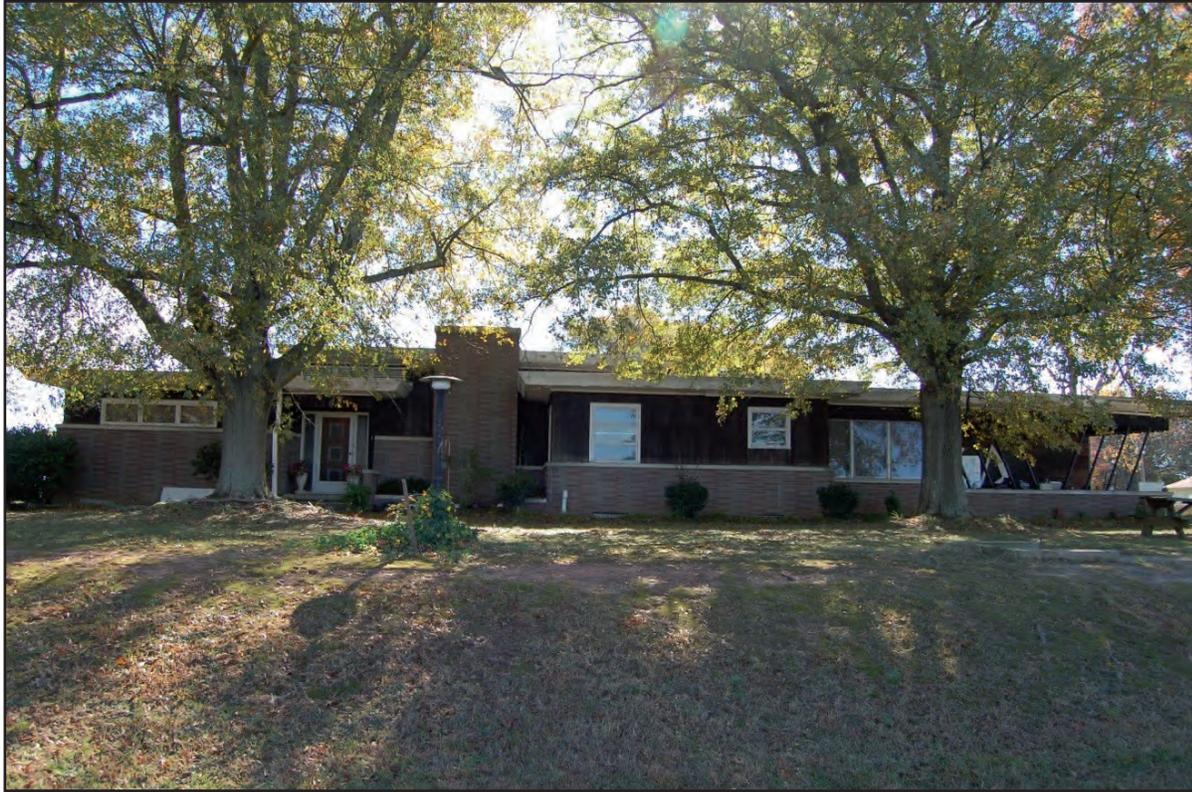
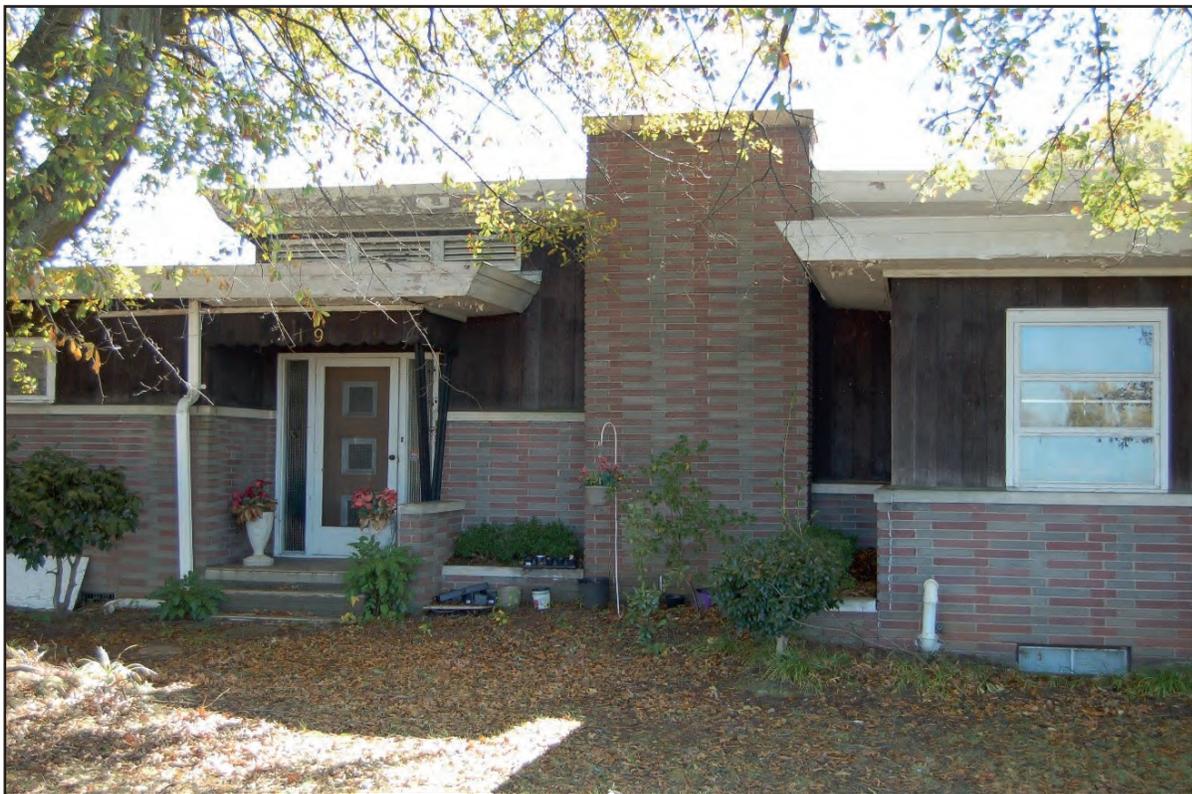
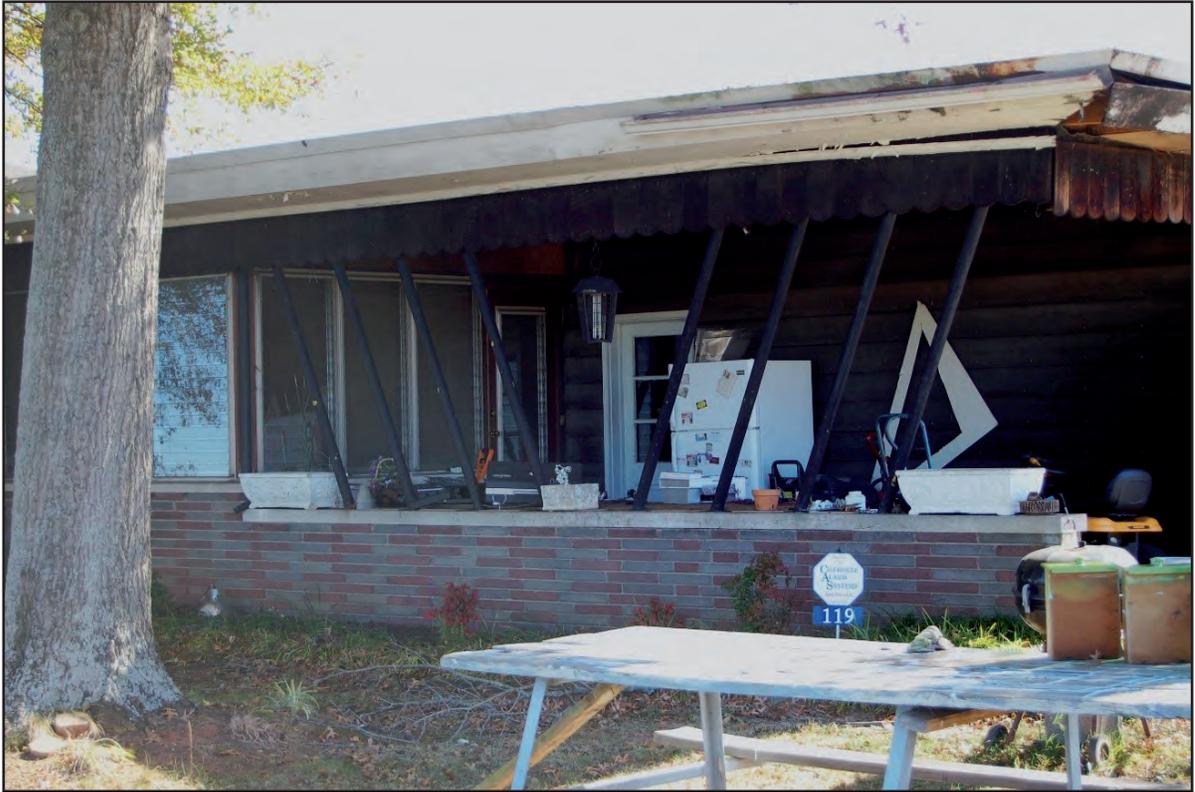
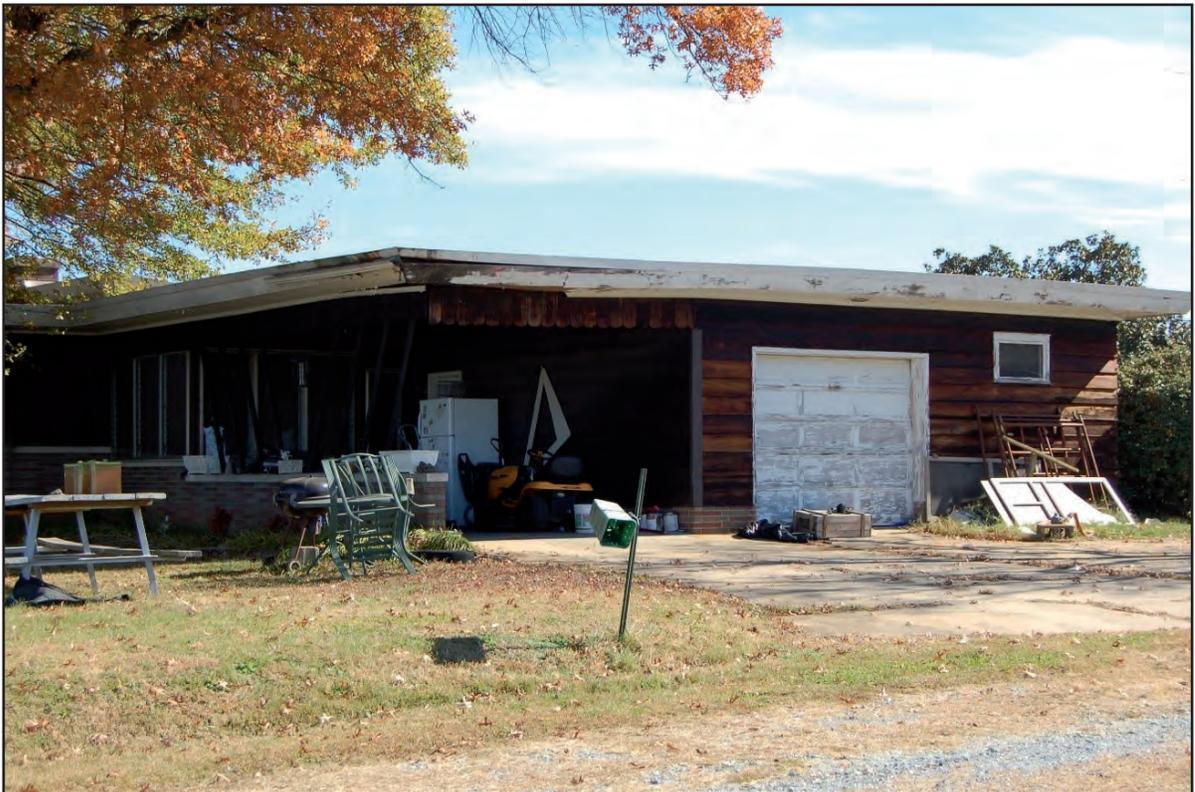
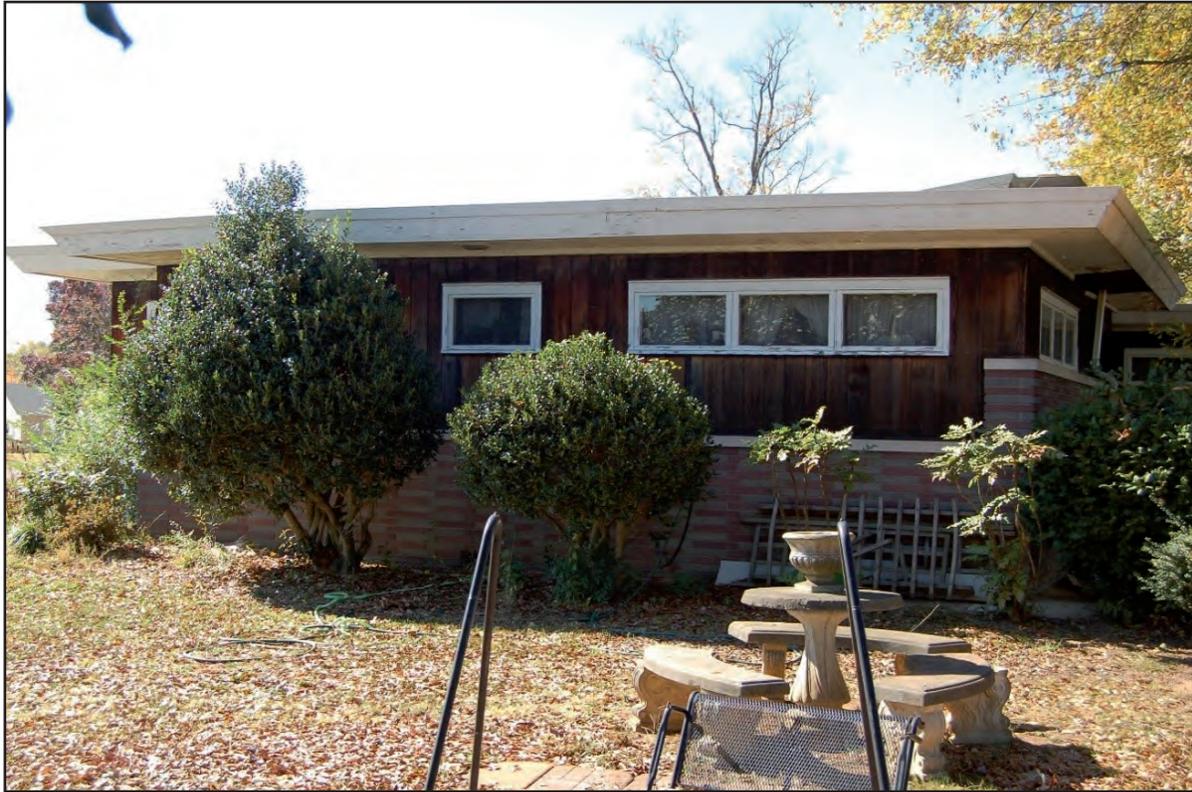
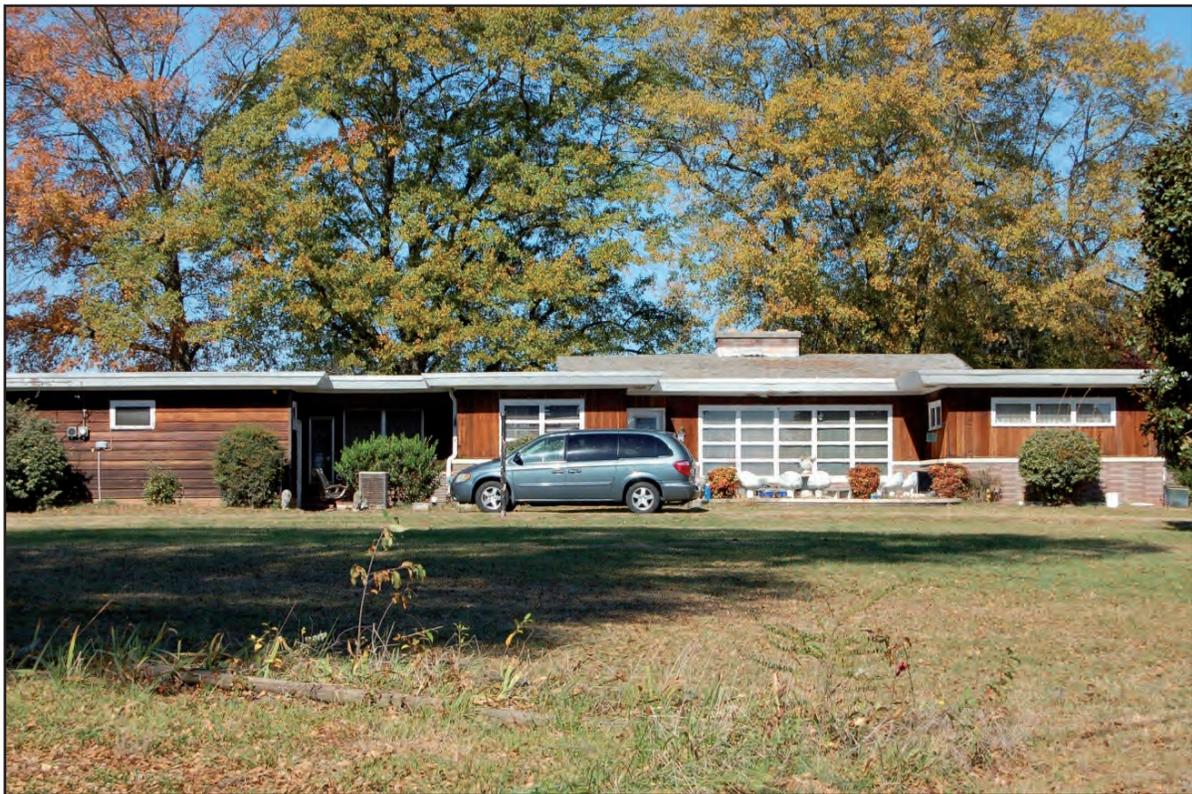
Resource 186-0207 features a two-level flat roof with wide eaves; a massive brick slab chimney on the façade; a projecting, flat-roofed stoop entry porch on the façade; an integral one-car carport and one-car garage on the west side elevation; and vertical board and weatherboard exterior siding above the lower level of Roman brick. The brick of the slab chimney and the lower portion of the exterior walls is Roman brick laid in a precise pattern of alternating courses. Each course is comprised of only red and gray bricks and the courses are laid so that the colors alternate both horizontally and vertically. There is a wide variety of window types and sizes on the resource that include jalousie windows around a sunroom or porch adjacent to the carport and awning wings singly, in a band of three, and across a large portion of the rear elevation in a mass that is four windows tall and five windows wide (see Figures 5.153 to 5.158). The roof over the open carport on the west end of the façade is supported by eight narrow poles - four parallel poles approximately 18" apart that slant toward the west side elevation and four parallel metal poles approximately 18" apart that slant toward the east side elevation.

**Figure 5.153.** Resource 186-0207 (119 Canty Way) - View of façade facing south.

**Figure 5.154.** Resource 186-0207 (119 Canty Way) - Close-up view of central portion of façade facing south.

**Figure 5.155.** Resource 186-0207 (119 Canty Way) - Close-up view of carport on west side elevation facing southeast.

**Figure 5.156.** Resource 186-0207 (119 Canty Way) - View of west side elevation facing southeast.

**Figure 5.157.** Resource 186-0207 (119 Canty Way) - View of east side elevation facing southwest.

**Figure 5.158.** Resource 186-0207 (119 Canty Way) - View of rear elevation facing north.

research questions in history or prehistory. The resource does not appear to have the potential to be the principal source of important information. Therefore, there was no basis for evaluating the resource under Criterion D. The resource was evaluated under Criterion C and appears to be eligible for inclusion in the NRHP in the area of architecture as a good and representative example of a Frank Lloyd Wright-influenced Usonian style Ranch. The resource exhibits many of the fundamental and defining characteristics of the Usonian style as described above: the long and low form; dominant horizontal lines; multi-level flat roof with wide eaves; the use of both wood and brick on the exterior; the integral open carport; a private side of the house (façade) and a more open side (rear elevation) that faces south; and the large floor-to-ceiling windows on the rear elevation. Therefore, Resource 186-0207 is recommended **Eligible** for listing in the NRHP under Criterion C in the area of architecture.

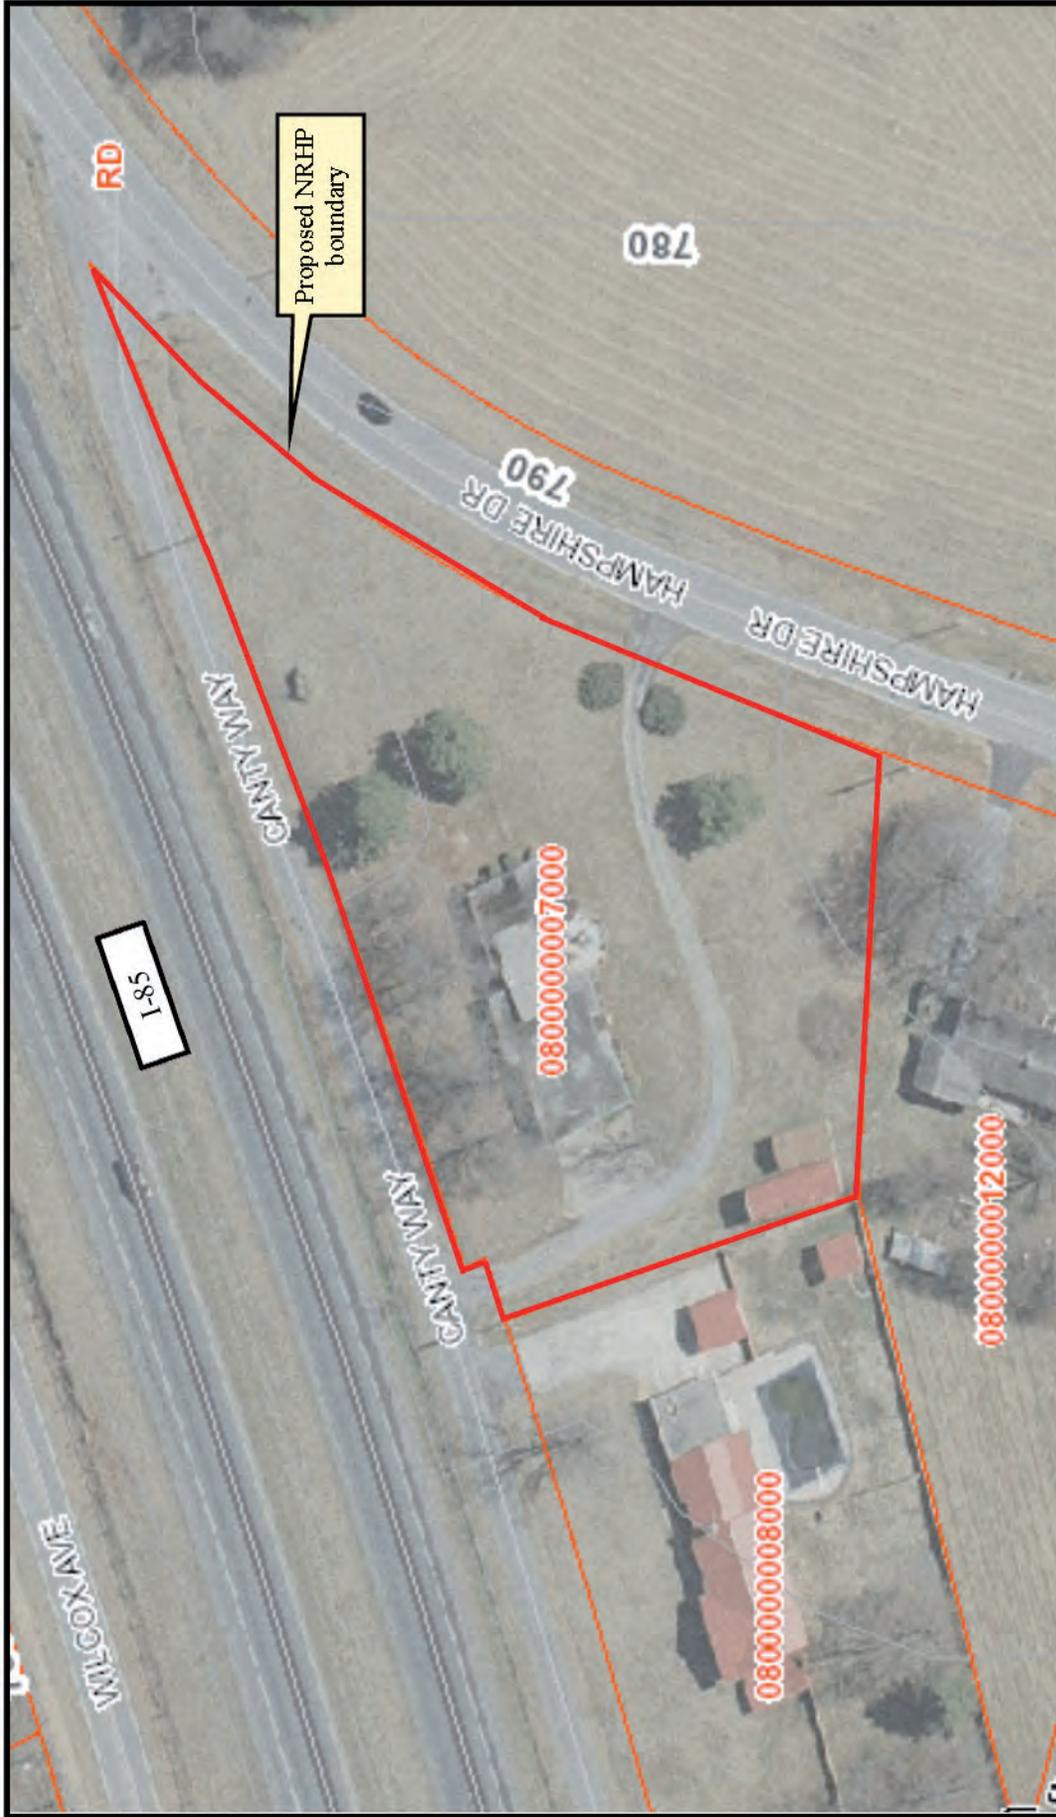
**Figure 5.159:** Proposed NRHP Boundary for Resource 186-0207

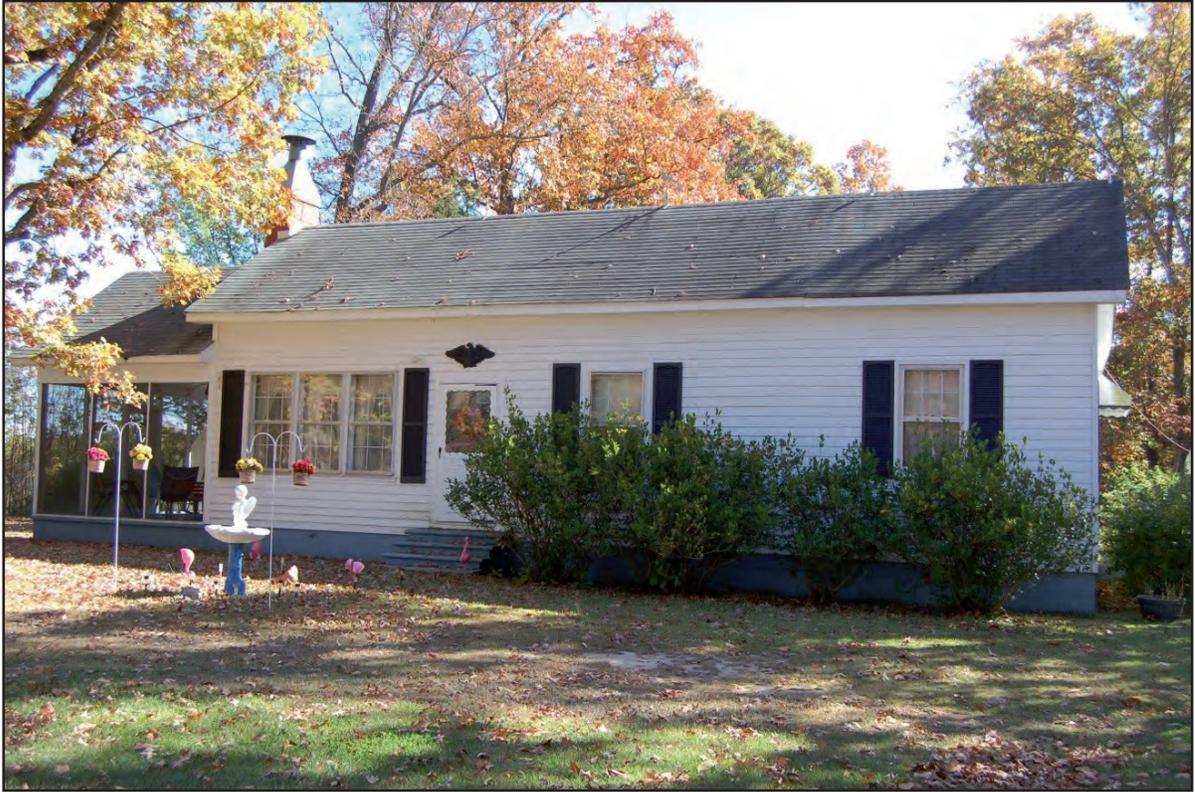
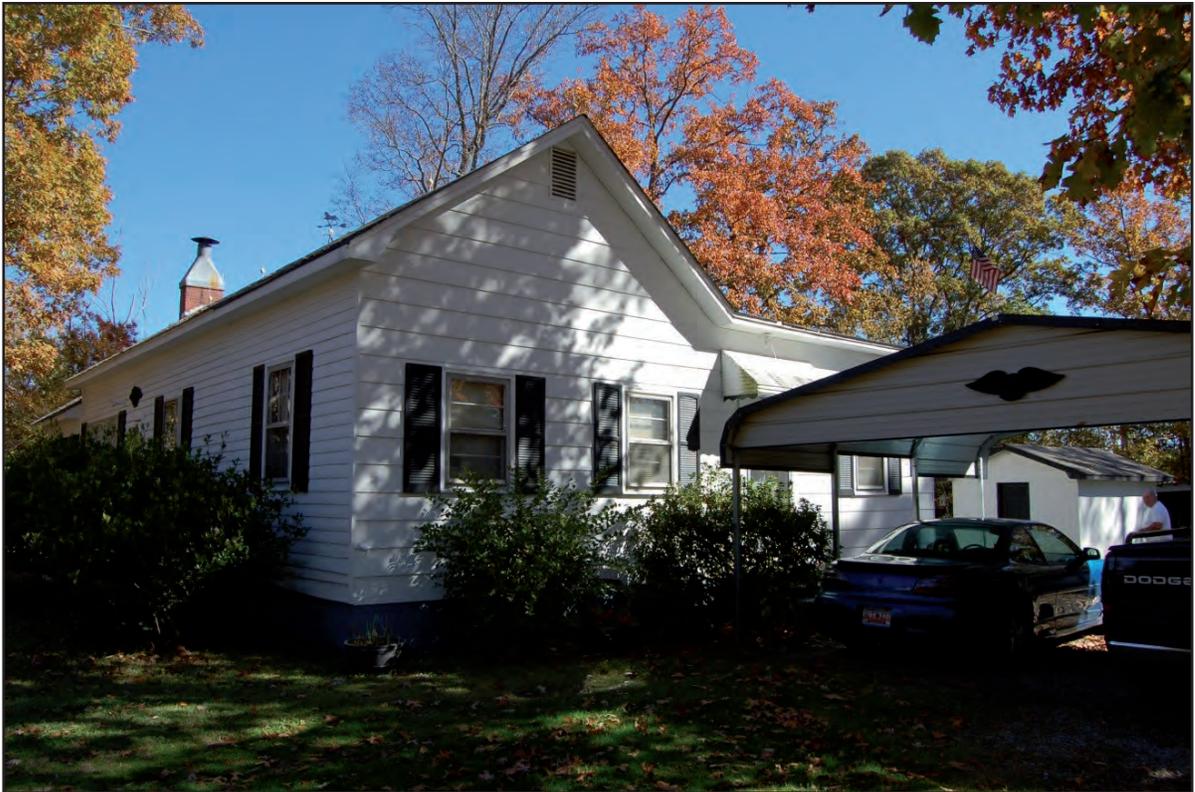
Resource 186-0208 is located at 334 Hampshire Drive on the south side of the roadway approximately 0.14 mile east of the intersection of Hampshire Drive and Lockhart Lane north of Gaffney in Cherokee County (refer to Figure 5.2d). The Cherokee County tax assessor's record does not have an estimated date of construction for the resource. Based on a review of historic aerial photography and topographic maps, and an evaluation of the resource's form and construction materials, Resource 186-0208 appears to have been constructed ca. 1940. This estimated date of construction is supported by the depiction of the resource in its current location on the earliest aerial photograph available on the [www.historicaerials.com](http://www.historicaerials.com) website dated 1955. The resource is a one-story, asymmetric, side-gabled residence of frame construction. The house features a side-gabled asphalt shingle roof; a continuous concrete block foundation; a larger brick exterior end wall chimney on the east side elevation with a metal chimney cap; a partial-width, gable-roofed porch on the east side elevation; and weatherboard exterior siding (see Figures 5.160 and 5.161). There is a tripartite window on the façade comprised of three 6/6-light double-hung sash windows. The remaining windows on the façade are 6/6-light double-hung sash and the windows on the west side elevation are 2/2-light double-hung sash. The siding on the west side elevation is much wider than

**Figure 5.160.** Resource 186-0208 (334 Hampshire Drive) - View of façade facing south.

**Figure 5.161.** Resource 186-0208 (334 Hampshire Drive) - Oblique view of façade and west side elevation facing southeast.

that observed on the façade and may be Hardie plank. Based on the different window and siding types on the resource, it appears to have been substantially altered from its historic appearance.

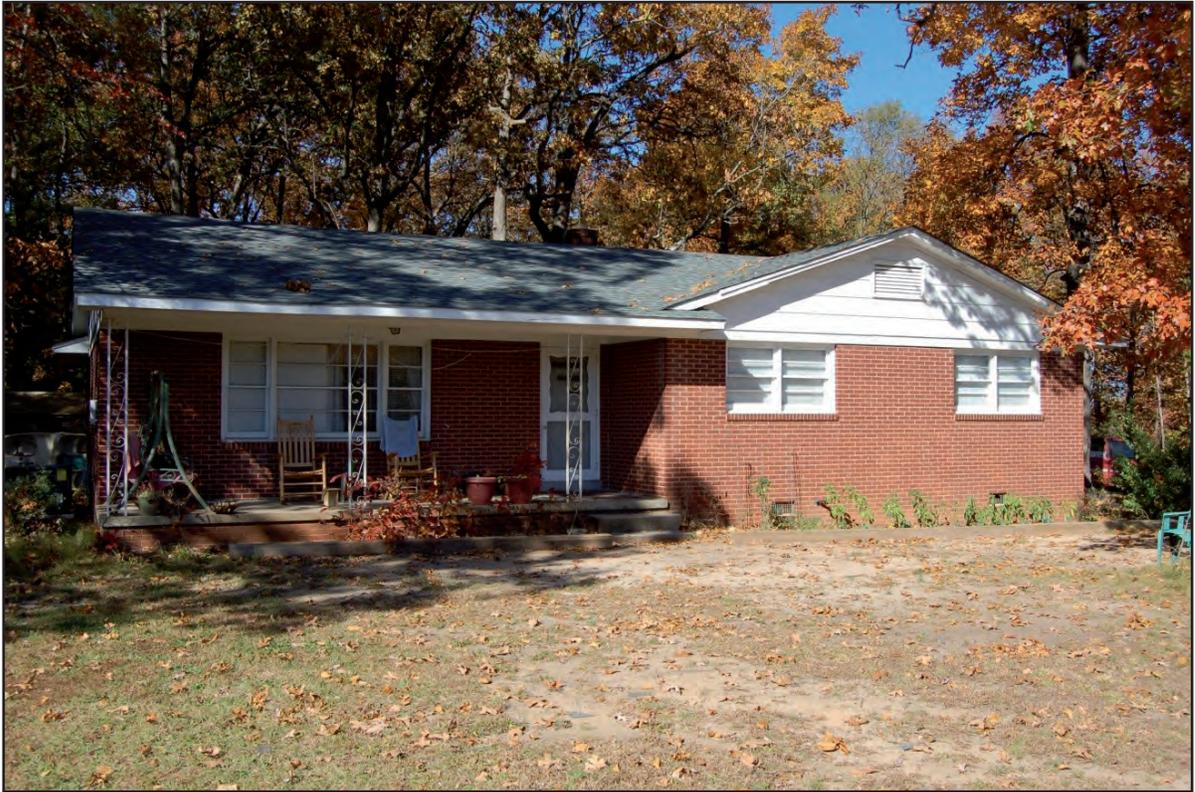
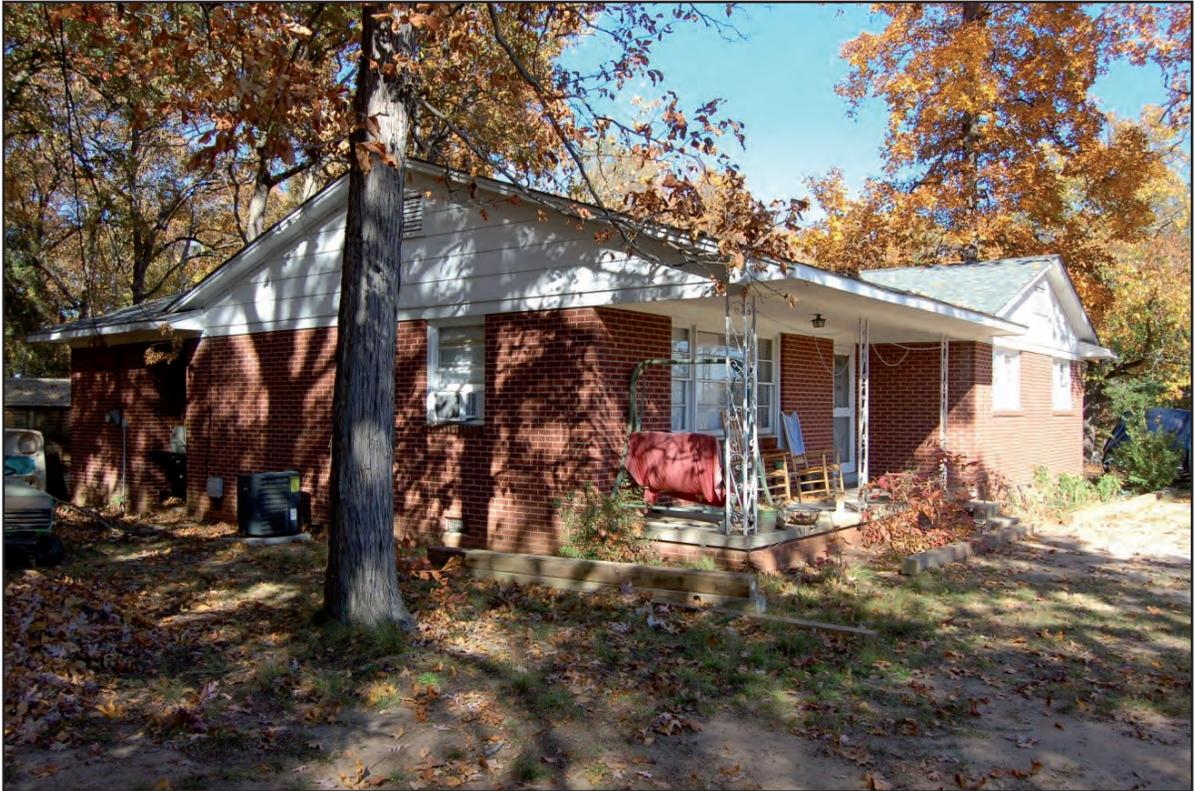
Resource 186-0209 is located at 621 Wilcox Avenue on the north side of the roadway in the northwest corner of the intersection of Wilcox Avenue and Pauline Drive north of Gaffney in Cherokee County (refer to Figure 5.2d). The Cherokee County tax assessor's record does not have an estimated date of construction for the resource. Based on a review of historic aerial photography and topographic maps, and an evaluation of the resource's form and construction materials, Resource 186-0209 appears to have been constructed ca. 1952. This estimated date of construction is supported by the depiction of the resource in its current location on the earliest aerial photograph available on the [www.historicaerials.com](http://www.historicaerials.com) website dated 1955. The resource is a one-story, asymmetric, cross-gabled residence. The house features a cross-gabled asphalt shingle roof; a brick interior ridgeline chimney; a partial-width, integral porch on the façade with roof supported by three decorative metal posts; and running bond brick exterior siding. There is a tripartite window on the façade comprised of a large rectangular window with four horizontal lights flanked by 2/2-light double-hung sash windows and the remaining windows are original single and paired wood-framed 2/2-light double-hung sash of various sizes (see Figures 5.162 and 5.163).

**Figure 5.162.** Resource 186-0209 (621 Wilcox Avenue) - View of façade facing north.

**Figure 5.163.** Resource 186-0209 (621 Wilcox Avenue) - Oblique view of façade and west side elevation facing northeast.

style and does not, otherwise appear to represent a significant trend in South Carolina's architectural history. Therefore, Resource 186-0209 is recommended **Not Eligible** for listing in the NRHP under Criterion C in the area of architecture.

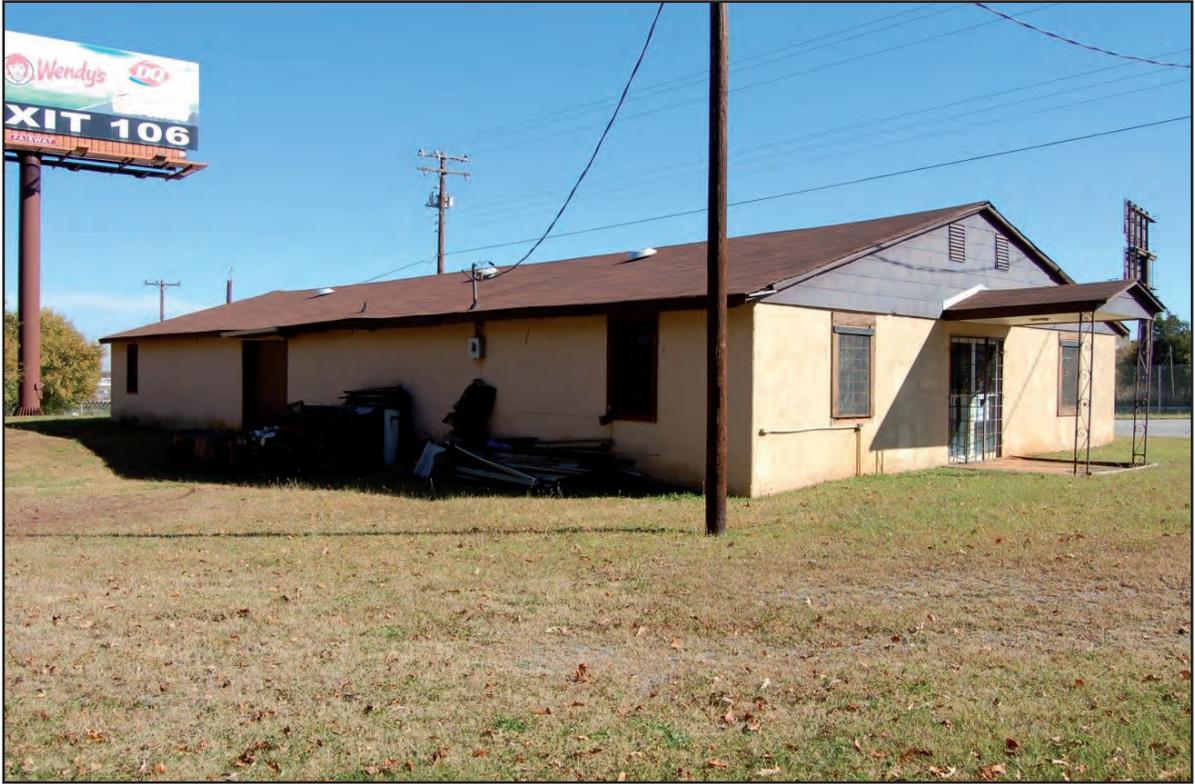
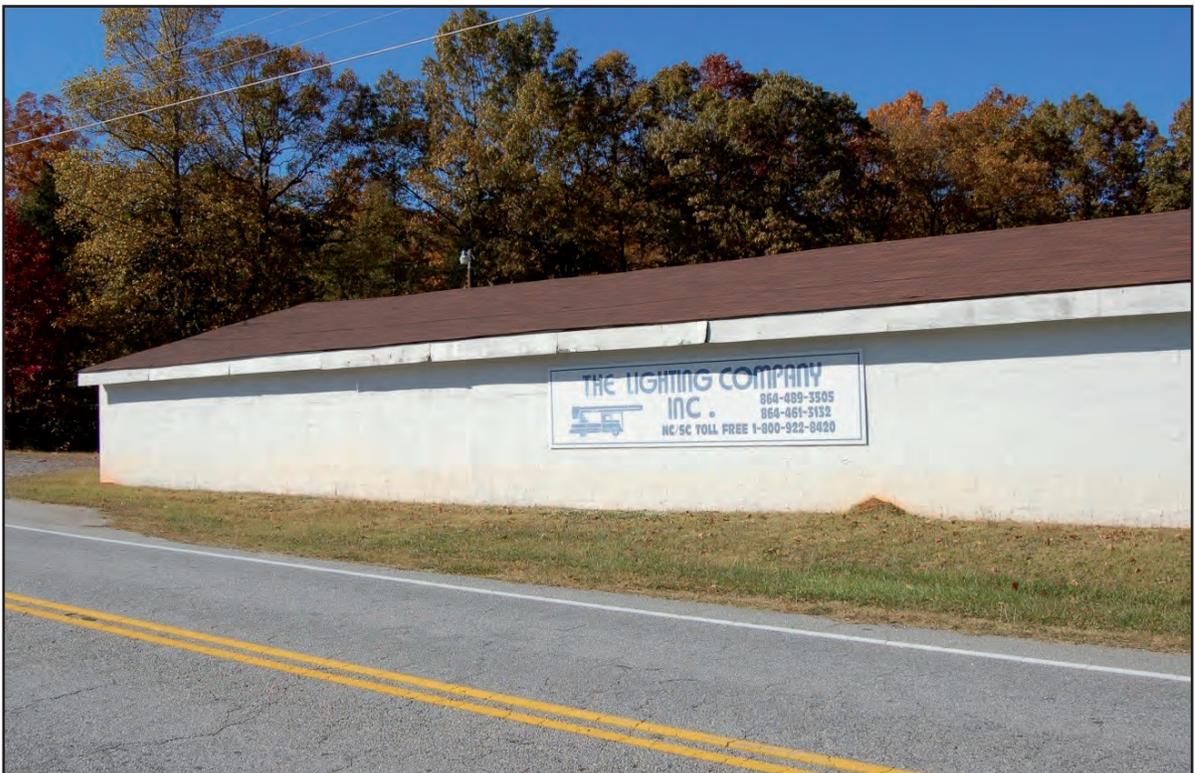
Resource 186-0210 is located at 141 Pauline Drive on the east side of the roadway in the north-east corner of the intersection of Pauline Drive and Wilcox Avenue north of Gaffney in Cherokee County (refer to Figure 2D). The Cherokee County tax assessor's record does not have an estimated date of construction for the resource. Based on a review of historic aerial photography and topographic maps, and an evaluation of the resource's form and construction materials, Resource 186-0210 appears to have been constructed ca. 1957. The resource is not depicted in its current location on the earliest aerial photograph available on the [www.historicaerials.com](http://www.historicaerials.com) website dated 1955. The resource is a one-story, symmetric, front-gabled former skating rink of concrete block load-bearing wall construction. The building features a front-gabled asphalt shingle roof, a small projecting gable-roofed entry porch on the façade; a loading dock with two large doors on the north side elevation (see Figures 5.164 and 5.165); weatherboard siding in the gable ends and concrete block exterior siding on the remainder of the building. Windows are wood-framed 6/6-light double-hung sash on the façade, rear elevation, and north side elevation. There are no doors or windows on the south side elevation of the resource.

**Figure 5.164.** Resource 186-0210 (141 Pauline Drive) – Oblique view of façade and north side elevation facing southeast.

**Figure 5.165.** Resource 186-0210 (141 Pauline Drive) - Oblique view of south side elevation facing northwest.

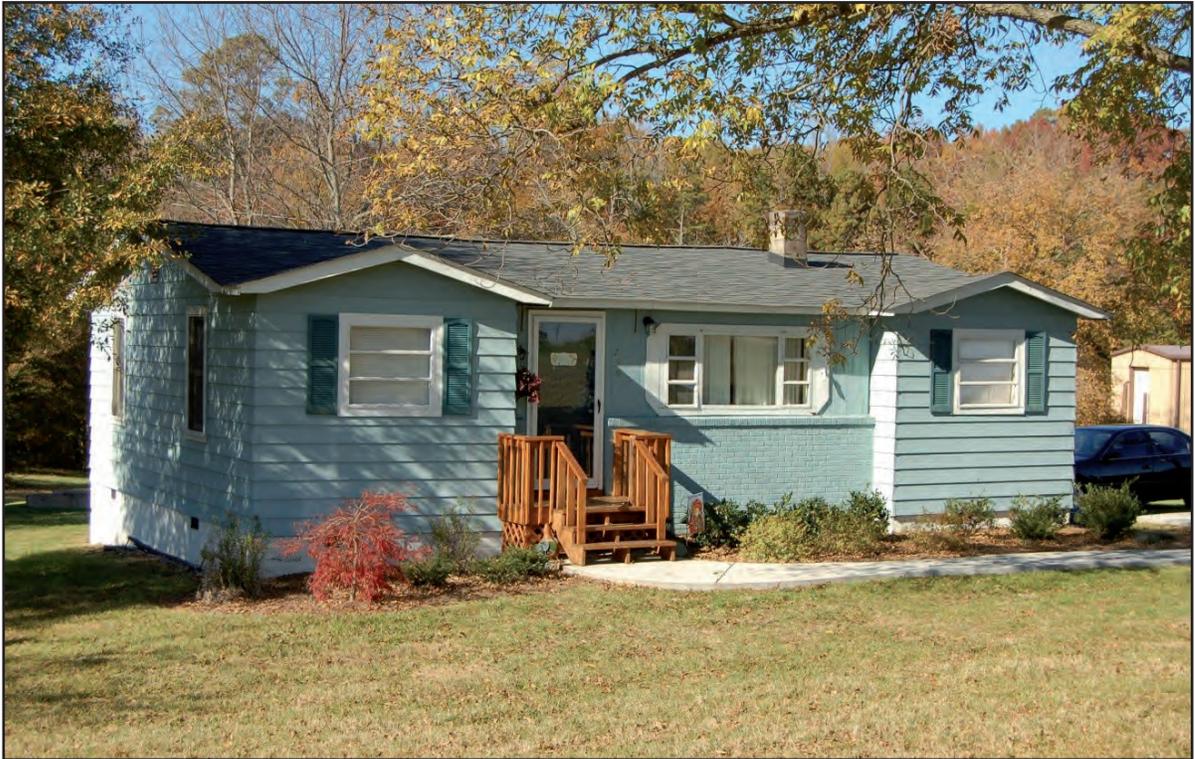
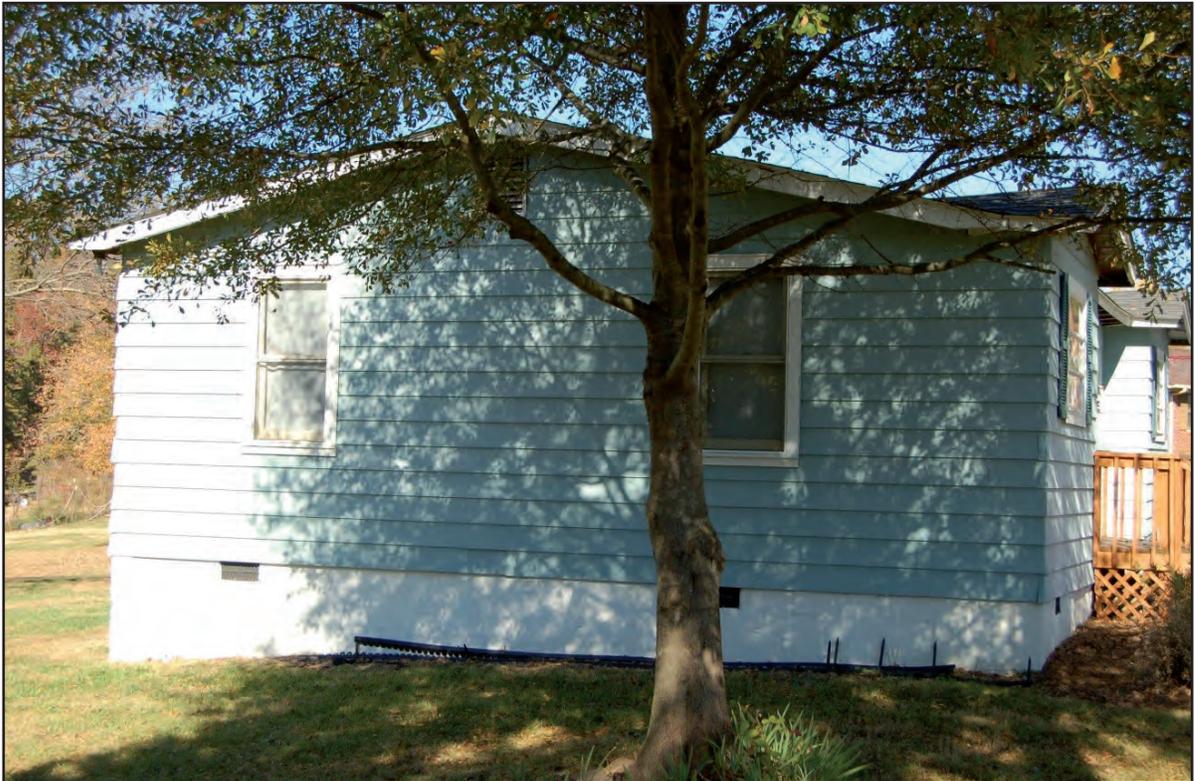
Resource 186-0211 appears to have been constructed ca. 1950. This estimated date of construction is supported by the depiction of the resource in its current location on the earliest aerial photograph available on the [www.historicaerials.com](http://www.historicaerials.com) website dated 1955. The resource is a one-story, asymmetric, cross-gabled residence of frame construction. The house features a cross-gabled asphalt shingle roof; a continuous concrete block foundation; a small masonry interior roof surface chimney on the front roof slope; a small non-historic stoop deck on the façade; and a mix of brick, vertical board, and aluminum exterior siding (see Figures 5.166 and 5.167). The brick and vertical board exterior siding is limited to the areas between the front-facing gables on the façade. There is a tripartite window comprised of a small rectangular fixed light flanked by small 3-light awning windows and two large 3-light awning windows on the façade. The remaining windows are 1/1-light double-hung sash.

**Figure 5.166.** Resource 186-0211 (759 Wilcox Avenue) - View of façade facing north.

**Figure 5.167.** Resource 186-0211 (759 Wilcox Avenue) - View of west side elevation facing northeast.

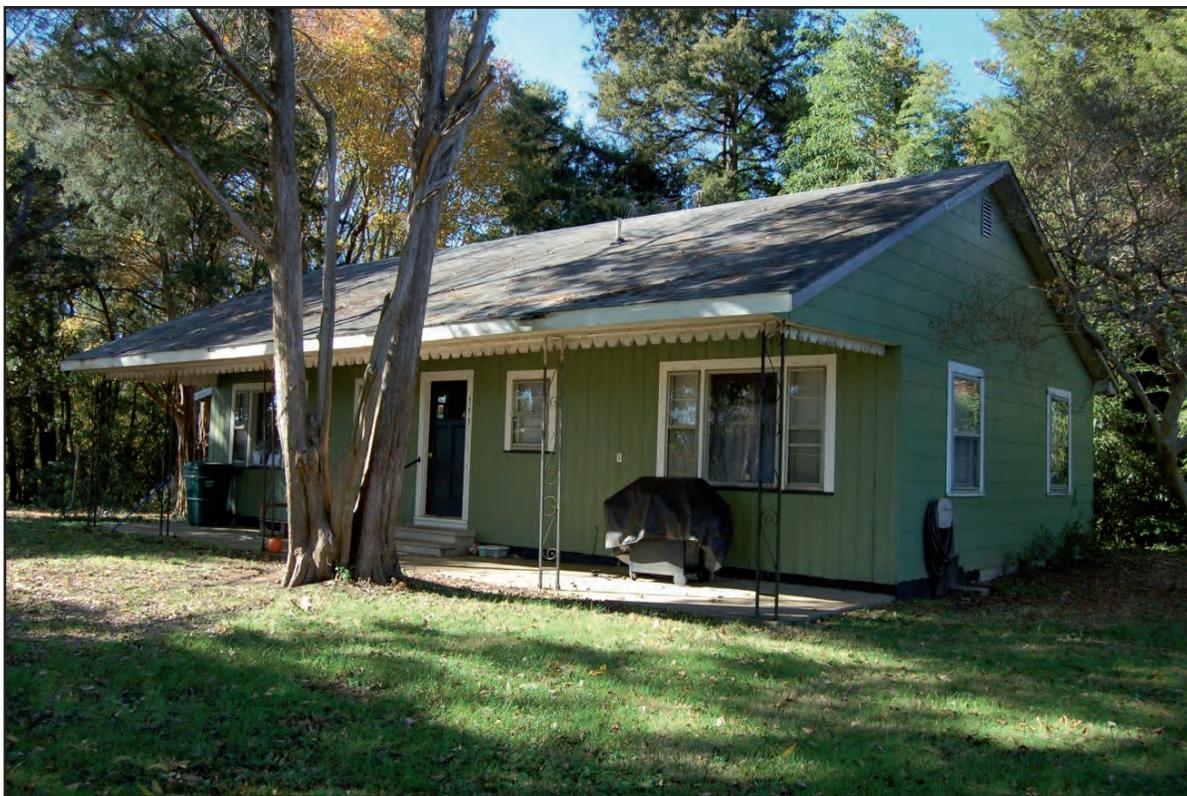
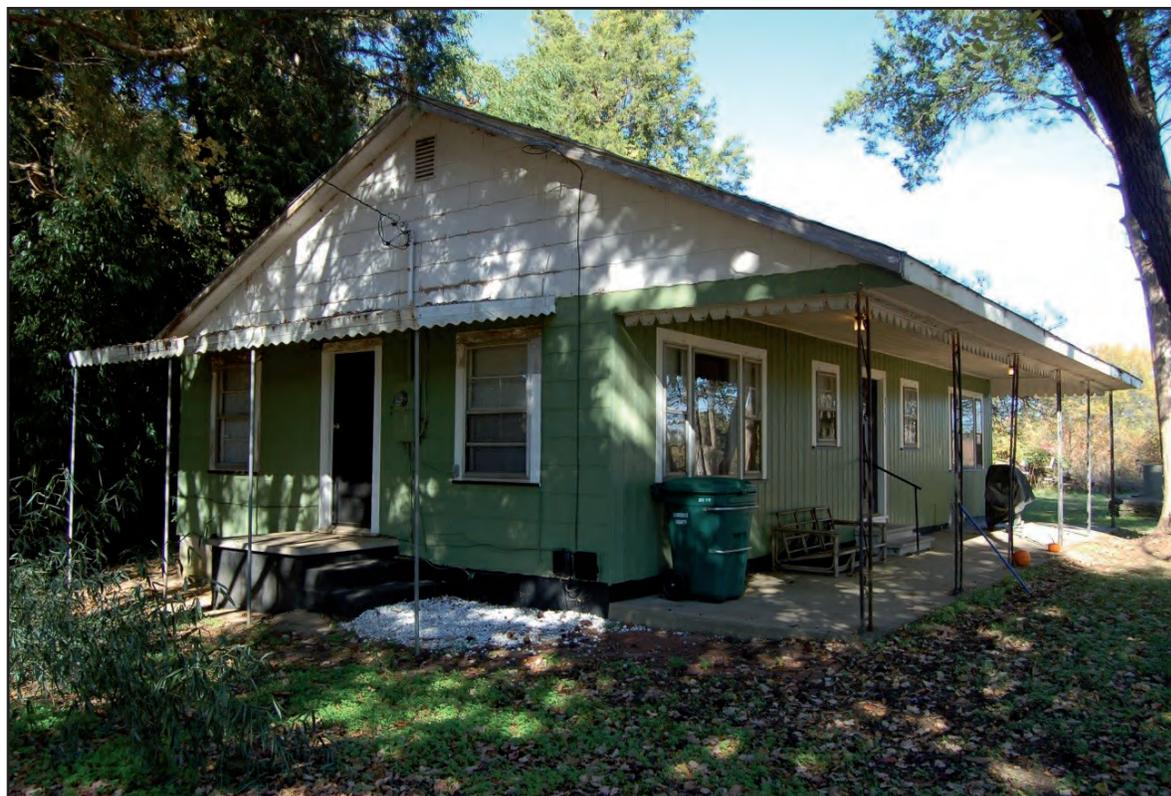
Resource 186-0212 is located at 775 Wilcox Avenue Drive on the north side of the roadway approximately 0.26 mile east of the intersection of Wilcox Avenue and Pauline Drive north of Gaffney in Cherokee County (refer to Figure 5.2d). The Cherokee County tax assessor's record has a 1952 estimated date of construction for the resource. This estimated date of construction is supported by the depiction of the resource in its current location on the earliest aerial photograph available on the [www.historicaerials.com](http://www.historicaerials.com) website dated 1955. The resource is a one-story, asymmetric, side-gabled residence of frame construction. The house features a side-gabled asphalt shingle roof; a full-width, integral, shed-roofed porch on the façade; a partial-width, shed-roofed metal porch on the west side elevation; and concrete asbestos tile exterior siding (see Figures 5.168 and 5.169). The roof of the porch on the façade is supported by five decorative metal posts and the porch on the west side elevation is supported by four narrow metal poles. There are two tripartite windows comprised of a large square fixed light flanked by 2/2-light double-hung sash windows on the façade and the remaining windows are wood-framed 2/2-light double-hung sash of various sizes.

**Figure 5.168.** Resource 186-0212 (775 Wilcox Avenue) – Oblique view of façade and east side elevation facing northwest.

**Figure 5.169.** Resource 186-0212 (775 Wilcox Avenue) - Oblique view of façade and west side elevation facing northeast.

The resource is not known to be associated with a significant activity or event and there is not a known connection between the resource and any individual whose activities or achievements are historically significant. Therefore, there was no basis for evaluating the resource under Criterion A or B. Also, there is no indication that the resource is likely to yield information on important research questions in history or prehistory. The resource does not appear to have the potential to be the principal source of important information. Therefore, there was no basis for evaluating the resource under Criterion D. The resource does not represent a recognized architectural type or style and does not otherwise appear to represent a significant trend in South Carolina's architectural history. Therefore, Resource 186-0212 is recommended **Not Eligible** for listing in the NRHP under Criterion C in the area of architecture.

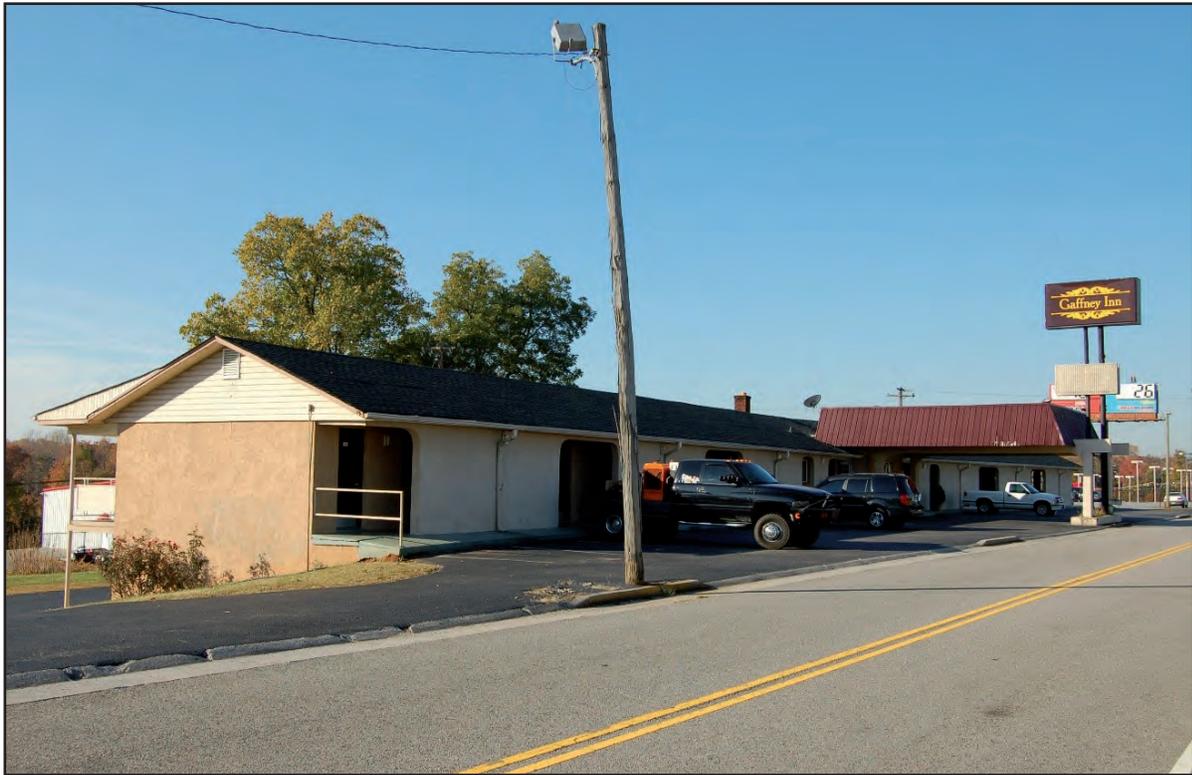
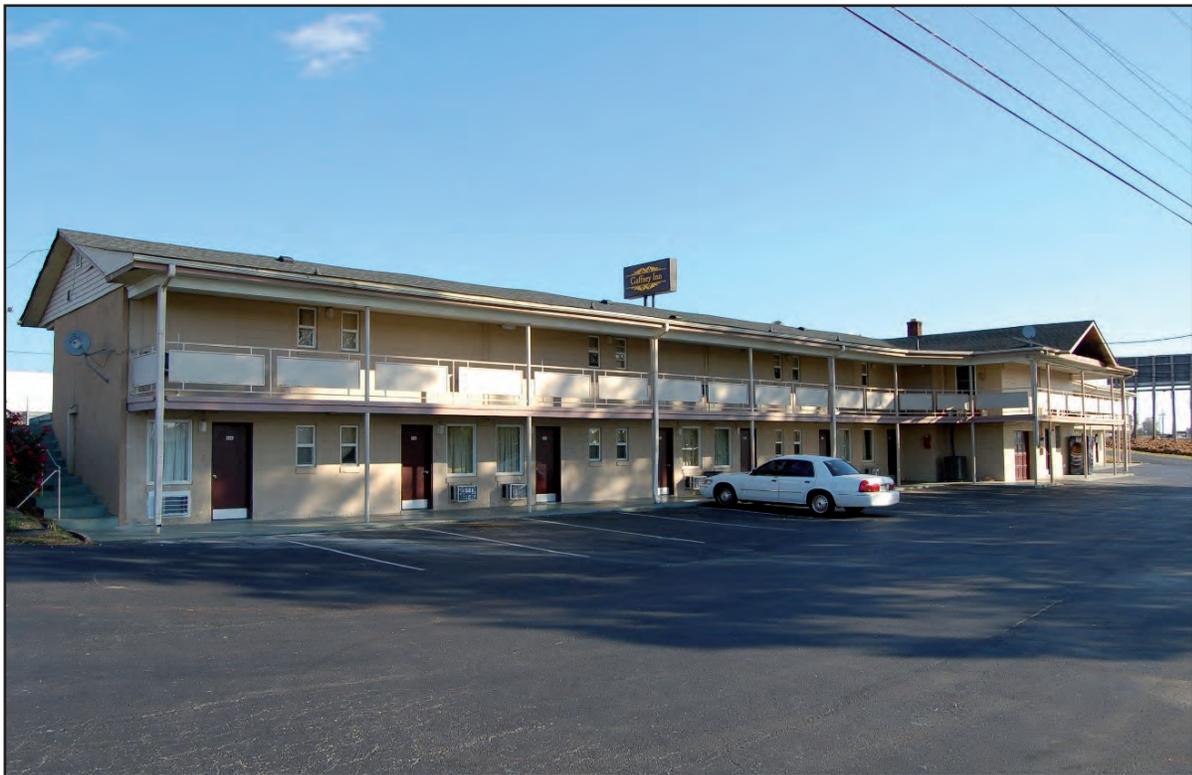
Resource 186-0213 is located at 722 Hampshire Drive on the south side of the roadway approximately 0.24 mile west of the intersection of Hampshire Drive and Fatz Drive north of Gaffney in Cherokee County (refer to Figure 5.2d). The Cherokee County tax assessor's record does not have an estimated date of construction for the resource. Based on a review of historic aerial photography and topographic maps, and an evaluation of the resource's form and construction materials, Resource 186-0213 appears to have been constructed ca. 1950. This estimated date of construction is supported by the depiction of the resource in its current location on the earliest aerial photograph available on the [www.historicaerials.com](http://www.historicaerials.com) website dated 1955. The resource is a two-story, side-gabled motel of masonry load-bearing wall construction. The motel is one room deep and one-story tall on the façade (Hampshire Drive side) and two stories tall on the rear elevation. The motel features a side-gabled asphalt shingle roof; a projecting porte cochere on the façade; a small brick interior ridgeline chimney; covered walkway on the façade; covered walkways on the upper and lower levels on the rear elevation; novelty board exterior siding on the gable ends and stuccoed masonry exterior siding (see Figures 5.170 and 5.171). The porte cochere on the façade is a non-historic addition and the windows and doors are non-historic replacements.

**Figure 5.170.** Resource 186-0213 (722 Hampshire Drive) - Oblique view of façade and east side elevation facing southwest.

**Figure 5.171.** Resource 186-0213 (722 Hampshire Drive) - Oblique view of east side and rear elevations facing northeast.

replacement of original doors and windows the resource has lost integrity in the areas of materials, workmanship, and feeling and cannot convey significance in the area of architecture. Therefore, Resource 186-0213 is recommended **Not Eligible** for listing in the NRHP under Criterion C in the area of architecture.
