**PHASE I CULTURAL RESOURCE SURVEY FOR PROPOSED  
WIDENING OF INTERSTATE 85 FROM MILE MARKER 80 TO 96,  
CHEROKEE AND SPARTANBURG COUNTIES, SOUTH CAROLINA.**

**FINAL REPORT**

**JULY 2015**

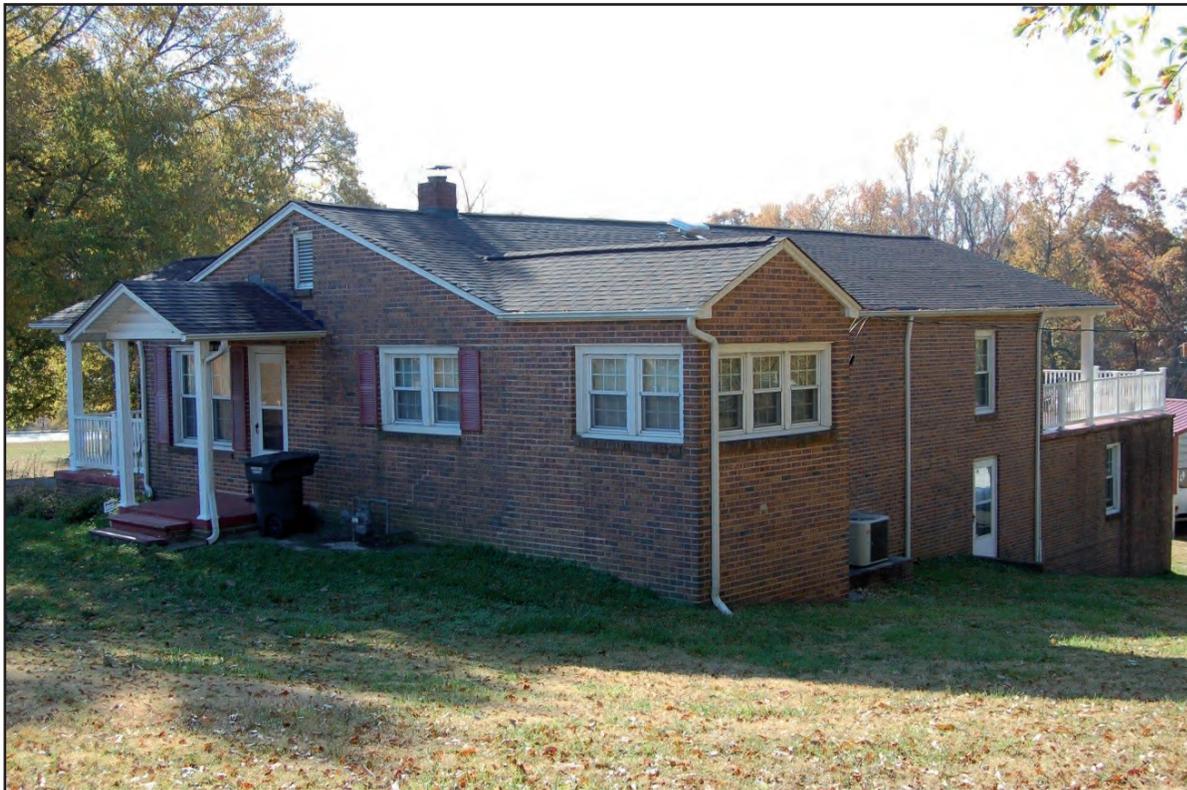
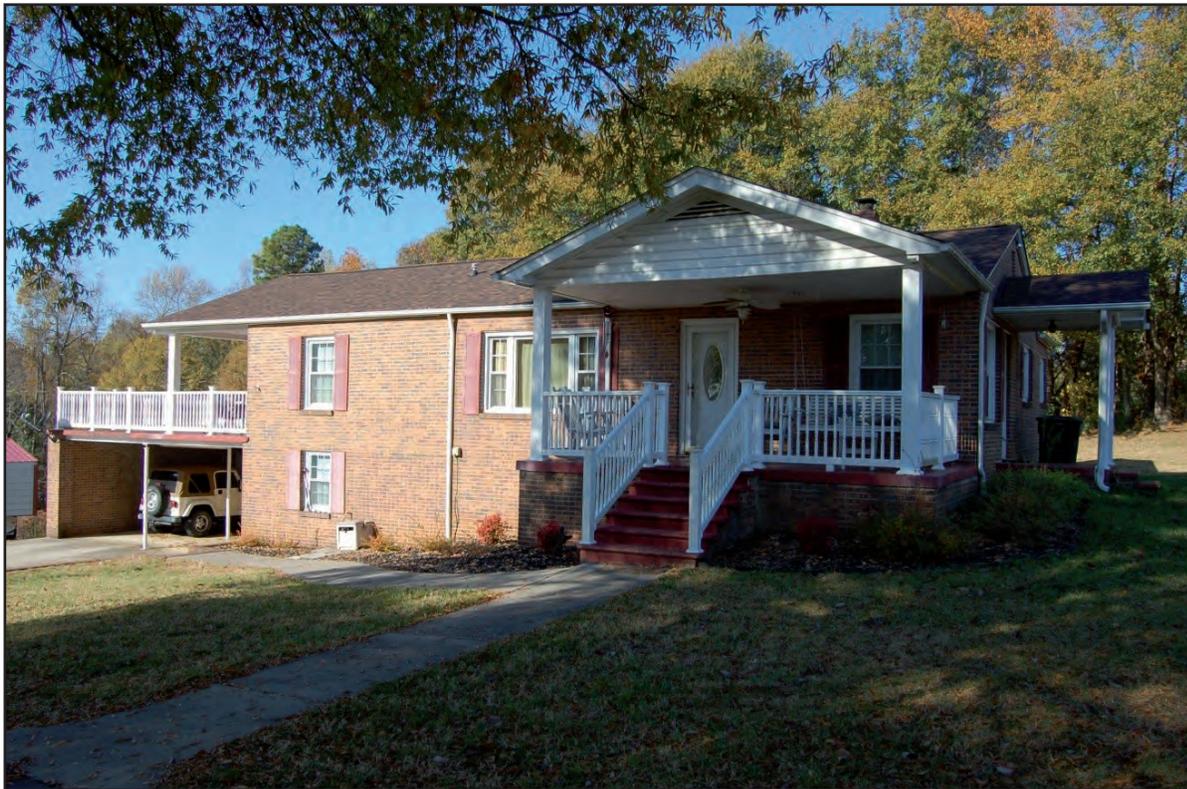
Resource 186-0214 is located at 346 Matthew Road on the south side of the roadway in the southwest corner of the intersection of Matthew Road and SC 19 (North Limestone Street) north of Gaffney in Cherokee County (refer to Figure 5.2d). The Cherokee County tax assessor's record does not have an estimated date of construction for the resource. Based on a review of historic aerial photography and topographic maps, and an evaluation of the resource's form and construction materials, Resource 186-0214 appears to have been constructed ca. 1958. The resource is not depicted in its current location on the earliest aerial photograph available on the [www.historicaerials.com](http://www.historicaerials.com) website dated 1955. The resource is a one-story, asymmetric, cross-gabled residence of frame construction. The house features a cross-gabled asphalt shingle roof with little to no eave overhang; a small brick interior ridgeline chimney; a projecting, gable-roofed entry porch on the façade; a partial-width, projecting gable-roofed porch on the east side elevation; vinyl exterior siding in the gable ends and running bond brick exterior siding on the remainder of the house (see Figures 5.172 and 5.173). The porch roofs are supported by wooden posts and the porch on the east side elevation has a wooden balustrade. There is a tripartite window on the east side elevation comprised of a large square fixed light flanked by 4/4-light double-hung sash windows with faux muntins and the remaining windows are single, paired, and triple 6/6-light double-hung sash. All of the windows are non-historic vinyl replacements and the doors are non-historic replacements. The rear ell has a covered porch above a carport at the southern end.

The resource is not known to be associated with a significant activity or event and there is not a known connection between the resource and any individual whose activities or achievements are historically significant. Therefore, there was no basis for evaluating the resource under Criterion A or B. Also, there is no indication that the resource is likely to yield information on important research questions in history or prehistory. The resource does not appear to have the potential to be the principal source of important information. Therefore, there was no basis for evaluating the resource under Criterion D. The resource does not represent a recognized architectural type or style and does not otherwise appear to represent a significant trend in South Carolina's architectural history. Additionally, due to the replacement of the original doors and windows the resource has lost integrity in the areas of materials, workmanship, and feeling and cannot convey significance in the area of architecture. Therefore, Resource 186-0214 is recommended **Not Eligible** for listing in the NRHP under Criterion C in the area of architecture.

**Figure 5.172.** Resource 186-0214 (346 Matthew Road) - Oblique view of north side and rear elevations facing southeast.

**Figure 5.173.** Resource 186-0214 (346 Matthew Road) - Oblique view of façade facing southwest.

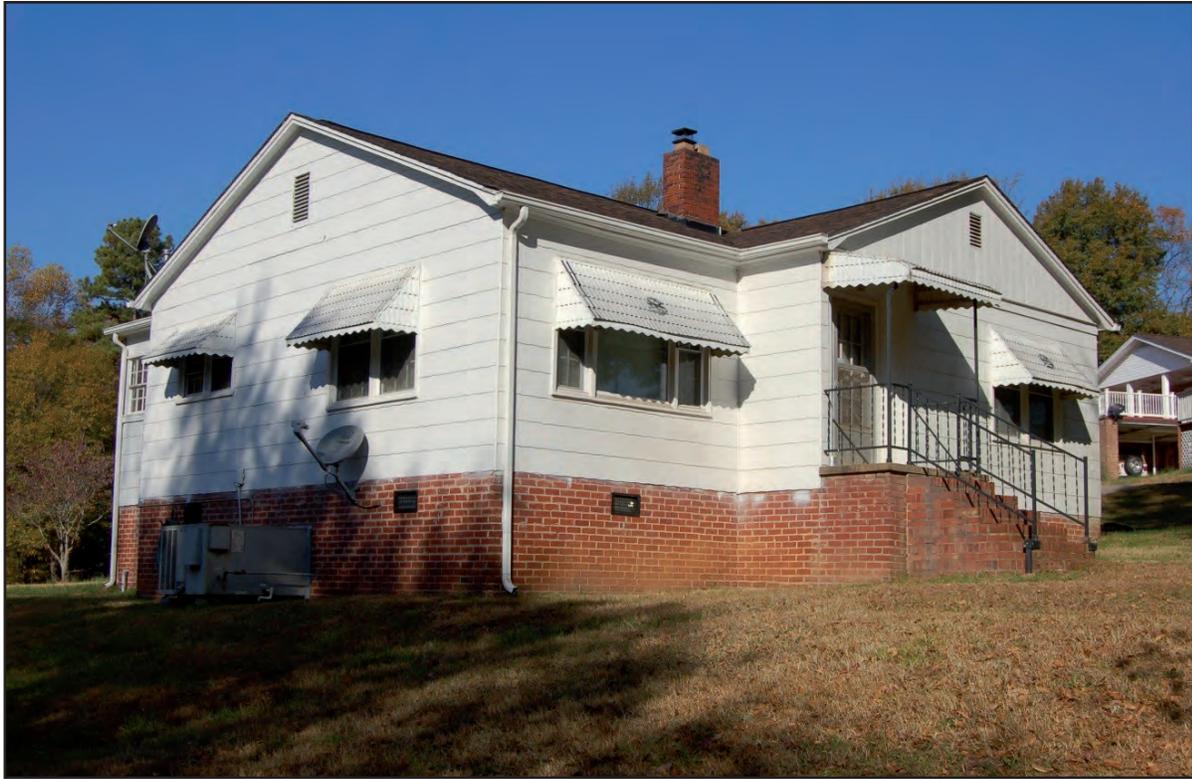
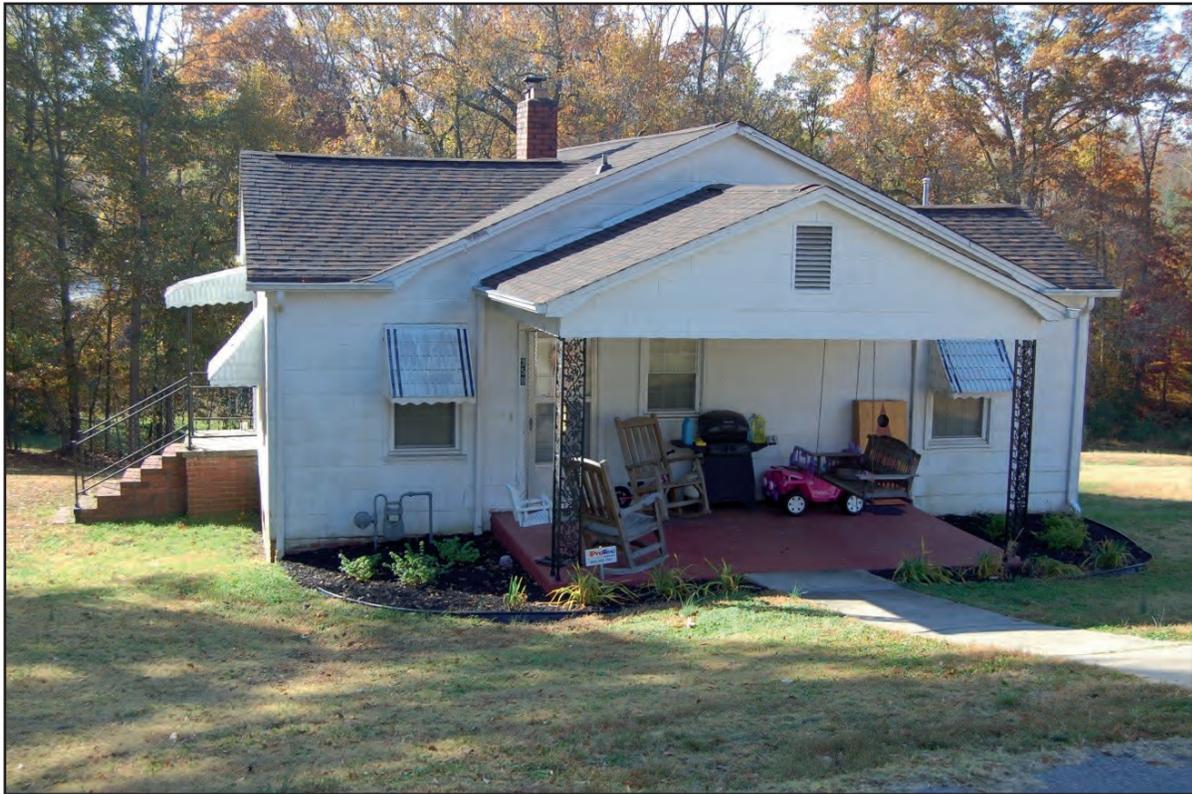
Resource 186-0215 is located at 358 Matthew Road on the south side of the roadway in the southwest corner of the intersection of Matthew Road and SC 19 (North Limestone Street) north of Gaffney in Cherokee County (refer to Figure 2D). The Cherokee County tax assessor's record does not have an estimated date of construction for the resource. Based on a review of historic aerial photography and topographic maps, and an evaluation of the resource's form and construction materials, Resource 186-0215 appears to have been constructed ca. 1950. This estimated date of construction is supported by the depiction of the resource in its current location on the earliest aerial photograph available on the [www.historicaerials.com](http://www.historicaerials.com) website dated 1955. The resource is a one-story, asymmetric, cross-gabled residence of frame construction. The house features a cross-gabled asphalt shingle roof with narrow eaves; a continuous brick foundation; a brick interior roof surface chimney within the front roof slope; a stoop entry porch on the façade with a metal awning roof; a partial-width, projecting, gable-roofed porch on the east side elevation; and a patio and projecting gable-roofed porch above a one-car carport on the rear elevation (see Figures 5.174 and 5.175). There is a tripartite window on the east side elevation and the remaining windows are single, paired, and triple 6/6-light double-hung sash.

**Figure 5.174.** Resource 186-0215 (358 Matthew Road) - Oblique view of façade and south side elevation facing northwest.

**Figure 5.175.** Resource 186-0215 (358 Matthew Road) -View of north side elevation facing south.

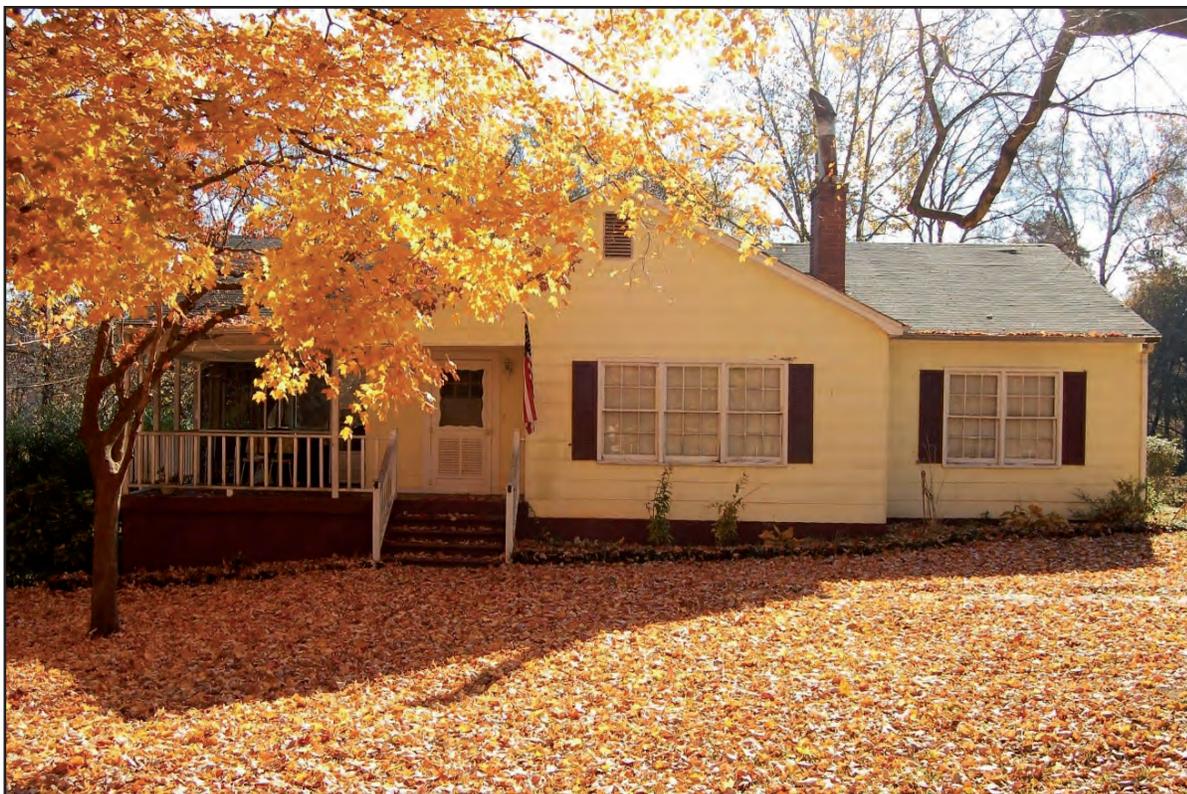
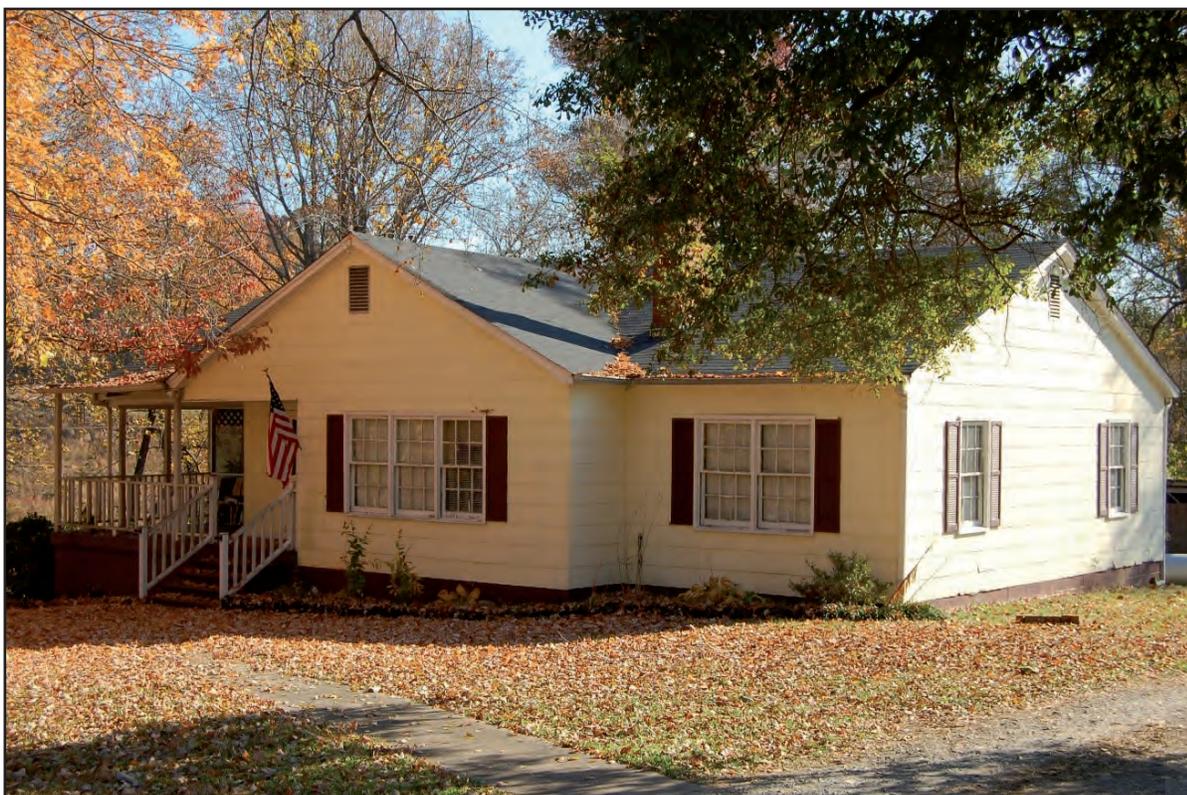
Resource 186-0216 is located at 1840 North Limestone Street on the east side of the roadway approximately 0.13 mile south of the intersection of North Limestone Street and Matthew Road north of Gaffney in Cherokee County (refer to Figure 5.2d). The Cherokee County tax assessor's record has a 1956 estimated date of construction for the resource. The resource is not depicted in its current location on the earliest aerial photograph available on the [www.historicaerials.com](http://www.historicaerials.com) website dated 1955. The resource is a one-story, asymmetric, cross-gabled residence of frame construction. The house features a cross-gabled asphalt shingle roof with narrow eaves; a continuous concrete block foundation; a tall brick interior roof surface chimney within the front roof surface; a wrap-around, integral porch on the façade and north side elevation; and concrete asbestos tile exterior

siding (see Figures 5.176 and 5.177). The wrap-around porch is supported by square wooden posts. Windows are a mix of single, paired, and triple wood-framed 6/6-light double-hung sash.

**Figure 5.176.** Resource 186-0216 (1840 North Limestone Street) - View of façade facing east.

**Figure 5.177.** Resource 186-0216 (1840 North Limestone Street) – Oblique view of façade and south side elevation facing northeast.

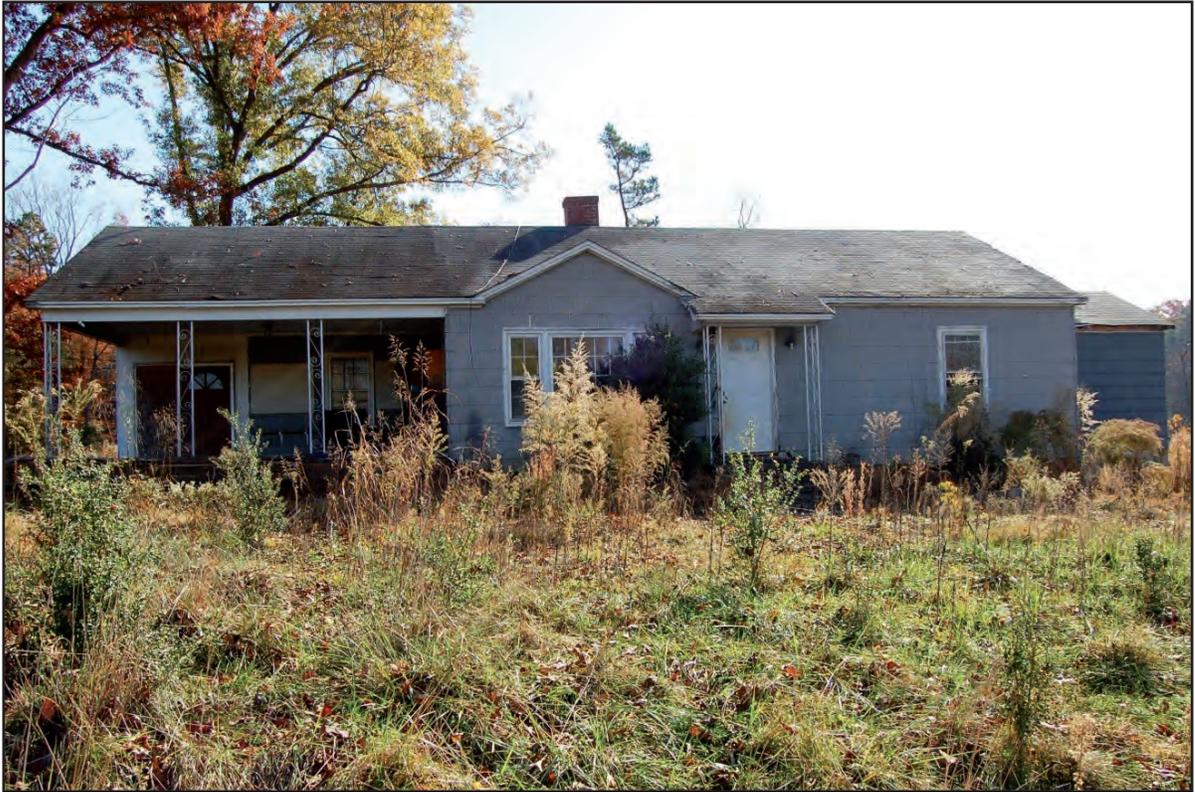
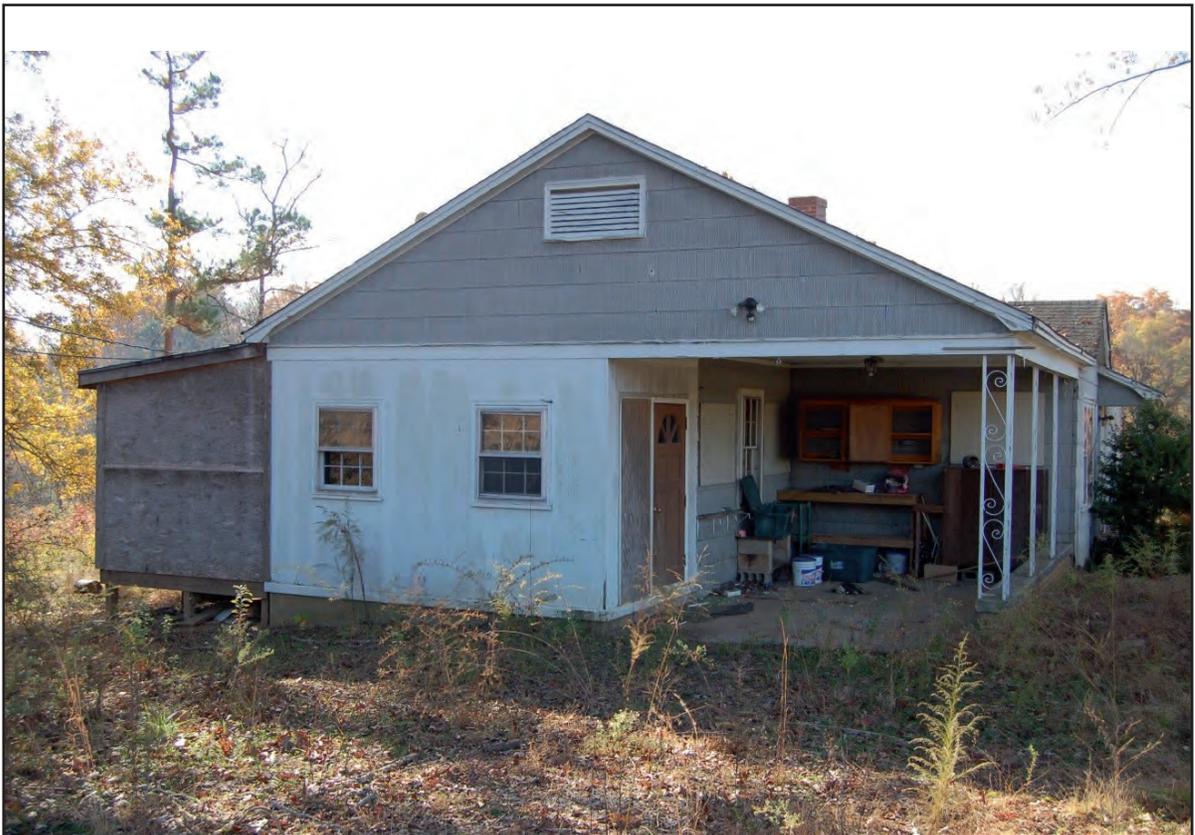
Resource 186-0217 is located at 1900 North Limestone Street on the east side of the roadway on the east side of the roadway opposite the intersection of North Limestone Street and Matthew Road north of Gaffney in Cherokee County (refer to Figure 5.2d). The Cherokee County tax assessor's record does not have an estimated date of construction for the resource. Based on a review of historic aerial photography and topographic maps, and an evaluation of the resource's form and construction materials, Resource 186-0217 appears to have been constructed ca. 1951. This estimated date of construction is supported by the depiction of the resource in its current location on the earliest aerial photograph available on the [www.historicaerials.com](http://www.historicaerials.com) website dated 1955. The resource is a one-story, asymmetric, cross-gabled residence of frame construction. The house features a cross-gabled asphalt shingle roof with narrow eaves; a continuous concrete block foundation; a small brick interior roof surface chimney within the rear roof surface; a partial-width, recessed, integral porch on the façade; an extended, shed-roofed stoop porch on the façade; and concrete asbestos tile exterior siding (see Figures 5.178 and 5.179). The roofs of both porches on the façade are supported by decorative metal posts. There is a tripartite window on the façade comprised of a large, square, 20-light window flanked by 4/4-light double-hung sash windows. The remaining windows are 2/2-light and 6/6-light double-hung sash. A small gable-roofed addition has been constructed on the south side elevation, a full-width, shed-roofed addition has been constructed on the rear elevation, and a portion of the porch on the north side elevation has been enclosed.

**Figure 5.178.** Resource 186-0217 (1900 North Limestone Street) - View of façade facing east.

**Figure 5.179.** Resource 186-0217 (1900 North Limestone Street) - View of north side elevation facing south-east.

research questions in history or prehistory. The resource does not appear to have the potential to be the principal source of important information. Therefore, there was no basis for evaluating the resource under Criterion D. The resource does not represent a recognized architectural type or style and does not otherwise appear to represent a significant trend in South Carolina's architectural history. Therefore, Resource 186-0217 is recommended **Not Eligible** for listing in the NRHP under Criterion C in the area of architecture.

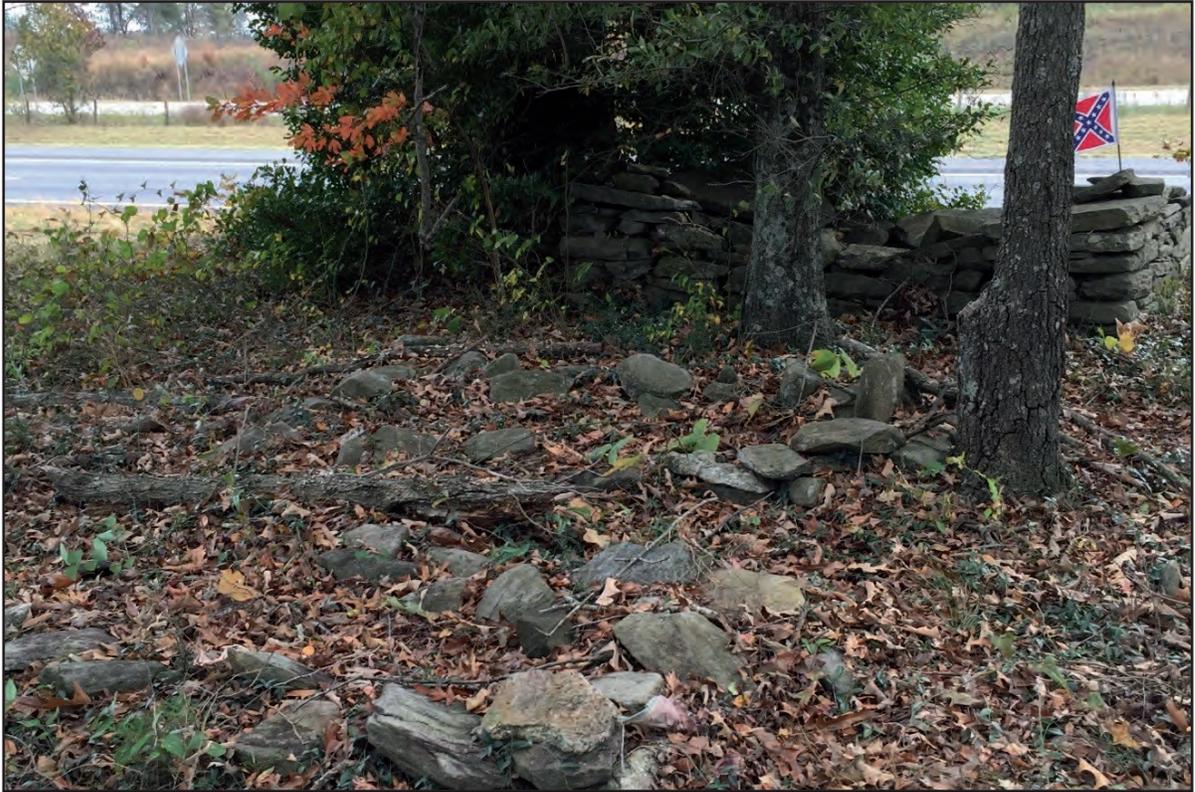
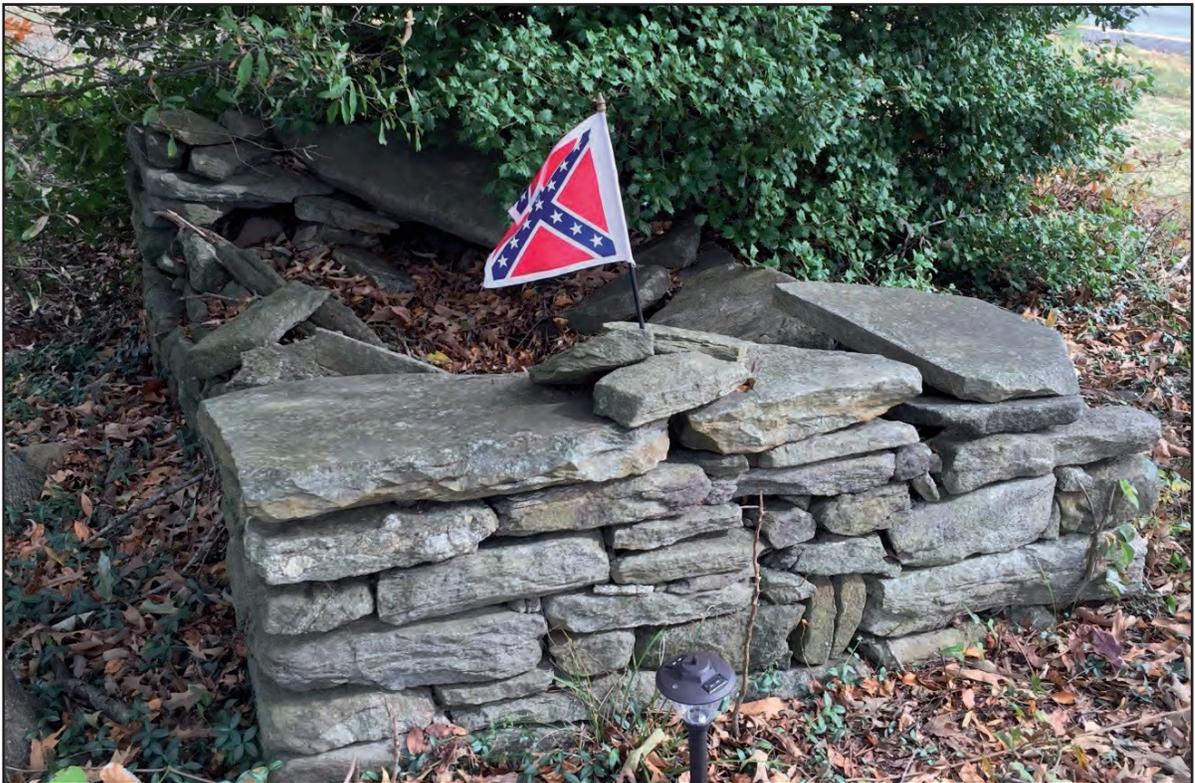
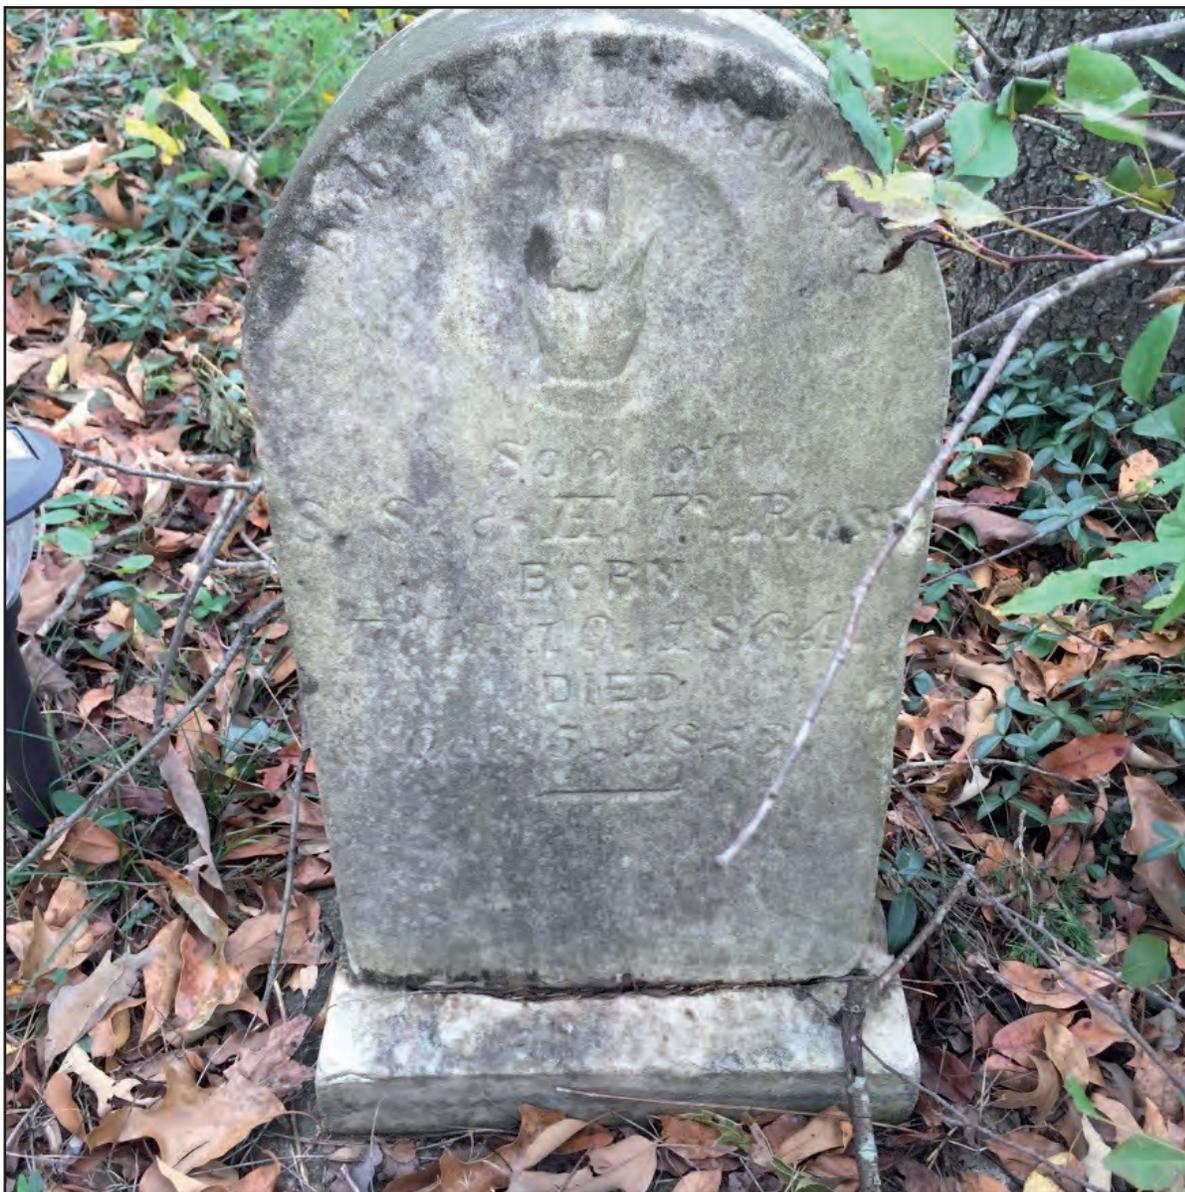
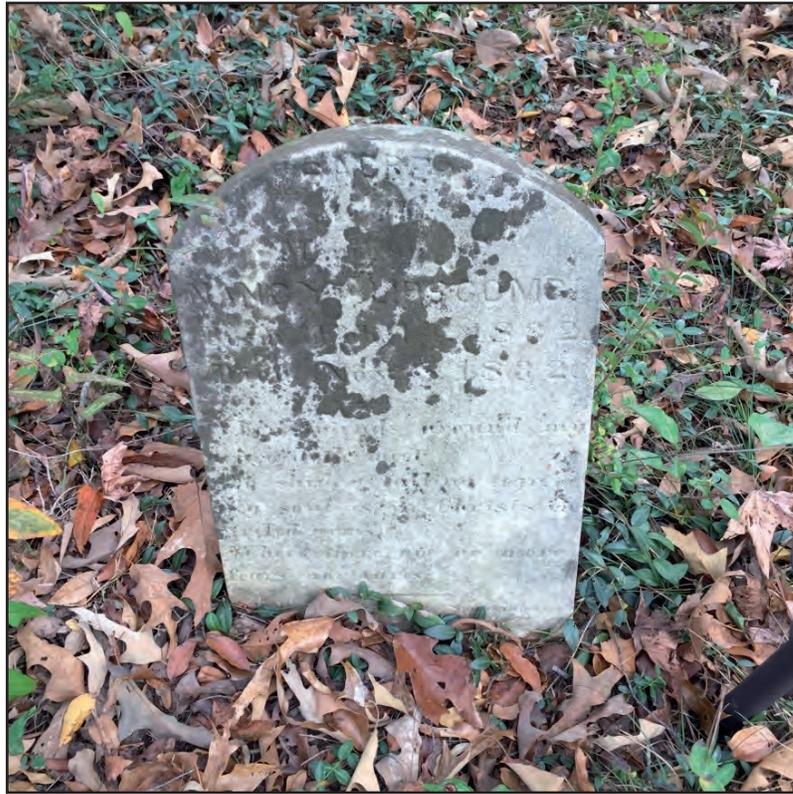
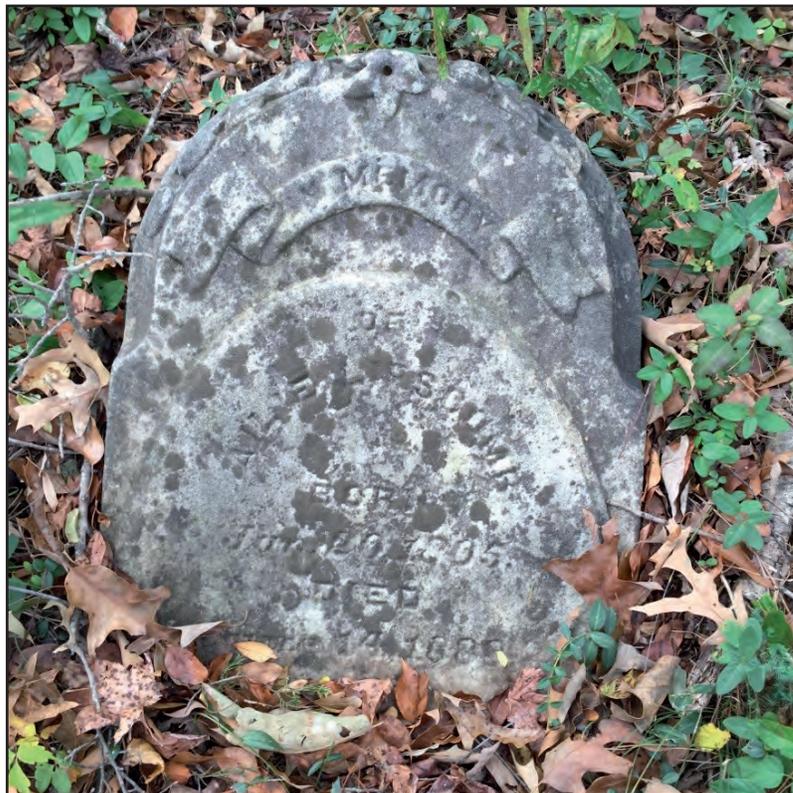
The cemetery is located within the I-85 median at a point where the median is approximately 230 feet wide. The area of the cemetery has several scattered evergreen and deciduous trees and the ground surface has areas of native grass. The three unmarked graves are indicated by rectangular fieldstone grave boundary markers on the ground surface. One grave is marked by a dry-stacked coursed ashlar wall that is approximately 2 feet high. The remaining graves are marked by headstones, a ledger, and a die on base monument (see Figures 5.180 – 5.184). The monuments appear to be limestone and generally face northeast.

**Figure 5.180.** Resource 040-0218 (I-85 median north of Exit 95) – Representative view of Lipscomb Cemetery facing south.

**Figure 5.181.** Resource 040-0218 (I-85 median north of Exit 95) – Representative view of Lipscomb Cemetery facing southeast.

**Figure 5.182.** Resource 040-0218 (I-85 median north of Exit 95) – Representative view of Lipscomb Cemetery facing west.

**Figure 5.183.** Resource 040-0218 (I-85 median north of Exit 95) – Representative view of Lipscomb Cemetery facing west.

**Figure 5.184.** Resource 040-0218 (I-85 median north of Exit 95) – Representative view of Lipscomb Cemetery facing west.

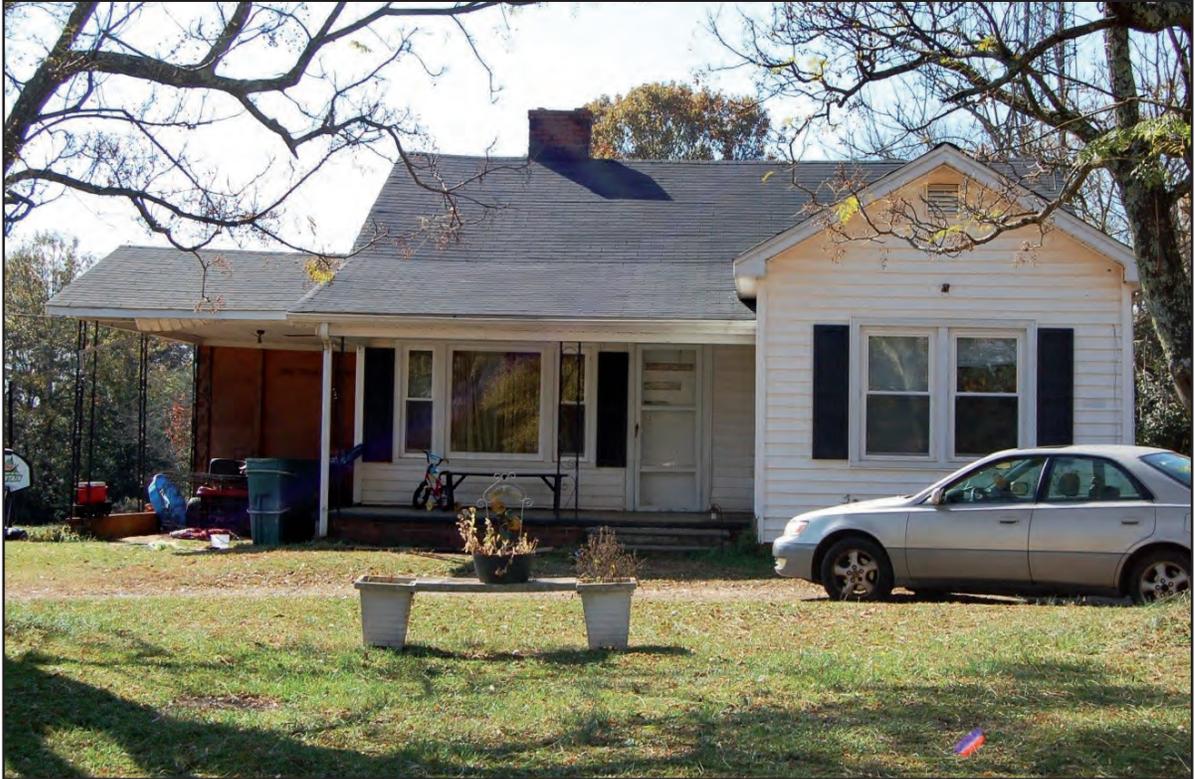
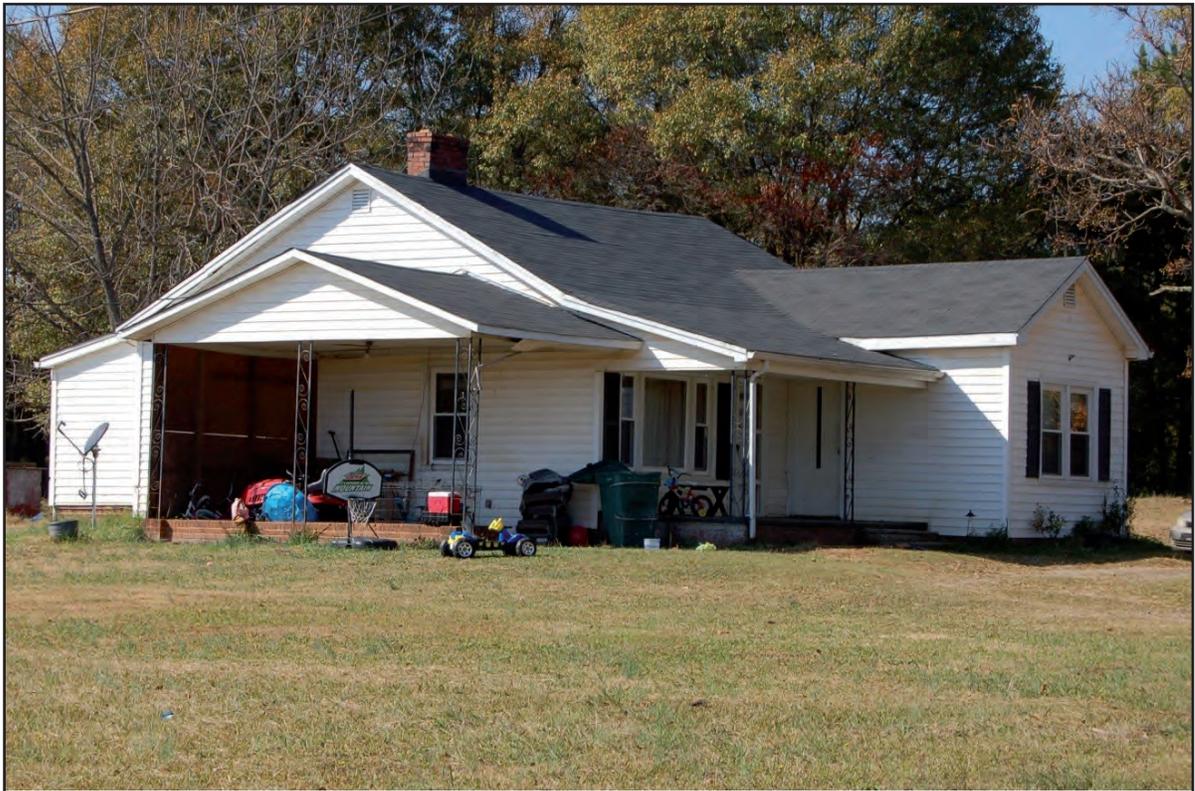
Resource 040-0219 is located at 114 Speedway Road on the west side of the roadway approximately 150 feet southeast of the intersection of Speedway Road and Wind Hill Road northeast of Gaffney in Cherokee County (refer to Figure 5.2d). The Cherokee County tax assessor's record does not have an estimated date of construction for the resource. The resource is not depicted in its current location on the earliest topographic map available on the [www.historicaerials.com](http://www.historicaerials.com) website dated 1945 and the earliest aerial photograph available on the same website is dated 1971. Based on an evaluation of the resource's form and construction materials, Resource 040-0219 appears to have been constructed ca. 1955. The resource is a one-story, asymmetric, cross-gabled cottage of frame construction without stylistic features. The house features a cross-gabled asphalt shingle

roof; a continuous brick foundation; a small brick interior ridgeline chimney; a partial-width, extended, shed-roofed porch on the façade; a partial-width, projecting, gable-roofed carport on the south side elevation; and vinyl exterior siding (see Figures 5.185 and 5.186). The porch roof on the façade and the carport on the south side elevation are supported by decorative metal posts. There is a tripartite window comprised of a large square fixed light flanked by 1/1-light double-hung sash windows on the façade and the remaining windows are 1/1-light double-hung sash of various sizes. All of the windows are non-historic vinyl replacements. A full-width, shed-roofed addition has been constructed on the rear elevation.

**Figure 5.185.** Resource 040-0219 (108 Speedway Road) - View of façade facing west.

**Figure 5.186.** Resource 040-0219 (108 Speedway Road) - Oblique view of façade and south side elevation facing northwest.

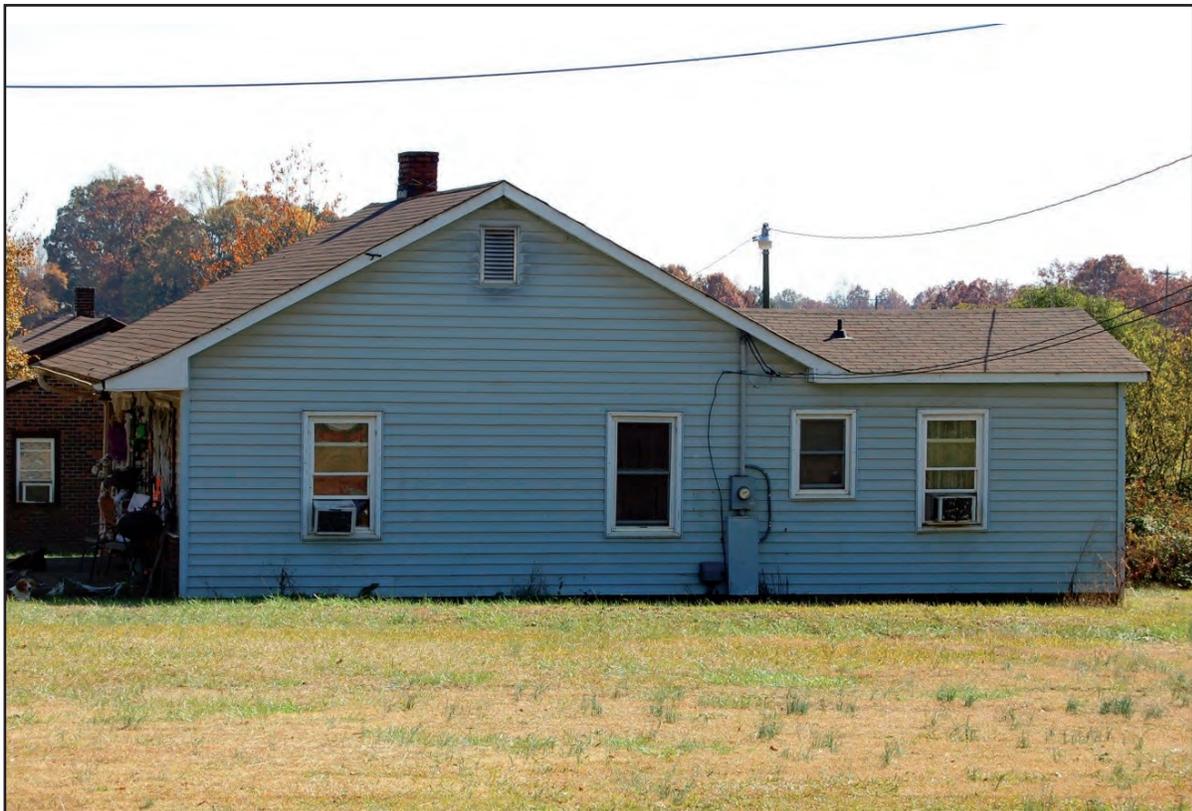
Resource 040-0220 is located at 108 Speedway Road on the west side of the roadway approximately 300 feet southeast of the intersection of Speedway Road and Wind Hill Road northeast of Gaffney in Cherokee County (refer to Figure 5.2d). The Cherokee County tax assessor's record does not have an estimated date of construction for the resource. The resource is not depicted in its current location on the earliest topographic map available on the [www.historicaerials.com](http://www.historicaerials.com) website dated 1945 and the earliest aerial photograph available on the same website is dated 1971. Based on an evaluation of the resource's form and construction materials, Resource 040-0219 appears to have been constructed ca. 1955. The resource is a one-story, asymmetric, side-gabled residence of frame construction. The house features a side-gabled asphalt shingle roof; a continuous brick foundation; a small brick interior ridgeline chimney; a narrow, full-width, extended, shed-roofed porch on the façade without any roof supports; a partial-width, projecting, gable-roofed carport on the south side elevation; and brick and vinyl exterior siding (see Figures 5.187 and 5.188). The carport on the south side elevation is supported by three metal poles. There is a tripartite window comprised of a large square fixed light flanked by 1/1-light double-hung sash windows on the

**Figure 5.188.** Resource 040-0220 (116 Speedway Road) - View of north side elevation facing southwest.

façade and the remaining windows are single and paired 1/1-light double-hung sash of various sizes. The windows appear to be non-historic replacements.

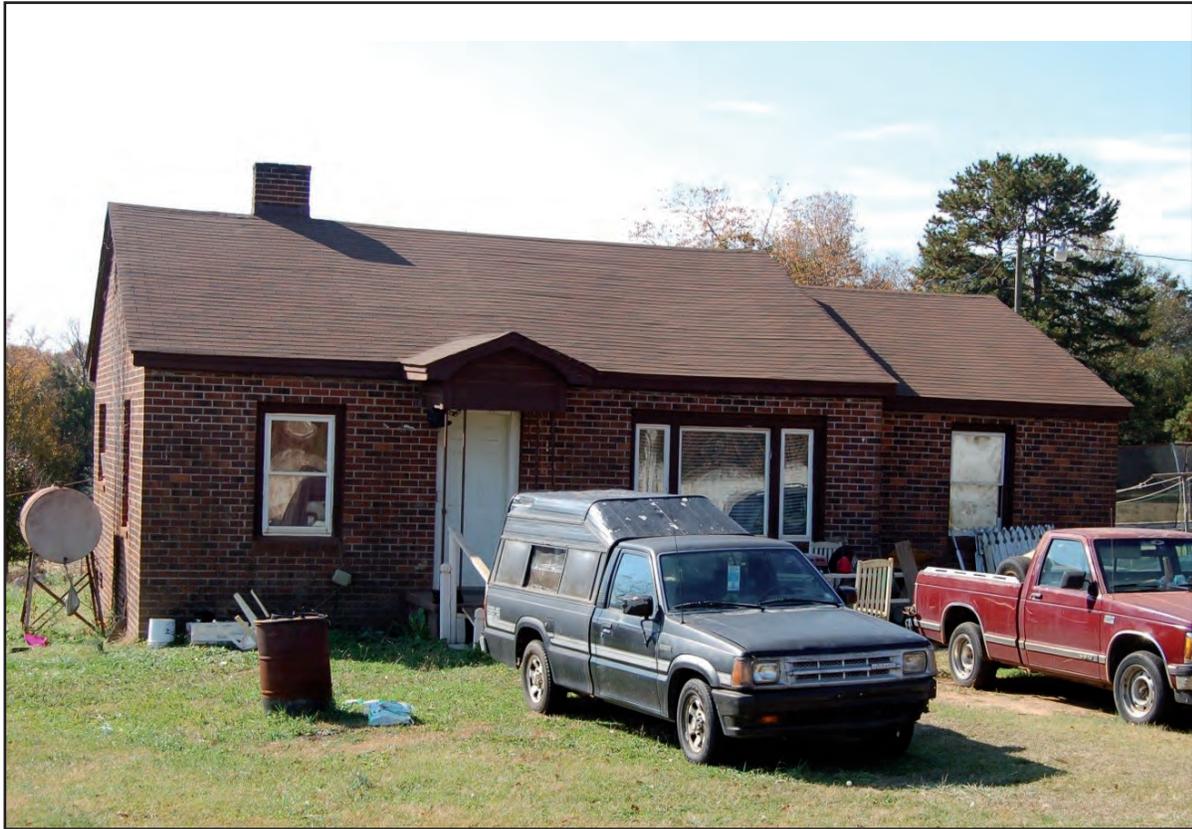
Resource 040-0221 is located at 122 Speedway Road on the west side of the roadway approximately 400 feet southeast of the intersection of Speedway Road and Wind Hill Road northeast of Gaffney in Cherokee County (refer to Figure 5.2d). The Cherokee County tax assessor's record does not have an estimated date of construction for the resource. The resource is not depicted in its current location on the earliest topographic map available on the [www.historicaerials.com](http://www.historicaerials.com) website dated 1945 or the earliest aerial photograph available on the same website is dated 1971. Based on an evaluation of the resource's form and construction materials, Resource 040-0219 appears to have been constructed ca. 1955. The resource is a one-story, asymmetric, side-gabled residence of frame construction without stylistic features. The house features a side-gabled asphalt shingle roof with narrow eaves; a small brick interior ridgeline chimney; a projecting stoop entry porch with a gablet roof on the façade; and running bond brick exterior siding (see Figures 5.189 and 5.190). The stoop porch roof is supported by two decorative metal posts. There is a tripartite window comprised of a large square fixed light flanked by 1/1-light double-hung sash windows on the façade and the remaining windows are 1/1-light double-hung sash of various sizes. All of the windows are non-historic vinyl replacements. There is a near-full-width, shed-roofed addition on the rear elevation. Due to the setback of the windows in the opening and the brick work around the doors, windows, and eaves, the brick exterior siding appears to be a later addition to the resource.

**Figure 5.189.** Resource 040-0221 (122 Speedway Road) - View of facade facing northwest.

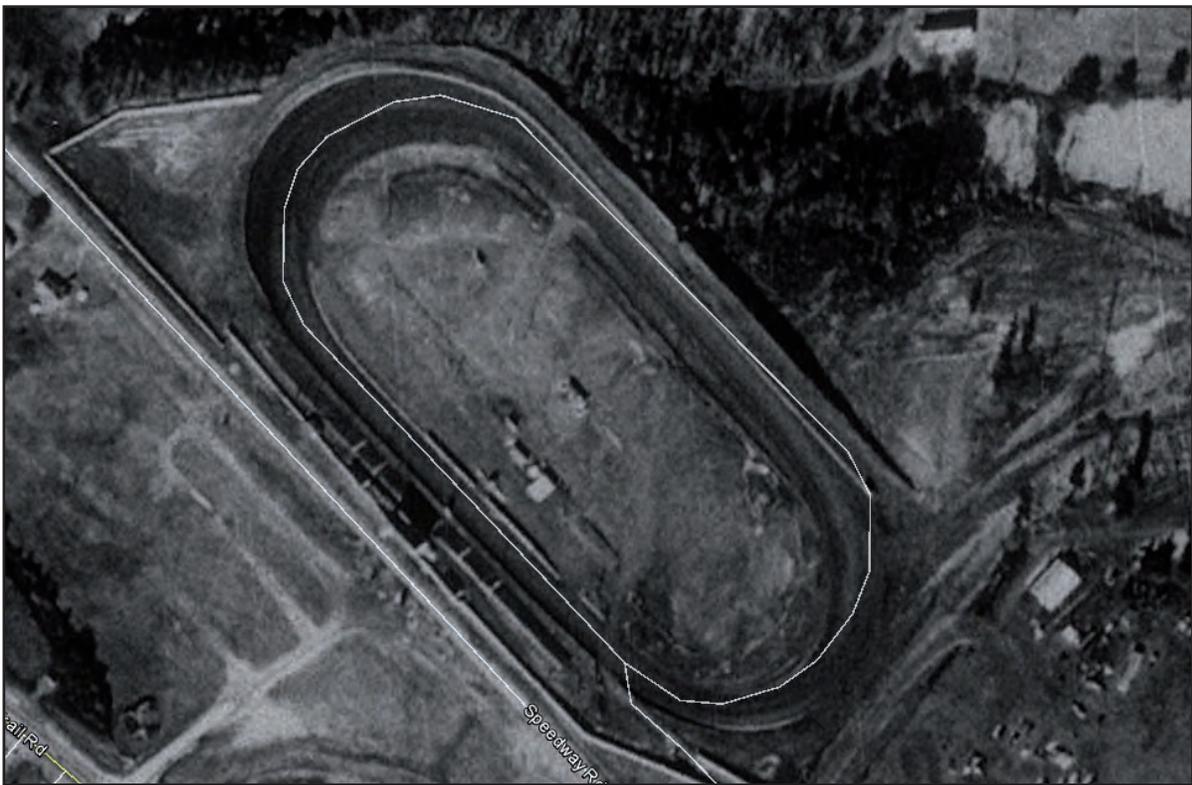
**Figure 5.192.** Resource 040-0222 (153 Speedway Road) - 1994 aerial photograph showing track at its original 1/2-mile length.

Resource 040-0222, the Cherokee Speedway, is located at 153 Speedway Road on the east side of the roadway approximately 750 feet southeast of the intersection of Speedway Road and Wind Hill Road northeast of Gaffney in Cherokee County (refer to Figure 5.2d). The Cherokee County tax assessor's record does not have an estimated date of construction for the resource, but background research indicates that the Cherokee Speedway opened ca. 1952. The resource is an oval dirt-track raceway that is 3/8 mile in length with the straight legs oriented on a northwest-to-southeast alignment. The raceway was originally constructed as an oval dirt track 1/2 mile in length, but was reduced to 3/8 mile in length ca. 1994 (see Figures 5.191 and 5.192). Parallel to the straight leg on the west side of the raceway, there is a spectator stand, press box, and concession stand/ticket sale block. Those structures and a wall that separates the race track from Speedway Road are constructed of primarily of concrete block (see Figures 5.193 – 5.196). The upper level of the press box, portions of the spectator stands, and the roof of the concession stand/ticket office have frame elements. The site was closed at the time of the field survey and all observations and evaluations had to be made from outside the perimeter wall and fences. Spectator parking is provided by gravel lots on the west side of Speedway Road opposite the race track.
