**PHASE I CULTURAL RESOURCE SURVEY FOR PROPOSED  
WIDENING OF INTERSTATE 85 FROM MILE MARKER 80 TO 96,  
CHEROKEE AND SPARTANBURG COUNTIES, SOUTH CAROLINA.**

**FINAL REPORT**

**JULY 2015**

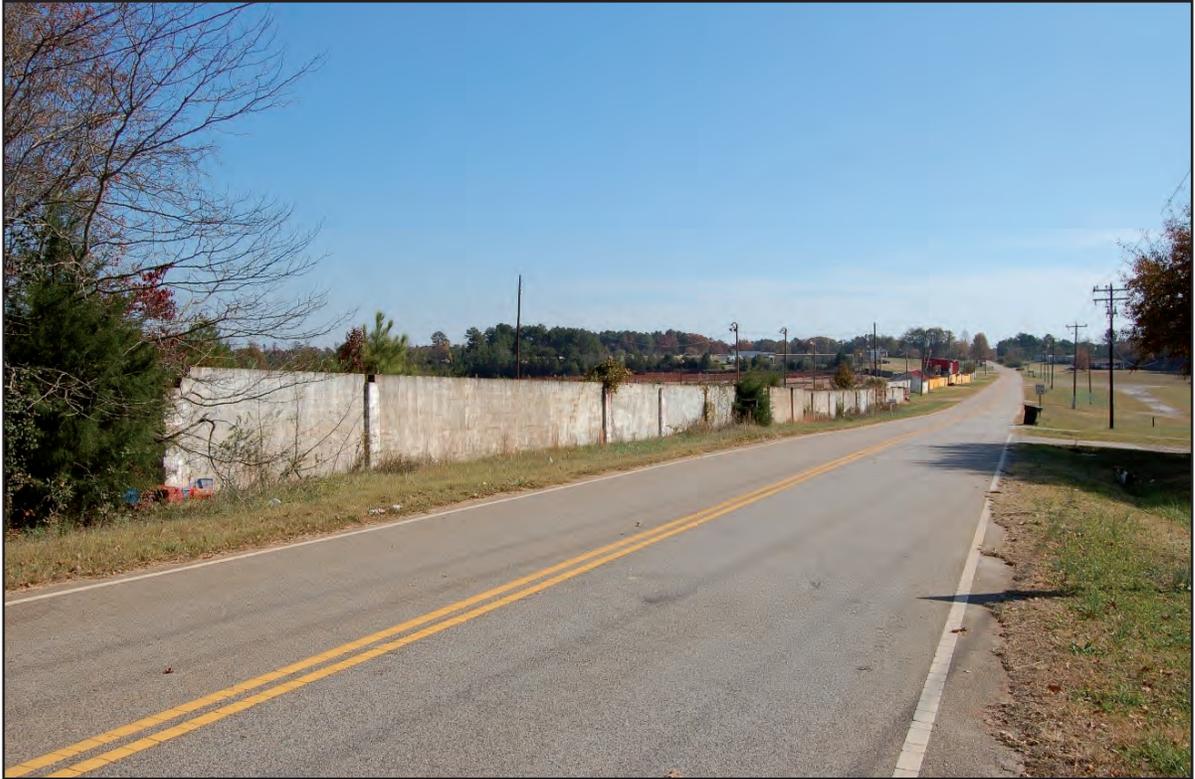
**Figure 5.193.** Resource 040-0222 (153 Speedway Road) - View of perimeter wall facing southeast.

Resource 040-0222, the Cherokee Speedway, is located at 153 Speedway Road on the east side of the roadway approximately 750 feet southeast of the intersection of Speedway Road and Wind Hill Road northeast of Gaffney in Cherokee County (refer to Figure 5.2d). The Cherokee County tax assessor's record does not have an estimated date of construction for the resource, but background research indicates that the Cherokee Speedway opened ca. 1952. The resource is an oval dirt-track raceway that is 3/8 mile in length with the straight legs oriented on a northwest-to-southeast alignment. The raceway was originally constructed as an oval dirt track 1/2 mile in length, but was reduced to 3/8 mile in length ca. 1994 (see Figures 5.191 and 5.192). Parallel to the straight leg on the west side of the raceway, there is a spectator stand, press box, and concession stand/ticket sale block. Those structures and a wall that separates the race track from Speedway Road are constructed of primarily of concrete block (see Figures 5.193 – 5.196). The upper level of the press box, portions of the spectator stands, and the roof of the concession stand/ticket office have frame elements. The site was closed at the time of the field survey and all observations and evaluations had to be made from outside the perimeter wall and fences. Spectator parking is provided by gravel lots on the west side of Speedway Road opposite the race track.

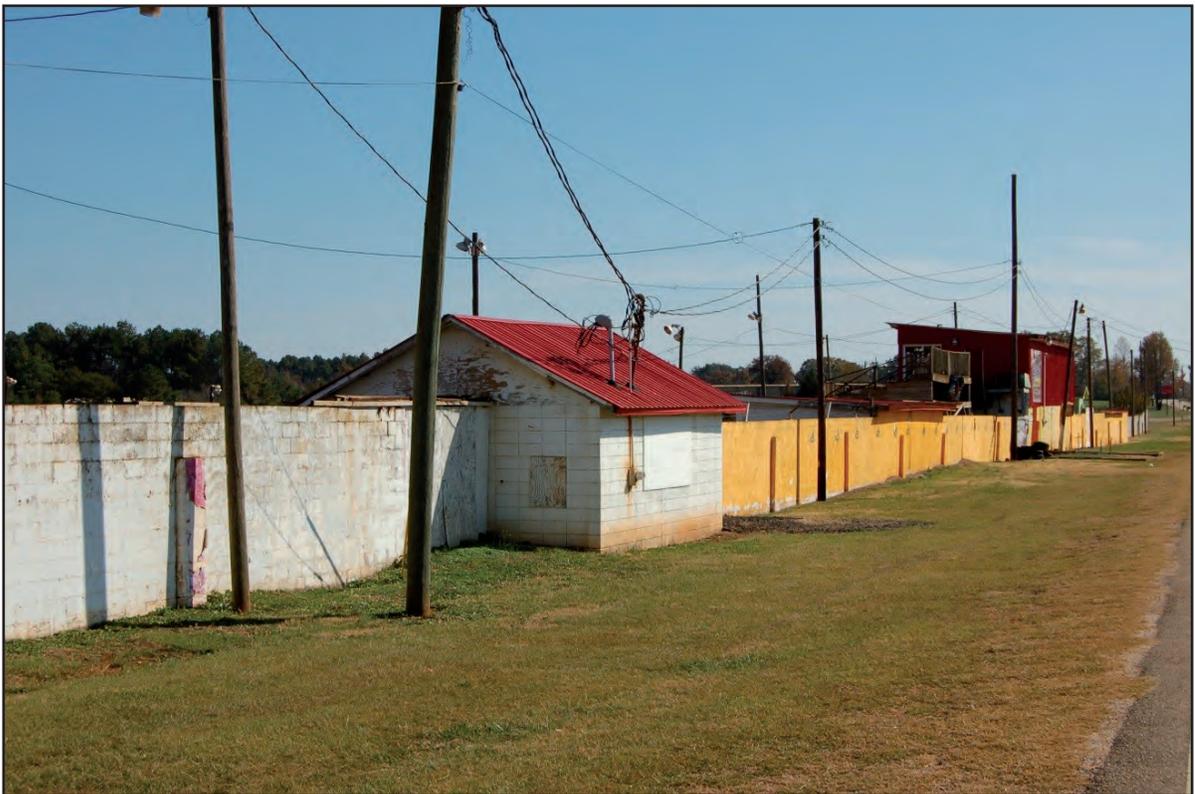
**Figure 5.194.** Resource 040-0222 (153 Speedway Road) - View of perimeter wall, rear of grandstand, and support buildings facing southeast.

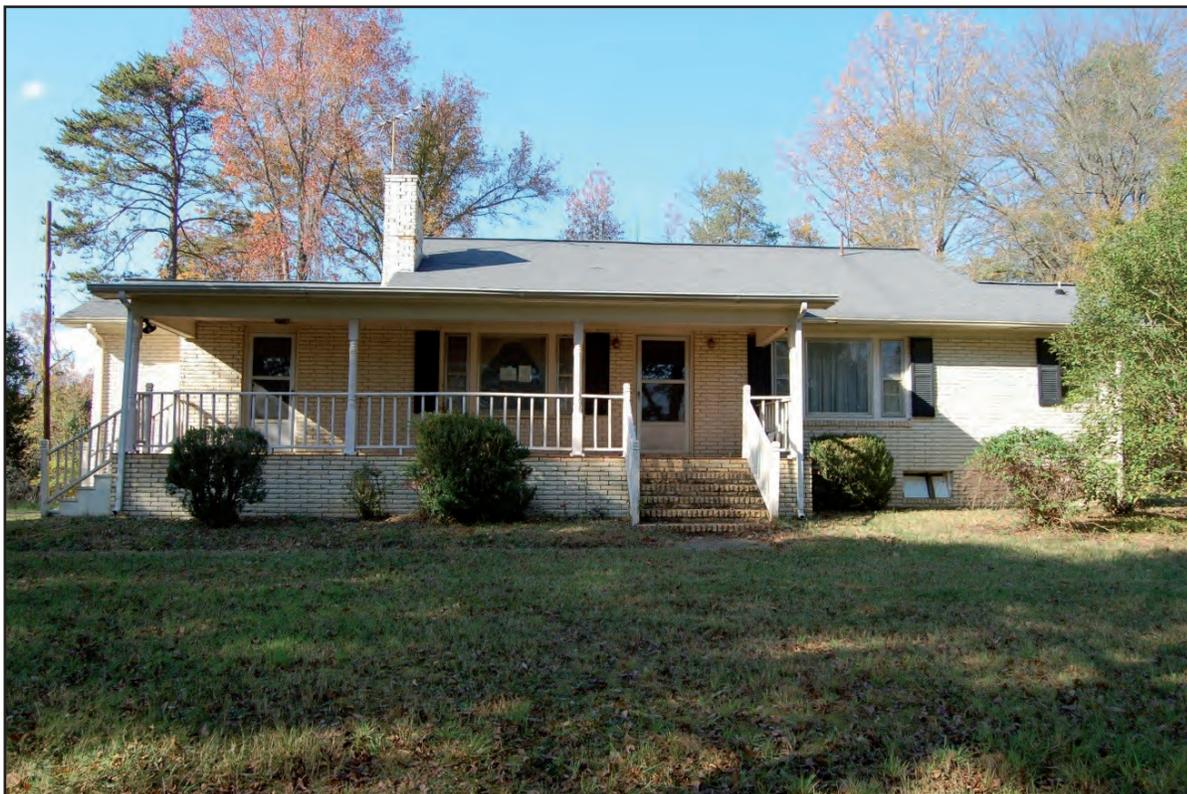
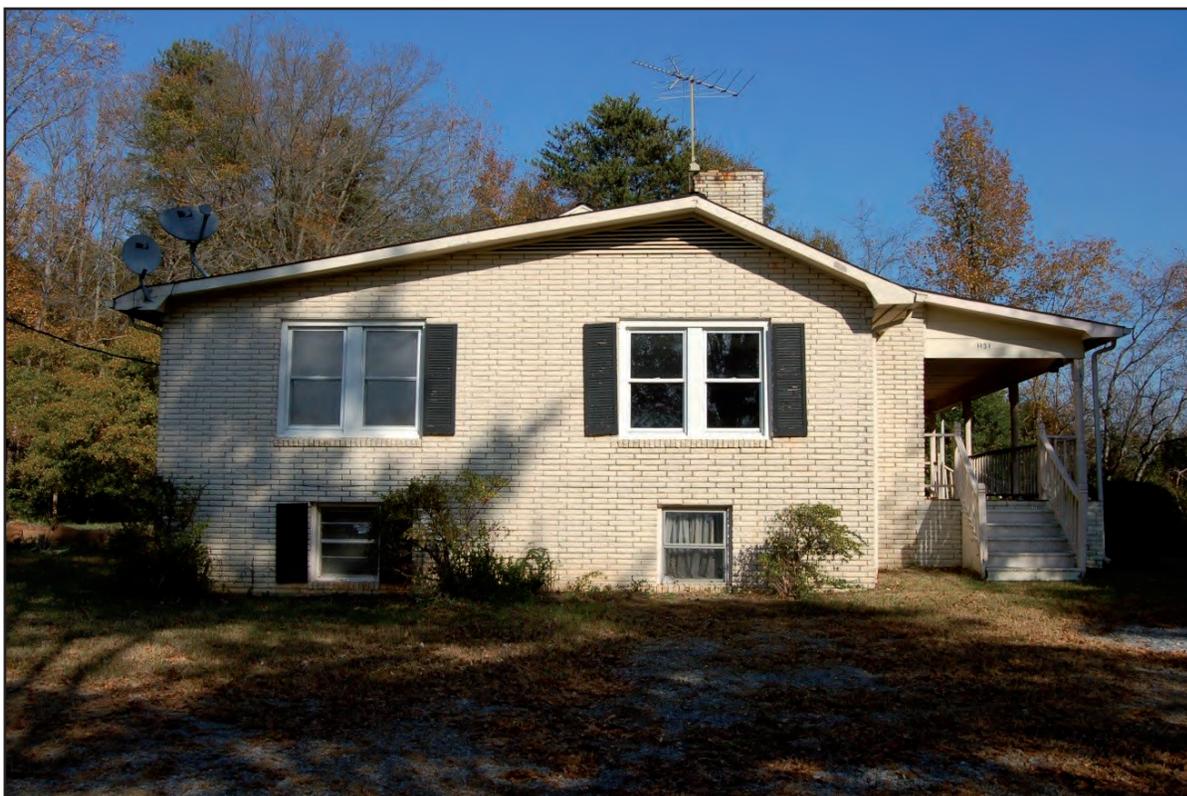
**Figure 5.197.** Resource 040-0223 (1131 Wilcox Avenue) - View of façade facing north.

**Figure 5.198.** Resource 040-0223 (1131 Wilcox Avenue) - View of west side elevation facing east.

Resource 040-0223 is located at 1131 Wilcox Avenue on the north side of the roadway approximately 530 feet east of the intersection of Wilcox Avenue and Providence School Road north of Gaffney in Cherokee County (refer to Figure 5.2d). The Cherokee County tax assessor's record does not have an estimated date of construction for the resource. Based on a review of historic topographic maps and an evaluation of the resource's form and construction materials, Resource 040-0223 appears to have been constructed ca. 1950. This estimated date of construction is supported by the depiction of the resource in its current location on the earliest aerial photograph available on the [www.historicaerials.com](http://www.historicaerials.com) website dated 1955. The resource is a one-story, asymmetric, side-gabled residence of frame construction. The house features a side-gabled asphalt shingle roof; a tall brick interior end wall chimney on the west side elevation; a partial-width, extended, shed-roofed porch on the facade; an enclosed partial-width, shed-roofed porch on the east side elevation; and running bond Roman brick exterior siding (see Figures 5.197 and 5.198). The roof of the porch on the façade is supported by four turned wooden posts and the porch and stairs has wooden balustrade railings. There are two tripartite windows comprised of a large square fixed light flanked by 2/2-light double-hung sash windows on the façade and the remaining windows are 6/6-light and 1/1-light double-hung sash of various sizes.

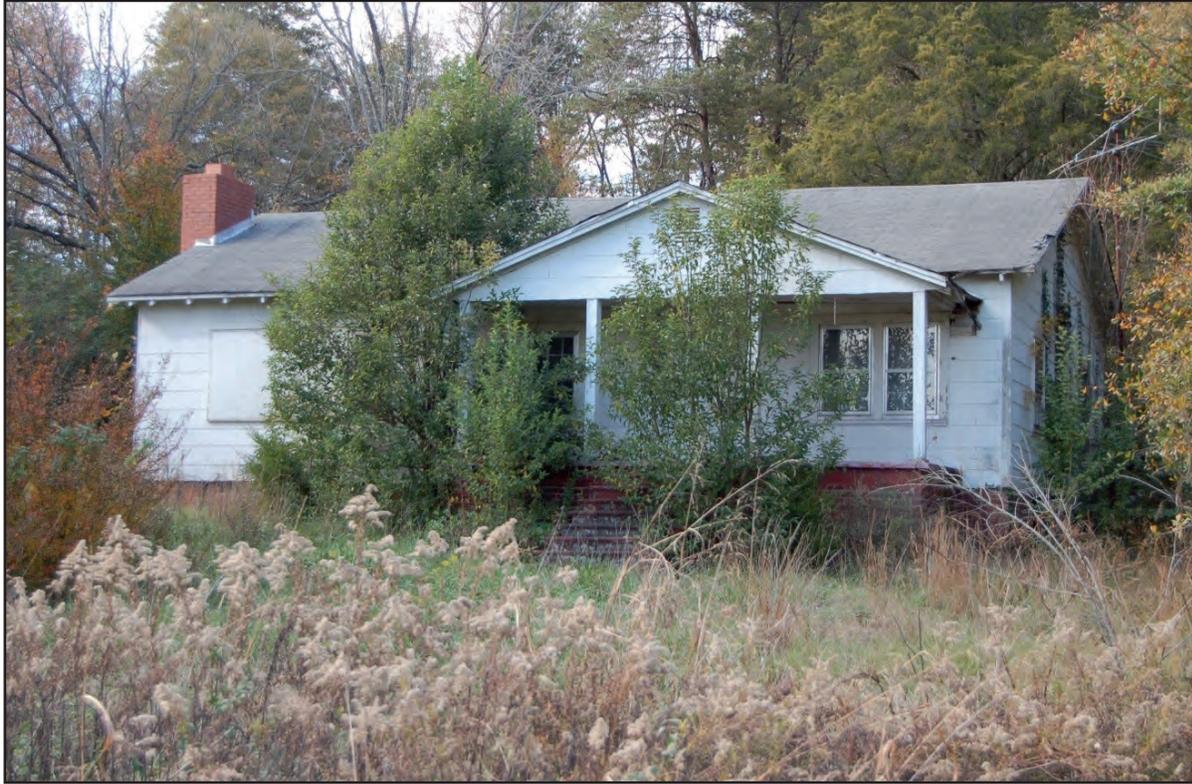
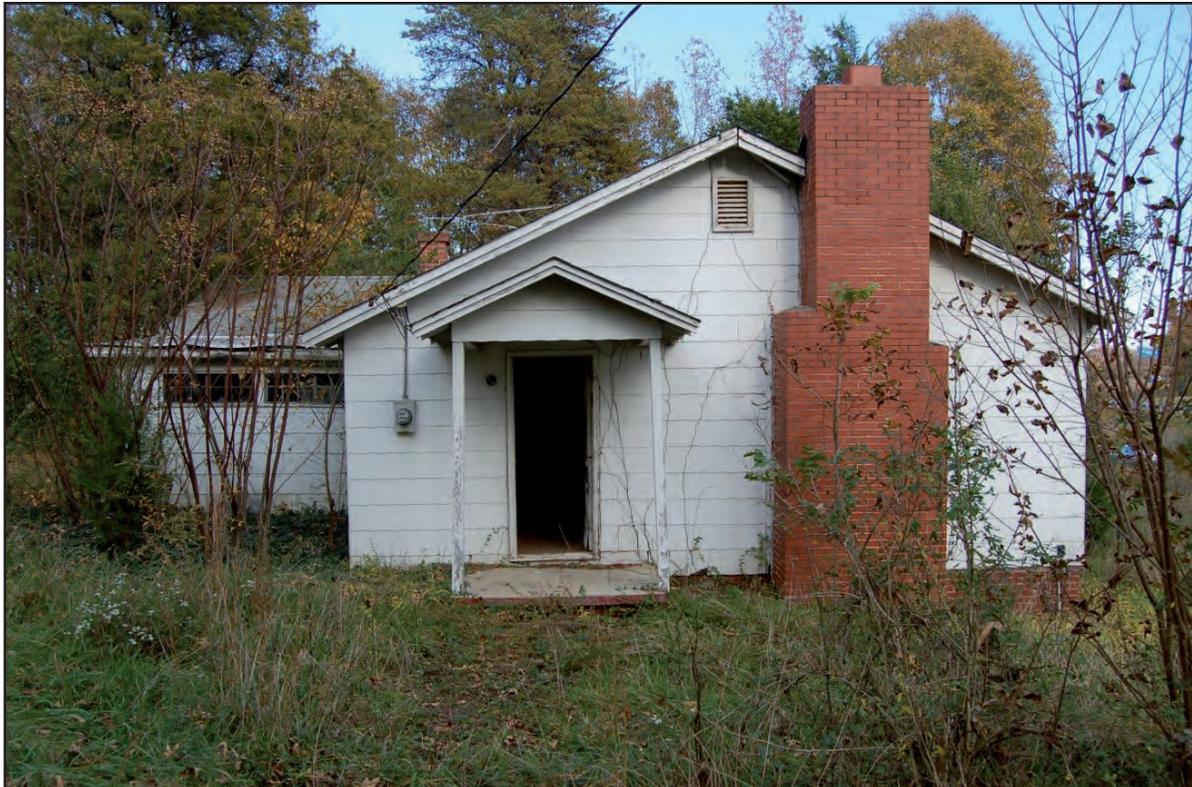
**Figure 5.199.** Resource 040-0224 (1143 Wilcox Avenue) - View of façade facing north.

**Figure 5.200.** Resource 040-0224 (1143 Wilcox Avenue) - View of west side elevation facing east.

Resource 040-0224 is located at 1143 Wilcox Avenue on the north side of the roadway approximately 0.15 mile east of the intersection of Wilcox Avenue and Providence School Road north of Gaffney in Cherokee County (refer to Figure 5.2d). The Cherokee County tax assessor's record does not have an estimated date of construction for the resource. Based on a review of historic topographic maps and an evaluation of the resource's form and construction materials, Resource 040-0224 appears to have been constructed ca. 1950. This estimated date of construction is supported by the depiction of the resource in its current location on the earliest aerial photograph available on the [www.historicaerials.com](http://www.historicaerials.com) website dated 1955. The resource is a one-story, asymmetric,

cross-gabled residence of frame construction. The house features a cross-gabled asphalt shingle roof; a continuous brick foundation; a large brick slab exterior end wall chimney on the west side elevation; a small brick interior roof surface chimney within the roof slope of the rear ell; a partial-width, projecting, gable-roofed porch on the façade; a gable-roofed stoop porch on the west side elevation; and concrete asbestos tile exterior siding (see Figures 5.199 and 5.200). The porch roofs are supported by wooden posts. Windows are primarily single and paired 6/6-light double-hung sash of various sizes, but the rear shed-roofed addition has narrow, fixed 8-light windows. A ribbon of windows on the western end of the façade has been partially enclosed with plywood.

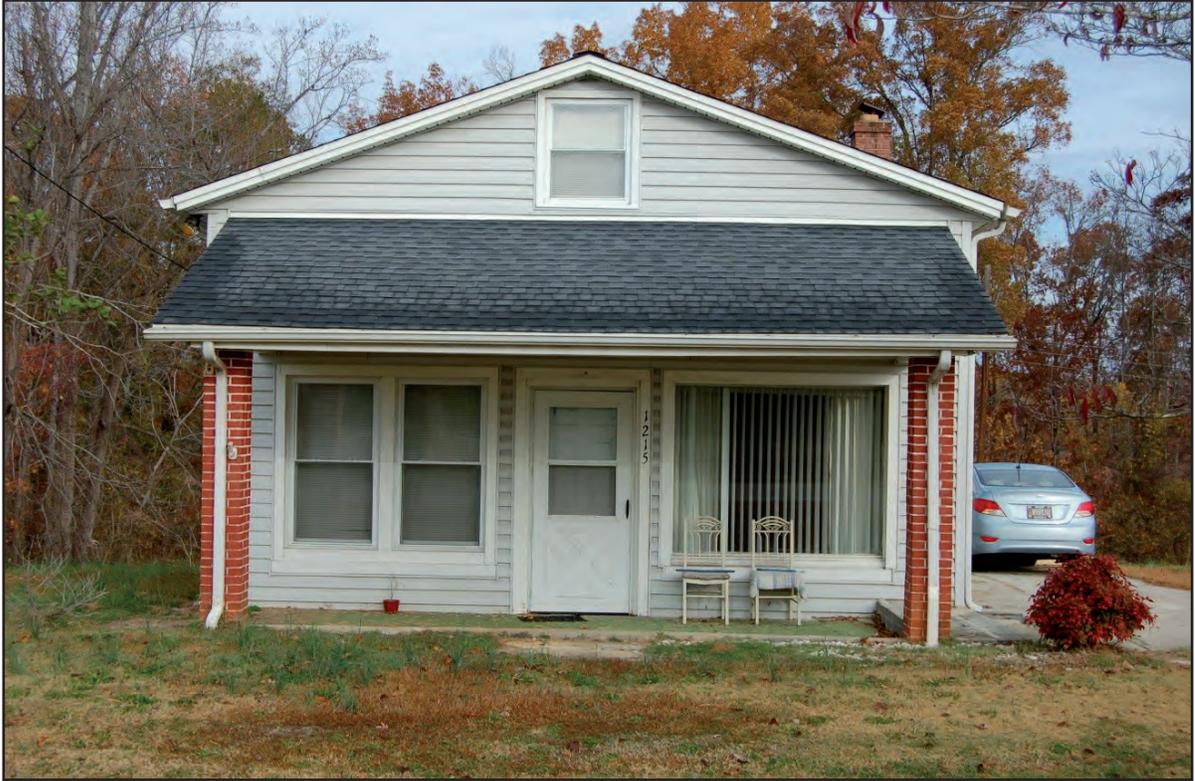
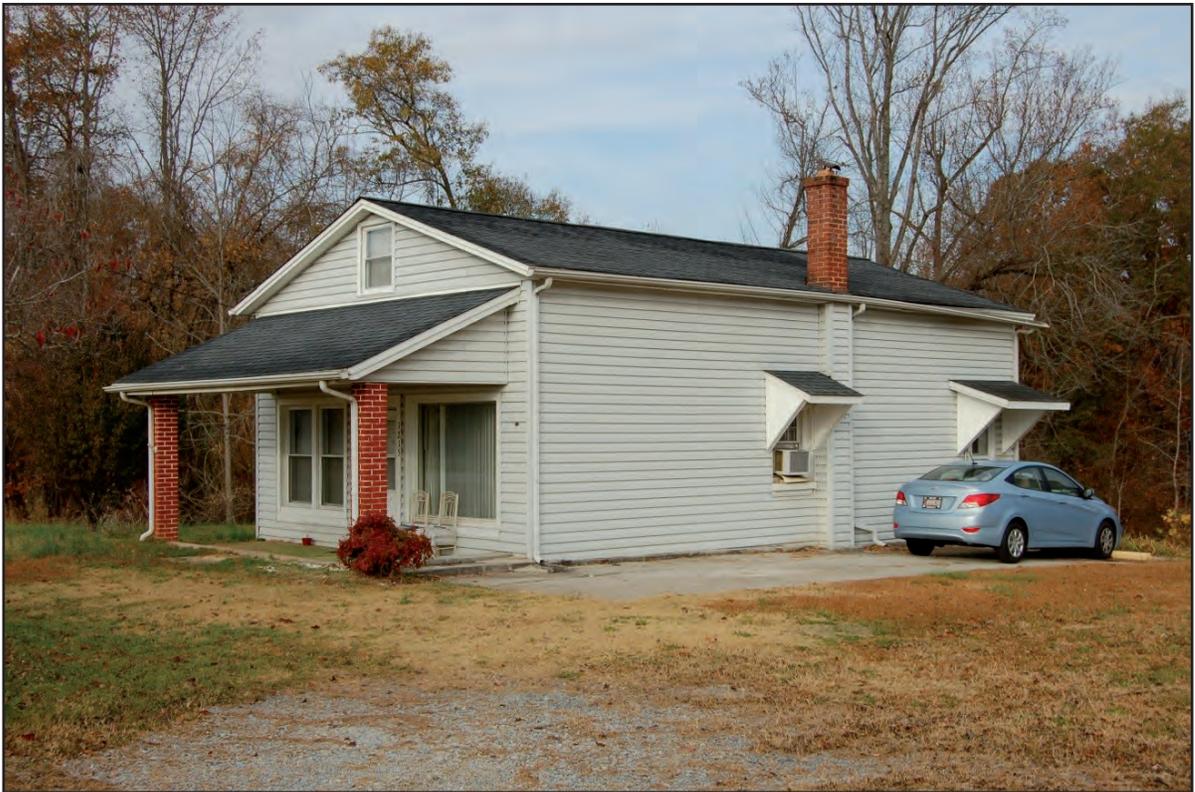
**Figure 5.201.** Resource 040-0225 (1215 Wilcox Avenue) - View of façade facing north.

**Figure 5.202.** Resource 040-0225 (1215 Wilcox Avenue) - Oblique view of façade and east side elevation facing northwest.

Resource 040-0225 is located at 1215 Wilcox Avenue on the north side of the roadway approximately 0.44 mile east of the intersection of Wilcox Avenue and Providence School Road north of Gaffney in Cherokee County (refer to Figure 5.2d). The Cherokee County tax assessor's record only has an estimated date of construction for the house located on the same legal parcel as the resource. The daughter of the original owners and builders of the property estimated that it was constructed ca. 1960. However, the building is depicted in its current location on the earliest aerial photograph available on the [www.historicaerials.com](http://www.historicaerials.com) website dated 1955. Based on the building's form and materials of construction, it is estimated to have been constructed ca. 1952. The resource is a former house type service station that was constructed by the owner of the adjacent house located at 1219 Wilcox Avenue identified as Resource 040-0226. The building is a one-story, asymmetric, front-gabled building of frame construction now used as a residence. It features a front-gabled asphalt shingle roof; a continuous concrete block foundation; a small brick exterior chimney on the east side elevation; a full-width, projecting, shed-roofed porch on the façade; and vinyl exterior siding (see Figures 5.201 and 5.202). The roof of the porch is supported by two brick piers. There is a large square picture window on the east side of the door on the façade and a pair of non-historic 1/1-light double-hung sash windows on the west side of the door on the façade. There are two windows on the east side elevation and one window on the west side elevations.

These windows are small non-historic 1/1-light double-hung sash and they have wooden awning structures on the top and sides of the windows.

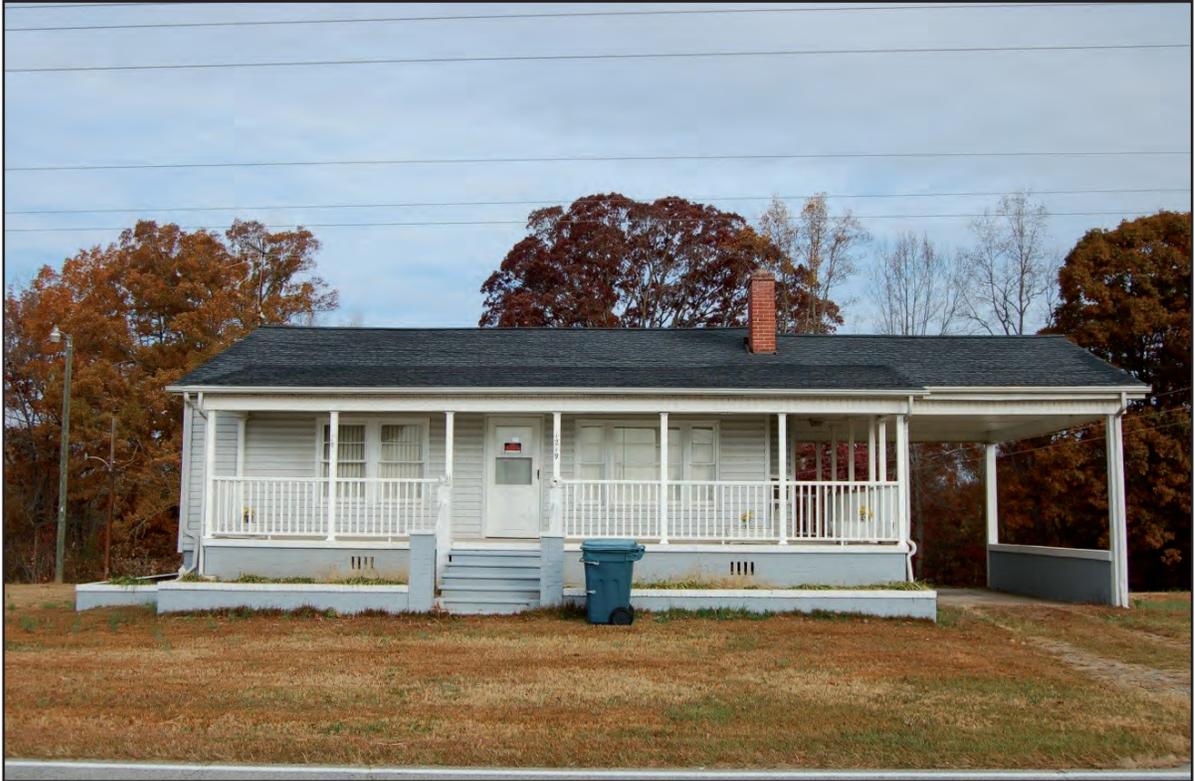
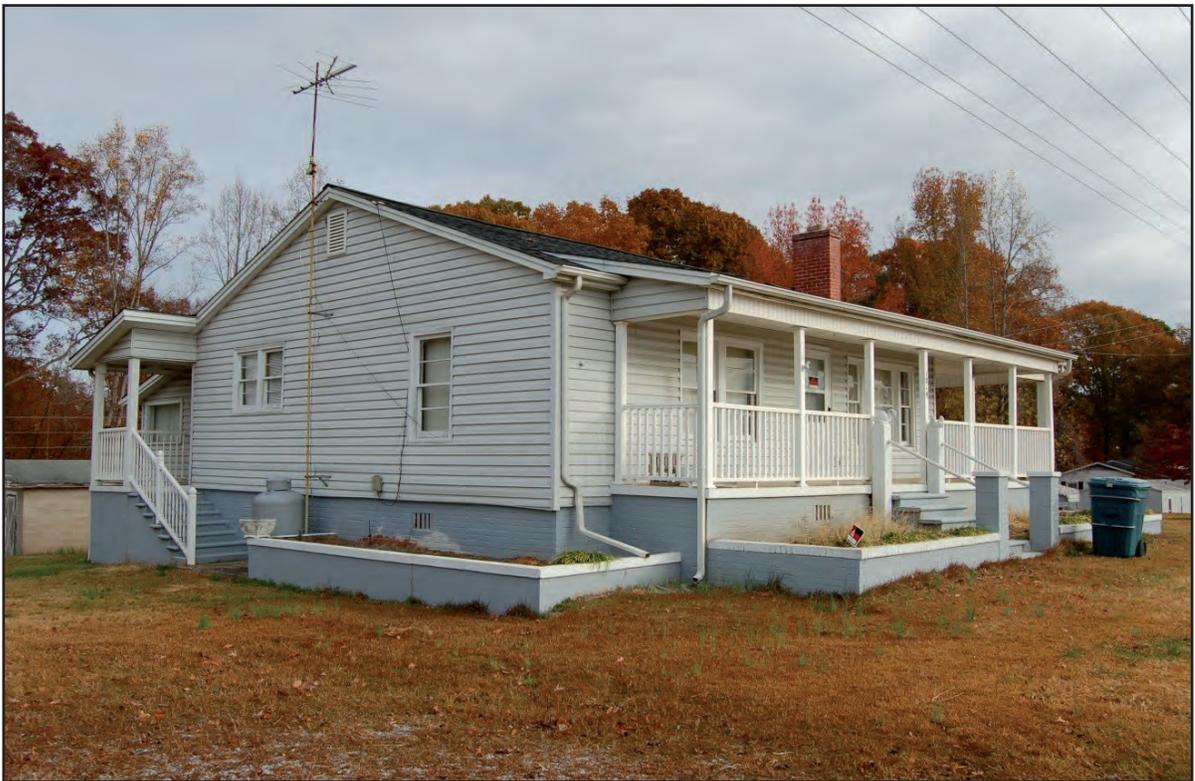
**Figure 5.203.** Resource 040-0226 (1219 Wilcox Avenue) - View of façade facing north.

**Figure 5.204.** Resource 040-0226 (1219 Wilcox Avenue) - Oblique view of façade and west side elevation facing northeast.

Resource 040-0226 is located at 1219 Wilcox Avenue on the north side of the roadway approximately 0.45 mile east of the intersection of Wilcox Avenue and Providence School Road north of Gaffney in Cherokee County (refer to Figure 5.2d). The Cherokee County tax assessor's record has a 1940 estimated date of construction for the resource. This estimated date of construction is supported by the depiction of the resource in its current location on the earliest aerial photograph available on the [www.historicaerials.com](http://www.historicaerials.com) website dated 1955. The resource is a one-story, asymmetric, side-gabled residence of frame construction. The house features a side-gabled asphalt shingle roof with narrow eaves; a continuous brick foundation; a tall brick interior roof surface chimney within the front roof slope; a near-full-width, projecting, wrap-around porch on the façade and east side elevation; a shed-roofed stoop entry porch on the west side elevation; a partial-width, projecting, gable-roofed carport on the east side elevation; and vinyl exterior siding (see Figures 5.203 and 5.204). The wrap-around porch and the carport roof are supported by square wooden posts. There is a tripartite window comprised of a large square 4-light window flanked by 2/2-light double-hung sash windows on the façade and the remaining windows are original single and paired wood-framed 2/2-light double-hung sash of various sizes.

resource under Criterion D. The resource does not represent a recognized architectural type or style and does not otherwise appear to represent a significant trend in South Carolina's architectural history. Therefore, Resource 040-0226 is recommended **Not Eligible** for listing in the NRHP under Criterion C in the area of architecture.

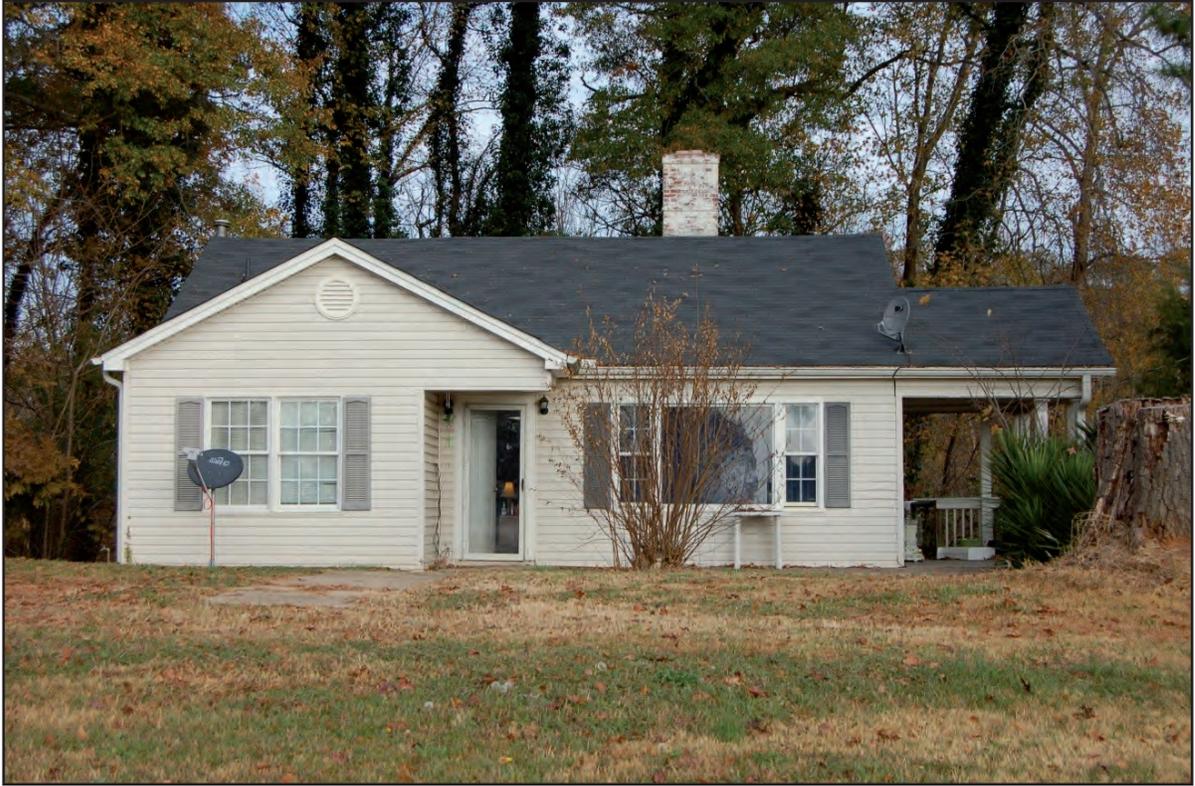
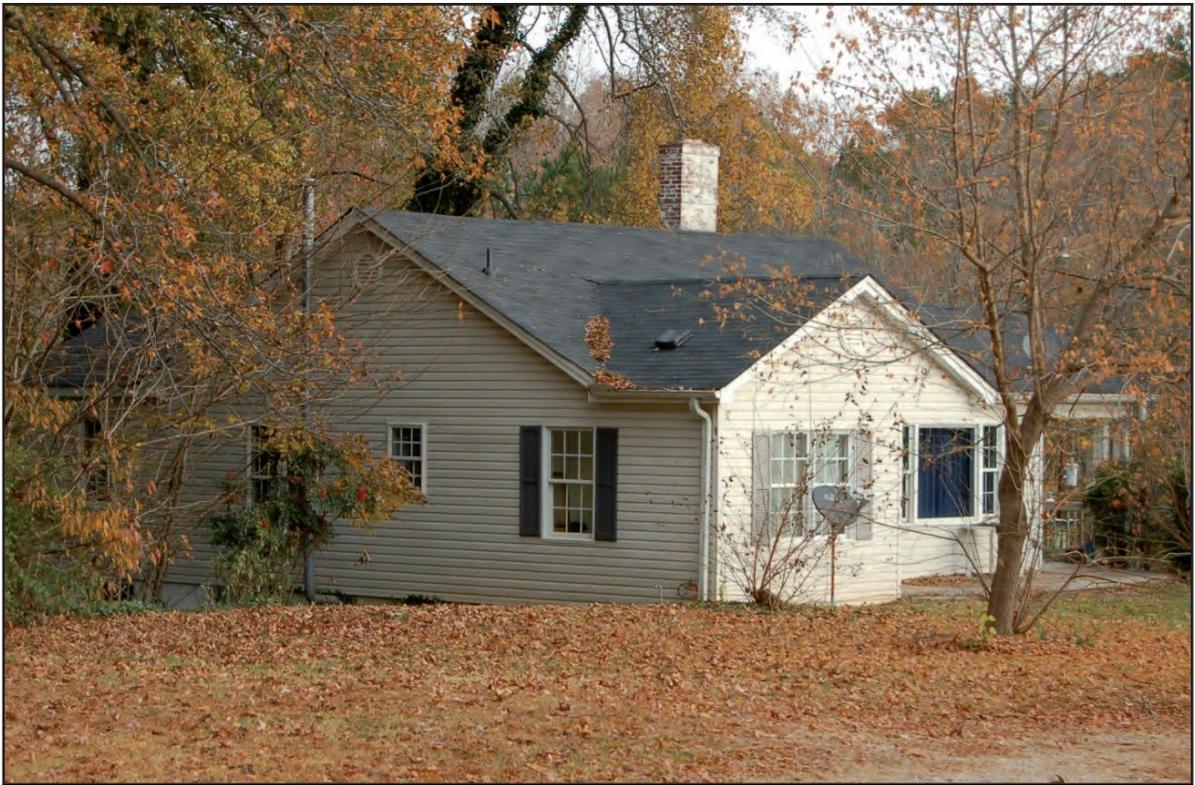
**Figure 5.205.** Resource 040-0227 (1259 Wilcox Avenue) - View of façade facing north.

**Figure 5.206.** Resource 040-0227 (1259 Wilcox Avenue) - Oblique view of façade and west side elevation facing northeast.

Resource 040-0227 is located at 1259 Wilcox Avenue on the north side of the roadway approximately 0.59 mile east of the intersection of Wilcox Avenue and Providence School Road north of Gaffney in Cherokee County (refer to Figure 5.2d). The Cherokee County tax assessor's record has a 1955 estimated date of construction for the resource. This estimated date of construction could not be confirmed in a review of historic aerial photography and topographic maps on the [www.historicaerials.com](http://www.historicaerials.com) website because there is a 30-year gap between the topographic maps dated 1945 and 1974 and the earliest aerial photography available is dated 1971. However, the form, massing, and construction materials are consistent with the 1955 estimated date of construction. The resource is a one-story, asymmetric, cross-gabled residence of frame construction. The house features a cross-gabled asphalt shingle roof with narrow eaves; a continuous concrete block foundation; a tall brick interior roof surface chimney within the rear roof slope; a small, recessed, entry porch inset within the projecting gable-roofed wing on the façade; a partial-width projecting gable-roofed carport on the east side elevation; and vinyl exterior siding (see Figures 5.205 and 5.206). The roof of the inset porch on the façade is not supported and the roof of the gable-roofed carport on the east side elevation is supported by paired wooden posts. There is a large tripartite window comprised of a large square fixed light flanked by 4/4-light double-hung sash windows on the façade and the remaining windows are single and paired 6/6-light double-hung sash of various sizes. All of the windows appear to be non-historic vinyl replacements with faux muntins.

The resource is not known to be associated with a significant activity or event and there is not a known connection between the resource and any individual whose activities or achievements are historically significant. Therefore, there was no basis for evaluating the resource under Criterion A or B. Also, there is no indication that the resource is likely to yield information on important research questions in history or prehistory. The resource does not appear to have the potential to be the principal source of important information. Therefore, there was no basis for evaluating the resource under Criterion D. The resource does not represent a recognized architectural type or style and does not otherwise appear to represent a significant trend in South Carolina's architectural history. Additionally, due to the application of vinyl exterior siding and the replacement of the original windows the resource has lost integrity in the areas of materials, workmanship, and feeling and cannot convey significance in the area of architecture. Therefore, Resource 040-0227 is recommended **Not Eligible** for listing in the NRHP under Criterion C in the area of architecture.

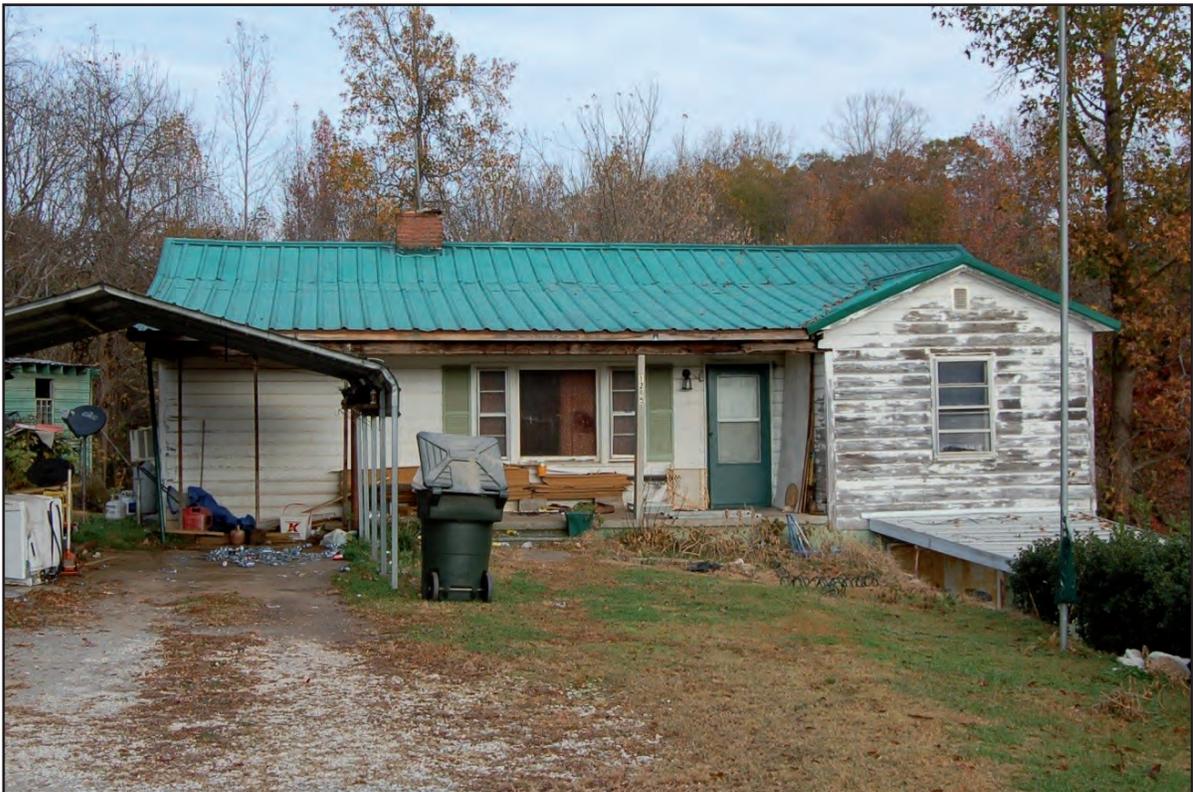
**Figure 5.207.** Resource 040-0228 (1265 Wilcox Avenue) - View of façade facing north.

are consistent with the 1950 estimated date of construction. The resource is a one-story, asymmetric, front-gabled bungalow of frame construction. The house features a front-gabled metal roof; a continuous concrete block foundation; a partial-width, projecting, gable-roofed porch on the façade; and vertical board exterior siding (see Figure 5.208). The roof of the front port is supported by four wooden posts. The windows are wood-framed 1/1-light double-hung sash. Due to an unrestrained dog, the property could not be accessed and only the façade could be observed and evaluated.

The resource is not known to be associated with a significant activity or event and there is not a known connection between the resource and any individual whose activities or achievements are historically significant. Therefore, there was no basis for evaluating the resource under Criterion A or B. Also, there is no indication that the resource is likely to yield information on important research questions in history or prehistory. The resource does not appear to have the potential to be the principal source of important information. Therefore, there was no basis for evaluating the resource under Criterion D. The resource is an undistinguished example of a common architectural type and is recommended **Not Eligible** for listing in the NRHP under Criterion C in the area of architecture.

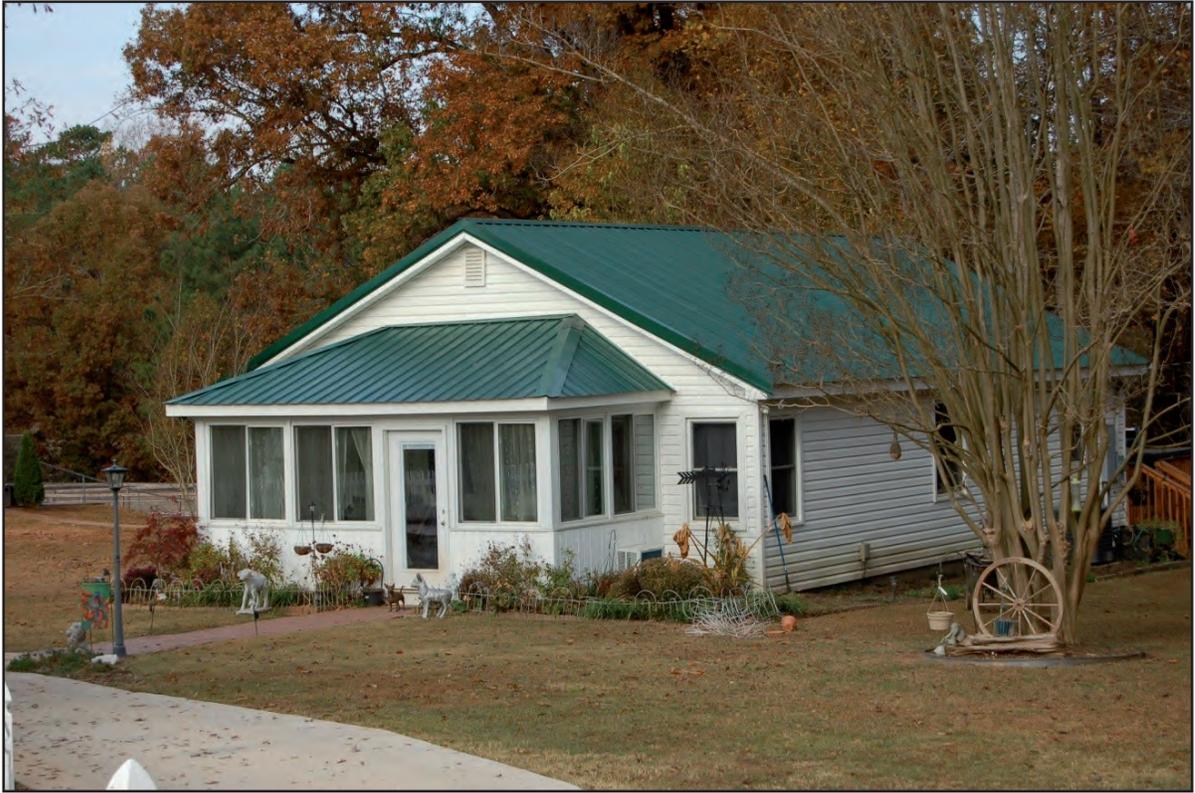
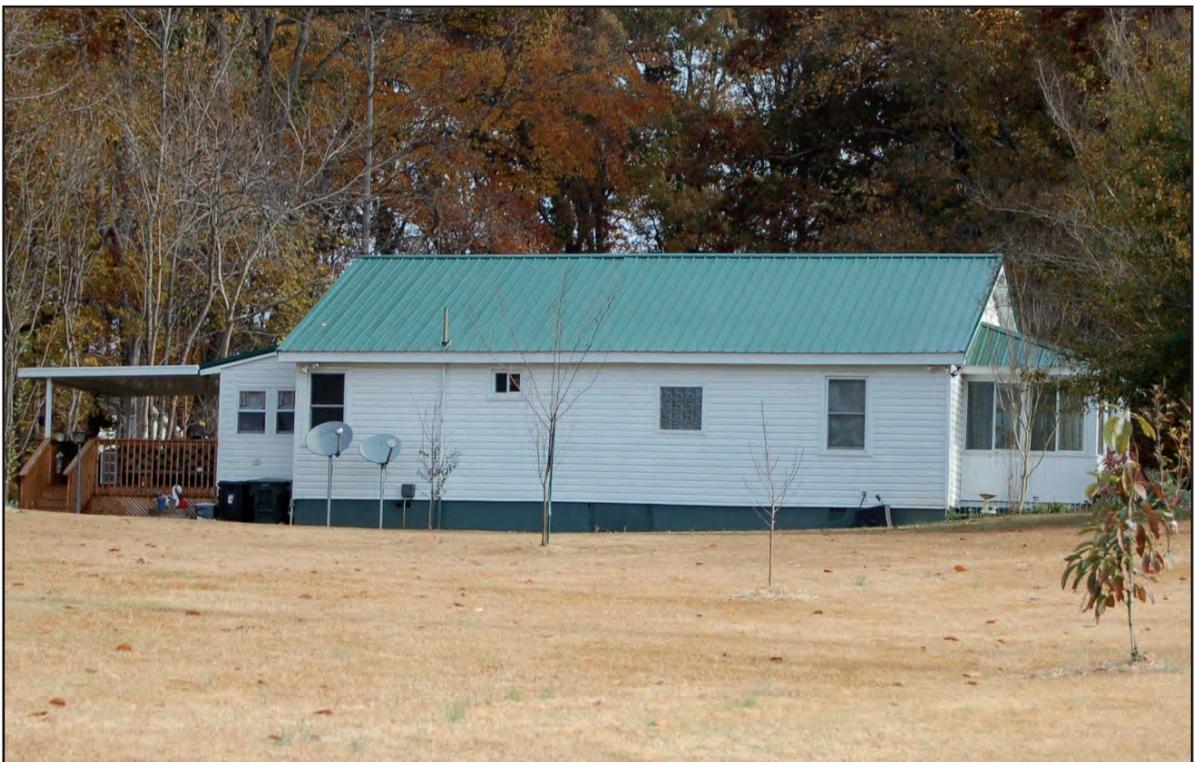
**Figure 5.209.** Resource 040-0230 (1353 Wilcox Avenue) – Oblique view of façade and east side elevation facing northwest.

**Figure 5.210.** Resource 040-0230 (1353 Wilcox Avenue) - View of west side elevation facing northeast.

Resource 040-0230 is located at 1353 Wilcox Avenue on the north side of the roadway approximately 0.37 mile west of the intersection of Wilcox Avenue and Lemuel Road northeast of Gaffney in Cherokee County (refer to Figure 5.2d). The Cherokee County tax assessor's record has a 1950 estimated date of construction for the resource. This estimated date of construction could not be confirmed in a review of historic aerial photography and topographic maps on the [www.historicmaterials.com](http://www.historicmaterials.com) website because there is a 30-year gap between the topographic maps dated 1945 and 1974 and the earliest aerial photography available is dated 1971. However, the form and massing are consistent with the 1950 estimated date of construction. The resource is a one-story, asymmetric, front-gabled bungalow of frame construction. The house features a front-gabled metal roof; a continuous concrete block foundation; a partial-width, projecting, hipped-roofed porch on the façade that has been enclosed; and vinyl exterior siding (see Figures 5.209 and 5.210). There is small shed-roofed addition on the rear elevation that connects to a shed-roofed deck patio. The enclosed porch on the façade has an off-center door with large rectangular light, vertical board exterior siding on the lower portion of the exterior, and a band of large horizontal sliding windows on the upper portion of the exterior. The windows on the resource are all non-historic replacements and include 1/1-light double-hung sash, horizontal sliding, and glass block.

historically significant. Therefore, there was no basis for evaluating the resource under Criterion A or B. Also, there is no indication that the resource is likely to yield information on important research questions in history or prehistory. The resource does not appear to have the potential to be the principal source of important information. Therefore, there was no basis for evaluating the resource under Criterion D. The resource is an undistinguished example of a common architectural type and due to the enclosure of the porch on the façade, the application of vinyl exterior siding, and the alteration to the fenestration the resource has lost integrity in the areas of design, materials, workmanship, and feeling and cannot convey significance in the area of architecture. Therefore, Resource 040-0230 is recommended **Not Eligible** for listing in the NRHP under Criterion C in the area of architecture.

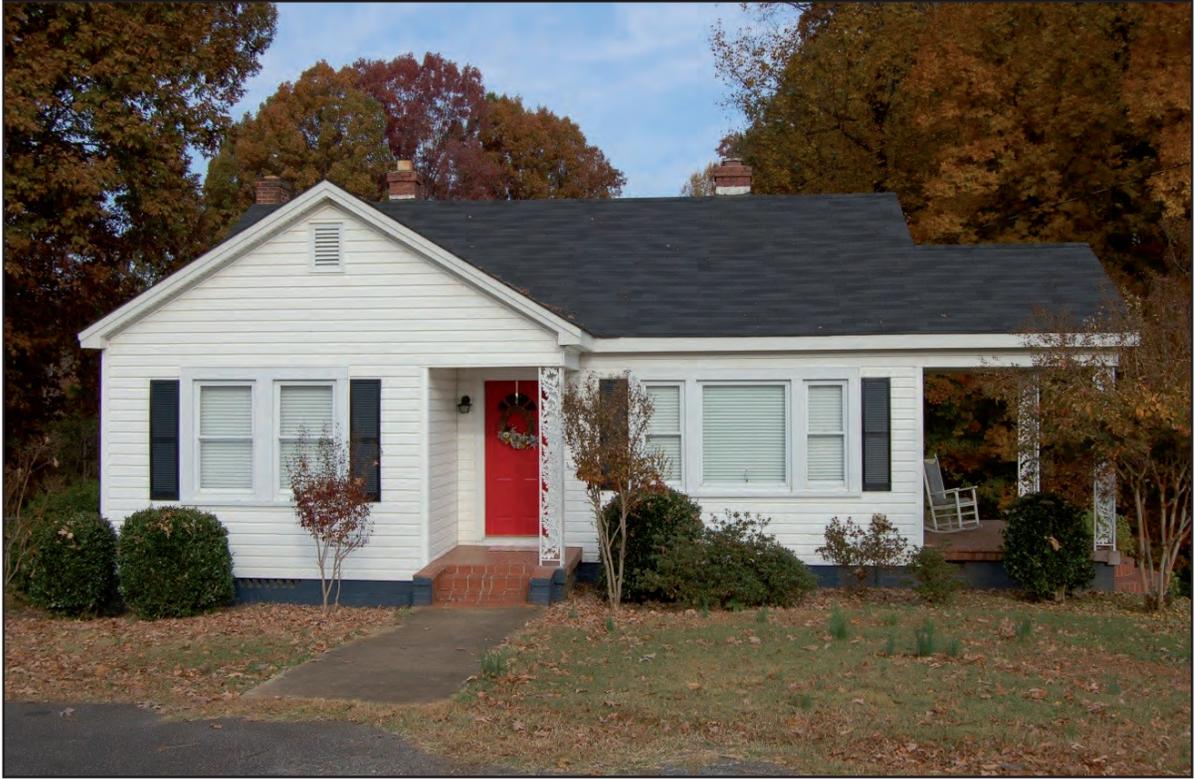
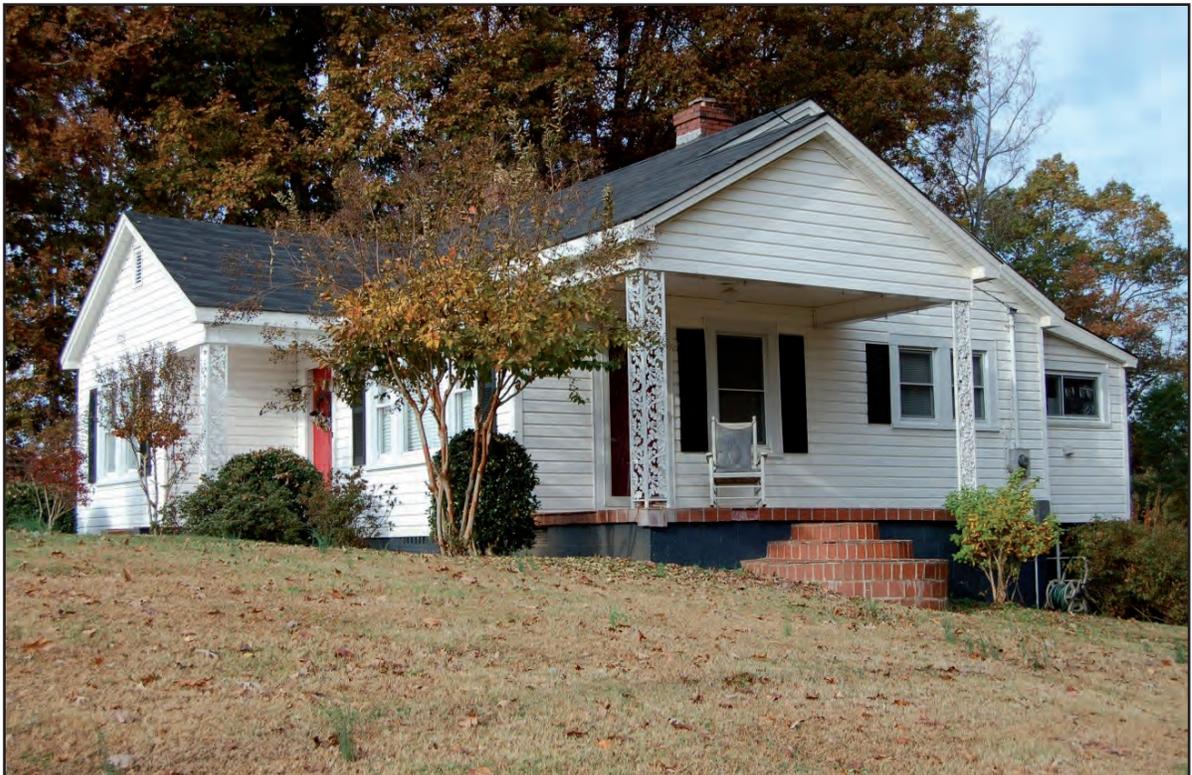
**Figure 5.211.** Resource 040-0231 (1355 Wilcox Avenue) - View of façade facing north.

**Figure 5.212.** Resource 040-0231 (1355 Wilcox Avenue) - Oblique view of façade and east side elevation facing northwest.

Resource 040-0231 is located at 1355 Wilcox Avenue on the north side of the roadway approximately 0.32 mile west of the intersection of Wilcox Avenue and Lemuel Road northeast of Gaffney in Cherokee County (refer to Figure 5.2d). The Cherokee County tax assessor's record has a 1950 estimated date of construction for the resource. This estimated date of construction could not be confirmed in a review of historic aerial photography and topographic maps on the [www.historicaerials.com](http://www.historicaerials.com) website because there is a 30-year gap between the topographic maps dated 1945 and 1974 and the earliest aerial photography available is dated 1971. However, the form, massing, and construction materials are consistent with the 1950 estimated date of construction. The resource is a one-story, asymmetric, cross-gabled residence of frame construction. The house features a cross-gabled asphalt shingle roof; a continuous concrete block foundation; a small brick exterior end wall chimney on the west side elevation; two small brick interior ridgeline chimneys; an integral, recessed stoop entry porch inset within the projecting gable-roofed mass on the façade; a partial-width, projecting, gable-roofed porch on the east side elevation; and vinyl exterior siding (see Figure 5.211 and 5.212). The roof of the porch on the façade is supported by a single decorative metal post and the roof of the porch on the east side elevation is supported by two decorative metal posts. There is a large tripartite window comprised of a large square fixed light flanked by 1/1-light double-hung sash windows on the façade. The windows on the basement level are metal casements and the majority of the windows on the upper level are single and paired 1/1-light double-hung sash of various sizes. There is a small shed-roofed addition on the rear elevation that has small horizontal sliding windows. While the casement windows on the basement level appear to be original, all of the windows on the main level appear to be non-historic replacements or non-historic additions.

A or B. Also, there is no indication that the resource is likely to yield information on important research questions in history or prehistory. The resource does not appear to have the potential to be the principal source of important information. Therefore, there was no basis for evaluating the resource under Criterion D. The resource does not represent a recognized architectural type or style and does not otherwise appear to represent a significant trend in South Carolina's architectural history. Additionally, due to the application of vinyl exterior siding and the replacement of original windows on the upper level the resource has lost integrity in the areas of materials, workmanship, and feeling and cannot convey significance in the area of architecture. Therefore, Resource 040-0231 is recommended **Not Eligible** for listing in the NRHP under Criterion C in the area of architecture.
