**PHASE I CULTURAL RESOURCE SURVEY FOR PROPOSED  
WIDENING OF INTERSTATE 85 FROM MILE MARKER 80 TO 96,  
CHEROKEE AND SPARTANBURG COUNTIES, SOUTH CAROLINA.**

**FINAL REPORT**

**JULY 2015**

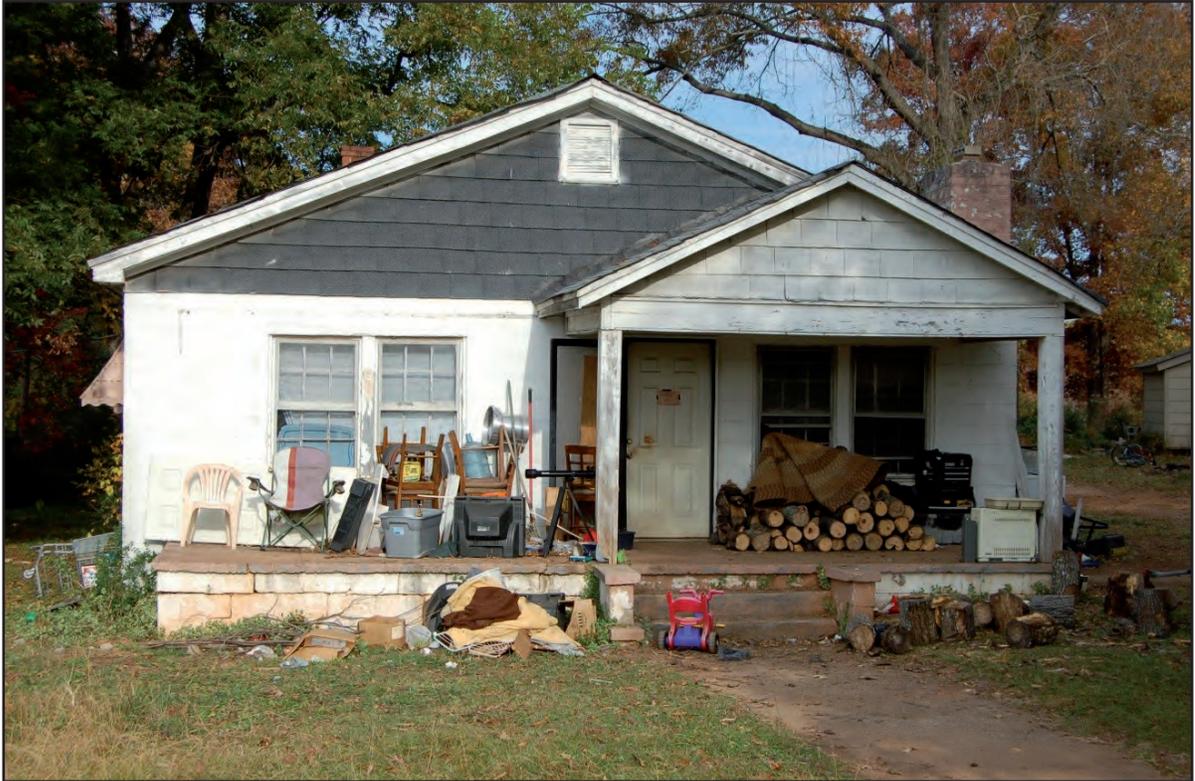
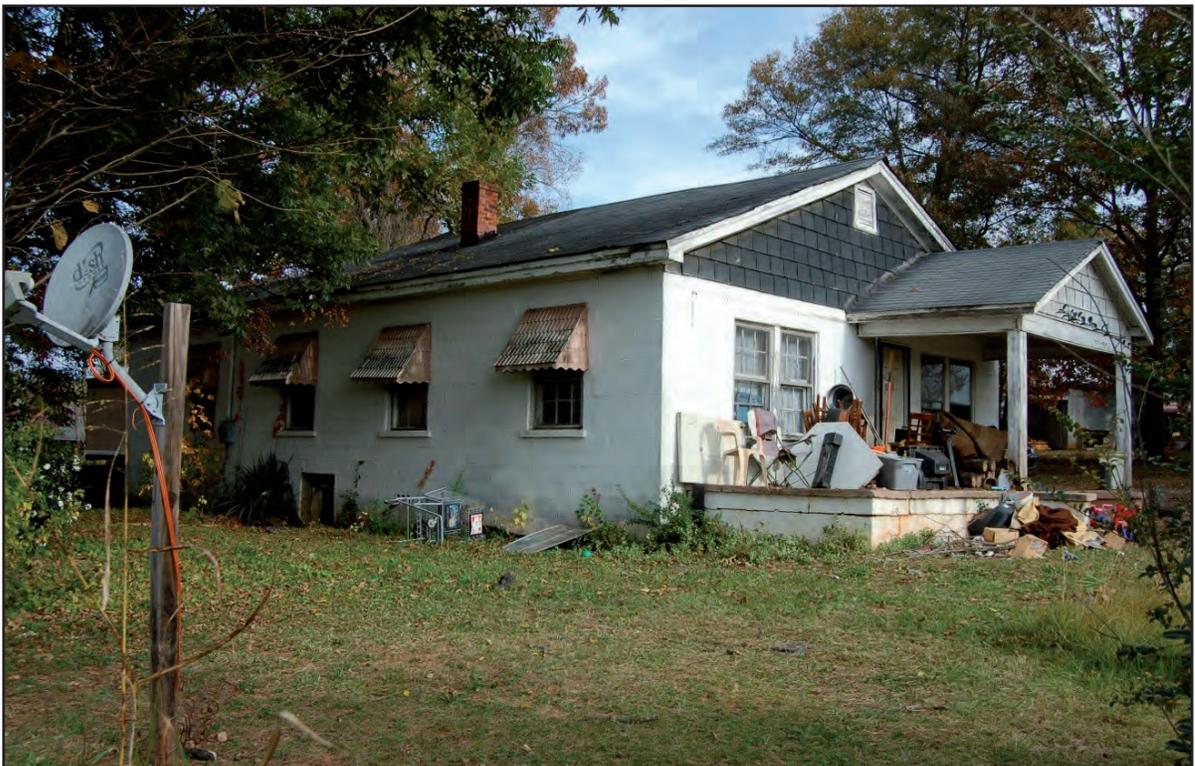
**Figure 5.213.** Resource 040-0232 (1379 Wilcox Avenue) - View of façade facing west.

**Figure 5.214.** Resource 040-0232 (1379 Wilcox Avenue) - Oblique view of façade and west side elevation facing northeast.

Resource 040-0232 is located at 1379 Wilcox Avenue on the north side of the roadway approximately 0.27 mile west of the intersection of Wilcox Avenue and Lemuel Road northeast of Gaffney in Cherokee County (refer to Figure 5.2d). The Cherokee County tax assessor's record has a 1950 estimated date of construction for the resource. This estimated date of construction could not be confirmed in a review of historic aerial photography and topographic maps on the [www.historicerials.com](http://www.historicerials.com) website because there is a 30-year gap between the topographic maps dated 1945 and 1974 and the earliest aerial photography available is dated 1971. However, the form, massing, and construction materials are consistent with the 1950 estimated date of construction. The resource is a one-story, asymmetric, front-gabled bungalow of concrete block load-bearing wall construction. The house features a front-gabled asphalt shingle roof; a small brick interior roof surface chimney within the west-side roof slope; a large, square masonry exterior chimney on the east side elevation; a partial-width, projecting, gable-roofed porch on the façade; asphalt shingle exterior siding in the gable ends and concrete block exterior siding on the remainder of the exterior walls (see Figures 5.213 and 5.214). The roof of the porch on the façade is supported by two wooden posts. The windows are single and paired original wood-framed 6/6-light double-hung sash with metal awning above the windows on the west and east side façades.

The resource is not known to be associated with a significant activity or event and there is not a known connection between the resource and any individual whose activities or achievements are historically significant. Therefore, there was no basis for evaluating the resource under Criterion A or B. Also, there is no indication that the resource is likely to yield information on important research questions in history or prehistory. The resource does not appear to have the potential to be the principal source of important information. Therefore, there was no basis for evaluating the resource under Criterion D. The resource is an undistinguished example of a common architectural type and is recommended **Not Eligible** for listing in the NRHP under Criterion C in the area of architecture.

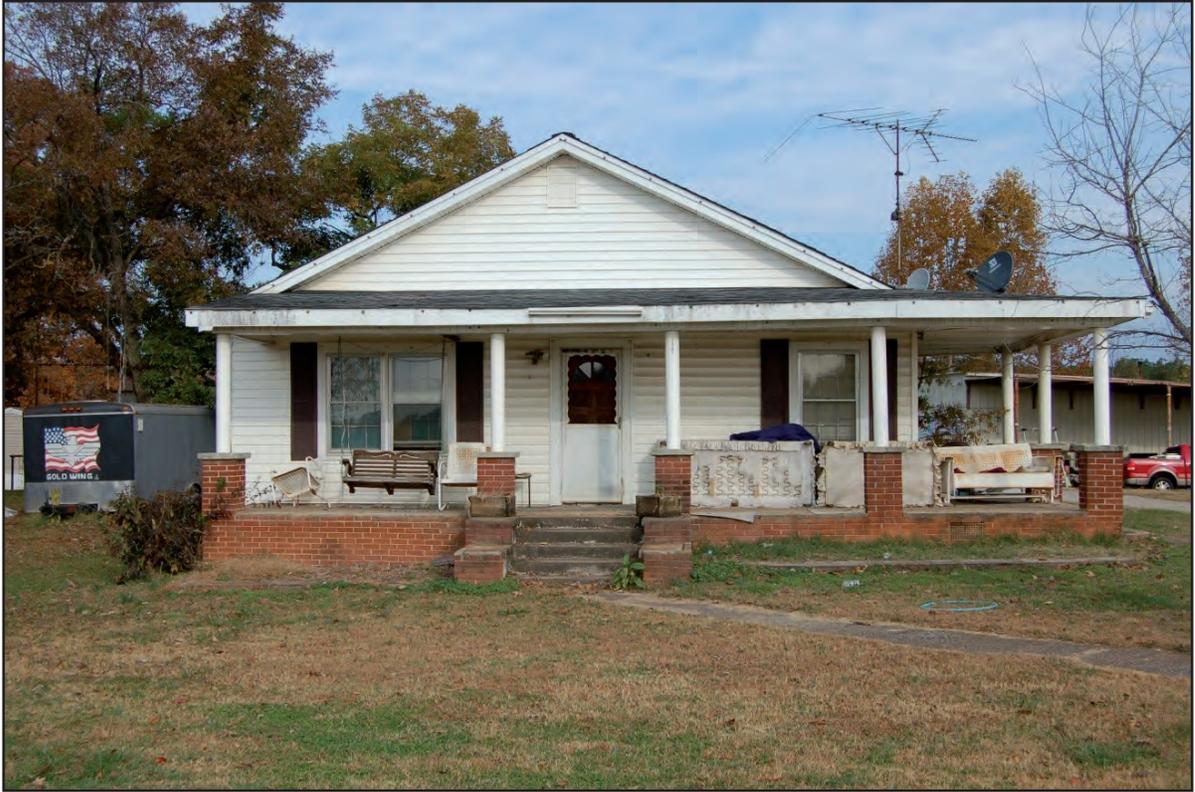
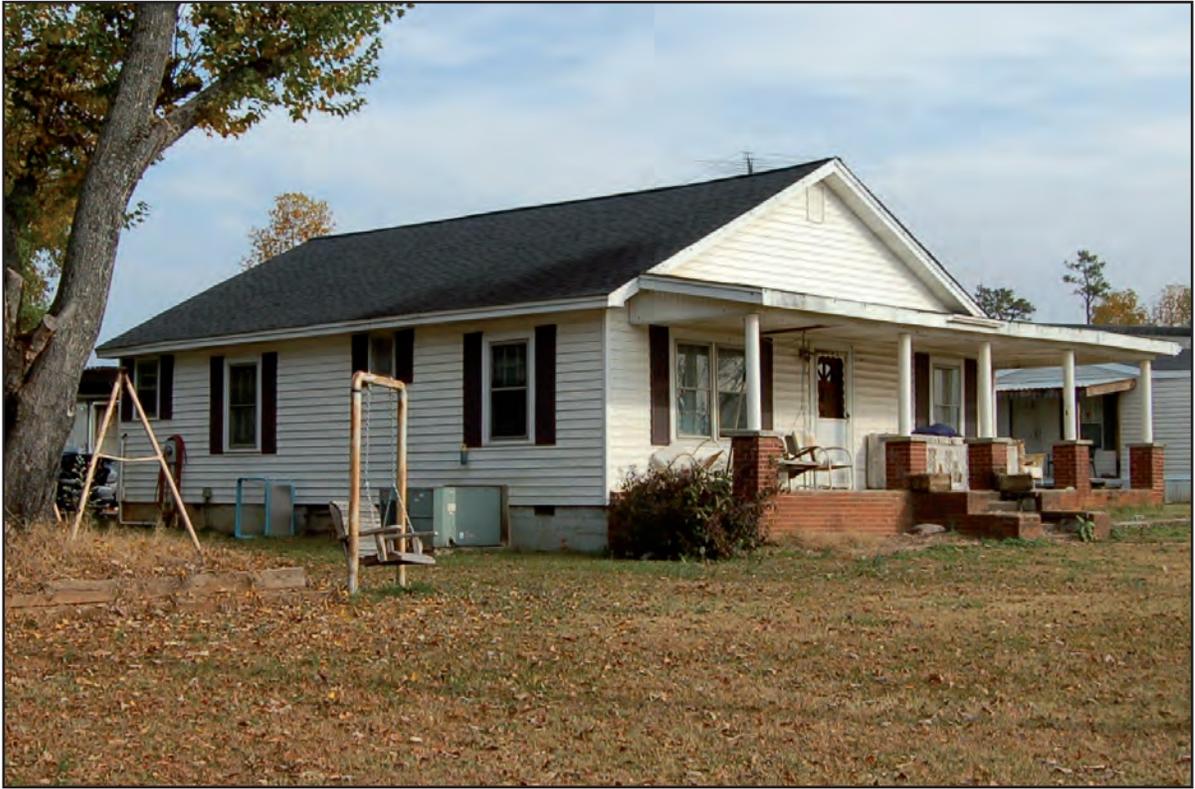
**Figure 5.215.** Resource 040-0233 (1387 Wilcox Avenue) - View of façade facing north.

**Figure 5.216.** Resource 040-0233 (1387 Wilcox Avenue) - Oblique view of façade and west side elevation facing northeast.

Resource 040-0233 is located at 1387 Wilcox Avenue on the north side of the roadway approximately 0.23 mile west of the intersection of Wilcox Avenue and Lemuel Road northeast of Gaffney in Cherokee County (refer to Figure 5.2d). The Cherokee County tax assessor's record has a 1950 estimated date of construction for the resource. This estimated date of construction could not be confirmed in a review of historic aerial photography and topographic maps on the [www.historicmaterials.com](http://www.historicmaterials.com) website because there is a 30-year gap between the topographic maps dated 1945 and 1974 and the earliest aerial photography available is dated 1971. However, the form, massing, and construction materials are consistent with the 1950 estimated date of construction. The resource is a one-story, asymmetric, front-gabled bungalow of frame construction. The house features a front-gabled asphalt shingle; a continuous concrete block foundation; a wrap-around, shed-roofed porch on the façade and east side elevation; and vinyl exterior siding. The wrap-around porch is supported by round poles atop brick piers (see Figures 5.215 and 5.216). The windows are single and paired wood-framed 6/6-light double-hung sash of various sizes. The resource is not known to be associated with a significant activity or event and there is not a known connection between the resource and any individual whose activities or achievements are historically significant. Therefore, there was no basis for evaluating the resource under Criterion A or B. Also, there is no indication that the resource is likely to yield information on important research questions in history or prehistory. The resource does not appear to have the potential to be the principal source of important information. Therefore, there was no basis for evaluating the resource under Criterion D. The resource is an undistinguished example of a common architectural type and is recommended **Not Eligible** for listing in the NRHP under Criterion C in the area of architecture.

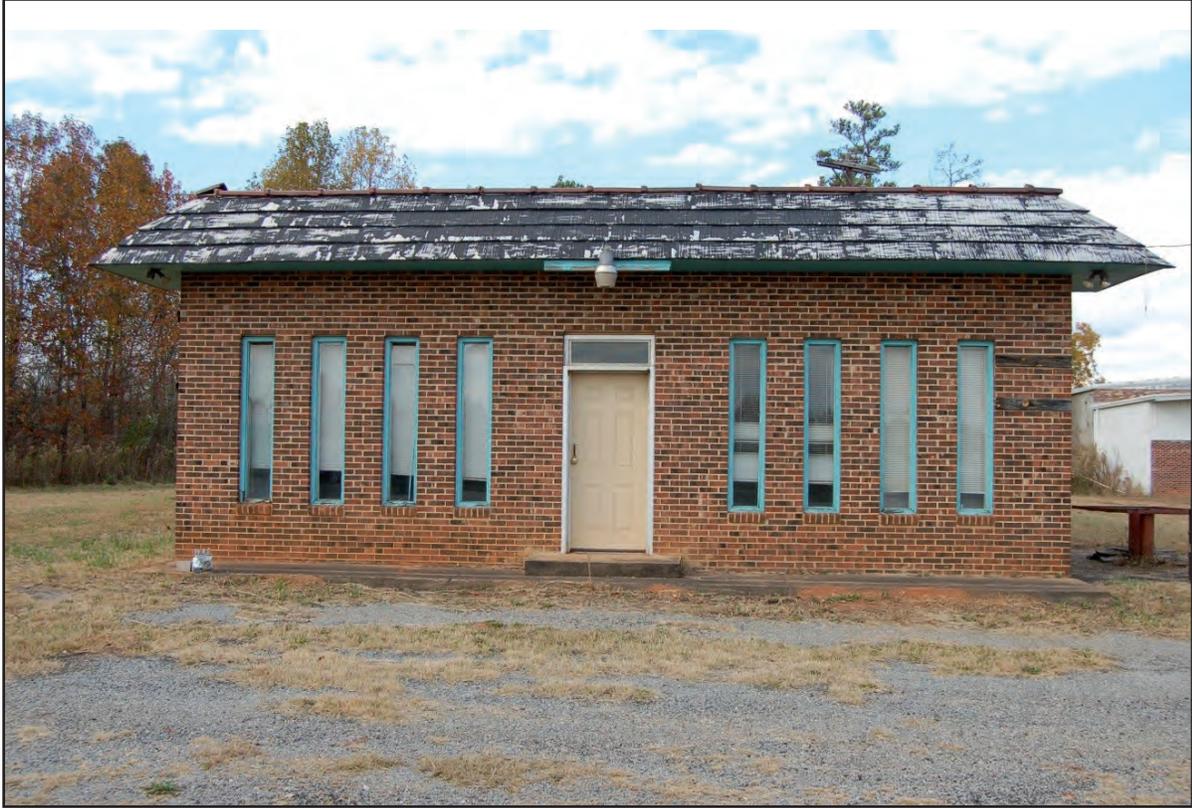
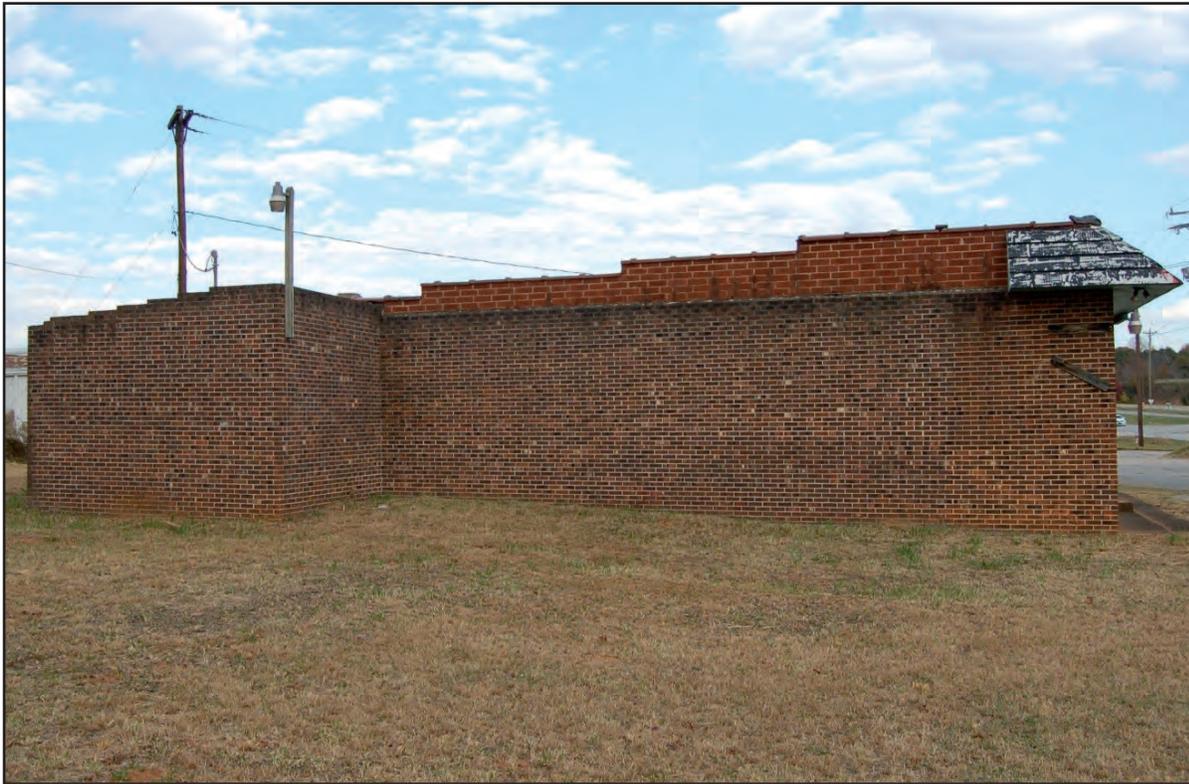
**Figure 5.217.** Resource 040-0234 (1411 Wilcox Avenue) - View of façade facing north.

**Figure 5.218.** Resource 40-0234 (1411 Wilcox Avenue) - View of west side elevation facing east.

Resource 040-0234 is located at 1411 Wilcox Avenue on the north side of the roadway approximately 730 feet west of the intersection of Wilcox Avenue and Lemuel Road northeast of Gaffney in Cherokee County (refer to Figure 5.2d). The Cherokee County tax assessor's record has a 1950 estimated date of construction for the resource. This estimated date of construction could not be confirmed in a review of historic aerial photography and topographic maps on the [www.historicmaterials.com](http://www.historicmaterials.com) website because there is a 30-year gap between the topographic maps dated 1945 and 1974 and the earliest aerial photography available is dated 1971. However, the form, massing, and construction materials are consistent with the 1950 estimated date of construction. The resource is a one-part vernacular commercial building of masonry load-bearing wall construction (see Figures 5.217 and 5.218). The building has been substantially altered and its original appearance is no longer evident. A second layer of brick veneer exterior siding has been applied on the entire west side elevation, the façade, and the southern portion of the east side elevation. Original windows on

the side elevations have all been enclosed. The façade is symmetric and has four tall and narrow fixed-light windows on each side of a central doorway.

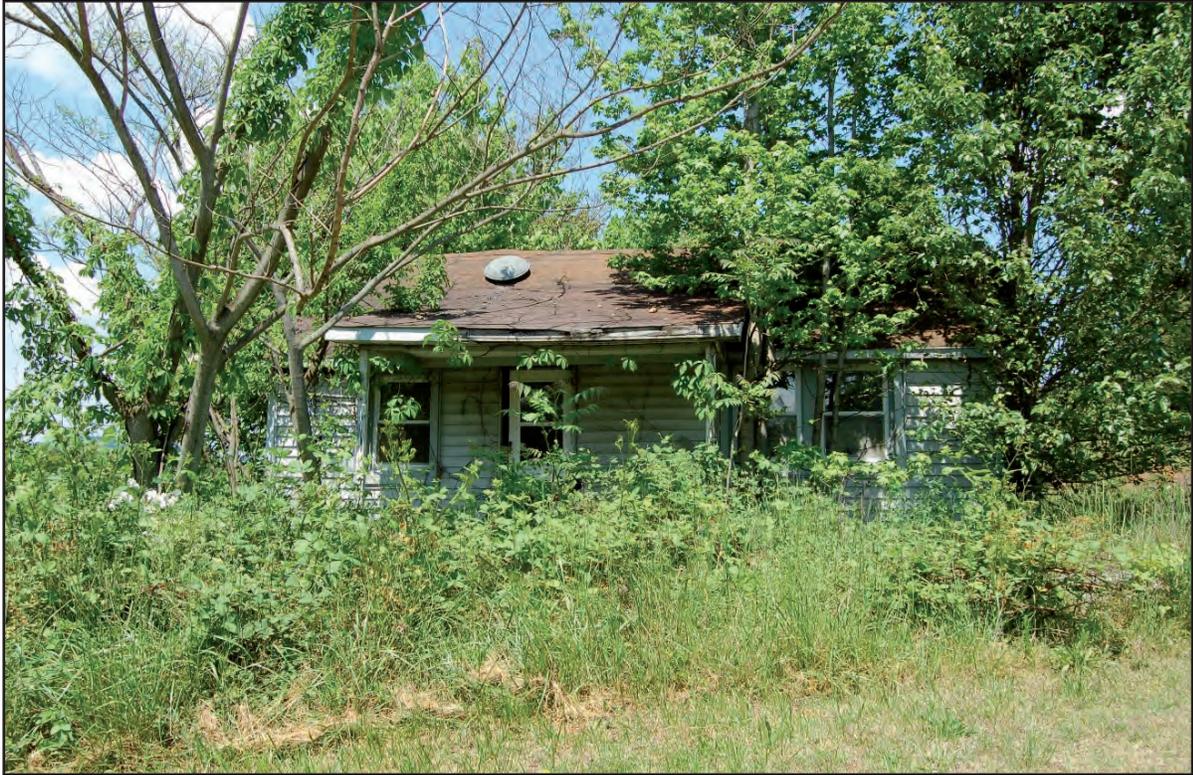
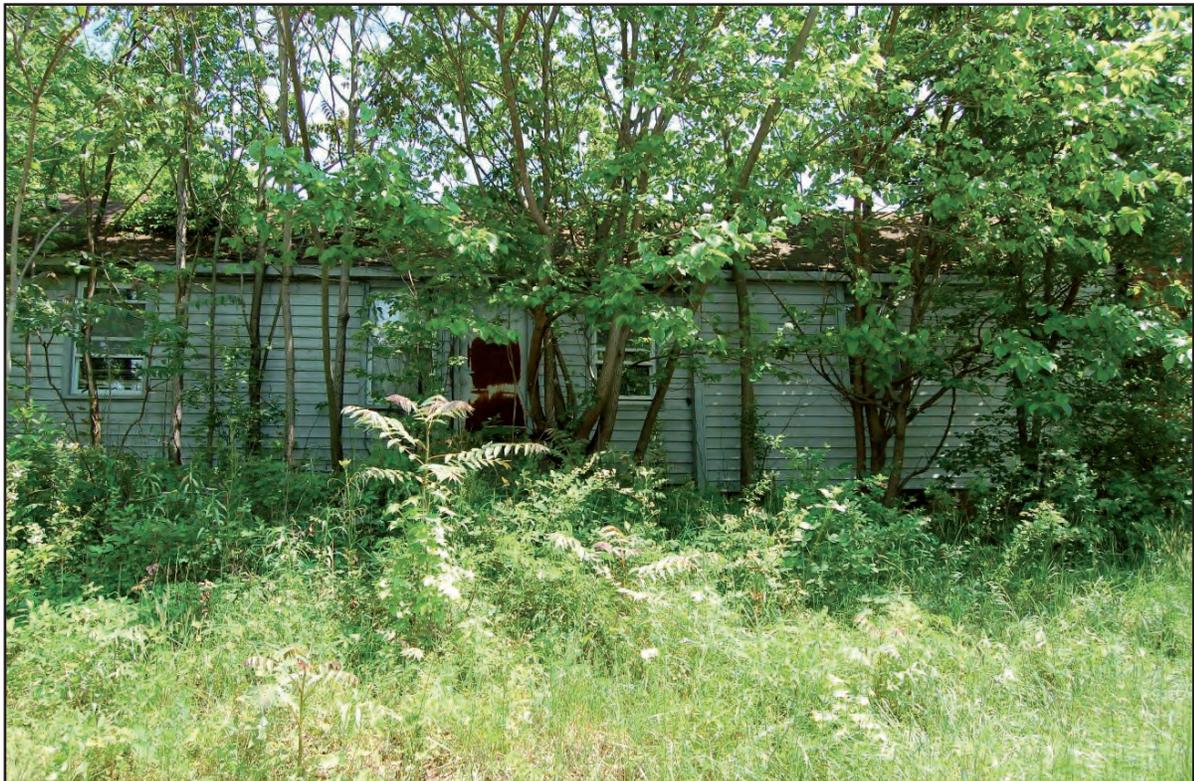
**Figure 5.219.** Resource 113-0235 (194 Vernie Road) - View of facade facing northeast.

**Figure 5.220.** Resource 113-0235 (194 Vernie Road) – View of west side elevation facing southeast.

Resource 113-0235 is located at 194 Vernie Road on the east side of the roadway approximately 1,400 feet north of the intersection Vernie Road and Webber Road west of Gaffney in Cherokee County (refer to Figure 5.2b). The Cherokee County tax assessor's record does not have an estimated date of construction for the resource. The resource is depicted in its current location on the earliest aerial photograph available on the [www.historicaerials.com](http://www.historicaerials.com) website dated 1955 and the earliest topographic map available on the same website is dated 1961. Based on an evaluation of the resource's form, massing, and construction materials, Resource 113-0235 appears to have been constructed ca. 1952. The resource is a one-story, asymmetric, cross-gabled residence of frame construction. The house features a cross-gabled asphalt shingle; a continuous concrete block foundation; a shed-roofed porch supported by wooden posts on the façade; and a long gable-roofed ell on the rear elevation (see Figures 5.219 and 5.220). Vinyl siding has been applied to the exterior of the resource, all original doors have been replaced, and all original windows have been replaced with metal-framed vinyl windows.

history. Additionally, due to the application of vinyl exterior siding and the replacement of original windows the resource has lost integrity in the areas of materials, workmanship, and feeling and cannot convey significance in the area of architecture. Therefore, Resource 113-0235 is recommended **Not Eligible** for listing in the NRHP under Criterion C in the area of architecture.

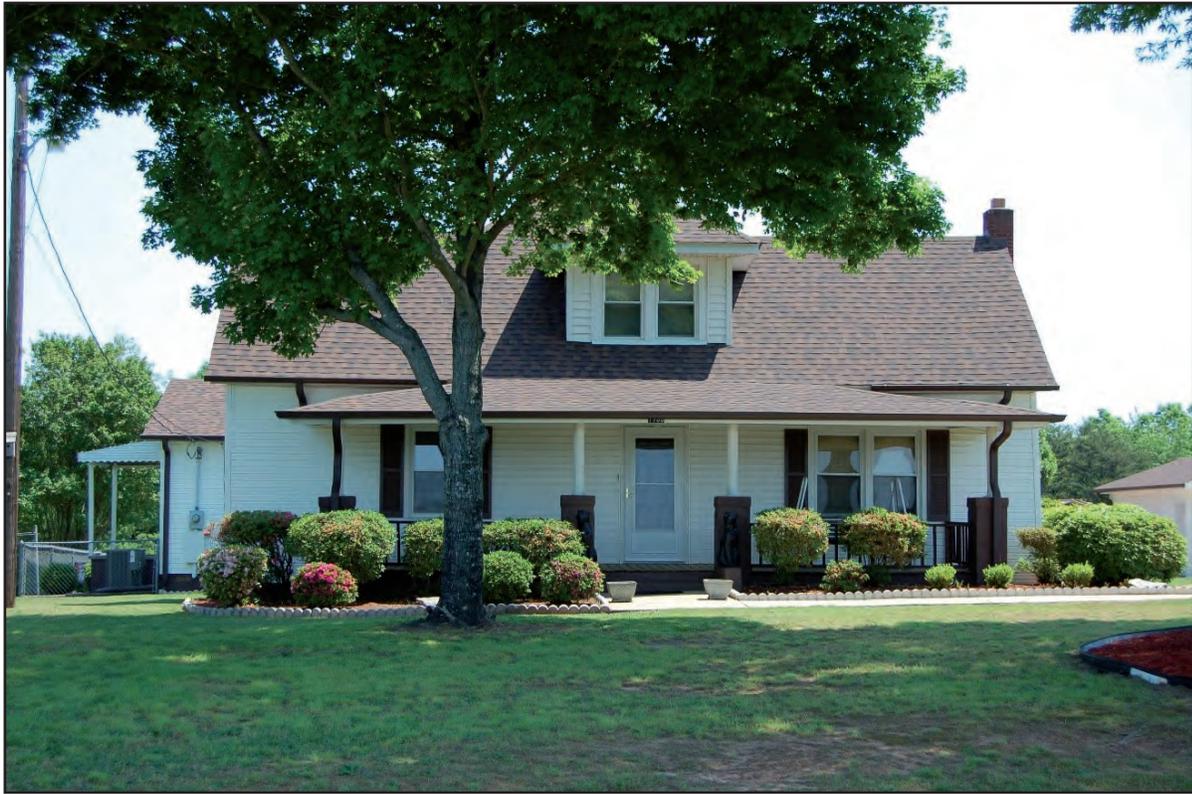
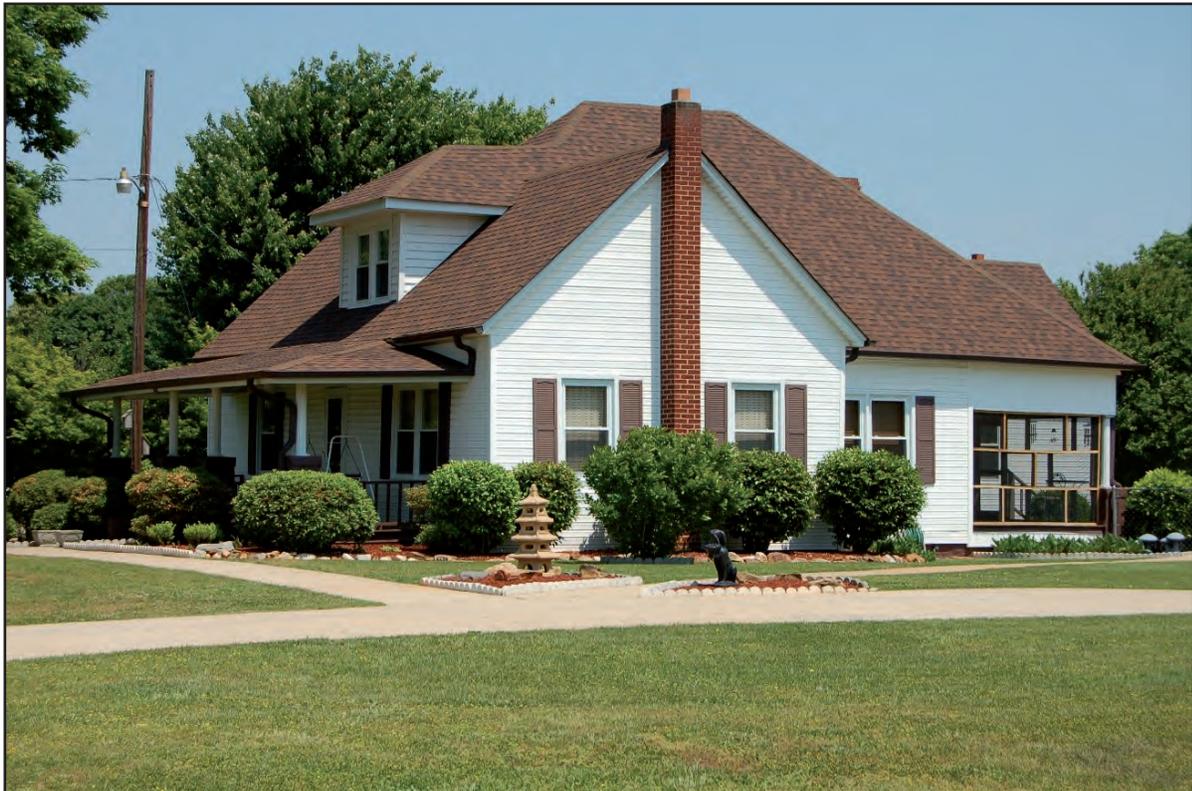
**Figure 5.221.** Resource 113-0236 (1786 Green River Road) - View of façade facing east.

**Figure 5.222.** Resource 113-0236 (1786 Green River Road) – Oblique view of façade and south side elevation facing northeast.

Resource 113-0236 is located at 1786 Green River Road on the east side of the roadway approximately 675 feet south of the intersection of Green River Road and Lindley Road west of Gaffney in Cherokee County (refer to Figure 5.2b). The Cherokee County tax assessor's record does not have an estimated date of construction for the resource. The resource is depicted in its current location on the earliest aerial photograph available on the [www.historicaerials.com](http://www.historicaerials.com) website dated 1955 and the earliest topographic map available on the same website is dated 1961. Based on an evaluation of the resource's form, massing, and construction materials, Resource 113-0236 appears to have been constructed ca. 1920. The resource is a one-and-one-half-story, asymmetric, hip-on-gable-roofed residence of frame construction. The house features a tall hip-on-gable asphalt shingle; a continuous concrete block foundation; a partial-width hipped-roof porch on the façade with roof supported by four fluted columns atop large brick piers; a small brick exterior end wall chimney on the south side elevation; and vinyl exterior siding (see Figures 5.221 and 5.222). The doors are non-historic replacements and all windows appear to be non-historic metal-framed vinyl replacements.

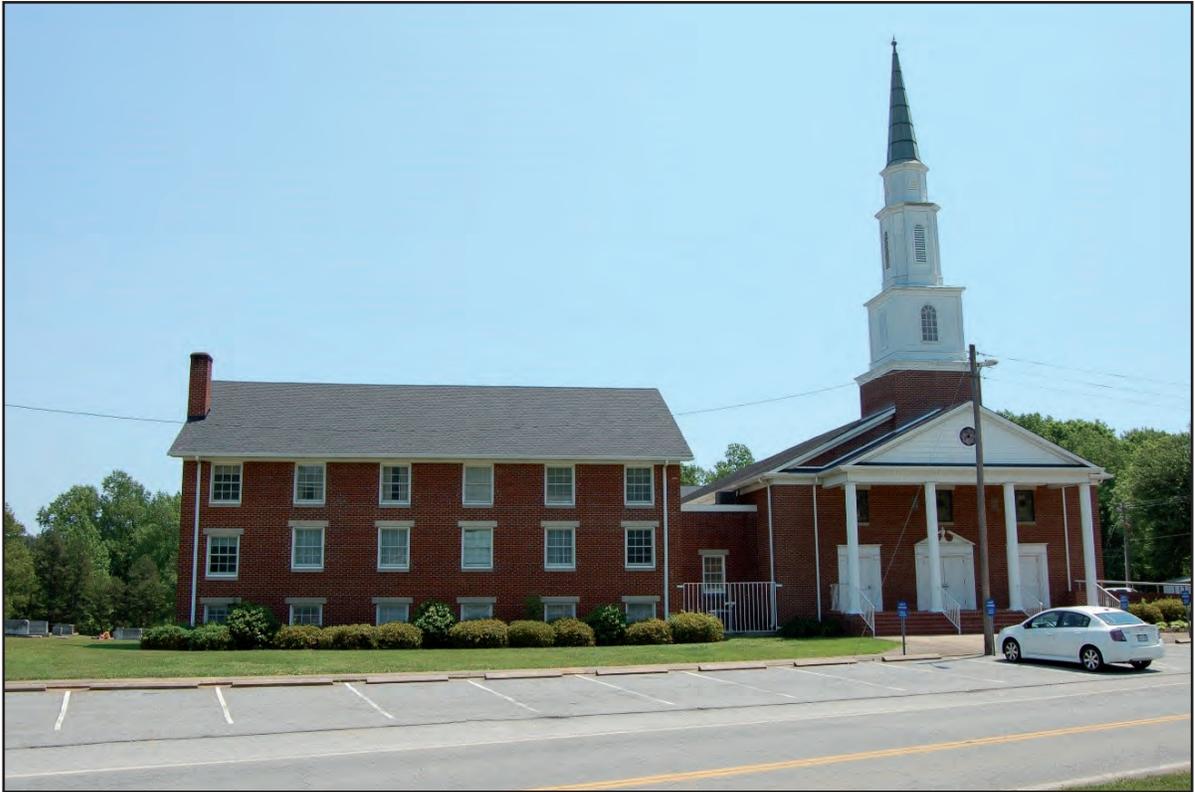
**Figure 5.225.** Resource 113-0238 (216 Macedonia Road) - View of education building on left and sanctuary building on right facing east.

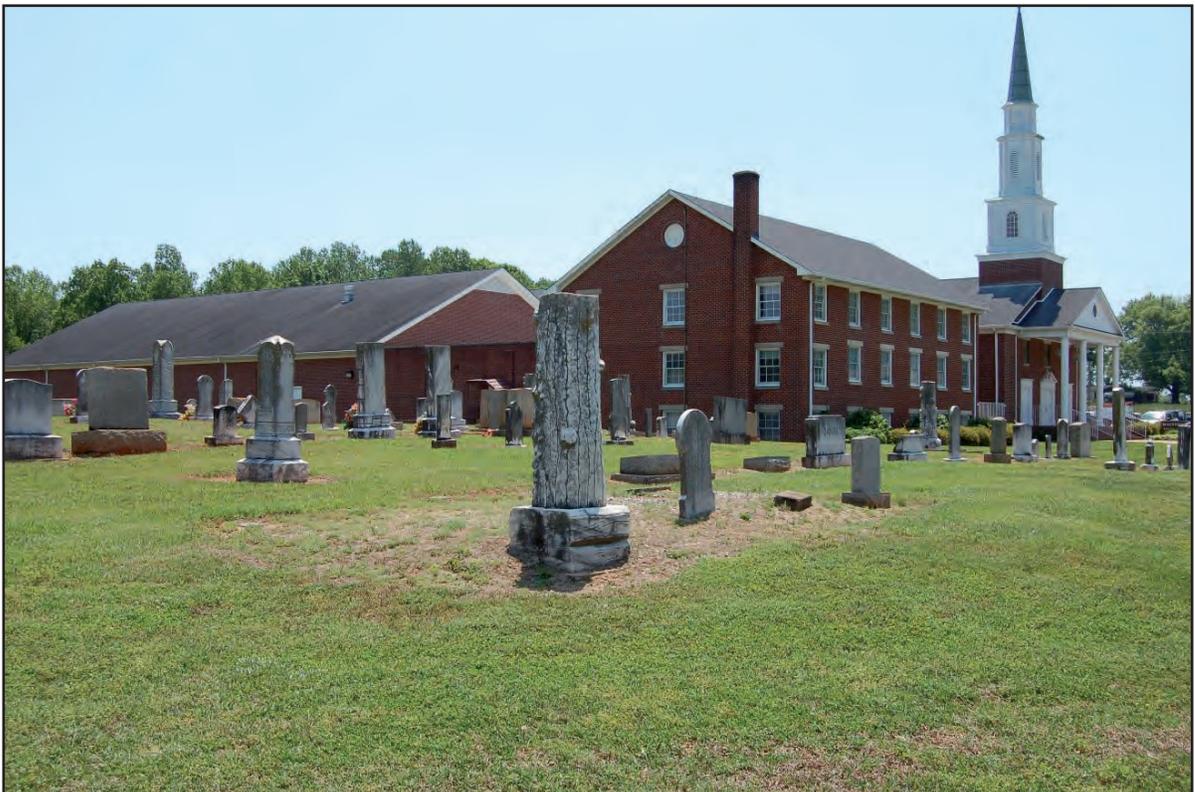
**Figure 5.226.** Resource 113-0238 (216 Macedonia Road) - View of cemetery, non-historic addition, education building, and sanctuary facing southeast.

the cemetery. The educational building was constructed in 1942 and the current sanctuary was constructed in 1963. A rear addition containing children's facilities and church offices was constructed in 1983 and a gymnasium building was constructed in 1999. At the time of the historic resources field survey, a large wrap-around addition on the south side and rear elevations of the present sanctuary building was under construction.

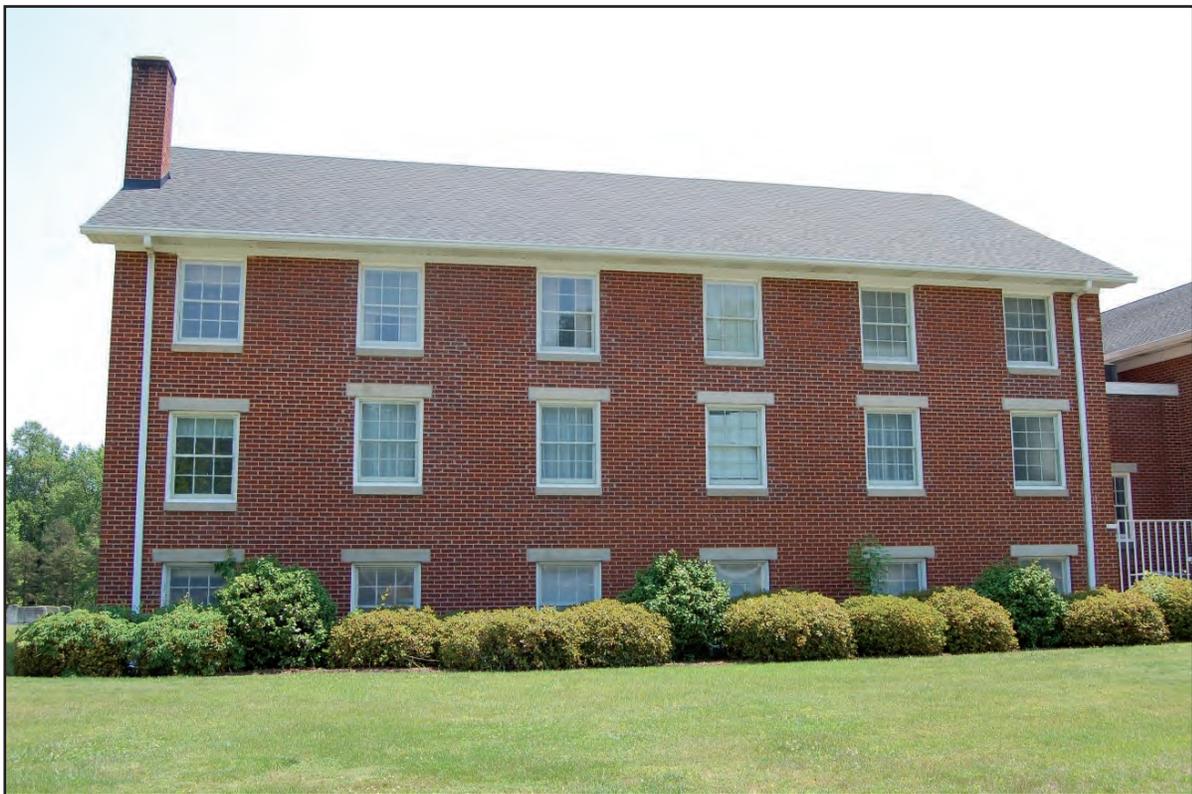
The Macedonia Baptist Church education building (Resource 113-0238.02), constructed in 1942, is a large, three-story classroom building with running bond brick exterior siding; a side-gabled asphalt shingle roof; a large brick exterior end wall chimney on the north side elevation; and 6/6-light double-hung sash windows (see Figure 5.230). The windows feature stone sill and stone flat-arch lintels.

**Figure 5.230.** Resource 113-0238.02 (216 Macedonia Road) – View of west elevation of education building facing east.

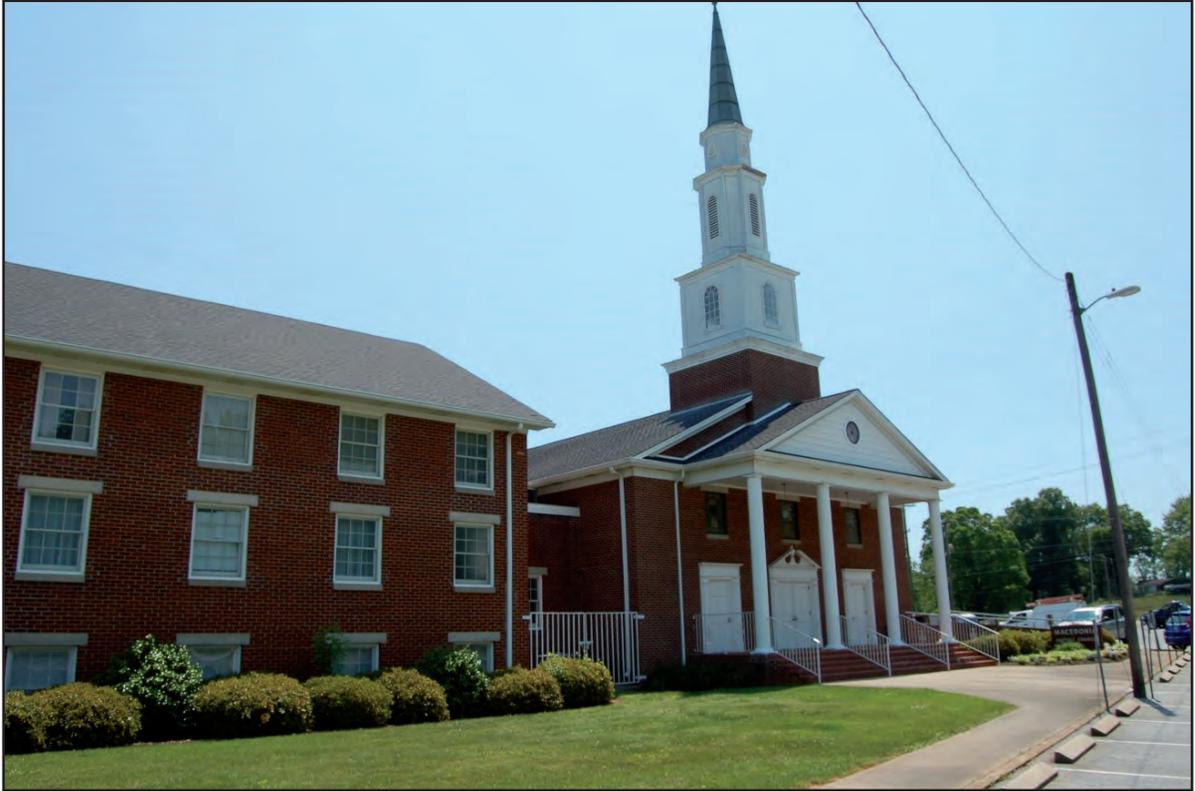
The Macedonia Baptist Church sanctuary building (Resource 113-0238.03), constructed in 1963, is a front-gabled, central-tower church with synthetic exterior siding in the gable on the façade and under the soffits; running bond brick exterior siding on the balance of the exterior; and a projecting gable-roofed portico on the façade (see Figure 5.231 and 5.232). The projecting portico is supported by four Doric columns. The symmetric façade has a double-leaf door flanked by two single-leaf doors. Each of the three doorways is flanked by fluted pilasters that support tall entablatures. The central doorway also has a large broken pediment. Above each doorway is a square stained-glass window with stone sill and stone flat-arch lintel. The central tower supports steeple

**Figure 5.231.** Resource 113-0238.03 (216 Macedonia Road) – View of façade of sanctuary building facing southeast.

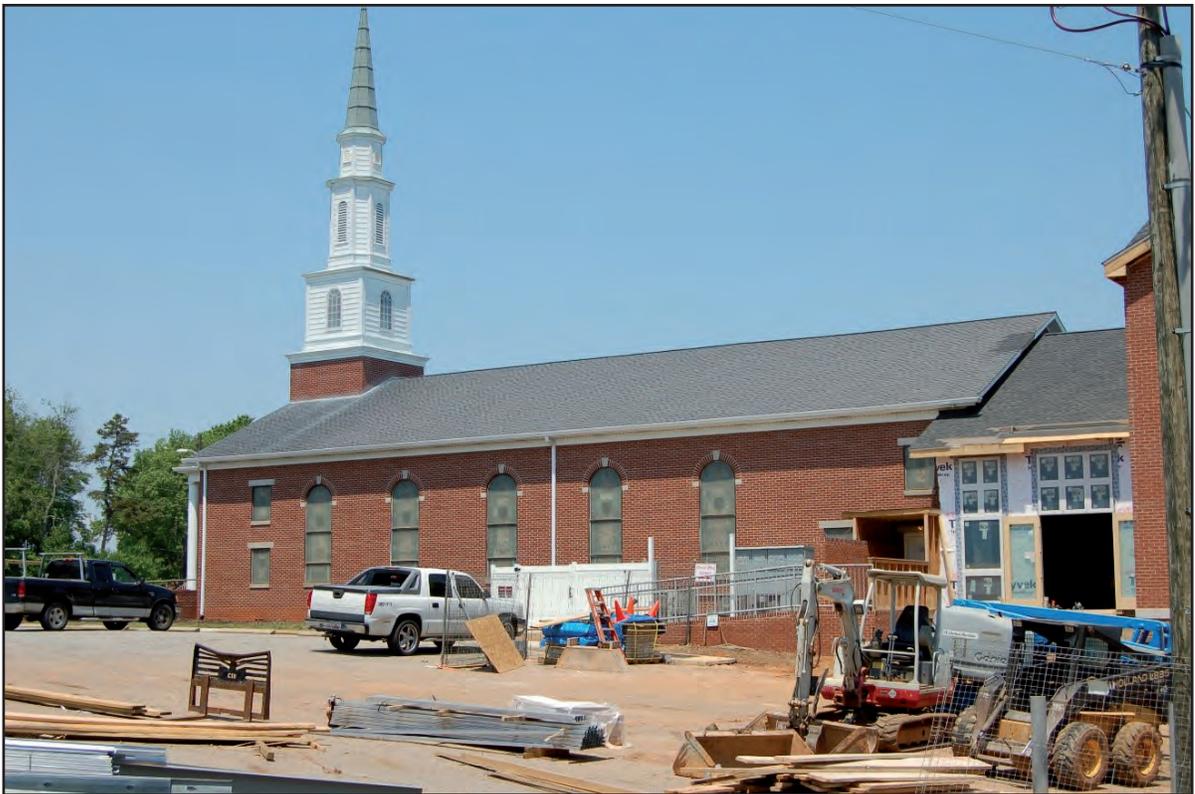
**Figure 5.232.** Resource 113-0238.03 (216 Macedonia Road) - View of south side elevation of sanctuary building and rear addition under construction facing northwest.

with belfry and spire. The south side elevation has similar square stained-glass windows as those on the façade and much taller round-top stained-glass windows. The taller stained-glass windows have stone stills and small round arches that are comprised of stone springers and keystones and brick voussoirs. The north side and rear elevations of the sanctuary are concealed by non-historic additions that are and could not be observed.

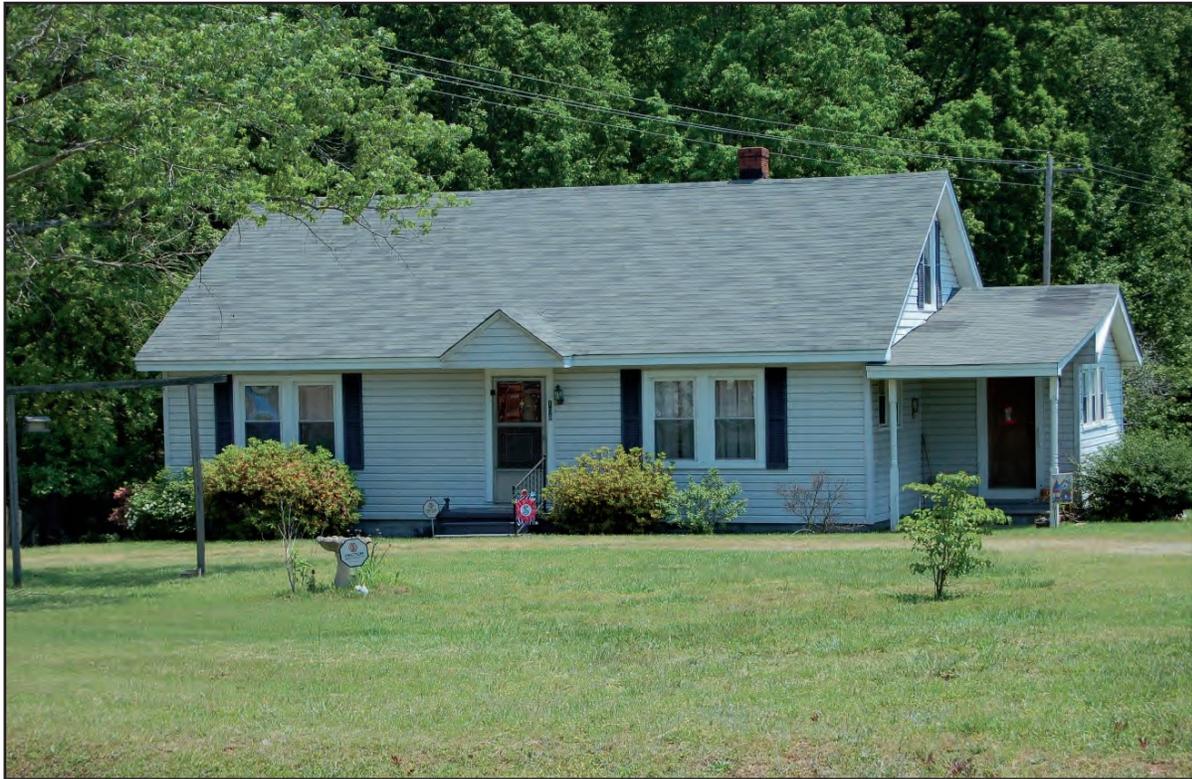
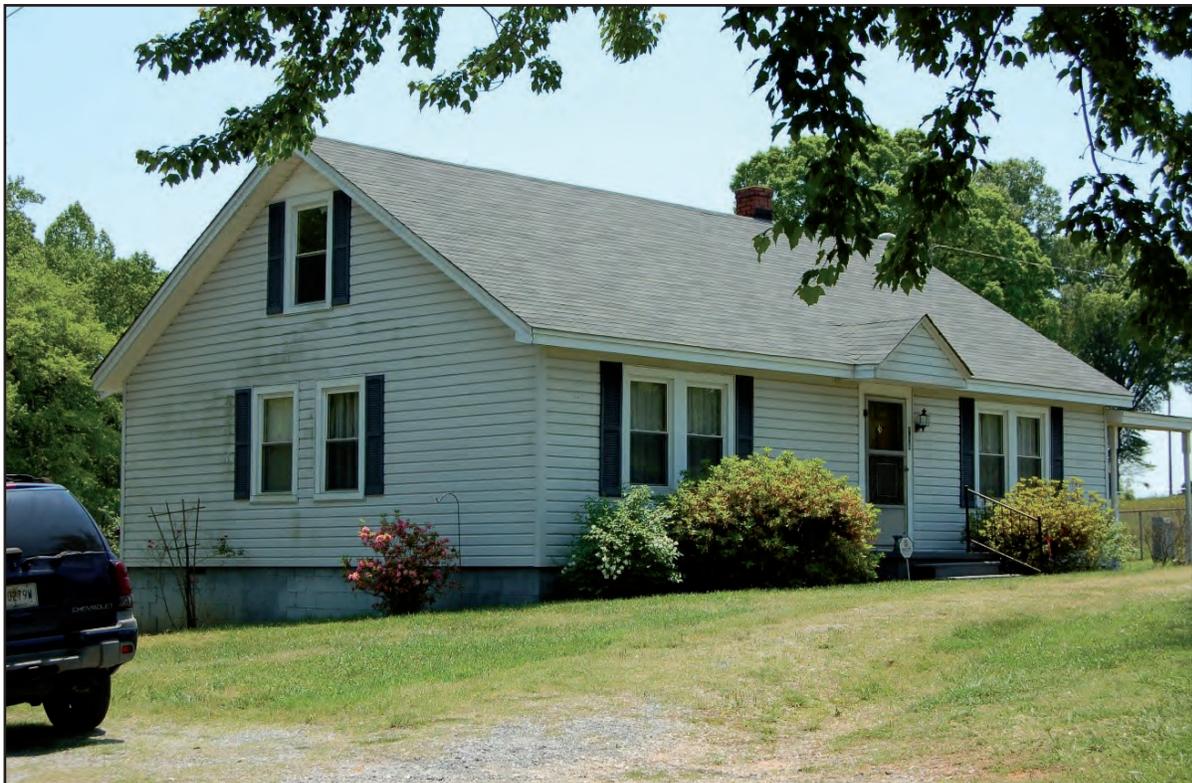
Resource 113-0239 is located at 108 Green River Road on the south side of the roadway approximately 150 feet east of the intersection of Green River Road and Macedonia Road west of Gaffney in Cherokee County (refer to Figure 5.2b). The Cherokee County tax assessor's record does not have an estimated date of construction for the resource. The resource is depicted in its current location on the earliest aerial photograph available on the [www.historicaerials.com](http://www.historicaerials.com) website dated 1955, but it is not depicted in its current location on the earliest topographic map available on the same website dated 1961. Based on an evaluation of the resource's form, massing, and construction materials, Resource 113-0239 appears to have been constructed ca. 1958. The resource is a one-and-one-half-story, symmetric, side-gabled residence of frame construction. The house features a side-gabled asphalt shingle roof; a continuous concrete block foundation; a small gable-roofed stoop porch on the façade; and vinyl exterior siding. All visible windows have been replaced with metal-framed 1/1-light double-hung sash vinyl windows (see Figures 5.235 and 5.236).

**Figure 5.235.** Resource 113-0239 (108 Green River Road) - View of façade facing southeast.

**Figure 5.236.** Resource 113-0239 (108 Green River Road) - Oblique view of façade and north side elevation facing southwest.

historically significant. Therefore, there was no basis for evaluating the resource under Criterion A or B. Also, there is no indication that the resource is likely to yield information on important research questions in history or prehistory. The resource does not appear to have the potential to be the principal source of important information. Therefore, there was no basis for evaluating the resource under Criterion D. The resource does not represent a recognized architectural type or style and does not otherwise appear to represent a significant trend in South Carolina's architectural history. Additionally, due to the application of vinyl exterior siding and the replacement of original windows, the resource has lost integrity in the areas of materials, workmanship, and feeling and cannot convey significance in the area of architecture. Therefore, Resource 113-0239 is recommended **Not Eligible** for listing in the NRHP under Criterion C in the area of architecture.

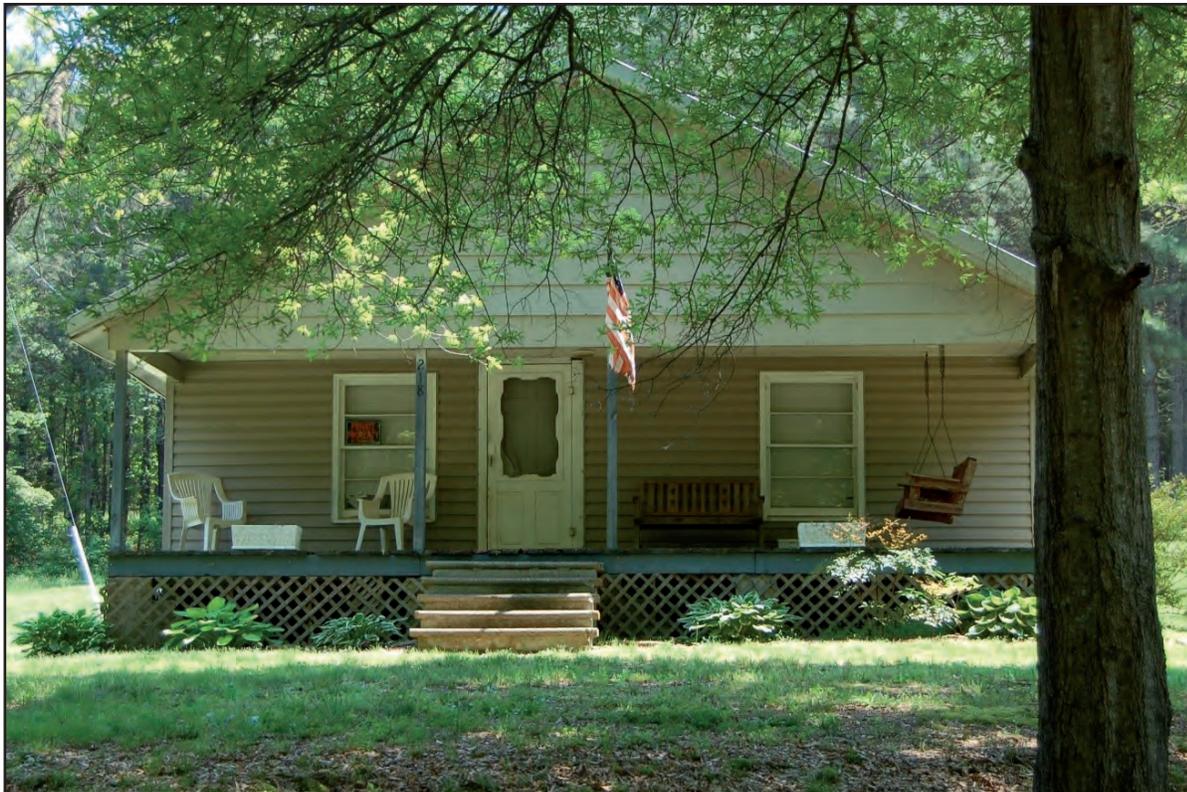
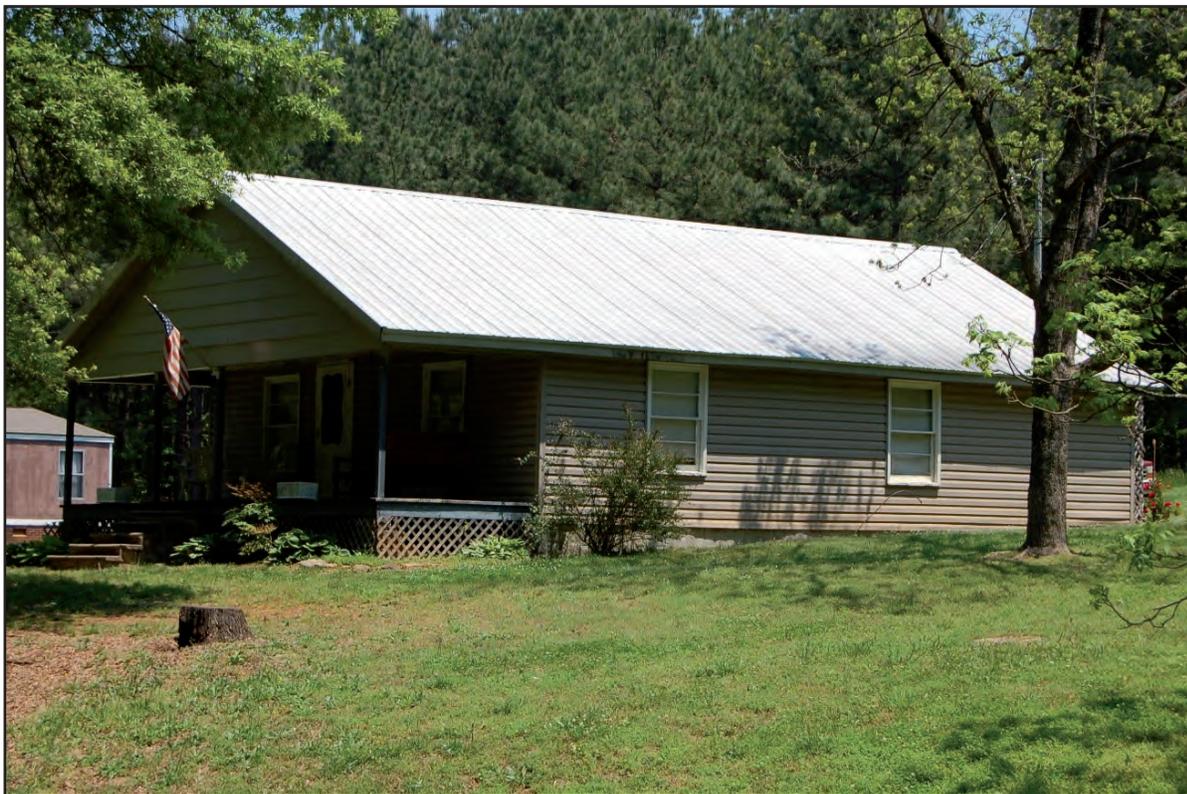
Resource 113-0241 is located at 220 Green River Road on the east side of the roadway approximately 380 feet north of the intersection of Green River Road and Malone Road west of Gaffney in Cherokee County (refer to Figure 5.2b). The Cherokee County tax assessor's record does not have an estimated date of construction for the resource. The resource is depicted in its current location on the earliest aerial photograph available on the [www.historicaerials.com](http://www.historicaerials.com) website dated 1955 and on the earliest topographic map available on the same website dated 1961. Based on an evaluation of the resource's form, massing, and construction materials, Resource 113-0241 appears to have been constructed ca. 1950. The resource is a one-story, asymmetric, front-gabled bungalow of frame construction. The house features a front-gabled metal roof; a continuous concrete block foundation; a full-width engaged porch supported by four wooden posts; and vinyl exterior siding (see Figures 5.239 and 5.240). The windows are wood-framed 3/3-light double-hung sash.

**Figure 5.239.** Resource 113-0241 (220 Green River Road) - View of façade facing southeast.

**Figure 5.240.** Resource 113-0241 (220 Green River Road) – View of west side elevation facing northeast.
