**PHASE I CULTURAL RESOURCE SURVEY FOR PROPOSED  
WIDENING OF INTERSTATE 85 FROM MILE MARKER 80 TO 96,  
CHEROKEE AND SPARTANBURG COUNTIES, SOUTH CAROLINA.**

**FINAL REPORT**

**JULY 2015**

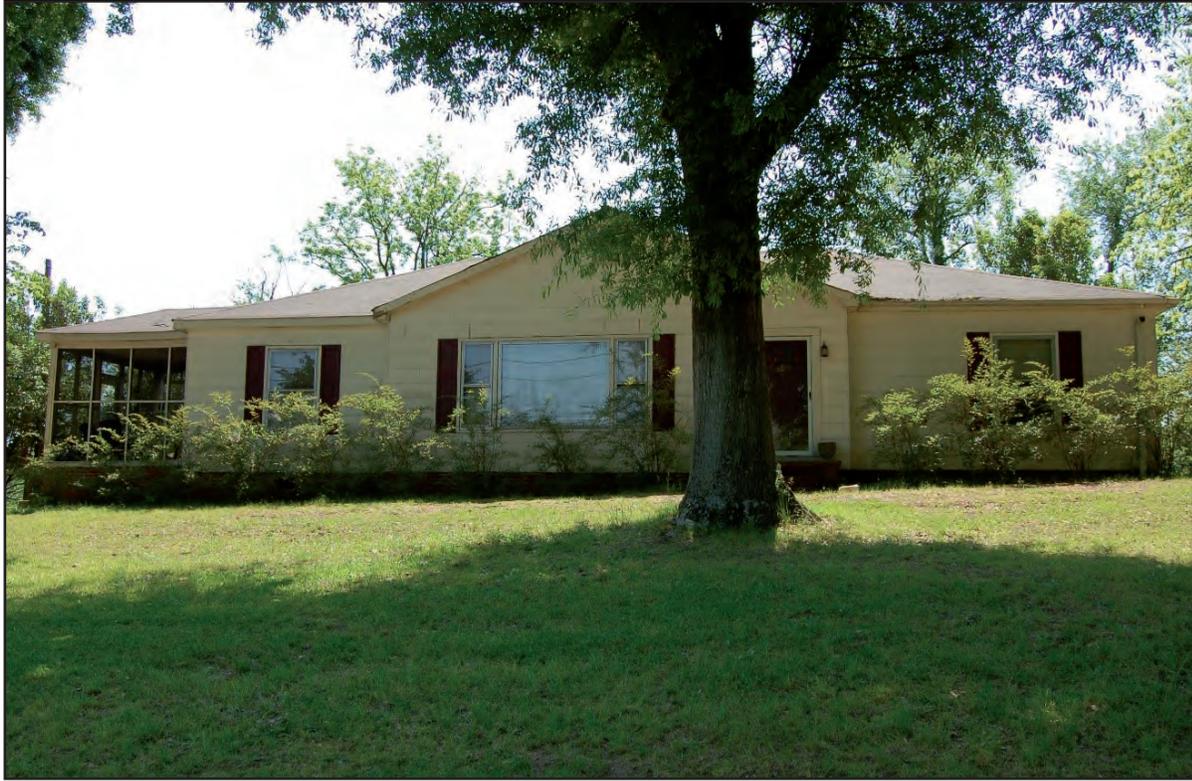
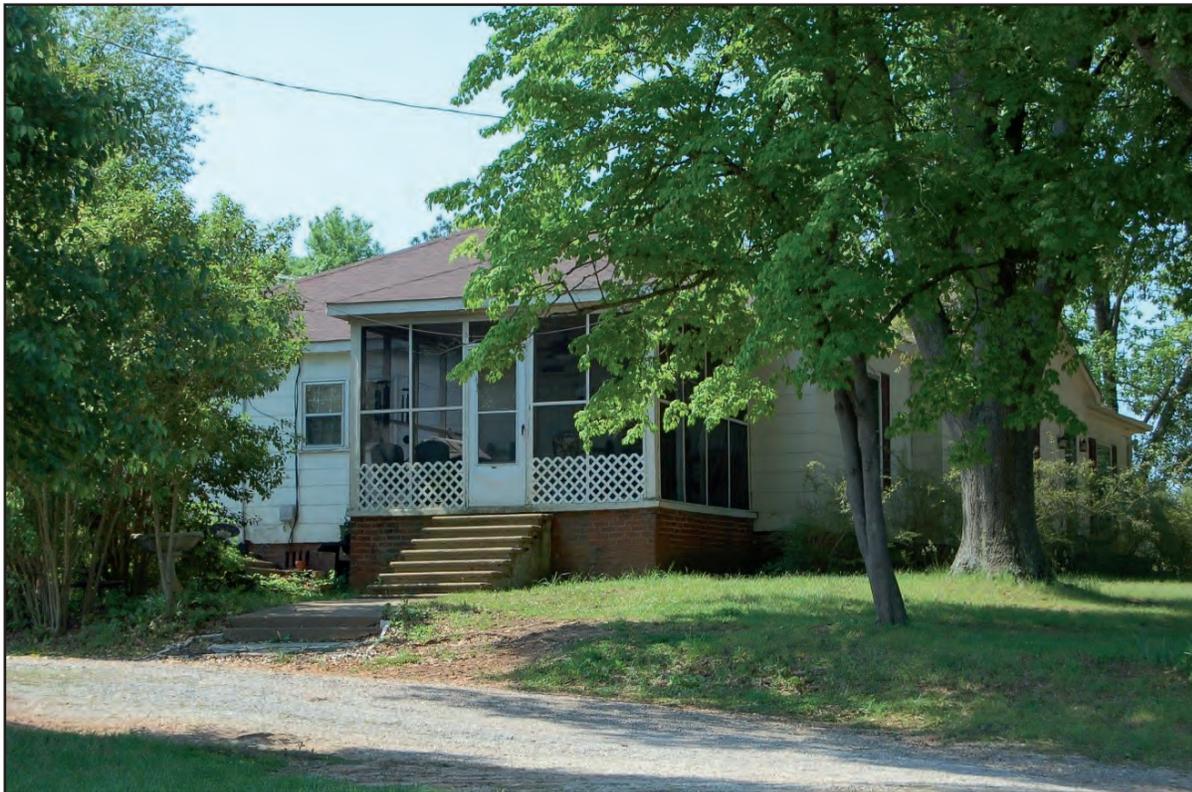
the north side elevation; a large tripartite window comprised of a large rectangular fixed window flanked by 1/1-light double-hung sash windows; and concrete asbestos tile exterior siding(see Figure 5.241 and 5.242). The remaining windows are original wood-framed 6/6-light double-hung sash.

**Figure 5.241.** Resource 186-0242 (1812 North Limestone Street) - View of façade facing north.

**Figure 5.242.** Resource 186-0242 (1812 North Limestone Street) - View of west side elevation facing east.

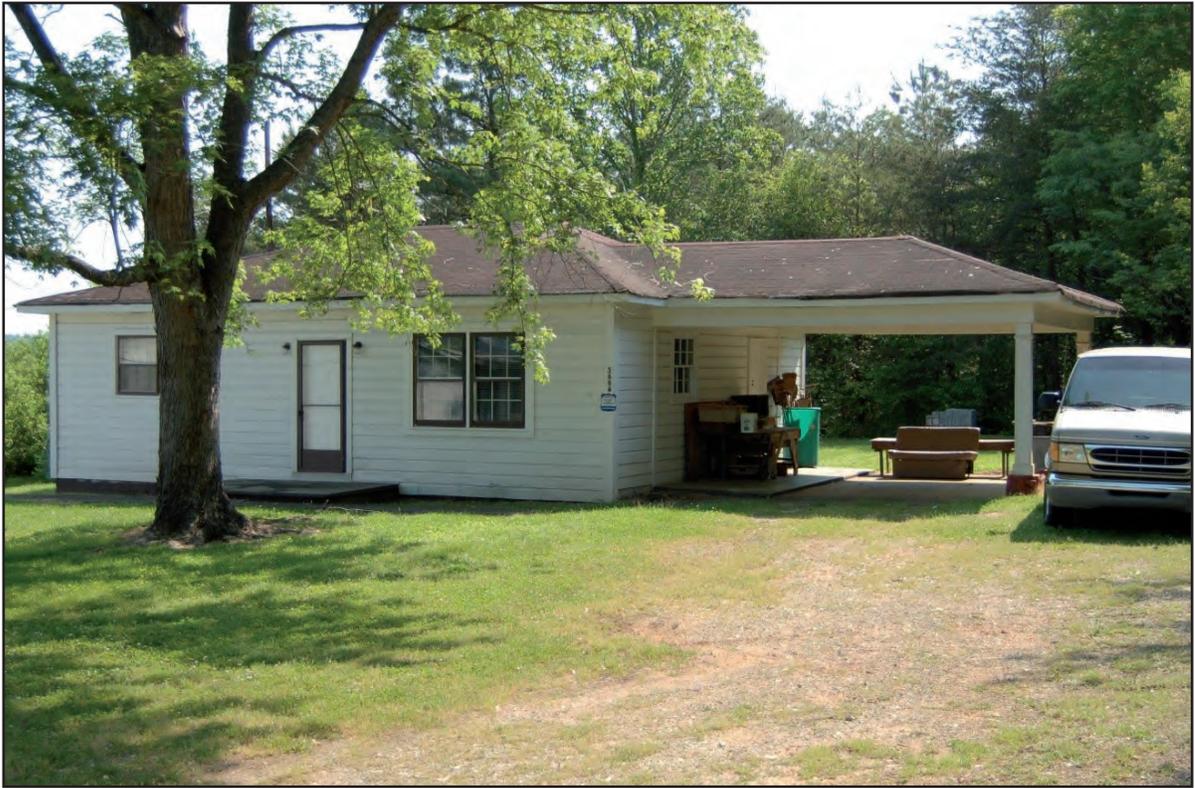
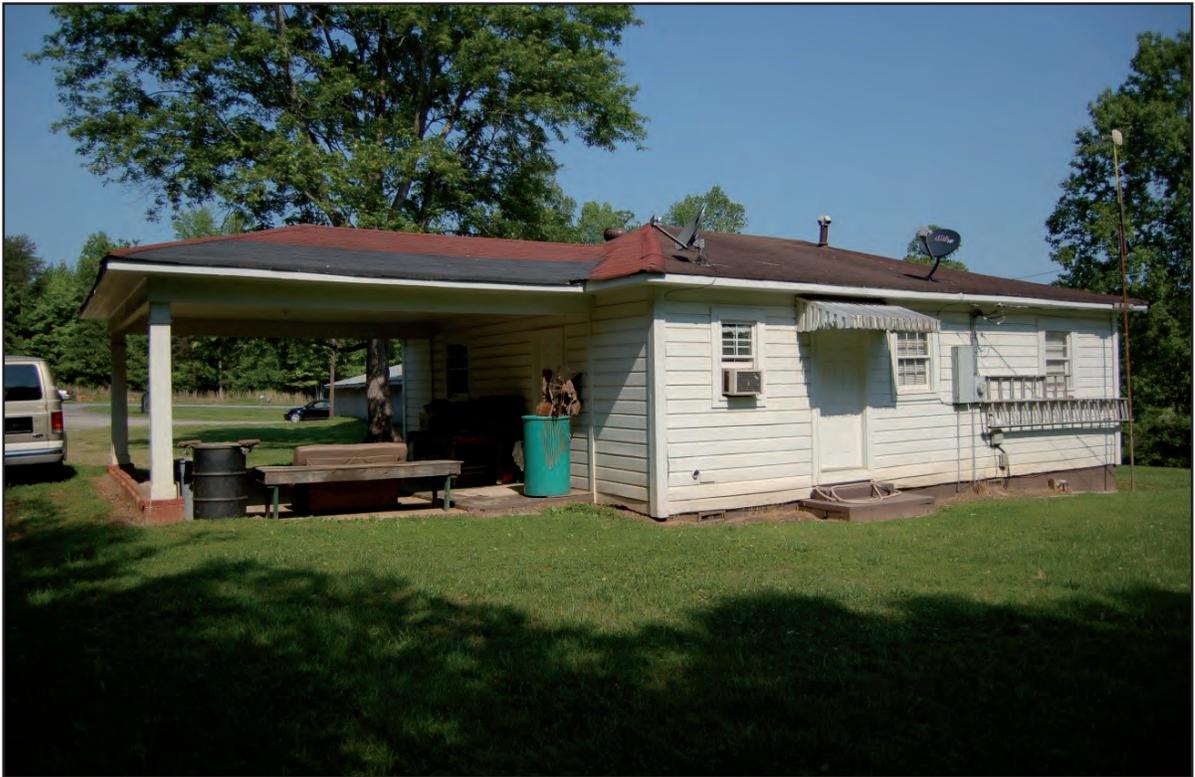
The house (Resource 040-0243.00) is a one-story, asymmetric, hipped-roof cottage of frame construction. The house features a hipped asphalt shingle roof; a continuous concrete block foundation; an extended hipped-roof carport on the south side elevation supported by two large square columns atop a low brick wall; and novelty board exterior siding (see Figures 5.243 and 5.244). The windows are a mix of wood-framed 2/2- and 6/6-light double-hung sash.

**Figure 5.243.** Resource 040-0243.00 (566 Shelby Highway) – Oblique view of façade and south side elevation facing northeast.

**Figure 5.244.** Resource 040-0243.00 (566 Shelby Highway) – Oblique view of south side and rear elevations facing northwest.

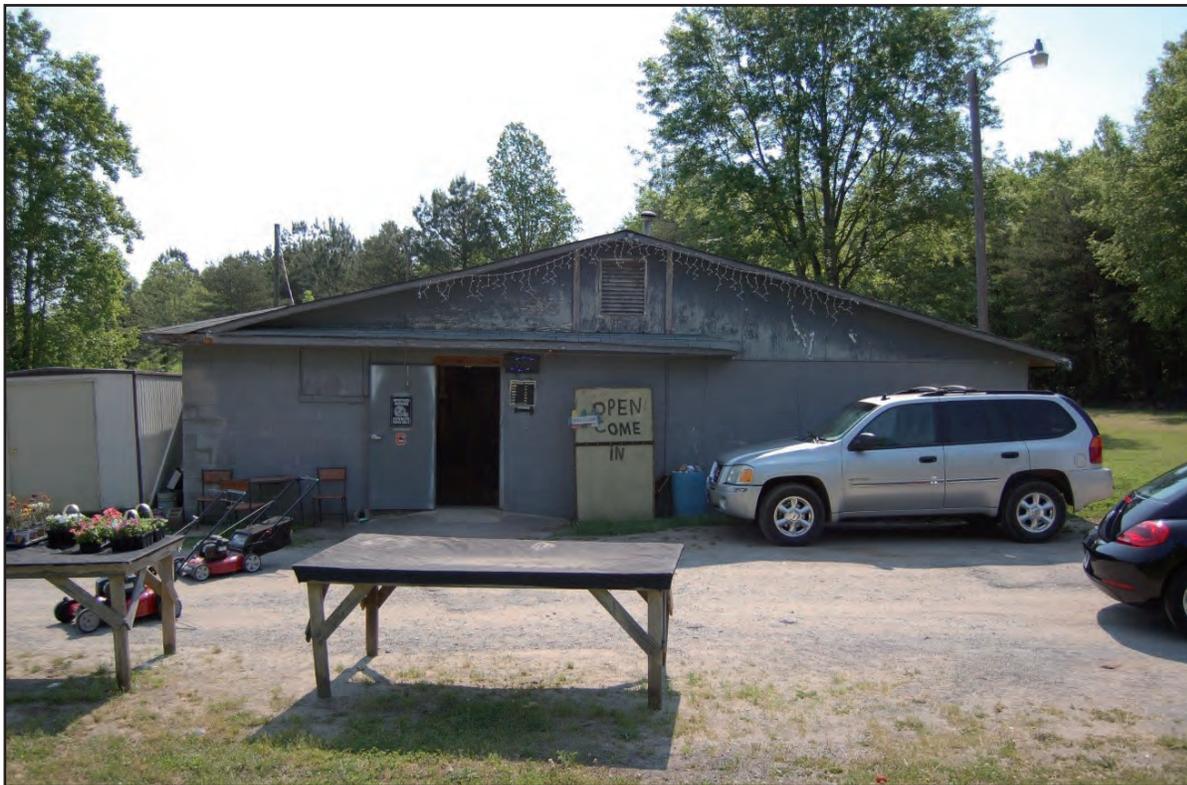
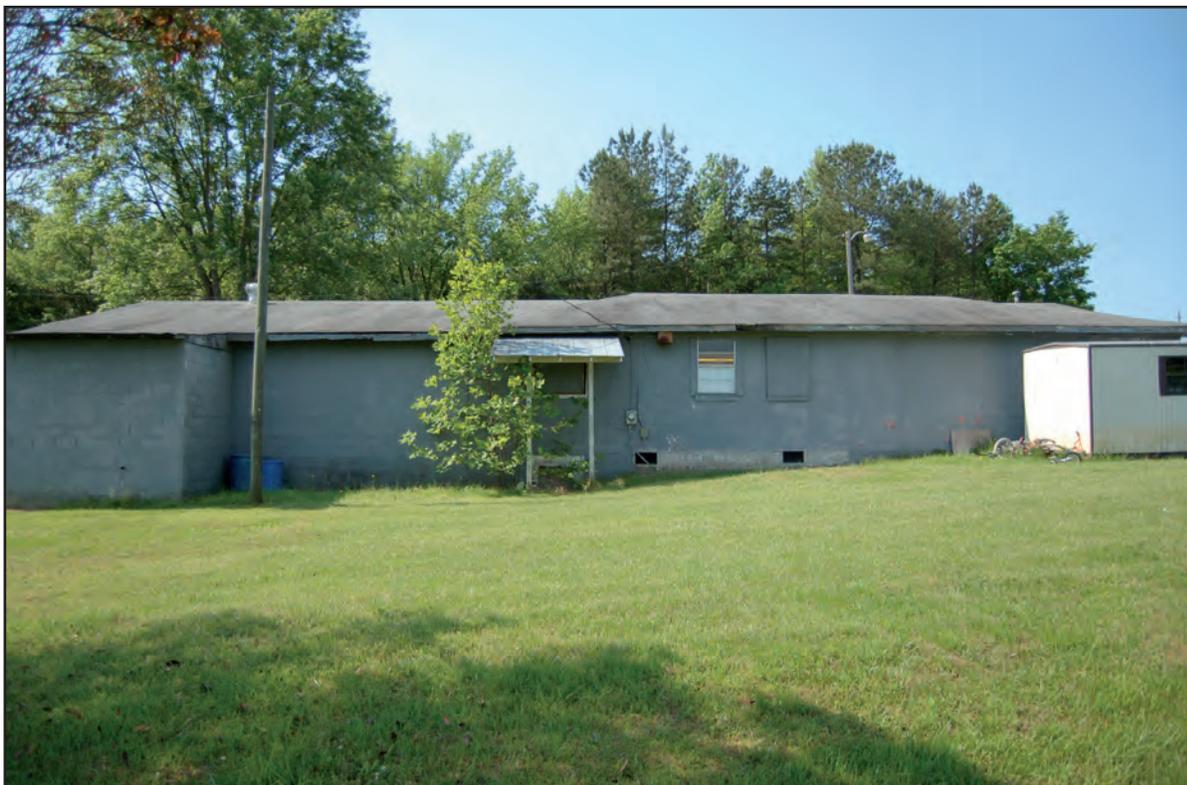
The store (Resource 040-0243.01) is a one-story, asymmetric, front-gabled commercial building of concrete block load-bearing wall construction. The building features a front-gabled asphalt shingle; concrete block exterior siding; and doorways on the façade and north side elevation (see Figures 5.245 and 5.246). There is metal-framed 2/2-light double-hung sash window and an enclosed window opening on the north side elevation. The length of the building has been increased

**Figure 5.245.** Resource 186-0243.01 (566 Shelby Highway) - View of façade facing east.

**Figure 5.246.** Resource 186-0243.01 (566 Shelby Highway) - View of north side elevation facing south.

as indicated by a change in the roof form and roofline and a vertical mortar joint visible on the north side elevation. There is also a shed-roofed addition on the north side elevation of the rear addition.

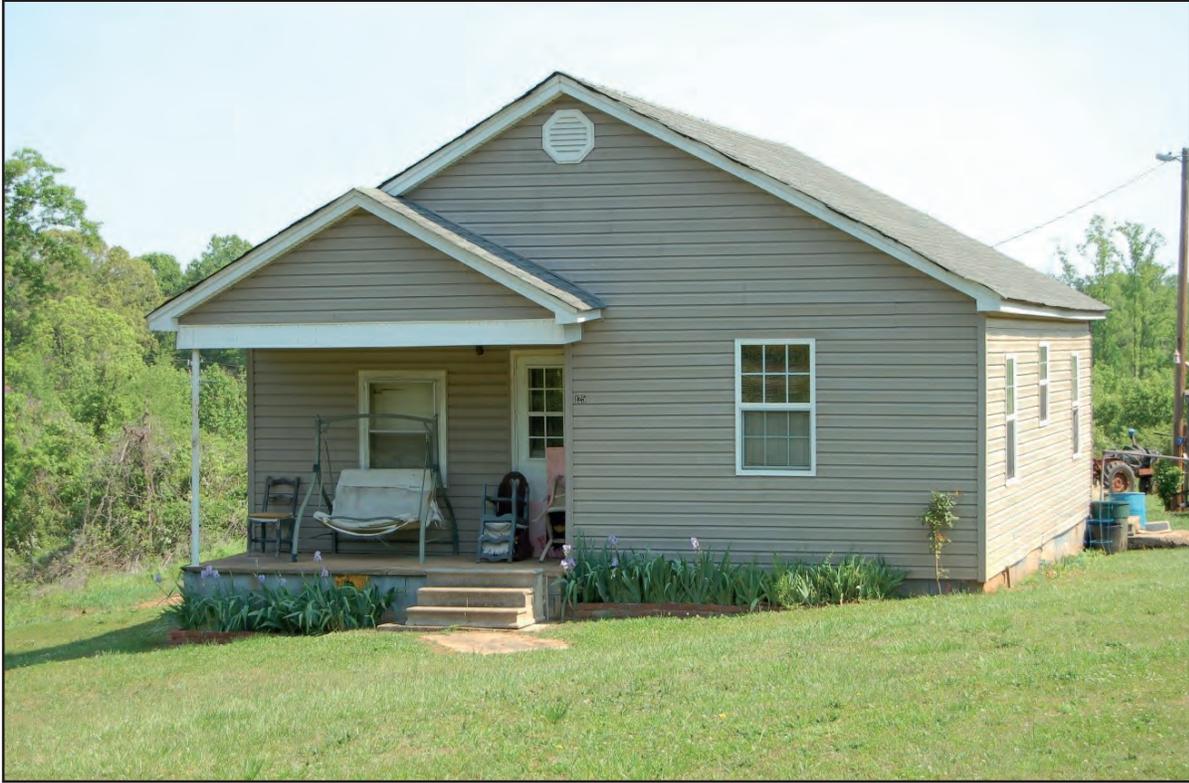
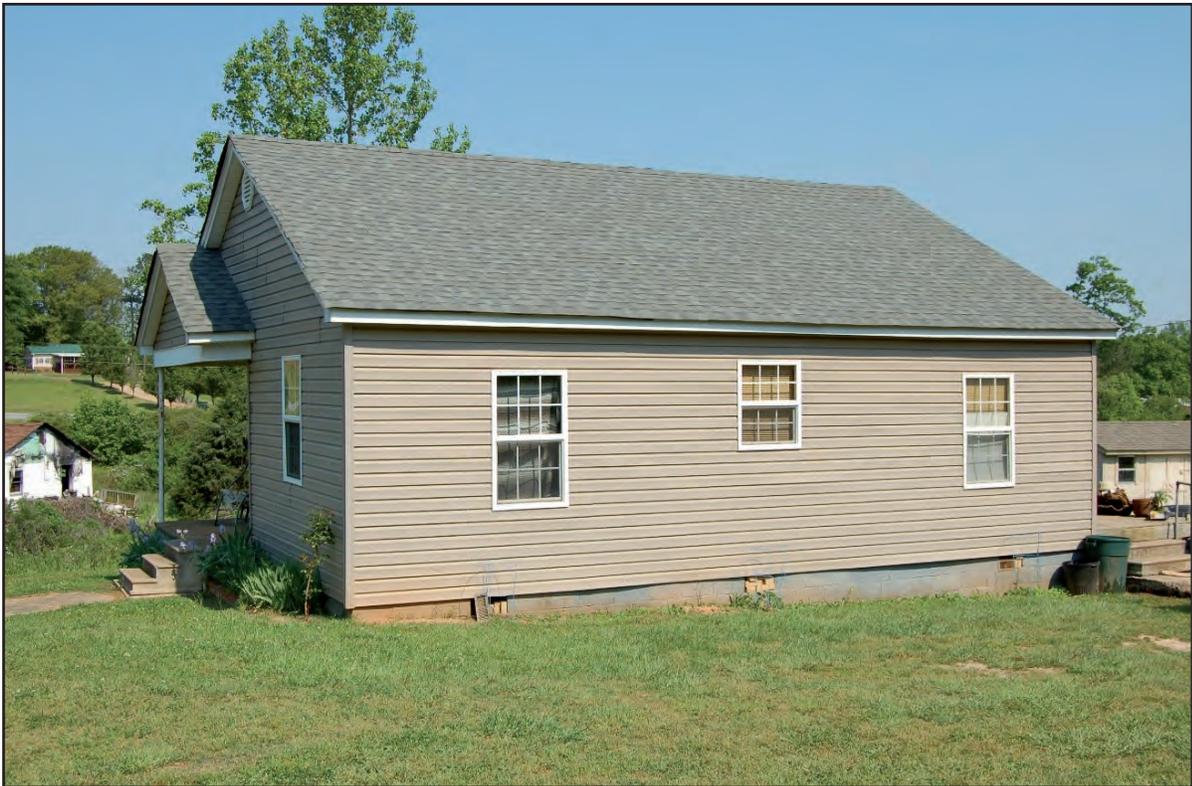
Resource 040-0244 is located at 125 Easler Road on the north side of the roadway approximately 480 feet east of the intersection of Easler Road and Shelby Highway northeast of Gaffney in Cherokee County (refer to Figure 5.2d). The Cherokee County tax assessor's record does not have an estimated date of construction for the resource. The resource is depicted in its current location on the earliest aerial photograph available on the [www.historicaerials.com](http://www.historicaerials.com) website dated 1971 and on the earliest topographic map available on the USGS [www.nationalmap.gov/historical/](http://www.nationalmap.gov/historical/) website dated 1971. Based on an evaluation of the resource's form, massing, and construction materials, Resource 113-0244 appears to have been constructed ca. 1950. The resource is a one-story, asymmetric, front-gabled bungalow of frame construction. The house features a front-gabled asphalt shingle; a continuous concrete block foundation; a partially-engaged and partially-projecting partial-width porch on the façade; and vinyl exterior siding. The porch roof is supported by a single metal post (see Figures 5.247 and 5.248). All windows are non-historic metal-framed vinyl replacements with faux muntins.

**Figure 5.247.** Resource 040-0244 (125 Easler Road) - View of façade facing north.

**Figure 5.248.** Resource 040-0244 (125 Easler Road) - View of east side elevation facing west.

resource under Criterion D. The resource is an undistinguished example of a common architectural type and is recommended **Not Eligible** for listing in the NRHP under Criterion C in the area of architecture.
