Asbestos & Lead Paint Survey Report

S-29-292 Bridge over Bear Creek
Lancaster, South Carolina
Bridge Asset No. 04157

Terracon Project No. 7323P100_4

Re: **Asbestos & Lead Paint Survey Report**
S-29-292 Bridge over Bear Creek
Bridge Asset No. 04157
Lancaster, South Carolina
Terracon Project No. 7323P100_4

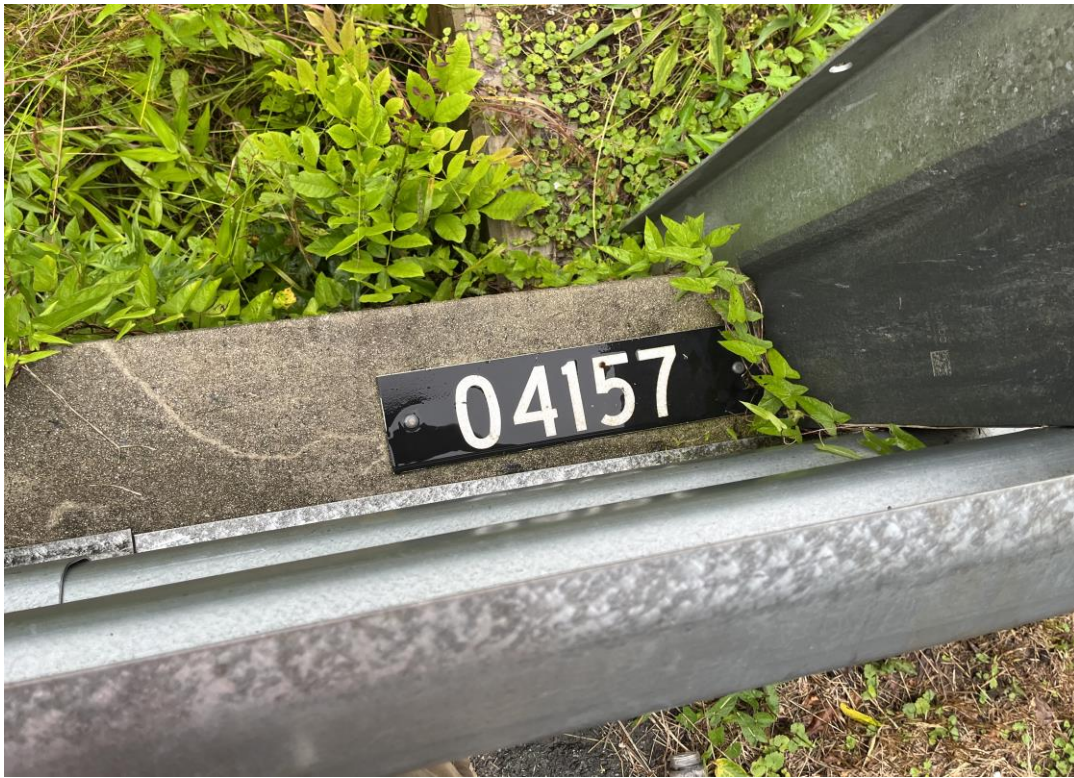
Photo 1 View of the bridge asset number.

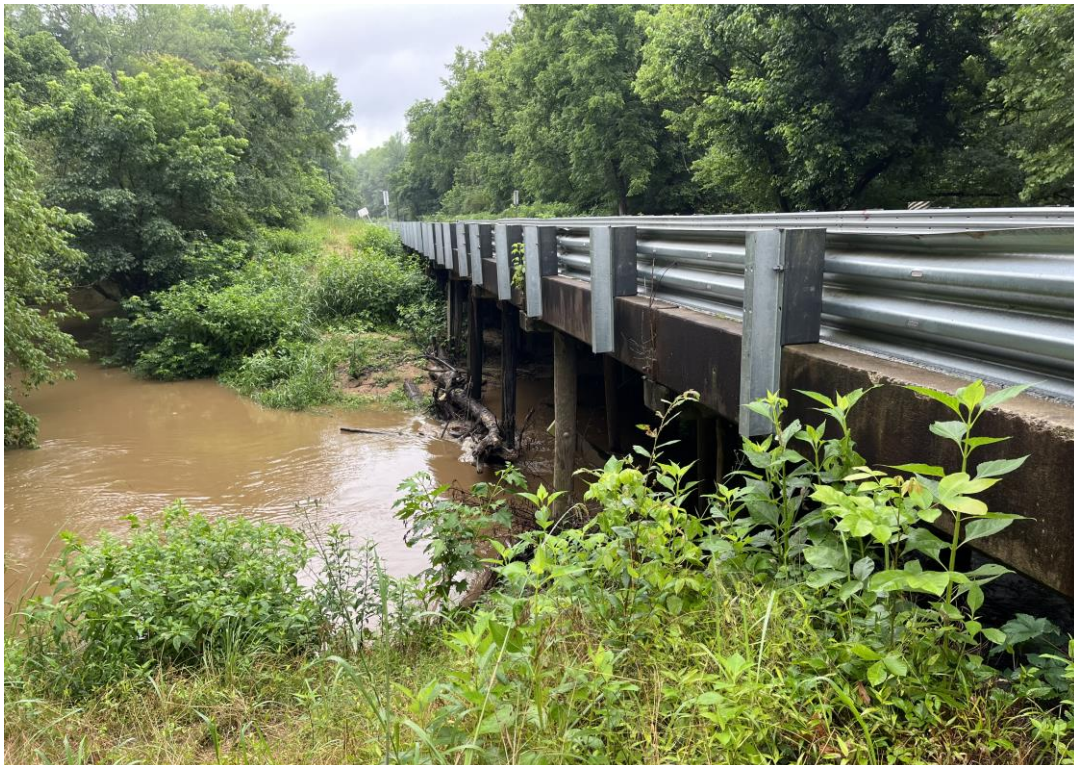
The bridge deck of the structure consists of concrete spans. The bridge structure has metal guardrails. The bridge deck is supported by concrete pier caps, which are located on wood piers. The bridge structure is approximately 180 feet long and 25 feet wide.

Photo 2 View of the side of bridge looking north.

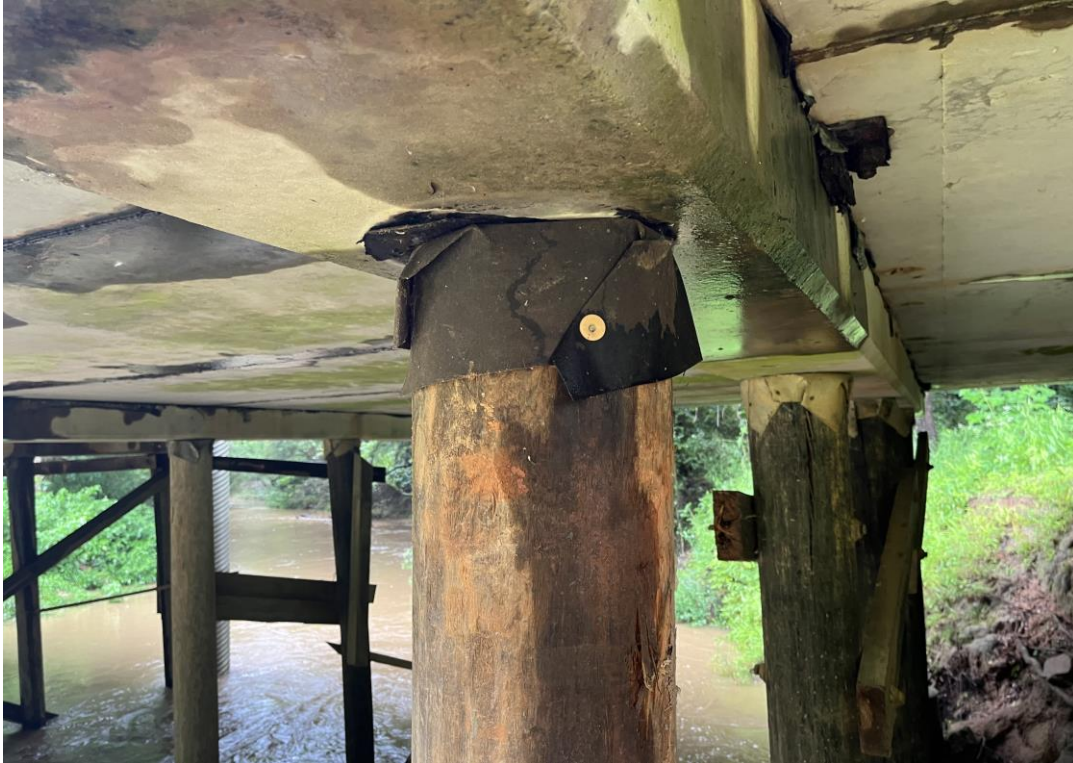
Based on the results of laboratory analyses, **asbestos was not detected** in the friction barrier samples collected from the bridge. These results were confirmed by TEM analysis. Asbestos laboratory analytical reports are included in Appendix B.

HA	Approx. Quantity (ft ²)	Samples Collected	Description	Sample Location	Lab Result	Category	Condition
1	130	3	Thin Friction Barrier	Between piers and pier caps	NAD	Misc	NF, Good
2	375	3	Thick Friction Barrier	Between pier caps and decking	NAD	Misc	NF, Good

Photo 3 View of thin friction barrier between pier and pier cap.

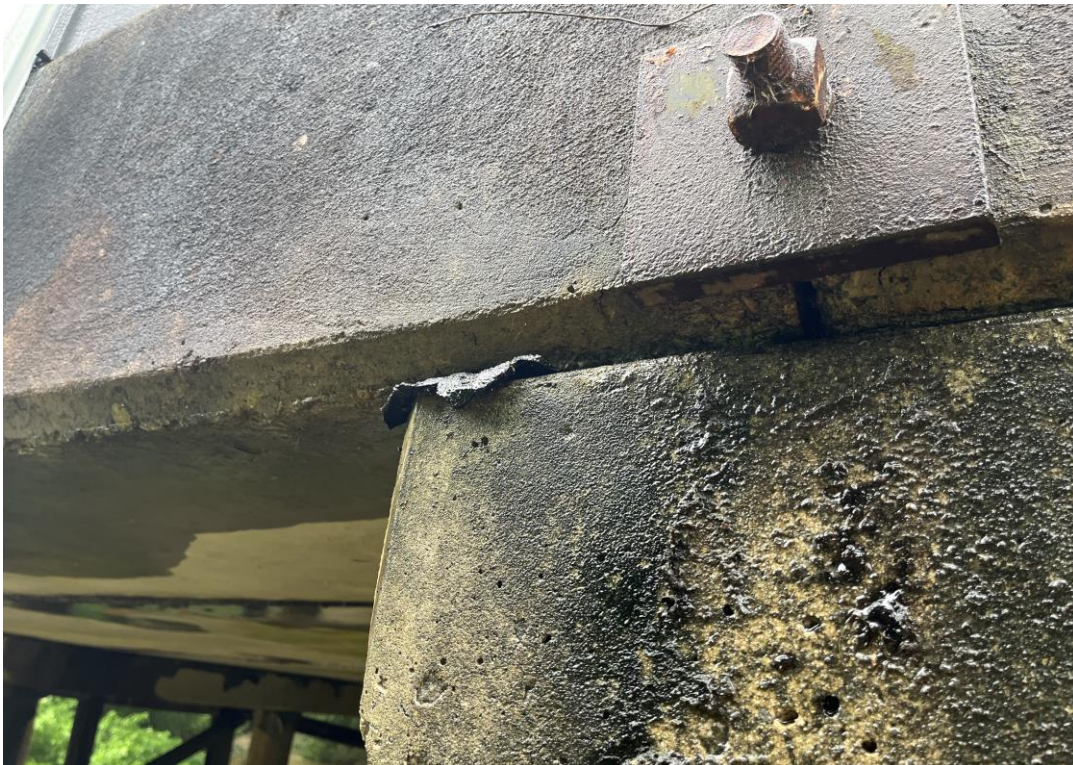
- Orange Metal Bracket – 14.32 mg/cm²;

It should be noted that on this bridge all metal brackets have rusted and decayed over time leaving behind little to no lead paint.

Sample Number	Description	Location	XRF Result
LP-1	Orange Metal Bracket	Between Decking Joints	14.32 mg/cm ²

Photo 4 View of thick friction barrier between pier cap and decking and orange metal bracket.

XRF analysis detected lead concentrations greater than 0.7 mg/cm² by weight. SCDHEC regulations require that lead painted demolition debris be disposed in a permitted Class II landfill. Landfills should be contacted to determine their specific disposal requirements. Metal components painted with lead-based paint may be recycled however the recycler should be contacted to determine their specific requirements. Additionally, the provisions in the OSHA Standard for Lead (29 CFR 1926.62) should be followed by contractor personnel conducting work activity during the demolition. A summary of the lead paint laboratory results is presented in Table 2 in Appendix A.
