South Carolina Department of Transportation On Behalf of the Federal Highway Administration - South Carolina Division Office PROCESSING FORM FOR PROGRAMMATIC CATEGORICAL EXCLUSIONS NON MAJOR FEDERAL ACTIONS									
Project ID	P029450								
	Part 1 - Project Description								
Include the	Project Name/Deso	ription							
I-20 Bridge F	Replacements over th	ne Wateree River							
The South Carolina Department of Transportation (SCDOT) proposes to replace the existing Interstate 20 (I-20) bridges (eastbound and westbound) over the Wateree River in Kershaw County, South Carolina. Specifically, the project is situated along the portion of I-20 between the I-20 Rest Areas in Lugoff to the west and the US 521 (Sumter Highway) interchange (Exit 98) to the east (refer to Appendix A - Project Location Map). The project includes replacing the existing bridge structures and improving the roadway approaches to meet current design standards. The new bridges would be built in phases to maintain traffic in both directions on I-20 for the duration of construction. The proposed project would accommodate two 12-foot lanes and 10-foot shoulders. The existing bridges are 1,500 feet long, and the ne

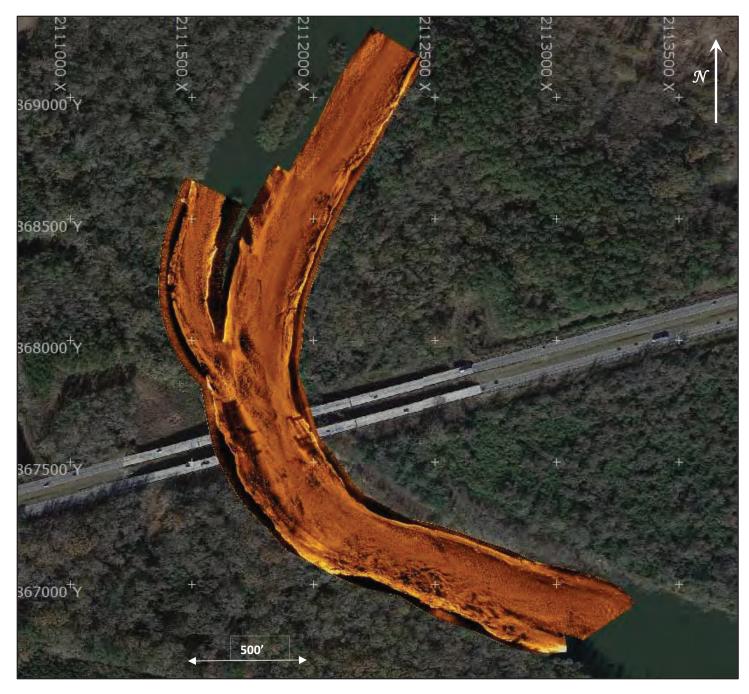
#### Figure 4. Sonar Mosaic of Wateree River Creek Project Area overlaid on an Aerial Photograph

Notes: 1) Sonar Data were collected with a *Klein 3900* 500/900 kHz transducer using ranges of 100' and 150' 2) Background Grid = South Carolina State Plane Coordinates, NAD83, int. feet

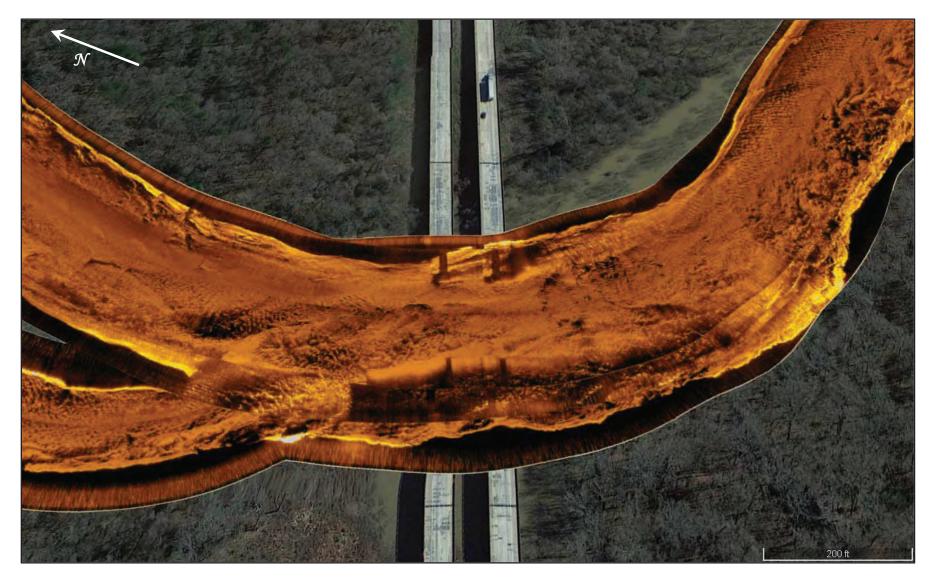
#### Figure 5. Detail of Sonar Mosaic of Wateree River Project Area overlaid on an Aerial Photograph

**Note:** No potentially significant sonar targets were identified in the APE.

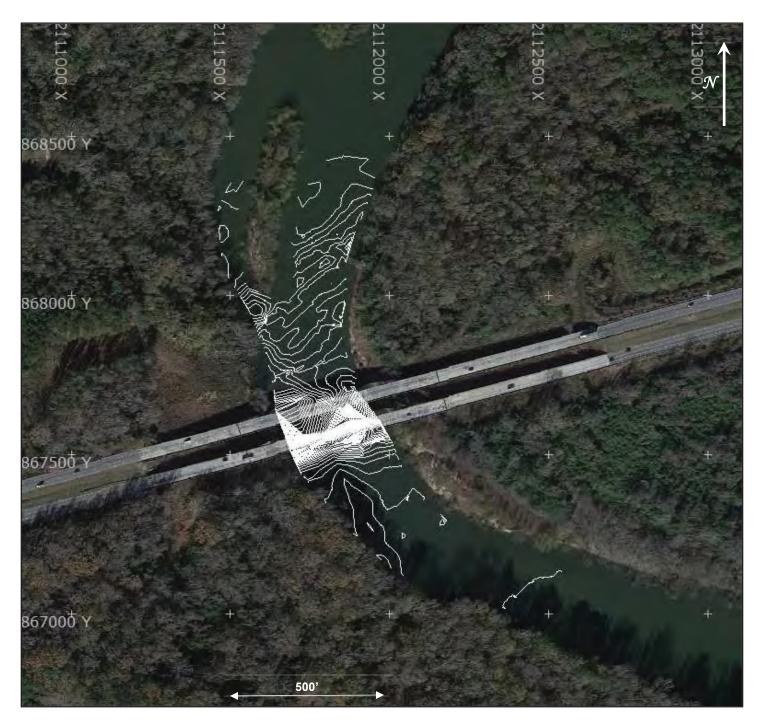
## Figure 6. Magnetic Contours at 100 nT (gamma) Intervals at Wateree River Project Area overlaid on an Aerial Photograph

3) Intense magnetic background was generated by proximity to bridges

4) Background Grid = South Carolina State Plane Coordinates, NAD83, int. feet

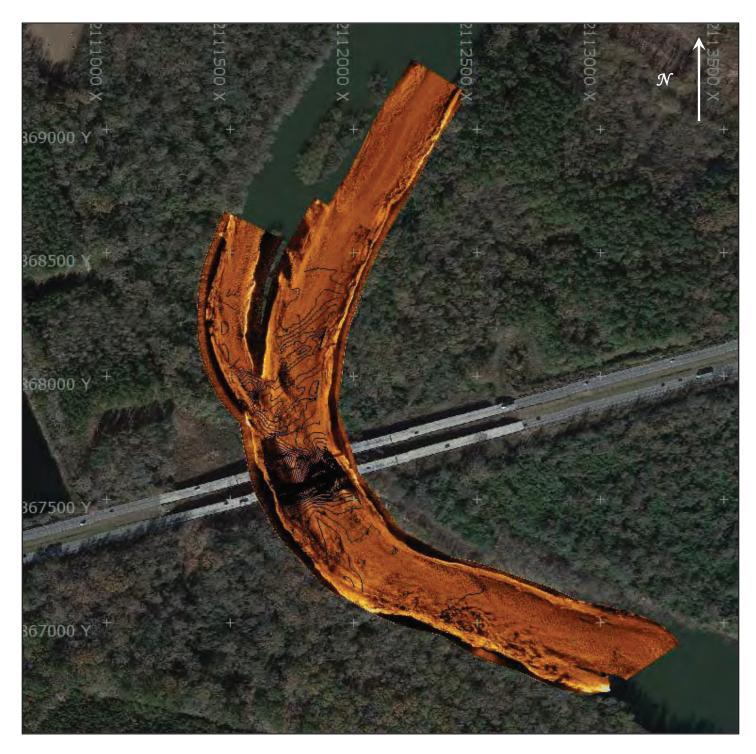
#### Figure 7. Sonar Mosaic overlaid with Magnetic Contours at 100 nT (gamma) Intervals

Notes: 1) Magnetic Contour Interval = 100 nT (gamma)

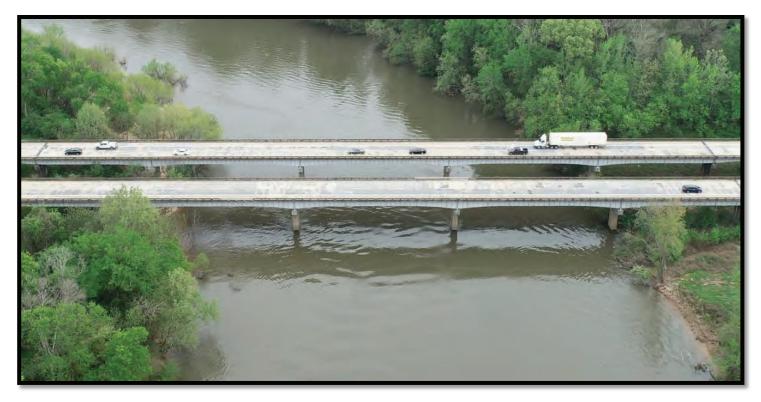
Existing bridge structures in the Wateree River.

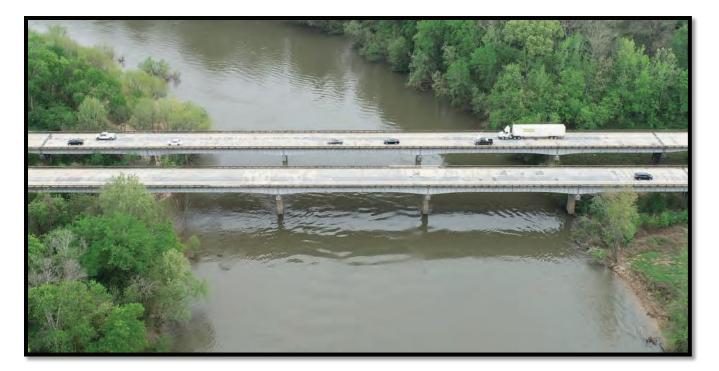
A view of the existing I-20 bridges facing south southeast.

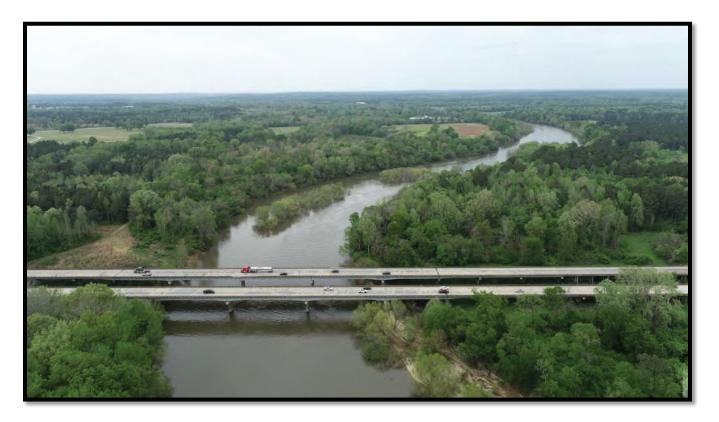
A view of the existing I-20 bridges facing north northeast.

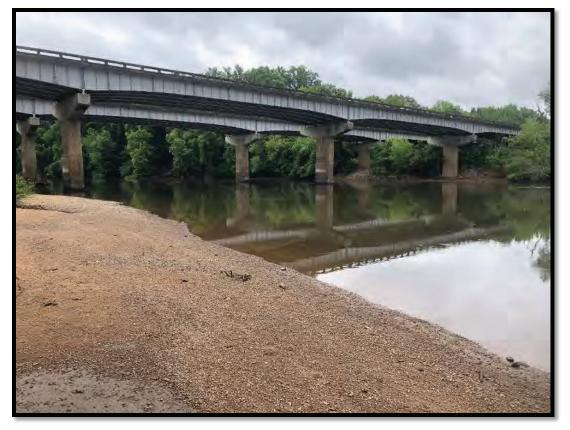
Existing I-20 bridge piers (facing south).

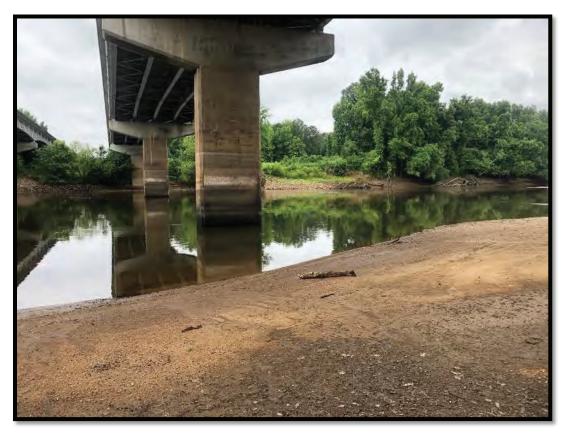
Westbound I-20 bridge (facing southwest).

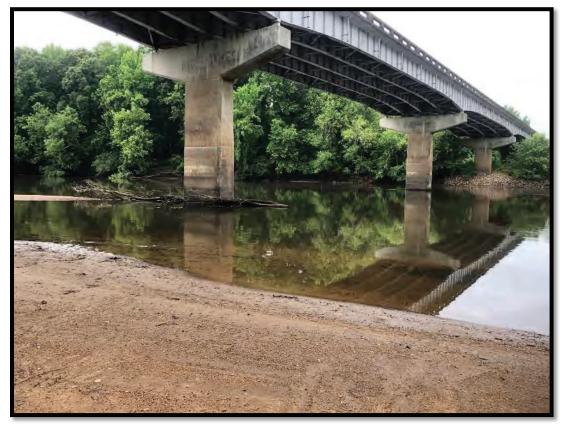
Eastbound I-20 bridge (facing southwest).
