## LEAD-BASED PAINT INVESTIGATION REPORT

S-108 (OUTEN RD.) RBO BROWN CREEK  
CHESTERFIELD COUNTY, SOUTH CAROLINA

**September 22, 2022**

FME Project No.: G6656.003

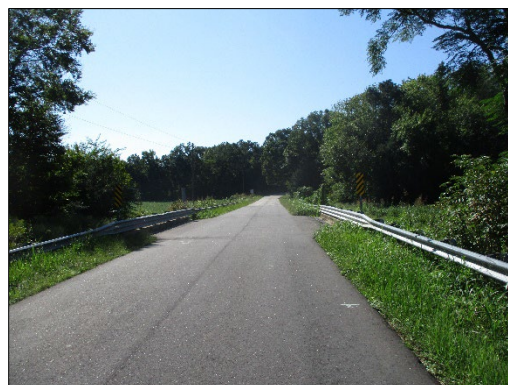
The existing Bridge ( $\sim 45'.0''\text{L} \times 26'.0''\text{W}$ , inside curb to inside curb), is located on S-108 (Outen Rd.) and crosses over Brown Creek in Chesterfield County, South Carolina. The Bridge was constructed in the late-1970's according to date engraved into concrete curbing on the southwest corner of the Bridge. The structure is a two (2) lane, three (3) span Bridge constructed with pre-fabricated concrete bridge deck, and concrete curbing with a asphalt overlay. Each end bent is supported by five (5) timber piles with poured-in-place bent caps. Pre-drilled holes were noted along the sides of the Bridge to allow for water drainage.. Galvanized metal guardrails are attached to the concrete curbing on

*Photo 1 – S-108 (Outen Rd.) Bridge over Brown Creek, Chesterfield County.*

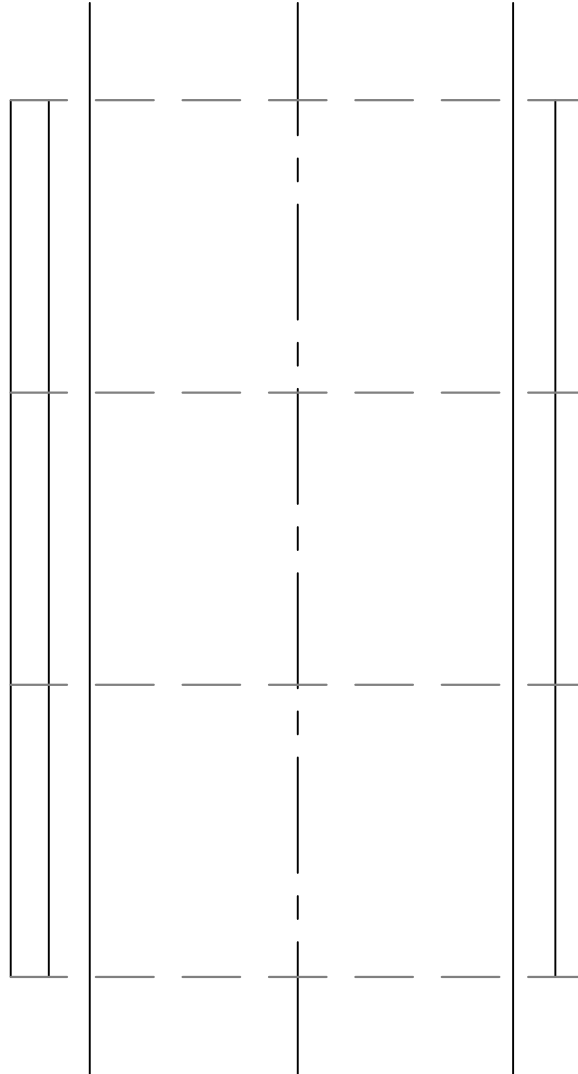
2

LEAD-BASED PAINT INVESTIGATION  
S-108 RBO Brown Creek  
Chesterfield County, SC  
Sample Location Plan  
Prepared for: HDR, Inc.  
1201 Main Street, Suite 800  
Columbia, SC 29201

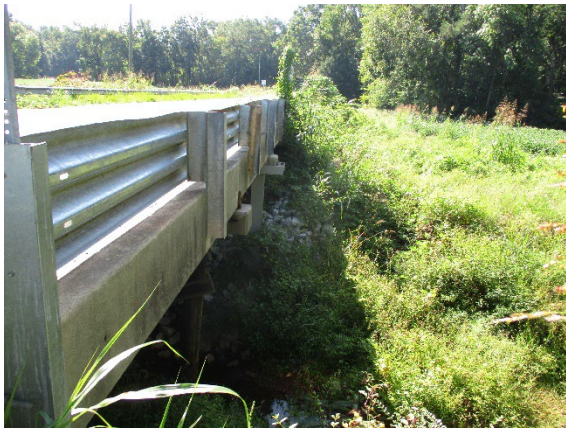
**Photo 3.** East Side View of Bridge.

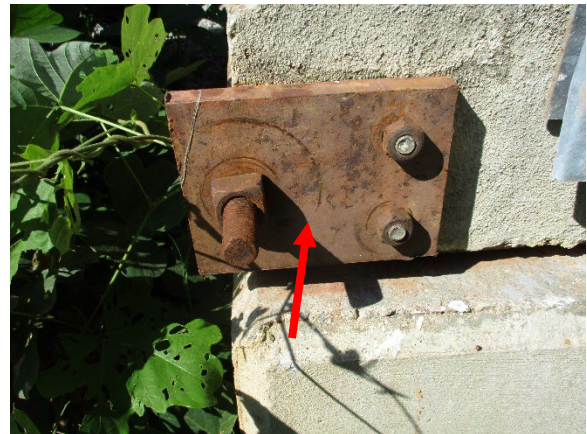
Scan No.	Pbc (mg/cm <sup>2</sup> )	Component	Substrate	Side	Condition	Color
1	0.97	Calibrate				
2	0.96	Calibrate				
3	0.99	Calibrate				
4	3.77	Tie Rod Washer	Metal	B	Poor	Rust/Orange
5	2.07	Exposed Tie-Rod	Metal	C	Poor	Rust/Orange
6	9.7	L-Bracket	Metal	Center	Poor	Rust/Orange
7	<LOD	H-Pile	Metal	Center	Intact	Gray
8	<LOD	H-Pile	Metal	Center	Intact	Gray
9	<LOD	H-Pile	Metal	Center	Intact	Gray
10	<LOD	Horizontal I-Beam	Metal	Center	Intact	Gray
11	<LOD	Horizontal I-Beam	Metal	Center	Intact	Gray
12	<LOD	Horizontal I-Beam	Metal	Center	Intact	Gray
13	<LOD	Side L-Bracket	Metal	B	Poor	Gray
14	<LOD	Side L-Bracket	Metal	B	Poor	Gray
15	<LOD	Side L-Bracket	Metal	D	Poor	Gray
16	0.93	Calibrate				
17	0.92	Calibrate				
18	0.96	Calibrate

**Photo 4.** LBP on Rust Colored Tie-Rod Washer.

Therefore, OSHA regulations and procedures should be followed when impacting these components. If possible, they should be removed in whole and disposed of properly. Also, SCDHEC disposal requirements for lead containing materials should also be followed.

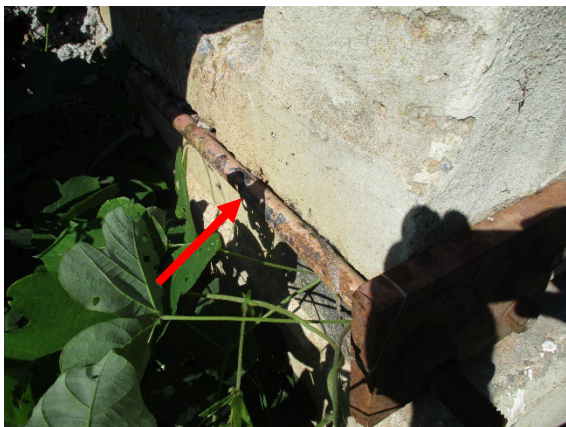
**Photo 5.** LBP on Exposed Tie-Rod.

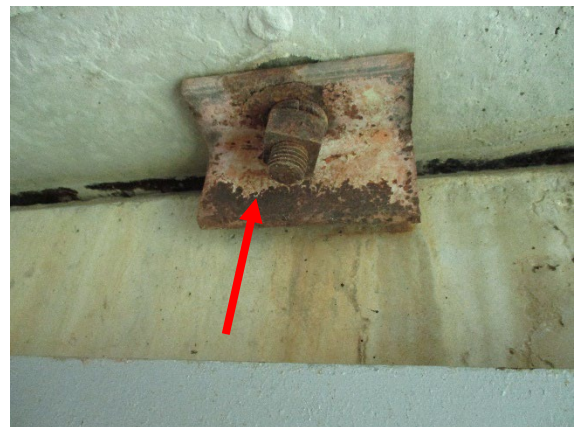
**Photo 6** LBP on Orange/Rust L-Bracket.
