## ASBESTOS CONTAINING MATERIAL INVESTIGATION REPORT

S-53 (ROSS DYE RD.) RBO LITTLE ROCKY CREEK  
CHESTER COUNTY, SOUTH CAROLINA

**September 22, 2022**

F&ME Project No.: E6656.002

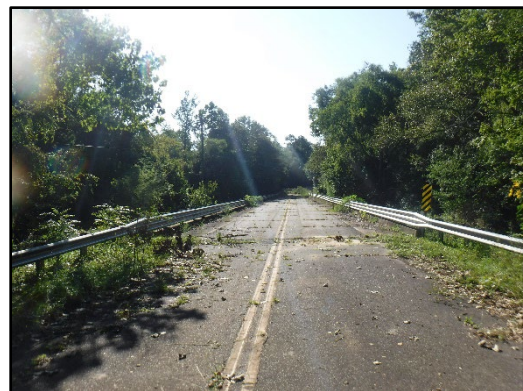
*Photo 1 – S-53 (Ross Dye Rd.) Bridge over Little Rocky Creek in Chester County, SC.*

The existing bridge structure (~300'.0"L x 31'.00"W, inside curb to inside curb), is located on S-53 (Ross Dye Rd.) and crosses over Little Rocky Creek in Chester County, South Carolina. The Bridge was constructed in the early 1970's according to date engraved into concrete curbing on the northeast corner of the Bridge. The structure is a two (2) lane, twenty-one (21) span Bridge constructed with pre-fabricated concrete bridge deck, concrete curbing with a asphalt overlay.

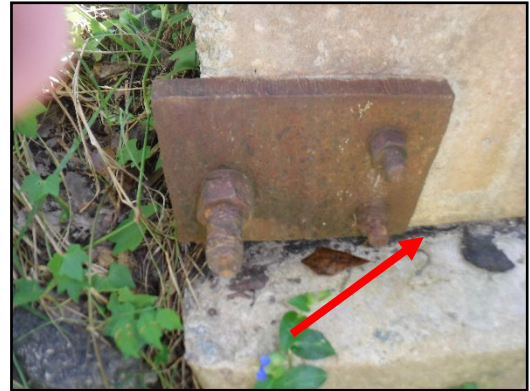
**HA-1 – Black Bond Break Pad Material (~700 SF).** ACM black bond break pad material was found between the bridge decking and the top of the bent caps of the Bridge. Overall, this material was intact with signs of deterioration due to age and exposure to elements. Removal of this material may render the material friable depending on the means and methods utilized. This material must be removed, handled, and disposed of as ACM. This material will need to be abated prior to the startup of demolition activities by a licensed abatement contractor.

ACM black bond break pad material was found between the bridge decking and the top of the interior and end bent caps of the Bridge structure. Overall, this material was intact with signs of deterioration due to age and exposure to elements.

It is our understanding that the existing bridge structure will to be demolished, in anticipation of the on-alignment replacement of the existing Bridge. Prior to the start of demolition activities, the black bond break pad material, timber pile cap felt, and Transite siding debris found on the shoulder of the road must be removed, handled and disposed of as ACM per SCDHEC regulations pertaining to asbestos waste. Removal of these types of bridge components prior to and during demolition activities is practical and will require coordination with a licensed abatement contractor.

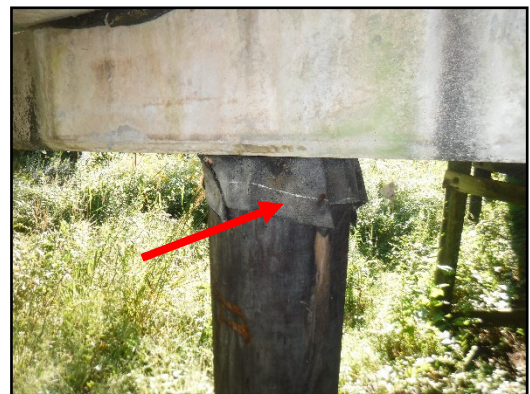
**HA-2 – Timber Pile Cap Felt (~150 SF).** ACM timber pile cap felt was found between the bent cap and the top of the supporting timber piles on the underside of the Bridge structure. Overall, this material was intact with no signs of damage. Removal of the timber pile cap felt may render the material friable depending on the means and methods utilized. This material is to be removed, handled, and disposed of as ACM. This material must be abated prior to the start of demolition activities that will impact it by a licensed abatement contractor.

ACM timber pile cap felt was found between the bent cap and the top of the supporting timber piles on the underside of the Bridge structure. Overall, this material was intact with no signs of damage.

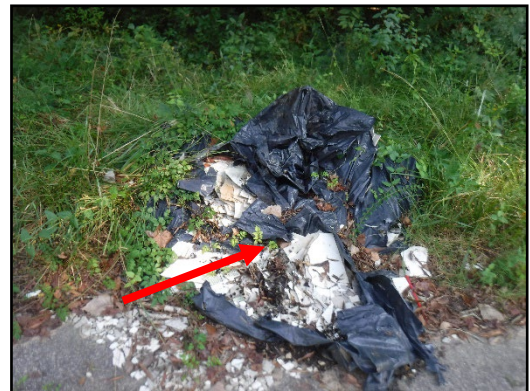
**HA-3 –Transite Siding Debris (~150 SF).** ACM Transite siding was observed on the SCDOT right away approximately 115 ft. north of the Bridge structure. Overall, this material was in a poor significantly damaged and friable condition. This material will need to be removed, handled, and disposed of as ACM as a component of the proposed Bridge construction. This material must be abated prior to the start of demolition activities that will impact it by a licensed abatement contractor.

ACM Exterior Transite siding was observed on the SCDOT right away approximately 115 ft. north of the Bridge structure. Overall, this material was in poor significantly damaged friable condition.

It should be noted that several bags of friable ACM Transite was found along the shoulder of the road approximately 115' north of the existing Bridge. The ACM Transite will be impacted during construction of the new Bridge and should be addressed during the planned demolition activities.

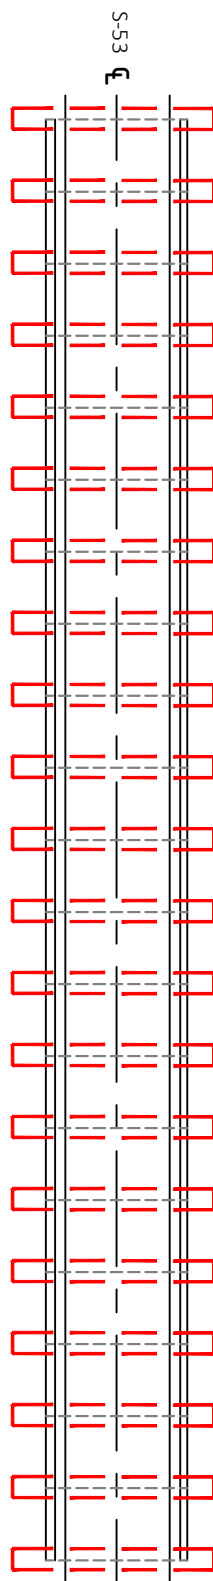
3

HA-1 Black Bond Break Material and HA-2 Timber Pile Cap Felt

Note: HA-3 - Multiple bags of ACM Transite siding (~150 SF) were noted 114' north of the Bridge on the west side of S-53.

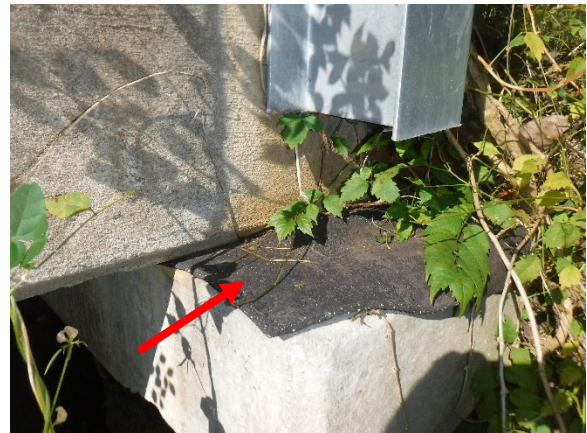
**Photo 4.** ACM Black bond Break Pad Material

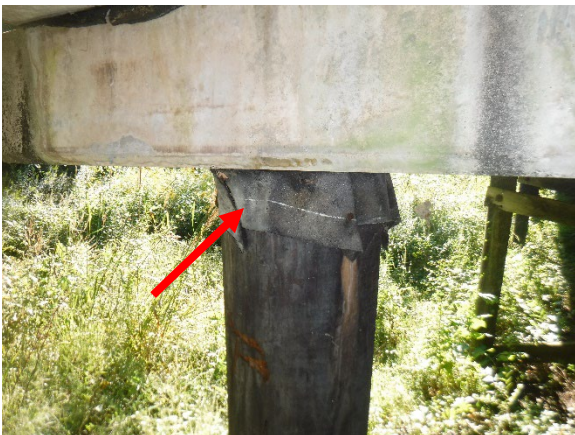
**Photo 5.** ACM timber Pile Cap Felt.

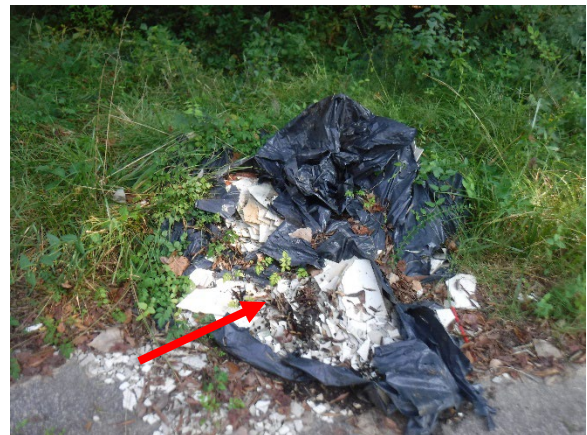
**Photo 6.** ACM Transite Siding Debris on SCDOT Right Away.
