ASBESTOS CONTAINING MATERIALS INVESTIGATION REPORT

**S-40-58 BRIDGE OVER I-26
SCDOT #4070005800100
RICHLAND COUNTY, SOUTH CAROLINA**

Re.: Asbestos Containing Materials Investigation Report
S-40-58 Bridge over I-26
SCDOT #4070005800100
Richland County, South Carolina
F&ME Project No.: E5350.02

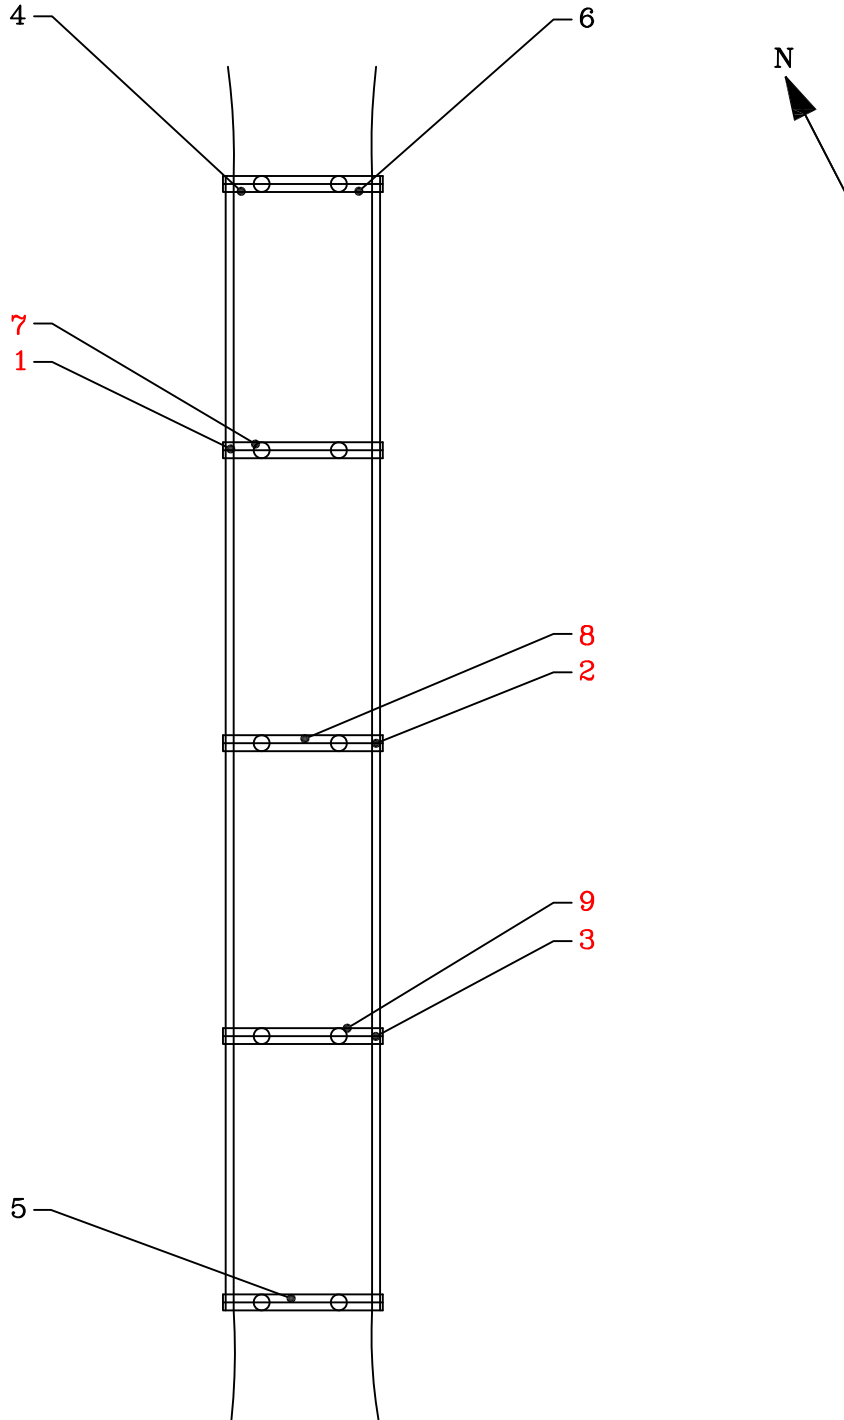
SCALE: N.T.S
PROJECT: E5350.02
FIGURE NO.: 2

SAMPLE LOCATION PLAN
S-40-58 BRIDGE OVER I-26
RICHLAND COUNTY, SOUTH CAROLINA

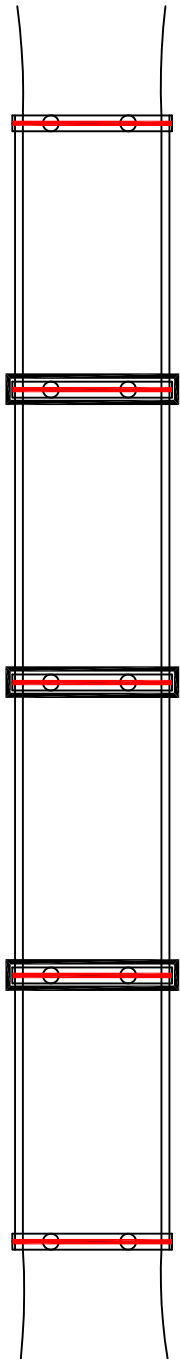
SCALE: N.T.S
PROJECT: E5350.02
FIGURE NO.: 3

HA-1 - Expansion Joint Material

HA-2 - Interior Bent Cap Felt Pads

HOMOGENEOUS AREA PLAN
S-40-58 BRIDGE OVER I-26
RICHLAND COUNTY, SOUTH CAROLINA

The following items are descriptions and quantities of the asbestos containing materials identified within the interior of the subject bridge structure (See Homogeneous Area Plan, Figure 3):

- HA-1 – Expansion Joint Material (~150 L.F.)

- HA-2 – Interior Bent Cap Felt Pads (~48 S.F.)

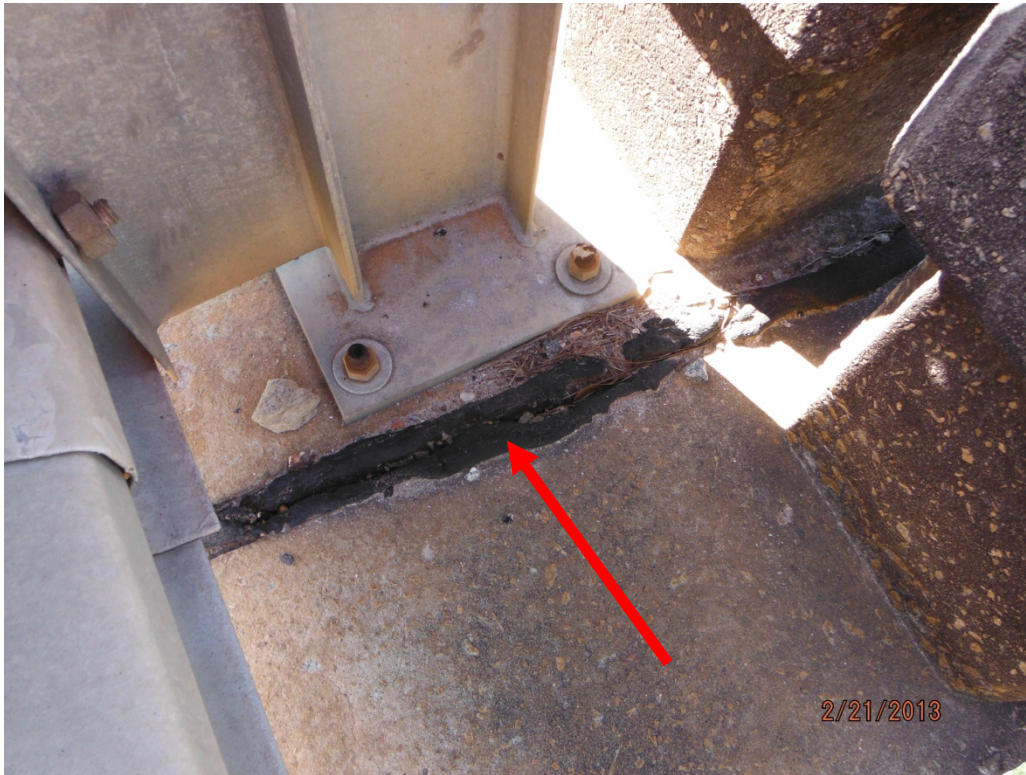
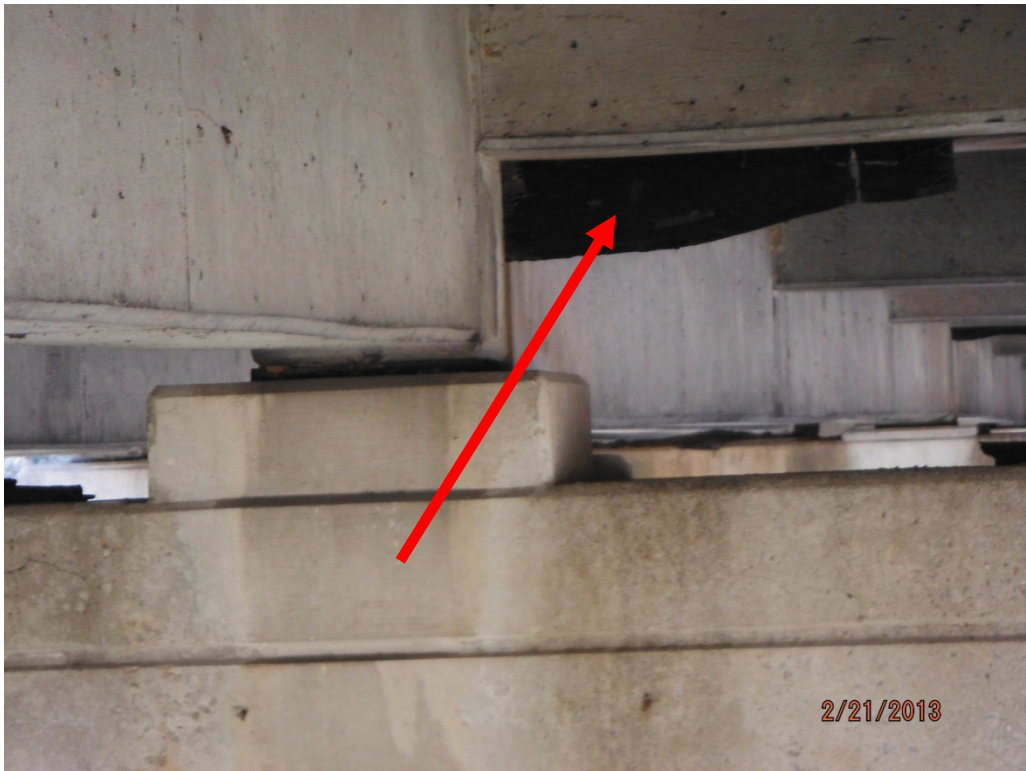
Asbestos-containing expansion joint material is located in each of the five (5) bridge deck expansion joints. This material fills each expansion joint from the top of the bridge deck to the underside of the bridge deck. Due to this material being encapsulated between adjacent concrete spans, assessment of its complete condition is not possible. The exposed portions where this material was sampled appeared to be in good condition. Since demolition and/or renovation activities will impact this material, it must be removed and disposed of as ACM by a licensed abatement contractor.

Asbestos-Containing Expansion Joint Material

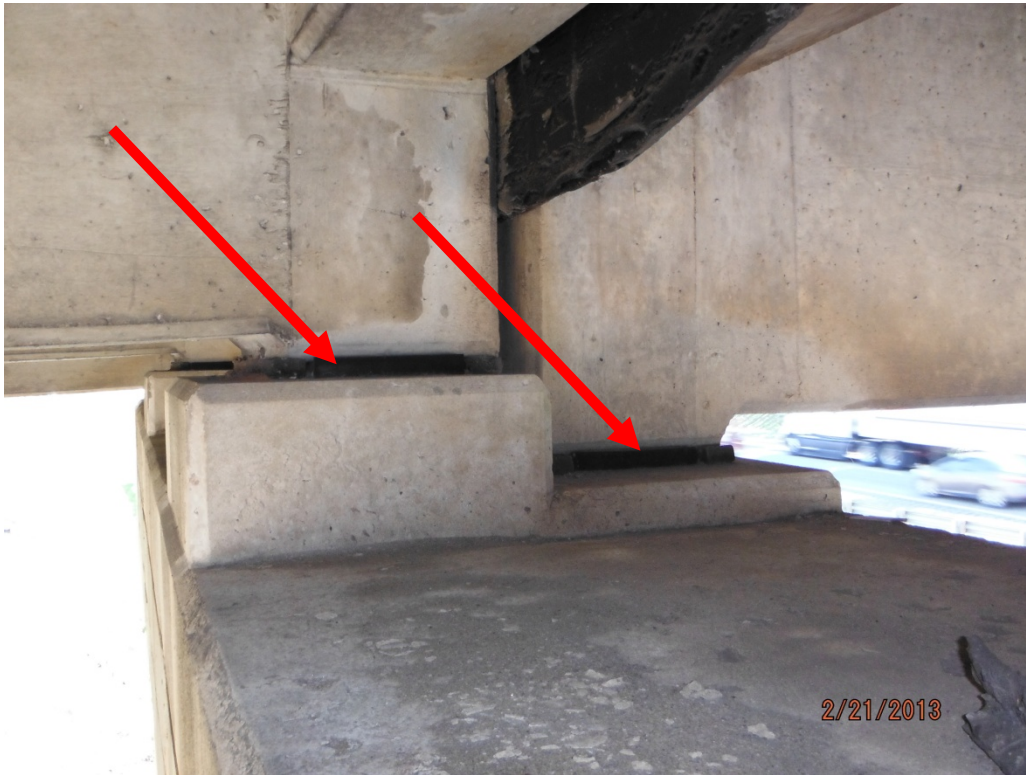
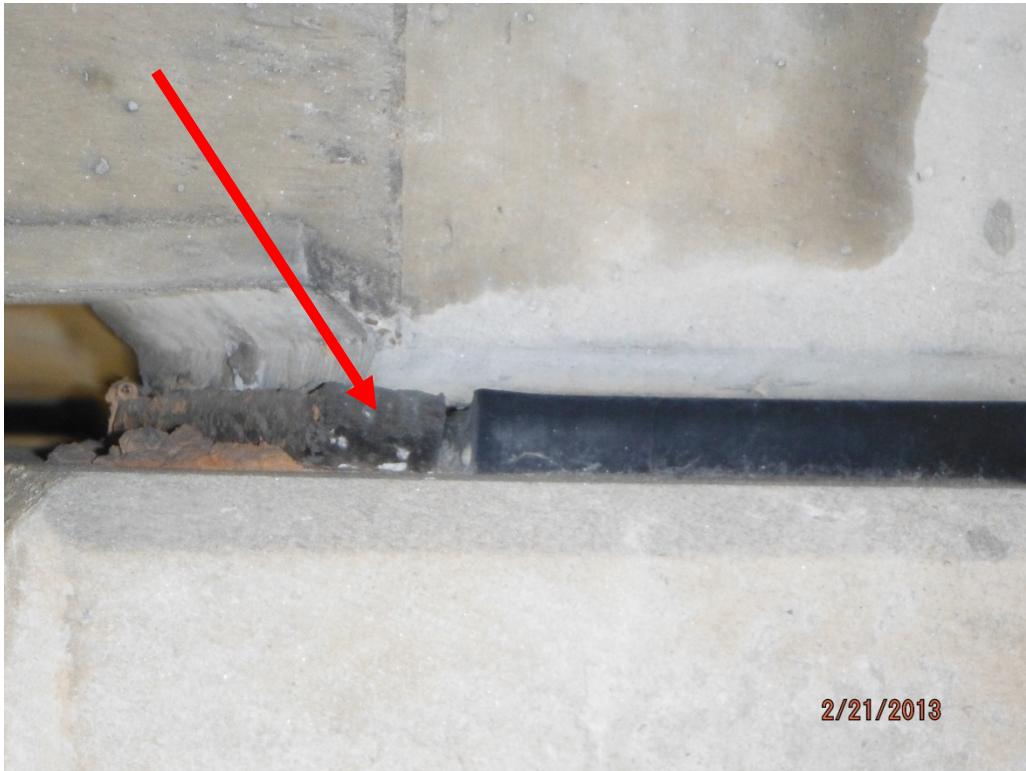
The asbestos-containing bent cap felt pads are located on top of each of the three (3) interior bent caps where the bent caps meet the bridge deck. There are four (4) pads per interior bent, resulting in a total of twelve (12) felt pads. Due to the majority of this material being encapsulated between the bent caps and the bridge deck, assessment of the condition of the entire pads is not possible. Based on the portions accessed for sample collection, the pads are more than likely intact. Since demolition and/or renovation activities will impact this material, it must be removed and disposed of as ACM by a licensed abatement contractor.

Asbestos-Containing Interior Bent Cap Pad
