ASBESTOS CONTAINING MATERIALS INVESTIGATION REPORT

**S-40-234 BRIDGE OVER I-26
SCDOT #407023400100
RICHLAND COUNTY, SOUTH CAROLINA**

Re.: Asbestos Containing Materials Investigation Report
S-40-234 Bridge over I-26
SCDOT #407023400100
Richland County, South Carolina
F&ME Project No.: E5350.02

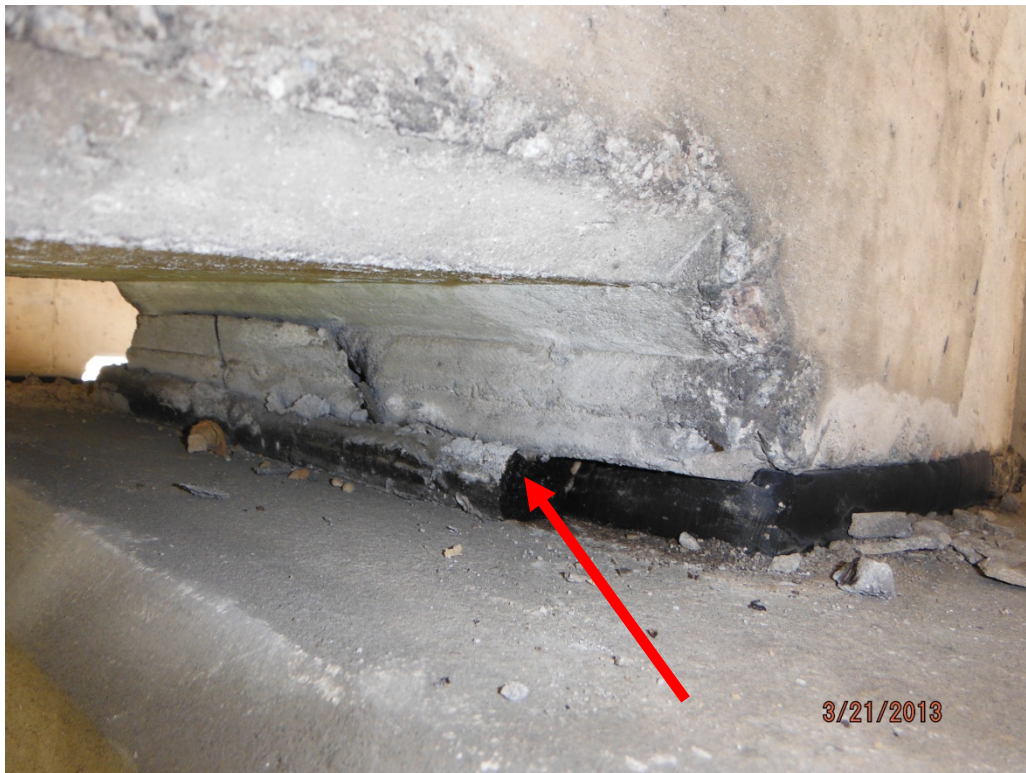
The asbestos-containing bent cap felt pads are located on top of each of the three (3) interior bent caps where the bent caps meet the bridge deck. There are four (4) pads per end bent, resulting in a total of twelve (12) pads. Due to the majority of this material being encapsulated between the bent caps and the bridge deck, assessment of the condition of the entire pads is not possible. Based on the portions accessed for sample collection, the pads are more than likely intact.

Asbestos-Containing Interior Bent Cap Pads

It is our understanding that the results of this investigation are intended to aide in the demolition and/or renovation planning of the subject bridge structure. Prior these activities, the identified ACM associated with the bridge structure must be removed, handled and disposed of per SCDHEC regulations pertaining to asbestos waste. Since removal of these types of bridge components (i.e. bent cap felt pads) prior to demolition and/or renovation activities is not practical, these activities will require coordination with a licensed abatement contractor. Based on the quantities of ACM identified, no abatement project design will be required.
