ASBESTOS CONTAINING MATERIALS INVESTIGATION REPORT

**S-32-48 BRIDGE OVER I-26
SCDOT #327004800100
LEXINGTON COUNTY, SOUTH CAROLINA**

Re.: Asbestos Containing Materials Investigation Report
S-32-48 Bridge over I-26
SCDOT #327004800100
Lexington County, South Carolina
F&ME Project No.: E5350.02

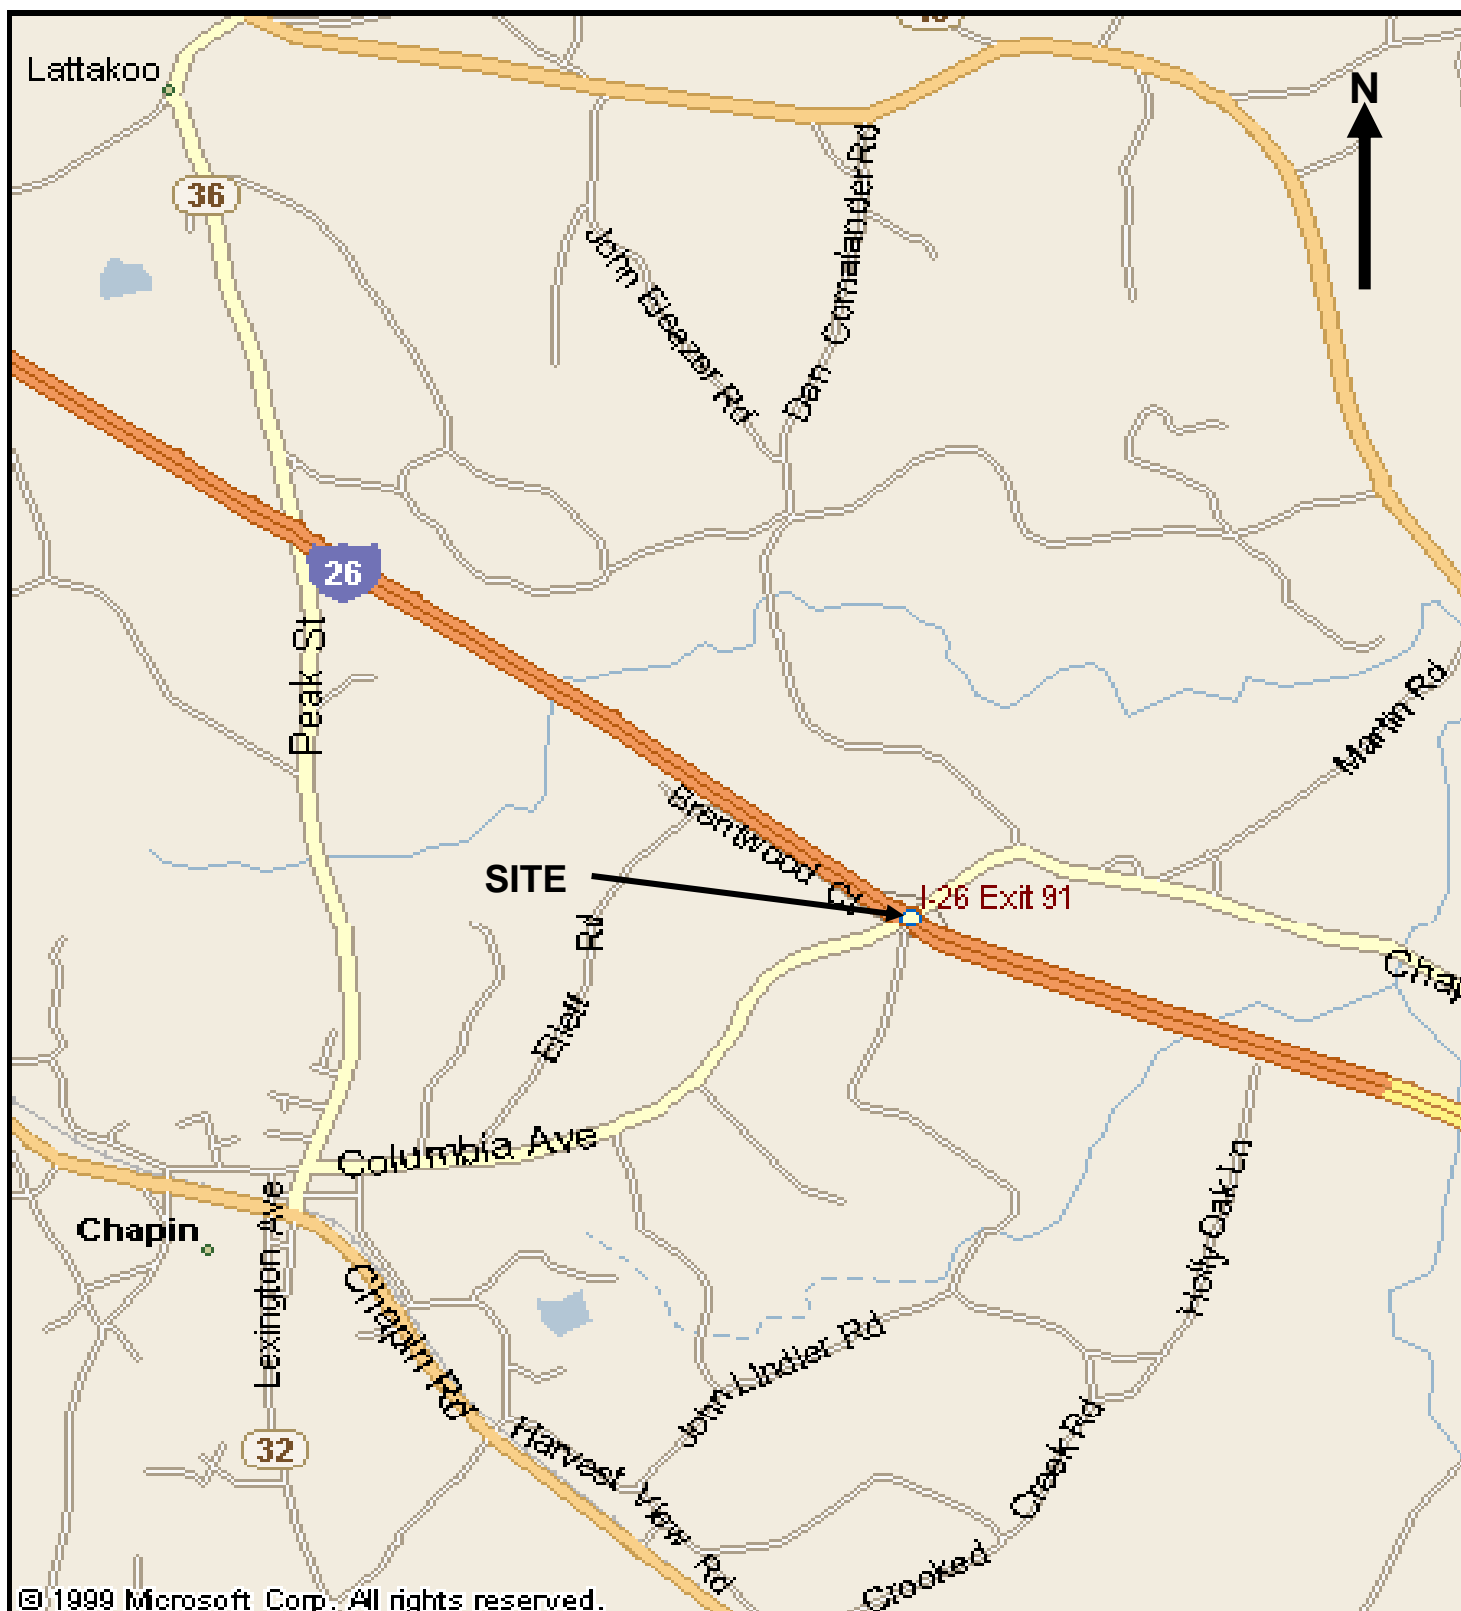
A total of fifteen (15) samples were collected from the subject bridge. Due to activation of the “first positive stop” protocol, nine (9) samples were analyzed by PLM and four (4) were TEM-confirmed. Of the materials analyzed, only the scuppers (drains) and the end bent felt pads were found to contain asbestos (also see Table II, Summary of Asbestos Containing Materials). For more information regarding the location of these materials, refer to the Homogeneous Area Plan (Figure 3) located in the appendix.

The following items are descriptions and quantities of the asbestos containing materials identified within the interior of the subject bridge structure (See Homogeneous Area Plan, Figure 3):

All ACM associated with the bridge structure must be removed, handled and disposed of per SCDHEC regulations pertaining to asbestos waste. Since removal of these types of bridge components prior to demolition and/or renovation activities is not practical, these activities will require coordination with a licensed abatement contractor. Based on the quantities of ACM identified, no abatement project design will be required.

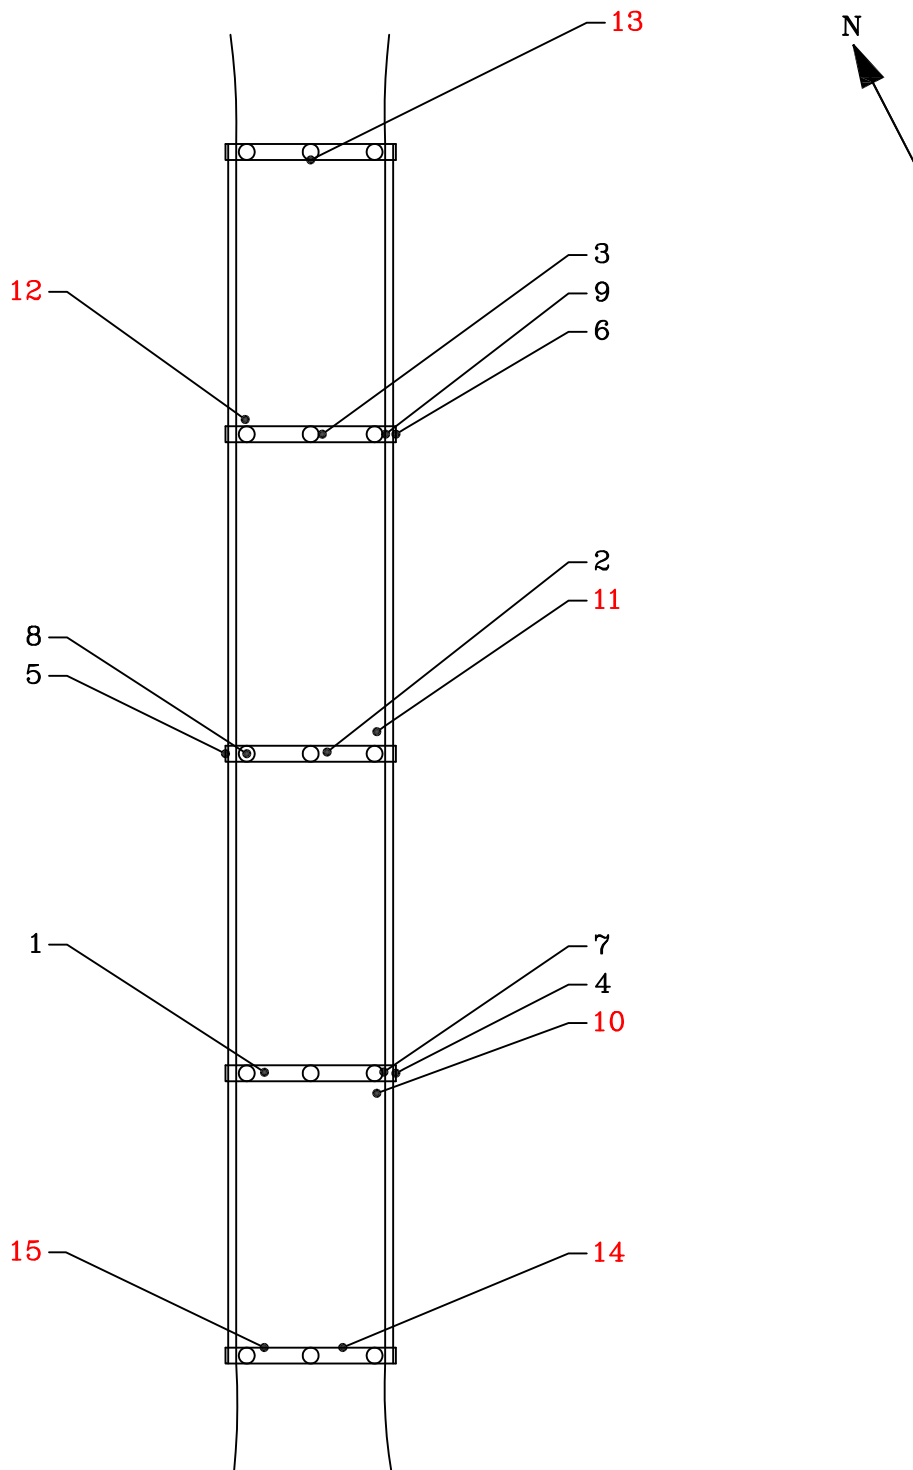
SCALE: N.T.S
PROJECT: E5350.02
FIGURE NO.: 2

SAMPLE LOCATION PLAN
S-32-48 BRIDGE OVER I-26
LEXINGTON COUNTY, SOUTH CAROLINA

HA-1 - Scuppers (Drains)

HA-2 - End Bent Felt Pad

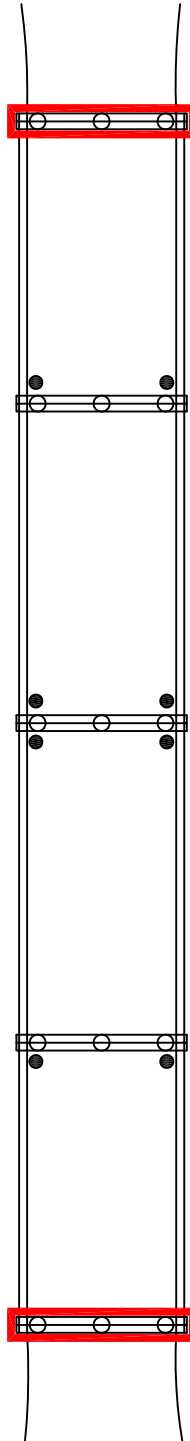
SCALE: N.T.S
PROJECT: E5350.02
FIGURE NO.: 3

HOMOGENEOUS AREA PLAN
S-32-48 BRIDGE OVER I-26
LEXINGTON COUNTY, SOUTH CAROLINA

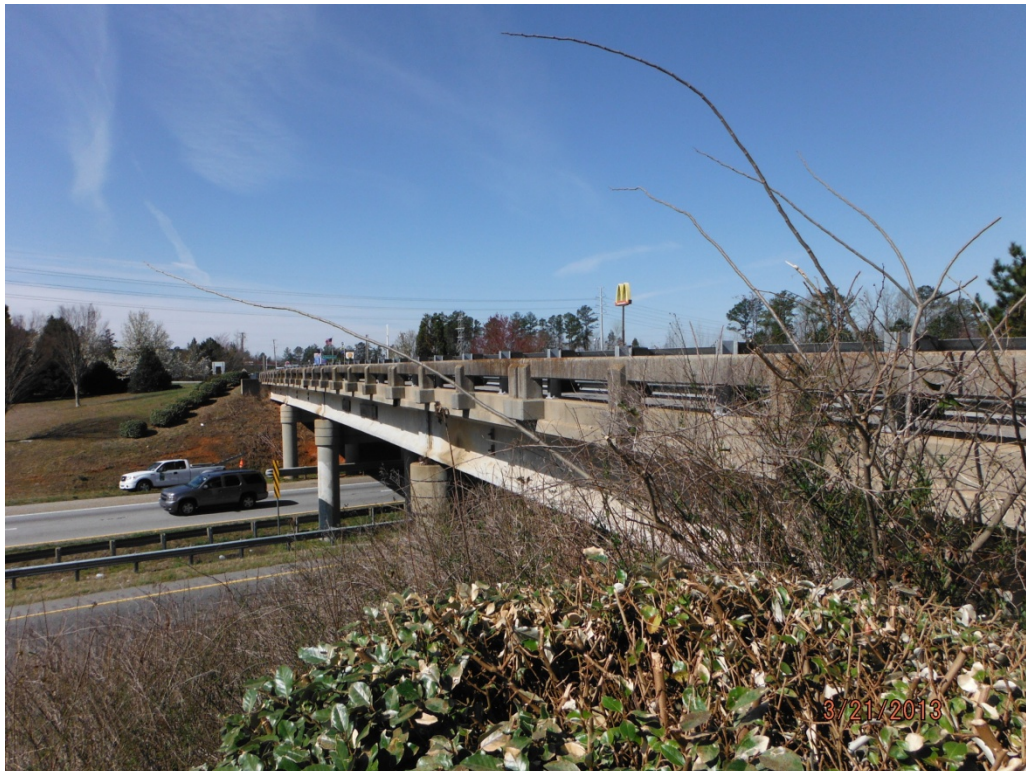
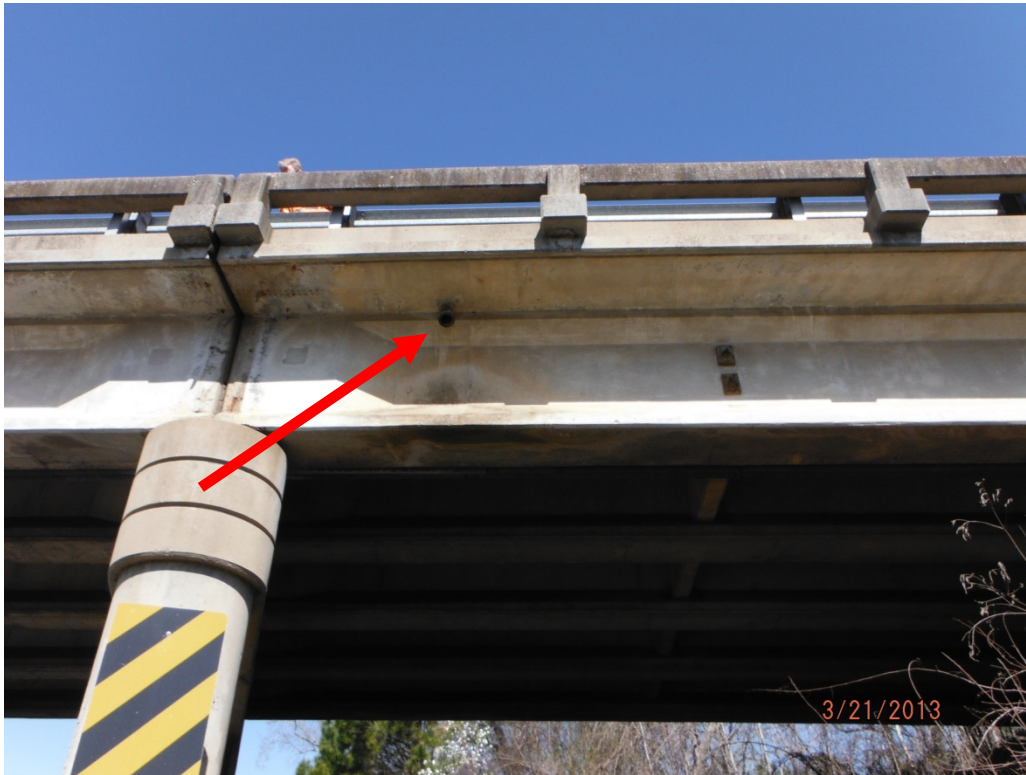
Asbestos-containing scuppers are located along the east and west sides of the bridge. Each scupper is approximately 4” in diameter and extends from the top of the bridge deck to the underside of the bridge deck. The bridge has a total of eight (8) scuppers, with four (4) on each side. The exposed portions where this material was sampled appeared to be in good condition. Since demolition and/or renovation activities will impact this material, it must be removed and disposed of as ACM by a licensed abatement contractor.

Asbestos-Containing Scuppers (Drains)

It is our understanding that the results of this investigation are intended to aide in the demolition and/or renovation planning of the subject bridge structure. Prior these activities, the identified ACM associated with the bridge structure must be removed, handled and disposed of per SCDHEC regulations pertaining to asbestos waste. Since removal of these types of bridge components (i.e. bent cap felt pads and expansion joint compound) prior to demolition and/or renovation activities is not practical, these activities will require coordination with a licensed abatement contractor. Based on the quantities of ACM identified, no abatement project design will be required.

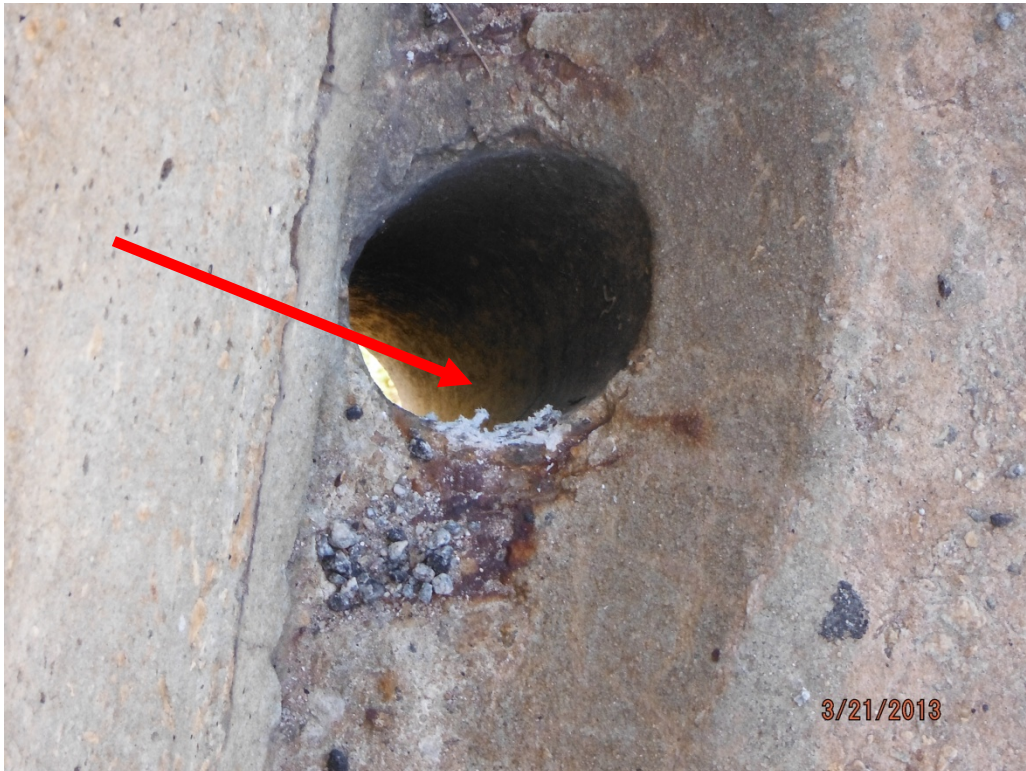
Asbestos-containing scuppers are located along the east and west sides of the bridge. Each scupper is approximately 4" in diameter and extends from the top of the bridge deck to the underside of the bridge deck. The bridge has a total of eight (8) scuppers, with four (4) on each side. The exposed portions where this material was sampled appeared to be in good condition.

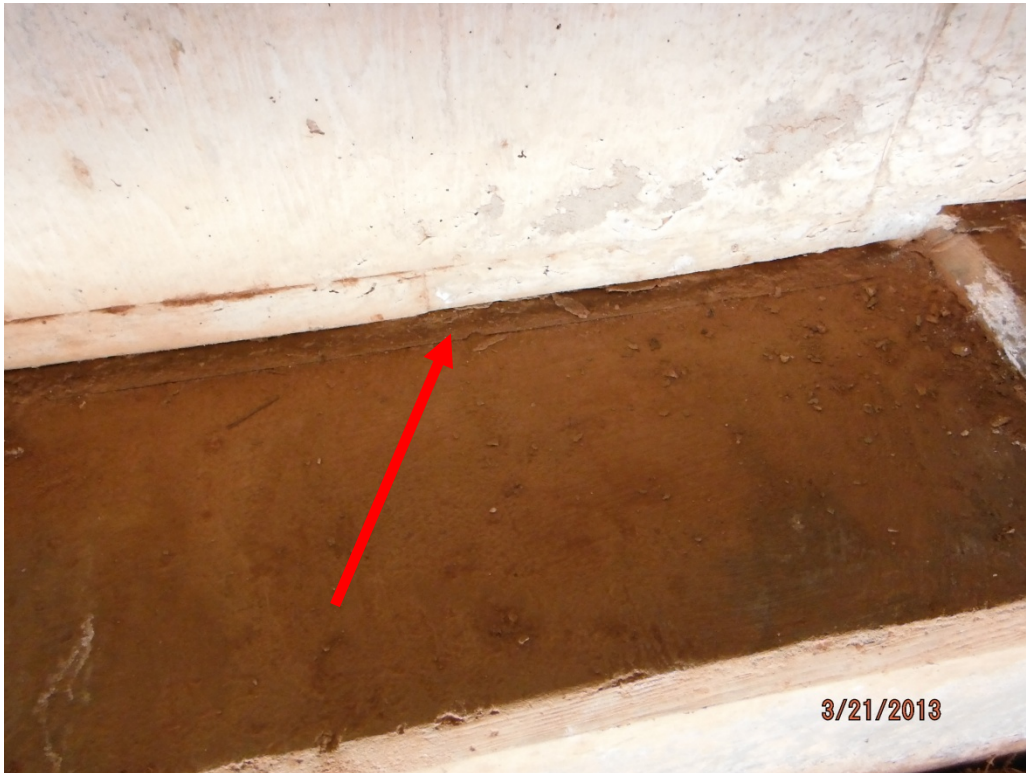
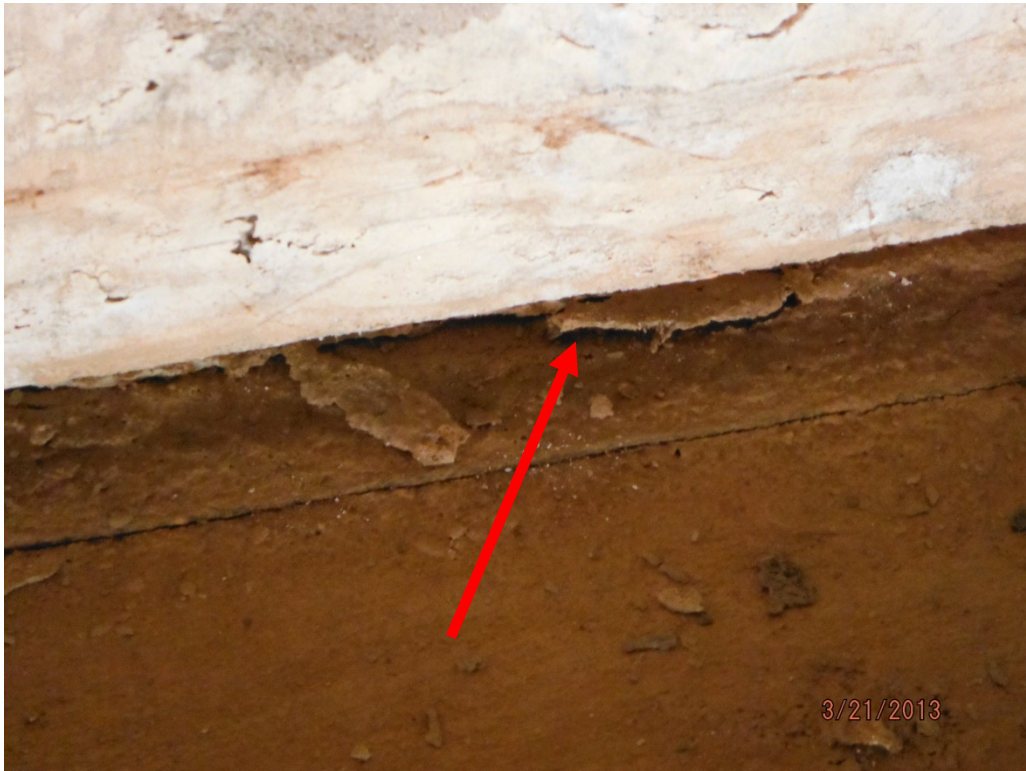
The asbestos-containing end bent felt pads are located beneath the two (2) end bents. Due to this material being encapsulated under each end bent, assessment of its complete condition is not possible. The exposed portions where this material was sampled appeared to be in good condition. Since demolition and/or renovation activities will impact this material, it must be removed and disposed of as ACM by a licensed abatement contractor.

Asbestos-Containing End Bent Felt Pads
