## CATEGORICAL EXCLUSION TYPE C

Project Number: P027002

To: Federal Highway Administration  
From: SCDOT, Heather Robbins, NEPA Division Manager  
Project: I-77 Roadway Widening and Improvements

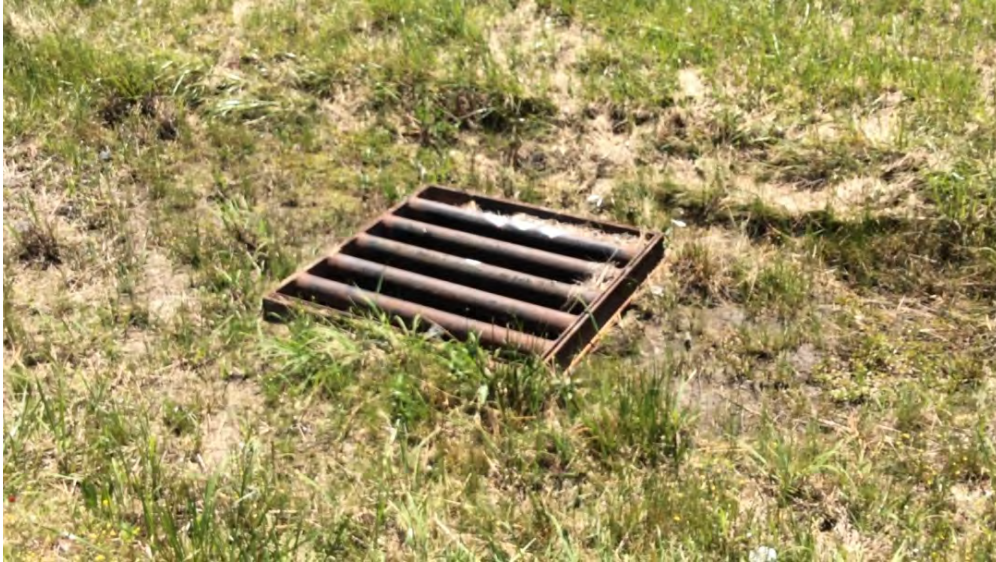
**EX-0801**

If this inlet is to be retained, the existing ground should be brought up to the rim elevation in order to reduce ponding. A paved apron could also be installed at this inlet.

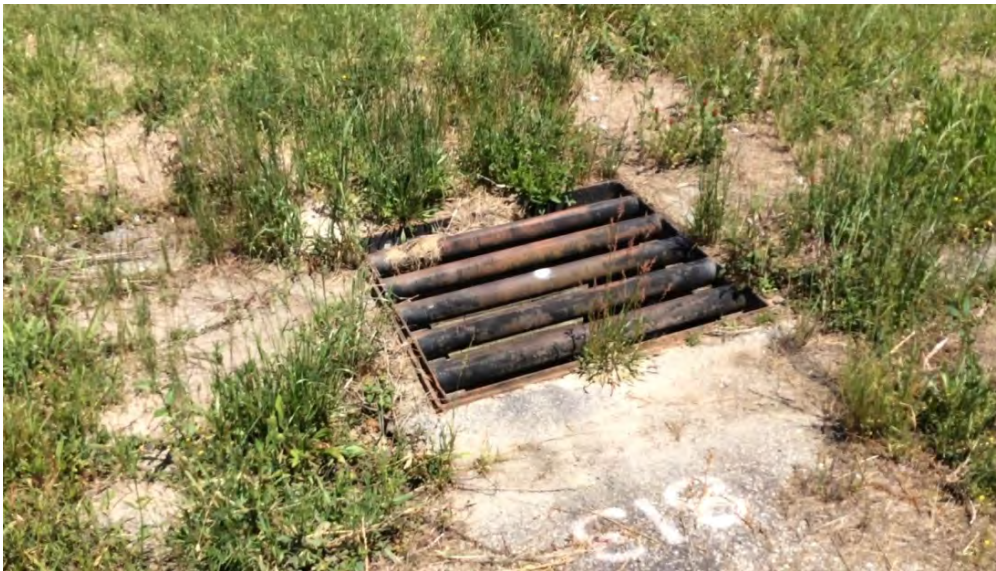
**EX-0901**

The paved apron for EX-0901 has some minor cracking. If this inlet is retained, the apron should be repaired or replaced.

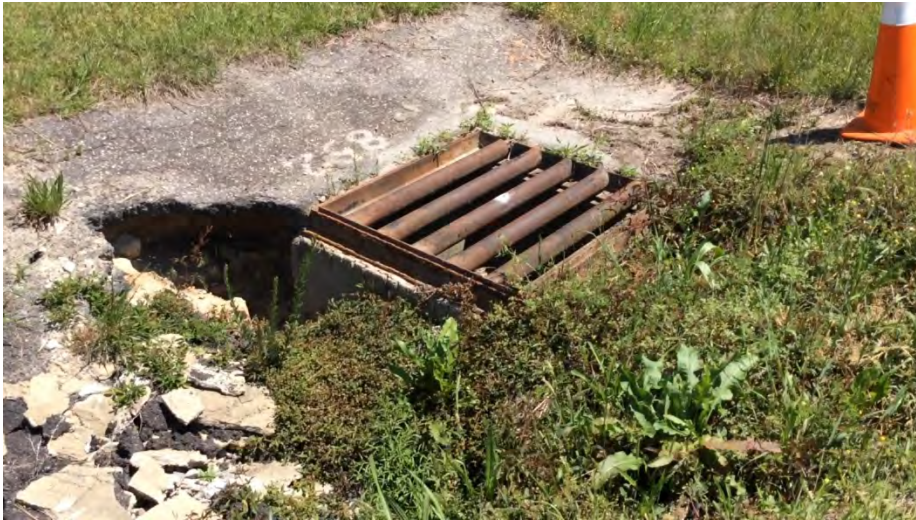
**EX-1404**

If this inlet is to be retained, the subgrade adjacent to the box should be excavated and replaced, and the paved apron should be removed and replaced. The pipe video inventory survey detailed in the next section contains recommendations for the connecting pipe.

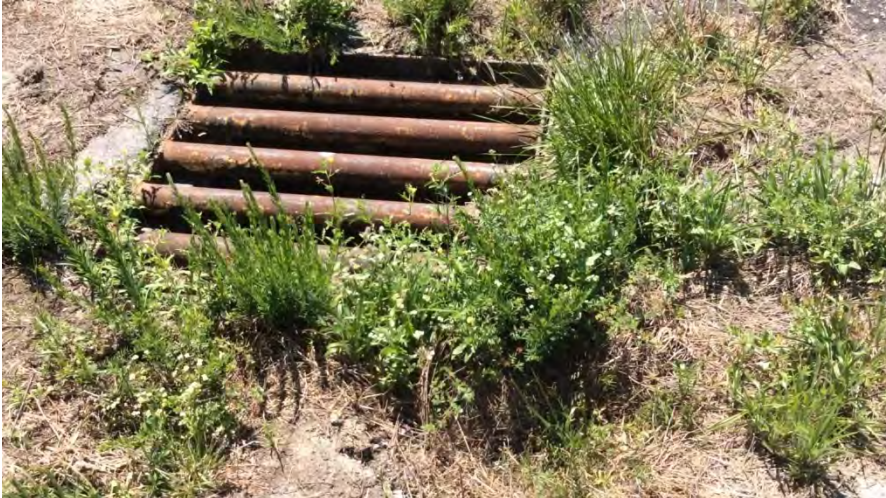
**EX-1501**

If this inlet is to be retained, the subgrade adjacent to the box should be excavated and replaced, and the paved apron should be removed and replaced, at least in the northeast corner where the hole was found.

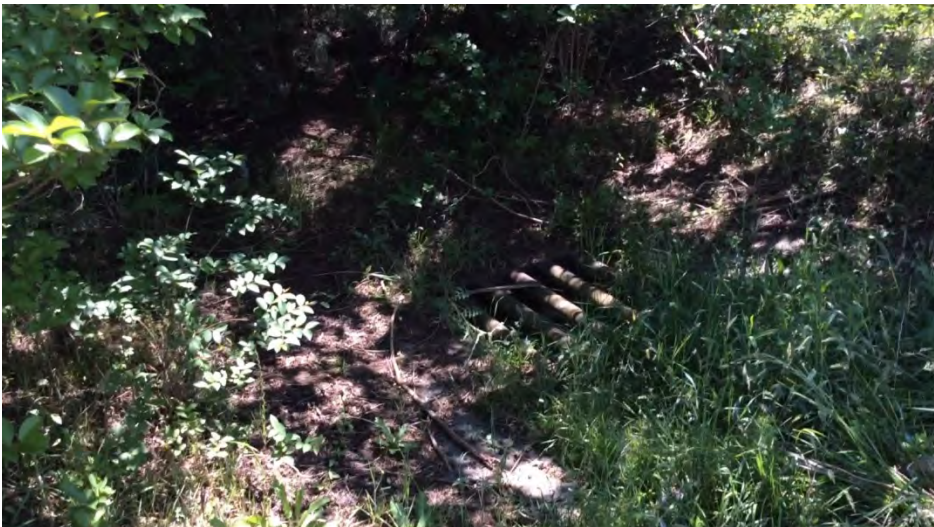
**EX-1607**

If this inlet is to be retained, the area adjacent to the inlet should be cleared and grubbed. A paved apron could also be installed at this inlet. The pipe video inventory survey detailed in the next section contains recommendations for the connecting pipes.

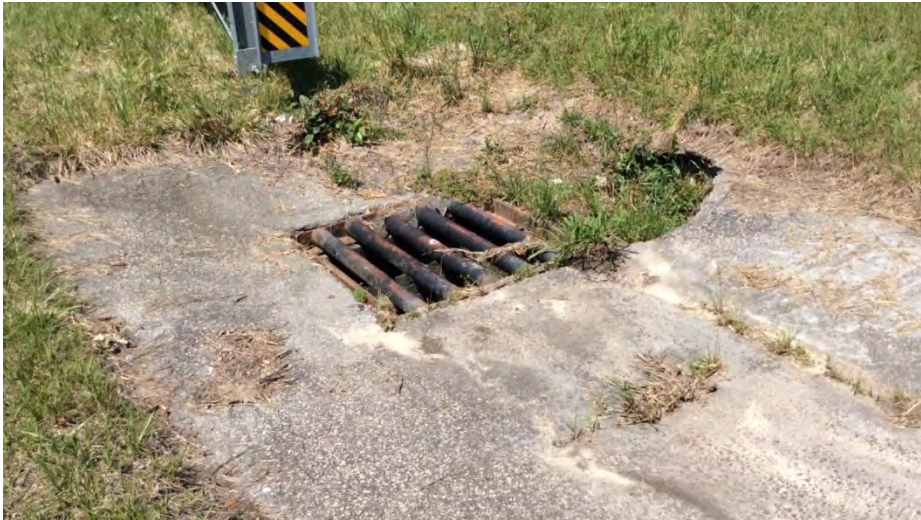
**EX-1701**

If this inlet is to be retained, the subgrade adjacent to the box should be excavated and replaced, and the paved apron should be removed and replaced.

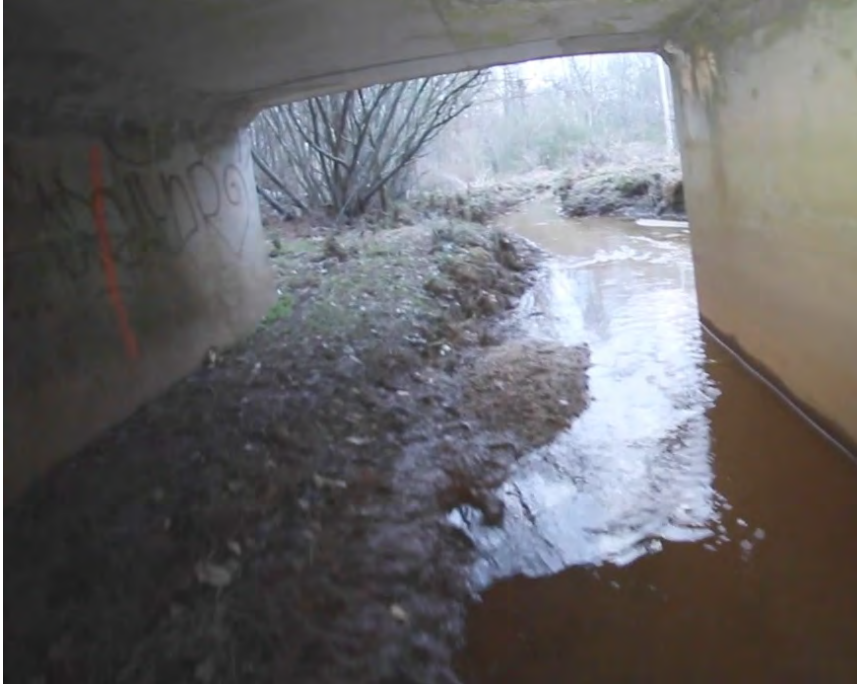
**OP-0100**

The inlet of box culvert EC-0211 is adjacent to the WB Percival Road ramp onto I-77 NB. This culvert and two others (EC-0102 & EC-0103) outfall at OP-0100 into an unnamed tributary of Gill's Creek to the south of the interchange. At the time of a field visit, the existing outfall beyond the culvert was clear, but the box itself had accumulated sediment for approximately 75' into the culvert, and should be cleaned out as noted in the previous section.

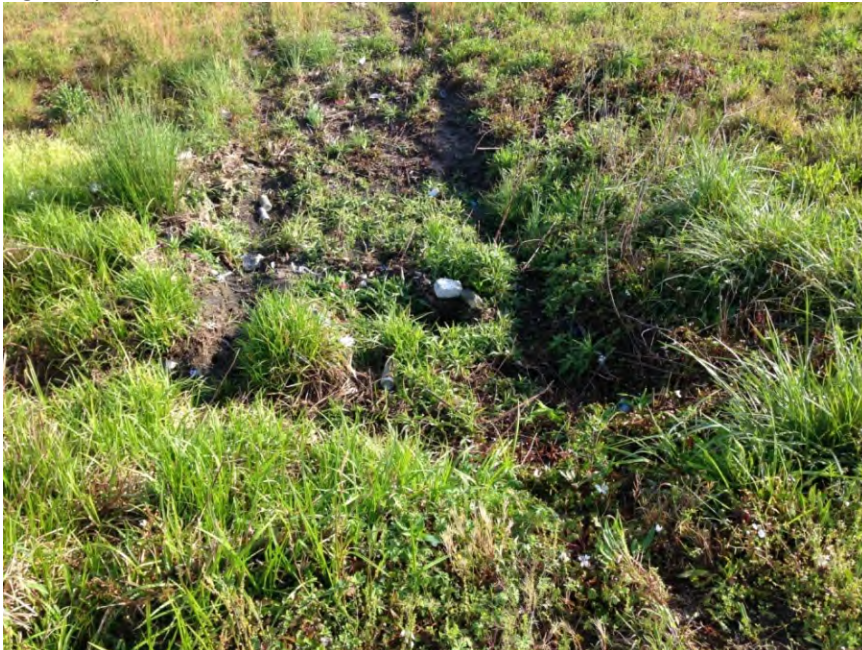
**OP-0286**

OP-0286 (Outfall of existing 18" RCP EP-0289)  
Approx. Sta. 1167+30, Offset 146' RT

EP-0289 crosses the I-77 NB off-ramp loop to WB Percival Road. At the time of the field visit, the end of the pipe was buried. The outfall should be excavated for several feet to ensure positive drainage from the pipe. There are no concerns associated with right-of-way for this outfall as it is located within the interchange loop.

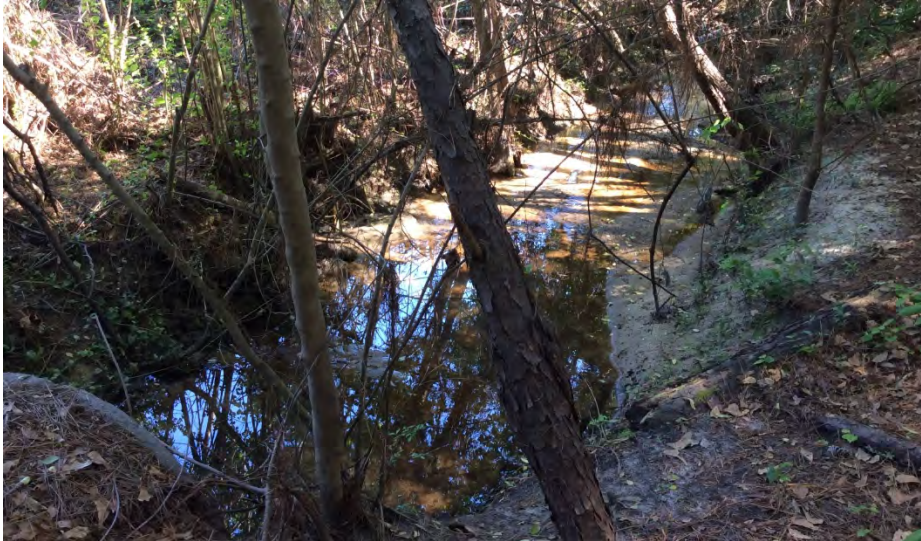
**OP-0394**

EP-0303 parallels I-77 SB and outfalls approximately 200' after the beginning of the taper for the Percival Road exit. At the time of the field visit, standing water was observed. The existing ditch that parallels I-77 SB, into which EP-0303 outfalls, should be cleared of debris as necessary to restore downstream flow. There should not be any right-of-way issues associated with clearing the ditch.

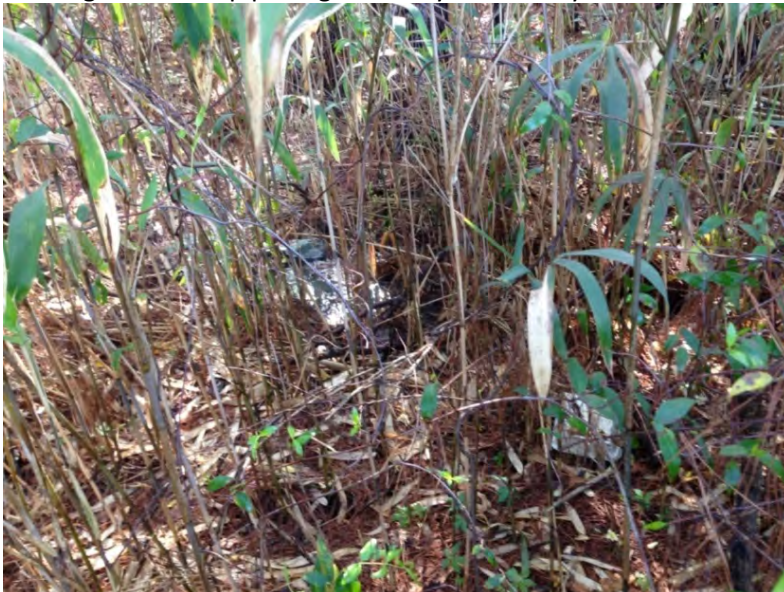
**OP-0398**

OP-0398 (Outfall of existing 18" RCP EP-0301)  
Approx. Sta. 1171+30, Offset 200' RT

EP-0301 crosses the WB Percival Road ramp onto I-77 NB and outfalls just to the southeast of EX-0308 (inlet of EC-0211). At the time of the field visit, the pipe was mostly buried and the outfall ditch was covered in vegetation. The outfall should be excavated and cleared of debris for several feet to ensure positive drainage from the pipe. Right-of-way issues may exist downstream of this outfall.

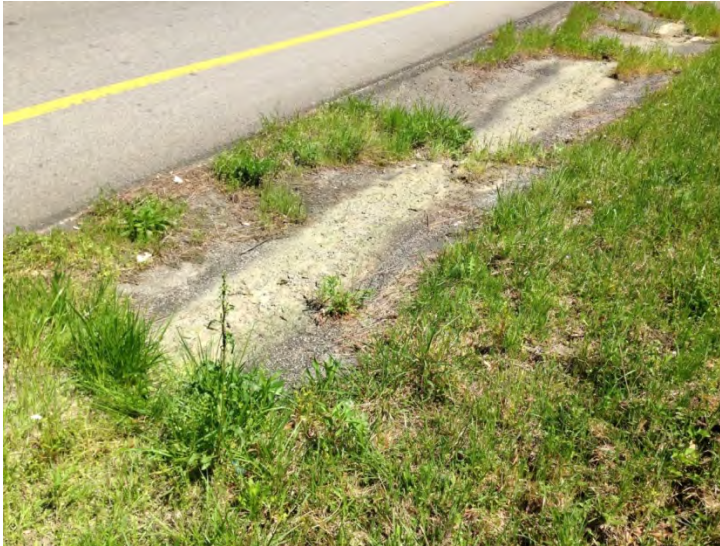
**OP-0683 (not located, assumed as buried)**

OP-0683 (Outfall of existing 18" RCP EP-0612)  
Approx. Sta. 1224+45, Offset 115' RT

EP-0612 parallels the loop ramp from I-20 WB / Alpine Road onto I-77 SB beneath the I-77 NB bridge overpass. The outfall was not located in the field and is assumed to be buried. The outfall needs to be located. If the outfall location is where the asbuilts imply, the outfall should be excavated to ensure positive drainage. There are no concerns with right-of-way for this outfall as it is located well within the interchange.

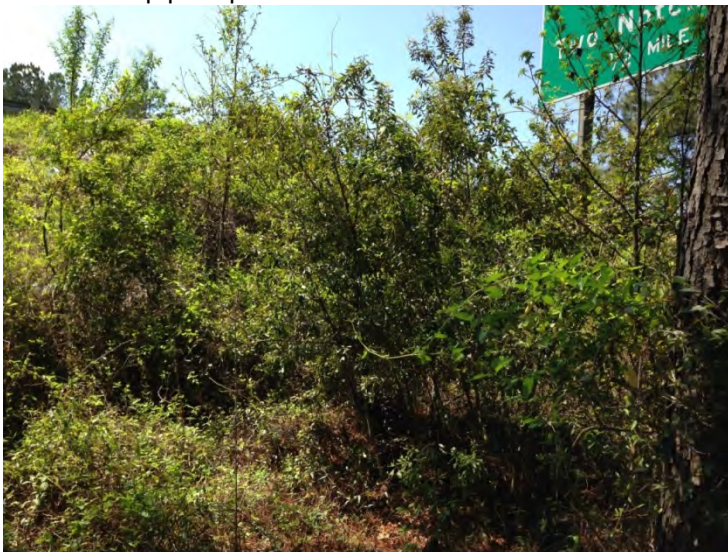
**OP-0798 (not located, collapsed)**

EP-0702 crosses I-77 NB approximately 50' before the I-77 bridge over Windsor Lake. The pipe has collapsed, and therefore the outfall was not located. The pipe should be replaced due to the collapse and other issues found during the video inspection. There should not be any right-of-way issues associated with the pipe replacement.

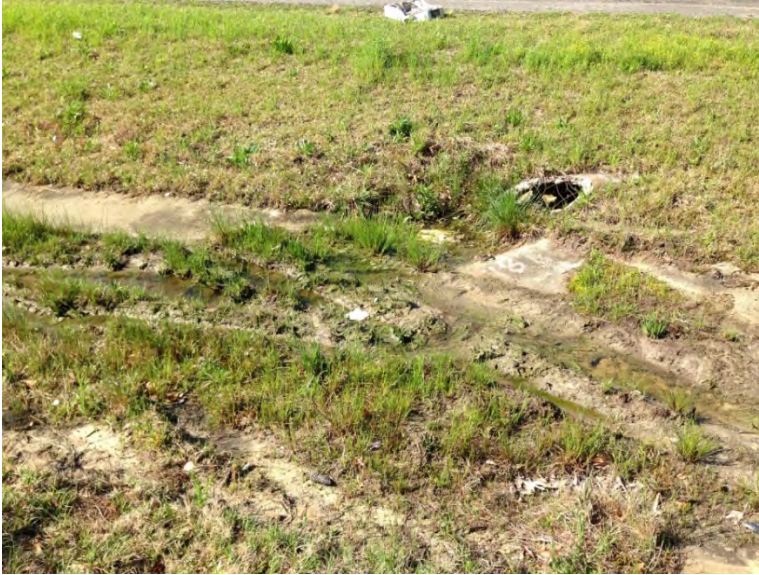
**OP-0897**

OP-0897 (Outfall of existing 18" RCP EP-0803)  
Approx. Sta. 1259+70, Offset 93' RT

EP-0803 crosses I-77 NB approximately 1,000' after the I-77 bridge over Windsor Lake. At the time of the field visit, the existing concrete channel downstream of the outfall had accumulated sediment, causing water to pond. The concrete channel should be cleaned for approximately 470'. There should not be any right-of-way issues associated with clearing the channel.

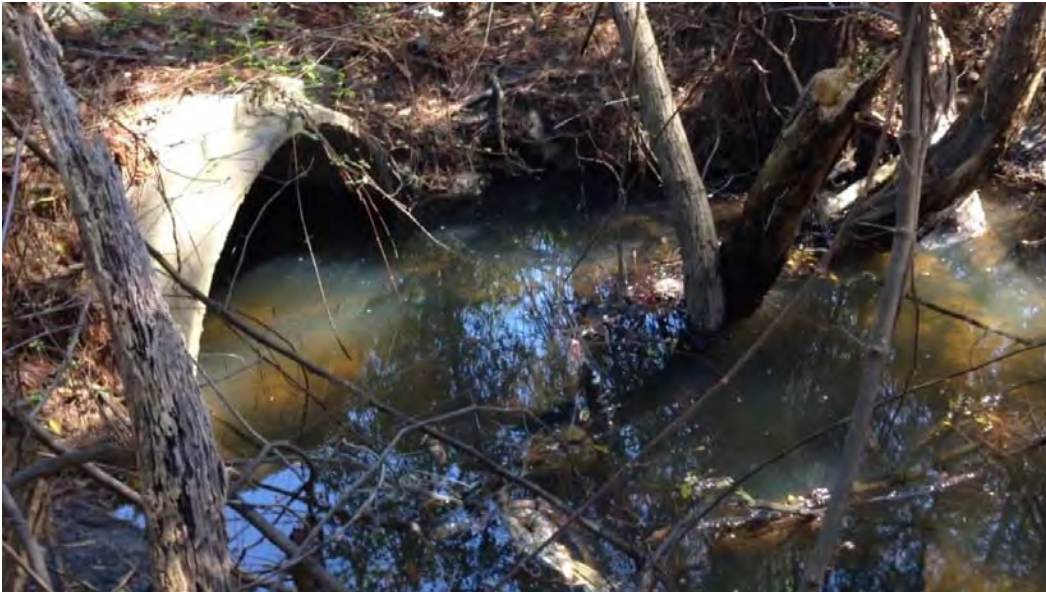
**OP-0995**

OP-0995 (Outfall of existing 36" RCP EP-0907)  
Approx. Sta. 1278+00, Offset 119' LT

EP-0907 crosses I-77 SB approximately 500' before the Trenholm Road bridge over I-77. At the time of the field visit, the pipe outfall and associated ditch were fill with vegetation and debris and will require cleaning. The ditch should be cleared and re-excavated to the edge of the right-of-way.

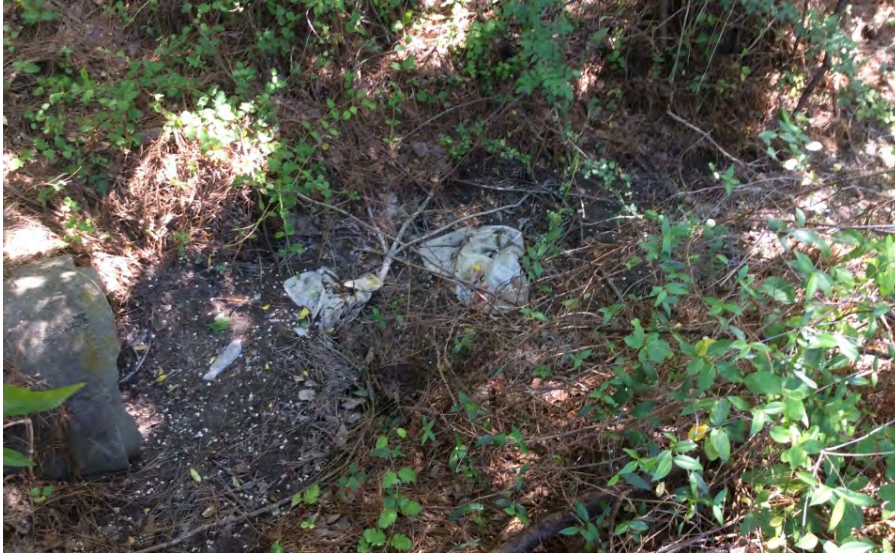
**OP-0999**

EP-0901 crosses I-77 SB approximately 1,250' before the Trenholm Road bridge over I-77. At the time of the field visit, standing water was observed. The pipe outfall and associated ditch were partially silted in and will require cleaning. The ditch should be cleared and re-excavated to the edge of the right-of-way.

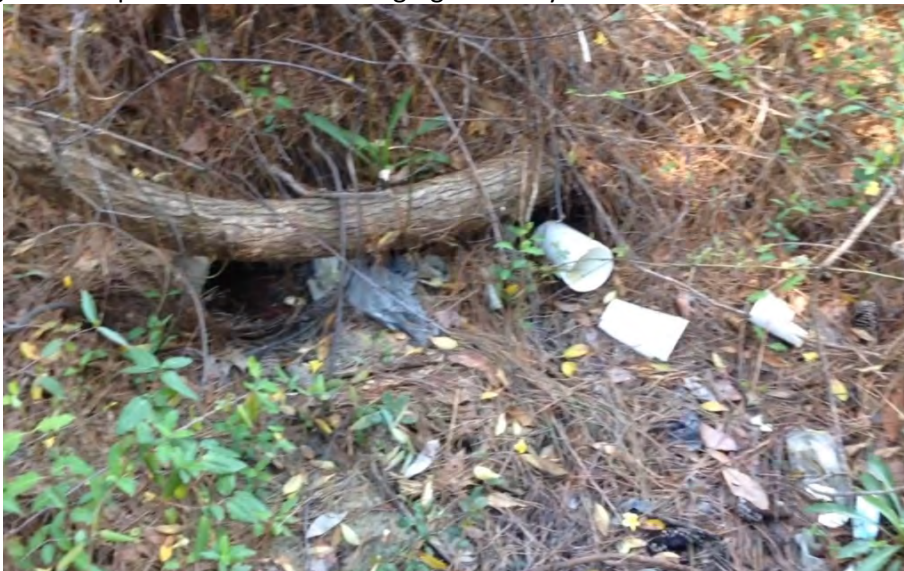
**OP-1010**

OP-1010 (Outfall of existing 30" RCP EP-1010)  
Approx. Sta. 1281+80, Offset 117' LT

EP-1010 parallels I-77 SB beneath the Trenholm Road bridge overpass and outfalls approximately 75' south of the bridge. At the time of the field visit, the pipe outfall and associated ditch were partially silted in and had accumulated debris. Cleaning will be required and re-excavate the ditch as necessary. Clearing can take place within the existing right-of-way.

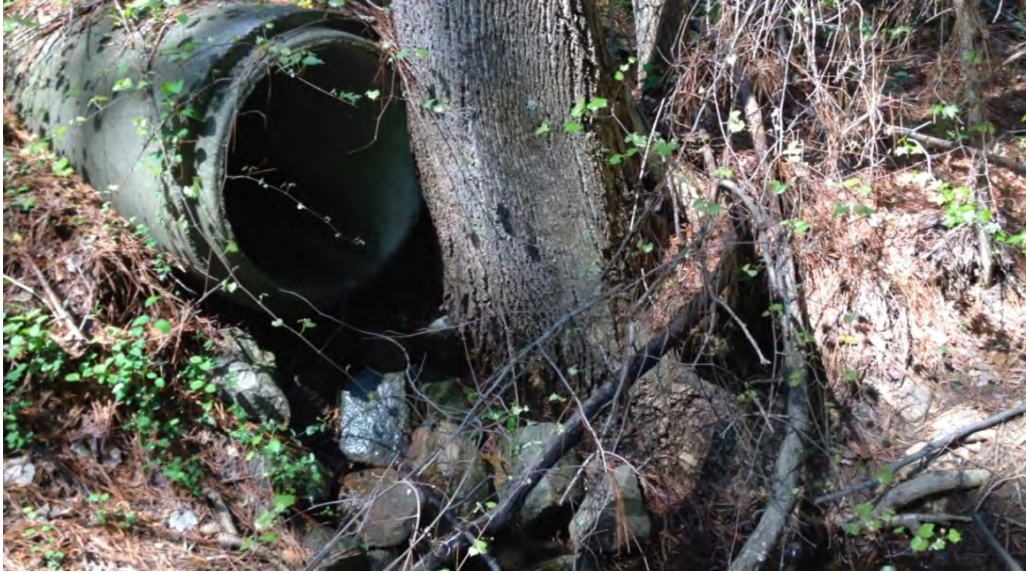
**OP-1396**

EP-1301 crosses I-77 NB approximately 50' after the I-77 bridge over Little Jackson Creek / Edgewater Drive. At the time of the field visit, a tree was growing immediately downstream of the outfall. This tree should be removed to prevent future damage and/or blockage to the pipe. There should not be any right-of-way issues associated with removing the tree.

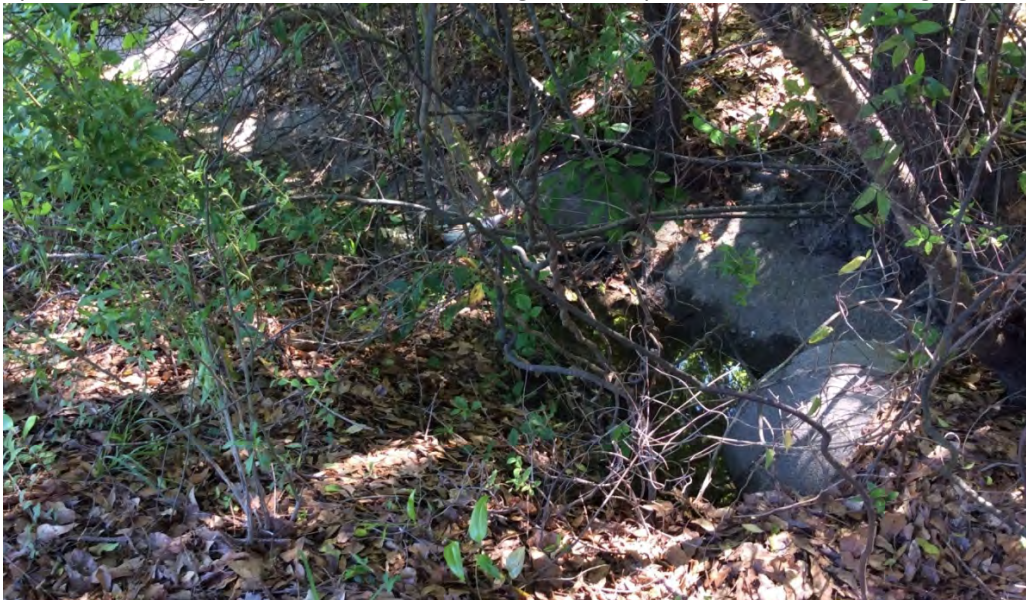
**OP-1499**

OP-1499 (Outfall of existing 18" RCP EP-1401)  
Approx. Sta. 1347+75, Offset 134' LT

EP-1401 crosses I-77 SB in the merging lane from the EB Farrow Road onramp. At the time of the field visit, the outfall ditch for the pipe was overgrown with vegetation and will need to be cleared to re-establish positive drainage from the outfall. Clearing can take place within the existing right-of-way.

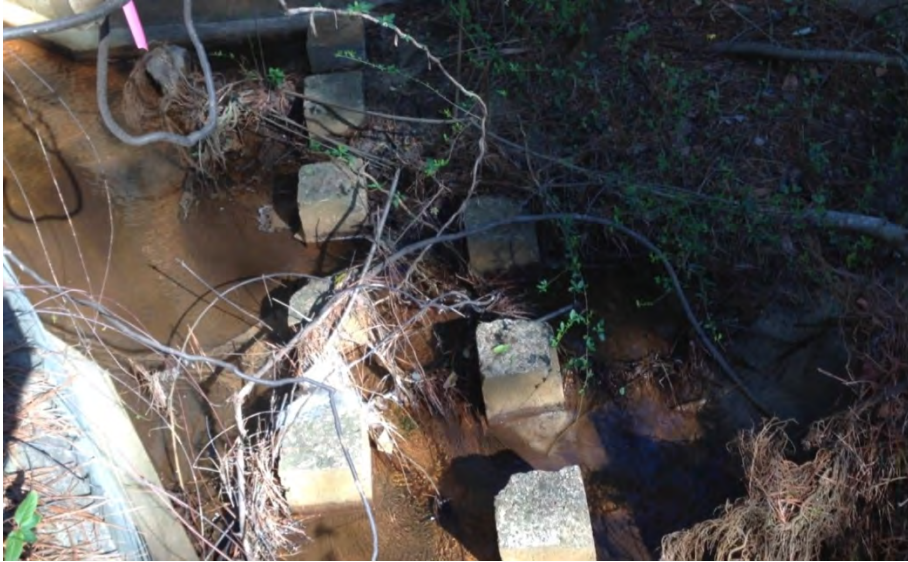
**OP-1598**

OP-1598 (Outfall of existing 4' x 4' concrete box culvert EC-1503)  
Approx. Sta. 1364+80, Offset 129' RT

EC-1503 outfalls between I-77 NB and the ramp from SC-277 EB. At the time of the field visit, debris had collected at the baffles along the concrete outlet apron of this box culvert and could further accumulate to impede flow. The baffles should be cleared of debris. This outfall is within the I-77 / SC-277 interchange area, and all clearing can take place within the existing right-of-way.

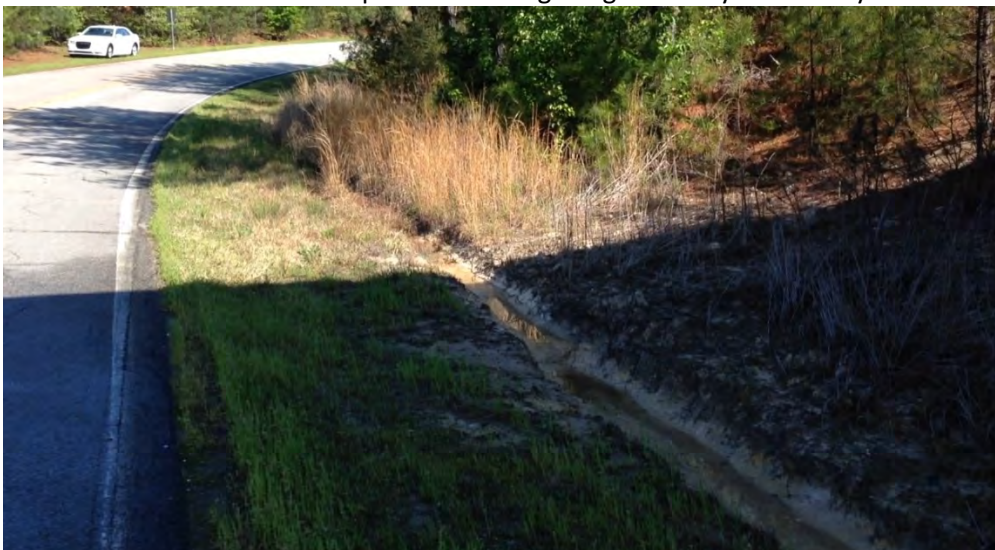
**OP-1698 (not located, assumed as buried)**

OP-1699 (Outfall of existing 36" RCP EP-1605)  
Approx. Sta. 1379+05, Offset 263' RT

There is some uncertainty regarding the location of this outfall. EP-1605 is assumed to cross under Legrand Road approximately 100' after the railroad bridge over I-77. It was not located in the field and is assumed to be buried. The outfall needs to be located. If the outfall location is where assumed, the outfall should be excavated to ensure positive drainage. Right-of-way issues may exist near this outfall.

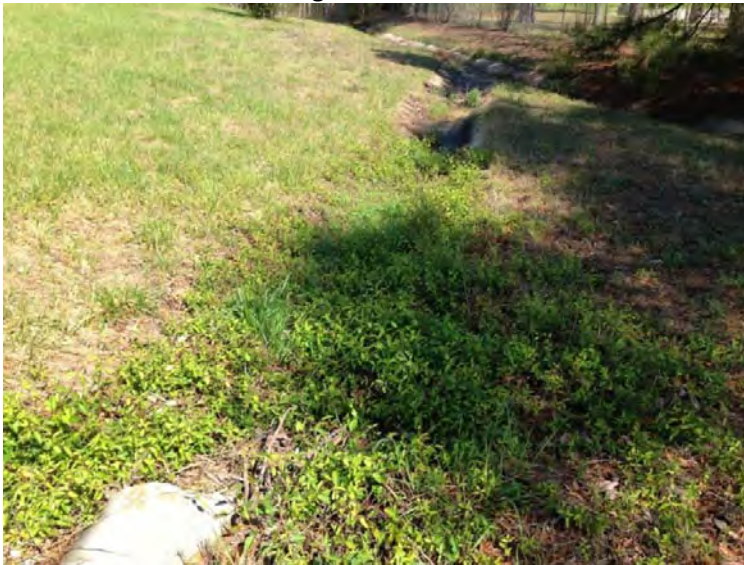
**OP-1799**

OP-1799 (Outfall of existing 24" RCP EP-1799)  
Approx. Sta. 1396+05, Offset 201' RT

EP-1799 crosses the ramp from Farrow Road to I-77 NB. At the time of the field visit, the end of the pipe was partially buried and the outfall ditch was silted in. The ditch should be excavated for approximately 25' between the pipe end and the concrete lined channel downstream. There should not be any right-of-way issues associated with clearing the ditch.

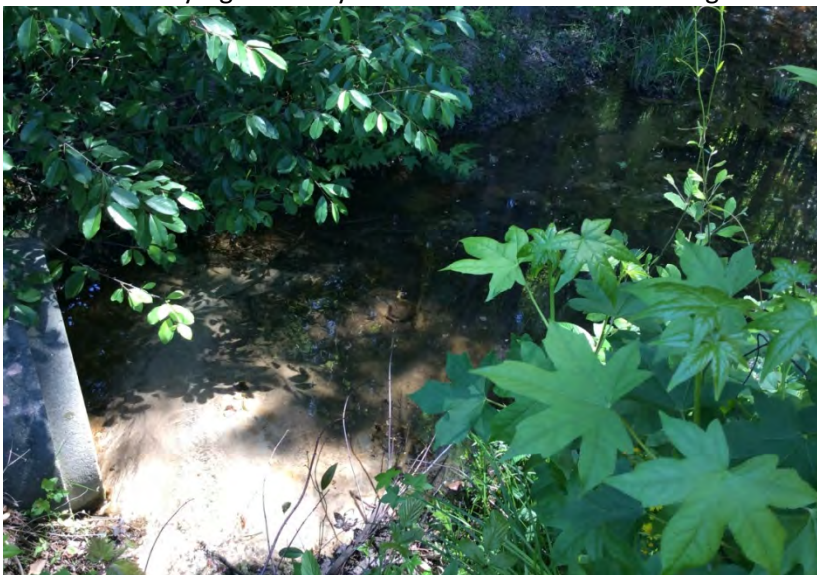
**OP-1895**

OP-1895 (Outfall of existing 30" RCP EP-1803)  
Approx. Sta. 1423+20, Offset 148' LT

EP-1803 crosses I-77 SB approximately 1,050' before the Hard Scrabble Road bridge over I-77. At the time of the field visit, the outfall was silted in and retaining water at the pipe end. The outfall ditch should be excavated for approximately 20' between the pipe end and the receiving ditch downstream. There should not be any right-of-way issues associated with clearing the ditch.

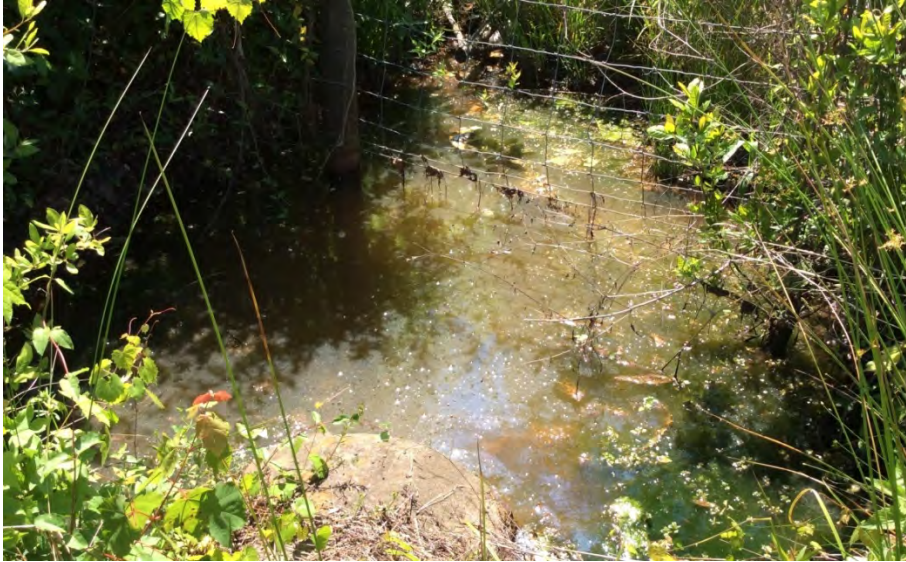
**OP-1896**

OP-1896 (Outfall of existing 24" RCP EP-1801)  
Approx. Sta. 1451+70, Offset 170' LT

EP-1801 crosses I-77 SB approximately 1,800' before the Hard Scrabble Road bridge over I-77. At the time of the field visit, the outfall ditch was silted in and retaining water at the pipe end. The outfall should be excavated to ensure positive drainage from the pipe. The pipe outfall is located only a couple of feet from right-of-way and permissions may be needed for excavation.

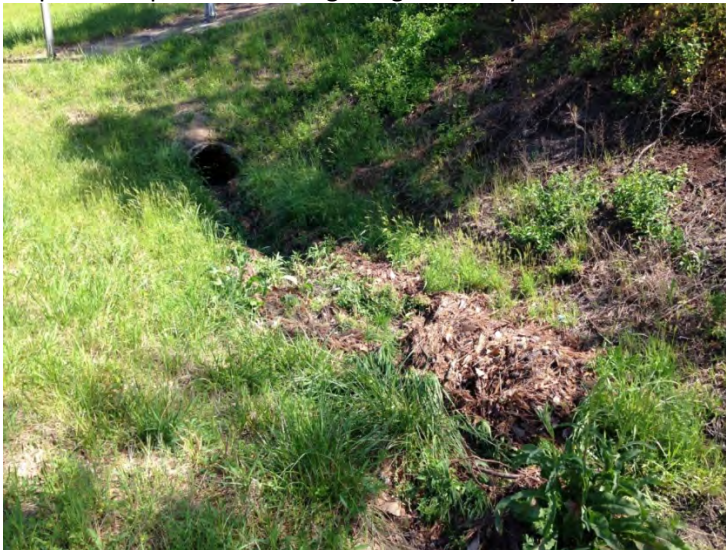
**OP-1998**

OP-1998 (Outfall of existing 30" RCP EP-1998)  
Approx. Sta. 1433+15, Offset 123' RT

EP-1998 parallels I-77 NB beneath the Hard Scrabble Road overpass and outfalls approximately 75' south of the bridge. At the time of the field visit, the outfall ditch was filled with debris and needs to be cleaned to promote positive drainage. Right-of-way is not an issue in this area.

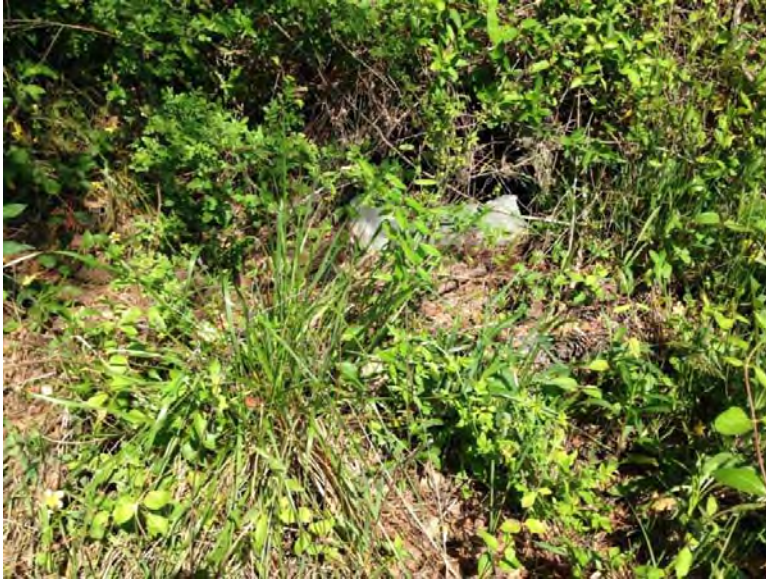
**OP-1999**

OP-1999 (Outfall of existing 24" RCP EP-1999)  
Approx. Sta. 1433+10, Offset 121' LT

EP-1999 parallels I-77 SB beneath the Hard Scrabble Road overpass and outfalls approximately 75' south of the bridge. At the time of the field visit, the pipe was partially buried and the outfall ditch was covered in vegetation and debris. The outfall should be excavated and cleared of debris to ensure positive drainage from the pipe. Right-of-way is not an issue in this area.

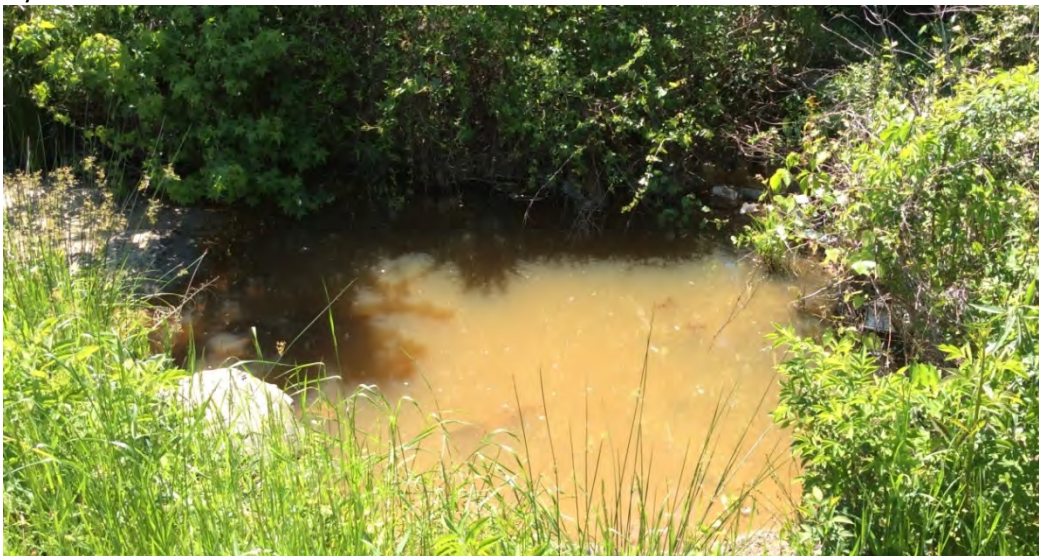
**OP-2199**

EP-2102 crosses I-77 SB approximately 2,550' after the Hard Scrabble Road bridge over I-77. At the time of the field visit, standing water was observed. The outfall was partially buried and the downstream channel was filled with silt. The outfall needs to be excavated to ensure positive drainage. Right-of-way issues may exist downstream of this outfall.

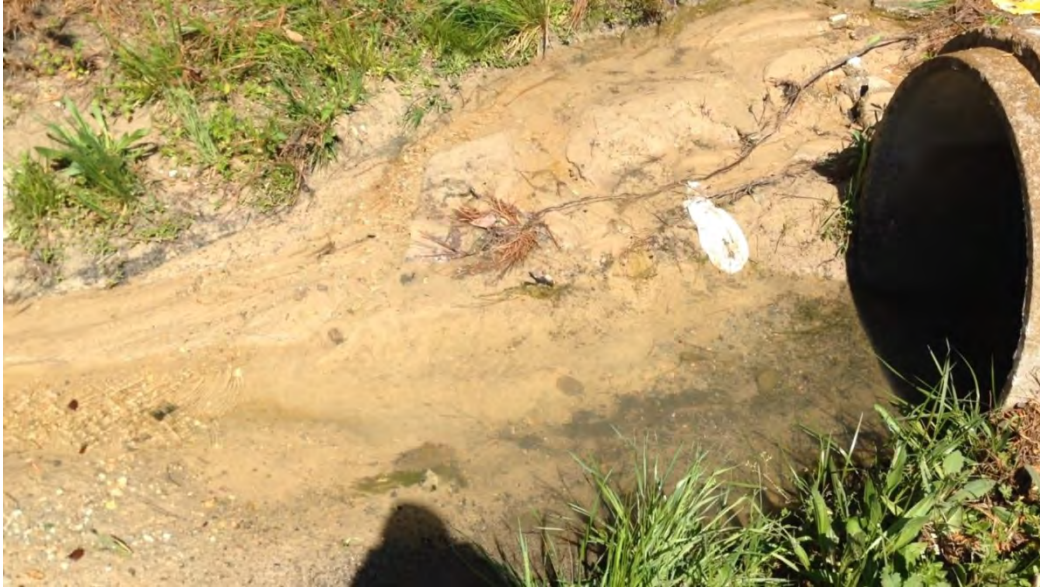
**OP-2298**

OP-2298 (Outfall of existing 36" RCP EP-2203)  
Approx. Sta. 1459+55, Offset 162' LT

EP-2203 crosses I-77 SB approximately 2,650' before the Killian Road bridge over I-77. At the time of the field visit, the outfall was slightly silted in with minimal positive drainage. The outfall ditch should be excavated as necessary to restore downstream flow. Right-of-way may be a concern if excavation occurs for several feet.

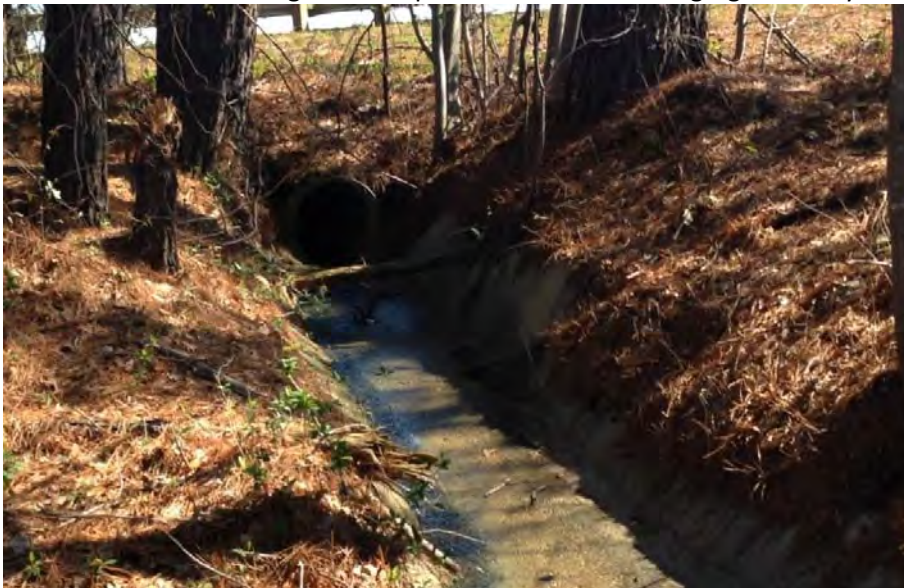
**OP-2299**

OP-2299 (Outfall of existing 24" RCP EP-2201)  
Approx. Sta. 1474+60, Offset 114' LT

EP-2201 crosses I-77 SB approximately 3,600' before the Killian Road bridge over I-77. A fallen tree limb is currently draped over the outfall ditch of this pipe. While it is not currently impeding flow, it should be cleared from the outfall. Clearing can take place within the existing right-of-way.

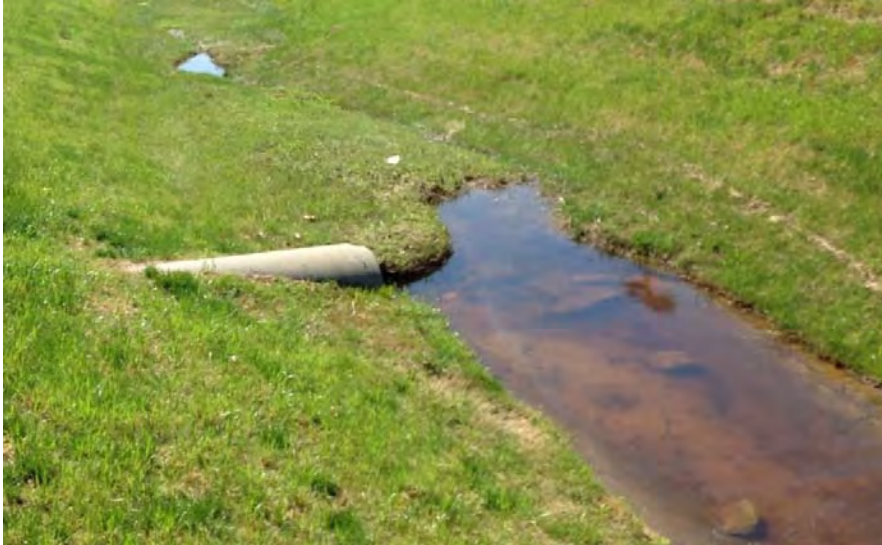
**OP-2396**

EP-2305 crosses the onramp from Killian Road to I-77 SB, approximately 570' before Killian Road bridge. At the time of the field visit, standing water was observed and the downstream channel was silted and established with grass. The channel should be excavated for several feet to restore downstream flow. There are no concerns associated with right-of-way in this area.

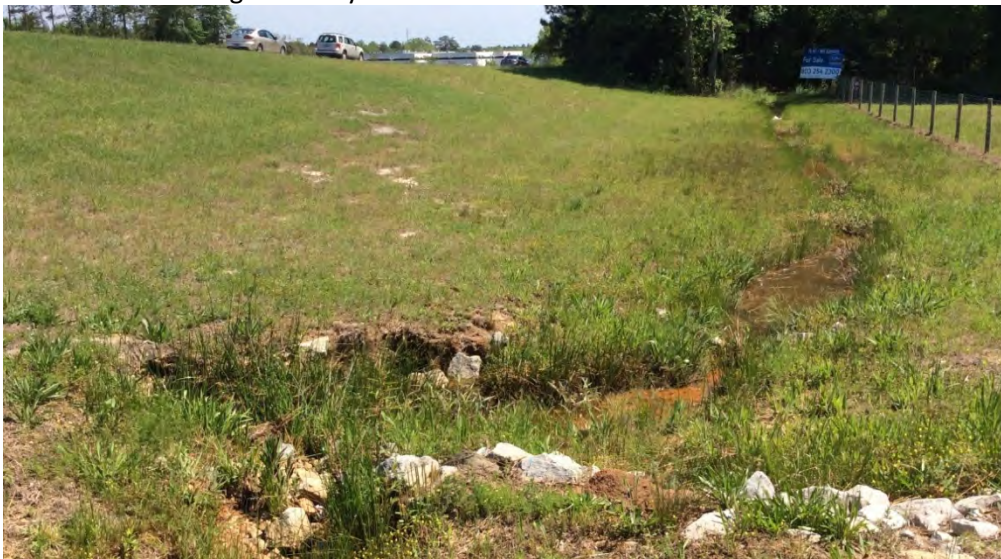
**OP-2397**

EP-2303 crosses the onramp from Killian Road to I-77 SB, approximately 800' before Killian Road bridge. At the time of the field visit, standing water was observed and the downstream channel was silted and filled with vegetation. In addition, the pipe end is slightly damaged. The outfall should be excavated for to restore positive drainage and the last pipe joint may need to be repaired or replaced. There are no concerns associated with right-of-way at this outfall.

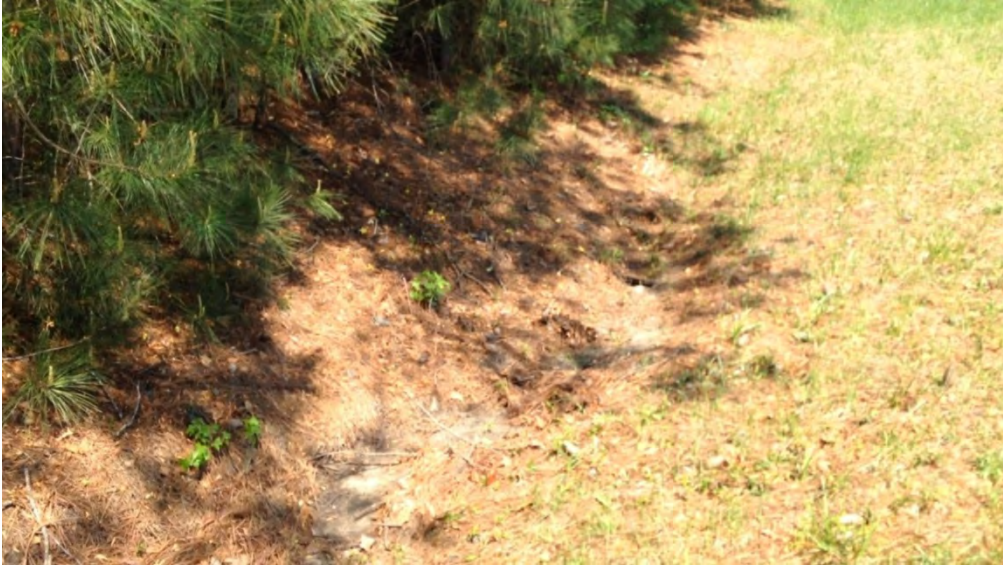
**OP-2398 (not located, assumed as buried)**

OP-2398 (Outfall of existing 18" RCP EP-2304)  
Approx. Sta. 1499+65, Offset 175' LT

EP-2304 crosses the onramp from Killian Road to I-77 SB, approximately 1,150' before the Killian Road bridge. The outfall was not located in the field and is assumed to be buried. The outfall needs to be located. If the outfall location is where assumed, the pipe end should be excavated to ensure positive drainage. There are no concerns associated with right-of-way at this outfall.

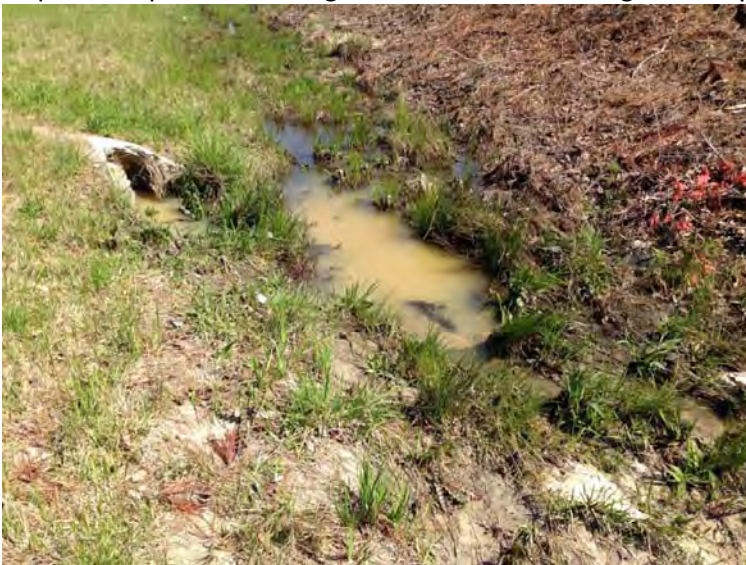
**OP-2399**

OP-2399 (Outfall of existing 24" RCP EP-2301)  
Approx. Sta. 1500+30, Offset 147' RT

EP-2301 crosses the Killian Road exit off-ramp from I-77 NB, approximately 1,090' before Killian Road bridge. At the time of the field visit, the outfall was partially buried and the downstream ditch was silted had accumulated sediment, causing water to pond. The outfall and ditch should be excavated and cleaned to promote positive drainage. There should be no right-of-way issues in this area.
