Attachment C

Photographs

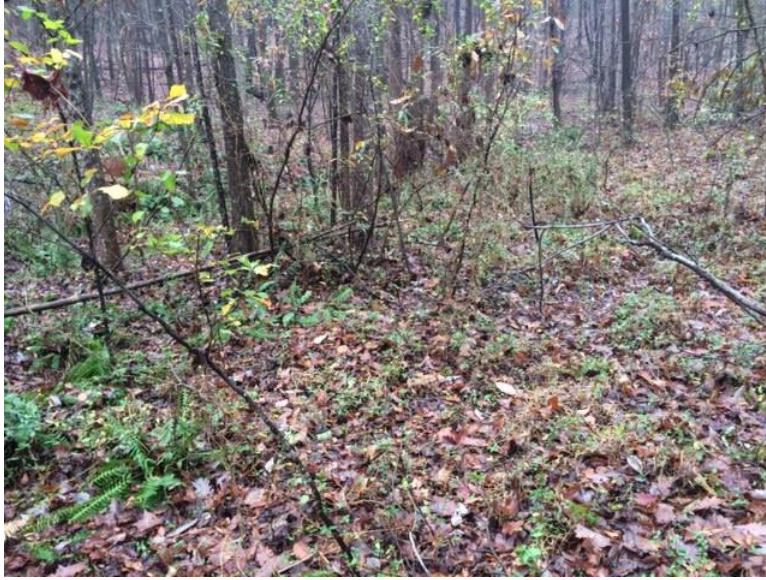
Photo 1

Title:
Wetland WA

Description:
Wetland WA is a small floodplain/toe-of-slope wetland located on the right side of Stream SK (North of I-85) if facing north from I-85. Photo taken at flag WA-3 facing northwest.

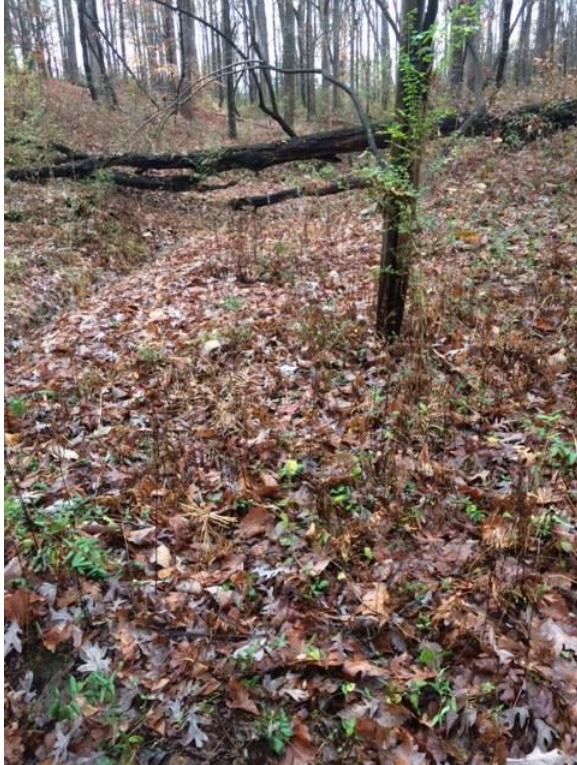
Photo 2

Description:
Wetland WB is a small floodplain/toe-of-slope wetland located on both sides of Stream SM (north of I-85). Photo taken at flag WB-3 facing northwest.

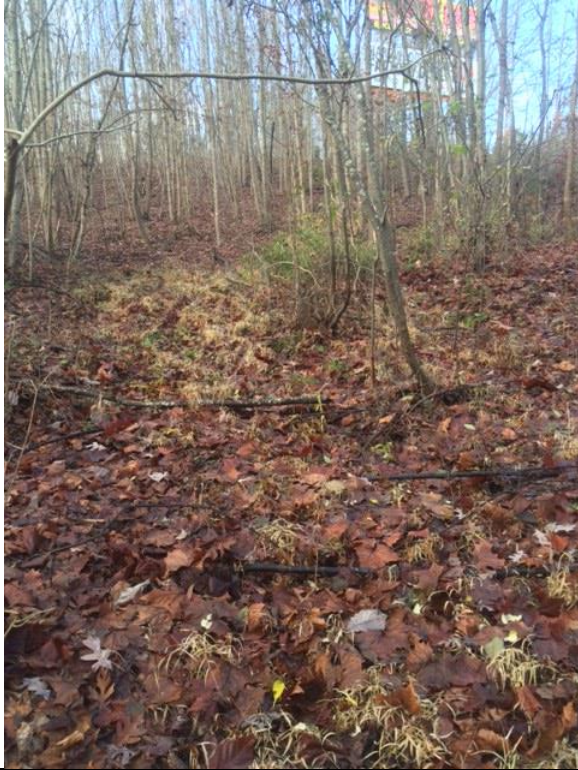
Photo 3

Title:
Wetland WC

Description:
Wetland WC is a seepage slope wetland located on the left side of Stream SM (South of I-85) when facing north toward I-85. Photo taken at point WC-10 facing west.

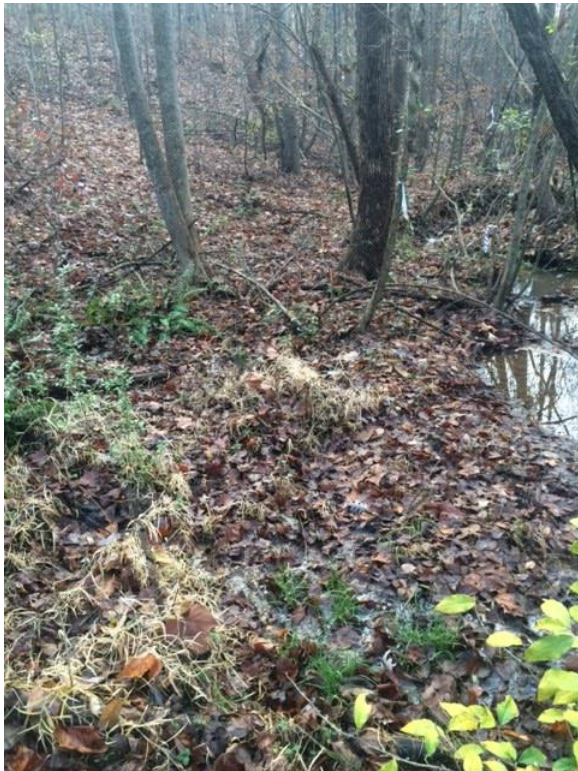
Photo 4

Title:
Wetland WD

Description:
Wetland WD is a small floodplain/toe-of-slope wetland located on the right side of Stream SM (South of I-85) when facing north toward I-85. Photo taken at point WD-3 facing south.

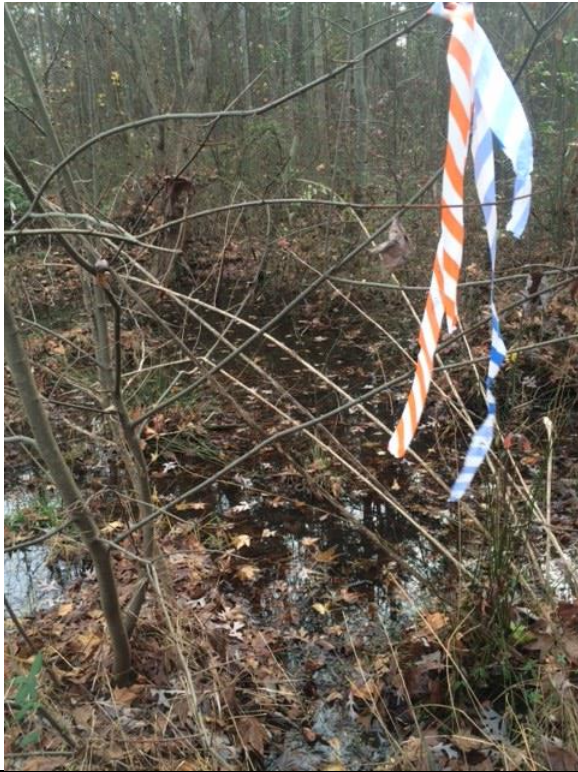
Photo 5

Title:
Wetland WE

Description:
Wetland WE is a wetland occurring in an old roadside cut on the south side of I-85 between a Love's Travel Stop and an open cool-season grass field north of Priester Rd. A jurisdictional ditch connects Wetland WE to Stream SO. Photo taken at point WE-1 facing southeast.

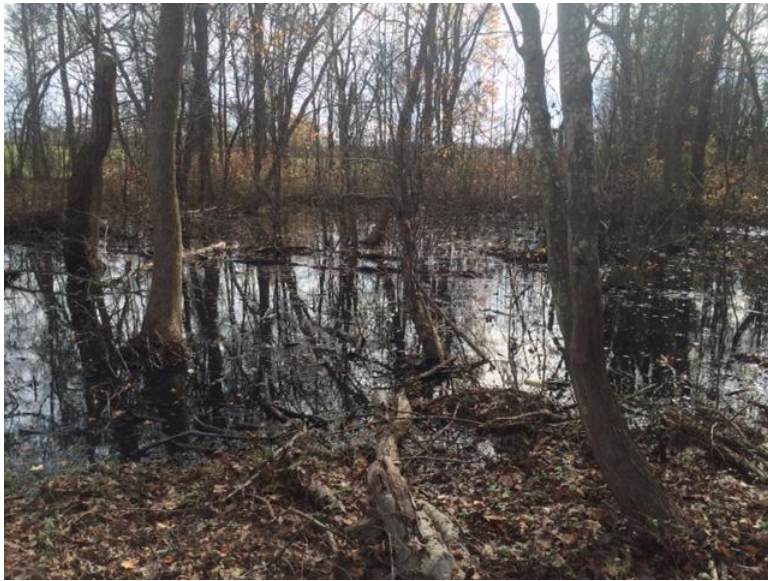
Photo 6

Title:
Wetland WF

Description:
Wetland WF is an upland depression wetland located on the south side of I-85 between a Loves Travel Stop and an open cool-season grass field north of Priester Rd. Photo taken at point WF-1 facing southeast.

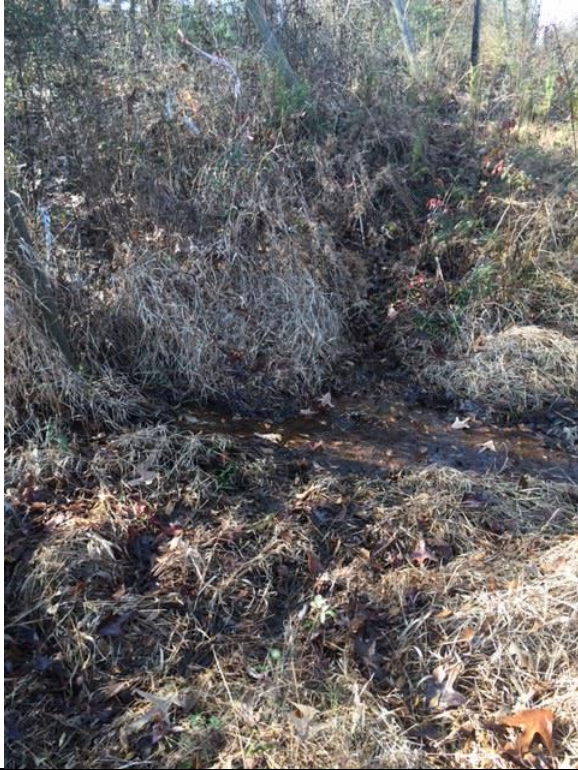
Photo 7

Title:
Wetland WG

Description:
Photo is taken from point WG-8 looking east towards a powerline right-of-way crossing of the wetland.

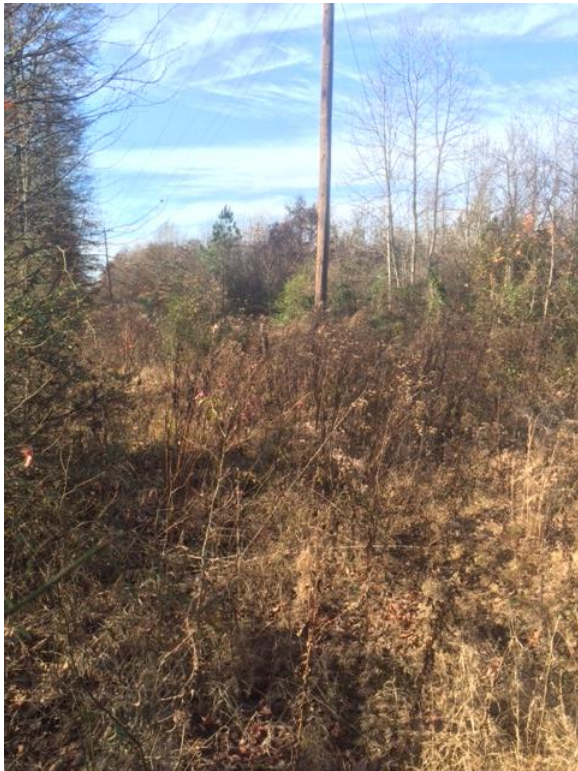
Photo 8

Title:
Wetland WH

Description:
Wetland H occurs along both sides of Stream SO. Photo is taken at flag WH-2 facing west, where the wetland crosses a powerline right-of-way.

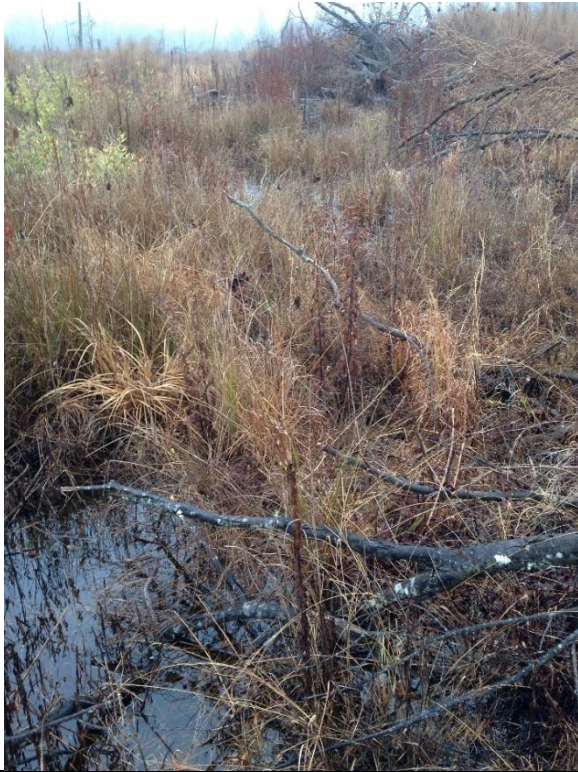
Photo 9

Title:
Wetland WDD

Description:
Small depression wetland in cutover area in floodplain of Broad River. Photo facing northeast at flag WDD-3b.

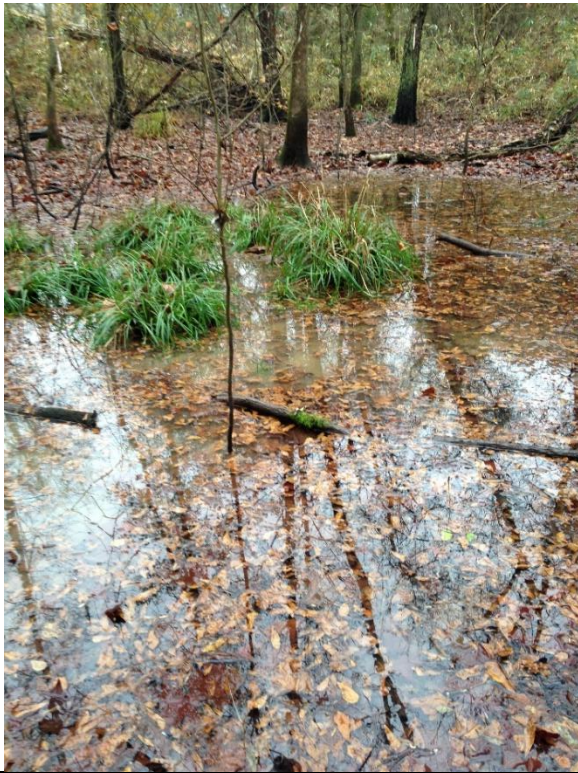
Photo 10

Title:
Wetland WEE

Description:
Small, isolated wetland in floodplain forest. Photo facing east at flag WEE-1.

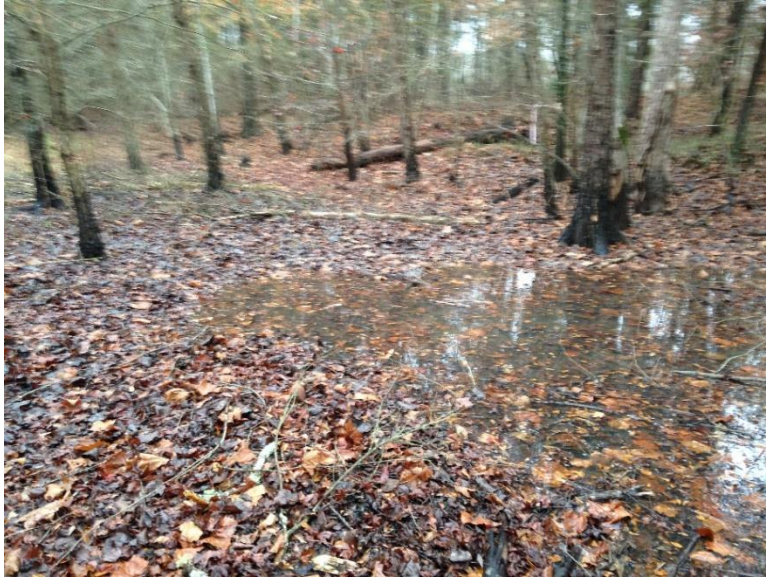
Photo 11

Title:
Wetland WFF

Description:
This wetland receives water from a roadside ditch and a culvert under I-85. It drains into the floodplain of the Broad River, but the drainage would only connect directly to the river under extreme flood conditions. Soil disturbed; probably an old borrow pit. Photo facing northwest at flag WFF-6a.

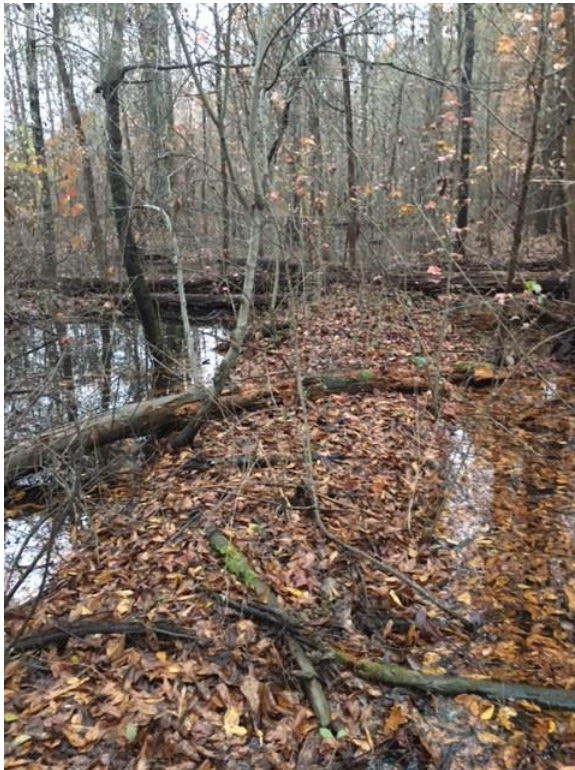
Photo 12

Title:
Wetland WGG

Description:
Wetland WGG is a palustrine forested wetland located north of I-85 and contained entirely within the PSA. Photo is taken from flag WGG-2A facing north.

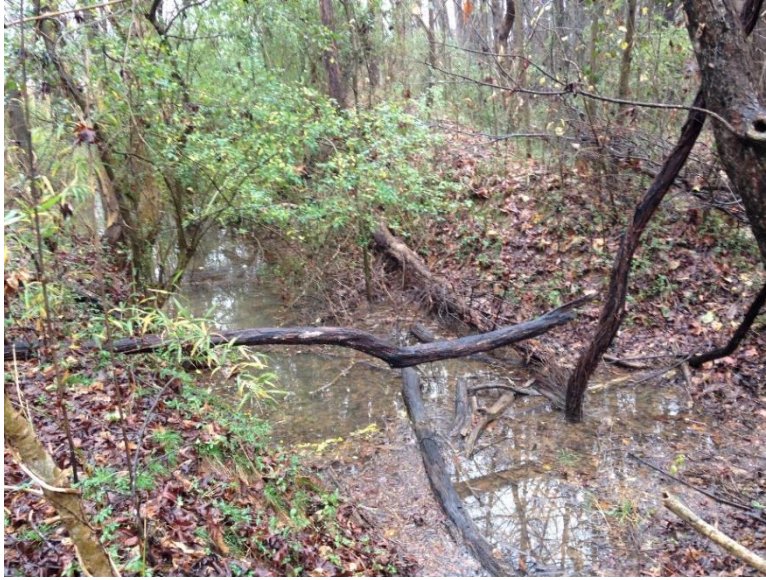
Photo 13

Title:
Wetland WII

Description:
This wetland is an old ditch leading toward Stream SBB, however the end of the ditch is dammed up with sediment. Photo facing north-northeast at flag WII-2.

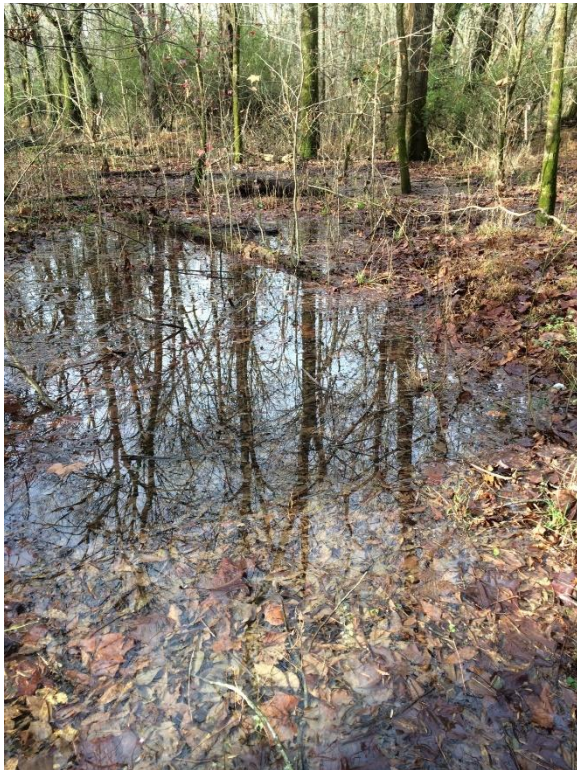
Photo 14

Title:
Wetland WJJ

Description:
Wetland WJJ is a palustrine, forested wetland located south of I-85. Photo taken at flag WJJ-1 facing west.

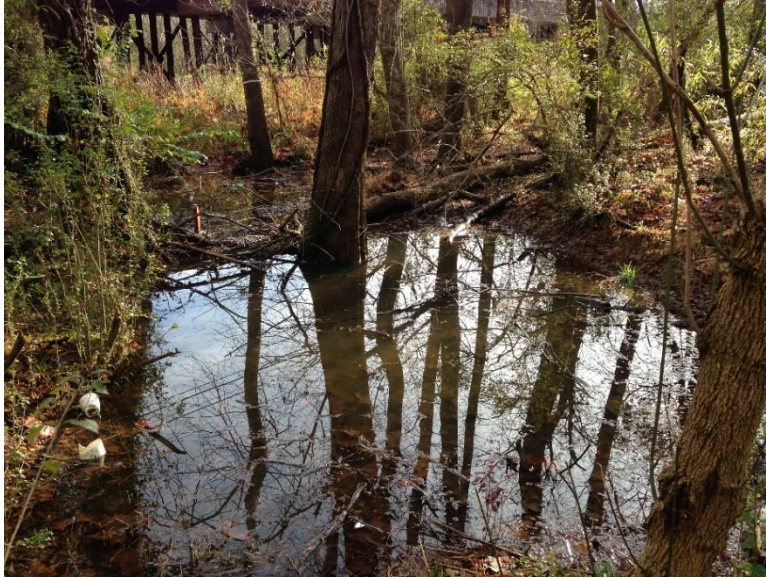
Photo 15

Description:
This wetland is a small ponded depression with scant vegetation; it is in the floodplain of Buffalo Creek. Photo facing southeast at flag WKK-1.

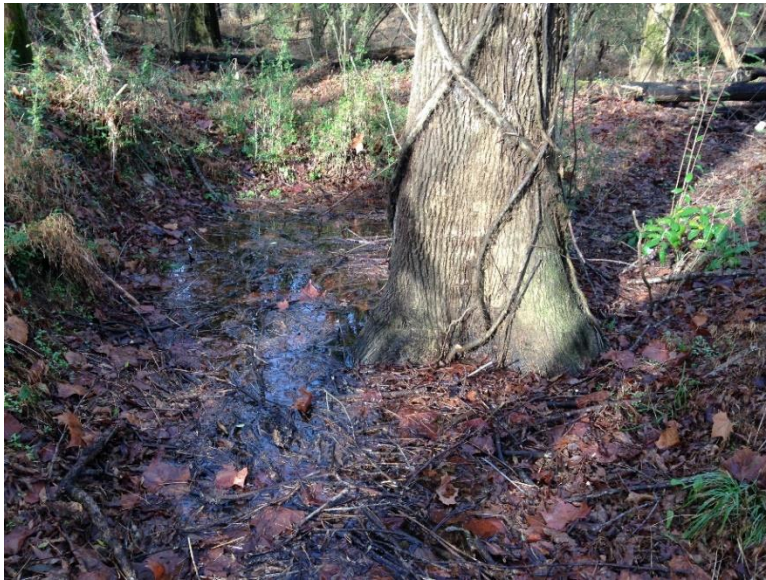
Photo 16

Title:
Wetland WLL

Description:
This is a small wetland in the floodplain of Buffalo Creek. It appears to have been a dug channel due to the adjacent berm. There are no hydric soils to connect it to Wetland WKK. Photo facing south at flag WLL-4.

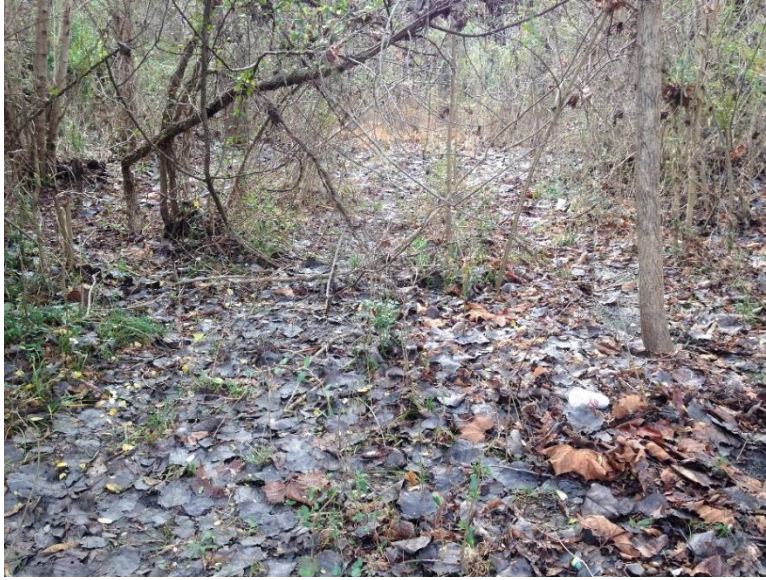
Photo 17

Title:
Wetland WMM

Description:
This area is in the floodplain of Buffalo Creek. It is a questionable wetland as the soils are not especially hydric. Flagged previously. Photo facing south at flag WMM-3.

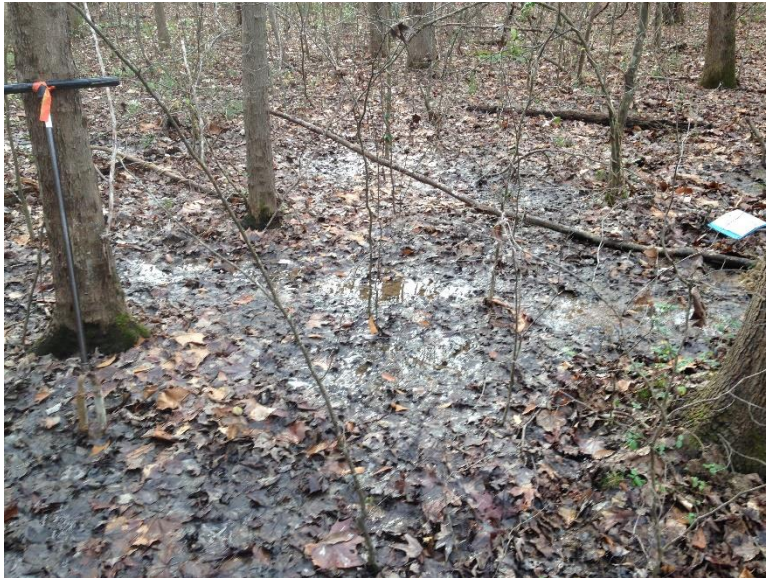
Photo 18

Description:
Wetland WNN is a small, palustrine, forested wetland located north of I-85 that is contained entirely within the PSA. Photo taken at flag WNN-1 facing west.

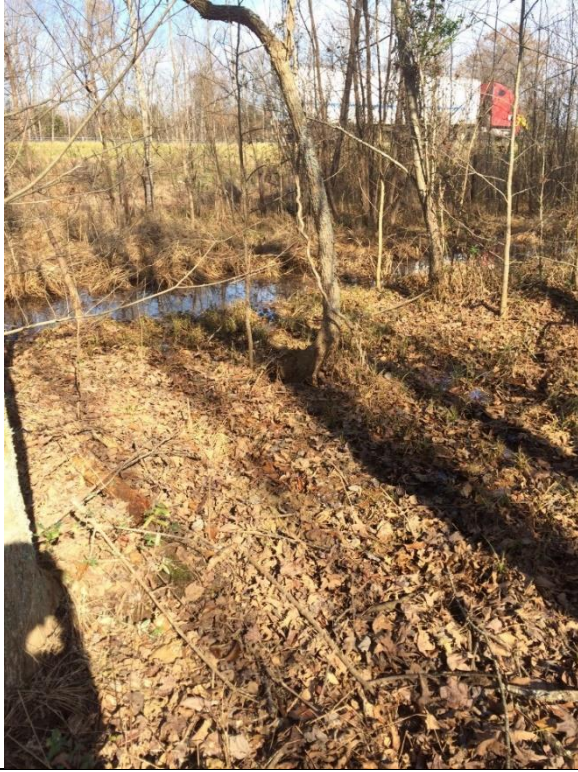
Photo 19

Description:
The photo was taken at flag WOO-2 facing north.

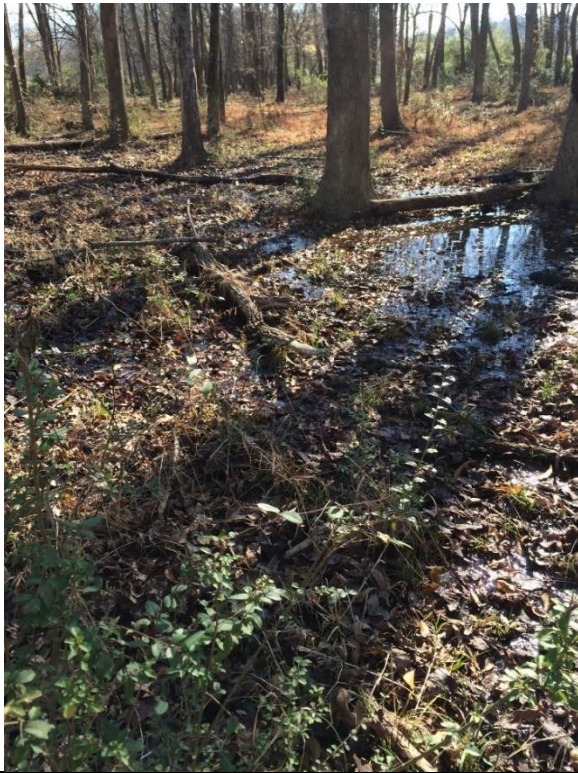
Photo 20

Title:
Wetland WPP

Description:
This wetland is located between pastures in a small depression. The photo is taken at flag QPP-7 facing south.

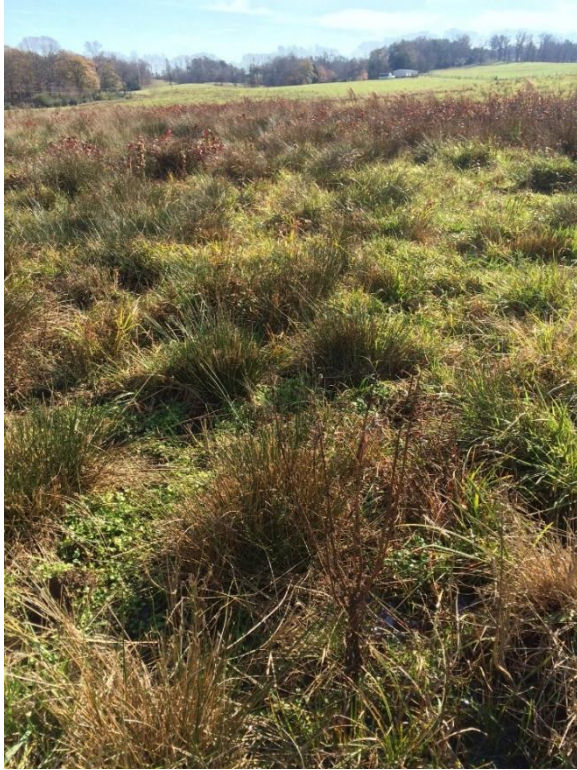
Photo 21

Title:
Wetland WQQ

Description:
Wetland WQQ is in an active pasture and drains to Stream SS. This photo was taken at flag WQQ-8 and is facing southeast.

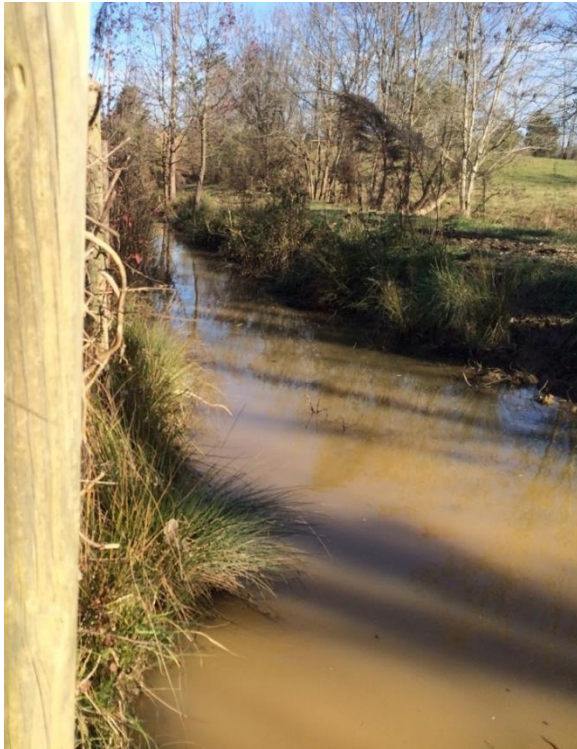
Photo 22

Description:
This is a linear wetland running alongside an access road to a pasture. The photo is taken at flag WRR-1 and is facing east.

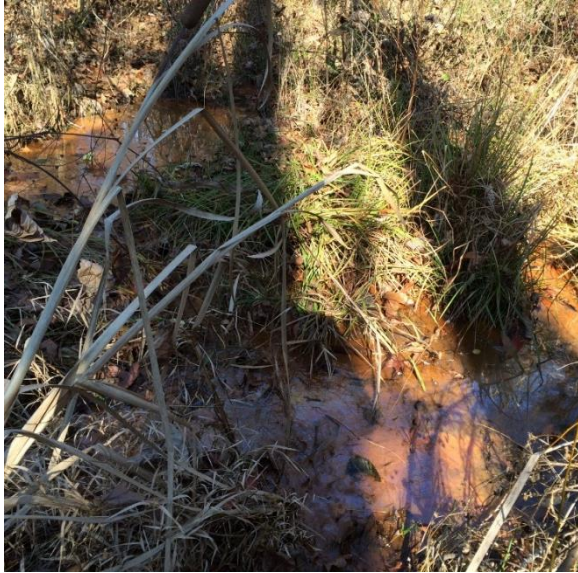
Photo 23

Description:
Wetland WSS is in a large depression and is connected to Stream DDD. This photo was taken at flag WSS-4 facing north.

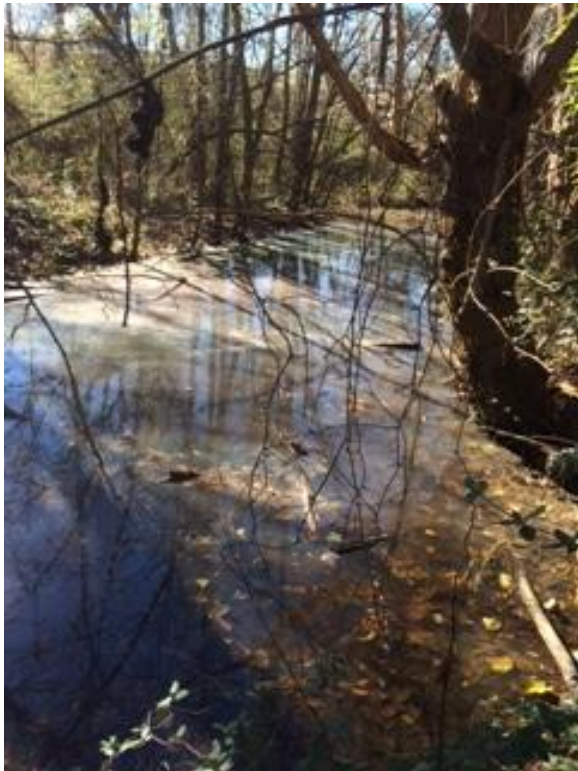
Photo 24

Title:
Wetland WTT

Description:
A portion of this wetland is a linear depression with standing water. The photo is taken at flag WTT-5 facing southwest.

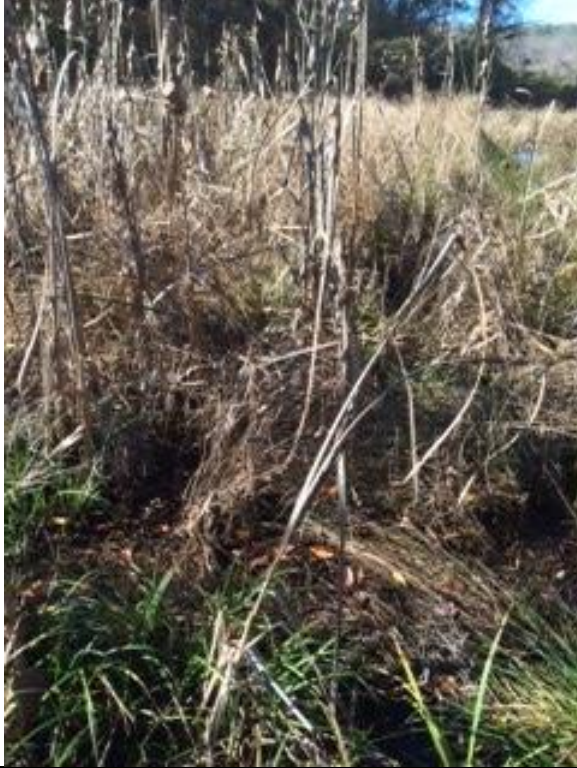
Photo 25

Description:
Wetland WUU is in an opening between woodlots. This photo was taken at flag WUU-12, facing southwest.

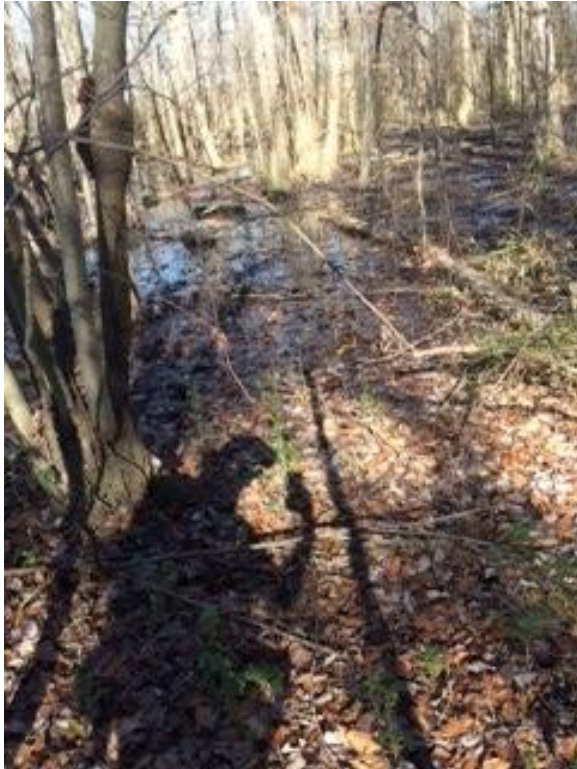
Photo 26

Description:
This wetland contains some standing water and is located in a depression next to a utility easement. This photo is taken at flag WVV-2 facing north.

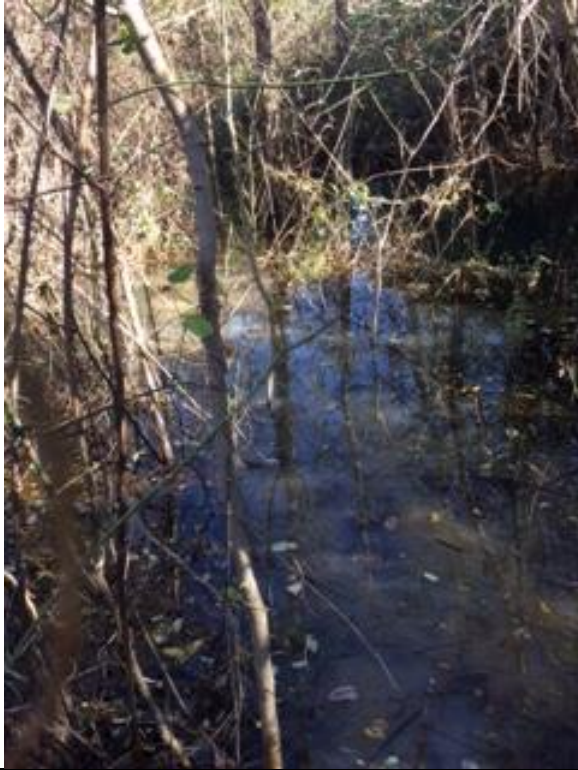
Photo 27

Title:
Wetland WWW

Description:
Wetland WWW is in a disturbed area with pockets of water. The photo is taken at flag WWW-1 facing east.

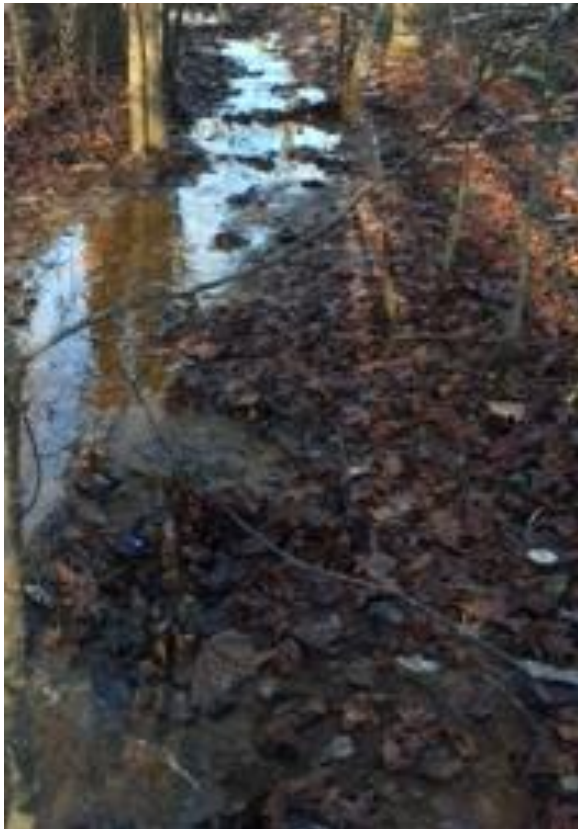
Photo 28

Title:
Wetland WXX

Description:
Wetland WXX is braided in with Stream SKKK. The photo is taken facing southwest at flag WXX-1.

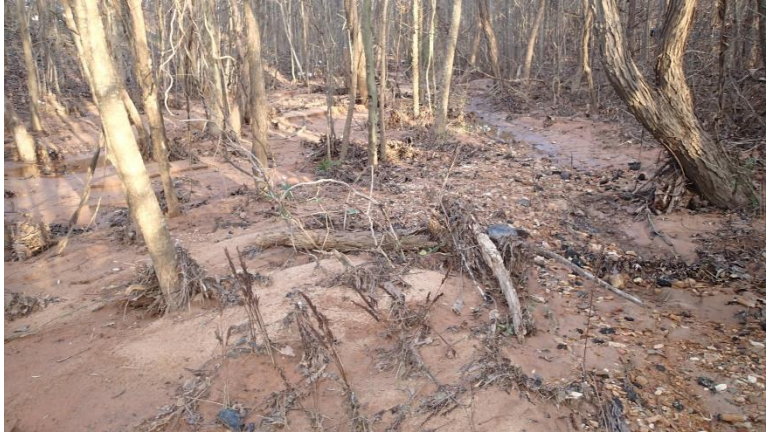
Photo 29

Description:
Wetland WYY is a palustrine, forested wetland located north of I-85 that directly abuts Stream SKKK. Photo was taken at flag WYY-3 facing southeast.

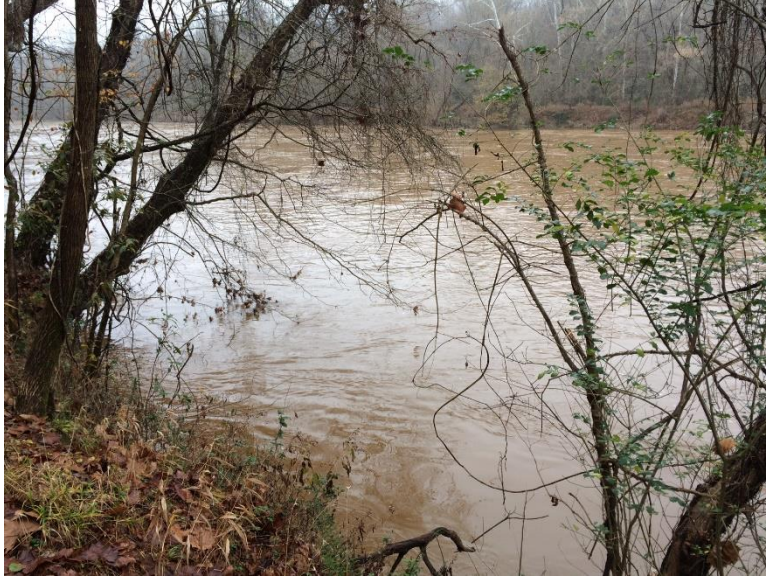
Photo 30

Broad River is a large, perennial stream that bisected the PSA. Photo taken facing upstream/northwest at flag BR-17.

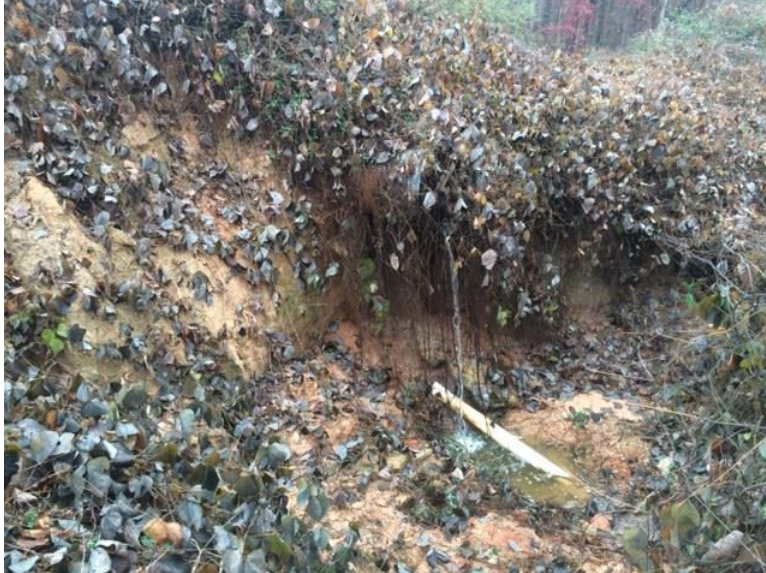
Photo 32

View of Stream SA origin (headcut) taken at flag SA-9 facing upstream/south. Stream is fed by a stormwater pond overflow/drainage pipe.

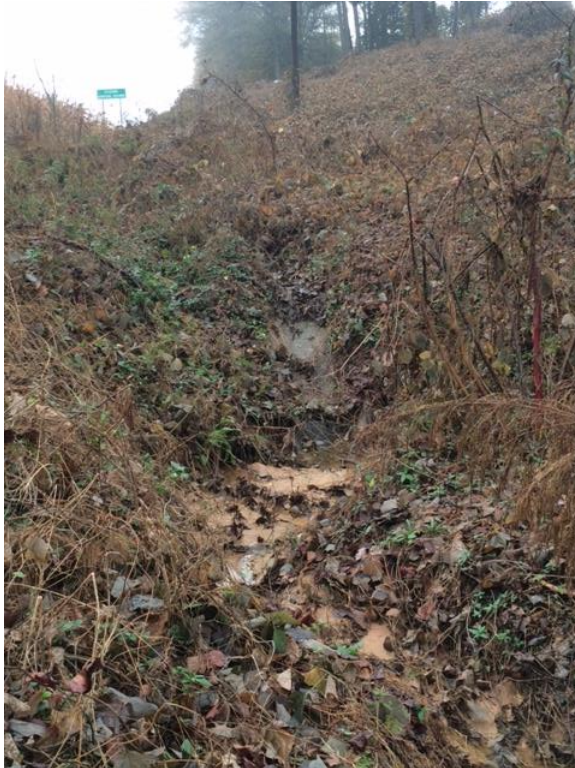
Photo 33

View of Stream SA facing upstream from flag SA-3a located just upstream from the confluence of Streams SA & SB. Streams SA & SB merge and immediately flow into a culvert that runs south under Interstate 85. Photo taken facing west.

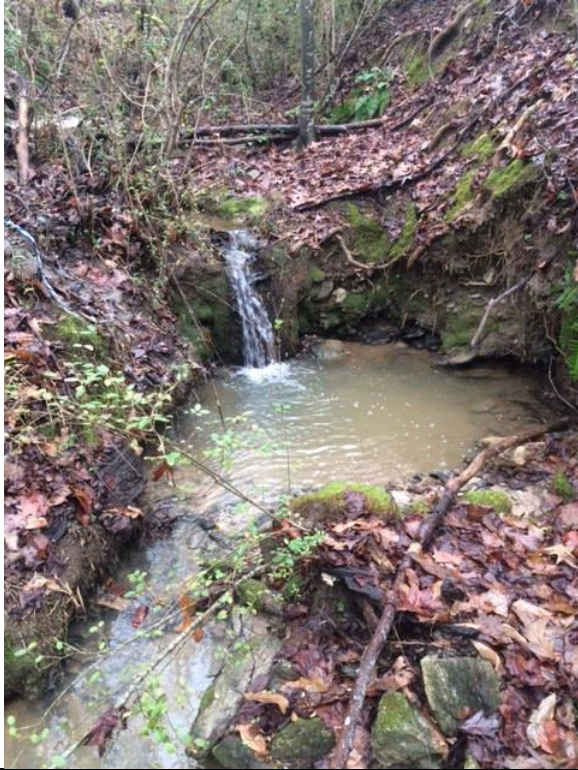
Photo 34

Title:
Perennial Stream SB/SG

Description:
Upstream view of Stream SB taken at flag SB-6. Stream SB is on the north side of I-85. Photo taken facing north.

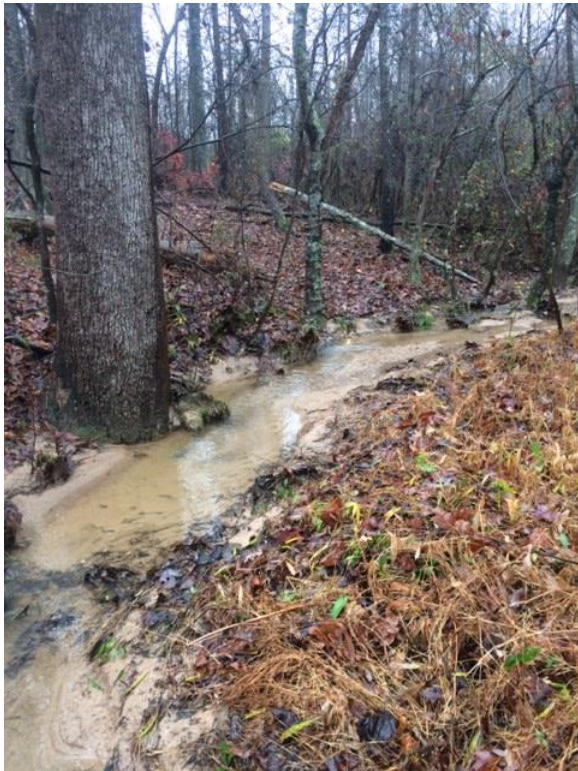
Photo 35

Title:
Perennial Stream SB/SG

Description:
Upstream view of Steam SG taken south of I-85 from flag SG-1b. This section of Stream SG is located on the south side of Interstate 85. Photo is taken facing north.

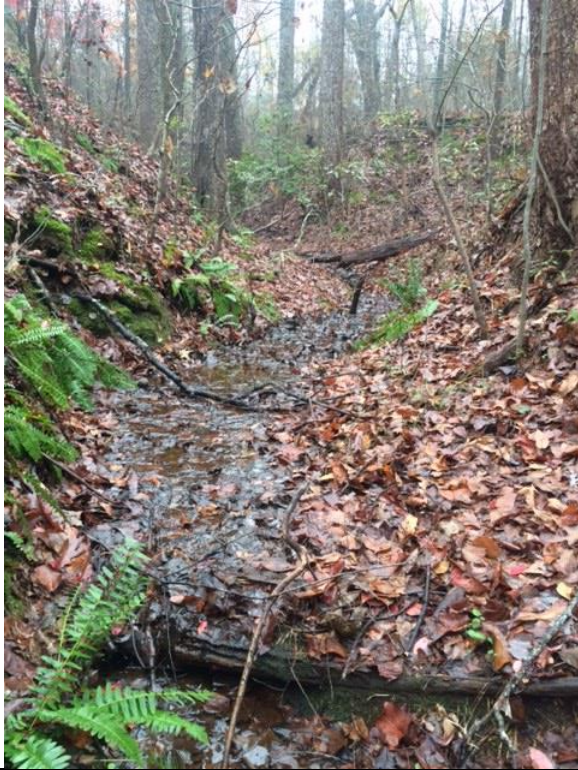
Photo 36

Title:
Intermittent Stream SC

Description:
Upstream view of Stream SC from the confluence of Streams SB & SC – flag SC-1. Stream SC originates from a groundwater seep upstream. Photo taken facing northwest.

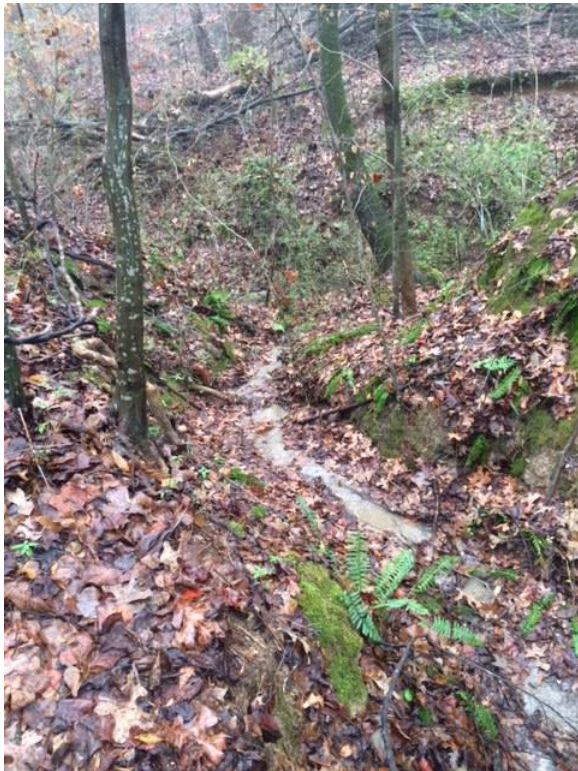
Photo 37

Title:
Intermittent Stream SD

Description:
Downstream view of Stream SD. Stream SD merges with Stream SB north of the confluence of Streams SB & SC. Photo taken facing west at flag SD-2.

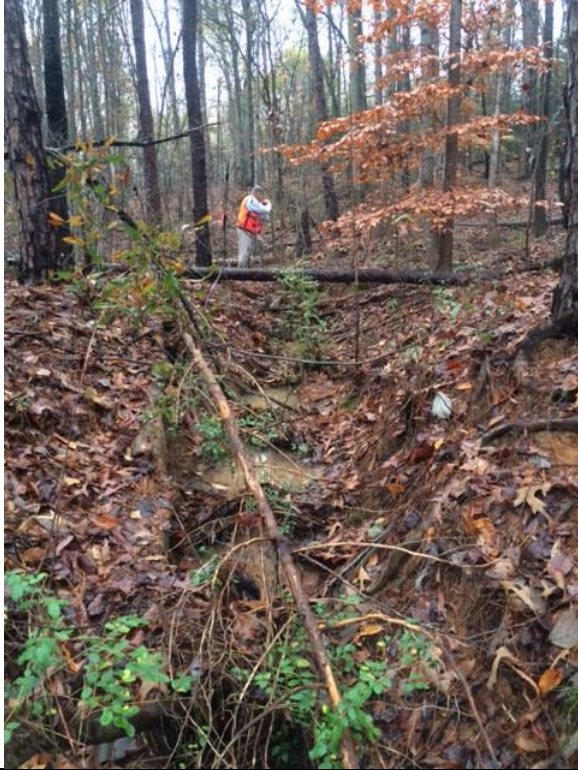
Photo 38

Title:
Intermittent Stream SE

Description:
Upstream view of Stream SE taken from flag SE-4a. Stream SE flows as intermittent surface water to an I-85 roadside ditch. Photo taken facing north.

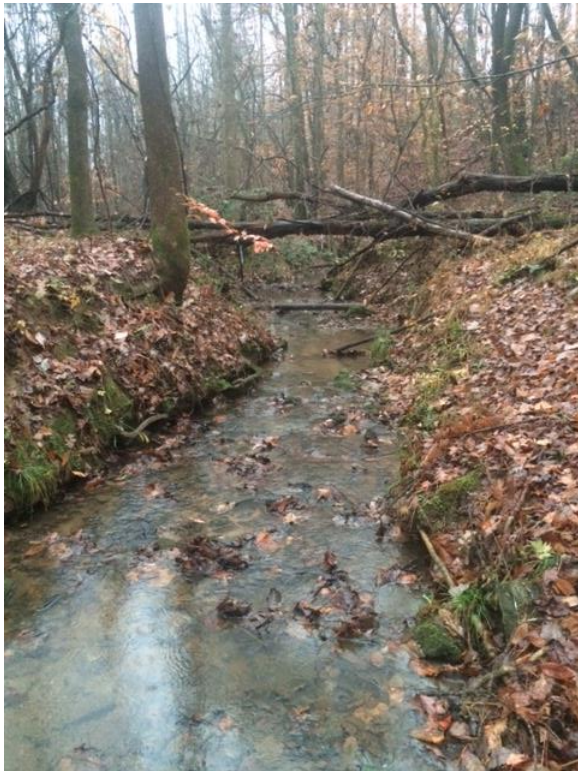
Photo 39

Description:
Downstream view of Stream SF taken at flag SF-5a. Photo taken facing south.

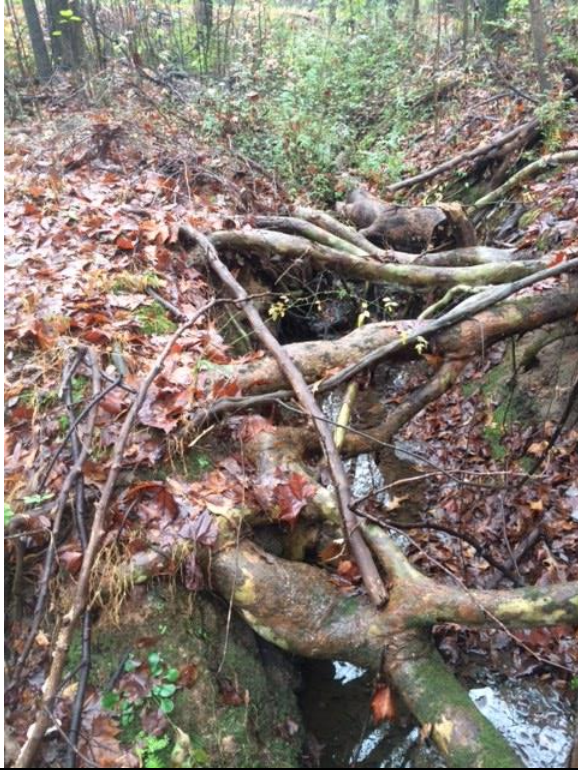
Photo 40

Description:
Upstream view of Stream H taken from confluence of Streams SG & SH at flag SH-1a. Photo taken facing northeast.

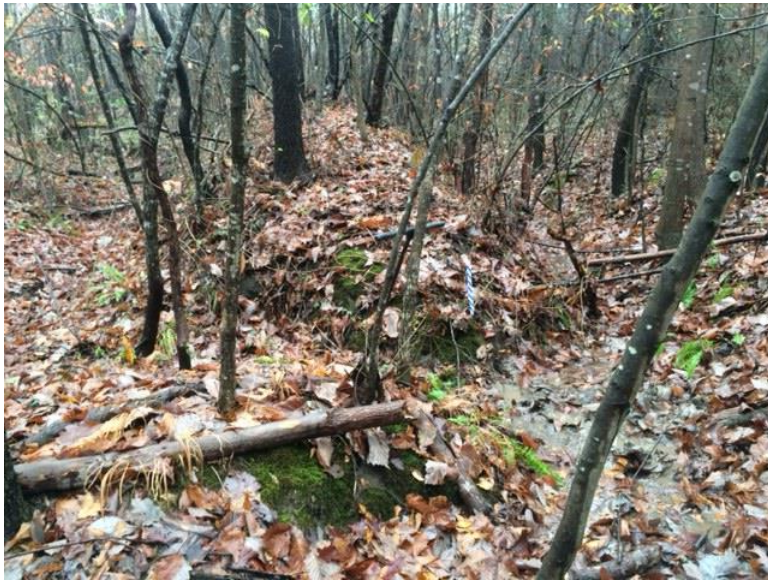
Photo 41

Description:
Upstream view of Streams SI & SJ taken at their confluence, flag SI-2b. Photo taken facing north.

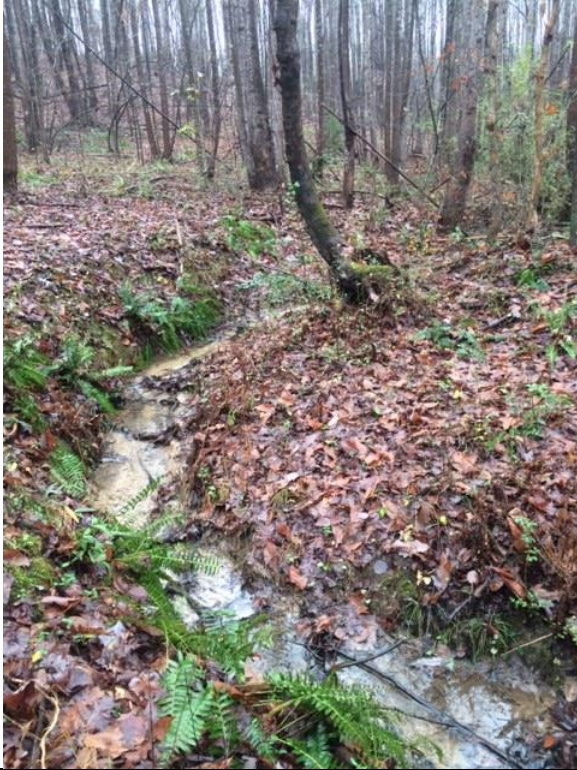
Photo 42

Description:
Upstream view of Stream SK taken at flag SK-1a. Photo taken facing north. Stream SK flows south through PSA and into a culvert, which then goes underneath I-85.

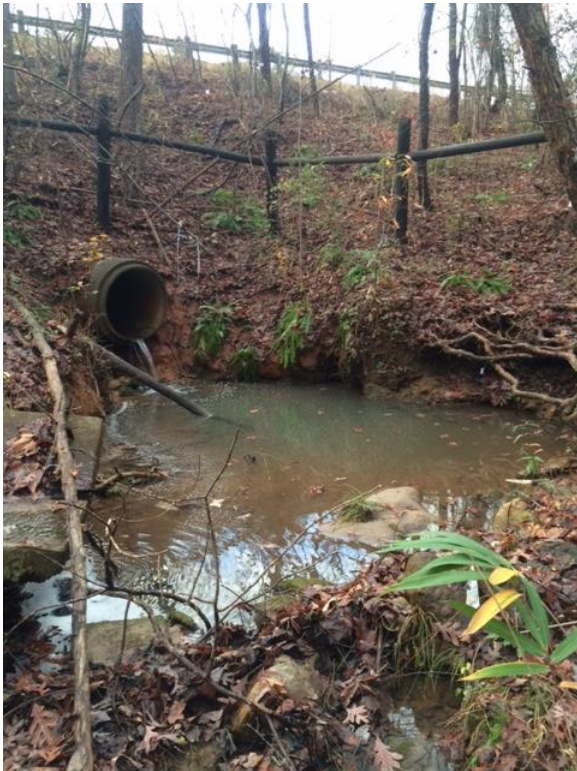
Photo 43

Title:
Perennial Stream SK

Description: Upstream view of Stream SK from flag SK-8b. Stream SK becomes perennial upon exiting the 3ft culvert on the south side of I-85. Photo taken facing north.

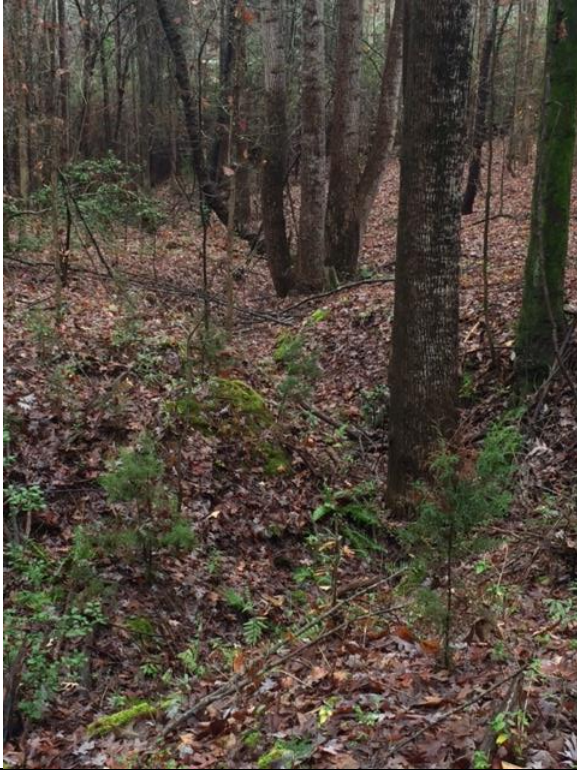
Photo 44

Description:
Downstream view of Stream SL from flag SL-2a. This feature contained leaf litter throughout 100% of the channel/gully and ended without merging with any other permanent or semi-permanent water bodies. Photo taken facing east.

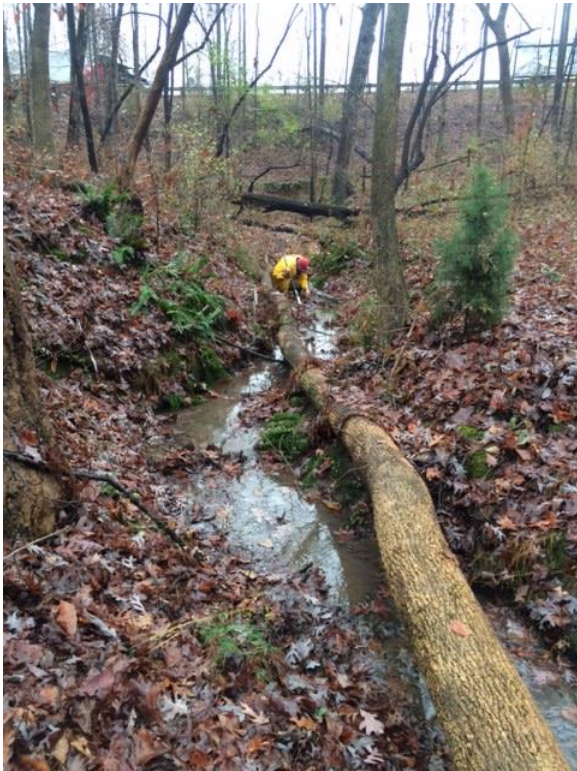
Photo 45

Title:
Perennial Stream SM

Description:
Downstream view of Stream SM taken at flag SM-1a. Stream SM flows south through PSA and into a culvert, which emerges on the south side of I-85. Photo taken facing south.

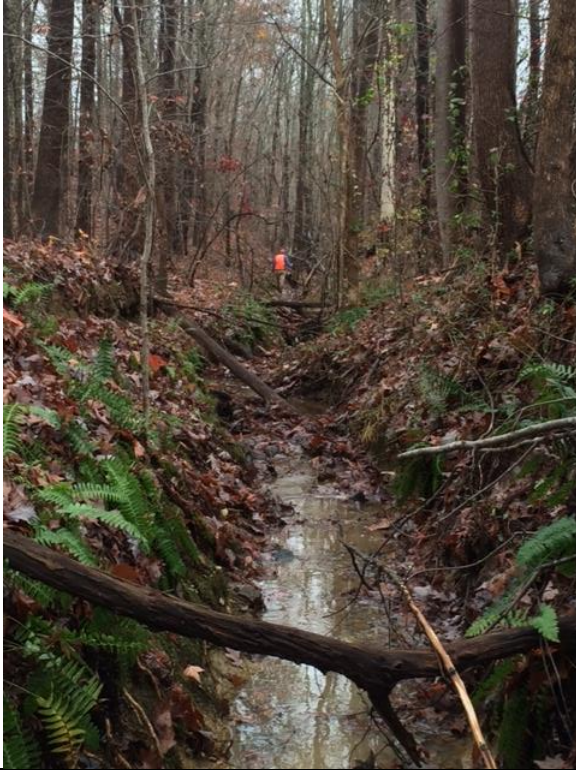
Photo 46

Description:
Downstream view of Stream SN from taken from flag SN-2. Stream SN originates on the north side of I-85 in a small circular wooded area between exit 106 off-ramp and the Interstate. Stream SN enters a culvert on the north side of the interstate and re-emerges on the south side, where it runs parallel with I-85 for several hundred feet. Photo taken facing west.

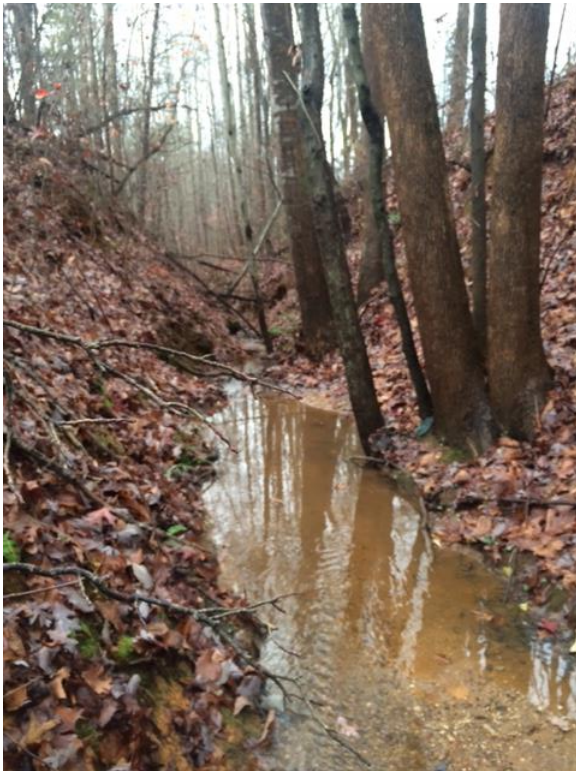
Photo 47

Description:
Seasonal portion of Stream SN. Photo taken facing upstream (northeast) at flag SN-7b.

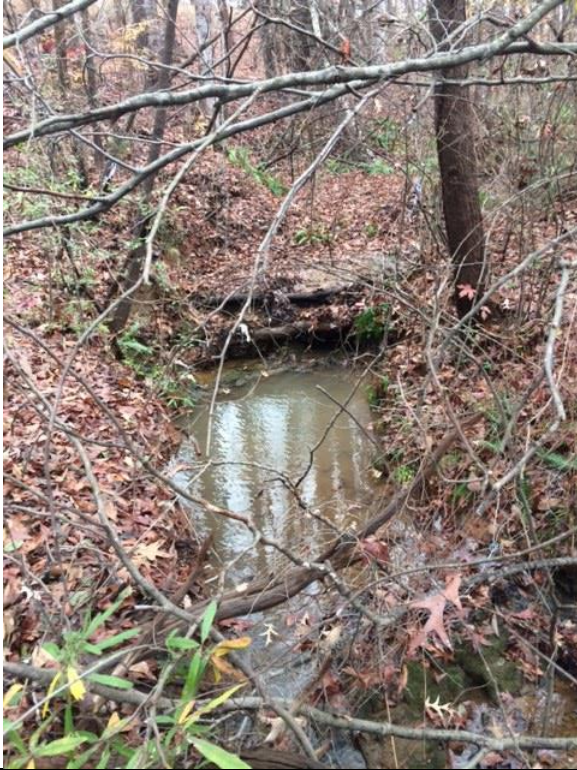
Photo 48

Description:
Upstream view of the perennial portion of Stream SN taken at flag SN-12a. Stream SN becomes perennial at this flag. Photo taken facing north.
