Attachment C

Photographs

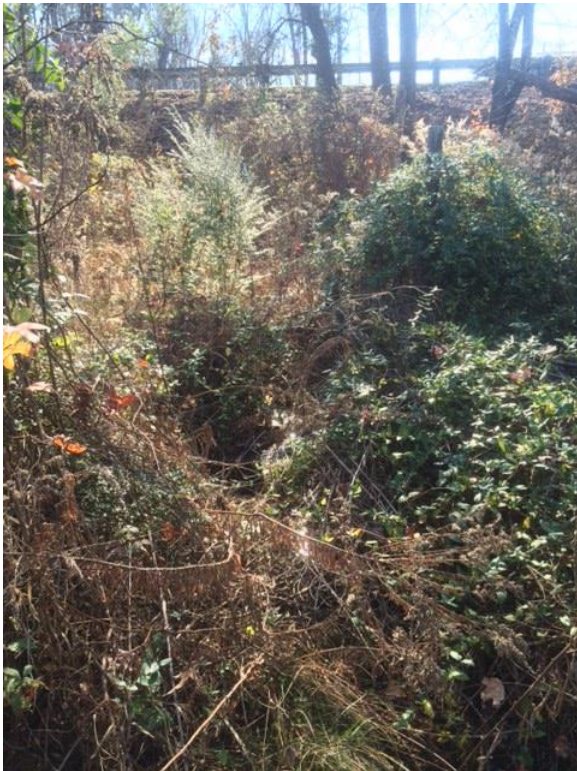
Photo 49

Description:
Stream SO originates in a hardwood forest north of Priester Rd and between a Love's Travel Stop to the west and an open field containing cool-season grasses to the east. Stream SO flows north to a jurisdictional roadside ditch that flows to a culvert and re-emerges on the north Side of Interstate 85. Photo taken at flag SO-9 facing upstream/south.

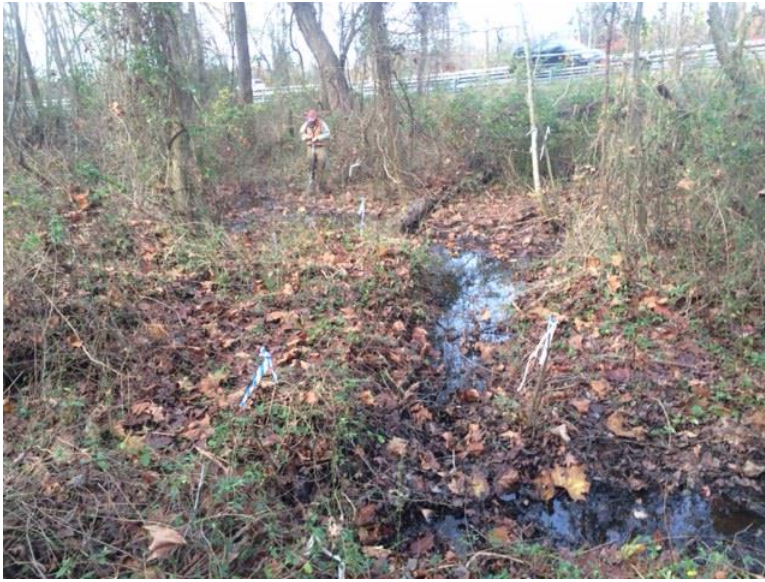
Photo 50

Intermittent Stream SP

Downstream view of Stream SP from flag SP-5b. Stream SP originates from an upland depressional wetland, flows north to a roadside culvert, and re-emerges on the north side of I-85. Photo taken facing north.

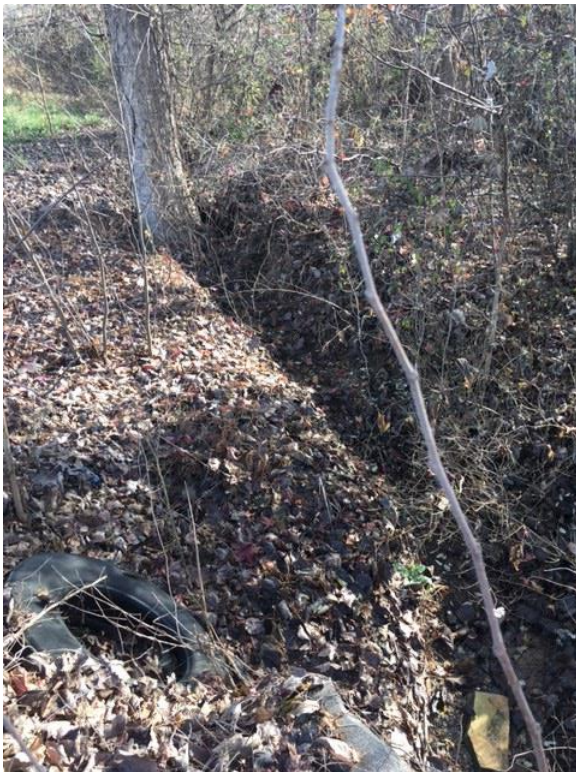
Photo 51

Upstream photo of Stream SQ from flag SQ-2 facing east.

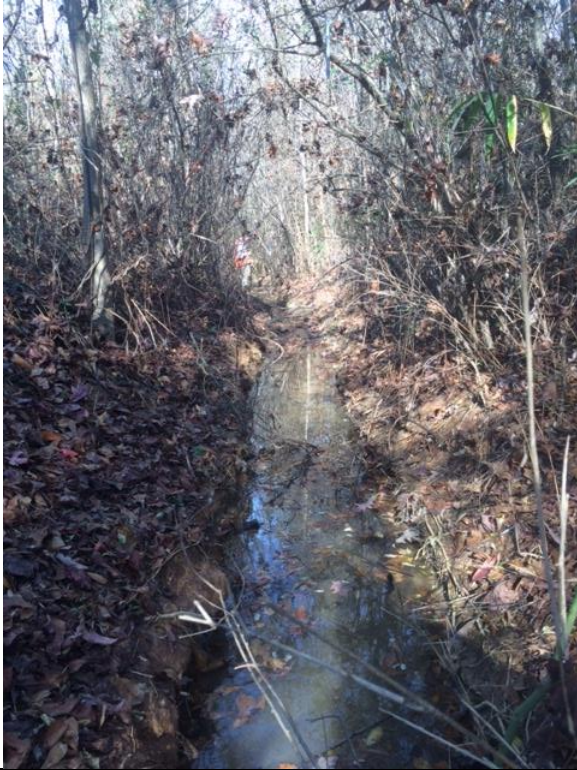
Photo 52

Title:
Intermittent Stream SR

Description:
Stream SR originates from a roadside stormwater retention area on the south side of I-85. A culvert directs water from the retention area to the north side of I-85 (Stream SR origin) during high rainfall events. Photo taken facing downstream (north) at flag SR-2a.

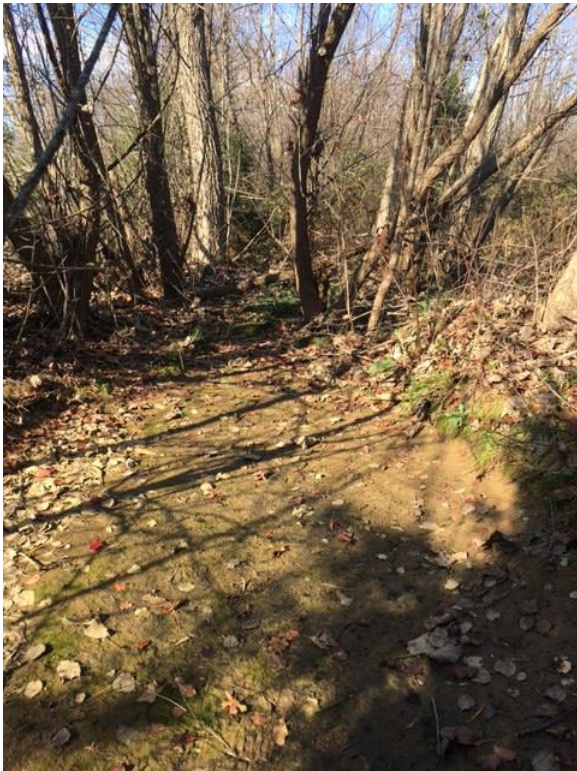
Photo 53

Description:
Photo of Stream SS facing downstream/north at flag SS-1.

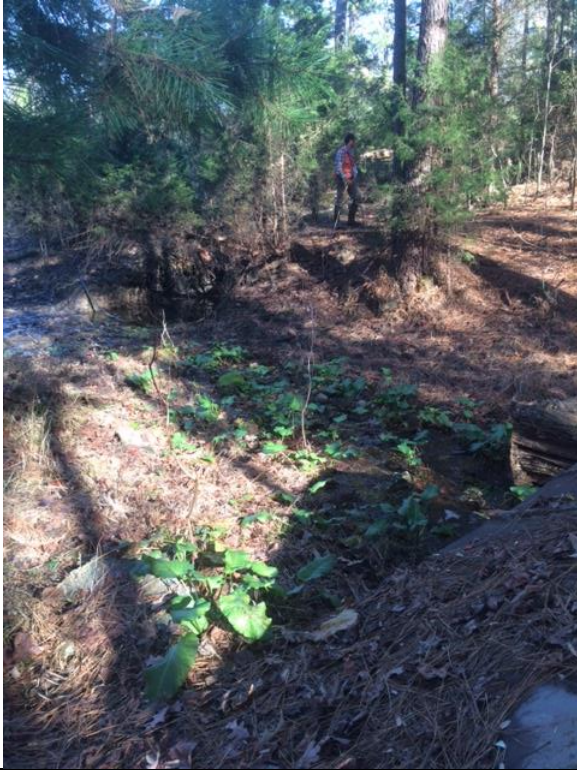
Photo 54

Description:
Stream ST originates as groundwater and flows north, parallel to the boundary of a large pasture. Photo is taken at stream origin facing downstream at flag ST-1b.

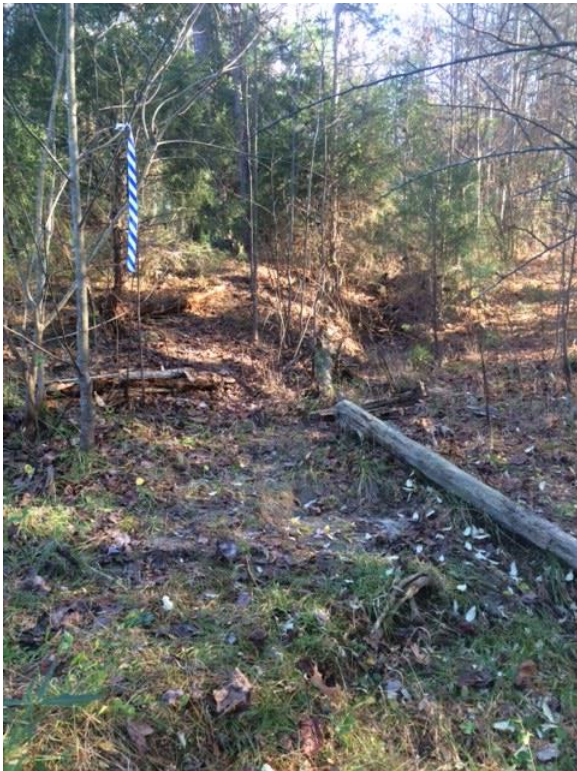
Photo 55

Description:
Stream SU originates as surface water runoff from an upland slope adjacent to Stream ST. Photo is taken facing upstream (south) at flag SU-3.

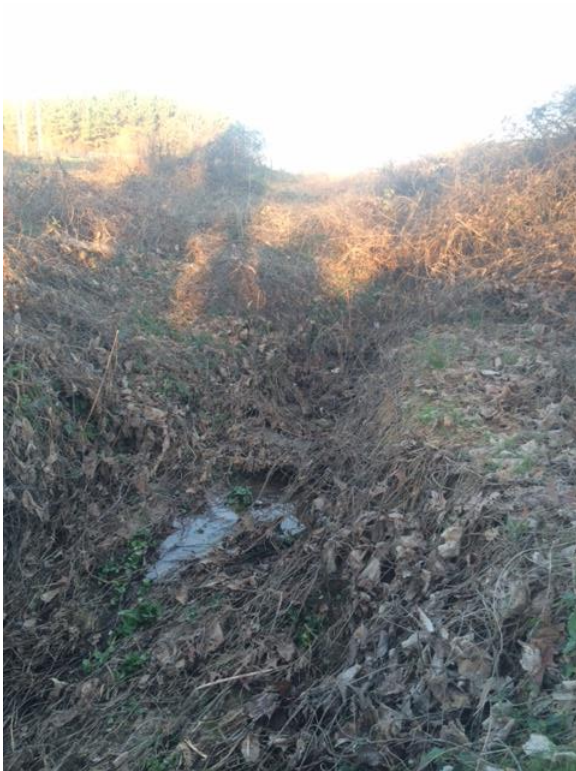
Photo 57

Seasonal Stream SW

Seasonal portion of Stream SW originates from a roadside culvert on the north side of I-85. Stormwater runoff from I-85, a large commercial business, and the Love's Travel Stop at exit 104 feed Stream SW. Photo taken at flag SW-1 facing downstream.

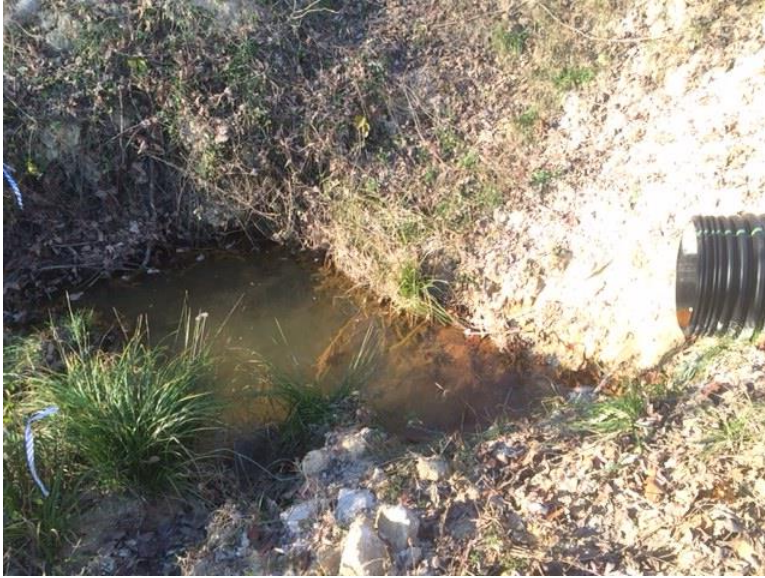
Photo 58

Description:
Perennial portion of Stream SW originates from a roadside ditch between a private business and White Farm Road, just West of exit 104 on I-85. Photo is taken at flag SW-7b facing North.

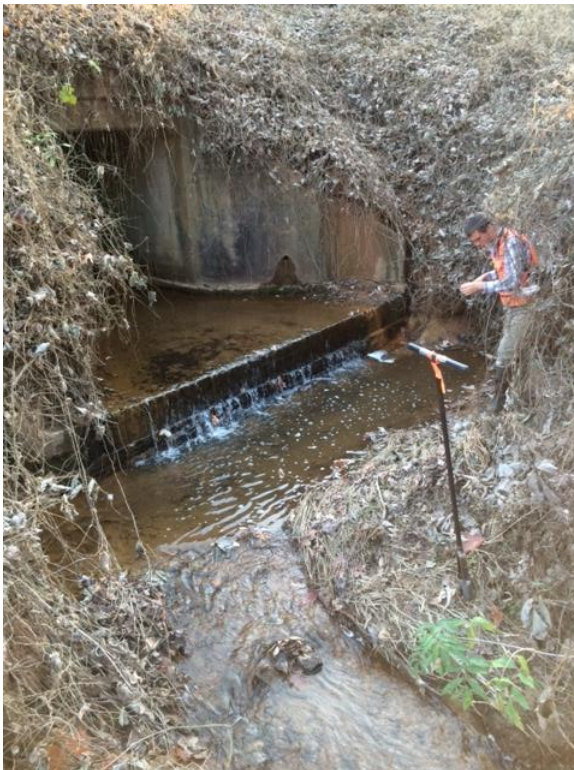
Photo 59

Description:
Perennial Stream SX/SRRR originates from a farm pond on the south side of I-85 and flows underneath I-85 via a large, 5-6 ft culvert. Photo is taken facing upstream (south) at flag SX-3b.

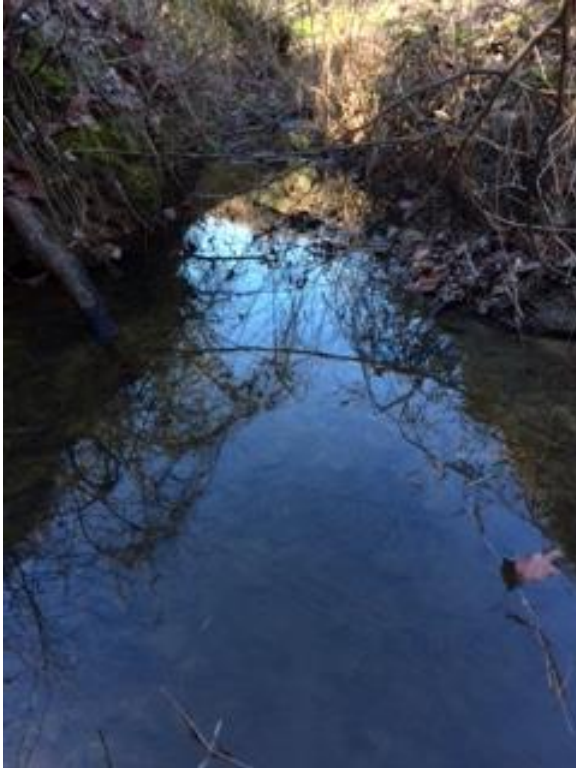
Photo 60

Description:
Stream SX/SRRR flows outside of the study area and collects water from stream SQQQ near the culvert that flows under I-85. This photo was taken at flag SRRR-3 facing downstream/northwest.

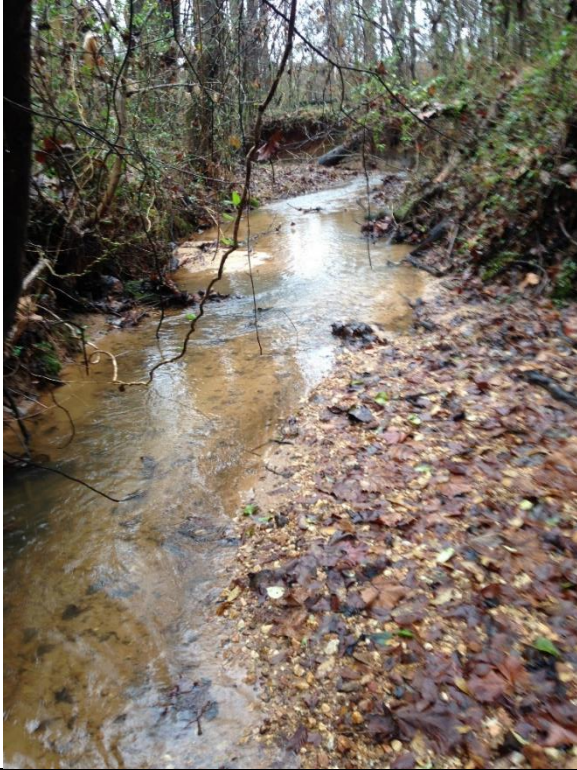
Photo 62

Title:
Perennial Stream SBB

Description: This stream begins on the northwest side of I-85 and flows under I-85 eventually flowing into Buffalo Creek. The photo is pointing upstream (north) at flag SBB-15a.

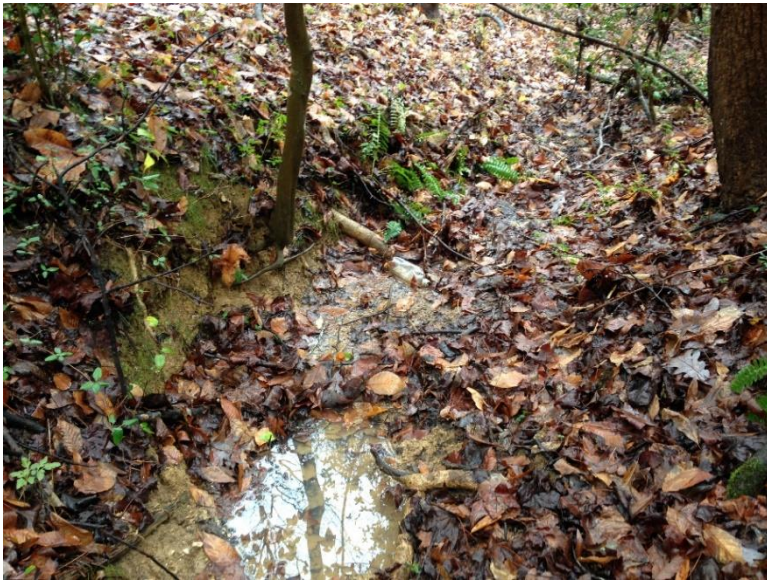
Photo 63

Title:
Seasonal Stream SCC

Description:
This unnamed tributary is fed by surface runoff from a frontage road. It becomes a diffuse braided channel just outside the project study area as it reaches a bottomland forest and the land levels out. The photo points upstream (north) at flag SCC-2a.

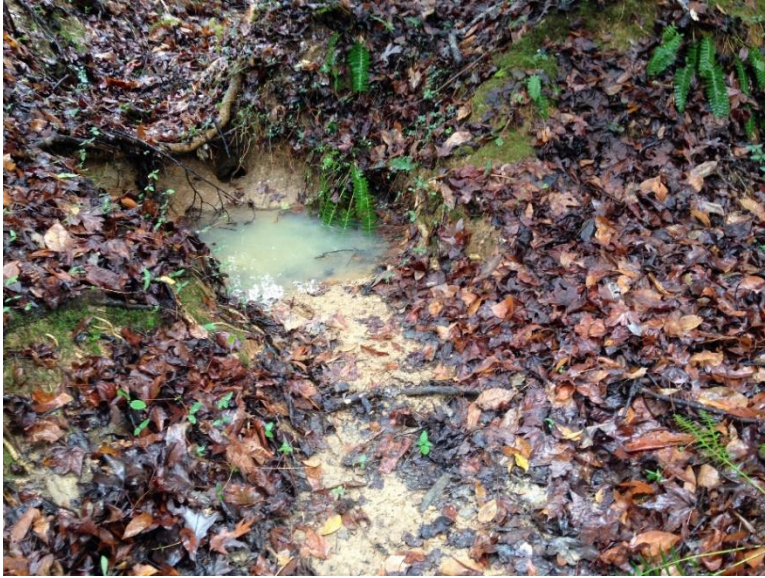
Photo 64

Description:
This incised tributary drains a gulley which collects surface water from a frontage road. Trash and refuse were present. Photo points upstream (north) at flag SDD-3a.

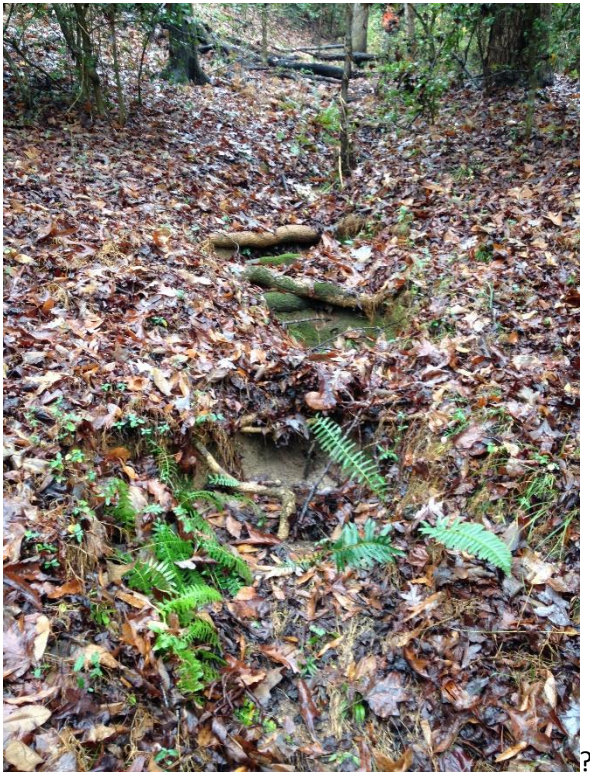
Photo 65

Description:
Photo taken at Flag SEE-3a facing north/upstream.

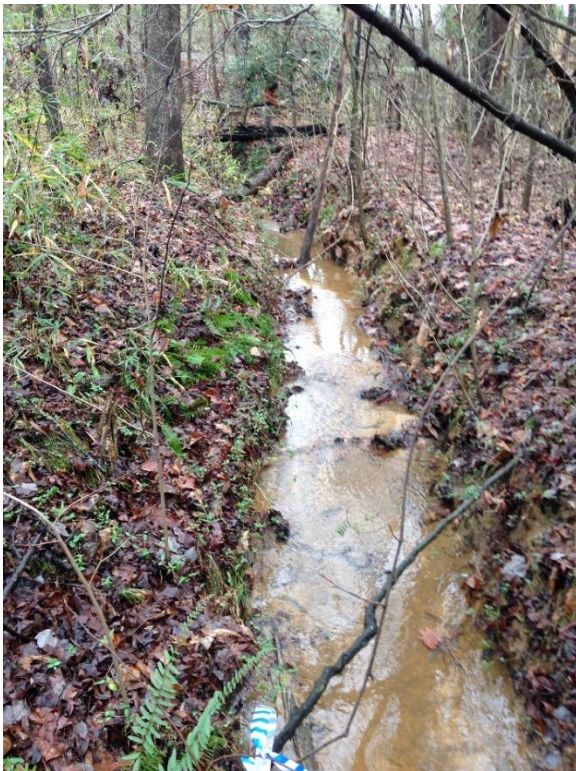
Photo 67

Perennial Stream SGG

This streams begins on the northeast side of I-85. It flows under I-85 and continues into a bottomland area outside the project study area. The photo was taken pointing upstream (north) at flag SGG-5b.

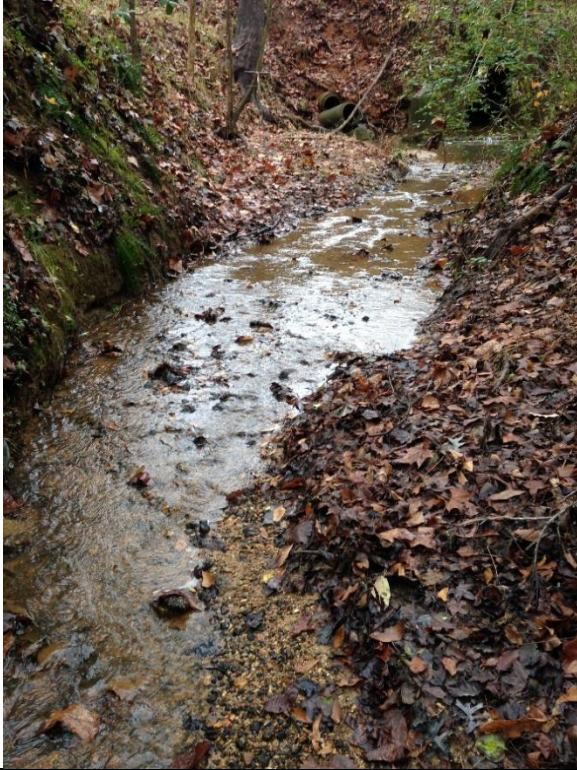
Photo 68

Title:
Perennial Stream SHH

Description:
This stream begins on the NW side of I-85. It flows under I-85 and a frontage road and continues outside the project study area. The photo was taken pointing upstream (north) at flag SHH-3b.

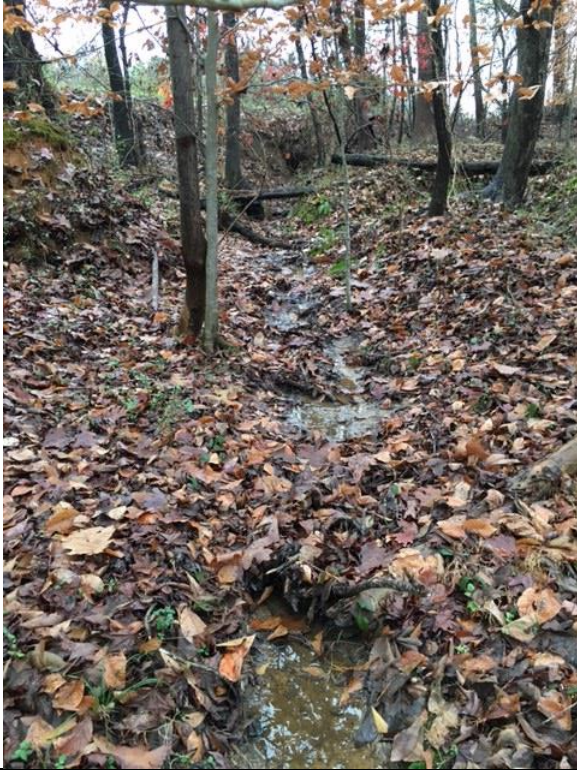
Photo 70

Title:
Intermittent Stream SJJ

Description:
This is an intermittent stream that forms from roadway runoff with a small culvert as its origin. Stream is located south of I-85 and service road. Photo taken facing upstream/north at flag SJJ-1A.

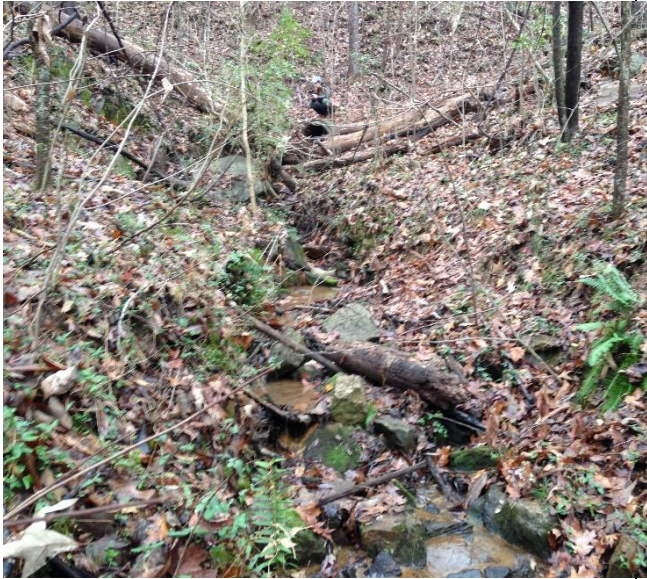
Photo 71

Description:
This tributary runs under a frontage road and drains to Buffalo Creek. The photo points upstream (northwest) at flag SKK-3b.

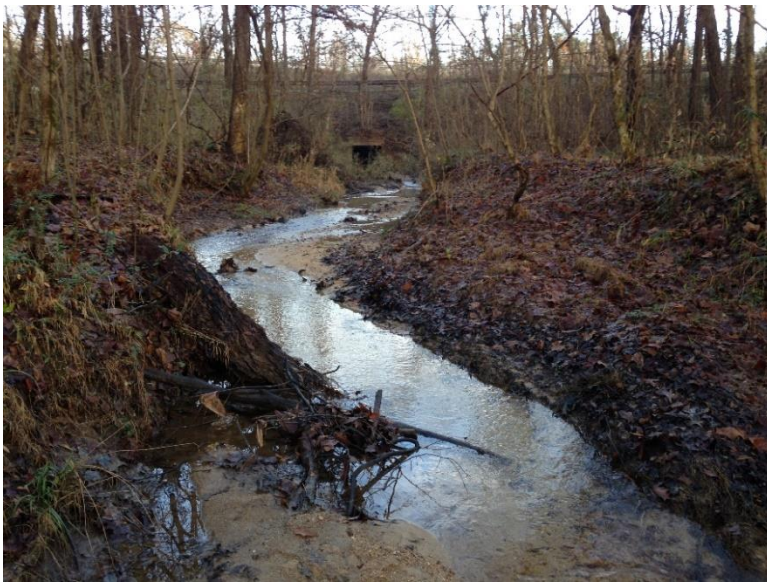
Photo 73

Title:
Perennial Stream SMM

Description:
This stream originates northwest of I-85 and flows under the interstate and a frontage road through a 6x6-foot box culvert. It drains to Buffalo Creek. Stream SLL drains into this stream. The photo was taken facing upstream (north) at flag SMM-8a.

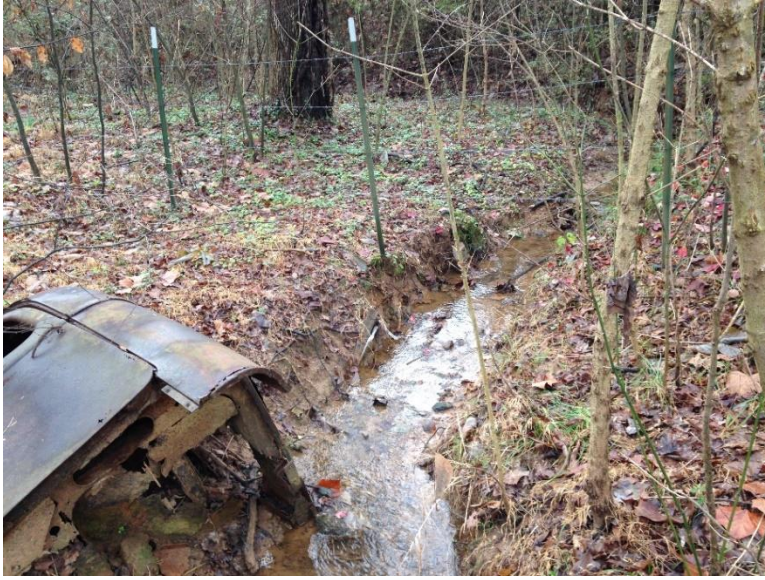
Photo 74

Description:
This tributary drains to Buffalo Creek near the boundary of the project study area. The photo faces downstream (north) at flag SNN-3b.

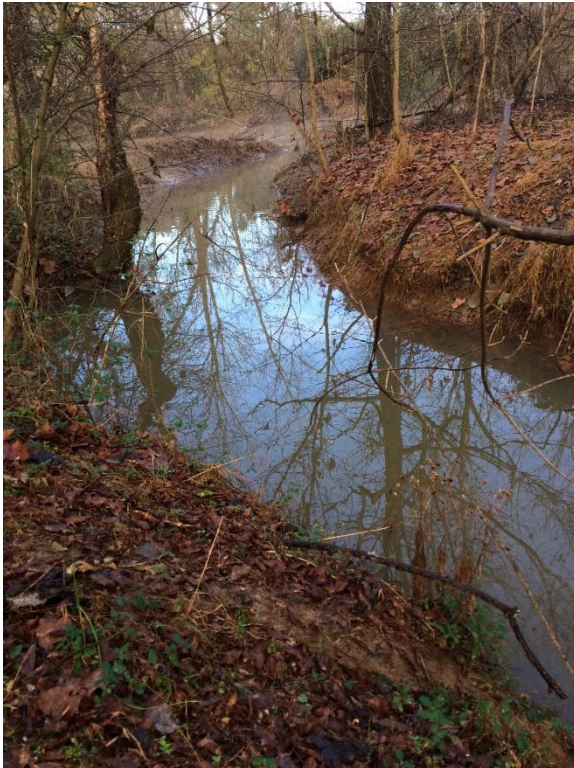
Photo 75

Description:
Photo taken at flag SOO-2a facing downstream/north.

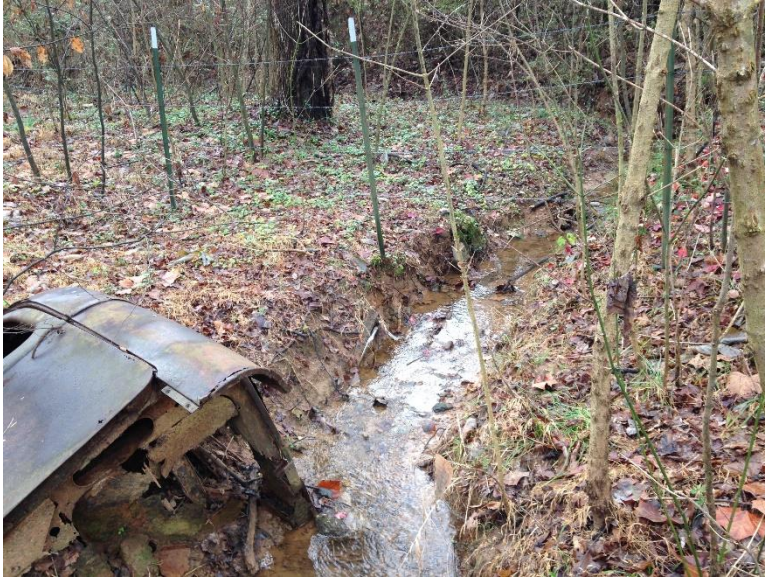
Photo 76

Description:
Photo taken at flag SPP-2a facing
downstream/north.

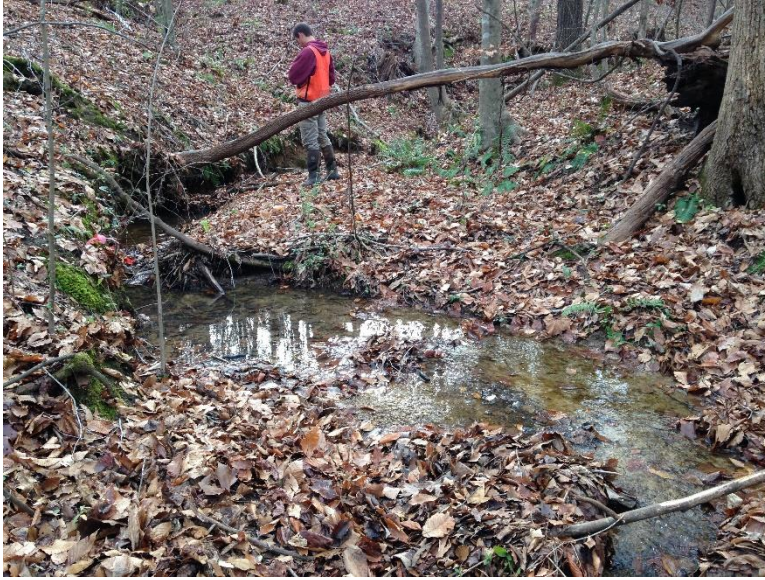
Photo 78

Title:
Perennial Stream SRR

Description:
Photo taken at flag SRR-3b facing
upstream/west.

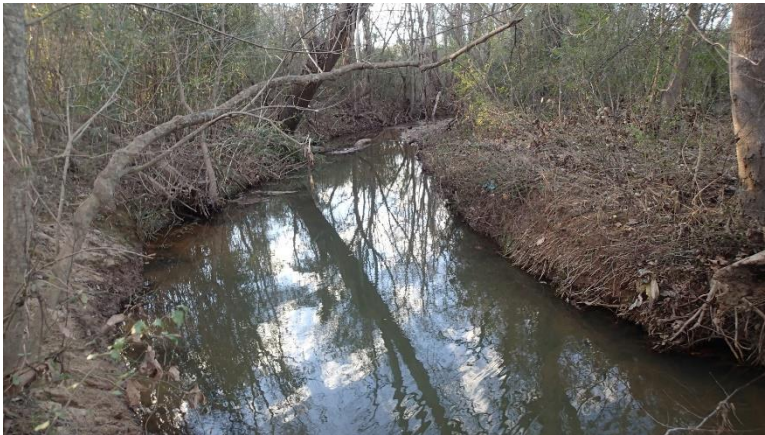
Photo 79

Title:
Perennial Stream SSS

Description:
Photo taken at flag SSS-7a facing
upstream/north.

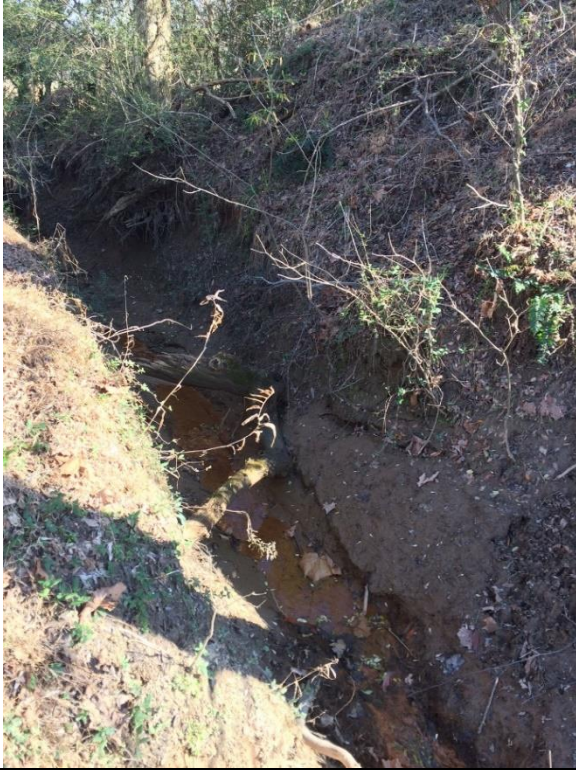
Photo 80

Title:
Seasonal Stream STT

Description:
Stream STT flows out from a pasture area to Buffalo Creek. It was created by the development of a roadway through the pasture. This photo was taken at flag STT-1a facing upstream/east.

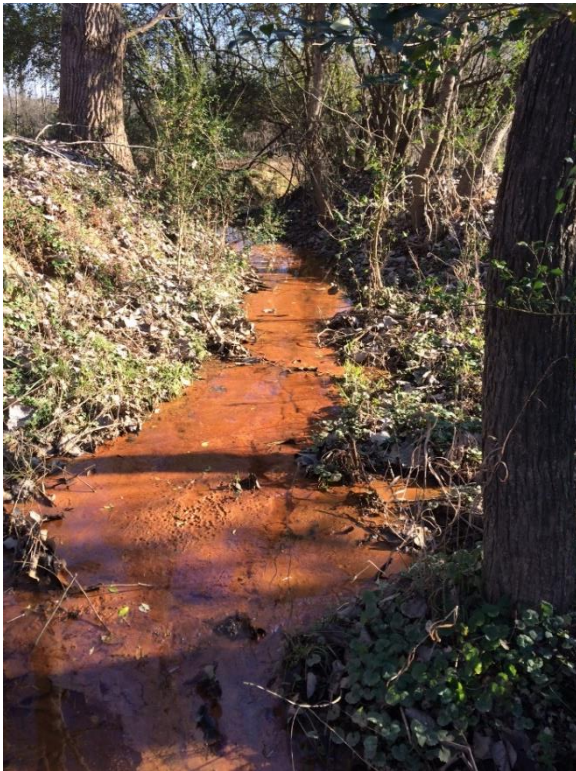
Photo 81

Title:
Seasonal Stream SUU

Description:
This stream is also located in an active pasture. It flows to Stream STT which deposits to Buffalo Creek. This photo was taken at flag SUU-1 and is facing upstream/south.

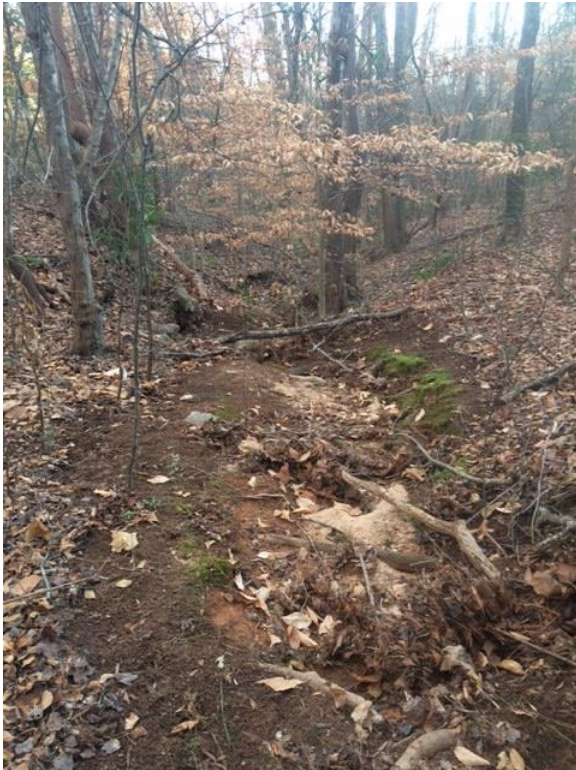
Photo 82

Title:
Intermittent Stream SVV

Description:
Photo taken at flag SVV-1 facing downstream/south.

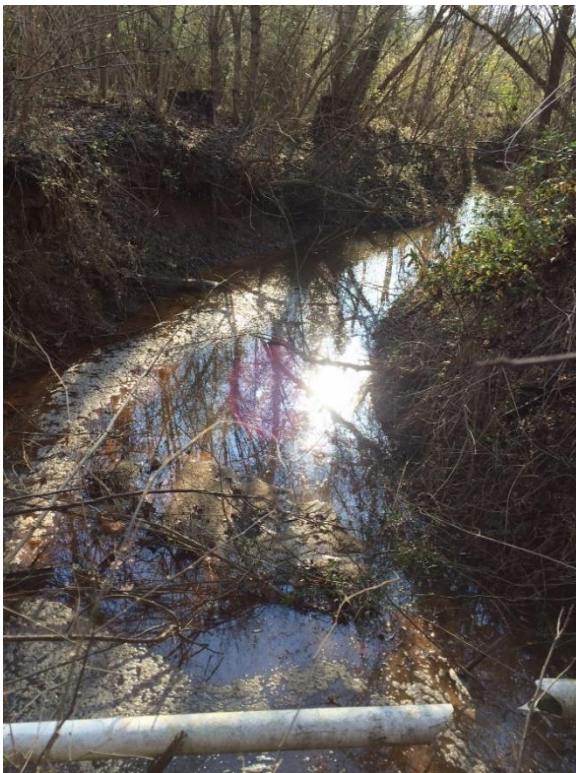
Photo 83

Title:
Perennial Stream SWW

Description:
Stream SWW flows to Buffalo Creek after crossing I-85. It collects runoff from several parking lots. This photo was taken at flag SWW-22B facing downstream/south.

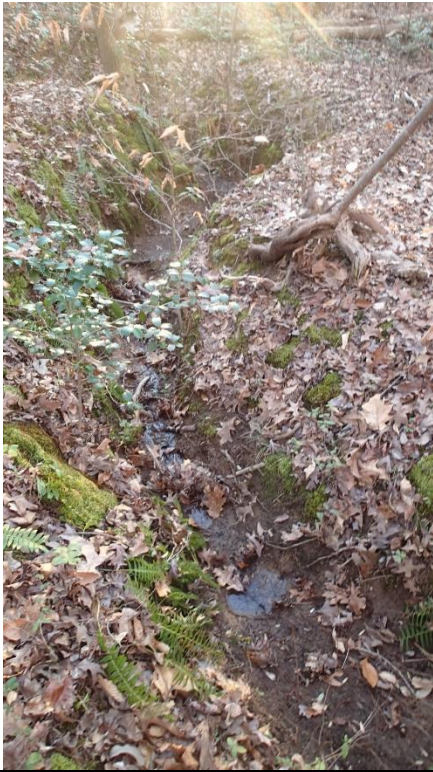
Photo 84

Title:
Intermittent Stream SXX

Description:
Photo taken at flag SXX-2 facing downstream/south.

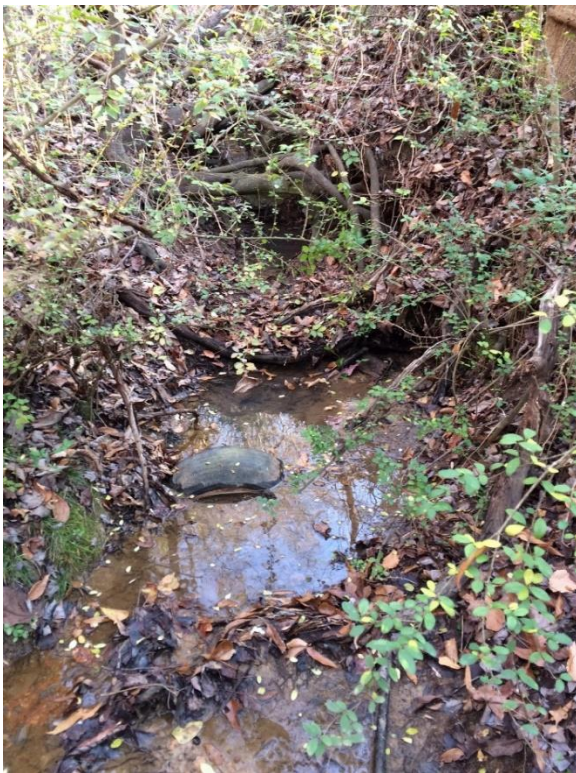
Photo 85

Title:
Seasonal Stream SYY

Description:
This photo was taken at SYY-4A facing upstream/east. Stream SYY begins with a large head-cut and flows down to Stream SZZ.

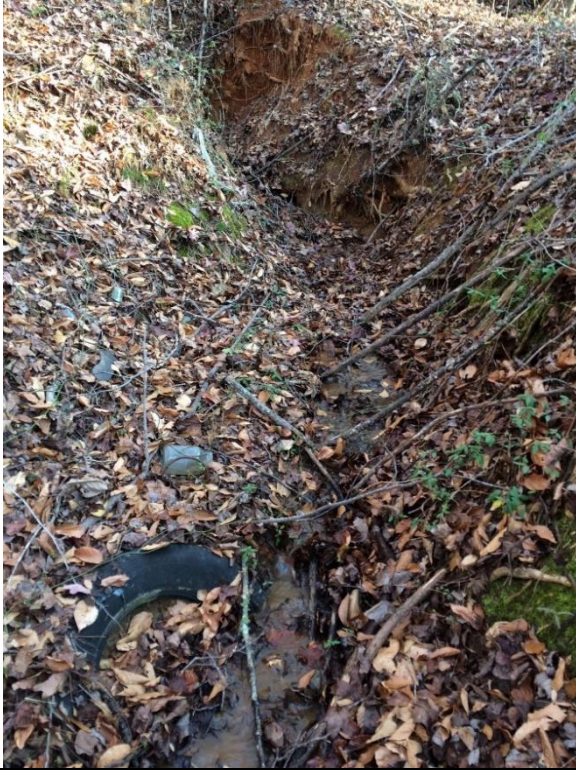
Photo 86

Title:
Seasonal Stream SZZ

Description:
Photo taken at flag SZZ-2b facing downstream/south.

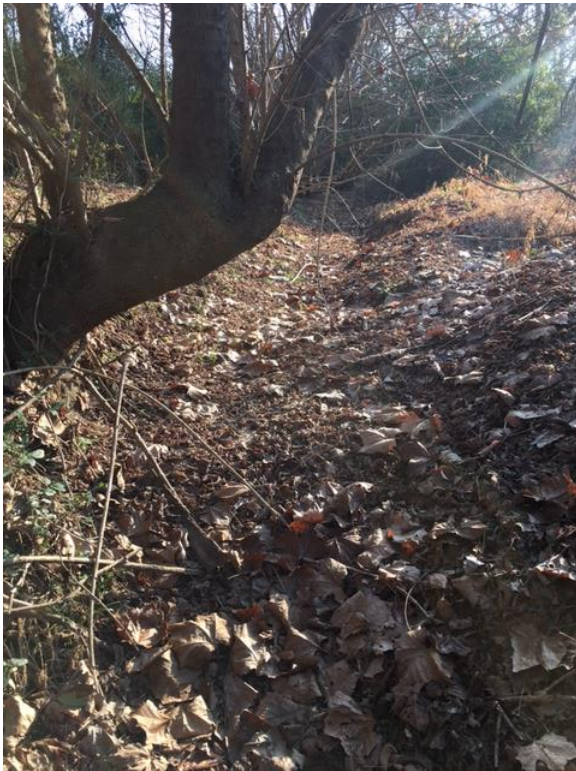
Photo 87

Title:
Intermittent Stream SAAA

Description:
Photo is taken facing upstream/east from flag SAAA-2. Stream forms from channelized surface runoff and directly flows in to adjacent Buffalo Creek.

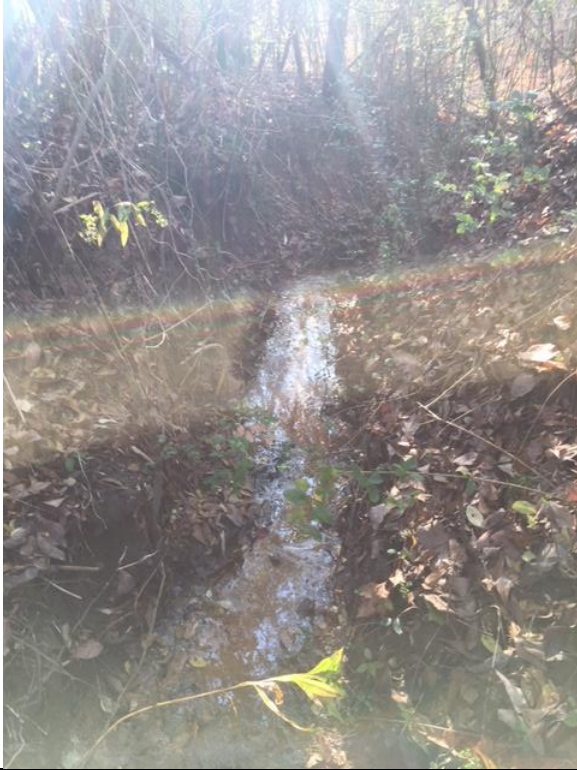
Photo 88

Title:
Intermittent Stream SBBB

Description:
This is an intermittent stream that forms from roadway runoff. Stream is located south of I-85 and service road. Photo taken facing downstream/south at flag SBBB-1. Stream runs directly in to Buffalo Creek.

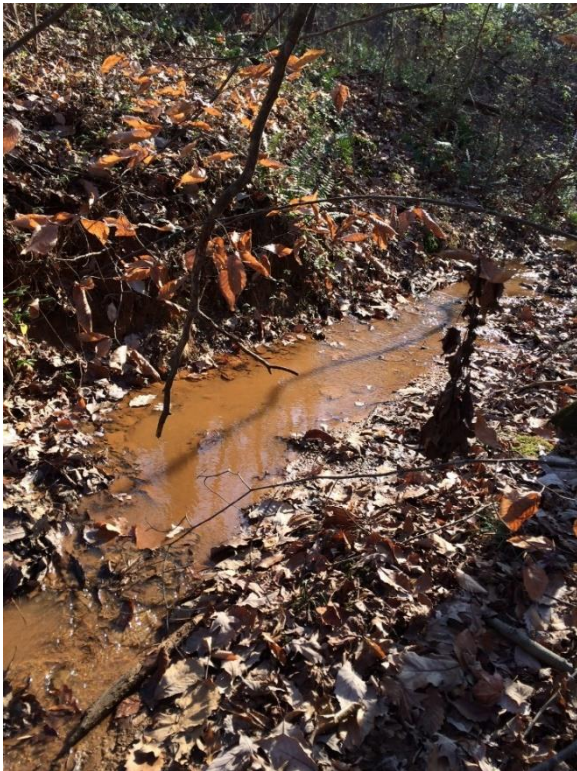
Photo 89

Title:
Seasonal Stream SCCC

Description:
Stream SCCC flows south out of the study area near a utility easement. This photo was taken at flag SCCC-3B facing upstream/west.

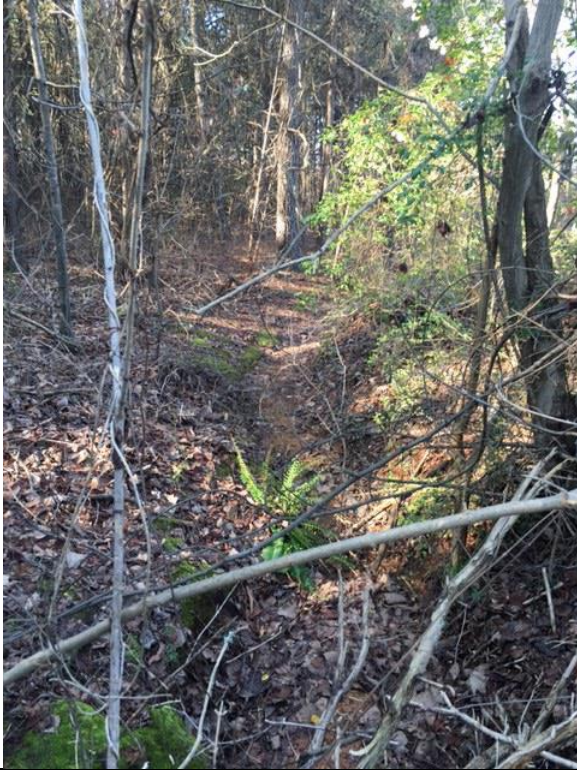
Photo 90

Title:
Intermittent Stream SDDD

Description:
Photo is taken from flag SDDD-1 facing downstream/northwest.

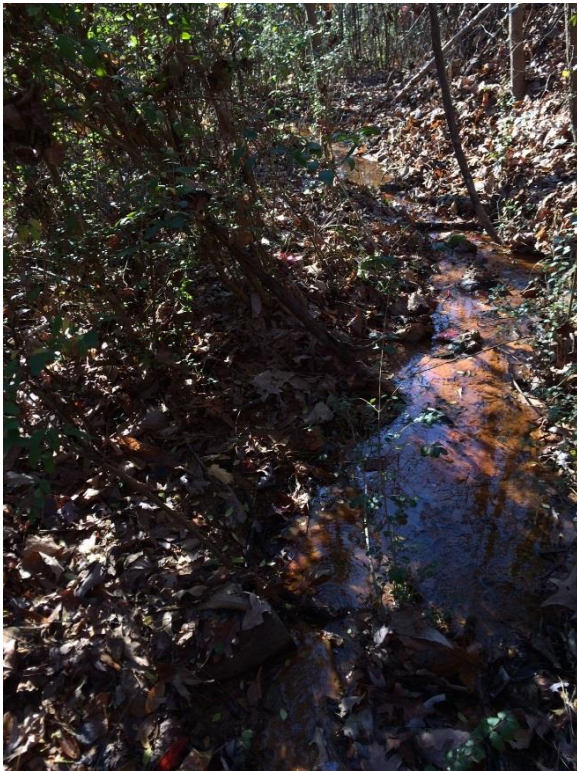
Photo 91

Title:
Seasonal Stream SDDD

Description:
This stream begins as intermittent but changes to seasonal at flag SDDD-4. It flows down to I-85 and becomes a braided channel surrounded by a wetland. This photo was taken at flag SDDD-6A facing downstream/southwest.

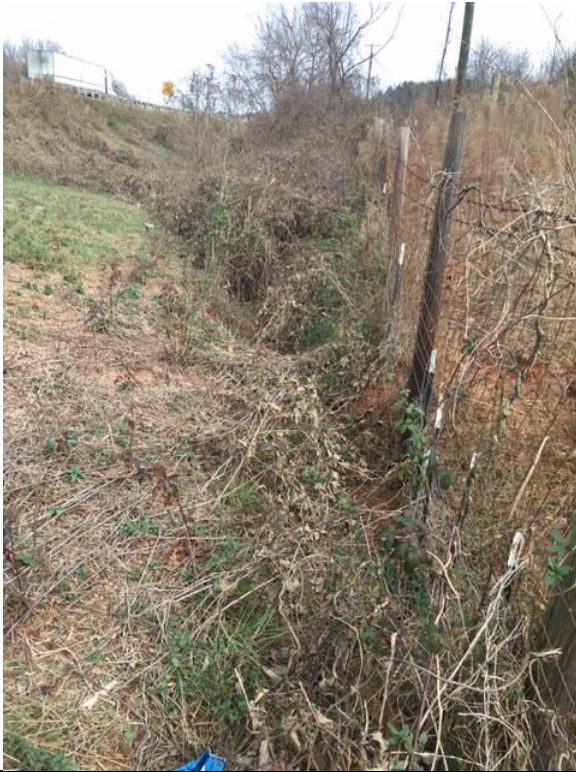
Photo 92

Title:
Intermittent Stream SEEE

Description:
Photo is taken from flag SEEE-1 facing downstream/northeast towards SCCC culvert under I-85. This is an intermittent stream that forms from runoff from the roadway and a small horse field to the right of the fence in the photo.

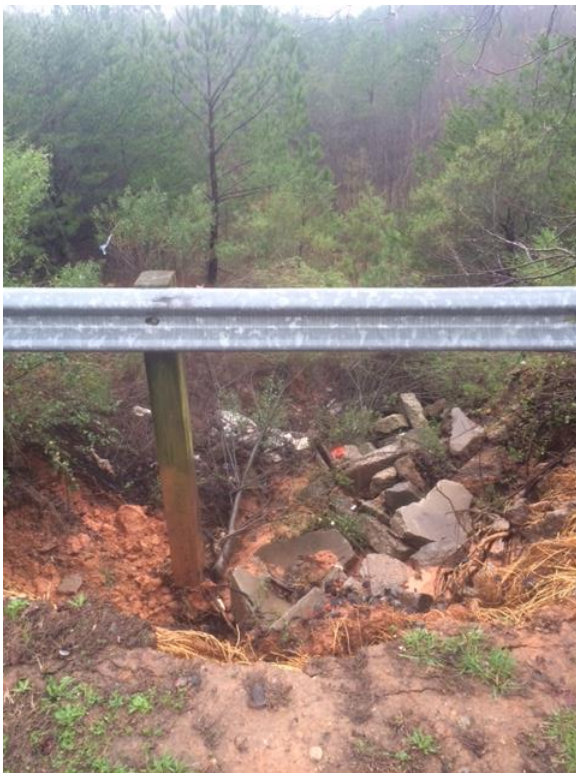
Photo 93

Title:
Intermittent Stream SFFF

Description:
Photo taken at the stream origin at flag SFFF-3 facing downstream/west.

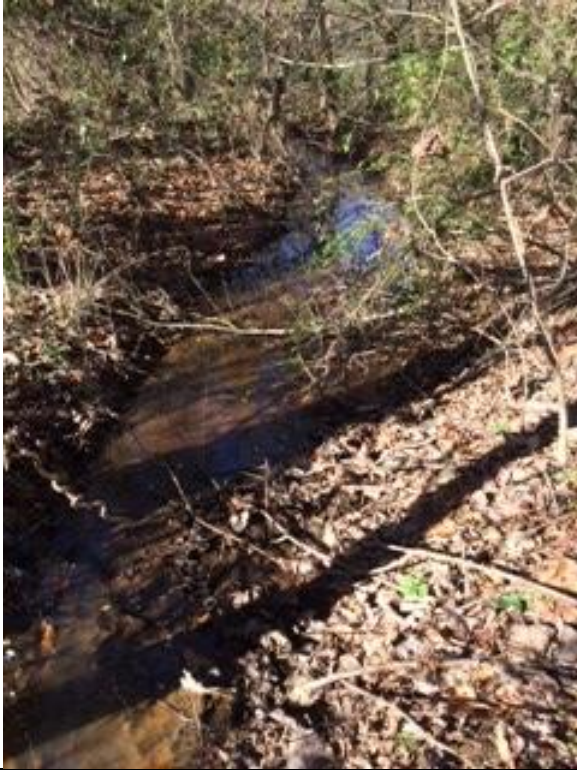
Photo 94

Title:
Seasonal Stream SGGG

Description:
Stream SGGG flows to Buffalo Creek. The photo was taken at flag SGGG-6A facing downstream/west.

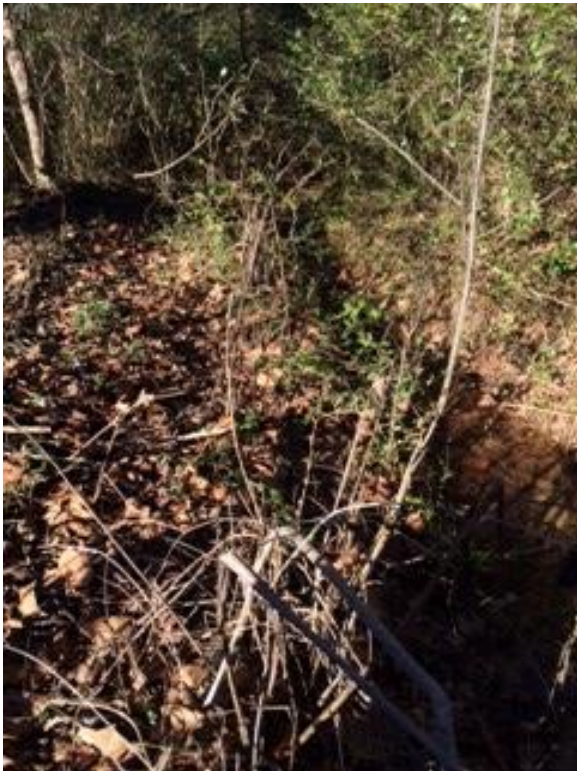
Photo 95

Title:
Seasonal Stream SHHH

Description:
This photo was taken at flag SHHH-2 facing downstream/north. The water source of stream SHHH comes from a pipe failure. During a site visit, water was observed flowing out of the pipe, creating the stream. This stream is the source for wetland WWW. Stream SHHH is only about 40 feet in length.

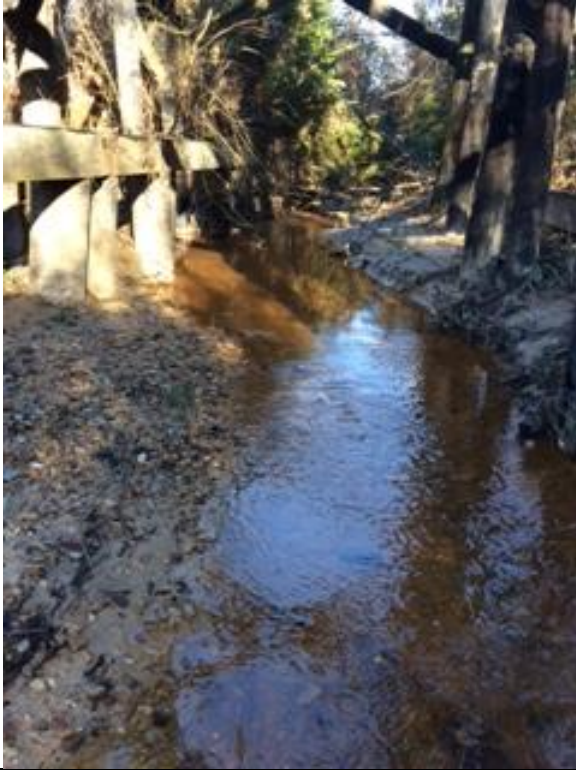
Photo 96

Title:
Perennial Stream SIII

Description:
Stream SIII flows west under a railroad bridge, eventually depositing into Buffalo Creek and can be seen on the USGS topography maps. This photo was taken at flag SIII-4 facing upstream/east.

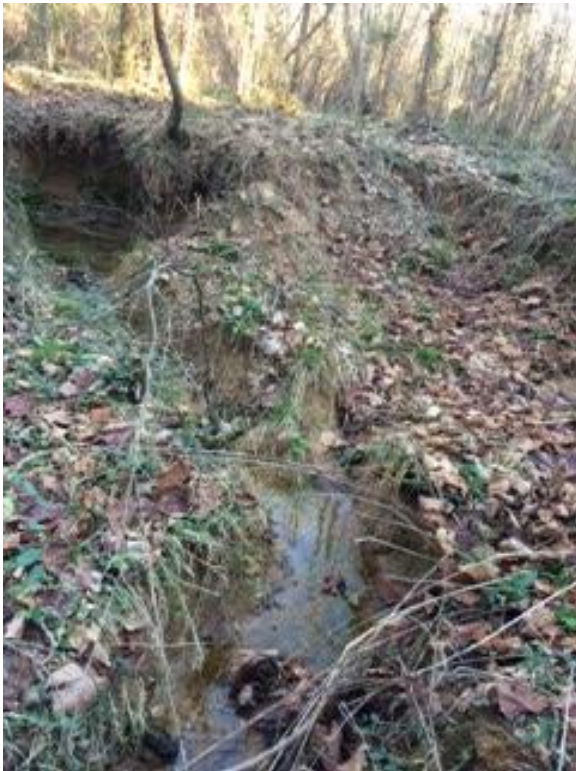
Photo 97

Title:
Seasonal Stream SJJJ

Description:
This stream flows to stream SIII, which then deposits into Buffalo Creek. A head-cut with groundwater flowing out was observed. This photo was taken at flag SJJJ-2 facing upstream/east.

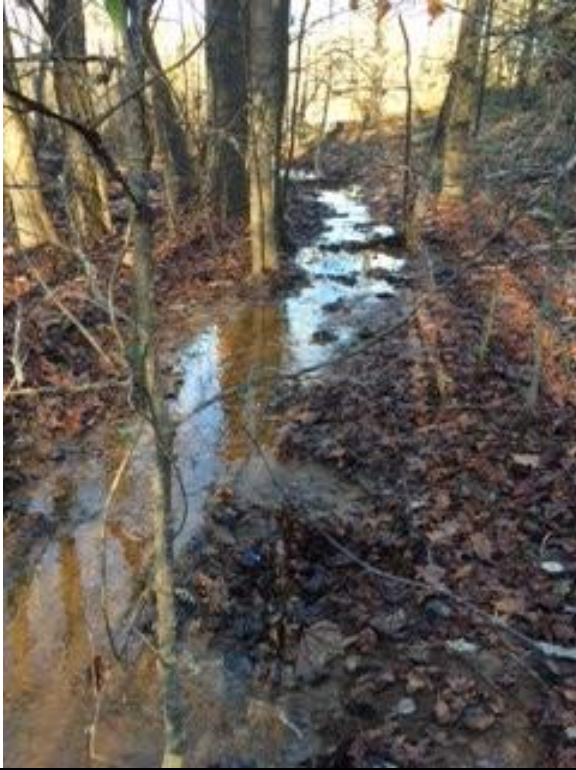
Photo 98

Title:
Seasonal Stream SKKK

Description:
This stream flows out of the study area to a large wetland/pond area. Wetland WXX is directly connected to the stream as well. This photo was taken at flag SKKK-2A facing downstream/west.

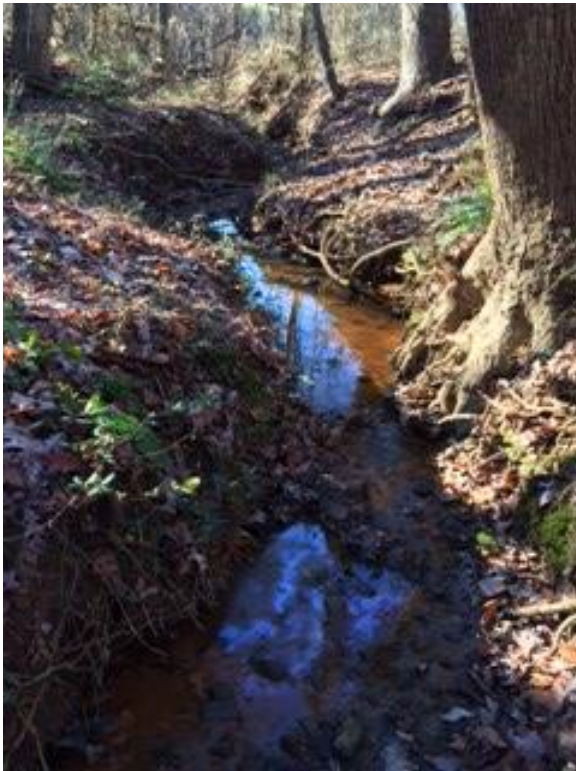
Photo 99

Title:
Perennial Stream SLLL

Description:
This stream is fed by an outflow pipe of a pond located outside of the study area. From flag SLLL-8 to flag SLLL-11 concrete was laid creating a more stable channel. At flag SLLL-11 this is a massive head-cut. This photo was taken at flag SLLL-3 facing downstream/south.

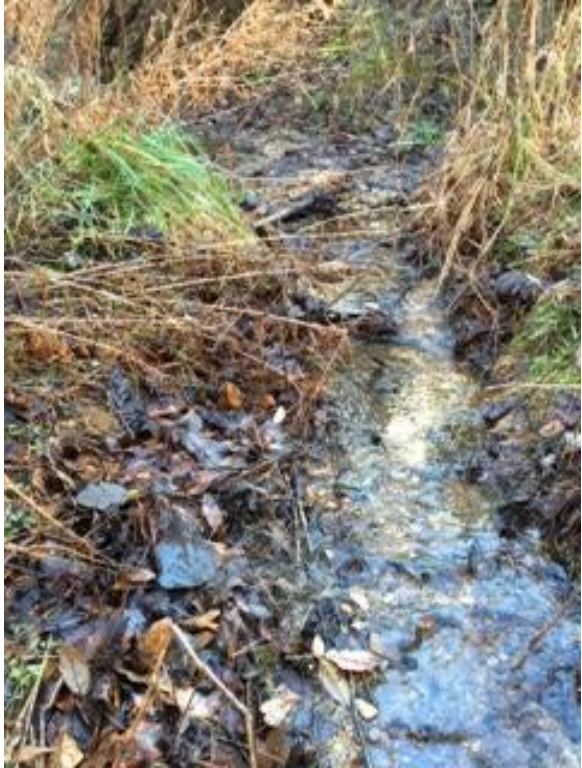
<p>Photo 100</p>

<p>Title: Perennial Stream SMMM</p> <p>Date: 12/16/2015</p> <p>Taken By: Sarah Burton</p> <p>Description: Stream MMM flows to a pond outside of the study area. This photo was taken at flag SMMM-1a facing upstream/south.</p>
<p>Photo 101</p>
