Attachment C

Photographs

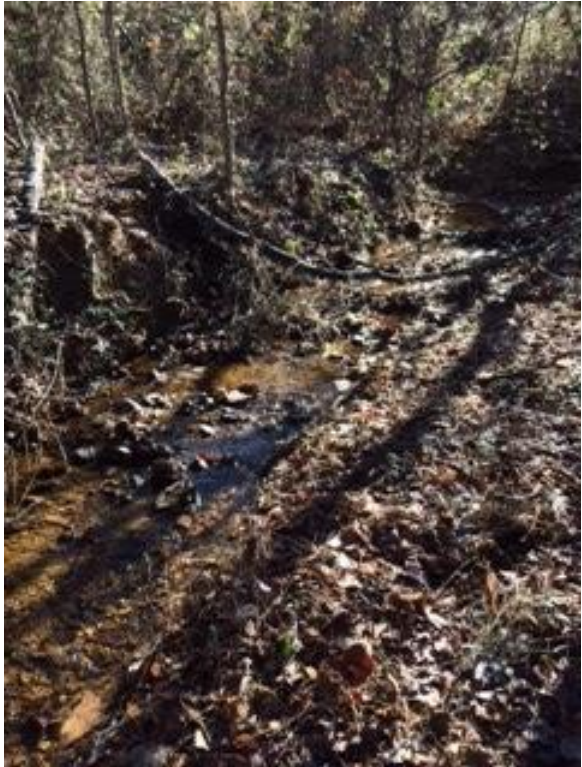
<p>Title: Perennial Stream SNNN</p> <p>Date: 12/16/2015</p> <p>Taken By: Sarah Burton</p> <p>Description: This stream flows outside of the study area and connects with stream SOOO. The picture is taken at flag SNNN-1 facing upstream/north.</p>

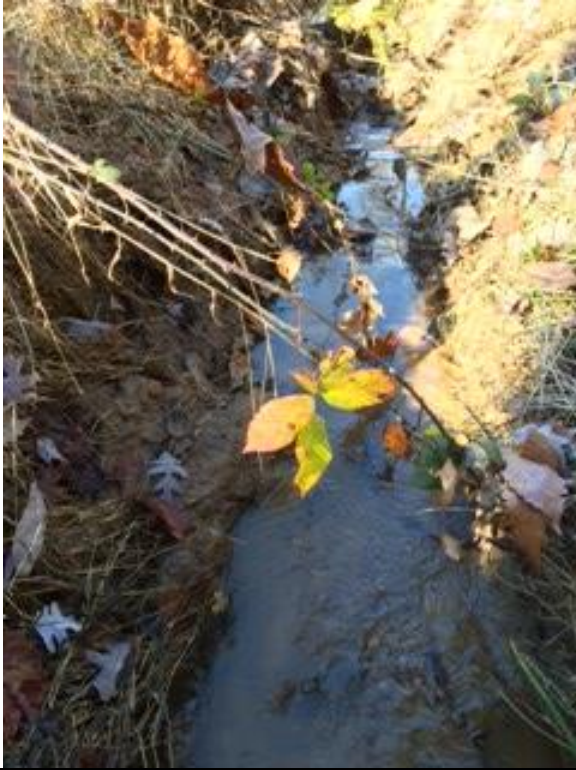
Photo 102

Title:
Perennial Stream SOOO

Description:
Stream SOOO confluences with SNN outside of the study area. A portion of the stream is in full sunlight. This photo was taken at flag SOOO-1 facing downstream/north.

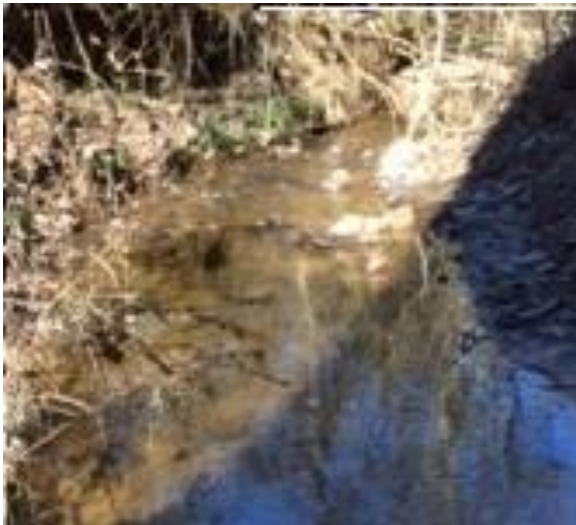
Photo 103

Title:
Perennial Stream SPPP

Description:
Photo taken at flag SPPP-2 facing downstream/northeast.

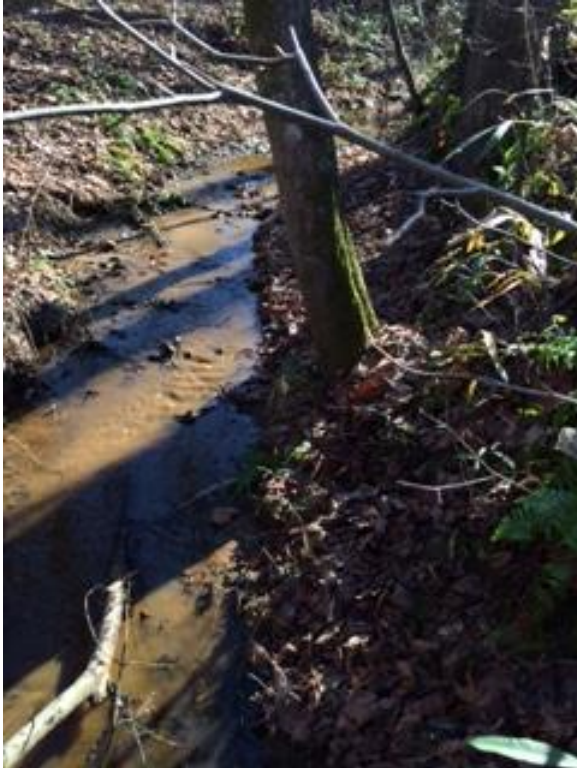
Photo 104

Title:
Perennial Stream SQQQ

Description:
This stream is on the USGS topography maps. It is sourced by a pond outside of the study area and flows to Stream RRR. This photo was taken at flag SQQQ-2 facing upstream/south.

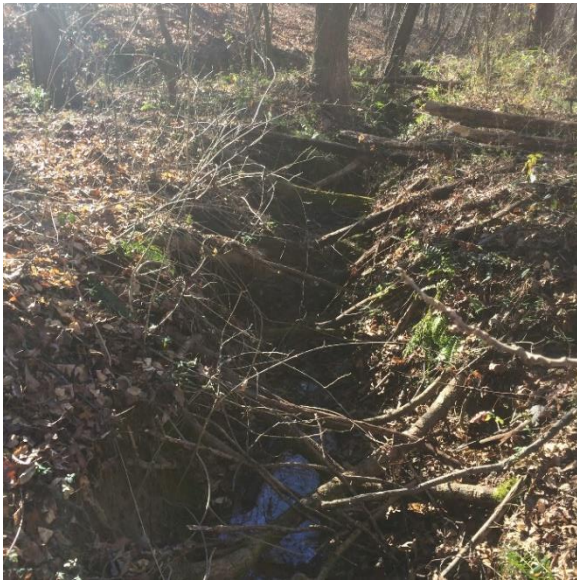
Photo 105

Title:
Seasonal Stream SSSS
