NON-PROGRAMMATIC CATEGORICAL EXCLUSION

Project ID No. 30711

Description: US 1 (Augusta Road) Bridge Replacement over I-20 and Interchange Improvements

PHASE I CULTURAL RESOURCE SURVEY OF THE PROPOSED US 1 BRIDGE REPLACEMENT OVER I-20 AND INTERCHANGE IMPROVEMENTS, LEXINGTON COUNTY, SOUTH CAROLINA

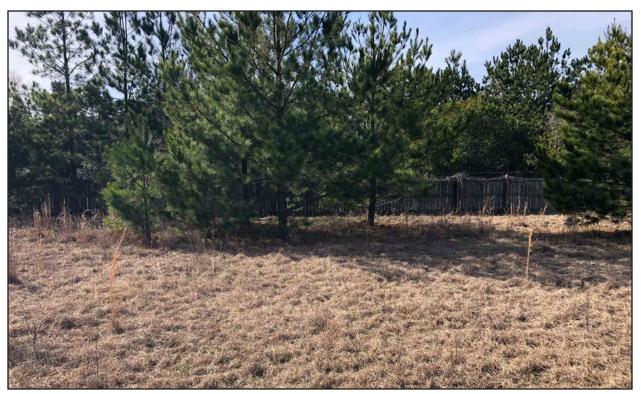
Figure 4.3. Photograph of 38LX644, facing west.

additional deposits or features that would change that evaluation. Figure 4.3 shows the current state of 38LX644.

Site 38LX644 was recorded during the 2014 survey conducted by New South Associates (Davis and Ciomek 2014). The site was recorded on the east bound side of I-20, within the northern portion of the current survey area. This site was a small, prehistoric lithic scatter located on a strip of land between the cut-fill section of I-20 and an existing parking lot. The site consisted of three quartz flakes and it was recommended as not eligible for NRHP listing based on its sparse assemblage from disturbed context (Davis and Ciomek 2014).

Site 38LX644 was revisited during the current survey; however, no additional testing was conducted. The site was recommended as not eligible for NRHP listing and EPEI did not encounter

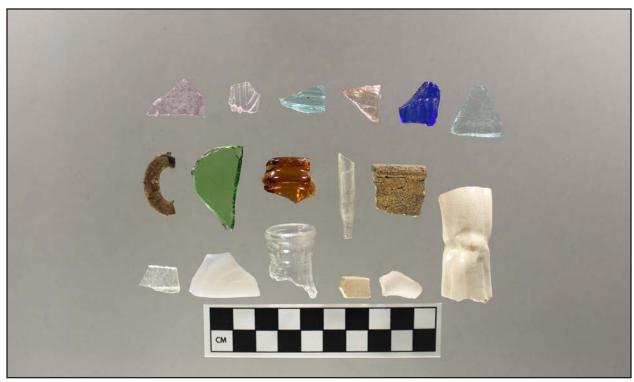
Figure 4.6. Top, left to right - amethyst (solarized) bottle glass (TR1ST11.5-4), amethyst (solarized) container glass (TR4ST4-4), aqua jar glass (TR0.5ST11.5-3), light pink table glass (GSC2-9), cobalt blue container glass (TR1ST11.5-5), light green bottle glass (GSC2-8); Middle, left to right - unclassified alloy unclassified object (TR1ST11.5-7), green bottle glass (TR4.5ST4-6), amber bottle glass (TR4.5ST4-7), light green glass dropper (TR4.5ST4-3), coarse unglazed earthenware (GSC2-2); Bottom, left to right - clear window glass (TR1ST11.5-6), milk glass lid liner (GSC2-5), clear bottle glass finish (GSC2-6), undecorated inronstone (TR1ST11.5-3), undecorated porcelain fragment (GSC2-4), whiteware strap handle (GSC2-3).

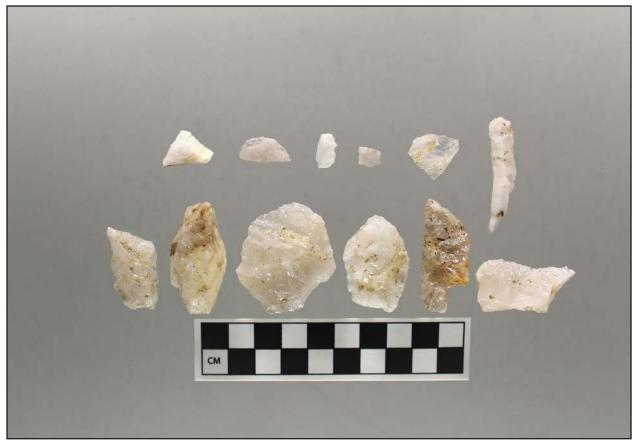
Figure 4.7. Top, left to right - quartz shatter (TR3.5ST5-3), quartz thinning flake (TR4ST0.5-4), quartz flake fragment (TR3.5ST5-2), quartz pressure flake (TR4ST0.5-3), quartz retouched flake (TR4ST0.5-2), quartz blade flake (TR4ST1-1); Bottom, left to right - quartz biface fragment (TR3.5ST7-1), quartz biface fragment (TR3.5ST4.5-1), quartz stage II biface (TR3.5ST7.5-1), quartz biface fragment (TR3.5ST5-1), quartz biface fragment (TR3.5ST5-1), quartz biface fragment (TR3.5ST5-1).

The vast majority of the assemblage (n=255) at 38LX671 was associated with precontact occupation of the site. This material consisted entirely of lithic artifacts of quartz (Figure 4.7). Most of

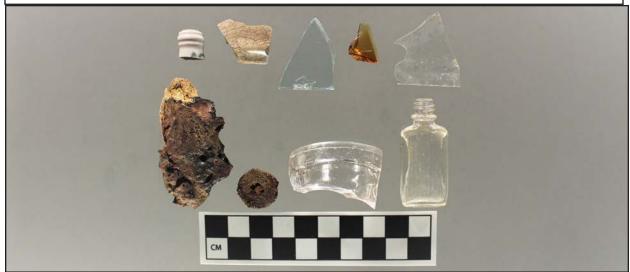
Figure 4.12. Top, left to right - porcelain spark plug insulator (TR2ST5-4), undecorated whitewrare (TR2ST5-1), aqua container glass (TR2.5ST3-4), amber container glass (TR2.5ST3-5), clear window glass (TR2ST5-2); Bottom, left to right - burned/melted brick (TR2ST3-3), iron button (TR2.5ST4.5-2), clear milk bottle glass (TR2ST3-2), clear perfume bottle glass (TR2ST3-1), amethyst (solarized) container glass (TR32ST1-1).

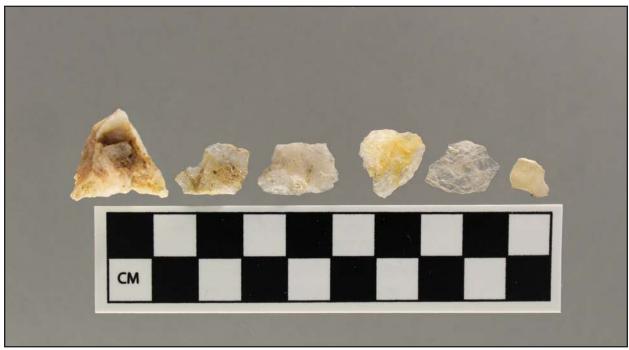
Figure 4.15. Left to right - quartz flake fragment (TR2ST12-1), quartz flake fragment (TR2ST3-2), quartz flake fragment (TRAST13-3), quartz thinning flake (TR2ST3-1), quartz thinning flake (TRAST13-2), CPC pressure flake (TRAST13-1).

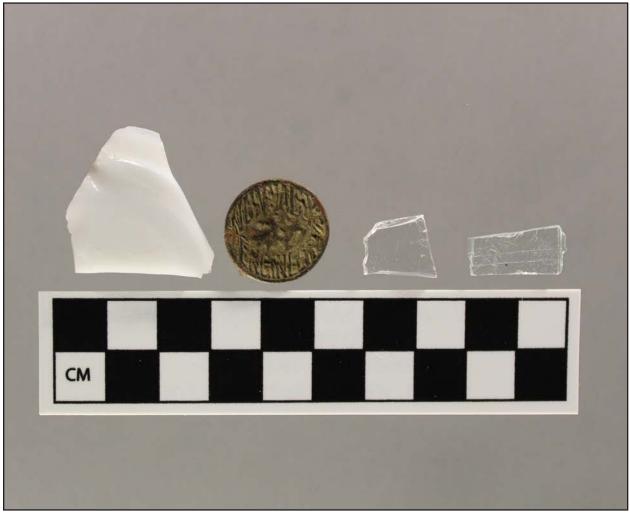
Figure 4.18. Left to right - milk glass lid liner (TR8ST5-1), copper alloy overall snap (TR7ST4-1), clear container glass (TR7ST4-2), light blue window glass (TR8ST5-2).

There was a total of four artifacts recovered from shovel tests at 38LX674 (Table 4.3). All of this material was historic and included one piece of clear container glass, a fragment of a milk glass lid liner, a piece of light blue window glass, and a copper alloy overall fastener (Figure 4.18). The overall fastener featured the embossed lettering "NUNNALLY'S ENGINEER," which is indicative of the Nunnally's company which produced overalls from 1908 to 1995. The 1982 Lexington, SC USGS topographic map depicts a structure at the corner of Cedar Road and US 1, approximately 50 meters southeast of 38LX674. This structure was also depicted on additional topographic maps as early as 1966 and clearly appears on aerial photography from 1971. Google Earth imagery indicates that this house was demolished sometime between 1994 and 2005. Based on this, 38LX674 likely represents a domestic scatter related to this house. None of the artifacts provide specific temporal data other than the general twentieth century; however, the house was

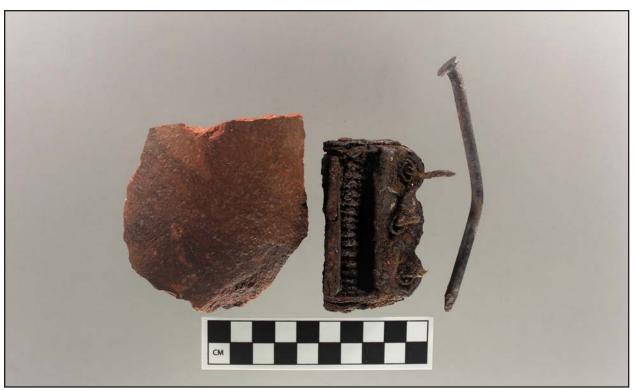
Figure 4.21. Left to right - terra cotta sewer pipe (TR19ST3-3), iron spring hinge (TR19ST3-1), iron wire nail (TR19ST3-2).

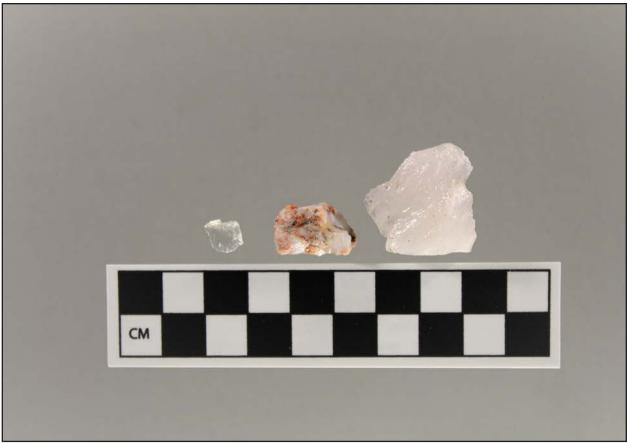
Figure 4.24. Left to right - quartz flake fragment (TR89ST2-1), quartz shatter (TR89ST1-1), quartz shatter (TR89ST1.5-1).

Three artifacts were recovered from three shovel tests at 38LX677. This assemblage consisted entirely of quartz debitage and included two fragments of quartz shatter and a single flake fragment (Figure 4.24). None of this material is considered temporally diagnostic beyond the general prehistoric period.

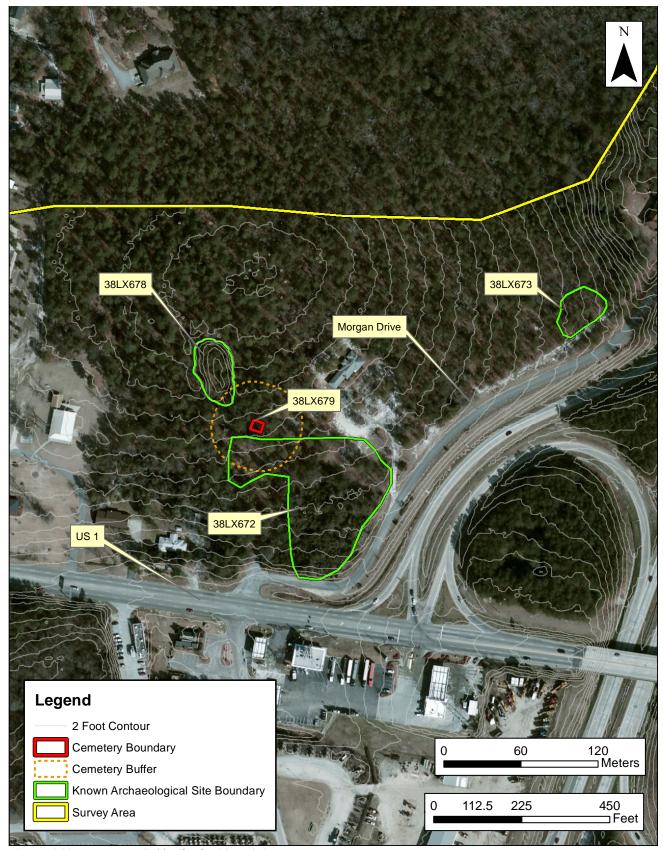
Figure 4.29. Recommended buffer for 38LX679.

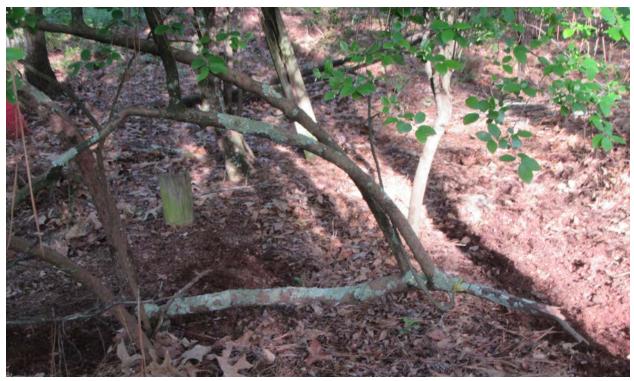
Figure 5.41. Photograph of Resource 0994, facing northwest.

Resource 0994, the Busbee Property Cemetery, was also recorded as archaeological site 38LX679, as discussed in Chapter 4. This resource was identified within the large residential property at 184 Morgan Drive. The above ground aspects of the cemetery include an undecorated wooden marker and two improvised fieldstone grave markers (Figure 5.41). There were also several faint depressions visible near the known markers. The resource is described in greater detail as an archaeological site in Chapter 4. Based on the current investigation, it seems likely that Resource 0994 represents a small family cemetery associated with a tenant family that worked the fields on

a farm belonging to Joel Corley. The cemetery is not associated with persons or events significant to the development of Lexington County and the improvised markers do not possess significance in design. Based on this, Resource 0994 is recommended as **Not Eligible** for NRHP listing under Criteria A, B, and C. As discussed in Chapter 4, the resource is considered of **Unknown** eligibility under Criterion D as it has not yielded data significant to the culture history of the study area thus far; however, no excavation or intensive historic investigation has yet been conducted. It is recommended that a 30-meter buffer be established around this resource and all impacts to the cemetery and buffer should be avoided. This boundary (see Figure 4.29) should be marked on all project plans and in the field during construction.

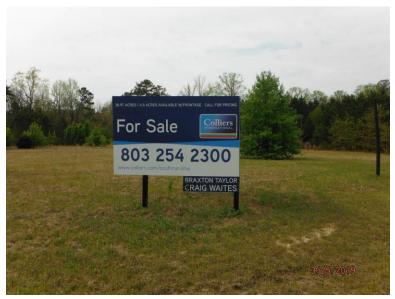
View of Parcel 1 (undeveloped land) within the Project Area. Photo is taken from the right-of-way on Highway 1.

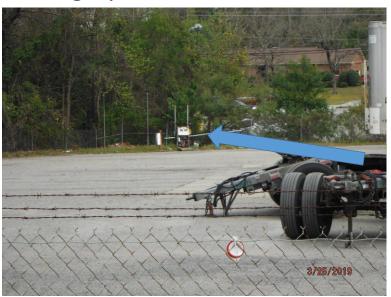
2

View of Parcel 6 (Wilson Trucking Company) within the Project Area. Photo is taken from the right-of-way on Fergon Road. Note the petroleum fuel pump located near the northwest corner of Parcel 6.

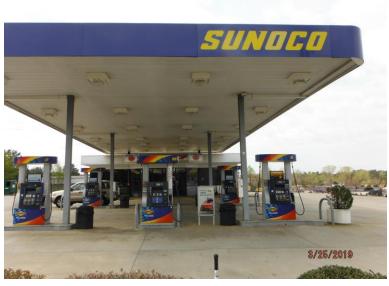
View of Parcel 11 (Sunoco gas station) within the Project Area. This is the former location of T. H. Wingard Exxon. Photo is taken from the right-of-way on Highway 1.

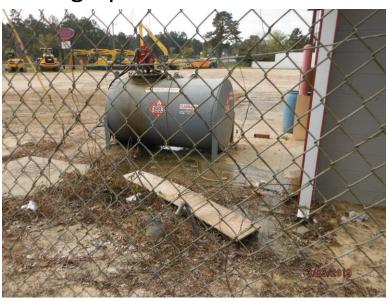
Photograph 6

View of Parcel 12 (Company Wrench) within the Project Area. This is the former location of Blanchard Machinery. Note the diesel AST appears rusted around and beneath the fill port. Also note the potential diesel fuel beneath the tank.

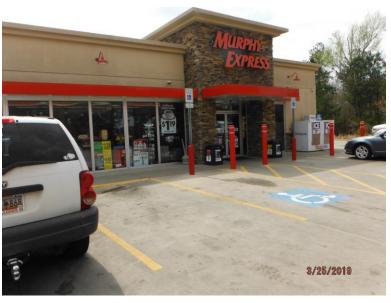
Photograph 8

View of Parcel 18 (Murphy Express gas station) within the Project Area.

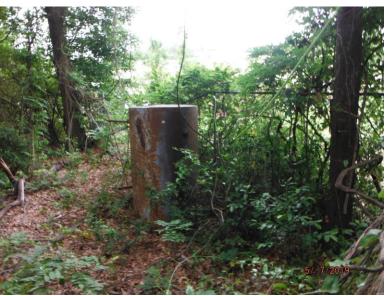
10

View of Parcel 67 (abandoned home) within the Project Area. Note the deteriorated AST turned on its side.

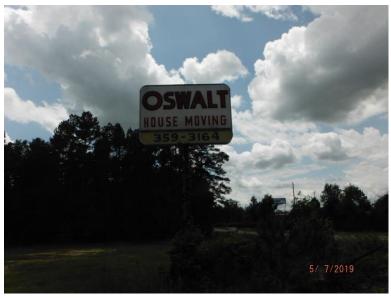
Photograph 12

View of Parcel 92 (Oswalt House Moving) within the Project Area. Photo taken from the right-of-way on Dooley Road.

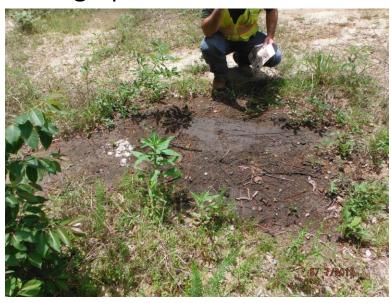
12

View of Parcel 92 (Oswalt House Moving) within the Project Area. Note the stained soil on Parcel 92.

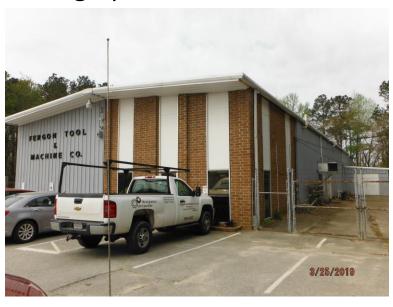
Photograph 14

View of Parcel 98 (Fergon Tool & Machine Company) within the Project Area. Photo is taken from the right-ofway on Fergon Road.

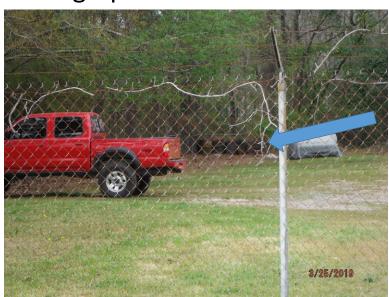
Photograph 15

View of Parcel 98 (Fergon Tool & Machine Company) within the Project Area. Note the half-buried 55-gallon drums.
