**South Carolina Department of Transportation
On Behalf of the Federal Highway Administration – South Carolina Division Office**

**PROCESSING FORM FOR PROGRAMMATIC CATEGORICAL EXCLUSIONS
NON MAJOR FEDERAL ACTIONS**

Project Name: Proposed Bridge Replacements on I-85 over Norfolk Southern in Cherokee County, South Carolina.

**Bridge Replacement on I-85 Over Norfolk Southern
Cherokee County, South Carolina
Categorical Exclusion – Type B**

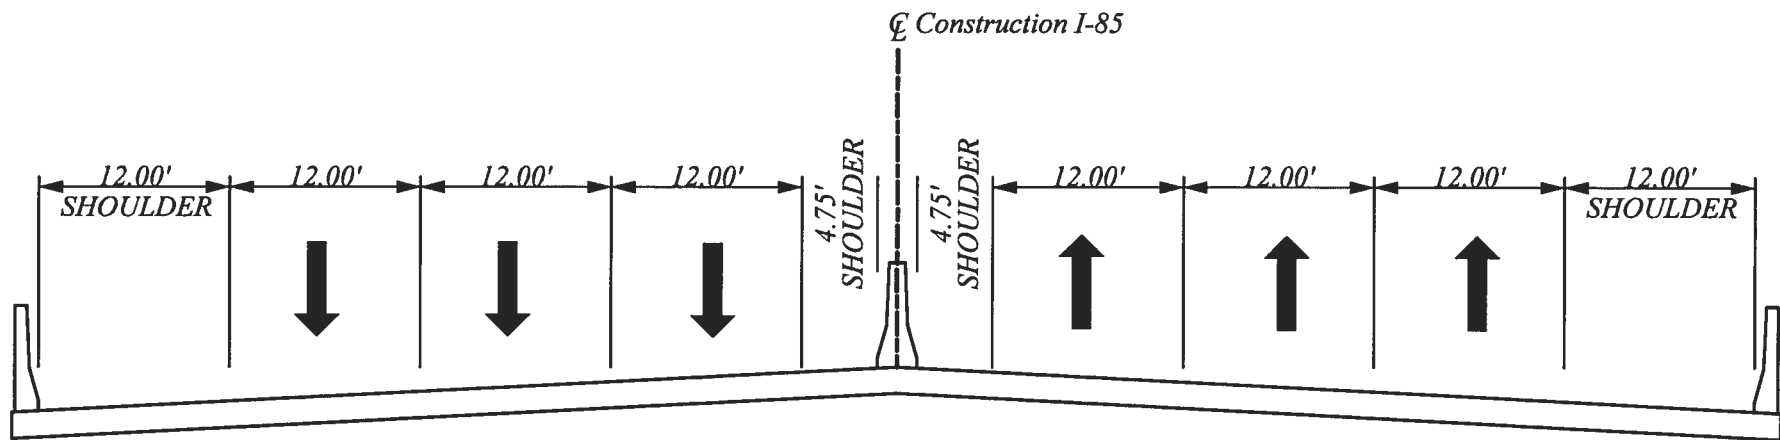
Figure 2b: Typical Section

TYPICAL SECTION -
COMPLETED STRUCTURE

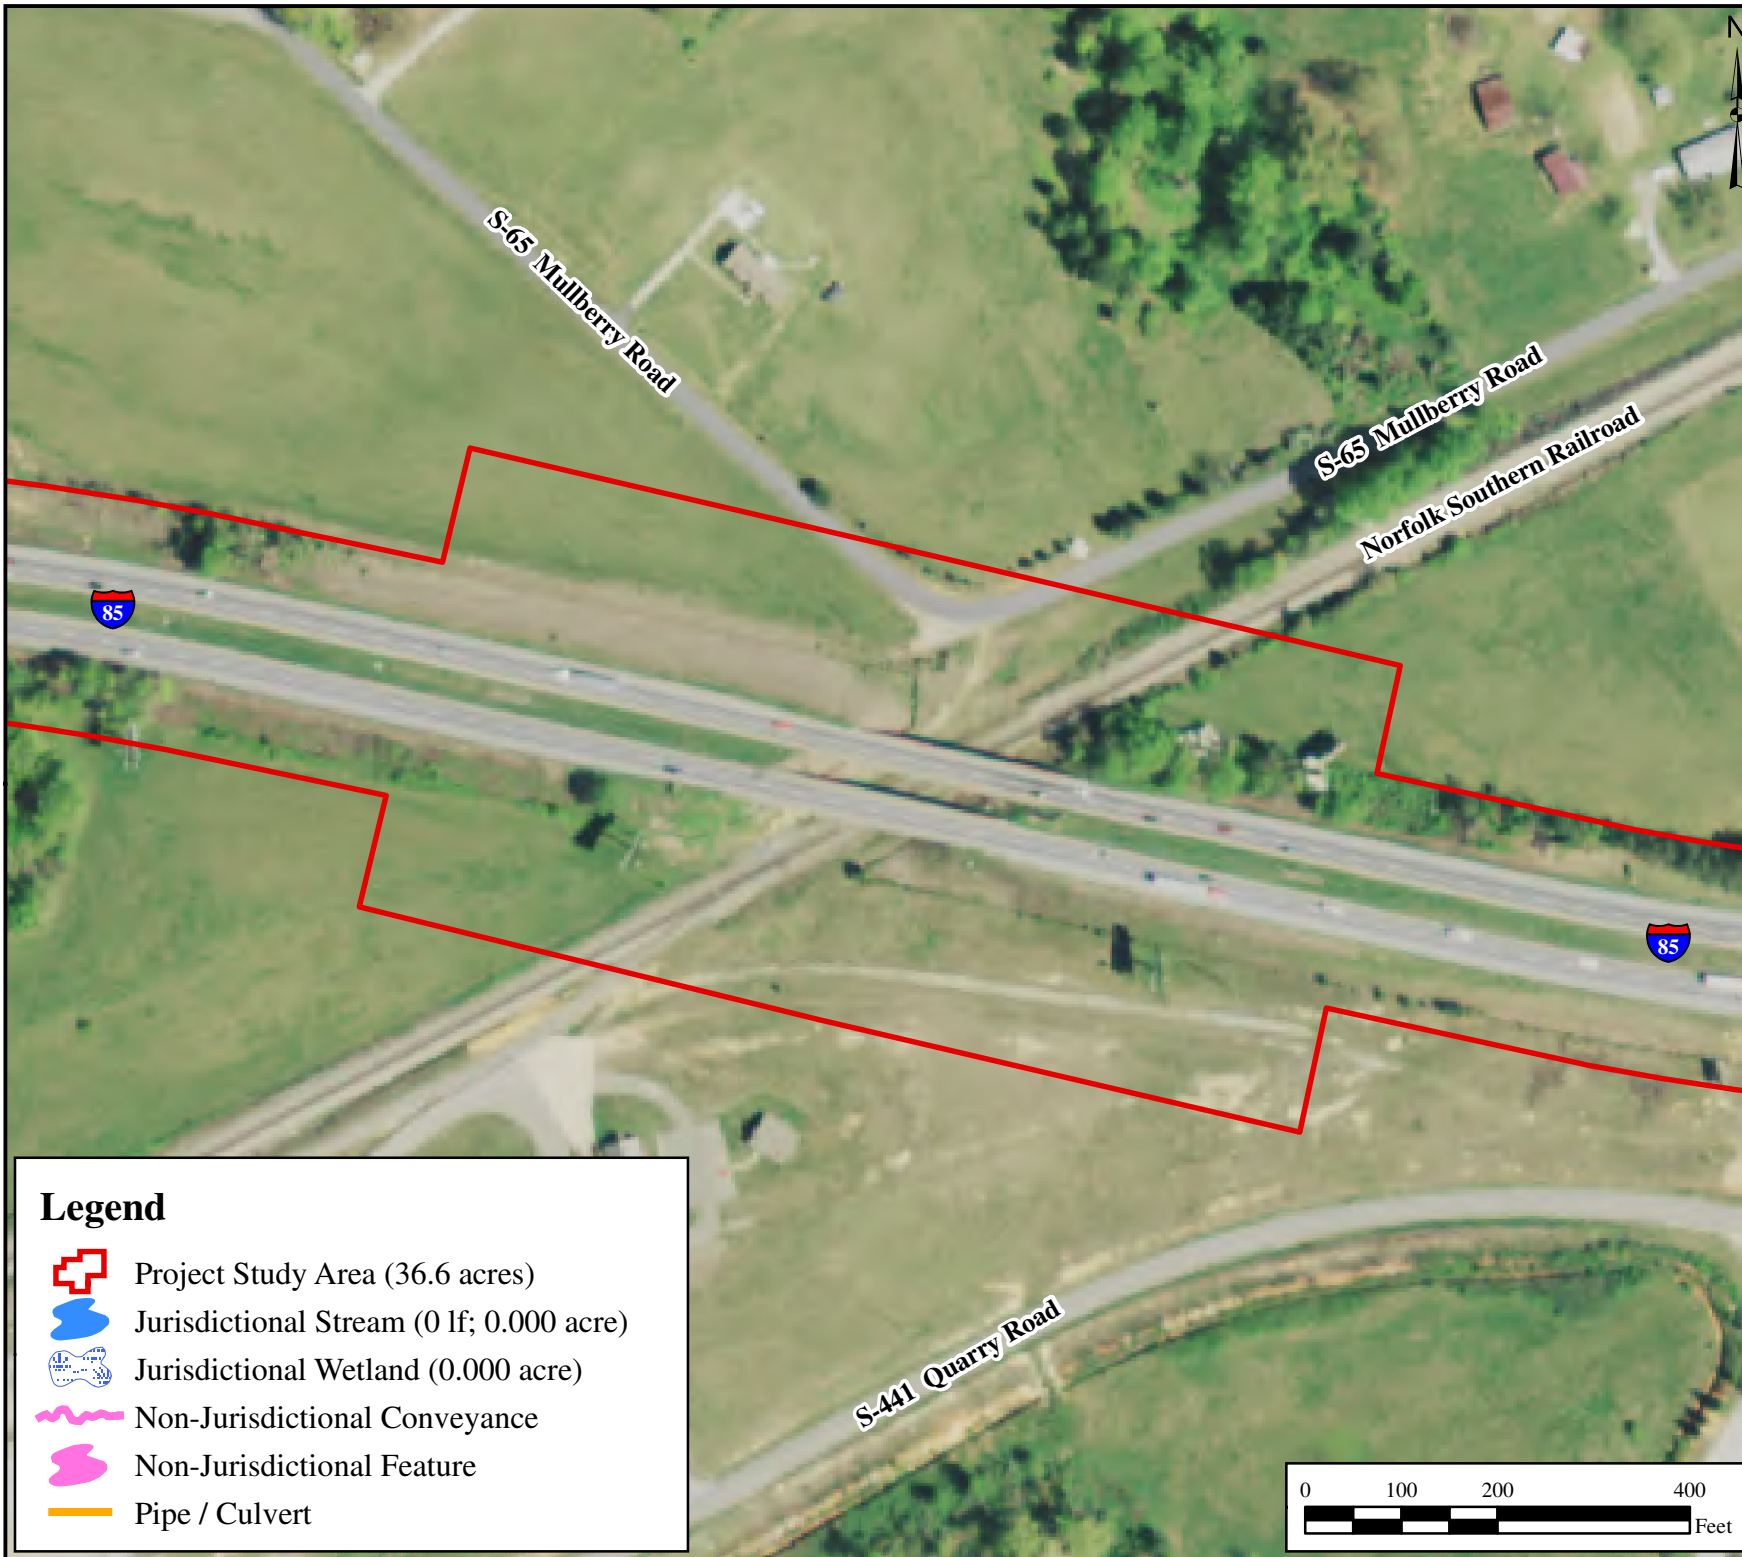
FIGURE 5

- Project Study Area (36.6 acres)
- Jurisdictional Stream (0 lf; 0.000 acre)
- Jurisdictional Wetland (0.000 acre)
- Non-Jurisdictional Conveyance
- Non-Jurisdictional Feature
- Pipe / Culvert

Three streams and two wetlands were identified within the project study area (**Figures 4 – 7**). It is anticipated that minor impacts to one stream and both wetlands could occur as a result of the proposed project. Stream impacts are anticipated to be 100 linear feet, or less, and wetland impacts are anticipated to be less than 0.2 acre. It is anticipated that the proposed project would be processed as a General Permit (GP) and that any required compensatory mitigation requirements for permanent project impacts would be attained through purchase of mitigation credits from an approved mitigation bank.

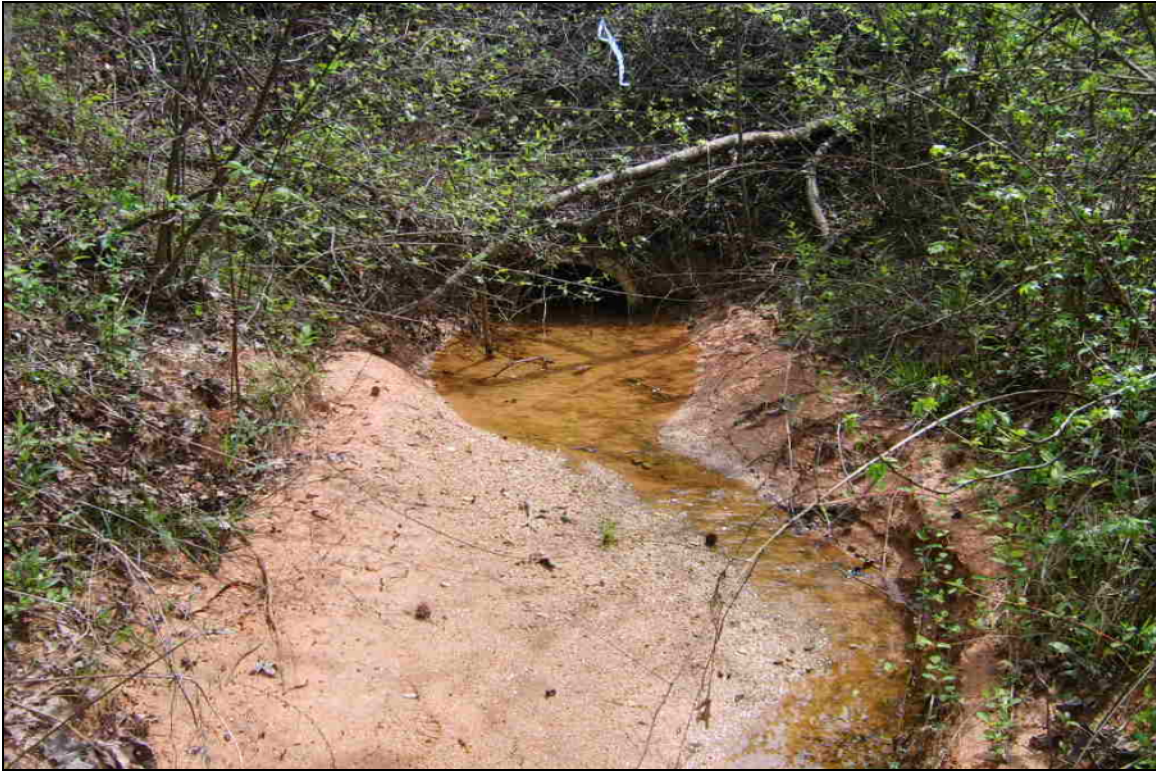
Photograph 1. View of RPW Stream A looking upstream (south) at the I-85 culvert crossing.

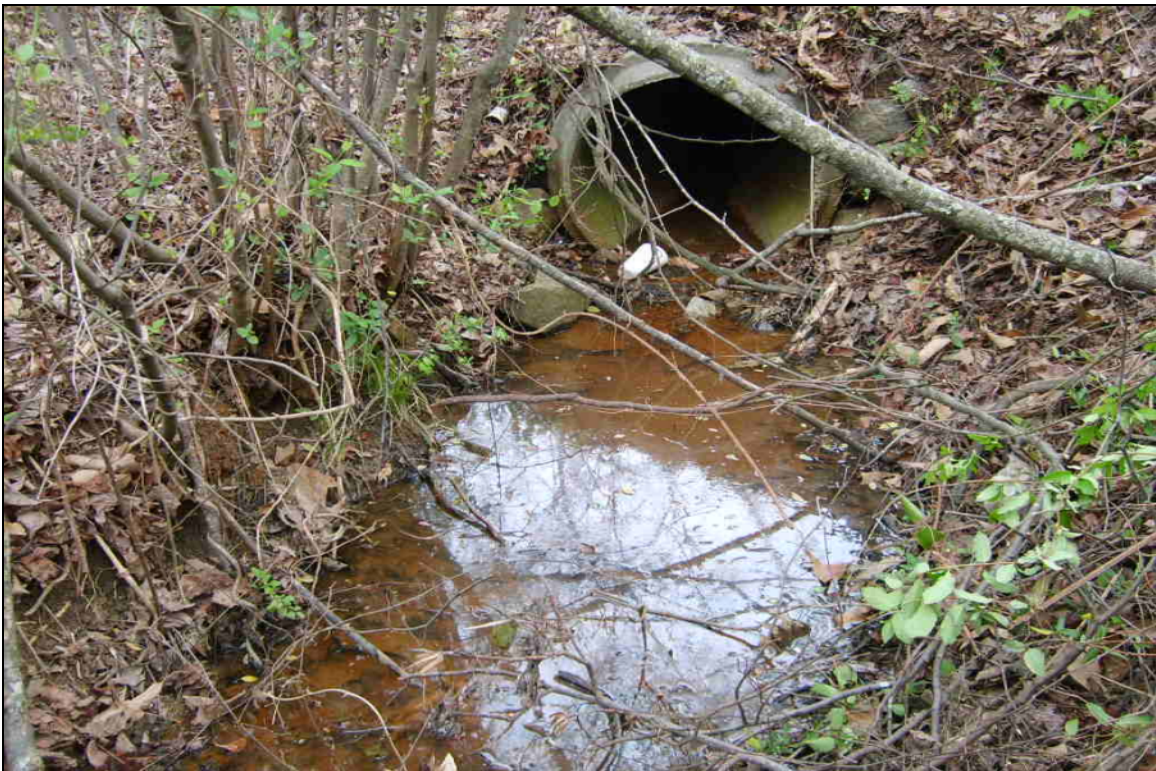
Photograph 2. View of RPW Stream B looking upstream (south) at the I-85 culvert crossing.

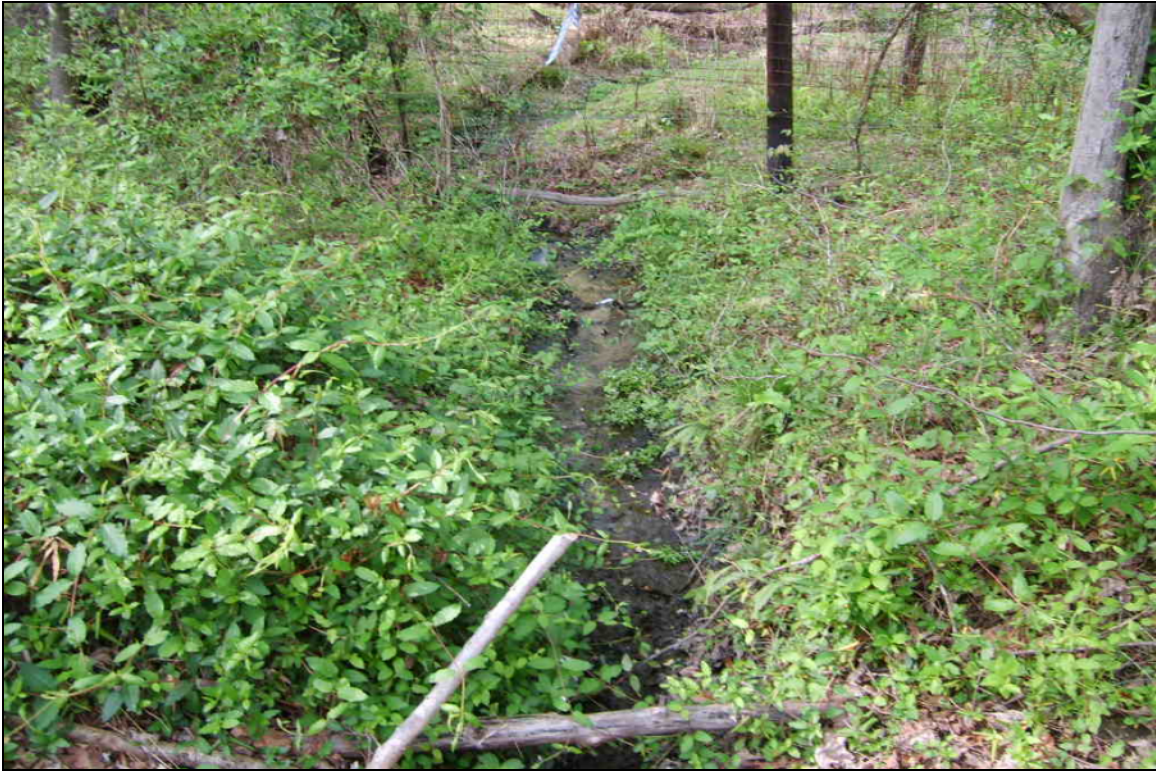
Photograph 3. View of RPW Stream C looking upstream (north) from the I-85 culvert crossing.

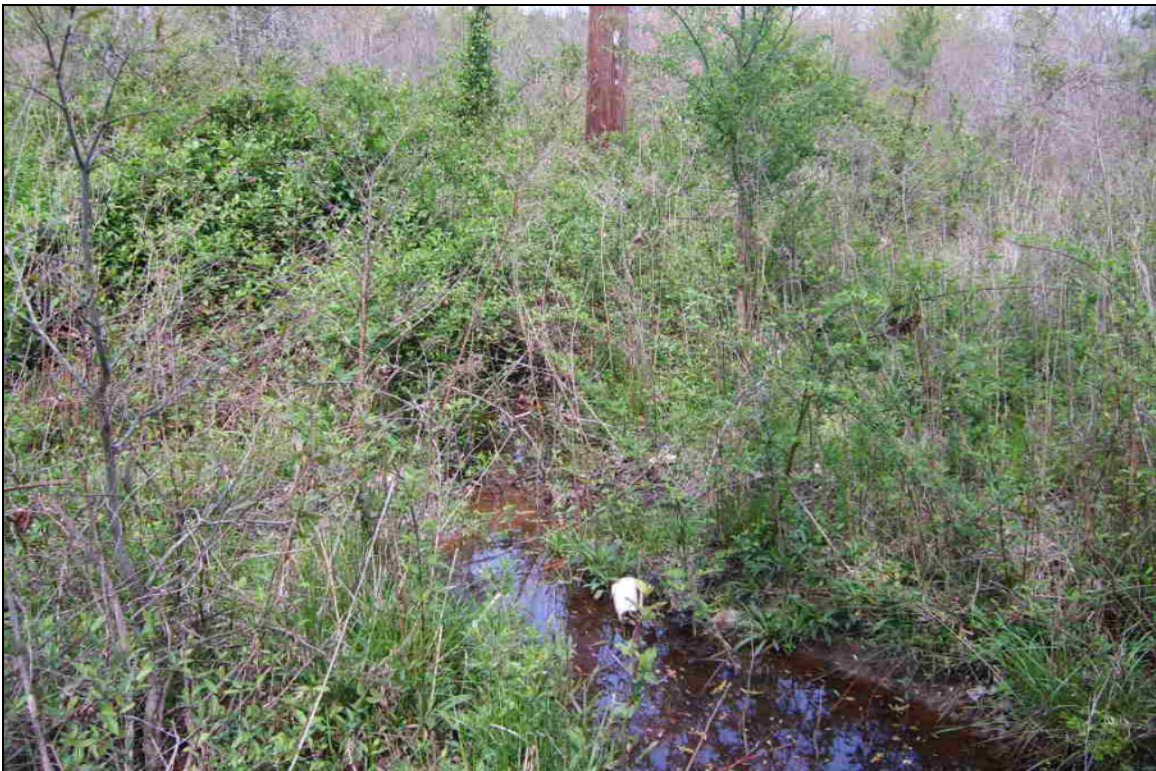
Photograph 4. View of the northern portion of Wetland A located north of I-85 in the western portion of the PSA.

Wetland A is a palustrine emergent herbaceous/scrub-shrub/forested wetland located in the western portion of the PSA within maintained and/or disturbed R/W. Within the PSA, Wetland A is approximately 0.186 acre in size. The eastern portion of the wetland located south of I-85 is forested and contained standing water. To the west of the forested portion of the wetland, the wetland becomes a ditch that runs along the south side of I-85 for approximately 225 feet to a pipe that crosses under I-85. Water flow was observed within the ditched portion of the wetland. At the pipe outfall on the north side of I-85, Wetland A continues as an emergent herbaceous/scrub-shrub wetland to the PSA boundary.

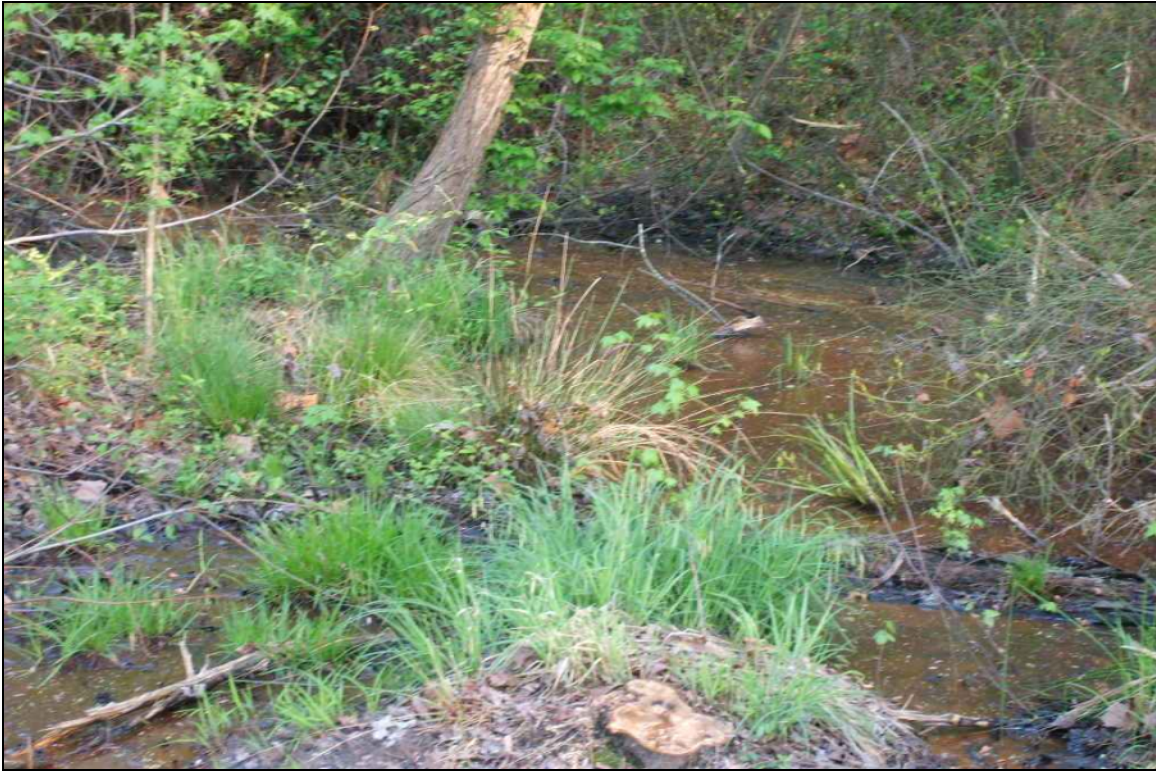
Photograph 5. View of the southern portion of Wetland A located south of I-85 in the western portion of the PSA.

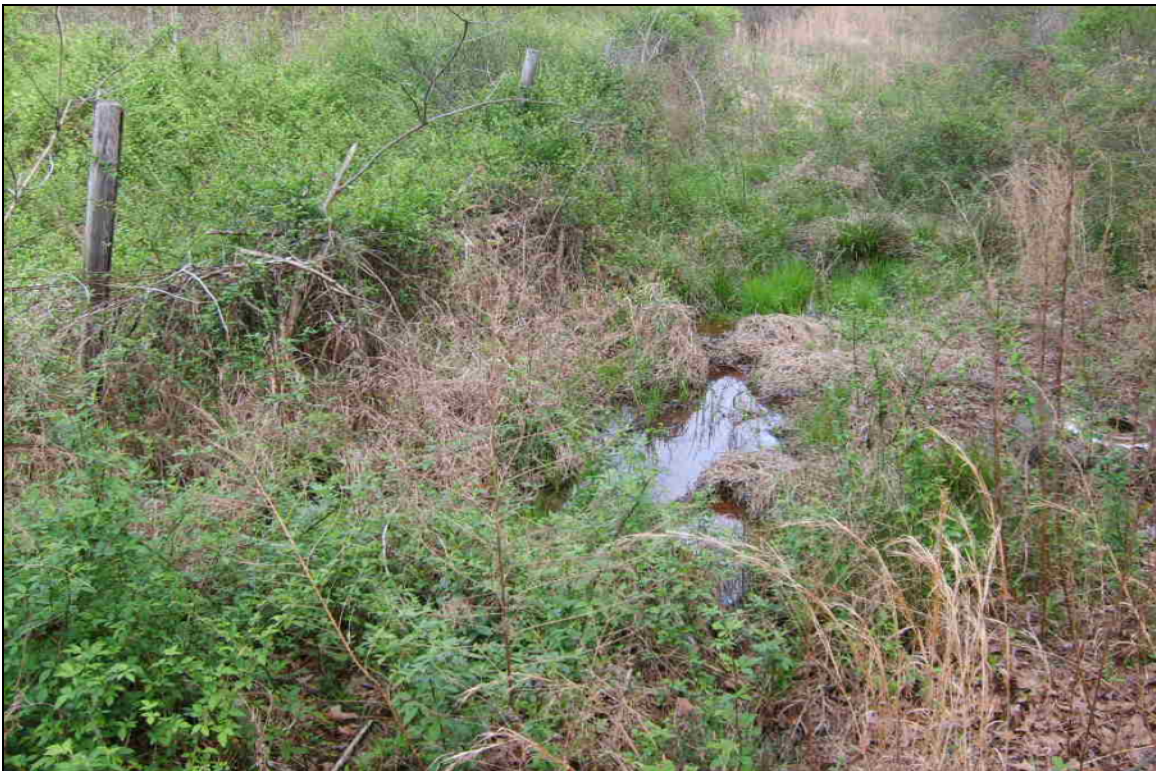
Photograph 6. View of Wetland B located north of I-85 in the west central portion of the PSA.
