**Asbestos & Lead-Based Paint  
Assessment  
Goforth Creek Bridge  
Route S-11-97  
Structure No. 1170009700100  
Cherokee County, South Carolina  
S&ME Project No. 1361-20-048**

Reference: **Asbestos & Lead-Based Paint Assessment**  
**Goforth Creek Bridge**  
Route S-11-97  
Structure No. 1170009700100  
Cherokee County, South Carolina  
S&ME Project No. 1361-20-048

An asbestos assessment and lead-based paint assessment was conducted on October 14, 2020 of the bridge over Goforth Creek (Structure No. 1170009700100) on Route S-11-97 in Cherokee County, South Carolina. The purpose of the assessment was to identify asbestos-containing materials (ACMs) and lead-based paint coatings associated with the structure prior to renovation or demolition activities.

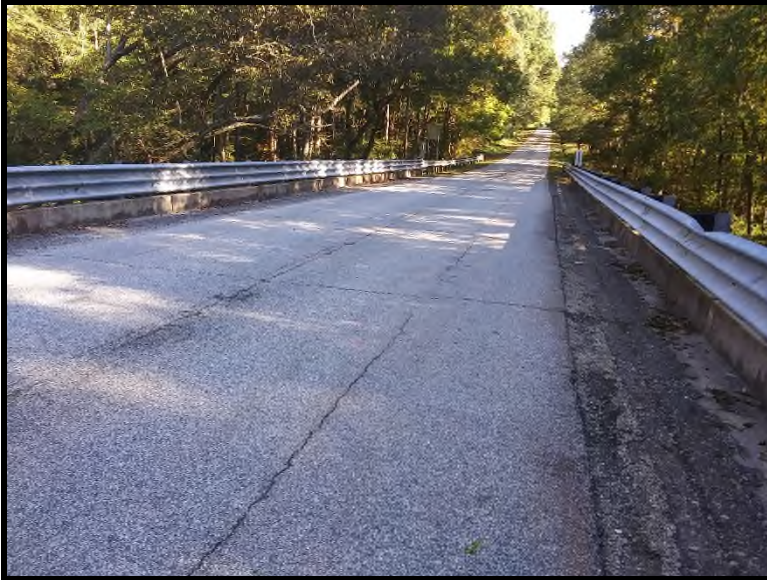
The bridge consists of a two-lane asphalt paved roadway with metal guard rails resting on concrete deck supported by wood pilings and concrete bents. The bridge is approximately 105 feet long and 27 feet wide.

**1** View of the subject bridge.

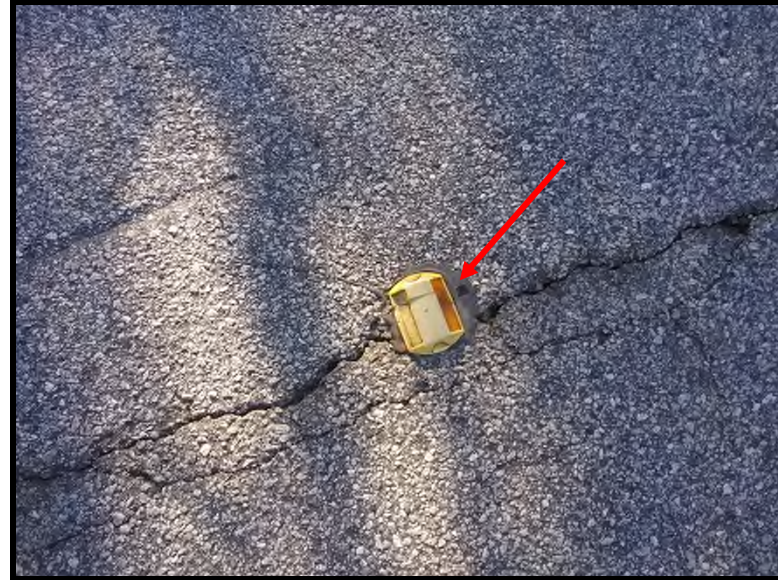
**2** Puck mastic associated with the reflectors tested negative for asbestos.

No asbestos-containing materials were identified on the structure. If additional suspect ACMs not addressed in this report are discovered during destructive activities, bulk samples should be collected by a SCDHEC licensed inspector and analyzed for asbestos content prior to disturbance or disposal of the suspect materials. This report should also be provided to the contractor(s) to assist with compliance with applicable State and Federal regulations.

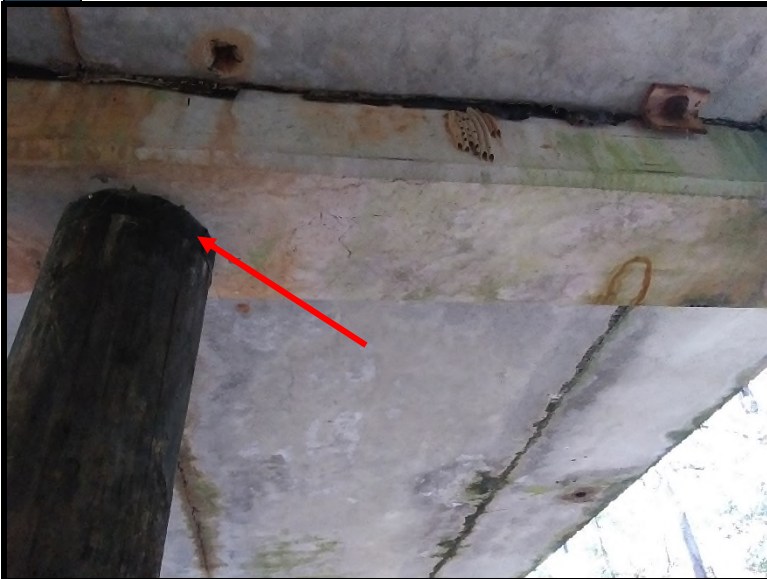
**3** Felt paper tested negative for asbestos.

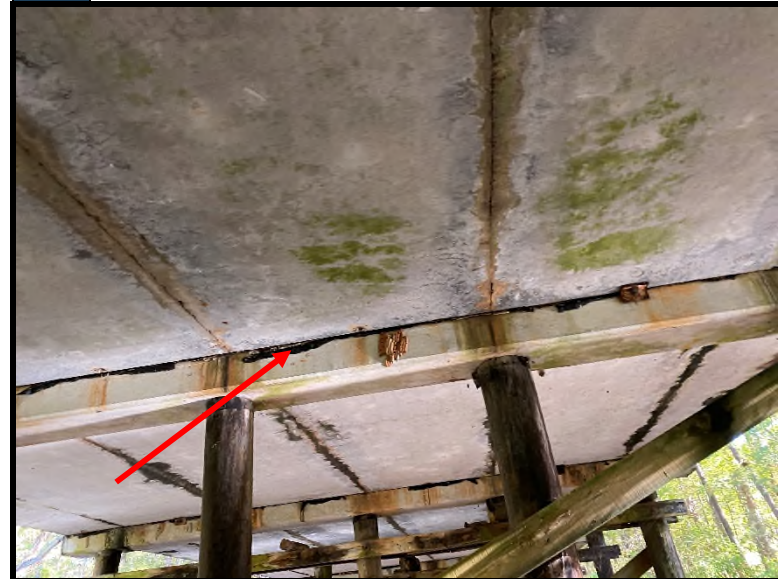
**4** Vibration dampener tested negative for asbestos.
