ASBESTOS CONTAINING MATERIAL INVESTIGATION REPORT

S-1-218 (VANDIVER RD.) BRIDGE OVER PENNY CREEK
BRIDGE #017021800100 (SCOPE BRIDGE ID# 01700218000100)
ABBEVILLE COUNTY, SOUTH CAROLINA

May 10, 2019

FME Project No.: G6100.050

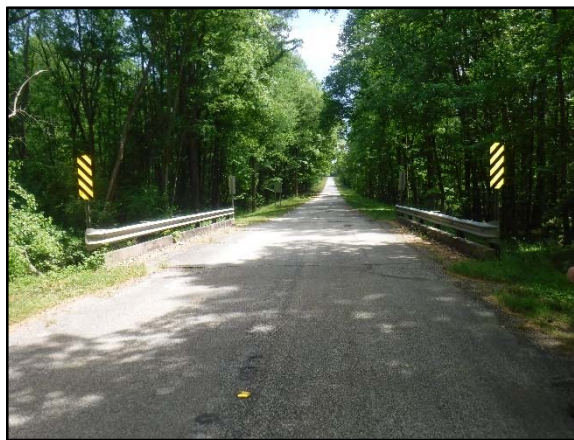
The existing bridge structure (~45.75'L x 26.0'W, inside curb to inside curb), is located on S-1-218 (Vandiver Rd.) and crosses over Penny Creek in Abbeville County, South Carolina. The date of construction for the bridge (SCDOT bridge # 017021800100) (Scope bridge # 0170021800100) is unknown. The existing bridge structure is a three (3) span, two lane precast concrete bridge, with an asphalt overlay. The bridge deck rests on concrete bents that are supported by timber piles. Each bent is supported by five (5) timber piles with soil covering the two (2) end bents. Drainage scuppers were precast holes through the concrete decking with no sleeves. Metal guardrails and wood posts are attached to the concrete curb and gutter. Refer to Appendix A – Site Vicinity Map, for the location of the structure.

Photo 1 – S-1-218 (Vandiver Road) Bridge over Penny Creek, in Abbeville county, SC

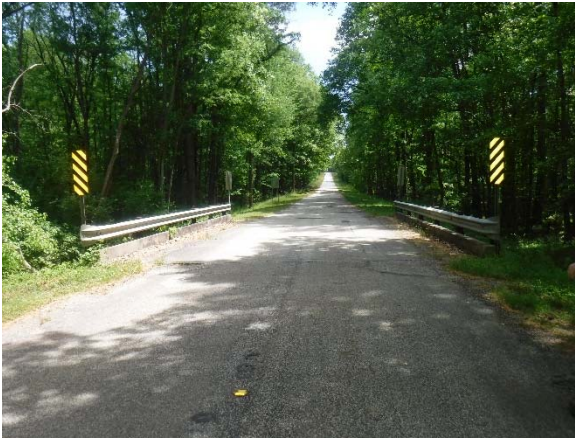
Photo 1. Top View of Bridge.

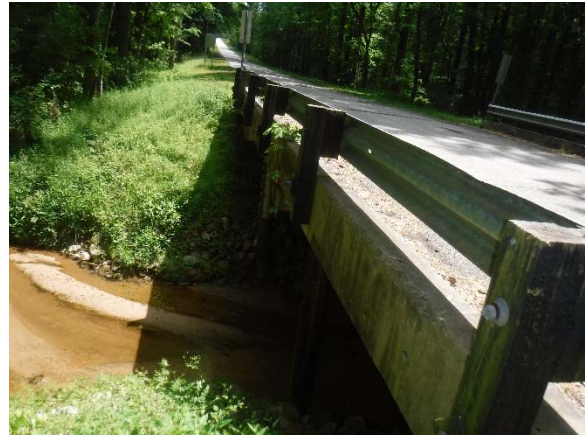
Photo 2. East Side View of Bridge.

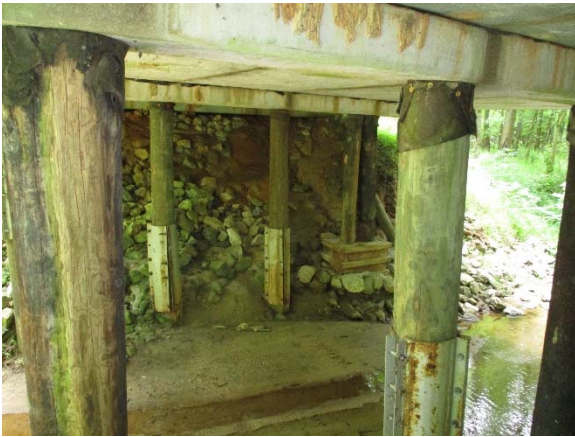
Photo 3. Underside View of Bridge

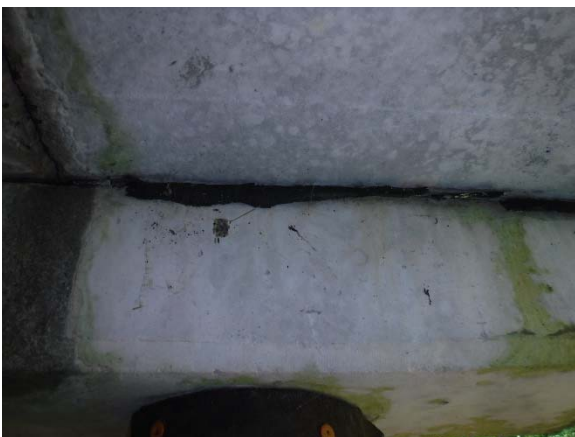
| Sample ID | Description | Appearance | Non-Asbestos % Fibrous | Non-Asbestos % Non-Fibrous | Asbestos % Type |
|---|---|--|---|---|---|
| G-6100.050-2-1 | Bond Break Pad | Brown/Black Non- Fibrous Homogeneous | 3% Cellulose<1% Synthetic | 97% Non-fibrous (Other) | None Detected |
| G-6100.050-2-2 | Bond Break Pad | Brown/Black Non- Fibrous Homogeneous | 1% Cellulose | 99% Non-fibrous (Other) | None Detected |
| G-6100.050-2-3 | Bond Break Pad | Brown/Black Non- Fibrous Heterogeneous | 100% Other | None | None Detected |

Photo 5. Bond Break Pad

It is our understanding that the existing bridge structure will be demolished. All accessible suspect materials have been sampled and analyzed by an accredited laboratory and found to contain no ACM. Therefore, there are no foreseen special handling or disposal requirements, regarding asbestos, that will be required for the demolition of this bridge.
