# Geotechnical Data Report

**S-13-757 (Davis Rivers Road)  
Emergency Bridge Replacement over Adams Creek  
Chesterfield County, South Carolina**

SCDOT Project ID.: P038247

Terracon Project No. 7318P119E

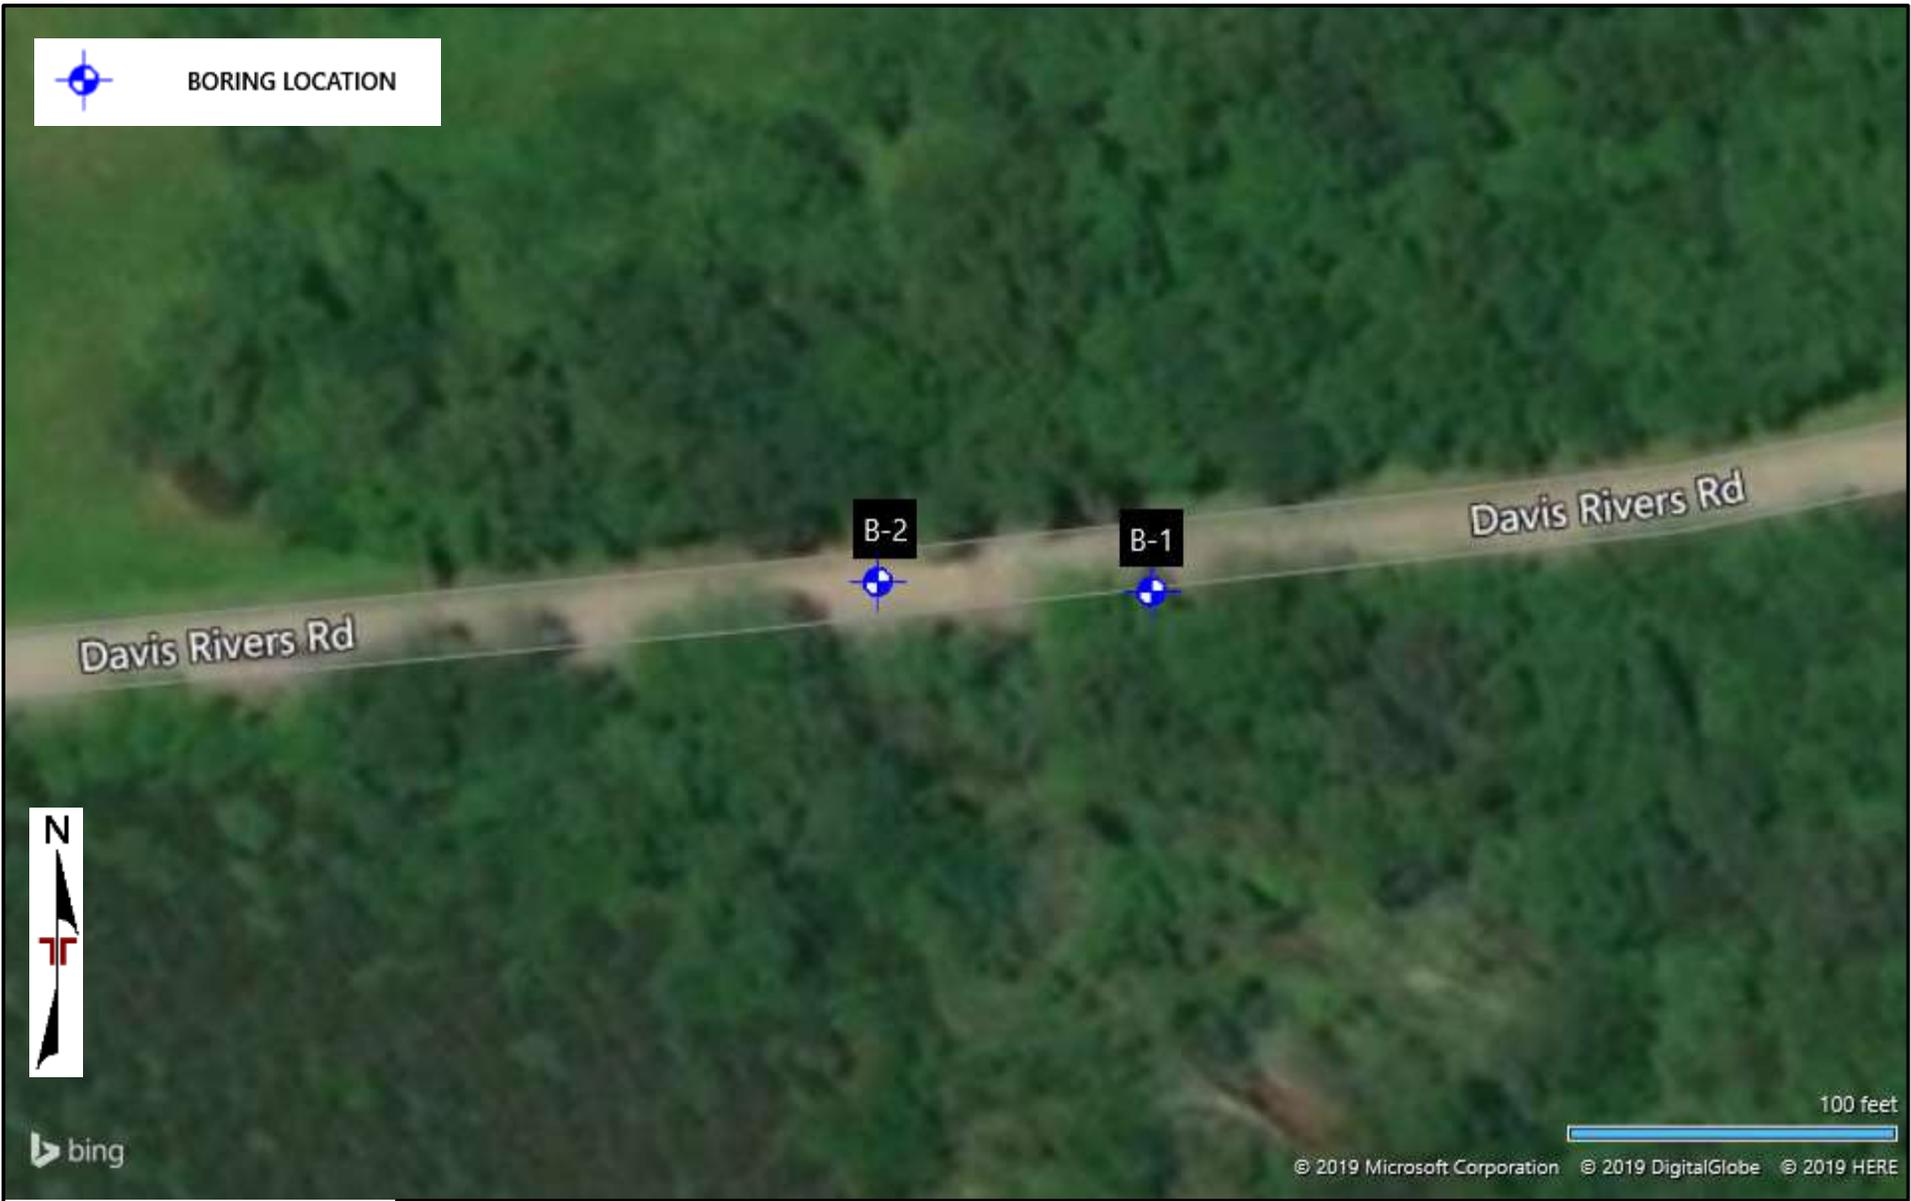
**A-2**

**EXPLORATION PLAN**

The general testing locations were provided by the SCDOT and located in the field by Terracon by taking measurements from existing structures. The borings were surveyed by Construction Support Services, LLC after testing and drilling was complete. The locations are shown on the appended Exploration Plan.

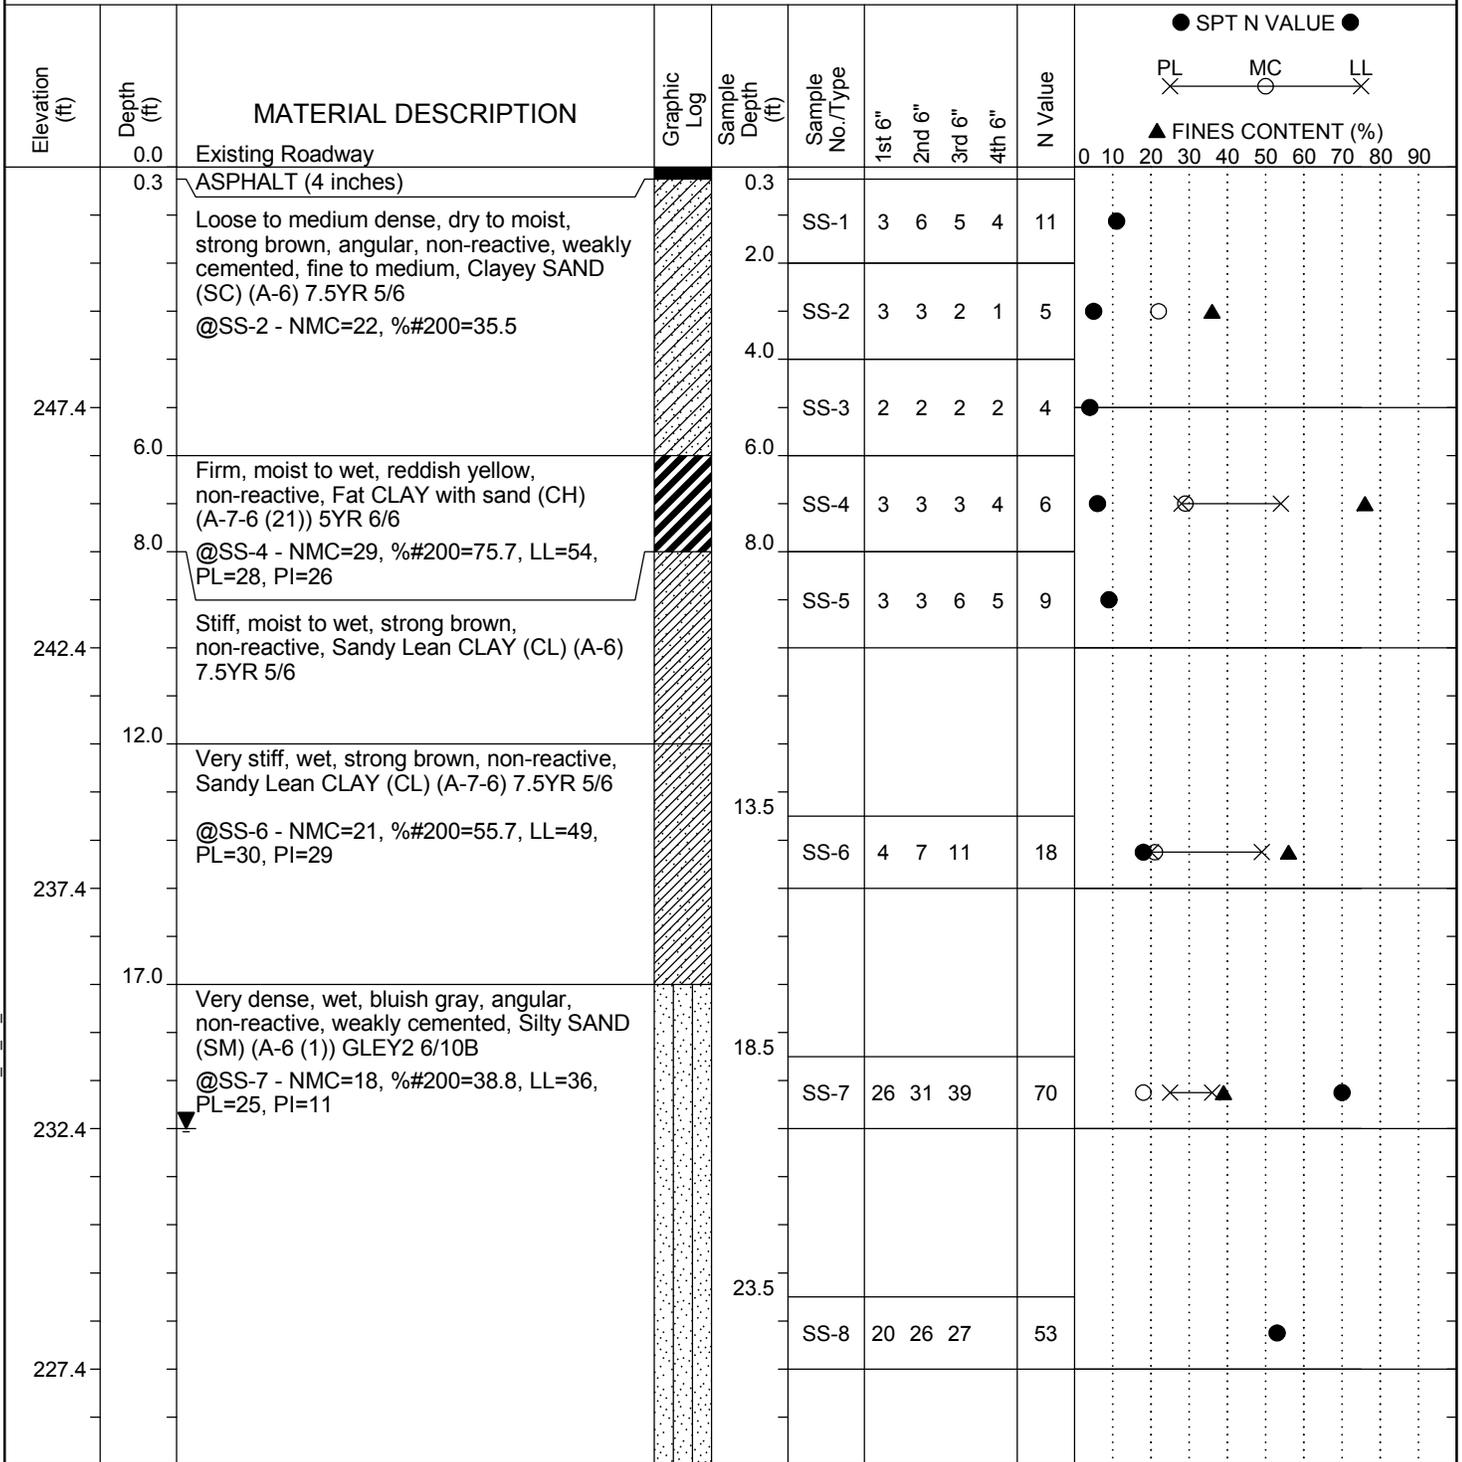
<b>Project ID:</b>	PO38247	<b>County:</b>	Chesterfield	<b>Boring No.:</b>	B-1
<b>Site Description:</b>	S-13-757 (Davis Rivers Road) RBO Adams Creek			<b>Route:</b>	S-13-757
<b>Eng./Geo.:</b>	RDS	<b>Boring Location:</b>		<b>Offset:</b>	
<b>Elev.:</b>	252.4 ft	<b>Latitude:</b>	34.787403	<b>Longitude:</b>	-80.079514
<b>Total Depth:</b>	47.7 ft	<b>Soil Depth:</b>	28.2 ft	<b>Core Depth:</b>	19.5 ft
<b>Bore Hole Diameter (in):</b>	3	<b>Sampler Configuration</b>		<b>Liner Required:</b>	Y (N)
<b>Drill Machine:</b>	CME-45/543	<b>Drill Method:</b>	RW/RC	<b>Hammer Type:</b>	Automatic
<b>Core Size:</b>	NQ2	<b>Driller:</b>	BH	<b>Energy Ratio:</b>	97.1%
		<b>Groundwater:</b>	TOB	N.A.	24HR
					20 ft

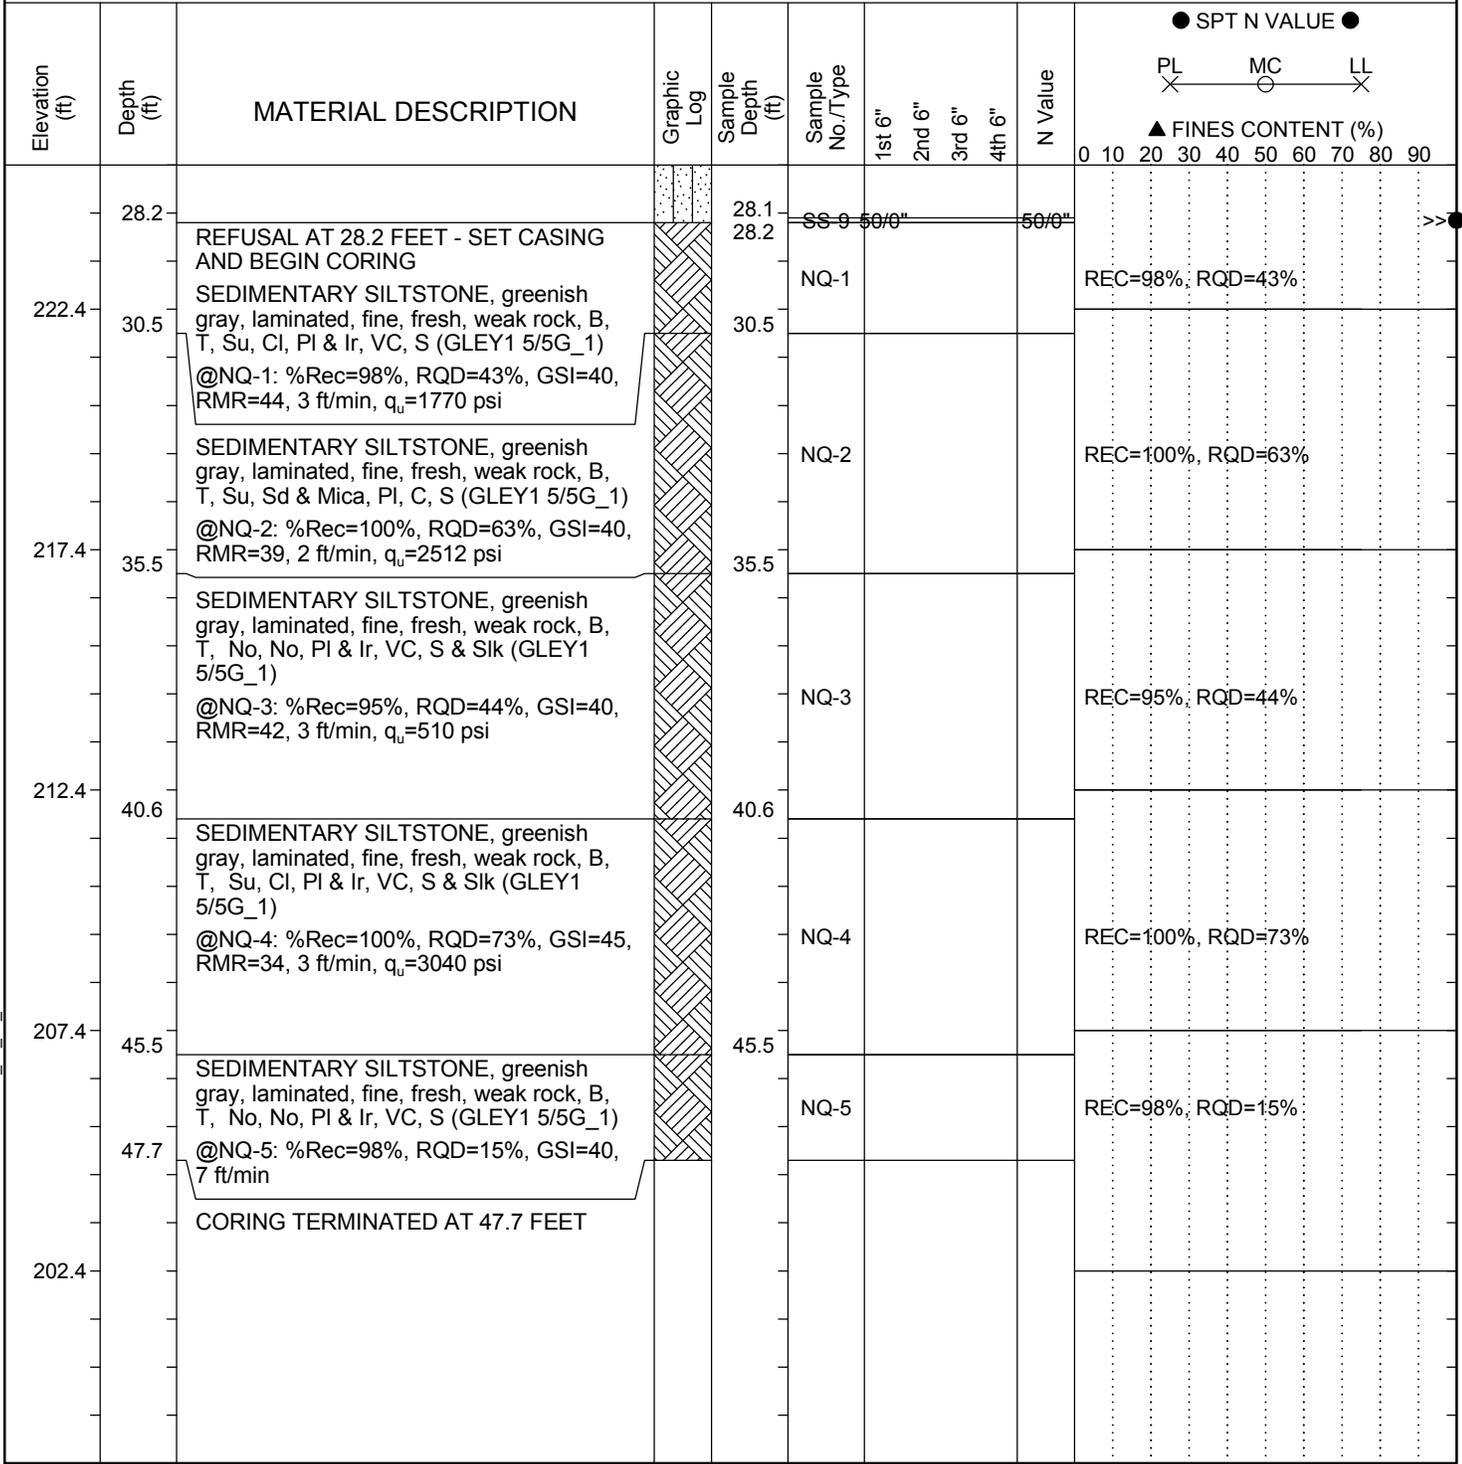
<b>Project ID:</b>	PO38247	<b>County:</b>	Chesterfield	<b>Boring No.:</b>	B-1
<b>Site Description:</b>	S-13-757 (Davis Rivers Road) RBO Adams Creek			<b>Route:</b>	S-13-757
<b>Eng./Geo.:</b>	RDS	<b>Boring Location:</b>		<b>Offset:</b>	
<b>Elev.:</b>	252.4 ft	<b>Latitude:</b>	34.787403	<b>Longitude:</b>	-80.079514
<b>Total Depth:</b>	47.7 ft	<b>Soil Depth:</b>	28.2 ft	<b>Core Depth:</b>	19.5 ft
<b>Bore Hole Diameter (in):</b>	3	<b>Sampler Configuration</b>		<b>Liner Required:</b>	Y (N)
<b>Drill Machine:</b>	CME-45/543	<b>Drill Method:</b>	RW/RC	<b>Hammer Type:</b>	Automatic
<b>Core Size:</b>	NQ2	<b>Driller:</b>	BH	<b>Energy Ratio:</b>	97.1%
		<b>Groundwater:</b>	TOB	N.A.	24HR
					20 ft

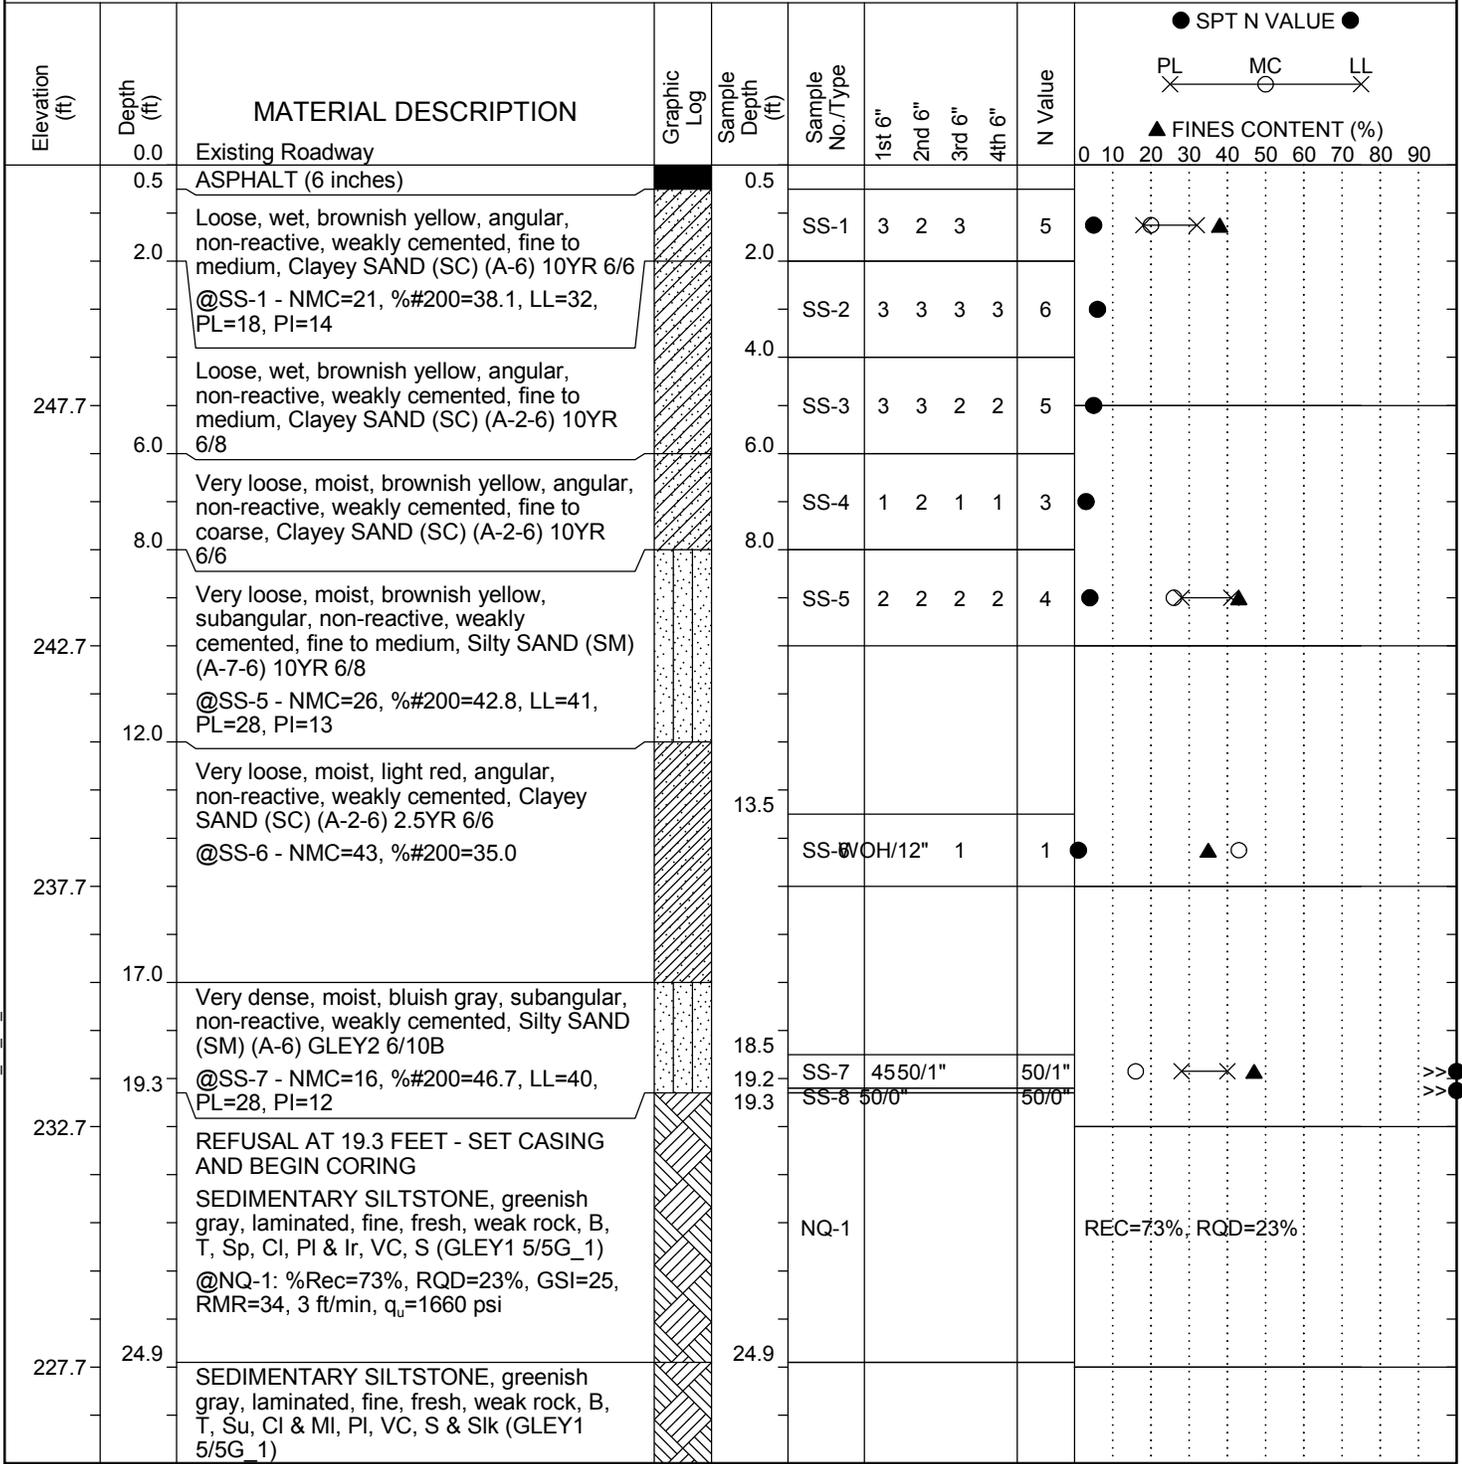
<b>Project ID:</b>	PO38247	<b>County:</b>	Chesterfield	<b>Boring No.:</b>	B-2
<b>Site Description:</b>	S-13-757 (Davis Rivers Road) RBO Adams Creek			<b>Route:</b>	S-13-757
<b>Eng./Geo.:</b>	RDS	<b>Boring Location:</b>		<b>Offset:</b>	
<b>Elev.:</b>	252.7 ft	<b>Latitude:</b>	34.787411	<b>Longitude:</b>	-80.079794
<b>Total Depth:</b>	39.6 ft	<b>Soil Depth:</b>	19.3 ft	<b>Core Depth:</b>	20.3 ft
<b>Bore Hole Diameter (in):</b>	3	<b>Sampler Configuration</b>		<b>Liner Required:</b>	Y (N)
<b>Drill Machine:</b>	CME-45/543	<b>Drill Method:</b>	RW/RC	<b>Hammer Type:</b>	Automatic
<b>Core Size:</b>	NQ2	<b>Driller:</b>	AM	<b>Energy Ratio:</b>	97.1%
				<b>Groundwater:</b>	TOB N.A. 24HR N.E.

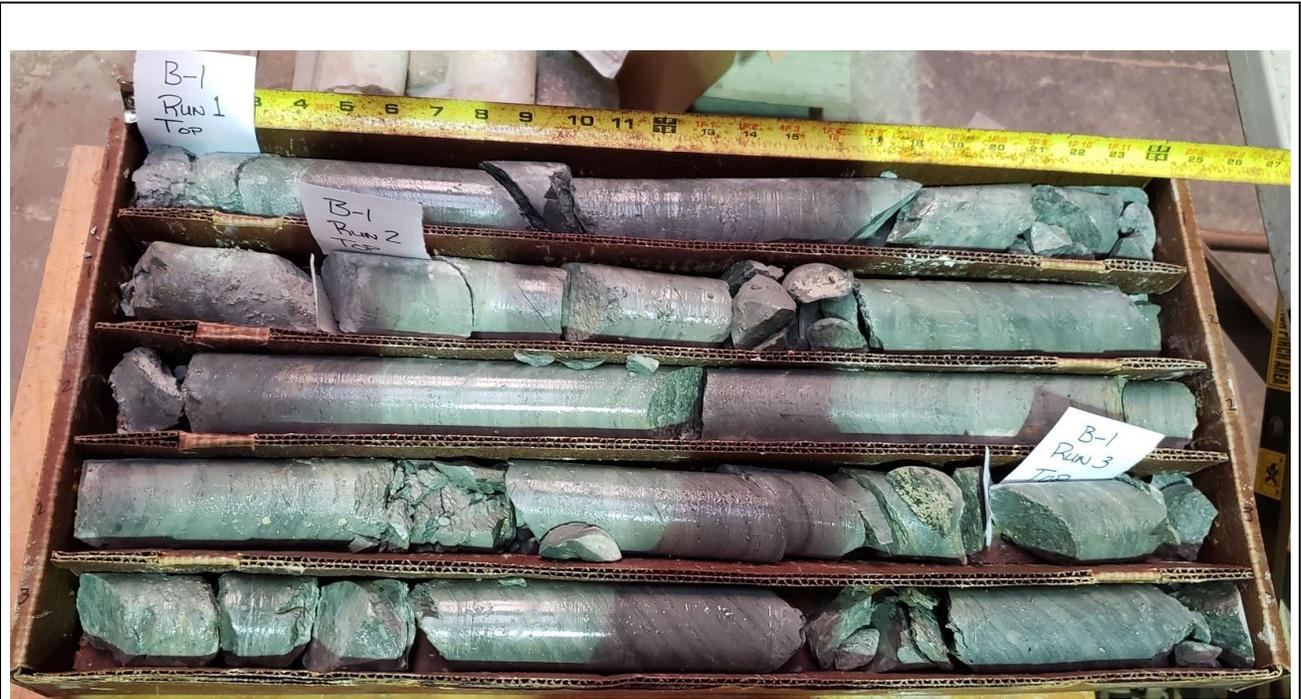
B-1: NQ-1: 28.2-30.5 feet; NQ-2: 30.5-35.5 feet; and NQ-3: 35.5-40.6 feet

description of the rock. An explanation of the rock descriptions shown on the logs is provided in Exhibit 6. Photos of the recovered rock core specimens are provided on Exhibit A-9 of the Appendix.

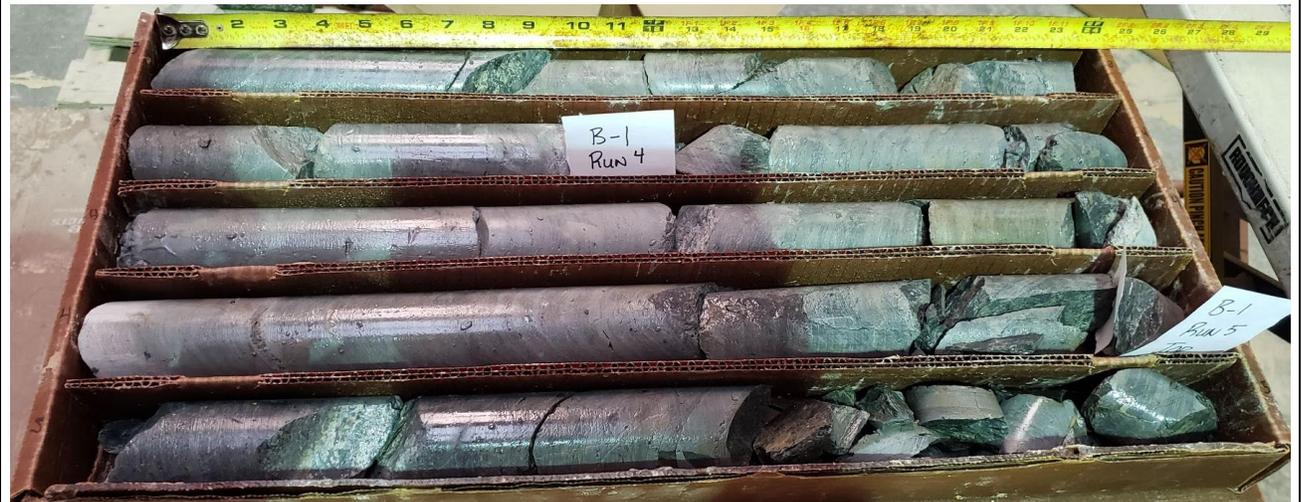
B-1 NQ-3: 35.5-40.6 feet, cont.; NQ-4: 40.6-45.5 feet; and NQ-5: 45.5-47.7 feet

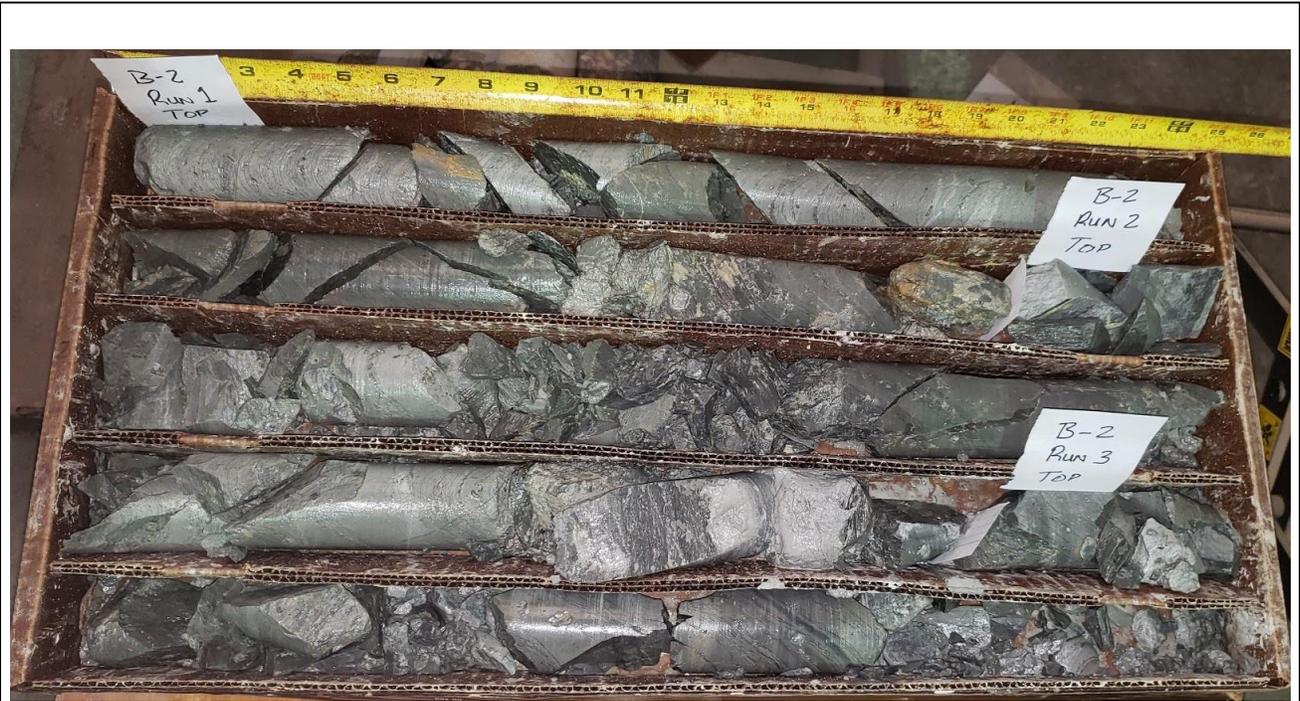
B-2 NQ-1:19.3-24.9 feet, NQ-2: 24.9-29.9 feet, and NQ-3: 29.9-34.8 feet

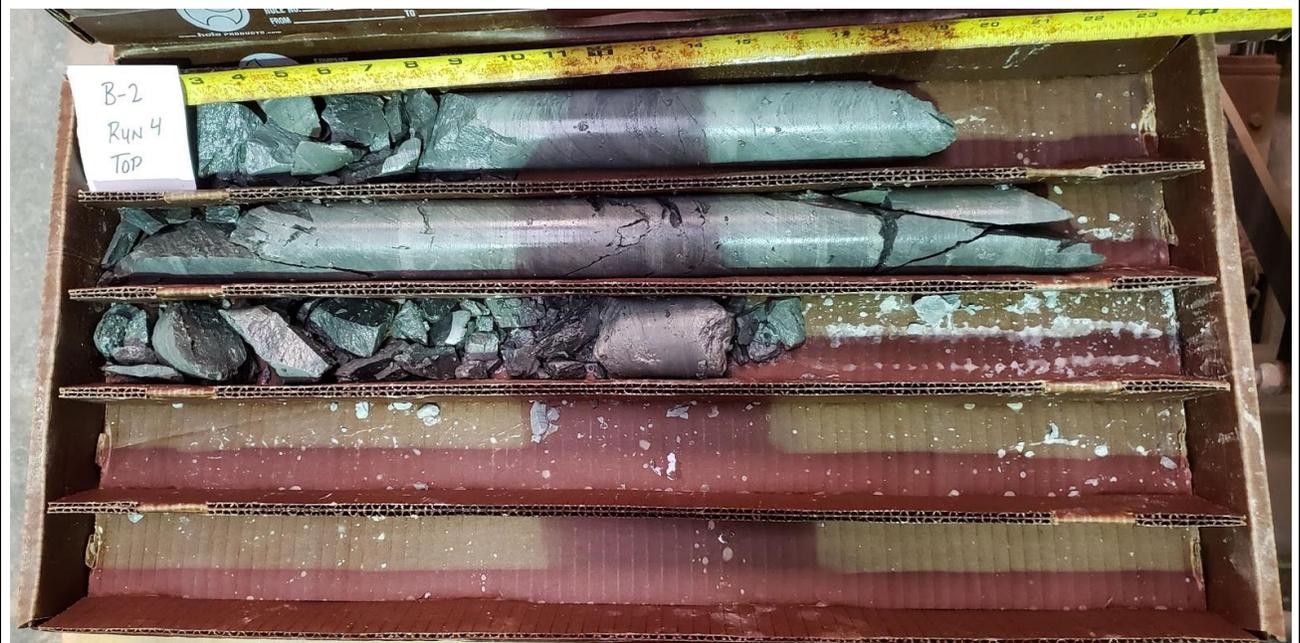
B-2 NQ-4: 34.8-39.6 feet

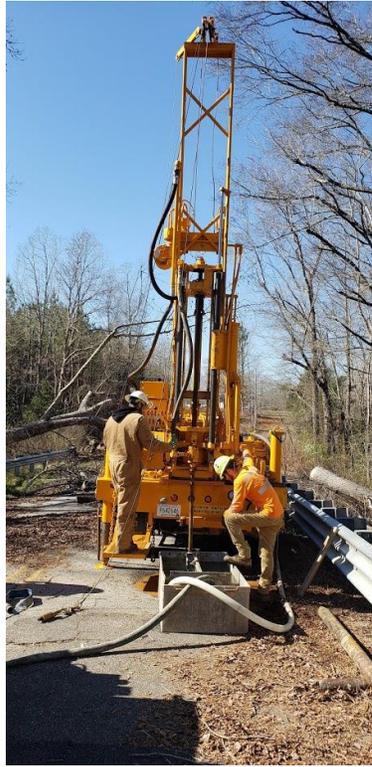
Drill rig on B-1

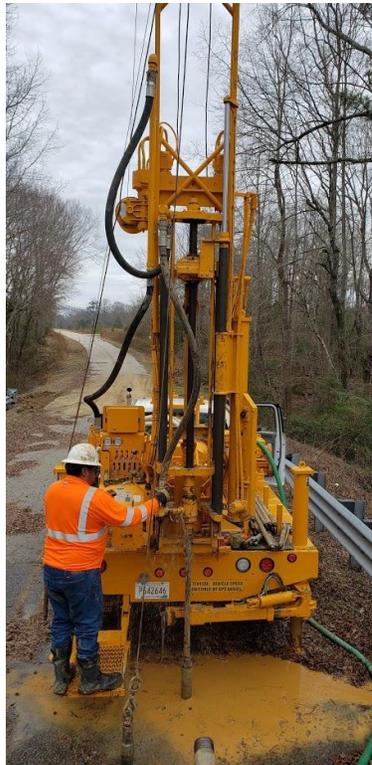
Drill rig on B-2

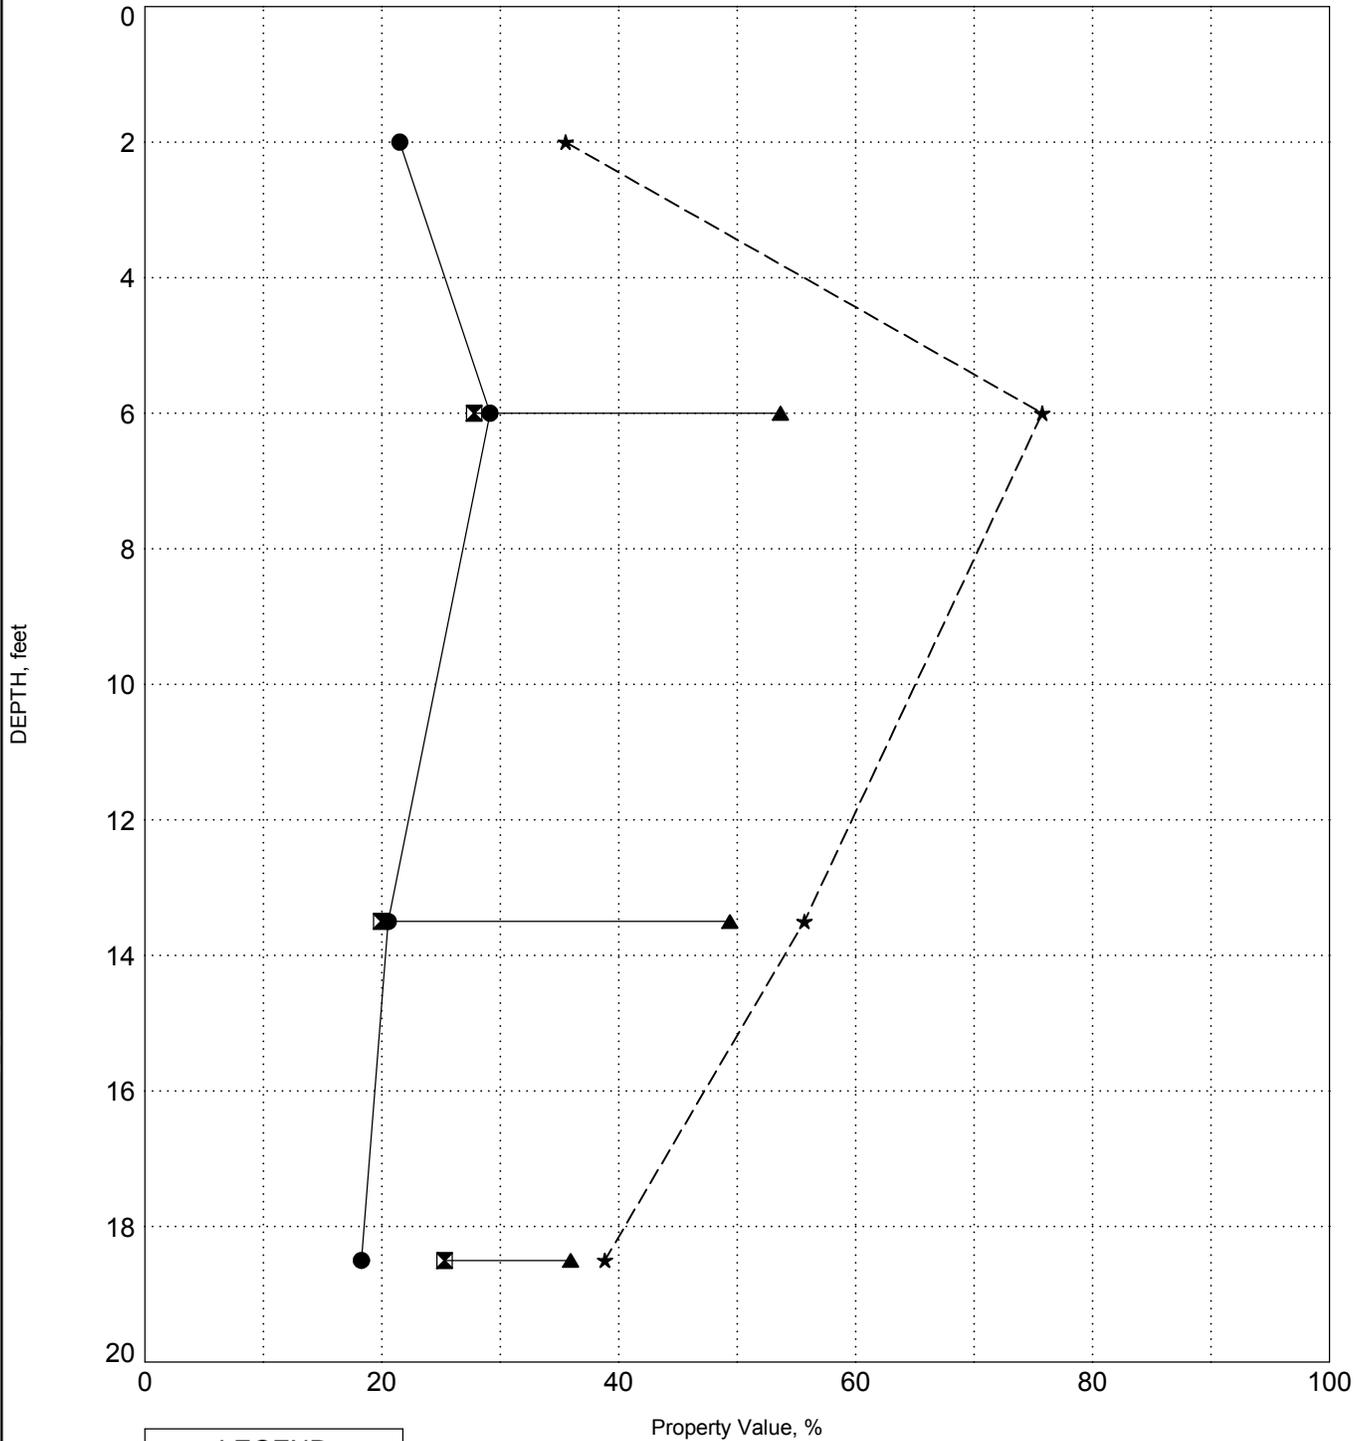
## BORING B-1

LEGEND	
●	Water Content
⊠	Plastic Limit
▲	Liquid Limit
★	Fines

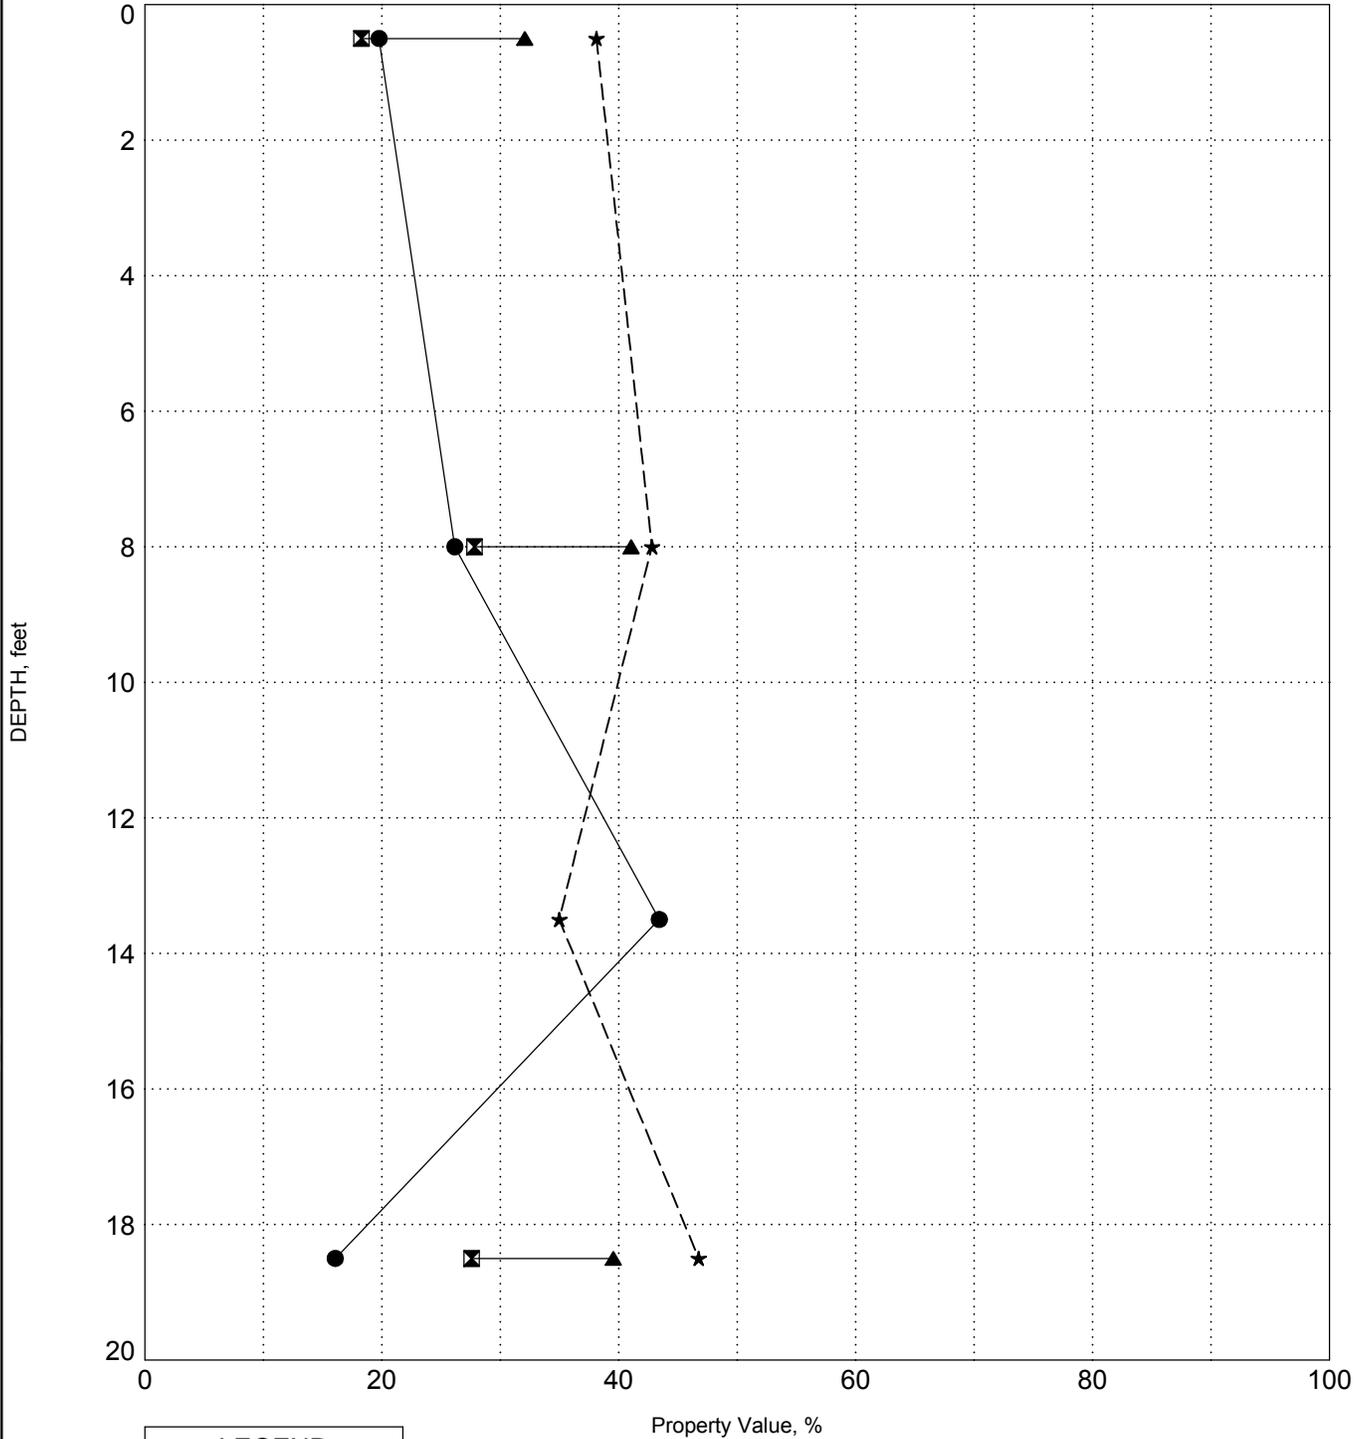
## BORING B-2

LEGEND	
●	Water Content
☒	Plastic Limit
▲	Liquid Limit
★	Fines

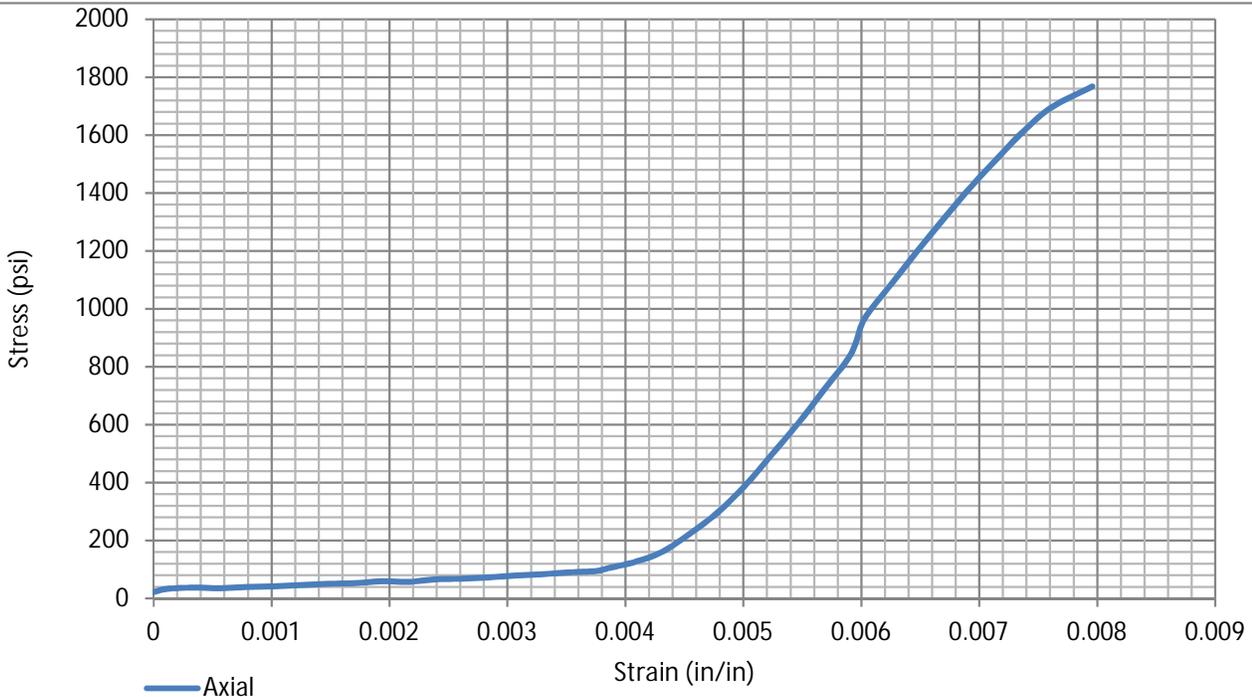
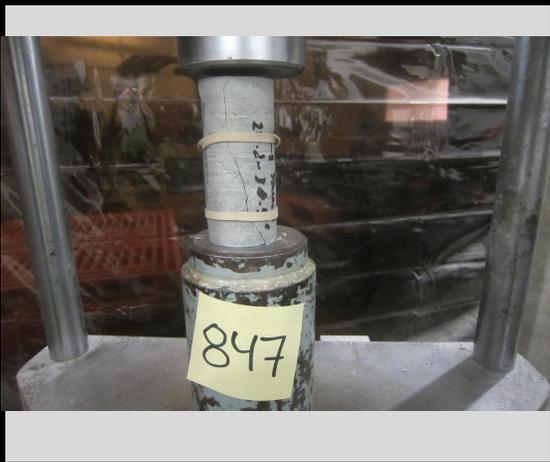
**COMPRESSIVE STRENGTH AND ELASTIC MODULUS OF  
INTACT ROCK ASTM D7012**

Boring:	1-B-1	Depth (feet):	28.2-30.5
---------	-------	---------------	-----------

Failure Load (lbs):	4,620
Failure Strain (%):	0.80
Unconfined Compressive Strength (psi):	1,768
Elastic Modulus, E, (ksi):	
Poisson's Ratio, v:

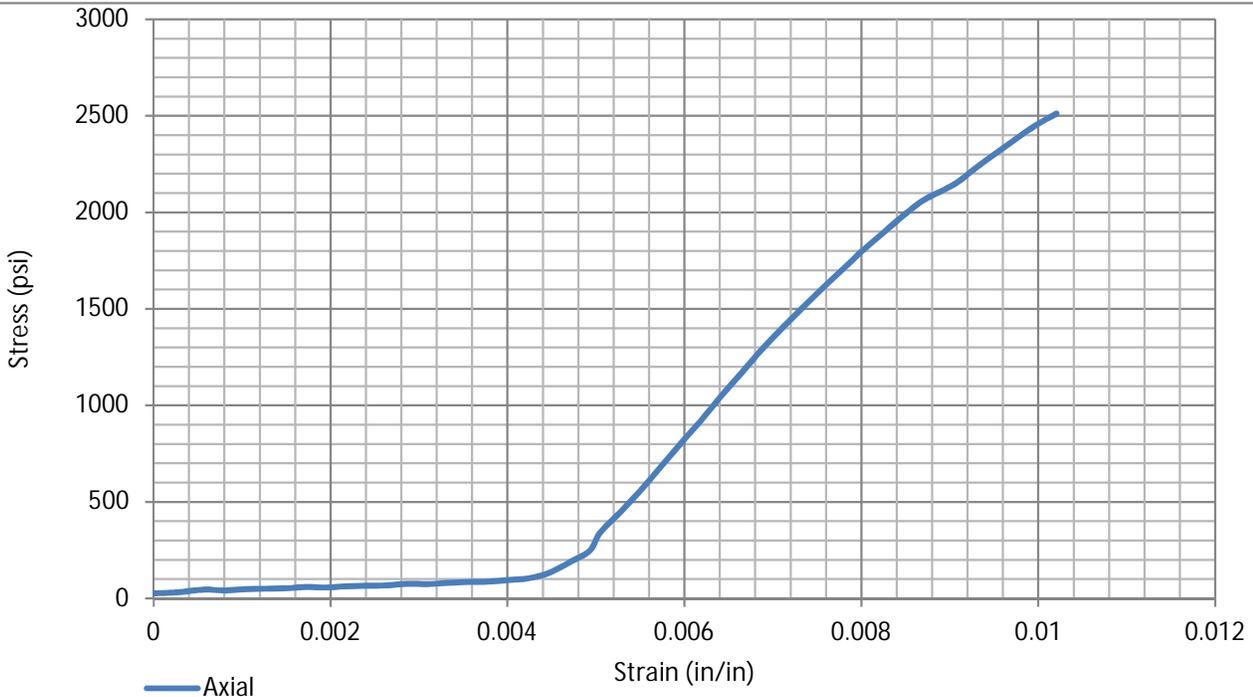
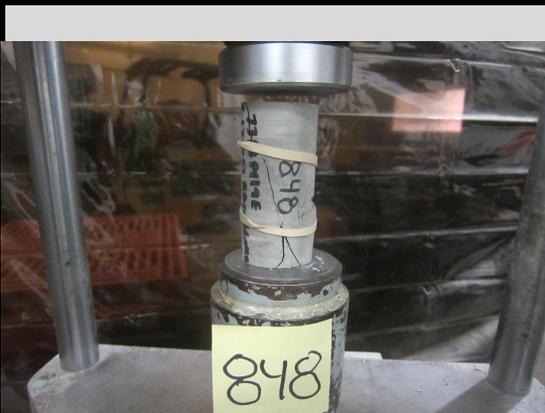
**COMPRESSIVE STRENGTH AND ELASTIC MODULUS OF  
INTACT ROCK ASTM D7012**

SAMPLE LOCATION			
Boring:	2-B-1	Depth (feet):	30.5-35.5

SPECIMEN INFORMATION			
Sample No.:	2	Mass (g):	495.10
Length (in.):	4.38	Diameter (in.):	1.83
L/D Ratio:	2.39	Density (pcf):	163.11

TEST RESULTS	
Failure Load (lbs):	6,629
Failure Strain (%):	1.02
Unconfined Compressive Strength (psi):	2,512
Elastic Modulus, E, (ksi):	
Poisson's Ratio, v:

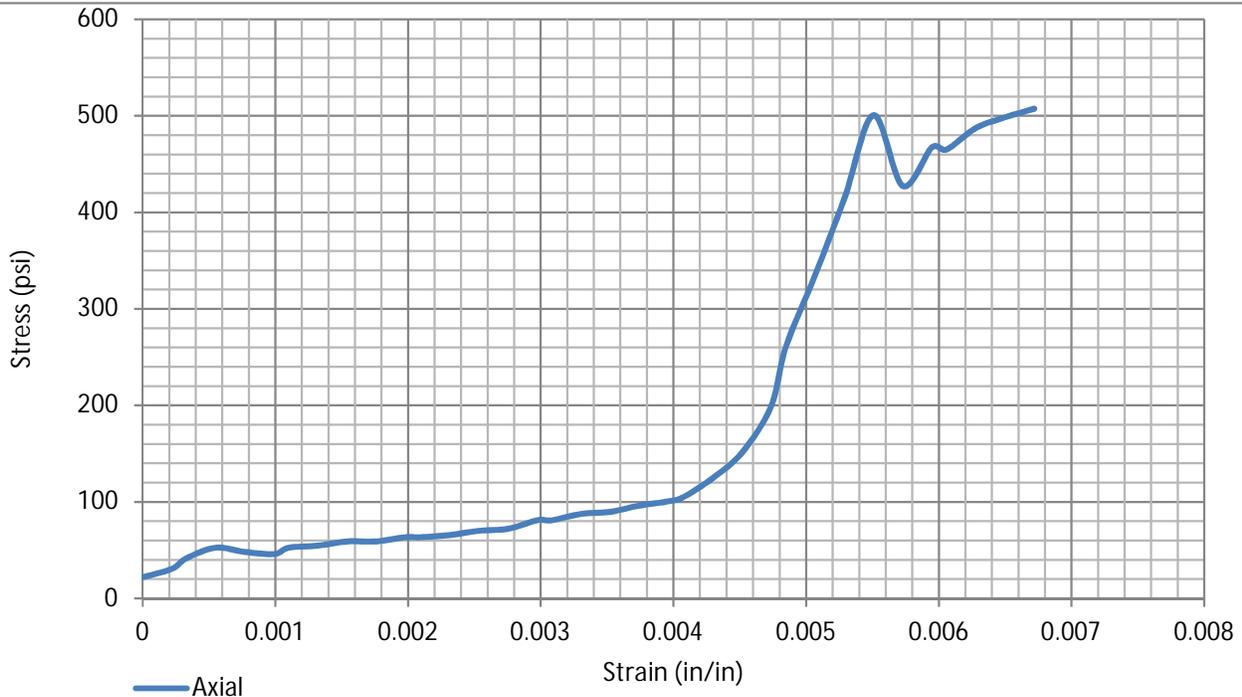
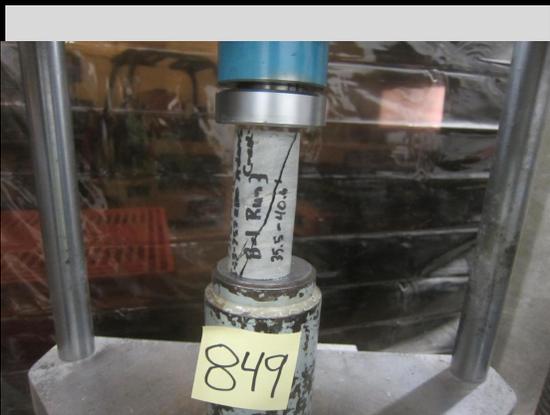
**COMPRESSIVE STRENGTH AND ELASTIC MODULUS OF  
INTACT ROCK ASTM D7012**

Boring:	3-B-1	Depth (feet):	35.5-40.6
---------	-------	---------------	-----------

Failure Load (lbs):	1,332
Failure Strain (%):	0.67
Unconfined Compressive Strength (psi):	507
Elastic Modulus, E, (ksi):	
Poisson's Ratio, v:

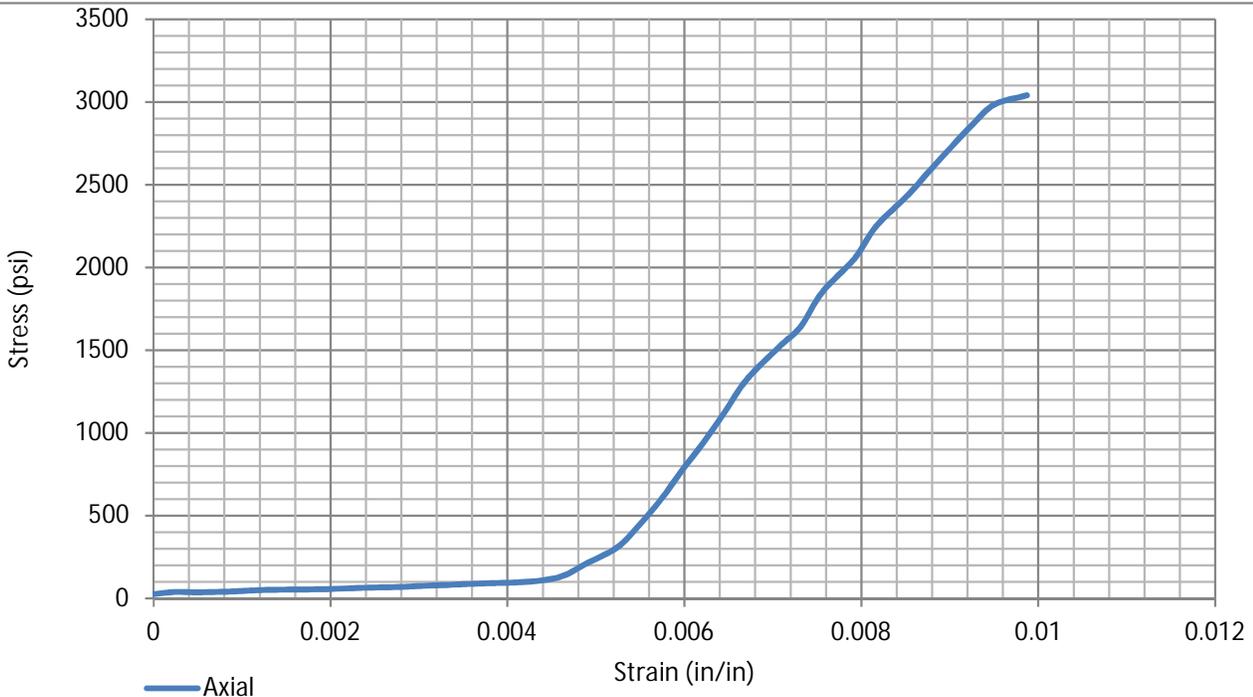
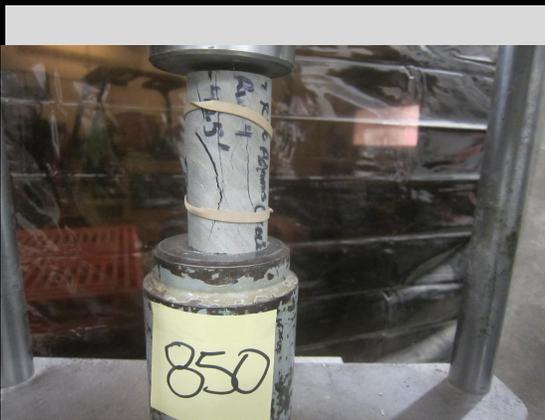
**COMPRESSIVE STRENGTH AND ELASTIC MODULUS OF  
INTACT ROCK ASTM D7012**

Boring:	4-B-1	Depth (feet):	40.6-45.5
---------	-------	---------------	-----------

Failure Load (lbs):	8,041
Failure Strain (%):	0.99
Unconfined Compressive Strength (psi):	3,041
Elastic Modulus, E, (ksi):	
Poisson's Ratio, v:
