# Geotechnical Data Report

**S-13-757 (Davis Rivers Road)  
Emergency Bridge Replacement over Adams Creek  
Chesterfield County, South Carolina**

SCDOT Project ID.: P038247

Terracon Project No. 7318P119E

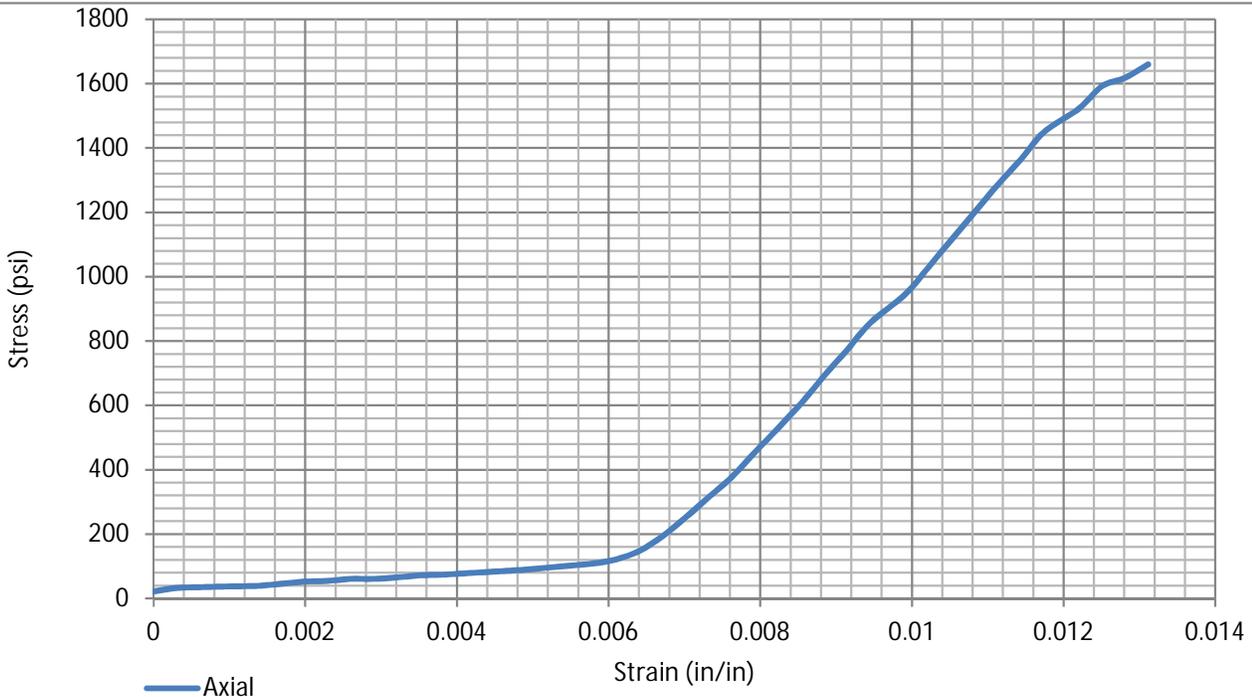
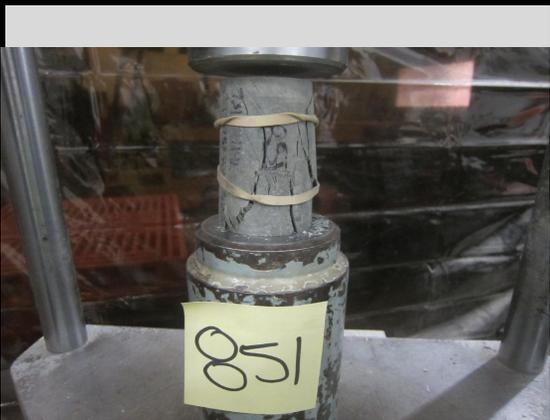
**COMPRESSIVE STRENGTH AND ELASTIC MODULUS OF  
INTACT ROCK ASTM D7012**

Boring:	5-B-2	Depth (feet):	19.3-24.9
---------	-------	---------------	-----------

Failure Load (lbs):	4,394
Failure Strain (%):	1.31
Unconfined Compressive Strength (psi):	1,660
Elastic Modulus, E, (ksi):	
Poisson's Ratio, v:

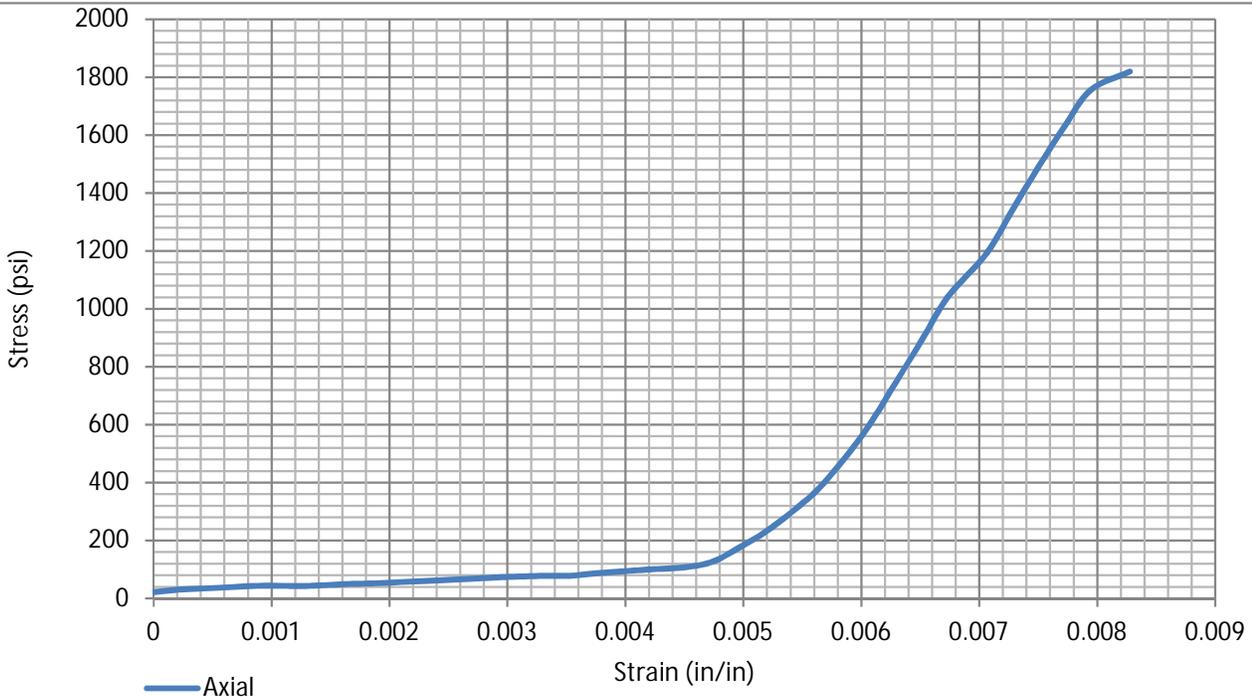
**COMPRESSIVE STRENGTH AND ELASTIC MODULUS OF  
INTACT ROCK ASTM D7012**

<b>SAMPLE LOCATION</b>			
	Boring:	6-B-2	Depth (feet):	34.8-39.6
	<b>SPECIMEN INFORMATION</b>			
	Sample No.:	4	Mass (g):	519.93
	Length (in.):	4.55	Diameter (in.):	1.84
	L/D Ratio:	2.48	Density (pcf):	163.57
	<b>TEST RESULTS</b>			
	Failure Load (lbs):	4,817		
	Failure Strain (%):	0.83		
	Unconfined Compressive Strength (psi):	1,819		
Elastic Modulus, E, (ksi):				
Poisson's Ratio, v:				
Description:	GR SILTSTONE W/ PYRITE

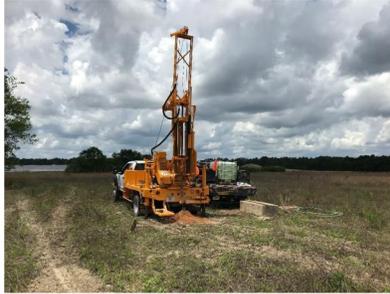
ITEM	DESCRIPTION
Drill Rig Identification	CME-45C, SN 406484 (see photograph on cover page)
Drill Rig Owner	Terracon
Drill Rig Operator	Spencer Blair
Testing Date	May 24, 2018
Testing Location	Gaston Solar Facility
Terracon Project Number	73185061
Boring Identification	SB-2
Energy Measurement Depths	30.0 ft.; 35.0 ft.; 40.0 ft.; 45.0 ft.; 50.0 ft.
Hammer Type	Automatic
Boring Method	Hollow Stem Auger
Drill Rods	<ul style="list-style-type: none"> <li>■ AWJ</li> <li>■ 1½" outside diameter</li> <li>■ 3/16" wall thickness</li> </ul>
SPT Calibration Testing Equipment	<ul style="list-style-type: none"> <li>■ 2 foot AWJ rod instrumented w/ 2 strain gauges and 2 accelerometers</li> <li>■ Model PAX Pile Driving Analyzer™ (PDA)</li> </ul>
SPT Calibration Personnel	R. Wakeford & Z. McIntosh

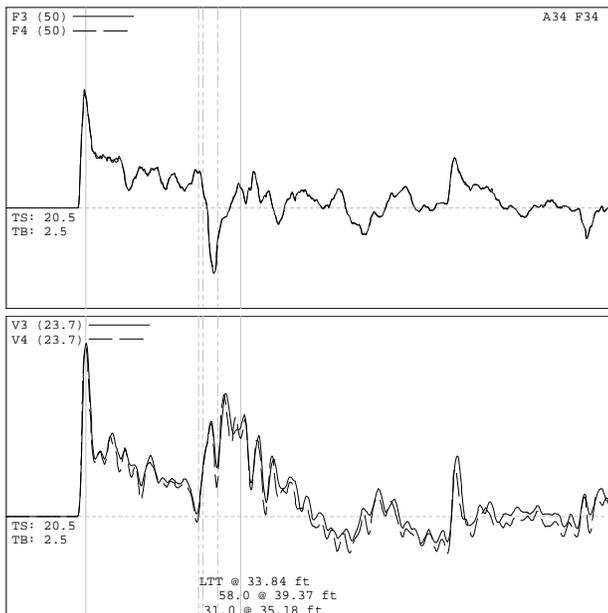
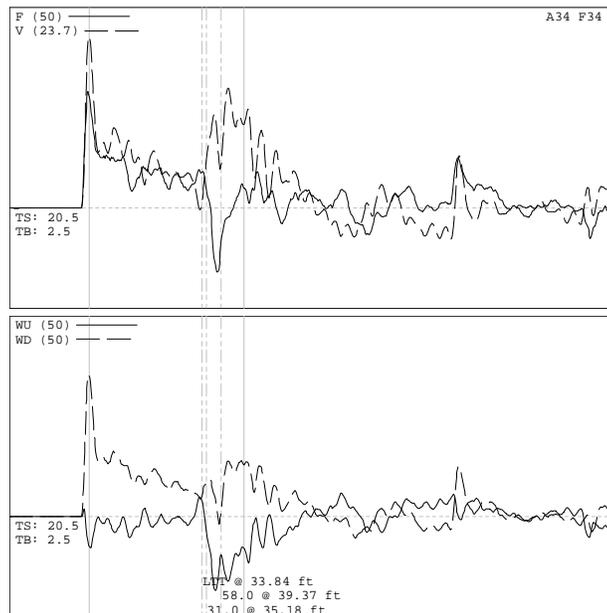
## Exhibit A-1 Representative Blow

**Project Information**  
 PROJECT: GASTON 2 SOLAR FACILITY  
 PILE NAME: SPT CAL 38.5-40  
 DESCR: CME 45C 38.5-40  
 OPERATOR: ZM  
 FILE: SPT\_CAL\_38.5\_40\_Log  
 5/24/2018 11:54:19 AM  
 Blow Number 9

**Pile Properties**  
 LE 43.70 ft  
 AR 1.18 in<sup>2</sup>  
 EM 30000 ksi  
 SP 0.492 k/ft<sup>3</sup>  
 WS 16807.9 f/s  
 EA/C 2.1 ksec/ft  
 2L/C 5.22 ms  
 JC []  
 LP 37.50 ft

**Quantity Results**  
 ETR 98.2 (%)  
 CSX 24.6 ksi  
 CSB 0.0 ksi  
 BPM 55.1 bpm  
 EMX 0.344 k-ft  
 DMX 0.69 in  
 SFR kips  
 MEX 820 µE  
 VMX 20.3 f/s

Based on our testing and subsequent analysis, drill rig CME-45C (No. 543) has an ETR of 97.1% ± 2.04%. Based on this ETR, the hammer efficiency correction (C<sub>e</sub>) is 1.62.

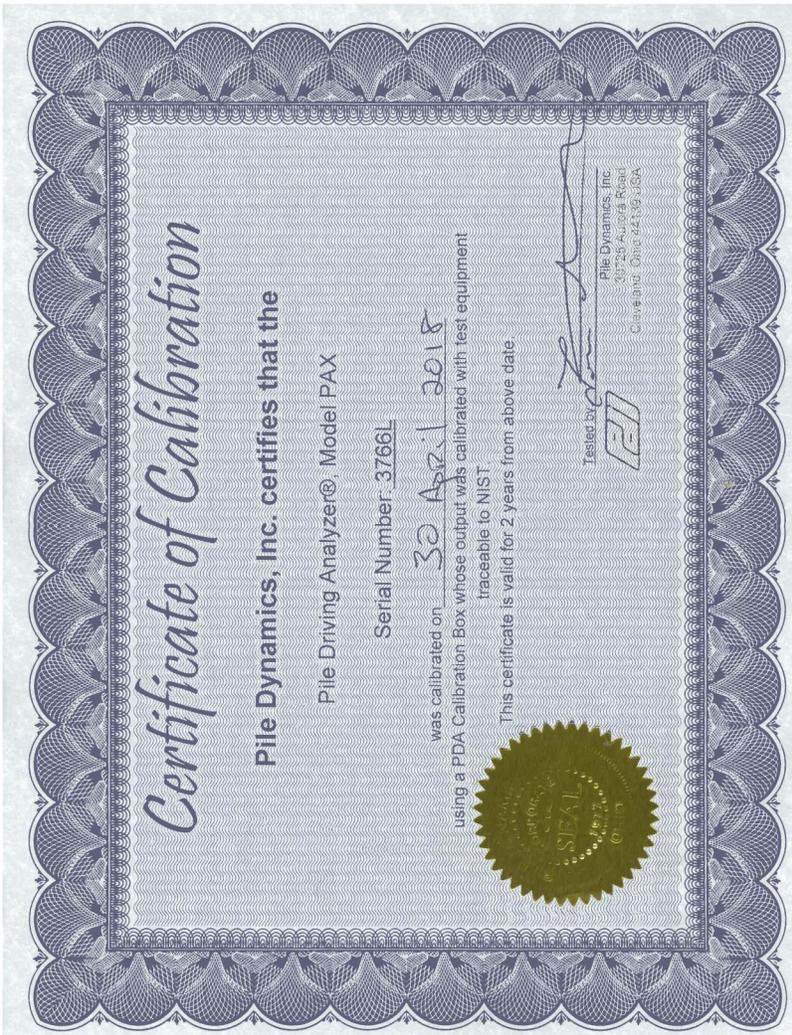
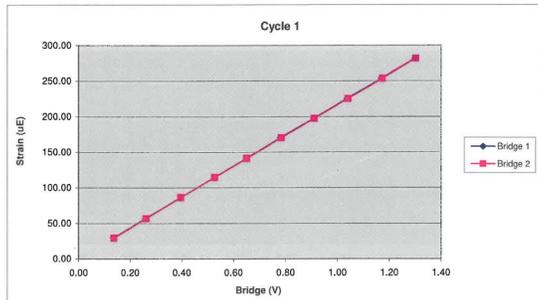
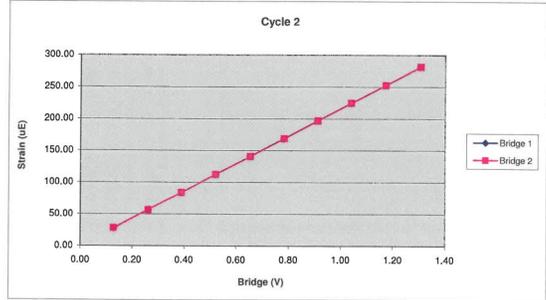
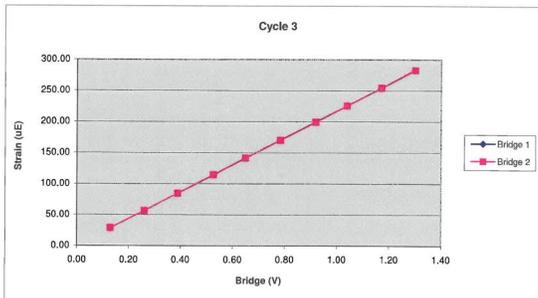
Exhibit A-2 PDA Equipment Calibrations

267AWJ		Cycle 1		
Sample	Force (lb)	Strain ( $\mu\text{E}$ )	Bridge 1 (V)	Bridge 2 (V)
1	0.00	0.00	0.00	0.00
2	1034.65	29.80	0.14	0.14
3	1995.74	57.07	0.26	0.26
4	3021.54	86.56	0.40	0.40
5	4013.51	114.64	0.53	0.53
6	4945.09	141.59	0.65	0.65
7	5967.55	170.38	0.78	0.78
8	6935.72	197.78	0.91	0.91
9	7944.21	225.43	1.04	1.04
10	8835.59	253.69	1.17	1.17
11	9924.61	282.06	1.30	1.30

Bridge 1		Bridge 2	
Force Calibration (lb/V)	7636.82	Force Calibration (lb/V)	7622.38
Offset	-7.82	Offset	-11.05
Correlation	0.999996	Correlation	0.999997
Strain Calibration ( $\mu\text{E/V}$ )	216.43	Strain Calibration ( $\mu\text{E/V}$ )	216.02
Offset	0.60	Offset	0.51
Correlation	0.999996	Correlation	0.999993

Force Strain Calibration	
EA (Kips)	35284.30
Offset	-29.01
Correlation	0.999989

267AWJ		Cycle 2		
Sample	Force (lb)	Strain ( $\mu\text{E}$ )	Bridge 1 (V)	Bridge 2 (V)
1	0.00	0.00	0.00	0.00
2	979.97	28.37	0.13	0.13
3	2002.82	57.00	0.26	0.26
4	2963.52	84.19	0.39	0.39
5	3965.12	112.62	0.52	0.52
6	4973.02	141.14	0.65	0.65
7	5964.01	169.13	0.78	0.78
8	6938.87	197.15	0.91	0.91
9	7932.41	224.93	1.04	1.04
10	8939.72	253.23	1.17	1.17
11	9962.18	281.86	1.30	1.31

267AWJ		Cycle 3		
Sample	Force (lb)	Strain ( $\mu\text{E}$ )	Bridge 1 (V)	Bridge 2 (V)
1	0.00	0.00	0.00	0.00
2	982.53	28.74	0.13	0.13
3	1993.97	56.89	0.26	0.26
4	2965.68	84.76	0.39	0.39
5	4014.49	114.61	0.53	0.53
6	4944.11	141.53	0.65	0.65
7	5962.04	170.43	0.78	0.78
8	6994.93	199.62	0.92	0.92
9	7922.38	225.92	1.04	1.04
10	8918.48	254.51	1.17	1.17
11	9909.26	283.02	1.30	1.30

Calibration Factors	267AWJ	Bridge 2 ( $\mu\text{E/V}$ )	216.20
Bridge 1 ( $\mu\text{E/V}$ )	216.53	Area (in <sup>2</sup> )	1.17
EA Factor (Kips)	35248.70

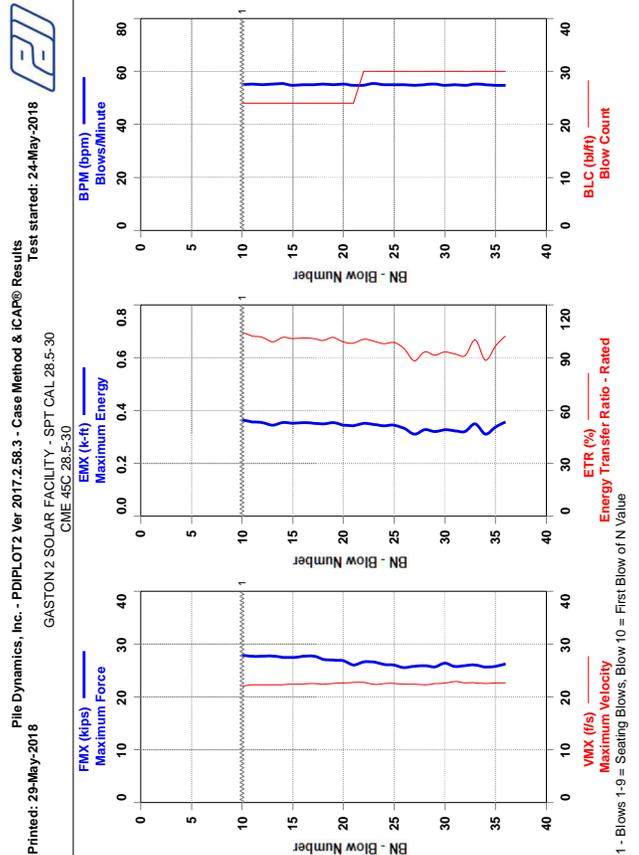
GASTON 2 SOLAR FACILITY - SPT CAL 28.5-30

10 Blows 1-9 = Seating Blows, Blow 10 = First Blow of N Value

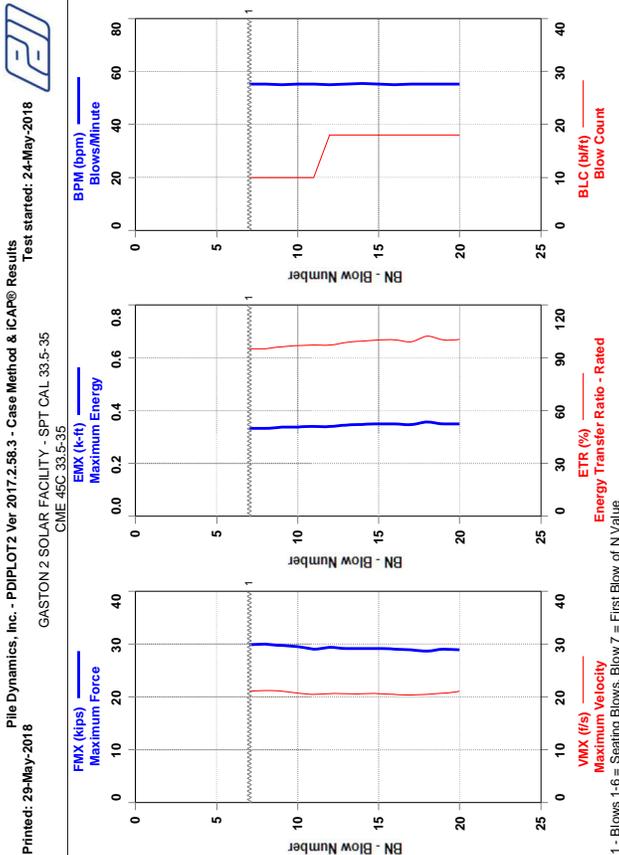
GASTON 2 SOLAR FACILITY - SPT CAL 33.5-35

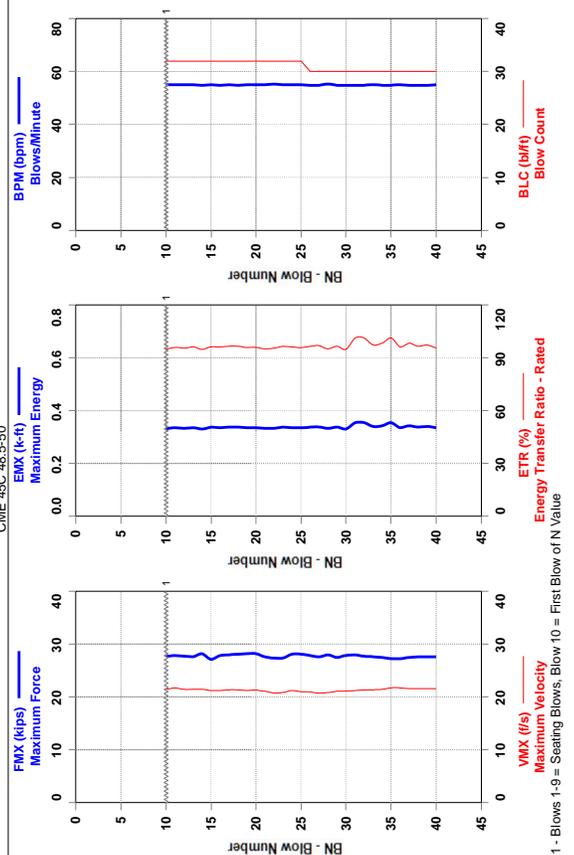
Pile Dynamics, Inc. - PDILOT2 Ver 2017.2.58.3 - Case Method & iCAP® Results  
Test started: 24-May-2018  
Printed: 29-May-2018  
GASTON 2 SOLAR FACILITY - SPT CAL 48.5-50  
CME 45C 48.5-50

GASTON 2 SOLAR FACILITY - SPT CAL 48.5-50 CME 45C 48.5-50  
OP: ZM Date: 24-May-2018
