**South Carolina Department of Transportation**  
On Behalf of the Federal Highway Administration - South Carolina Division Office

PROCESSING FORM FOR PROGRAMMATIC CATEGORICAL EXCLUSIONS  
NON MAJOR FEDERAL ACTIONS

Project Name: SC 4 Bridge Replacement over the South Fork Edisto River

SC 4 (Wagener Rd) Over the South Fork Edisto River Bridge Replacement

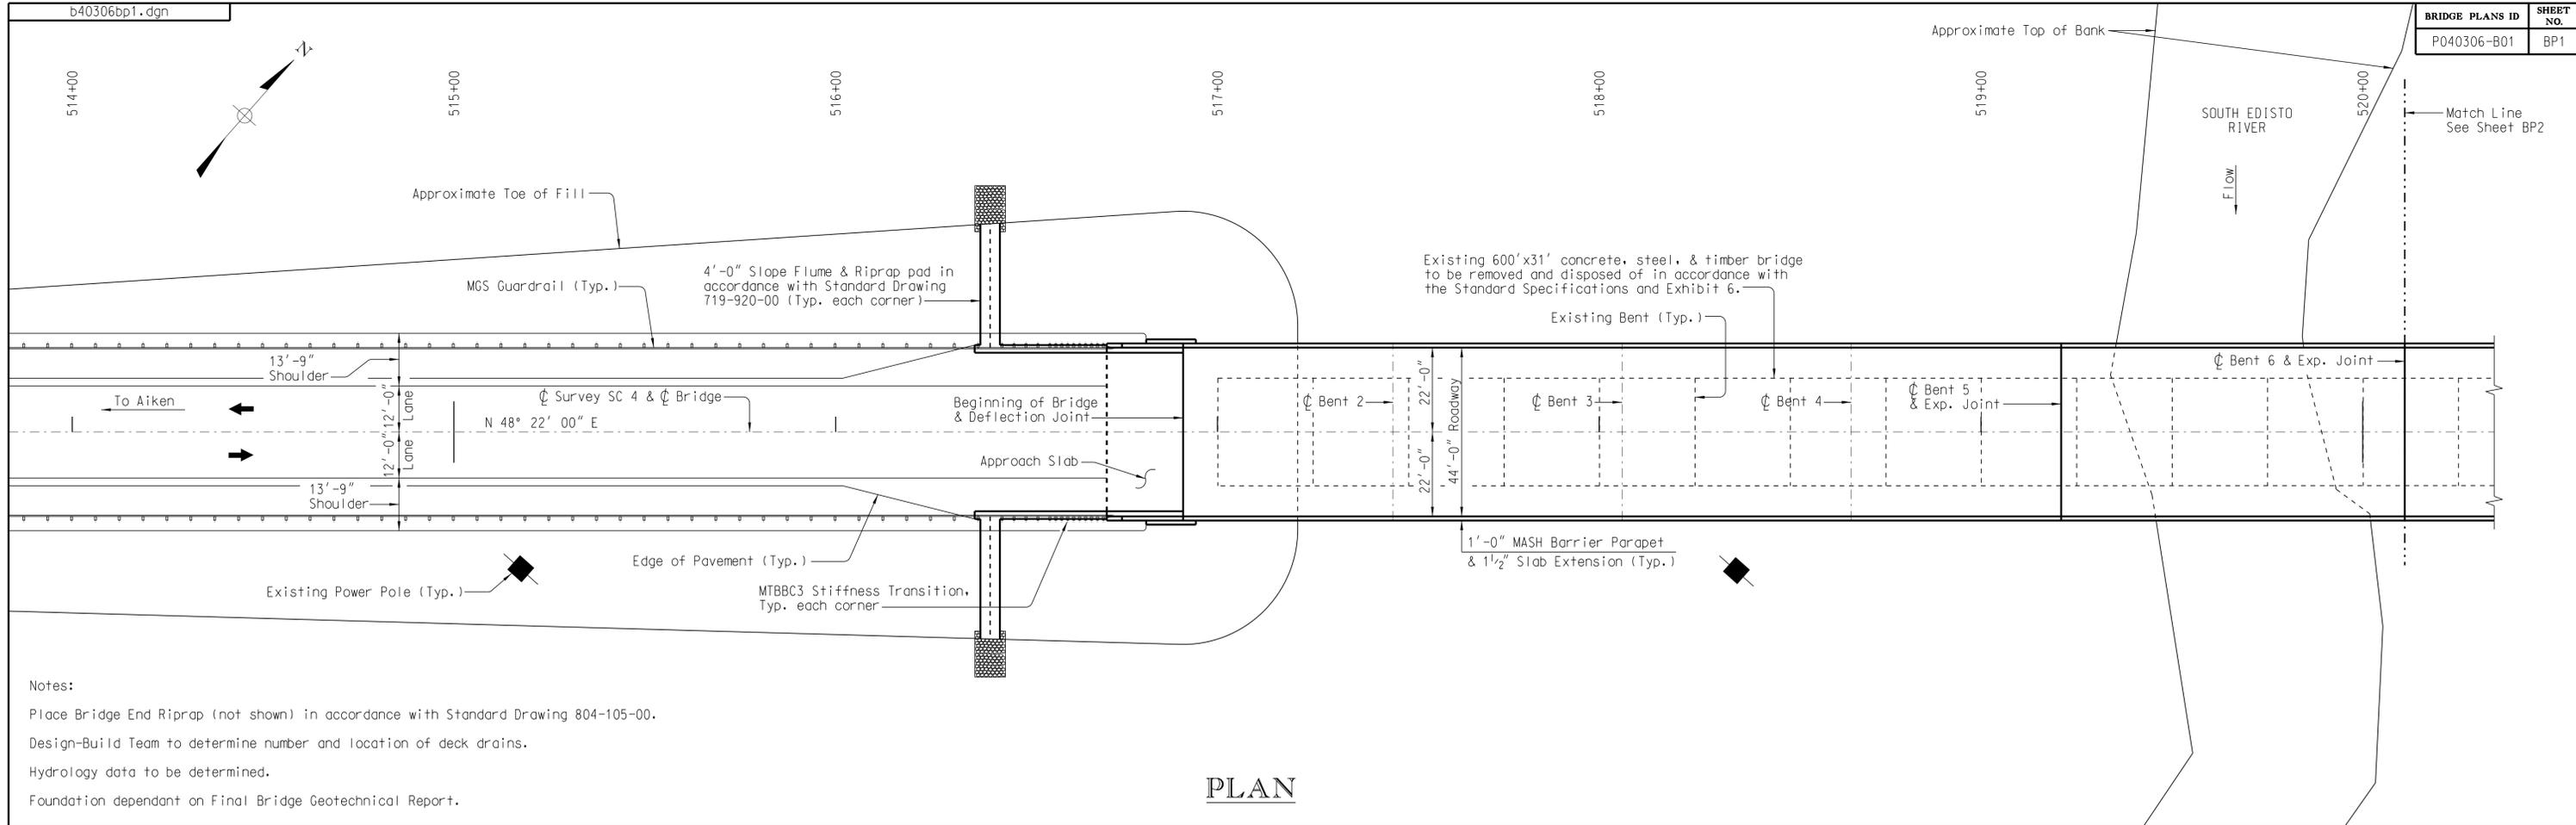
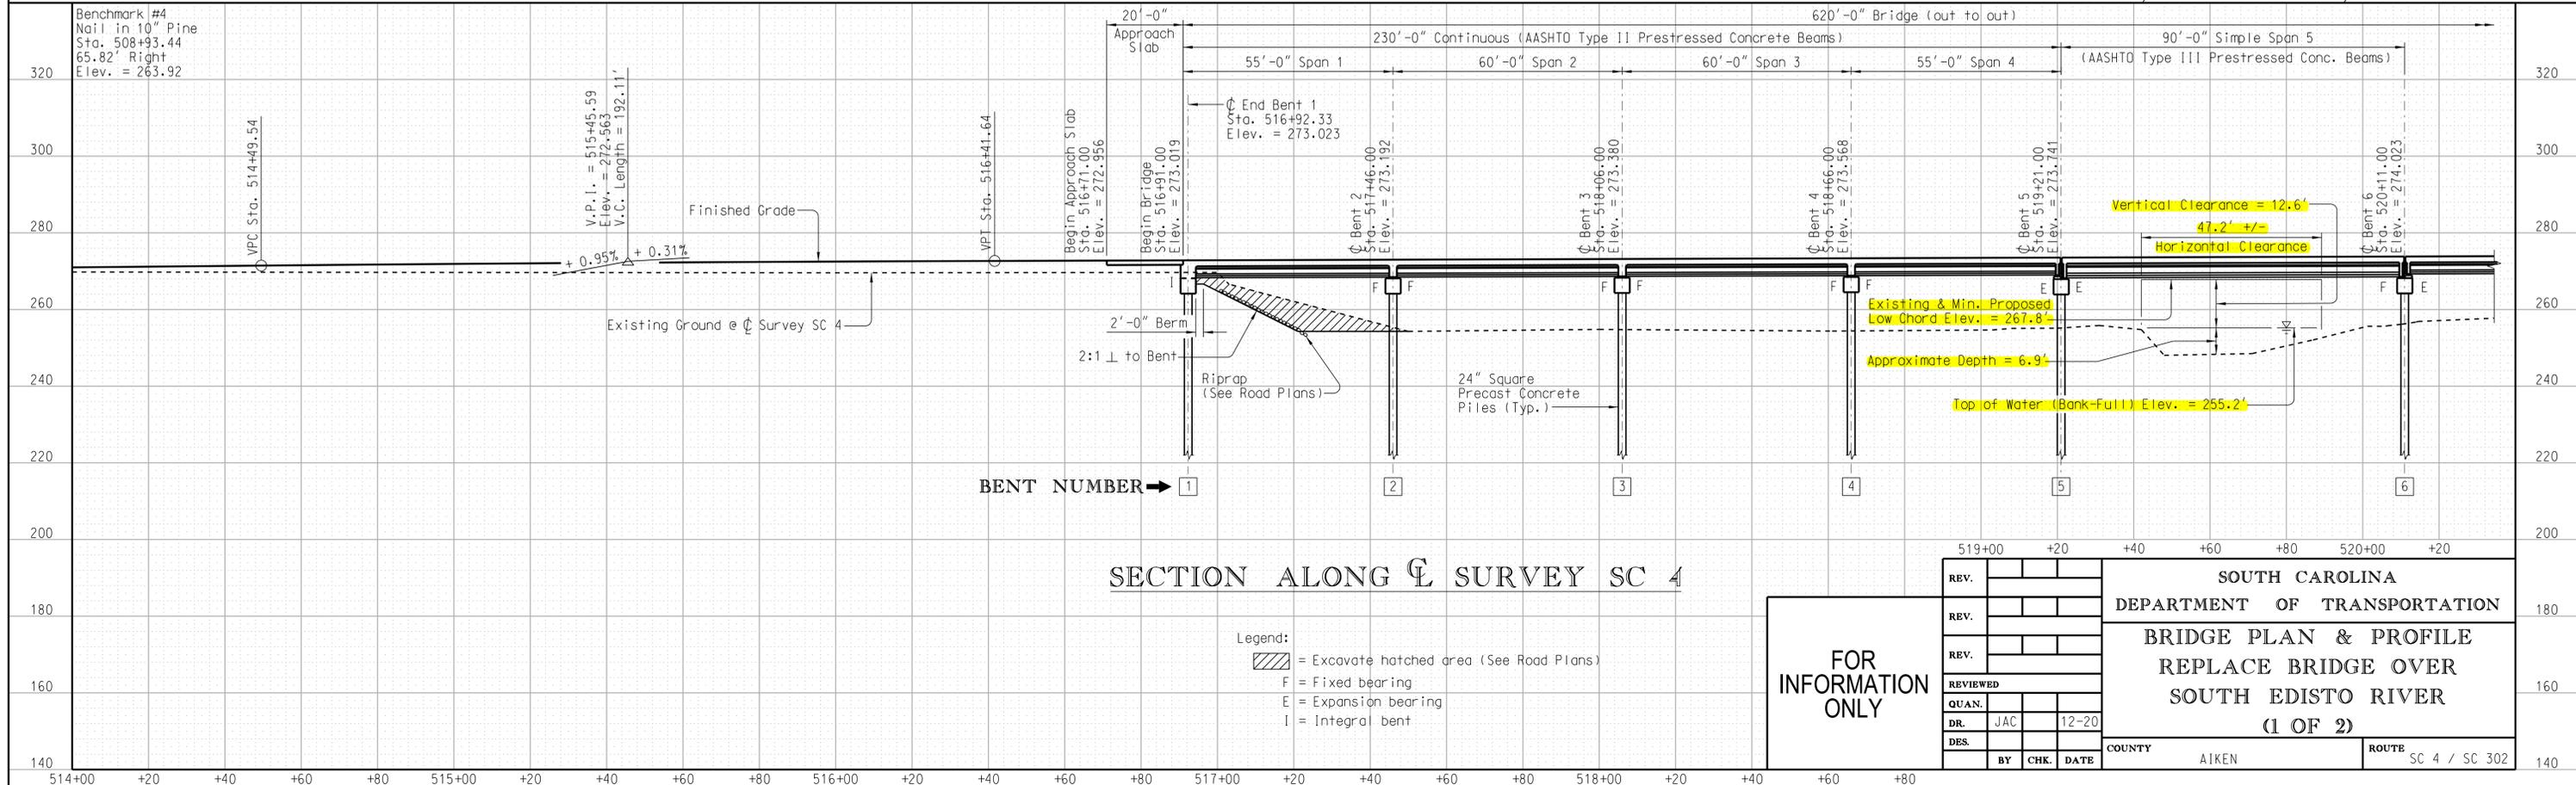
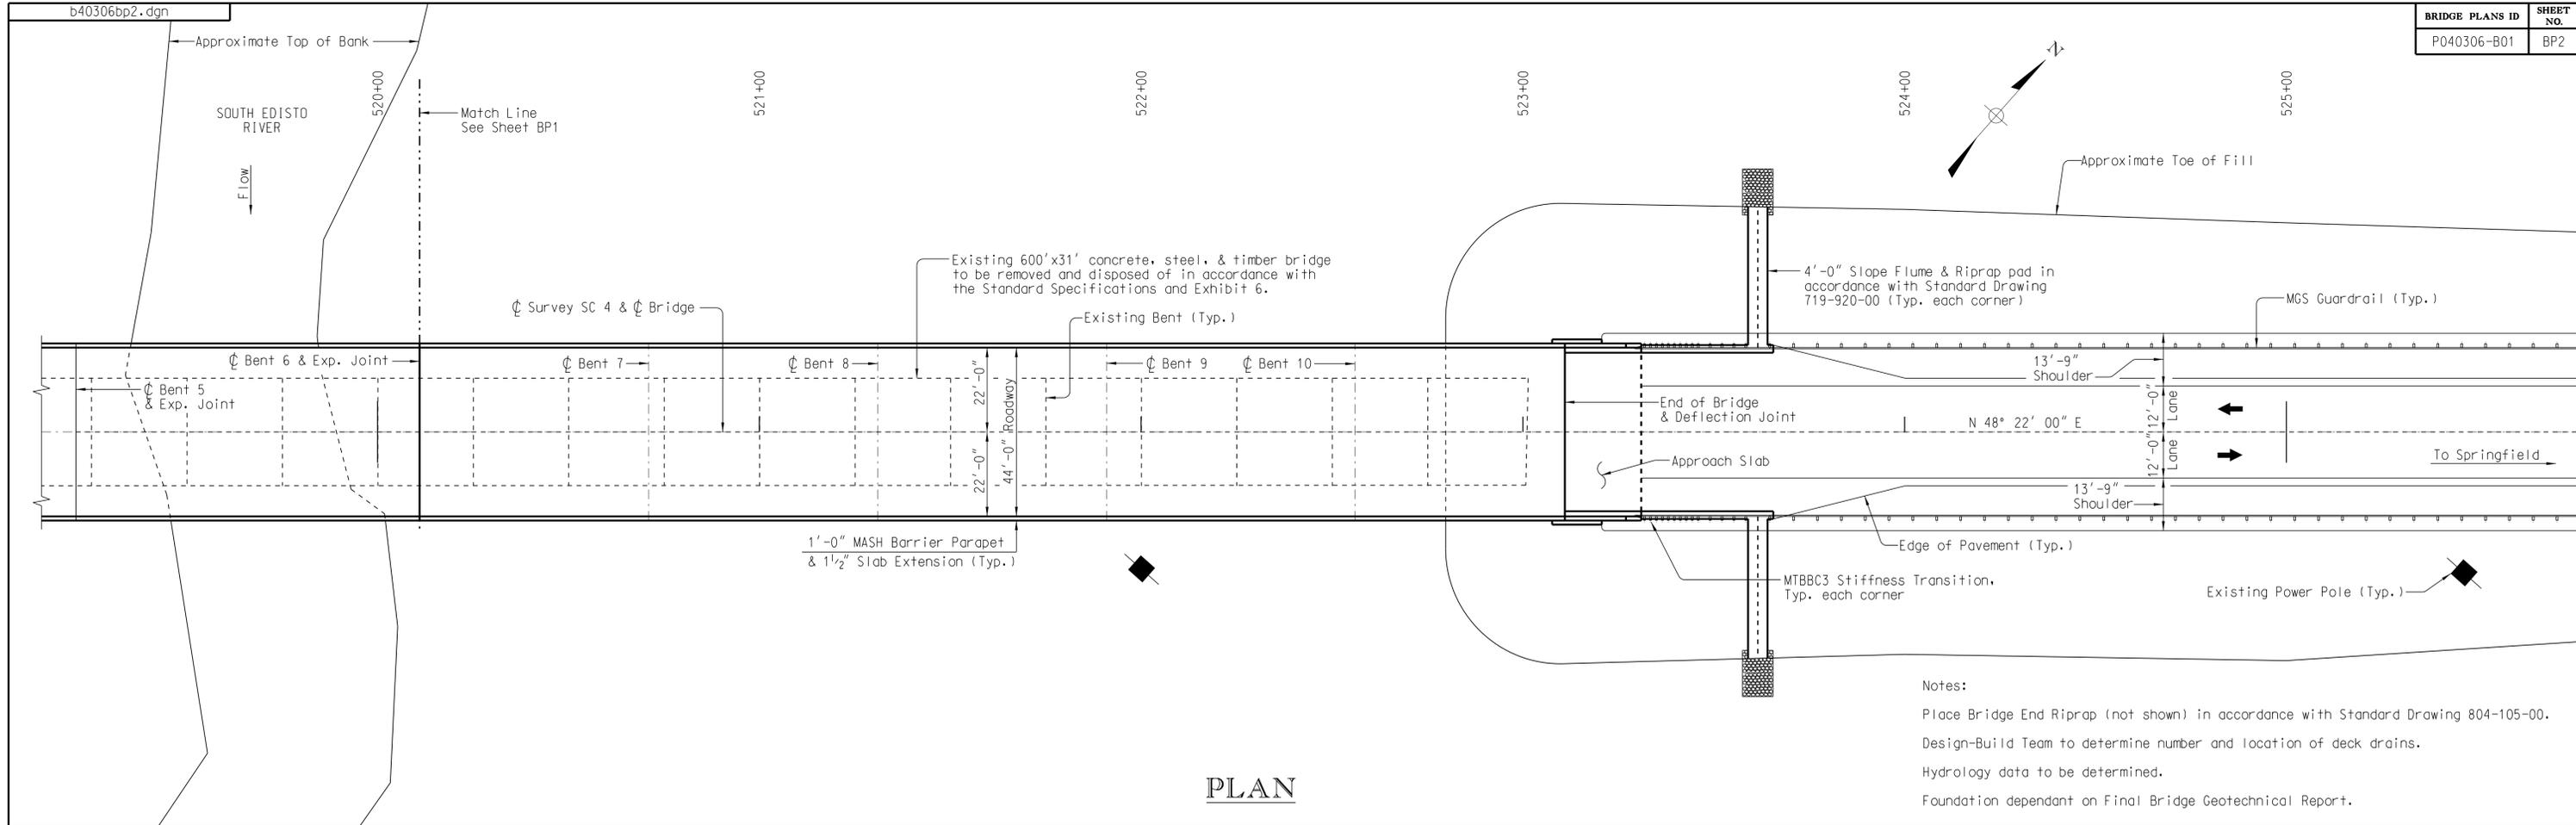
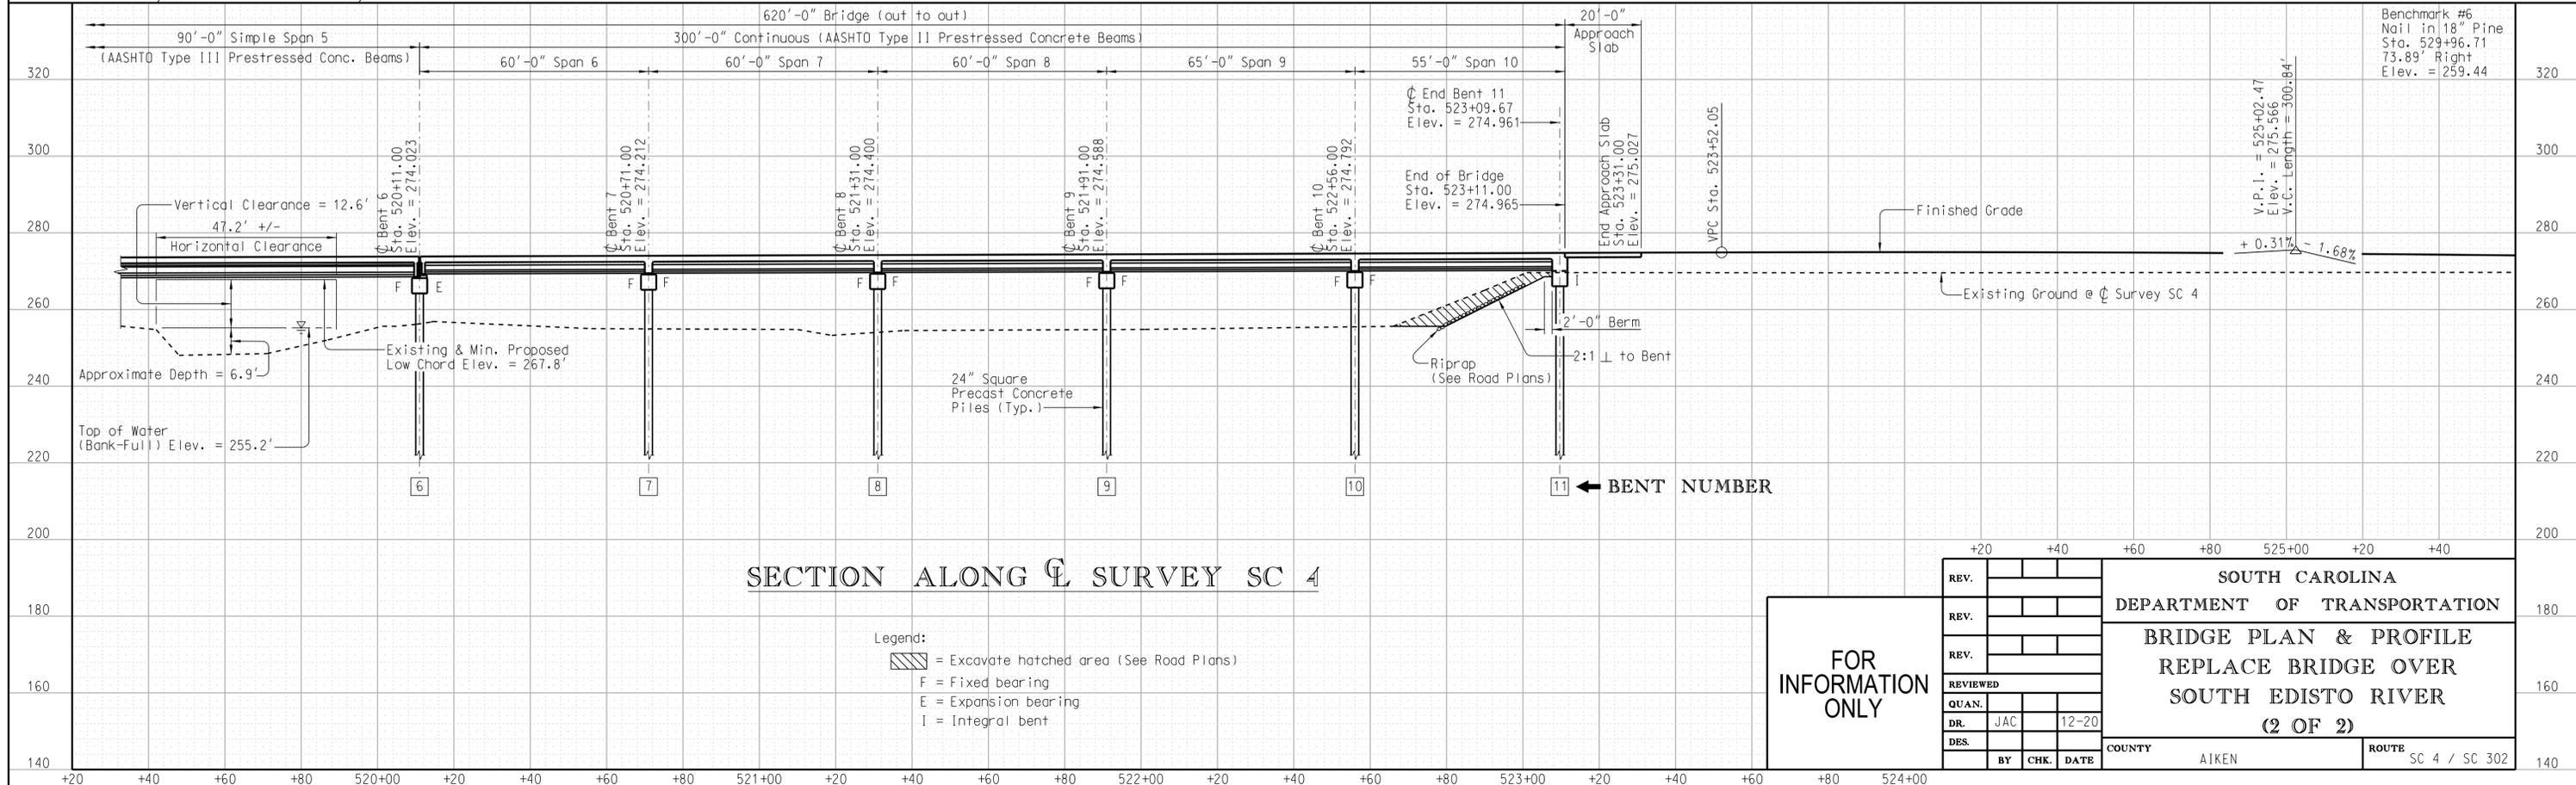
REV.				SOUTH CAROLINA DEPARTMENT OF TRANSPORTATION <b>BRIDGE PLAN &amp; PROFILE</b> <b>REPLACE BRIDGE OVER</b> <b>SOUTH EDISTO RIVER</b> <b>(2 OF 2)</b>			
REV.							
REV.							
REVIEWED							
QUAN.				COUNTY		ROUTE	
DR.	JAC		12-20	AIKEN		SC 4 / SC 302	
DES.							
BY	CHK.		DATE

Place Bridge End Riprap (not shown) in accordance with Standard Drawing 804-105-00.

Foundation dependant on Final Bridge Geotechnical Report.

SECTION ALONG CL SURVEY SC 4

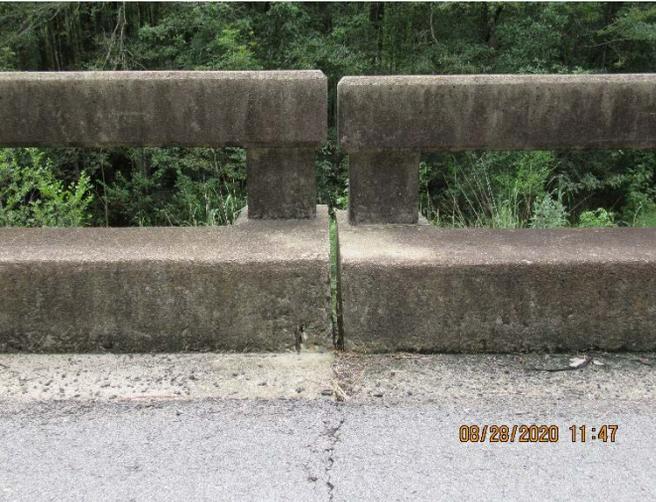
PHOTO #1 BT23 RT-SIDE OVERVIEW

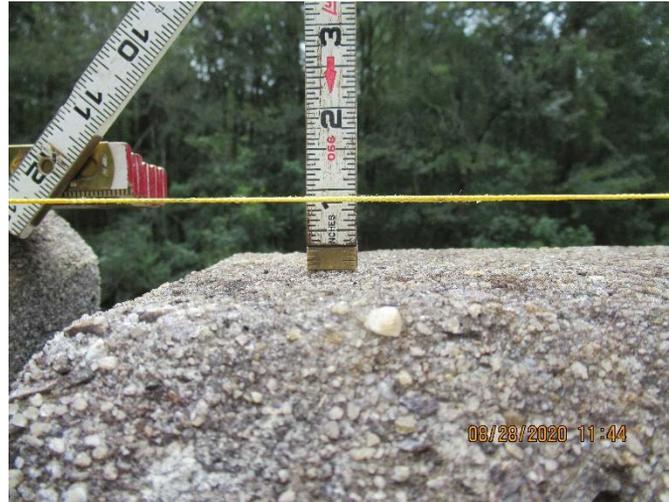
PHOTO #2 RAILING OVER BM6 SP22  
BT23= 0.875" (FEB-20 WAS 0.843")

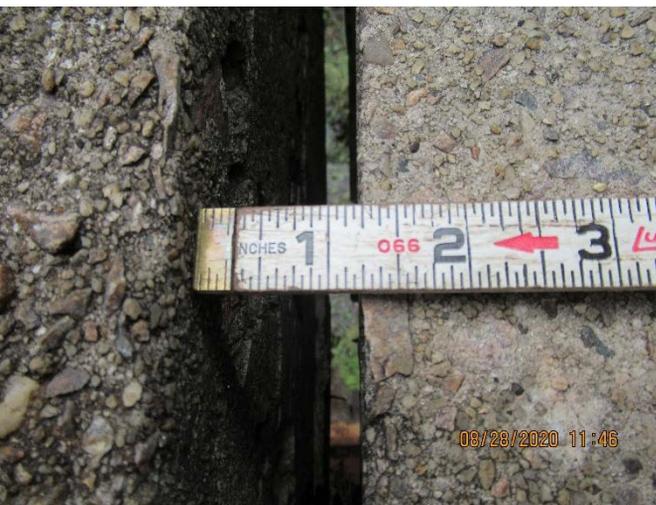
PHOTO #3 CURB GAP OVER BM AT BT23=  
1.21" (FEB-20 WAS 1.40" at 51 deg)

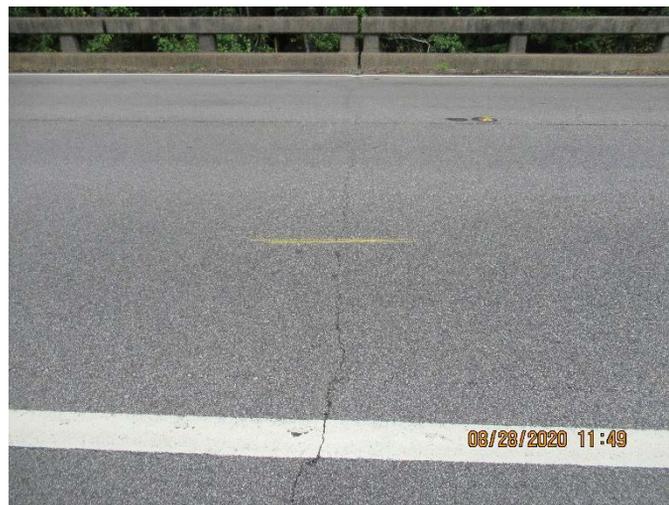
PHOTO #4 WEARING SURFACE OVER  
BT23

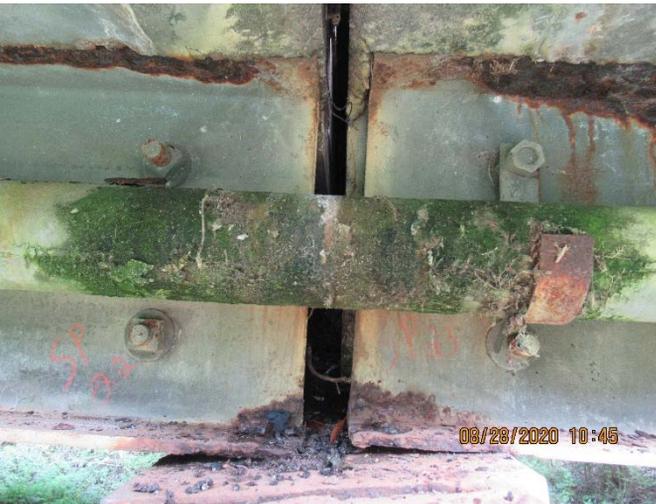
PHOTO #5 BM6 (RT-SIDE) AT BT23  
OVERVIEW

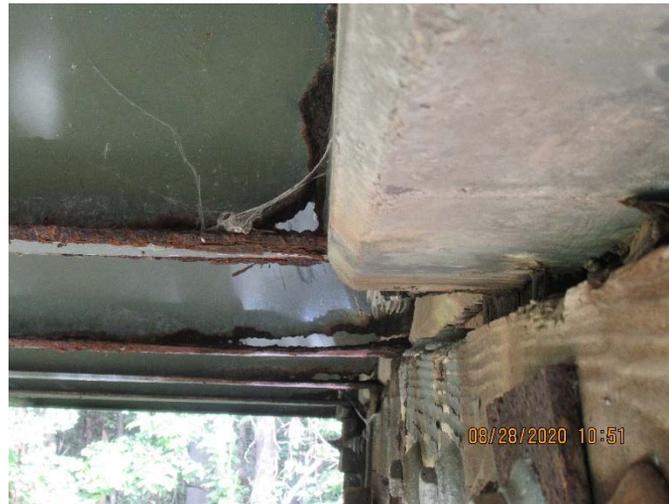
PHOTO #6 SPAN 22 BEAM ENDS AT  
BT23

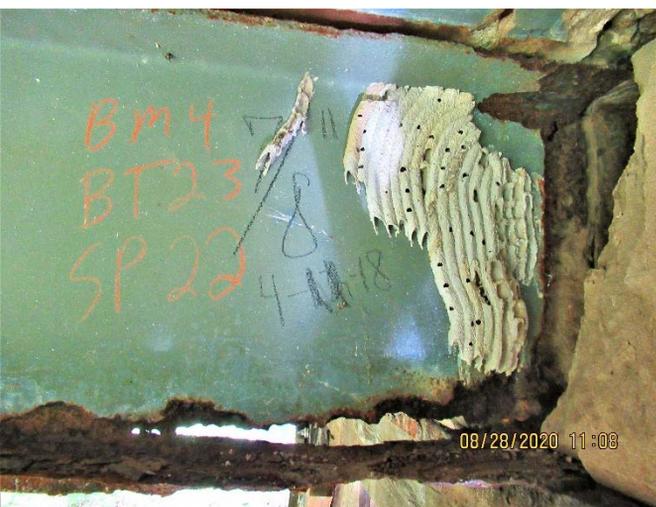
PHOTO #7 BM4 OF SP22 AT BT23=  
0.1875 DEFL+ SQUEAK UNDER LOAD

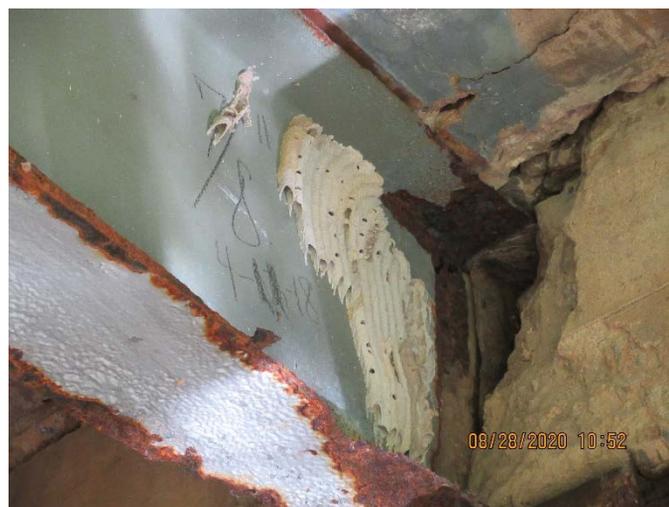
PHOTO #8 BM4 OF SP22 AT BT23= 0.1875  
DEFL+ SQUEAK UNDER LOAD (bot view)

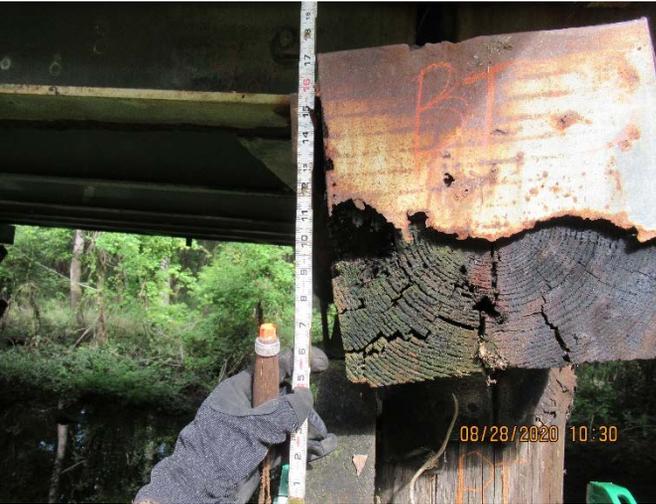
PHOTO #8 SWAY BRACING CORNER TO CAP TOP MEASUREMENT OVERVIEW= 17' 7]16"

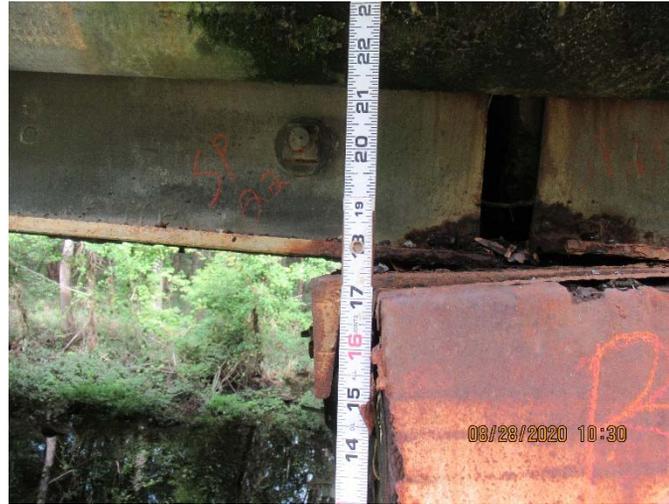
PHOTO #9 SWAY BRACING CORNER TO CAP TOP MEASUREMENT CLOSEUP= 17' 7]16"

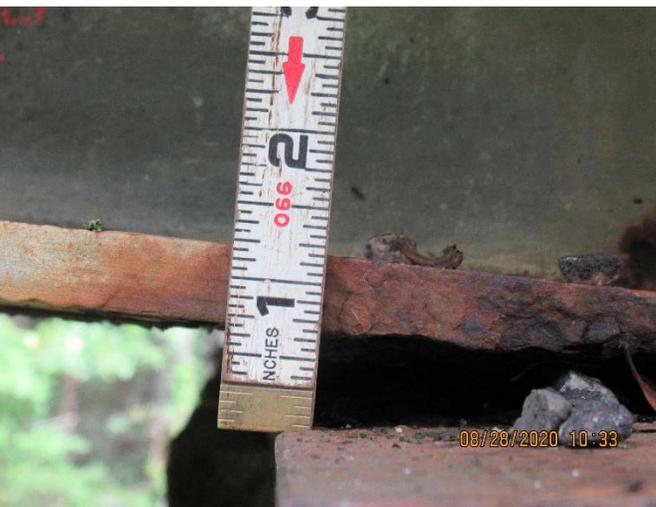
PHOTO #10 BM6 OF SP22 AT BT23= BEARING GAP

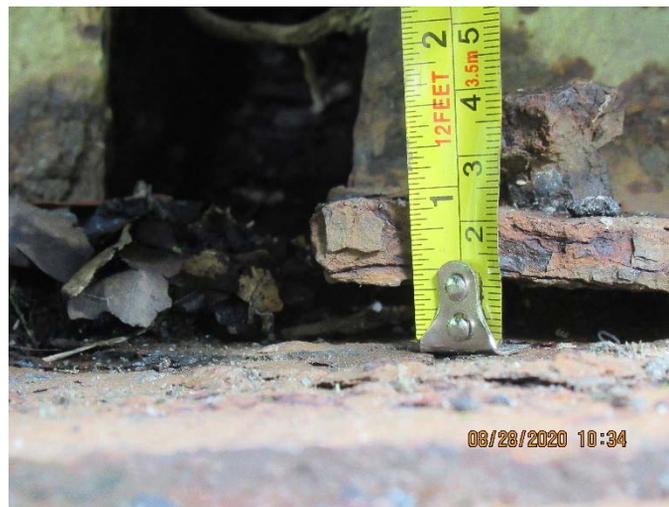
PHOTO #11 BM6 OF SP23 AT BT23= BEARING GAP

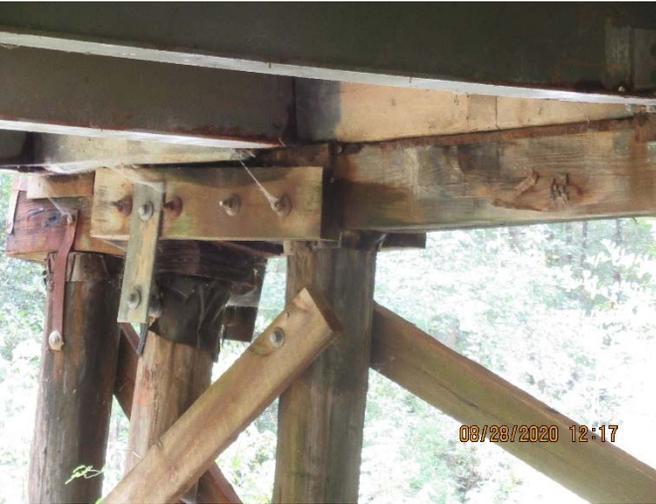
PHOTO #12 WIDENING TYP (BT23 SHOWN)

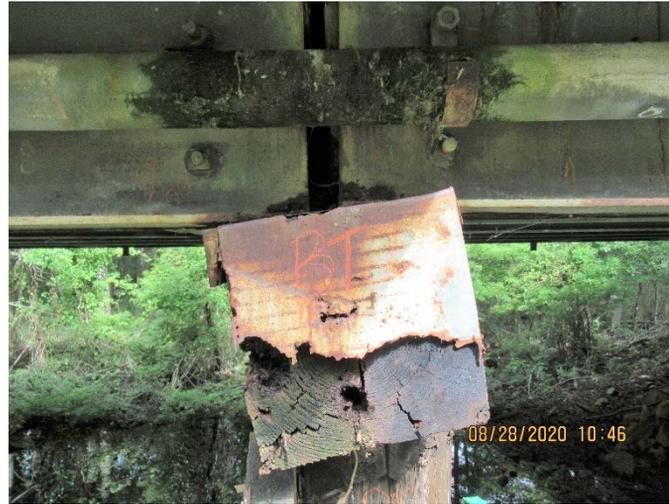
PHOTO #13 BT23 RT-SIDE CAP= ROTATION

Recent bridge inspections determined that the steel bridge girders had become detached from the deteriorated timber bent caps and that the bridge was unsafe for public travel. The bridge was closed near the beginning of December 2020 to all traffic. The bridge is located in Aiken County on SC 4. Due to the poor substructure condition, the bridge was determined to be an emergency replacement and assigned to Design-Build for delivery.

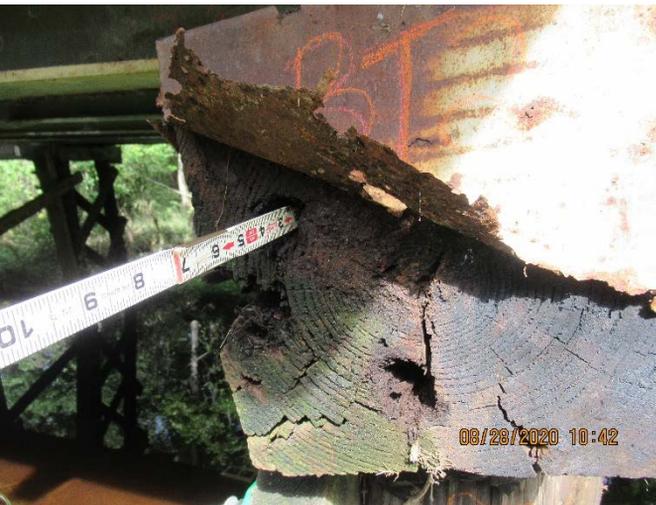
PHOTO #14 BT23 RT-SIDE CAP= 3" DECAY

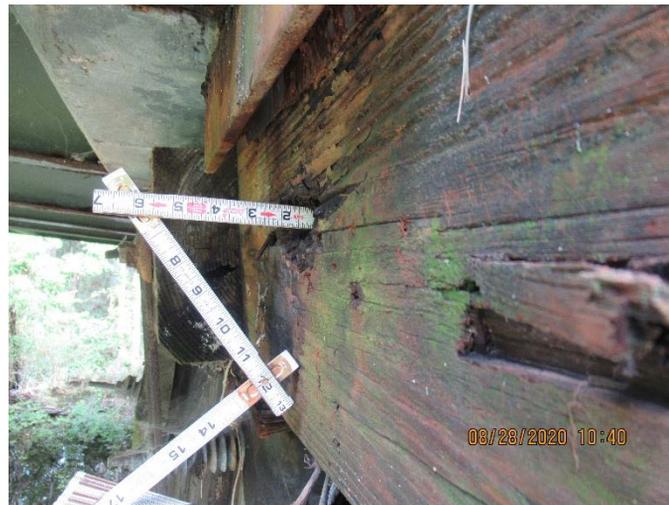
PHOTO #15 BT23 RT-SIDE= 2" HOLE AT BEG END

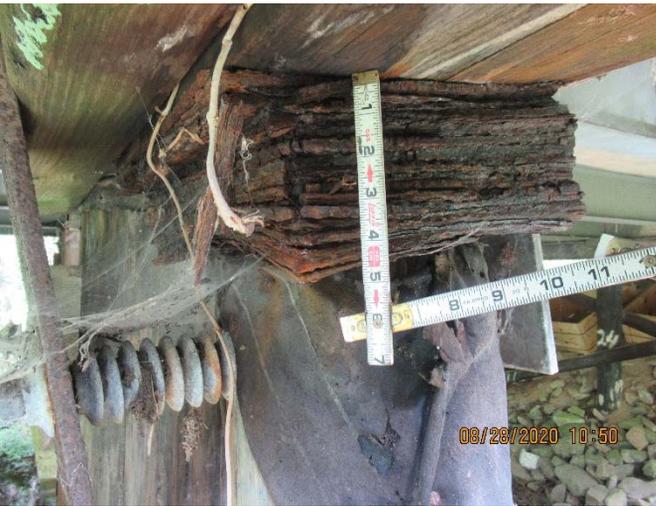
PHOTO #16 BT23 HELPER PILE 5A=  
SEVERE PACT RUST IN SHIMS

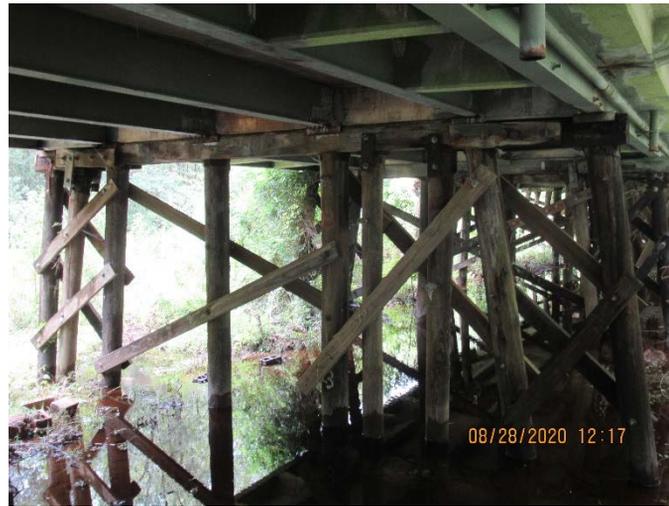
PHOTO #17 BENT TYP (23 SHOWN)

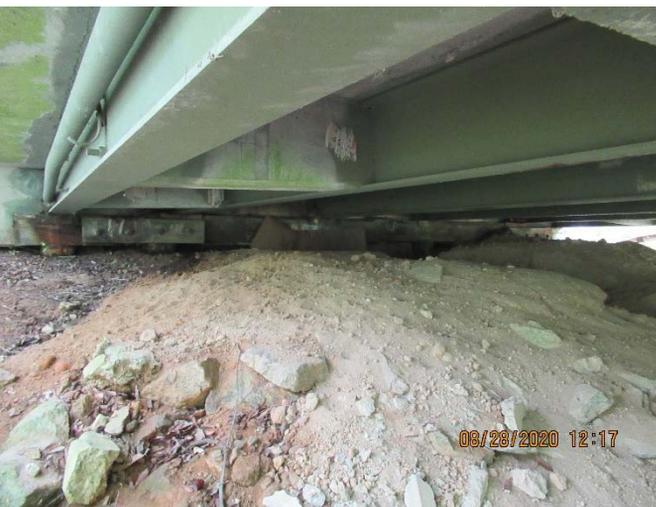
PHOTO #18 END BENT TYP

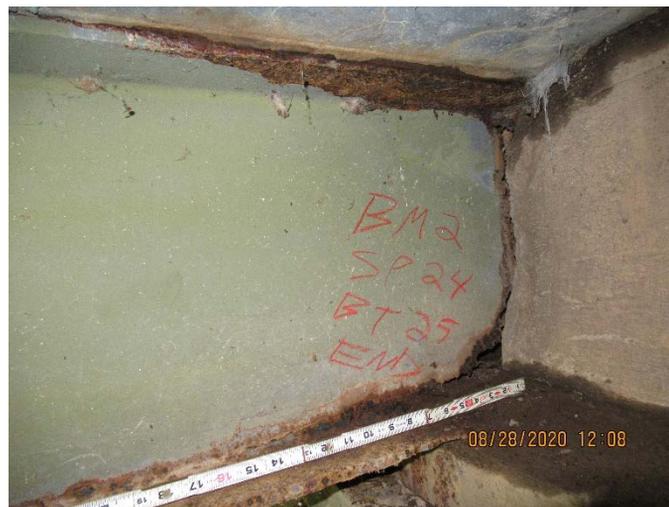
PHOTO #19 BM2 OF SP24 ON  
BT25(END)= 0.125 DEFL + SQUECK

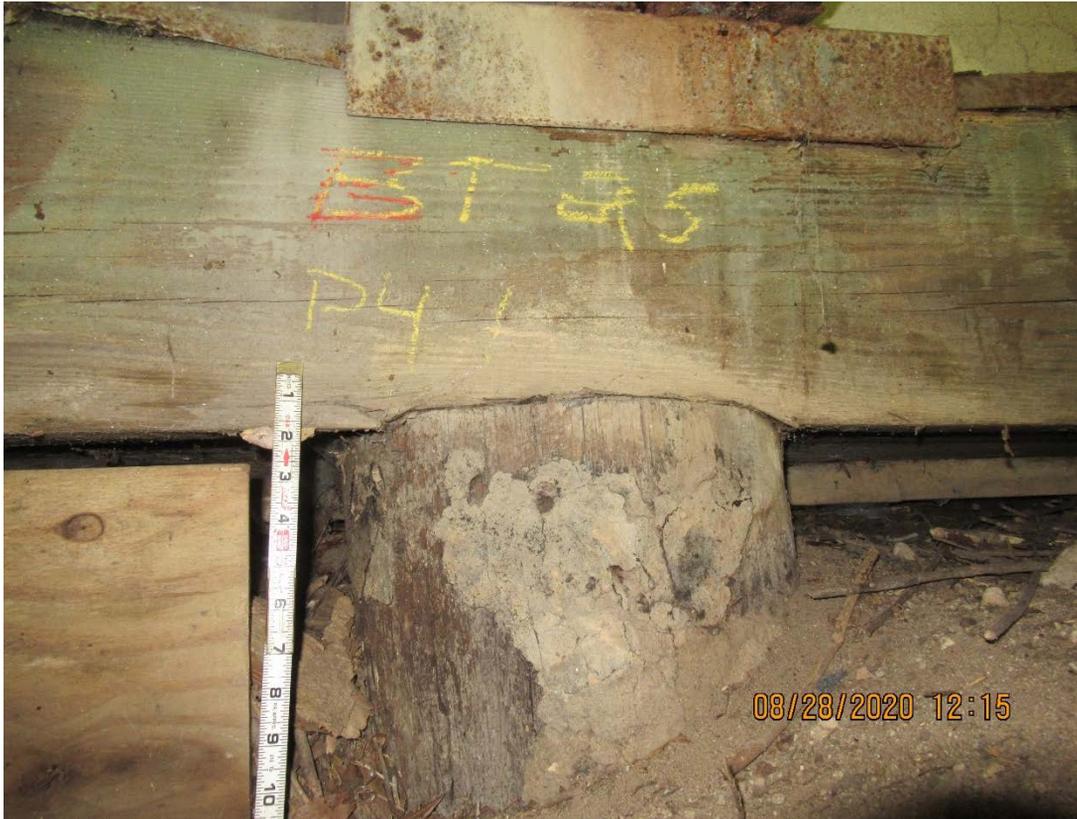
PHOTO #20 BT25 CAP OVER P4= 0.5" OF CRUSHING

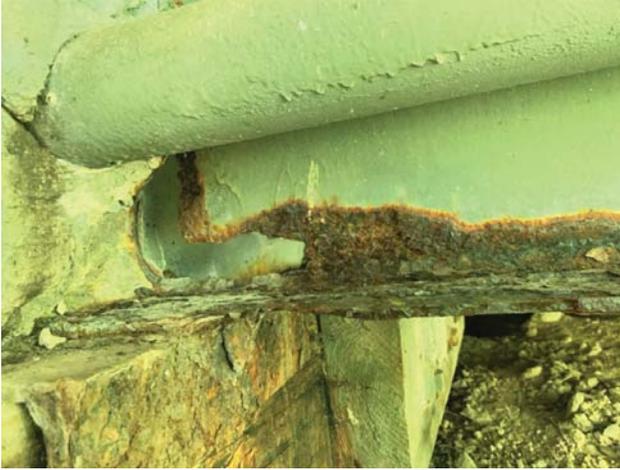
Typical section loss with holes on web. See table condition for more details

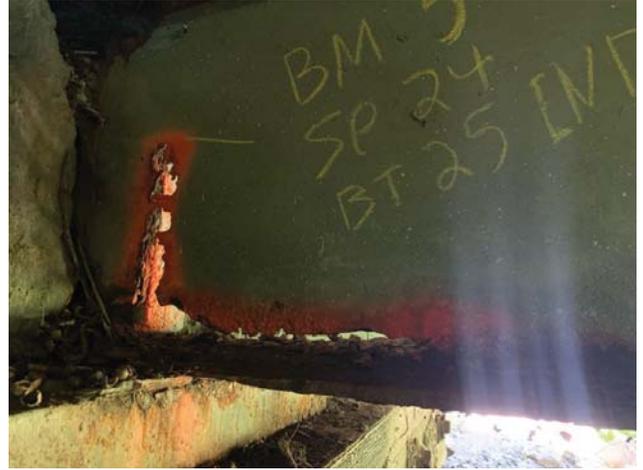
Typical section loss with holes on web. See table condition for more details

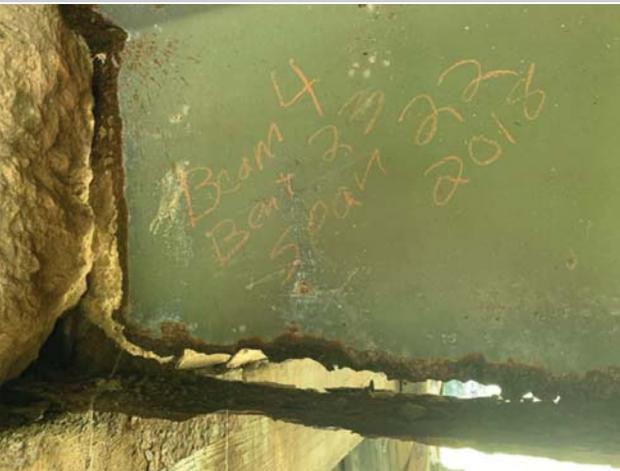
Typical section loss with holes on web. See table condition for more details

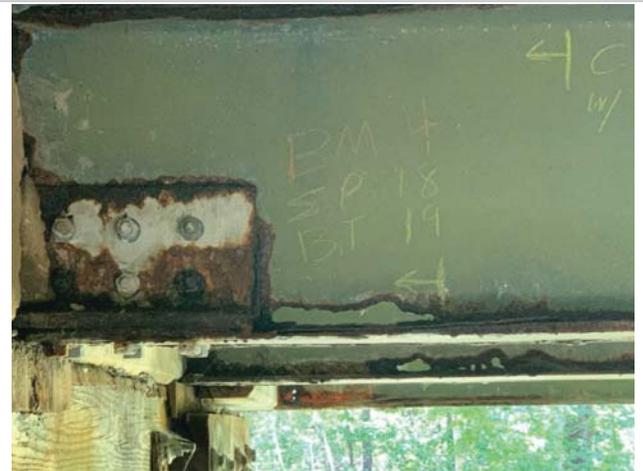
Typical section loss with holes on web. See table condition for more details

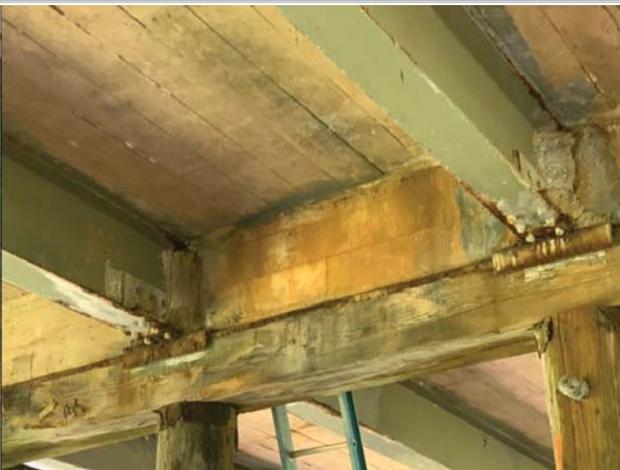
Temporary repair plates throughout. See table for locations

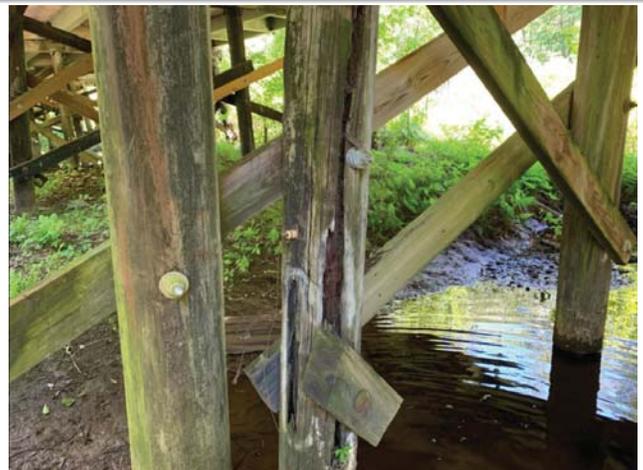
Bent 13 pile 3 south face at base, decay (10in x 5ft x 3in) (sister pile attached)

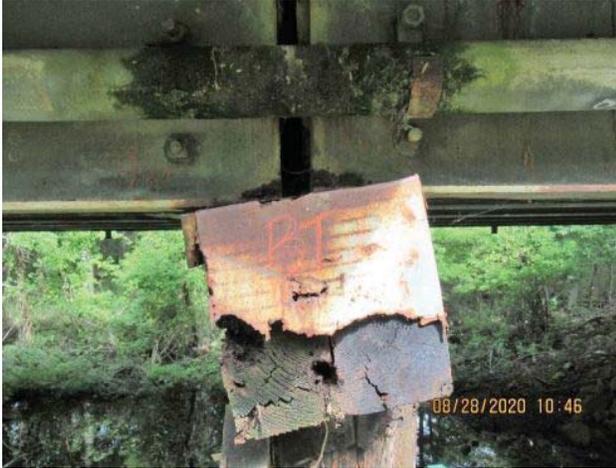
Rotation on bent 23 cap under beams 5 and 6

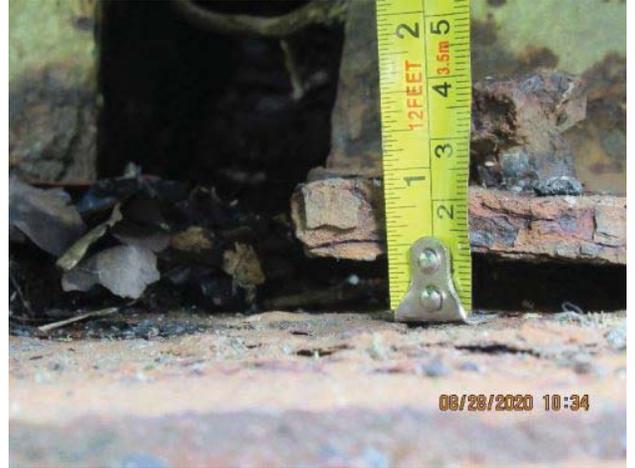
Gap between beams and cap at bent 23

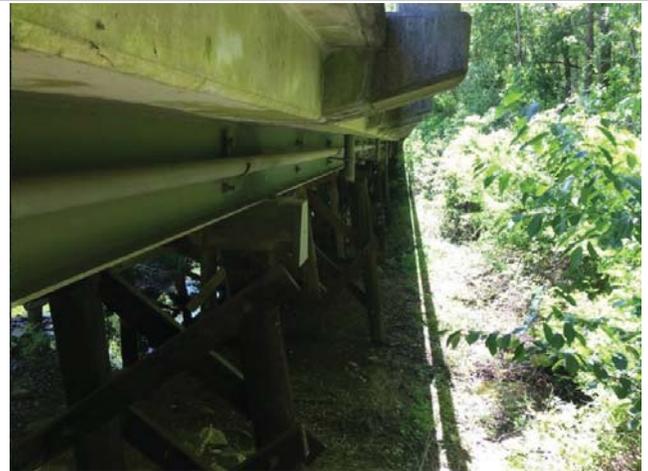
3.5" steel pipe attached to beam 1

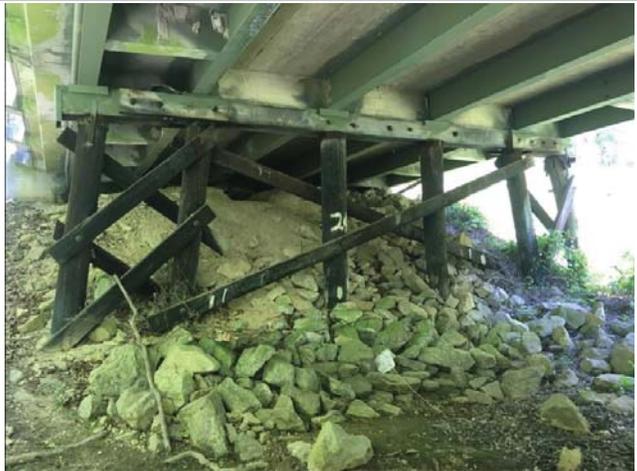
Typical interior bents

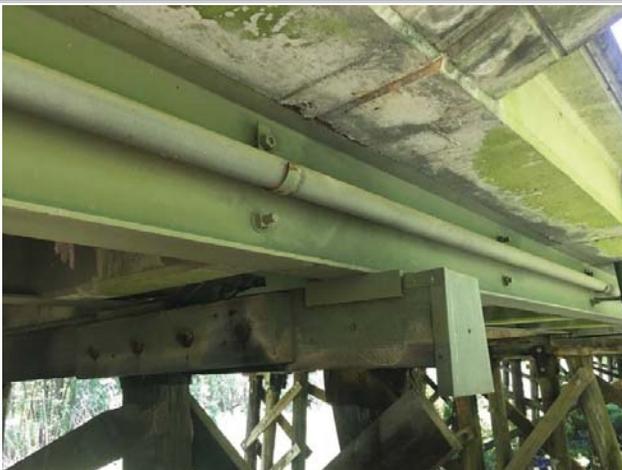
Girders continuous over every other bent. 12 (2) span continuous.
