Preliminary Geotechnical Data Report

Emergency Bridge Package 3 – SC 34 Bridge Replacement over Heller’s Creek Newberry County, South Carolina

November 10, 2015 (Rev. 2)
Terracon Project No. 73155050F

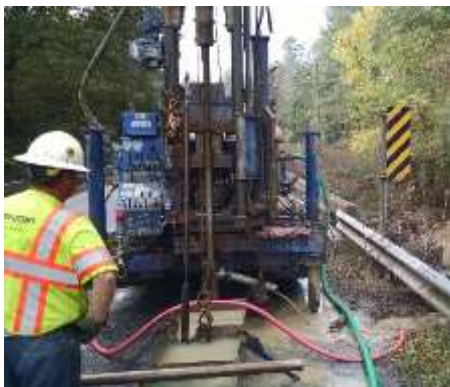
Photo 1. Drill rig at STB-1 (SC-34)

Our field exploration at the site consisted of two (2) Standard Penetration Test (SPT) Borings (STB-1, STB-2) at the general test locations provided to Terracon by the SCDOT. A description of our testing methods and graphical logs outlining the soil conditions at each test location are presented in Appendix A. The test locations were established in the field by Terracon and surveyed by Construction Support Services, LLC, after completion. At the time of our field exploration, the roadway in the area of the bridge was closed due to a washout on the east side of the bridge. The set up at each boring is provided in the photographs below.

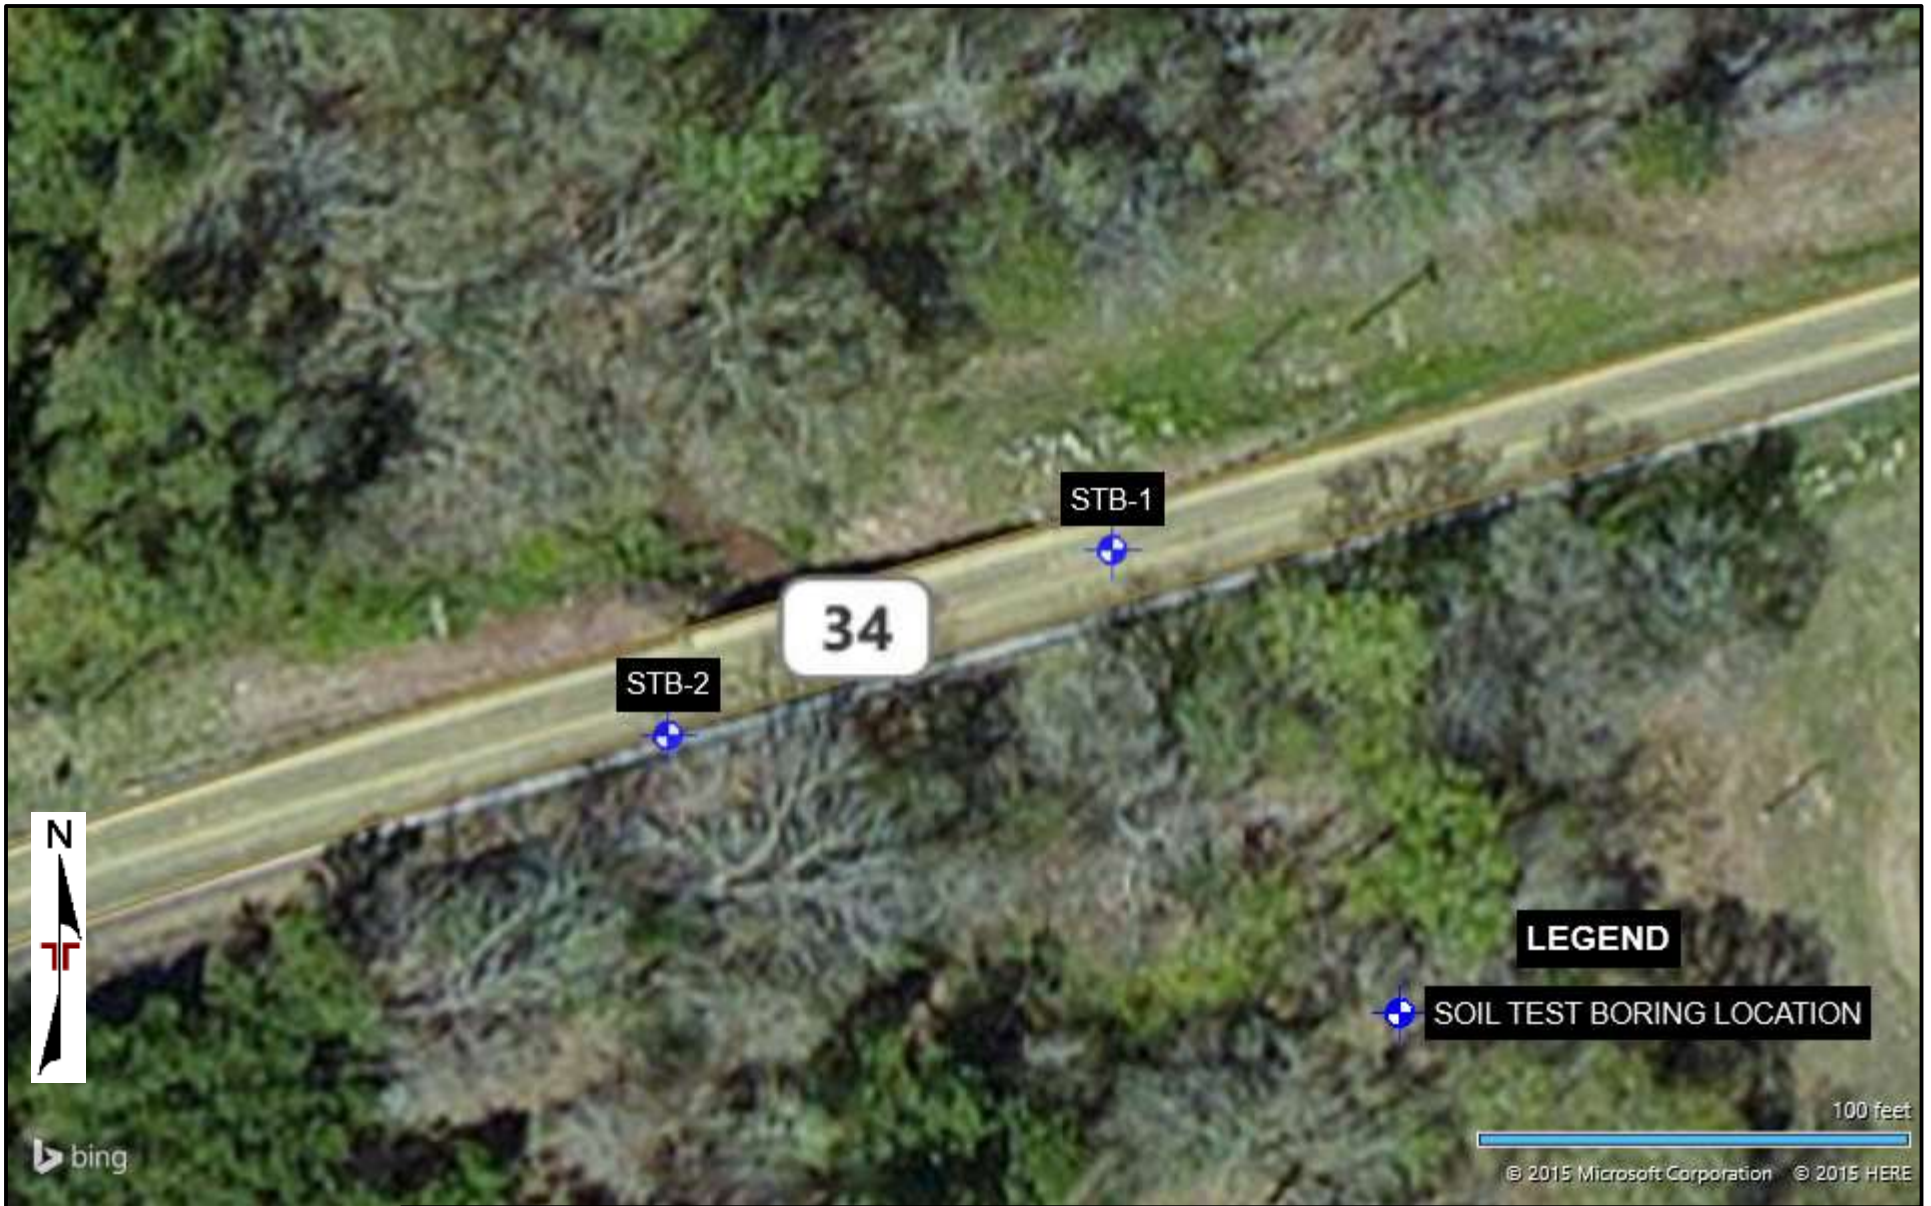
EXPLORATION PLAN

Between October 29 and October 30 2015, two (2) soil test borings (designated STB-1 and STB-2) were performed at the bridge location. Borings STB-1 and STB-2 were performed approximately 10 feet to the east and west of the ends of the existing bridge, respectively, as shown on Exhibit A-2 in Appendix A.

The testing locations were provided by the SCDOT and located in the field by Terracon by taking measurements from the existing bridge. The borings were surveyed by Construction Support Services, LLC after drilling was complete. The locations are shown on the Exploration Plan (Exhibit A-2).

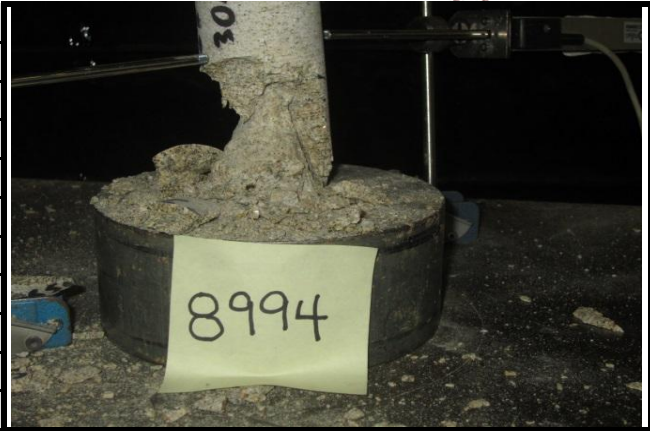
Slightly Weathered Granite

Core Length		Core Diameter		L/D Ratio	Mass g	Density	
in	cm	in	cm			lb/ft ³	g/cm ³
4.11	10.44	1.98	5.03	2.08	539.7	162.48	2.60

Failure Load	Failure Stress	Elastic Modulus, E		Poisson's Ratio, v
lbs	psi	ksi	Gpa	
31,425	10,206	933	6.4	0.12

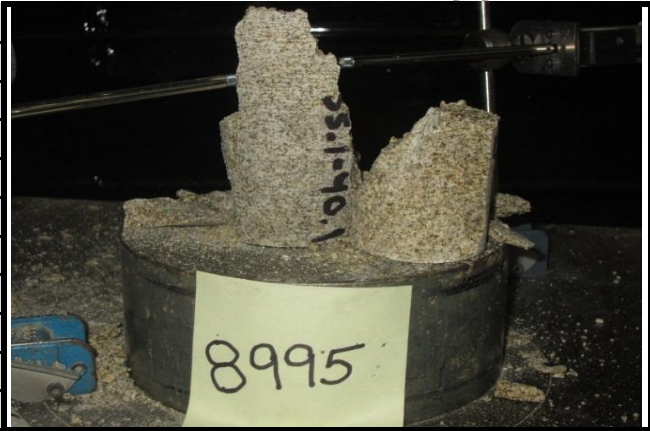
Slightly Weathered Granite

Core Length		Core Diameter		L/D Ratio	Mass g	Density	
in	cm	in	cm			lb/ft ³	g/cm ³
3.97	10.08	1.98	5.03	2.01	510.6	159.14	2.55

Failure Load	Failure Stress	Elastic Modulus, E		Poisson's Ratio, v
lbs	psi	ksi	Gpa	
17,136	5,565	375	2.6	0.19

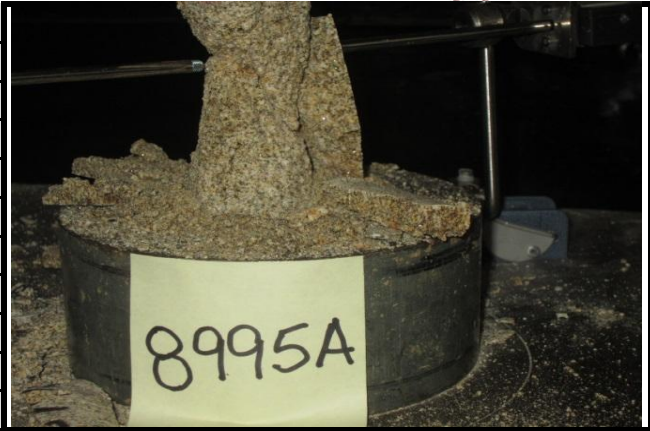
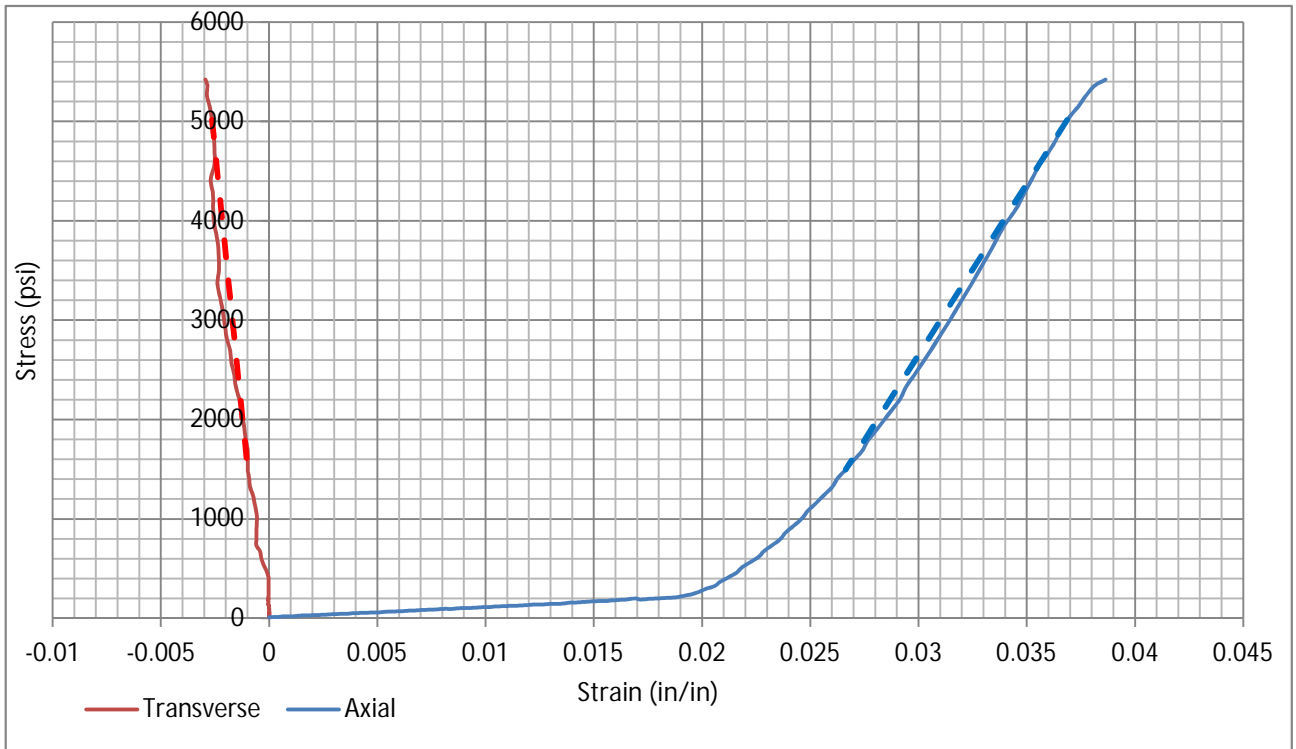
Slightly Weathered Granite

Core Length		Core Diameter		L/D Ratio	Mass g	Density	
in	cm	in	cm			lb/ft ³	g/cm ³
3.96	10.06	1.98	5.03	2.00	509.7	159.25	2.55

Failure Load	Failure Stress	Elastic Modulus, E		Poisson's Ratio,
lbs	psi	ksi	Gpa	v
16,692	5,421	344	2.4	0.16

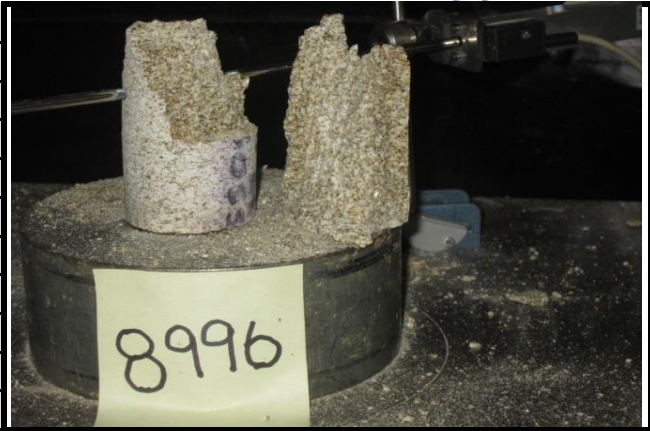
Slightly Weathered Granite

Core Length		Core Diameter		L/D Ratio	Mass g	Density	
in	cm	in	cm			lb/ft ³	g/cm ³
3.98	10.11	1.98	5.03	2.01	518.3	161.12	2.58

Failure Load	Failure Stress	Elastic Modulus, E		Poisson's Ratio, v
lbs	psi	ksi	Gpa	
18,528	6,018	486	3.4	0.22

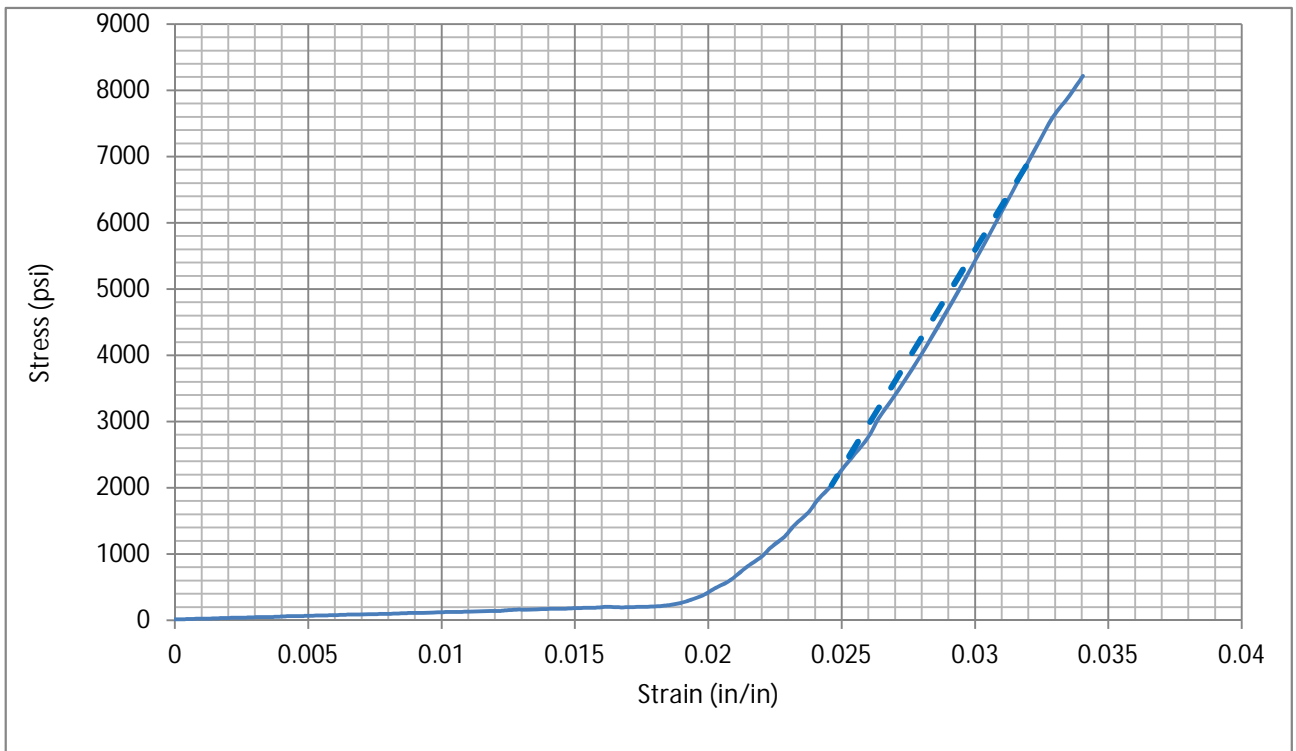
Exhibit: B-9

Slightly Weathered Granite

Core Length		Core Diameter		L/D Ratio	Mass g	Density	
in	cm	in	cm			lb/ft ³	g/cm ³
3.98	10.11	1.98	5.03	2.01	520.3	161.74	2.59

Unconfined Compressive Strength		Failure Load	Failure Strain
psi	kPa		
8,218	56,660	25,303	3.40
Elastic Modulus, E			
		ksi	Gpa
		661	4.6

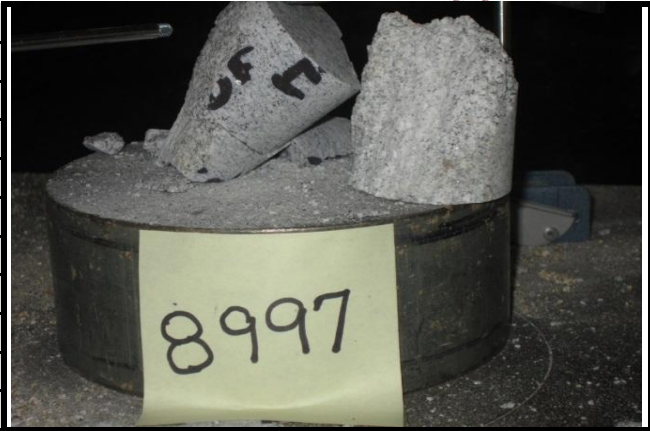
Granite

Core Length		Core Diameter		L/D Ratio	Mass g	Density	
in	cm	in	cm			lb/ft ³	g/cm ³
4.02	10.21	1.98	5.03	2.03	534.5	164.51	2.64

Failure Load	Failure Stress	Elastic Modulus, E		Poisson's Ratio,
lbs	psi	ksi	Gpa	v
84,978	27,599	1,734	12.0	0.09

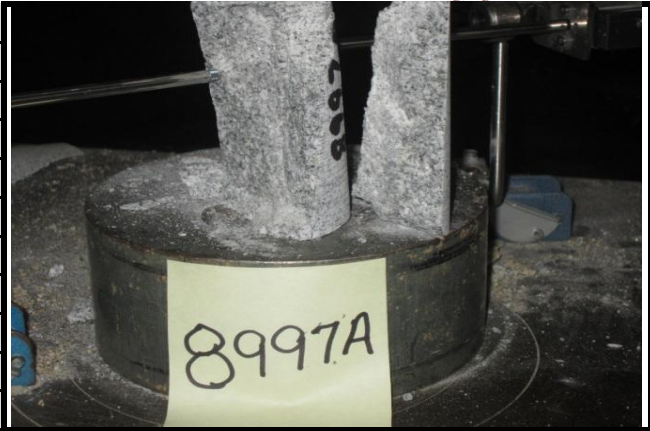
Exhibit: B-11

Granite

Core Length		Core Diameter		L/D Ratio	Mass g	Density	
in	cm	in	cm			lb/ft ³	g/cm ³
3.96	10.06	1.98	5.03	2.00	529.3	165.38	2.65

Unconfined Compressive Strength		Failure Load	Failure Strain
psi	kPa		
11,539	79,555	35,528	1.53
Elastic Modulus, E			
	ksi	Gpa	
	1,235	8.5

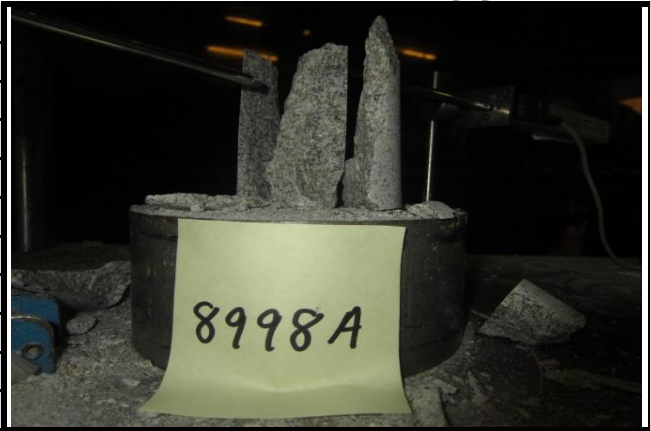
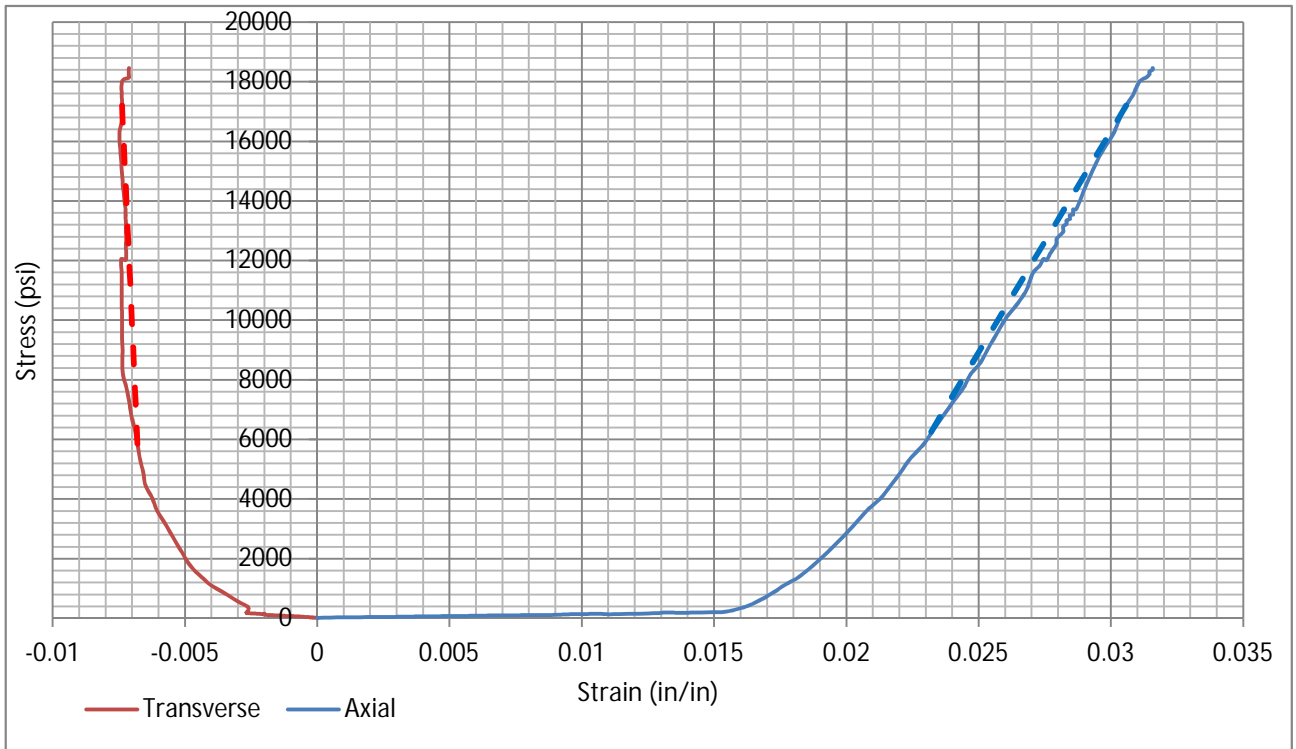
Granite

Core Length		Core Diameter		L/D Ratio	Mass g	Density	
in	cm	in	cm			lb/ft ³	g/cm ³
3.99	10.13	1.98	5.03	2.02	527.2	163.48	2.62

Failure Load	Failure Stress	Elastic Modulus, E		Poisson's Ratio, v
lbs	psi	ksi	Gpa	
56,832	18,458	1,485	10.2	0.08

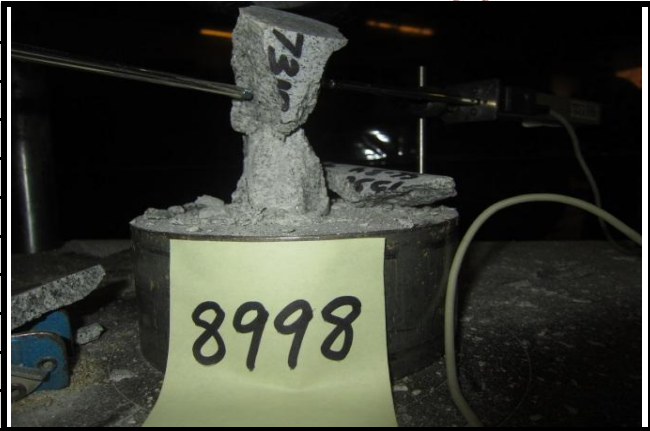
Exhibit: B-13

Granite

Core Length		Core Diameter		L/D Ratio	Mass g	Density	
in	cm	in	cm			lb/ft ³	g/cm ³
3.98	10.11	1.98	5.03	2.01	526.2	163.56	2.62

Unconfined Compressive Strength		Failure Load	Failure Strain
psi	kPa		
21,268	146,641	65,487	3.28
Elastic Modulus, E			
ksi	Gpa		
1,434	9.9

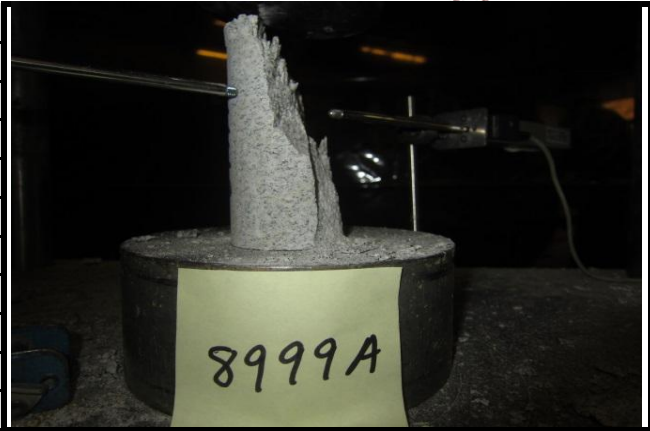
Granite

Core Length		Core Diameter		L/D Ratio	Mass g	Density	
in	cm	in	cm			lb/ft ³	g/cm ³
3.97	10.08	1.98	5.03	2.01	528.2	164.61	2.64

Failure Load	Failure Stress	Elastic Modulus, E		Poisson's Ratio, v
lbs	psi	ksi	Gpa	
57,023	18,519	1,573	10.8	0.05

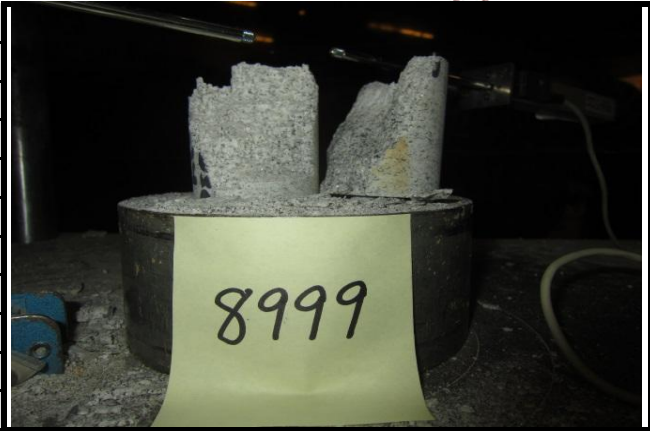
Exhibit: B-15

Granite

Core Length		Core Diameter		L/D Ratio	Mass g	Density	
in	cm	in	cm			lb/ft ³	g/cm ³
4.01	10.19	1.98	5.03	2.03	532.8	164.38	2.63

Unconfined Compressive Strength		Failure Load	Failure Strain
psi	kPa	lbs	%
17,138	118,164	52,770	2.44
Elastic Modulus, E			
ksi		Gpa	
1,667		11.5
