Phase I Cultural Resources Survey of Approximately 12 Miles of Improvements Along I-85

Cherokee County, South Carolina

October 10, 2016 • **Draft Report**
New South Associates Technical Report 2589

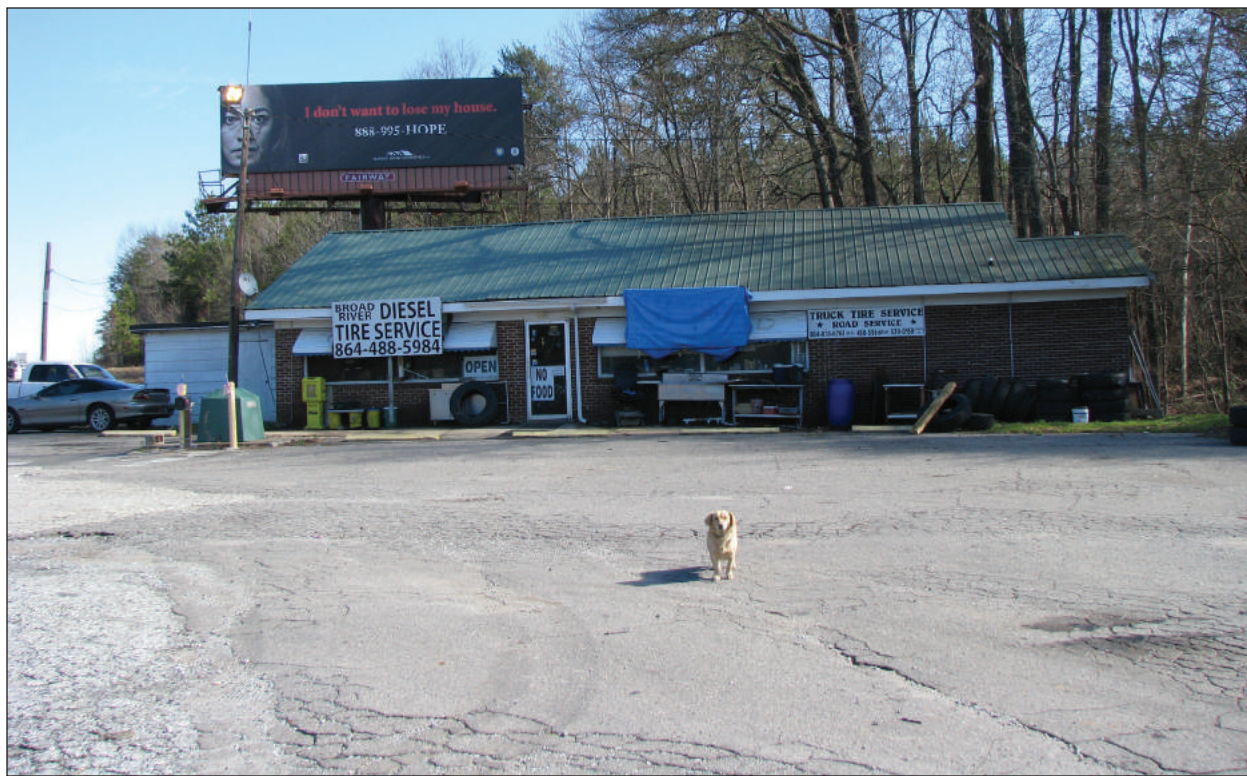
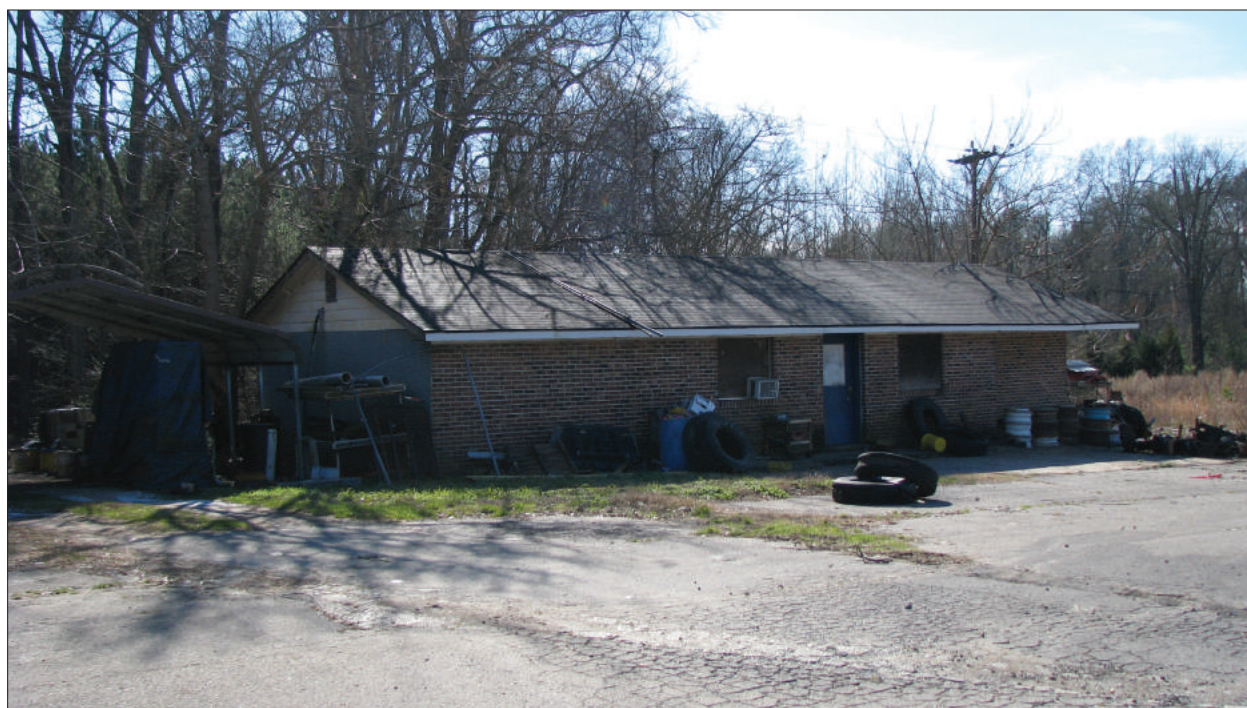
Figure 5.
415 Milliken/Frontage Road (U/21/0247 and U/21/0247.01)

Resources U/21/0247 and U/21/0247.01 are a former restaurant and gas station located at 415 Milliken (Frontage) Road on the south side of I-85, just off the highway at Exit 98 (Figure 5A-B and 6A-B). According to the current owner of the Broad River Truck and Trailer Repair business and other local residents, the buildings were originally constructed circa 1965 as the Broad River Truck Stop. The restaurant apparently remained in operation until the 1980s or early 1990s and the property was filmed in a scene of the 1983 3-D cult trucker movie “Hit the Road Running” (Bill Pennington, personal communication, February 2016). Various subsequent owners have used the former restaurant building as an automobile repair shop up to the present. The former gas station is currently vacant.

A. Restaurant (U/21/0247), View to East

B. Gas Station (U/21/0247.01), View to Southwest

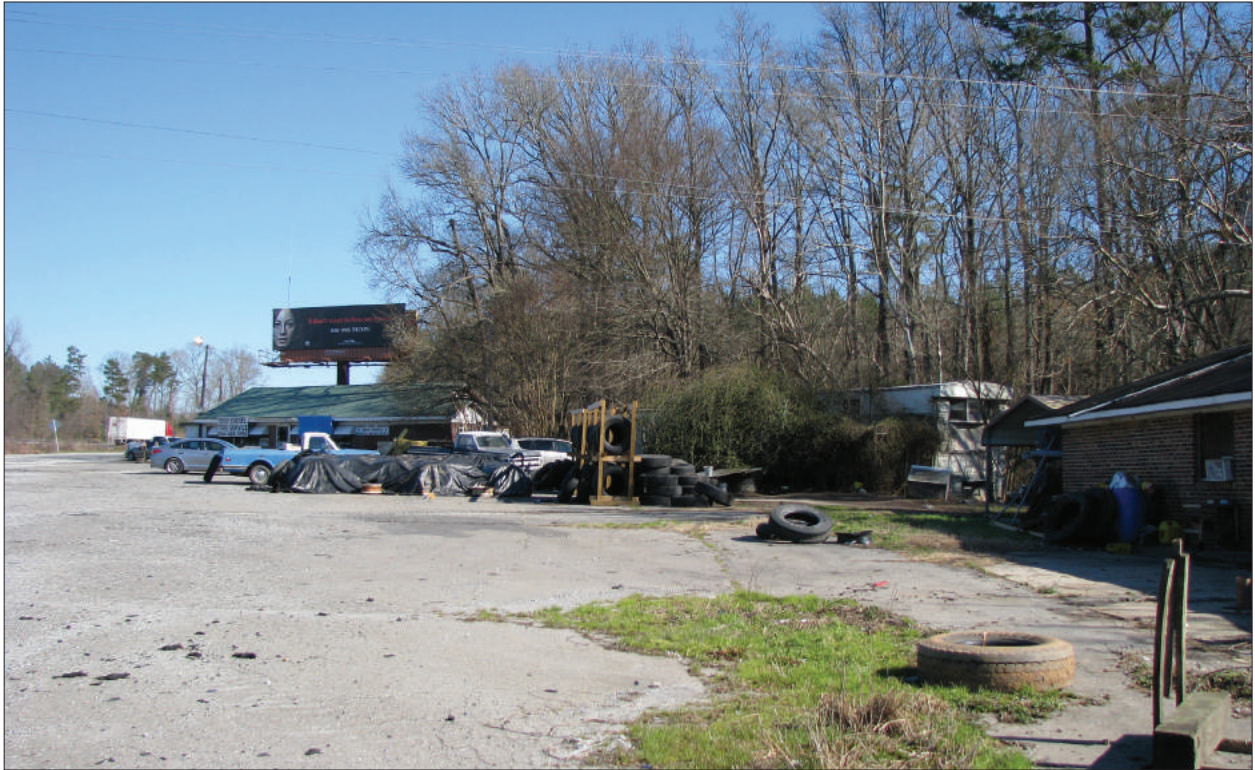
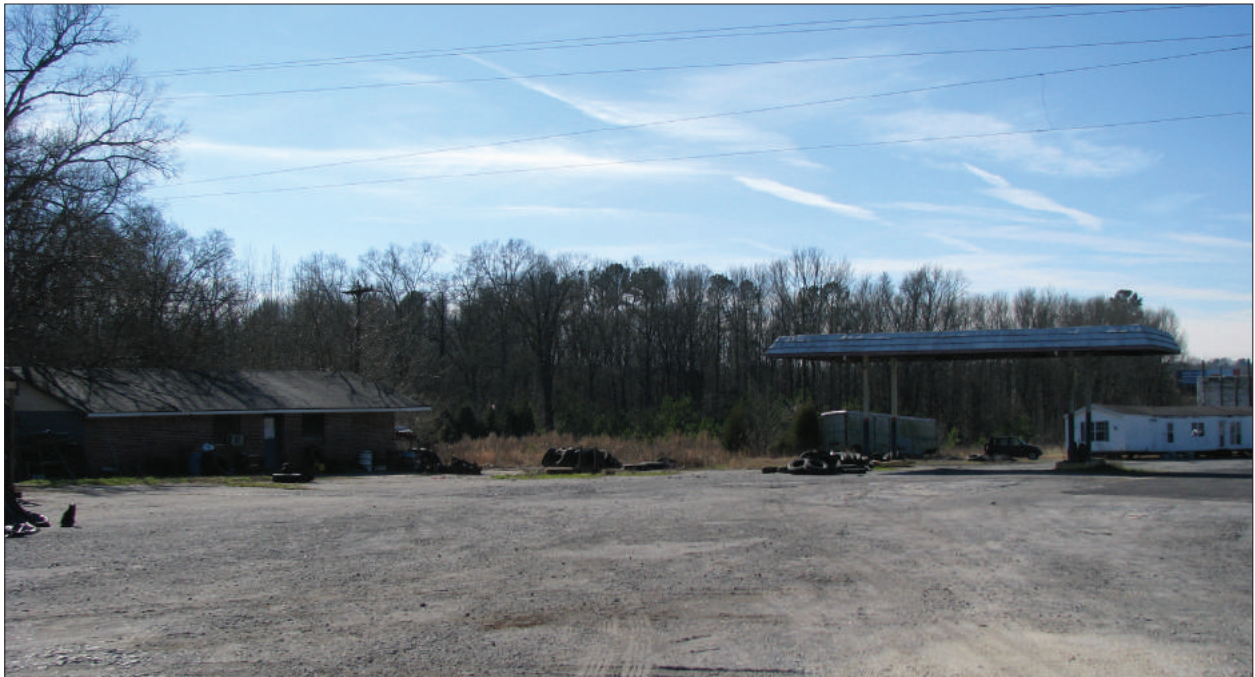
Figure 6.
415 Milliken/Frontage Road (U/21/0247 and U/21/0247.01)

A. Restaurant and Mobile Home, View to East/Northeast

B. Gas Station and Canopy, View to Southwest

The restaurant building (U/21/0247) is located at the western edge of the large surface parking lot. The one-story, linear plan building has a slab-on-grade foundation, concrete masonry unit (CMU) block construction, and shallow-pitched side gable roof clad with ribbed sheet metal. The building has a red brick veneer exterior with vertical wood panel siding present in the gable ends. The building has a single entrance, glass and aluminum door. Pairs of large fixed windows with metal awnings flank the entrance door on the façade. A single fixed window is also present at the on the north side of the building. A small, flat-roofed frame shed addition extends from the north side of the building. The addition appears to date from the original period of development. It is covered with wood weatherboard siding with a wide reveal.

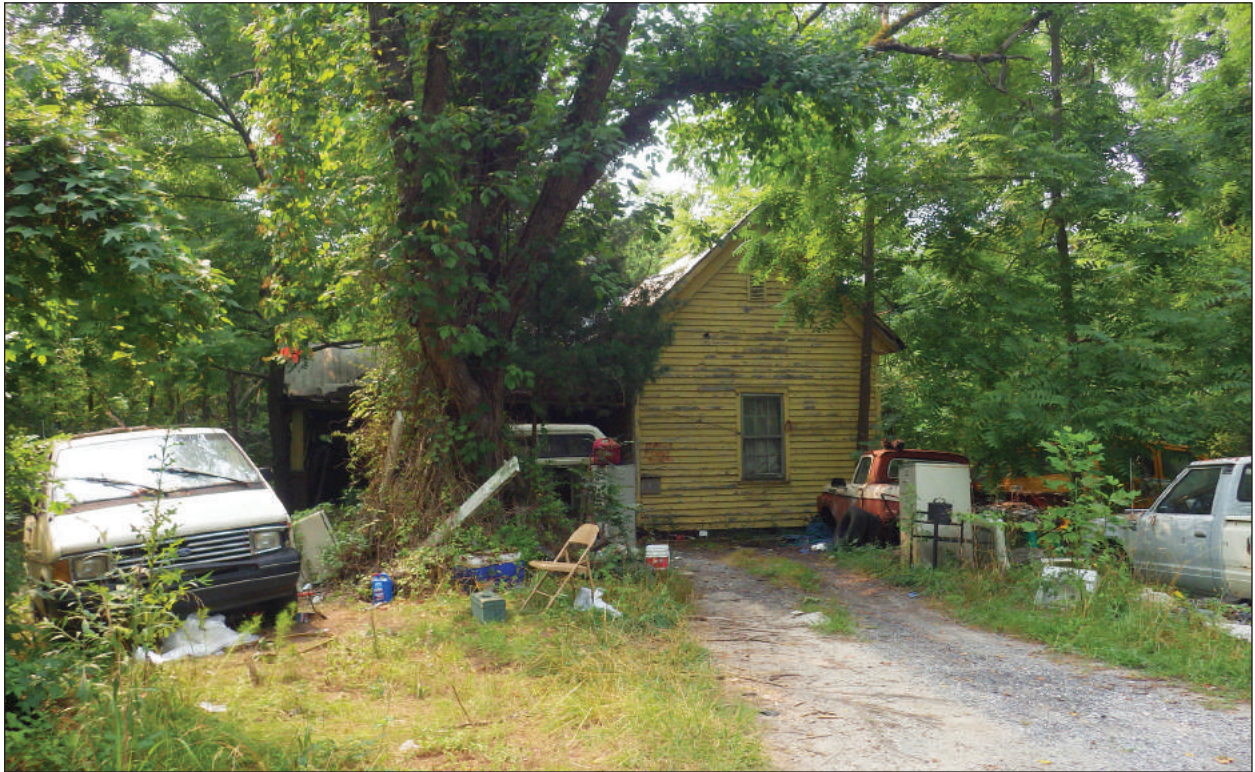
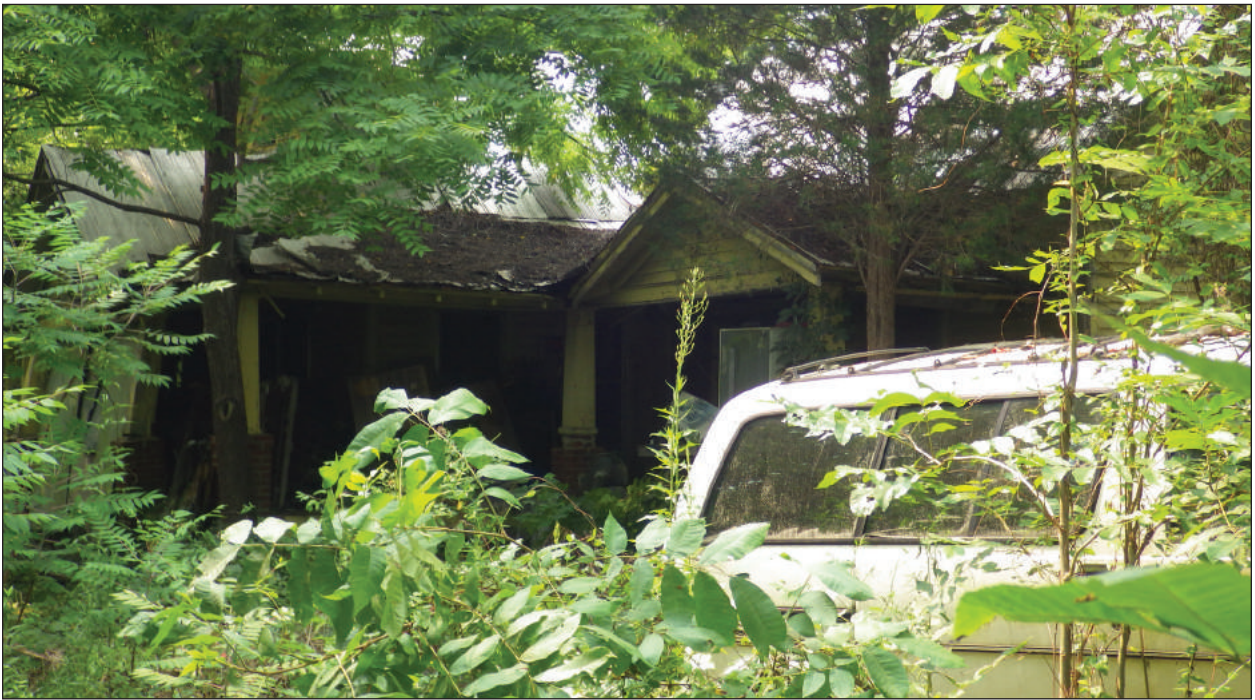
Figure 7.
137 Crawford Road (U/21/0248)

Resource U/21/0248 is a single-family dwelling located on a 19-acre, wooded parcel at 137 Crawford Road, just north of the I-85 (Figure 7A-B). The presence of a visibly prominent no trespassing sign and dense vegetation surrounding the building made access for documentation and

A. Façade, View to Southeast

B. Detail of Porch, View to South

photography difficult. The one-and-a-half story, frame house appears to have been constructed circa 1900. It has an irregular plan with a filled-in, brick pier foundation, weatherboard siding, and a cross-gable roof covered with ribbed sheet metal. A wrap around porch is present along the east side of the façade. Battered wood columns on brick piers support the extended porch roof. A brick chimney is present on the rear roof slope. Identified window types include an original six-over-six sash unit on the projecting front gable. An aluminum sliding glass door serves as the front door from the porch area. According to aerial photographs, an addition has been built at the rear of the building.

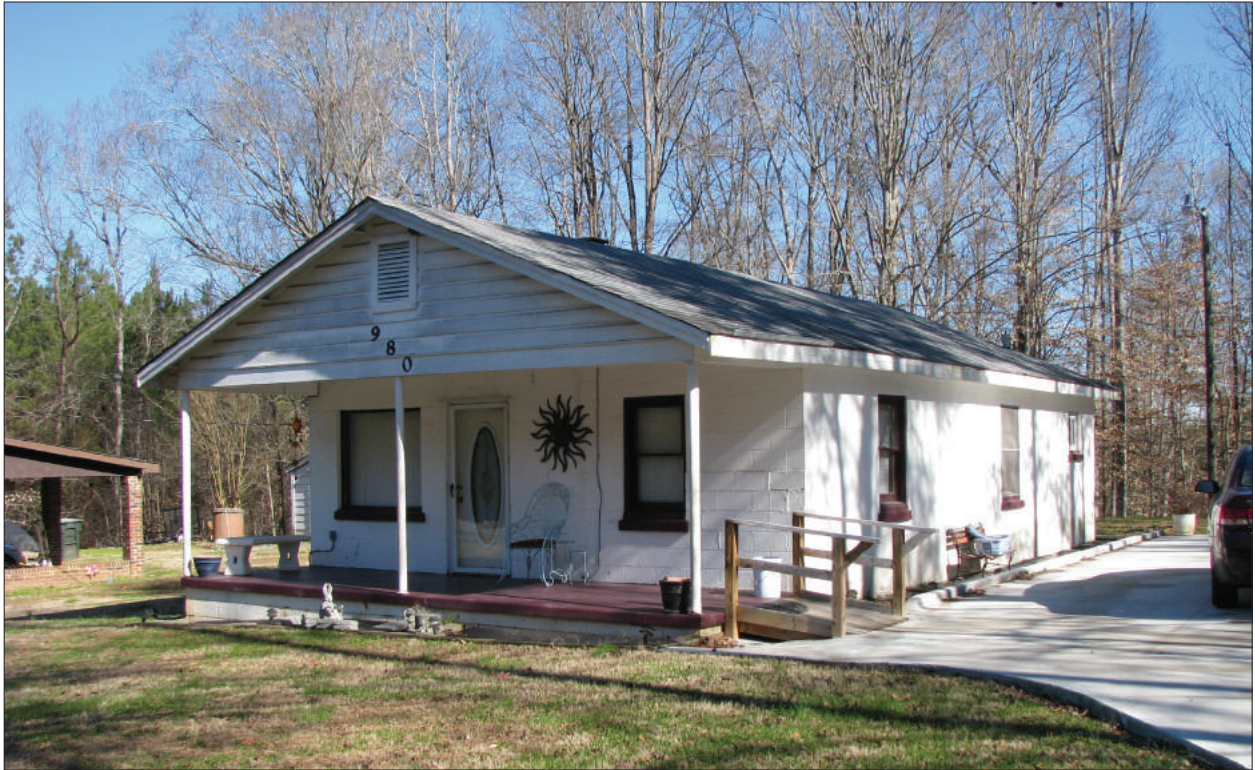
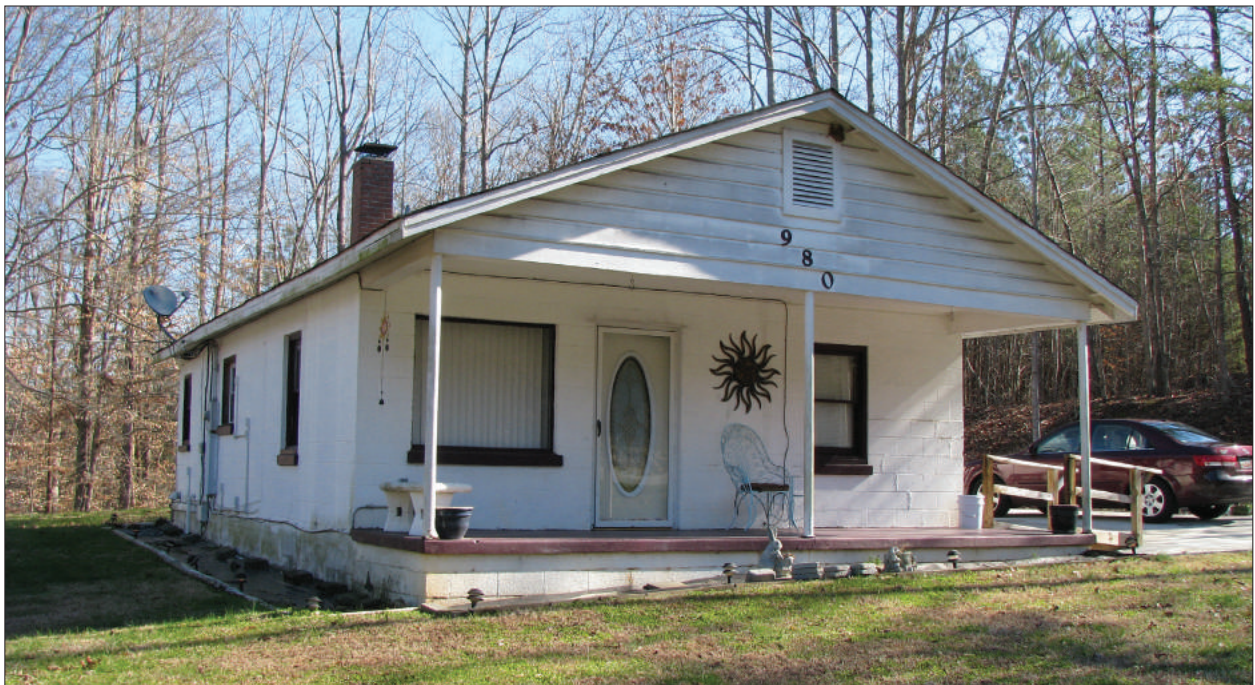
Figure 8.
980 Blacksburg Highway (U/21/0249)

Resources U/21/0249 and U/21/0249.01 are a single-family dwelling and small outbuilding built circa 1950 and located at 980 Blacksburg Highway, on the east side of the road (Figure 8A-B). The one-story, CMU-constructed Bungalow has a rectangular plan, continuous CMU foundation, and front gable roof covered with asphalt shingles. A full-width, engaged porch lines the residence's asymmetrical façade. Three evenly spaced metal poles support the porch roof. Imitation weatherboard vinyl siding is present in the roof gable end. A brick chimney is located on the north roof slope. The original front entrance door has been replaced with a modern fiberglass unit with a centered, and large, oval window. A large fixed window is present on the north side of the façade. Other identifiable window types include original two-over-two sash units and vinyl replacement sash and sliding windows on the north and south walls of the building.

A. South Oblique, View to Northeast

B. North Oblique, View to Southeast

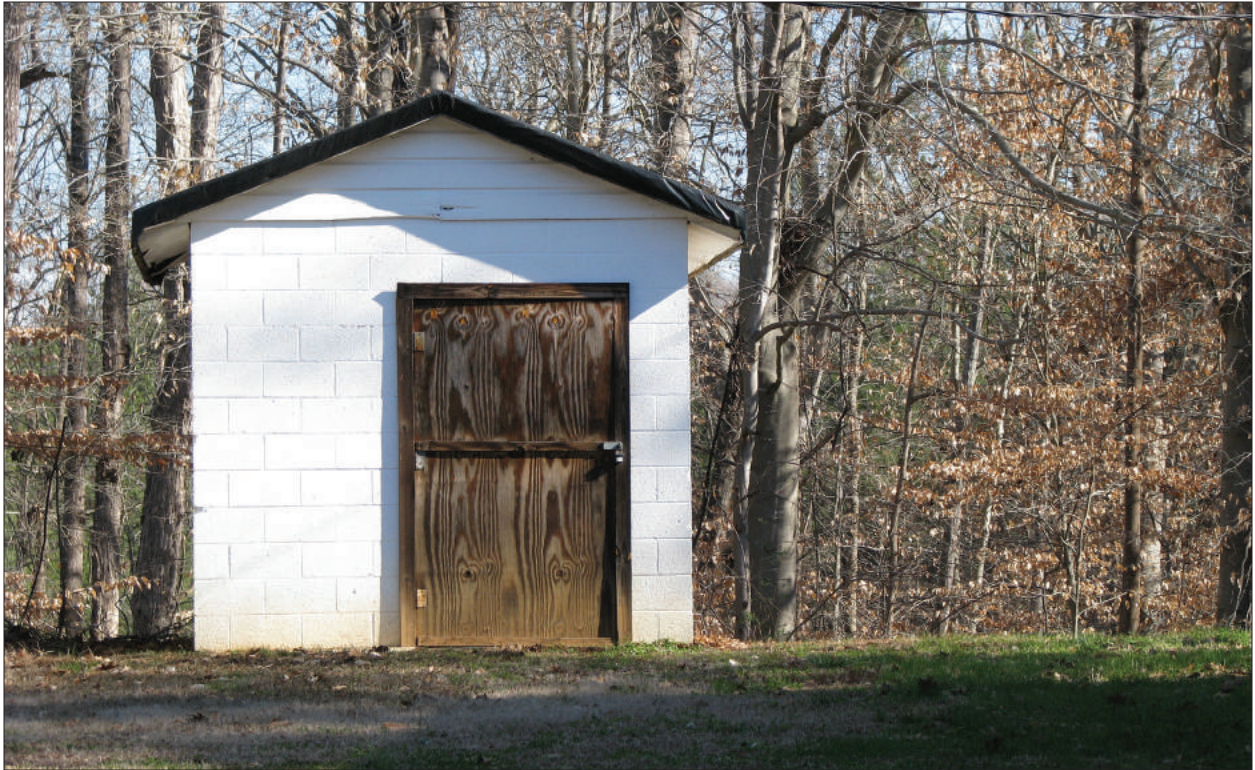
Figure 9.
Outbuilding at 980 Blacksburg Highway (U/21/0249.01), View to West

The single-pen, CMU-constructed shed outbuilding is located on the north side of the house at the rear of the lot (Figure 9). It has a shallow-pitched, front gable roof and a plywood door and surround. Wood shiplap siding is present in the gable end. A relatively new poured concrete driveway and parking pad occupies the southern edge of the parcel. A small, wood frame disability ramp connects the parking area to the front porch.

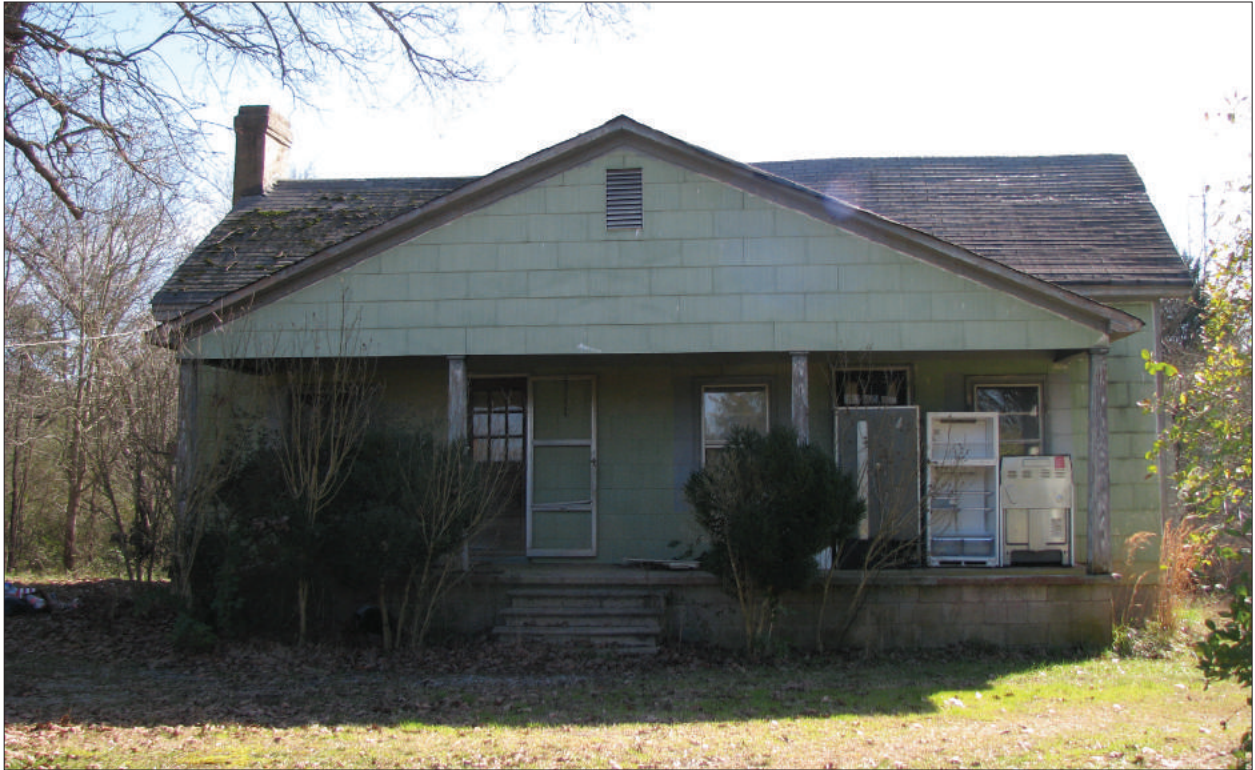
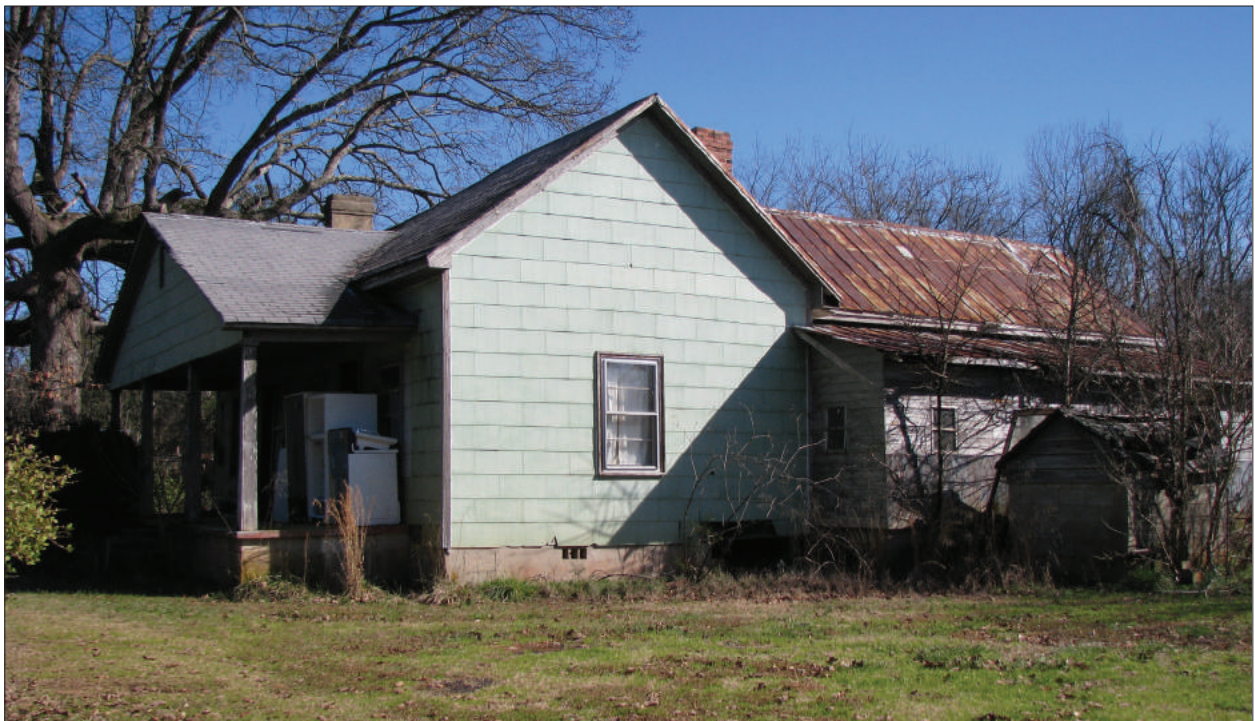
Figure 10.
316 Henson Road (U/21/0250)

Resources U/21/0250, U/21/0250.01, and U/21/0250.02 are a multi-family dwelling, well house and garage or shed outbuilding located at 316 Henson Road, on the south side of the right-of-way. The buildings reside on an approximate 42-acre lot. The one-and-a-half story residence (U/21/0250) is a frame duplex with no identifiable house type or architectural style (Figure 10A-B). It has a rectangular plan with a brick pier with infill foundation, asbestos shingle siding, and cross-gable roof covered with asphalt shingles at the front of the structure and standing seam sheet metal on the rear addition. One-story shed roof additions with weatherboard siding line the larger rear addition on the east and west sides. The raised, partial width front porch has a front gable extended roof supported by four battered wood columns. The porch has a CMU foundation and is accessed by a small flight of concrete stairs. Brick chimneys are located on the east wall and at the rear roof slope on the west side. The two front doors are wood paneled with nine-fixed lights. Common window types include the original two-over-two wood sash units and smaller, one-over-one aluminum windows. The building appears to be vacant.

A. Façade, View to South

B. West Side, View to Southeast

Research has not demonstrated that Resources U/21/0250, U/21/0250.01, and U/21/0250.02 have a documented association with important events or a person who is important to Blacksburg or Cherokee County's past. Therefore, this property was not evaluated under Criteria A or B. The property was evaluated under Criterion C for architecture and does not appear to be eligible for the NRHP. The dwelling does not embody the distinctive characteristics of a significant house type, style or method of construction nor does it employ any noteworthy building materials. While it retains integrity of location, it no longer has integrity of setting, design, materials or workmanship. The development of I-85 to the immediate north has diminished the area's once

rural setting. Unsympathetic additions to the side and rear of the house have altered the building's original form and caused a loss of historic fabric. The property has lost its feeling and association as a duplex residence within a larger rural farmstead. It now sits vacant with its outbuildings in a state of deterioration and overgrown with vegetation.

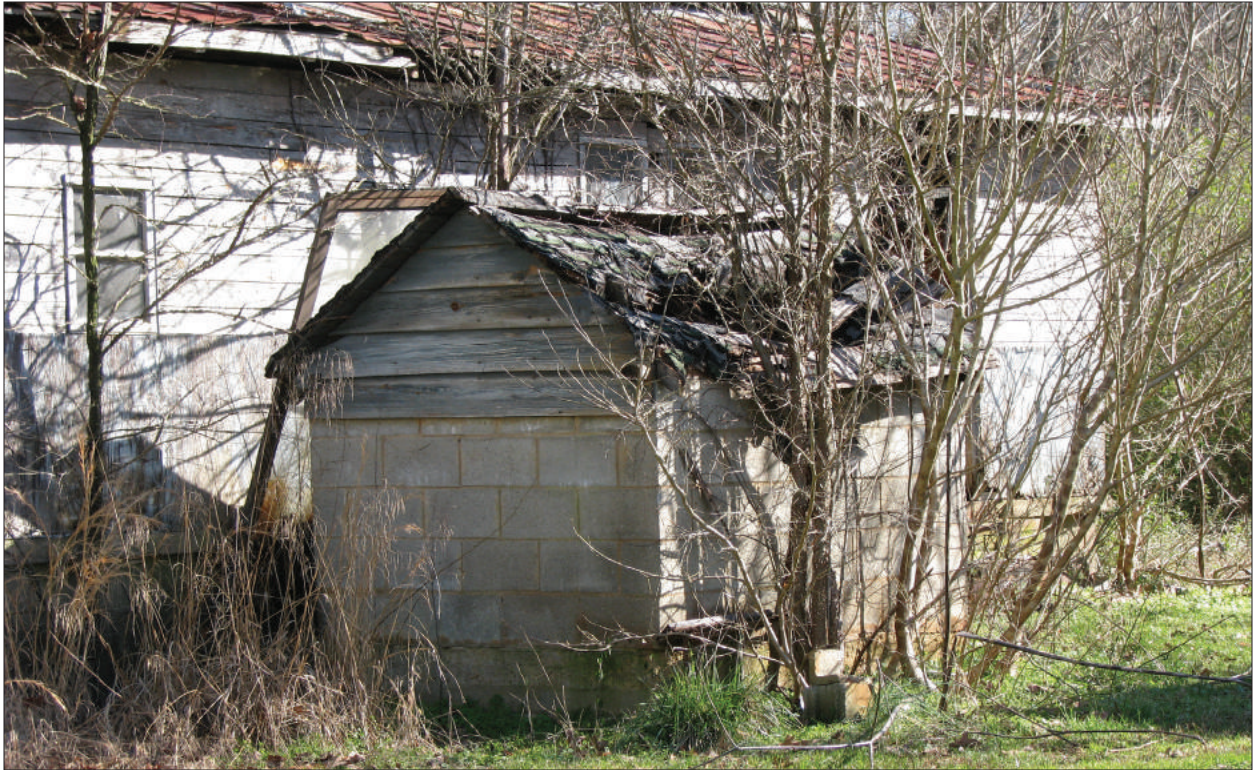
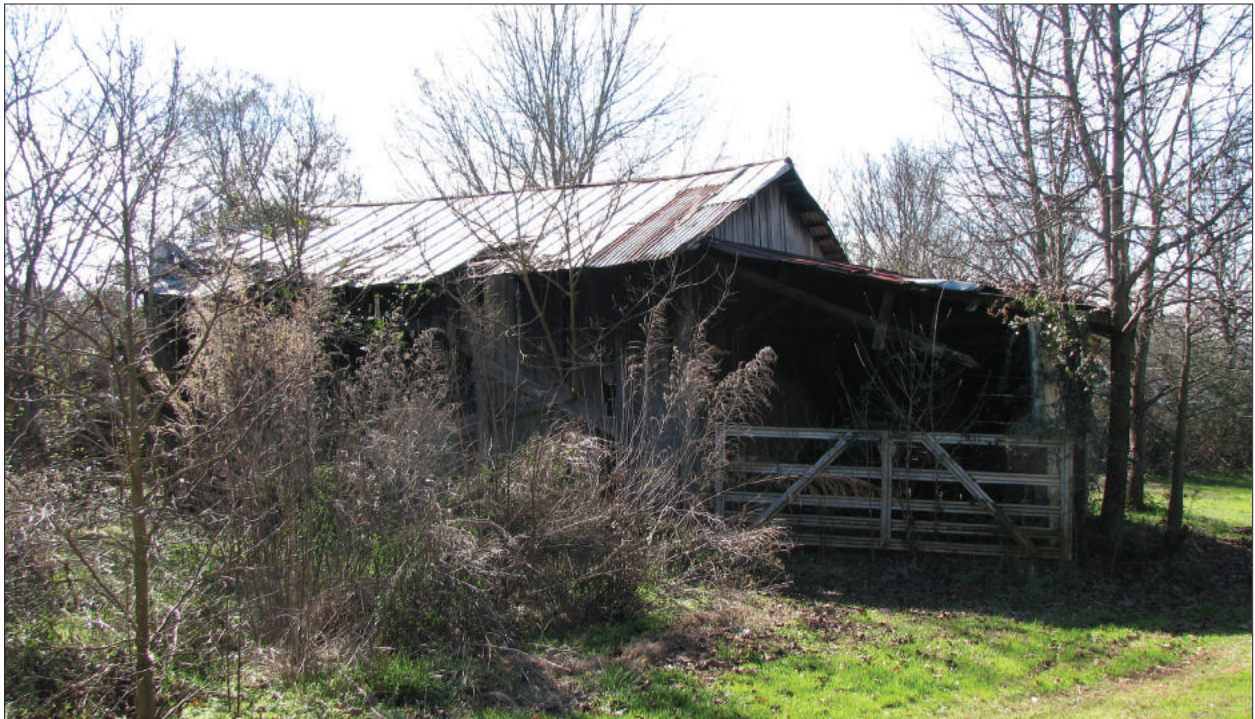
Figure 11.
Outbuildings at 316 Henson Road (U/21/0250.01 and U/21/0250.02)

The small CMU-constructed well house (U/21/0250.01) is located to the immediate west of the main building. The one-story, front gable wood frame shed (U/21/0250.02) is located further to the west (Figure 11A-B). It has a corrugated metal roof. A larger, non-historic wood shed is located at the rear of the lot between the house and smaller historic shed.

A. U/21/0250.01, View to Southeast

B. U/21/0250.02, View to West

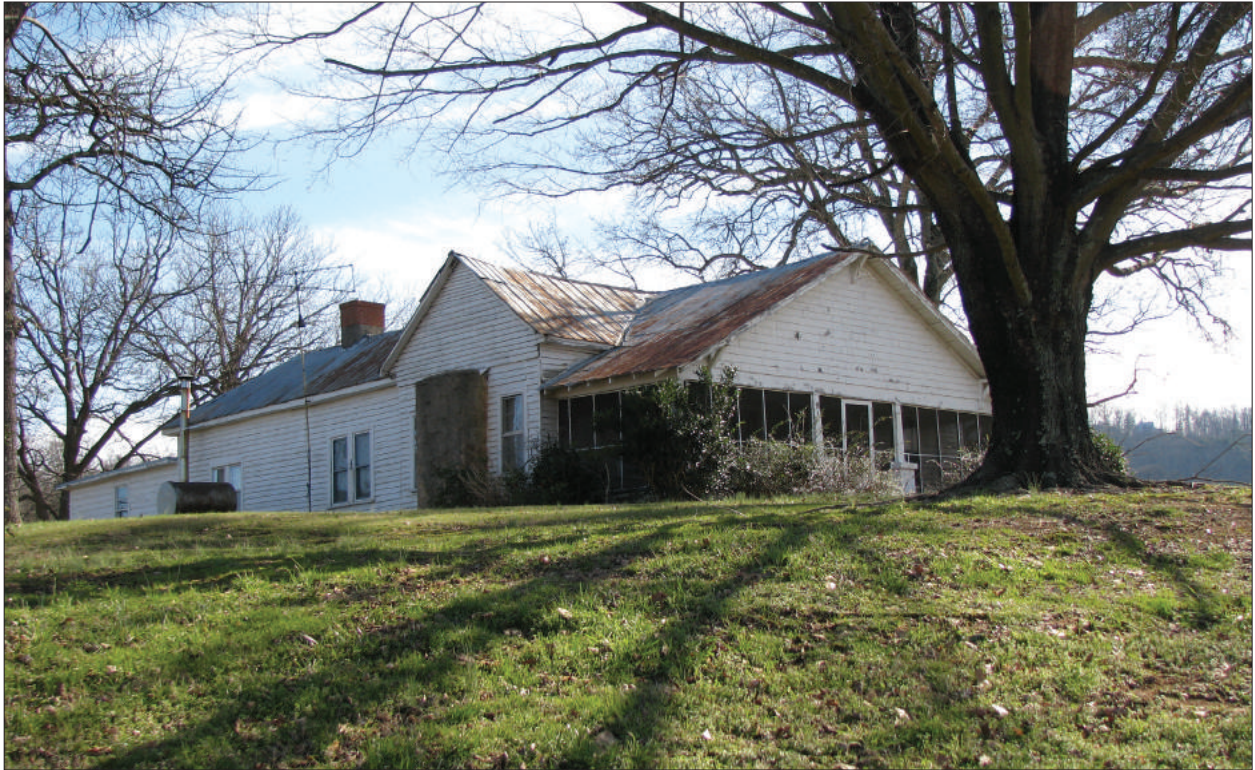
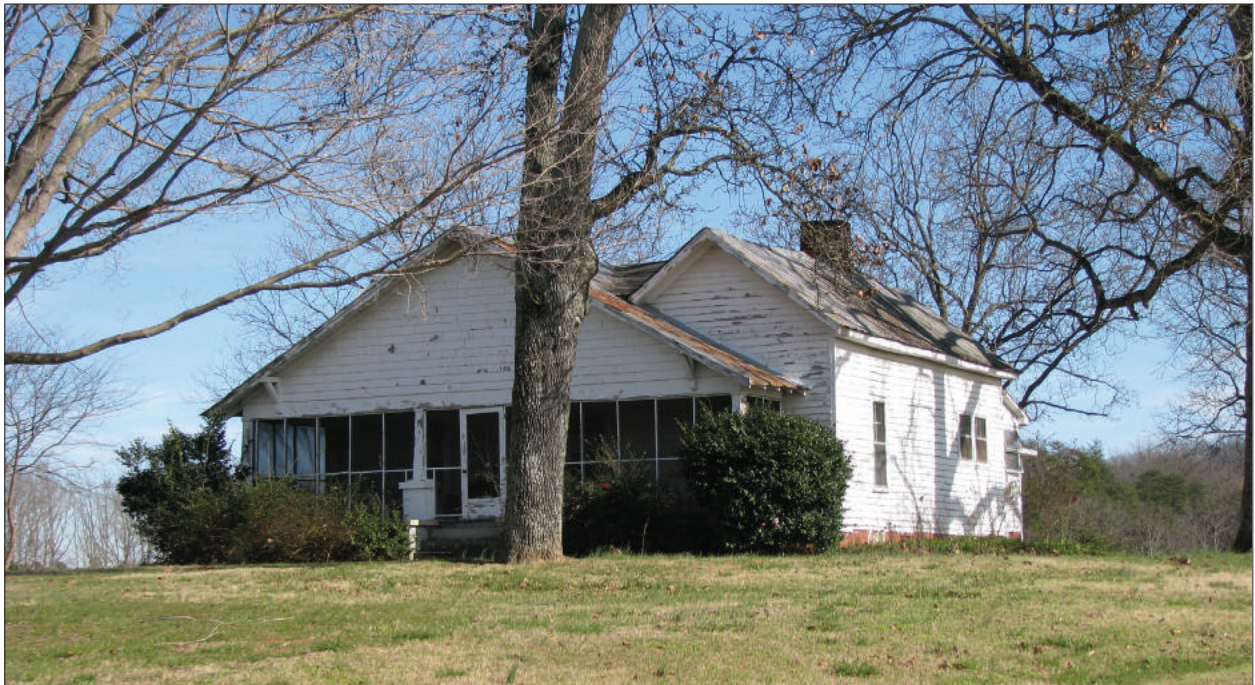
Figure 12.
147 Whites Farm Road (U/21/0251)

The one-and-a-half-story frame residence has an irregular plan, stone pier-with-fill foundation, white painted wood weatherboard siding, and cross-gable roof covered with corrugated metal (Figure 12A-B). The screened-in front porch has a front gable roof with exposed rafter tails and supported by battered wood columns on brick pier supports. Wood shingles and Craftsman style triangular knee braces are present in the gable end. The partial remnant of a stone and concrete chimney is present on the east wing of the house. Two other brick chimneys occupy the ridgelines of the original gable front and a rear circa 1920 gable addition. Observable window types include four-over-four, wood double-hung sash units, three-over-one sash, six-over-six, and one-over-one modern replacement windows.

A. East Oblique, View to South

B. West Oblique, View to East

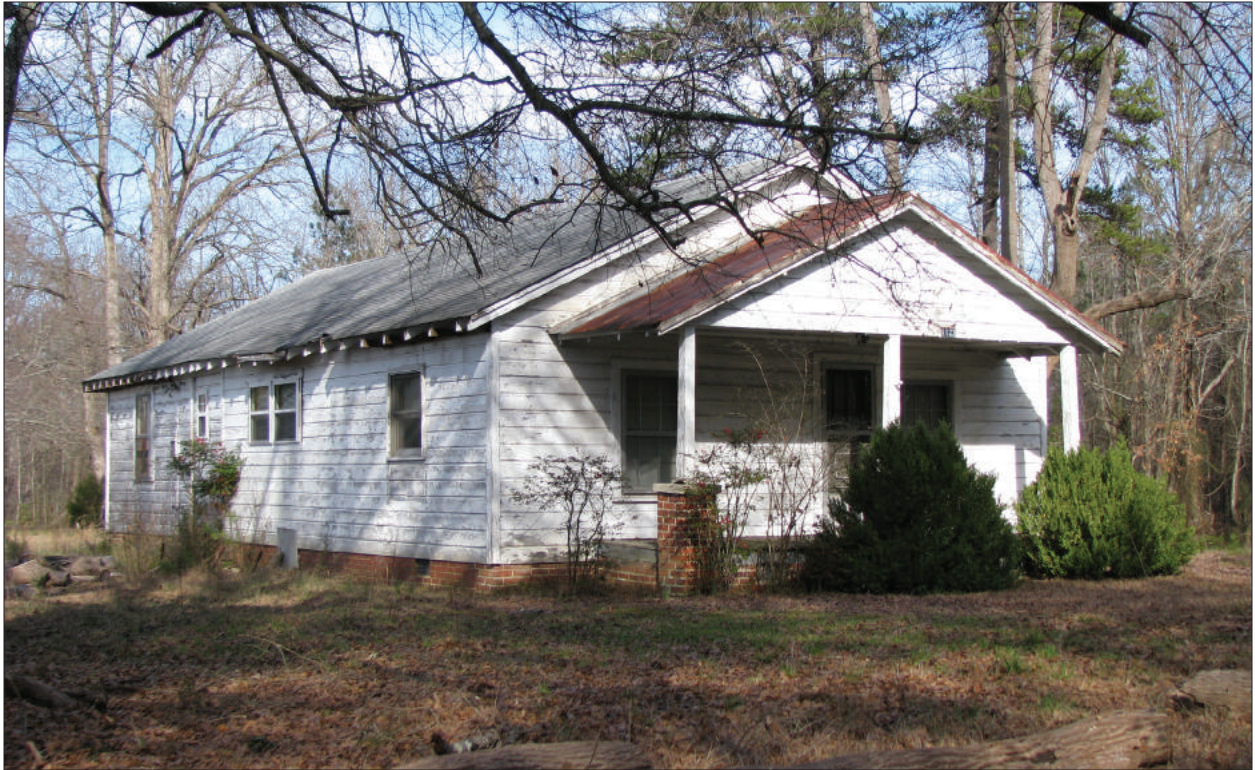
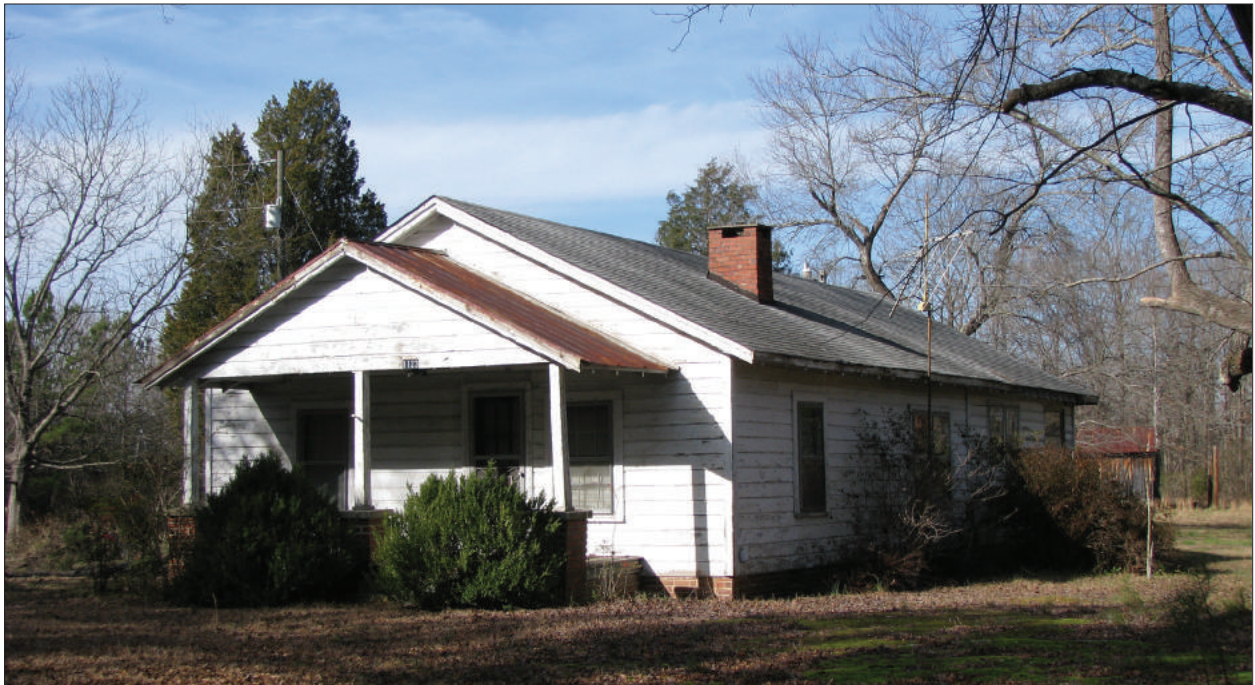
Figure 13.
1123 Holly Grove Road (U/21/0252)

Resources U/21/0252, U/21/0252.01, and U/21/0252.02 are a single-family residence, well house, and shed located at 1123 Holly Grove Road (SR S-11-52), just west of the intersection with Whites Farm Road. The one-story, wood frame Bungalow house type was built circa 1940. The dwelling (U/21/0252) has a simple linear plan, brick-pier-with-infill foundation, shiplap wood siding, and a front gable roof with exposed rafters and asphalt shingles (Figure 13A-B). A brick chimney is located on the eastern slope of the roof. The partial width front entrance porch has a front gable drop roof covered with ribbed sheet metal. Three square wood columns on brick piers support the porch roof. The front windows are six-over-six wood sash units and appear to be original to the house. A mix of replacement two-over-two wood sash windows and more recent vinyl units are present on the sides and rear of the building. The rear (north) side is also clad with synthetic vinyl siding. Single entrance doors are present at the façade and back of the house.

A. West Oblique, View to Northeast

B. East Oblique, View to Northwest

The dwelling and associated outbuildings at 1123 Holly Grove Road (SR S-11-52) are not known to be associated with a significant historic event or a person important to the area's past and were therefore not evaluated under Criteria A or B. The house was evaluated for significance at the local level under Criterion C for architecture and does not appear to be eligible for the NRHP. The small frame house (U/21/0252) retains integrity of location, setting, feeling and association as an early twentieth-century residence, but is not a distinctive example of the Bungalow house type. It also does not reflect the aesthetic of an architectural style and has few character-defining design or material features. Furthermore, the replacement of original windows with non-sympathetic units has caused the property to lose its integrity of design, materials, and workmanship. Therefore, Resources U/21/0252, U/21/0252.01, U/21/0252.02 are recommended not eligible for listing in the NRHP.

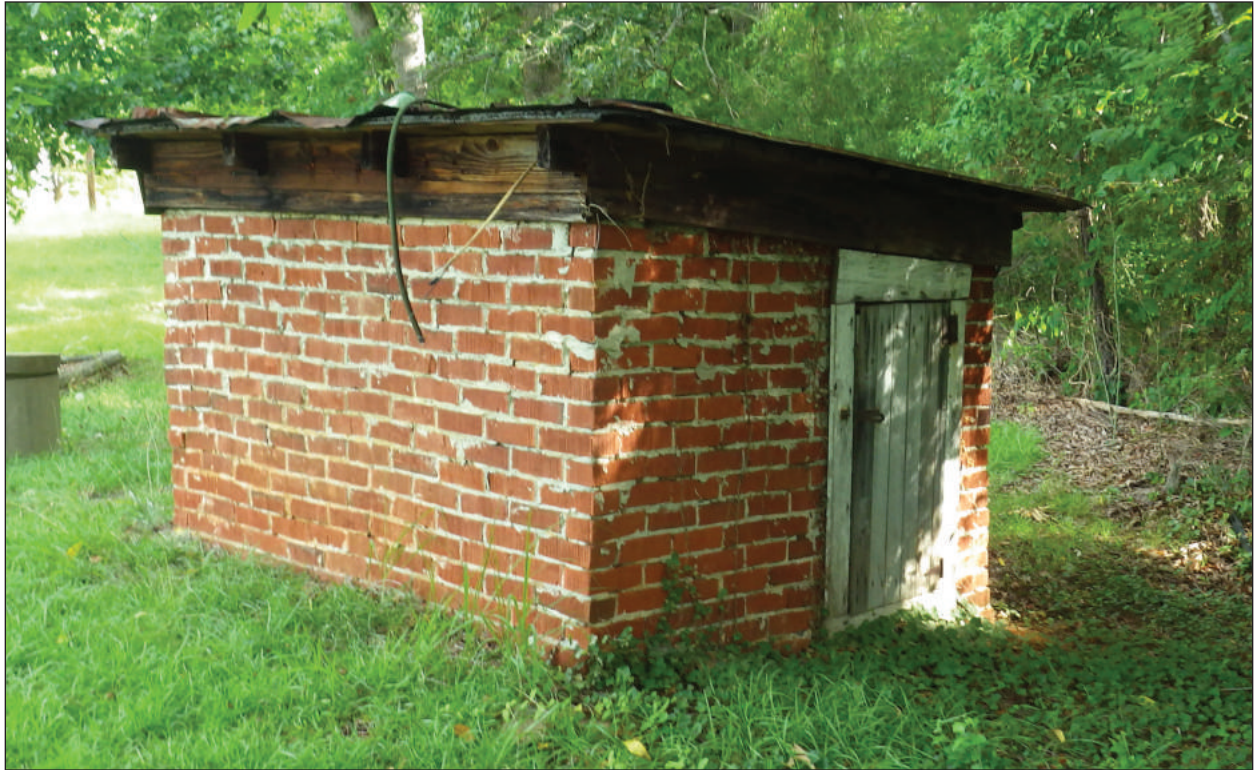
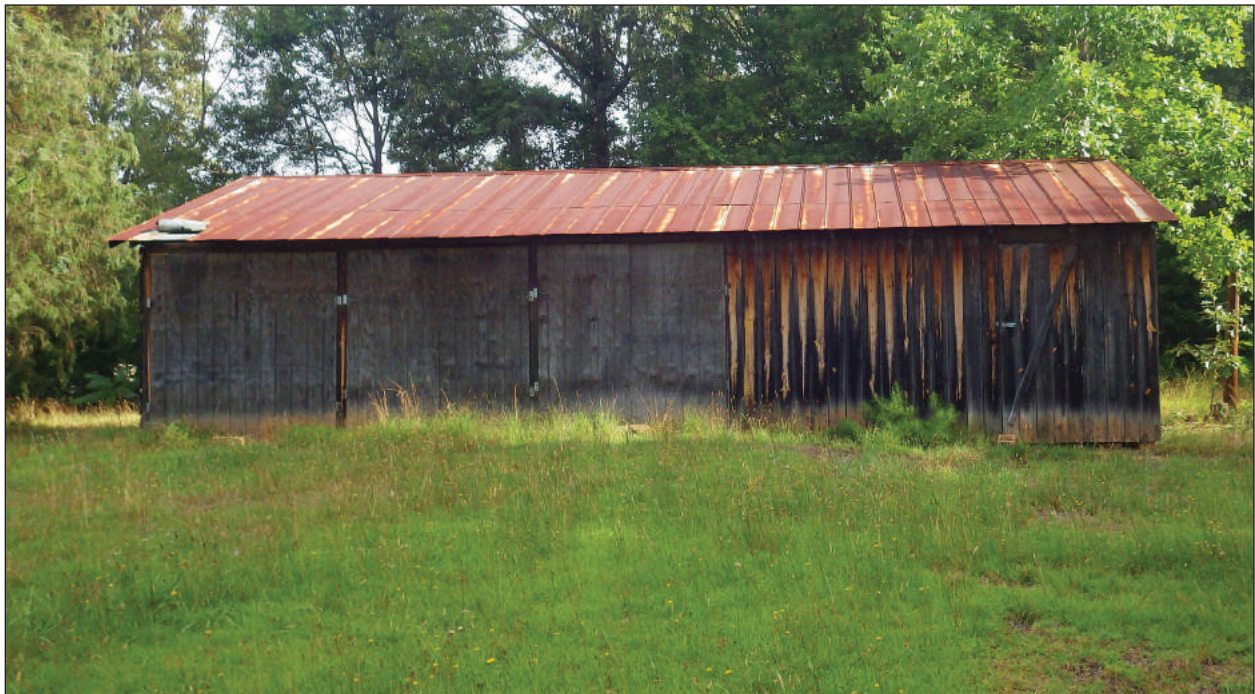
Figure 14.
Outbuildings at 1123 Holly Grove Road (U/21/0252.01 and U/21/0252.02)

A brick masonry well house (U/21/0252.01) with a shed roof is located in the northeast corner of the rear yard. A larger, wood frame, multi-door shed/barn outbuilding (U/21/0252.02) with a long linear plan and standing-seam metal side gable roof is located just to the west. Both outbuildings appear to post-date the construction of the residence and were built circa 1960 (Figure 14A-B). The ruins of a third, wood frame outbuilding are located closer to the house.

A. U/21/0252.01, View to Northeast

B. U/21/0252.02, View to North

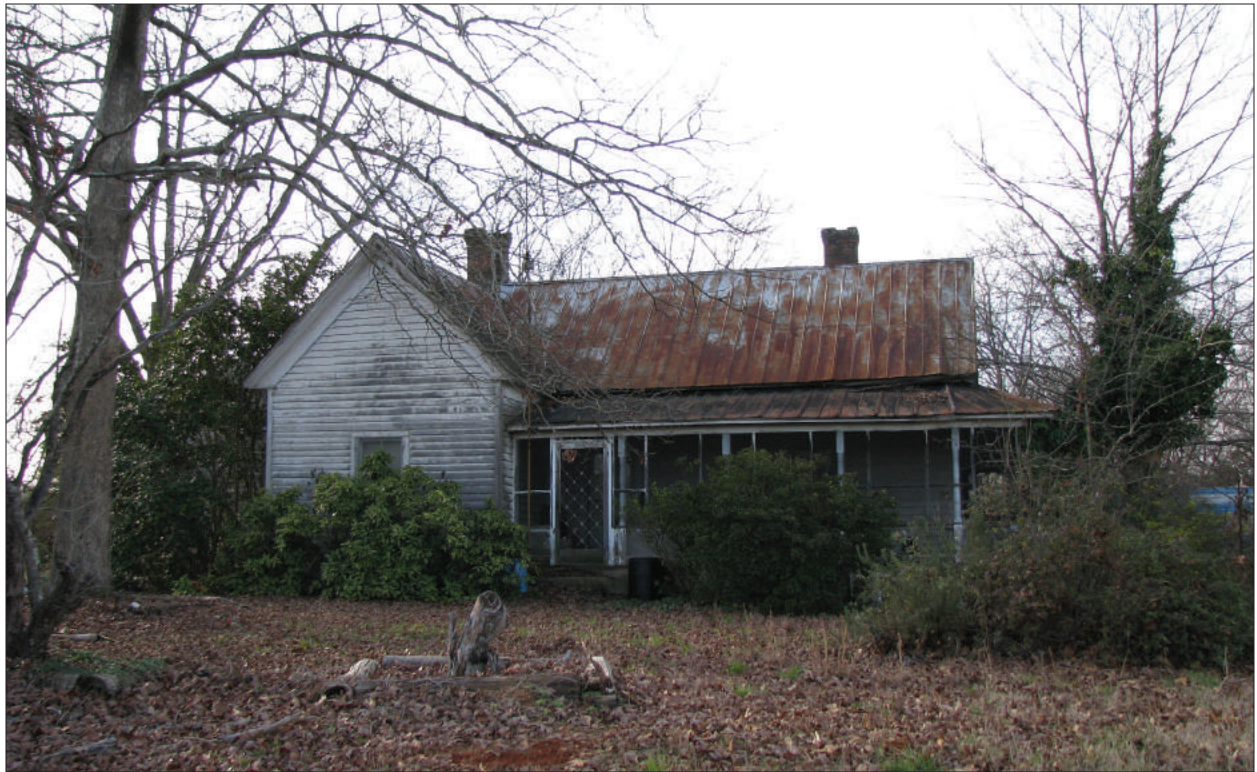
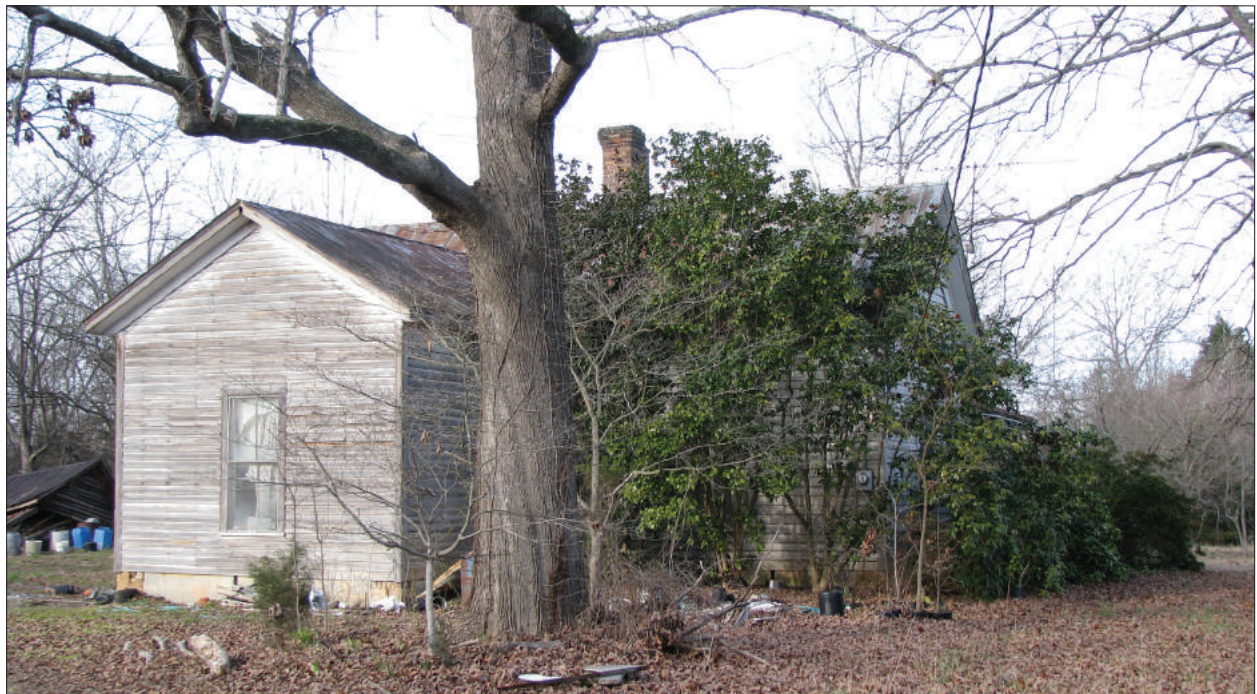
Figure 15.
653 Tribal Road (U/21/0253)

A. Façade, View to West

B. South Oblique, View to Northwest
