Phase I Cultural Resources Survey of Approximately 12 Miles of Improvements Along I-85

Cherokee County, South Carolina

October 10, 2016 • **Draft Report**
New South Associates Technical Report 2589

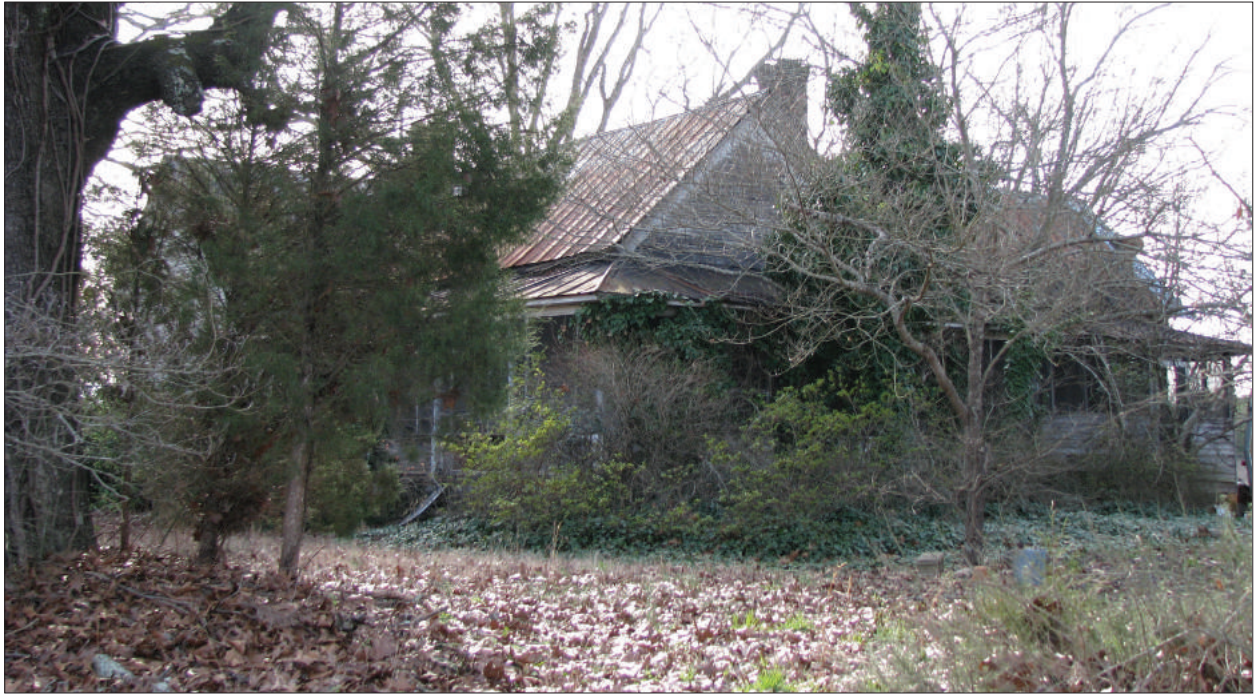
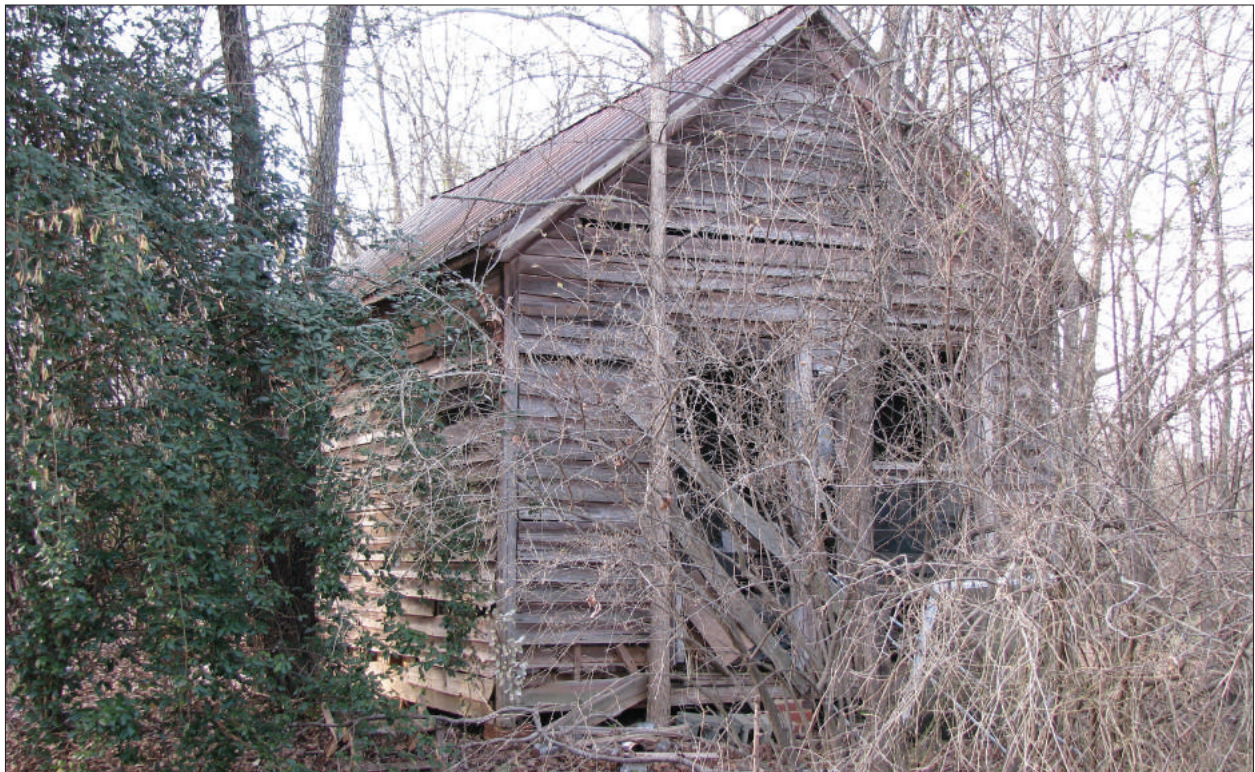
Figure 16.
653 Tribal Road (U/21/0253 and U/21/0253.01)

The ruins of a frame outbuilding are located behind the house. Further to the east is a wood frame, single crib shed, constructed circa 1940 that is also in a deteriorated state (U/21/0253.01). The shed is clad with unpainted weatherboard with a front gable roof covered with ribbed sheet metal. The front double doors are open and the building is unsecured to the elements (Figure 16).

A. U/21/0253 North Oblique, View to Southwest

B. U/21/0253.01, View to Northwest

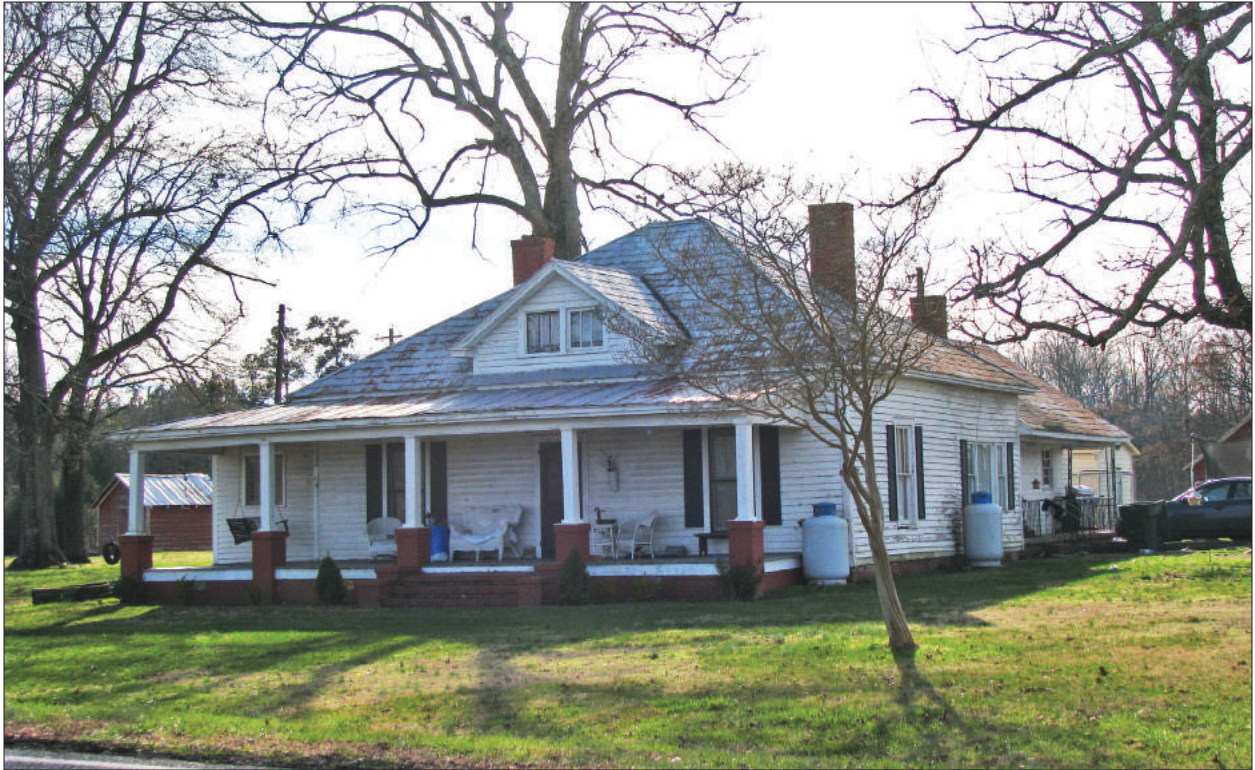
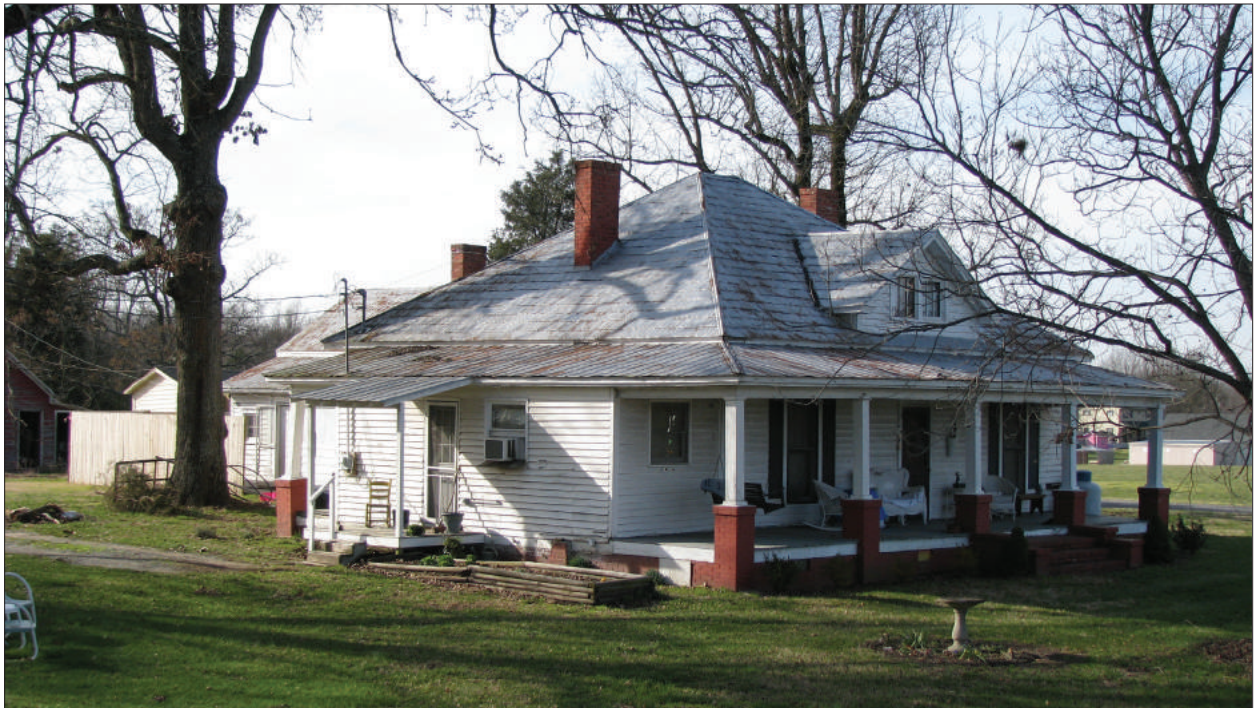
Figure 17.
569 Tribal Road (U/21/0254)

a one-and-a-half story Queen Anne Cottage house type constructed circa 1890 (Figure 17A-B). It has a rectangular central mass-plan set on a brick-pier-with-infill foundation and a steeply pitched hipped roof with a gable roof front dormer. Paired square windows with three vertical lights are set in the dormer gable. A rear gable roof wing appears to have been added circa 1950. The original house and rear addition are both clad with painted weatherboard siding. A partial width porch with a drop ceiling lines the house façade. The front porch structure has a brick foundation, wood flooring, and is supported by squared wood columns on brick piers. An extended roof porch with wrought iron supports runs along the north side of the rear addition. A small shed roof porch covers a secondary entrance area on the south side of the house. All roof structures, save the front porch and small south porch roofs, are covered with galvanized sheet metal shingles. The other porches are covered with ribbed sheet metal. Brick chimneys occupy the north and south roof slopes of the front mass and the ridgeline of the rear addition. In addition to the dormer windows, other prominent window types include three-over-one double hung sash units along the façade and north sides of the house, one-over-one replacement sash windows, a tripartite replacement window on the north side of the house, and six-over-six sash window at the rear gable addition. Windows along the façade and north sides are framed with black ornamental louvered shutters.

A. North Oblique, View to Southwest

B. South Oblique, View to Northwest

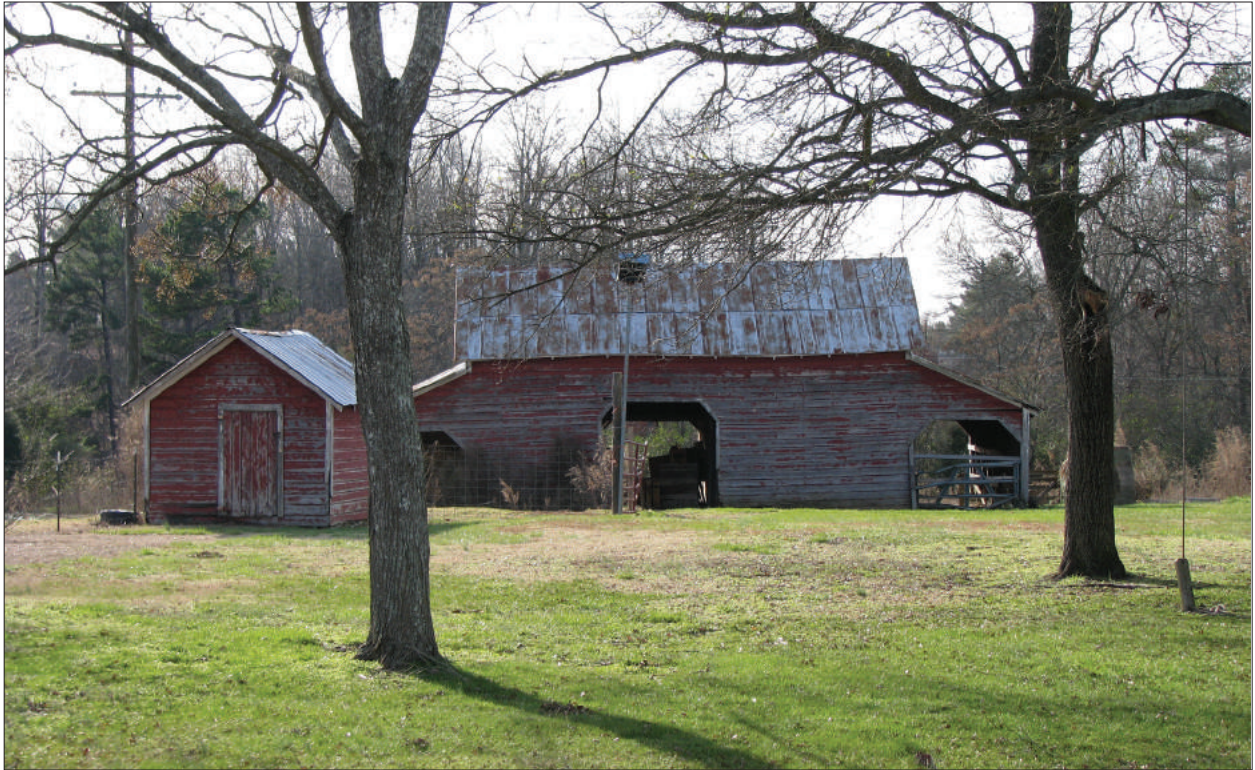
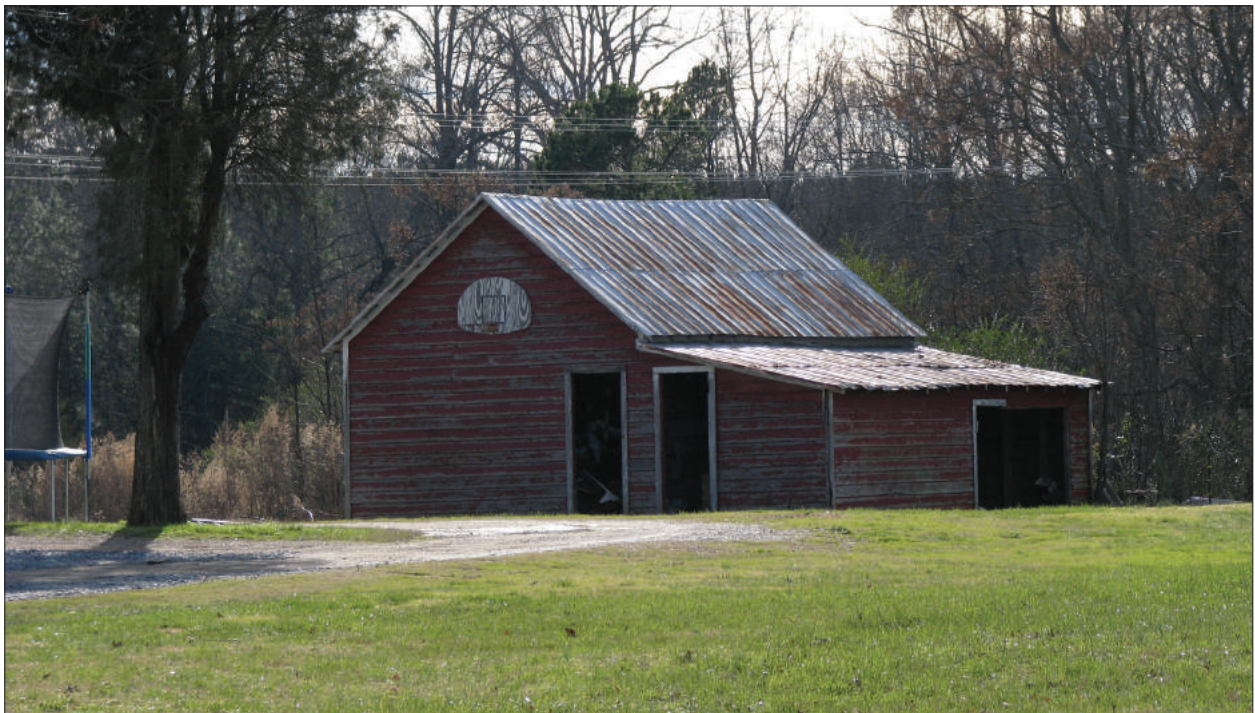
Figure 18.
Outbuildings at 569 Tribal Road (U/21/0254.01, U/21/0254.02, and U/21/0254.03)

A. U/21/0254.01 and U/21/0254.02, View to West

B. U/21/0254.03, View to Southwest

evaluated under Criteria A or B. The dwelling and associated outbuildings do not appear to be eligible for the NRHP under Criterion C for architecture. The resources retain integrity of location; however, the integrity of the once rural setting has been lost with the construction of the I-85 interchange to the south and subsequent large-scale commercial development on the opposite side of Tribal Road. Although the dwelling is a representative example of the Queen Anne Cottage house type, it does not appear to be distinctive in this regard. The building's integrity of design, materials, and workmanship has also been somewhat diminished with the replacement of original windows with non-sympathetic units. Despite these alterations, the property still has integrity of feeling and association for being late nineteenth/early twentieth-century family farmstead. Nevertheless, it is not recommended eligible for listing in the NRHP.

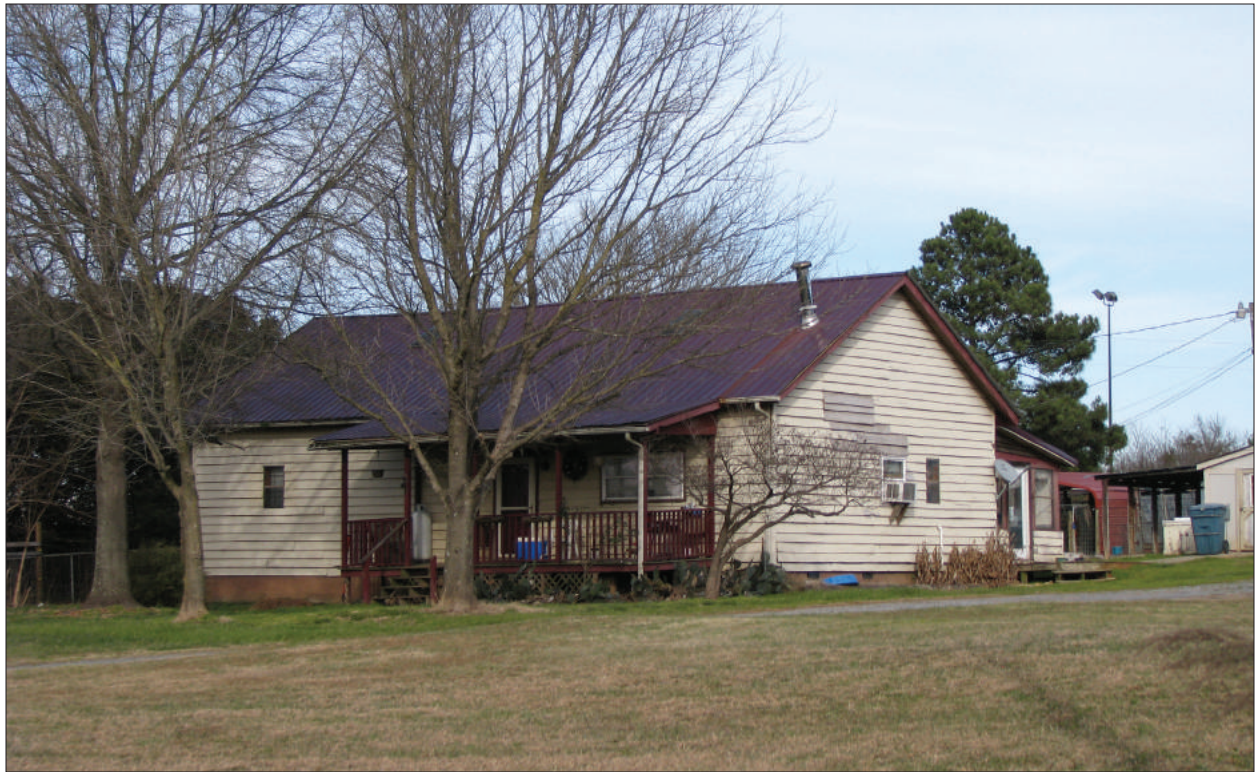
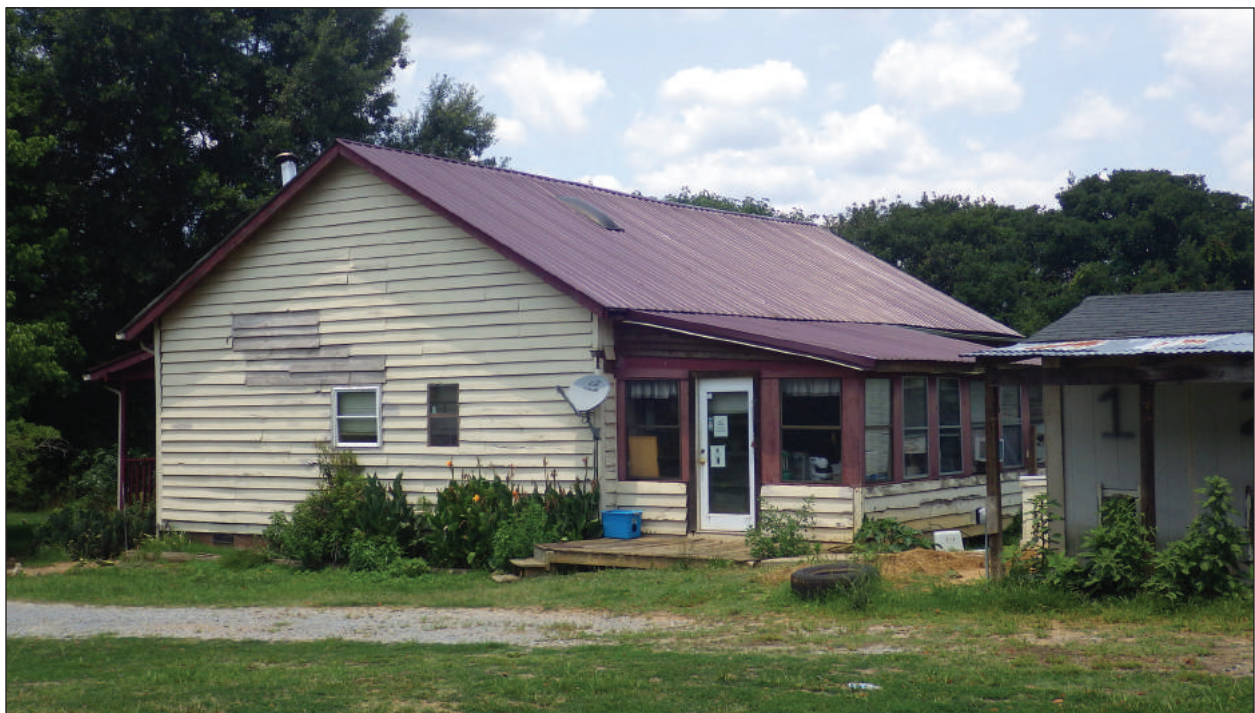
Figure 19.
548 Tribal Road (U/21/0255)

Resource U/21/0255 is a single-family dwelling located at 548 Tribal Road, on the east side of the right-of-way, just south of the I-85 interchange and the Love's Travel Stop. The one-story frame residence appears to have been constructed circa 1950. It has a brick and CMU foundation, wood weatherboard siding, and a steeply pitched side-gable roof covered with standing seam metal. A raised, partial width front porch, with a drop shed roof and simple wood supports, lines the south end of the façade. An enclosed porch addition with a drop-shed roof is also present at the rear of the house. All of the windows are metal or vinyl sash units and are not original to the house (Figure 19A-B).

A. Façade and South Side, View to Northeast

B. Rear (East) and South Side, View to North/Northwest

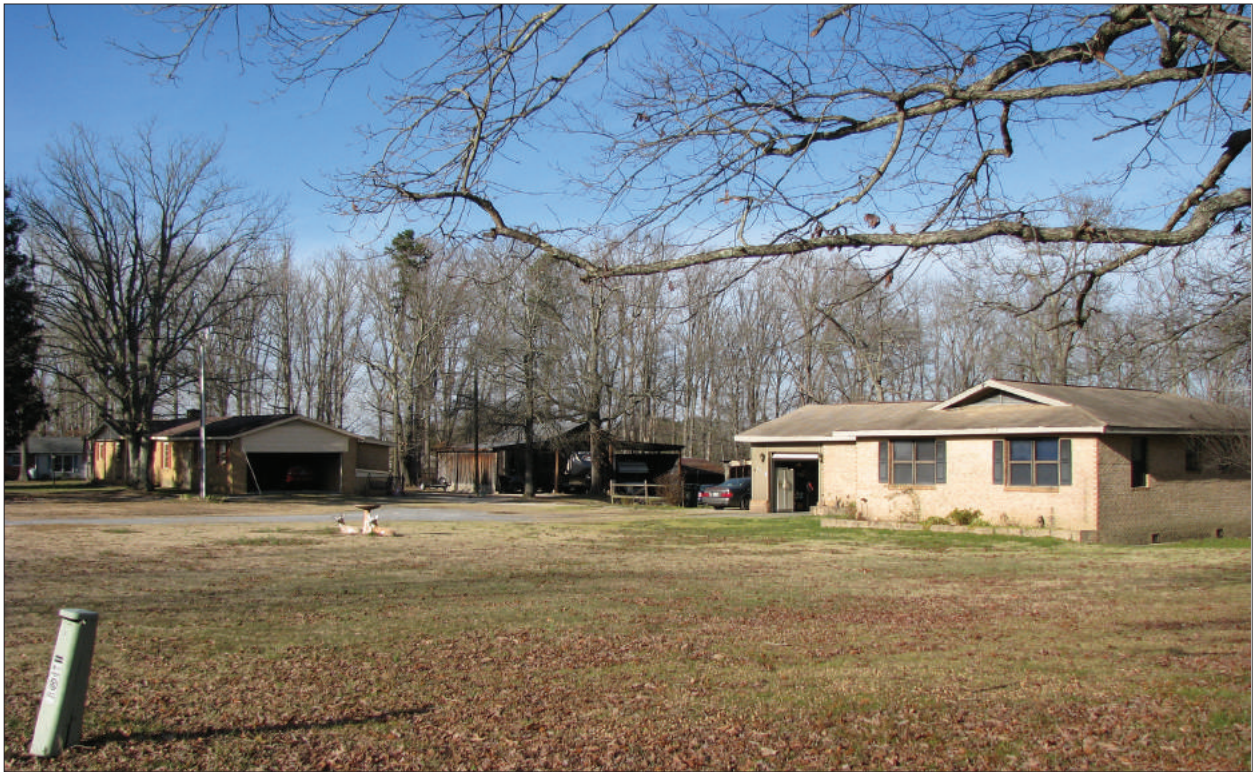
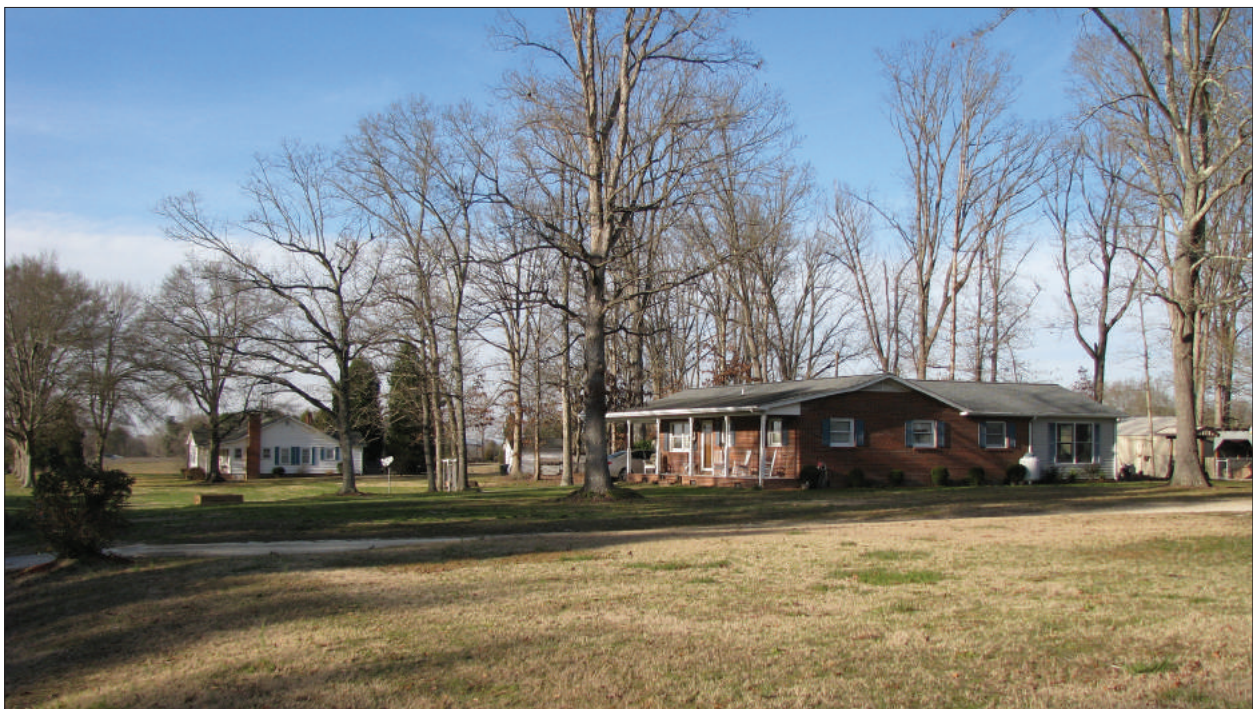
Figure 20.
Holly Ridge Road District (U/21/0256)

Resource U/21/0256 was recorded as a district that contains seven, one-story houses located along the east side of Holly Ridge Road (SR S-11-65) near the intersection with Roark Road (SR S-11-375). The seven houses (1137-1209 Holly Ridge Road) are a mix of two Minimal Traditional houses and five Ranch houses built between circa 1950 and circa 1965 (Figures 20A-B and 21A-B). All dwellings are present on a 1971 aerial photograph of the north Blacksburg vicinity.

A. View of 1169 (Right) and 1155 (Left) Holly Ridge Road, View to North

B. View of 1149 (Right) and 1137 (Left) Holly Ridge Road, View to North

Resource U/21/0256 no longer retains integrity to convey significance in the area of architecture as a district that is united by design and historic development. The six, single-family dwelling within the proposed district have not been moved and retain their integrity of location. Modern infill development on the west side of Holly Ridge Road has caused the property to lose its integrity of setting. Due to alterations and the removal of historic fabric on a few of the houses, the district

no longer retains integrity of design, materials, and workmanship. While the resource retains integrity of association through the continued residential use of the houses, the cumulative loss of other aspects of integrity have caused the district to lose feeling as a postwar residential rural development.

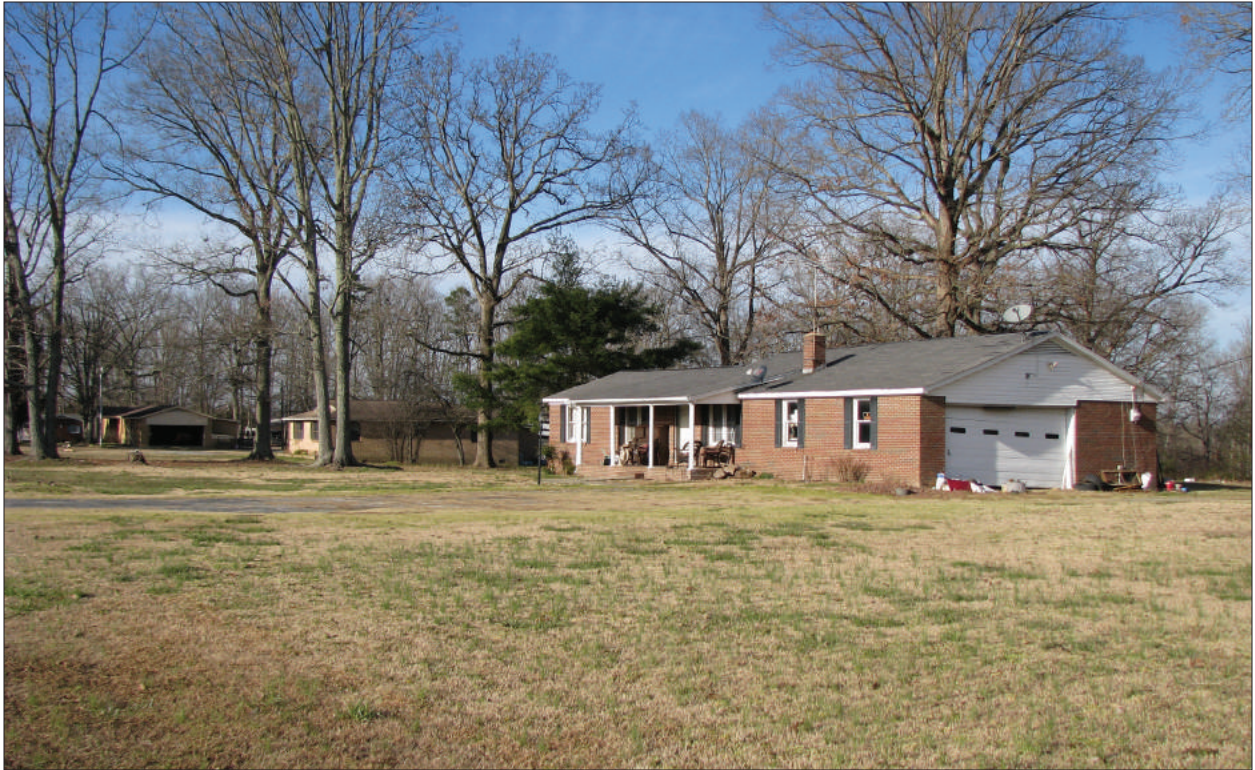
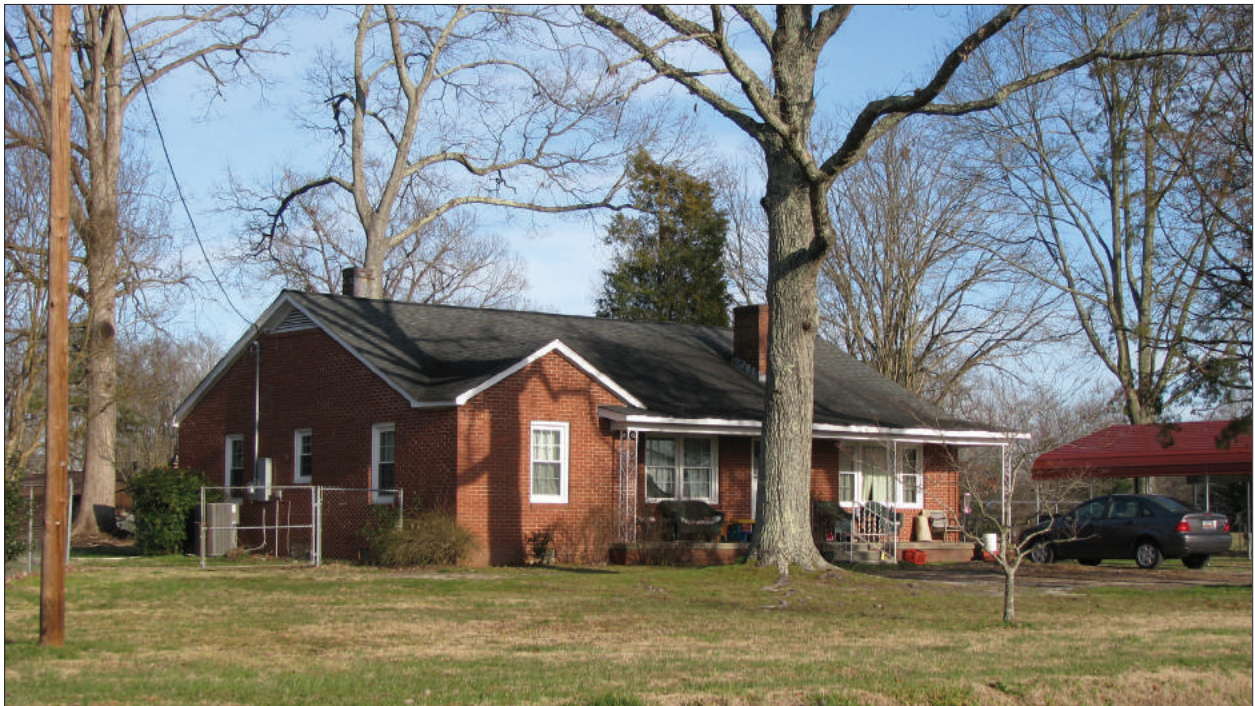
Figure 21.
Holly Ridge Road District (U/21/0256)

A. View of 1179 Holly Ridge Road, View to North

B. 1203 Holly Ridge Road, View to East

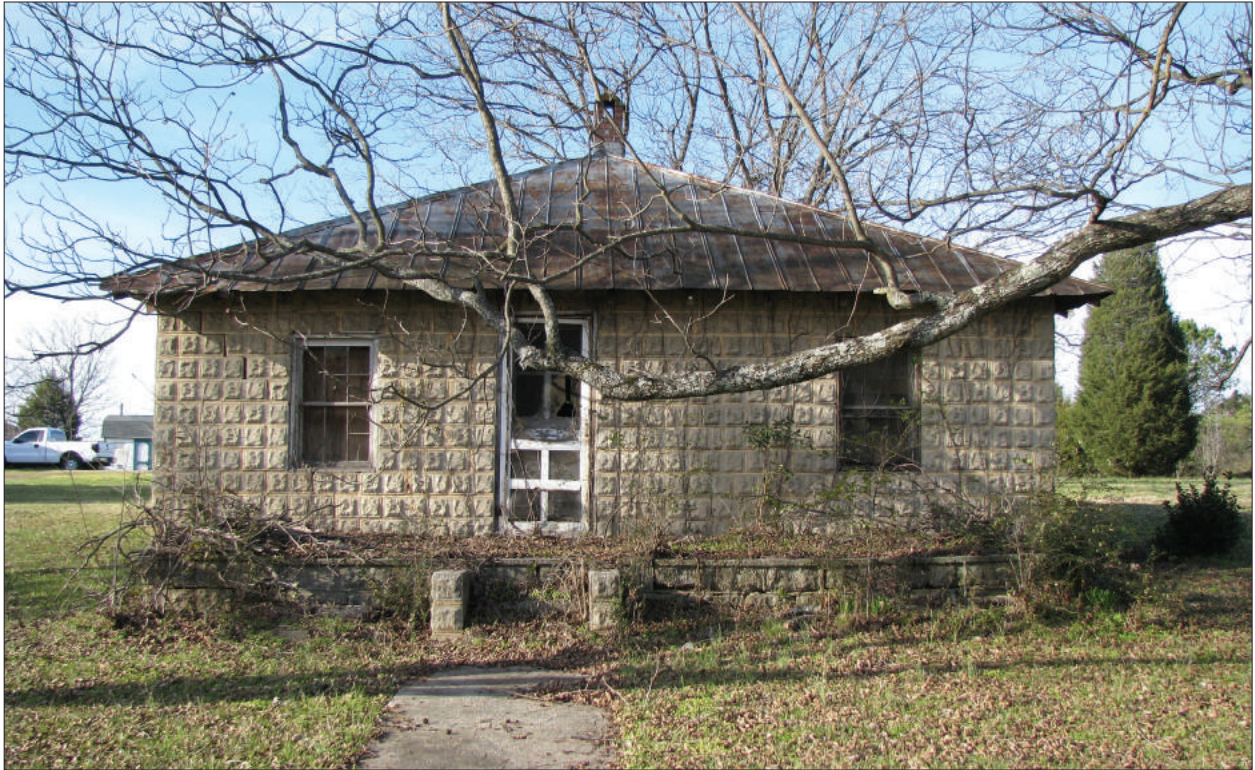
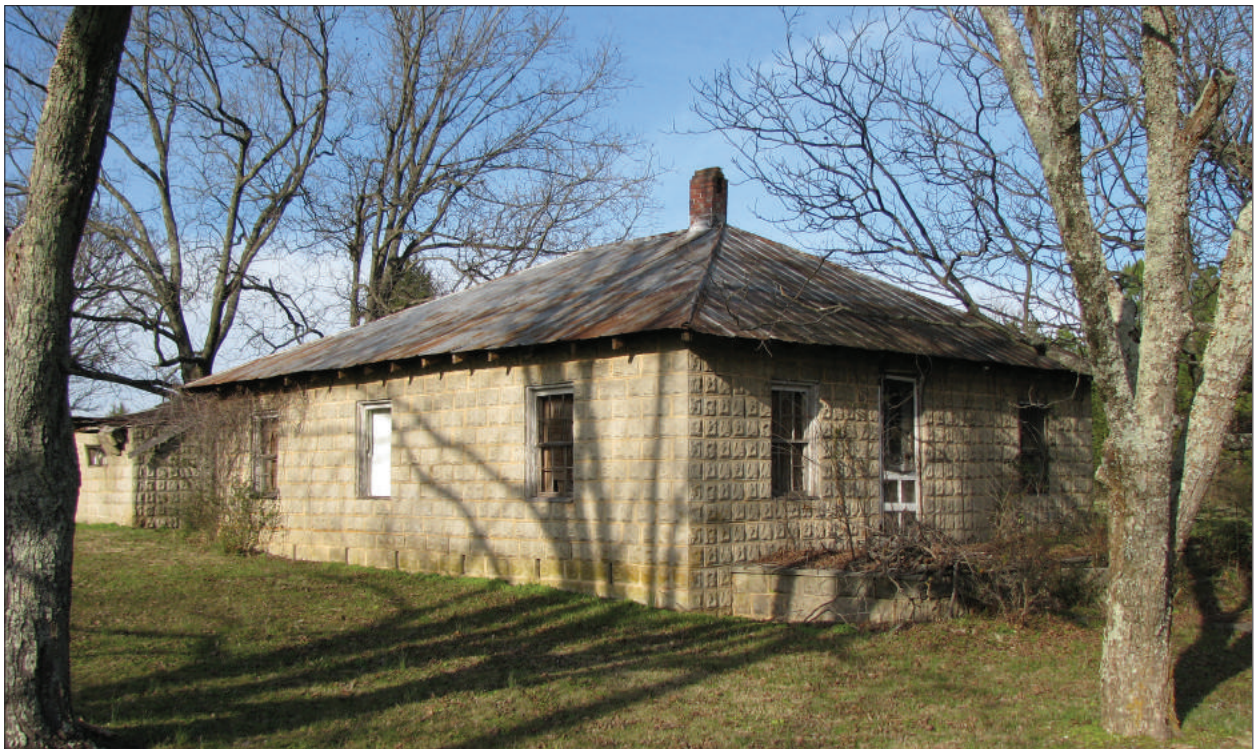
Figure 22.
173 Mulberry Road (U/21/0257)

Resources U/21/0257 and U/21/0257.1 are a circa 1925 single-family house and associated outbuilding located at 173 Mulberry Road (SR S-11-227) on the north side of the road (Figure 22A-B). The one-story residence is a Bungalow house type with a rectangular plan and asymmetrical façade. It is constructed of rusticated face concrete block and has a hipped roof with moderately overhanging eaves and exposed rafters. The roof is covered with ribbed sheet metal. A thin brick chimney occupies the center roof ridge. A raised front patio with a concrete block foundation provides access to the front entrance door. The wood panel door has four lights, a screen door, and appears to be original to the building. Two wood six-over-six sash windows flank the door. Similar units are located on the west side of the building; however, many of the windows openings are devoid of sashes.

A. Façade, View to North

B. West Oblique, View to Northeast

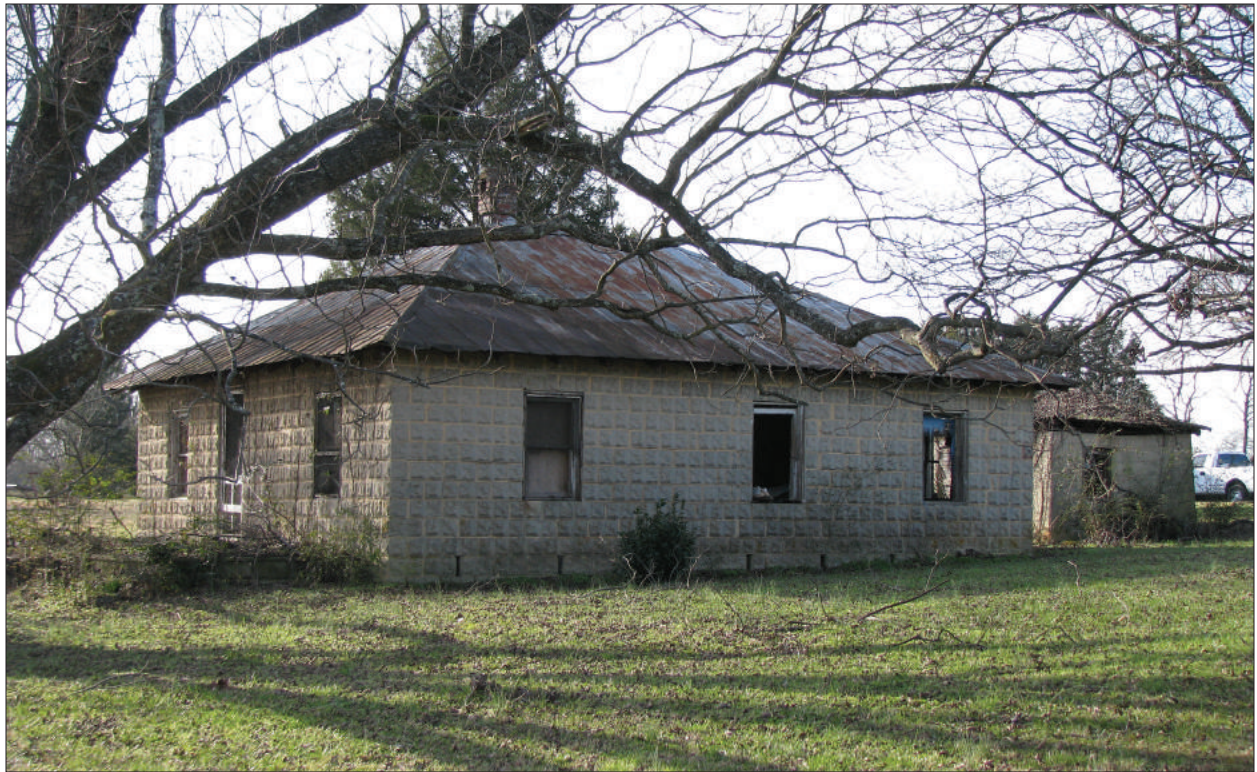
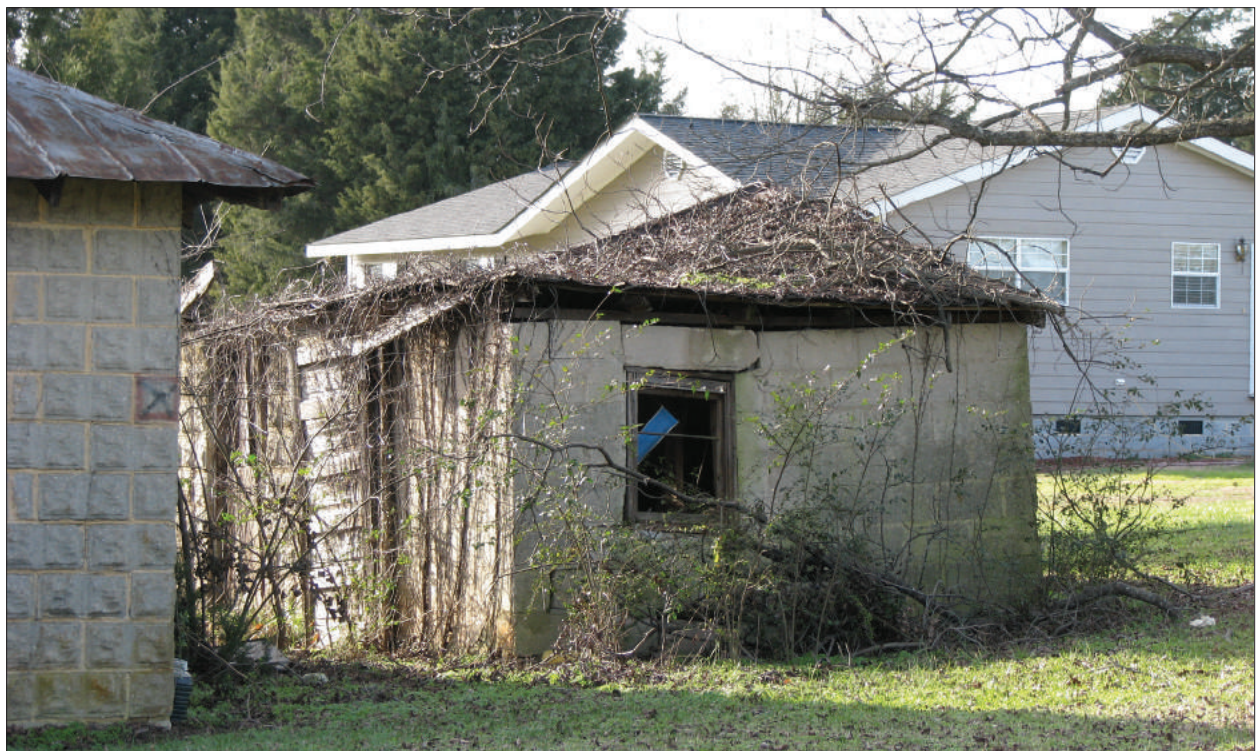
Figure 23.
173 Mulberry Road (U/21/0257 and U/21/0257.01)

A one-story CMU and rusticated face concrete block constructed outbuilding is located directly behind the primary residence (Figure 23A-B). The outbuilding is in an extreme state of disrepair and covered with overgrown vegetation. The roof has collapsed and the walls are cracked and buckling.

A. East Oblique, View to Northwest

B. Outbuilding, View to West

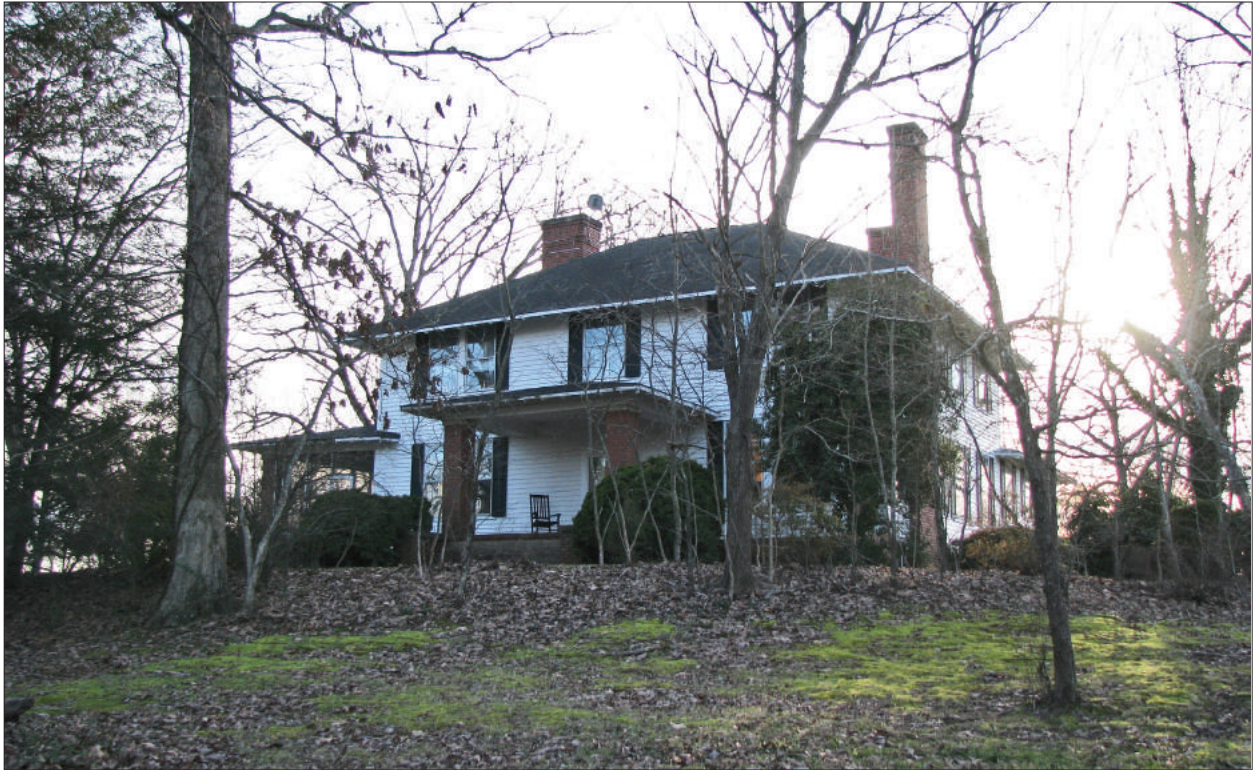
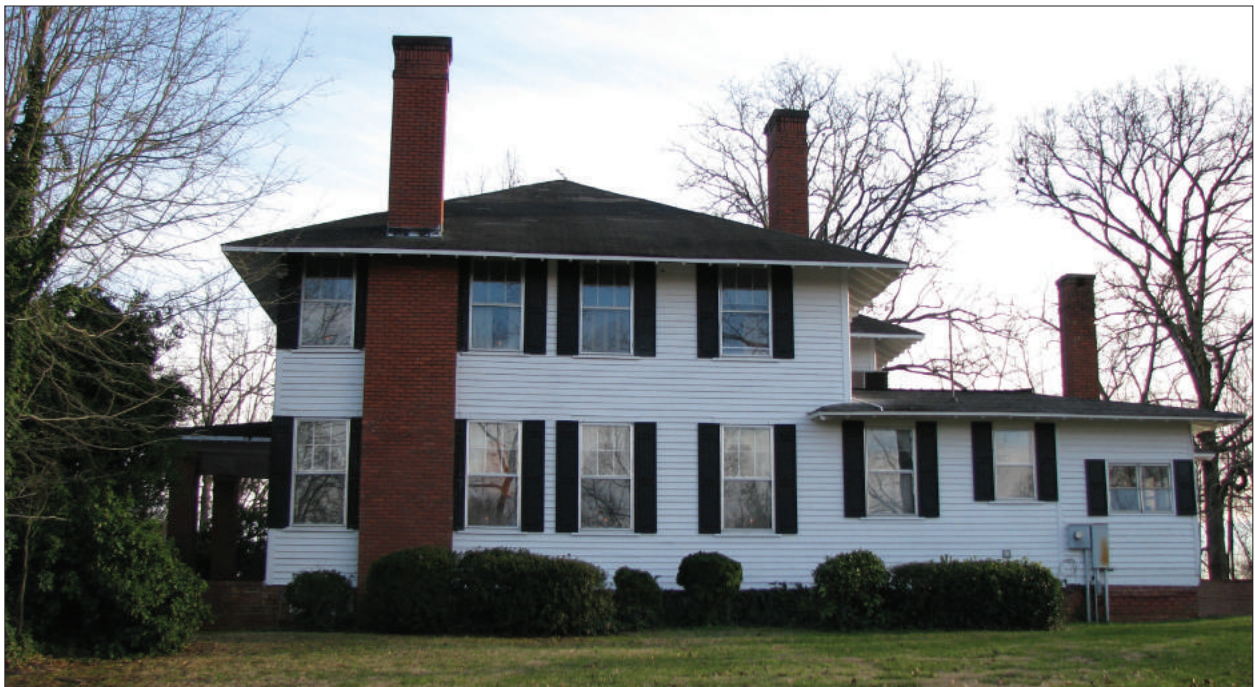
Figure 24.
2509 East Cherokee Street (U/21/0258)

The two-story, wood frame dwelling does not conform to any identifiable house type or style (Figure 24A-B). It has an irregular plan that appears to consist of a central hall with rooms on both sides and a kitchen at the rear of the building. The eclectic architectural design contains a mixture of both Colonial Revival and Prairie stylistic features that are expressed through: the symmetrical relationship of solids and voids on the façade and side elevations; hipped roof with wide, overhanging eaves and exposed rafters; prominent stature of the corbeled brick chimneys; and multiple one-story porches and wings (McAlester 2013:552–564). The building is set on a continuous brick foundation with a white painted weatherboard exterior. The hipped roof is covered with asphalt shingles and the house has four brick chimneys. Three are located on the roof slopes of the building core. A fourth, smaller chimney is located on the rear eave wall. The front entrance porch is supported by two, large square brick supports. A side porch on the southeast corner of the building has similar brick supports and is enclosed with weatherboard siding and screens. Exterior access to the screened porch is via three concrete stairs and a screen door at the rear of the porch. Both front porches have shallow hipped roofs. The rear door now functions as the primary entrance. It has a raised brick foundation and is covered by a hipped porch with squared wood column supports. Most windows are six-over-one wood sash units and are outfitted with storm window coverings. A fourth doorway and four smaller one-over-one sash windows are located in an enclosed area at the northwest corner of the building. The windows may be arranged in single and paired configurations and flanked by paneled vinyl shutters.

A. East Oblique, View to Northwest

B. Outbuilding, View to West

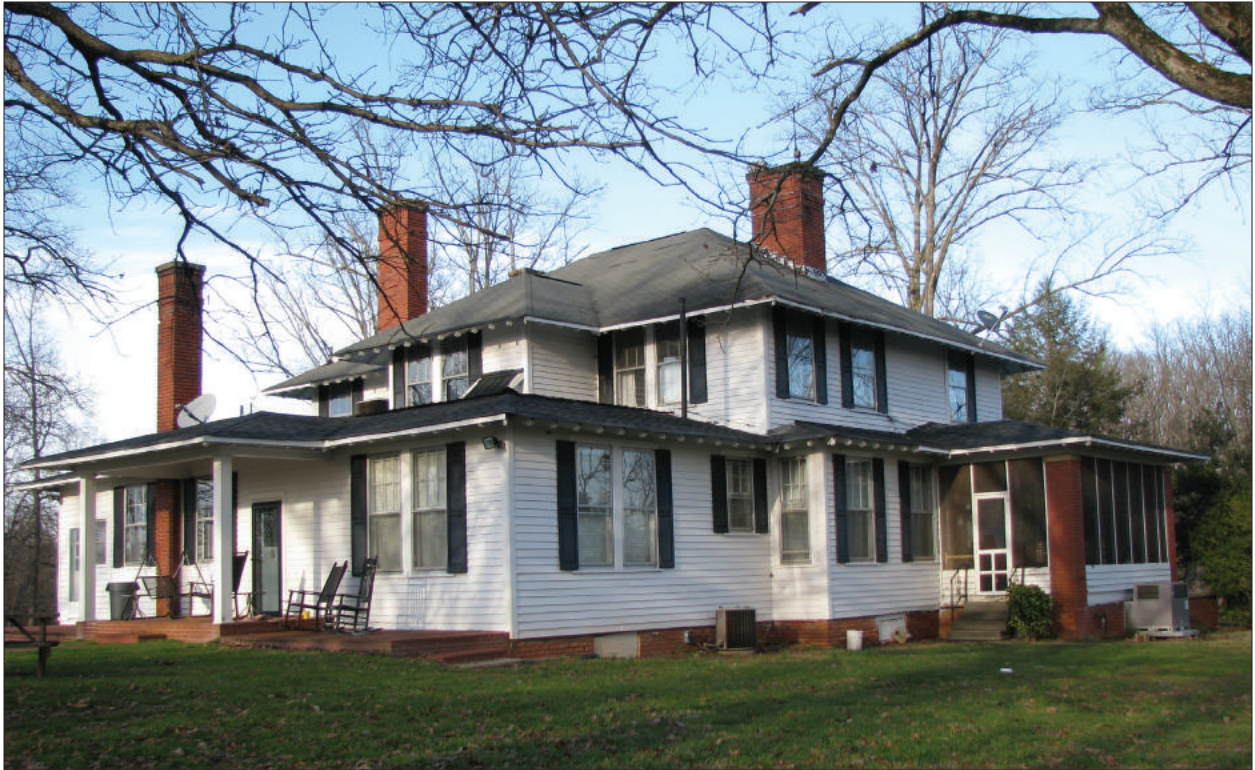
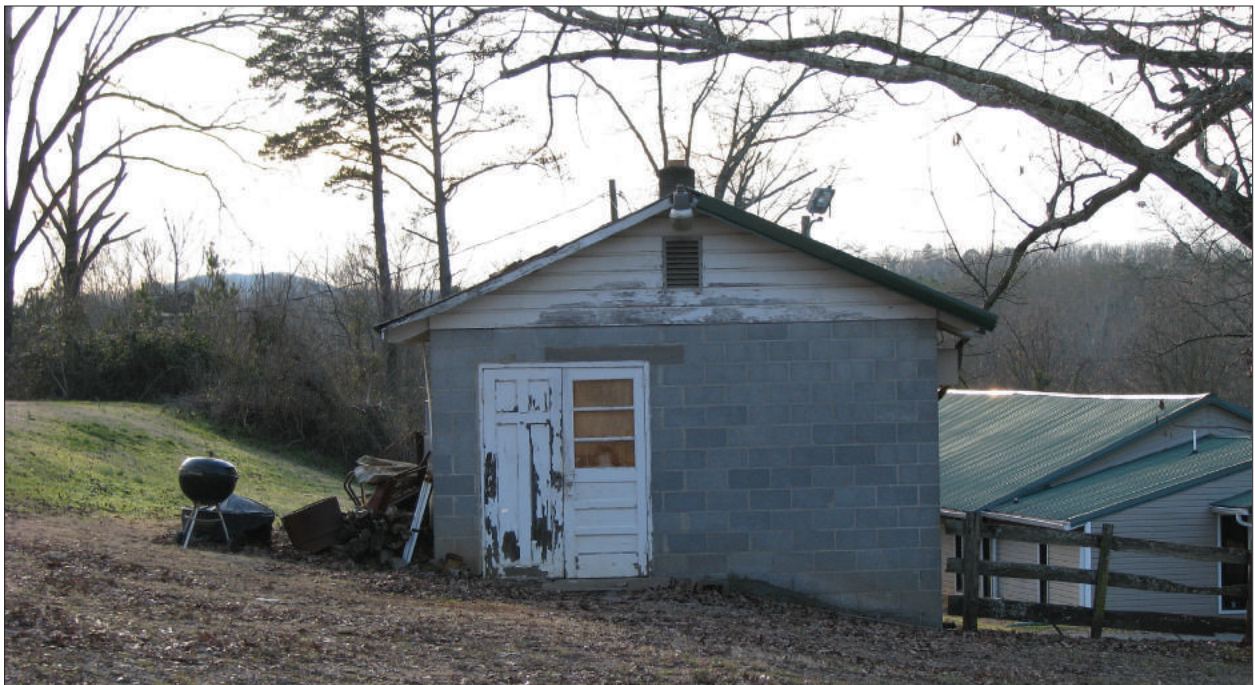
Figure 25.
2509 East Cherokee Street (U/21/0258 and U/21/0258.01)

The circa 1965 one-story shed outbuilding is located behind (west) of the house and is constructed of unpainted CMU (Figure 25). It has a rectangular plan and front gable roof covered with ribbed sheet metal. Wood shiplap siding is located in the gable ends. A CMU chimney vent stack is located at the rear of the roof ridge. Mismatched wood double doors are located at the south end of the façade. A glass block window is present at the rear, northwest corner.

A. South Oblique, View to Northeast

B. Shed Outbuilding, View to West

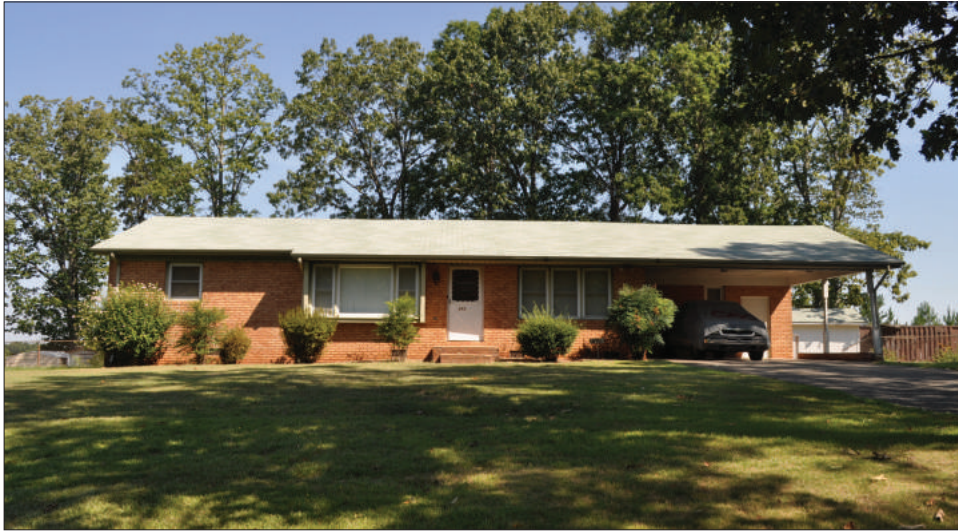
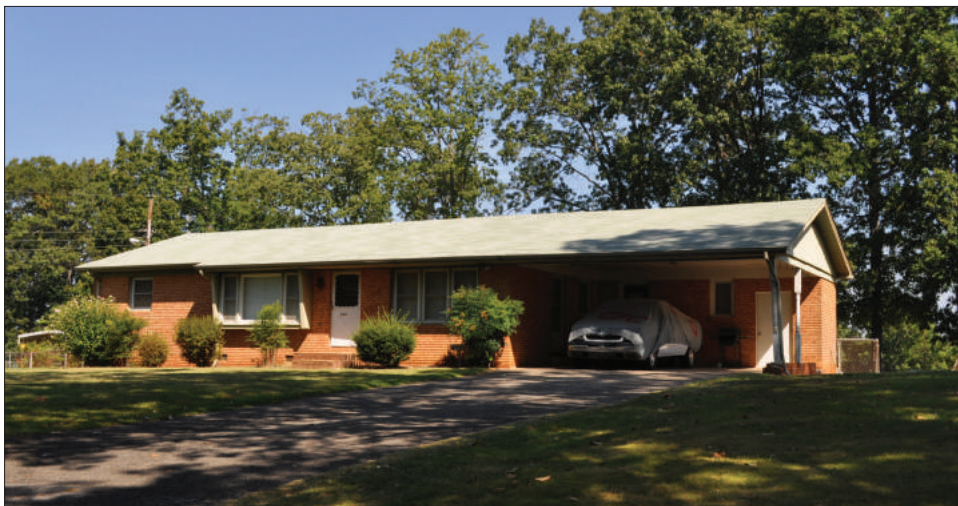
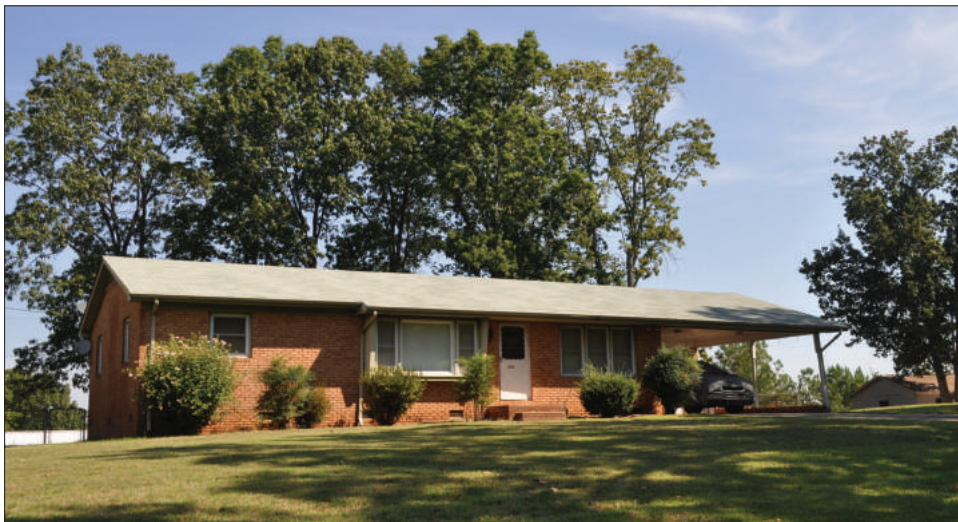
Figure 26.
242 Lakeview Drive (U/21/0259)

Resource U/21/0259 is a circa 1965 Compact Ranch House located at 242 Lakeview Drive (Figure 26). The one-story single family residence is clad in brick veneer and has a laterally-gabled composition shingle roof which extends over a portion of the front (south) elevation to create an unsupported shed roof porch. Fenestration beneath the porch includes a tripartite picture window with one-over-one vinyl double-hung sash window side pieces, a wood panel door with three small horizontal windows, and a set of tripled one-over-one vinyl double-hung sash windows. A smaller one-over-one vinyl double-hung sash window lies to the west of the porch. A carport with turned wood supports lies to the east.

A. South Elevation

B. Southeast
Oblique

C. Southwest
Oblique
