Phase I Cultural Resources Survey of Approximately 12 Miles of Improvements Along I-85

Cherokee County, South Carolina

October 10, 2016 • **Draft Report**
New South Associates Technical Report 2589

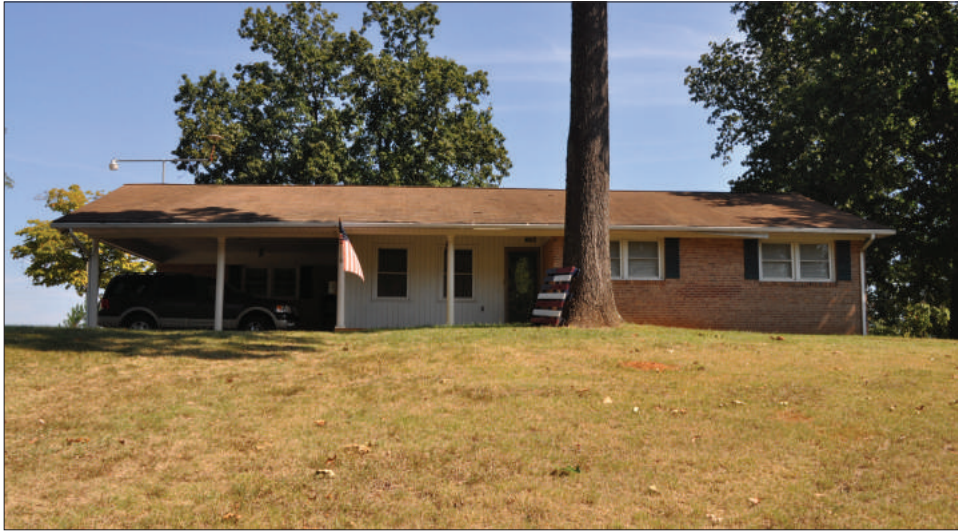
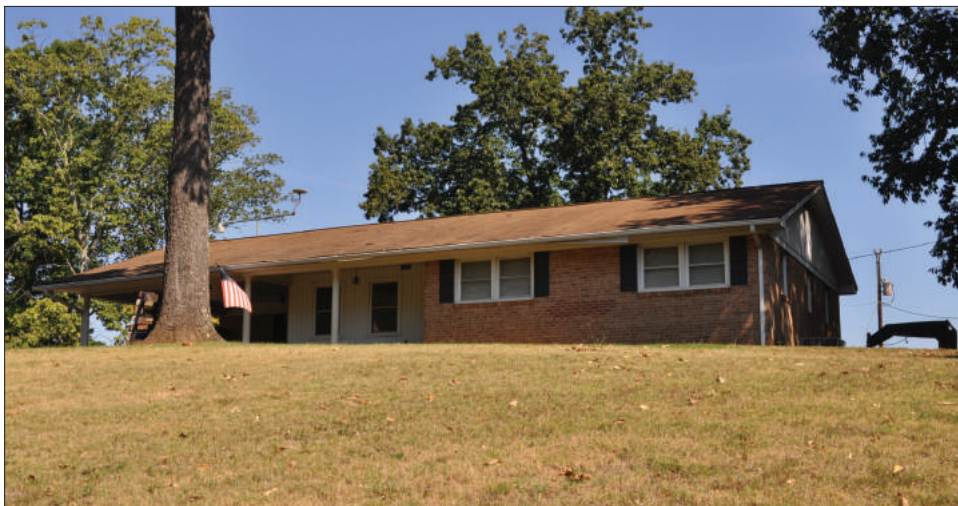
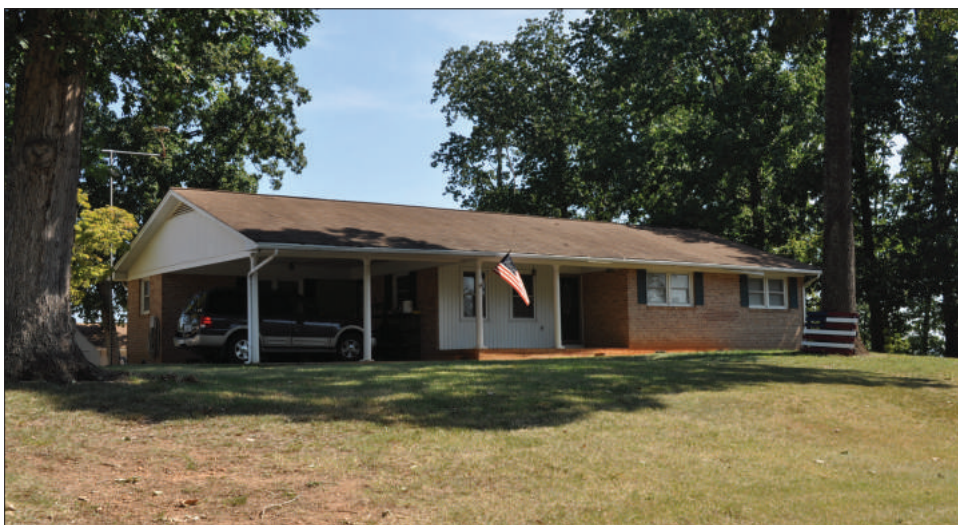
Figure 27.
238 Lakeview Drive (U/21/0260)

Resource U/21/0260 is a circa 1965 Compact Ranch House located at 238 Lakeview Drive (Figure 27). It is a single-family residence that is clad in brick veneer with a laterally-gabled composition shingle roof. The resource is L-shaped in plan, with a recessed doorway roughly in the center of the front (south) elevation. The main roofline extends to create a shed roof porch with wood column supports over the west half of the front elevation. The porch extends over the recessed modern wood door as well as a section of the house with vertical wood siding which contains two one-over-one aluminum-frame double-hung sash windows. A carport lies to the far west. The front L lies to the east of the entrance, with two sets of paired one-over-one vinyl double-hung sash windows with wood shutters.

A. South Elevation

B. Southeast
Oblique

C. Southwest
Oblique

Resource U/21/0260 lies on Lakeview Drive, which is a curvilinear two-lane residential road that contains single family houses and manufactured homes sited on fairly large lots. Resource U/21/0260 has a generous setback and a grass lawn along with mature coniferous and deciduous trees. Resource U/21/0260 is not known to be associated with any significant historic events or persons and was therefore not evaluated under Criteria A and B. The resource was evaluated for significance at the local level under Criterion C for architecture. Although it is a Ranch House, it

does not feature distinctive architectural design elements or a noteworthy method of construction, and its integrity has been affected by a modern window replacement. It was found not to embody the distinctive characteristics of a house type, period, or method of construction, and therefore is not recommended as eligible under Criterion C.

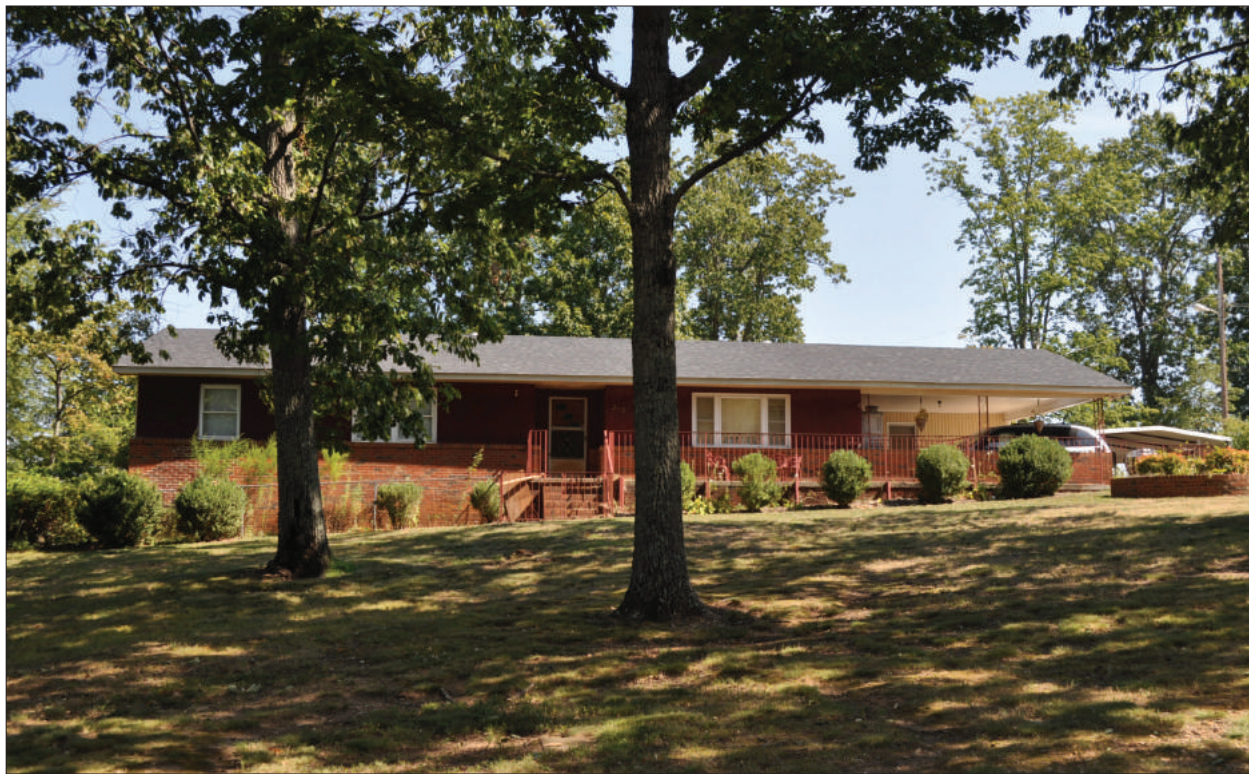
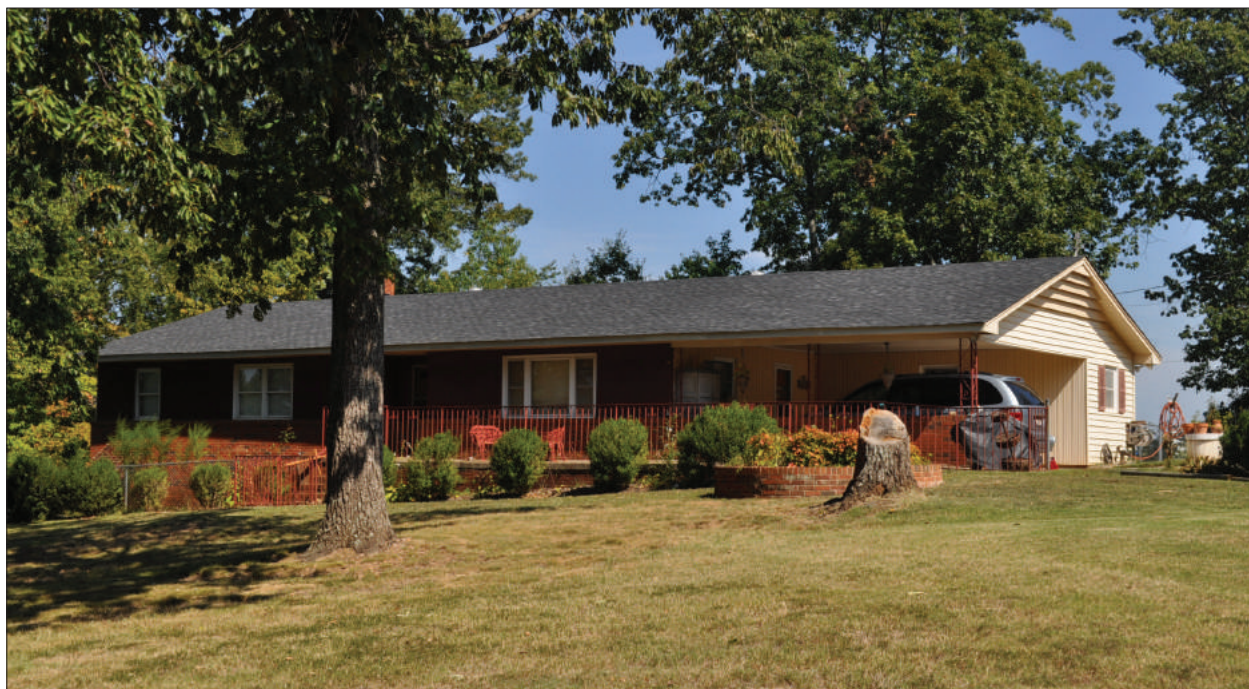
Figure 28.
212 Lakeview Drive (U/21/0261)

A. South Elevation

B. Southeast Oblique

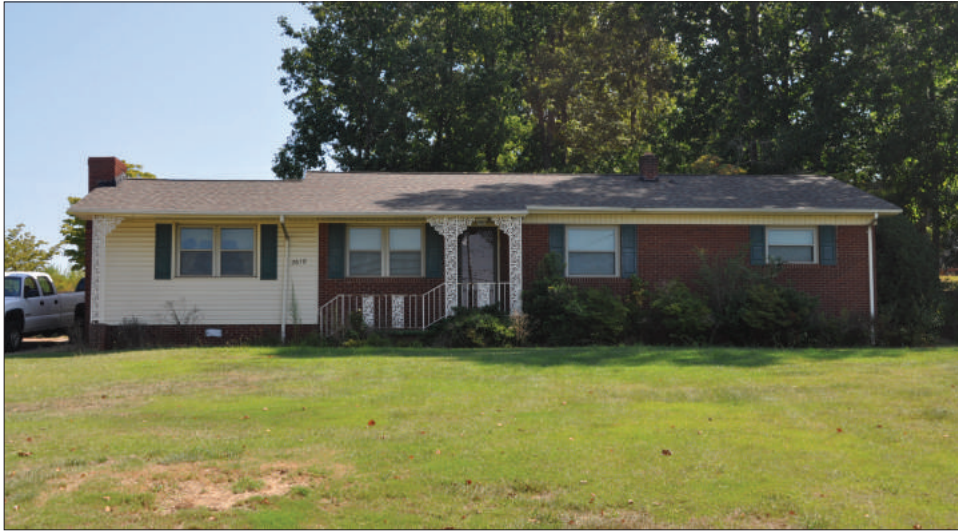
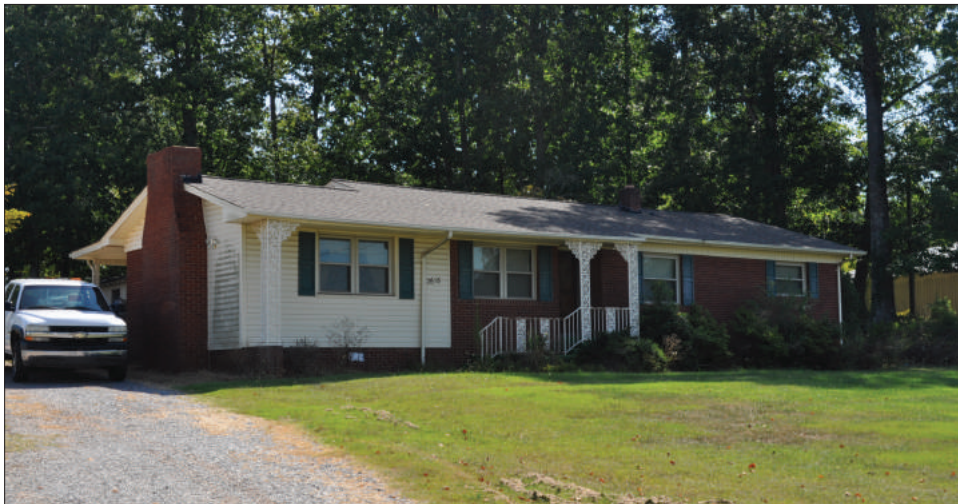
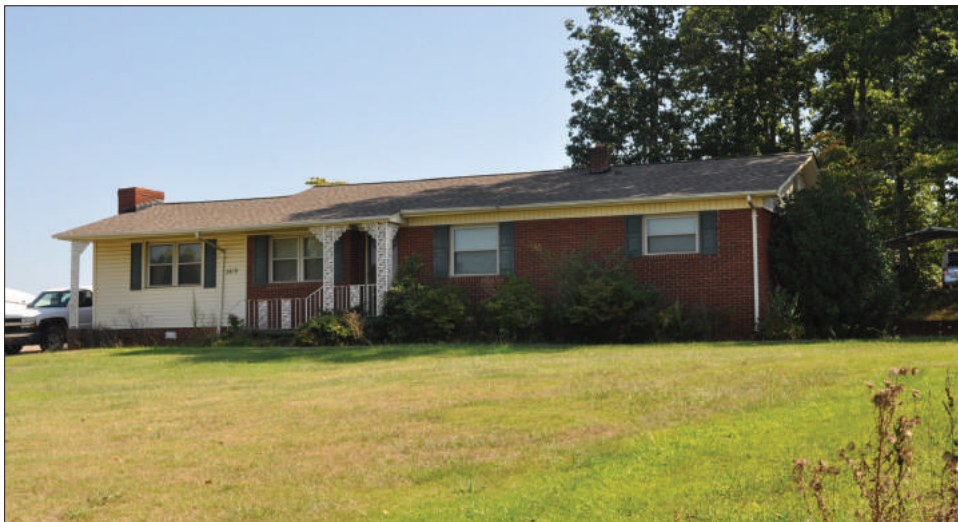
Figure 29.
2618 E. Cherokee Street/U.S. Highway 29 (U/21/0262)

Resource U/21/0262 is a circa 1965 Compact Ranch House located at 2618 E. Cherokee St/U.S. Highway 29 (Figure 29). The single-family residence is clad in brick veneer and synthetic siding and has a laterally-gabled composition shingle roof. The main roofline extends to create a shed roof porch over the north half of the front (west) elevation. The porch is supported by decorative cast aluminum supports and the walkway to the recessed wood panel front door has an aluminum railing with matching balusters. To the east of the front door lie two single one-over-one vinyl double hung sash windows of differing sizes. To the west of the door lie two sets of paired one-over-one vinyl double-hung sash windows. All windows have wood panel shutters. A carport on the far west side of the building has been enclosed and is clad in synthetic siding. An external brick chimney has been added to the west elevation as well.

A. West Elevation

B. Northwest
Oblique

C. Southwest
Oblique

Resource U/21/0262 is situated near the corner of E. Cherokee Street and Frontage Road, which leads to I-85. This is a busy commercial intersection with convenience stores as well as vacant buildings that formerly housed gambling facilities. Resource U/21/0262 is sited on a somewhat narrow and deep lot with a grass lawn, ornamental shrubs, and a windbreak of coniferous trees to the rear. Resource U/21/0262 is not known to be associated with any significant historic events or persons and was therefore not evaluated under Criteria A and B. The resource was evaluated for significance at the local level under Criterion C for architecture. Although it is a Ranch House, it does not feature distinctive architectural design elements or a noteworthy method of construction, and its integrity has been affected by the unsympathetic enclosure of its carport and the replacement of its original windows. It was found not to embody the distinctive characteristics of a house type, period, or method of construction, and therefore is not recommended as eligible under Criterion C.

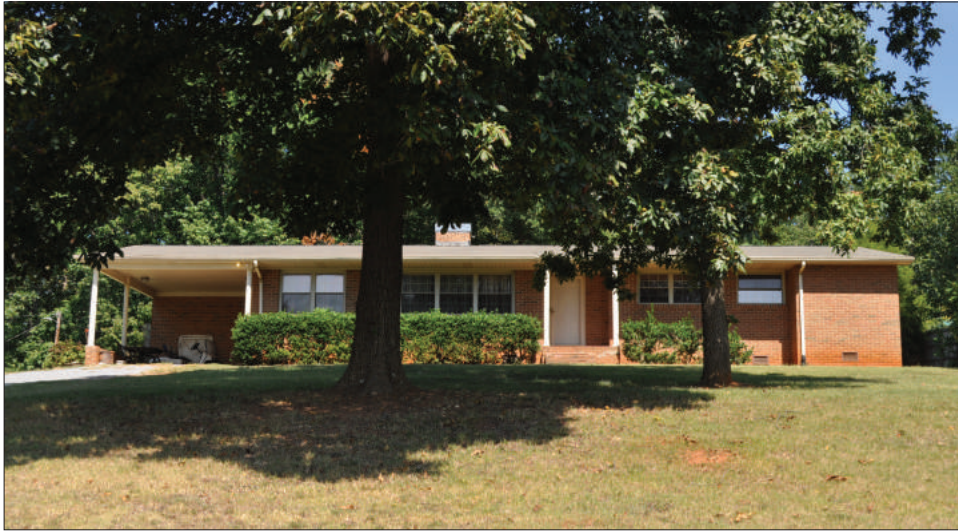
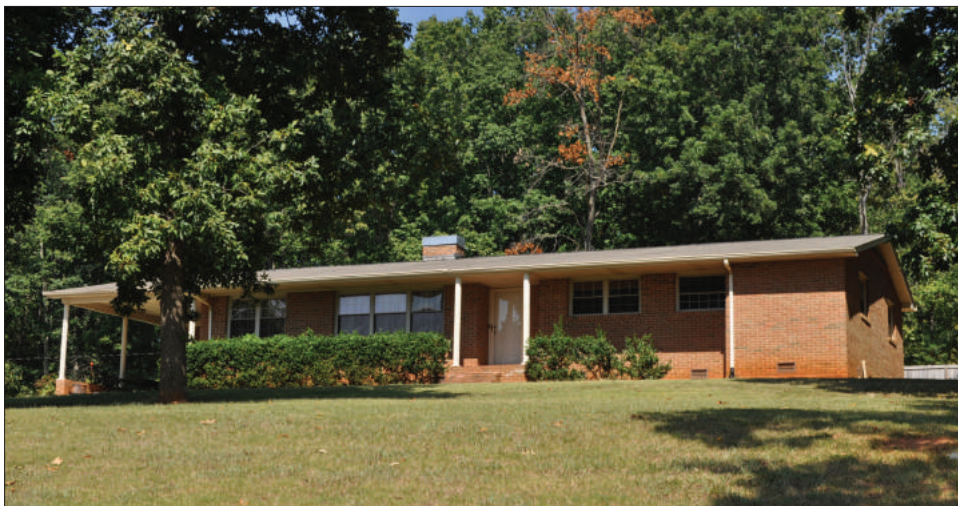
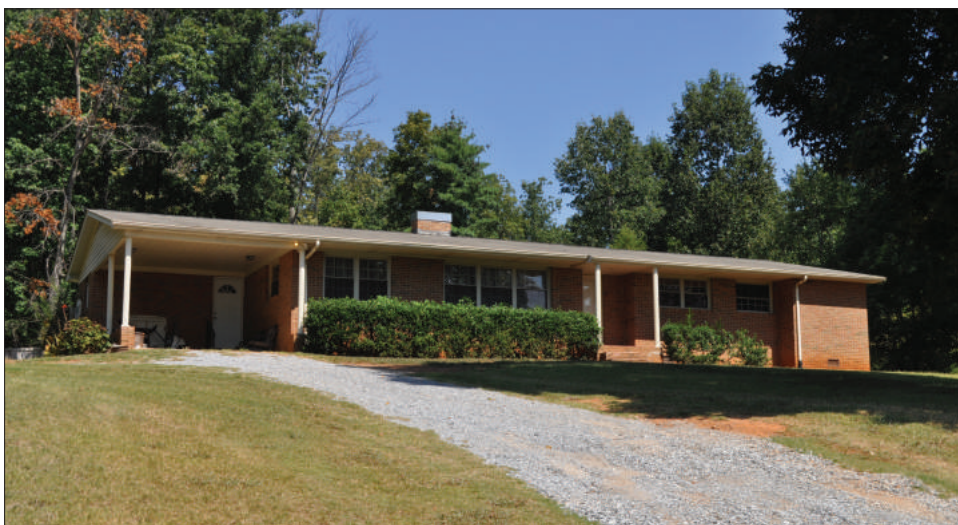
Figure 30.
119 Lakeview Drive (U/21/0263)

Resource U/21/0263 is located on Lakeview Drive, which is a curvilinear two-lane residential road that contains single family houses and manufactured homes. It is directly adjacent to the T intersection of Lakeview Drive and Wendy Drive, which extends to the southeast and primarily houses manufactured homes on large lots. Resource U/21/0263 is sited on a large lot with a grass lawn, mature deciduous trees, and manicured ornamental shrubs. Resource U/21/0263 is not known to be associated with any significant historic events or persons and was therefore not evaluated under Criteria A and B. The resource was evaluated for significance at the local level under Criterion C for architecture. Although it is a Ranch House, it does not feature distinctive architectural design elements or a noteworthy method of construction, and its integrity has been affected by the replacement of its original windows. It was found not to embody the distinctive characteristics of a house type, period, or method of construction, and therefore is not recommended as eligible under Criterion C.

A. South Elevation

B. Southeast
Oblique

C. Southwest
Oblique

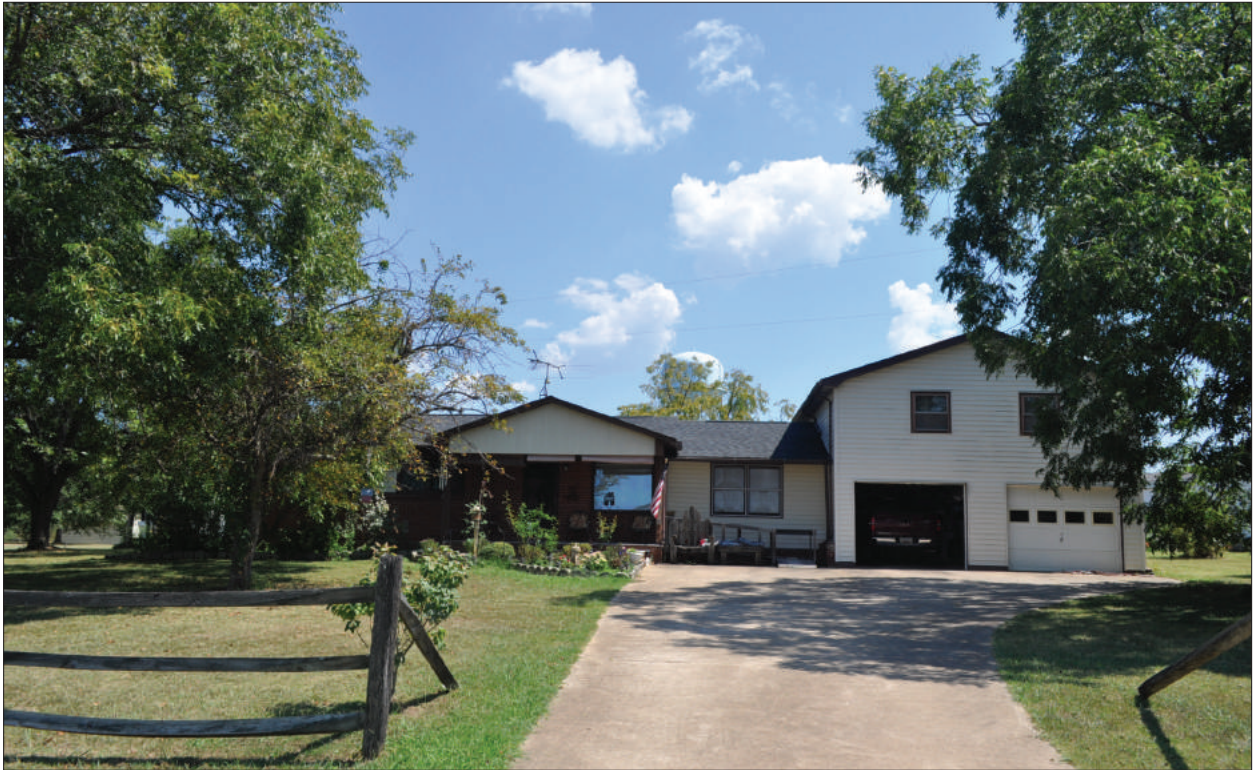
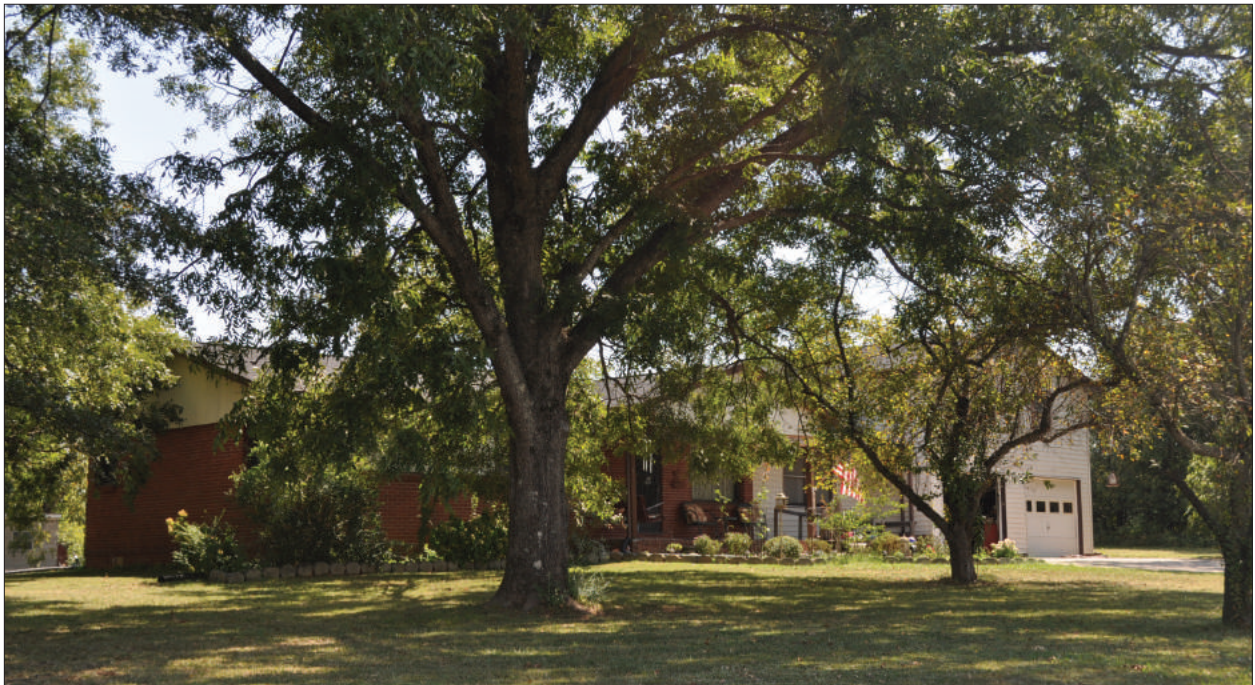
Figure 31.
514 Tribal Road (U/21/0264)

A. West Elevation

B. Northwest Oblique

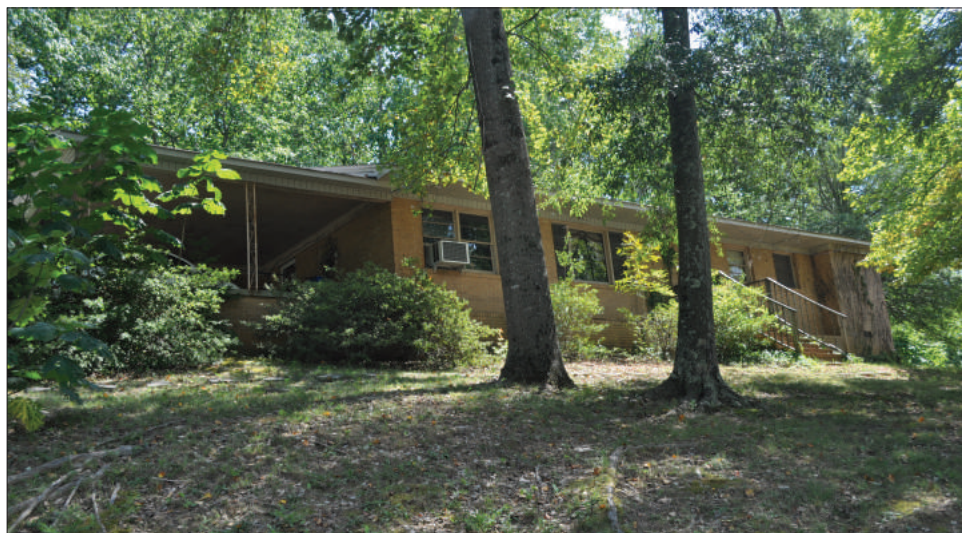
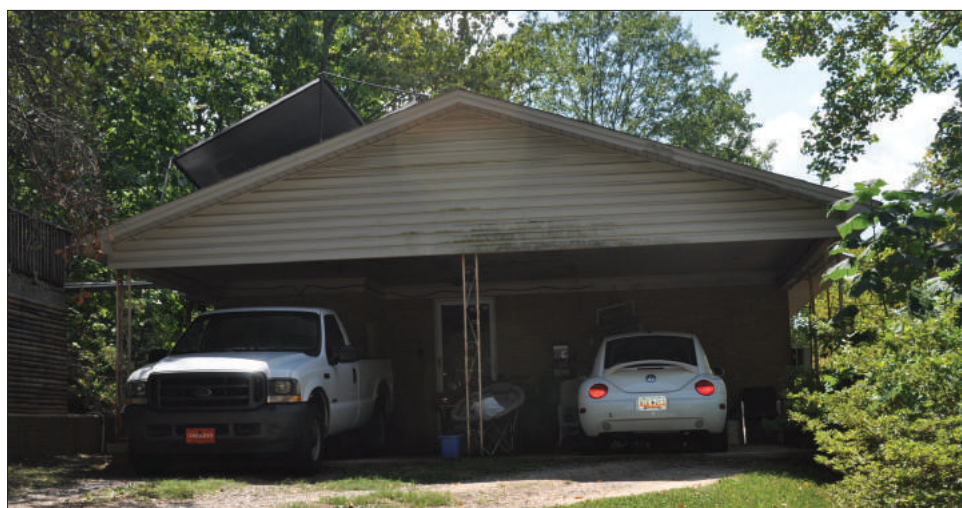
Figure 32.
Sizemore Acres Lane (U/21/0265)

Resource U/21/0265 is a circa 1965 Linear Ranch House located at the corner of Sizemore Acres Lane and North Mountain Street (Figure 32). The single-family residence is clad in brick veneer and has a laterally-gabled composition shingle roof. There is a shallow, windowless L on the south side of the front (west) elevation. The rest of the front elevation is recessed, and all fenestration lies beneath an unsupported shed roof porch created by overhanging eaves. Brick stairs with a wood railing and turned wood balusters lead to the recessed front entrance. The wood panel door has three small windows. To the south of the entrance are two two-over-two wood frame double-hung sash windows. To the north of the entrance are a wood frame tripartite picture window and a set pf paired two-over-two wood frame double-hung sash windows. A carport lies on the north elevation with aluminum supports.

A. Northwest
Oblique

B. North Elevation

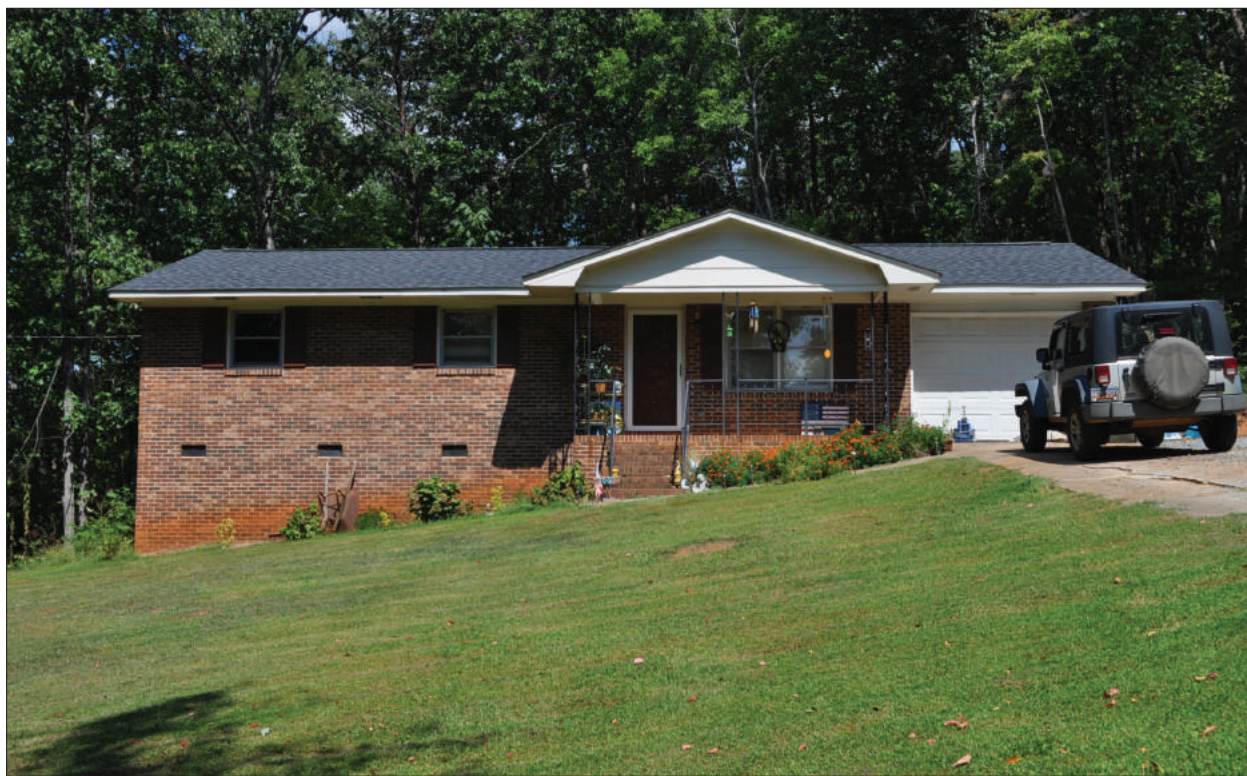
Figure 33.
109 Sizemore Acres Lane (U/21/0266)

Resource U/21/0266 is located on Sizemore Acres Lane, a small one-lane road that rises at a steep grade from busy North Mountain Street. It is one of under five houses on the lane, each separated by a wooded buffer. Resource U/21/0266 has a large grass lawn and ornamental flowering shrubs in addition to the buffer of coniferous and deciduous trees. Resource U/21/0266 is not known to be associated with any significant historic events or persons and was therefore not evaluated under Criteria A and B. The resource was evaluated for significance at the local level under Criterion C for architecture. Although it is a Ranch House, it does not feature distinctive architectural design elements or a noteworthy method of construction. It was found not to embody the distinctive characteristics of a house type, period, or method of construction, and therefore is not recommended as eligible under Criterion C.

A. South Elevation

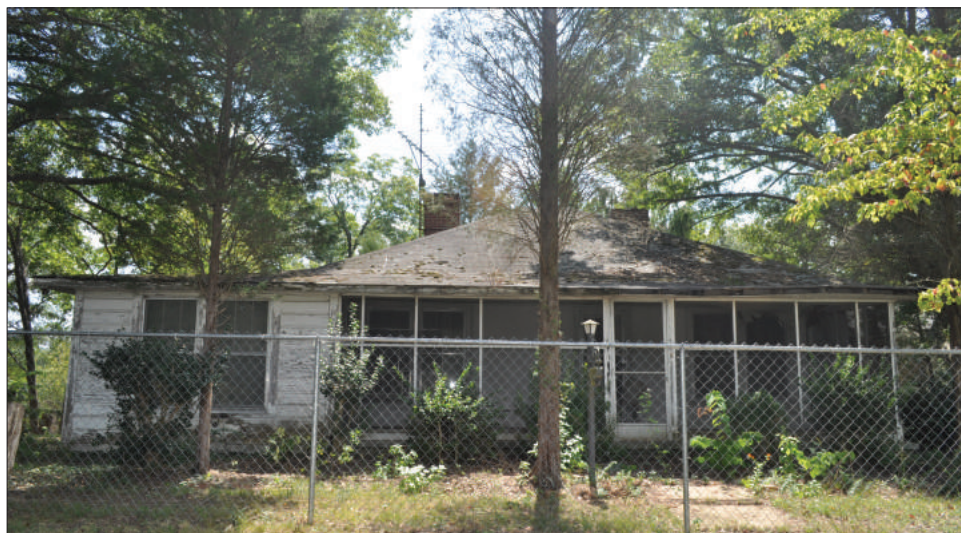
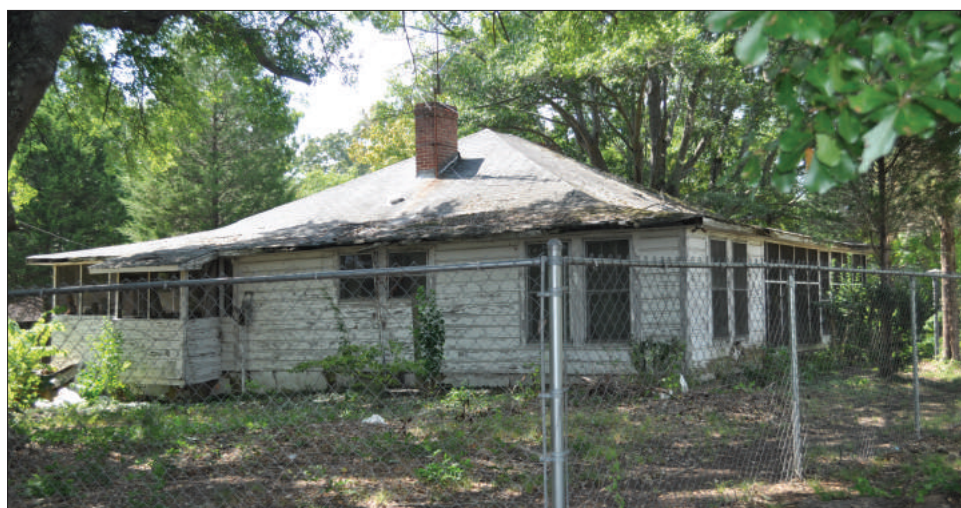
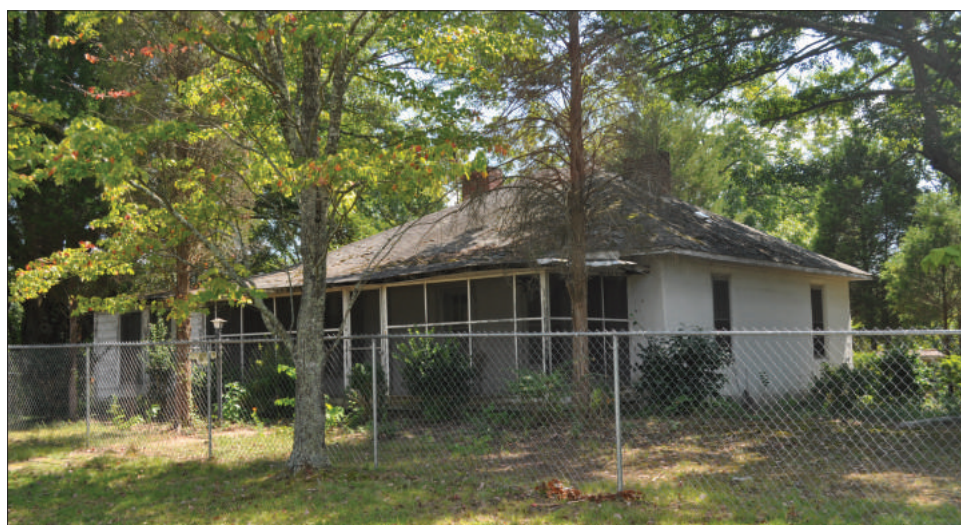
Figure 34.
1153 North Mountain Street (U/21/0267)

Resource U/21/0267 is a circa 1890 Georgian Cottage located at 1153 North Mountain Street (SC 198) (Figure 34). The one-story single-family residence is clad in smooth stucco and has a steeply pitched composition shingle hipped roof. The historic core of the front (north) elevation is covered by an added shed roofed screened porch. The front elevation is symmetrical with a central three pane half-light door flanked by paired three-over-one wood frame double-hung sash windows. Two internal brick chimneys rise symmetrically from the center of the house behind the paired windows. A historic addition has been made to the east elevation of the building. The addition extends from the line of the porch to the rear of the house, and has one set of three-over-one wood frame double-hung sash windows on the front elevation as well as two sets on the east elevation. A shed roofed side porch has also been added to the east elevation. The additions are clad in German novelty siding and the original hipped roof is extended to cover them.

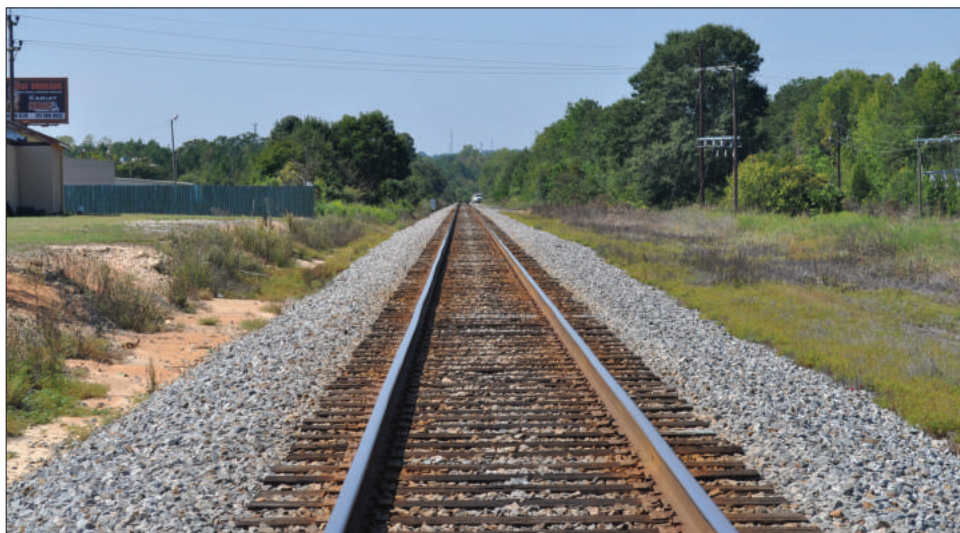
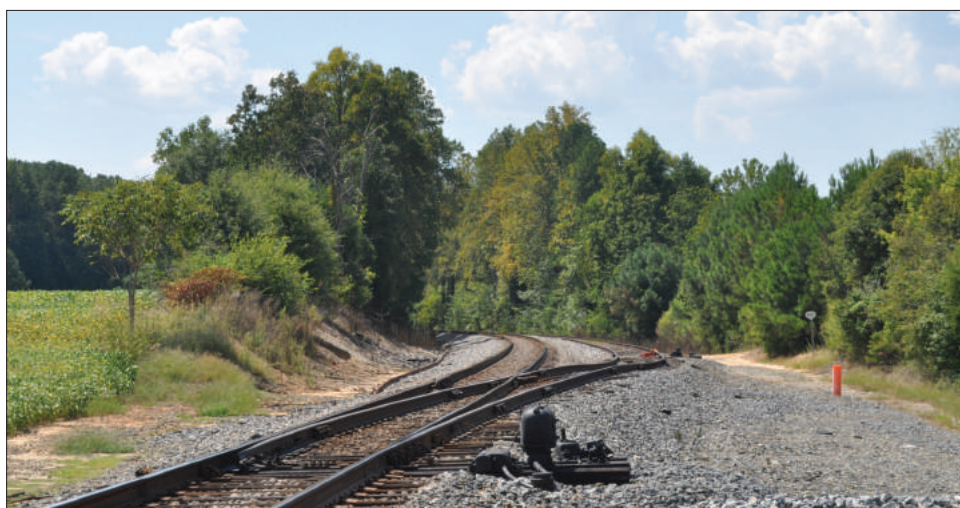
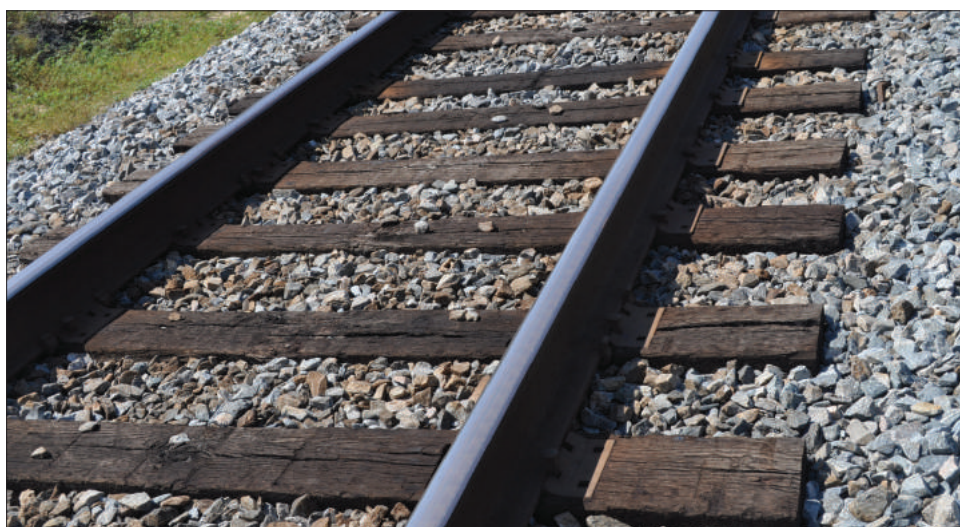
Figure 36.
Southern Railroad (U/21/0268)

Resource U/21/0268 is a circa 1873 section of track belonging to the Southern Railroad which runs through the project area for roughly two miles (Figures 35-36). This section of track was originally part of the Atlanta & Richmond Air Line which ran through South Carolina from the North Carolina state line at Kings Mountain west into Georgia, passing through Blacksburg as well as Spartanburg and Greenville on the way. In 1877, bankruptcy forced the reorganization of the railroad as the Atlanta & Charlotte Air Line Railway, and by 1894 it has been acquired by the Southern Railway, which operated it as the Atlanta Line (Lewis 2016). Today, this section of track is a standard gauge track in active use, and makes crossings with Tribal Road, I-85, and E. Cherokee Street within the project area. The majority of Resource U/21/0268 as it runs through the project area is a single-track linear line, although it splits into a double-track linear line as it exits the project area to the southwest by Tribal Road. There is an additional siding track that dead ends directly southwest of the intersection with I-85 at an industrial complex.

Resource U/21/0268 is an example of a common rail line type in South Carolina. It was not found to embody the distinctive characteristics of a type, period, or method of construction, and does not possess significance for its engineering or materials. It is recommended not eligible for inclusion on the NRHP under Criterion C. It was evaluated under Criterion A due to its association with patterns of development in both commerce and transportation. It was not found to rise to the level of significance necessary for inclusion on the NRHP due to either of these associations, particularly given that there are no additional historic elements, which would help communicate the association of this resource with those patterns of development within the APE. It is not known to be associated with any significant person and therefore was not evaluated under Criterion B.

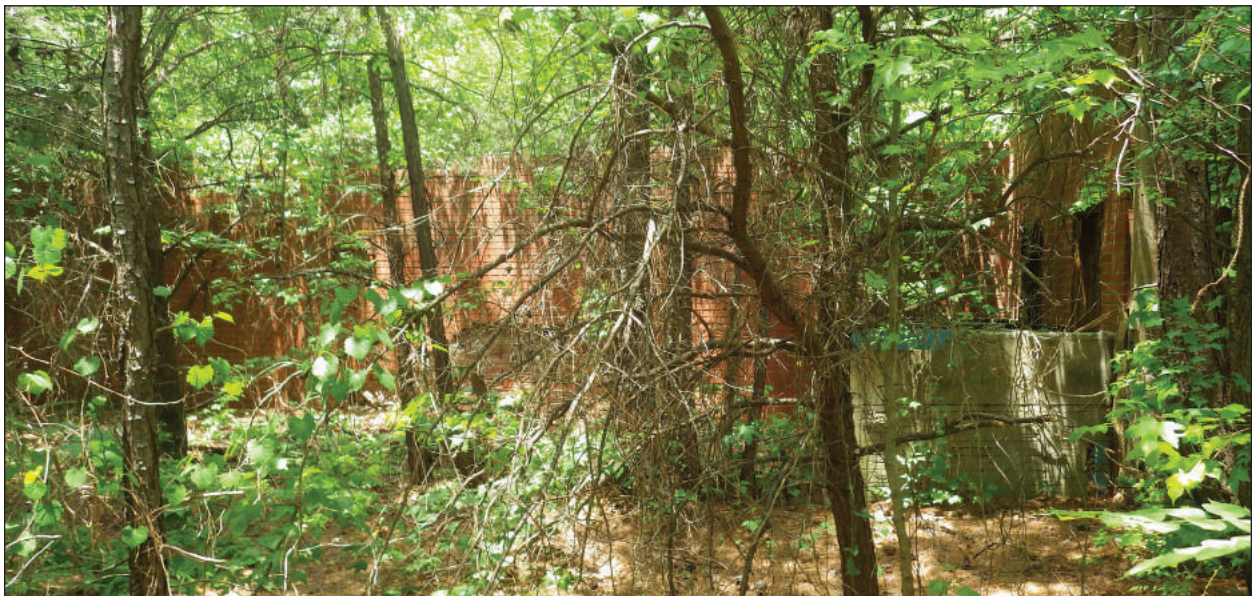
Figure 37.
Site Map of 38CK199 and View of Partial Walls

indicated graded surfaces within the survey corridor and did not produce any artifacts. Surface inspection, however, revealed several beverage containers that were identified as modern (probably last quarter of the twentieth century) along with brick rubble. These were not collected.

The site appears to date to the second half of the nineteenth century, and almost certainly was in use during the last third of the century, based on surface artifacts. The site appears to have been graded and does not contain archaeological deposits dating to a historic occupation. Given its relatively recent age and lack of archaeological data, this site is recommended not eligible for the NRHP.
