ADVERSE IMPACT ASSESSMENT

Project Soter

Ridgeville, Berkeley County, SC

Project No. 6250-15-0079

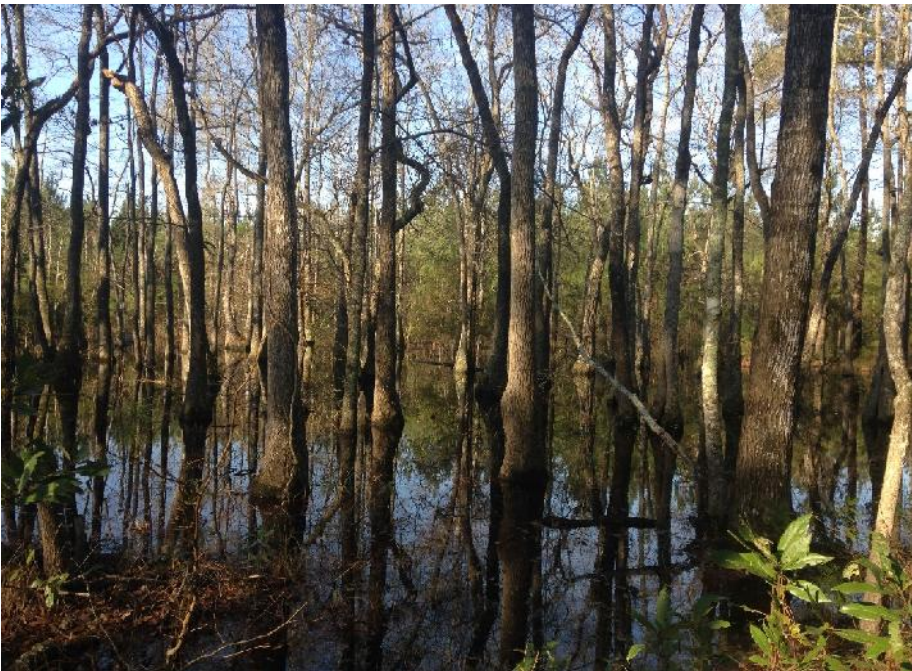
| | Description: Longleaf pine (<i>Pinus palustris</i>) plantation planted in 1976, Plot LL-71, along Fish Road in the northeast portion of the tract. |

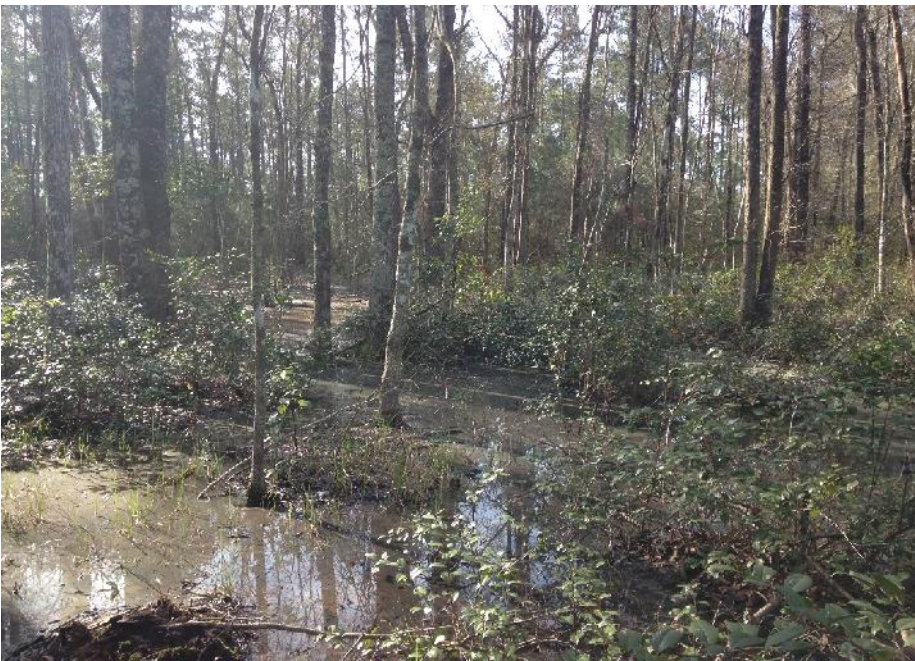
| | Description: Loblolly pine plantation planted in 1976, Plot LOB-64, located in the southwest portion of the tract. This stand has been thinned, and now includes a dense understory of saplings and shrubs. |

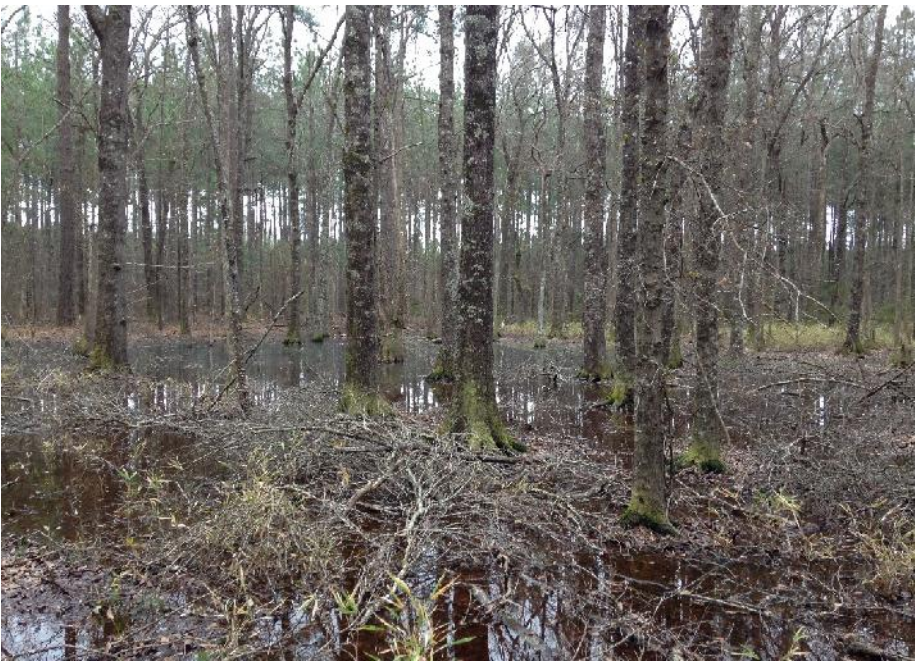
| | Photo No.: 7 |

| | Description: Isolated pond located in loblolly pine plantation, Plot LOB-73, in the southeast portion of the tract. The pond margins have been altered by silviculture activities. |

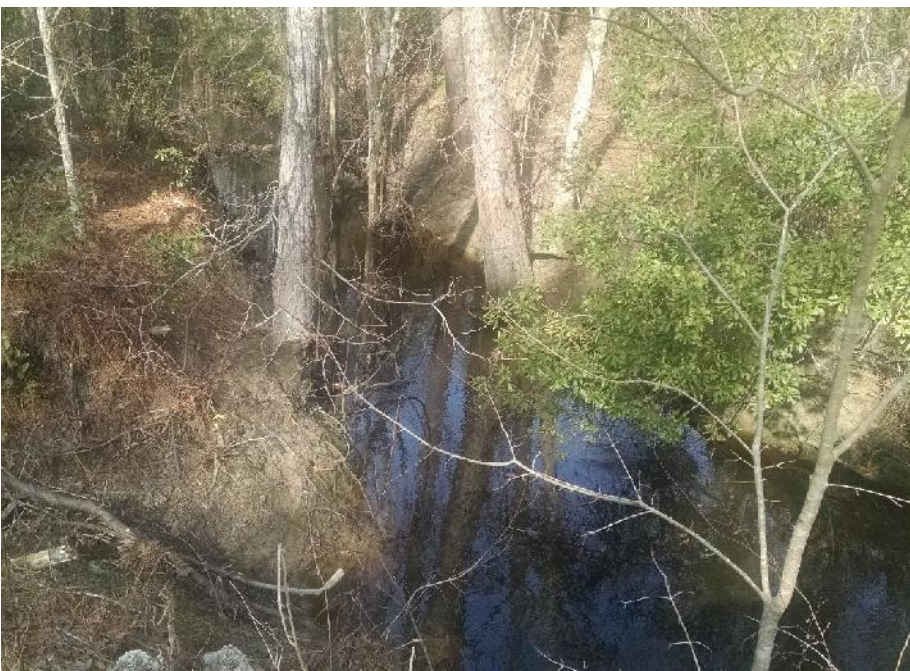
| | Description: Timothy Creek flowing south, and off site, under Wild Fire Road. The stream is channelized and has been heavily altered from silviculture activities. |

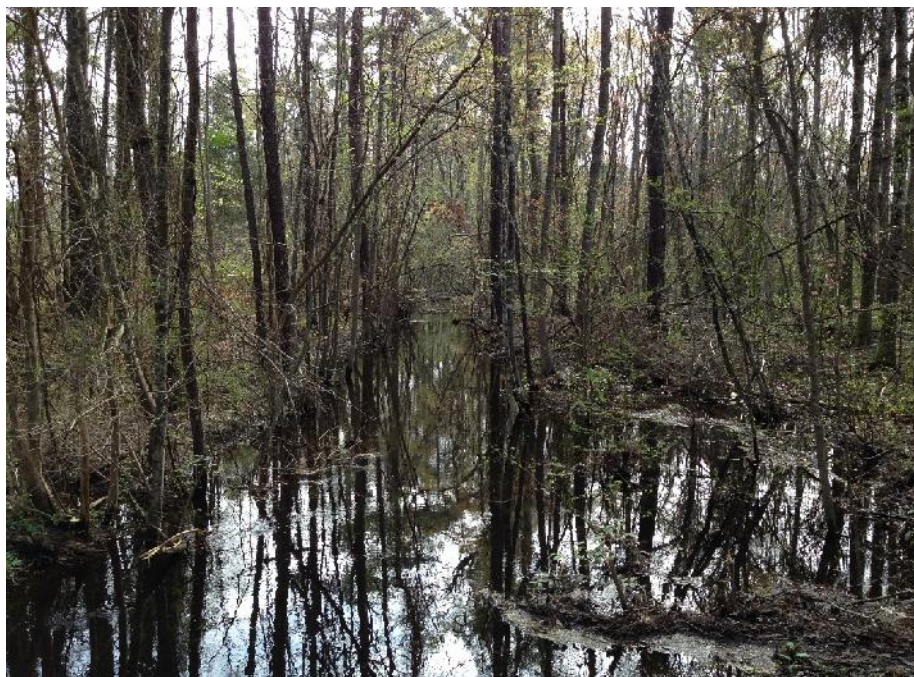
| Location: Center Line Road, Flag F-8 |

| Description: Bottomland hardwood forest along an unnamed tributary to Mill Branch, southeast of the intersection of State Road 176 and Center Line Road. |
