Asbestos & Lead Paint Survey Report

Interstate 20 Bridges Over Wateree River Overflow 2
Kershaw County, South Carolina
Bridge Nos. 05781 & 05786

March 11, 2022
Terracon Project No. 7321P043A
SCDOT Project ID: P029777

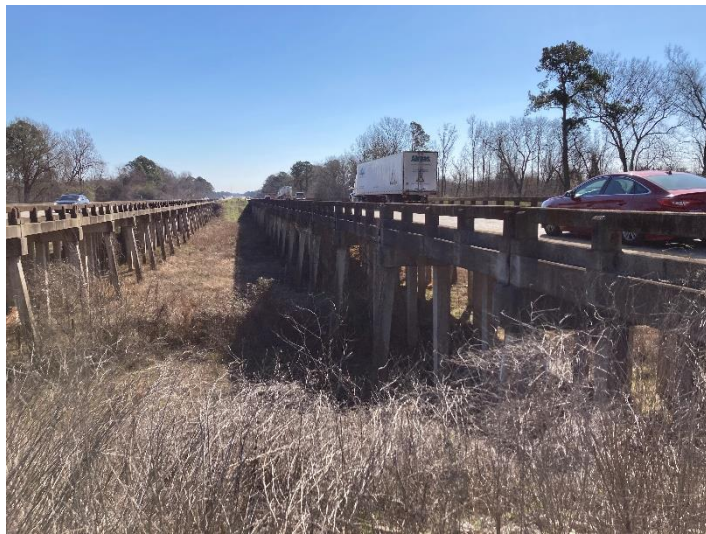
Photo 3: View of side of bridge (05781)

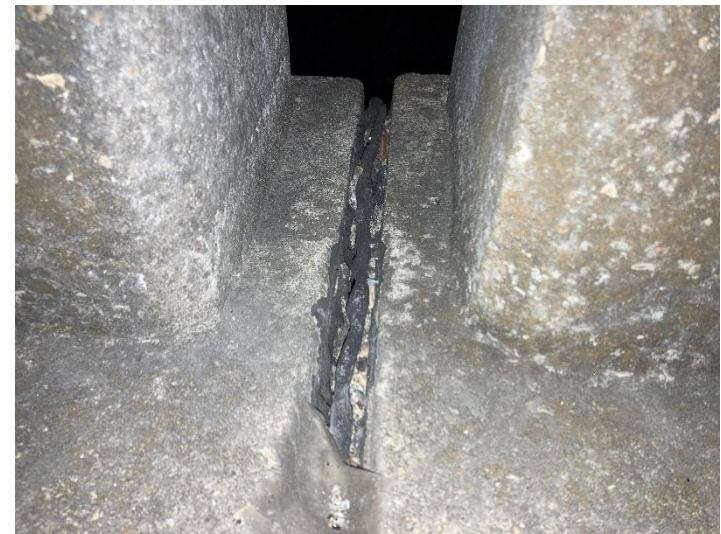
| HA | Approx. Quantity | Sample Number | Description | Sample Location | Lab Result | Category | Condition |
|---|---|---|---|---|---|---|---|
| 1 | 850 LF | 1E.1 | Tar | Expansion Joints | NAD | NF, MISC | Good |

| HA | Approx. Quantity | Sample Number | Description | Sample Location | Lab Result | Category | Condition |
|---|---|---|---|---|---|---|---|
| 1 | 850 LF | 1W.1 | Tar | Expansion Joints | NAD | NF, MISC | Good |

Photo 4: HA #1E and HA #1W Tar expansion joint (05781 +05786)

Based on the results of laboratory analyses, **no asbestos was detected** in the expansion joint samples collected from the bridges. These results were confirmed by TEM analysis. Asbestos laboratory analytical reports are included in Appendix B.

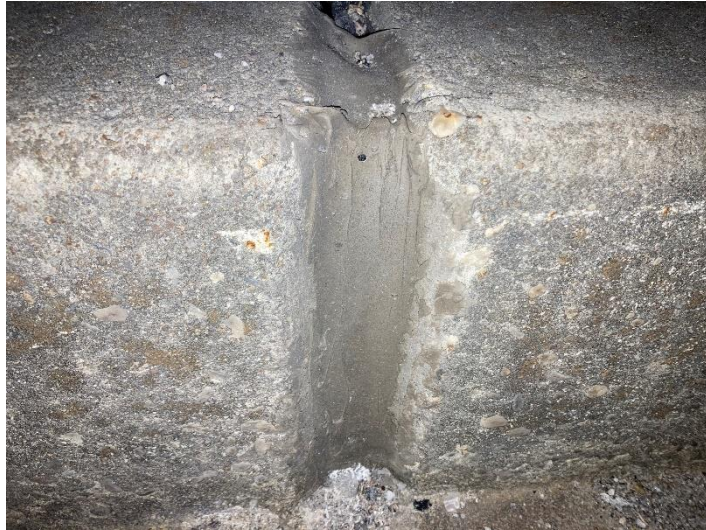
| HA | Approx. Quantity | Sample Number | Description | Sample Location | Lab Result | Category | Condition |
|---|---|---|---|---|---|---|---|
| 2 | 100 LF | 2E.1 | Putty | Expansion Joints | NAD | NF, MISC | Good |

| HA | Approx. Quantity | Sample Number | Description | Sample Location | Lab Result | Category | Condition |
|---|---|---|---|---|---|---|---|
| 2 | 100 LF | 2W.1 | Putty | Expansion Joints | NAD | NF, MISC | Good |

Photo 5: HA #2E and HA #2W Putty expansion joint (05781 +05786)

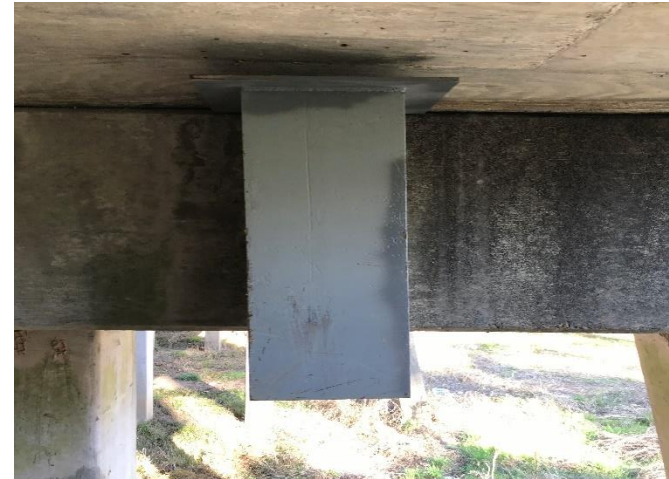
| Sample Number | Description | Location | Lab Result |
|---|---|---|---|
| LPE-1 | Silver | Metal decking support | <0.0080% |

| Sample Number | Description | Location | Lab Result |
|---|---|---|---|
| LPW-1 | Silver | Metal decking support | <0.0085% |

Photo 6: LPE-1 and LPW-1 Silver paint on bridge (05781 +05786)

Laboratory analysis **did not detect lead concentrations** greater than laboratory detection limits in the samples submitted.

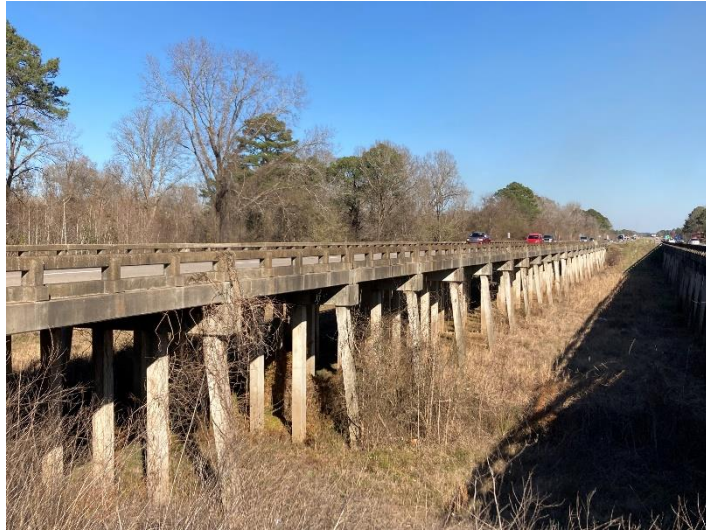
Photo 9: View of side of bridge (05786)
