PROCESSING FORM FOR PROGRAMMATIC CATEGORICAL EXCLUSIONS
NON MAJOR FEDERAL ACTIONS

Project ID P041239

SC 114 (Bobby Faucette Road) Bridge Replacement over Sandy Run Creek

TITLE: Cultural Resources Survey of the SC 114 (Bobby Faucette Road) over Sandy Run Creek Bridge Replacement Project, Union County, South Carolina

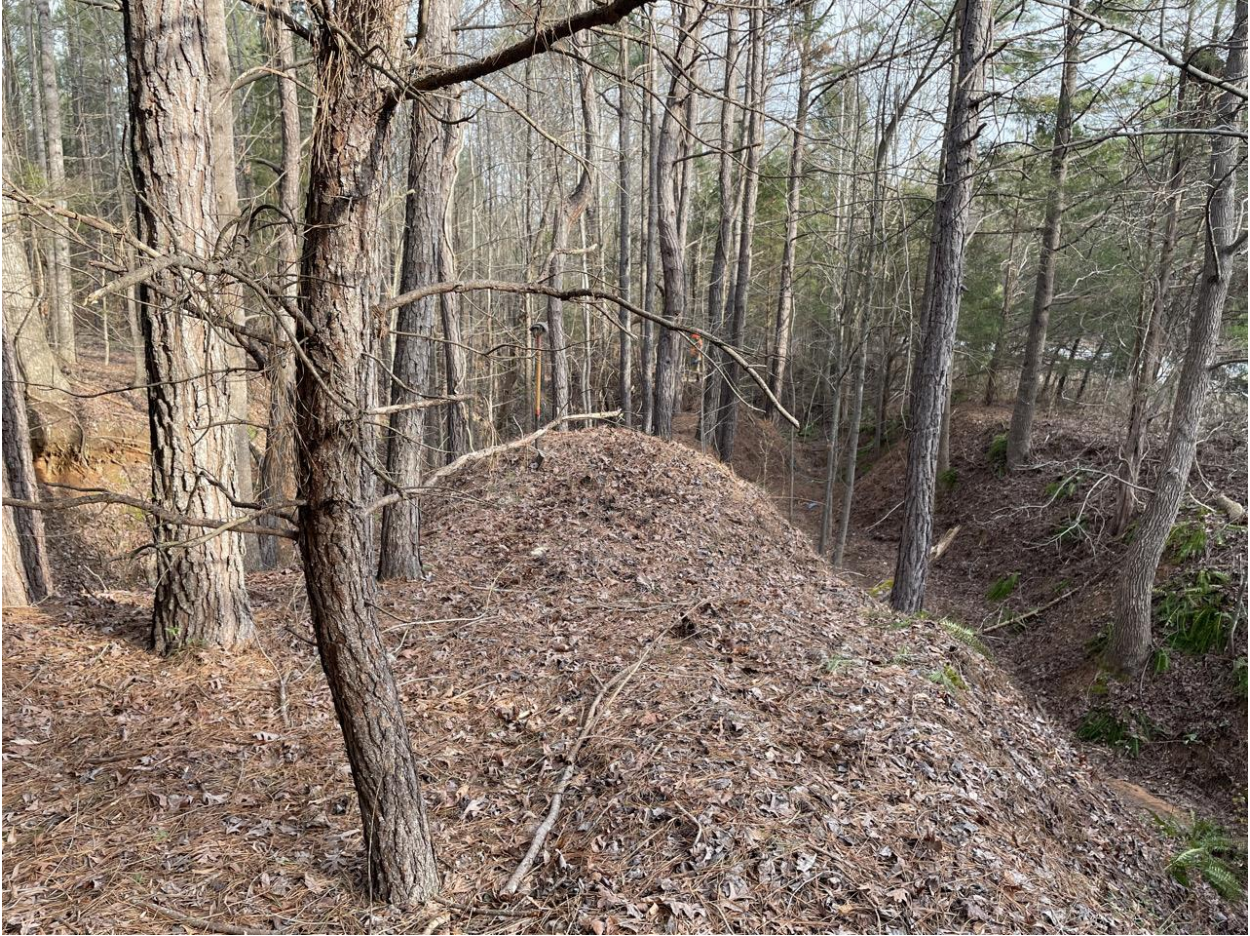
Figure 3. Severe erosion within the southwestern quadrant of the APE, looking northwest.

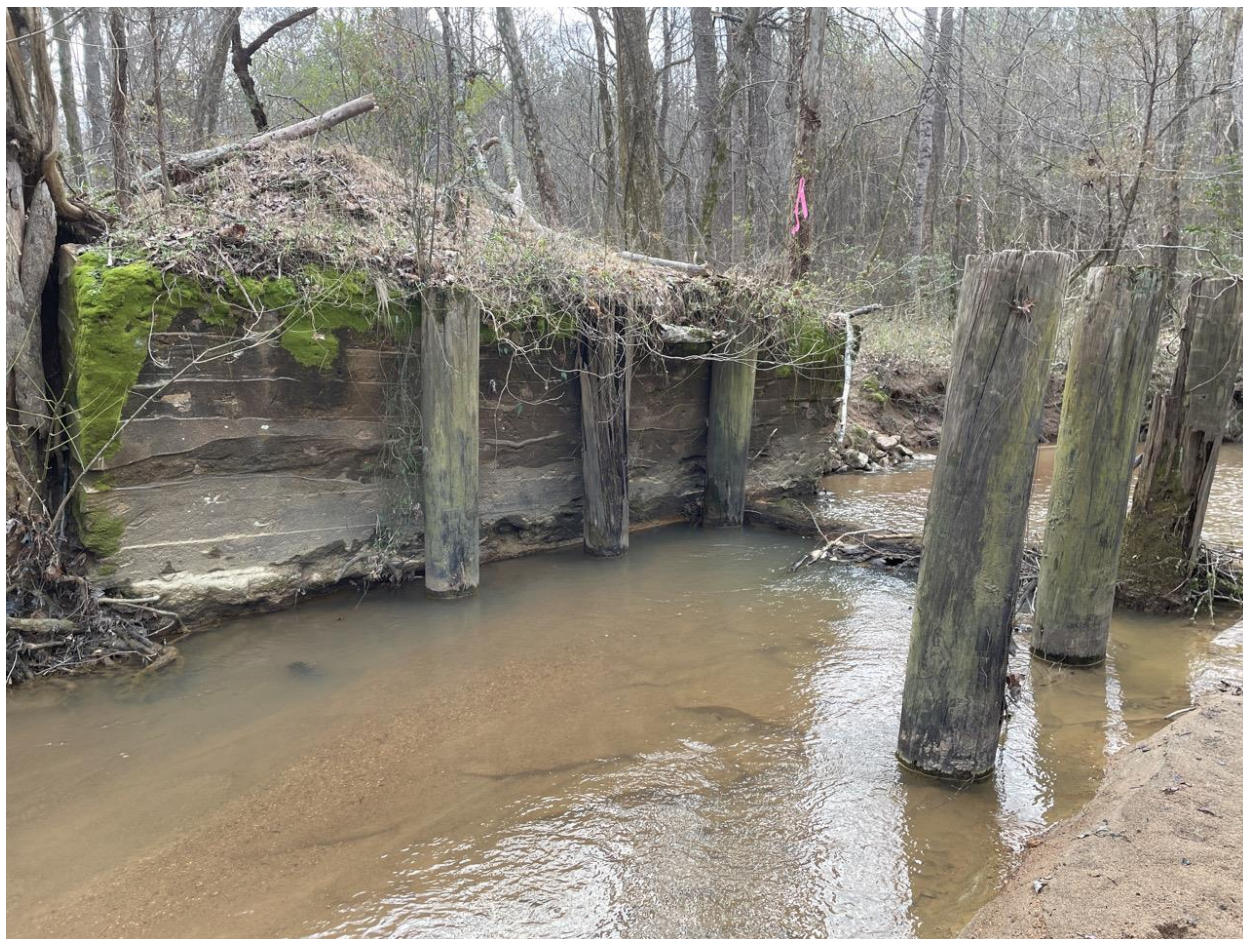
Figure 6. View of the eastern concrete endwall and wooden posts at Site 38UN1860, looking southeast.

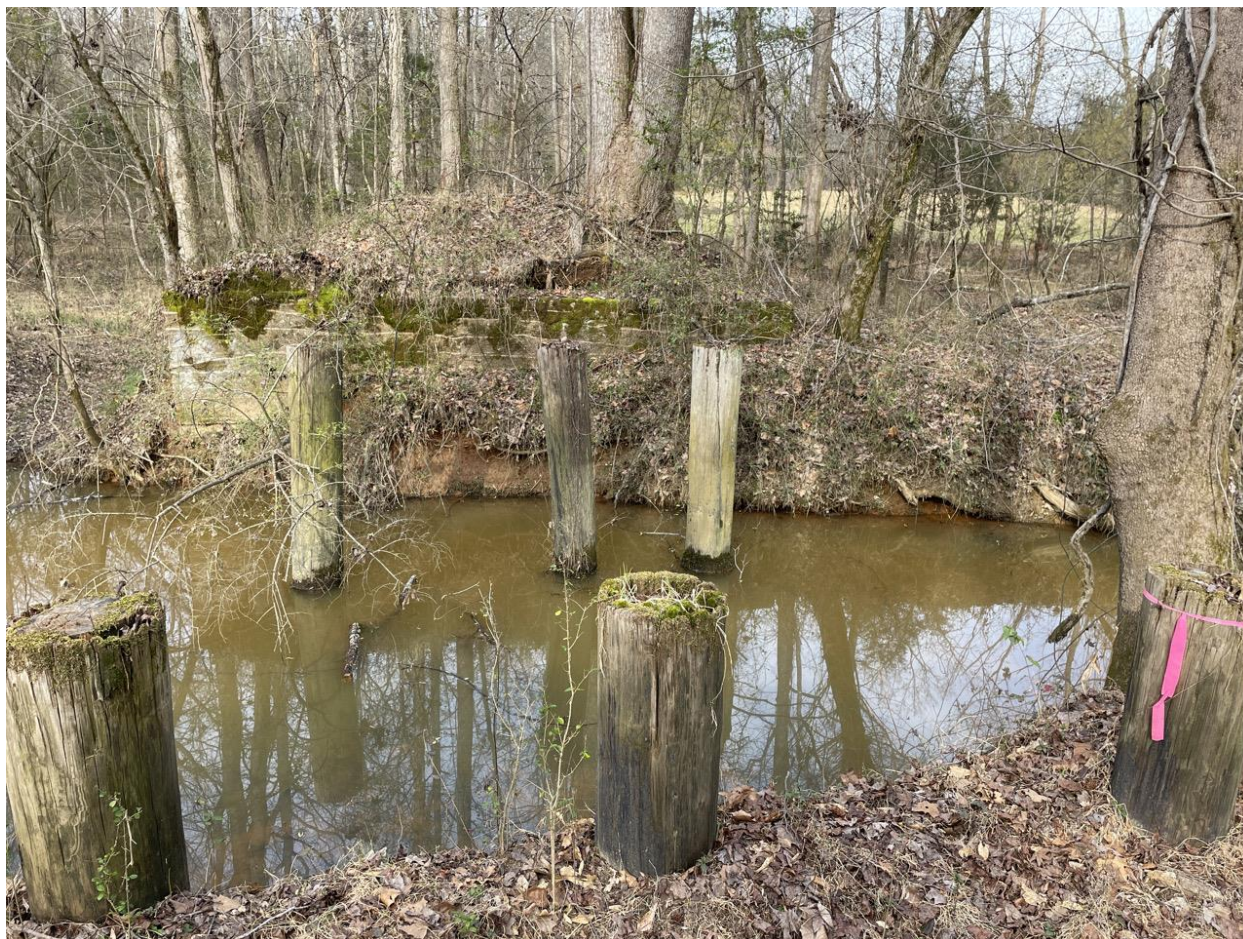
Figure 8. View of the western concrete endwall and wooden posts at Site 38UN1860, looking northwest.

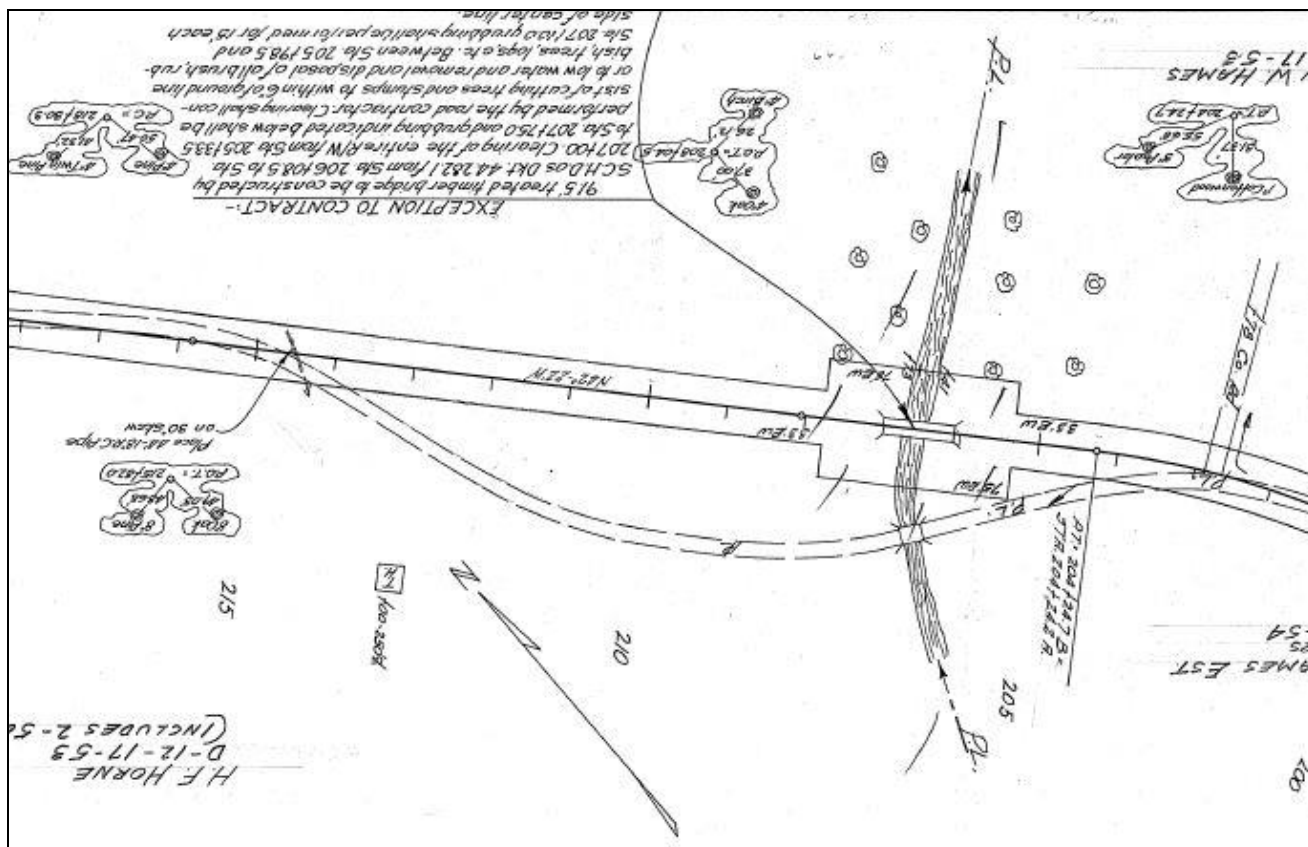
Figure 9. Portion of the 1953 construction plans showing the old road alignment.

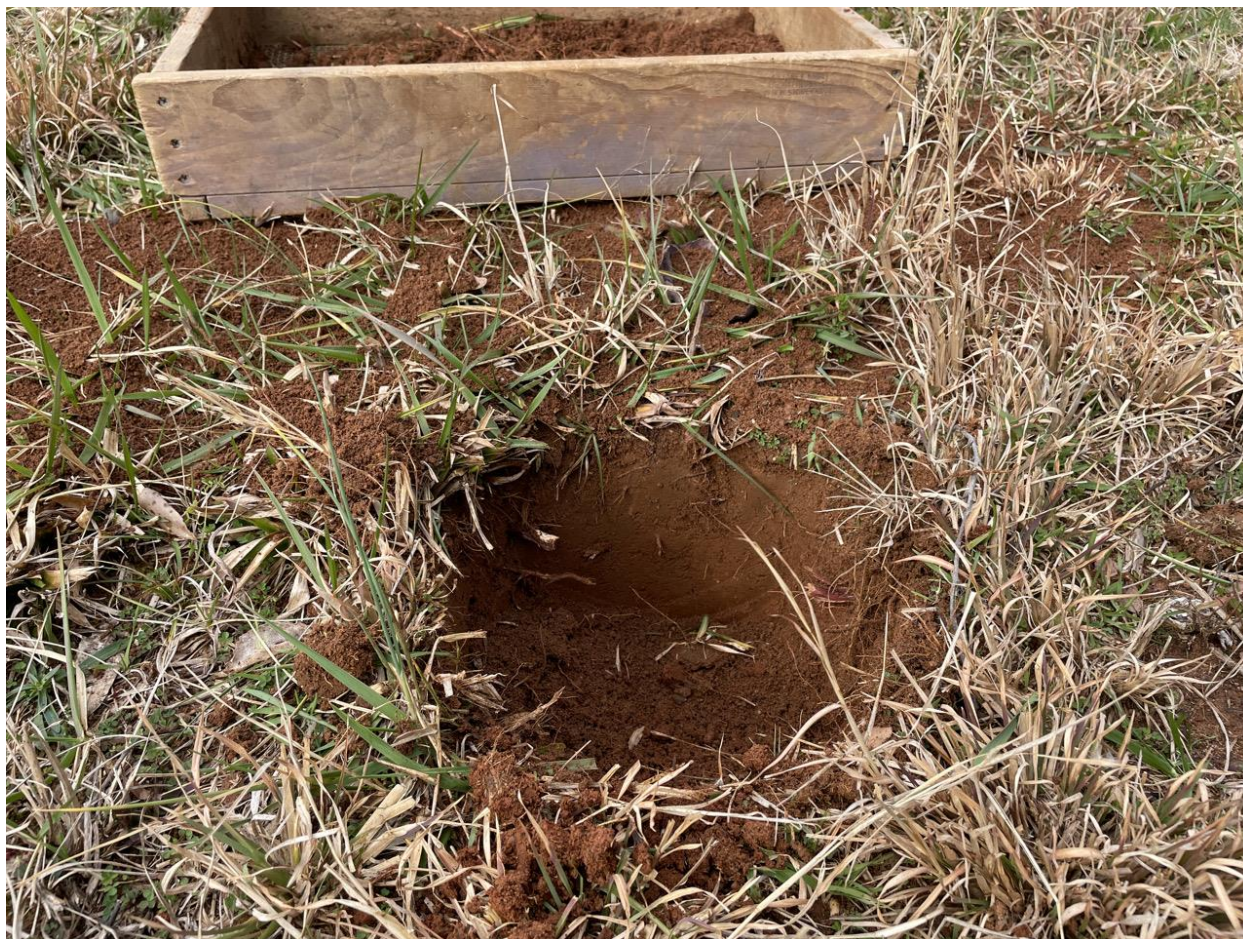
Figure 13. Typical shovel test soil profile at Site 38UN1861.

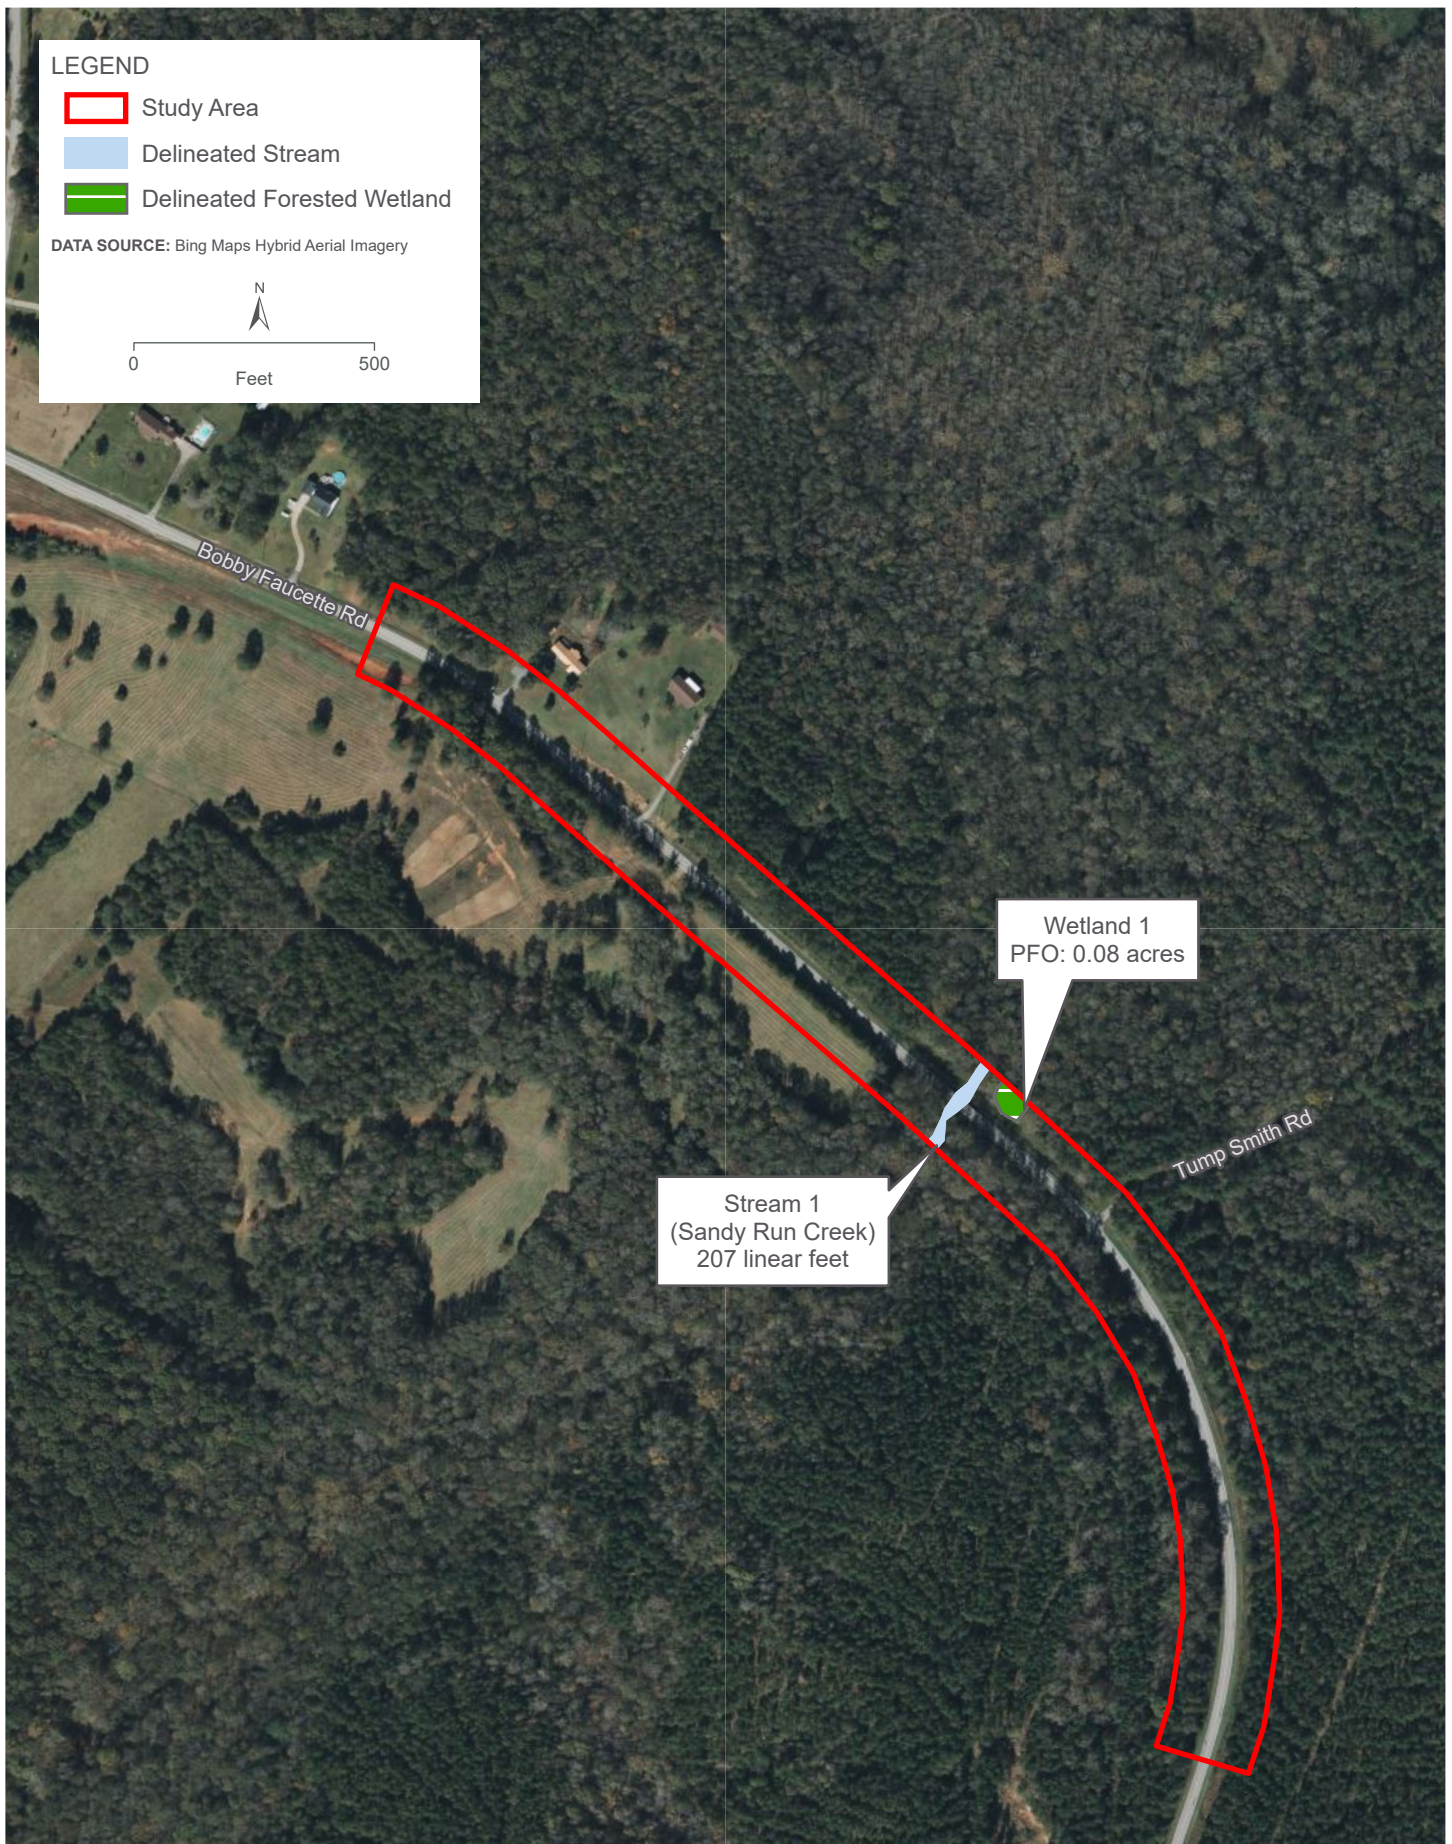
Figure 4

SC-114 BRIDGE REPLACEMENT OVER SANDY RUN CREEK APPROXIMATE BOUNDARIES OF WATERS OF THE U.S.

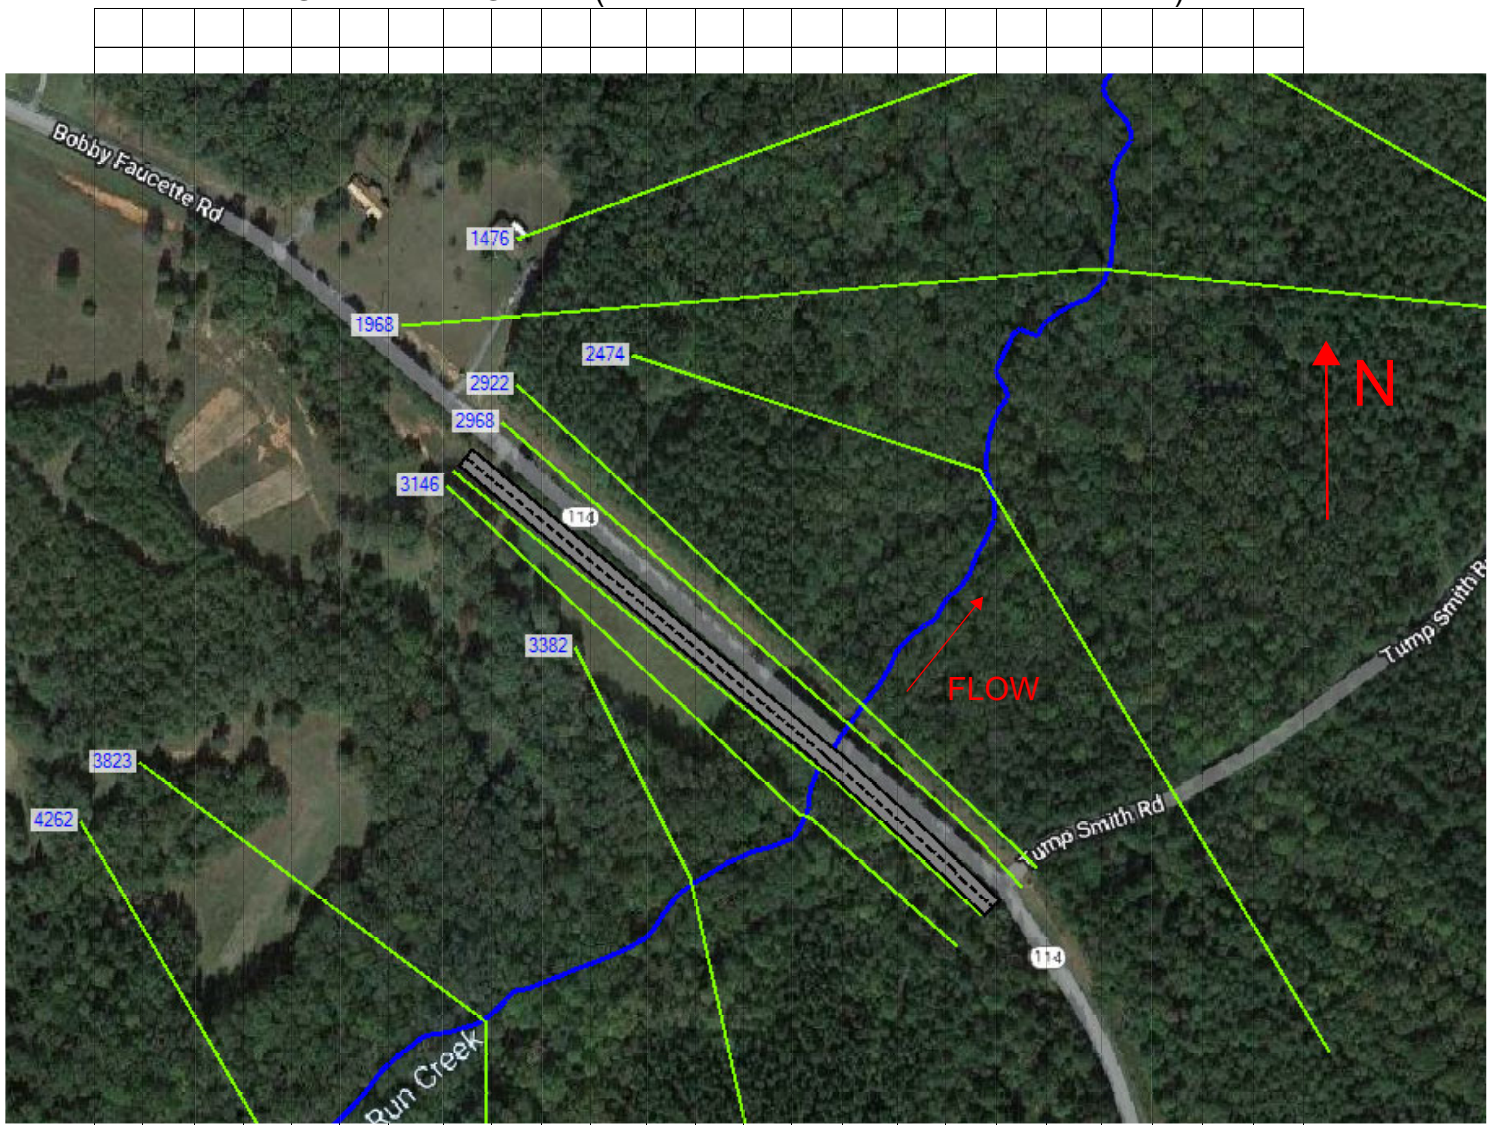
BRIDGE SITE DIAGRAM: (Show North Arrow and Direction of Flow)

Notes: The proposed bridge is aligned approximately 37' upstream of the existing bridge.
