ASBESTOS CONTAINING MATERIAL INVESTIGATION REPORT

SC-49 (CROSS KEYS HWY.) RBO FAIRFOREST CREEK
SCDOT BRIDGE #444004900200
UNION COUNTY, SOUTH CAROLINA

February 24, 2023

F&ME Project No.: G6658.003

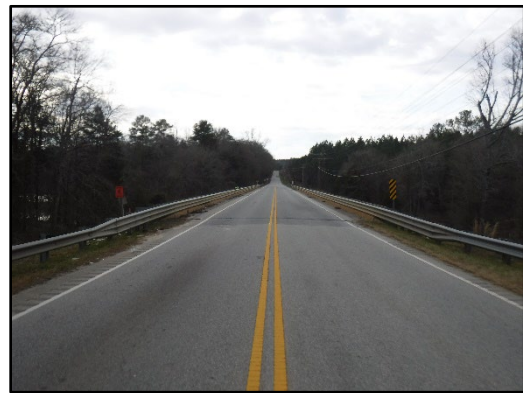
Photo 1 – SC-49 (Cross Keys Hwy.) Bridge over Fairforest Creek in Union County, SC.

The existing Bridge (~377'.0"L x 32'.6"W inside curb to inside curb), is located on SC-49 (Cross Keys Hwy.) and crosses over Fairforest Creek in Union County, South Carolina. The date of construction for the original Bridge is unknown. It was widened approximately 8.0' along both sides of the Bridge in the mid-1960's, according to the date embossed in the concrete guardrail. The overall structure is a two (2) lane, ten (10) span concrete and steel bridge structure with poured-in-place concrete bridge decking and concrete curbing. The bridge deck is supported by four (4) original poured-in-place (PIP) concrete beam

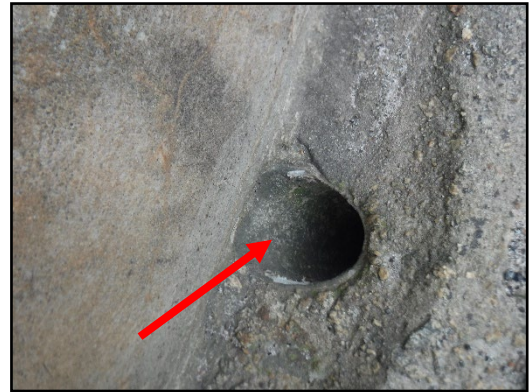
HA-1 – Transite Scuppers (~120 LF). ACM Transite scuppers were utilized for surface water drainage off of the Bridge structure. Overall, the scuppers were intact with some signs of deterioration due to age and exposure to the elements. Removal of the scuppers will likely render the material friable depending on the means and methods utilized. During the demolition, this material must be removed, handled, and disposed of as ACM. This material will need to be abated as a function of demolition activities by a licensed abatement contractor.

It is our understanding that the existing bridge structure will to be demolished, in anticipation of the on-alignment replacement of the existing Bridge. Prior to the start of demolition activities, the Transite drainage scuppers must be removed, handled and disposed of as ACM per SCDHEC regulations pertaining to asbestos waste. Removal of these types of bridge components prior to and during demolition activities is practical but will require coordination with a licensed abatement contractor to ensure they are properly handled and disposed of. Based on the quantities and type of ACM identified, a written abatement project design will not be required if non-friable abatement methods are utilized.

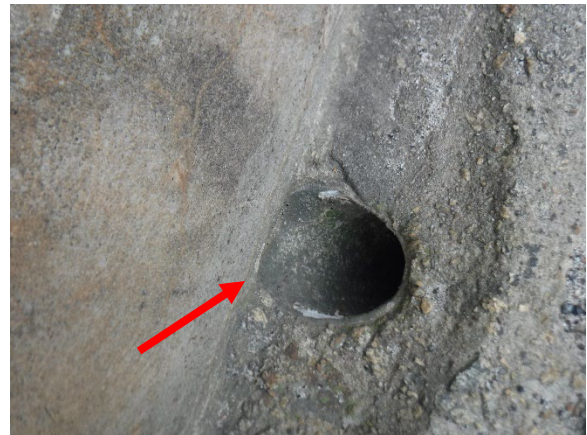
Photo 4. ACM Transite Scupper Material.

ACM Transite scuppers were utilized for surface water drainage off of the Bridge structure. Overall, the scuppers were intact with some signs of deterioration due to age and exposure to the elements.
