Geotechnical Baseline Report

SC 72 (Carlisle Chester Hwy) Bridge
Replacement over Cox Creek

Union County, SC
March 22, 2023

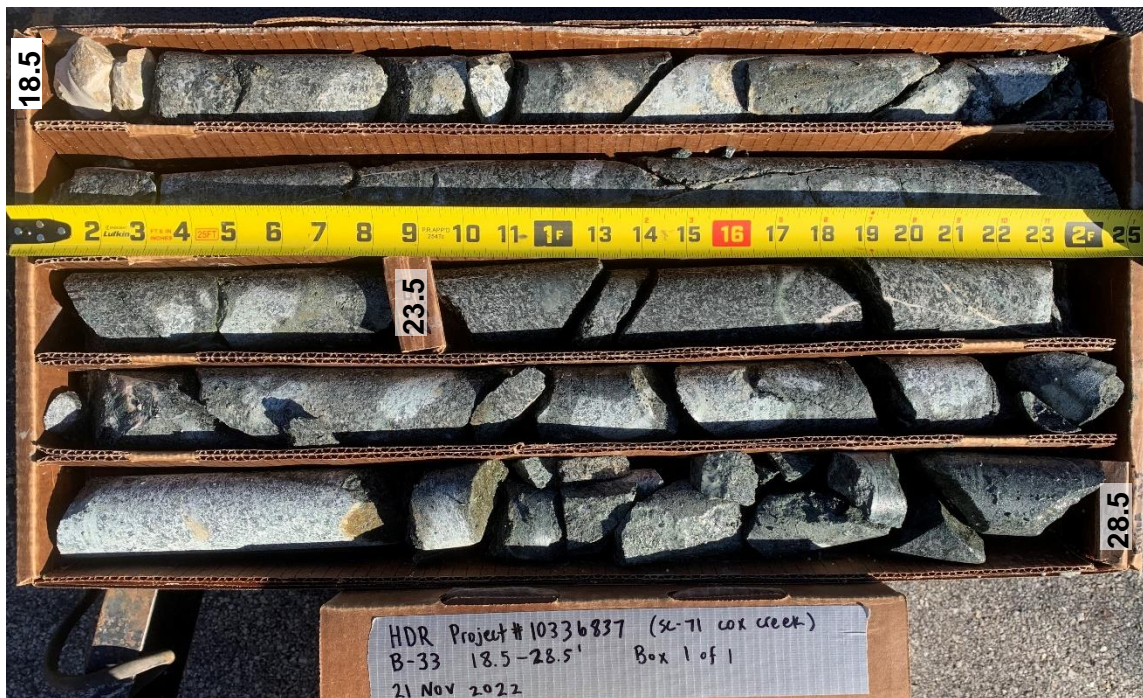
Box 1 of 1 (18.5' to 28.5')

B-33

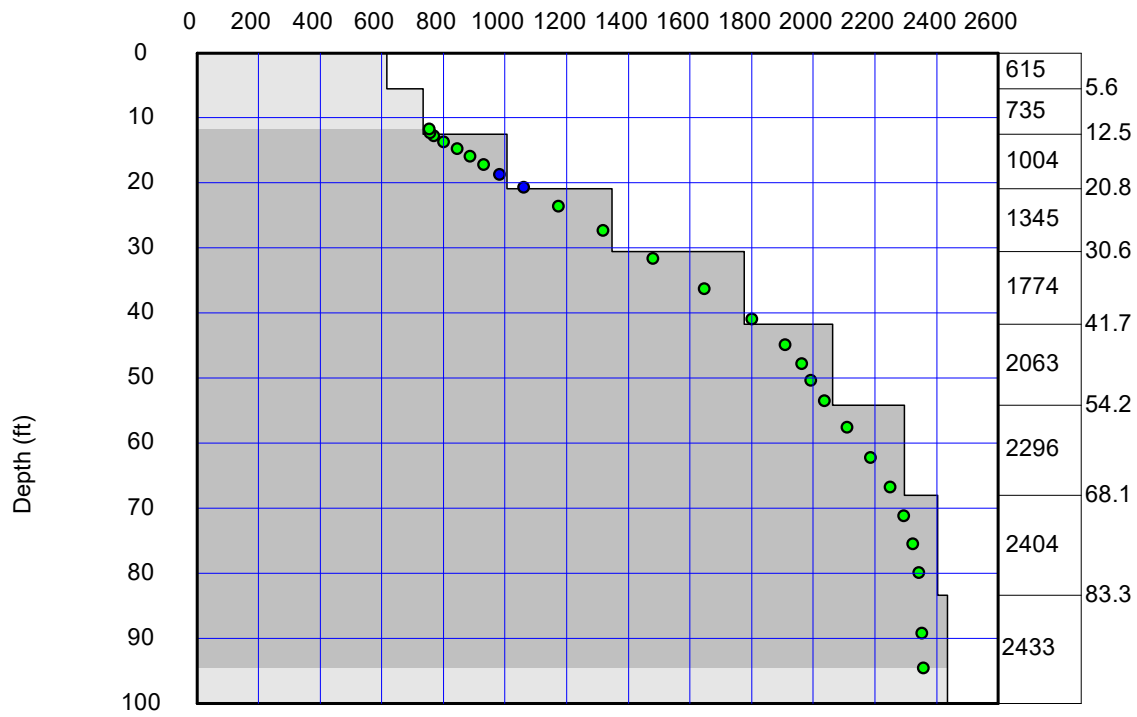
S-wave velocity (ft/s)

S-wave velocity model (initial) : SC72RBOCoxCreek.rst

Average Vs 100ft = 1525.3 ft/sec

The shear wave velocity results, as measured from the MASW test, were provided to SCDOT (Pre-Construction Support - Geotechnical Design Section). SCDOT used these results to determine the site amplification factors that would be used to correct for site effects the bedrock motion determined from regional probabilistic seismic hazard maps.

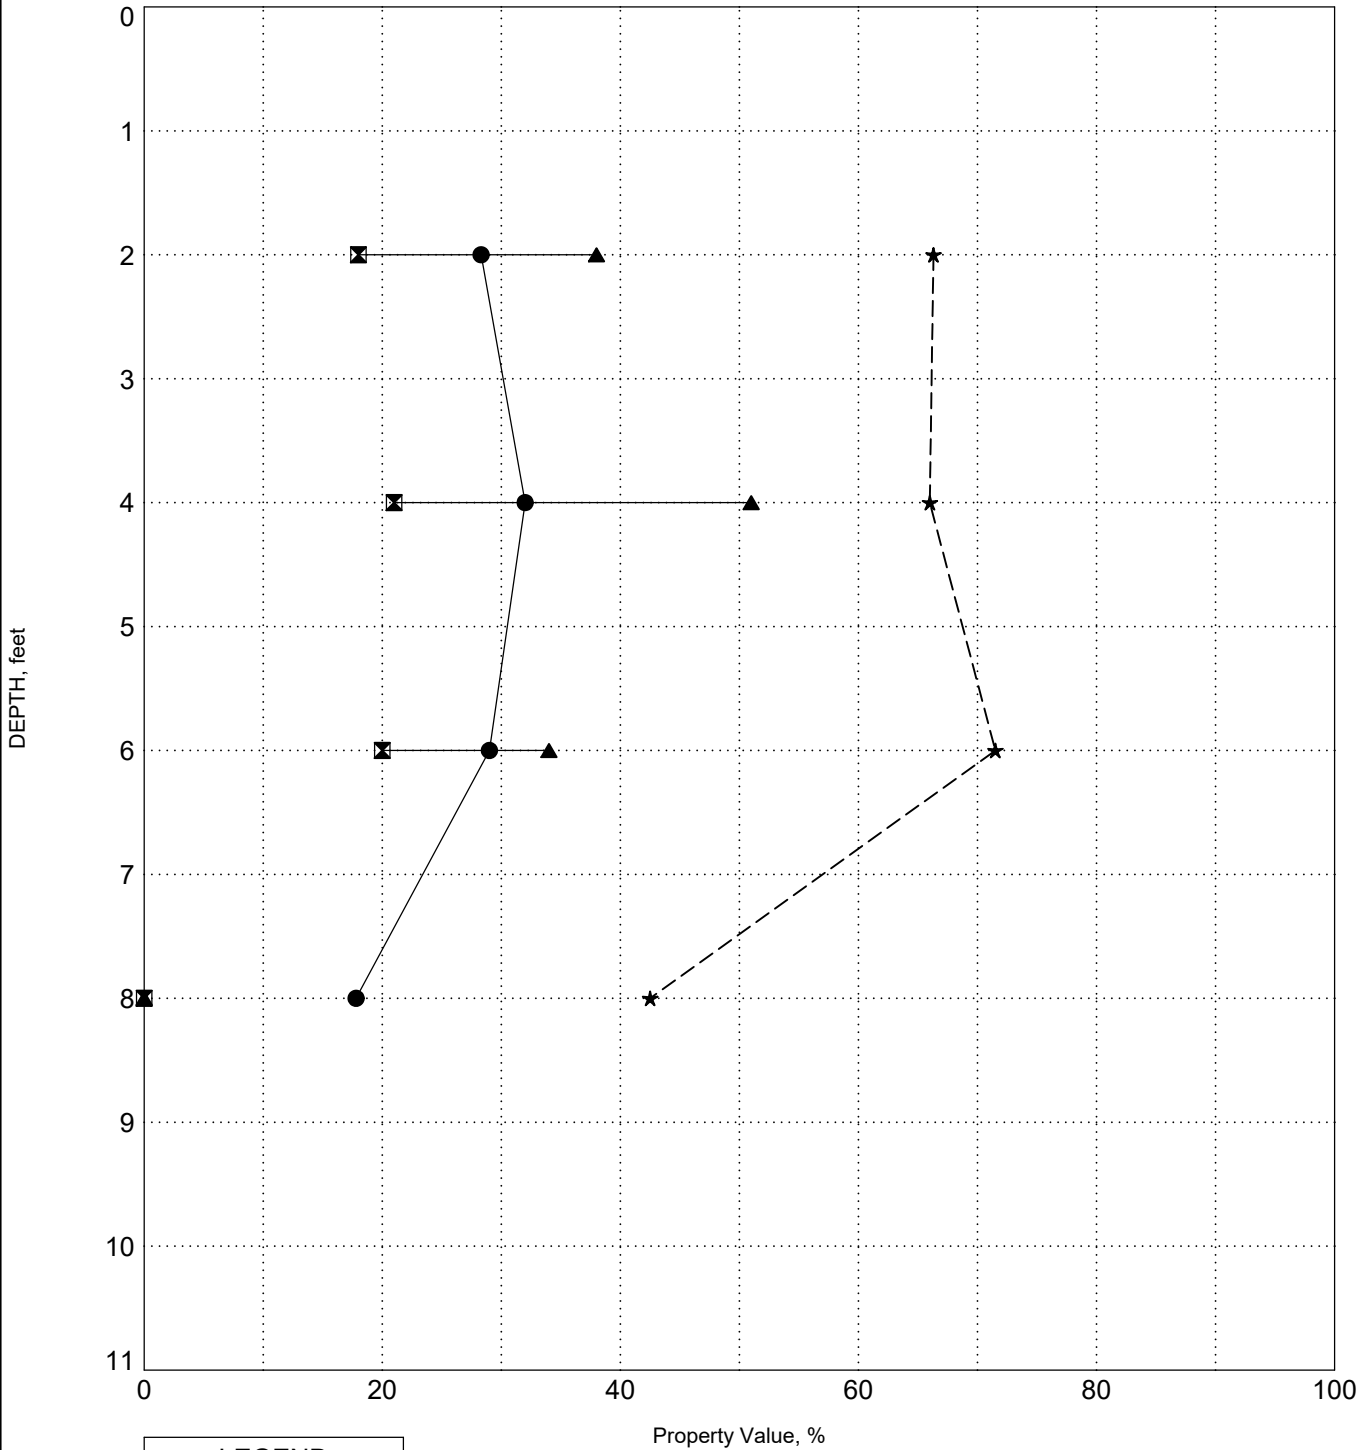
BORING B-33

SURFACE ELEVATION: 340.2

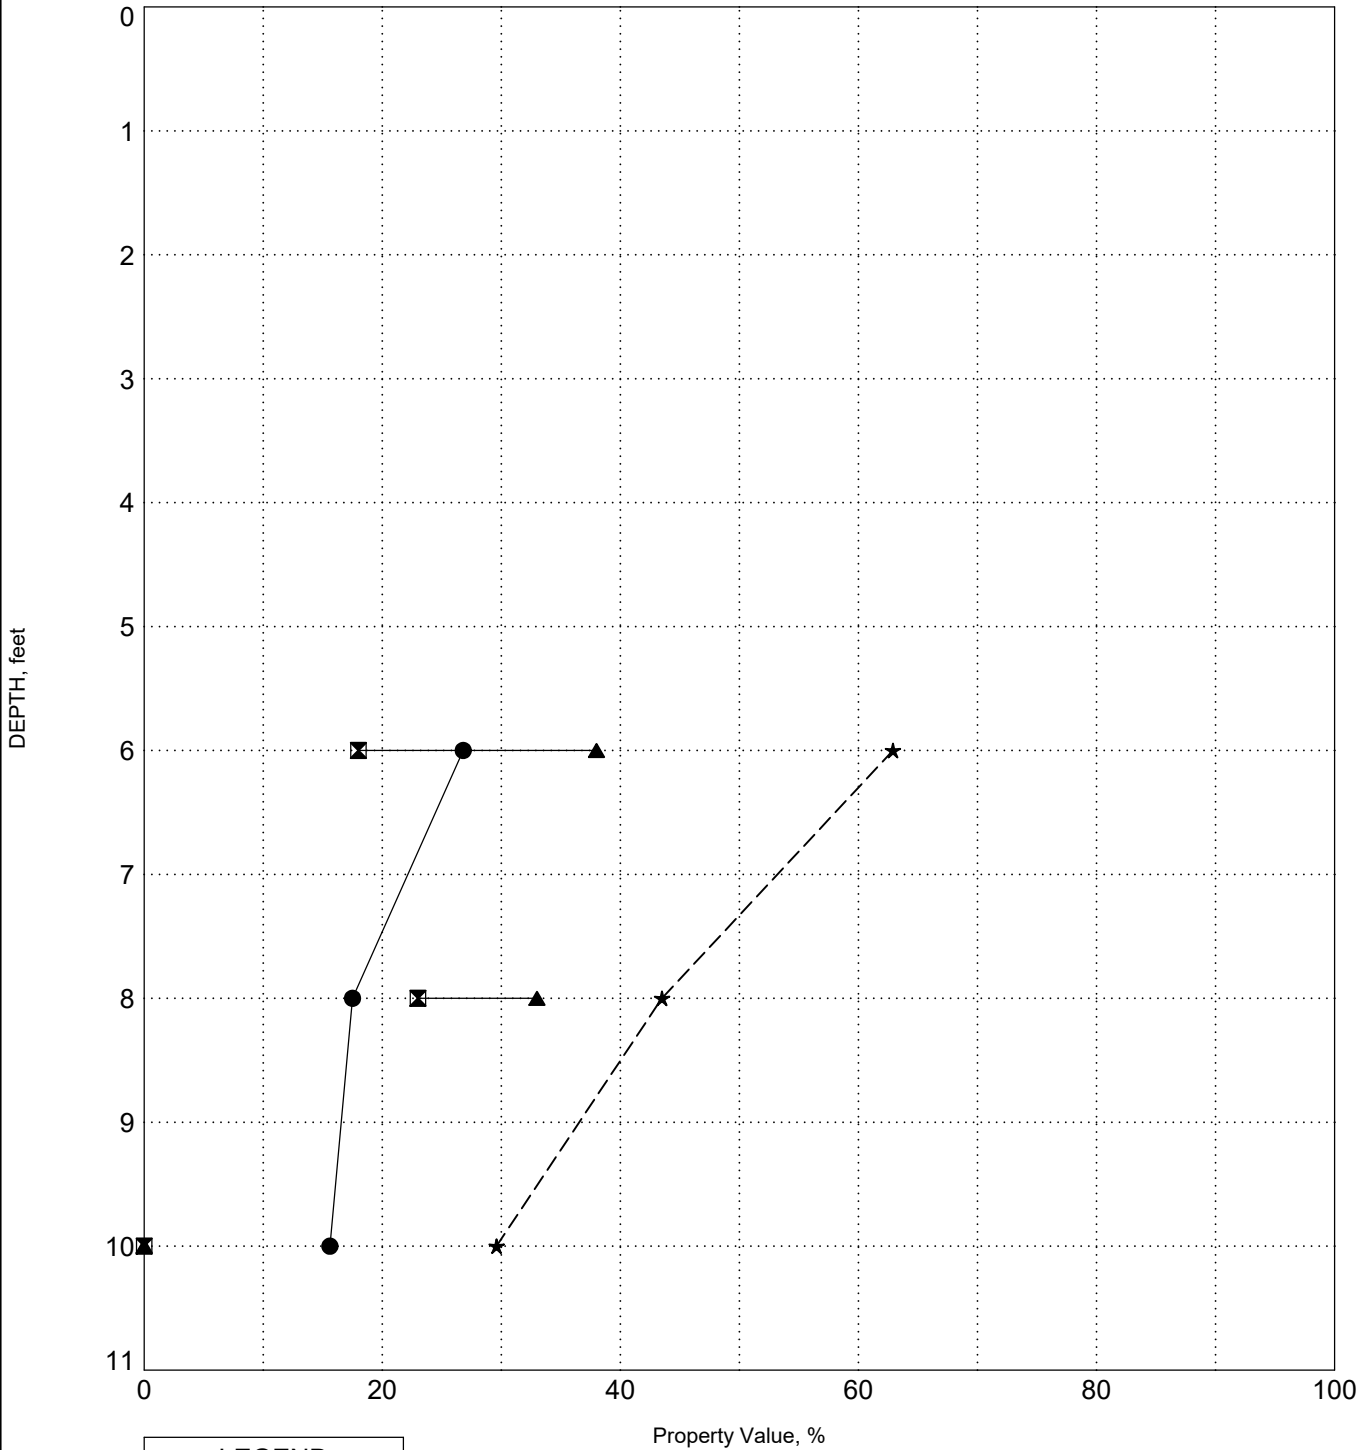
BORING B-34

SURFACE ELEVATION: 340.3

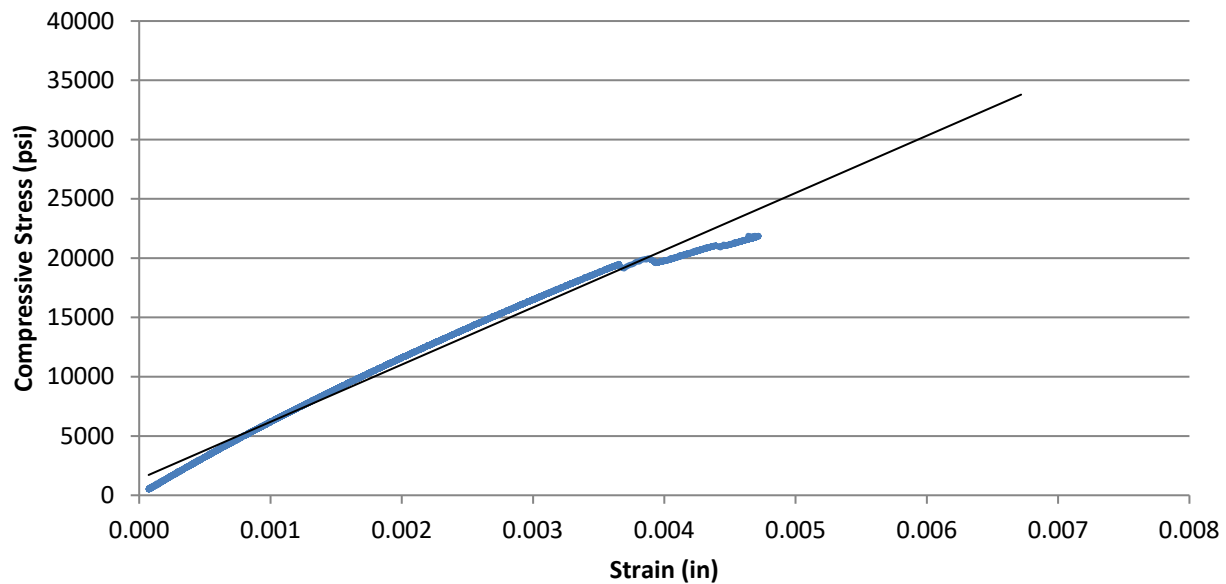
Axial Stress vs. Strain

| Test Results | | | | |
|---|--|---|---|---|
| Unconfined Compressive Strength (psi) | | 21,890 | Elastic Modulus (psi) | 1.17E+07 |

| Description | White/Gray/Black Granodiorite | | | | |

Corrosion series test were performed on select split spoon samples. Standard proctor testing and remolded CU triaxial tests were performed on the collected bulk sample. Finally, two (2) unconfined compression tests were performed on recovered rock samples with unconfined strength results ranging from 21,890 psi to 22,800 psi. Results of laboratory testing are included in Appendix C.

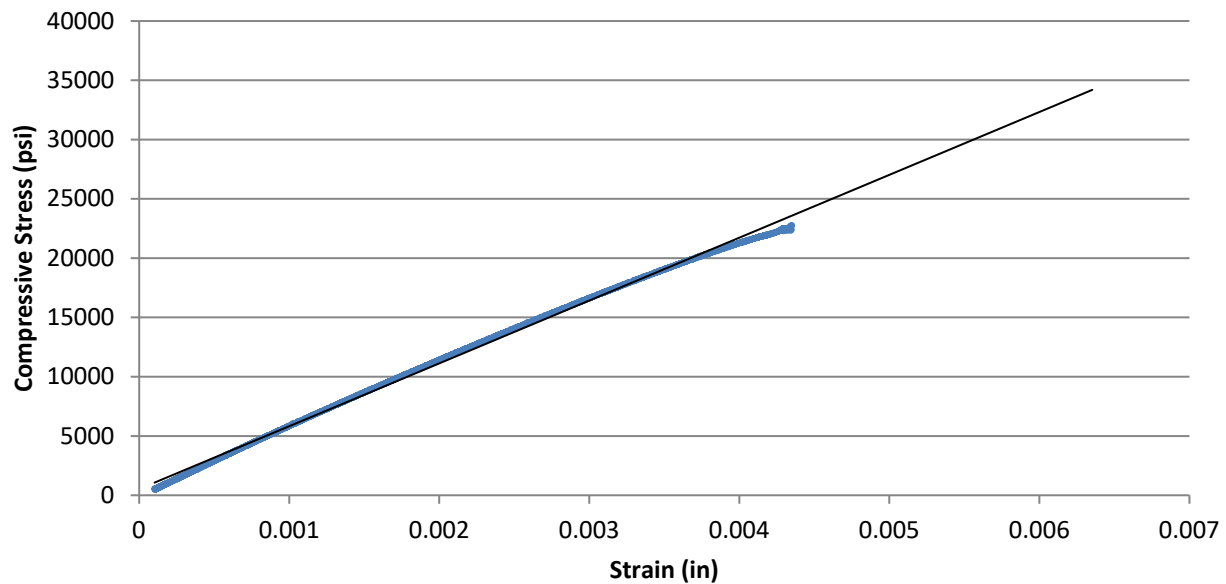
Axial Stress vs. Strain

| Test Results | | | | |
|---|--|---|---|---|
| Unconfined Compressive Strength (psi) | | 22,800 | Elastic Modulus (psi) | 1.14E+07 |

| Description | White/Gray/Black Granodiorite | | | | |

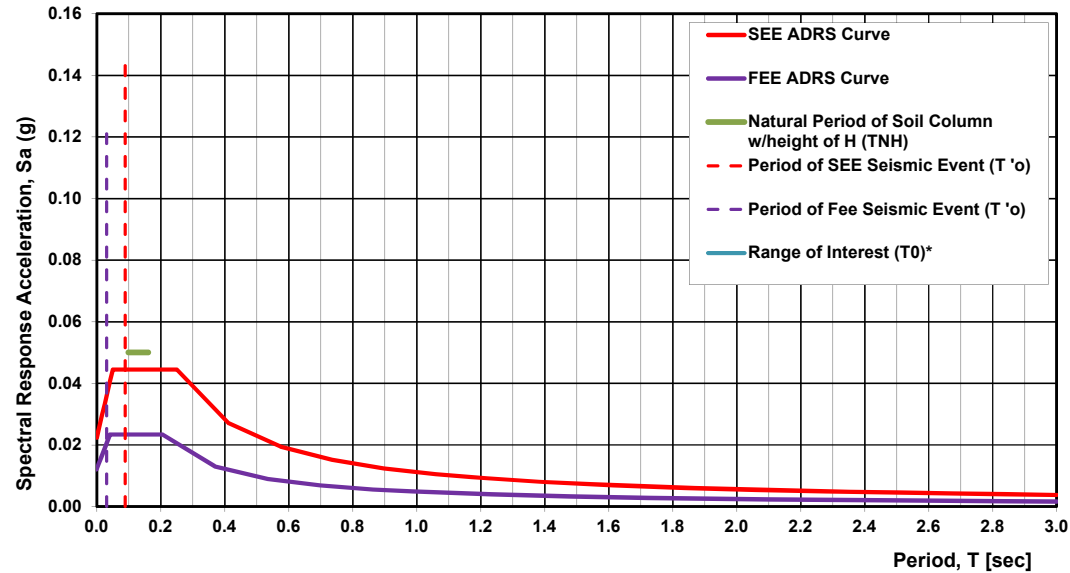
SC Seismic ADRS Curve

3-Point Acceleration Design Response Spectrum

| Geologic Condition: | Geologically Realistic (Q = 100)* |

SCDOT provided a “3-Point Acceleration Design Response Spectrum” data sheet that included pseudo-spectral accelerations (PSA) for 5% critical damping and at selected frequencies, consistent with a Geologically Realistic condition (shear wave velocity, $V_s=2,500$ fps). PSA values were provided for the:
