S-39-32 (Shady Grove Road) Bridge Replacement over Crow Creek

Project ID: P041168

TITLE: Phase I Cultural Resources Survey of Proposed Improvements to the S-39-32 Bridge over Crow Creek

Natural Resources Technical Memorandum

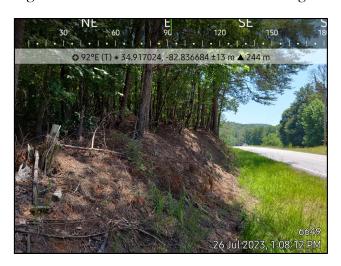
Figure 5. Subsoil Visible on Cut Banks along Road (Looking East)

The vegetation in the project area primarily consists of mixed pines and hardwoods with a fairly open understory. This understory becomes denser along the banks of Crow Creek on either side of the bridge. The majority of the project area consists of mixed hardwood and pine forest with fairly open understory; however, the western portion of the project area consists of manicured landscapes and fallow fields. Additionally, exposed subsoil is present along the cut banks parallel to the road (Figures 3–5).

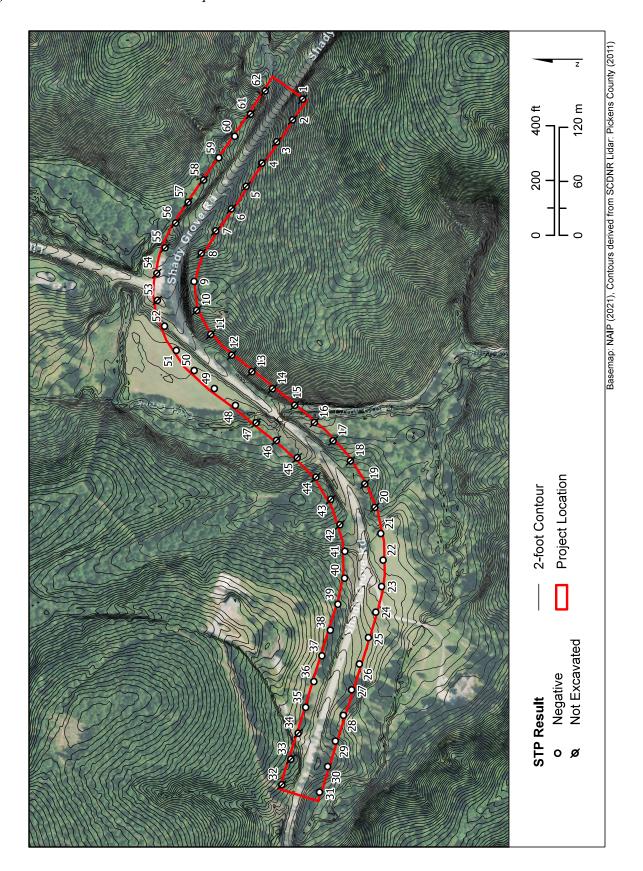
Figure 6. Shovel Tests Results Map

Sixty-two shovel test locations were plotted at 30-meter intervals across the project area. However, shovel tests that occurred in developed/modified areas, side slopes, or in wetlands were not excavated. All other areas were documented by shovel test excavation or by examining exposed subsoil. As a result, 26 were either excavated or were documented based on surface visibility (Figure 6). On the south side of Shady Grove Road, STs 1 to ST 15 were on steep side slope all the way to the Crow Creek bridge, although a relatively level area was examined at ST 9. On the opposite side of the creek, the landform became relatively level at ST 21 with shovel tests excavated in an open field to ST 31. On the north side of the road, STs 32 to ST 34 were not excavated due to slope, but the terrain was gently rolling at ST 35, and shovel testing occurred through ST 41, where the terrain began sloping to the creek and its wetlands. On the west side of the creek, shovel testing occurred between ST 47 and ST 52. After this point, intersection modifications and steep slope was present., but STs 59 and 60 were excavated.

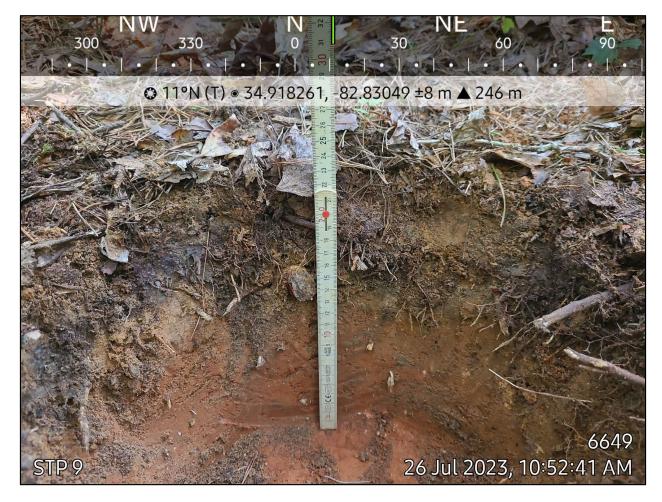
Figure 7. Soil Profile of STP 9 (Looking North)

One general soil profile was noted, consisting of approximately 10 centimeters of dark brown (10YR 3/3) sandy loam Ap horizon overlying a yellowish red (5YR 4/6) sandy clay subsoil (Figure 7). No new or previously recorded archaeological sites were identified in the project area.

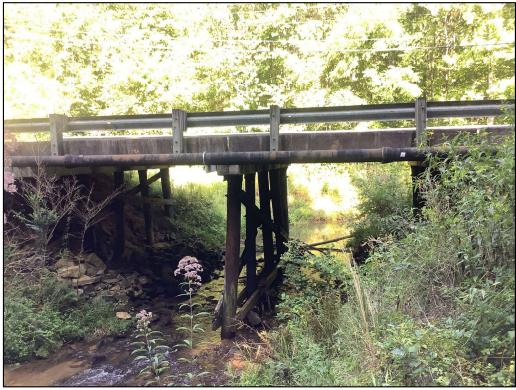
Figure 8. S-39-32 Bridge over Crow Creek, Built 1960 and Not Assessed

a. Bridge Structure, Looking West

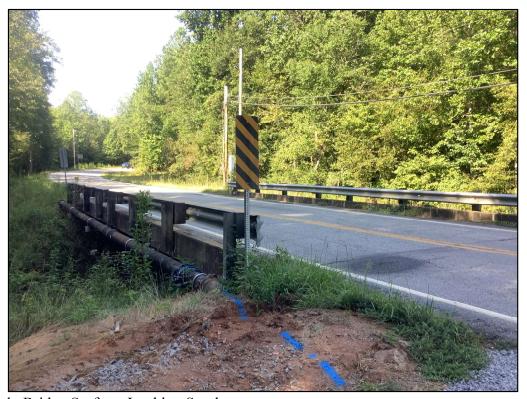
b. Bridge Surface, Looking Southwest

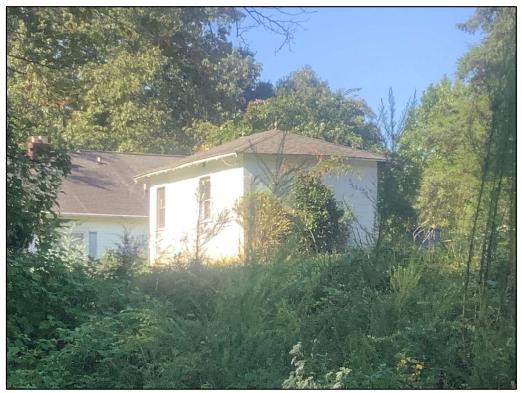
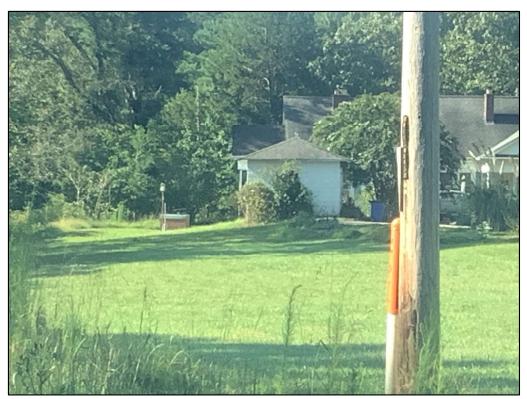
Figure 11. SHPO Site Number 0222.01 – 864 Little Eastatoee Road

a. Oblique, Looking Southwest

b. North Elevation, Looking South

SHPO Site Number 0222.01 is a CMU outbuilding with a hipped composition shingle roof with exposed rafter tails. The one-by-two bay building is set back about 50 feet behind the house, and it has a window centered on the north elevation and two unevenly spaced windows that are staggered towards the south corner on its east elevation. The entrance is centered on the south elevation, while the west elevation is not visible from the public right-of-way (ROW). The windows appear to be six-over-six wood sash with what seems to be a screen door in the entry (Figure 11).

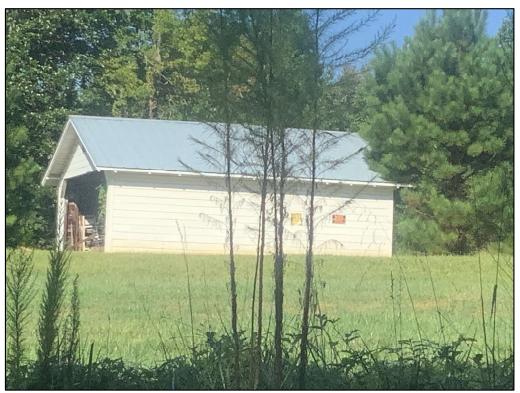
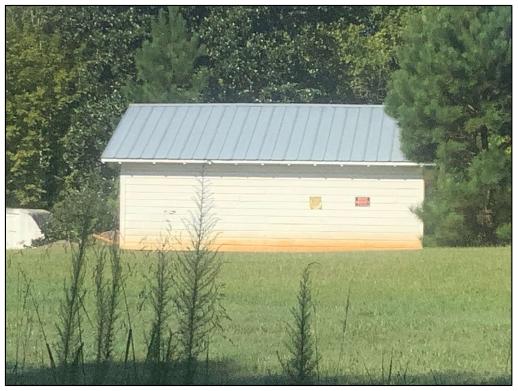
Figure 12. SHPO Site Number 0222.02 – 864 Little Eastatoee Road

a. Oblique, Looking Northwest

b. East Elevation, Looking West

SHPO Site Number 0222.02 is a frame garage building with a front-gabled raised seam metal roof with exposed rafter tails. Facing south, it is set back nearly 250 feet behind the house and is located about halfway down the driveway, whose entrance is located about 400 feet to the rear of the house. The open garage bay spans the entirety of the south elevation, while the north elevation has two evenly spaced windows. The east elevation is unfenestrated; the west elevation is not visible from the ROW. The siding is weatherboard, and wooden plank roof decking is visible in the overhanging eaves. The foundation is CMU piers, and there are rectangular louver vents in both gable ends (Figure 12).

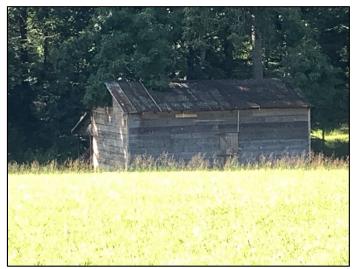
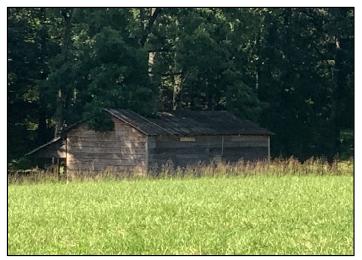
Figure 14. SHPO Site Number 0223.01 – 2767 Shady Grove Road

a. Oblique, Looking Southwest

b. Oblique, Looking Southwest

Sited about 300 feet northwest of SHPO Site Number 0223 and only about 200 feet from the road, SHPO Site Number 0223.01 is a laterally gabled frame building that predates the house. It does not seem to appear in 1948 aerial imagery but is visible in 1955. It appears on the topographic map from 1963, so it is assumed to have been built circa 1950 (NETRonline 2023). Google Streetview imagery from as recently as 2017 shows a dilapidated agricultural outbuilding with a garage bay centered on the north elevation, frame walls with no cladding on the east and west sides, and a shed roof wing extending across the south elevation that was partially enclosed. The roof structure was failing with missing roof panels at the east end, and the hayloft was visible through the open wall on that elevation. The current survey documented a reconfigured building with a single-leaf entry door centered on the north elevation, a garage bay centered on the west elevation, an unfenestrated east side, and a fully open shed roof structure across the south elevation. The entry door has an old appearance but seems to be new, and the weatherboard siding is rusticated but appears to be replacement. The roof may have been retained, with a panel added where one was missing at the east end (Figure 14).

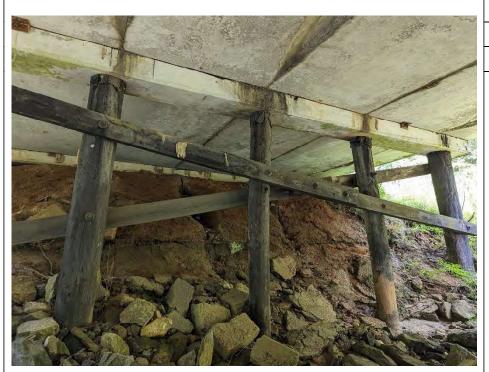
Photograph 1

Under S-32 bridge, concrete flat slab

Suitable habitat for tri-colored bat exists in the PSA. Roosting habitat exists under the existing S-32 bridge and in cavities and crevices of trees within the PSA. A structure survey of the existing S-32 bridge found no evidence of bat roosting. Additionally, a visual inspection and borescope review of cavities and

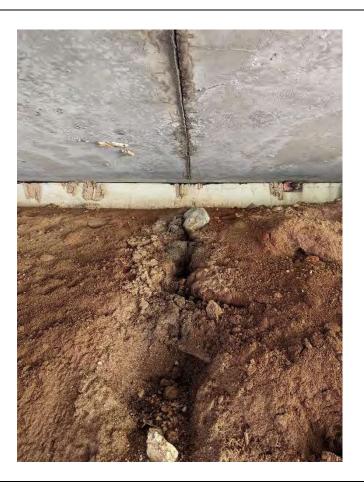
Photograph 2

End bent of S-32 bridge and crevices under the bridge deck

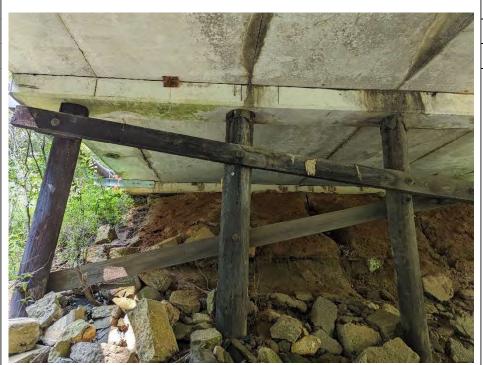
Photograph 3

Under S-32 bridge, concrete flat slab
