SCDOT

LOAD TESTING OF MULTIPLE WIDE LEG CHANNEL BRIDGES

STATEWIDE – SOUTH CAROLINA

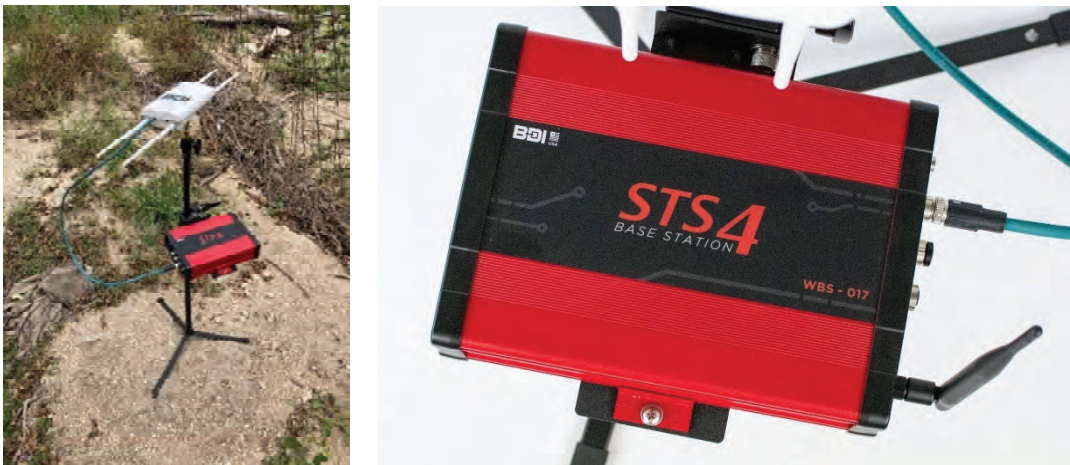
Figure 6: STS4 System used in the Load Test (BDI)

The data collection from the sensors used the STS4 system manufactured by Bridge Diagnostic Inc (BDI) (See Figure 6). All strain/displacement sensors are connected to the STS nodes through electrical cables. The STS4 nodes communicate with the STS4 base station via Wi-Fi connection. A laptop with STS4 data collection software (STS-LIVE) communicates with the base station via Wi-Fi during the load test (See Figure 7).

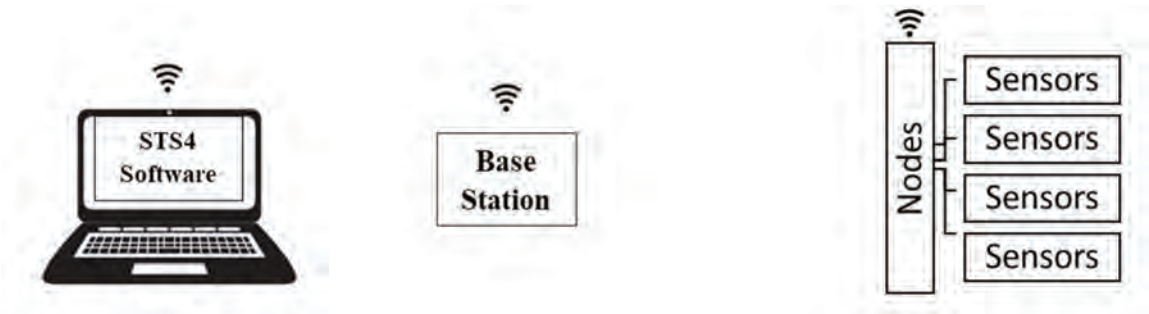
Figure 7: Data Collection Schematics

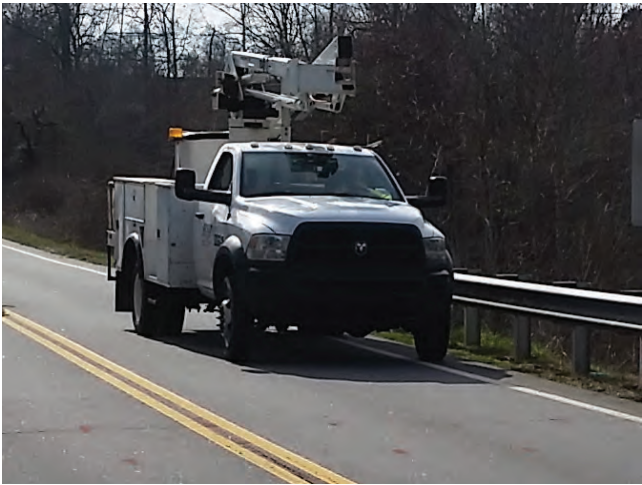
Figure 10: Standard Bucket Truck

A bucket truck, as shown in Figure 10, loaded to approximately nine (9) tons was used for the 1st phase of the load testing to determine the live load distribution factors. The bucket truck was measured before the start of the tests. Figure 11 and Table 3 show the measured dimensions and weights of the bucket truck.

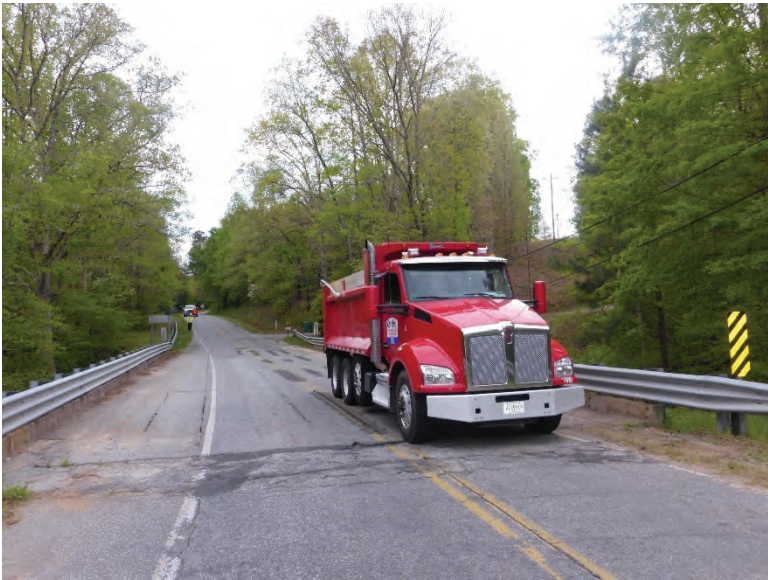
Figure 12: Standard Dump Truck

A tri-axle dump truck, as shown in Figure 12, loaded to approximately thirty-one (31) tons was used for the second phase of the load testing to determine the K-factors. The dump truck was measured and weighed prior to each test. Figure 13 and Table 4 show the measured dimensions and weights respectively.

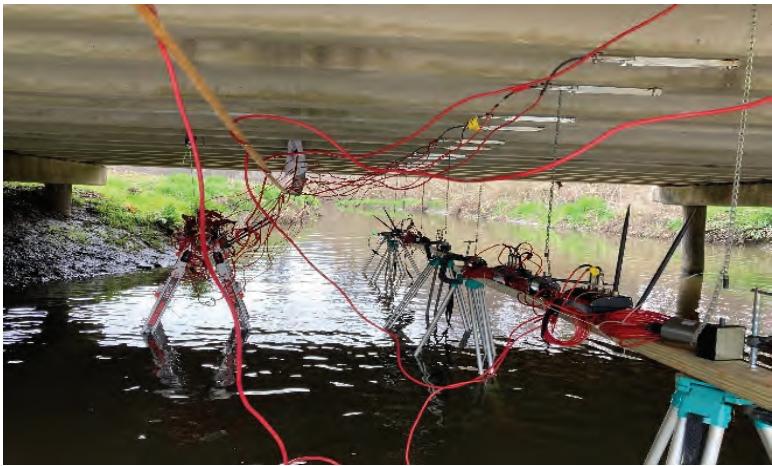
Figure 15: Wide-leg Channel Bridge Installed with Strain Gauge (Typ.)

The instrumentation used in phase 1 was used to measure the strain of each girder and use that information to calculate the live load distribution factors. To get the structure's response to live load, the mid-span of each girder was instrumented with a strain gauge under each channel leg, as shown in Figure 14 and Figure 15.

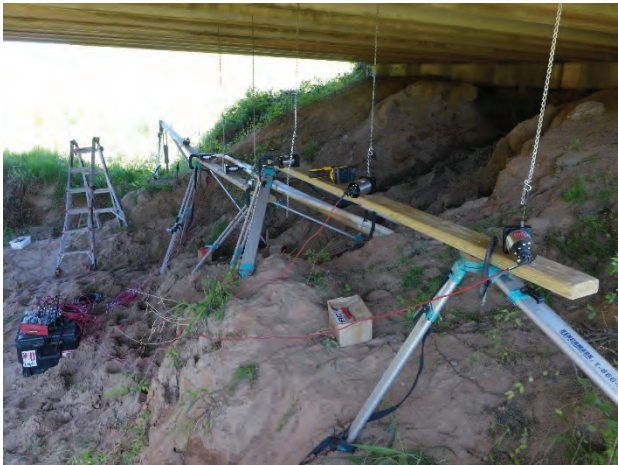
Figure 17: Wide-leg Channel Bridge Installed with Cable Potentiometer (Typ.)

The instrumentation used in phase 2 is designed to measure the displacement of girders which is then used to calculate the k-factors. To get the structure’s response to live load, the mid-span of each bridges was instrumented with a Cable Potentiometer under all interior beams, as shown in Figure 16 and Figure 17.

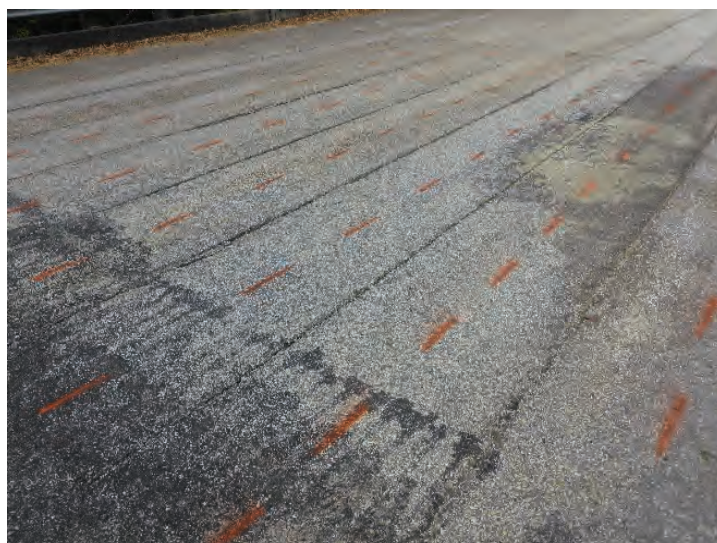
Figure 18: Temporary Marking Lines on the Bridge Deck

During testing, one person monitored the laptop and recorded data. A second person was responsible for guiding trucks onto assigned marks and coordinating with all team members (see Figure 19). During phase 1, each of the test cases were repeated twice to ensure the repeatability of results. Based on the width of the bridge and number of channels, 5 to 7 tests were run with 2 passes per test for a total of 10 to 14 tests per bridge. During phase 2, each test was repeated three times to ensure the repeatability of the results. Based again on the bridge width and number of channels, 4 to 6 tests were run with 3 passes per test for a total of 12 to 18 tests per bridge. The wheel path for each test is summarized in the next section.

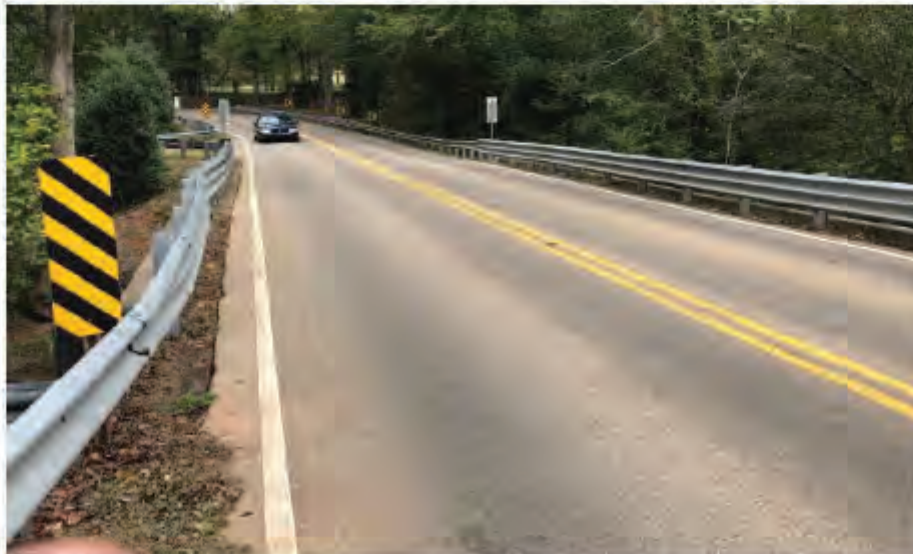
Reflective Cracking: None/Minor - DF - Follow AASHTO

Reflective Crack Condition	Tie Rod Condition	Recommended DF (Lane)
None/Minor	Good	Follow AASHTO
Moderate	Good	0.35
Severe	Good	0.5
Any Condition	Poor/Loose	0.5

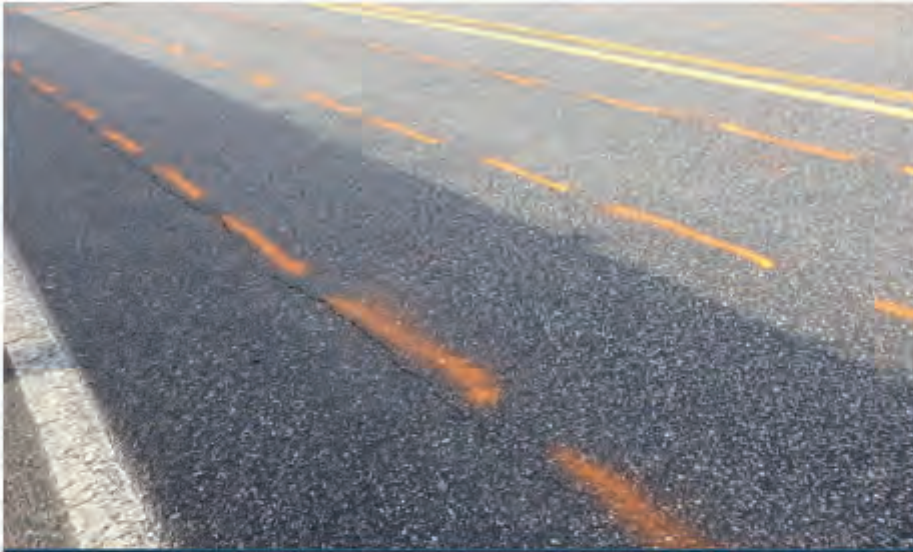
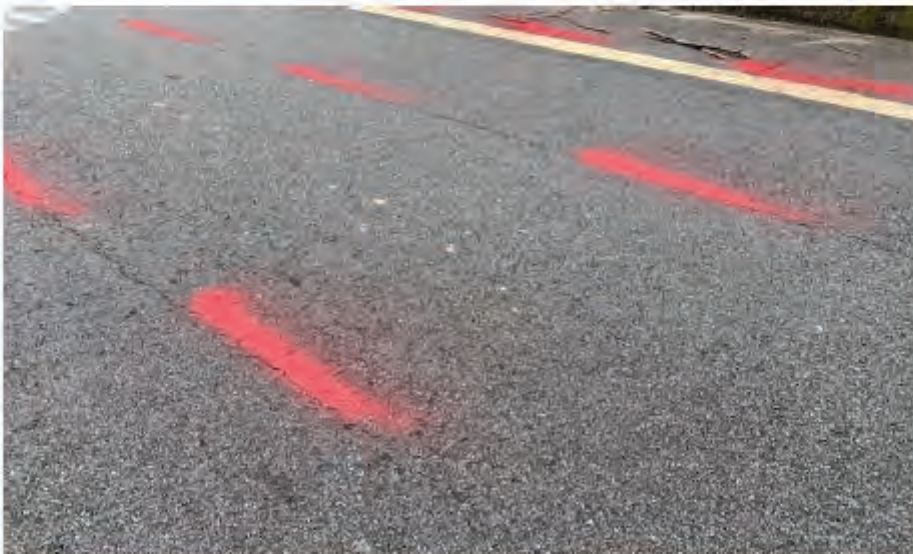
Reflective Cracking: Moderate - DF = 0.35 Lane

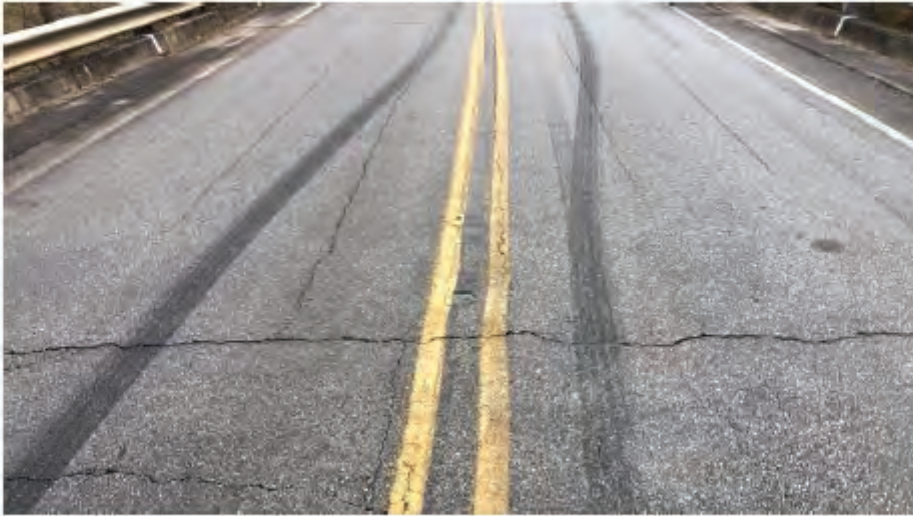
Reflective Cracking: Severe - DF = 0.5 Lane
